**REPORT ON THE
ROCK SLOPE FAILURE
AT CUT SLOPE 11NE-D/C7
ALONG SAU MAU PING ROAD
ON 4 DECEMBER 1997**

GEO REPORT No. 94

B.N. Leung, S.C. Leung & C.A.M. Franks

**GEOTECHNICAL ENGINEERING OFFICE
CIVIL ENGINEERING DEPARTMENT
THE GOVERNMENT OF THE HONG KONG
SPECIAL ADMINISTRATIVE REGION**

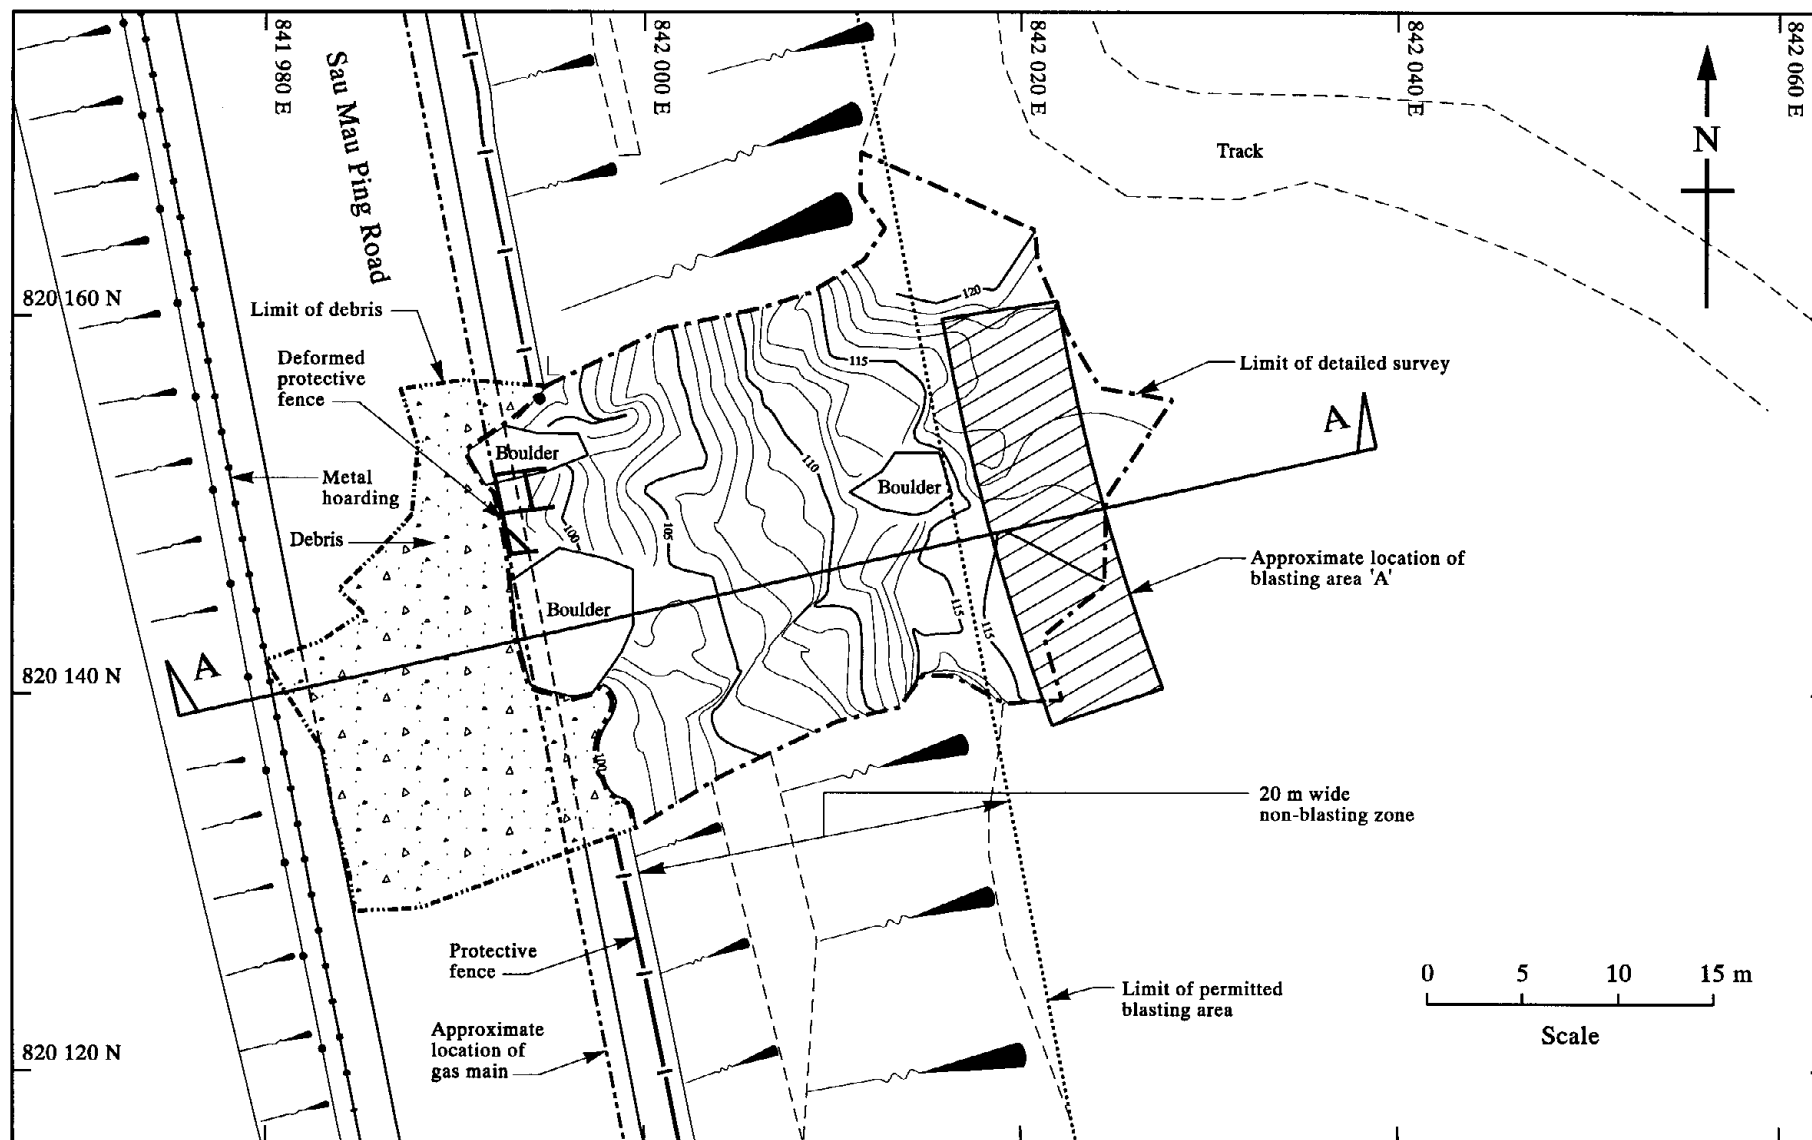
Figure 2 - Plan of the Failure

Figure 2 shows a plan of the failure and Figure 3 shows a cross section across the failure site.

Based on the assessed location of the Blasting Area 'A' as discussed in Section 4.3, the closest distance between the blastholes within this Area and the crest of the failed slope was found to be within 3 m (see Figures 2 and 3). At such a close distance, the surface of the failed slope facing west (i.e. towards the Sau Mau Ping Road) could have become another free face for the blast (in addition to the one at the back of the failed slope facing east), and the failure could have been triggered by the shock waves and gas pressures generated within the blastholes in the Blasting Area. No data on gas pressures were collected at this site. More importantly, the current state of knowledge does not permit any meaningful stability analysis of rock slopes subjected to near-field blast-induced gas pressures to be carried out. Therefore, no analysis of the failed slope subjected to gas pressures was undertaken. Nevertheless, an attempt had been made to estimate the cumulative displacement of the rock mass that moved down the slope along the shallow dipping failure surface (25° on average, see Section 8.2), assuming that it had been subjected to blast-induced ground vibration alone (see Appendix B). It was found that the cumulative displacement due to ground vibration alone could not have resulted in the complete detachment of the largest rock block from the slope.

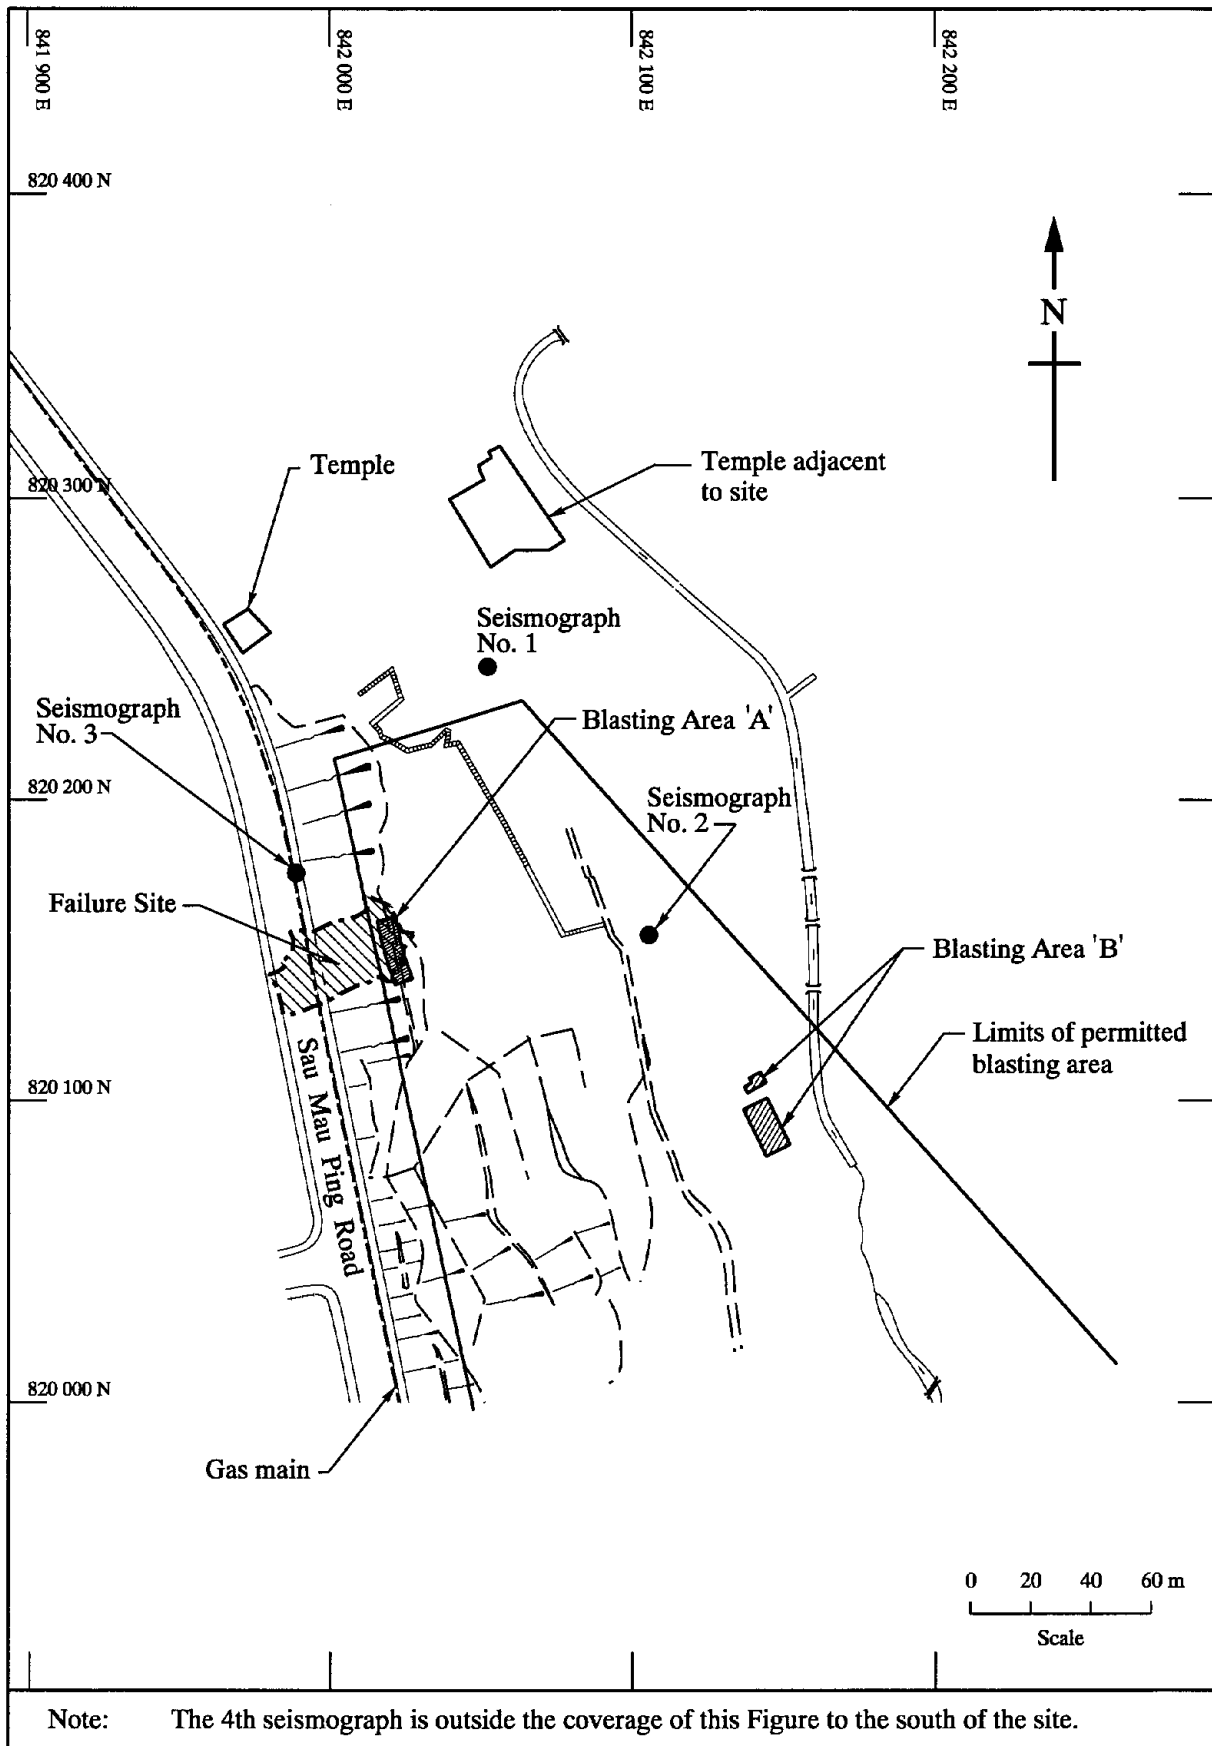
Figure 7 - Limits of Permitted Blasting Area

The failure took place immediately after blasting in Areas 'A' and 'B' which were fired almost simultaneously. An assessment has been made of the locations of Areas 'A' and 'B'. For Area 'A', the assessment relied on photographs taken both before (see Plates 7 and 8) and after the incident, the interim record survey plan dated 29.11.97 provided by the Resident Engineer (see Figure 9), site inspections made before and after clearing up of the failure debris as well as interviews with the shotfirer. Plate 7 which was a progress photograph taken by the Resident Site Staff in the morning on the day of the failure (i.e. 4.12.97) shows a view of the relevant part of the site before the failure, and Plate 8 is an enlarged part of Plate 7 giving a close-up view of the crest and the cut face at the back of the failed slope. From Plate 8, holes can be seen to have been drilled close to the crest of the failed slope. It had subsequently been confirmed by the shotfirer that the Blasting Area 'A' was at the location of these drillholes. The assessed locations of Areas 'A' and 'B' are shown in Figure 7 (see also Figures 2, 3 and 9 for location of Blasting Area 'A').

Vibration monitoring was carried out by the Contractor using seismographs at four locations in the vicinity of the site during the blasting event. The two seismographs (Seismographs No. 2 and No. 3, see Figure 7) nearest to the failed slope registered a ground

vibration duration of about 1.8 seconds during the event, and Seismograph No.2, at a distance 80 m away from Blasting Area 'A', recorded a maximum peak particle velocity of 10.6 mm/s. Table 5 summarizes the peak particle velocities recorded by the seismographs. However, no detailed records of acceleration/velocity-time history were available, and no monitoring was carried out at the subject failed slope.

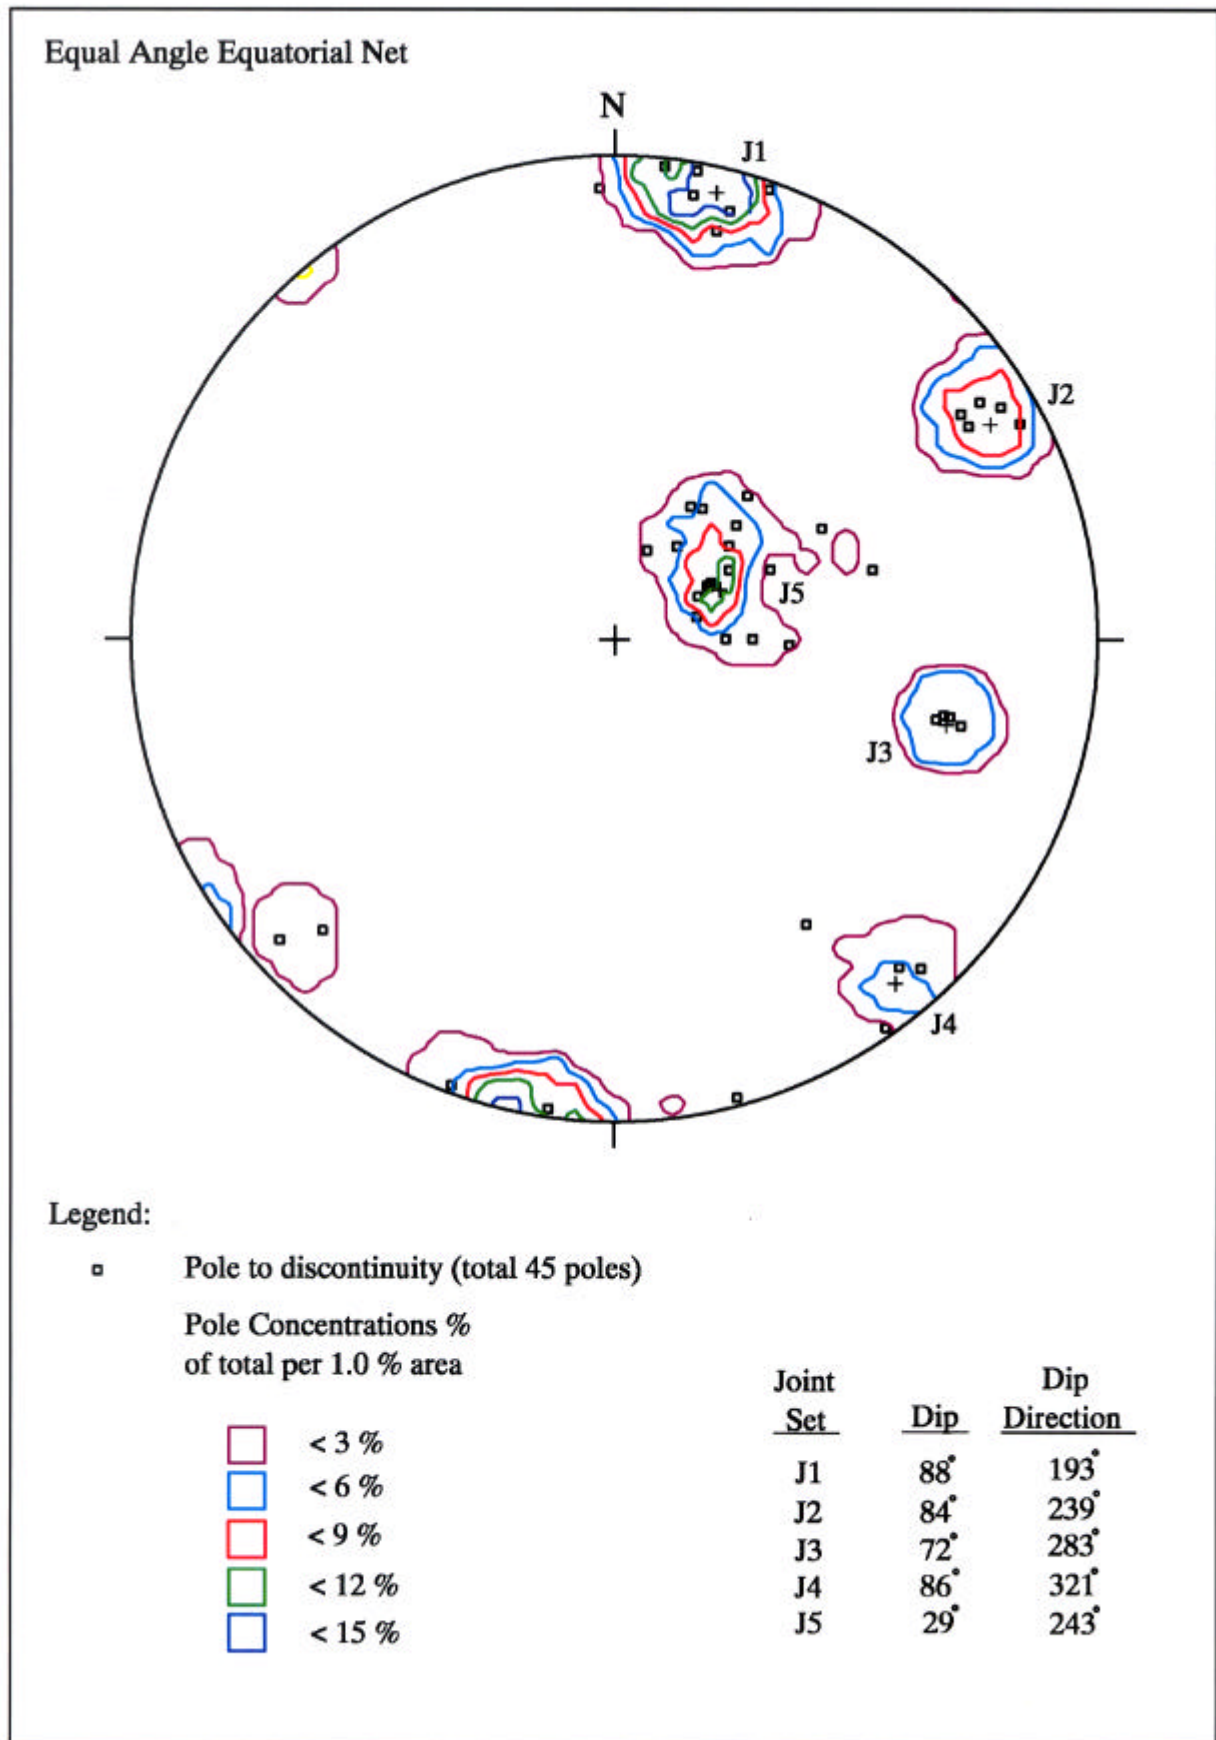
Figure 12 - Stereoplot of Poles to Joints at the Failure Site

Rock joint surveys were carried out at the site after the failure. A total of 45 joint orientation measurements were taken at the site, and the results are shown on the stereographic projection in Figure 12. Joint infills, roughness and weathering state were also noted. As can be seen from the stereographic projection and based on field observations, five major joint sets, J1 to J5, could be identified. Four of the joint sets, J1 to J4, are sub-vertical, and generally widely spaced, and the joint set J5 is very widely spaced and dipping at a low angle. Most of these joint sets are persistent. The characteristics of these joint sets are summarised in Table 6. The major joint sets identified were generally consistent with those given in the geotechnical design report prepared for the site formation works by the consultants to the HKHA (OAP, 1994).

The most dominant joint sets at the failure site are joint sets J1, J4 and J5 with mean orientations of 88°/193°, 86°/321°, 29°/243° respectively. Joint sets J2 and J3 are less well developed and have mean orientations of 84°/239° and 72°/283° respectively. Although these two joint sets are less well developed, they could form a potential release surface to the back scarp of the landslide.

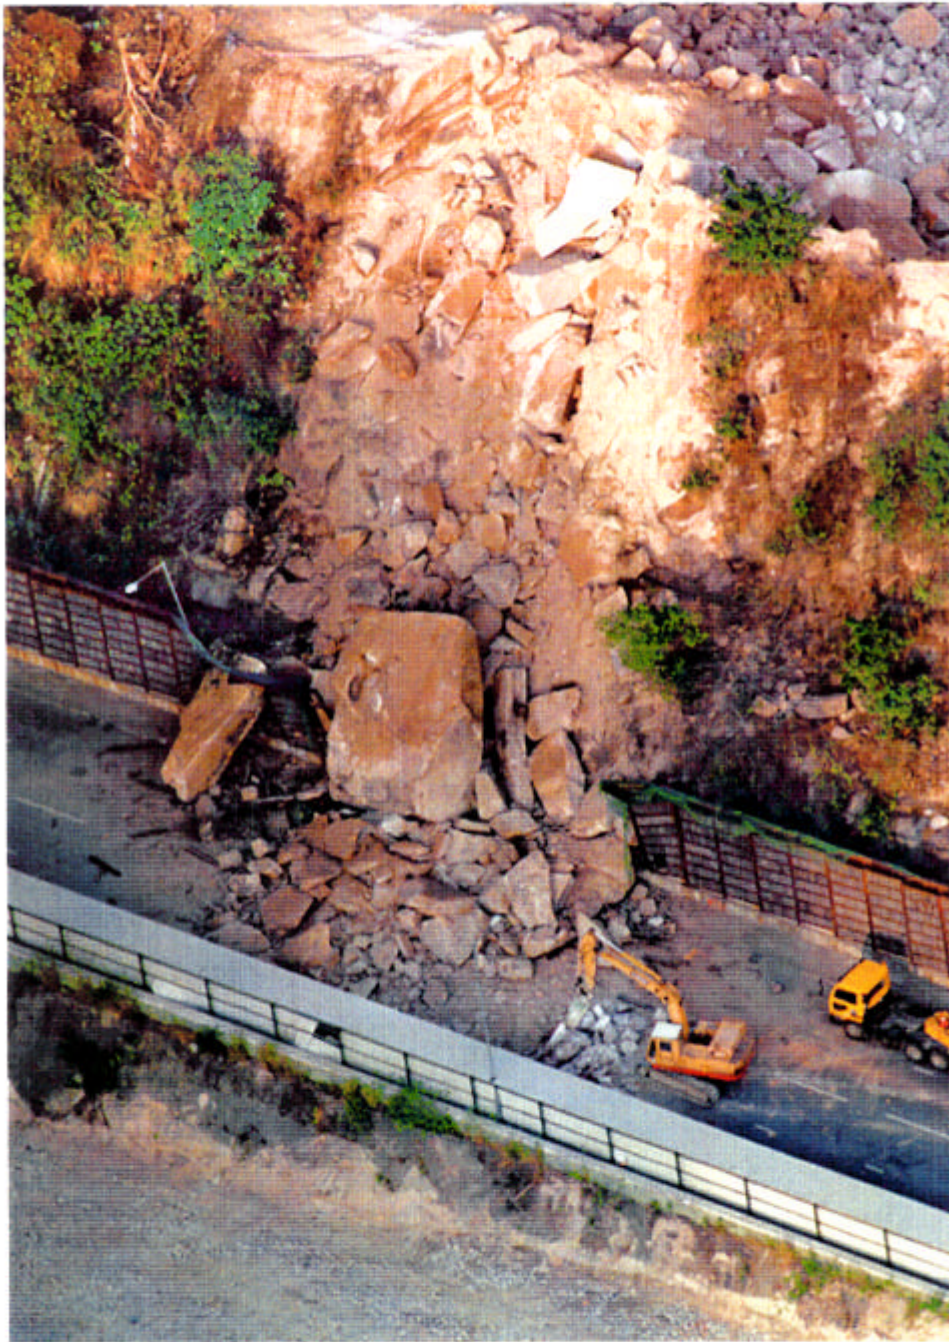
Around 2:20 p.m. on 4 December 1997, a rock slope along Sau Mau Ping Road failed (see Figure 1 and Plate 1). The rock slope was the lower part of a cut slope of reference 11NE-D/C7, the top portion of which had been removed under an ongoing Hong Kong Housing Authority (HKHA) site formation contract.

Plate 1 - Aerial View of the Failure Taken on 4.12.97 Shortly after the Failure
(Reproduced from Sing Pao dated 5.12.97)

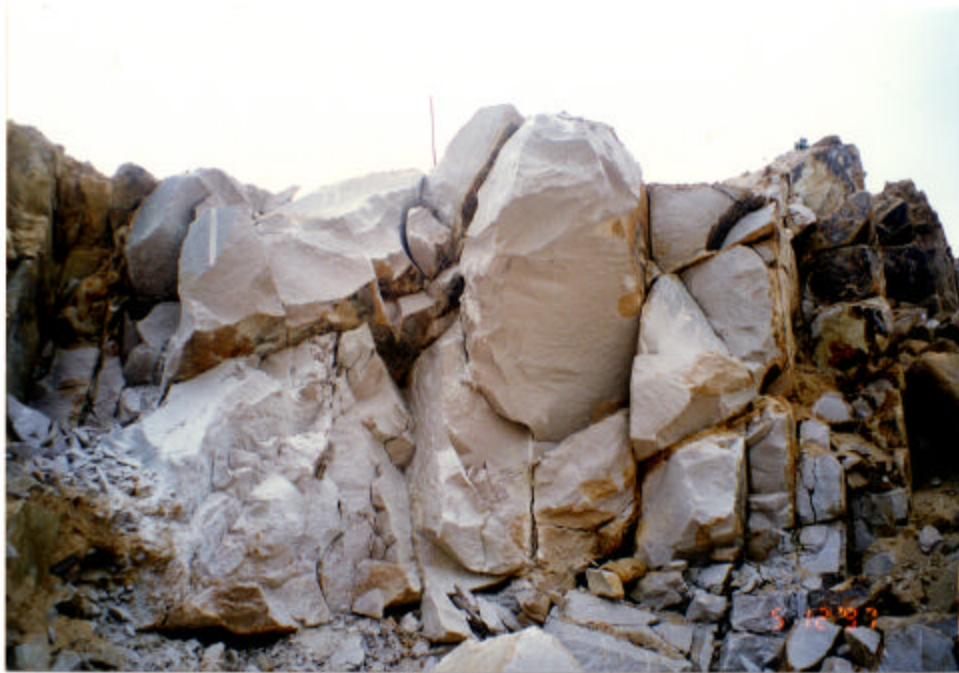
Negative No : SP 9710/C13

The failed rock slope was about 25 m high with a berm at a level of about 6 to 7 m above the road. The failure mainly originated from the upper part of the slope. The volume of the failure was about 1 000 m³. Although the failure debris was scattered along the bottom of the slope covering the road surface, soil and individual pieces of rock could be seen covering the entire slope face. The debris contained a number of very large and smaller angular blocks of rock of predominantly moderately to slightly decomposed medium-grained granite, completely decomposed locally. Blasting damage to the rock material and opening up of rock joints were generally observed on rock faces found in the vicinity of the failure site (see Plate 2).

Blast-induced rock fractures and joint openings could be seen on the excavated rock faces around the failure site (see Plate 2). Blasting which had taken place progressively around and towards the failure site might have resulted in progressive deterioration of the stability of the slopes. However, as the locations of the blast areas were not accurately surveyed, the blasting history of the areas around the failure site cannot be known with certainty and its effects on the stability of the failed slope cannot be quantified.

Plate 2 - Blast Damages Observed in the Vicinity of the Failed Site

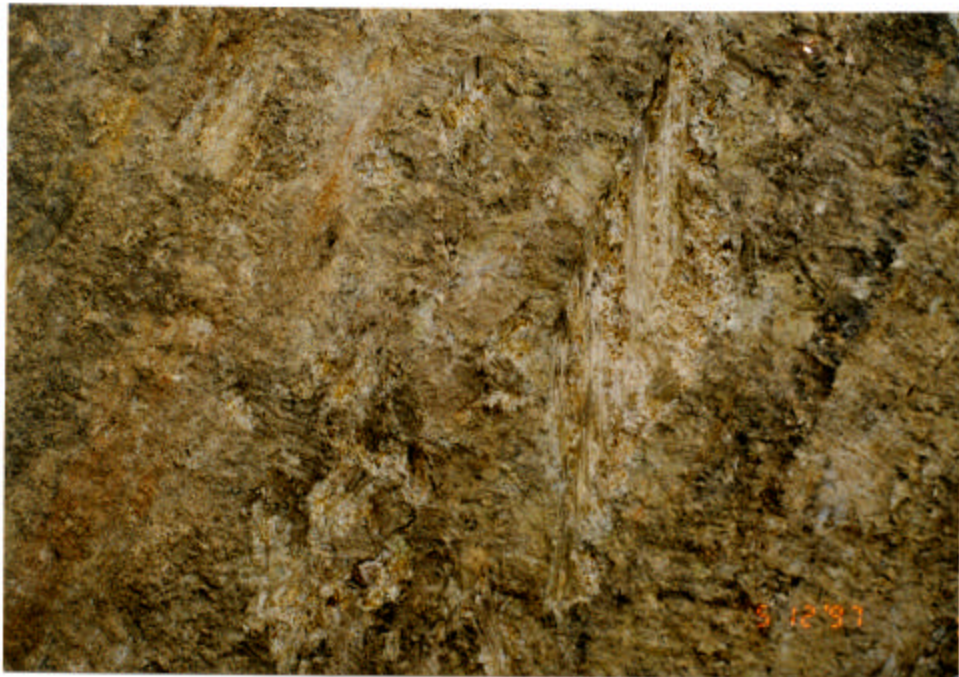
Negative No : SP 9710/C23

The largest block of rock was about 150 m³. As no signs of rolling were observed for this block and due to its non-circular shape, it is considered to have failed by sliding down the slope. The block rested partly against the lower unfailed portion of the slope and partly on the road, leaving a void underneath its base. Observations of the sub-vertical face of this rock block revealed extensive slickensiding on the joint infill material (Plate 3). This sub-vertical joint face had an apparent orientation of about 86°/190° and is considered to be part of joint set J1 (see Section 8.2).

Plate 3 - Slickensiding Observed on the Sub-vertical Face
of the Largest Block of Rock

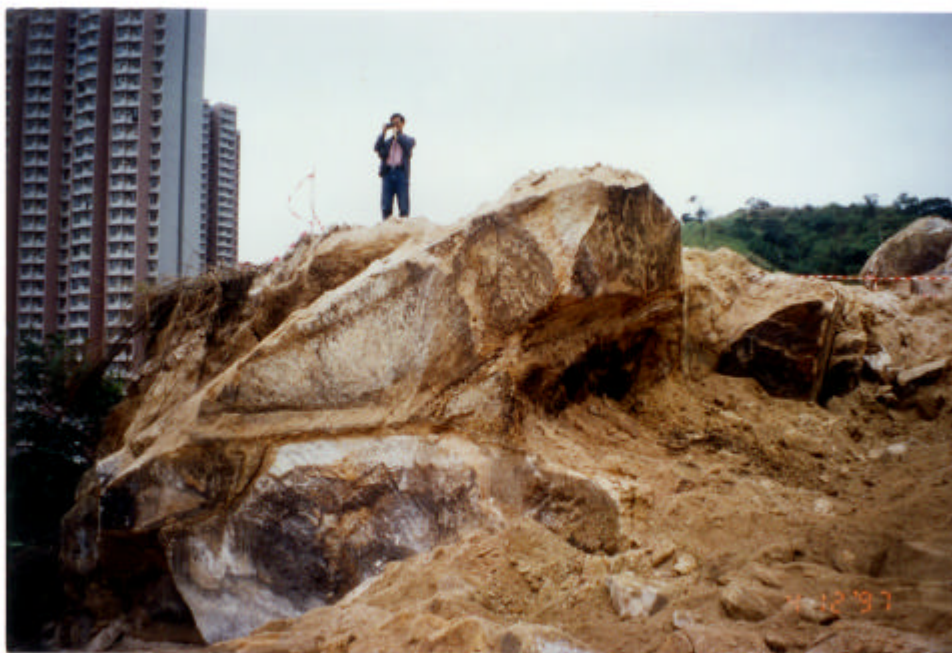
Negative No : SP 97105/99

Inspection of the failed slope indicated that it is formed in partially weathered fine- to medium-grained granite. The lateral boundaries of the failure are constrained by sub-vertical joints striking E-W, i.e. approximately perpendicular to the slope face. Sub-vertical joints, widely spaced and of very high persistence (mostly > 6 m and up to 10 m for some joints), which strike generally in the dip direction of the slope can be seen exposed at the top of the slope bounding the northern and southern ends of the failure (see Plates 4 and 5). Judging from the disposition of the largest block of rock which came down the slope, this block was bounded on its two sides by the sub-vertical joints observed.

Plate 4 - View of the Sub-vertical and Very High Persistence Rock Joint Bounding the Northern End of the Failure

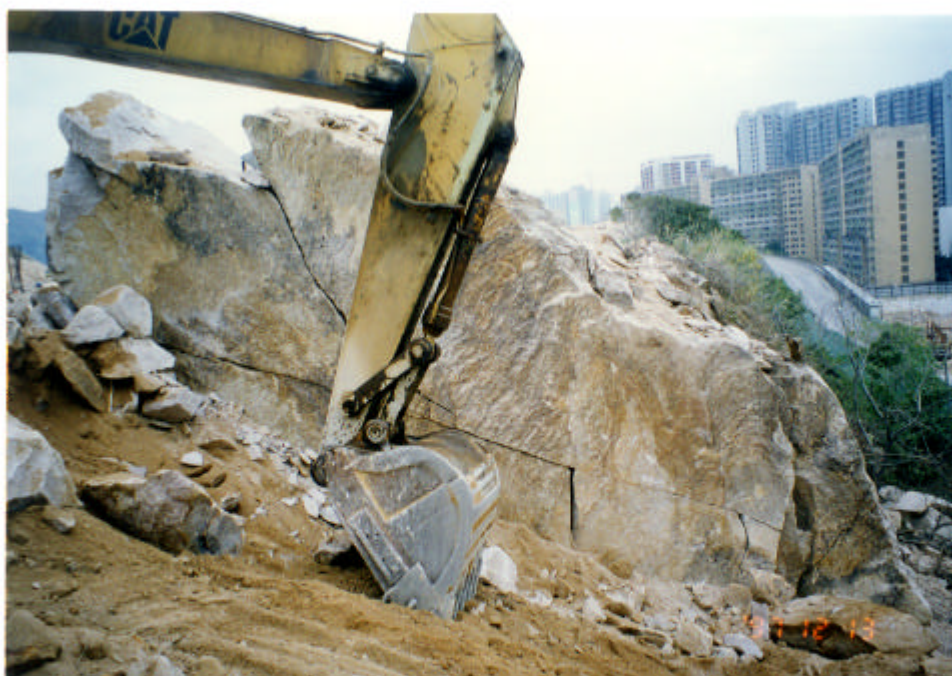
Negative No : SP 97106/9

Plate 5 - View of the Sub-vertical and Very High Persistence Rock Joint Bounding the Southern End of the Failure

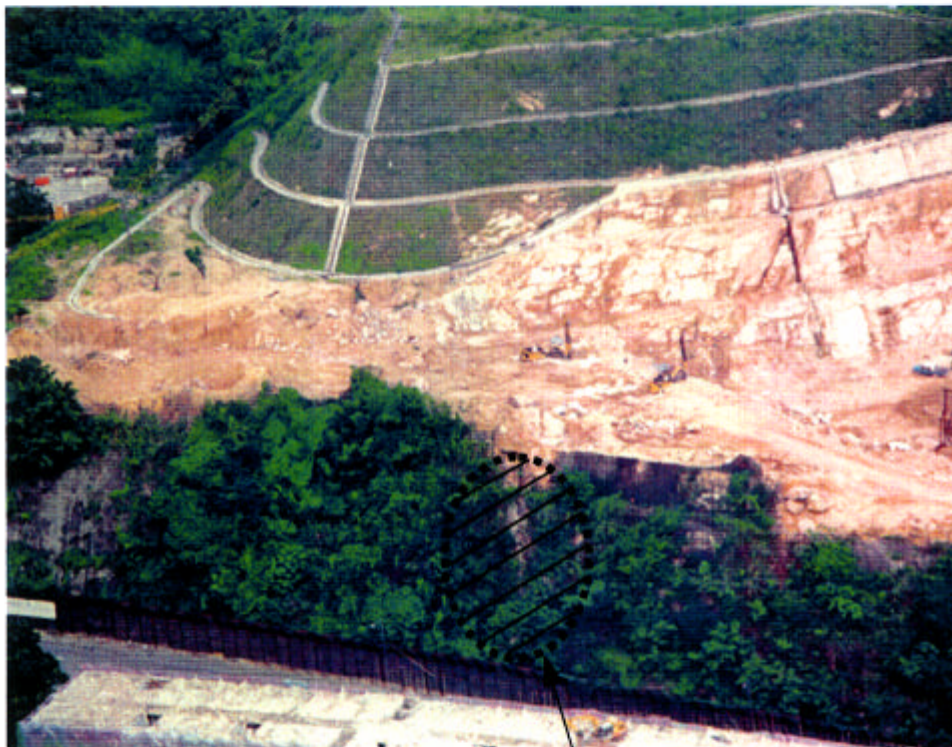
Plate 6 shows the appearance of the site about three months before the failure.

Plate 6 - View of the Failure Site about Three Months before the Failure
(Photograph Taken on 11.9.97 by Resident Site Staff)

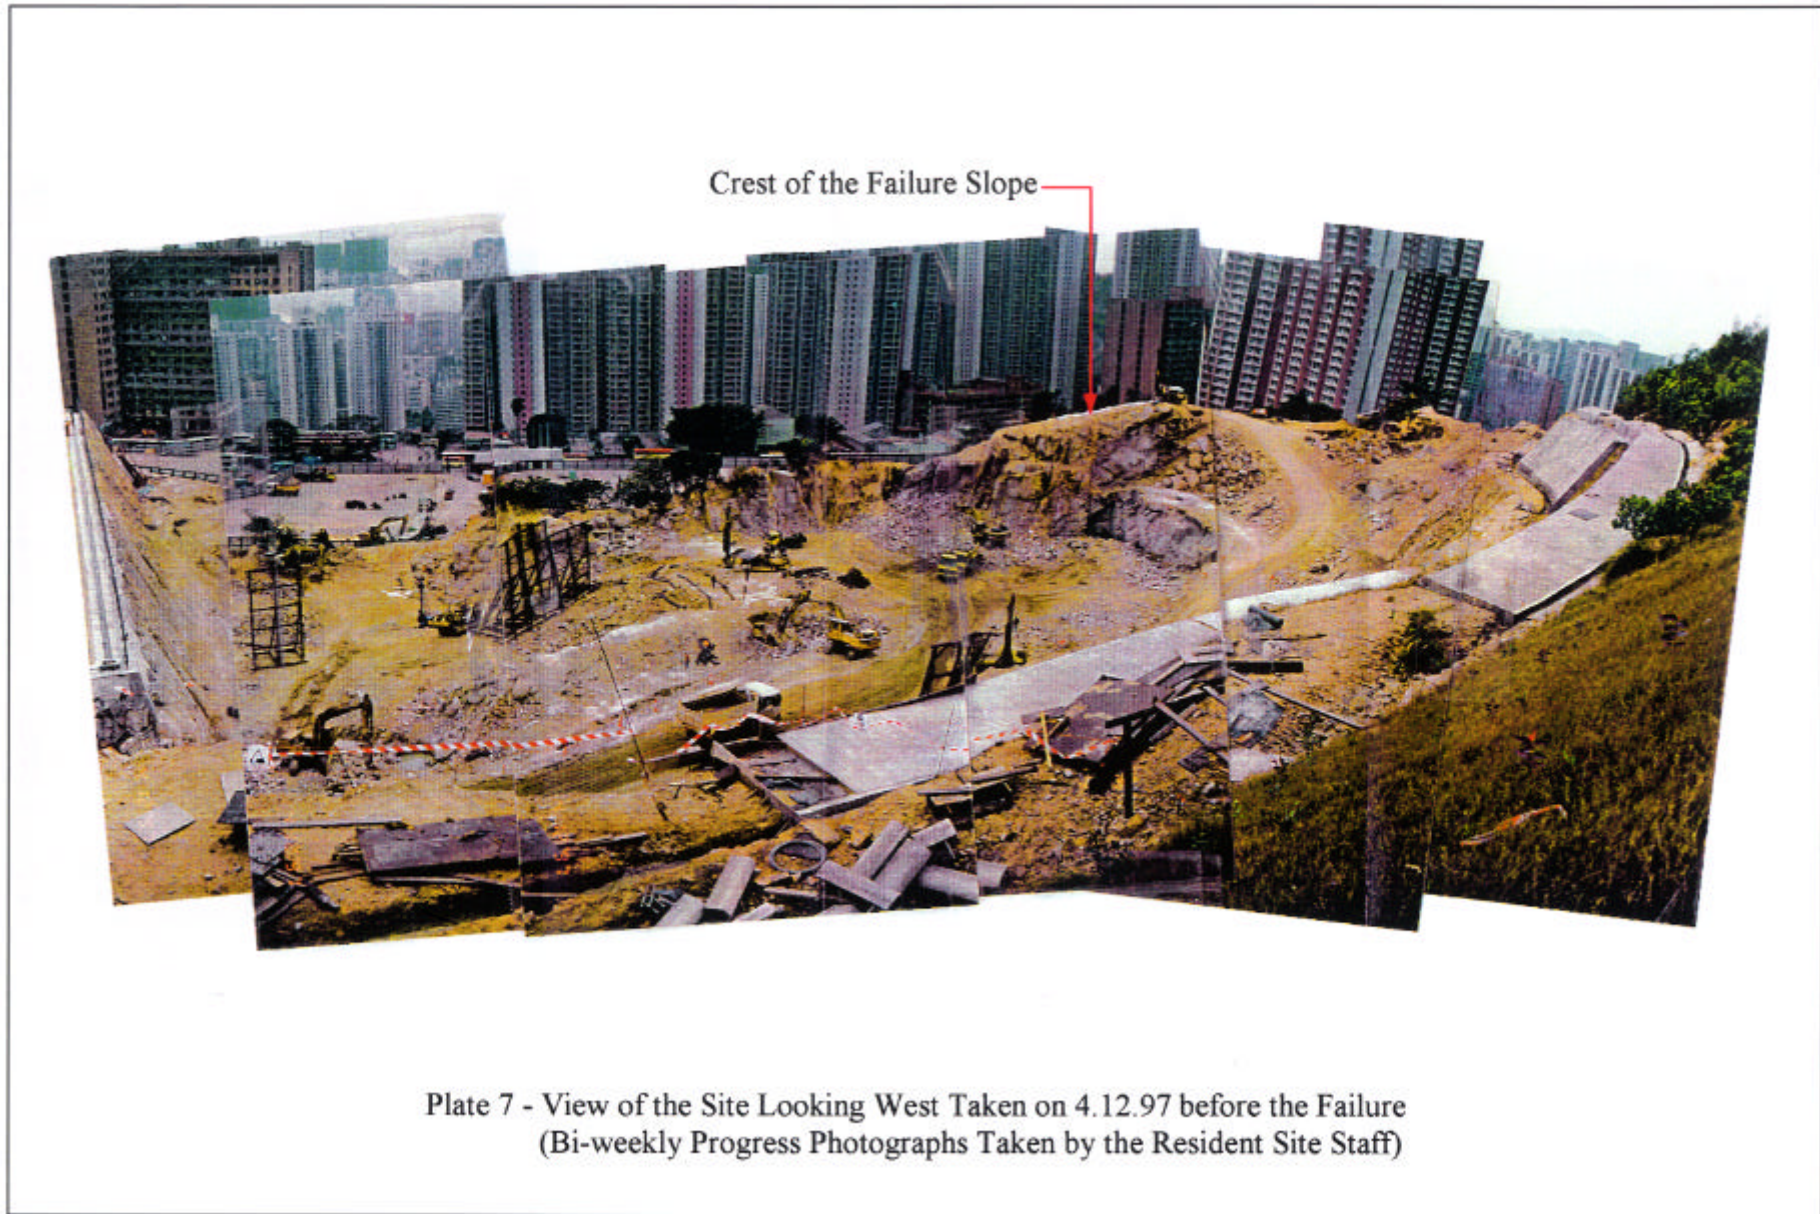
Plate 7 - View of the Site Looking West Taken on 4.12.97 before the Failure
(Bi-weekly Progress Photographs Taken by the Resident Site Staff)

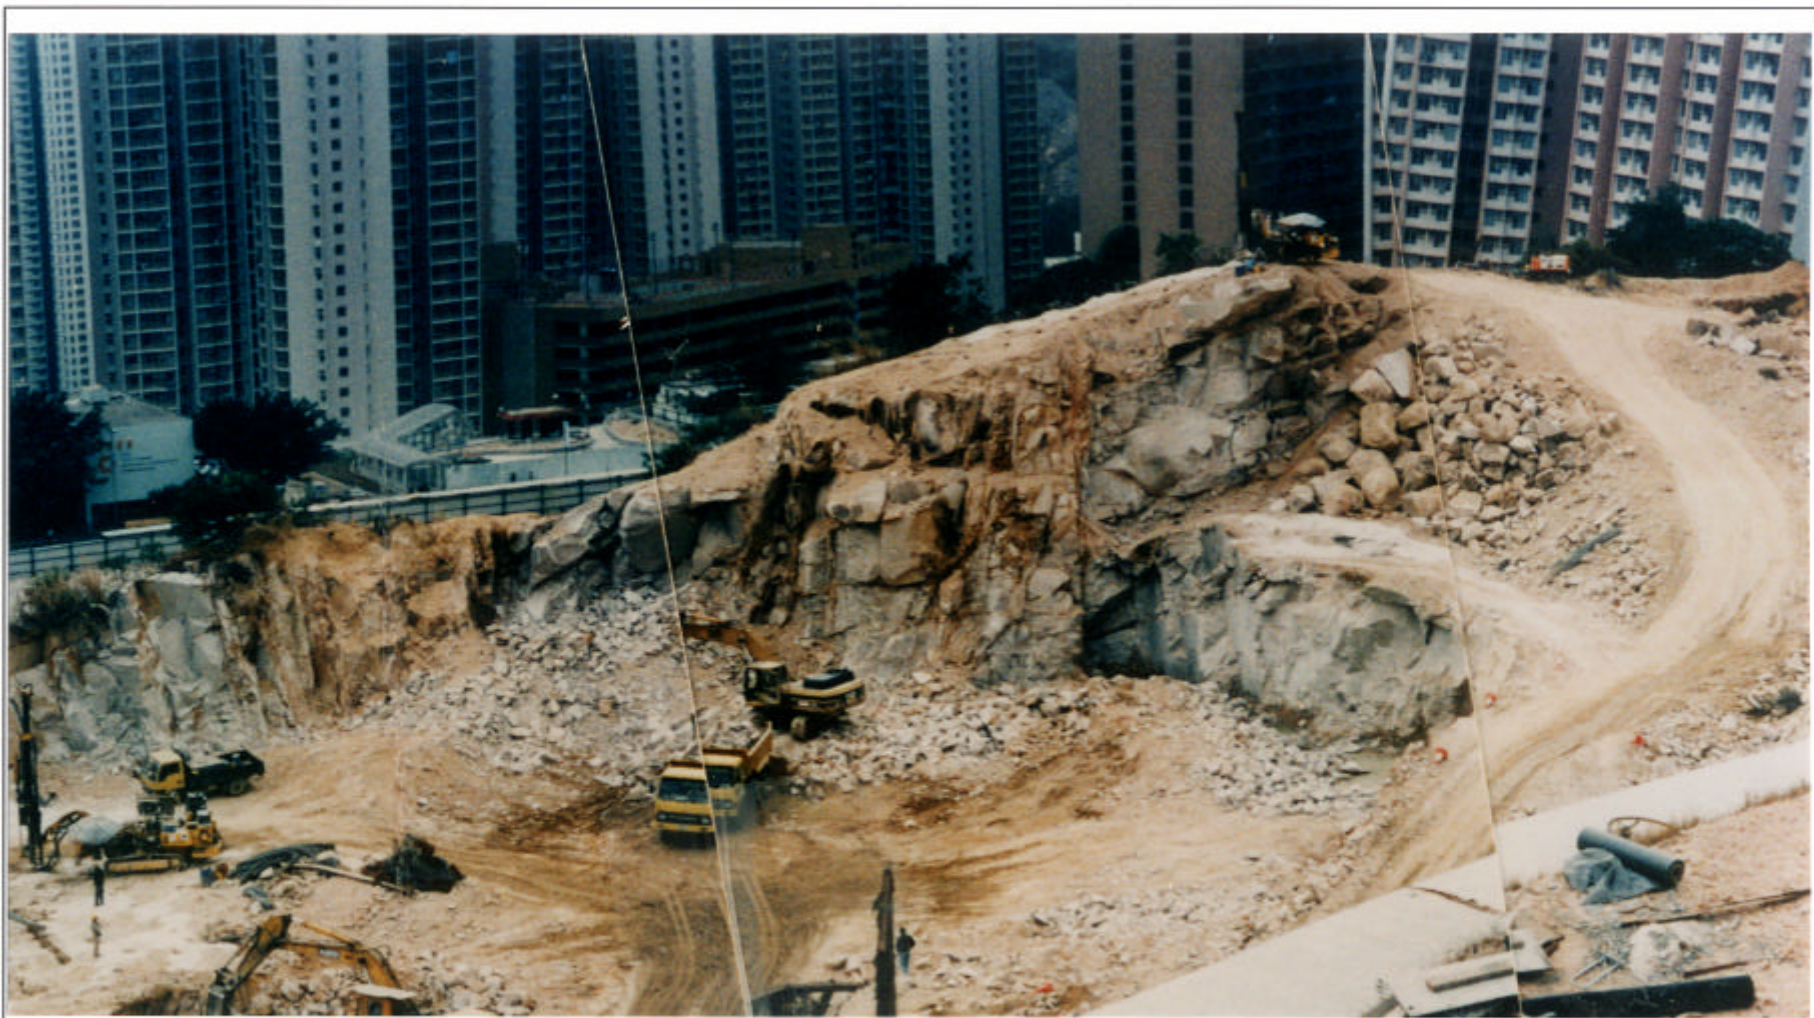
Plate 8 - An Enlarged View of the Crest and the Cut Face at the Back of the Failed Slope before the Failure
(Extracted and Enlarged from Plate 7)

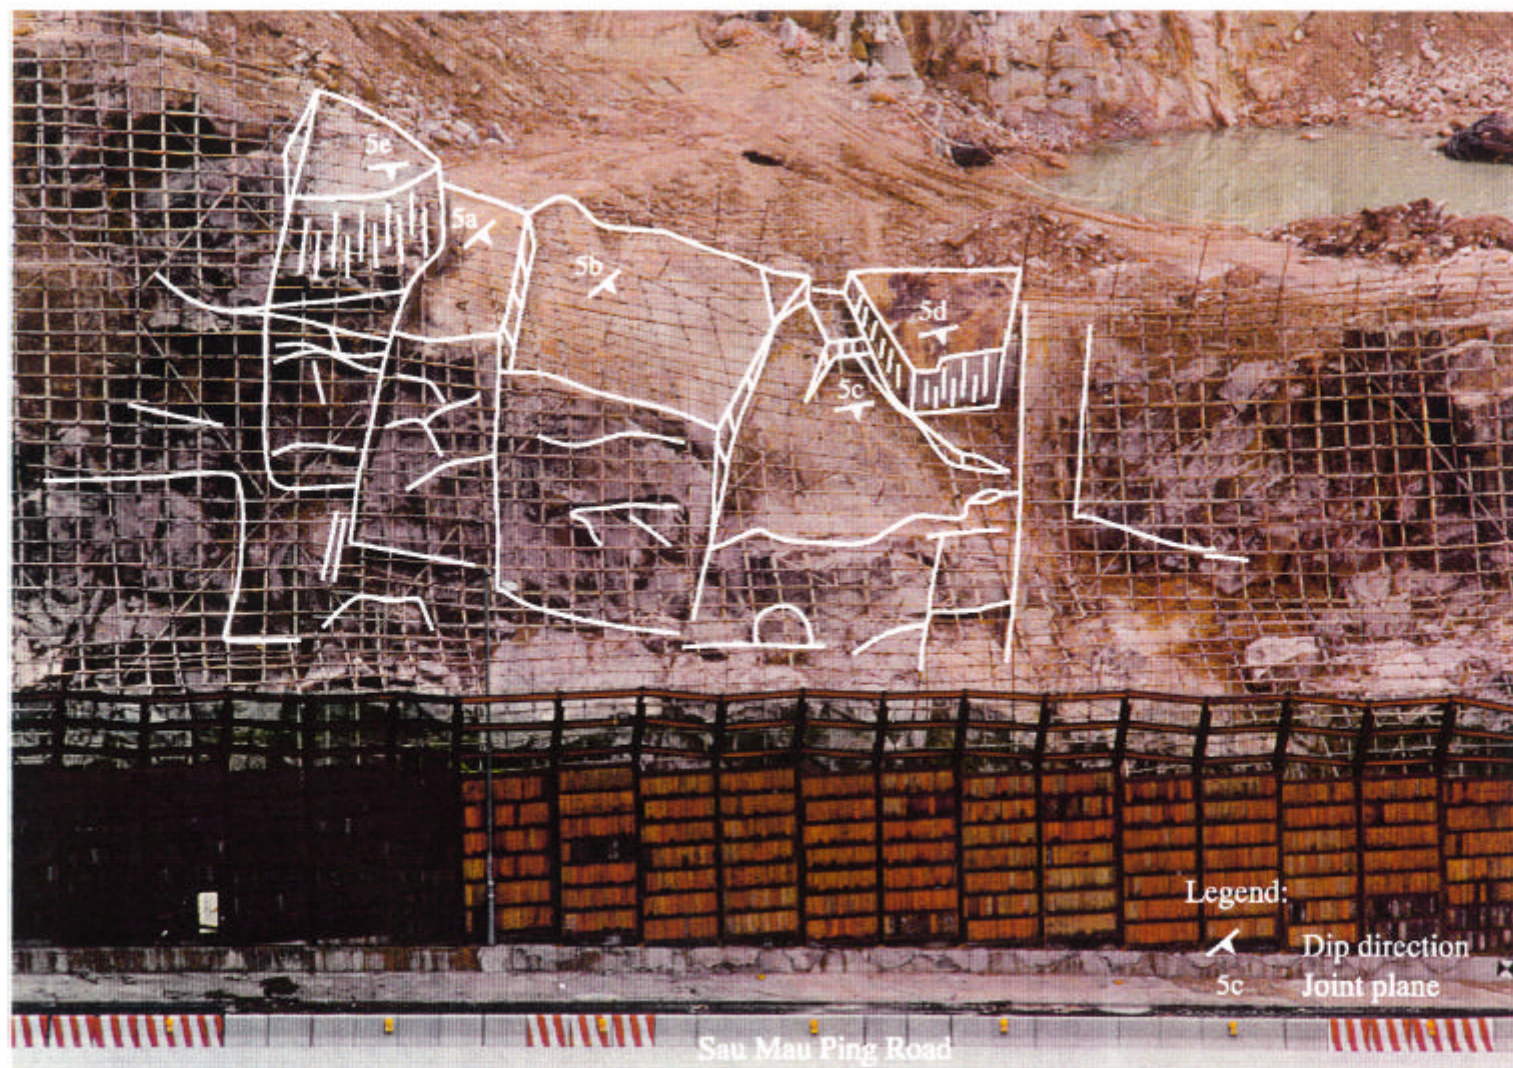
After the clearing up of the failure debris from the failed slope, five persistent joint surfaces were exposed dipping at an average angle ranging from 16° to 29° in a direction (bearing in the range of 215° to 252°) towards the Sau Mau Ping Road. These joint surfaces, annotated as J5a to J5e (see Plate 9), belong to the joint set J5 and are considered to be the surfaces along which the failure took place. Joint surface J5c, which has an average dip angle of 25° , is considered to be the most likely failure surface along which the largest block of rock slid.

Plate 9 - View of the Site Following Removal of Failure Debris
