APPENDIX A  
AERIAL PHOTOGRAPH INTERPRETATION

## A.1 SUMMARY

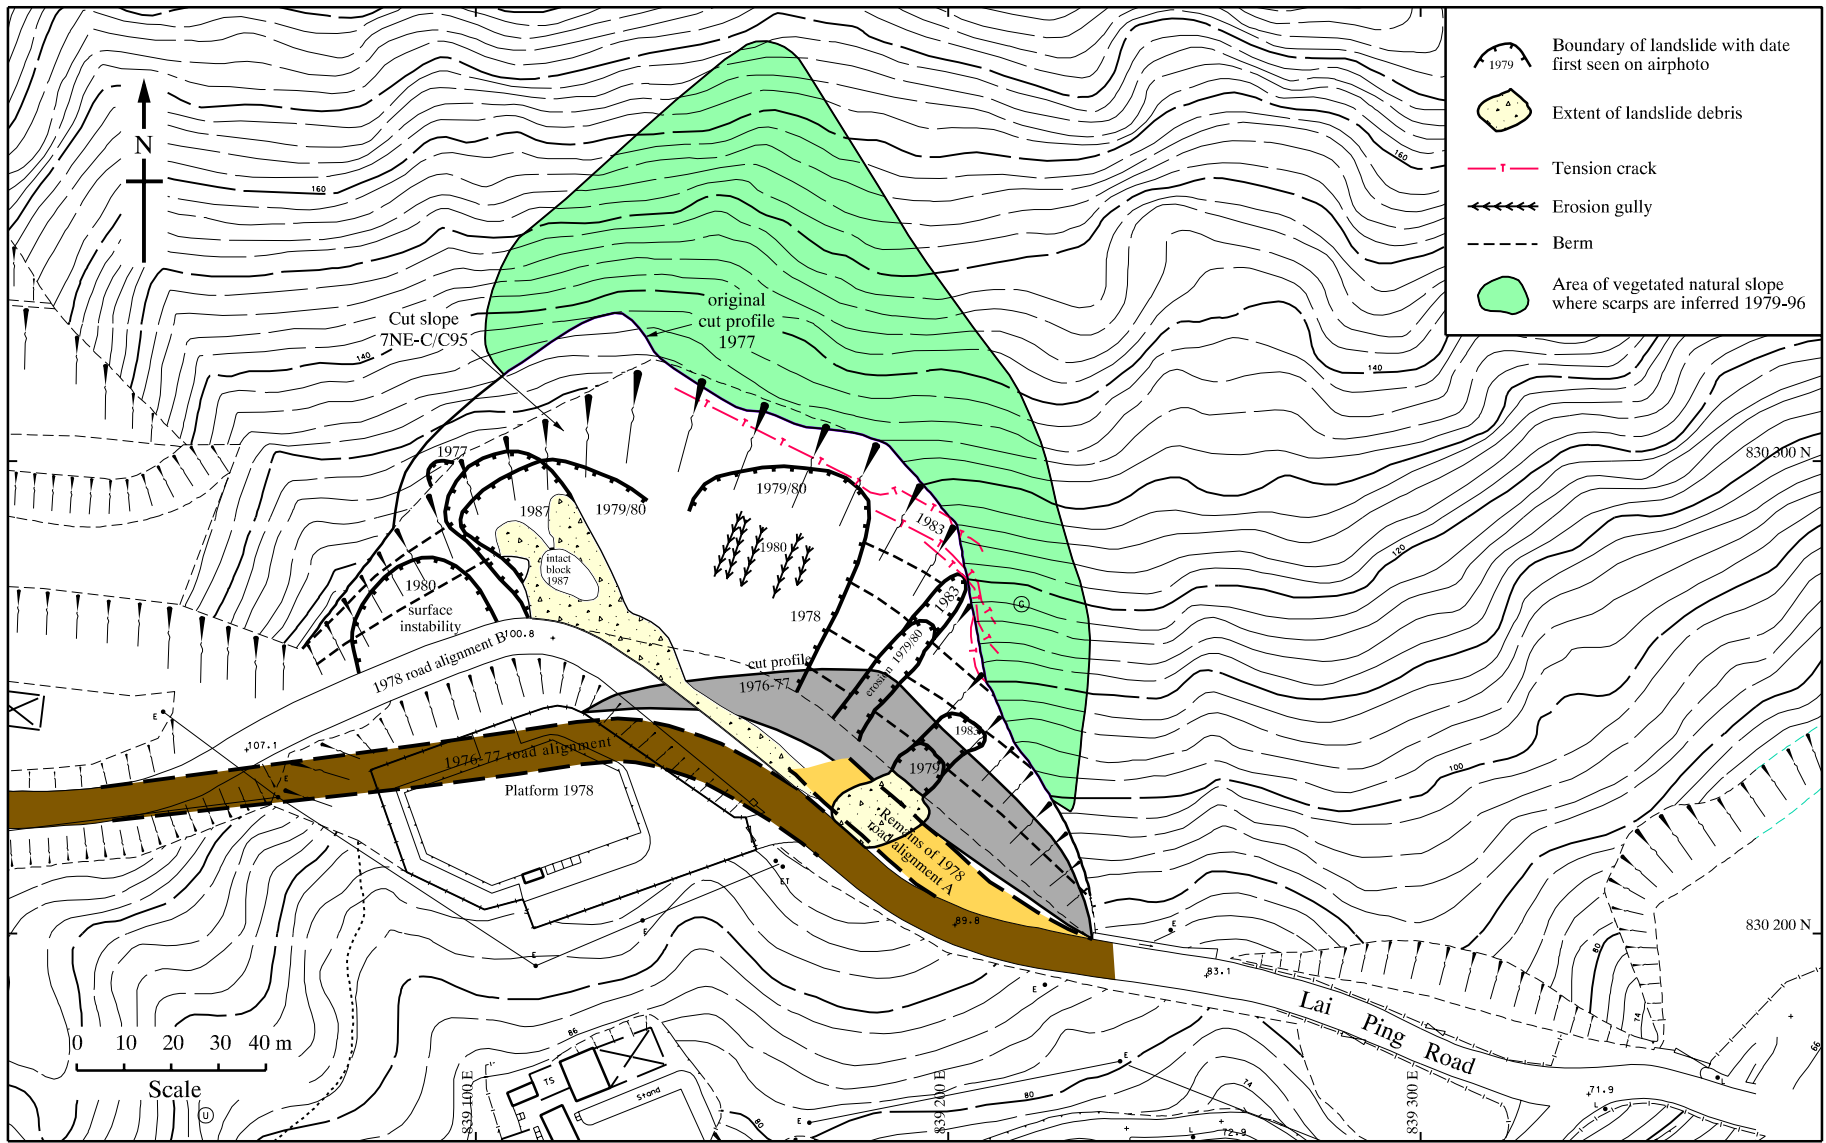
Figure A1 - Aerial Photograph Interpretation of Slope 7NE-C/C95

- (h) 15.12.1978 The slope excavation has been completed. However, there appears to have been a large failure in its central portion although the northern and western limits of this failure are hard to establish precisely. A cut and fill platform has been constructed on the southwest side of the slope and the route of the haul road has been realigned to its present route. The road is constructed in part along a ramp, and is northeast of its previous alignment, thus avoiding the platform (Figure A1) and nearer the base of the slope. However, yet closer to the slope at its eastern end, there appear to be the remains of an earlier ramp suggesting an earlier road alignment. The ramp extends northwest as far as the approximate location of the slope failure, suggesting that the ramp may originally have continued further along the base of the slope but was damaged by the slope failure and abandoned and removed. The bottom half of the eastern side of the slope appears darker (some chunam or grass protection?) in tone, and three horizontal berms with drainage channels and batters have been formed (Figure A1). The possible failure scar seen on the 1977 photographs appears slightly larger.

- (i) 29.11.1979 A small failure has occurred in the approximate centre of the bottom batter at the eastern side of the slope (Figure A1). A slip/erosion of the eastern slope face also appears to have occurred, cutting vertically through the berms and drainage channels. Large scars are evident in the central and western parts of the slope. Intact berms/batters on the western side of the slope help to identify the western limit of the failure. On the natural slope above the cut slope there are paths converging on a possible drill site in the east. In addition, there appear to be some areas of disturbance of the vegetation that could reflect the development of scarps.

- (j) 18.6.1980 Failures across the central part of the slope face, seen on the 1979 aerial photographs, are more prominent. There is also evidence of severe erosion, probably increasing the depth of the failure scars. There does not appear to be much debris at the base of the slope (Figure A1). The upper eastern and lower eastern

- (m) 22.12.1983 The small failure on the eastern side has advanced up to the top of the second batter, but has not really increased in width. Two open fractures have developed across part of the top of the cut slope, above and further to the east of the central/eastern slip/erosion scar (Figure A1). These are interpreted as tension cracks. Some re-vegetation of the lower parts of the central slip/erosion scars is evident.

- (y) 6.12.1993 Further instability/erosion? across the central western scar clearing away the vegetation. The eastern side erosion which had split the part of the slope with berms in 1979 (Figure A1) has also moved further up slope (another possible slip scar) to the edge of the original cut. The tension cracks are still visible. Construction of the service reservoir south of Lai Ping Road has commenced.

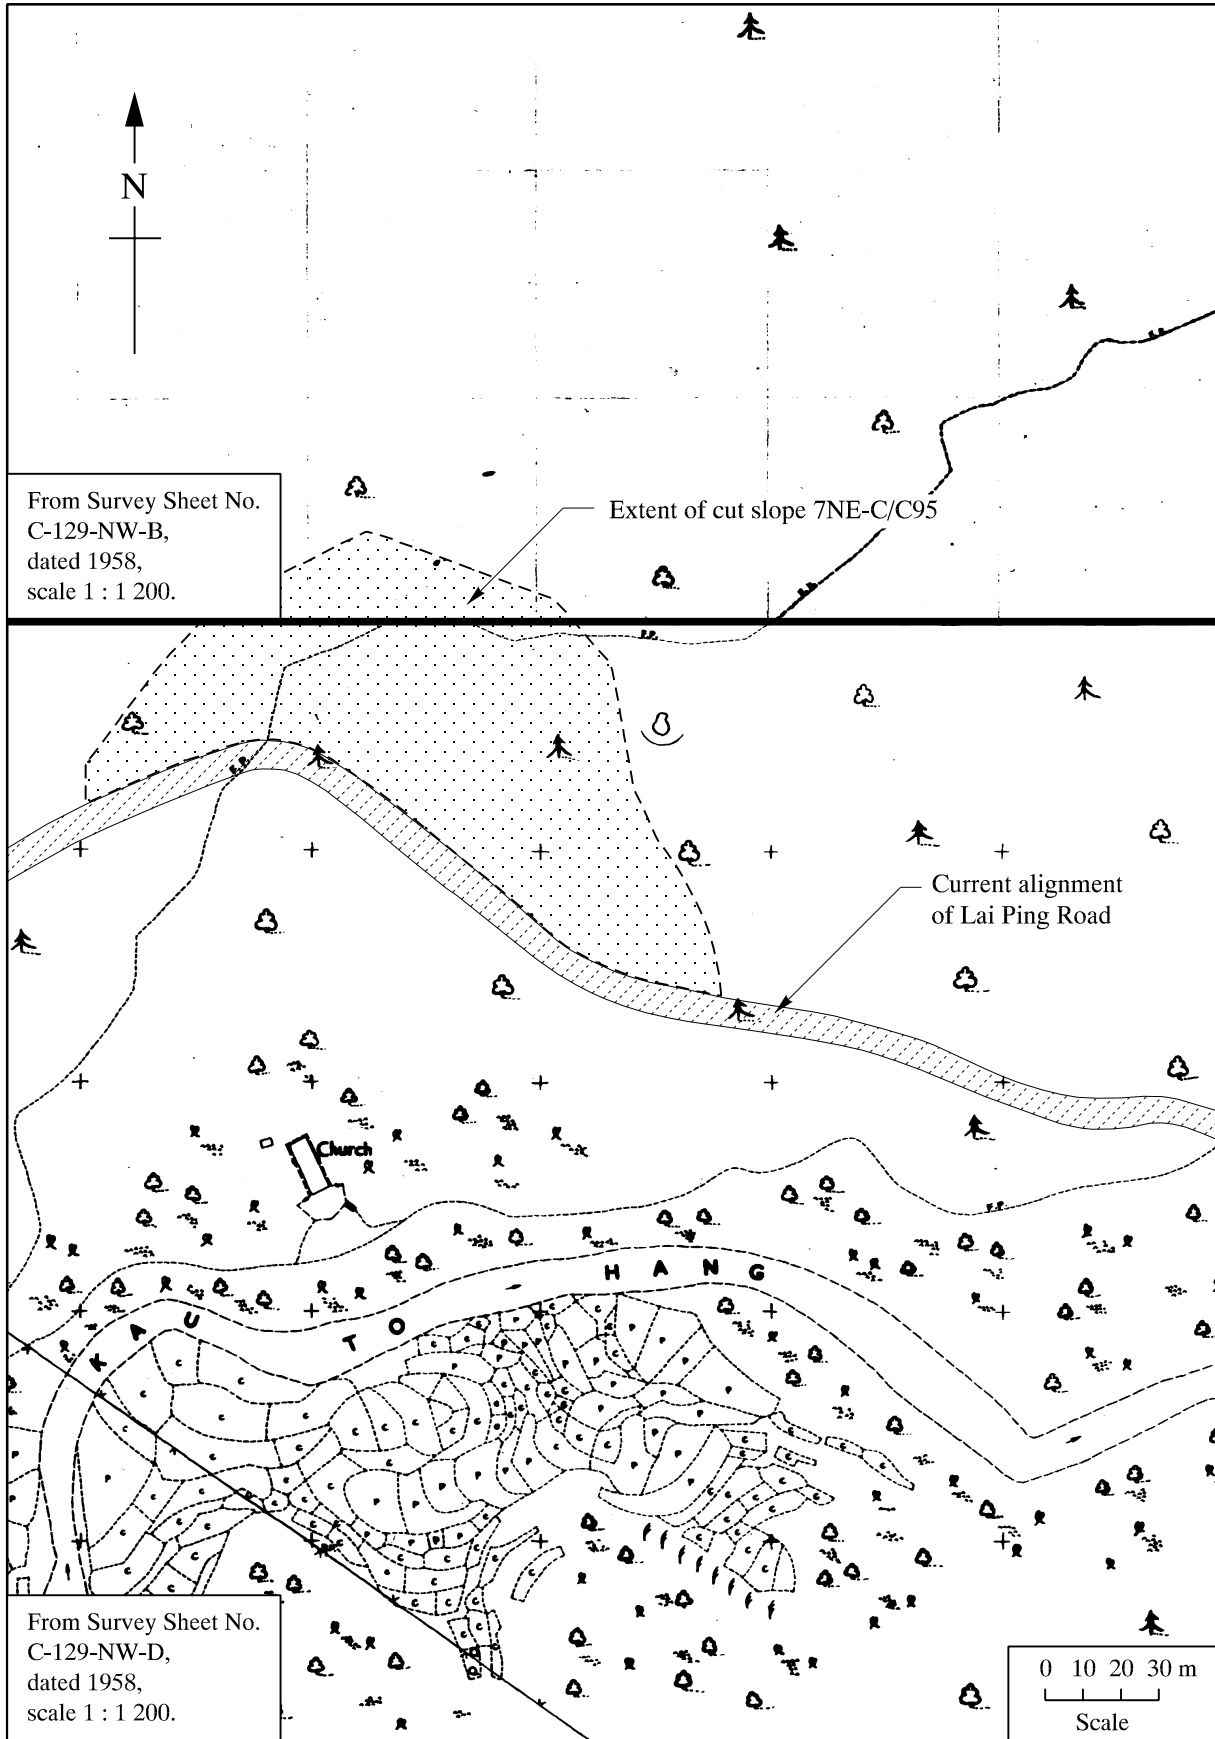
Figure B1 - Topographic Maps (1958)

Year	Figure No.	Observation
1958	B1	This, the earliest available map, is at a scale of 1:1 200. The site area was shown as woodland. A church building is shown north of a stream, which is called Kau To Hang. A footpath runs from east to west and leads to a church and Kau To Village further west of the site. From Kau To Village, a footpath is shown leading north to the hill. A grave is shown at north east of the site.
1966	Not Shown	There is practically no difference from the 1958 map.
1969	B2	The site of the church building was extended. This involved cutting into the hillside and filling in front. A school building, a latrine and a ruined building are shown in the church compound. The footpath, running east-west to the front of the church complex, appears to have been widened from the west until within about 60 m of the church complex. This footpath is marked 'Occupational Road' and a turning bay has been built at the end of it. The road has also been constructed with culverts where the road intercepts the valleys. The footpath leading uphill to the north, and the grave, appear as before.

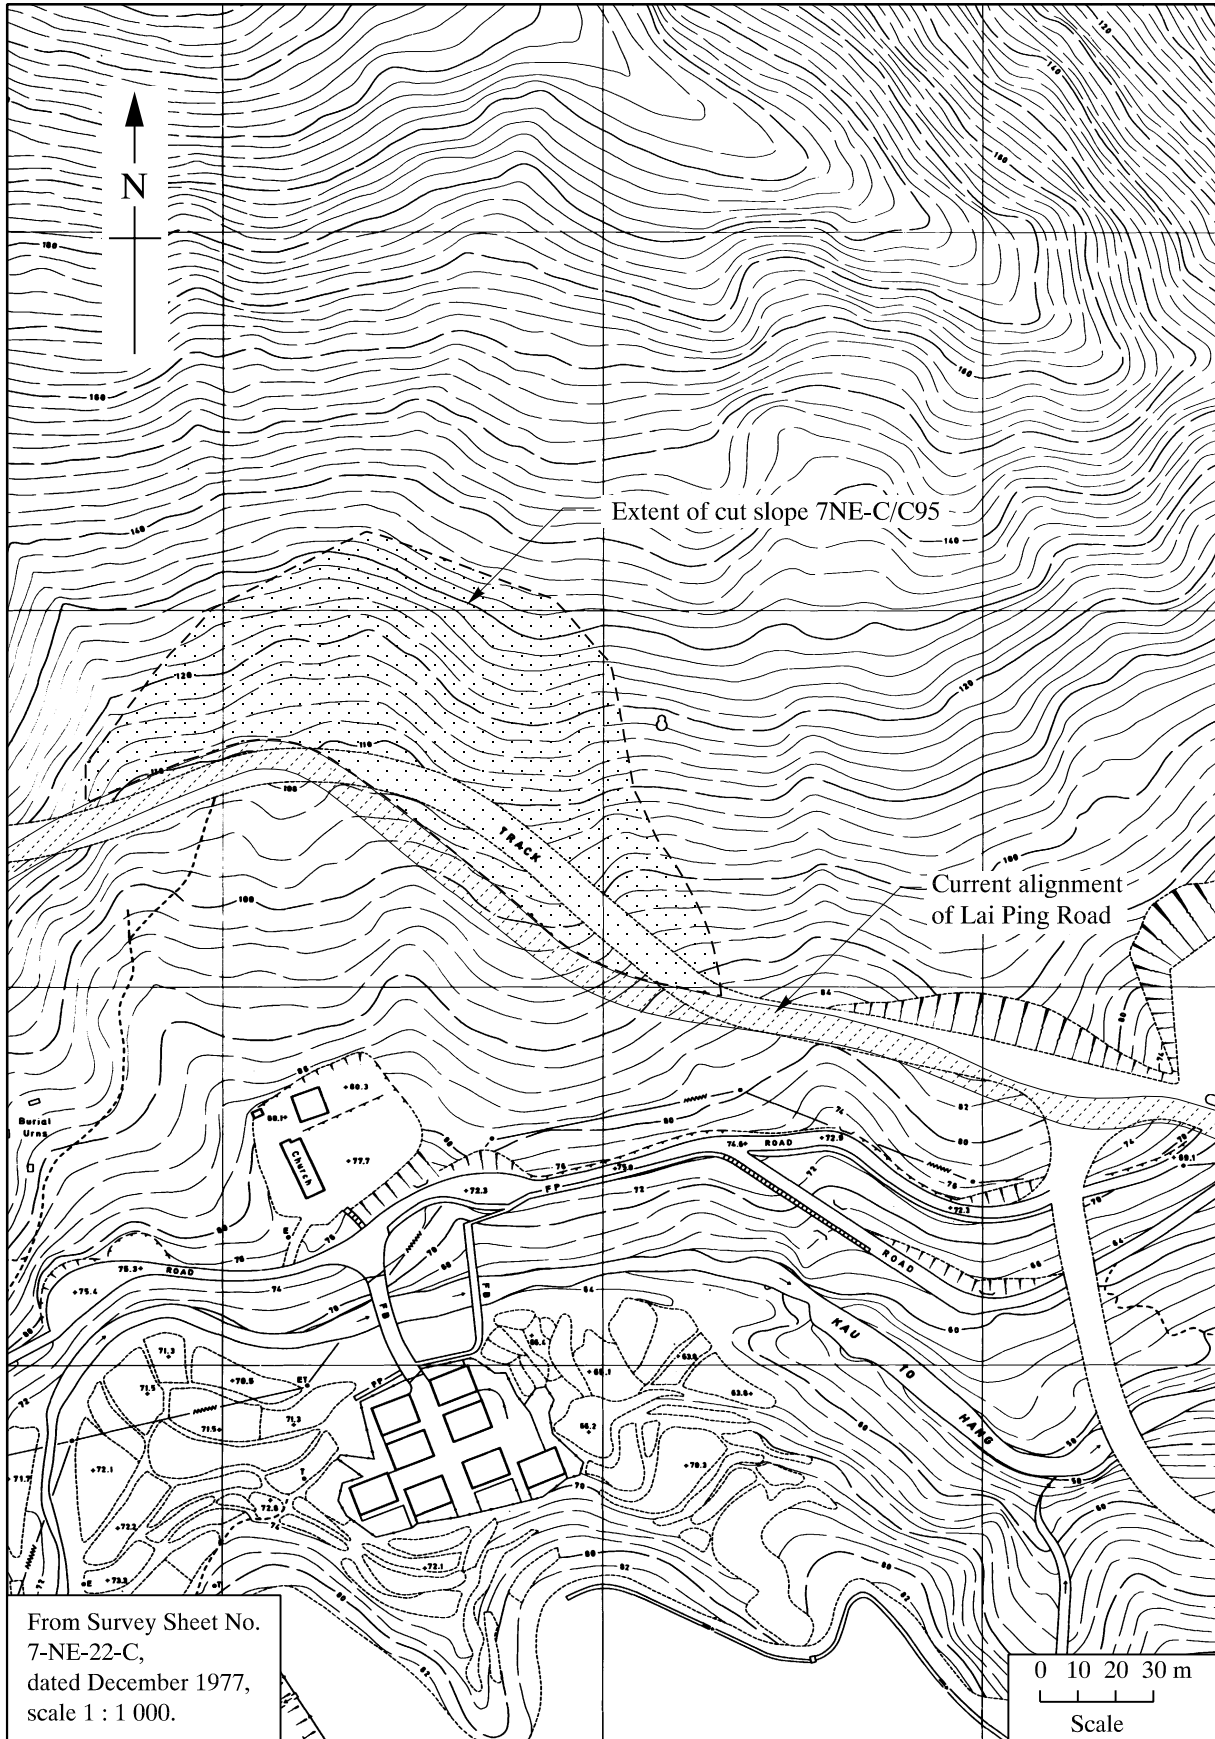
Figure B4 - Topographic Map (December 1977)

Year	Figure No.	Observation
1977	B4	<p>A 10-m wide track is shown approximately along the current alignment of Lai Ping Road. In the area of the landslide site, the track is positioned about 20 m northeast of the current road. The footpath running uphill from Kau To Village was intercepted by the track. The stream course, previously shown in the small concave slope across the western part of the landslide site, and the footpath uphill of the track are no longer shown on the map. More earthworks and roadworks (associated with the Kau To Borrow Area for the Sha Tin Reclamation) are shown east and west of the current landslide site. The road running along the north bank of Kau To Hang merges with the new track. Part of the road in front of the church complex appears to have been widened. The inlet of a culvert (which possibly goes underneath the road) is shown at the toe of the fill platform of the church complex. A footpath and a footbridge are shown crossing Kau To Hang to the building site on the other side of the stream. Eight buildings are shown on the building site immediately opposite the church complex.</p>

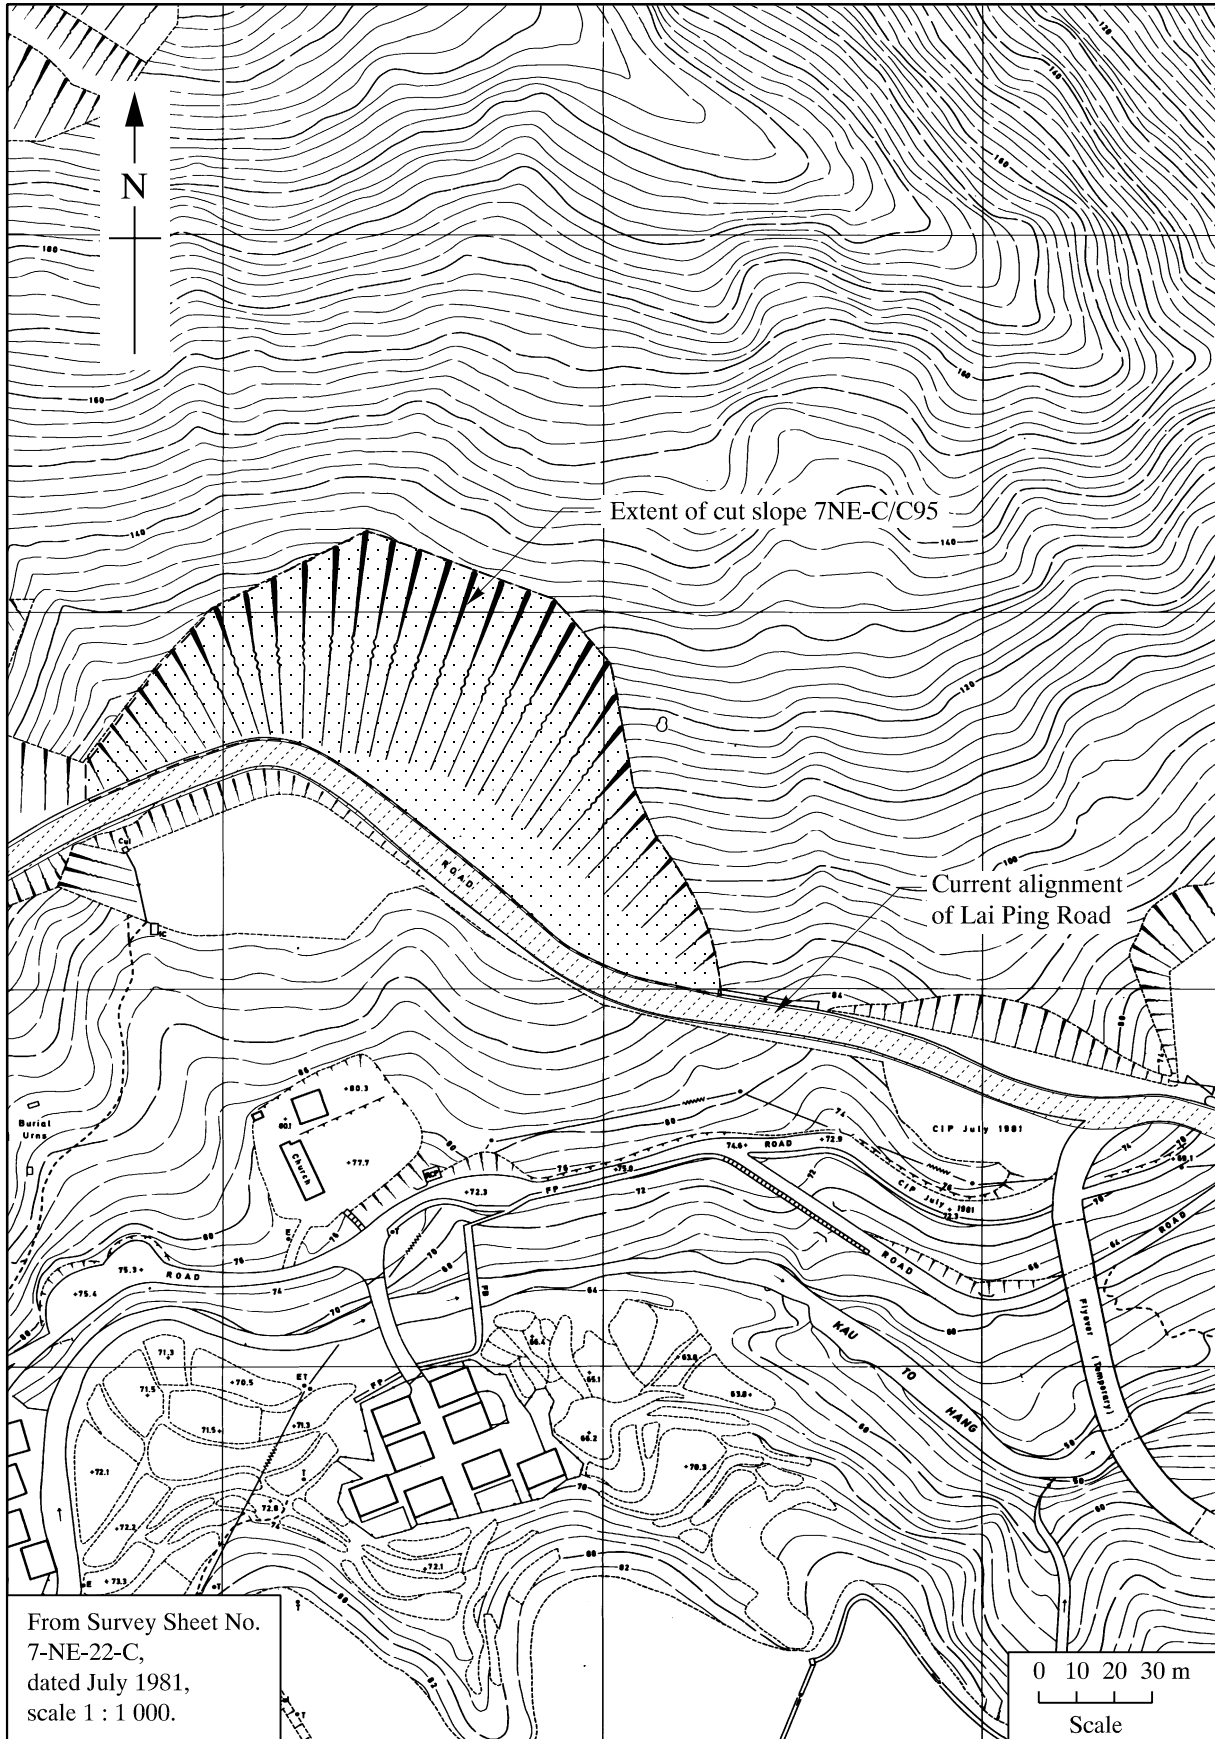
Figure B5 - Topographic Map (July 1981)

1981	B5	<p>The cut slope of the current landslide site is shown. A road is drawn along the current alignment of Lai Ping Road (i.e. the road along the toe of the subject cut slope has shifted about 20 m from its previous alignment of the track in 1977). The footpath and stream uphill of the road are no longer shown. The grave northeast of the cut slope appears unaffected. A platform has been formed to the south of the road which occupies the same position as the current WSD salt water service reservoir. Along the western side of the platform, a drainage channel is shown to be fed by a culvert (which possibly runs underneath the road) and leading to an inspection chamber at the southwest corner of the platform. Large-scale cutting in the borrow area appears to have been completed. Part of the catchment feeding the stream course as shown in the pre-1977 maps has been removed by formation of the borrow area. Construction facilities for the borrow area are still shown. For the road in front of the church complex, a reinforced concrete pit is shown next to the culvert headwall.</p>

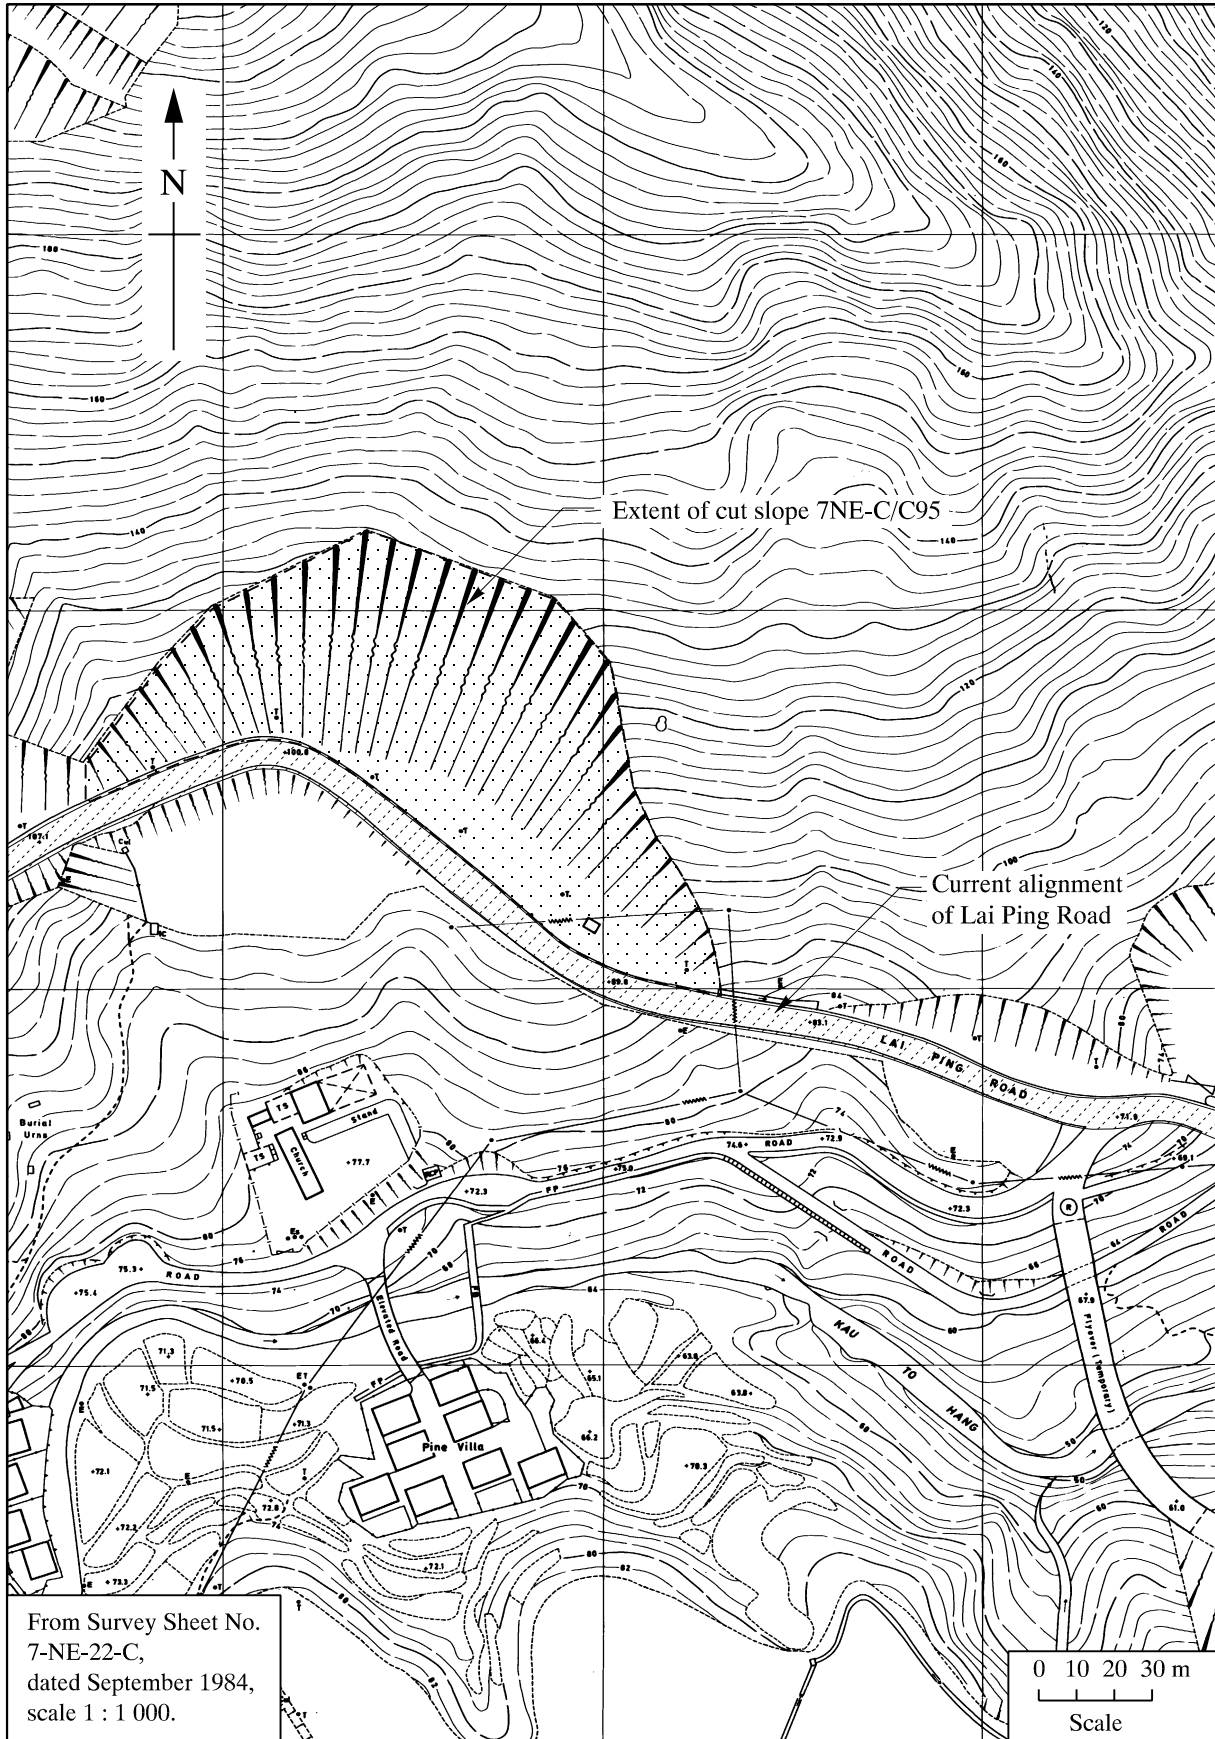
Figure B6 - Topographic Map (September 1984)

1984	B6	<p>The road in front of the cut slope is named Lai Ping Road and a facility has been built at the toe of the cut slope. An overhead electricity supply line has been brought to the east of the cut slope. Telephone poles have also been erected along the toe of the cut slope. The platform to the south is shown as fenced. The church complex has been further developed with an additional stand, sheds, etc.. The building development south of Kau To Hang is named Pine Villa.</p>

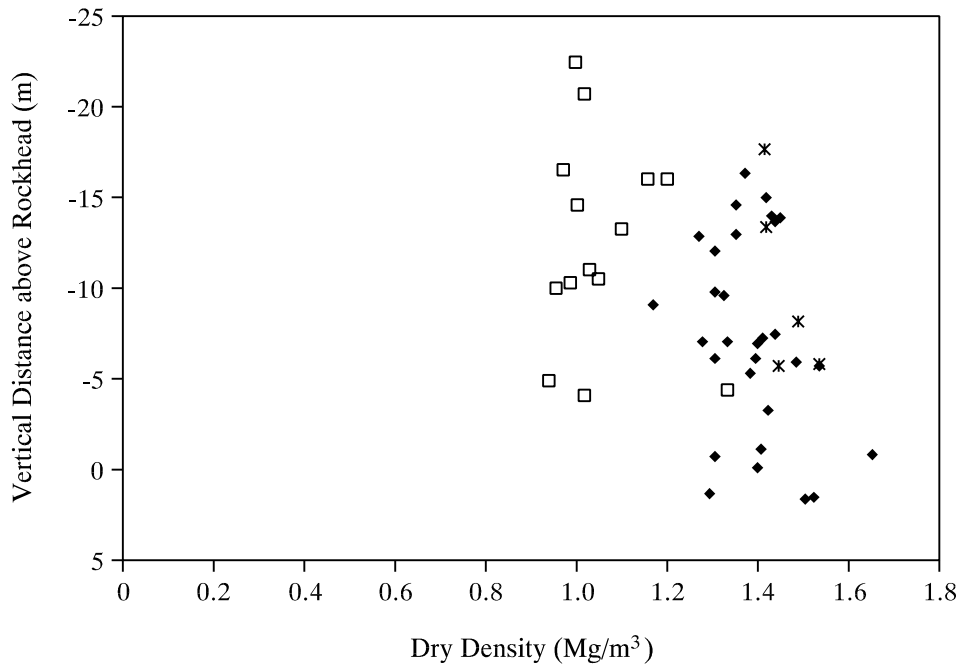
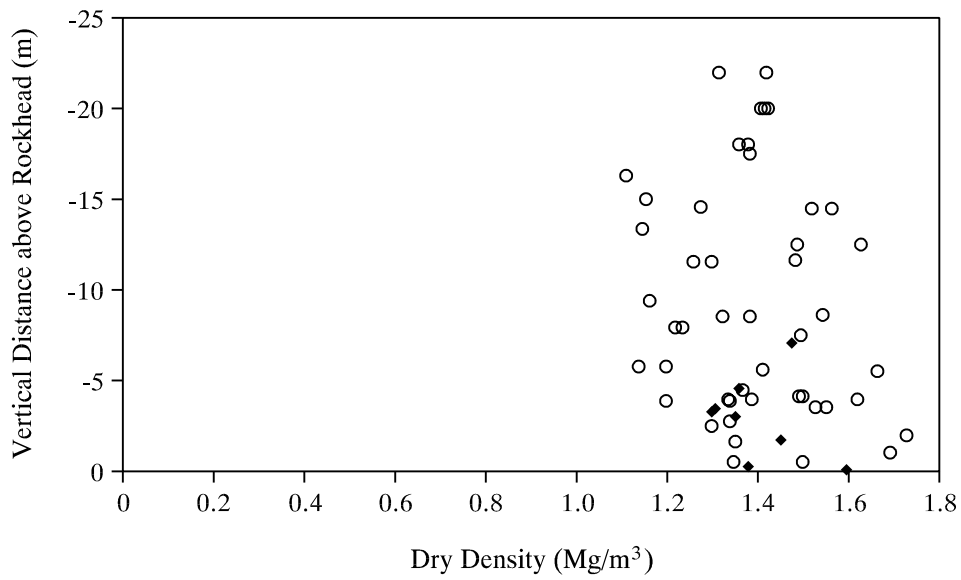
Figure C1 - Dry Density Values versus Distance above Rockhead for Drillhole Samples

Dry density values of undisturbed samples taken within and outside the landslide complex were obtained during different phases of the ground investigations. The data are plotted in Figure C1. Data for samples obtained in 1979 and 1982 investigations either have much lower values, or vary widely, possibly due to sample disturbance. Based on the 1995 and 1997 G.I. information, dry densities, close to the rockhead, do not vary significantly between areas within and outside the landslide complex.

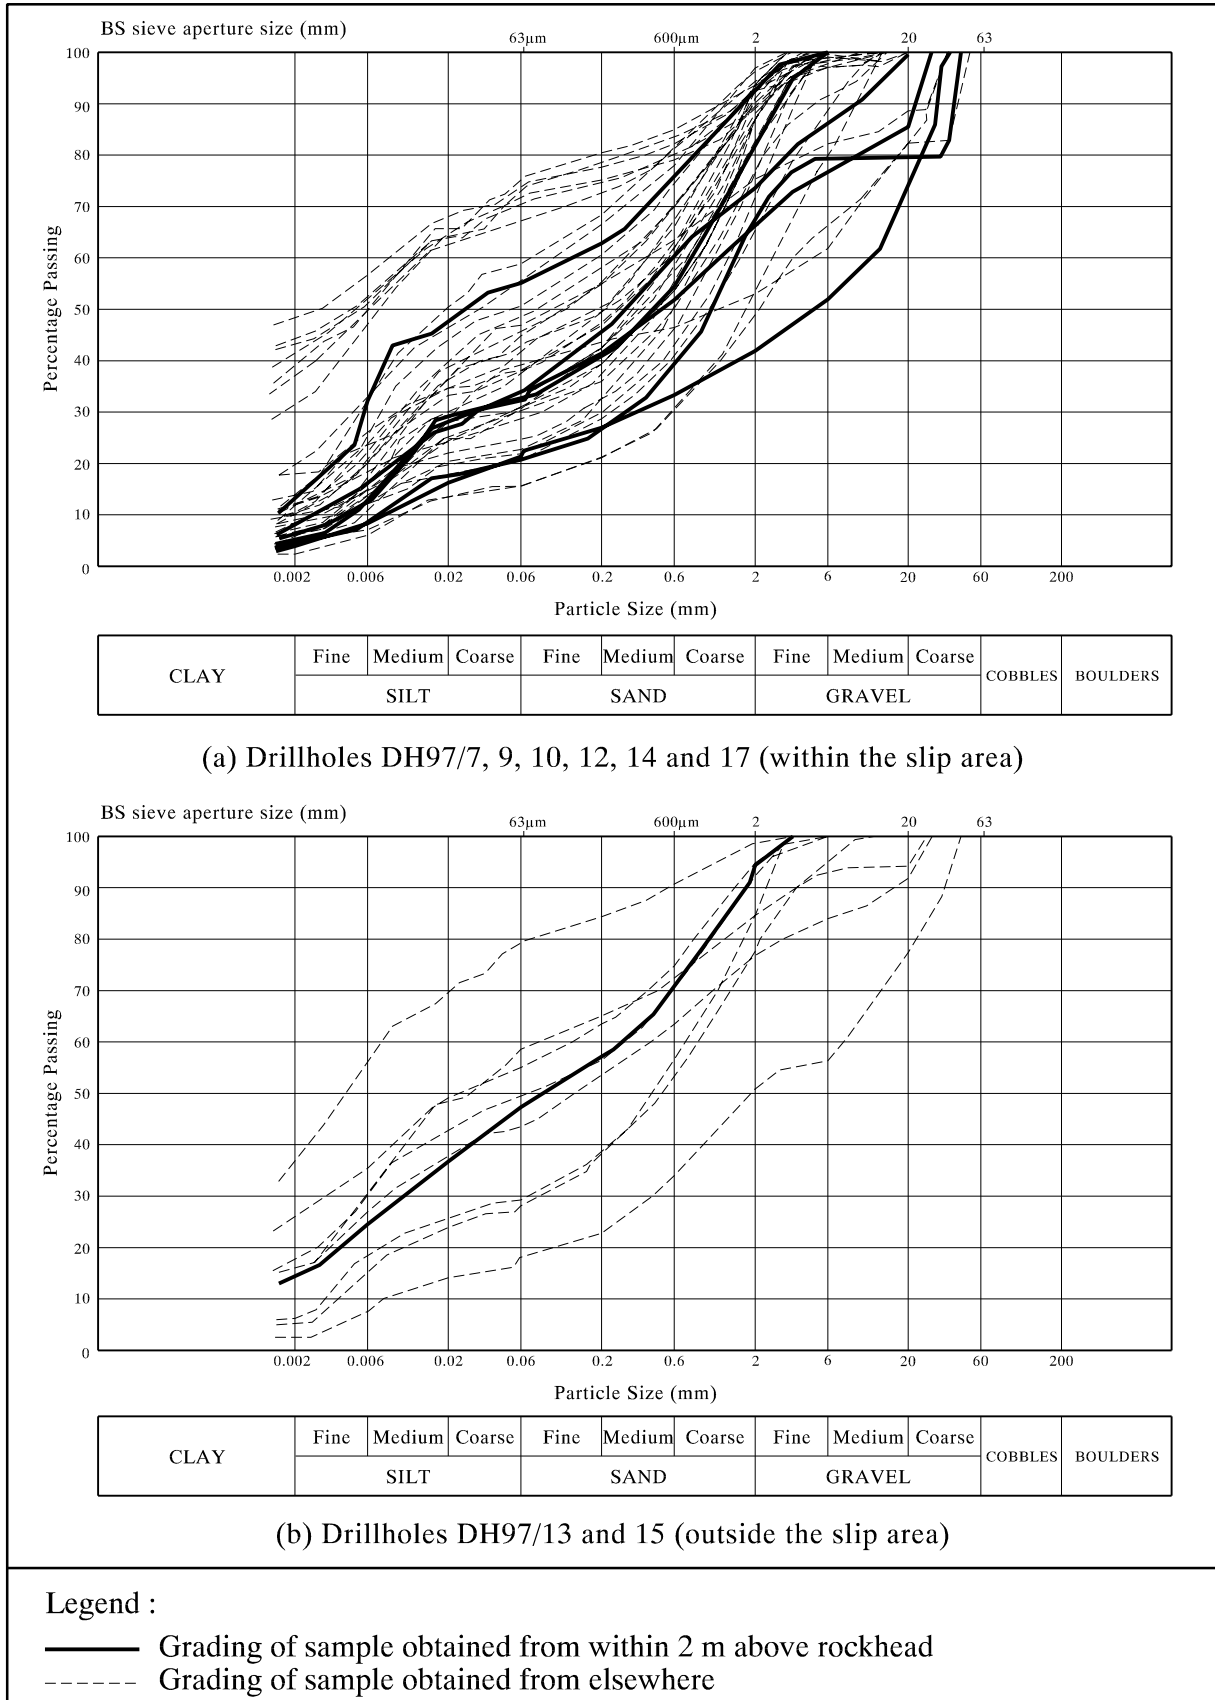
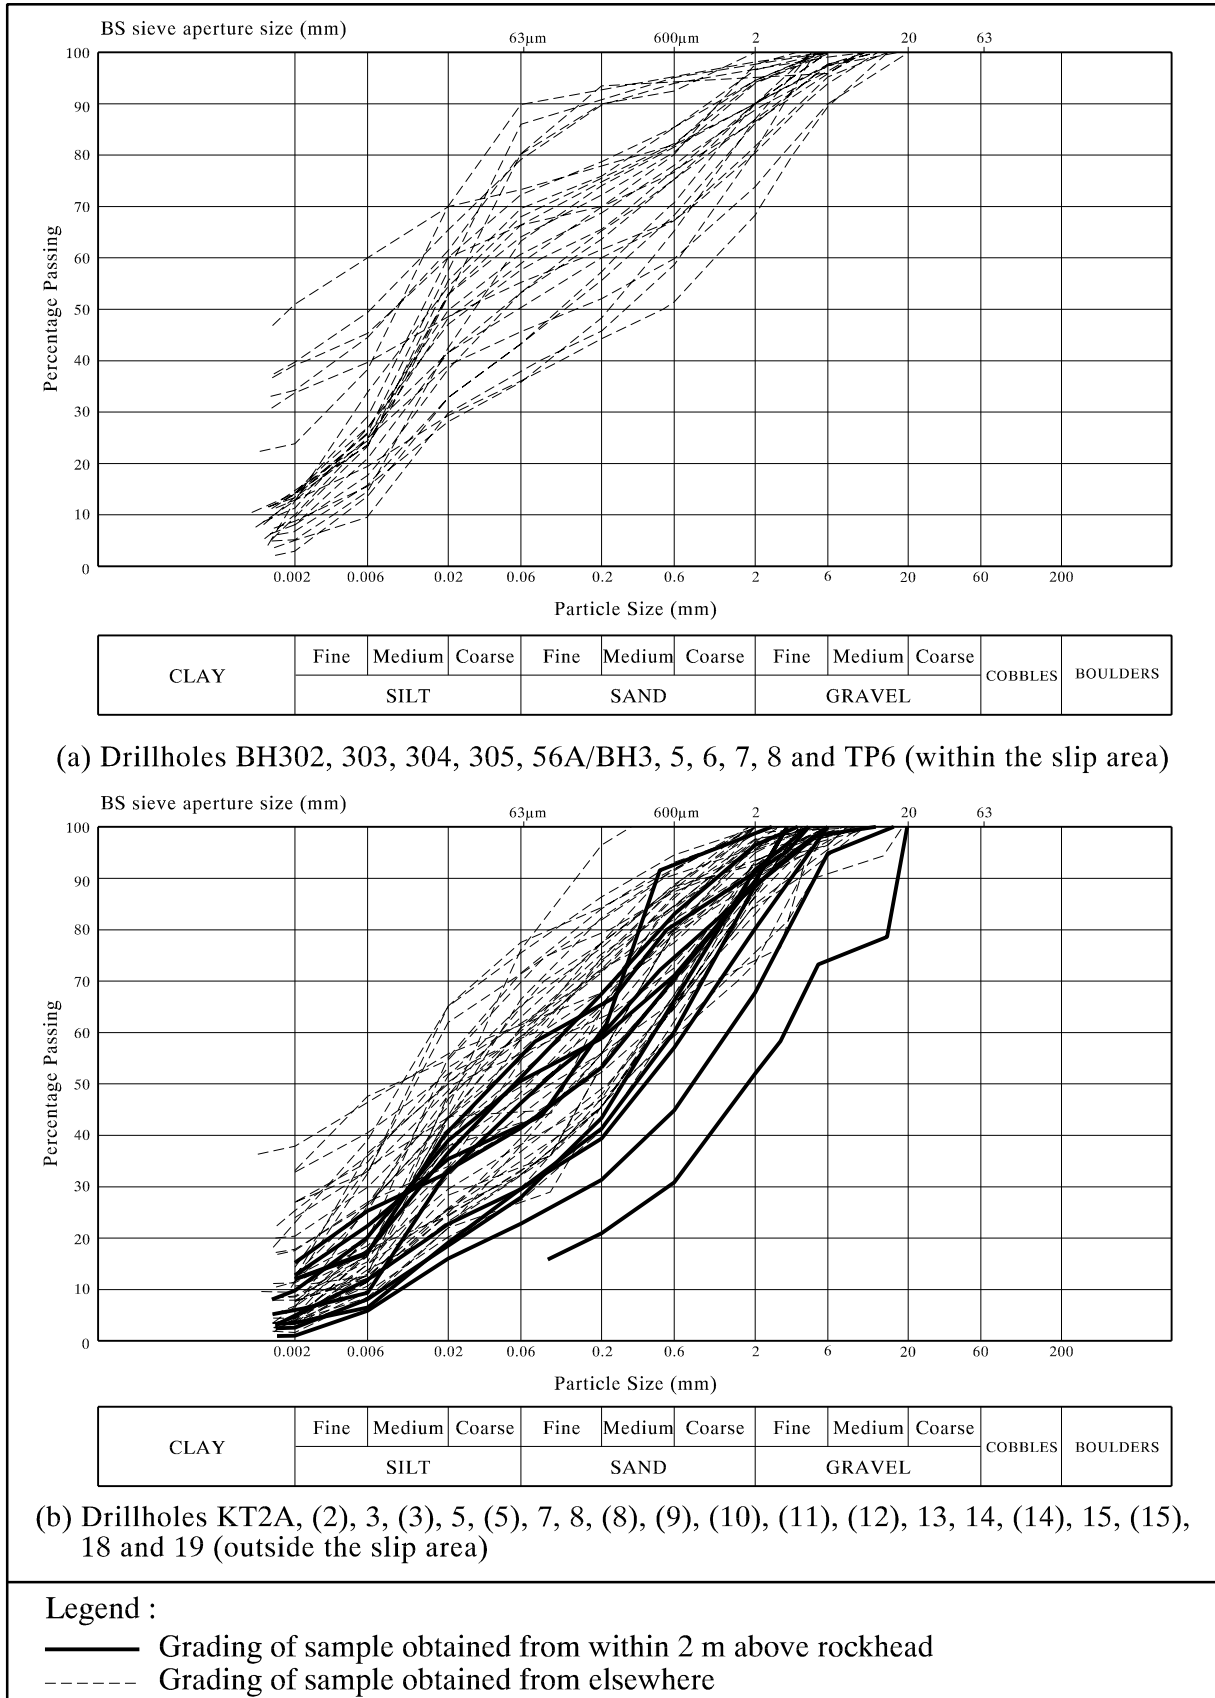
Particle size distribution curves (Figures C2 and C3), determined for samples from drillholes, indicate wide variability of the saprolite, but no systematic difference is observed within and outside the landslide area. It is noted however that particle size distribution curves for samples less than 2 m above rockhead are less variable than elsewhere and have a smaller proportion of fine particles.

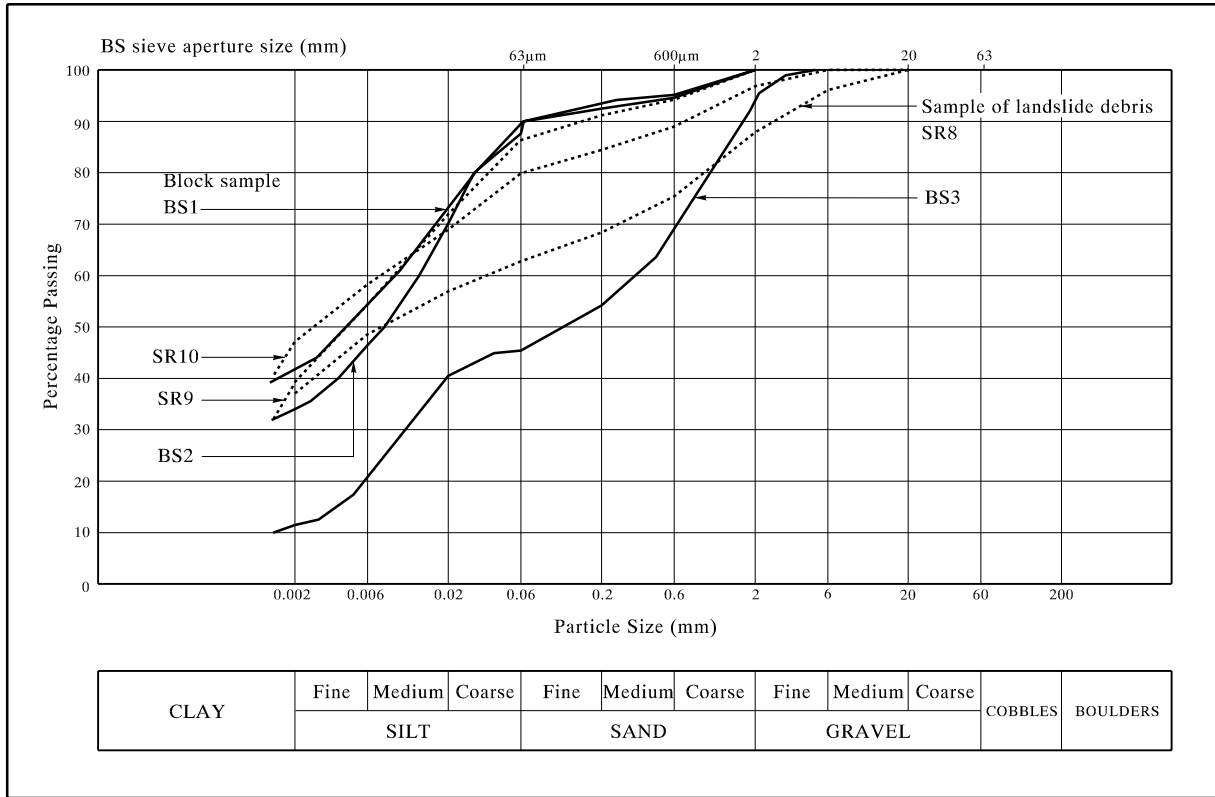
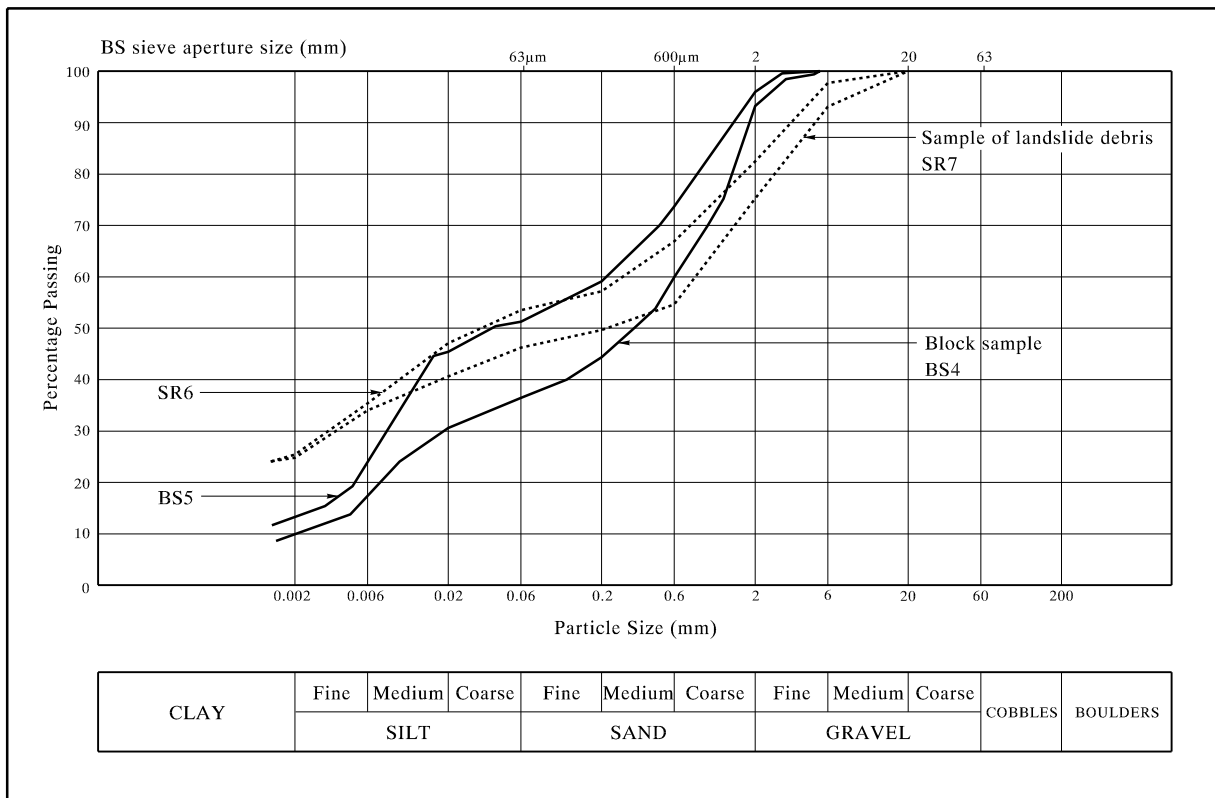
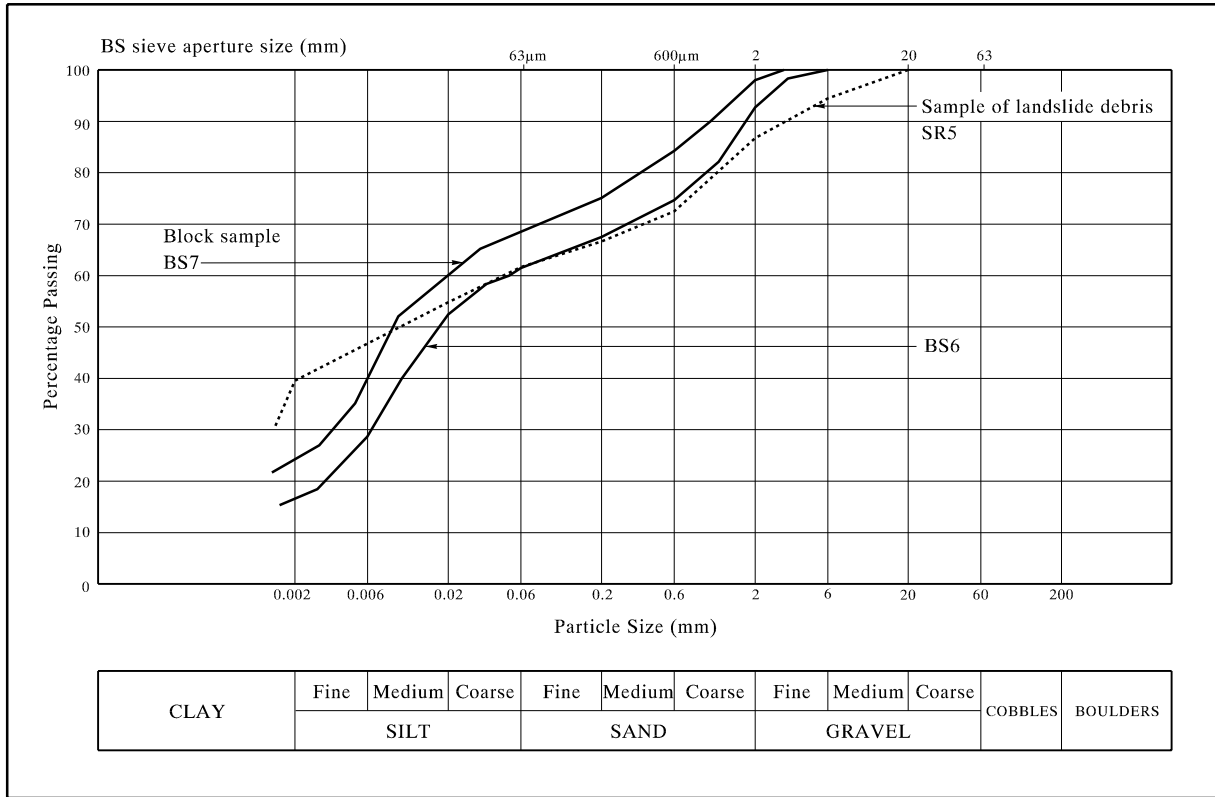
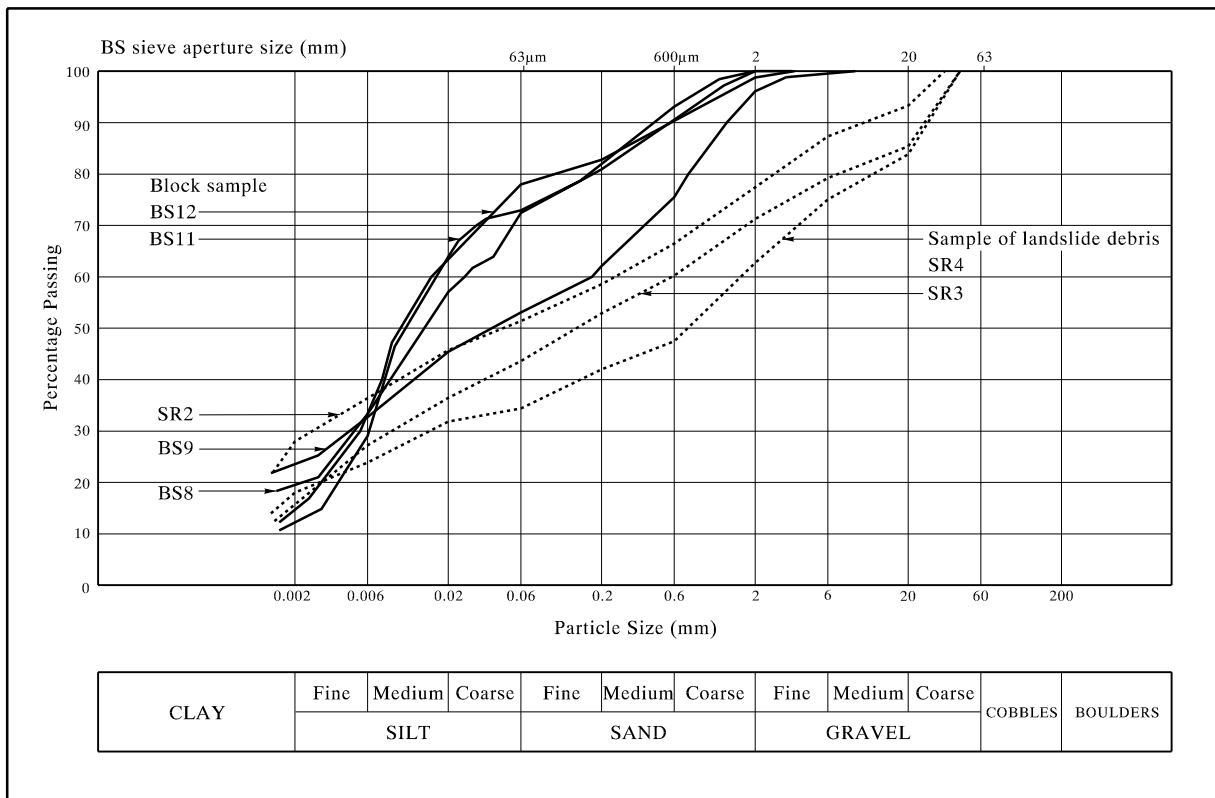
Figures C4 to C7 show particle size distribution curves for block samples of insitu material taken from the landslide scars (except BS9, which is landslide debris) and bulk samples of landslide debris associated with the landslide in 1997. In general, grading of the landslide debris is similar to that of the corresponding landslide scars. Near-surface materials on the east side of the cut slope appear to be finer than those on the west side, but samples from drillholes vary as much with depth as location. Debris from landslide scar 4 appears to be coarser. Such differences may however be due to bias in selection of sample locations on site.
