APPENDIX A  
AERIAL PHOTOGRAPH INTERPRETATION

## A.1 SUMMARY

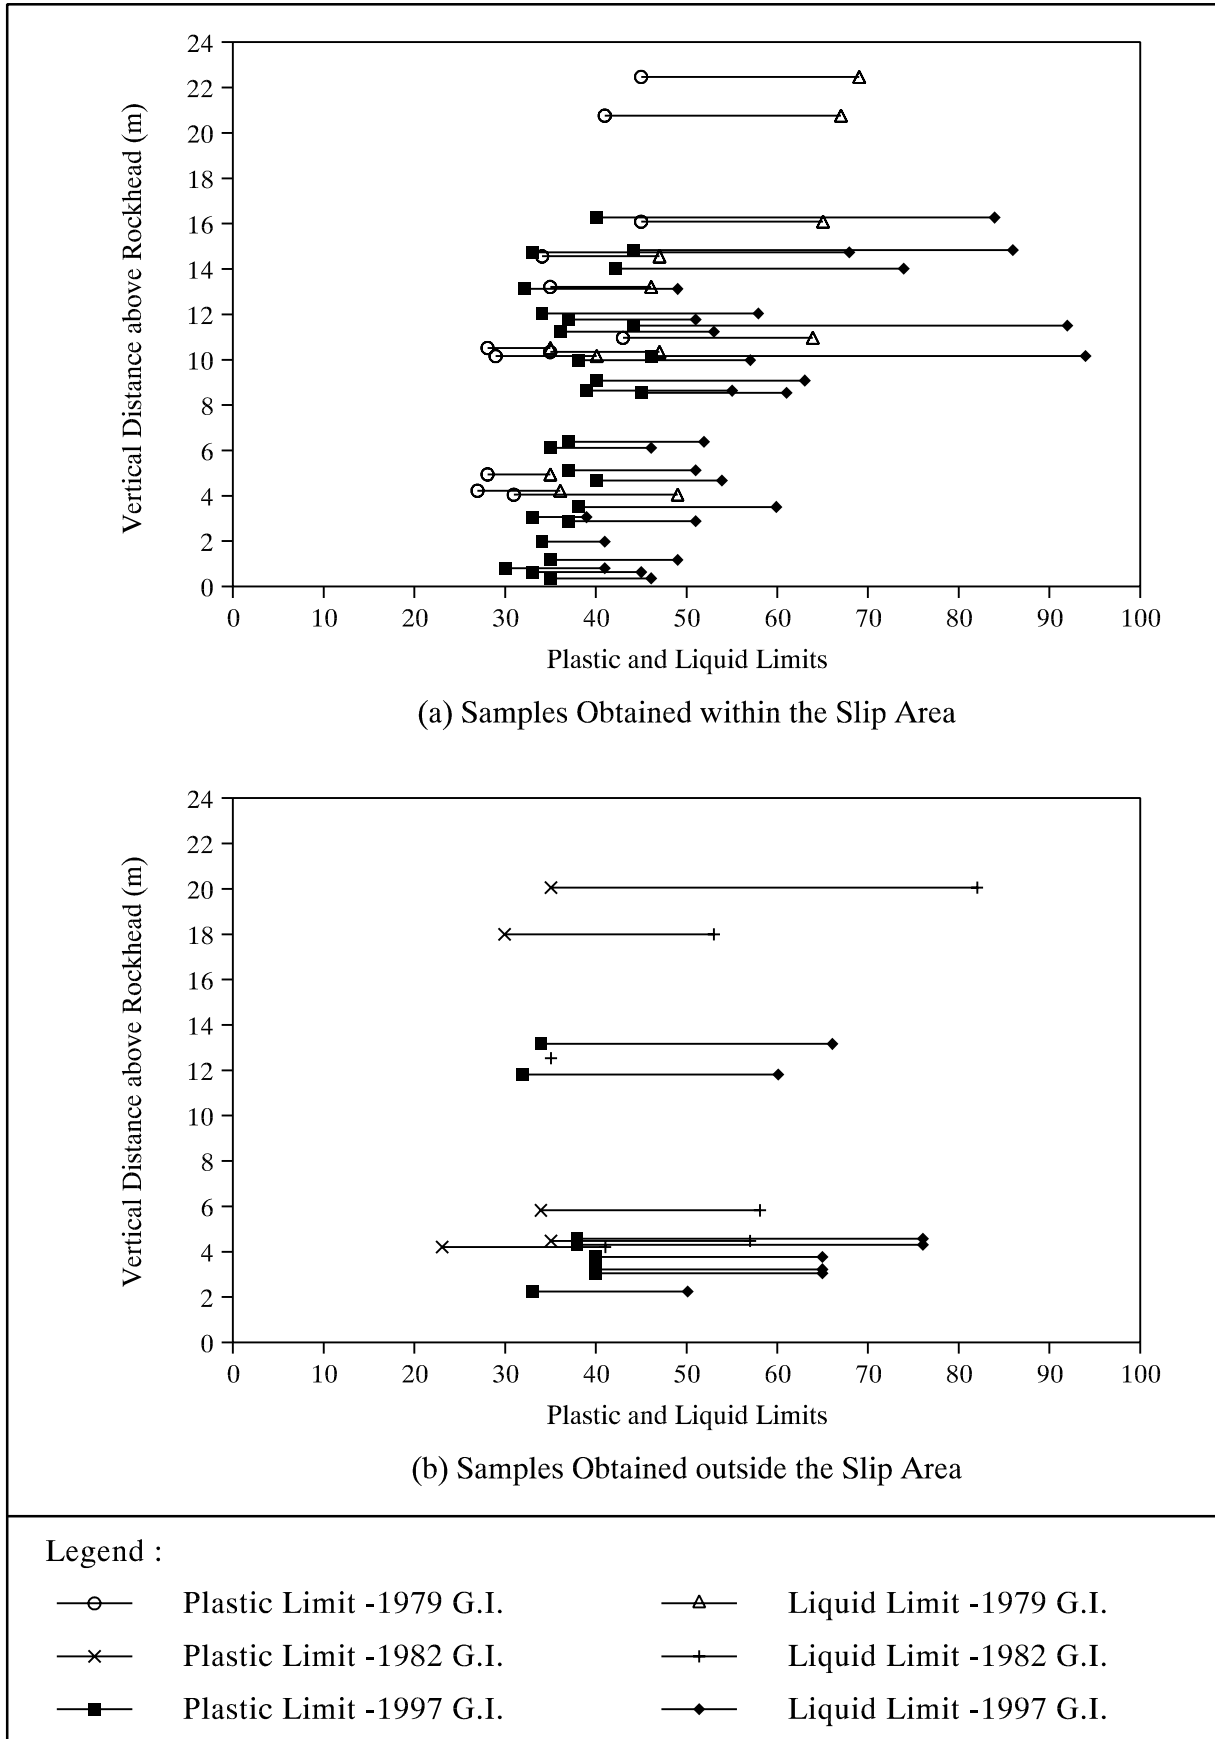
Figure C8 - Plasticity versus Distance above Rockhead for Drillhole Samples

Figure C8 shows the plasticity indices with respect to height above rockhead. Samples taken a few metres above rockhead appear to have a lower plasticity. This is consistent with the variations in particle size distributions.

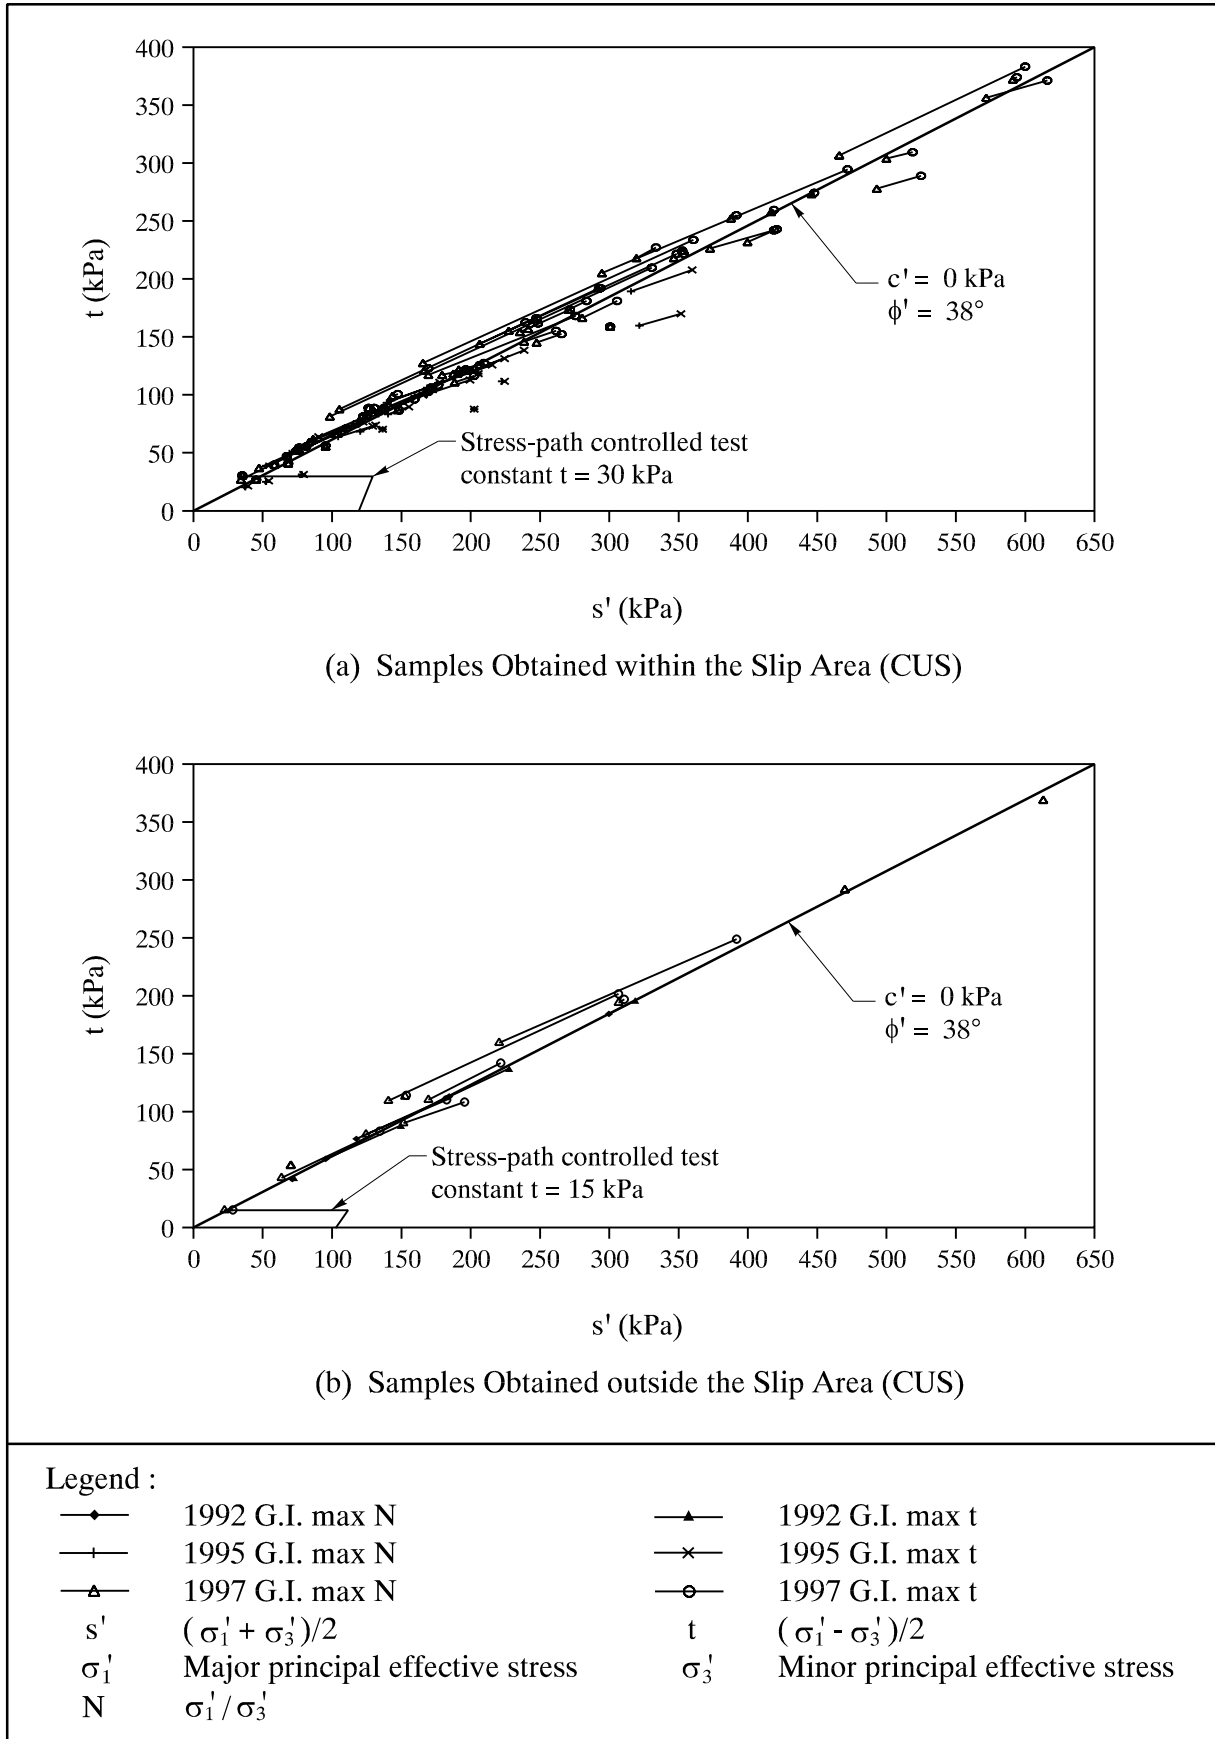
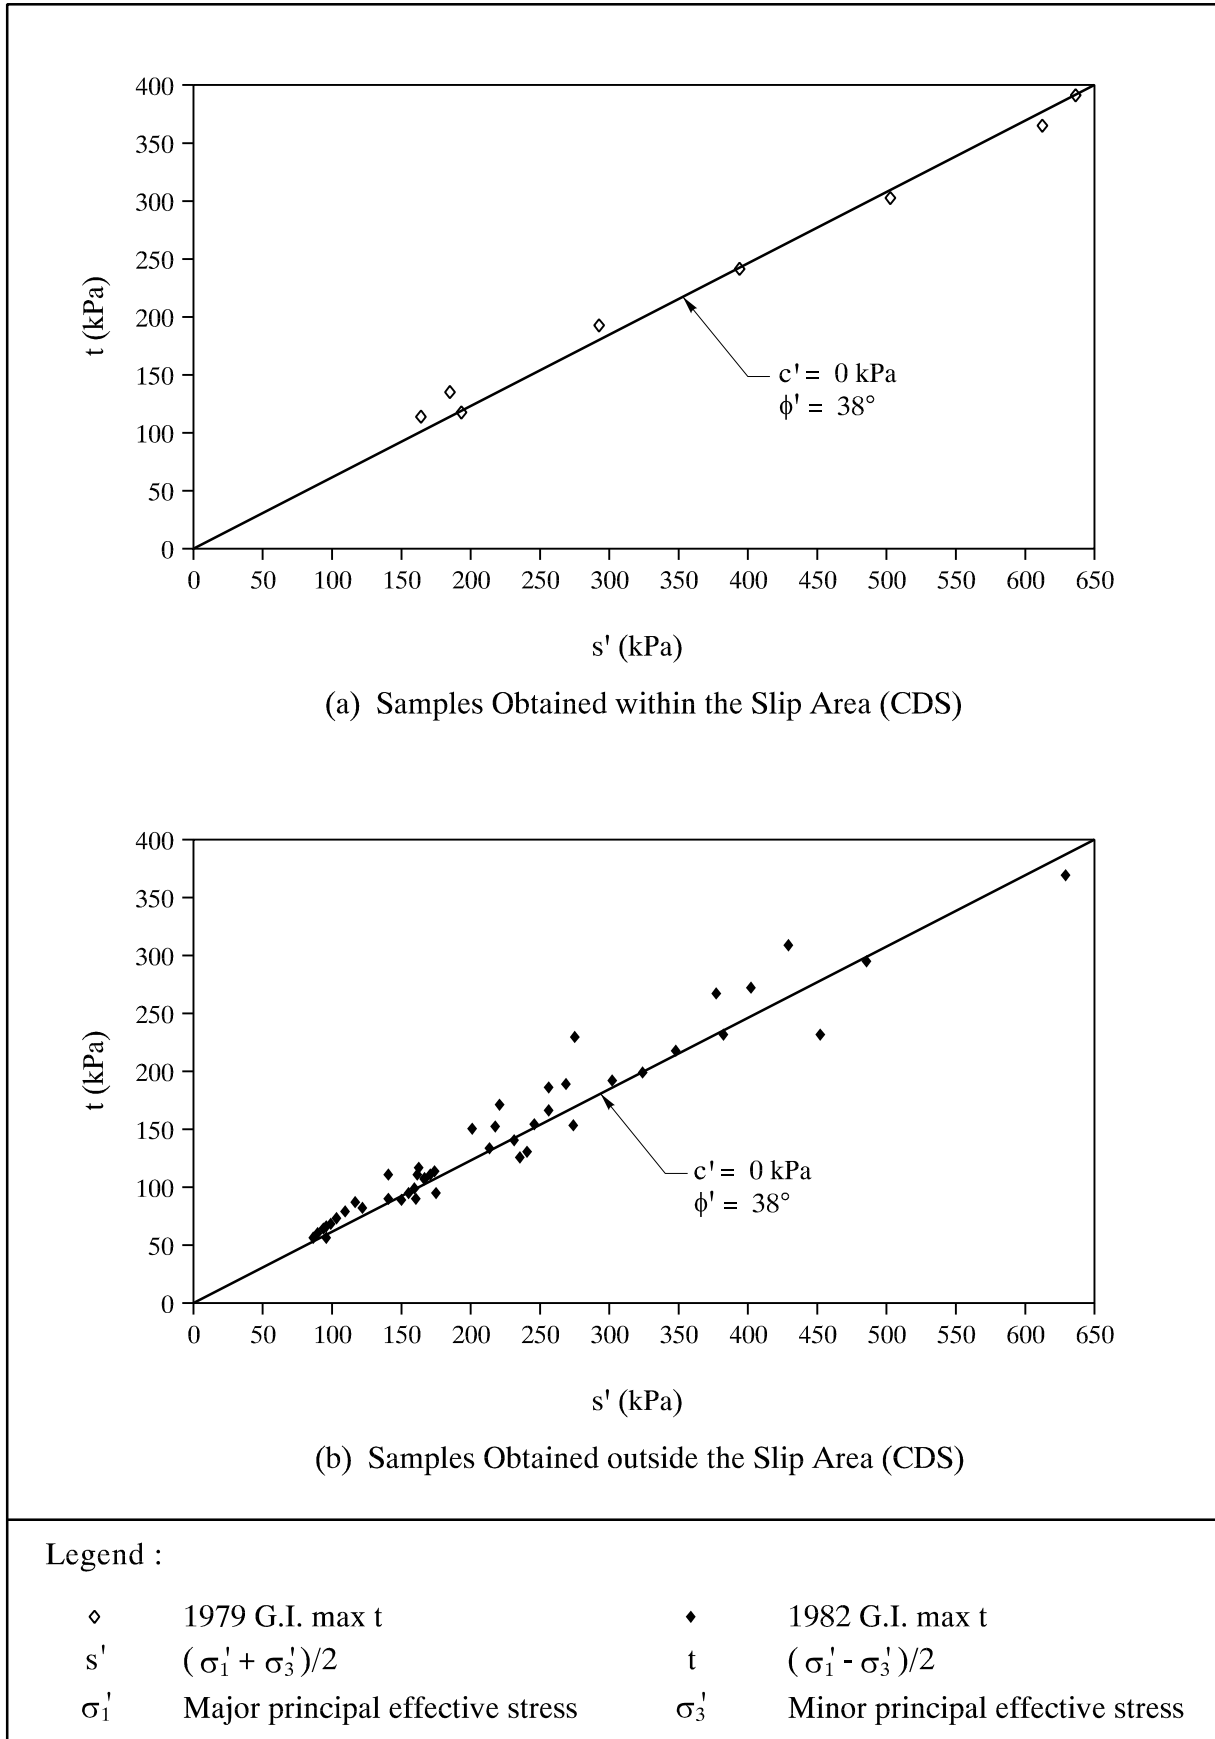
Figures C9 and C10 present the triaxial test results. The effective stress paths from stress-path controlled constant  $t$  tests are plotted on the Figure C9. Effective stress maximum shear strength parameters deduced from these tests, for completely decomposed material, taken within and outside the landslide area, are  $c' = 0 \text{ kPa}$  and  $\phi' = 38^\circ$ . The possible effects of changes in

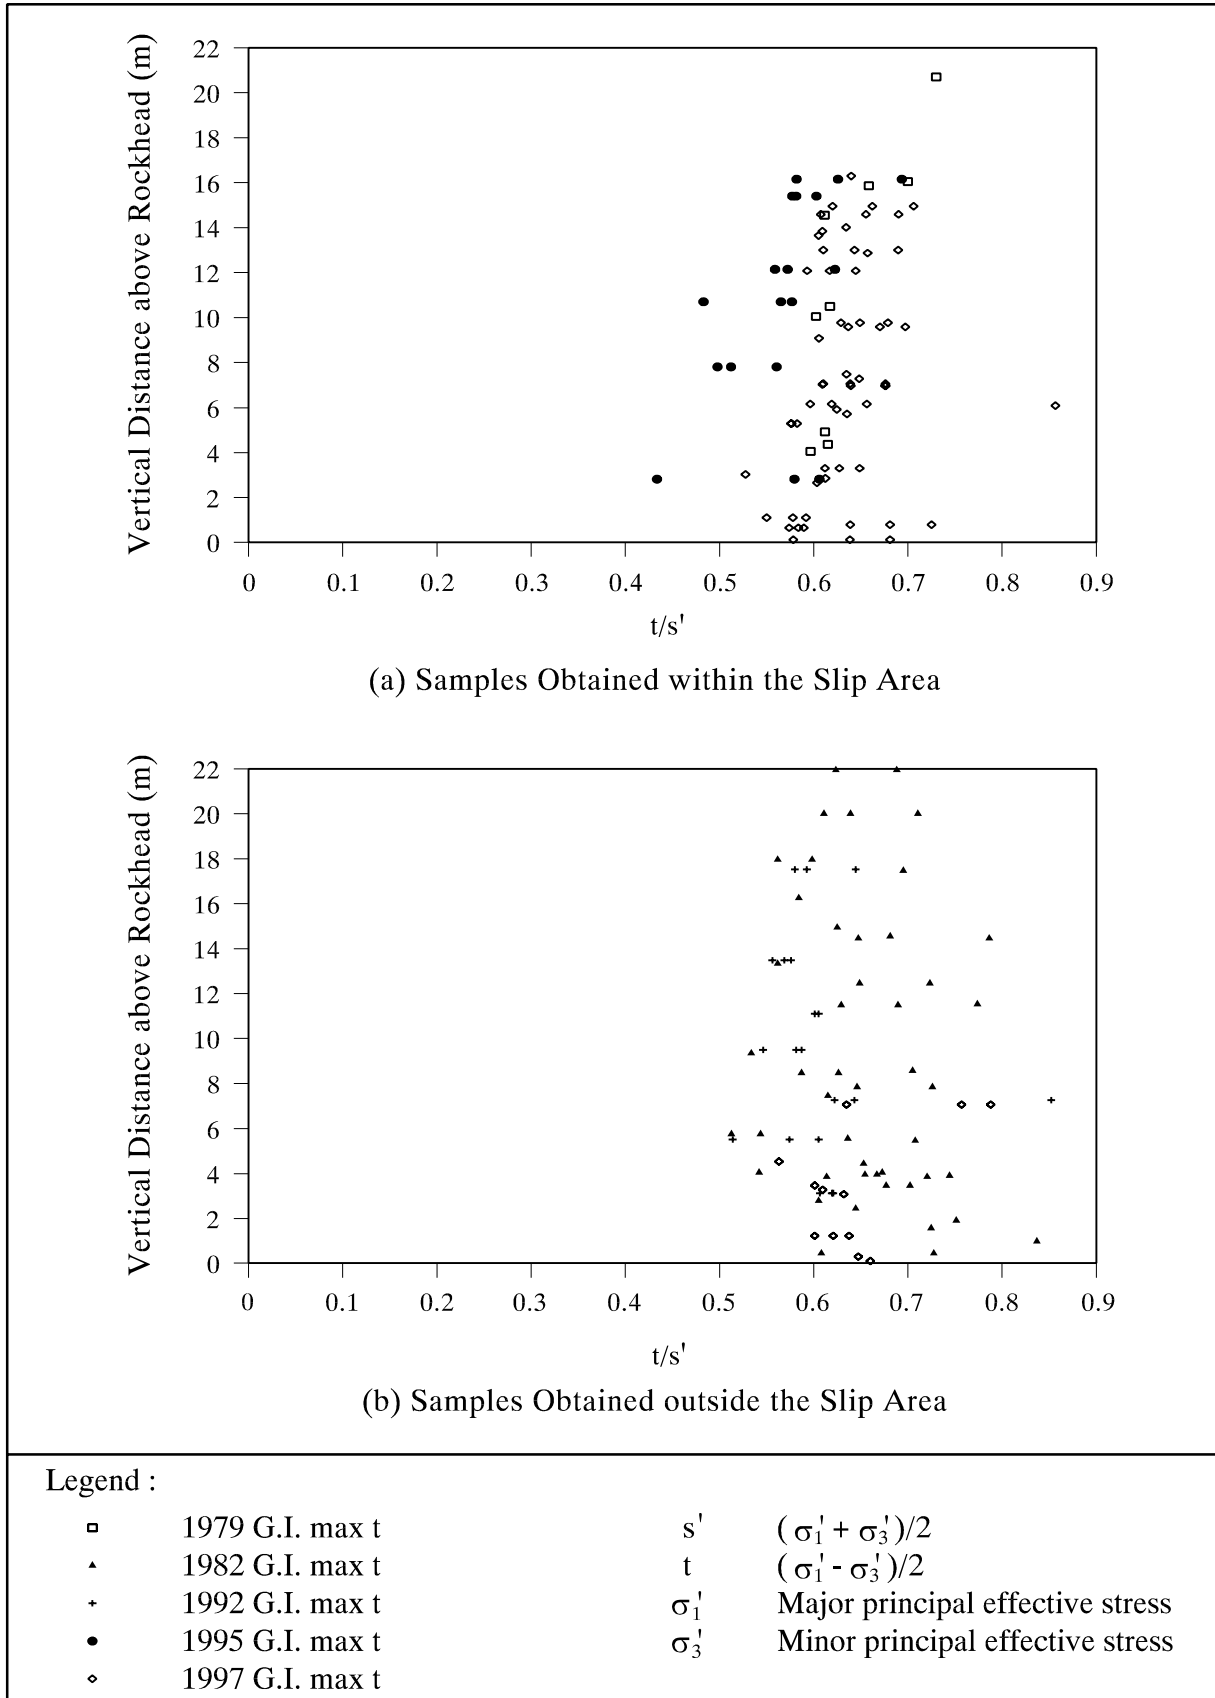
Figure C11 - Stress Ratio Values at Maximum Deviator Stress versus Distance above Rockhead for Drillhole Samples

grading and plasticity near the rockhead on shear strength have been examined but no systematic variation can be observed (Figure C11). Post-peak dilative pore water pressure responses with reduction of principal stress ratio were observed in all undrained triaxial tests on undisturbed specimens. This indicates post-peak strain-softening behaviour of the material. Due to limited strain level in triaxial test specimens, the fully softened conditions were not usually attained at the end of the test.

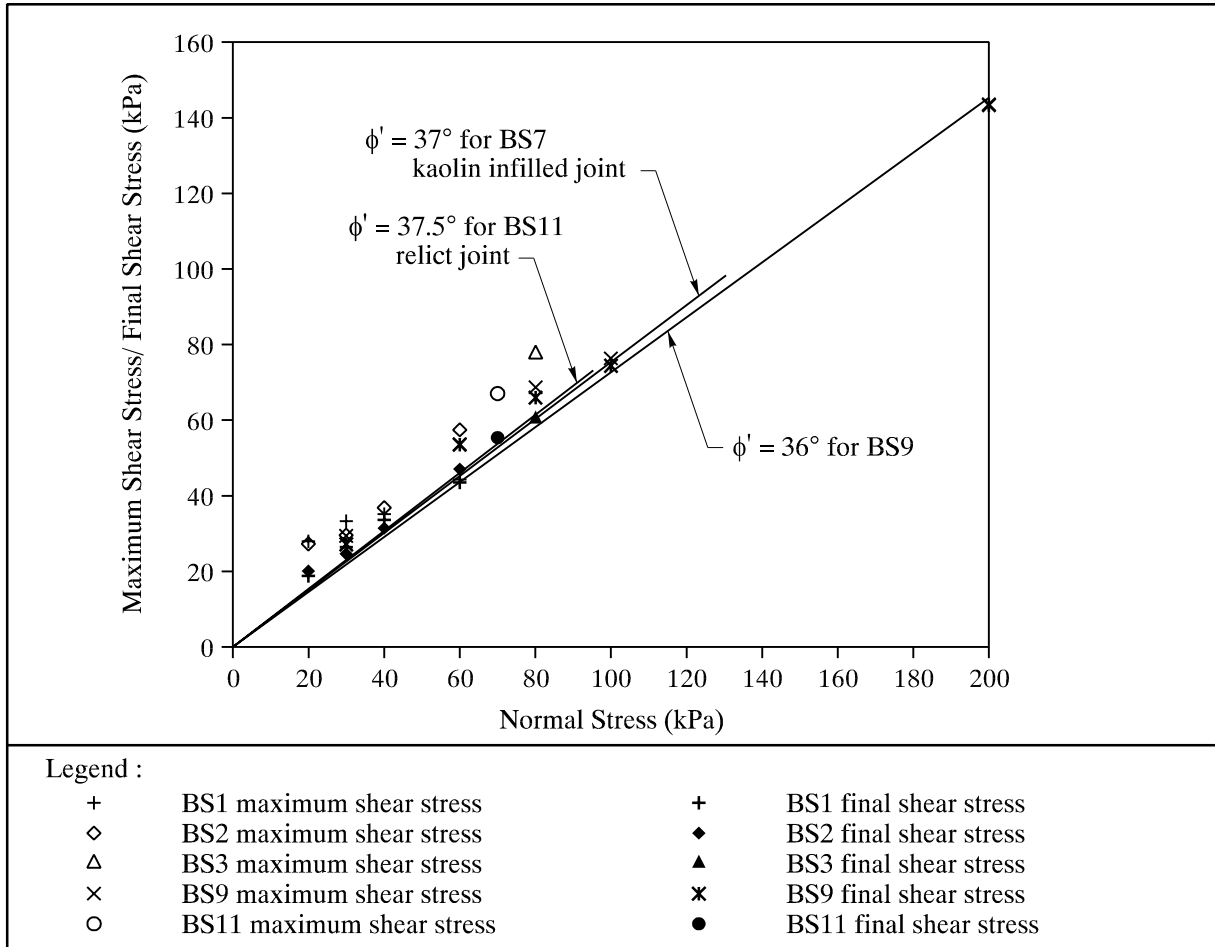
Figure C12 - Summary of Direct Shear Test Results

Figure C12 summarises the results of the direct shear tests. Due to the limited length of travel, steady state shear strength might not be attained at the end of the test. The best estimate of the steady state  $\phi'$  for BS9 (landslide debris from landslide scar 4) is  $36^\circ$ . This is similar to the kaolin infilled joint in BS3, which has a  $\phi'$  of  $37^\circ$ , under a normal load of 80 kPa. For the relict joint in BS11, the  $\phi'$  value is equal to  $37.5^\circ$ , under a normal load of 70 kPa. The end-of-test  $\phi'$  values for BS1 and BS2 vary between  $35.5^\circ$  and  $38^\circ$ .

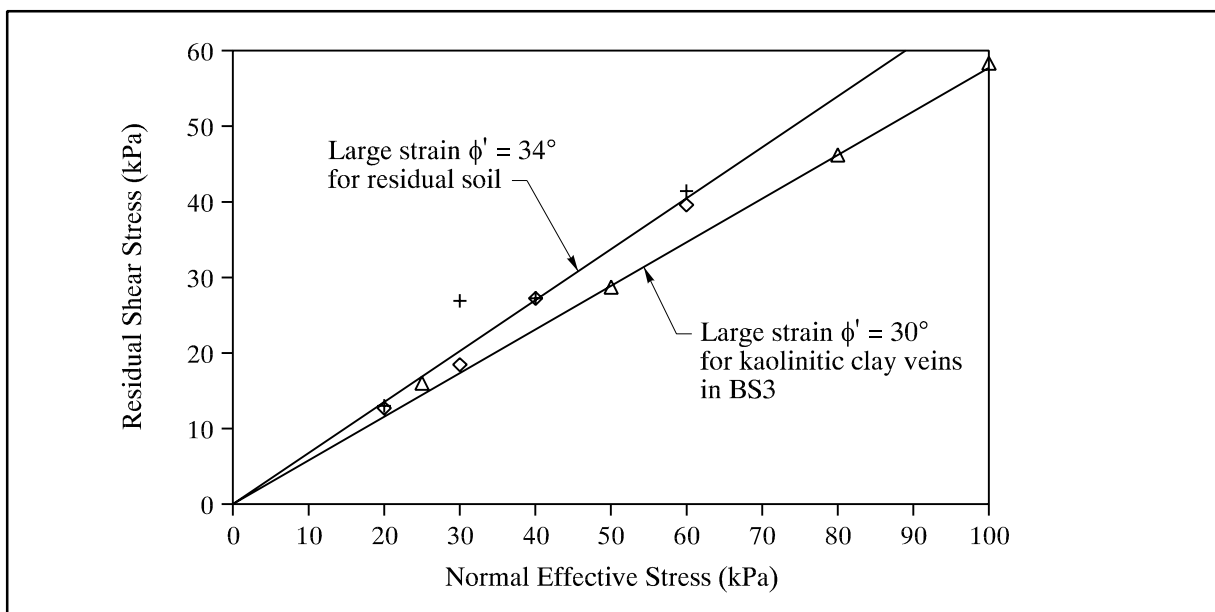
Figure C13 - Summary of Ring Shear Test Results

Ring shear tests were carried out on remoulded specimens from BS1 and BS3 in line with the requirements of BS1377 : Part 7 (BSI, 1990). As shown in Figure C13, the large strain  $\phi'$  of the residual soil (BS1) was  $34^\circ$  and was  $30^\circ$  for a kaolinitic clay vein in BS3.

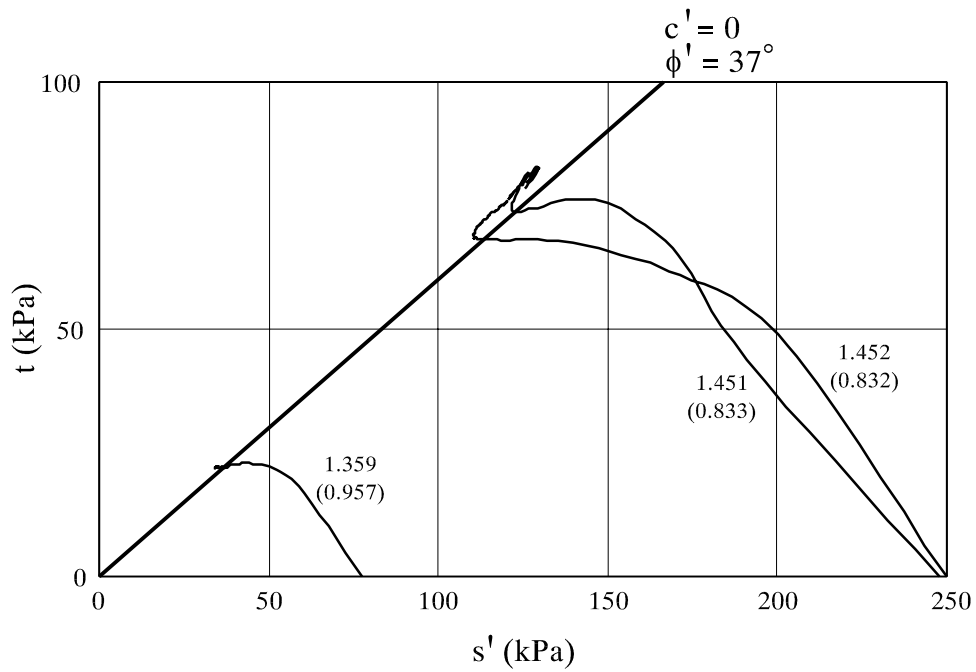
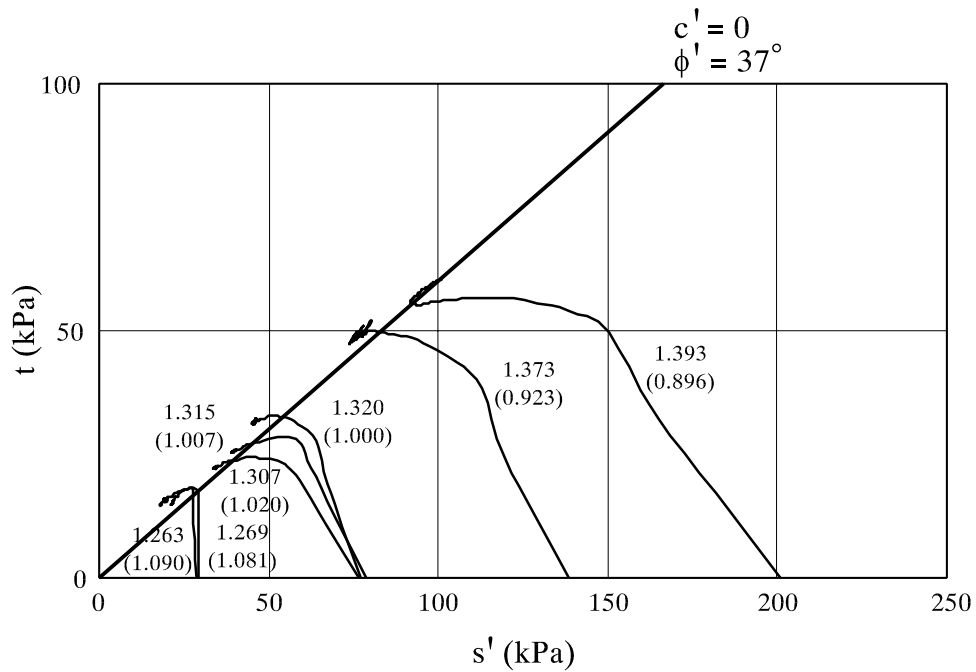
Figure C14 - Shearing Behaviour of Loose Specimens of Landslide Debris

Figure C14 shows the stress paths of consolidated undrained triaxial tests on specimens of landslide debris prepared at dry densities similar to those measured on site. Samples SR5 and SR4, taken from landslide scars 3 and 4 respectively, were compacted by moist tamping and consolidated to different mean stresses prior to compression in an undrained condition. All stress paths indicate contractive behaviour. For dry density values of 1.2 to 1.3 Mg/m<sup>3</sup>, as for the debris from landslide scars 1 and 4, the specimens exhibit near-collapse behaviour upon shearing similar to that of loose, completely decomposed granite fills (Law et al, 1998). A steady state  $\phi'$  value of  $37^\circ$  was obtained from these tests.
