LIST OF PLATES

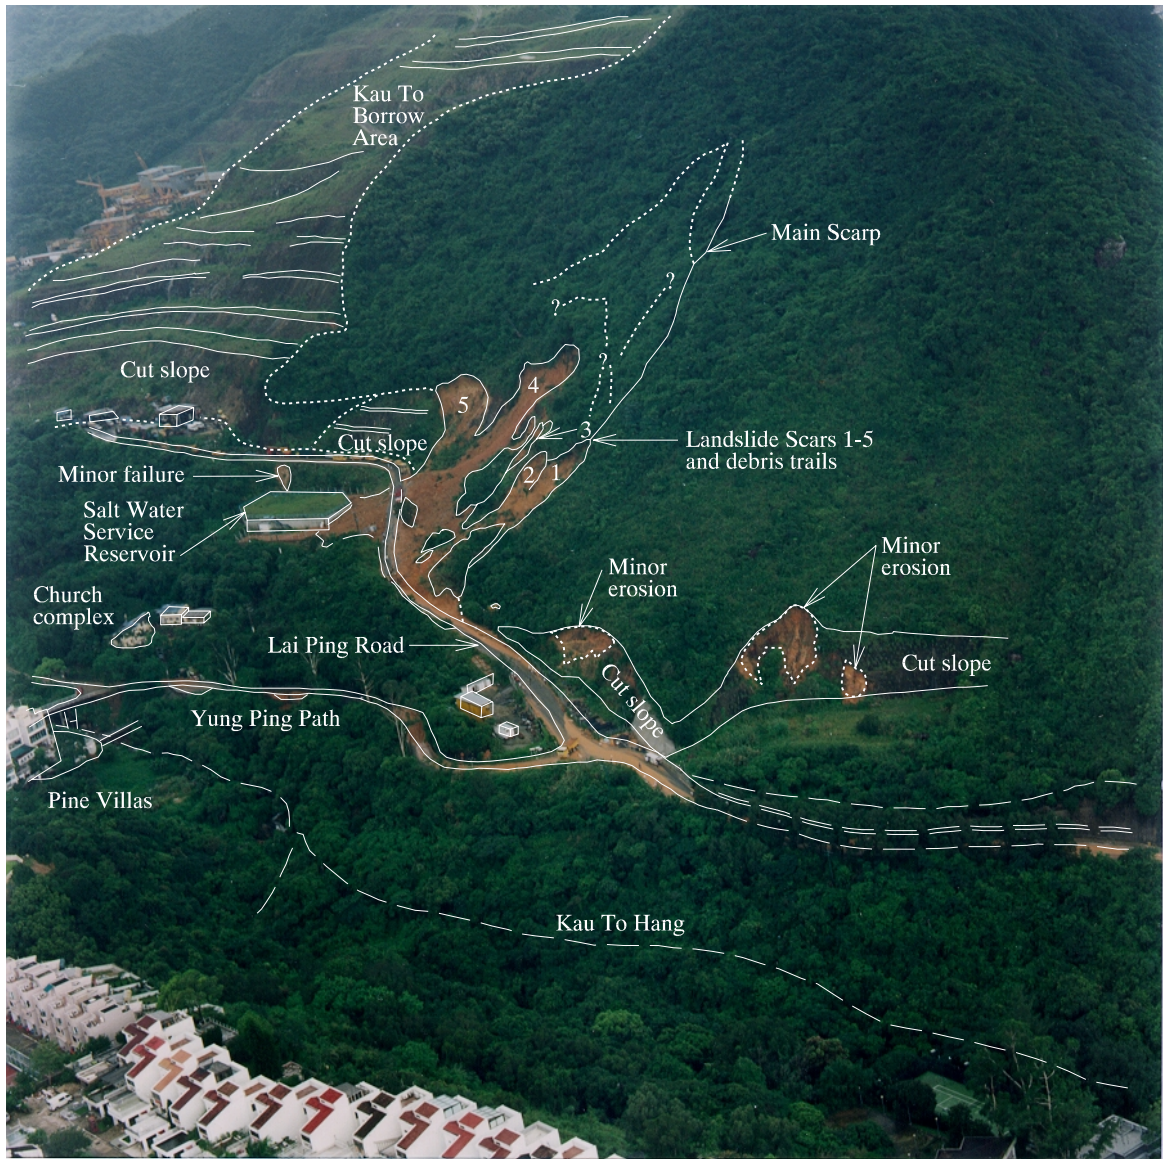
Plate 1 - Oblique Aerial Photograph of the Site (Taken on 4 July 1997)

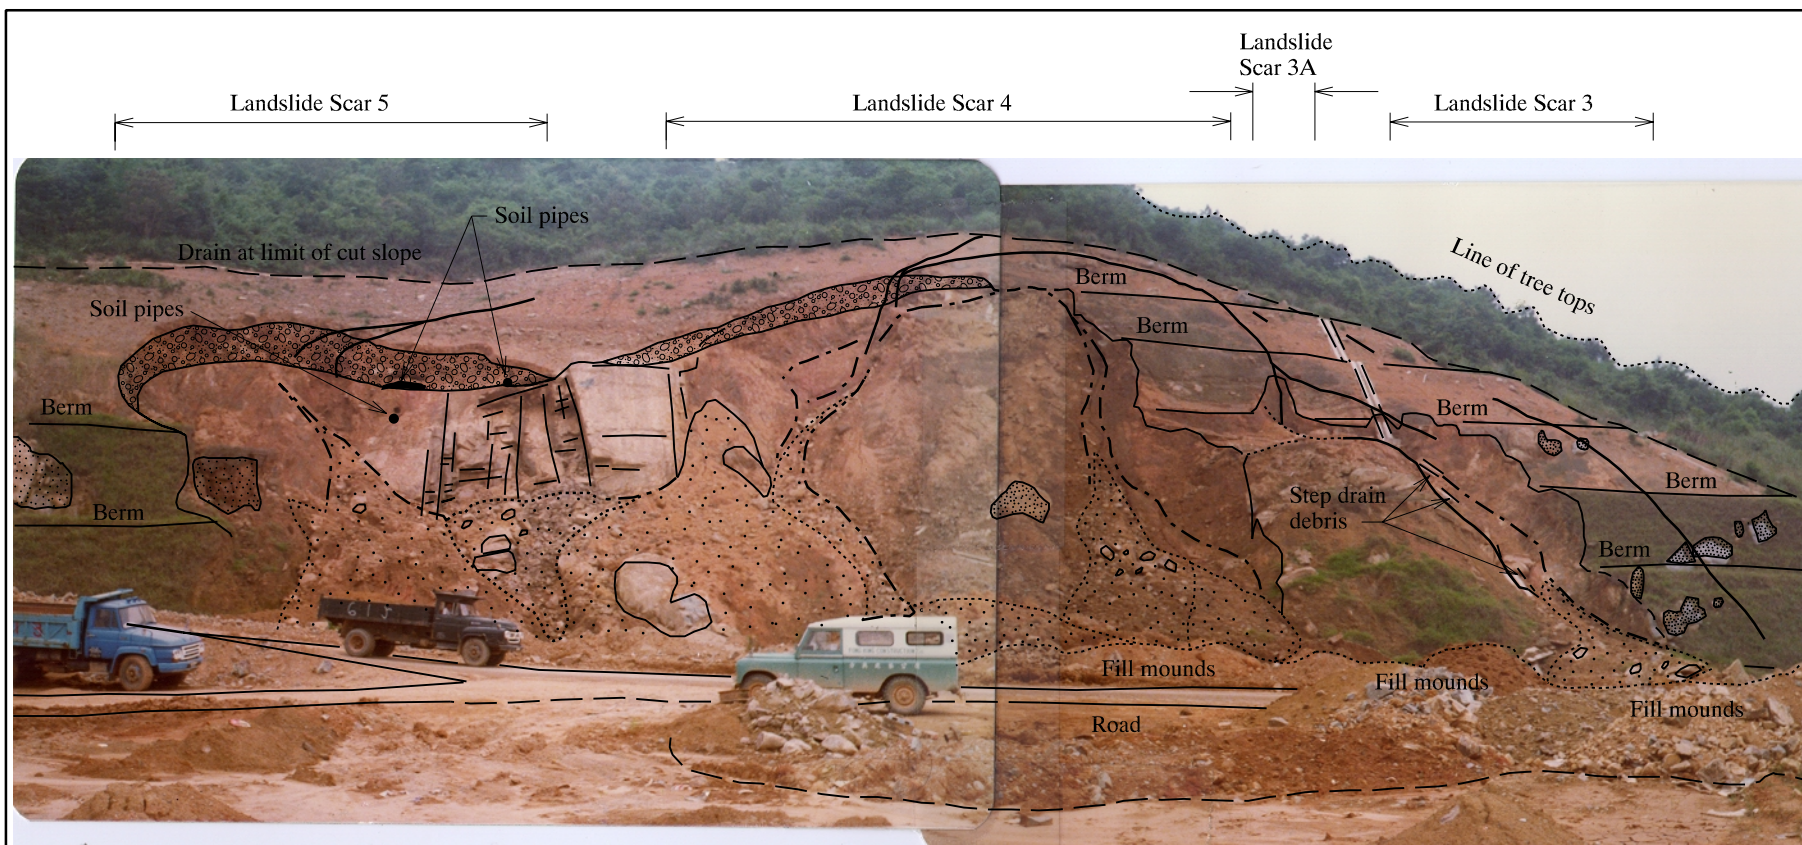
Plate 2 - Oblique View of the Cut Slope after the First Reported Failure in June 1978  
(Taken in October 1979 by Maunsell Consultants Asia)

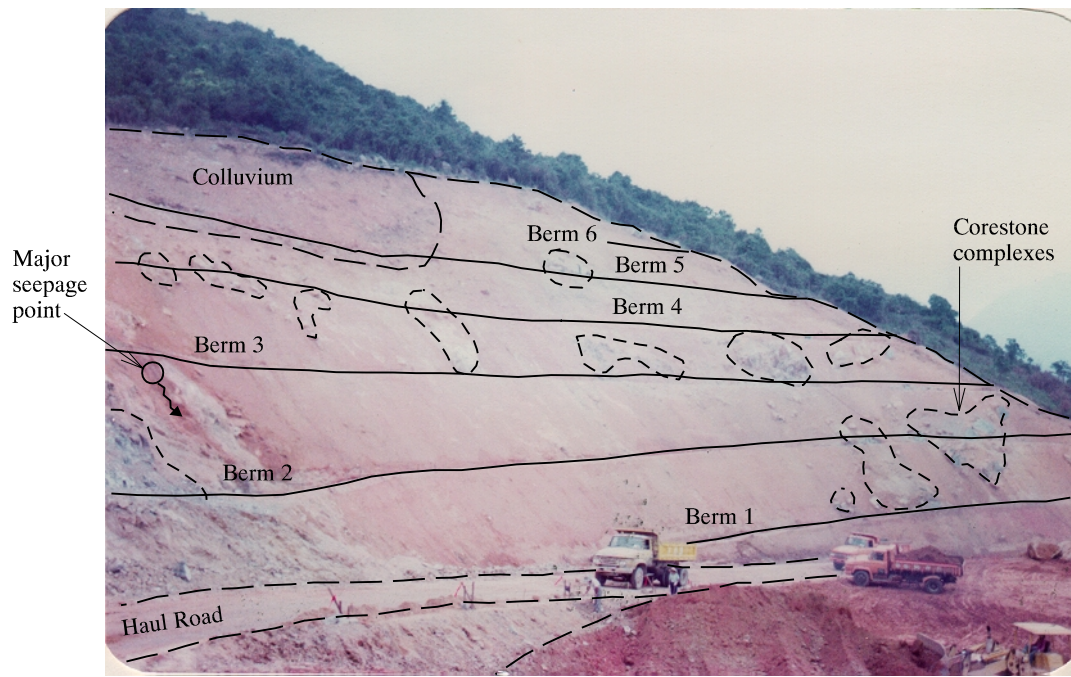
Plate 3 - Oblique View of the Cut Slope During Construction  
(Taken on 3 March 1978 by Binnie & Partners H.K.)

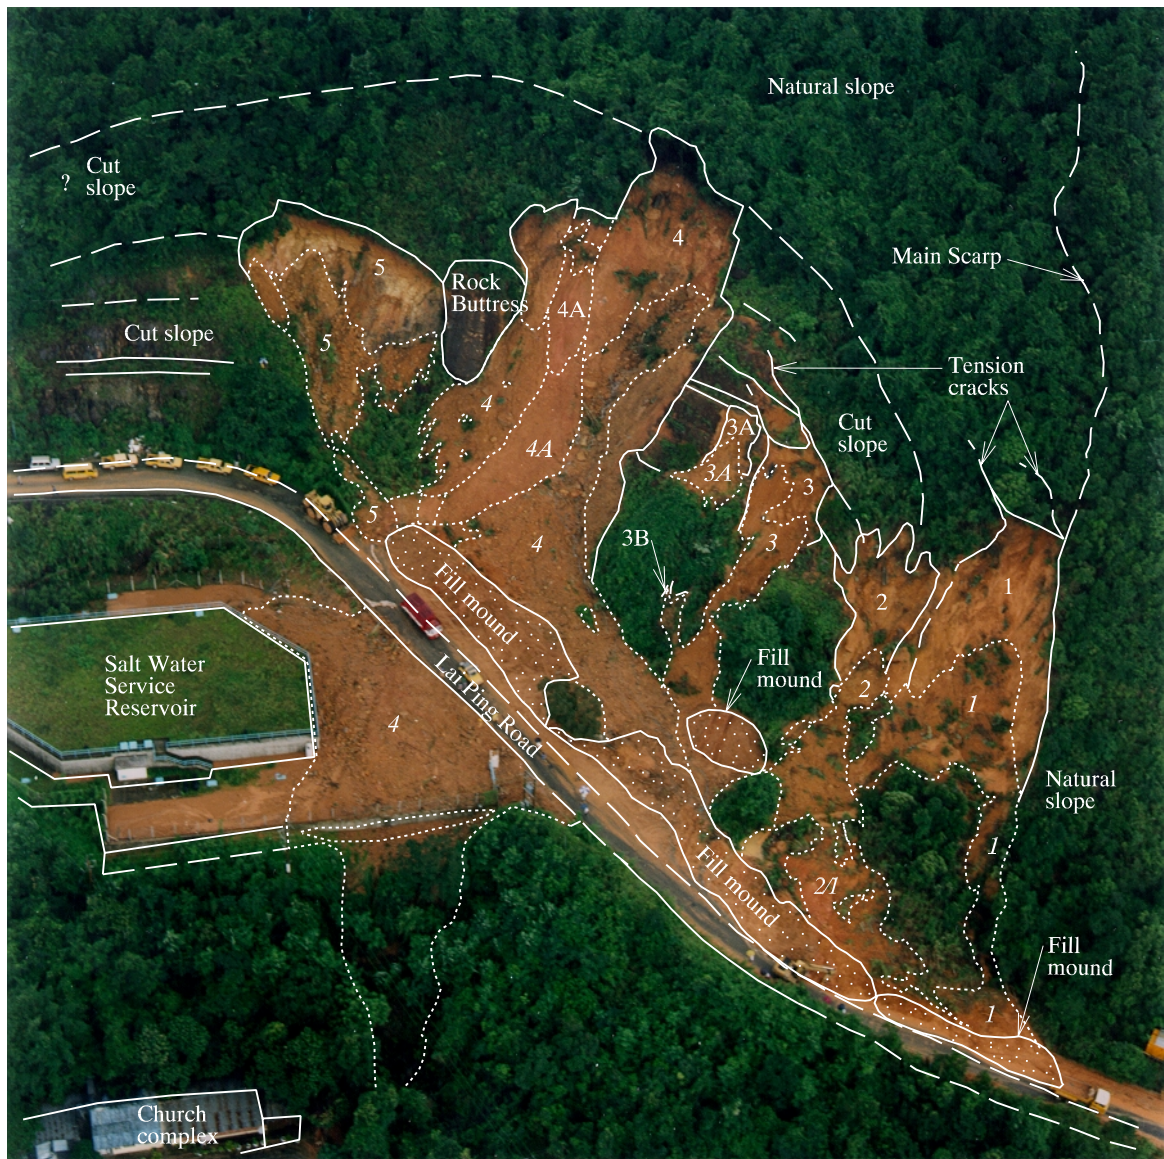
Plate 4 - Oblique Aerial View of Lai Ping Road Landslide (Annotated to Show the Landslide Scars 1-5 and Associated Debris and Part of the Main Scarp, Taken on 4 July 1997)

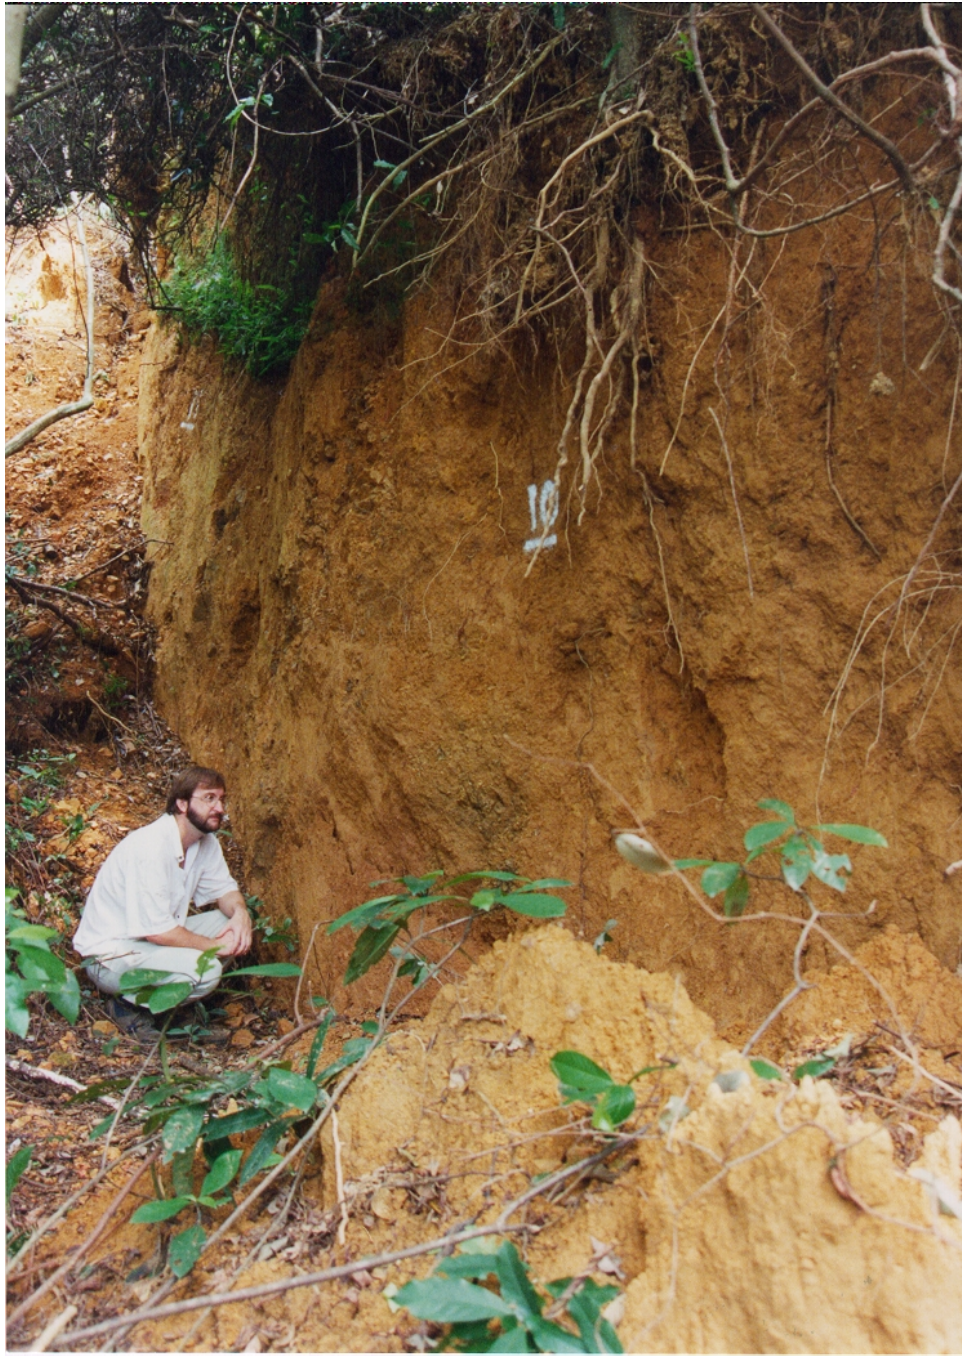
Plate 5 - Main Scarp, Vertical Displacement at this Point is 3.8 m  
(Taken on 26 September 1997)

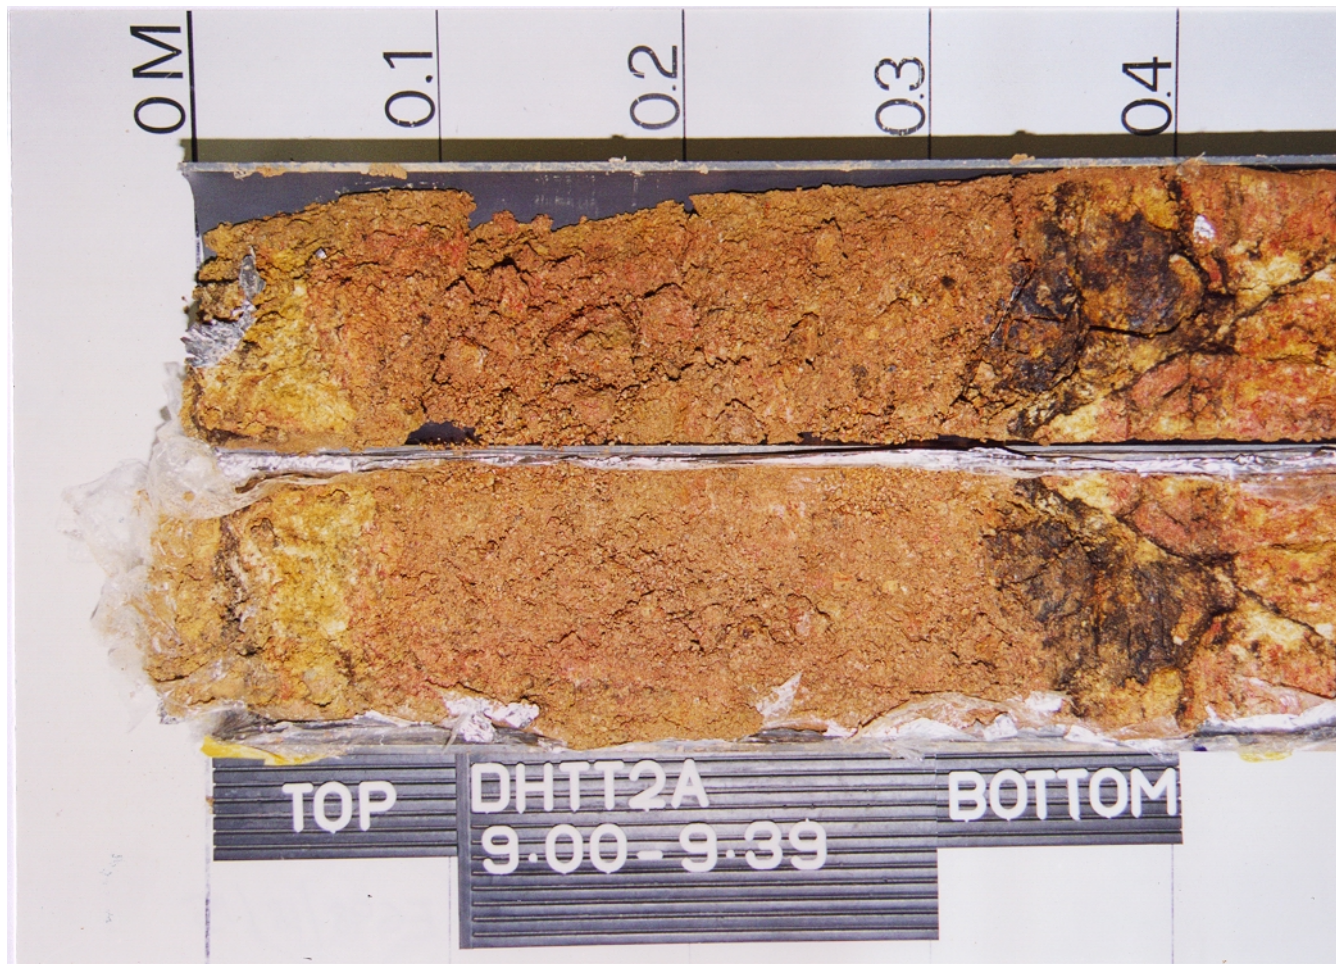
Plate 6 - Close-up of Split 4CMLC Core from Drillhole TT2A Showing an Anomalous Zone within Grade V Saprolite Interpreted as Being either an Infilled Soil Pipe or a High Permeability Shear Zone (Taken on 6 May 1998)
