SECTION 2: REPORT ON THE RAINSTORM AND LANDSLIDES OF 1-4 JULY 1997

T.W.K. Lam

ABSTRACT

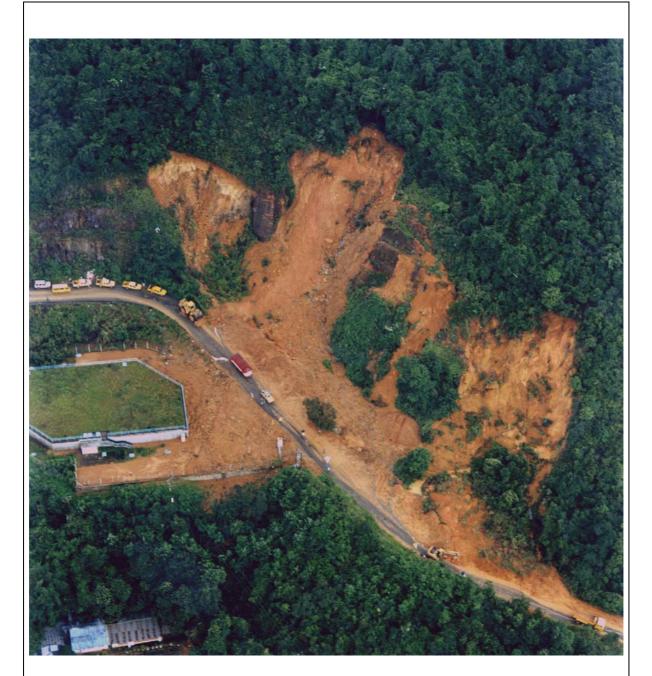
(A major soil cut slope failure resulting in the total blockage of Lai Ping Road and one lane of Tai Po Road, Plate 1)

On 2 July 1997, the landslide occurred on a soil cut slope (7NE-C/C95) along Lai Ping Road in Kau To Shan, Sha Tin. The landslide consisted of several discrete failures but two were dominant. The first dominant failure occurred at around 8:00 p.m. on 2 July 1997 with an estimated volume of 2 250 m³. The travel angle, that is the inclination of the line jointing the distal end of the debris and the crest of the landslide, was about 21°. A subsequent dominant failure occurred between 10:00 p.m. and midnight on 2 July 1997 with an estimated volume of 1 250 m³. The travel angle of the failure debris was about 18°. The landslide comprised several discrete failures and extended along a 135-m section of the cut slope. The total volume of the detached failures was about 4 000 m³. The landslide debris totally blocked Lai Ping Road and trapped a truck driver, who was rescued.

A major backscarp complex was found in the densely-vegetated terrain, 30 to 50 m

beyond the crest of the cutting. Evidence of fresh ground disturbance with up to several metres of both vertical and horizontal displacements were observed. The total volume of this potentially unstable mass was estimated to be about 100 000 m³.

Description: Major landslide of a cut slope resulting in total blockage of Lai Ping Road.

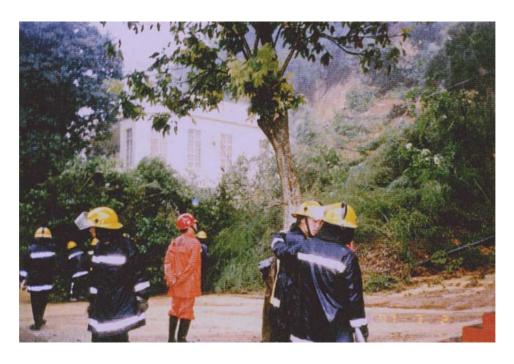
Plate 3 - Ten Thousand Buddhas' Monastery, Sha Tin (Incident ME 97/7/3)

(Major soil cut slope failure which resulted in one fatality, one injury and building damage, Plates 2 and 3)

This landslide occurred at the Ten Thousand Buddhas' Monastery, Sha Tin at 6:15 a.m. on 2 July 1997. The landslide involved the collapse of part of the registered soil cut slope No.7SW-B/C116 and part of the hillside above. About 1 500 m³ of debris was released during the landslide, leaving a main scarp about 25 m wide with a rupture surface about 25 m long and 6 m deep on the southwest flank, and about 1 m deep on the northeast flank. The maximum horizontal travel distance of the debris was about 40 m, as measured from the crest of the landslide to the distal end of the debris. The travel angle of the landslide was about 32°. Copious seepage was observed from about 2 m below ground level in the main scarp of the landslide. Seepage flow and surface water runoff resulted in the formation of gullies along both sides of the debris. A building known as Kun Yam Din was damaged and an adjacent annex building was buried by the landslide debris. The landslide resulted in one fatality in the annex building and one person in Kun Yam Din was slightly injured.

The landslide at Ten Thousand Buddhas' Monastery was probably caused by elevated water pressure along adversely oriented discontinuities in the weathered granite of the slope, following the heavy rainfall that immediately preceded the failure. A lack of maintenance of the cut slope prior to the failure had probably resulted in local progressive slope deterioration.

Description: A close-up of the Kum Yam Din building and the annex building buried by landslide debris.

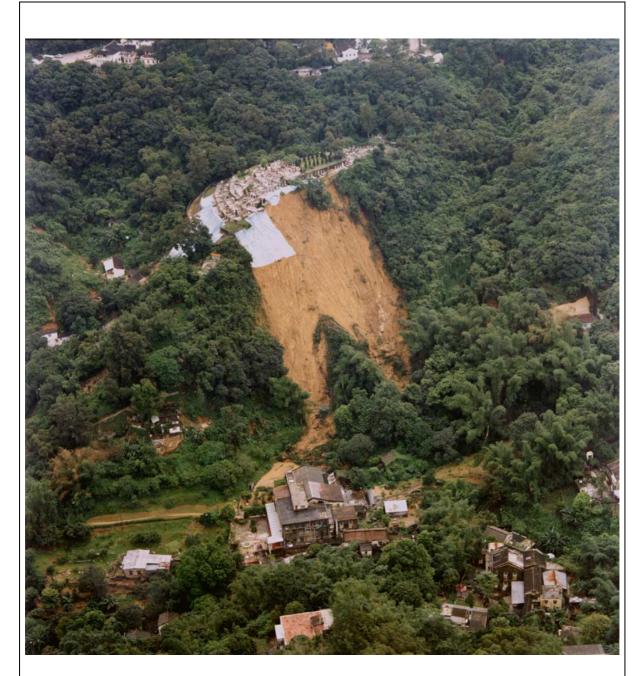
Plate 4 - Tao Fung Shan Christian Cemetery, Sha Tin (Incident ME 97/7/69)

The main scarp of the northern landslide (ME97/7/69) was 52 m wide and comprised two back scarps separated by an area of vegetated loose fill which did not collapse in the failure. The larger back scarp to the east was about 32 m wide, 15 m long and 3 m high.

The smaller back scarp to the west was about 10 m wide, 10 m long and 2 m high. The failure was shallow (about 0.3 m to 1 m). The volume of debris derived from the main scarp was estimated to be about 600 m³ and an estimated volume of about 300 m³ of soil and debris was entrained as the landslide displaced down the natural hillside. The overall travel angle of the landslide was about 30°. The northern landslide resulted in a closure order for the cemetery.

The probable cause of the landslides was saturation of the fill slopes, with contributory factors including: (a) substandard formation and construction of fill platforms, terraces and retaining walls, (b) inadequate maintenance of the fill platforms, terraces, and retaining walls, and (c) inadequate drainage provision for surface water runoff from the fill platforms and terraces.

Description: An aerial view of the landslide on the northern slope.

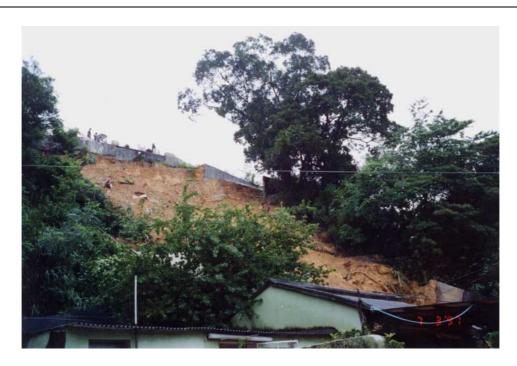
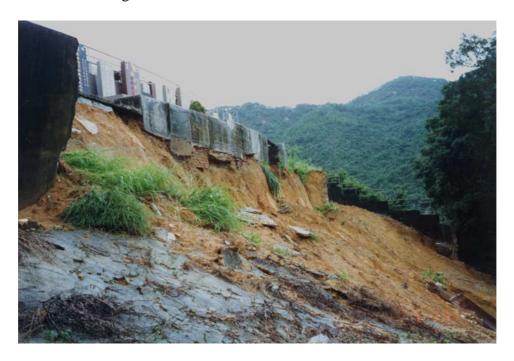
Plates 5 & 6 - Tao Fung Shan Christian Cemetery, Sha Tin (Incident ME 97/7/5)

The eastern landslide (ME97/7/5) primarily involved the failure of two retaining walls at the eastern end of the cemetery. Most of the landslide debris from behind the retaining walls travelled down slope, stripping about 150 m³ of additional material from the natural hillside, and came to rest on the cut and fill platform below the cemetery, demolishing part of house No. 163. The estimated total volume of landslide debris was 400 m³. The travel angle of the landslide was about 35°. The main scarp extended about 2 m up slope from the original position of the retaining wall and was about 28 m wide and 2 m high. During an inspection of the landslide on 2 July, a heavy flow of water was observed over the terrace behind the failed walls and down the slope. The chunam cover on the terrace was severely cracked and numerous cracks were also observed in the paving of the cemetery above the retaining walls. The eastern landslide resulted in the permanent evacuation of four huts, temporary evacuation of one hut and the closure of the cemetery.

Description: The main scarp of the eastern landslide, which resulted in the permanent evacuation of four huts, temporary evacuation of one hut and closure of the cemetery.

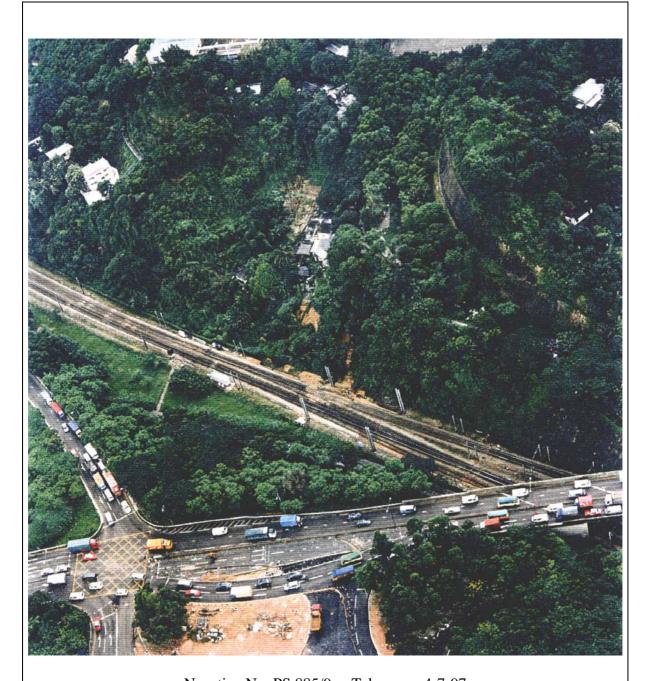
(Major failure of a partly modified natural hillside which occurred about 250 m southwest of Fo Tan Station along the Kowloon-Canton Railway (KCR), resulting in the derailment of a northbound train and significant disruption of rail services, Plates 7, 8 and 9)

This landslide occurred between 0:40 a.m. and 5:54 a.m. on 2 July 1997, at about 250 m southwest of the Fo Tan Station. The landslide originated from the upper part of a partly modified natural hillside and produced a failure scar about 15 m long and 8 m wide with an average depth of about 1.5 m. The volume of failure was estimated to be about 100 m³. The shape of the main scarp of the landslide suggests that there might have been two phases of movement. The first phase of failure was a translational debris slide with an estimated volume of 80 m³, occurred immediately north of the squatter platform. The travel angle of this first phase of failure was about 30°. The second phase of failure was also a translational debris slide, involving about 20 m³ of debris. The travel angle of this second phase of failure was about 38°. Debris from the landslide obstructed the northbound KCR rail track. The first northbound train of the day was derailed by the landslide debris, causing

Surface water flowing along the platform at the crest of slope was observed by KCRC staff on the day of the failure. Part of the surface water flow was channelled into the landslide. The washout action of the surface water flow eroded a gully below the rupture zone of the failure and significantly reworked the debris at the toe of the slope.

The probable cause of failure was build-up of transient water pressure due to heavy rainfall within the soil mass along an adversely oriented sheeting joint system.

Description : An aerial view of a partly modified natural hillside landslide resulting in the blockage of a northbound rail track and the derailment of a train.

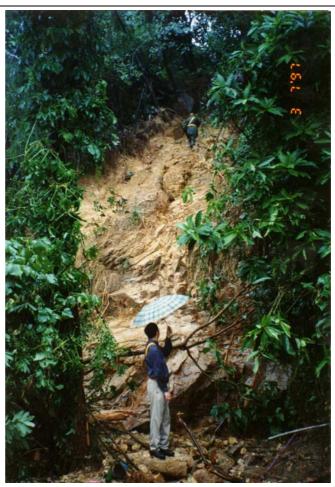
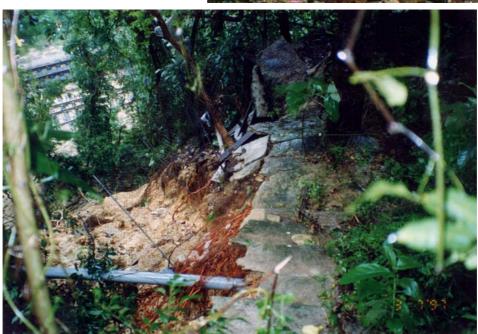
Plates 8 & 9 - Near Fo Tan Station of the Kowloon-Canton Railway, Sha Tin (Incident ME 97/7/30)

Description: A partly modified natural hillside landslide resulting in the blockage of a northbound rail track and the derailment of a train.

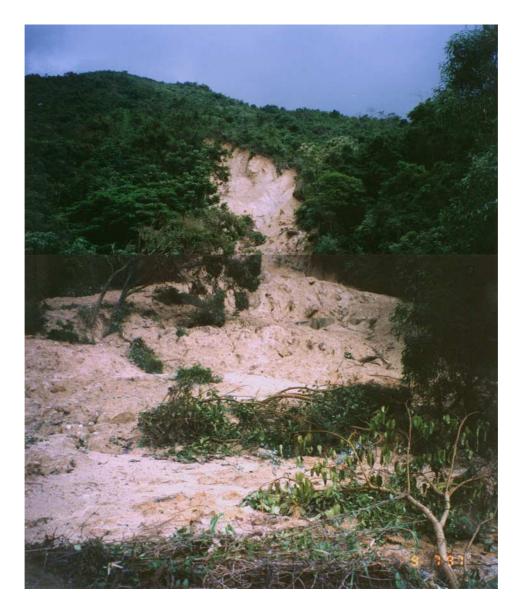
Plate 10 - Ma On Shan Road, near the Shing On Temporary Housing Area, Ma On Shan (Incident ME 97/7/51)

The landslide was probably triggered by intense rainfall. The contributing factors to the failure include: (a) the presence of a pre-existing gully that led to concentrated surface water flowing into the area of the landslide, (b) the presence of a persistent, planar discontinuity, (c) the oversteep soil cut slope above the fill platform, (d) the presence of loose fill, and (e) infiltration of rainfall and surface water directly into the slope and natural hillside above.

Description: A natural slope failure affecting a cycle track.

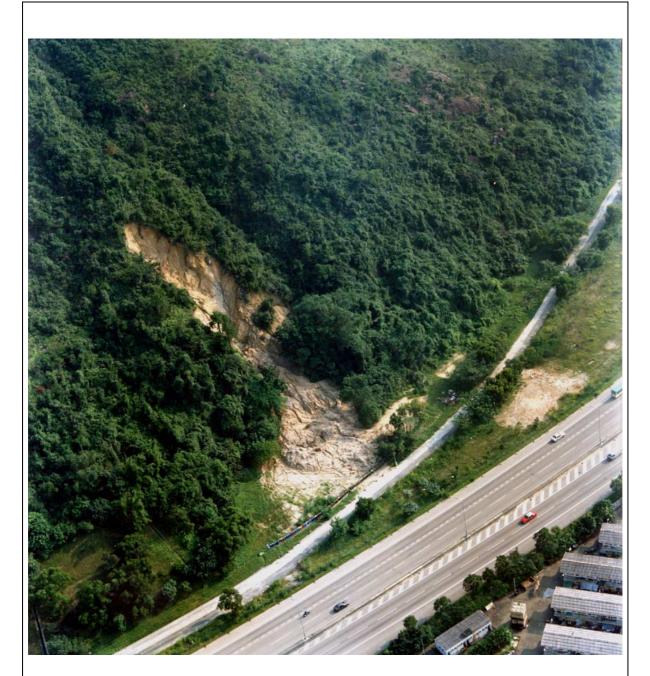
Plate 11 - Ma On Shan Road, near the Shing On Temporary Housing Area, Ma On Shan (Incident ME 97/7/51)

Description: An aerial view of a natural slope failure affecting a cycle track.

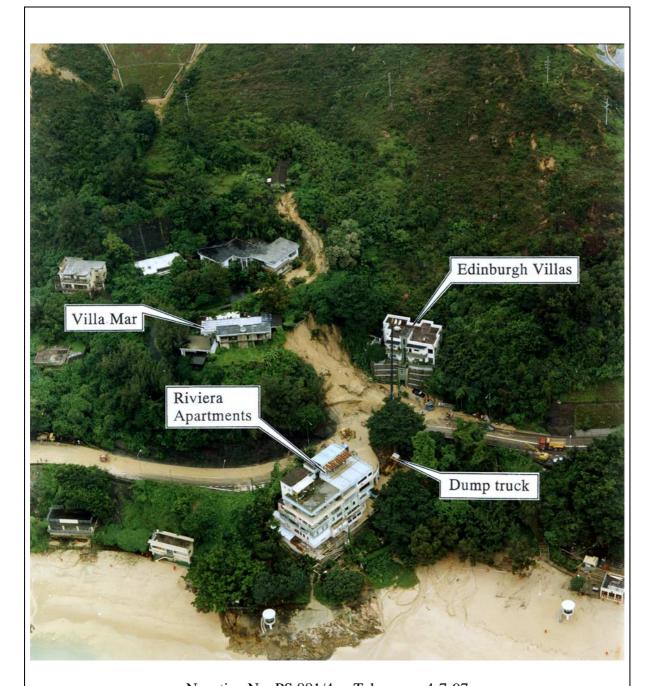
Plate 12 - Castle Peak Road near Lido Beach (Incident MW 97/7/10)

On the morning of 2 July 1997 at 8:00 a.m. a large washout of a sandy fill occurred from the Ting Kau Bridge construction site, about 200 m east of the major failure. The fill material washed onto the Castle Peak Road blocking one lane. At around 8:30 a.m., workers from the Ting Kau Bridge Contractors (TKBC) commenced clearing the debris, but fifteen minutes later a second large washout of sand reached Castle Peak Road and spread as far as Edinburgh Villas, accumulating to a depth of around 300 mm. A double decker bus became stuck in the debris at 9:00 a.m., resulting in the closure of both lanes of Castle Peak Road. An excavator and a six-wheel dump truck with five workers from TKBC were mobilized to undertake the clearance work. By 11:45 a.m., the TKBC workers had cleared most of the debris from Castle Peak Road and were clearing up in front of Edinburgh Villas. At 11:45 a.m., a major landslide occurred on a 15-m high partly modified natural slope beneath the property on the crest. Landslide debris ran over the access road and lifted the truck and carried it down the slope towards the swimming pool at Riviera Apartment. The landslide also affected a registered fill slope (Slope No.6SE-C/F3) downhill. The rupture surface of the landslide was 25 m wide, 20 m long and up to 3 m deep. The travel angle of the landslide, measured from the crest of the main scarp to a point on top of the debris on the downslope side of Castle Peak Road was 20°. Approximately 750 m³ of debris from the landslide completely blocked Castle Peak Road and an access road to six abandoned properties. Eight persons were injured.

The probable landslide trigger was a rise in the groundwater table created by the combined effects of direct infiltration from rainfall and from surface water around the flooded abandoned properties.

Description: An aerial view of a landslide resulting in complete closure of Castle Peak Road and a dump truck which was carried by the landslide debris down the slope.

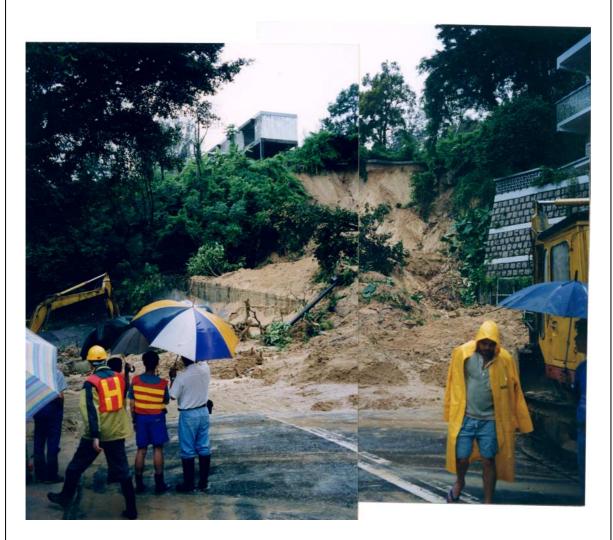
Plate 13 - Castle Peak Road near Lido Beach (Incident MW 97/7/10)

No obvious seepage was noted in the main scarp during the inspections on 2 July and 3 July 1997. However, on 7 July 1997 when the debris had been removed from the lower part of the slope and rockfill had been placed, a moderately strong seepage was observed at two locations near the toe of the slope.

Description: A close-up of a landslide resulting in complete closure of Castle Peak Road.

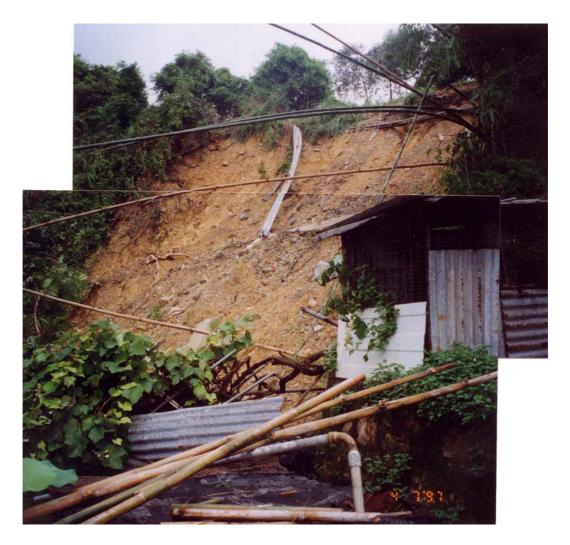
Plate 14 - Milestone $6\frac{1}{2}$, Tai Po Road, Sha Tin Heights, Sha Tin (Incident MW 97/7/27)

A landslide was reported at Milestone 6-1/2, Tai Po Road, Sha Tin Heights at 2:00 p.m. on 4 July 1997. The landslide occurred in a fill slope (Slope No.7SW-D/F158) with poor vegetation cover and no surface drainage system. A tension crack was observed near the scarp. The failure involved a scar about 10 m wide and 5 m high. The estimated failure

volume was about 50 m³. The landslide debris punched through a corner of a squatter hut on the slope and damaged a second hut near the toe. Six squatter huts were permanently evacuated as a result.

The probable landslide trigger was infiltration during the heavy rainfall.

Description: A fill slope failure which damaged a squatter hut.

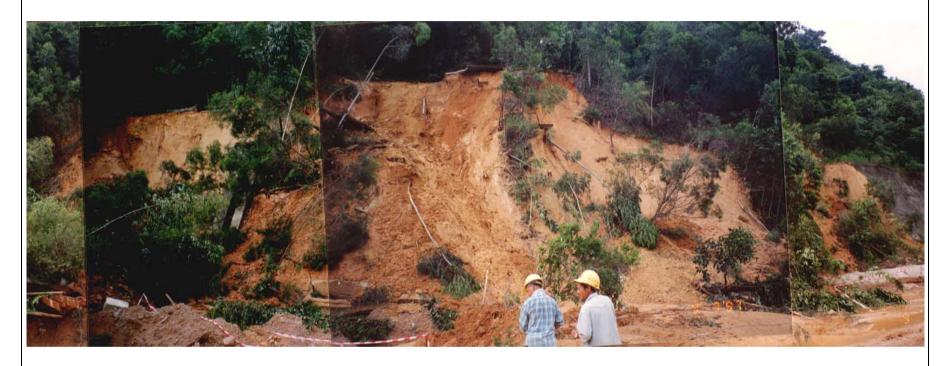
Plate 15 - Ching Cheung Road, Cheung Sha Wan (Incident MW 97/7/70)

A cut slope failure occurred at 9:00 a.m. on 7 July 1997, followed by two progressive failures on 17 July and 3 August 1997. The initial slope failure involved about 500 m³ of soil detached from the lower part of the central eastern portion of the cut slope (Slope No. 11NW-A/C55). The debris just reached a section of Ching Cheung Road which was closed as part of construction works for a Highways Department Improvement Project. observed failure scar was confined to the lower two batters, and affected a 52 m length of slope that extended up to 15 m above Ching Cheung Road. The exposed failure surface was apparently shallow but variable in depth, typically less than 2 m. A second progressive failure occurred on 17 July 1997 and involved an estimated volume of 700 m³ of soil from the concave section of the slope immediately above the western part of the first failure. failure debris run out was again confined to the closed section of Ching Cheung Road. failure reached up to 30 m above the road and was 30 m long, 15 m wide and about 5 m deep (maximum). A third progressive failure occurred on 3 August 1997 and resulted in the complete blockage of a 50 m section of Ching Cheung Road, trapping a car travelling on the westbound carriageway. The driver of the car was uninjured. The estimated failed volume of the landslide was 2 000 m³. The travel angle of the 3 August 1997 failure was about 20°. A depression was formed up to 7 m deep and 20 m wide extending 30 m above Ching Cheung Road and the earlier landslide scars were deepened and eroded.

The principal cause of failure was adverse transient groundwater conditions, which developed following severe rainfall in early July 1997 and the previous month. The site was unusual in that it had a long history of deep-seated failures and had a well-developed natural pipe system which controlled the hydrogeology. A system of raking drains, installed in the slope in 1972, was unable to prevent the critical water pressures developing.

Description: A major initial cut slope failure resulting in the landslide debris encroached onto the closed section of Ching Cheung Road.

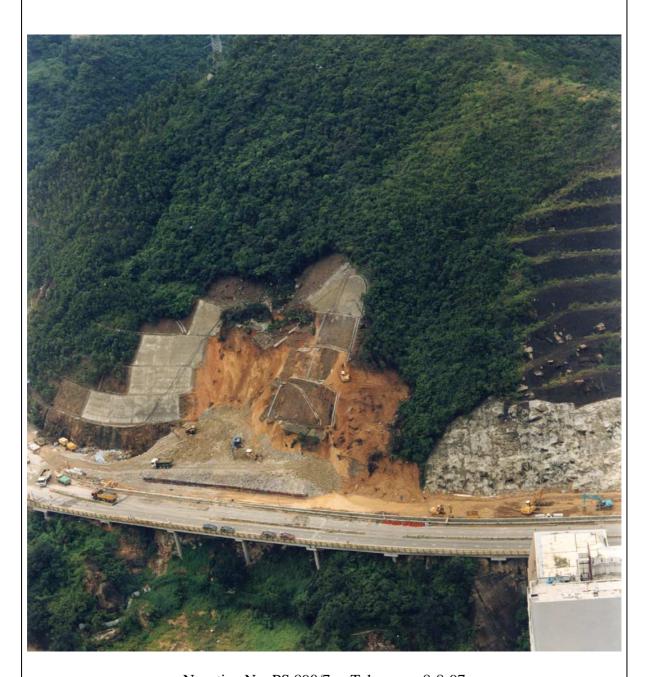
Plate 16 - Ching Cheung Road, Cheung Sha Wan (Incident MW 97/7/70)

Description: An aerial view of urgent remedial works following initial slope failure on 7-7-97 and two subsequent failures on 17-7-97 and 3-8-97.

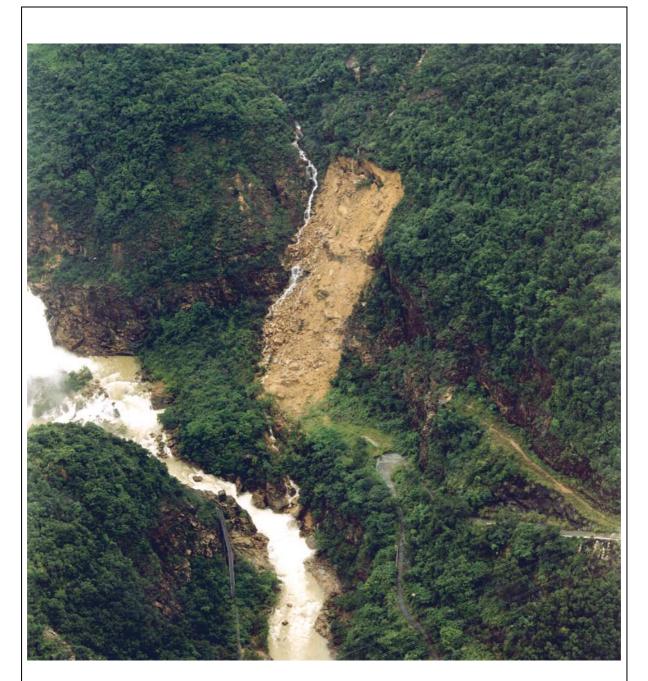
Plate 17 - Shing Mun Main (Upper) Dam, Tsuen Wan

A failure of a rock cut slope first noted by GEO on 3 July 1997 and which almost certainly occurred on 2 July 1997, was located approximately 200 m below the Shing Mun

Main (upper) Dam. The main scarp of the failure was about 45 m wide, 8 m to 10 m deep and at an elevation of about 175 m. The estimated failed mass was about 10 m deep and from 3 m wide in the south to 20 m wide in the north with an estimated volume of about 3 000 m³. The landslide debris travelled a maximum distance of 70 m (in plan), with a maximum fall of about 60 m, passing over two steep rock steps at elevations of approximately 125 m and 150 m. A considerable proportion (perhaps 40%) of the debris remained on the site of the failure, on the landslide scar below the failure, or in the stream course which passes down the northern side of the landslide. The remaining debris came to rest as a debris lobe on flat ground at an elevation of about 115 m. The toe of the landslide has a travel angle of about 38° to 41° to the main scarp. Seepage was noted at the top of the cut slopes adjacent to the landslide, at the elevation of the crest of the second rock step.

The probable causes of failure were adverse geological conditions and water filling up a number of open sub-vertical joints at the slope crest by direct infiltration, giving rise to high water pressures and lateral forces behind and at the base of the joints.

Description: An aerial view of a rock cut slope failure.

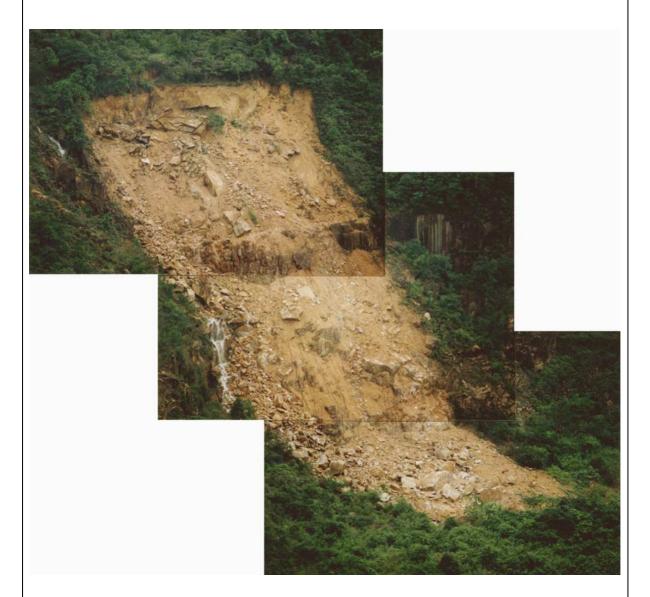
Description: A close-up of a rock cut slope failure.
