APPENDIX A  
DOCUMENTS VIEWED FOR THE INVESTIGATION

All known documents relevant to the 23 July 1994 failure were reviewed during the landslide investigation. These are listed in this Appendix for reference.

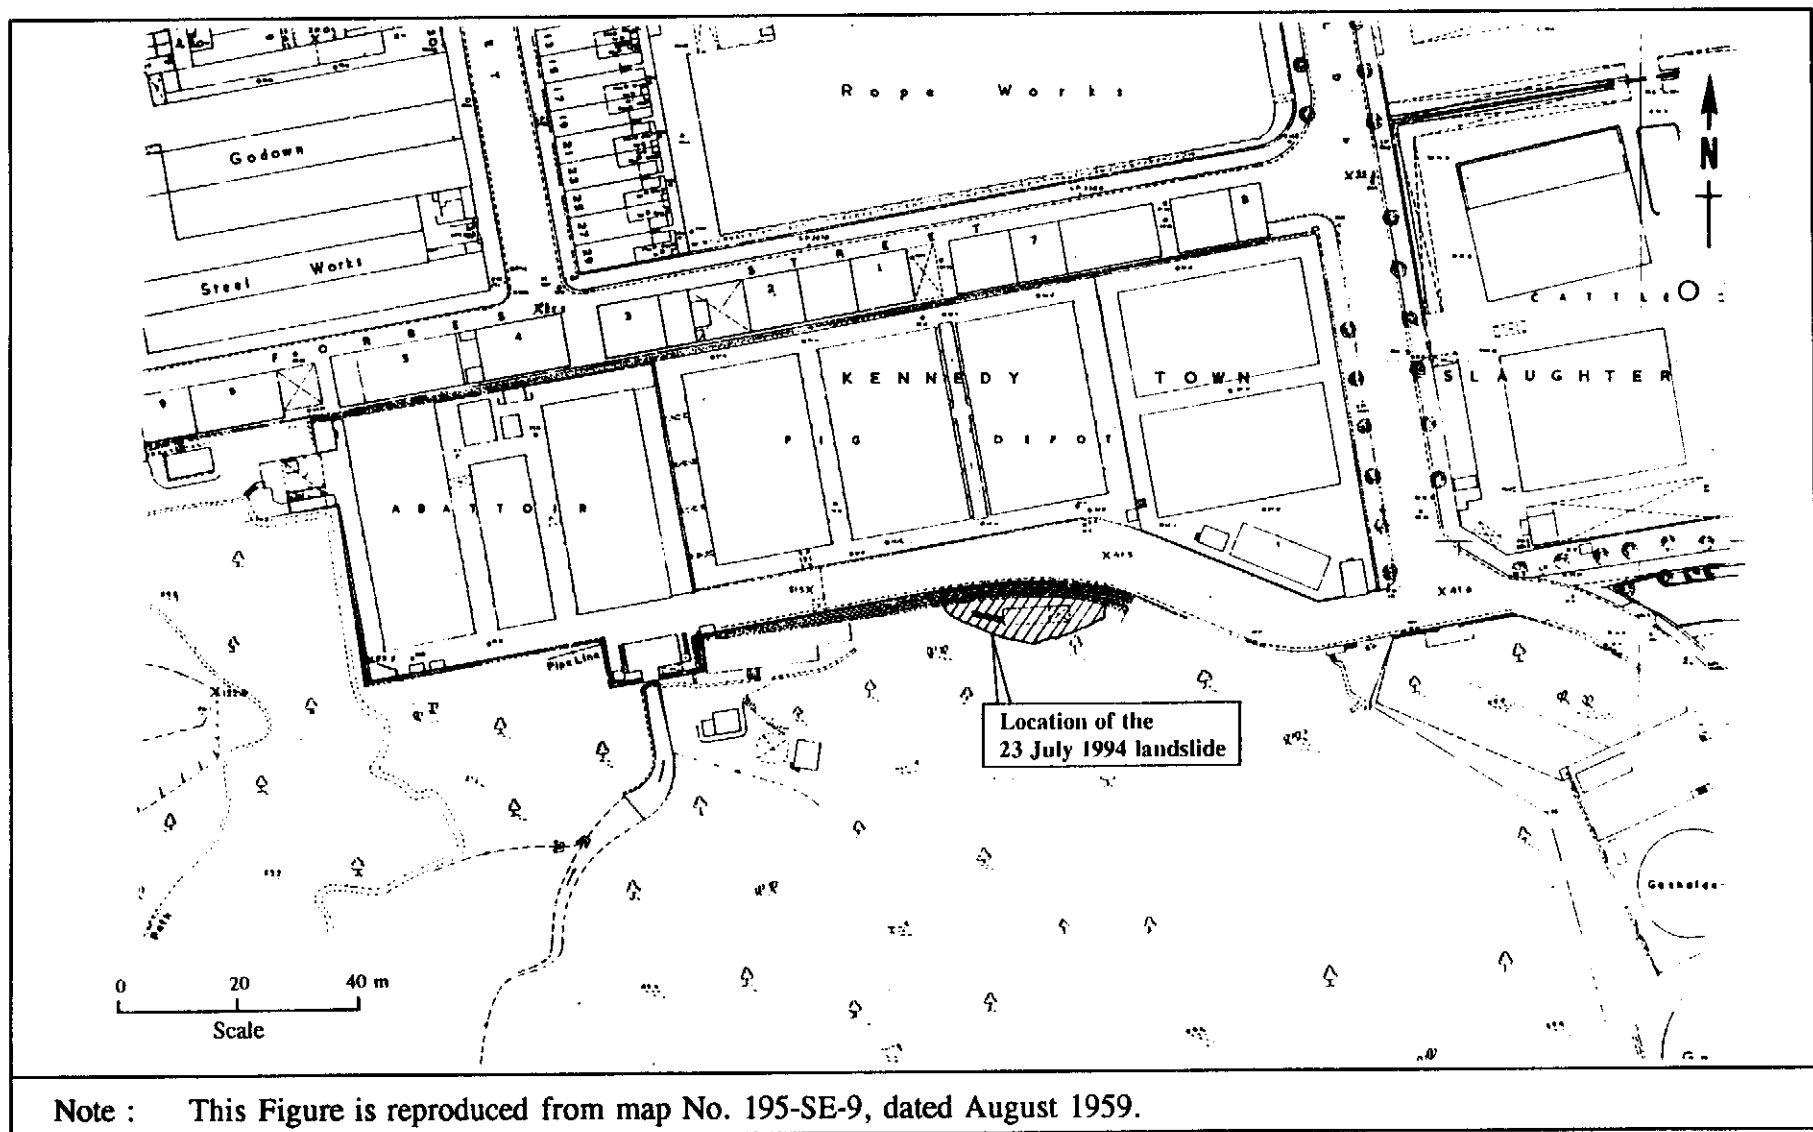
Figure B5 - Part of the 1959 Topographic Map

1959	The masonry wall that failed in the 23 July 1994 landslide is shown on the plan. A structure was present in the recessed area. Features, probably steps and squatter structures, are marked on the ground to the immediate south of the wall which failed in the landslide. Marks indicating vegetation are drawn on the ground further to the south, i.e. where the present Kwun Lung Lau is located.
1960	"SQUATTER AREA" is marked in the area to the south of the crest of the masonry wall.

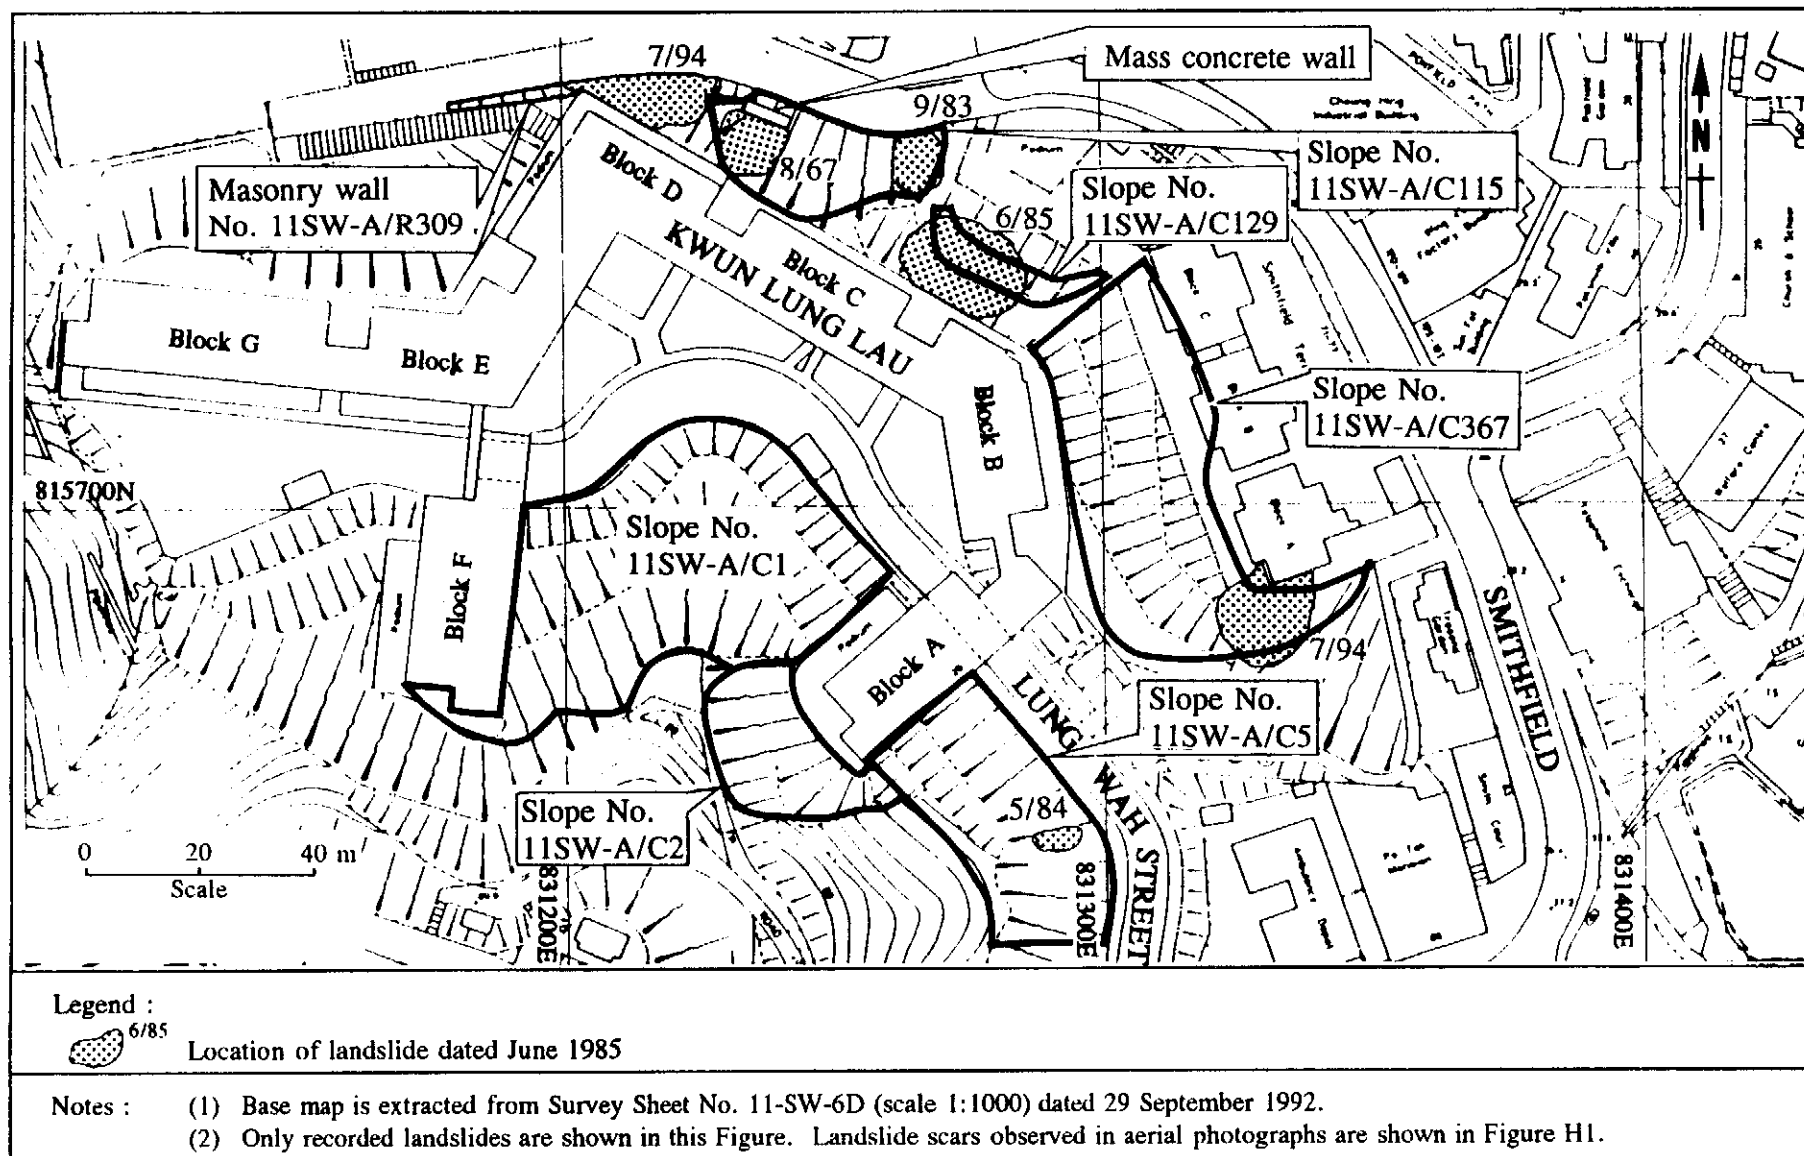
Figure C1 - Locations of Previous Landslides at Kwun Lung Lau

Date	Key Event	Points to Note
22 Aug 1967	Western part of slope No. 11SW-A/C115 failed (Figure C1).	A concrete wall was subsequently constructed near the toe of the slope, and soil/cement backfill was placed on the failed slope under the direction of W.Szeto & Partners.
1 Oct 1968	Amendments to Site Formation Plans submitted by W.Szeto & Partners were approved by BA.	Surface and subsurface drainage provisions to the north of Building Block D were amended.
3 Oct 1968	Occupation Permit was issued by BA for Block D of KLL.	
26 Sep 1977	Plans in connection with the addition of a canopy to the existing access steps leading to Block D submitted by W.Szeto & Partners on 28 July 1977 were approved by BA.	<p>One of the approved drawings indicated that two of the columns for the canopy at the northwest corner of Block D were to be founded on separate mass concrete bases which, as a typical detail, partially rested on the existing stepped "stone retaining wall" (drawn in dotted lines) and extended to the base of the masonry wall.</p> <p>The footings for these two columns were exposed after the landslide on 23 July 1994, and it transpired that they had not been constructed in accordance with the approved drawings.</p>

30 May 1984	Minor landslide (about 20 m <sup>3</sup> ) occurred at slope No. 11SW-A/C5 (Figure C1).	
11 July 1984	BA wrote to HKHS consultants, Fugro, following the landslide at slope No. 11SW-A/C5 in relation to Notice No. DH 38/HK/83.	"In view of the recent failure of slope No. 11SW-A/C5 you are advised to review the geotechnical report dated December 1983 submitted to me and to make formal submissions to me on the slope remedial works to the above slope as well as the slope referred to in the above captioned notice without further delay".

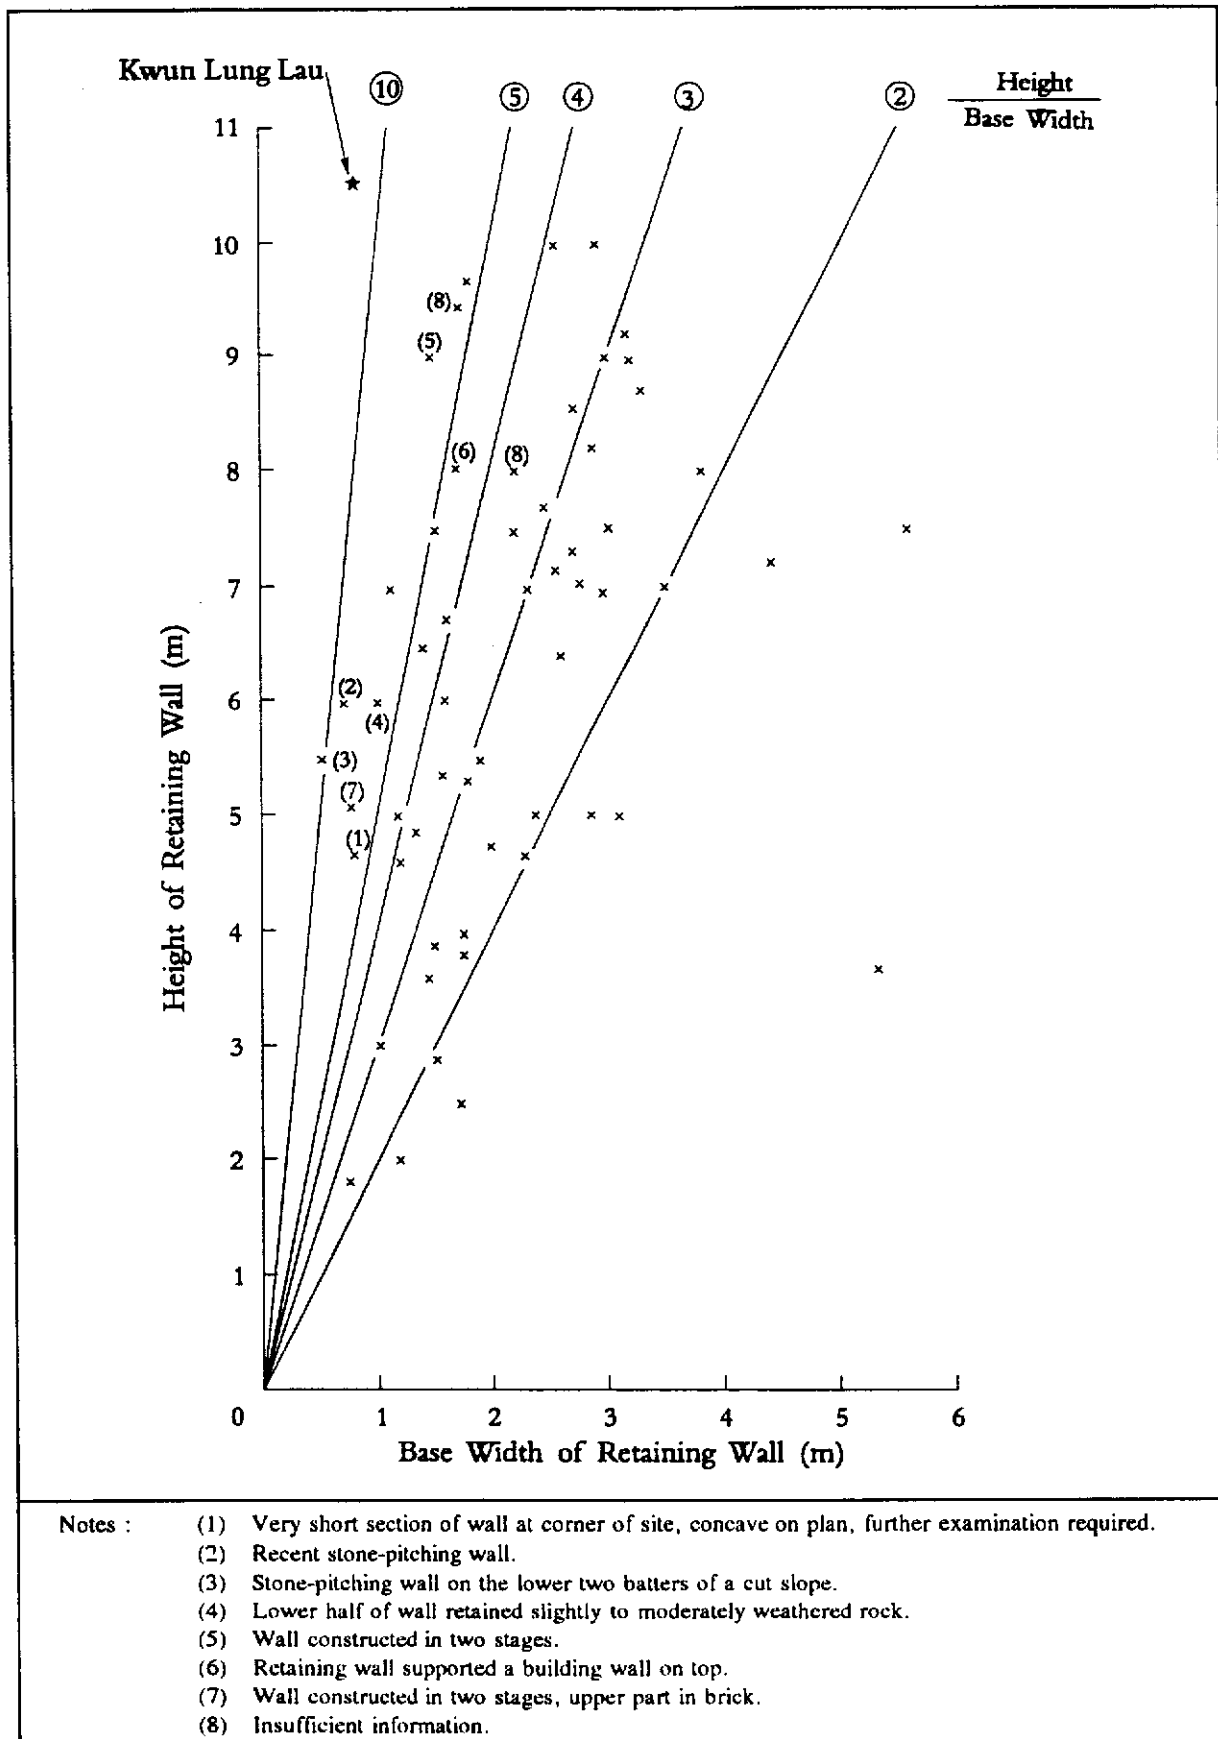
Figure E1 - Dimensions of Masonry Retaining Walls Examined in GEO Stage 2 Studies

The masonry wall at Kwun Lung Lau which partly failed in July 1994 was unusually thin. In order to judge this 'thinness' in the context of old masonry retaining walls in Hong Kong, two data sets with information on wall dimensions have been examined. The first data set was collated from reports on Stage 2 Studies carried out on retaining walls by the Geotechnical Engineering Office (GEO). The second data set comprised a collection of inspection records of old walls prepared on cards in the late 1970s when the Geotechnical Control Branch (GCB) of the Buildings Ordinance Office started an investigation of masonry walls. The GCB merged with the Geotechnical Control Office (renamed Geotechnical Engineering Office in 1991) in 1983.

The first data set could well be biased towards thinner walls, because these are more likely to have been picked out for Stage 2 Studies. The second data set should have a more random population, because the inspections were carried out on whatever walls were exposed by construction activities at that time. Two walls exposed by failures were included in the inspections, but details of their base widths were absent, and these two cases have not been included.

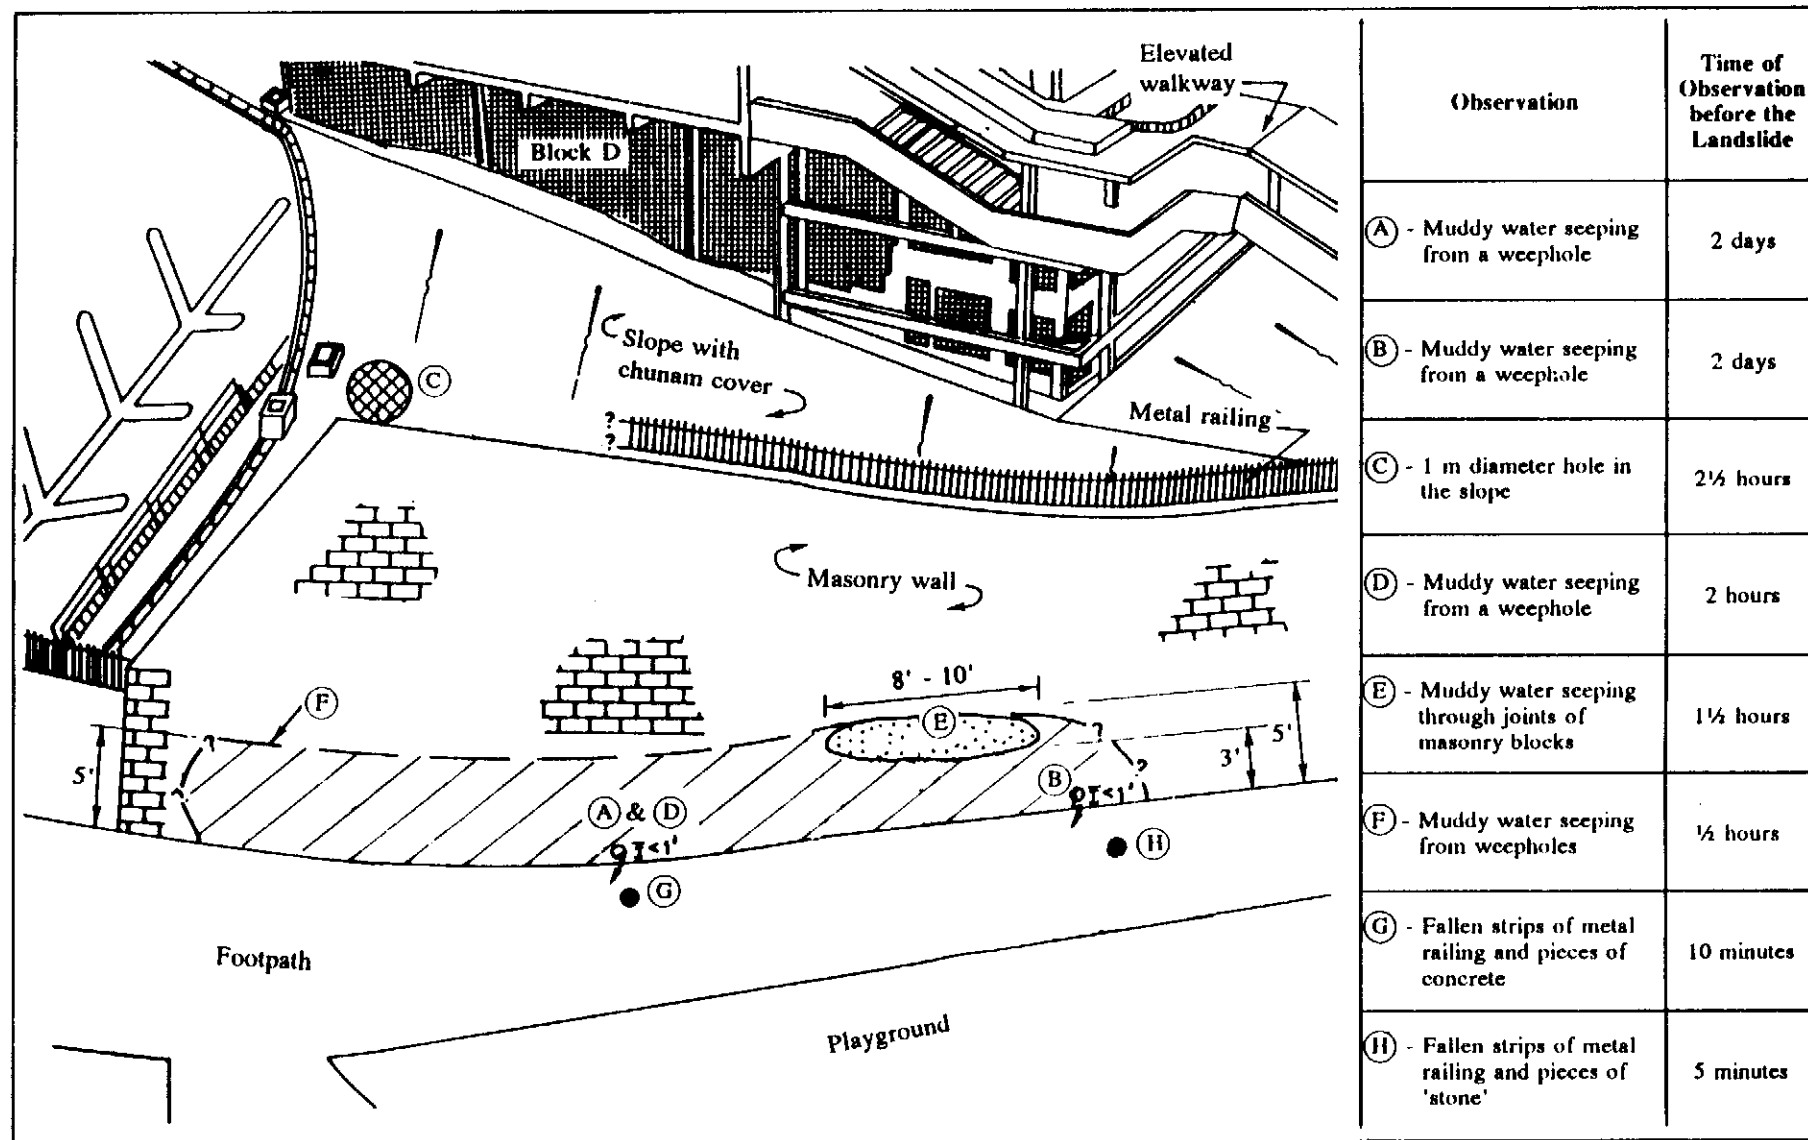
Figure F2 - Summary of Key Observations Reported by Witnesses

A brief account of the information obtained from the returned questionnaires and from the witness interviews is given below. Some important features observed by the witnesses are marked in Figure F2.

Seven witnesses reported that muddy water had been seeping through the weepholes within the lower part of the masonry wall. This was also reported in eight other returned questionnaires. Four of them reported seeing the seepage two days before the landslide, and the other eleven reported seeing this on the day of the failure.

About two-and-a-half hours before the landslide, a witness reported seeing a hole in the chunam near the manhole on the slope at the eastern edge of the landslide area while walking along the footway. The hole was noted to be about 1 m in diameter, and soil was apparently exposed due to the loss of the chunam cover.

About one-and-a-half hours before the failure, a witness noticed muddy water seeping through the weepholes and joints of the masonry wall at the failure location. The seepage level was reportedly up to, and may have been higher than, five feet above the level of the footway. The seepage area was reported as about ten feet wide, which is more extensive than the seepage areas reported in the morning of the day of the landslide and two days before. About half an hour before the landslide, another witness observed that seepage of muddy water covered an extensive portion of the failure area from the wall toe to about five feet high on the masonry wall.

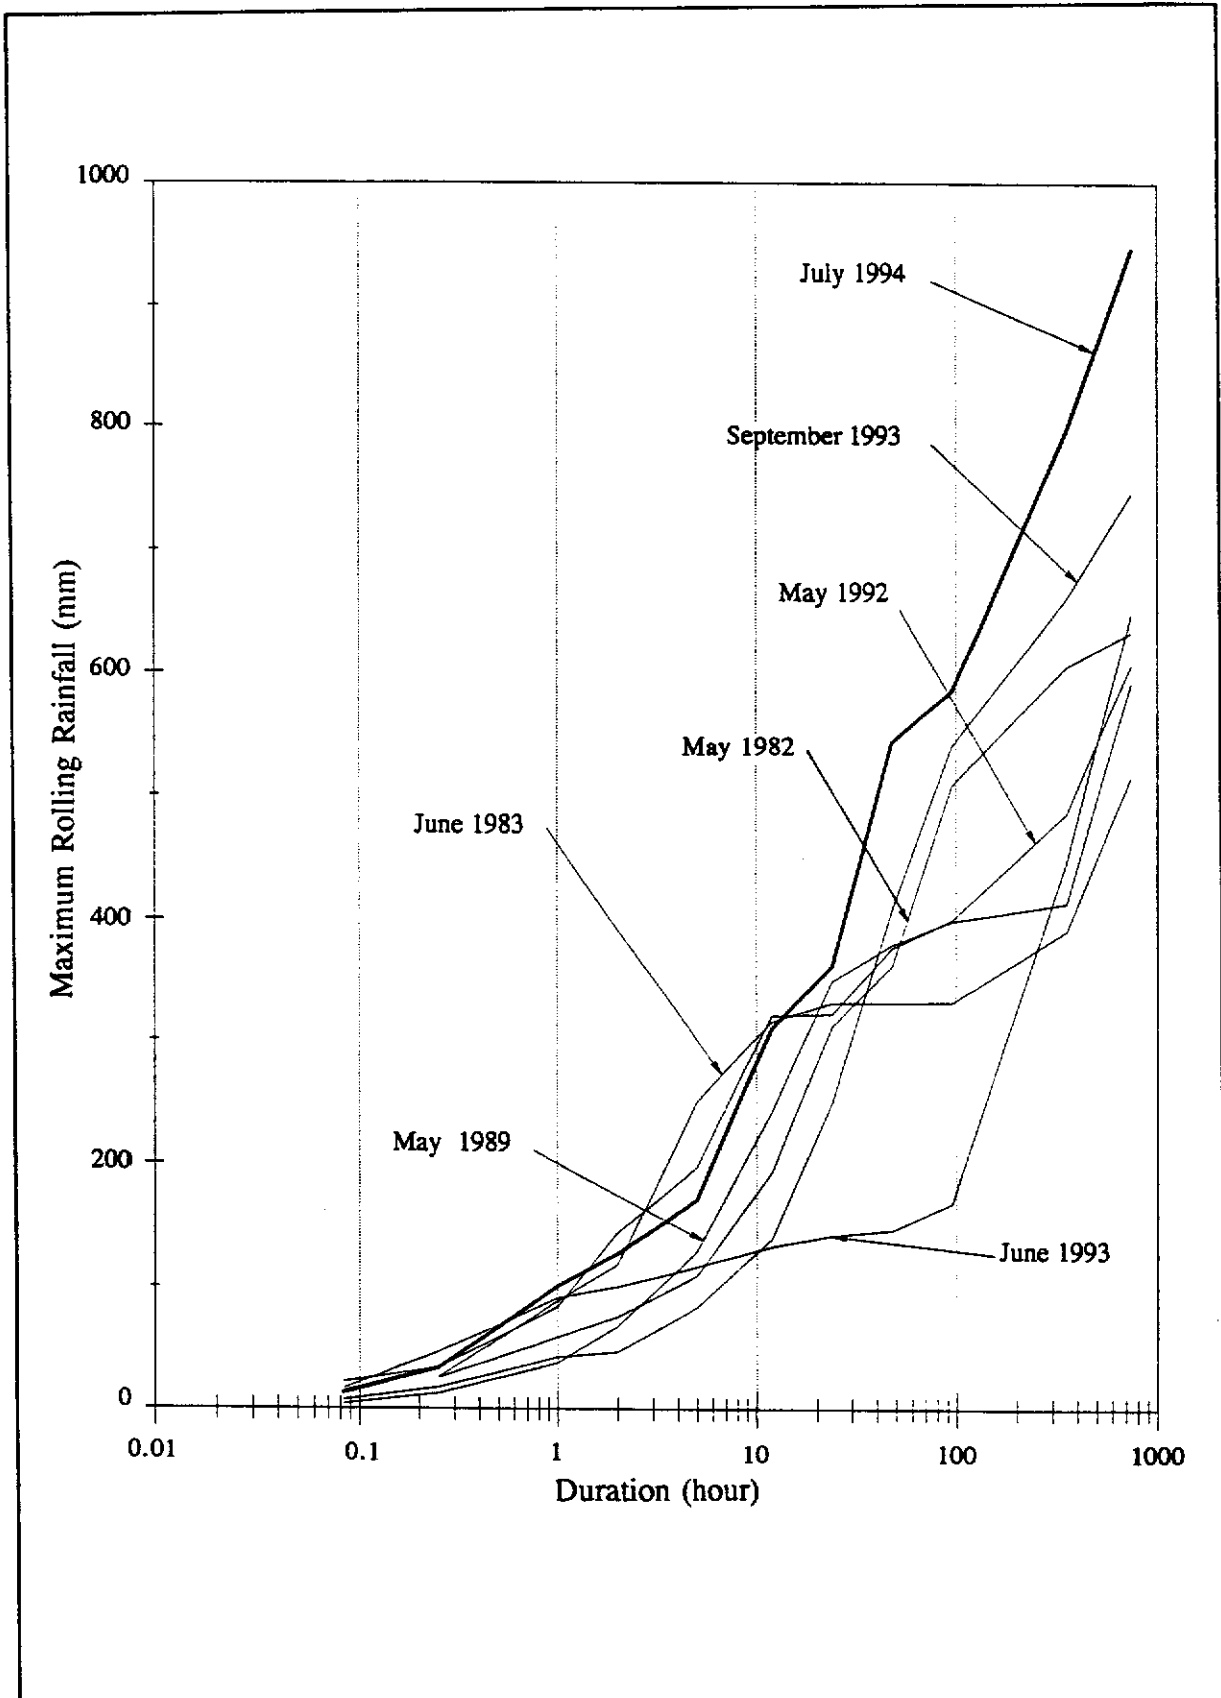
Figure G5 - Maximum Rolling Rainfalls at Raingauge No. H02 for Major Rainstorm

Fourteen previous heavy rainstorms with daily rainfalls exceeding 150 mm were identified from the rainfall records, and the maximum rainfalls for different durations of these rainstorms were processed. The results are shown in Table G2 and Figure G5. The following are observed :
