APPENDIX H
GROUND INVESTIGATION AND
ENGINEERING GEOLOGICAL STUDY

H.1 INTRODUCTION

A comprehensive ground investigation and engineering geological study were carried out by the Geotechnical Engineering Office (GEO) shortly after the landslide. The main objectives were :

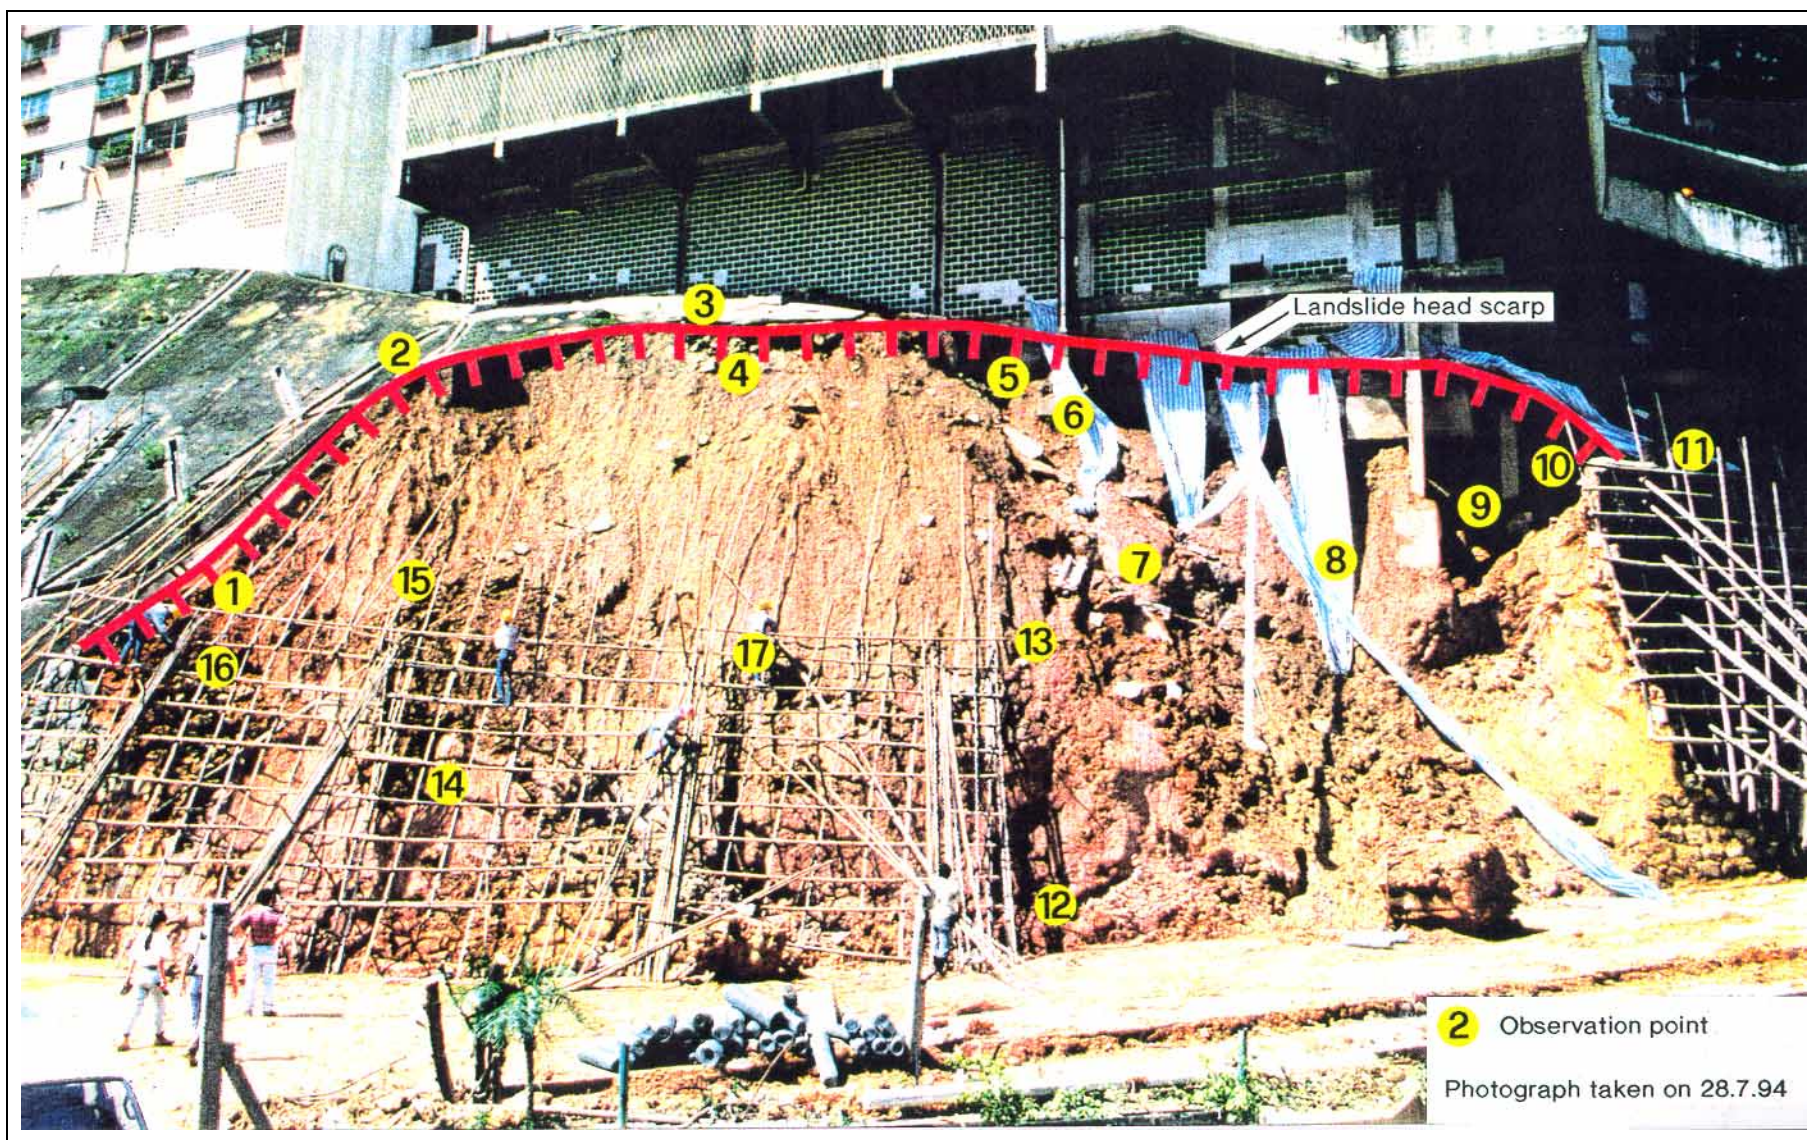
Observation Point	Description
1	FILL. Loose, moist, light brown, gravelly, silty fine SAND, structureless.
2	Sewage flowing from the underground pipe in a manhole.
3	10 mm to 50 mm wide cracks in the chunam surface. The slope of the adjacent intact surface dips at 30°
4	FILL. Loose, moist, gravelly, silty fine SAND with boulders and concrete fragments.
5	Boundary of FILL(Qf) and COMPLETELY DECOMPOSED VOLCANICS(CDV). The CDV is weak, mottled reddish brown, gravelly, silty fine SAND with relict texture. Based on the 1:20 000 geological map and drillcore examination the parent rock is a lapilli coarse to fine ash TUFF belonging to the Mount Davis Formation (JMD).
6	The column footing is mainly founded on CDV. A thin layer of compacted fill varying from 0 to 50 mm thick occurs between the column footing and CDV.
7	HIGHLY DECOMPOSED VOLCANICS(HDV). Moderately weak, light grey with yellowish brown patches. The parent rock is a lapilli coarse to fine ash TUFF belonging to the Mount Davis Formation(JMD). The exposure is partially weathered rock mass with rock less than 50 % (PW 30/50). Relict joints with dip directions and dip angles of 040/80, 035/78, 045/80 and 347/56 are exposed.

8	HDV. Relict joints could be clearly seen.
9	Boundary between FILL and CDV. The fill is loose, moist, yellowish brown, gravelly, silty fine SAND with concrete fragments and building debris. The interface between FILL and CDV is at about 1.2 m to 1.5 m below the base of the pile cap.
10	FILL. Loose, dry, yellowish brown, silty fine SAND with boulders, concrete fragments and rubbish. The thickness of the fill is 2.4 m. The slope surface dips at 50°, and is protected by chunam. Behind the masonry wall a layer of fill 0.5 m to 0.8 m thick overlies the CDV. The average thickness of the wall at this location is 700 mm, varying from 500 mm to 750 mm. The height of the wall at this location is 8.46 m, inclining at 73° to the horizontal.
11	Joints between the coping stones wedged open by vegetation roots. The width of the cracks varies from 30 mm to 80 mm. A coping stone of the remaining masonry wall was observed to have been dislocated by 150mm.

Figure H5 - Photograph of the Failure Scar Showing the Field Observation Points Described in Table H3

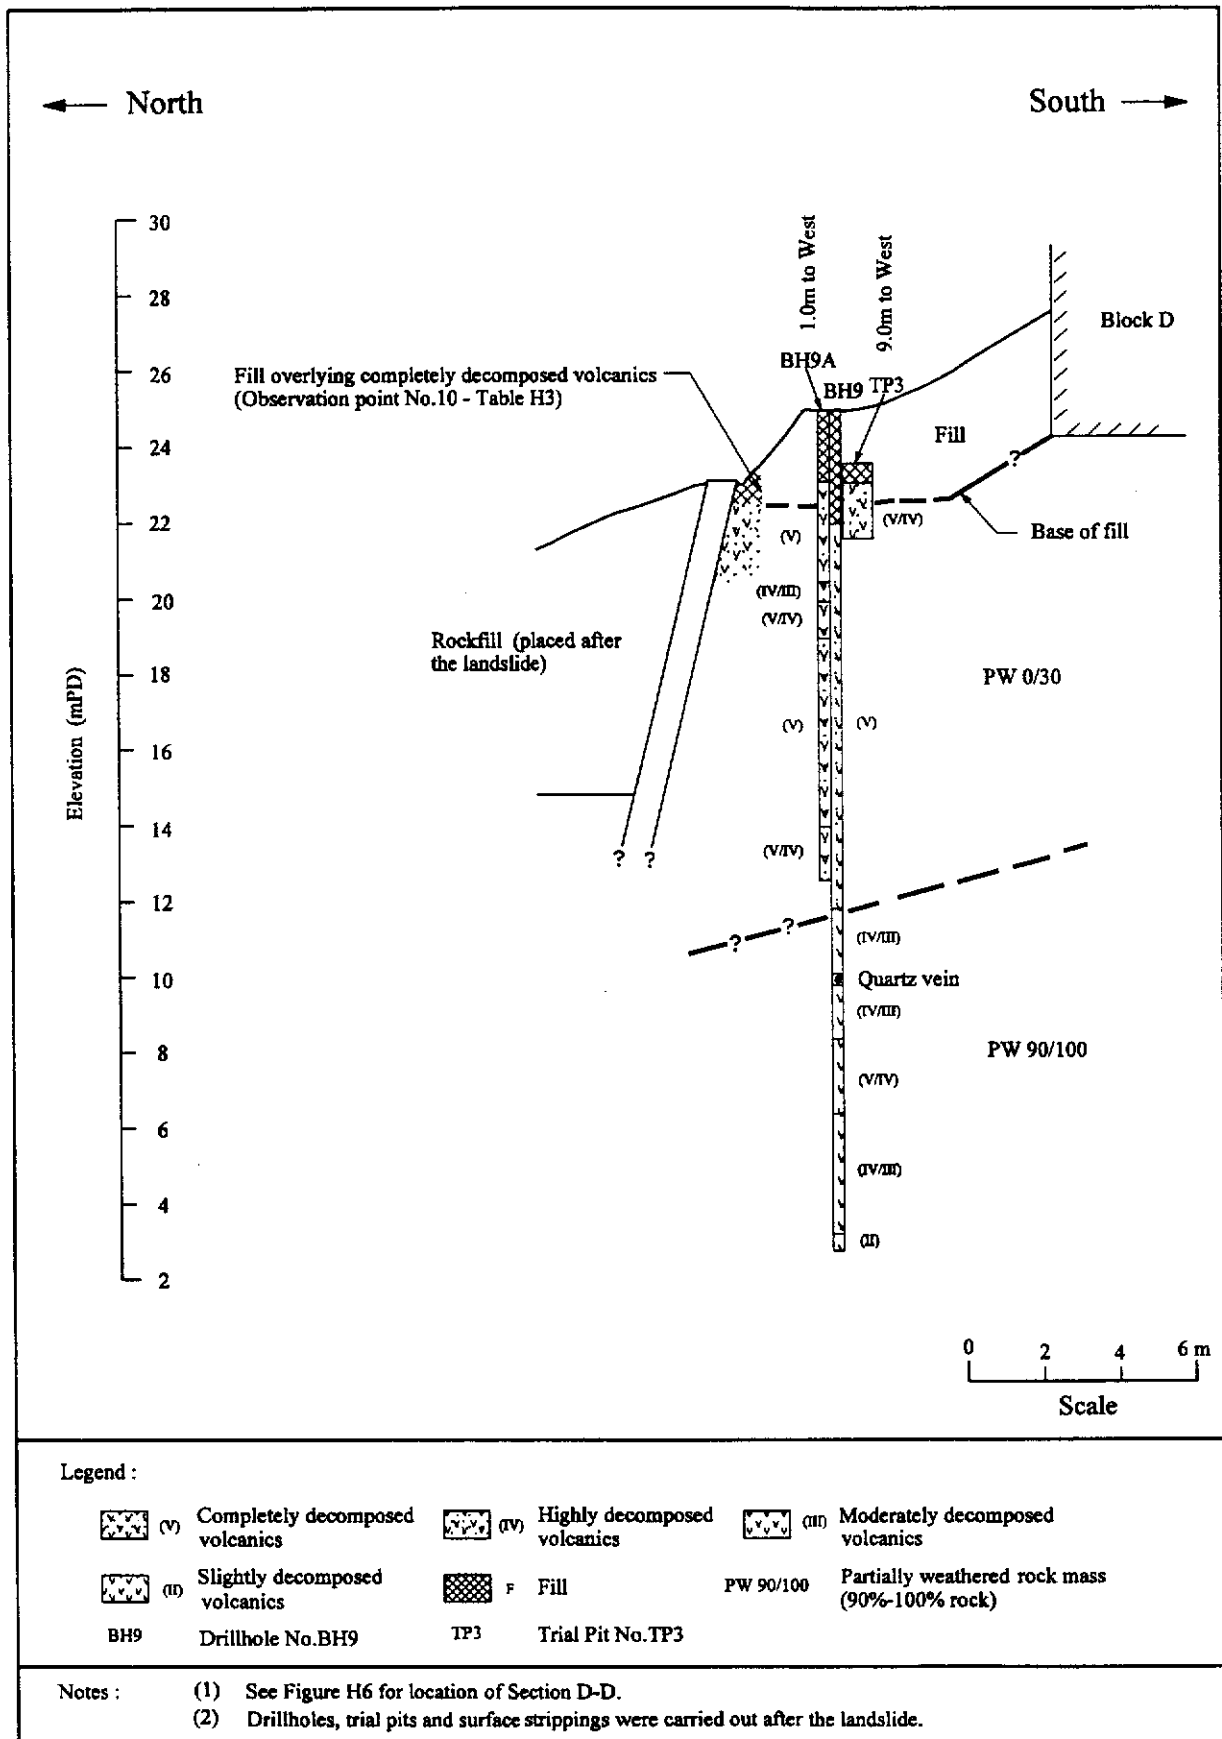
- (b) Part of the buried platform was exposed in trial pit No. TP19, and partially weathered volcanics were found below the platform.
- (c) Along Section D-D (Figure H13) to the immediate west of the landslide area, the presence of the buried platform was inferred by correlating information from drillholes No. BH9 & BH9A and from field observation point No. 10 (Table H3).

Figure H13 - Section D-D Showing the Geological Profile behind the Remaining Masonry wall

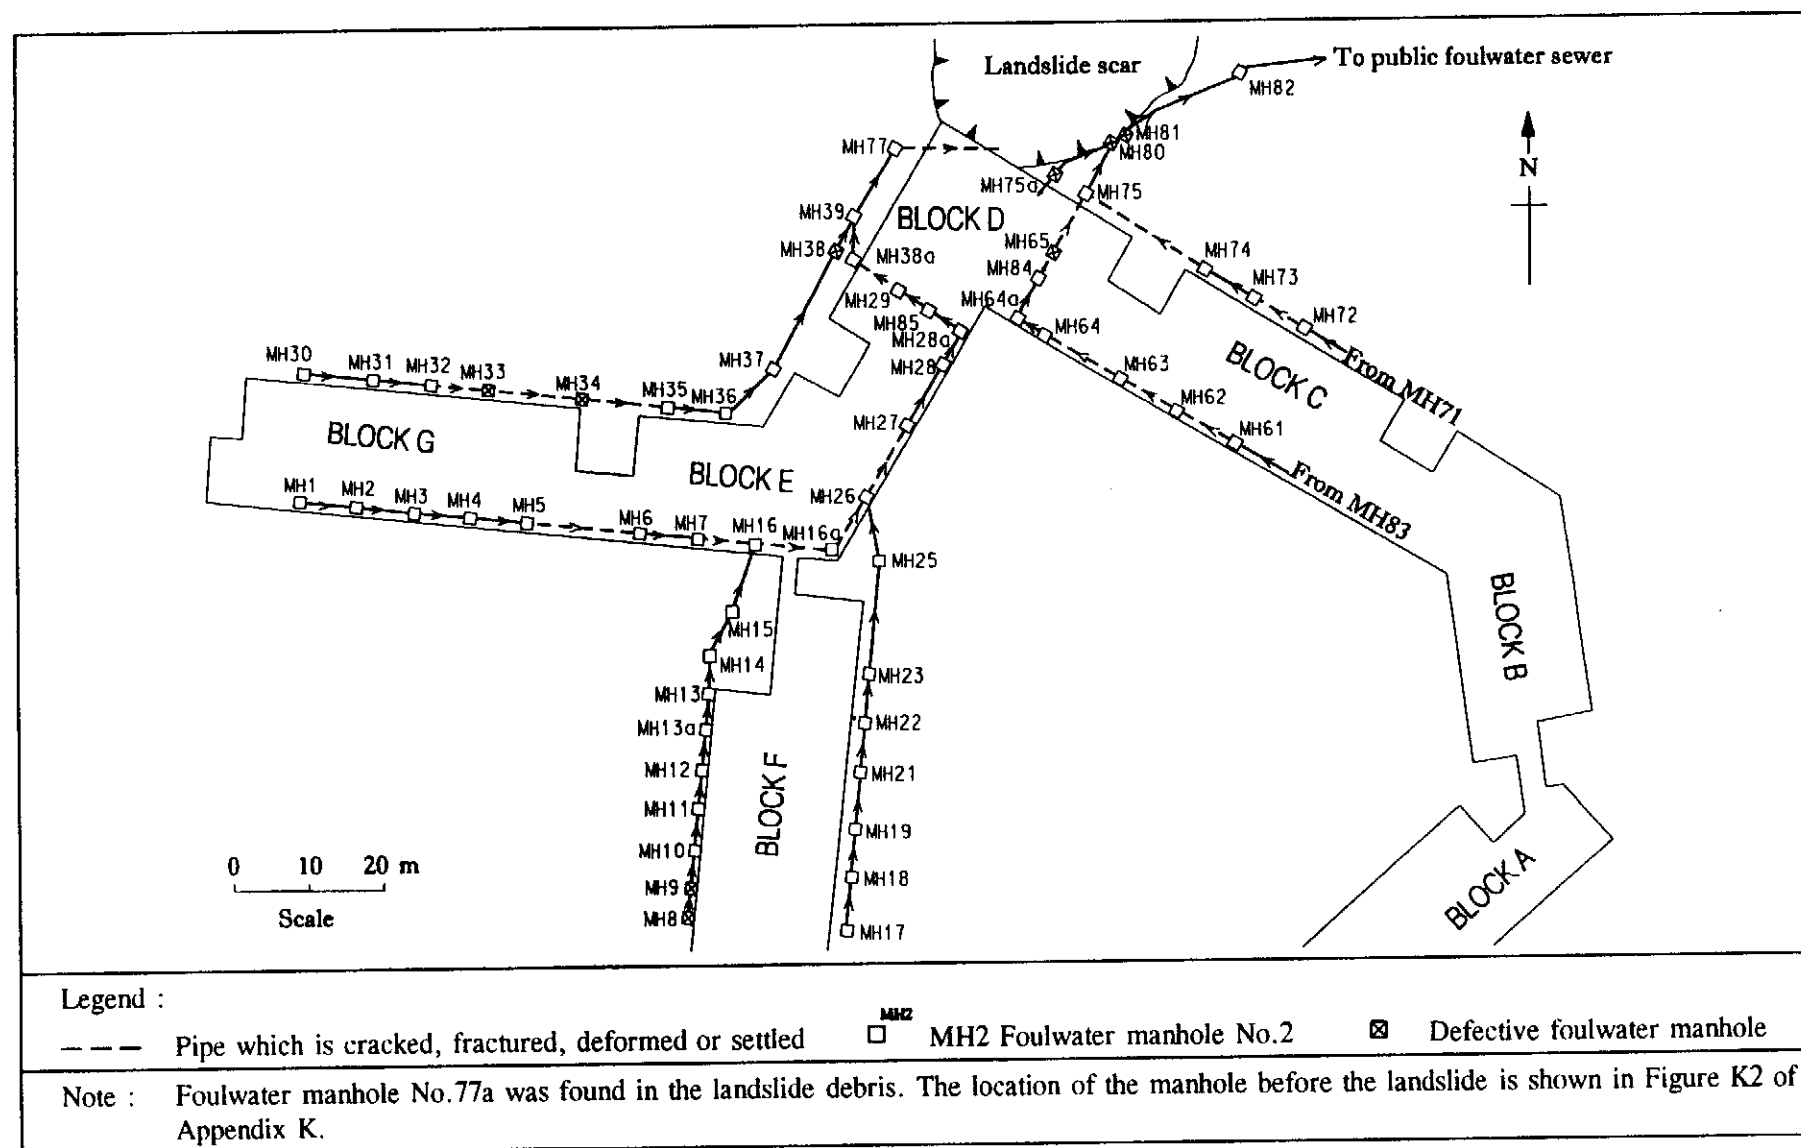
Figure J1 - Layout and Condition of the Foulwater Sewers at the Time of the Post-failure Investigation

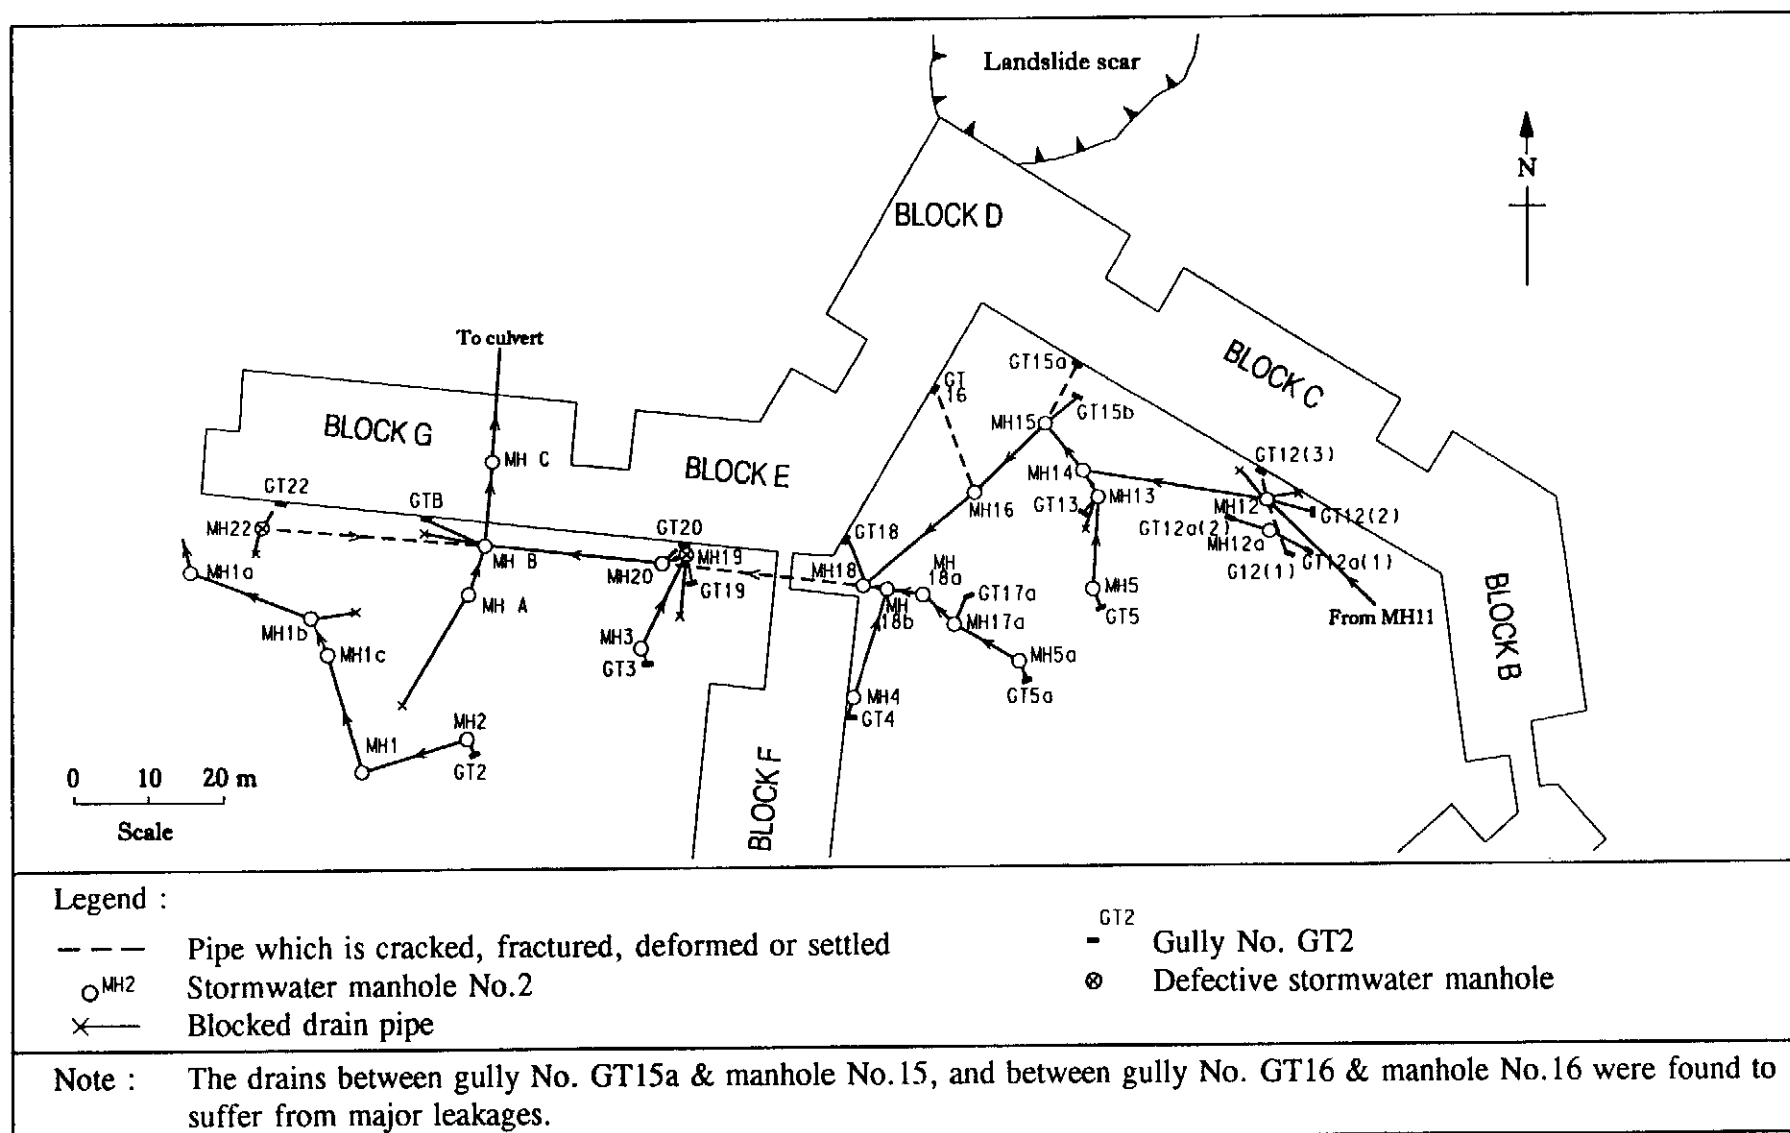
Figure J2 - Layout and Condition of the Stormwater Pipes at the Time of the Post-failure Investigation

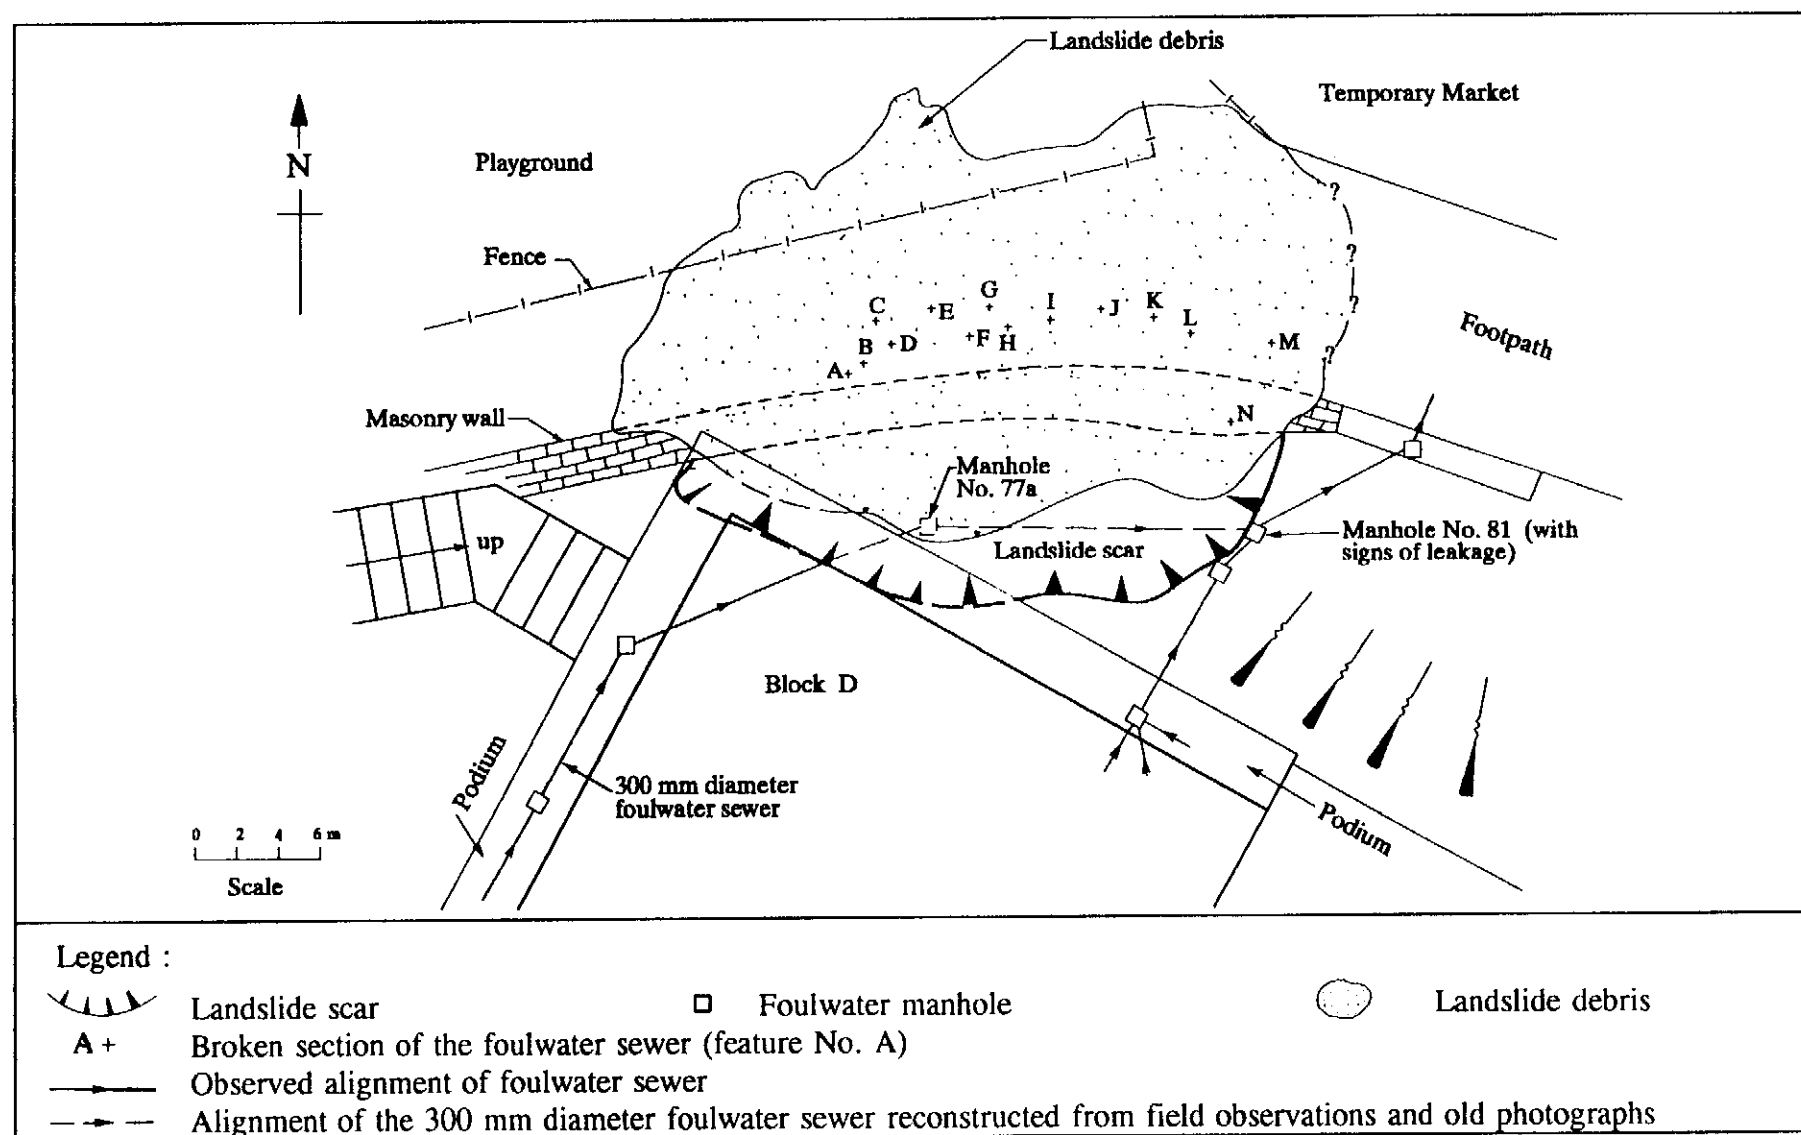
Figure K2 - Locations of Broken Sections of the Foulwater Sewer

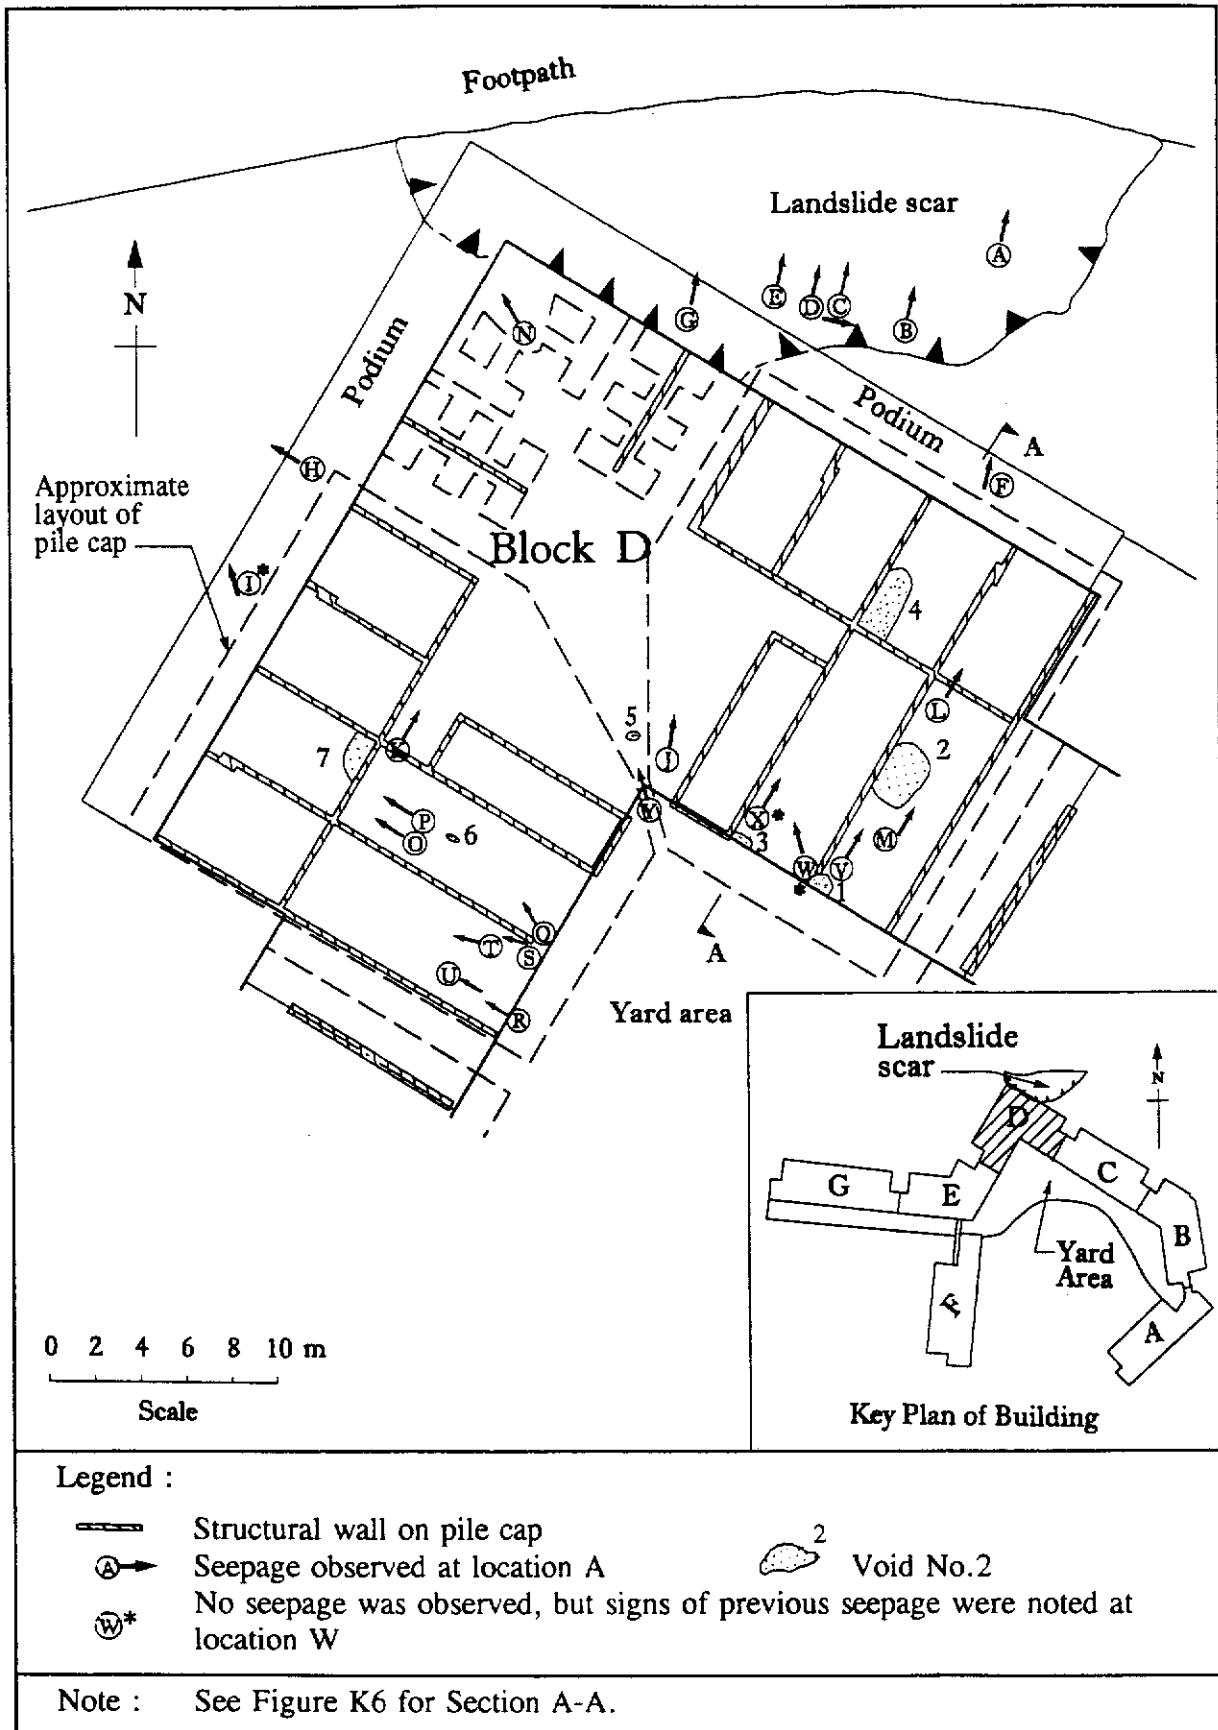
Figure K4 - Locations of Voids and Seepages underneath Block D

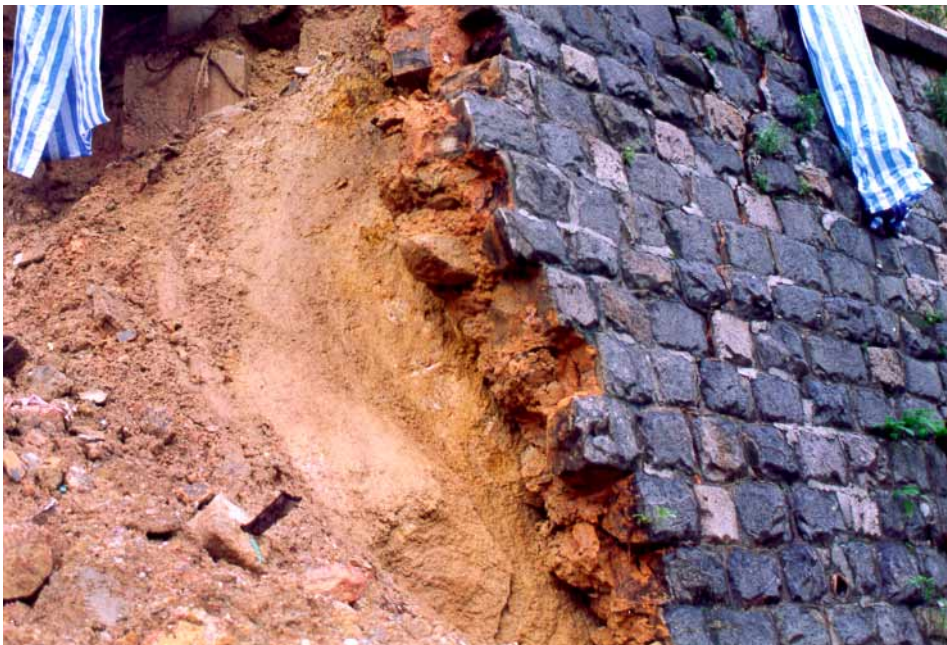
Plate M9 - Unfailed Part of the Masonry Wall Immediately to the West of the Landslide Area Photograph taken on 25 July 1994)

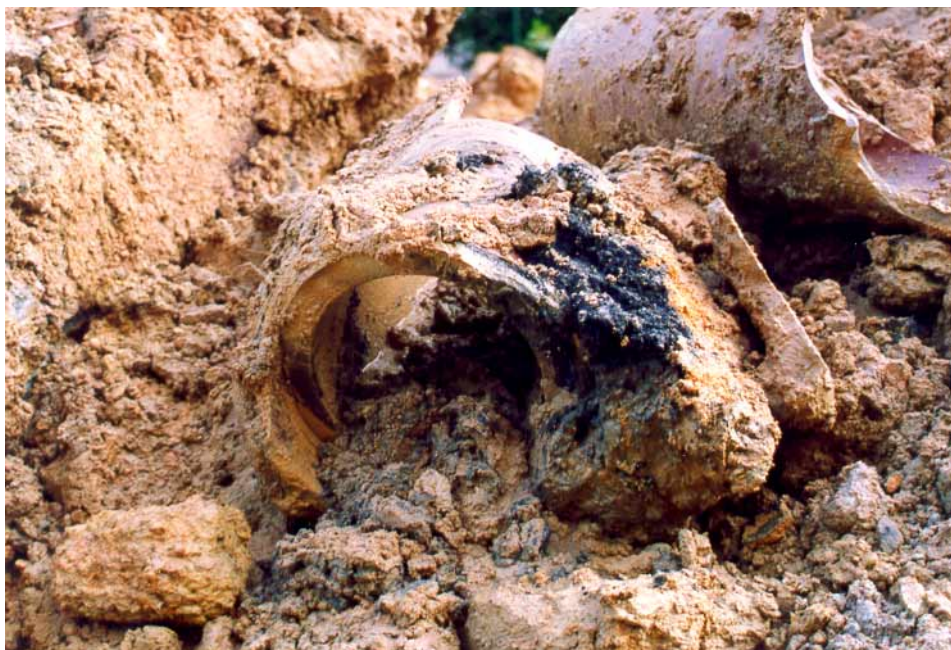
Plate M10 - Broken Section of the Foulwater Sewer with Black-stained Soil Recovered from the Landslide Debris (Photograph taken on 27 July 1994)

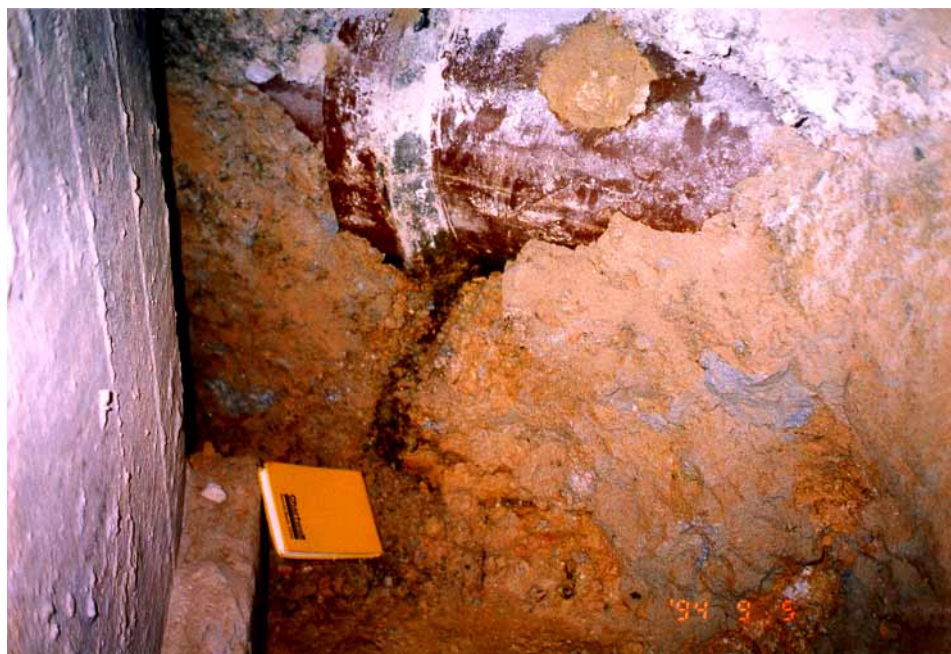
Plate M11 - Part of the Foulwater Sewer with Minor Leakage between Manhole No. 77 and the Landslide Scar (Photograph taken on 5 September 1994)

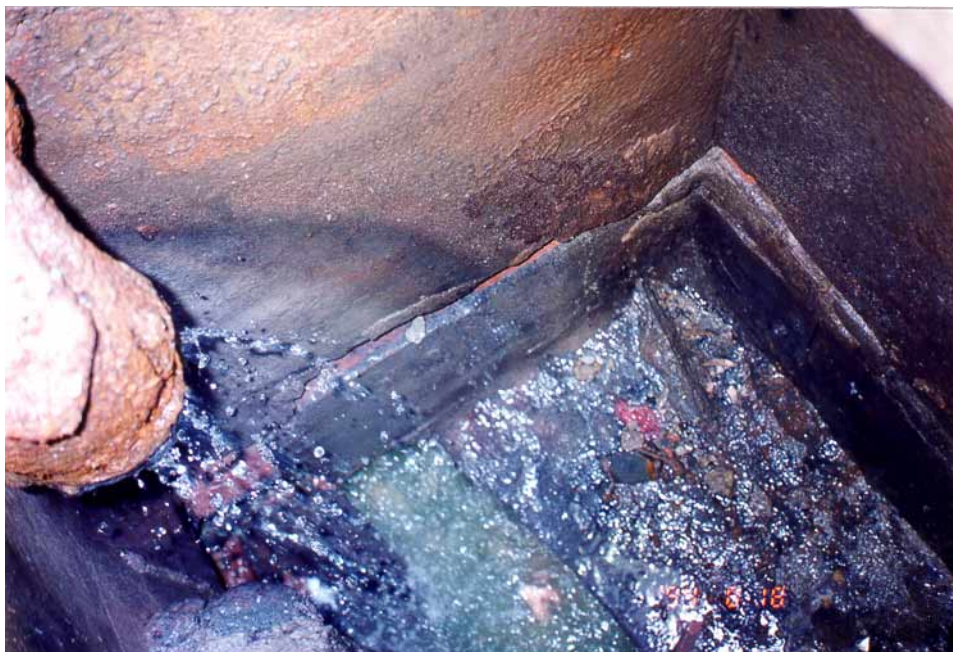
Plate M12 - Foulwater Manhole No. 34 with a Crack near the Base
(Photograph taken on 18 August 1994)

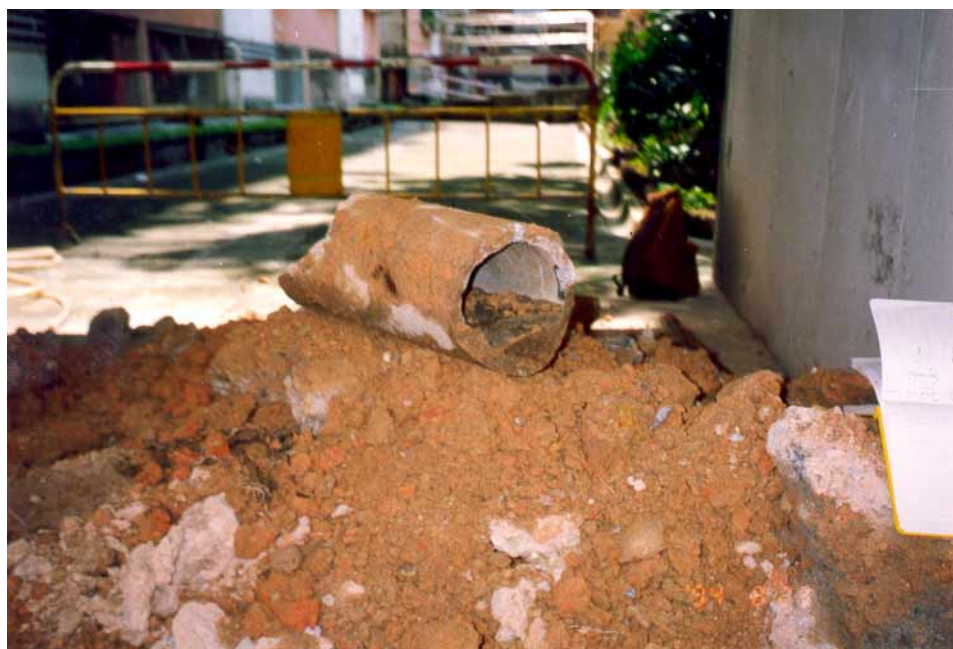
Plate M13 - Part of the Defective Stormwater Drain between Gully No. GT15a and
Manhole No. 15 in the Yard Area (Photograph taken on 23 August 1994)

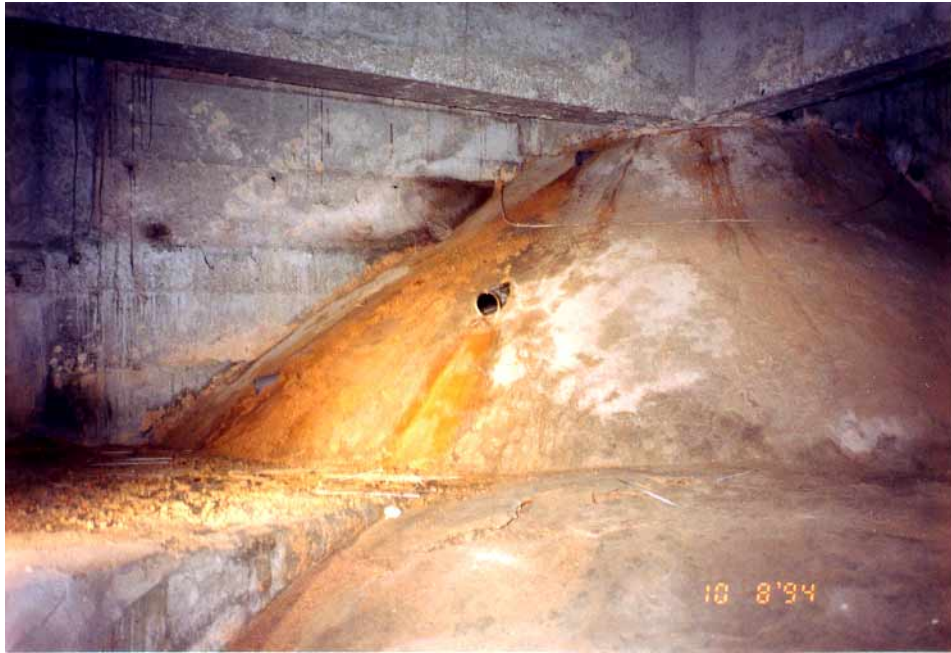
Plate M14 - The Ground underneath Block D Adjoining the Yard Area, with Signs of Seepage through the Weepholes, before Excavation of Trial Pit No. TP 35 (Photograph taken on 10 August 1994)

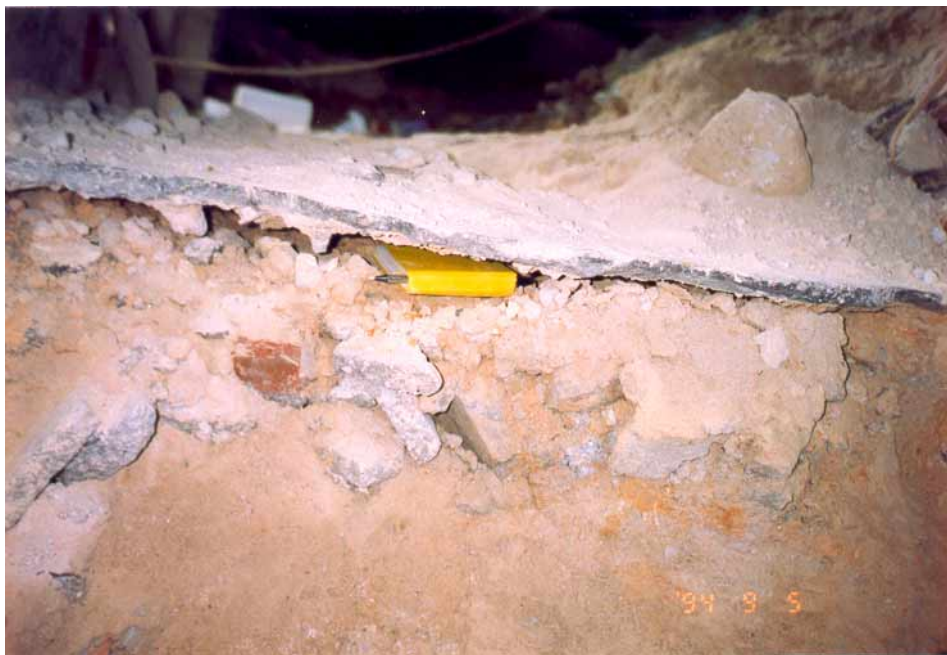
Plate M16 - Loose Fill near the Surface of the Ground underneath Block D
(Photograph taken on 5 September 1994)

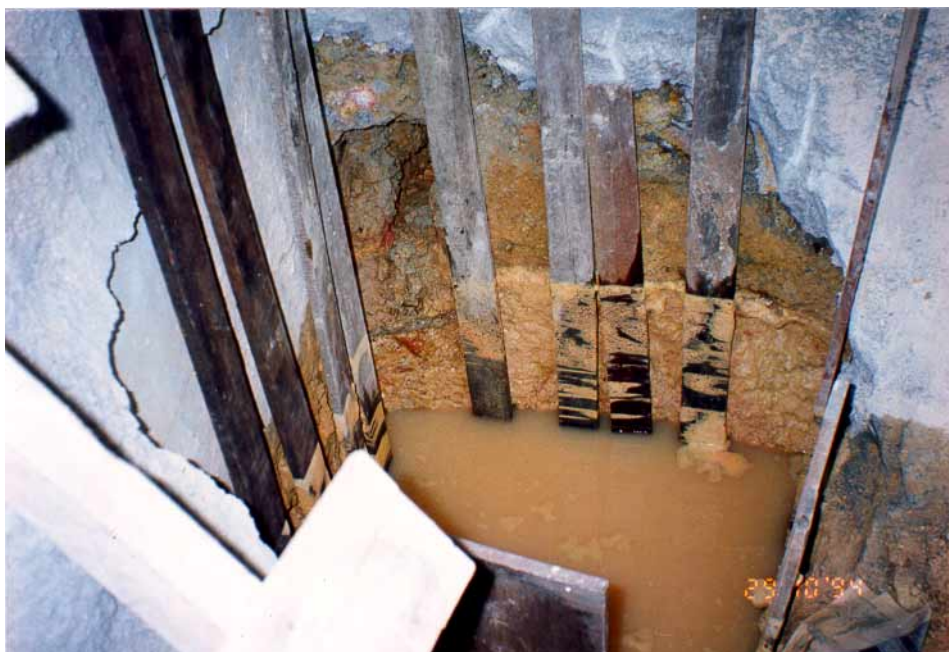
Plate M17 - Subsurface Seepage Flow into Trial Pit No. TP26 at the Crest of the
Landslide Scar during the Water Test underneath Block D
(Photograph taken on 29 October 1994)
