# **REPORT ON THE KWUN LUNG LAU LANDSLIDE OF 23 JULY 1994**

**GEO REPORT No. 103**

**N.R. Morgenstern & Geotechnical Engineering Office**

# **VOLUME 1: CAUSES OF THE LANDSLIDE AND ADEQUACY OF SLOPE SAFETY PRACTICE IN HONG KONG**

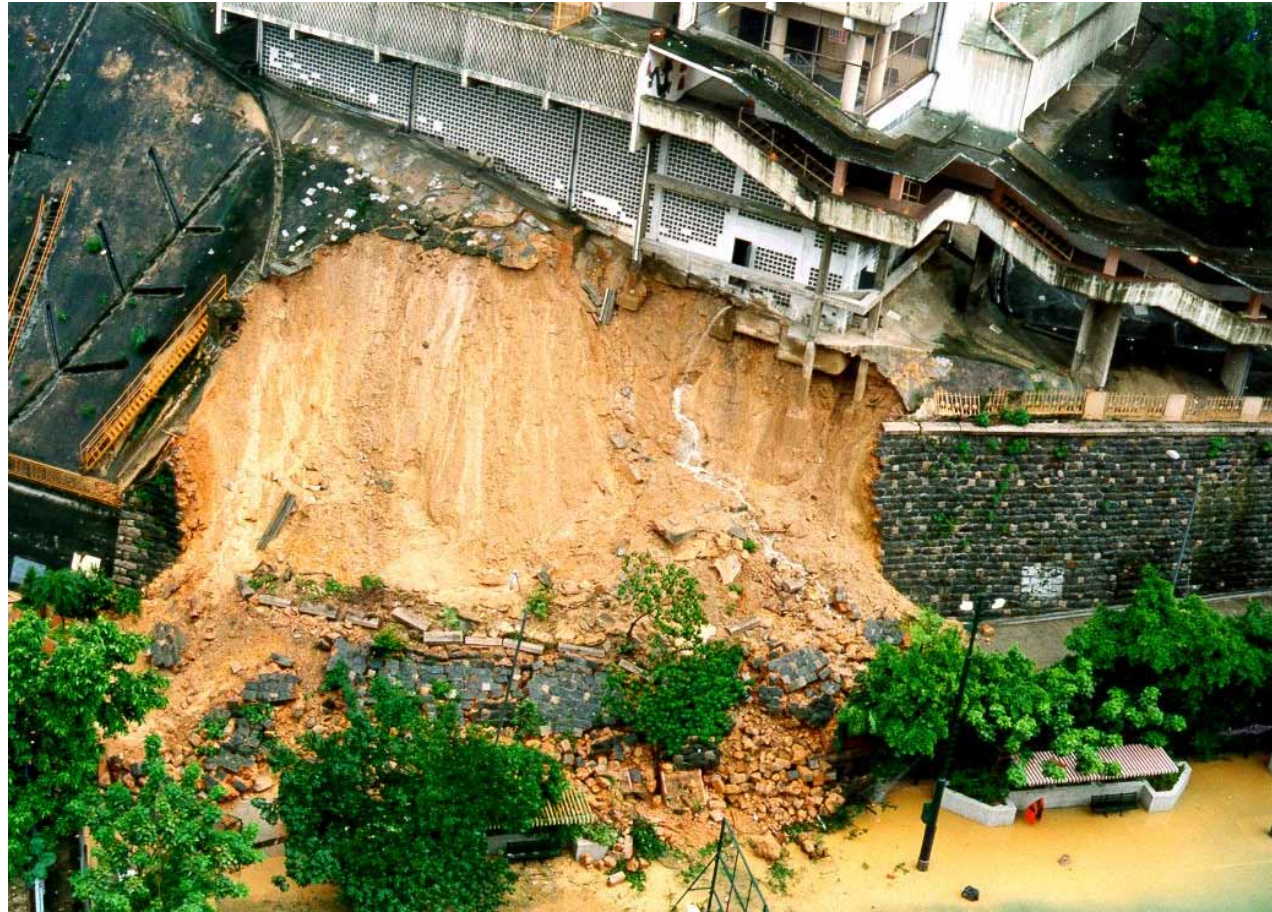
Figure 1 - Photograph of the Landslide Taken on 24 July 1994

- (e) Failure was sudden, taking place over a very short period of time.
- (f) The masonry wall burst out at about mid-height, followed by the instant collapse of the wall and slope.

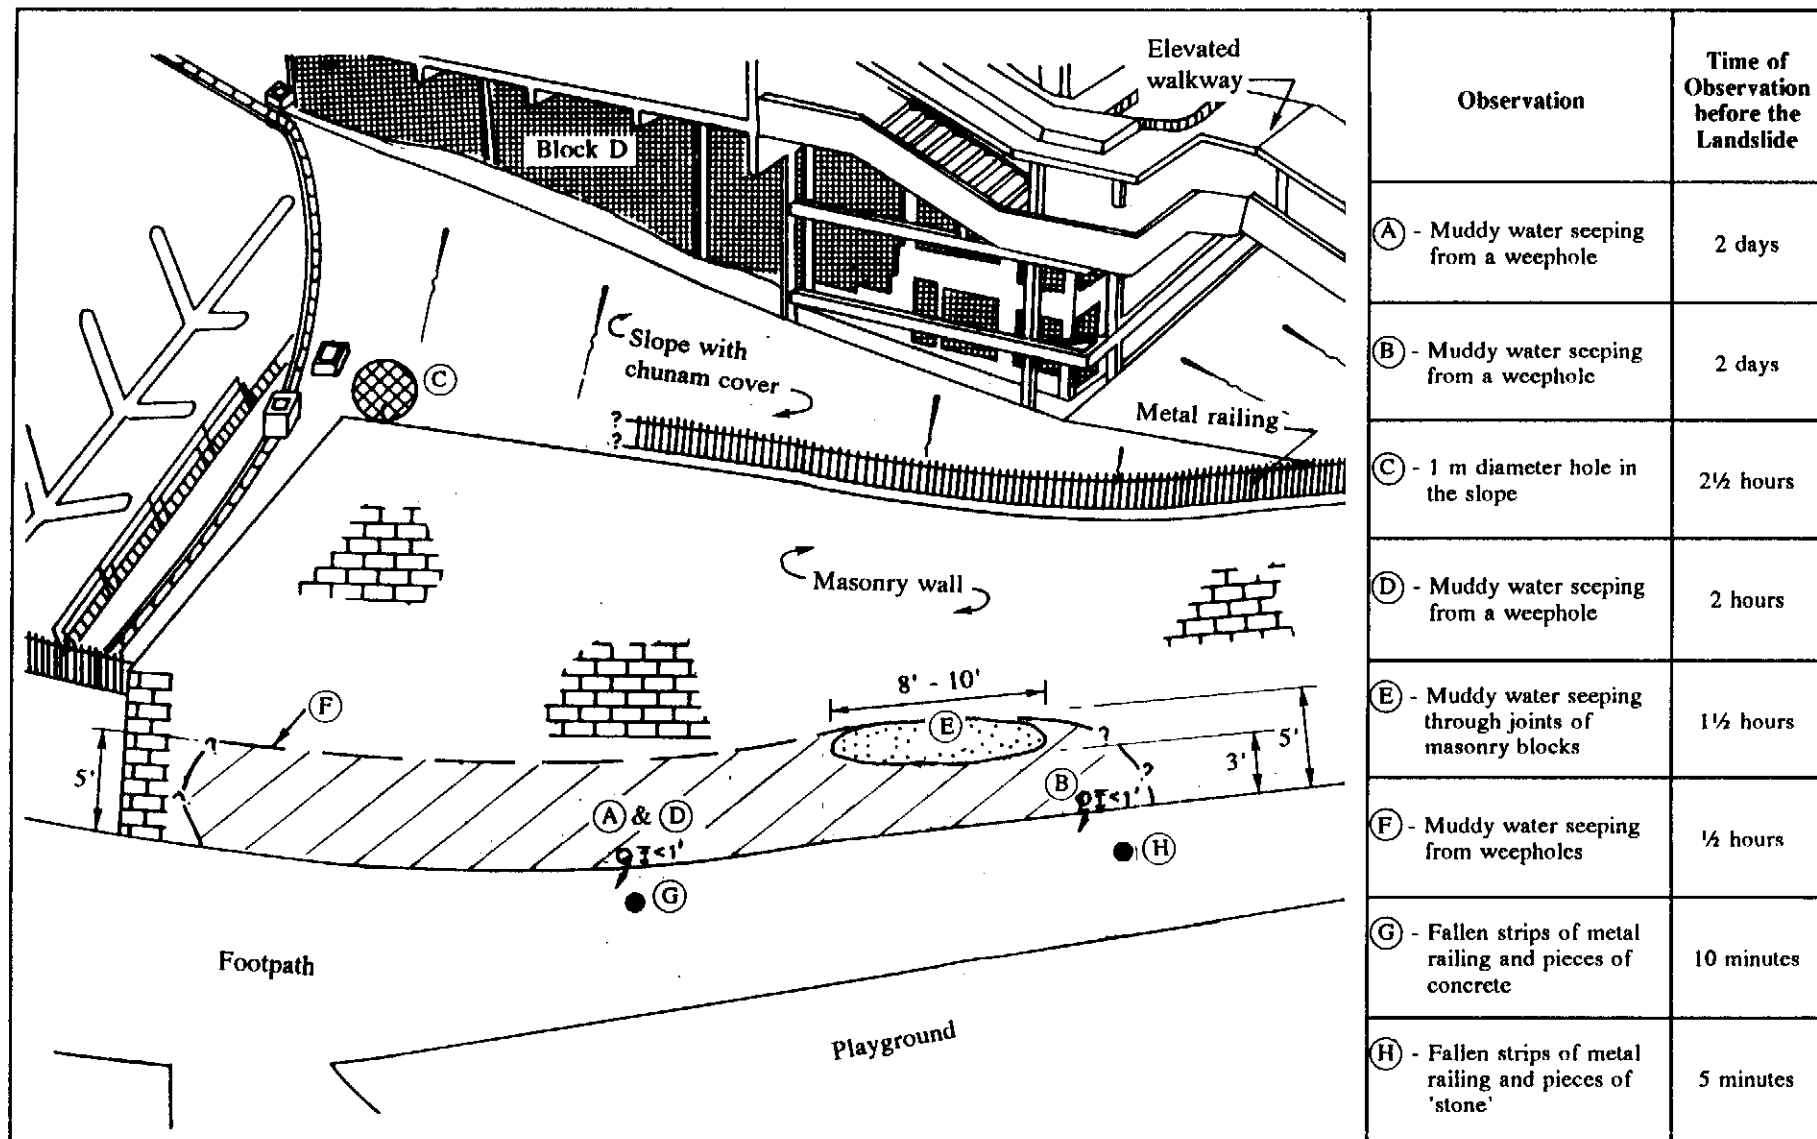
Figure 6 - Summary of Key Observations Reported by Witnesses

- (a) Prior to the slide, muddy waters had been observed seeping through the weepholes and joints of the masonry wall supporting the slope. The extent of the seeping zone increased upward with time.

- (b) Caretakers of Kwun Lung Lau had inspected the slope above the masonry wall from the slope crest twice on the day before the landslide. There were three inspections on the day of the landslide. The last inspection was about six hours before the landslide. Neither signs of defects nor blockage of drainage channels were detected.

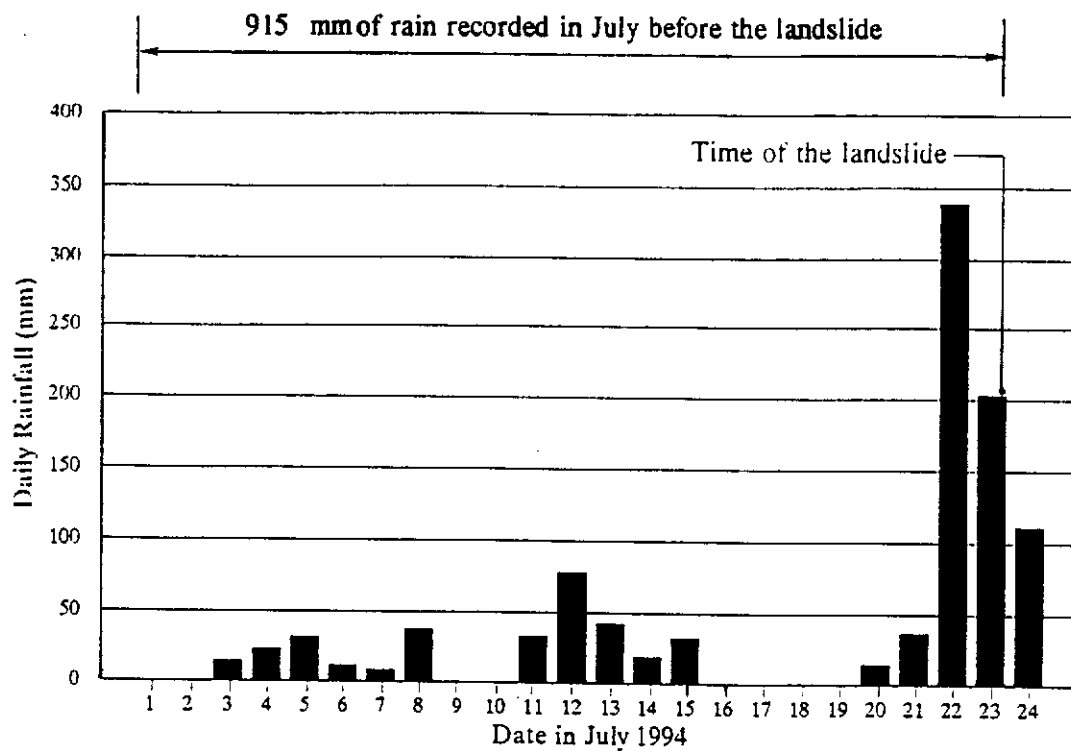
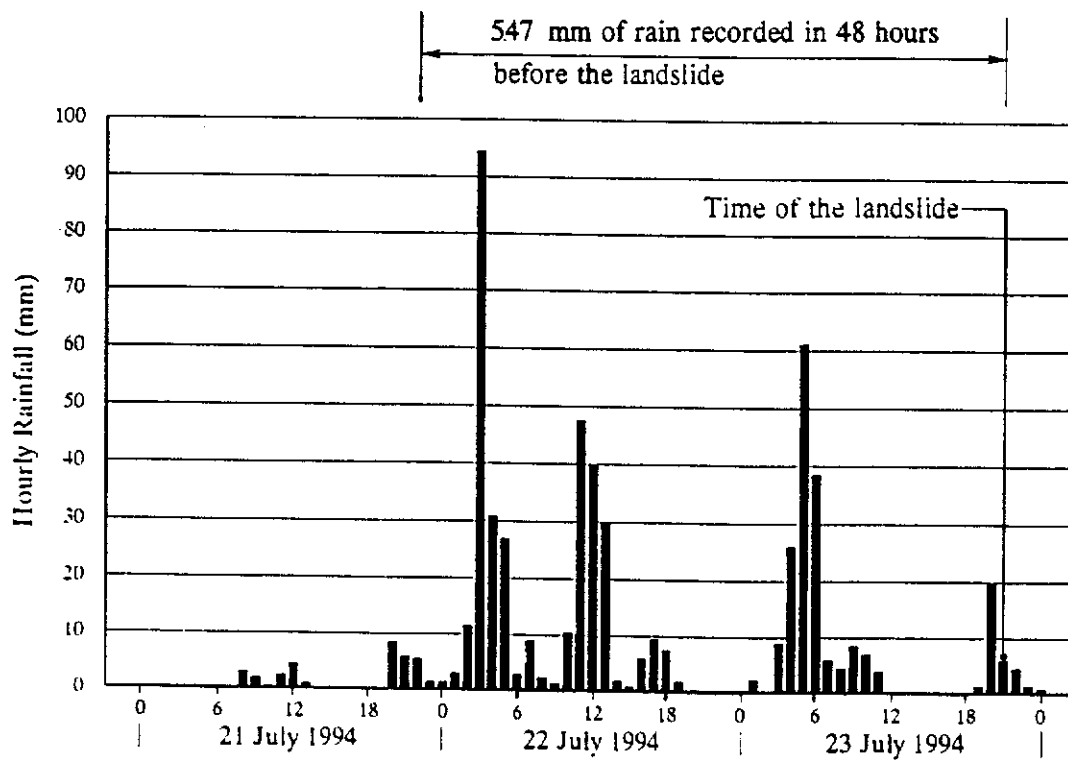
Figure 7 - Rainfall Records of Raingauge No. H02

Rainfall records have been obtained at Kwun Lung Lau since September, 1978. July, 1994 was the wettest month recorded since the local raingauge was installed. Rainfall data and related statistical information are compiled in Appendix G, Volume 2. There can be little doubt that this exceptional rainfall was an important factor contributing to the cause of the landslide. However the timing of the landslide with respect to rainfall history leads to some interesting observations.

The Kwun Lung Lau landslide does not fit the normal pattern of rainfall triggering of landslides observed in Hong Kong. It is an example of a delayed failure that occurred some prolonged time after the end of the highest rainfall intensity. Some examples of delayed failure have been encountered in Hong Kong but they are not common.

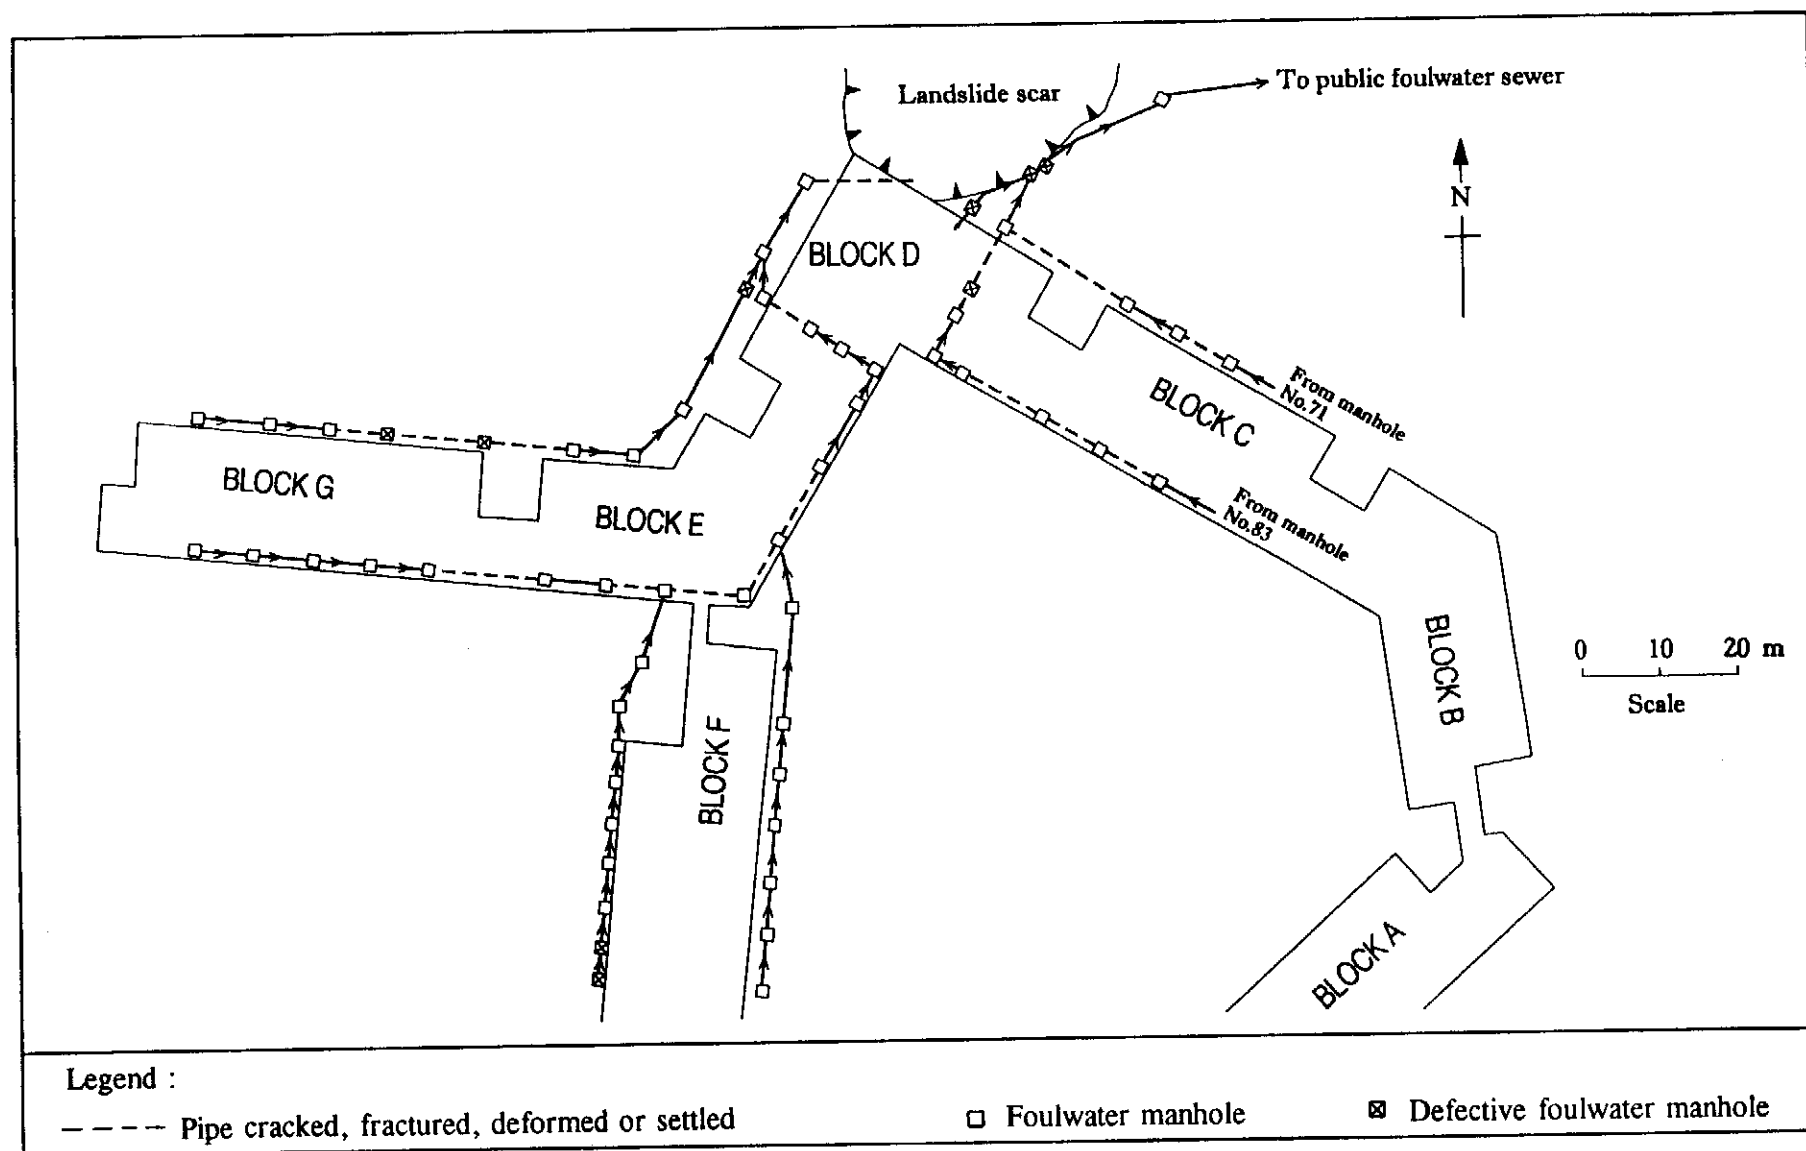
Figure 8 - Layout and Condition of the Foulwater Sewers as Revealed by the Post-failure Investigation

The 300 mm diameter foulwater sewer traversed the upper part of the landslide area and it was ruptured by the slide. Segments recovered revealed that the pipe was of a rigid construction and there was black staining on the soil adjacent to the pipe, symptomatic of long term leakage. This was confirmed by chemical analyses of soilwater obtained from samples at depth below the landslide base and downslope of the sewer. The analyses displayed high chloride content characteristic of the seawater used for flushing. A considerable time would be required to achieve the extent of penetration of the contaminated water and therefore it is likely that this sewer had been leaking for some time before the slide.

It is likely that the foulwater sewer had been leaking for some time prior to the landslide. The sewer was of a rigid construction and it was buried in loose fill which could have settled differentially in the past resulting in cracking of the earthenware pipes and/or their joints. Considerable organic staining in the soil adjacent to the pipe and deep migration of chloride contaminated water attest to the long duration of foulwater sewer leakage. Leakage from the foulwater sewer alone was inadequate to account for the slide. If one were to attribute most of the wetting to be associated with infiltration from the foulwater sewer, it would be necessary to conclude that any relationship with the rainfall was only coincidental since the foulwater and stormwater systems were not connected.

- (b) The Government should develop a program for direct monitoring and repair of buried services at housing estates and other developments in all cases where leakage might impact on slope stability. Priority should be given to older estates where loose fill is known to have been used in site development. Periodic inspection of buried services at hazardous locations should become mandatory. The appropriate period is best established by experience, but a five year interval appears reasonable at this stage.

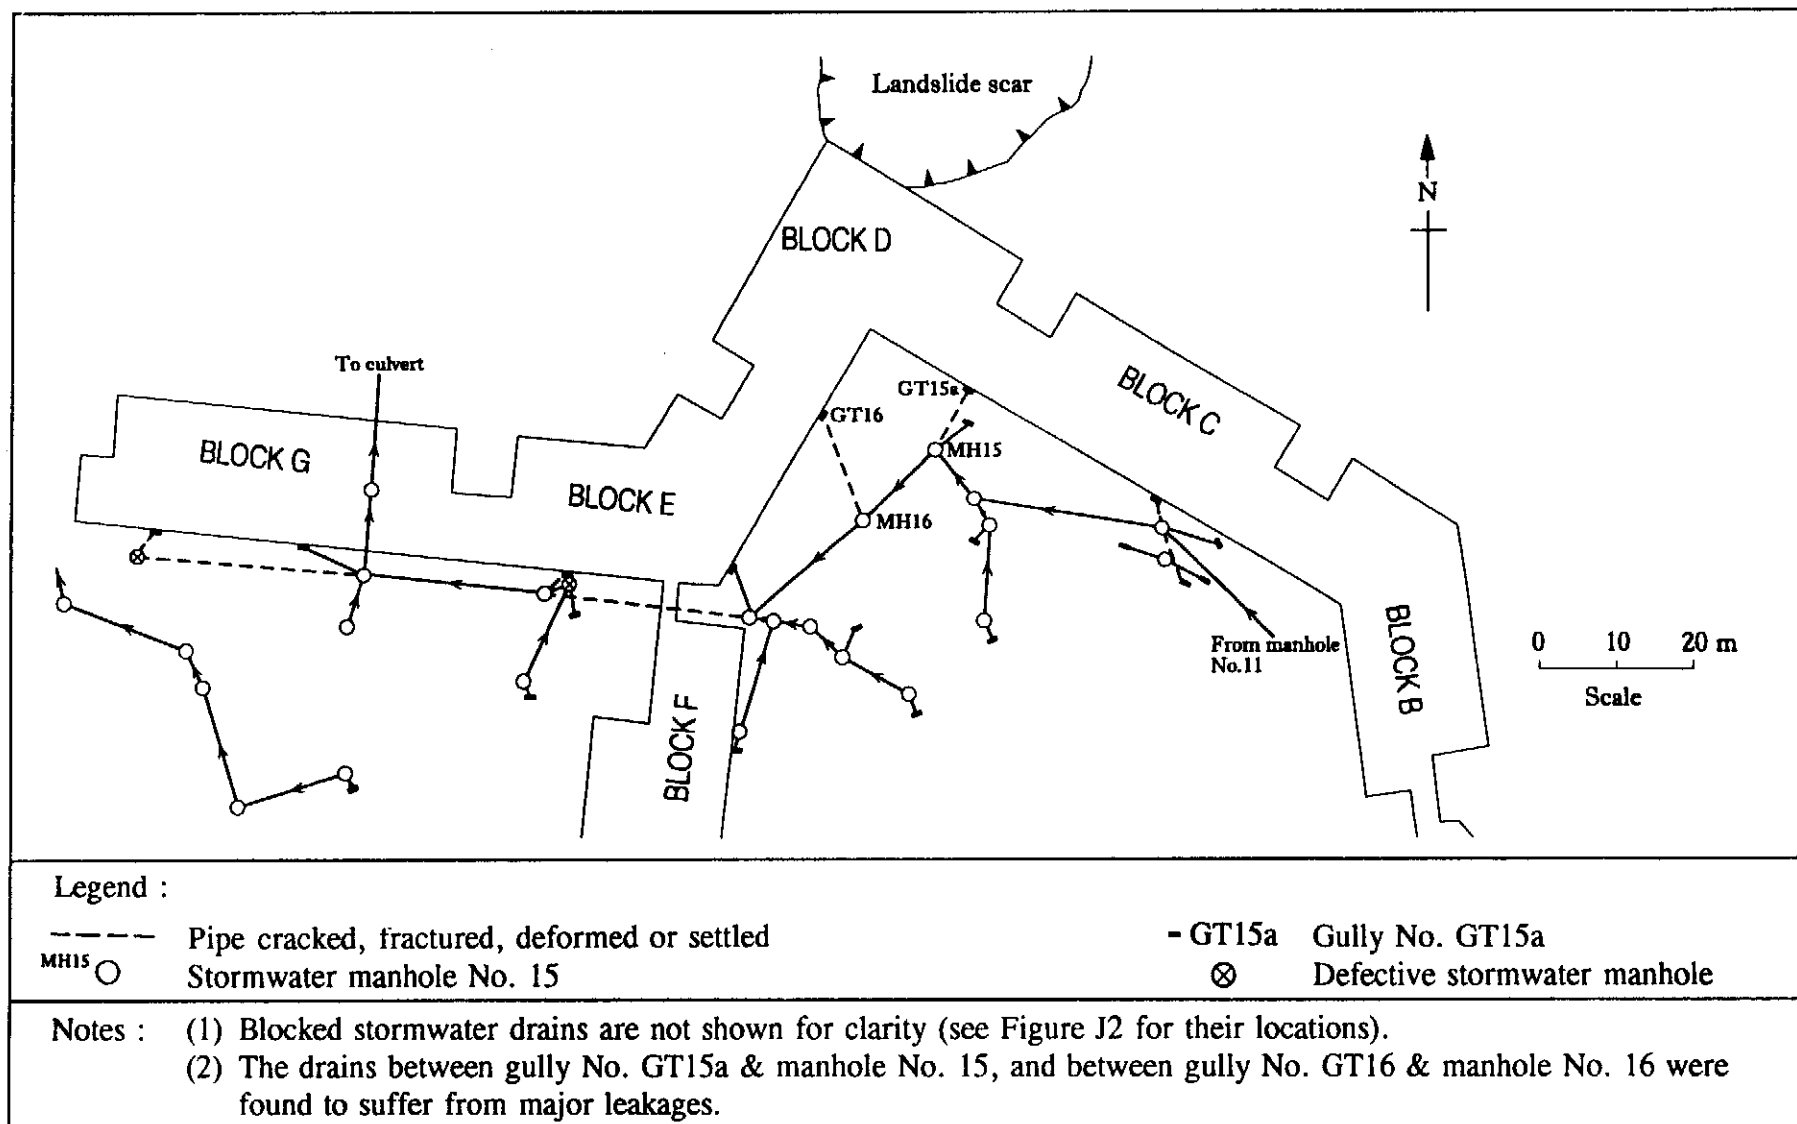
Figure 9 - Layout and Condition of the Stormwater Drains as Revealed by the Post-failure Investigation

The investigation also discovered that two stormwater drains in the yard area to the south of Block D were defective in a manner that would allow stormwater to enter the porous subsoil, as opposed to being carried away. The leakage from these sources was likely to be

Leakage from the defective stormwater system was an important factor. Pathways for substantial subsurface flow beneath Block D into the landslide mass have been shown to exist, see Appendix K, Volume 2. Water chemistry tests reveal that there is another source of water contributing to saturation of the landslide mass, other than the chloride contaminated foulwater. In addition, the pathway from the defective stormwater system to the landslide provides a logical explanation for the delayed failure process.

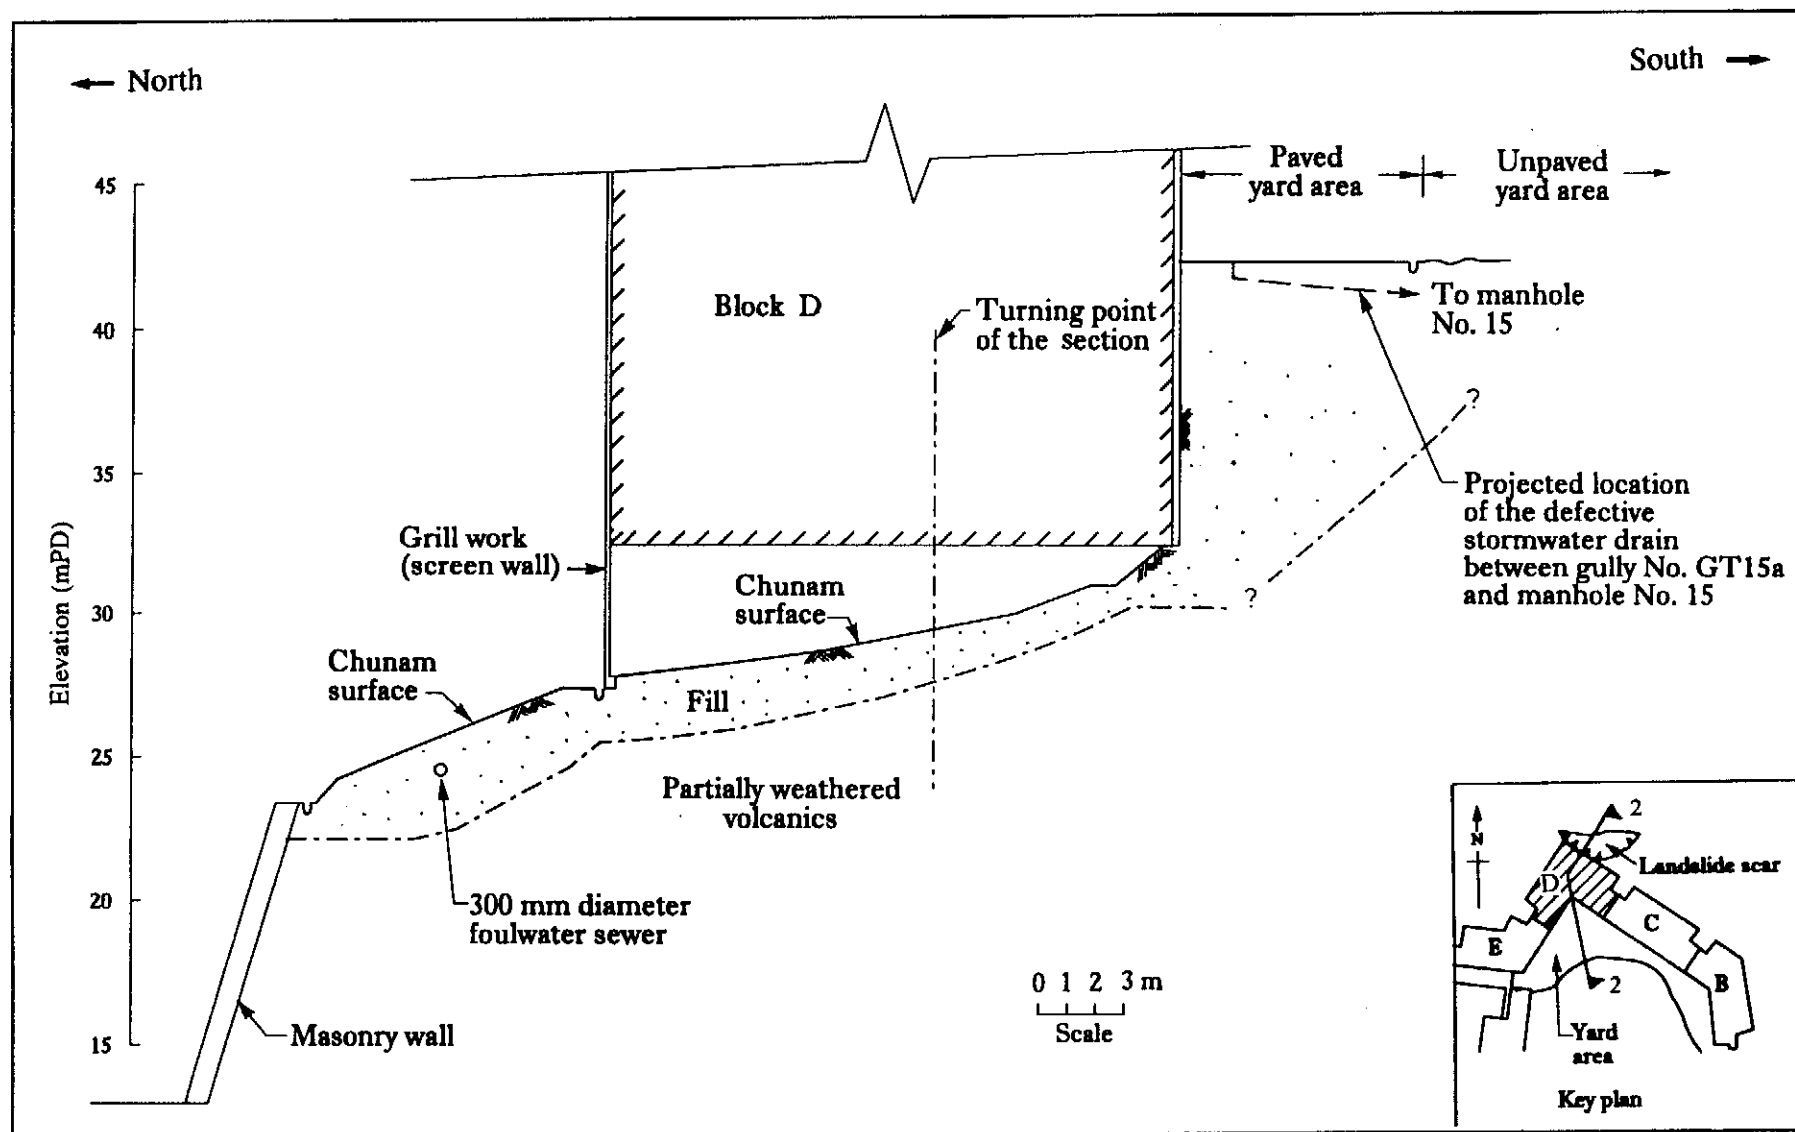
Figure 11 - Section 2-2 through the Landslide Location, Block D and the Yard Area

Seepage analyses are presented in Appendix L as well. These analyses are intended to be illustrative of the process of how water might find its way from the defective storm sewer, through the pathways discovered beneath Block D, and into the landslide mass. They also indicate how time is involved in this process thereby accounting for the delayed failure and they show how infiltration from the two buried drainage pipes can account for the extensive depth of wetting that occurred.

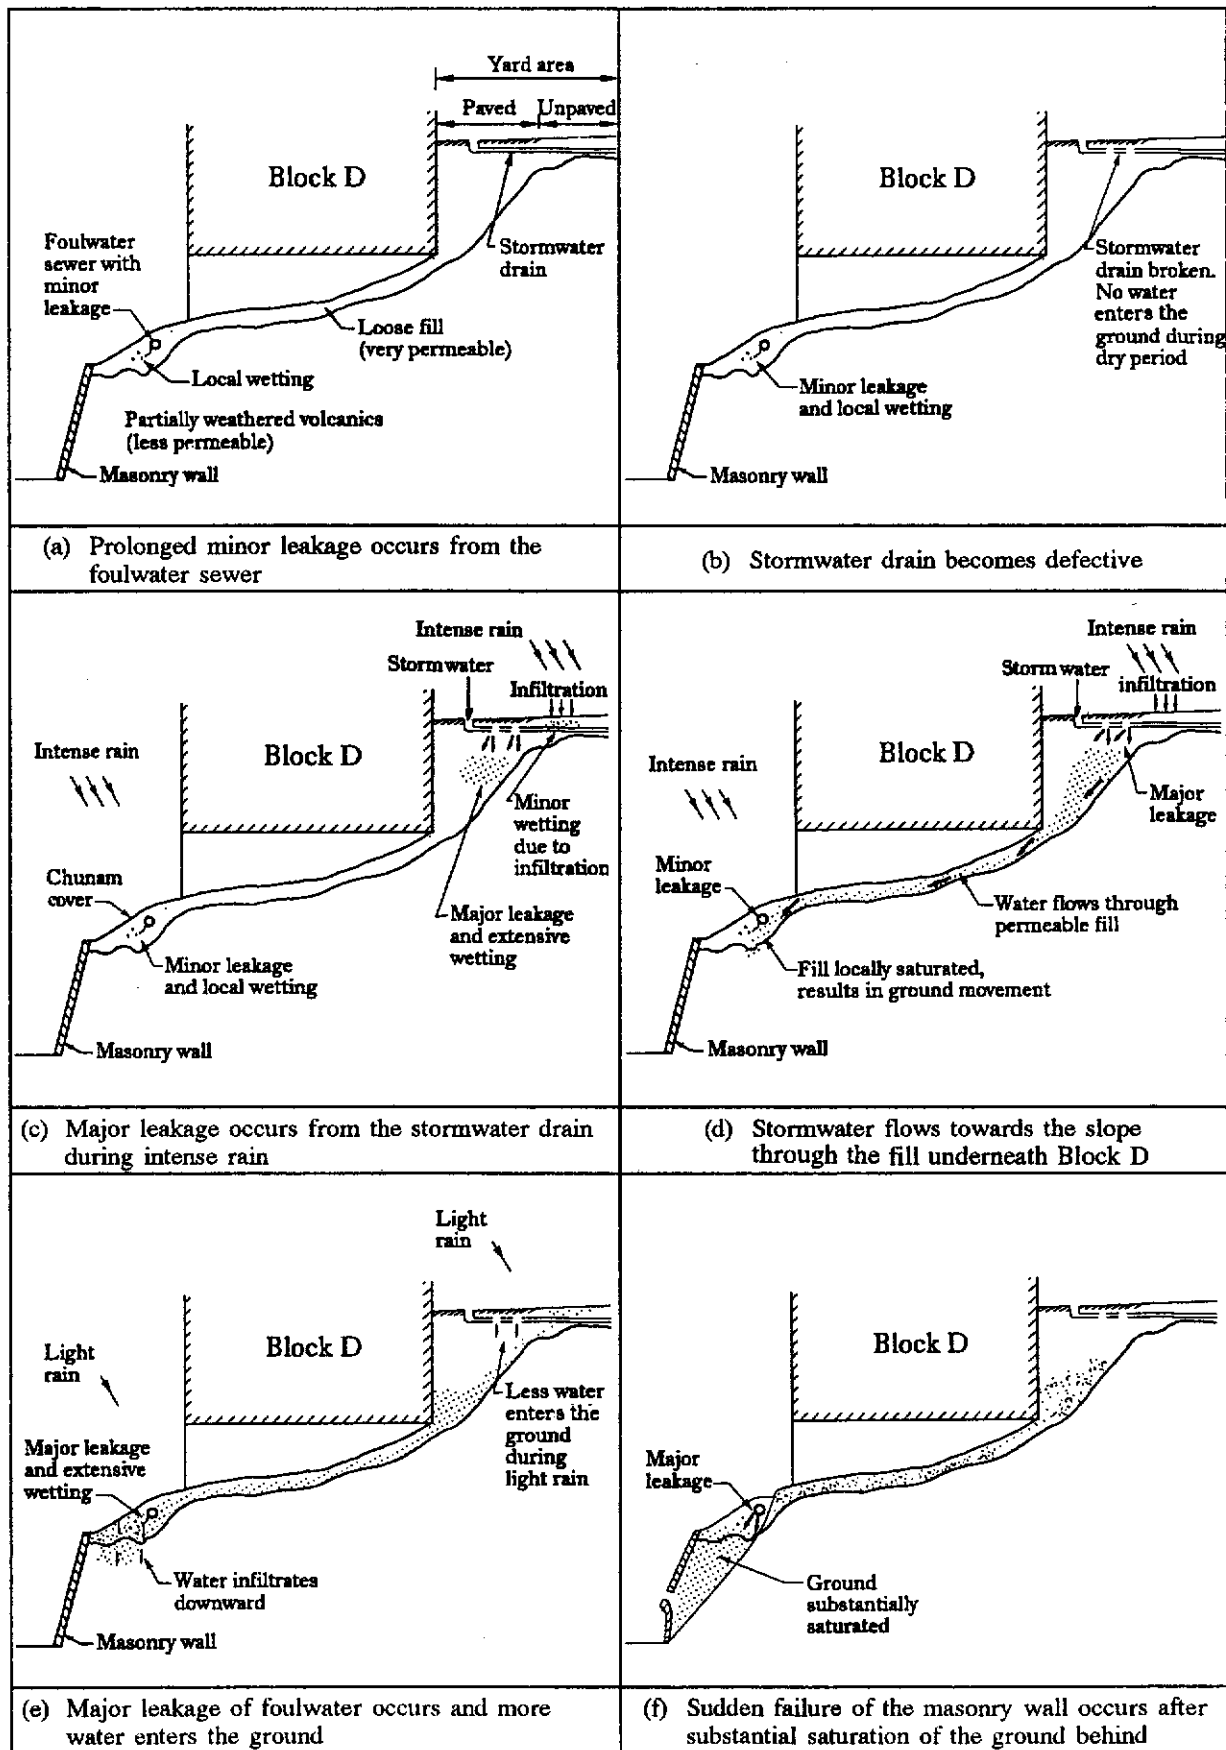
Figure 12 - Probable Mechanism of the Landslide

It is likely that the additional infiltration of stormwater brought the landslide mass close to failure. As movements developed, the foulwater sewer ruptured. An increase in foulwater flow would account for the observation by a witness of a hole in the chunam near the manhole on the slope at the eastern edge of the landslide area.

The two sources of water began to saturate the soil mass and increased volumes of water reached the retaining wall. The sequence is illustrated in Figure 12, Volume 2. Initially, when the depth of wetting was relatively low, the wall remained stable and held the weakened soil back. As the depth of wetting increased the forces on the wall increased until failure was initiated. Failure occurred by buckling and brittle collapse. The volume and mobility of the slide mass was increased by the presence of the wall. The failure mode was sudden providing little to no warning to anyone at risk. That is, the presence of the wall aggravated the consequences of the landslide. Had the wall been thicker, it likely would have
