HONG KONG RAINFALL AND LANDSLIDES IN 1998

GEO REPORT No. 105

**GEOTECHNICAL ENGINEERING OFFICE
CIVIL ENGINEERING DEPARTMENT
THE GOVERNMENT OF THE HONG KONG
SPECIAL ADMINISTRATIVE REGION**

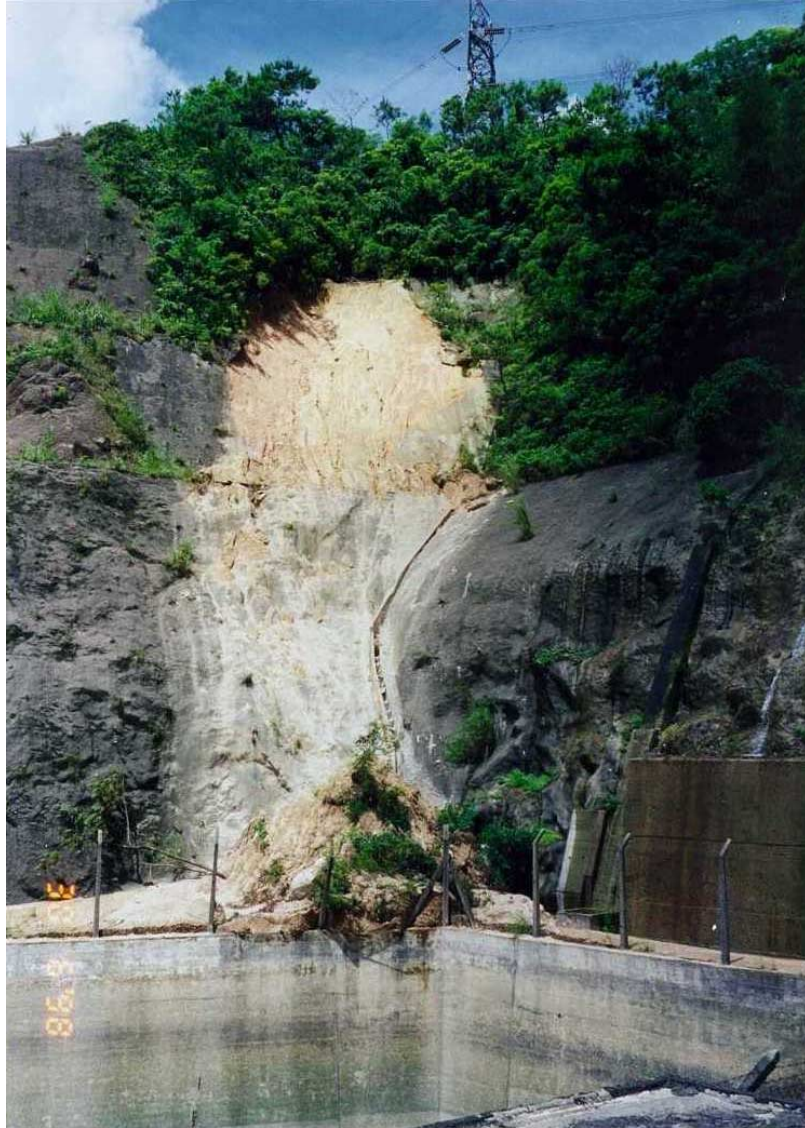
Plate 1 - Fung Wong Service Reservoir, Sha Tin Pass Road, near Tze Wan Shan
(Incident K 98/6/13)

(A major soil cut slope failure which resulted in the disruption of the reservoir operation, Plate 1)

On the morning of 9 June 1998, a major soil cut slope failure occurred at the southwestern corner of cut slope No. 11NE-A/C21, adjoining Fung Wong Service Reservoir, to the west of Sha Tin Pass Road. The landslide produced a wedge-shaped scar of about 19 m in length and 12 m in width, with a maximum depth of about 2.5 m. The estimated failure volume was about 120 m³. The travel angle of the landslide debris, measured from the crown of the landslide to the fence at the toe was about 46°, however, this may not reflect the actual mobility of the debris because of the influence of the fence. Debris from the landslide blocked the 3 m-wide access track between the toe of the slope and the edge of the reservoir, and some debris spilled over into the uncovered reservoir.

The landslide seems to have been triggered by rainfall. Other factors were: (a) the presence of a flat area formed along the ridgeline above the landslide allowing possible ponding and run off onto the landslide site; (b) the presence of an unprotected area of natural terrain directly above the crown of the landslide which allowed ingress of water; (c) the presence of adverse, partly kaolin and manganese infilled, relict joints in the soil mass; (d) the build-up of transient water pressures in the soil mass, particularly along relict discontinuities; and (e) inadequate slope maintenance.

Description: A major soil cut slope failure which resulted in the disruption of the reservoir operation.

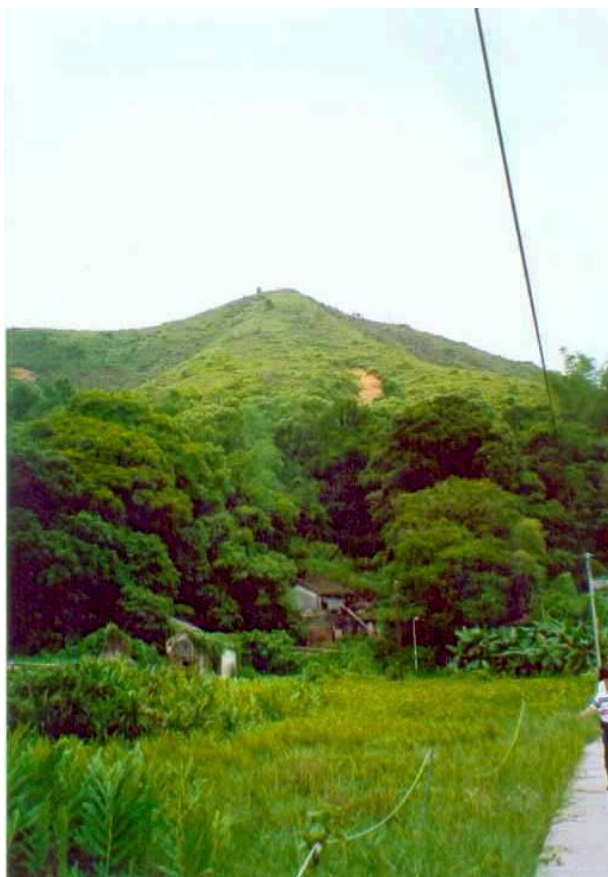
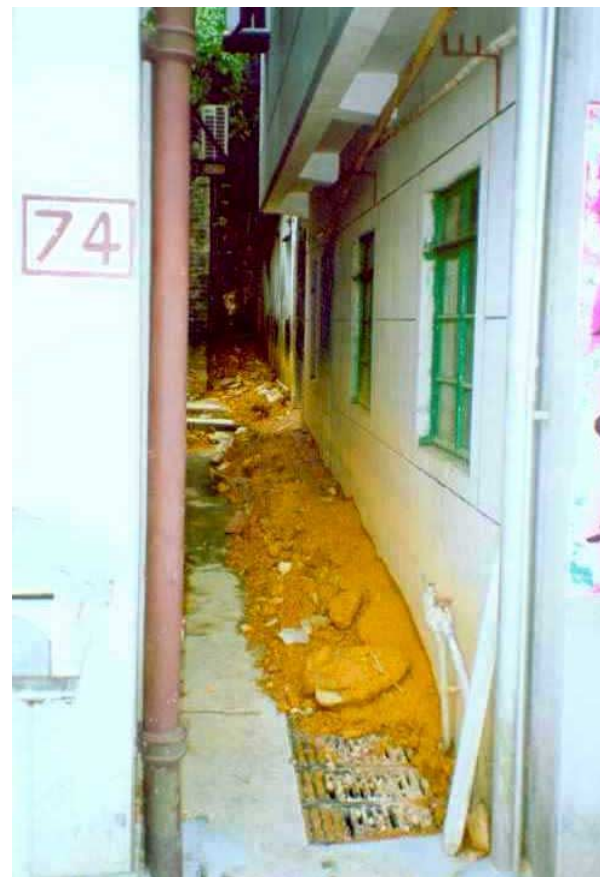
Plate 2 - Luk Keng Wong Uk, New Territories (Incident ME 98/5/10)

(A major natural slope failure which resulted in the deposition of debris between house Nos. 73 and 74, Plate 2)

On the morning of 24 May 1998, a major failure occurred on the natural hillside above village housing at Luk Keng Wong Uk in the northeast New Territories. Approximately 9 m³ of debris was deposited around the village houses.

The form of the rupture surface was of an elongated spoon-shape approximately 30 m long, 10 m wide and a maximum of 1 m deep. The total volume of displaced material was about 150 m³. Debris from the landslide was channelised along the stream course until it deposited on more gently inclined ground. The debris deposited around the village houses was either from the accumulated debris of the initial failure or from secondary outwash of debris deposited on the hillside.

The landslide was triggered by rainfall. The location of the landslide towards the top of the stream course suggested that the failure might be part of the geomorphologic development of the hillside.

Description: A major natural slope failure which resulted in the debris deposited between houses Nos. 73 and 74.

Description: Debris deposited between Village Houses Nos. 73 and 74.

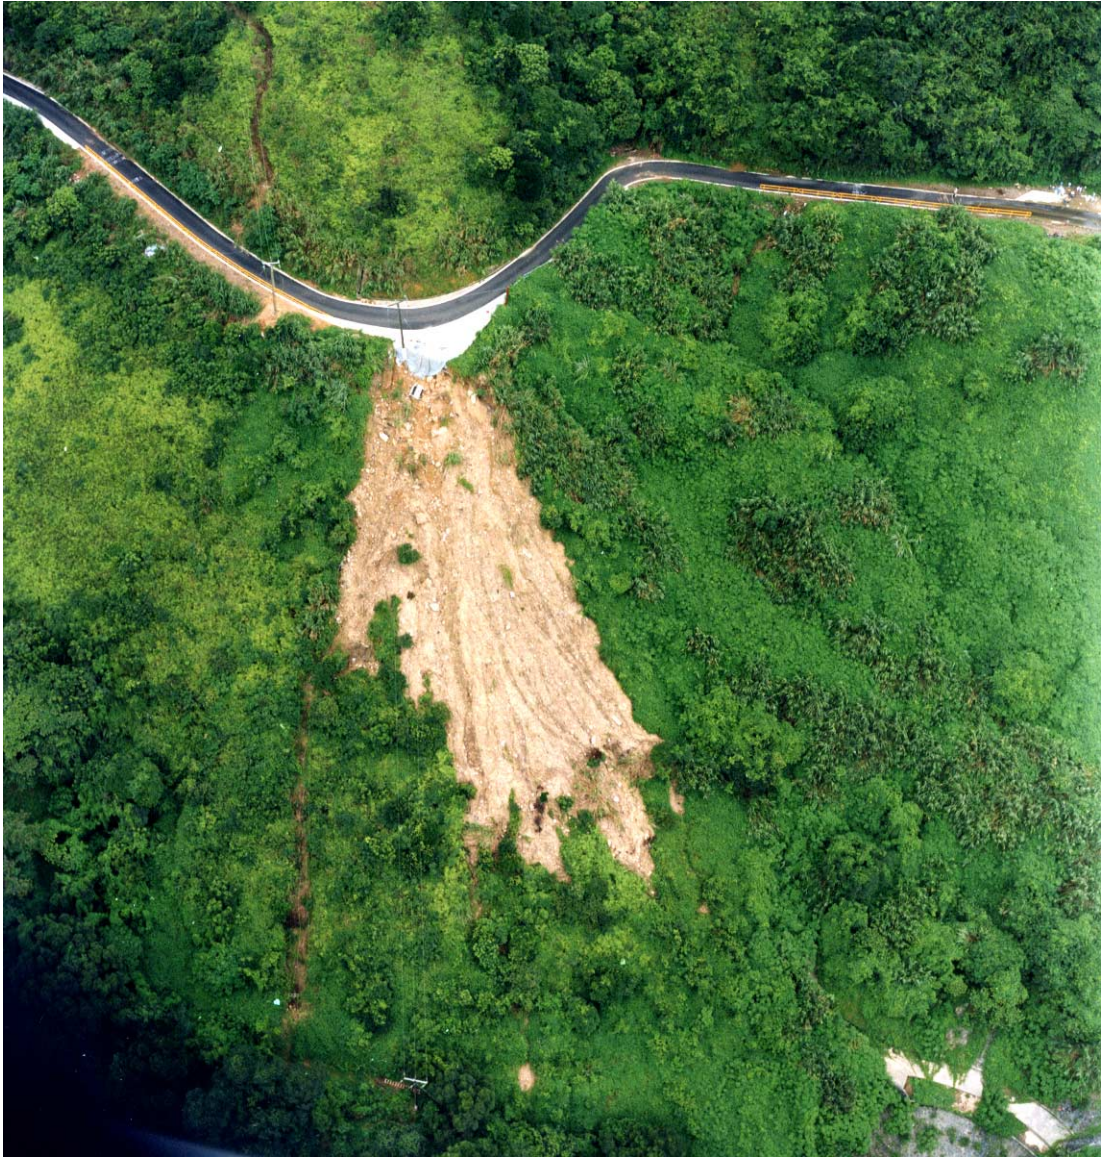
Plate 3 - Below Au Tau Village Road, Tseung Kwan O (Incident ME 98/6/10)

(A major fill slope failure which resulted in the closure of Au Tau Village Road and the open space at the toe of the rock slope, Plate 3)

The investigation concluded that the landslide primarily involved liquefaction of a loose fill slope. The probable contributory factors of the landslide include: (a) the uncontrolled dumping of fill between 1976 and 1991; (b) the loose nature of the fill which was susceptible to collapse and liquefaction upon water ingress; (c) overland flow from the road bend above the crest of the fill slope; and (d) discharge of water from an open-jointed PVC pipe.

Description: A major fill slope failure which resulted in the closure of Au Tau Village Road and the open space at the toe of the rock slope.

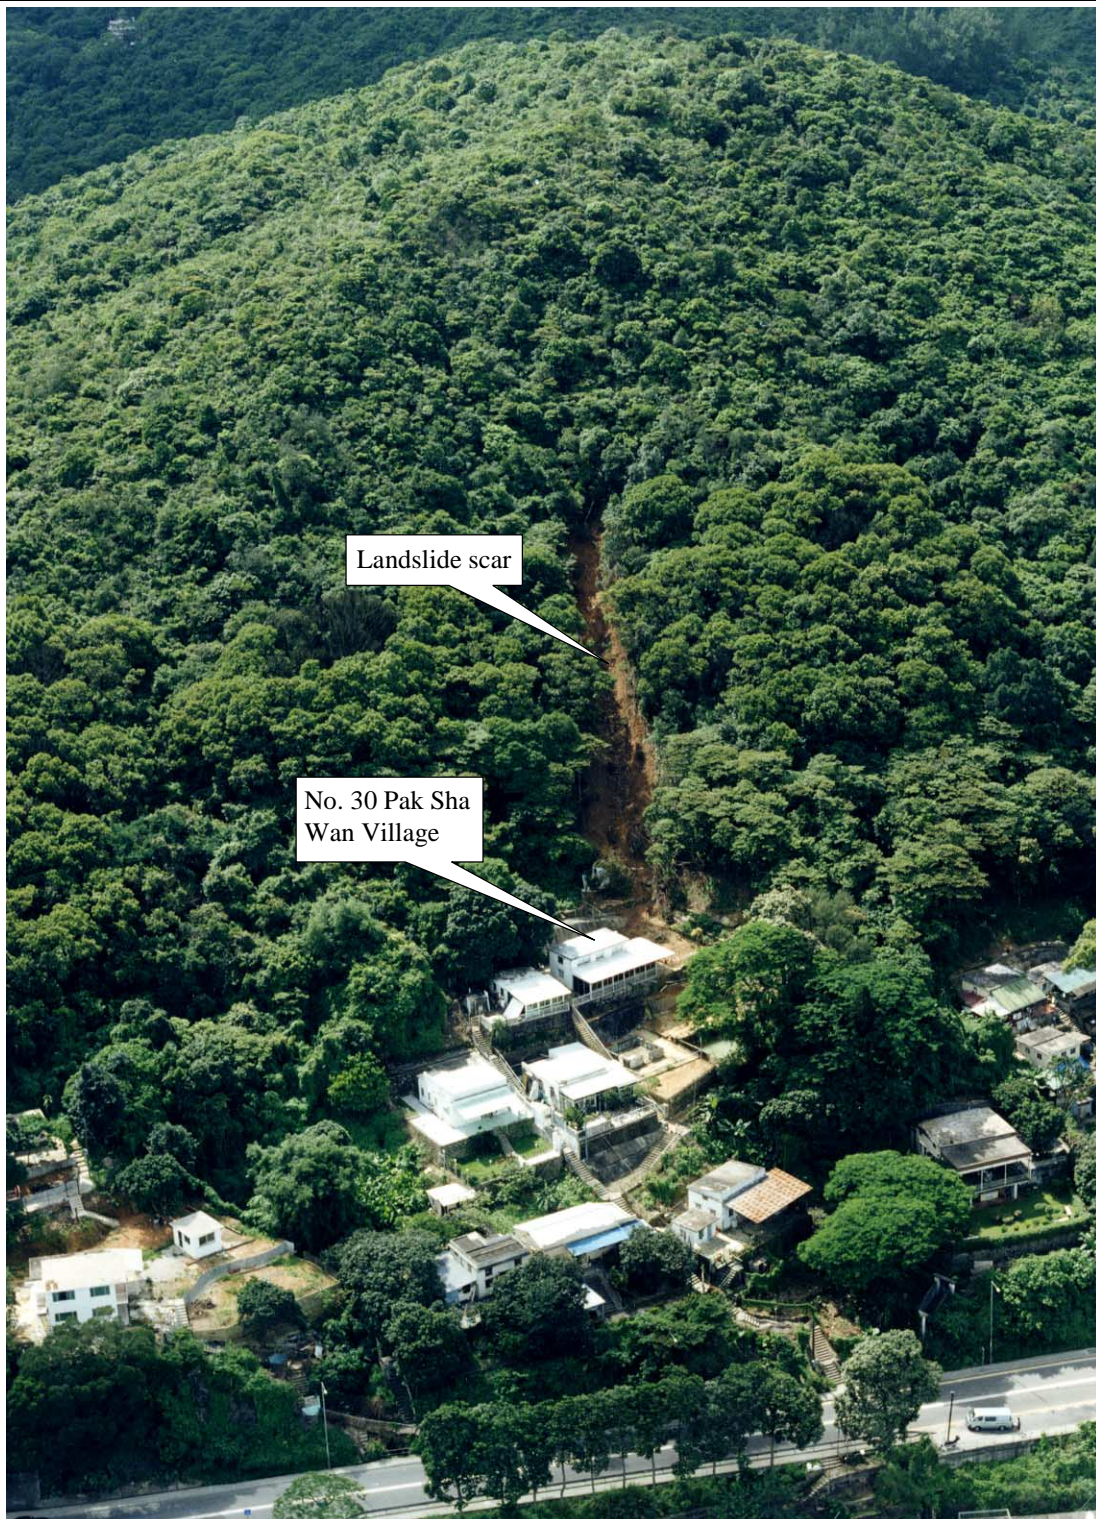
Plate 4 - No. 30 Pak Sha Wan Village, Sai Kung (Incident ME 98/6/22)

A major natural slope failure occurred during the evening of 9 June 1998 on the natural hillside above Pak Sha Wan Village, Sai Kung. The landslide occurred within a drainage line and formed a shallow channel of 7 m to 10 m width and approximately 90 m length in colluvial soils. The height of the back scarp was 2 m and the volume of the landslide was about 300 m³. The travel angle, as measured to the toe of the main terminal deposit immediately below a retaining wall, was 25°. After detailed study, more than one phase of landsliding had been identified. The debris appears to have been relatively mobile, probably as a result of channelisation within the drainage line. The debris was deposited above and on the platforms formed for village houses. No fatalities or injuries were reported but the landslide resulted in the temporary evacuation of one dwelling.

The natural terrain landslide was triggered by very severe rainfall. The probable cause of the failure was the development of transient elevated water pressures in the surface colluvium. Both concentrated surface and subsurface water flows also contributed to the landslide.

Description: A major natural slope failure which resulted in the temporary evacuation of one dwelling, No. 30 Pak Sha Wan Village.

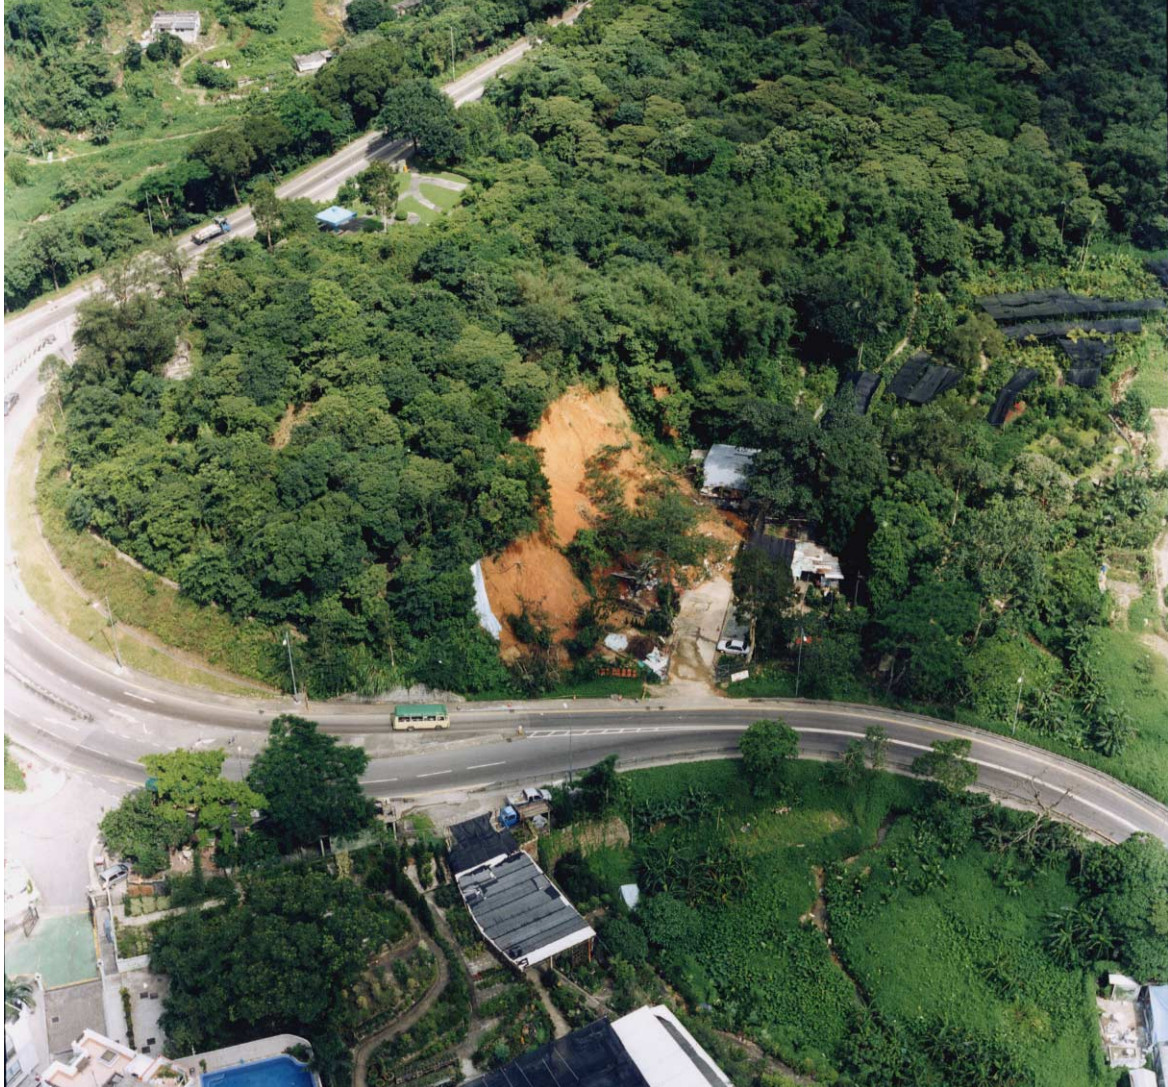
Plate 5 - Yue Sun Garden, Wo Mei, Hiram's Highway near Sai Kung
(Incident ME 98/6/36)

(Three soil cut slope failures which resulted in the permanent evacuation of one hut and the temporary evacuation of five huts within Yue Sun Garden, Plate 5)

On 9 June 1998, three major soil cut slope failures occurred within the L-shaped cut slope No. 11NE-B/C513 adjacent to Yue Sun Garden, Wo Mei, adjacent to Hiram's Highway near Sai Kung. The landslides comprised the failure of approximately 50 m of the slope and involved a total volume of about 1350 m³ of decomposed tuff.

Landslide No. 1 occurred at about 9:00 a.m. and involved about 200 m³ of material. The scar was about 15 m wide and 13 m long with a maximum depth of approximately 2 m. The landslide scar was generally "spoon-shaped". Landslide No. 2 occurred at 6:00 p.m. It appeared to have been essentially an extension of the first landslide southwards. This incident released about 1100 m³ of material, with the resulting scar being approximately 35 m wide and 25 m long with a maximum depth of about 3 m. Landslide No. 3 occurred at about 7:00 p.m. and comprised a shallow surficial failure involving about 50 m³ of material. The scar was about 10 m wide and 8 m long with a maximum depth of approximately 1 m. This landslide does not appear to have been directly connected to the first two incidents. The travel angles of the debris for the three landslides were about 34°, 30° and 50° respectively. Following the landslides, a structure damaged by the landslide debris was evacuated and subsequently dismantled. The remaining structures within Yue Sun Garden were temporarily evacuated.

The failures were probably caused by a combination of the build-up of transient elevated water pressures in the soil mass following severe rainfall, inadequate surface water

Description: Three major soil cut slope failures which resulted in the permanently evacuation of one hut and temporarily evacuation of five huts.

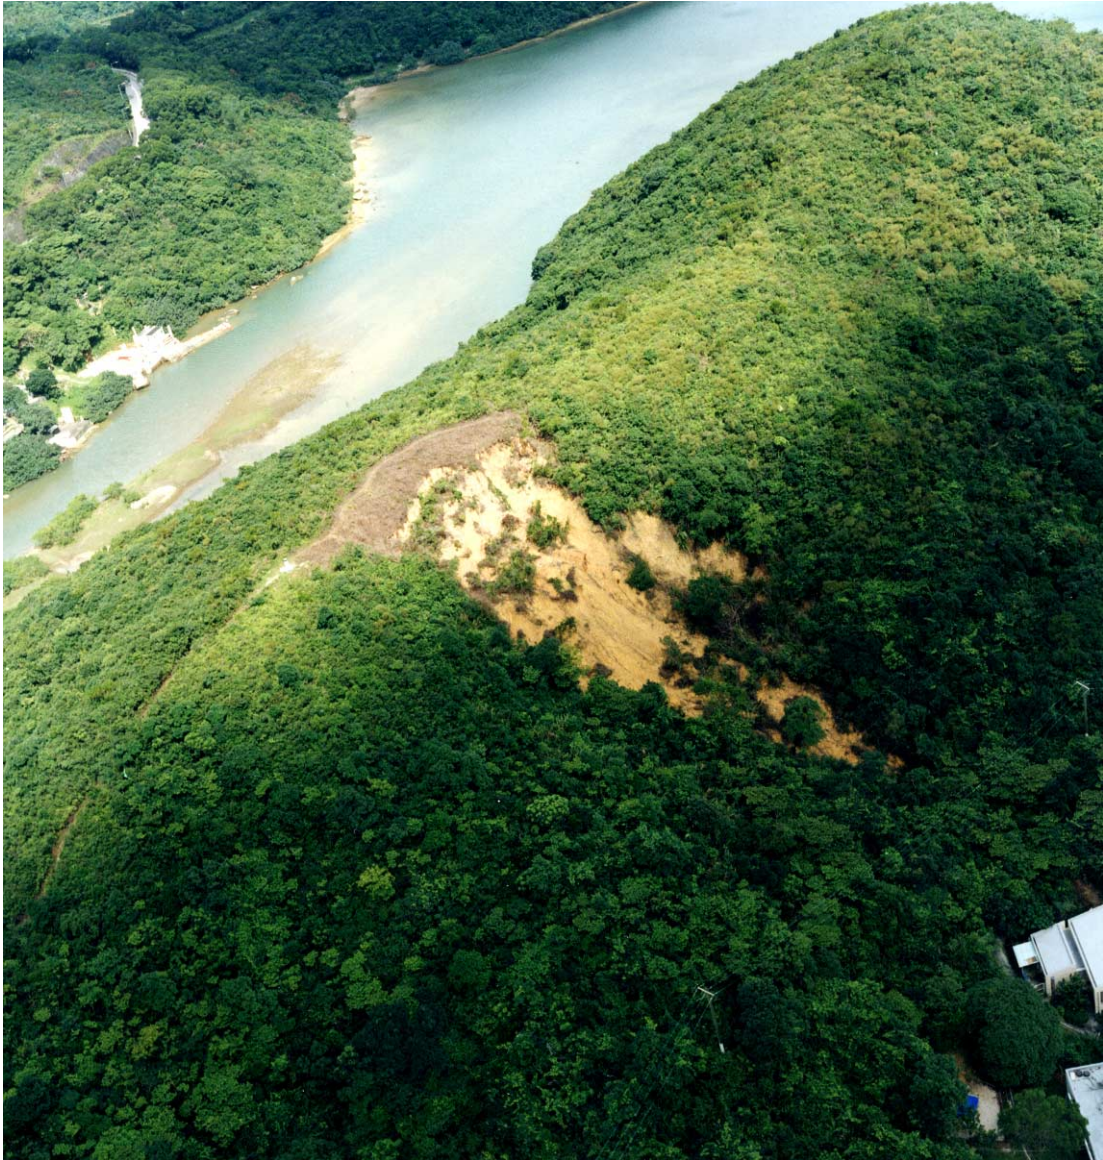
Plate 6 - Above the Outward Bound School, Tai Mong Tsai near Sai Kung
(Incident ME 98/6/55)

(A natural slope failure which resulted in the temporary evacuation of the "Captain's House", Plate 6)

At about 5:30 p.m. on 9 June 1998, a major natural slope failure occurred adjacent to the Outward Bound School, Tai Mong Tsai, near Sai Kung. The landslide involved the failure of the natural hillside close to the main ridgeline of a coastal peninsula. The failure volume was about 900 m³ and debris from the main body of the landslide came within 20 m of a dwelling known as the "Captain's House" at the toe of the hillside.

Two main backscarps (termed "upper" and "lower") were identified, as were zones of depletion and accumulation. The upper backscarp, which corresponded to the main area of failure, was located immediately below the main ridge of the peninsula and was about 30 m in length and typically between 2 m and 3 m high. The lower backscarp was about 15 m wide and 6 m high with a slope angle and it typically between 35° and 50°. The travel angle of the landslide was approximately 27°, and it resulted in the temporary evacuation of the "Captain's House".

The landslide was triggered by very severe rainfall. The open-jointed nature of the volcanoclastic rock in the vicinity of the main scarp probably resulted in an increased susceptibility to surface water infiltration. The presence of numerous near-surface erosion pipes would also have promoted concentrated subsurface water flow into this area of the hillside. The failure was probably caused by either the development of water pressures in open joints within the volcanoclastic rocks, or elevated water pressure in the soil mass, or a combination of both these factors.

Description: A major natural slope failure which resulted in the temporarily evacuation of the Captain's house.

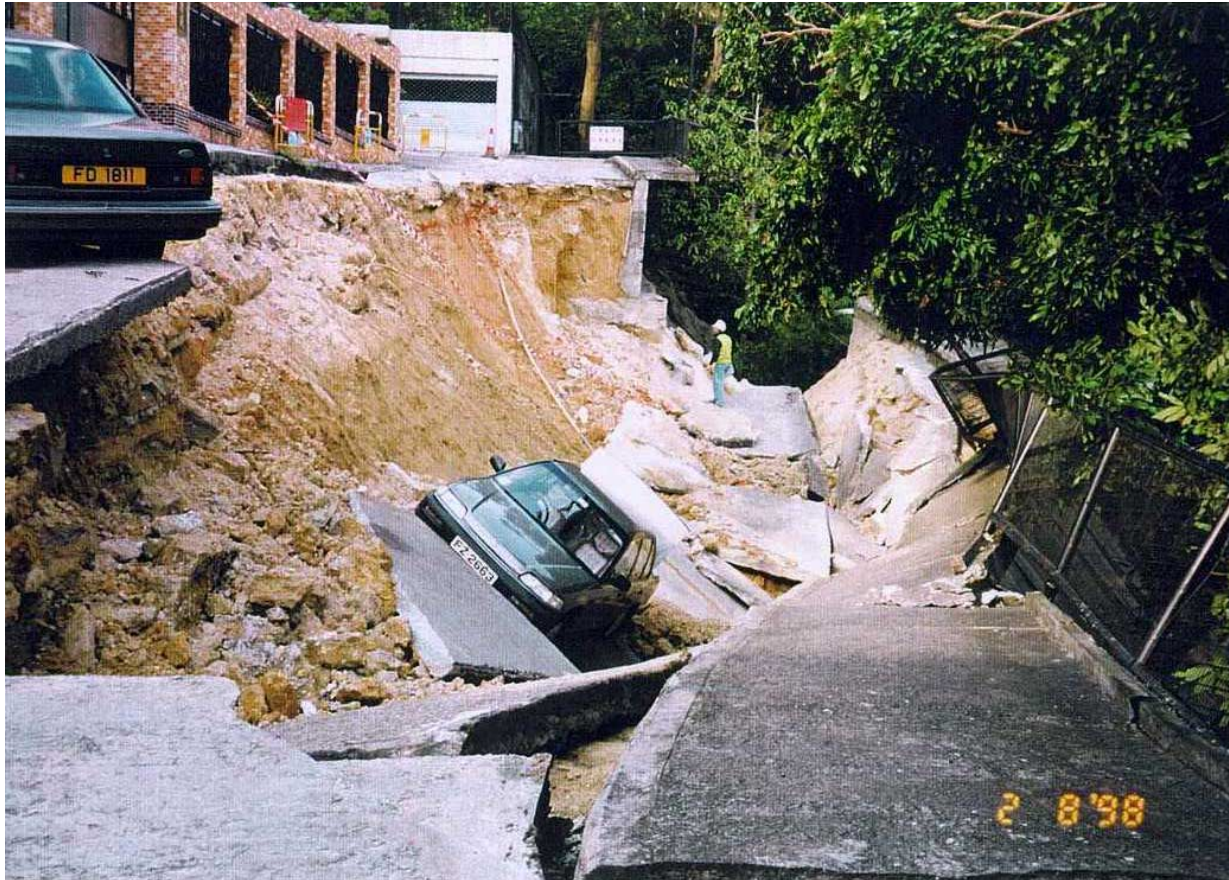
Plate 7 - Hang Lok Lane, Sha Tin (Incident MW 98/2/1)

(A major cut slope failure which involved a section of Hang Lok Lane and resulted in the temporary evacuation of a total of 143 residents, Plate 7)

At about 8:50 a.m. on 8 February 1998, a major cut slope failure occurred at slope No. 7SW-D/C293 between Hang Lok Lane and To Fung Shan Road, Shatin. The landslide

involved an approximately 36 m long section of the slope together with a section of retaining wall and Hang Lok Lane above the slope. The failed slope was a shotcrete-covered cut slope, about 5.5 m in height and inclined at an angle of about 55° to the horizontal. The landslide resulted in a 9 m high and 36 m wide landslide surface and the failure volume was about 1100 m^3 . The travel angle of the landslide was about 26° as measured from the crest to the distal end of the debris. The landslide debris comprised mainly soil, collapsed retaining wall segments, fragments of shotcrete cover, bricks and trees. The lower portion of the slope and the full width of To Fung Shan Road were buried by debris and 143 residents who lived in Nos. 5, 7 to 10 and 12 Hang Lok Lane were evacuated.

The landslide was probably caused by leakage from a 3 inch fresh water main which was located under Hang Lok Lane. Because of water ingress, the soil behind the retaining wall was wetted up and weakened. The prolonged seepage flow resulted in an increase in pore water pressure near the slope toe triggering the failure.

Description: A major soil cut slope failure which involved a section of Hang Lok Lane and resulted in the temporarily evacuation of a total of 143 residents.

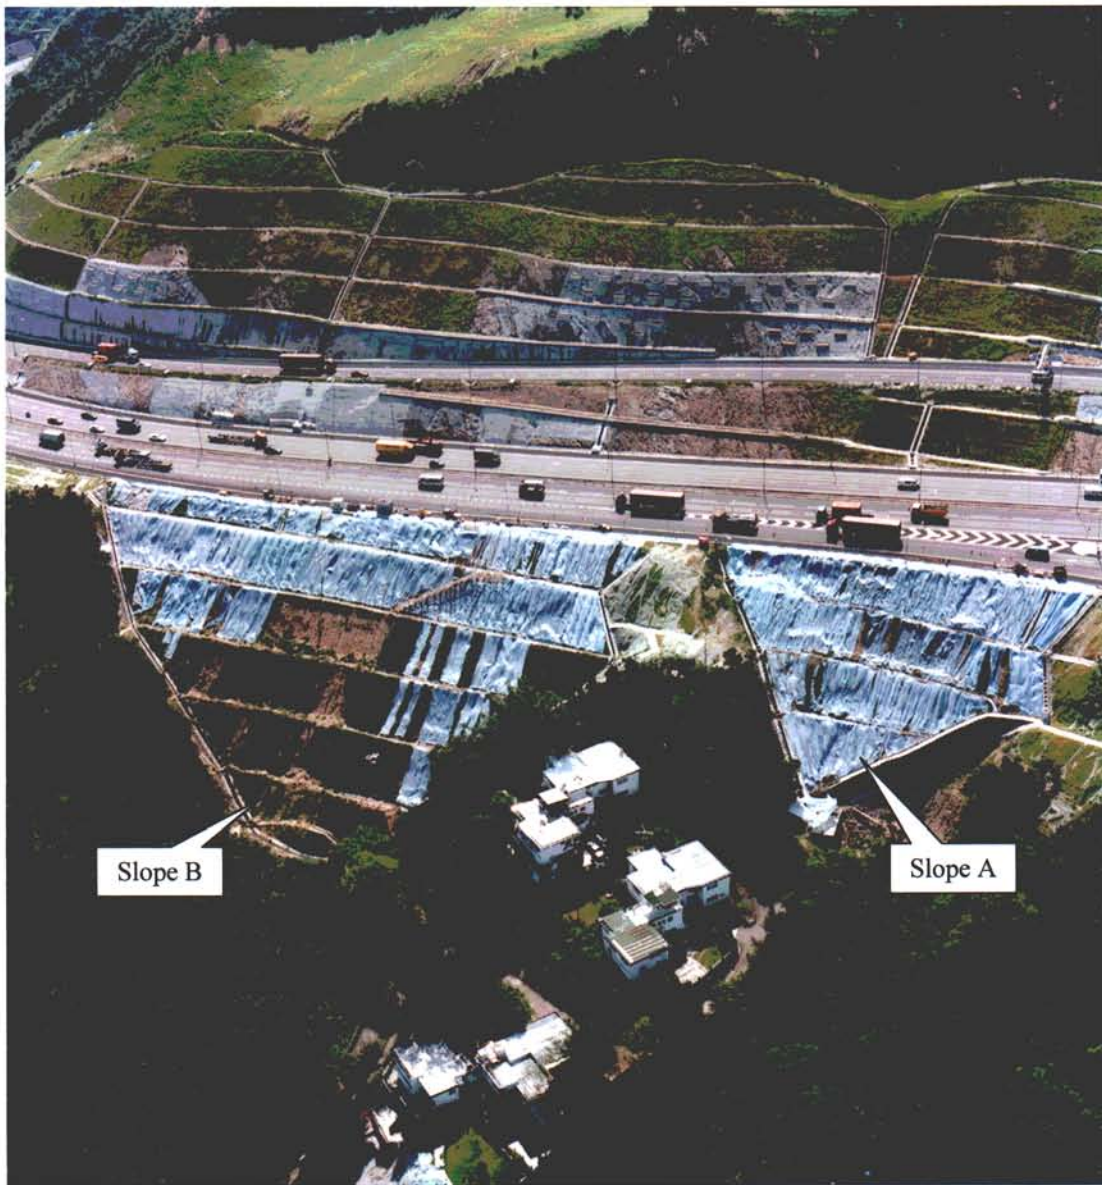
Plate 8 - Below Ramp G of the Ting Kau Bridge and Approach Viaduct at Ting Kau
(Incident MW 98/5/2)

(Three major fill slope failures affecting approximately 40% of the combined face area (3300 m^2 out of 7200 m^2) of two newly formed fill slopes, Plate 8)

Between 4 May 1998 and 9 June 1998, three major fill slope failures occurred successively during separate rainstorm events in two newly constructed fill slopes located below Ramp G of the Ting Kau Bridge and Approach Viaduct along Tuen Mun Road, Ting Kau. The landslides ultimately affected approximately 40% of the combined face area of the slopes (3300 m^2 out of 7200 m^2) and had an estimated total debris volume of 1300 m^3 .

The landslides were probably triggered by rainfall. The failures were diagnosed as

being caused by the development of transient elevated water pressures above a planar interface in the near-surface fill following direct infiltration. The method of construction adopted is liable to have resulted in the near-surface fill being in a less well-compacted state, which could have contributed to the failure.

Description: Three major fill slope failures affected approximately 40% of the combined slope surface (3300 m^2 out of 7200 m^2) of two newly-formed fill slopes.

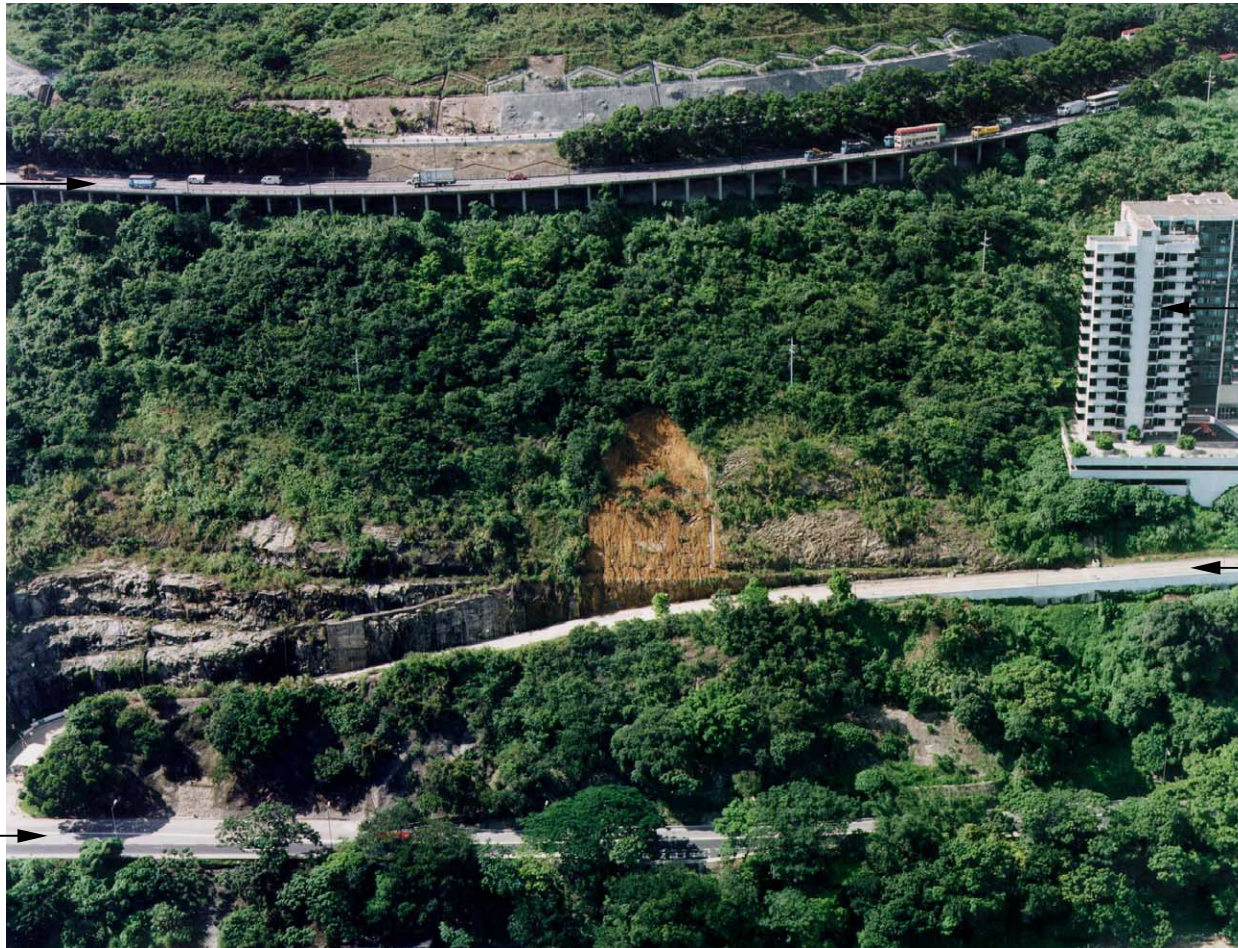
Plate 9 - Sunny Villa, 218 Castle Peak Road, New Territories (Incident MW 98/6/9)

(A soil/rock cut slope failure which resulted in the closure of the access road to Sunny Villa, Plate 9)

A major soil/rock cut slope failure occurred at about 5:50 p.m. on 9 June 1998. The landslide occurred in the upper part of the eastern portion of slope No. 6SE-D/C304 located above the access road to the Sunny Villa Apartment blocks at 218 Castle Peak Road, New Territories. The maximum height of the slope was about 45 m and 30 m at its western and eastern portion, respectively. The slope face was generally formed in three batters and each batter was separated by a 1.5 m wide berm. The soil portion of the cut slope was heavily vegetated while the rock portion was generally bare.

The main scarp of the landslide was about 28 m wide and 4.5 m high as measured at the middle section of the scarp. The surface of rupture was about 2 m deep and 15 m long, with the lower three-quarters covered by detached materials. The landslide released about 200 m³ of debris that completely blocked the access road to Sunny Villa. As the landslide debris was constrained by the bank at the far side of the access road, the travel angle of the landslide debris could not be determined reliably.

The landslide was probably triggered by rainfall. The probable causes of the failure include wetting up of the near-surface material and development of transient elevated water pressures as a result of ingress of water during rainfall. Overtopping of surface water from the blocked crest channel immediately above the landslide site probably promoted water ingress into the soil mass. The presence of adversely oriented relict joints with kaolin infill within the completely decomposed volcanics gave rise to relatively low shear strength, and inadequate slope maintenance was probably a contributory factor.

Description: A major soil cut slope failure which resulted in the closure of the access road to Sunny Villa.

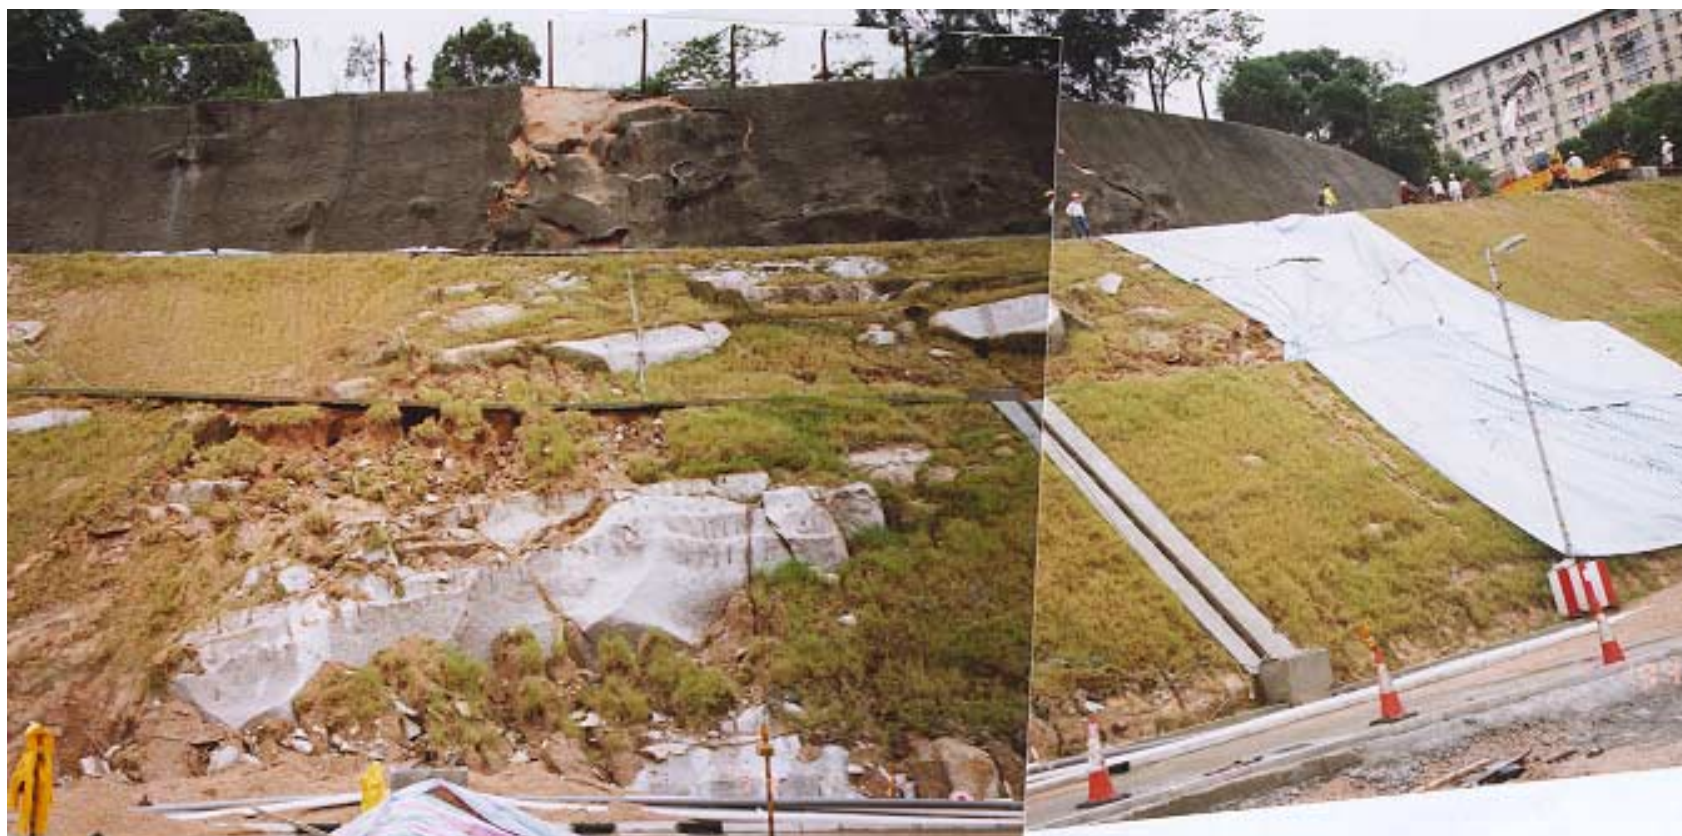
Plate 10 - Tai Po Road near Chak On Estate (Incident MW 98/6/11)

(A major cut slope failure which resulted in the closure of Tai Po Road, Plate 10)

Some time before 16:50 on 9 June 1998, a major failure occurred within an active construction site at a newly-formed cut slope (No. 11NW-B/C60) above Tai Po Road, near

The landslide area was trapezoidal in plan, about 17 m high and 37 m wide at its base, tapering to about 10 m wide at the crest and wedge-shaped in section, with an average depth of about 4 m. The total volume of the landslide debris was about 1400 m³. No travel angle was determined since the landslide traveled only a fairly short distance (about 1 m) and the debris remained largely on the relatively shallow cut slope. The landslide mass remained relatively intact, apart from shear/tension cracks dividing it into separate blocks. However, extensive signs of distress, in the form of significant cracking and dislocation of berm slabs, were observed. The western margin of the landslide was delineated by a planar, persistent, subvertical discontinuity running the whole height of the landslide. The slip moved approximately 1 m before coming to rest whilst a large amount of material was eroded onto the slip road under construction.

The landslide was probably triggered by moderately heavy rainfall. Inadequate surface water drainage provision, together with poor maintenance and the existence of cracks in the damaged road pavement, could have played a role in causing surface erosion and probably increased infiltration. The presence of an adversely oriented persistent, thin sandy silty clay layer and persistent relict discontinuities were also contributory factors.

Description: A major cut slope failure which resulted in the closure of Tai Po Road.

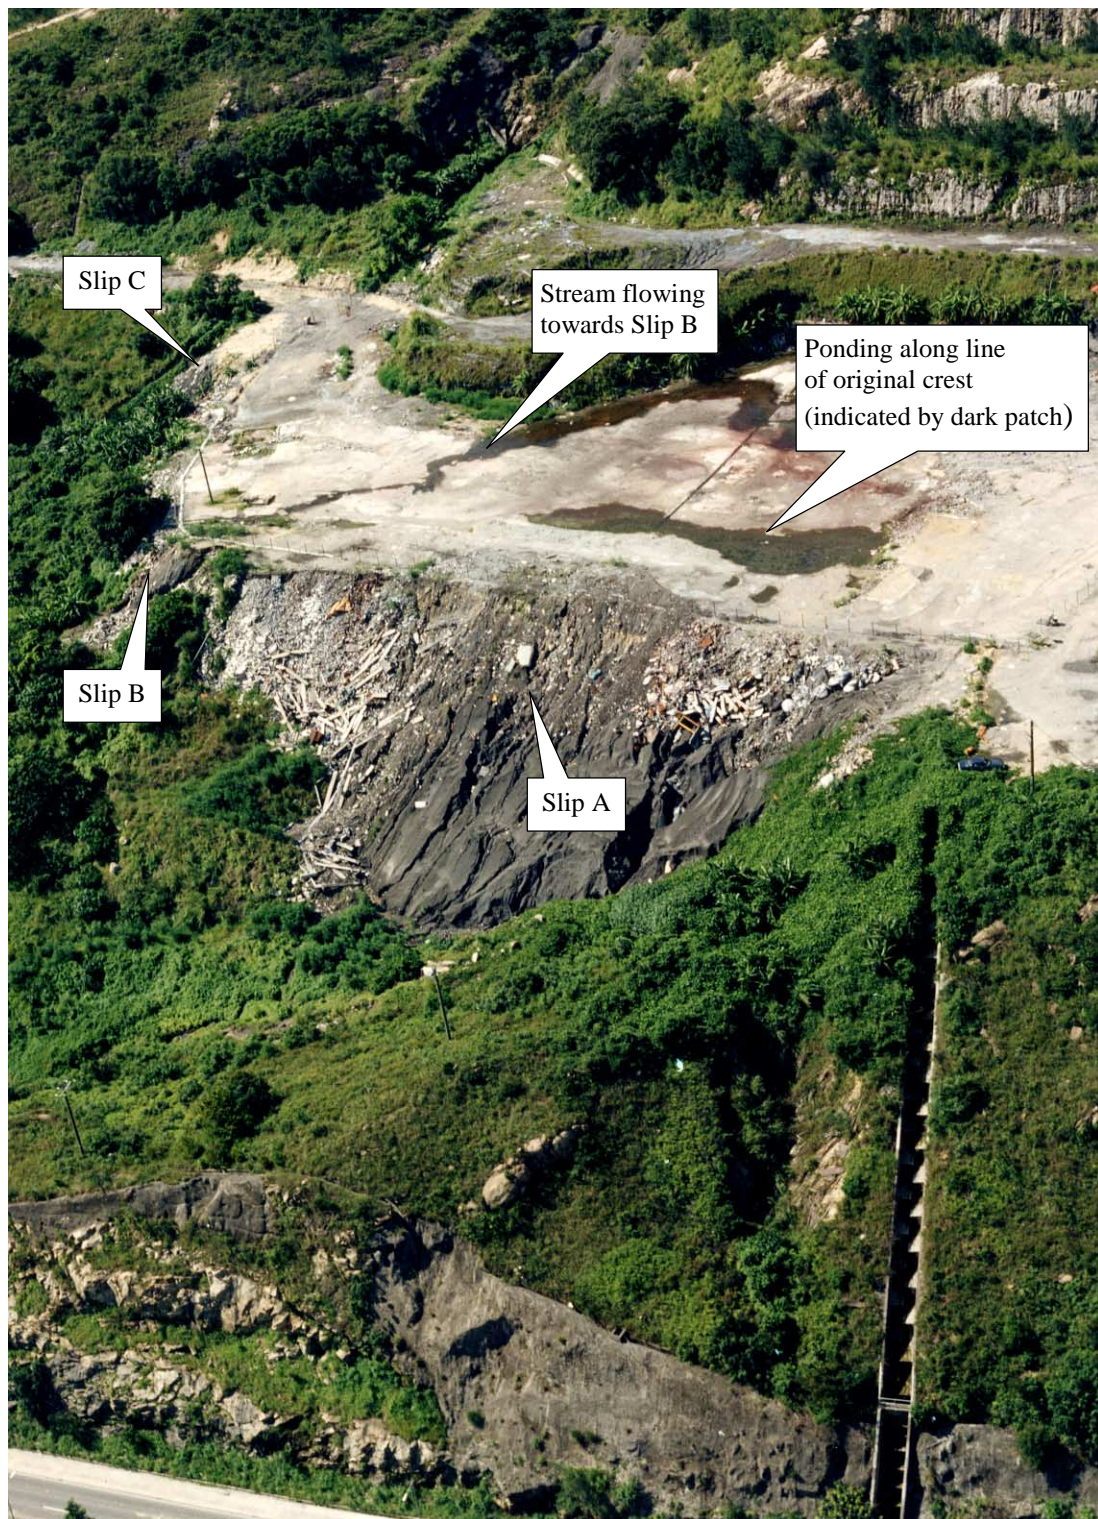
(Two major and one minor fill slope failures which resulted in the closure of one lane of road, Plate 11)

Two major and one minor failures occurred on 9 June 1998 within an unauthorized Pulverized Fuel Ash (PFA) fill slope (No. 5SE-D/F17), at Siu Lang Shui, Tuen Mun. The fill slope formed an "L"-shaped extension to a cut platform and was inclined at around 35°. The main landslide occurred within the main body of end-tipped PFA on the south-facing embankment, and was 60 m wide, 30 m long and 2 m deep with a volume of about 1000 m³. Another major landslide occurred at the southwestern corner of the platform and the scar was 8 m wide, 10 m long and 4 m (maximum) deep, with a volume of approximately 80 m³. The minor failure occurred at the northern end of the western section. The disturbed area measured about 7 m wide and 10 m long, involving a volume of around 20 m³. The main consequence of the landslides was that PFA fill was washed out of the failed area, and debris was deposited as far as Lung Mun Road resulting in the closure of one lane.

These landslides were probably triggered by heavy rainfall. Direct infiltration and subsurface seepage from localised ponding on the platform caused the main failure. The second major failure was caused by concentrated surface water flows overtopping the crest of the PFA slope. The cause of the minor failure was considered to be the wetting up of loose PFA and building debris causing collapse settlement of the loose soil structure. The low density of the PFA fill was a contributory factor.

Description: Three PFA fill slope failures which resulted in the closure of one lane of road.
