REVIEW OF 1997 AND 1998 LANDSLIDES

GEO REPORT No. 107

H.N. Wong & K.K.S. Ho

**GEOTECHNICAL ENGINEERING OFFICE
CIVIL ENGINEERING DEPARTMENT
THE GOVERNMENT OF THE HONG KONG
SPECIAL ADMINISTRATIVE REGION**

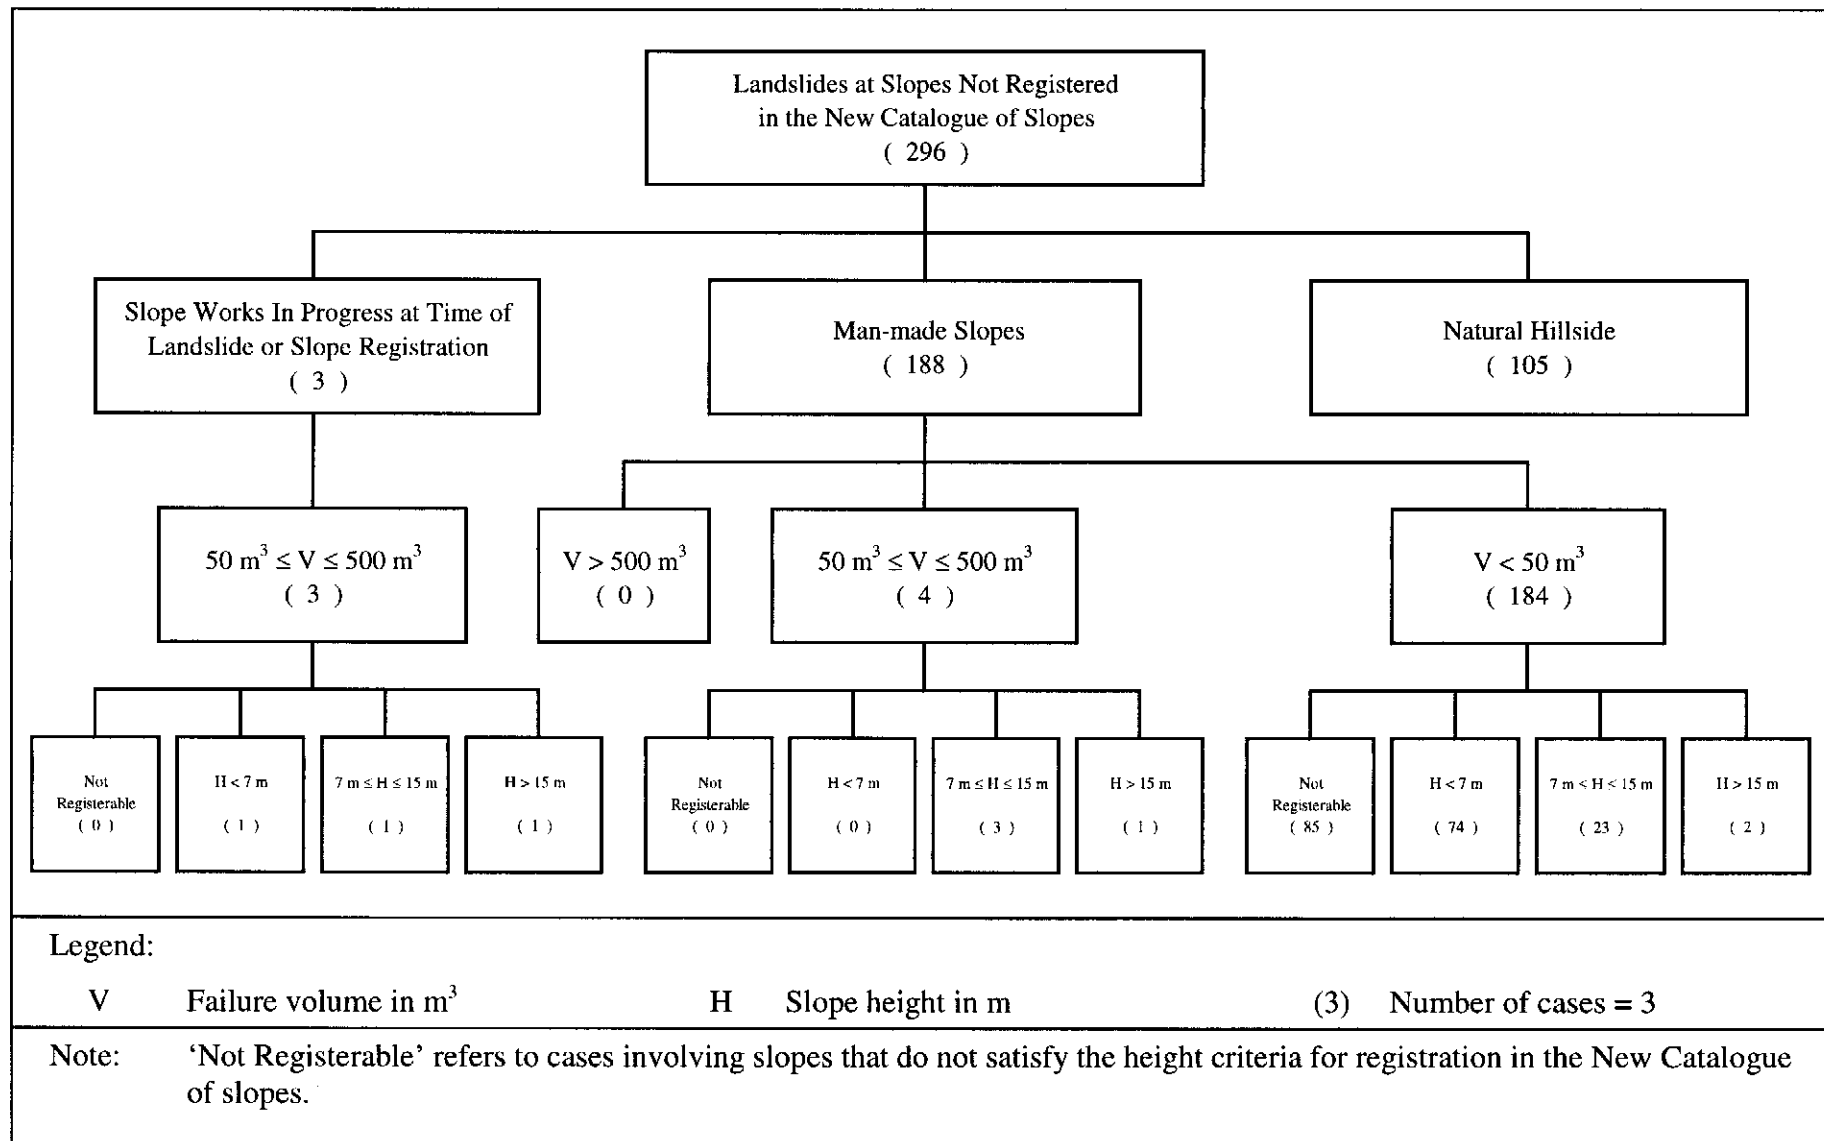
Figure 1 - Breakdown of Landslides at Unregistered Slopes in 1997 and 1998

In terms of the overall landslide data, about 37% (i.e. 296 out of 787) of the landslide incidents occurred on unregistered slope features at the time of their failure. A breakdown of these incidents is given in Figure 1.

A total of 103 incidents involved registerable man-made slope features which were yet to be registered at the time of failure. Of the 103 incidents, four cases involved major failures. These affected an abandoned quarry, a squatter hut and two village access roads respectively.
