INVESTIGATION OF SOME SELECTED LANDSLIDES IN 1998 (VOLUME 1)

GEO REPORT No. 108

**SECTION 1 :
DETAILED STUDY OF THE
NATURAL TERRAIN
LANDSLIDE AT NO. 30
PAK SHA WAN ON 9 JUNE 1998**

**This report was originally produced in June 1999
as GEO Landslide Study Report No. LSR 1/99**

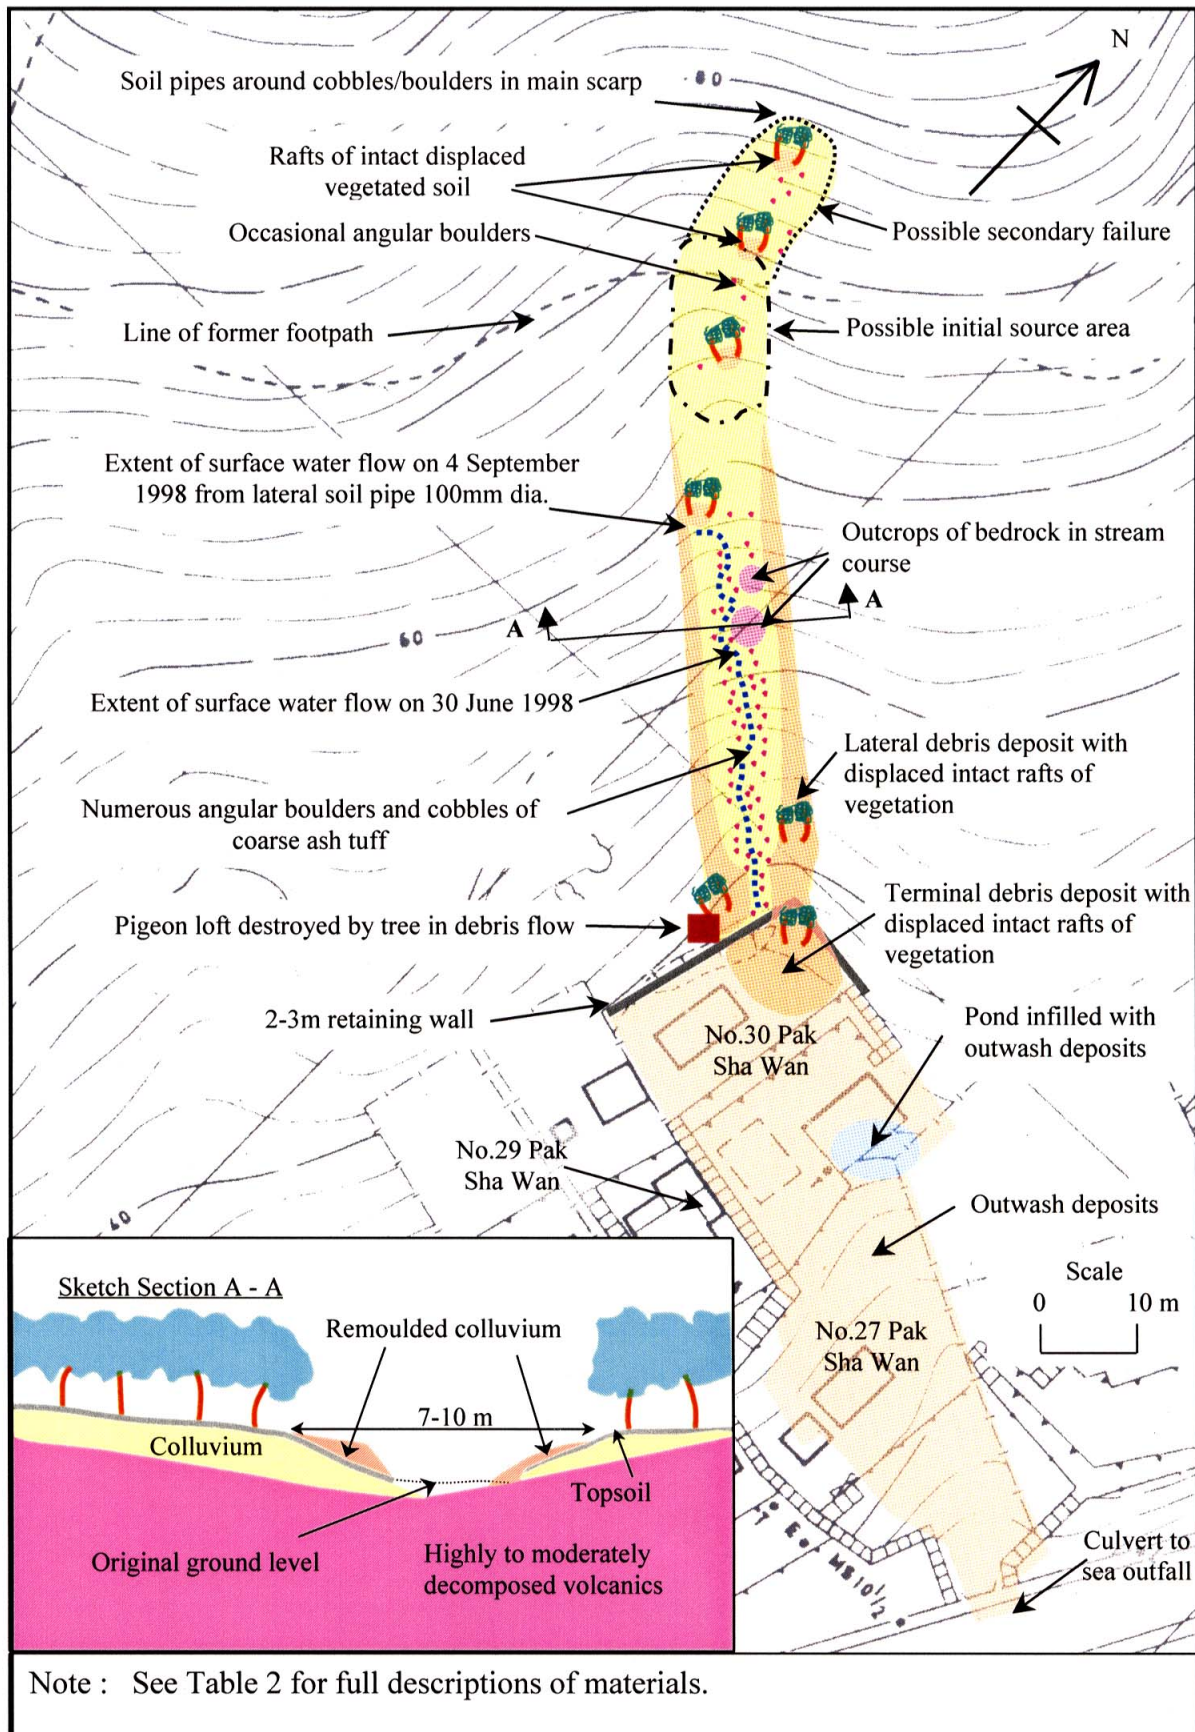
Figure 2 – Sketch Plan of the Landslide

- (e) Secondary failure of the obliquely-aligned area above the source area (Figure 2), due to loss of support associated with the initial slide, resulting in the deposition of rafts of vegetated and relatively intact material along the debris trail further downhill.

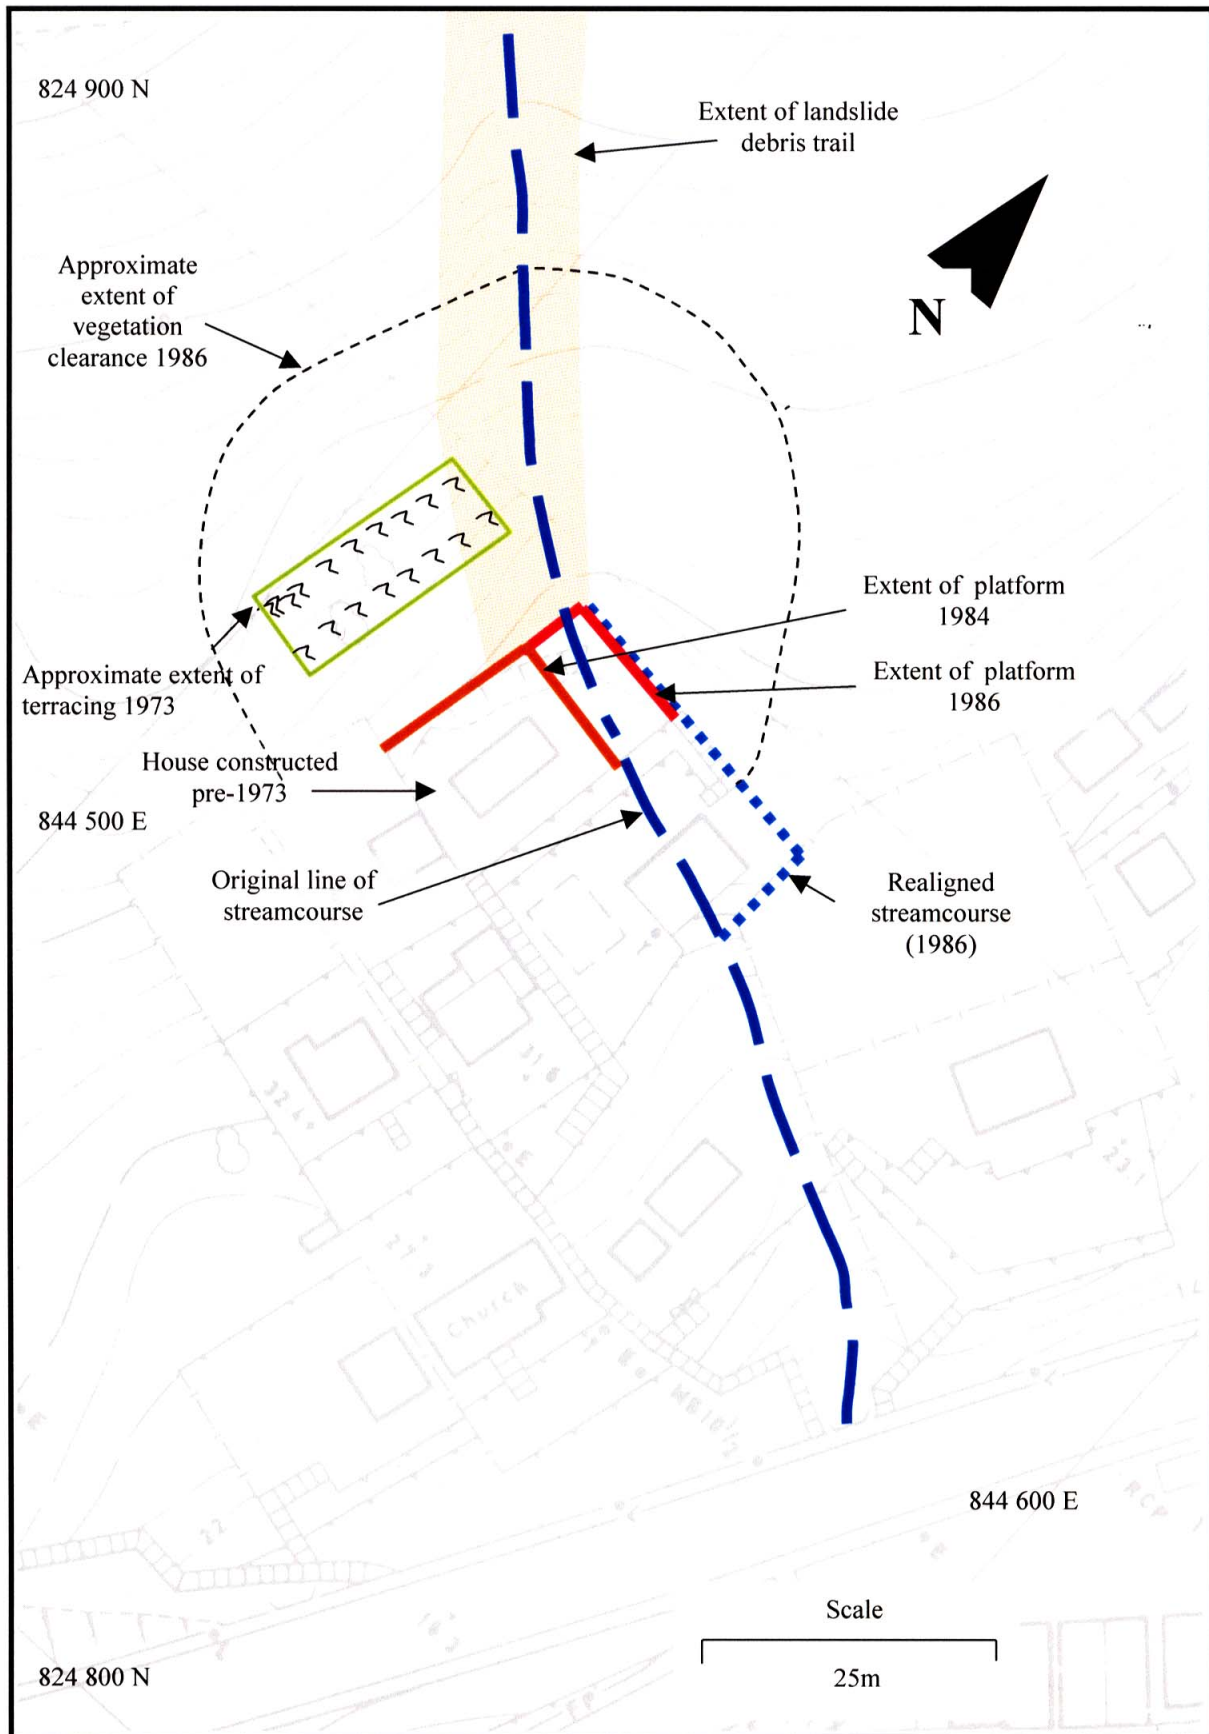
Figure 4 – Plan of Key Features Observed in API

Conditions in 1984 appear much the same as 1973, except that agricultural activities may have ceased and become overgrown, although the area is partly shielded from view due to the angle of sight. A footpath is evident crossing the valley about mid-way, close to the crest of the 1998 landslide.

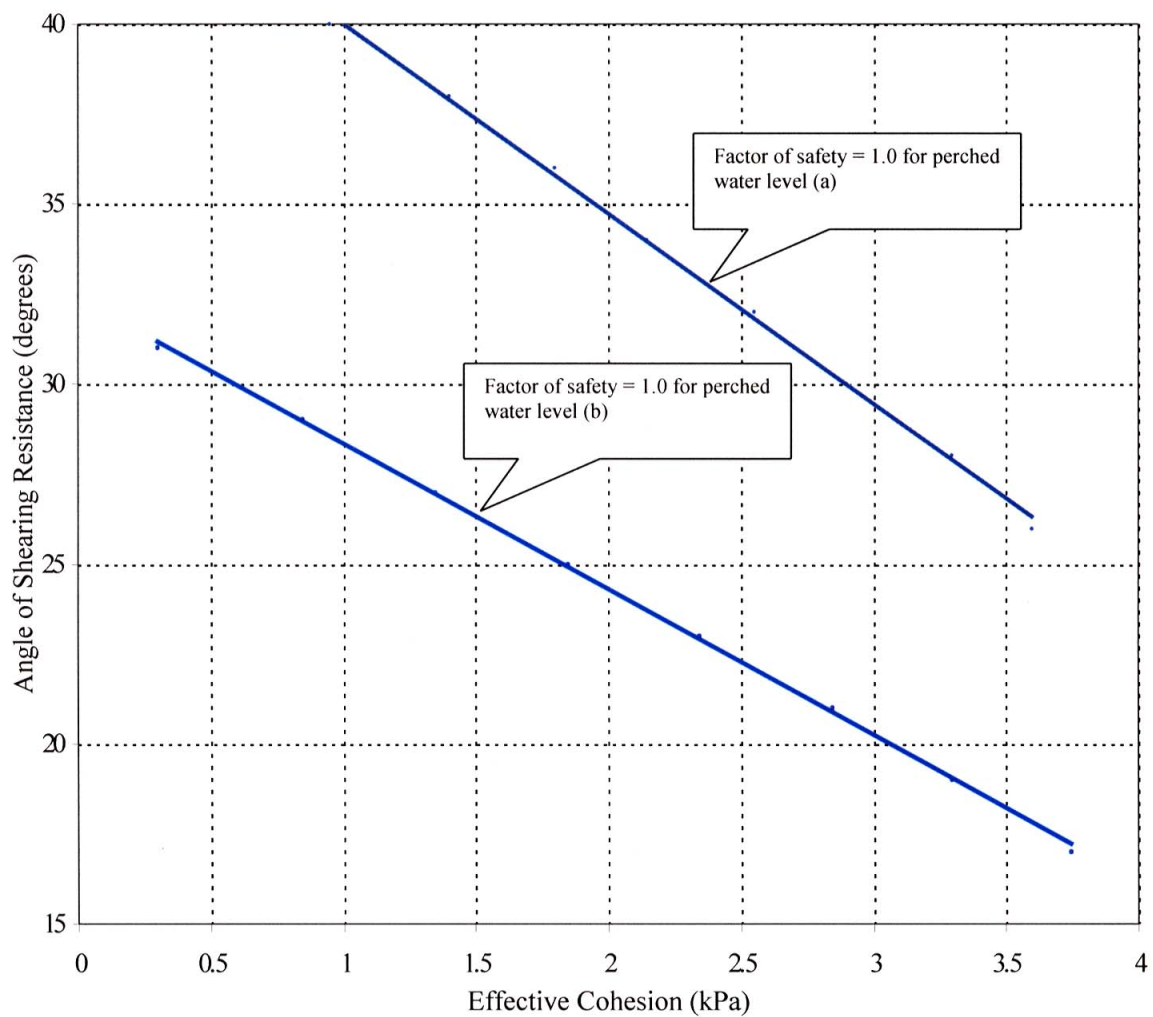
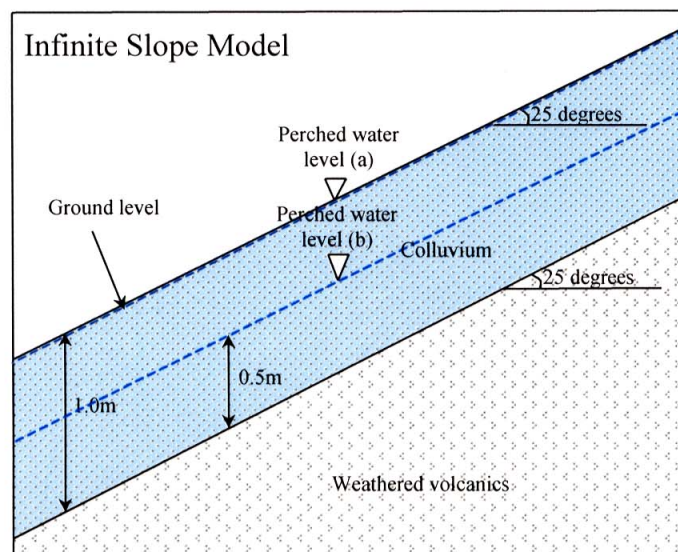
Figure 9 – Results of Theoretical Analyses

The geological model assumed in the analyses consists of a 1 m thickness of colluvium overlying a relatively impermeable stable stratum that dips at an average slope of 25°. A sensitivity analysis has been carried out using different assumptions of groundwater conditions within the colluvium, to examine the likely range of c' and ϕ' values that might apply (Figure 9). The results suggest that for typical saturated strength parameters for the nature of the material as observed (i.e. c' up to 2 kPa and ϕ' of 30° to 35°), the groundwater condition at failure is likely to have been somewhere between an elevated water level of 0.5 m and 1.0 m above the colluvium/tuff interface with seepage flow being parallel to the ground surface.

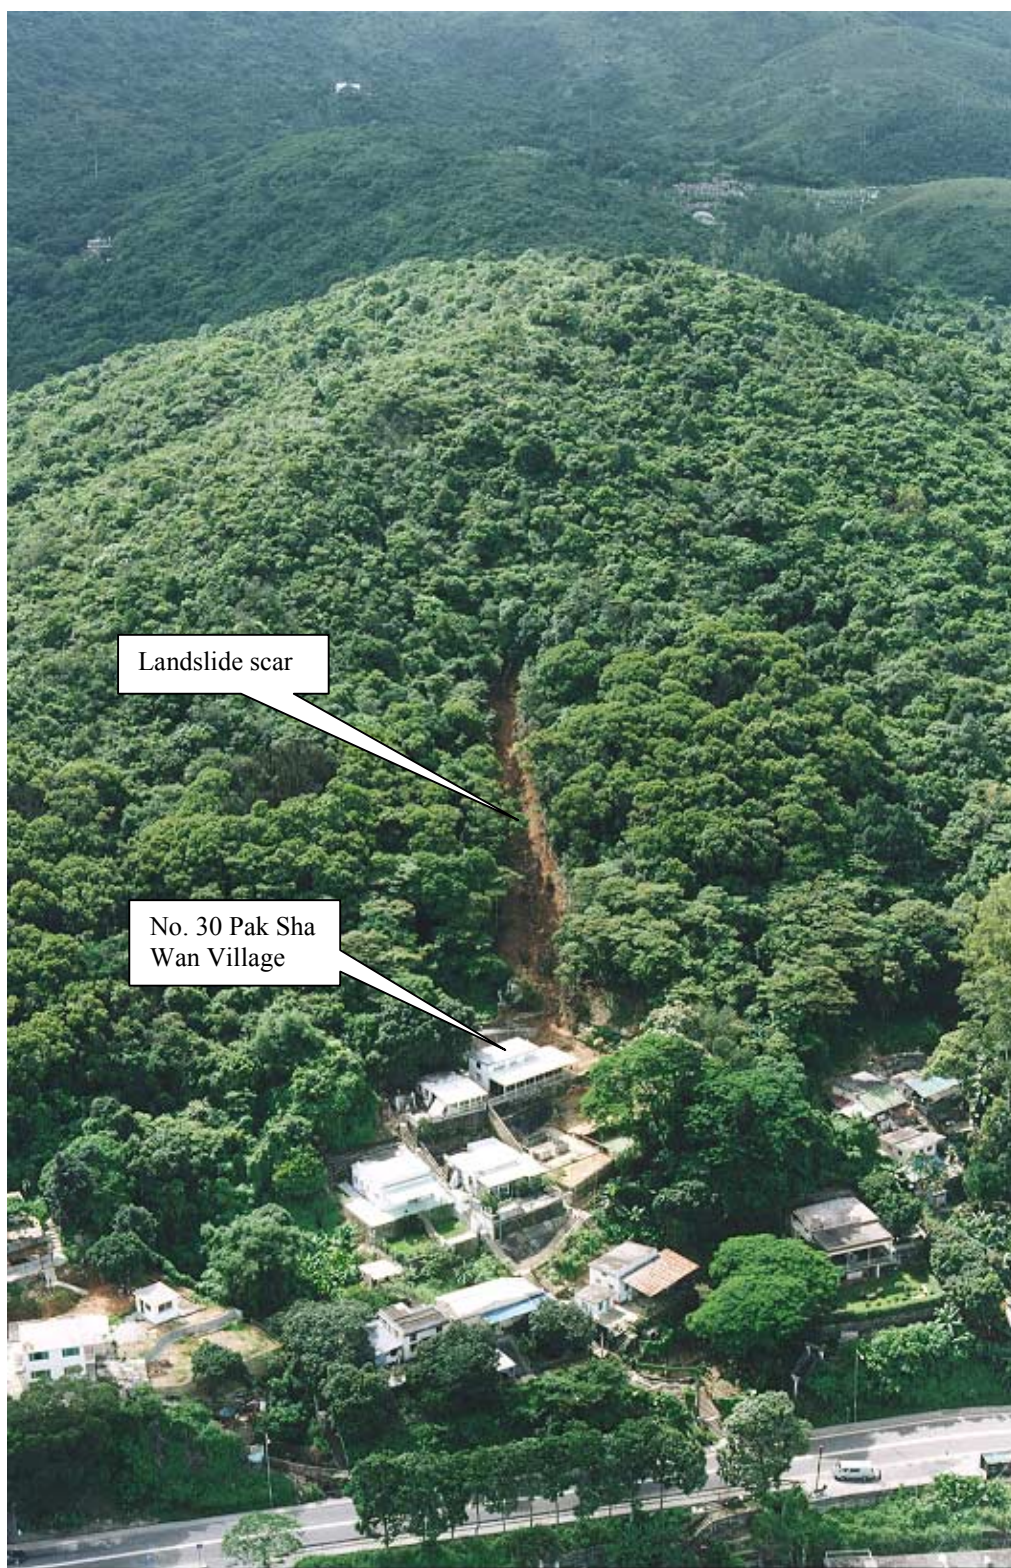
Plate 1 – Aerial View of the Landslide
(Photograph taken on 29 June 1998)

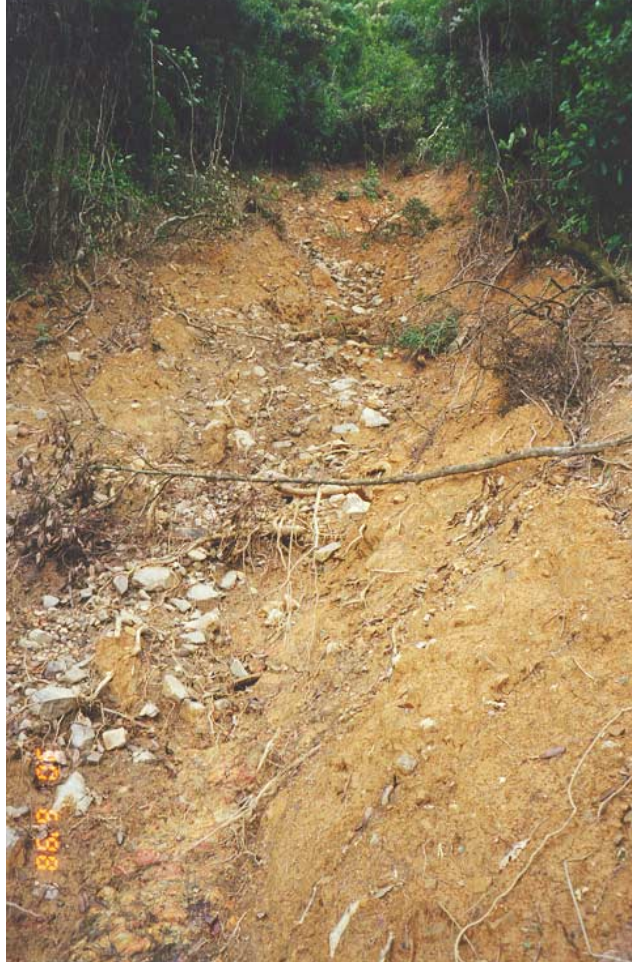
Plate 2 – General View of the Landslide
(Photograph taken on 30 June 1998)

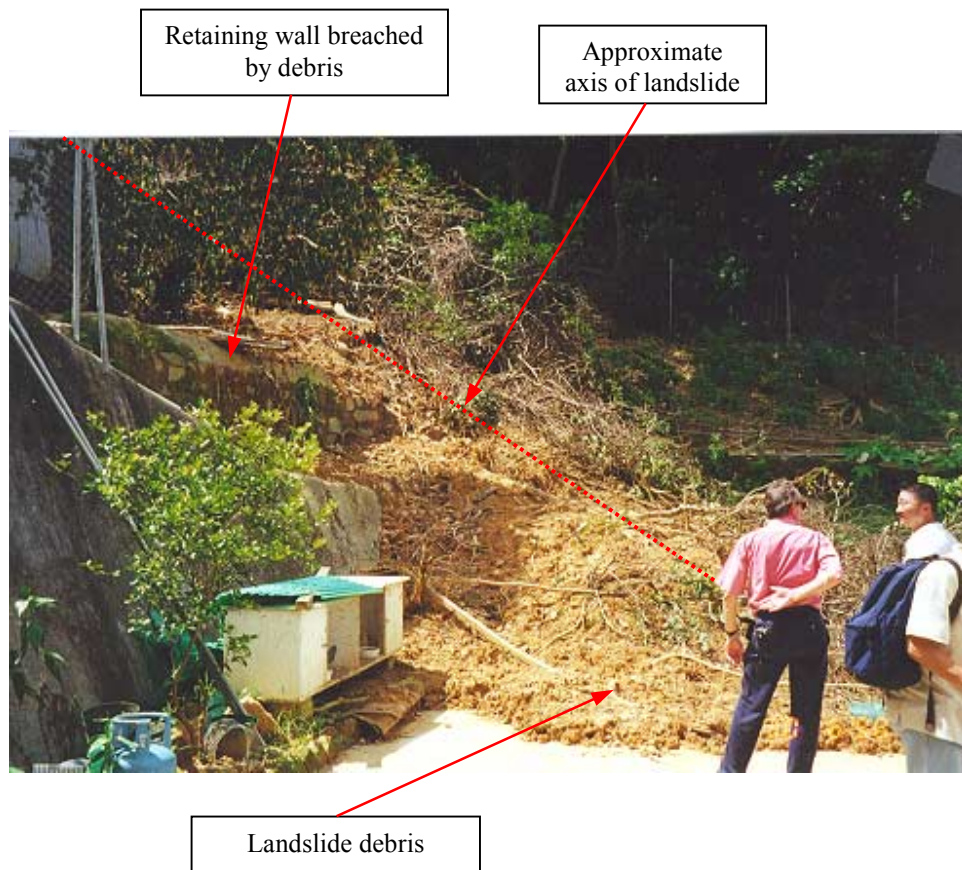
Plate 3 – View of Toe of Landslide
(Photograph taken on 30 June 1998)

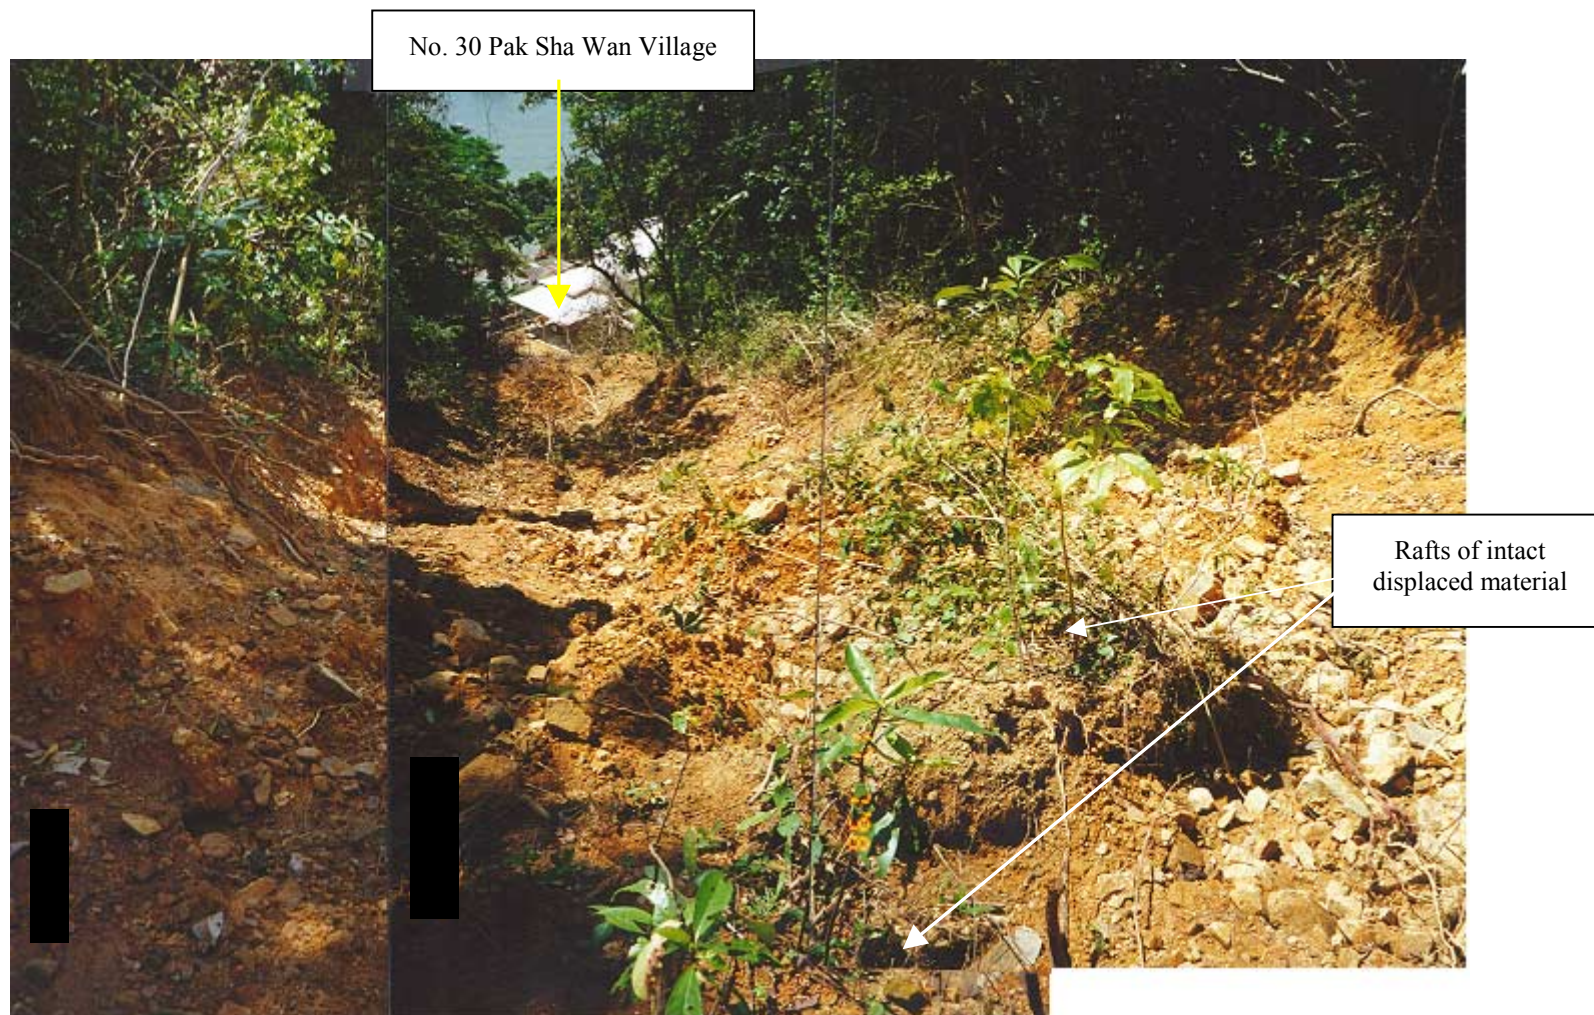
Plate 4 – General View Down the Landslide
(Photograph taken on 30 June 1998)

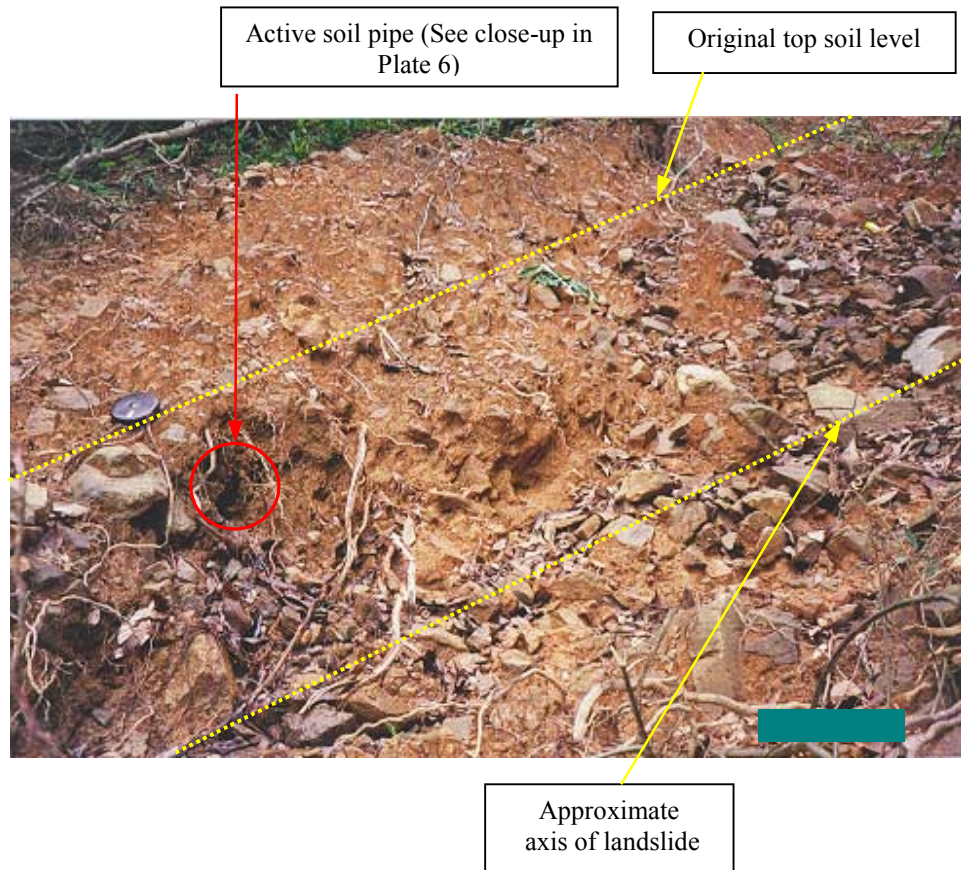
During a site visit made on 4 September 1998, after two dry days following a thunderstorm, a stream was observed running for over half the length of the landslide debris trail. The source of the stream was seen to be a soil pipe within the in-situ colluvium, beneath lateral debris, forming the southwestern side scarp of the debris trail (Figures 2 and 3), at approximately 60 mPD. The water flow which was issuing into the drainage line from a southwesterly direction, was estimated to be around 1.0 litres per second. This soil pipe is shown in Plates 5 and 6.

Plate 5 – View of a Soil Pipe at Side of Debris Trail
(Photograph Taken on 4 September 1998)

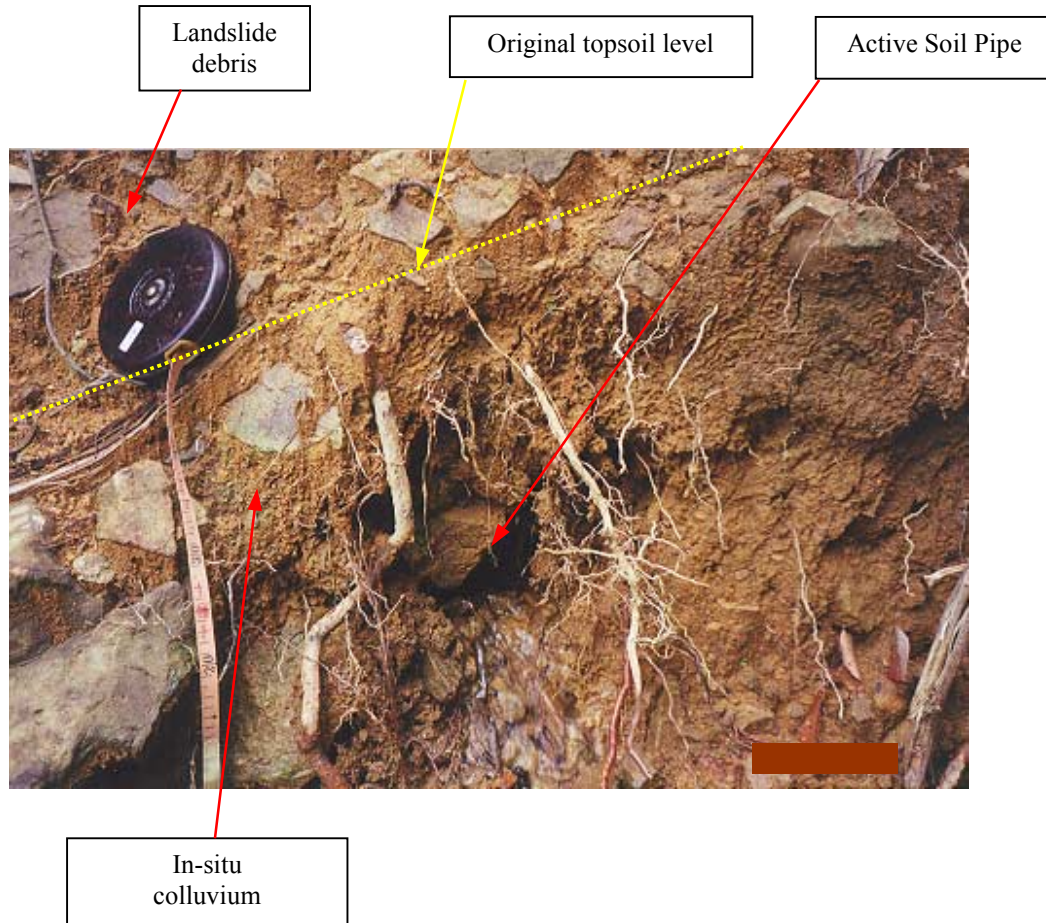
Plate 6 – Close-up of an Active Soil Pipe at Side of Debris Trail
(Photograph Taken on 4 September 1998)

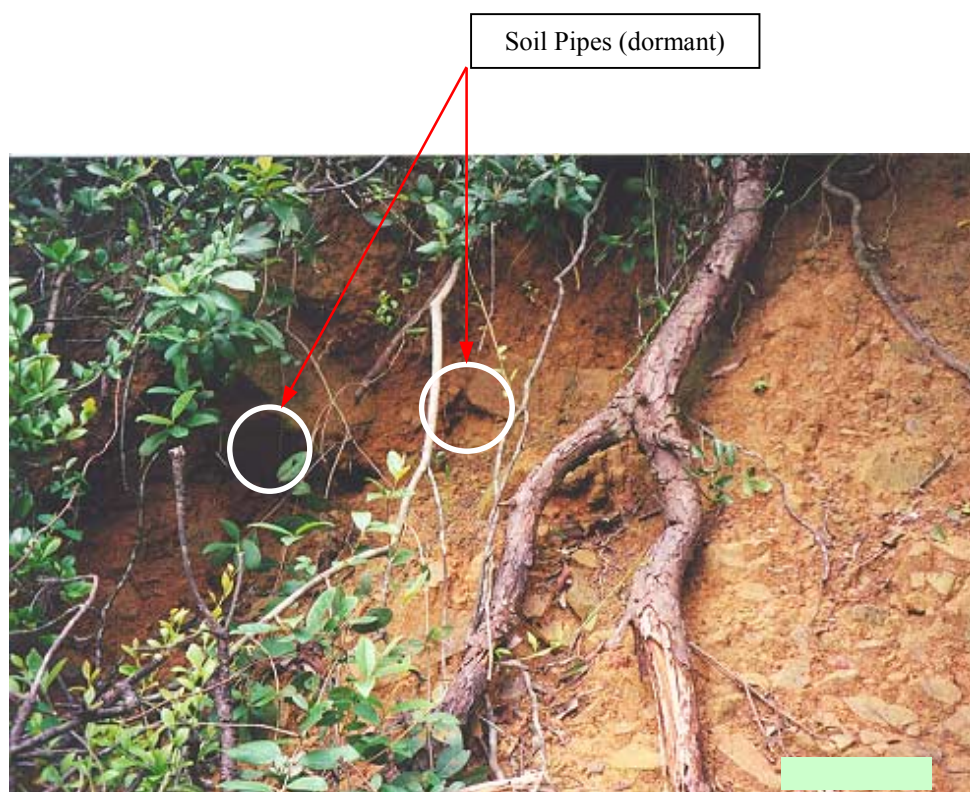
Plate 7 – View of Soil Pipes in the Main Scarp
(Photograph taken on 30 June 1998)

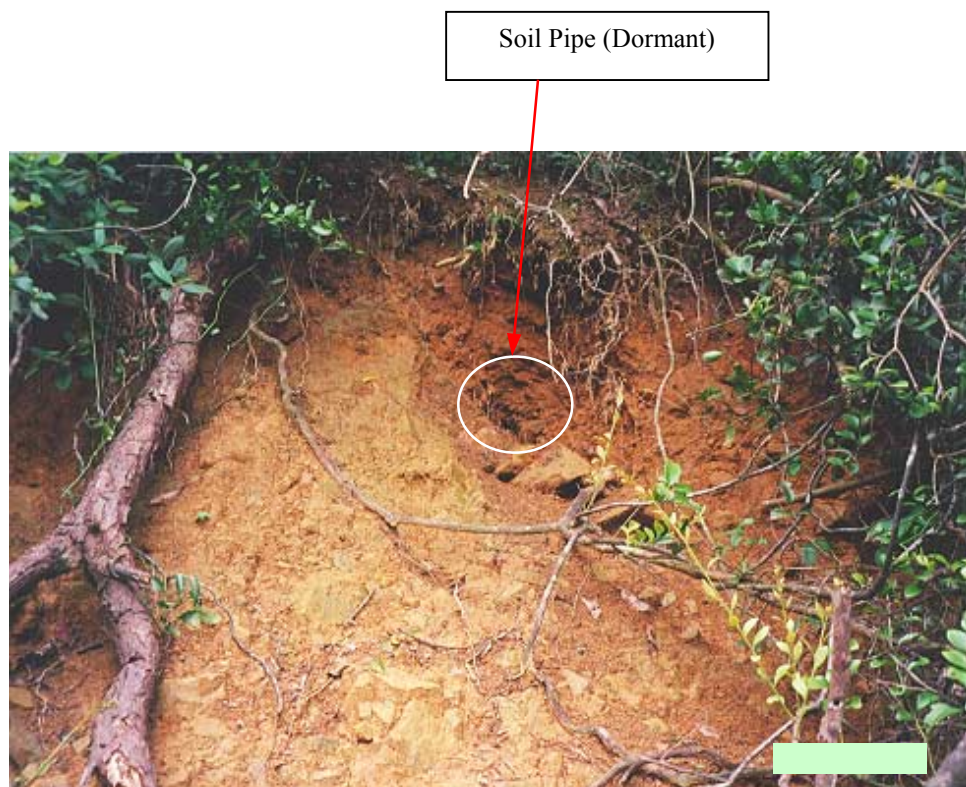
Plate 8 – View of a Soil Pipe in the Main Scarp
(Photograph taken on 30 June 1998)

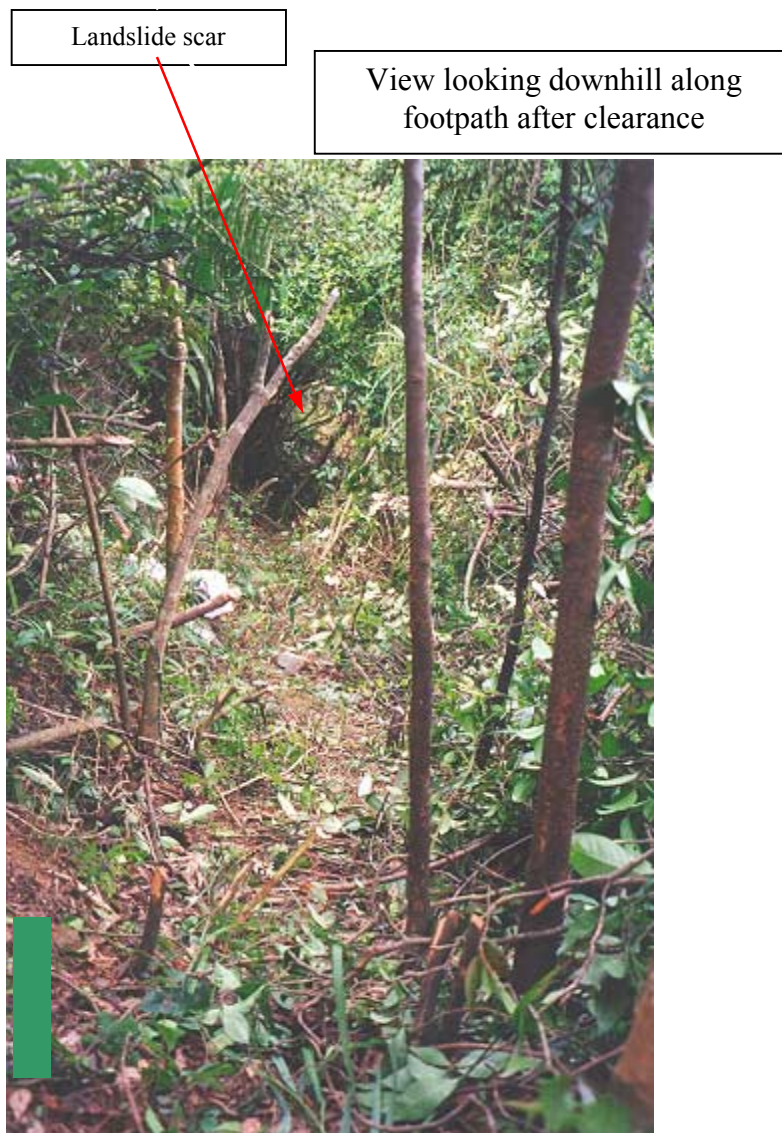
During the site visit of 4 September 1998, efforts were made to expose and inspect the former footpath that was first observed in the 1963 aerial photographs, and may have contributed to channelling water towards the landslide site. The path was identified and traced for approximately 50 m in a westerly direction from the edge of the debris trail close to the main scarp of the landslide. The overgrown path followed an uphill, sidelong route, and was seen to be about 0.5 m to 1.0 m wide. The orientation of the path, with a fall towards the centre of the drainage channel, suggests that it could have acted as an intercepting catchwater-type channel. However, the undulating nature of the surface of the path suggests that it may not have promoted significant water flow and there was no obvious evidence of severe water flow along its length (e.g. erosion). Photographs of the path are shown in Plate 9, and its location is indicated on Figure 2.

Plate 9 – View along Overgrown Footpath near the Main Scarp
(Photograph taken on 4 September 1998)

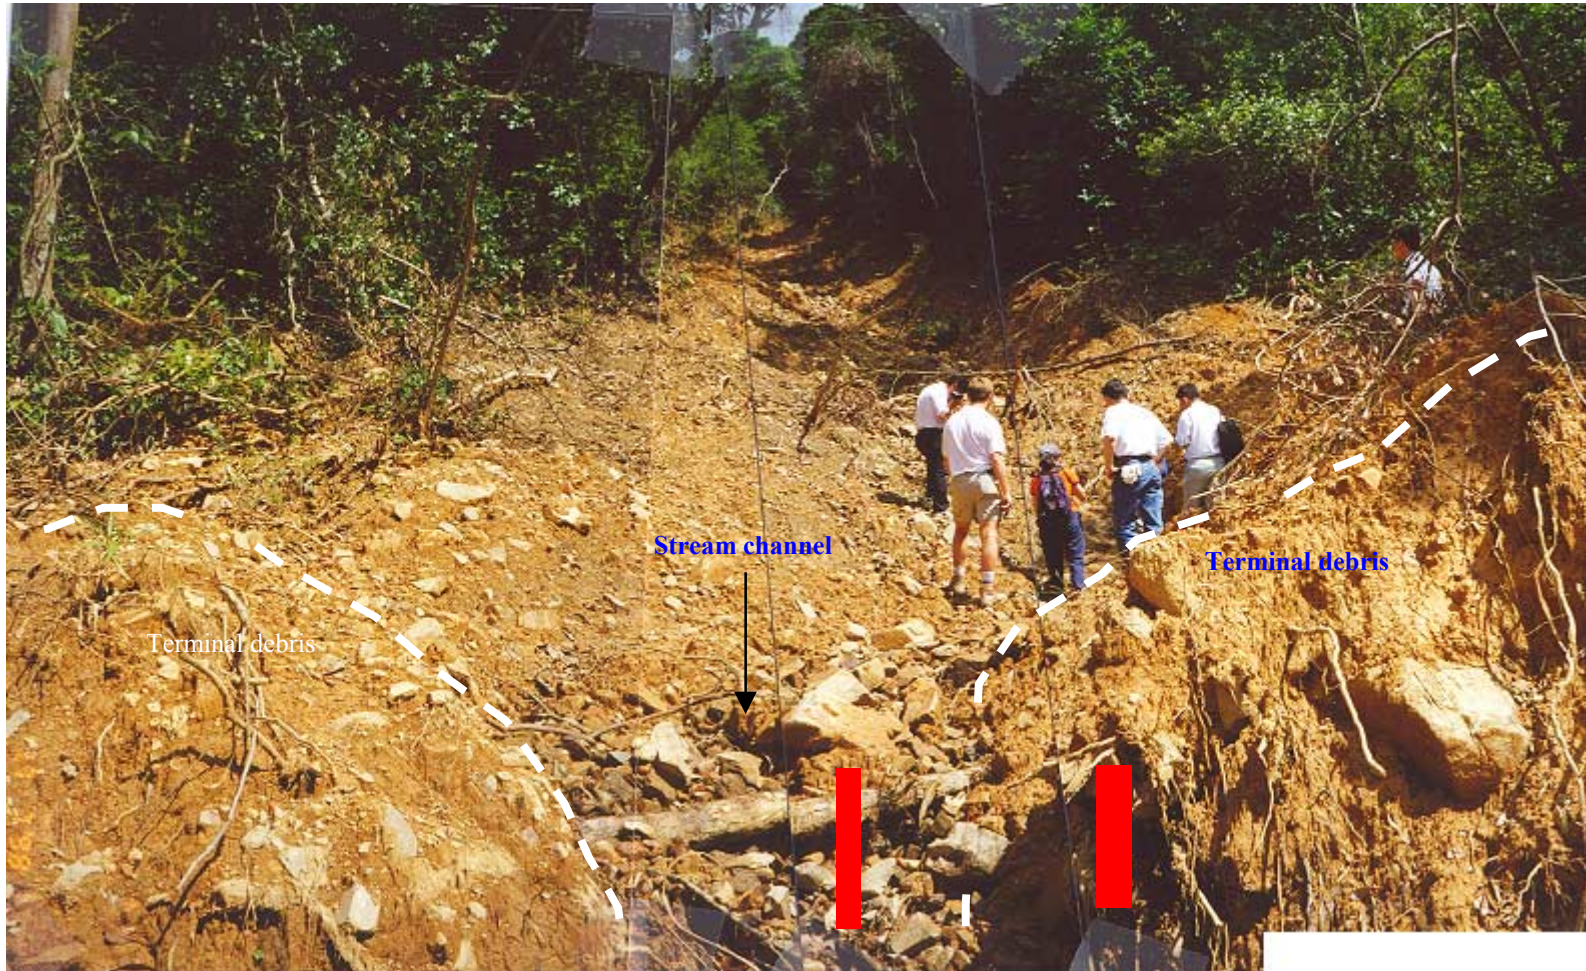
On a subsequent visit to site on 14 January 1999, the lobe of debris left at the toe of the retaining wall had been partly removed, exposing a section through the deposit. The deposit was observed to be locally made up of three separate units. The bottom comprised a layer of grey remoulded topsoil, which graded up into a layer of vegetation, including roots and tree trunks. Overlying this mat, and extending to the surface, was a layer of remoulded colluvium, with scattered intact rafts of vegetated material above. This profile indicates the order in which each distinct unit was deposited.

Plate 10 – View of Channel Cut through Terminal Debris above Toe Retaining Wall
