SECTION 2 : DETAILED STUDY OF THE LANDSLIDE AT THE OUTWARD BOUND SCHOOL ON 9 JUNE 1998

**This report was originally produced in August 1999
as GEO Landslide Study Report No. LSR 7/99**

This report presents the findings of a detailed study of the landslide (GEO Incident No. ME 98/6/55) that occurred on the natural hillside adjacent to the Outward Bound School, Tai Mong Tsai, near Sai Kung in the Eastern New Territories on 9 June 1998. The landslide involved the failure of approximately 30 m of the natural hillside close to the main ridgeline of a coastal peninsula. The resulting debris, estimated at about 900 m³ in volume, came within 20 m of a house at the foot of the hillside, with the subsequent alluvial outwash reaching the road and beach below. The house was uninhabited at the time of the landslide. No fatalities or injuries were reported following the landslide.

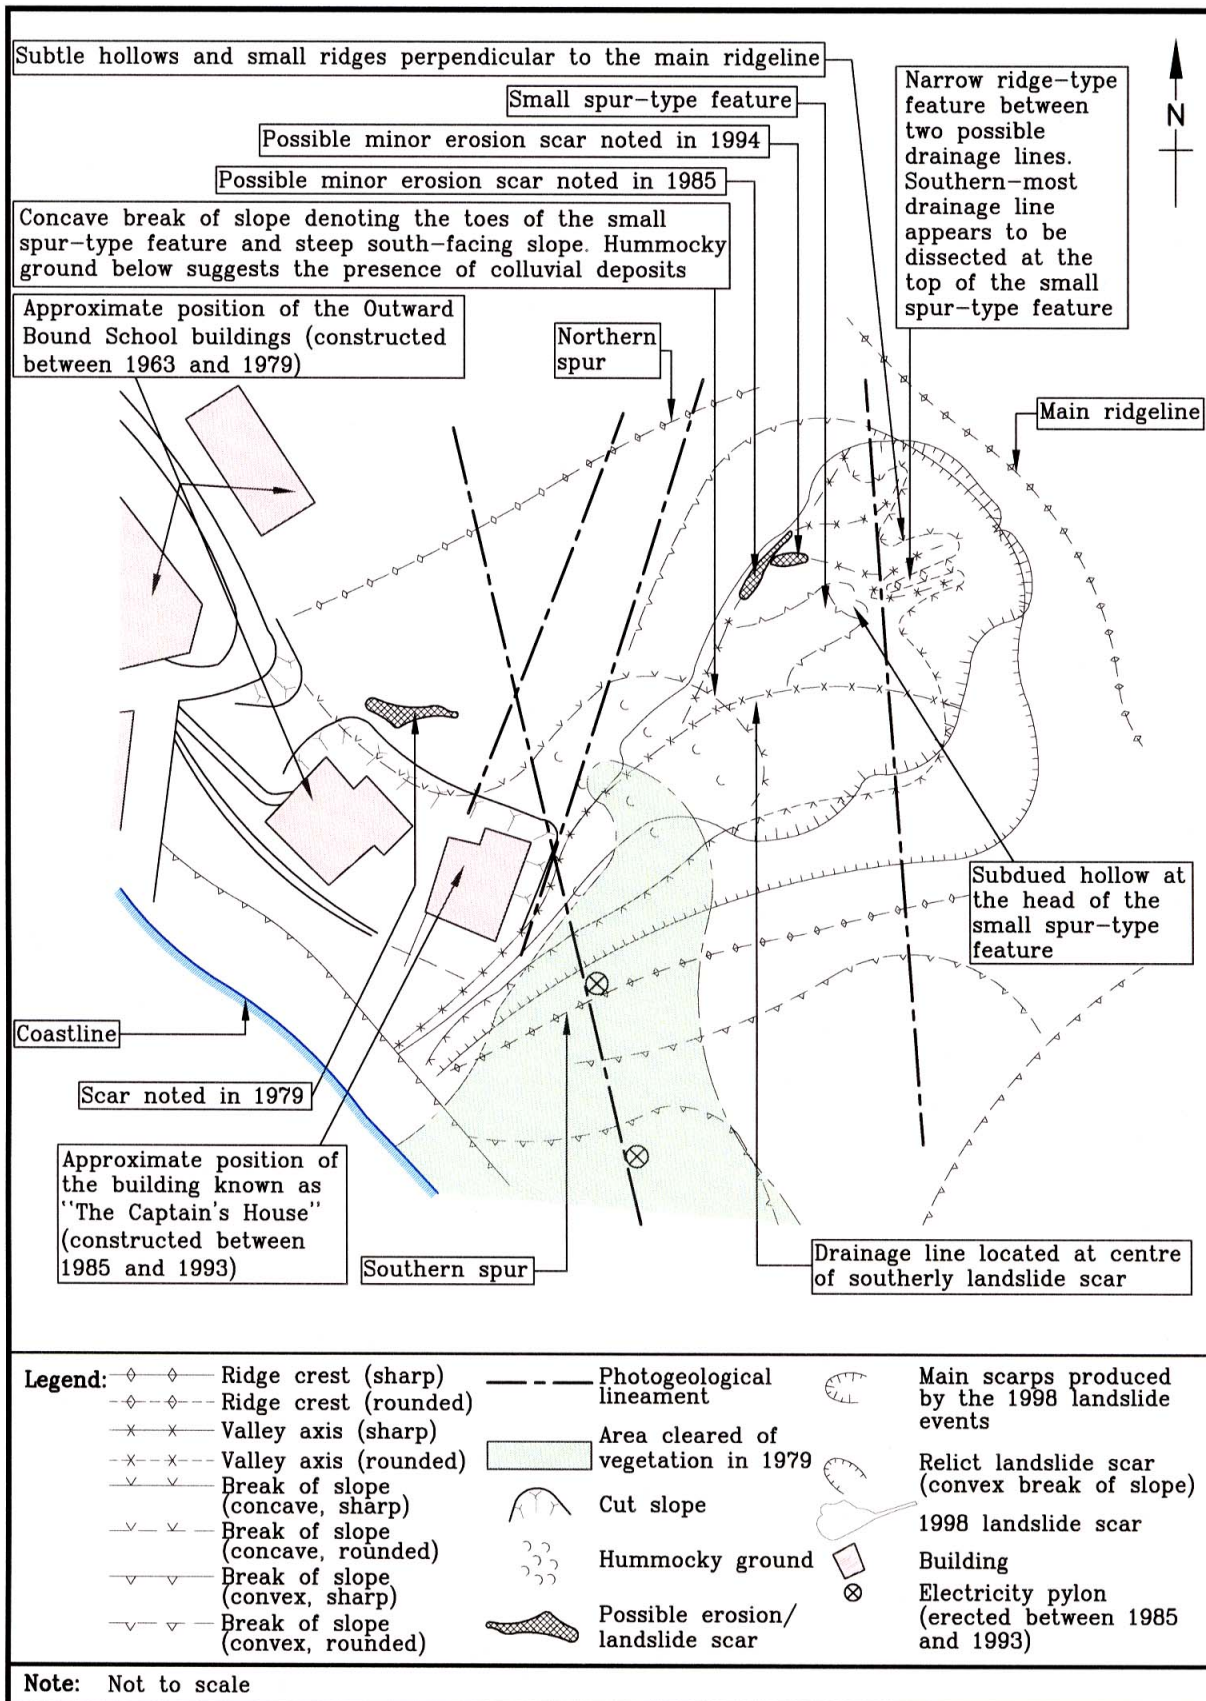
Figure 6 - Aerial Photograph Interpretation of the Landslide Site and Immediate Vicinity (based on photographs taken between 1924 and 1997)

A small erosion scar was also noted at the toe of the hillside, to the rear of the house (built between 1968 and 1978), and to the south of the northern spur (of the depression), on the 1979 aerial photographs, whilst a further local erosion scar, located within the drainage line below the northern spur, was recorded on the 1985 photographs. Another local erosion

scar was observed, in a similar location to that noted in 1985, on the 1994 aerial photographs (Figure 6).

Prior to the recent failure the area between the small spur-type feature and the main ridgeline above appears to have comprised a series of subtle hollows and small ridges, approximately perpendicular to the main ridgeline, defined to the west by a slight concave break of slope above the spur-type feature. The small drainage lines within these hollows generally converged on the drainage line which bounds the small spur-type feature in the north, indicating a general northwestwards fall across the upper portion of the depression (Figure 6).

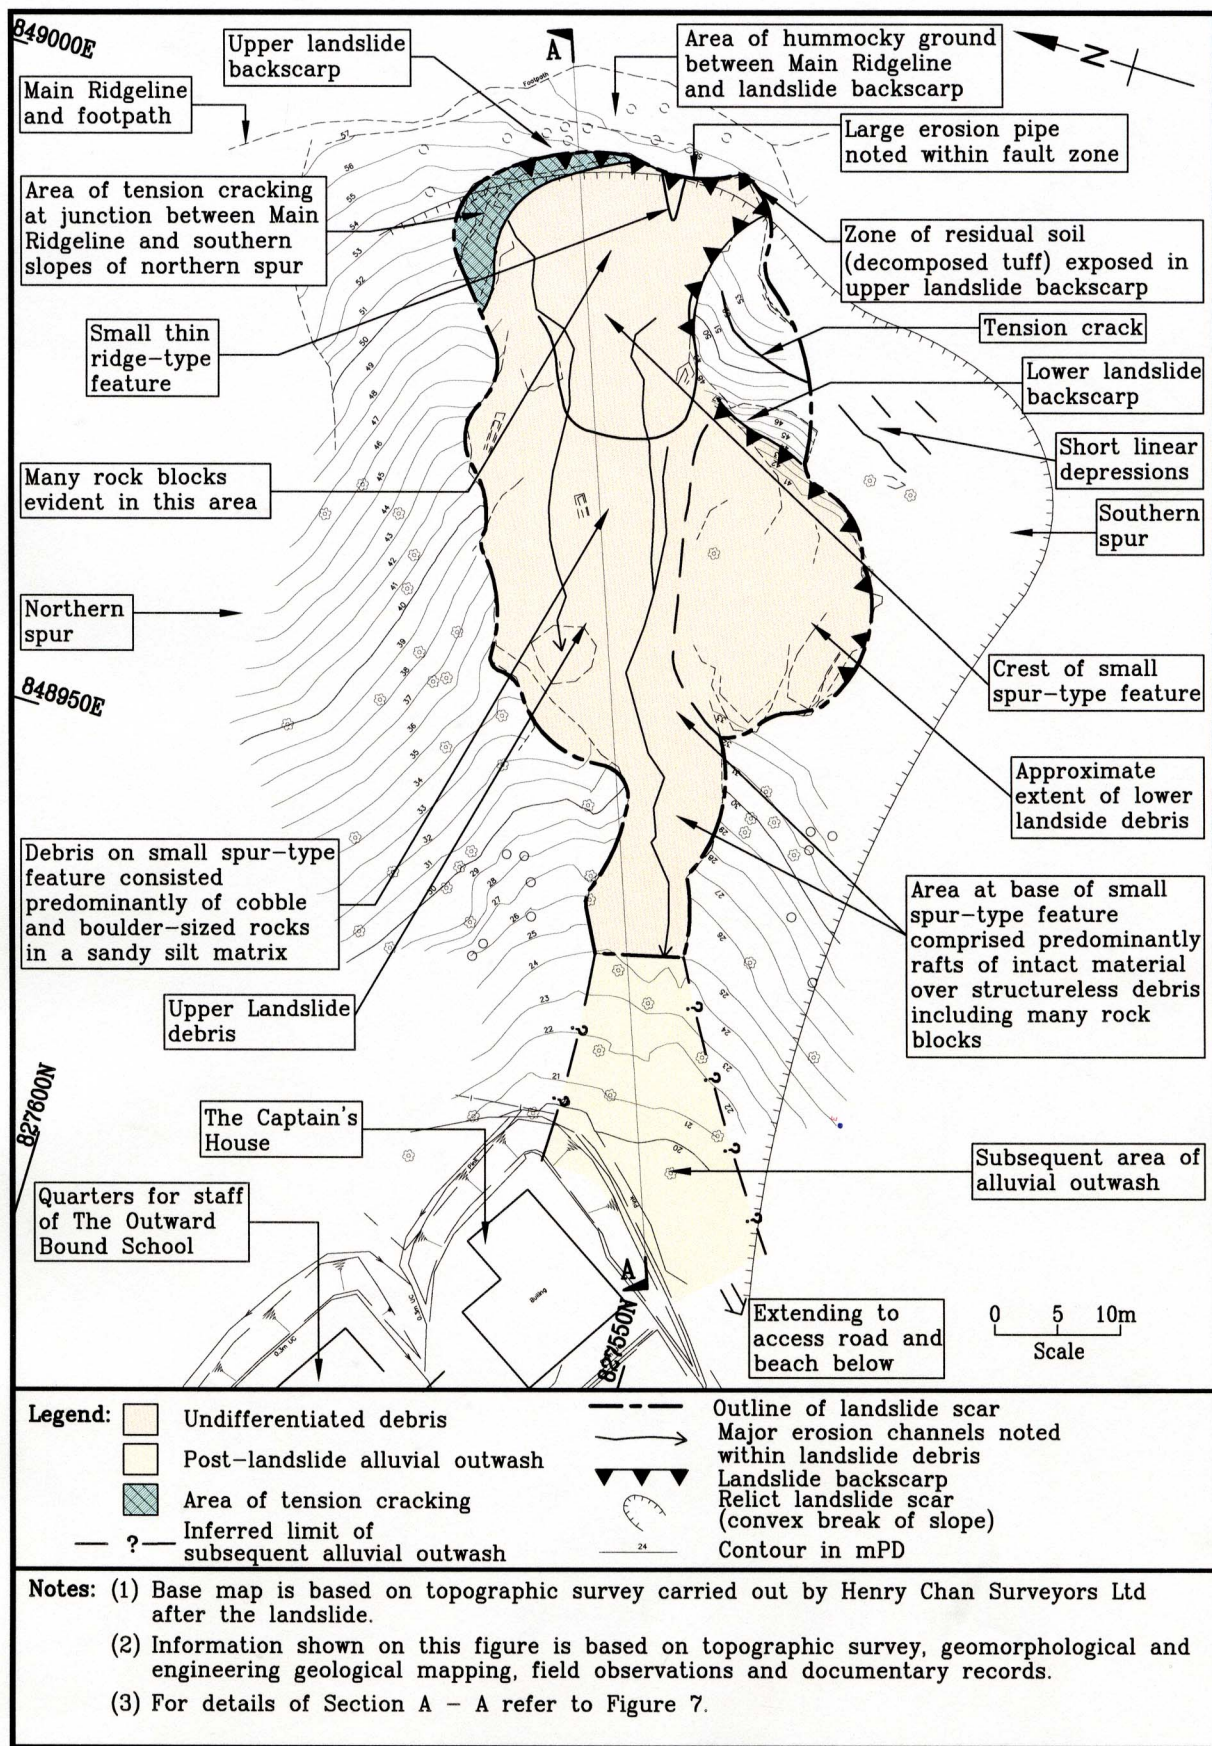
Figure 7 - Plan of the Landslide

The landslide scar was observed to consist of several distinct areas possibly corresponding to different phases of landsliding. Two main backscarps (termed "upper" and "lower") were identified, as were zones of depletion and accumulation (Figures 7 and 8, and Plates 5, 6 and 7). The upper backscarp, which corresponds to the main area of failure, was located immediately below the main ridgeline of the peninsula, trending approximately parallel to it and was about 30 m in length and typically between 2 and 3 m high.

noted (Figure 7 and Plate 11). The cracks were typically 0.6 m in depth and 0.2 m wide with a corresponding vertical displacement of the order of 0.3 m. Some of the tension cracking had resulted in the formation of discrete rafts of intact material, which moved downslope a distance typically between about 1 m and 2 m during the 1998 landslide.

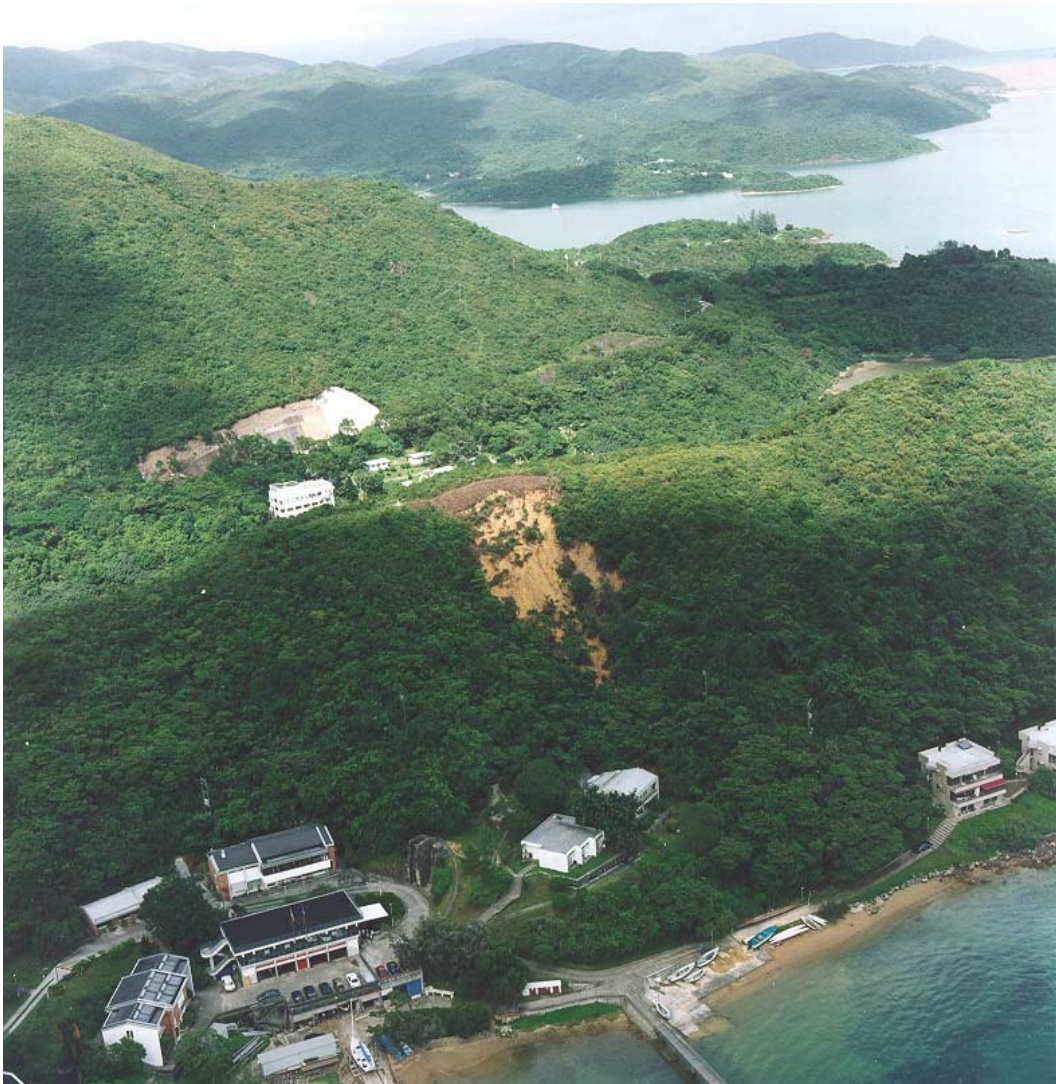
Plate 1 – The Landslide of 9 June 1998 (Photograph taken on 29 June 1998)

Vegetation Clearance has been undertaken in the Area between the Main Ridgeline and the Head of the Landslide following the Incident on 9 June 1998

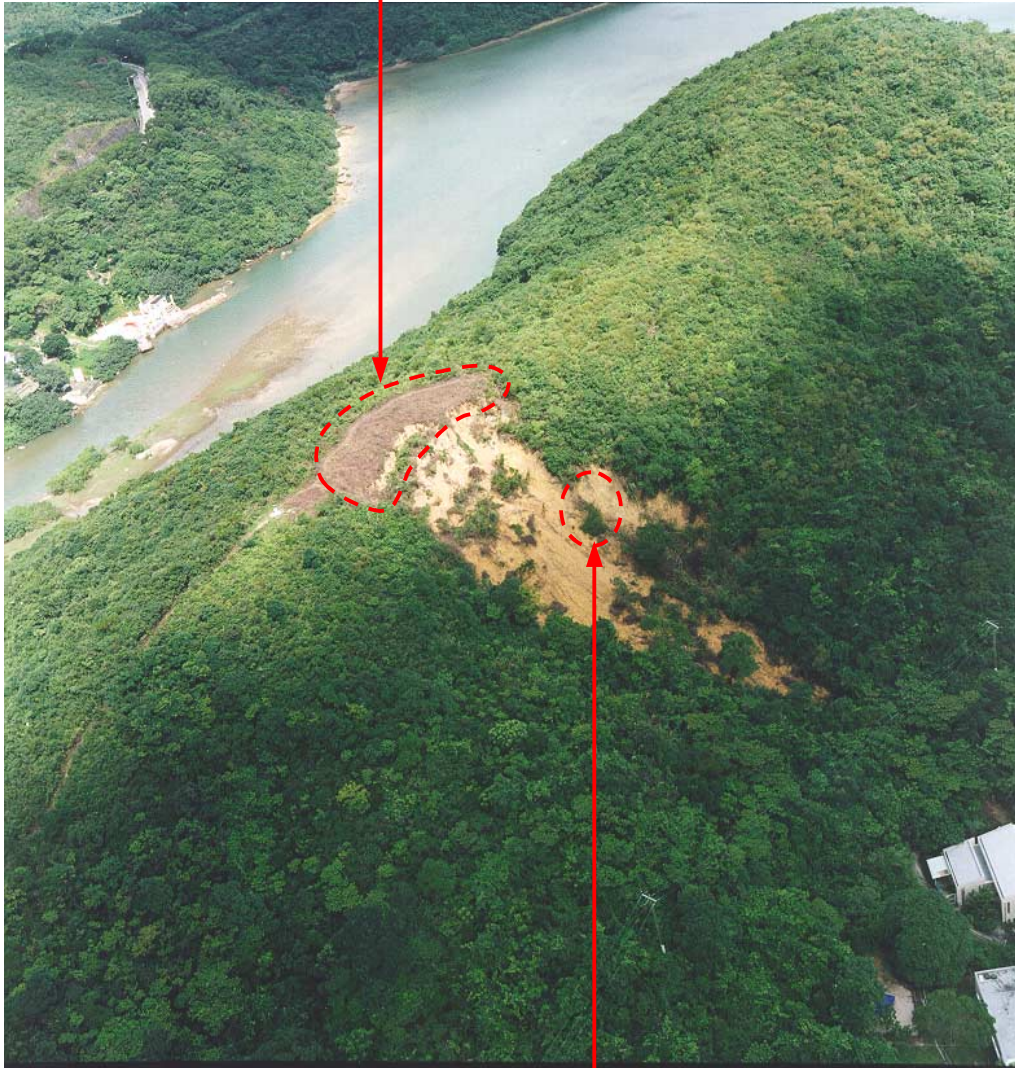
A feature of the upper backscarp was the presence of the remnants of a small thin ridge-type feature (Plates 2 and 8), which effectively divided the upper backscarp into southern and northern portions. This feature was also clearly identified on the 1945 and 1963 aerial photographs (Figure 6). Tuff-derived residual soil, was exposed in the southern portion of this backscarp and formed a "spoon-shaped" surface of rupture. This zone was bounded on both sides by slightly to moderately decomposed volcanoclastic rocks. Probable erosion pipes, typically 5 mm in diameter, were recorded in this part of the upper backscarp. A larger possible erosion pipe, approximately 50 mm in diameter, was also observed in this area (Plates 9 and 10). To the southwest of this portion of the upper backscarp, and directly above the lower backscarp, a tension crack with a vertical displacement of between 0.5 m and 1 m and typically 0.2 m wide was noted. This feature extended to the adjacent north-facing slopes of the southern spur to the depression. Some short linear depressions, typically about 2 m in length and 0.2 m in depth were also evident on these north-facing slopes during FSW's field mapping.

Material displaced at the Junction between the North-facing Slopes of the Southern Spur and the Small Spur-type Feature

Plate 2 – Oblique View of the Landslide of 9 June 1998
(Photograph taken on 29 June 1998)

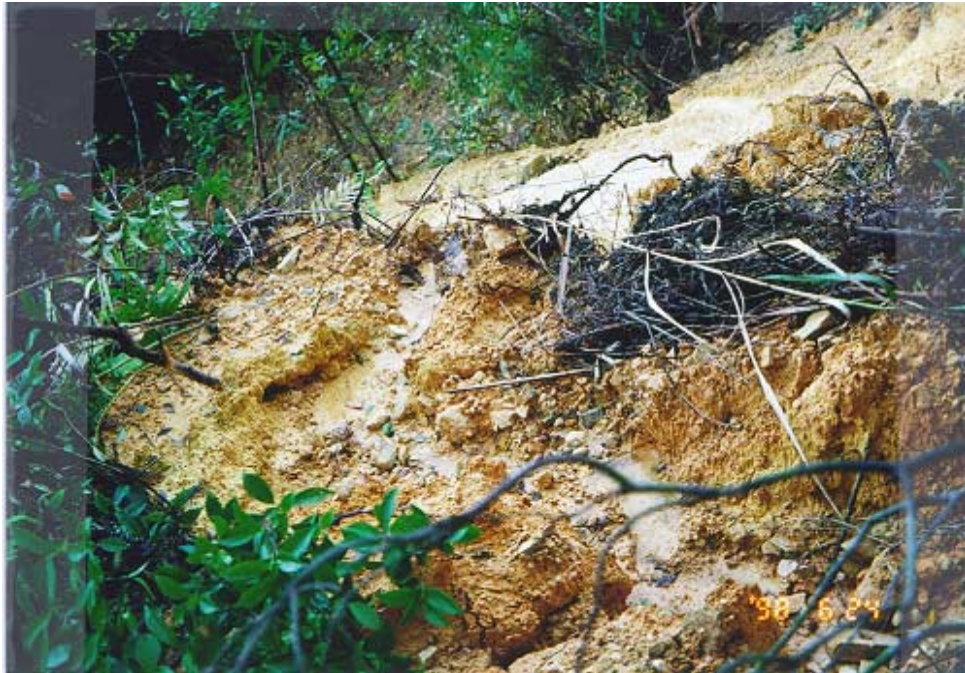
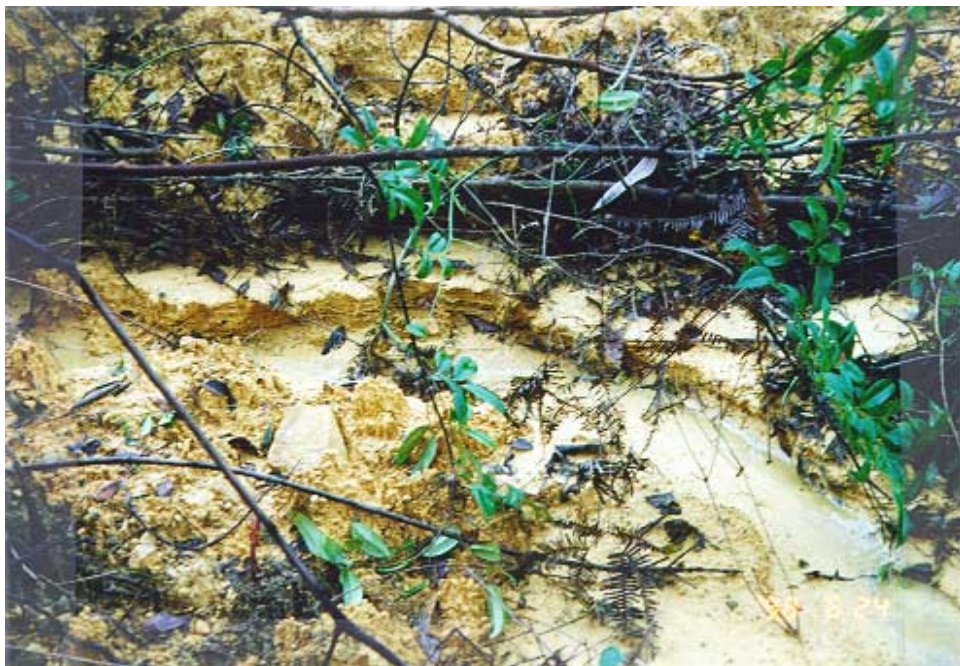
Plate 3 – Erosion Channels within Debris at Base of Landslide. Flowing Water Evident (Photographs taken on 24 June 1998)

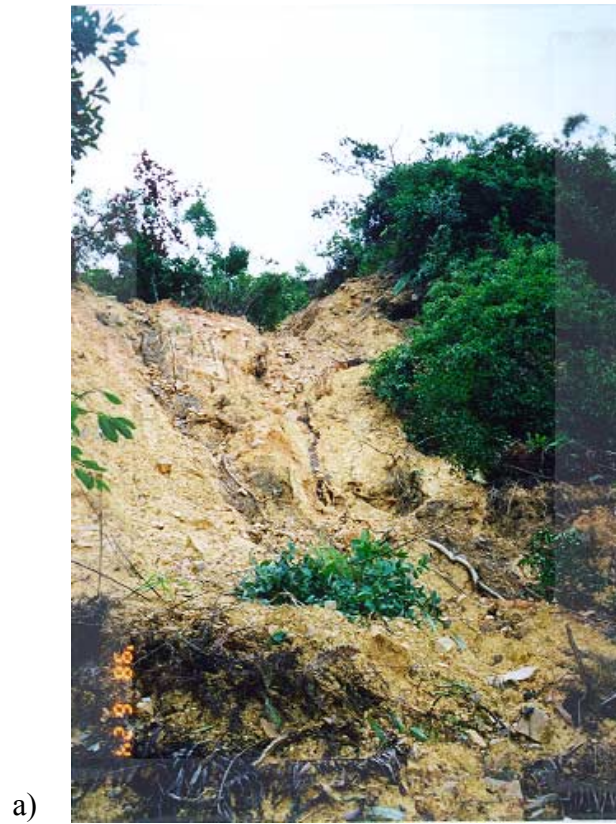
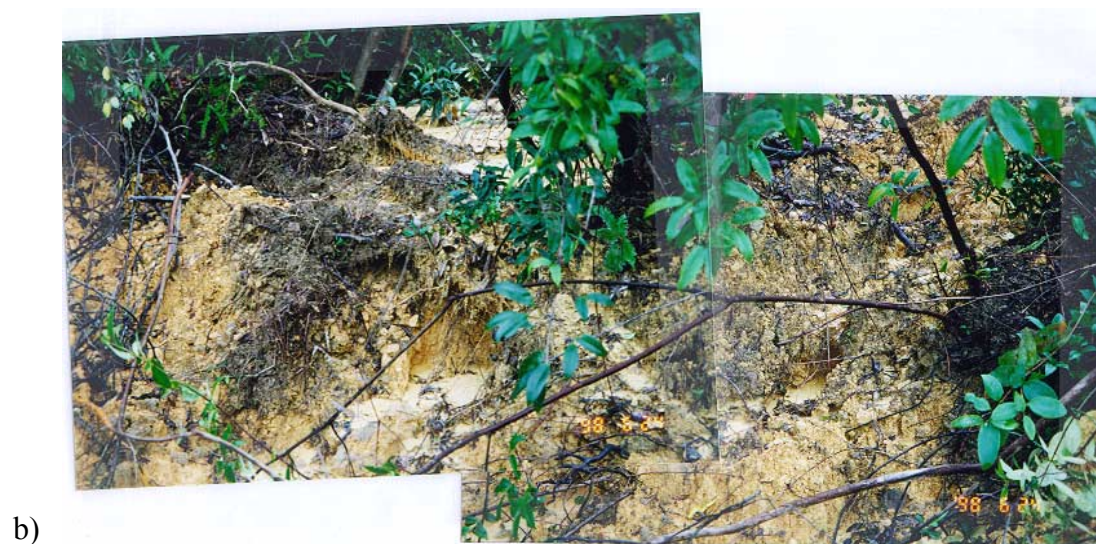
Plate 4 – Erosion Channels within Landslide Debris Immediately to the South of the Small Spur-type Feature (Photographs taken on 24 June 1998)

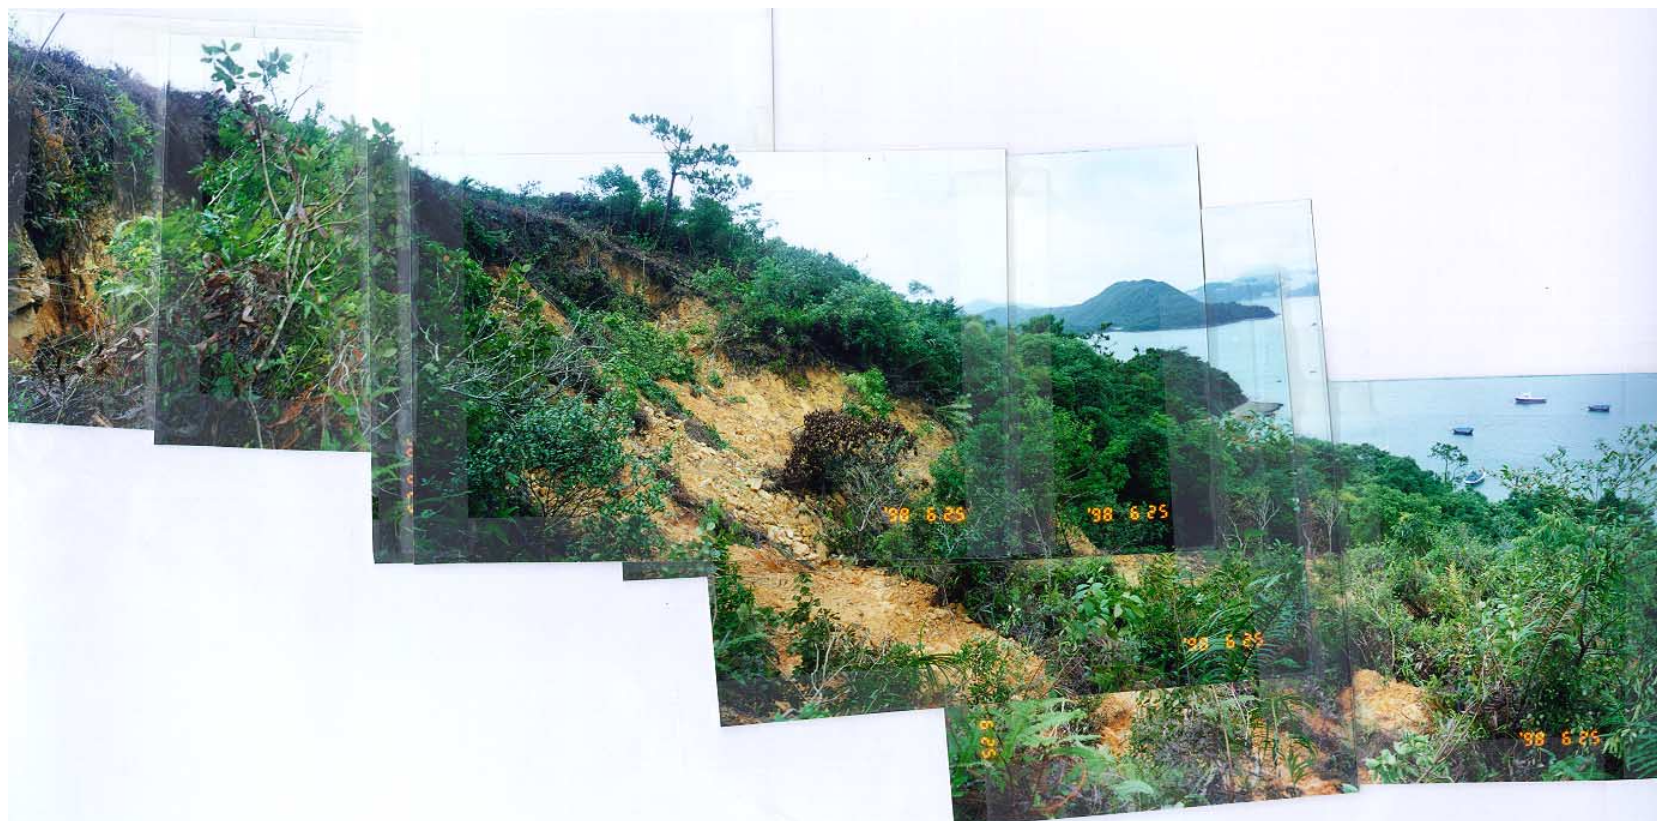
Plate 5 – General View of the Upper Landslide Backscarp and Top of the Small Spur-type Feature
(Photographs taken on 25 June 1998)

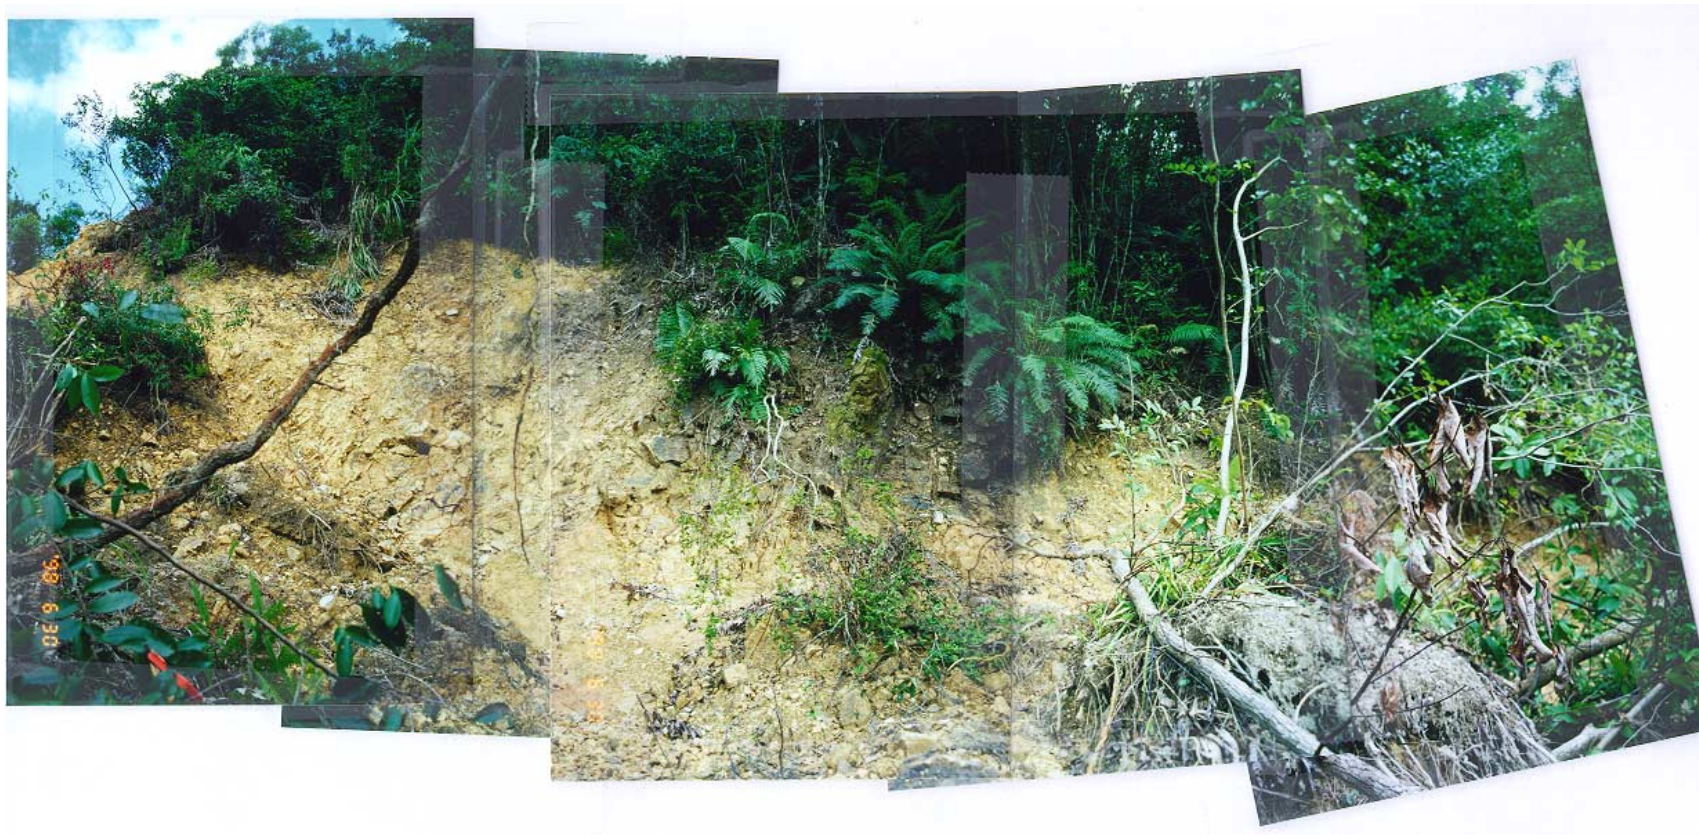
The main part of the lower backscarp was about 15 m wide and 6 m high (maximum) with slope angles typically between 35° and 50°. The remainder of the backscarp was typically 1 m high and extended in a generally westward direction, for a further 10 m to 15 m (Figure 7). The depth of the lower landslide was of the order of 1 m. Moderately to highly decomposed volcanoclastic rock was exposed in the upper portion of the backscarp. The volcanoclastic rock is underlain by highly to completely decomposed tuff. Possible columnar jointing was observed in the highly decomposed tuff.

Plate 6 – General View of the Lower Landslide Backscarp
(Photographs taken on 30 June 1998)

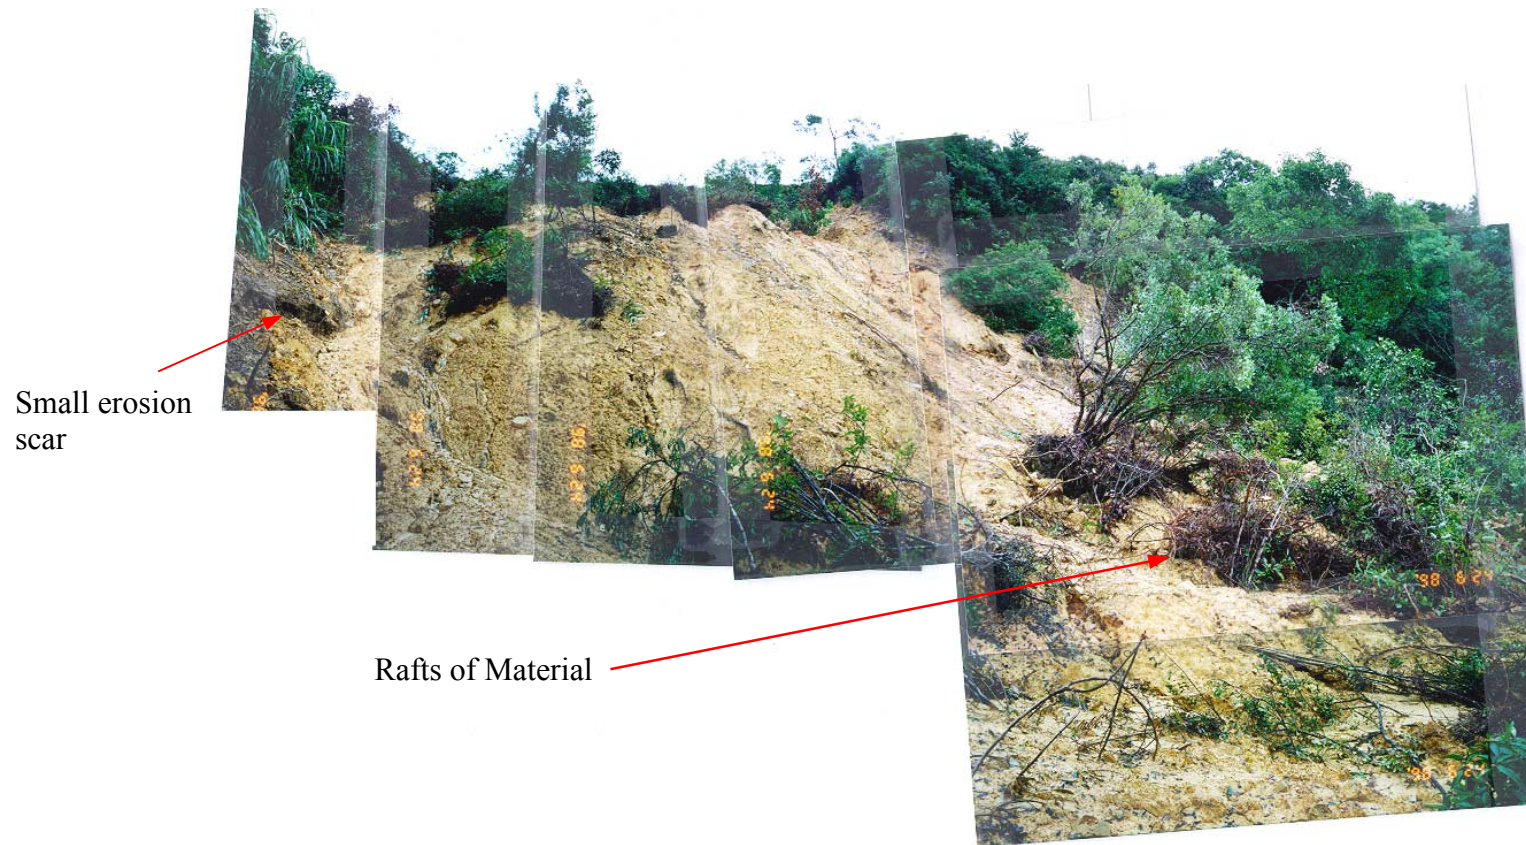
A small erosion scar in a similar location to those identified on the 1985 and 1994 aerial photographs (within the drainage line below the northern spur), was also observed in the field during FSW's field mapping (Plate 7). The scar was approximately 3 m long with a vertical displacement of about 0.2 m.

Plate 7 – General View of the Landslide Looking up to the Small Spur-type Feature from Below. Note the Rafts of Material in the Foreground as well as the Erosion Channels that have formed within the Landslide Debris (Photographs taken on 24 June 1998)

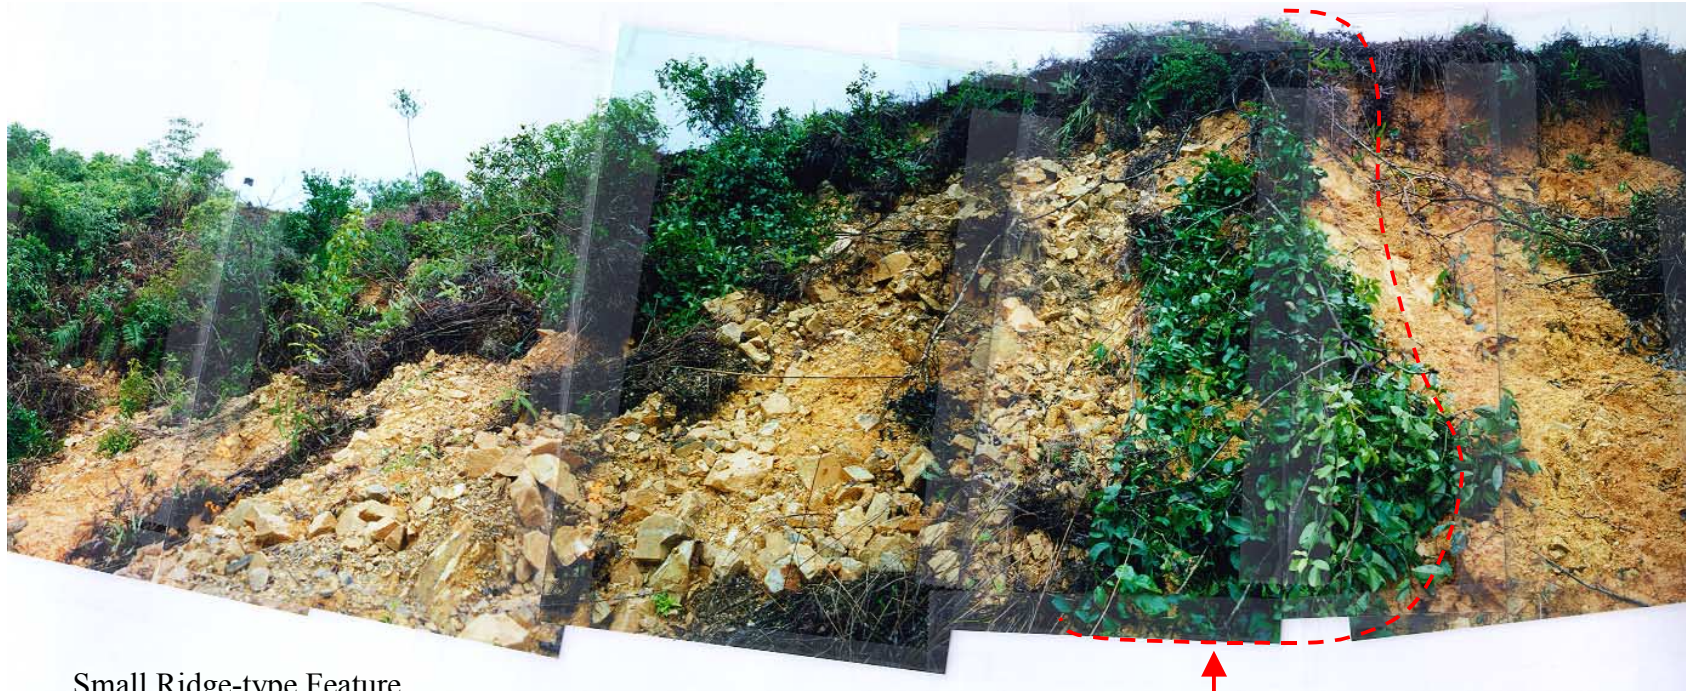
Small Ridge-type Feature

Plate 8 – View of the Upper Landslide Backscarp showing Small Ridge-type Feature (defined by Vine) as well as Many Blocks of Rock in the Foreground (Photographs taken on 2 July 1998)

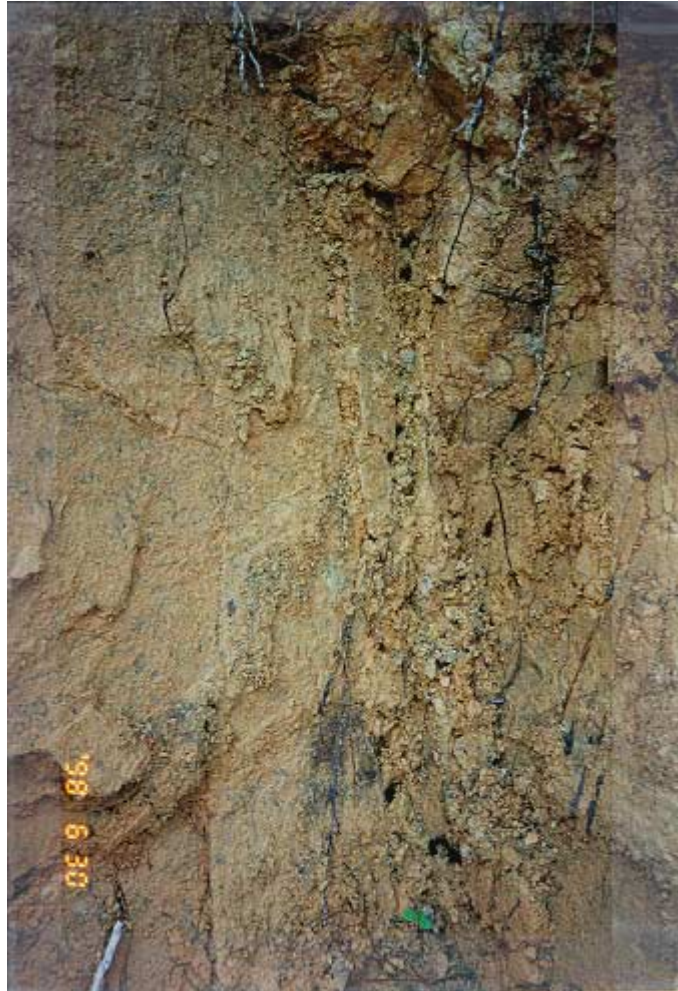
Plate 9 – Probable Erosion Pipes, typically 5 mm in Diameter,
Observed adjacent to the Southern Fault Plane of the
Fault Zone in the Upper Landslide Backscarp
(Photograph taken on 30 June 1998)

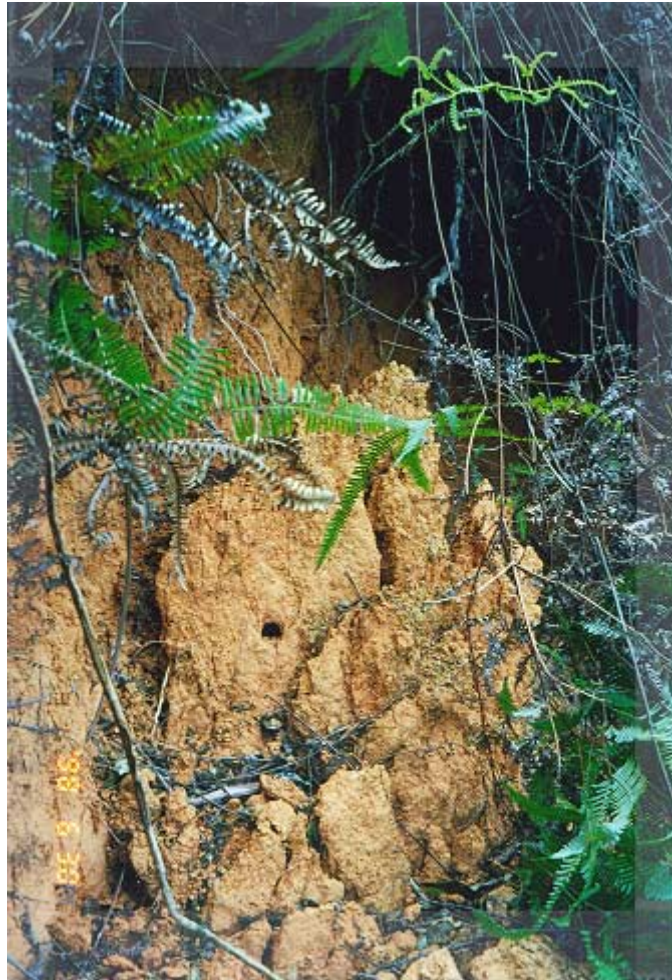
Plate 10 – Possible Erosion Pipe, approximately 50 mm in Diameter,
Observed within the Fault Zone in the Upper Landslide
Backscarp (Photograph taken on 30 June 1998)

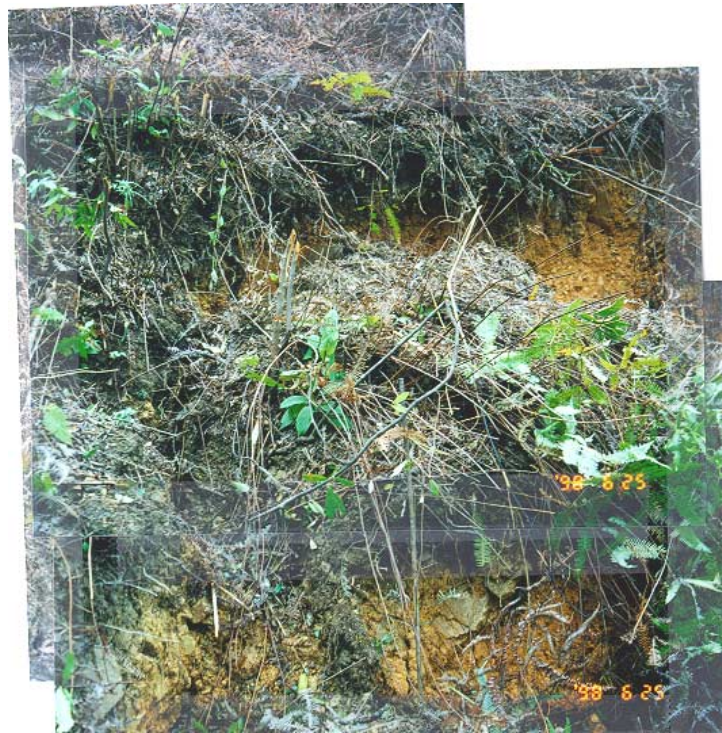
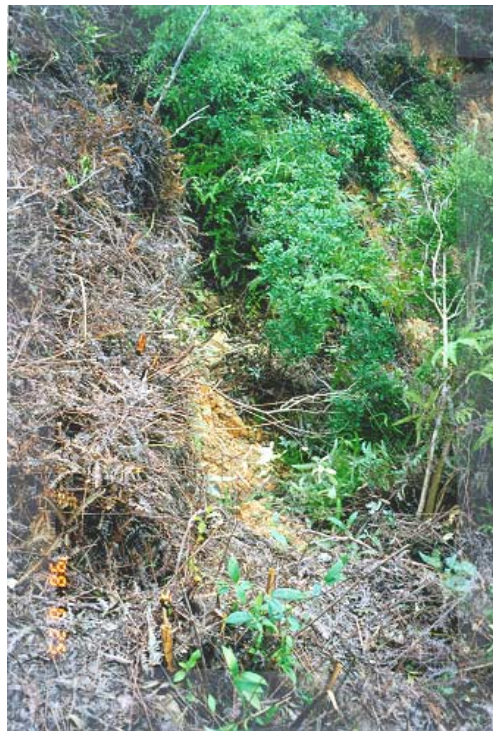
Plate 11 – Remnants of Tension Cracking in the Northern Portion of the Upper Landslide Backscarp (Photographs taken on 25 June 1998)

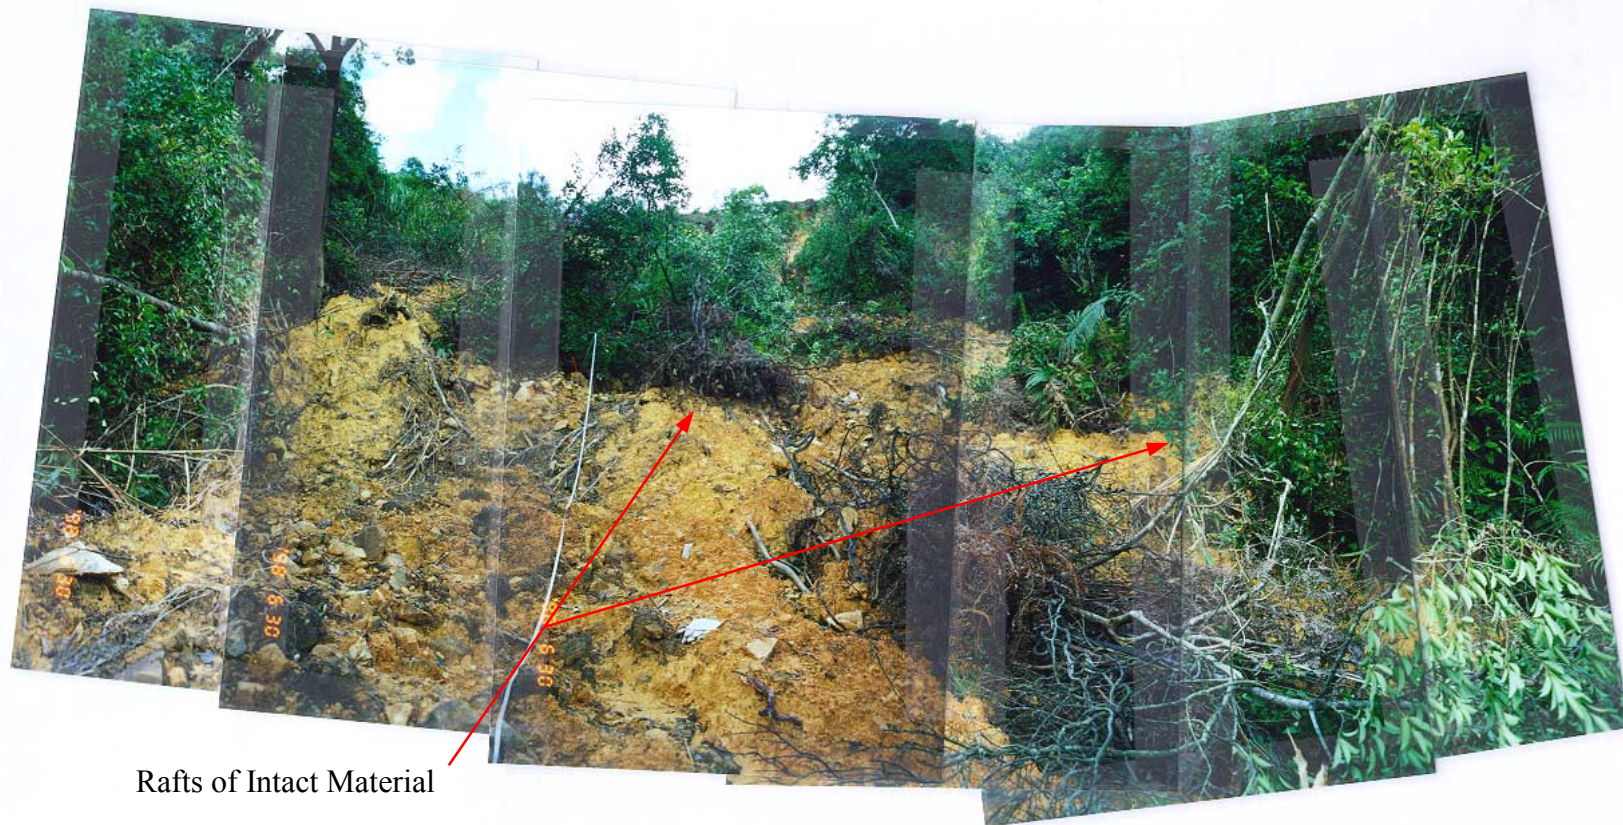
The material, which was displaced as part of this lower translational failure, comprised essentially rafts of intact material about 1 m thick. The remoulded landslide debris, which was evident in the upper landsliding, was largely absent, possibly because less weathered material and water were involved in the failure. The remoulded debris present was located on the tops of the rafts. The "clean break" evident between this material and the edges of the rafts suggests that the debris had been deposited before the rafts were displaced. The rafts of material from the lower failure also appear to have been far less mobile than the corresponding rafts associated with the upper, main phase of landsliding. Additionally, at the junction delineating the lower landslide debris from the material released during the main phase of landsliding, possible localised scouring, maximum dimension about 0.25 m, was observed (at the base of the rafts).

Rafts of Intact Material

Plate 12 – General View of Debris Trail. Rafts of Intact Material Clearly Evident.
(Photographs taken on 30 June 1998)

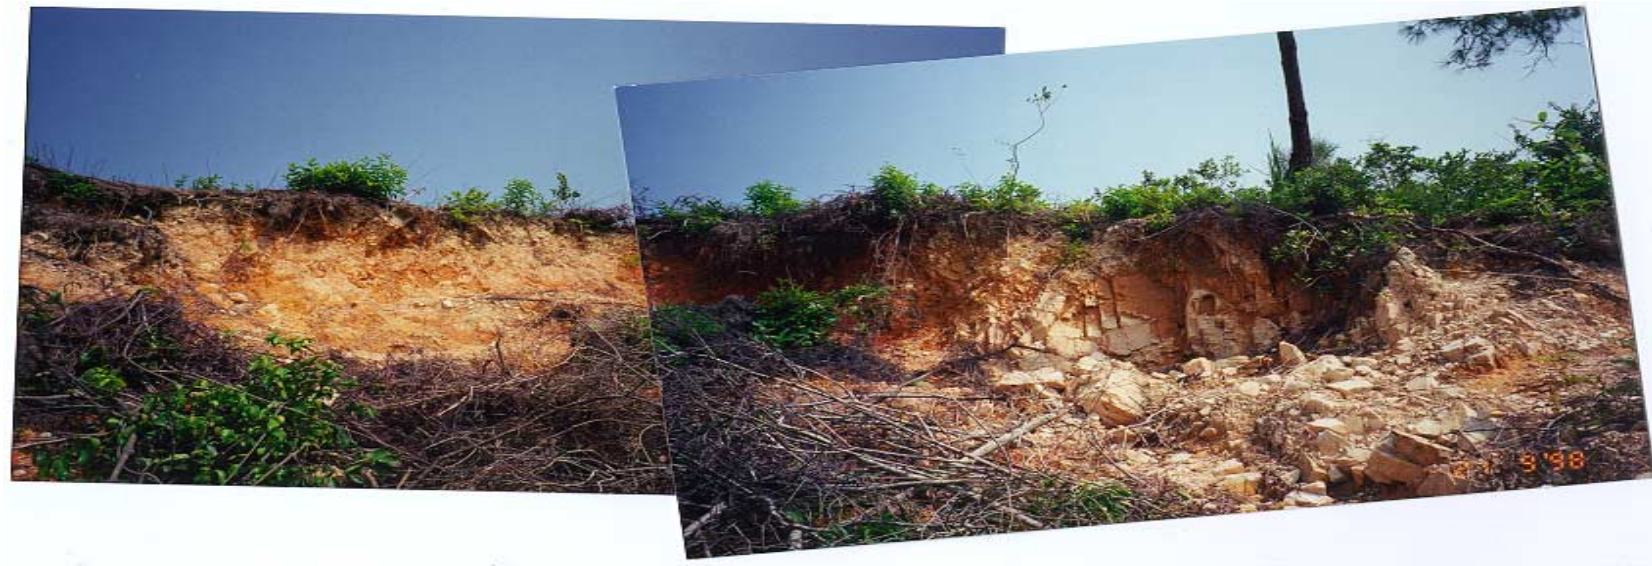
Approximate Extent of Fault Zone

Plate 13 – Panoramic View of the Southern Fault Plane and Associated Fault Zone
(Photographs taken on 21 September 1998)

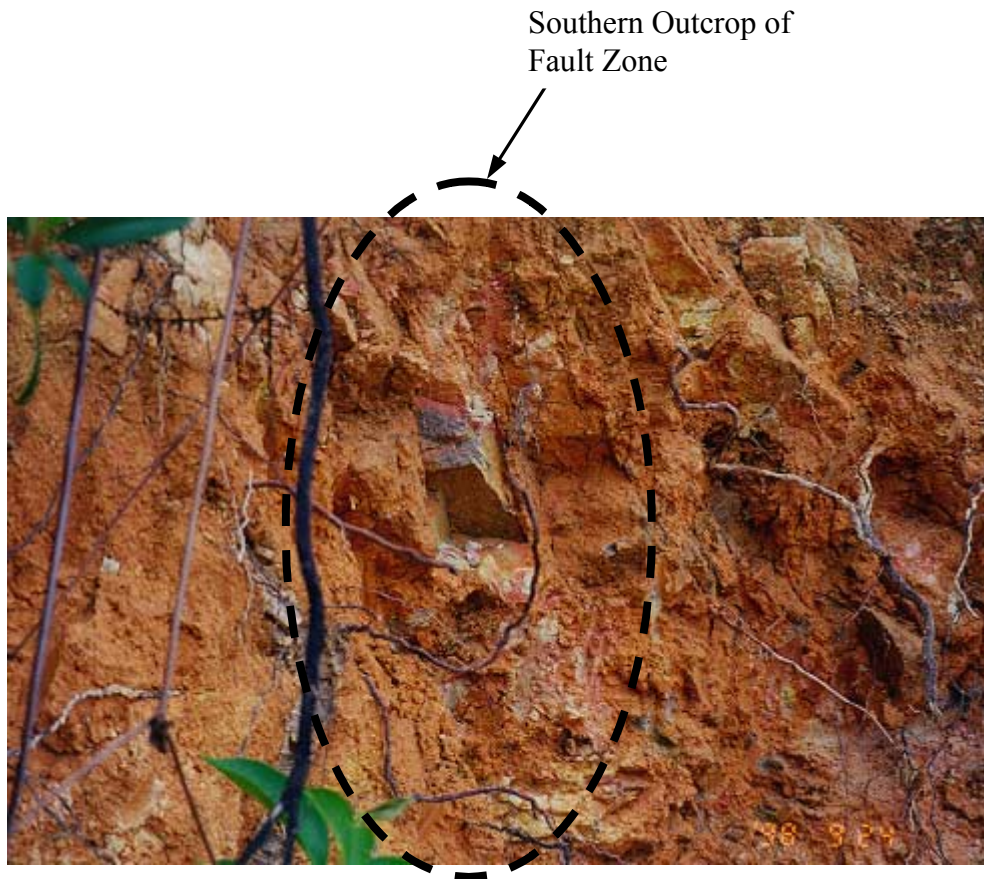
Plate 14 – Close-up Showing Southern Outcrop of the Fault Zone
(Photograph taken on 24 September 1998)

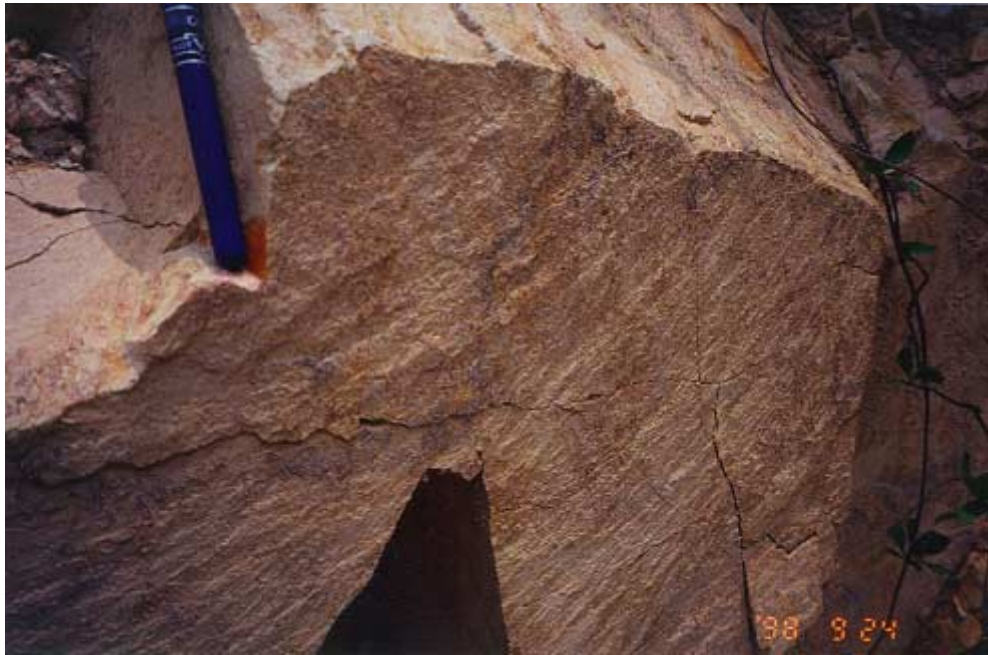
Plate 15 – Close-up Showing Slickensided Outcrop in the Northern Fault Plane
(Photograph taken on 24 September 1998)

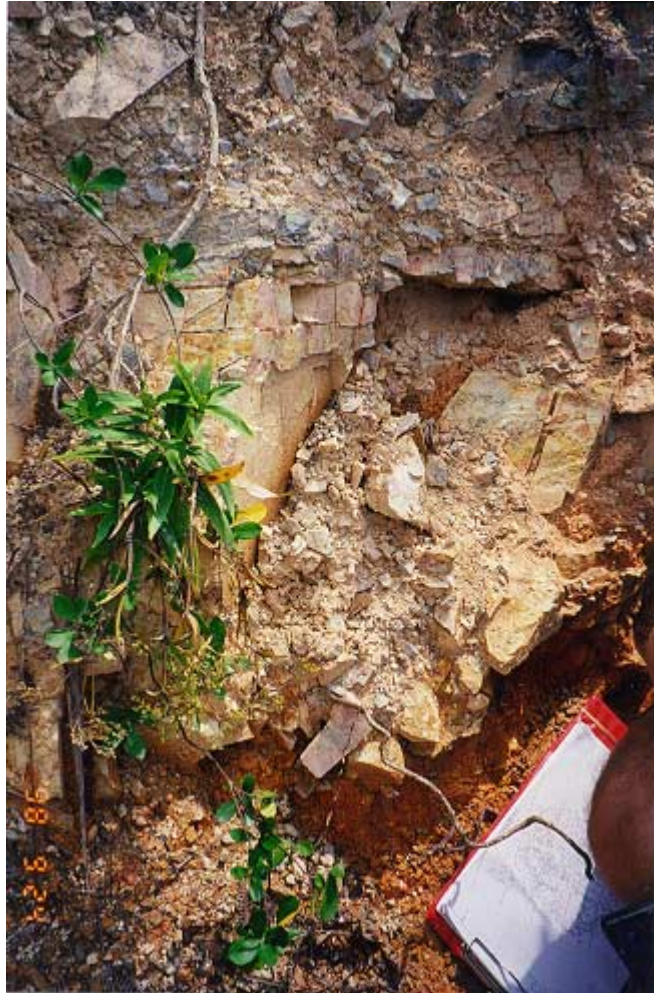
Plate 16 – General View of the Northern Fault Plane
(Photograph taken on 24 September 1998)
