SECTION 2 : DETAILED STUDY OF THE LANDSLIDE AT THE OUTWARD BOUND SCHOOL ON 9 JUNE 1998

**This report was originally produced in August 1999
as GEO Landslide Study Report No. LSR 7/99**

This report presents the findings of a detailed study of the landslide (GEO Incident No. ME 98/6/55) that occurred on the natural hillside adjacent to the Outward Bound School, Tai Mong Tsai, near Sai Kung in the Eastern New Territories on 9 June 1998. The landslide involved the failure of approximately 30 m of the natural hillside close to the main ridgeline of a coastal peninsula. The resulting debris, estimated at about 900 m³ in volume, came within 20 m of a house at the foot of the hillside, with the subsequent alluvial outwash reaching the road and beach below. The house was uninhabited at the time of the landslide. No fatalities or injuries were reported following the landslide.

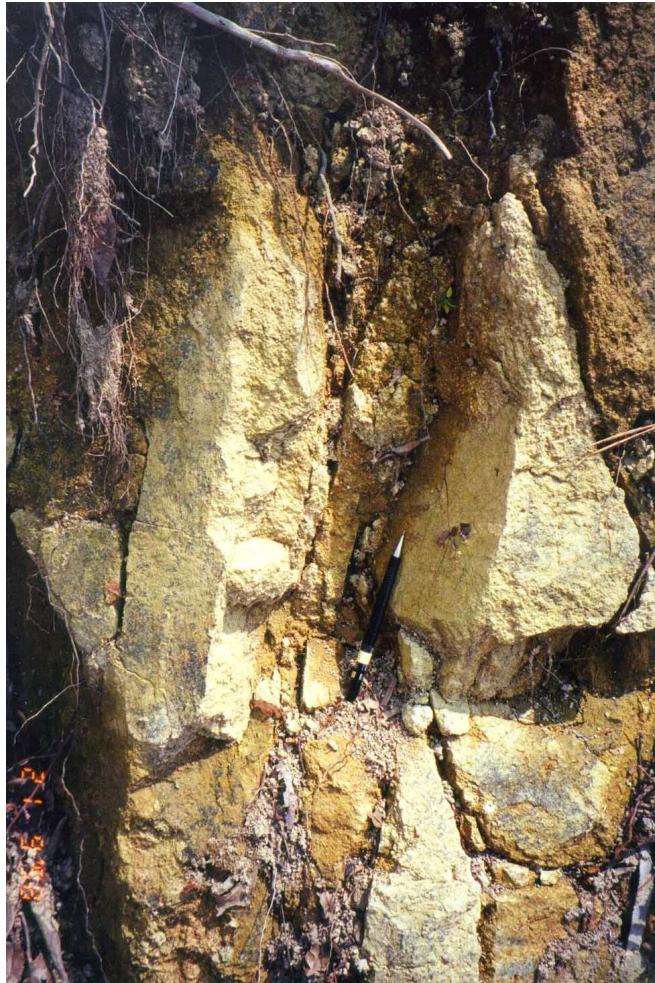
Plate 17 – Open Nature of Joints in the Upper Landslide Backscarp below the Main Ridgeline (Photograph taken on 21 September 1998)

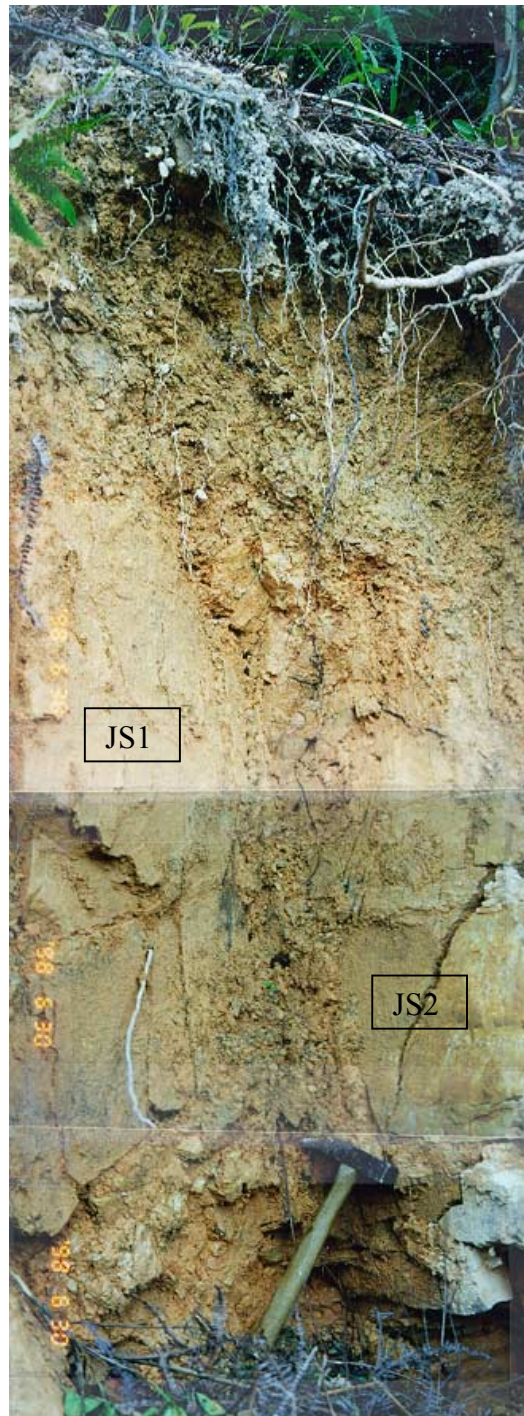
Plate 18 – Dominant West to West-Northwest (JS1) and North-Northeast (JS2) dipping Joint Sets in the Upper Landslide Backscarp (Photographs taken on 30 June 1998)

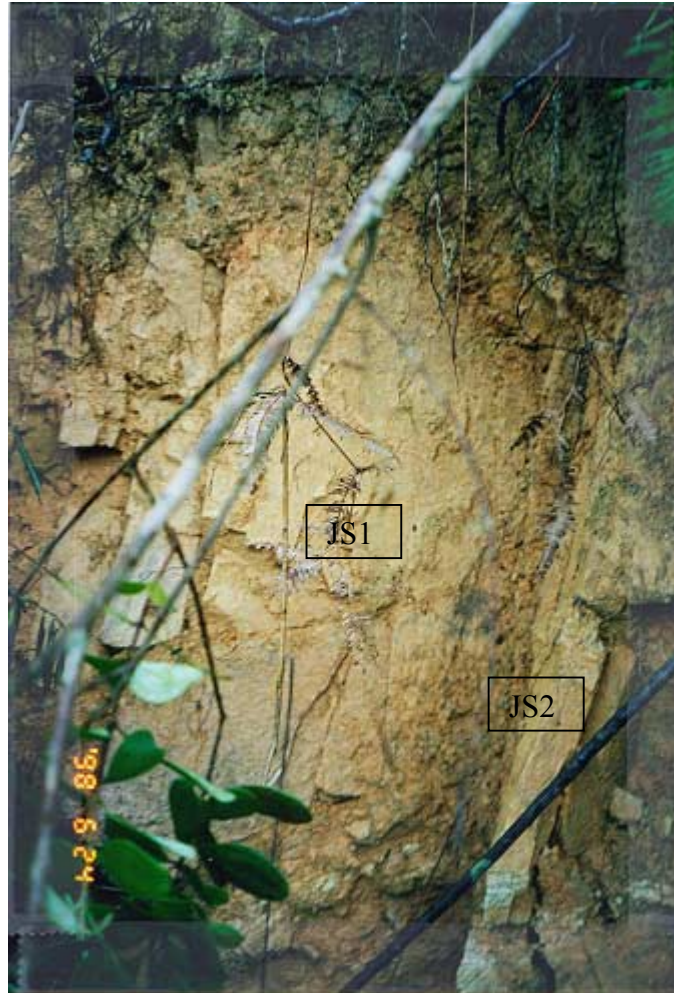
Plate 19 – Upper Landslide Backscarp Joint Planes –
Dominant West to West-Northwest (JS1) and
North-Northeast (JS2) dipping Joint Sets
(Photograph taken on 24 June 1998)

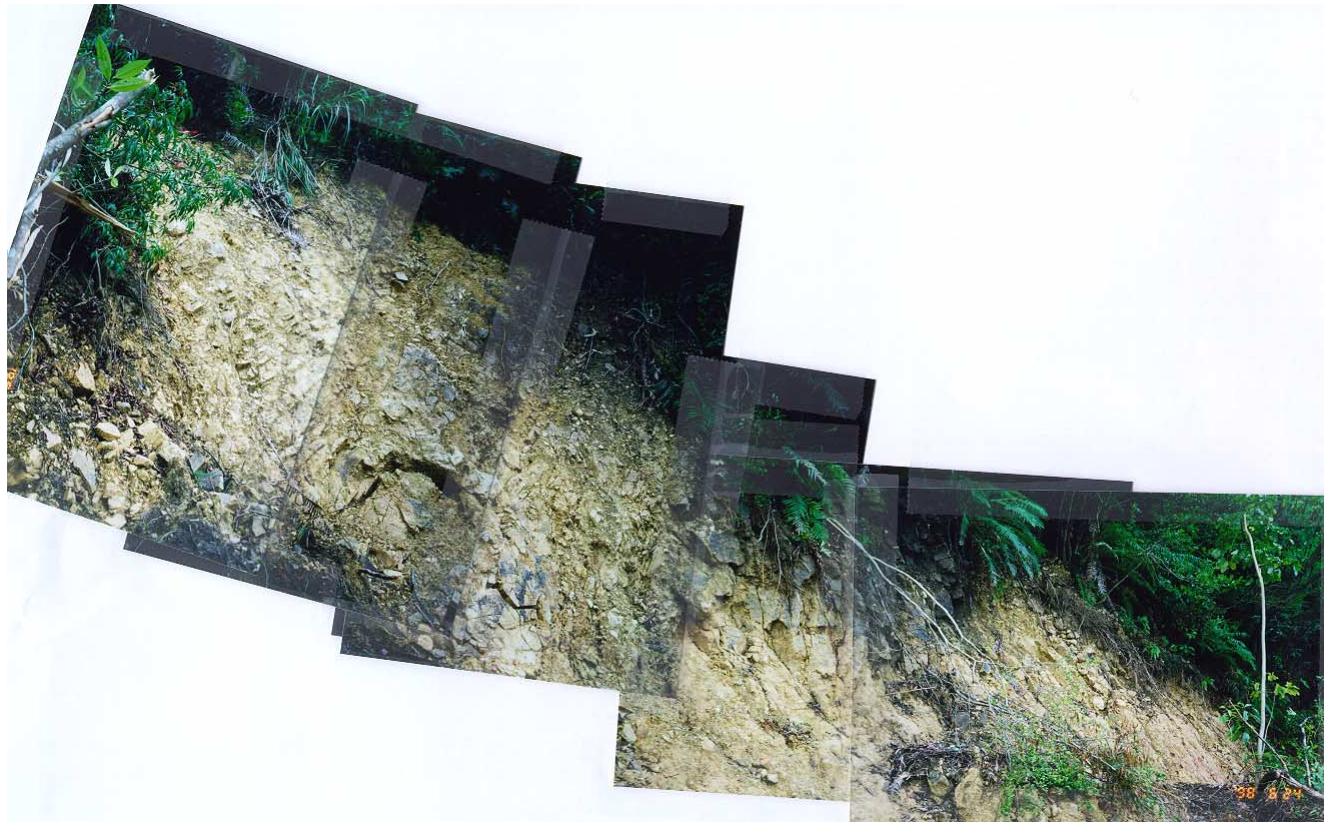
Plate 20 – Lower Landslide Backscarp – Dominant Westward dipping Joint Set Evident
(Photographs taken on 24 June 1998)

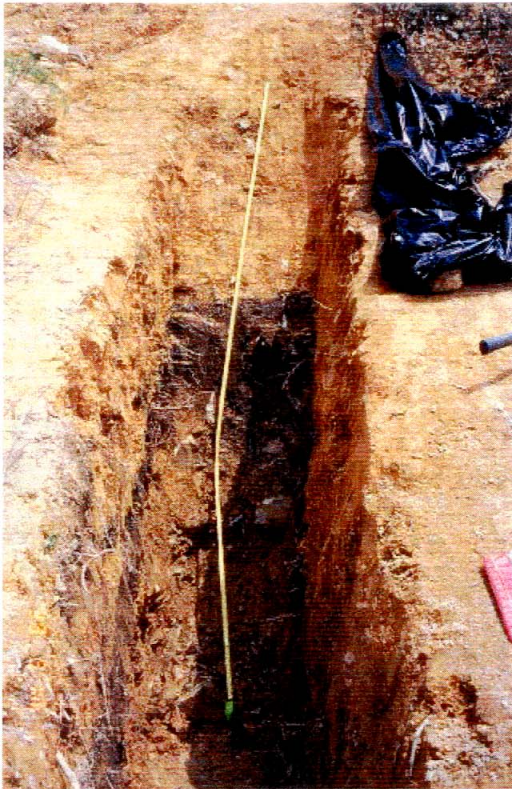
General View of Trial Pit. Note layer of topsoil between recent landslide debris (above) and colluvium (below) in Face A.

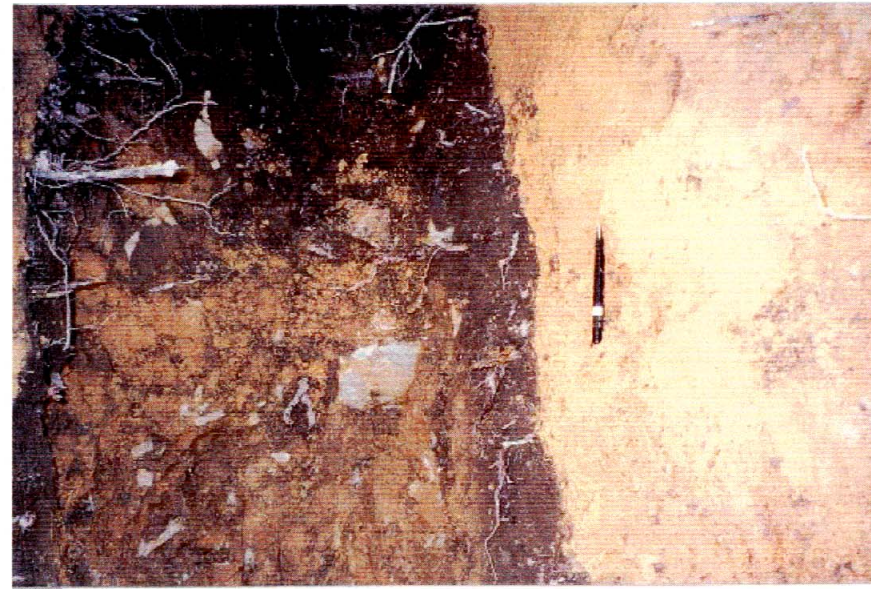
Close-up of Face A. Note irregular interface between topsoil and colluvium. Recent landslide debris above topsoil on the right side of the photograph

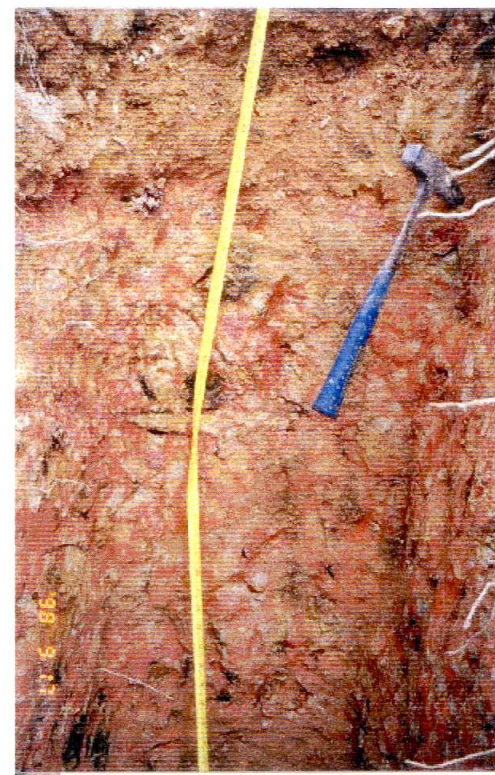
Close-up of Face A. Point of hammer indicates top of Completely Decomposed Tuff (CDT). Note presence of impersistent manganese-stained relict joints in CDT.

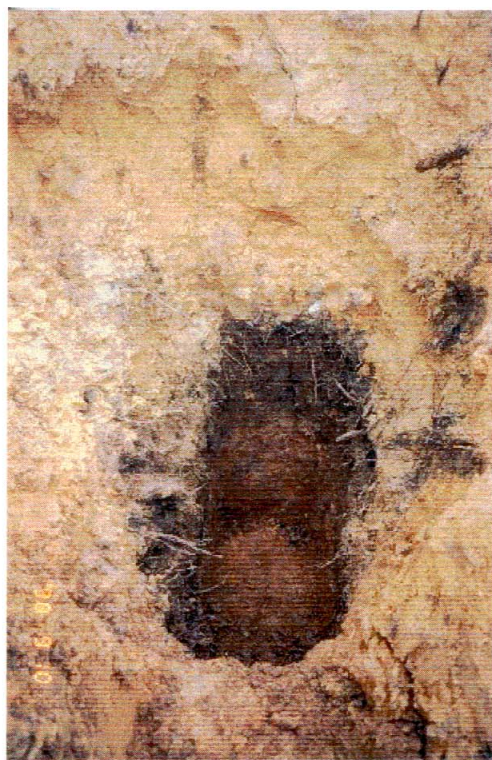
General View of Trial Pit Note recent landslide debris above original ground surface

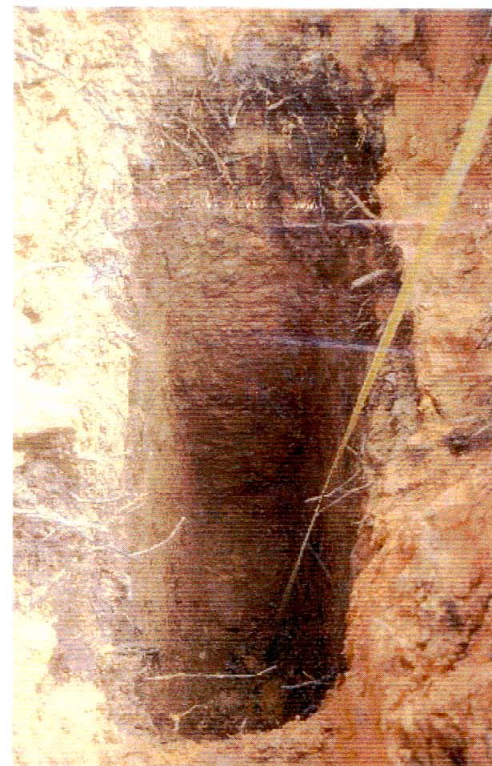
General View of Trial Pit. Note topsoil layer with roots above colluvium in Face A.
