**SECTION 3 :
PRELIMINARY STUDY OF
THE LANDSLIDE AT
LUK KENG WONG UK
ON 24 MAY 1998**

Fugro Scott Wilson Joint Venture

**This report was originally produced in November 1999
as GEO Landslide Study Report No. LSR 14/99**

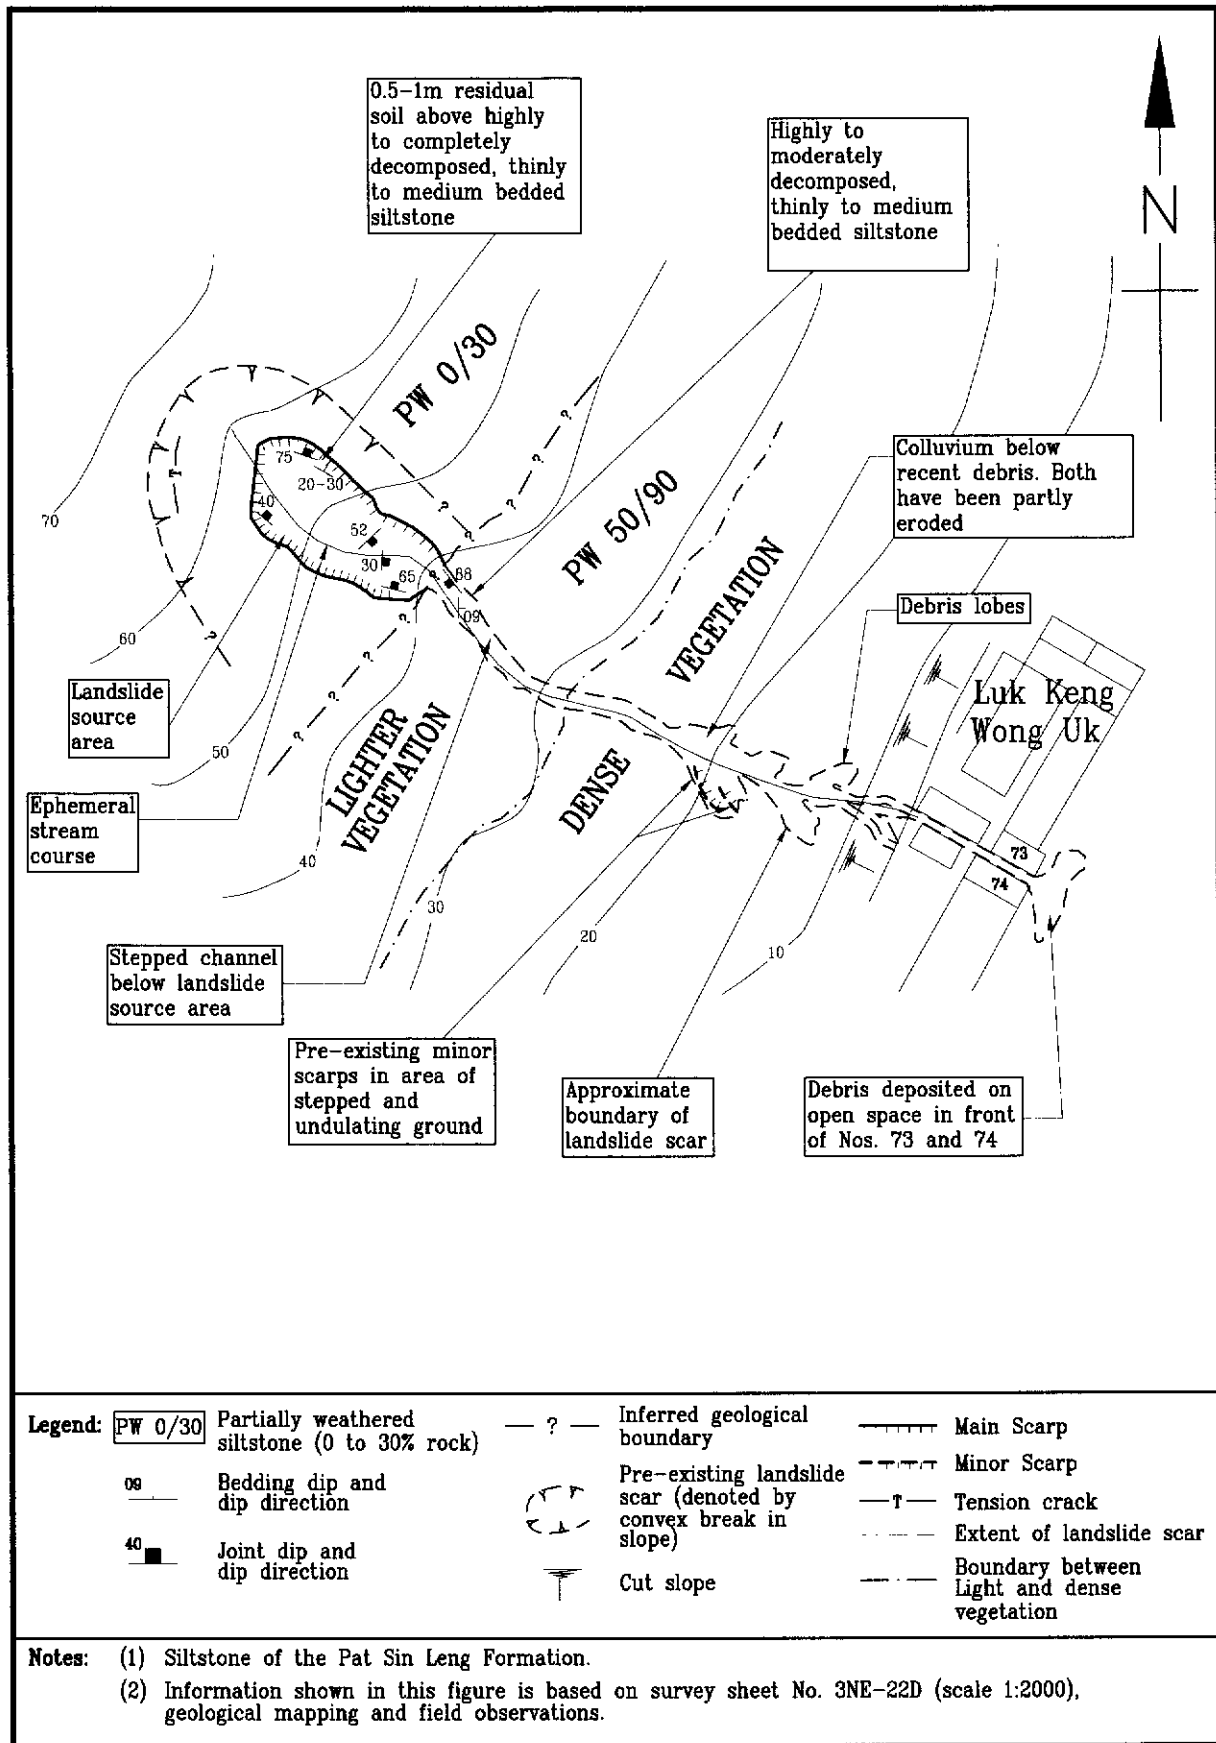
Figure 4 - Geological Plan of the Landslide

The landslide site was inspected and mapped by FSW on 17 June 1998. The source area (Plates 3 and 4) was observed to be larger than initially reported, suggesting the possibility of enlargement since 25 May 1998. However, comparison of record photographs indicates that the overall width and upper portion (lower portion obscured by vegetation in Plate 1) were essentially unchanged. A section through the hillside at the landslide location is presented in Figure 5.

Two sub-vertical joint sets were mapped in the siltstone at or close to the landslide scar, striking southeast. A third joint set with clayey infilling was mapped dipping between 40° and 75° towards the northeast (dip direction 020° to 054°) and a fourth, generally smooth and undulating joint set, dipping at about 30° to 50° to the southeast (dip direction 100° to 140°).

The presence of adverse joint orientations in the source area indicates that relict jointing in the weathered rock mass probably contributed to the failure.

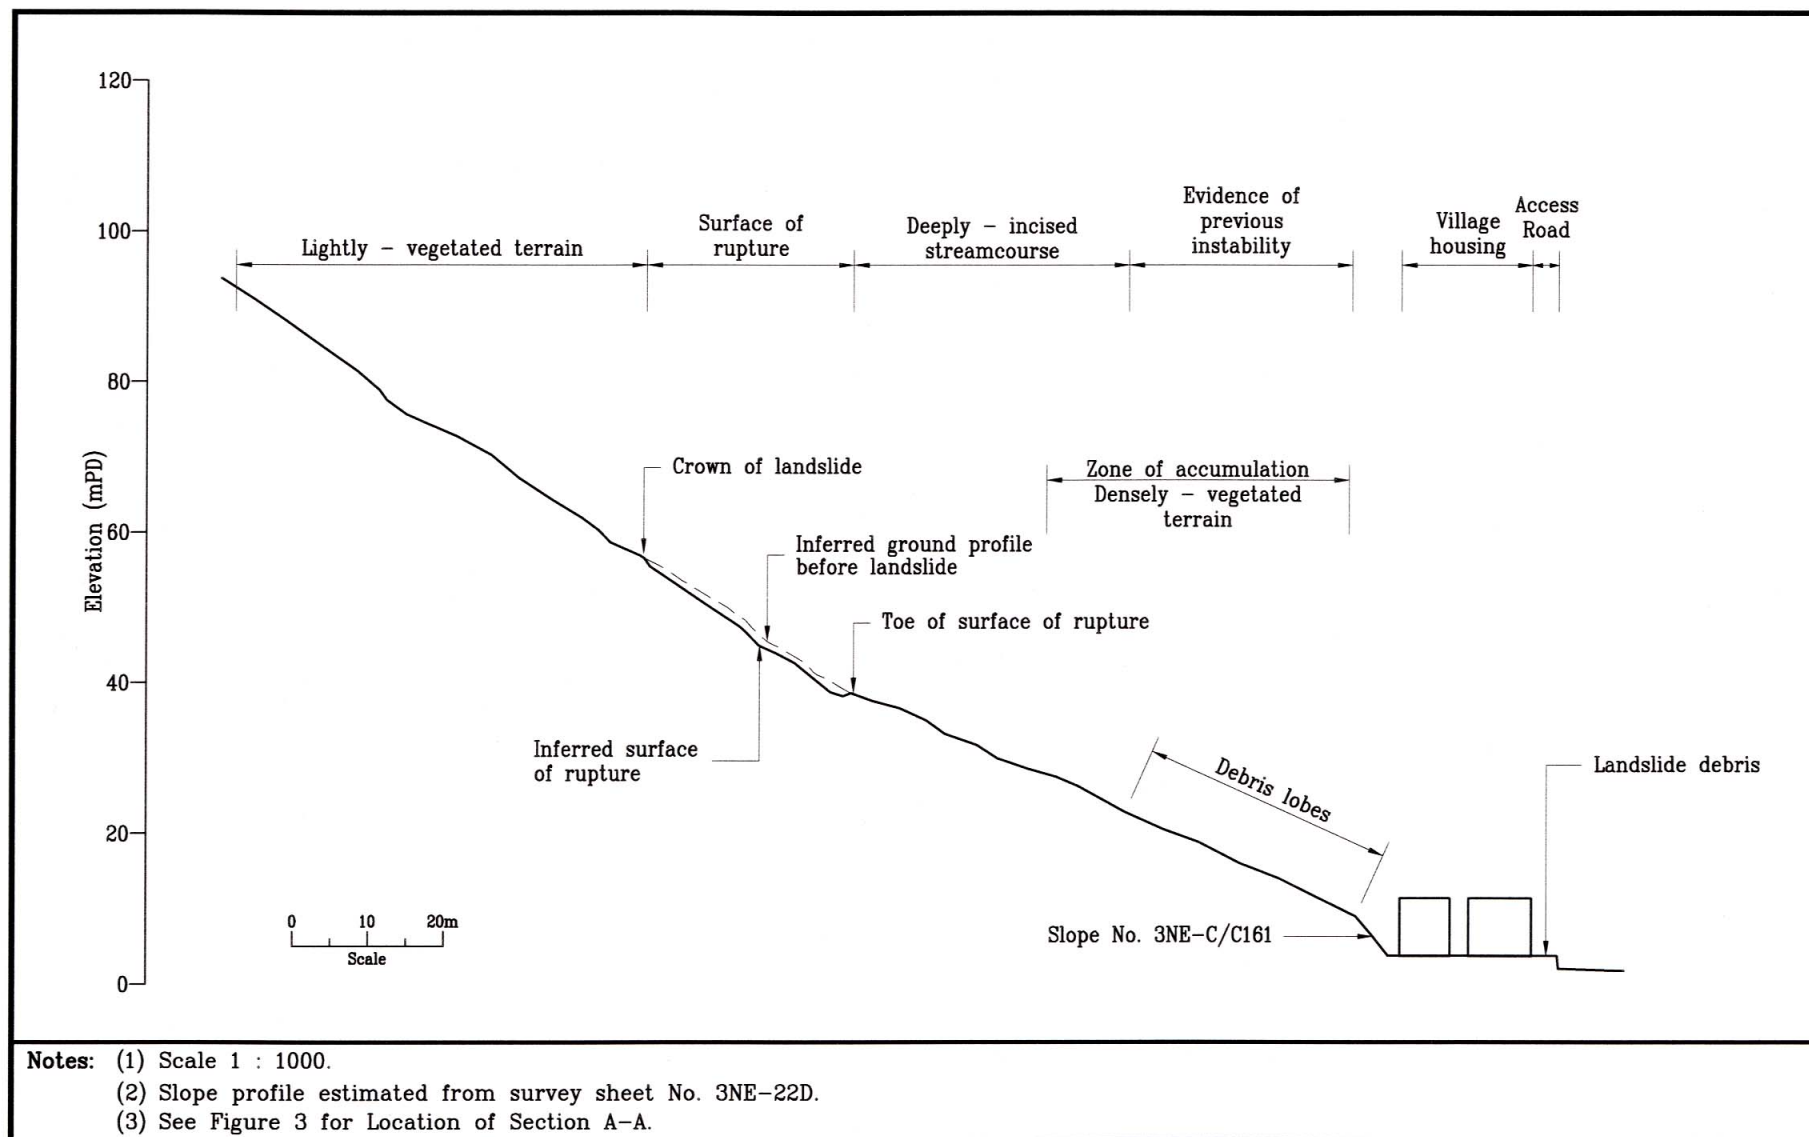
Figure 5 - Section A - A through the Landslide

The form of the surface of rupture was an elongate spoon-shape approximately 30 m long, 10 m wide and a maximum of 1 m deep. The total volume of displaced material is estimated at about 150 m³. The surface of rupture was located above and along the stream course, with the crown of the failure at about 55 mPD to 60 mPD. The hillside at the source area is locally inclined at an angle of about 35° to 40°, flattening to around 25° to 35°

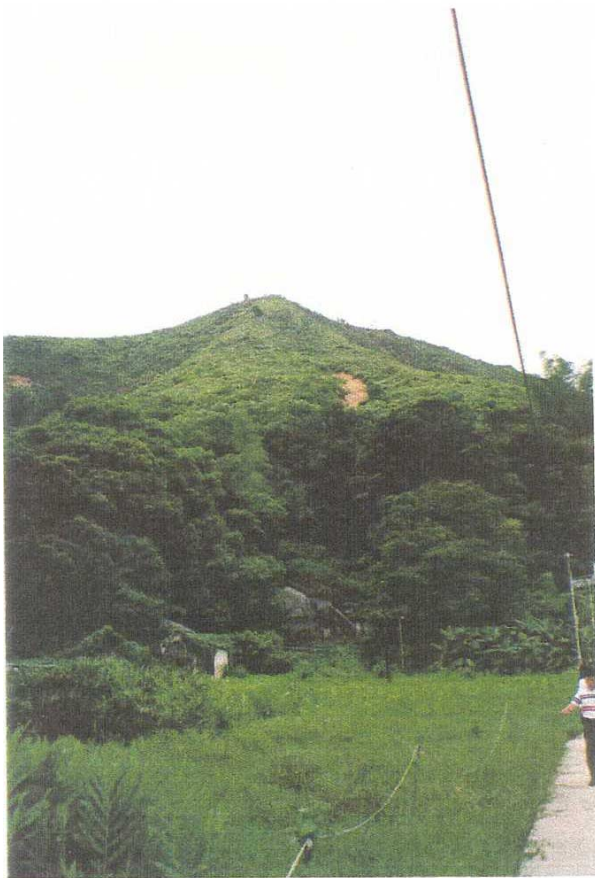
The landslide was reported to the GEO on the afternoon of 25 May 1998 (GEO Incident No. ME 98/5/10) and inspected by the GEO on the same day. A photograph taken by the GEO (Plate 1) shows the landslide scar on the hillside above the village. Based on site sketches produced by the GEO, the source area was about 90 m on plan from the village houses and located at the top of a natural drainage line, along which the debris travelled to reach the village. The source area of the landslide was inspected by a representative of the Highways Department. The dimensions of the scar reported in the GEO Incident Report were 15 m length downslope, 3 m width and 0.3 m depth.

Plate 1 – View North Towards
Landslide Scar.
(Photograph taken on
25 May 1998)

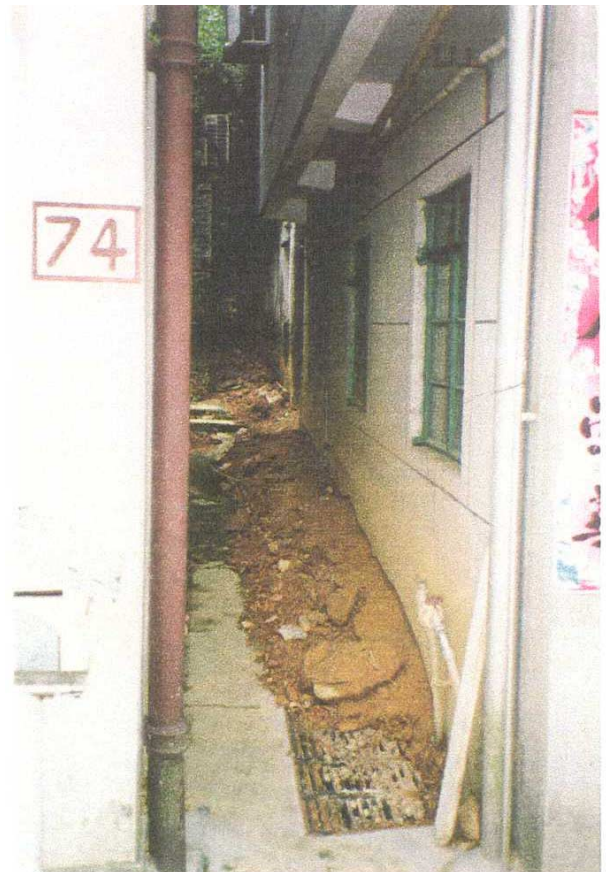
It was noted in the Incident Report that about 9 m³ of debris had deposited around the village houses (Plate 2). No recorded observations regarding deposition of debris on the hillside are available.

Plate 2 – Debris Deposited Between
Village Houses Nos. 73 and
74. (Photograph taken on
25 May 1998)

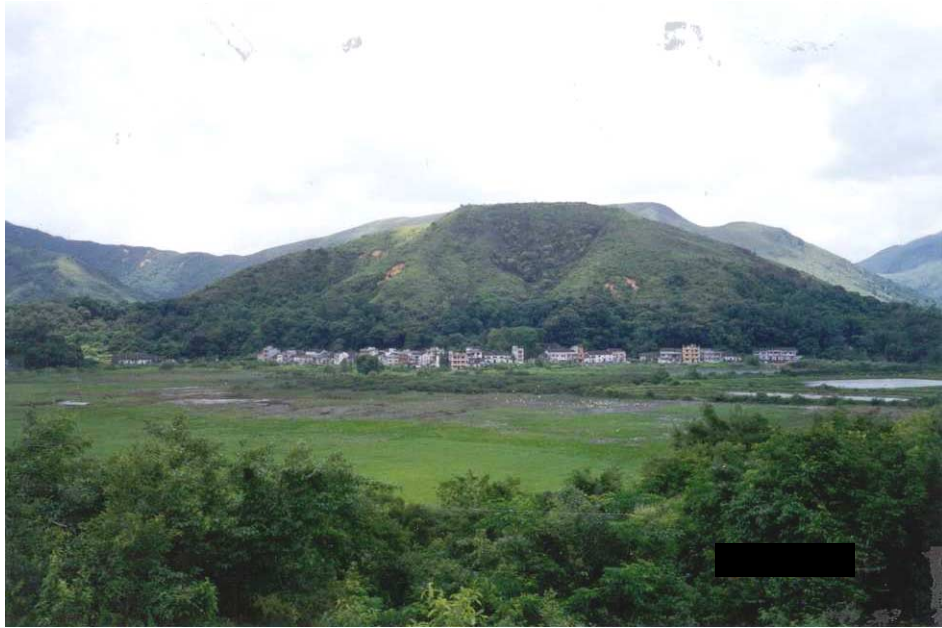
Plate 3 – View Looking West Towards Luk Keng Wong Uk
(Photograph taken on 17 June 1998)

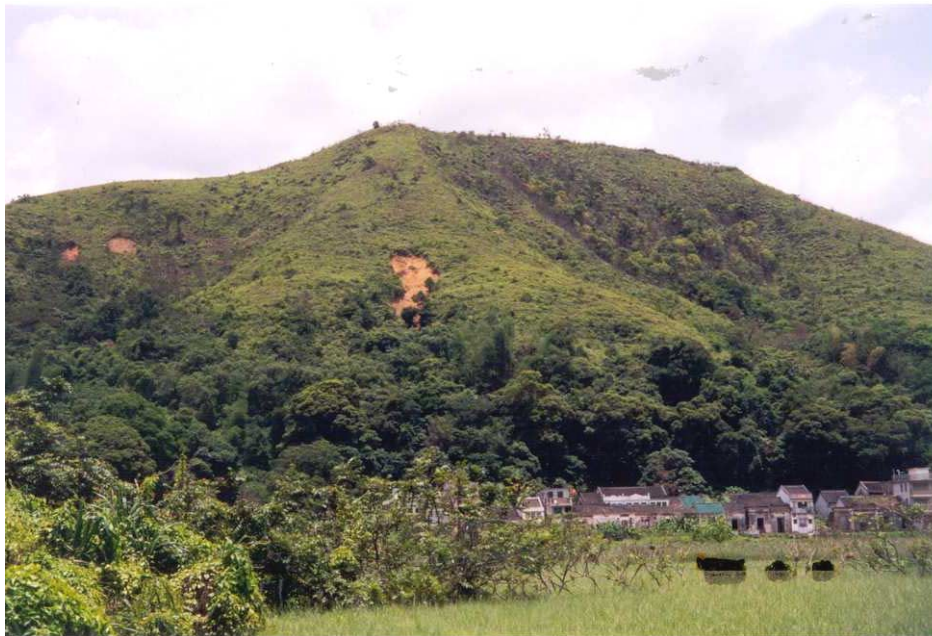
Plate 4 – Landslide Scar Behind Luk Keng Wong Uk
(Photograph taken on 17 June 1998)

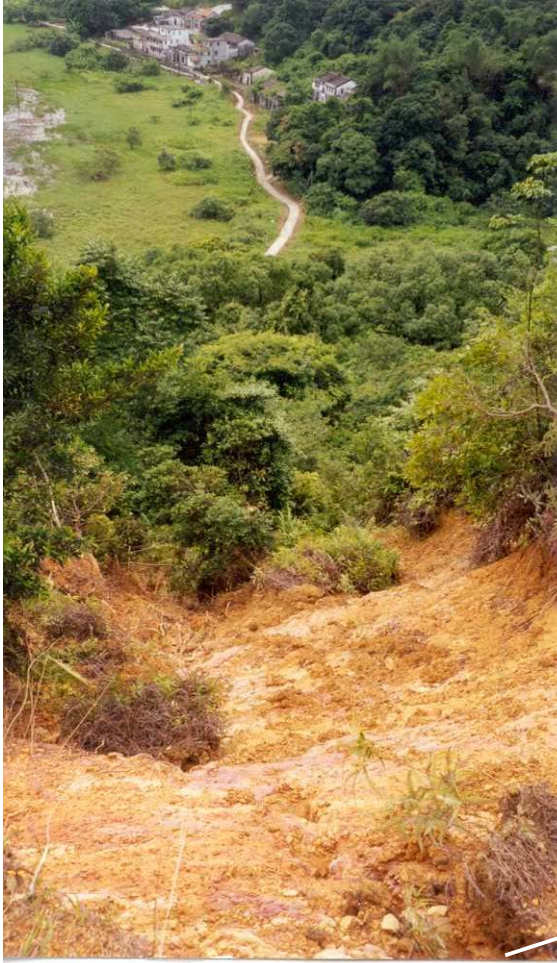
Plate 5 – View of Landslide Scar
(Photograph taken on
17 June 1998)

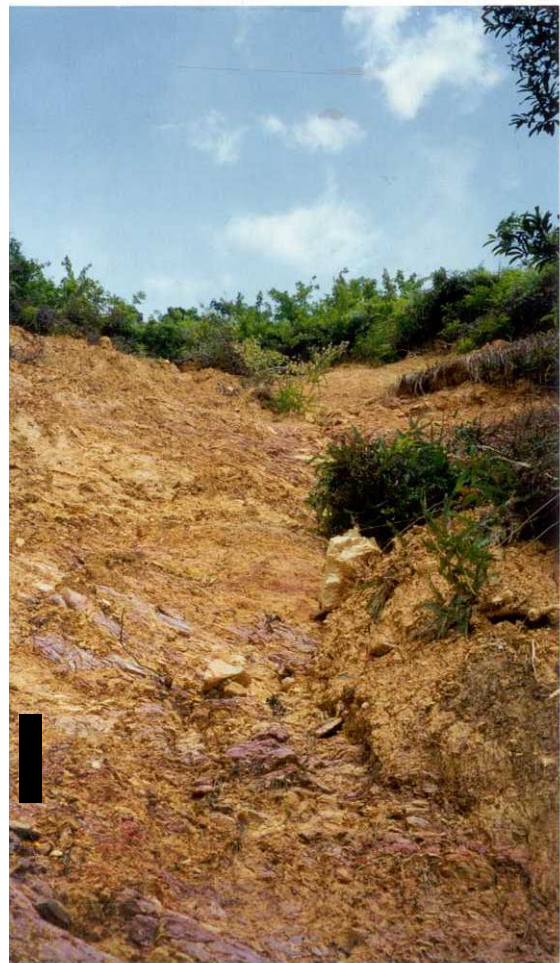
Plate 6 – View of Toe of Surface Rupture
and Dense Vegetation Towards
the Lower Portion of the Slope
(Photograph taken on
17 June 1998)

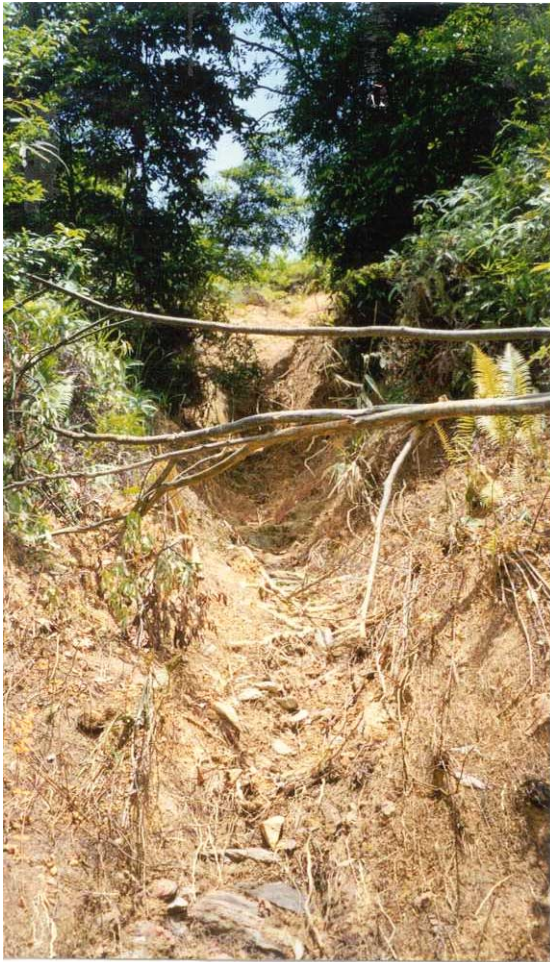
Debris from the landslide was channelised along the stream course below the estimated toe of the source area (about 40 mPD), before a significant portion was deposited below about 25 mPD (Plates 7 and 8) on the more gently inclined, densely vegetated ground extending to the crest of slope No. 3NE-C/C161. The stream course was deeply incised, narrow and stepped (up to 1.5 m in width and 1.5 m deep). Debris observed on the hillside comprised light orange brown, clayey, very sandy, very gravelly silt with many to occasional, angular to sub-rounded cobbles and boulders of siltstone. The debris was generally in the form of lobate, lateral and intermediate deposits. Some of the debris towards the toe of the slope appeared to have been partly eroded (Plate 10), suggesting the occurrence of secondary outwash and erosion following deposition.

Plate 7 – Ephemeral Stream Course
Below the Toe of the
Surface of Rupture
(Photograph taken on
17 June 1998)

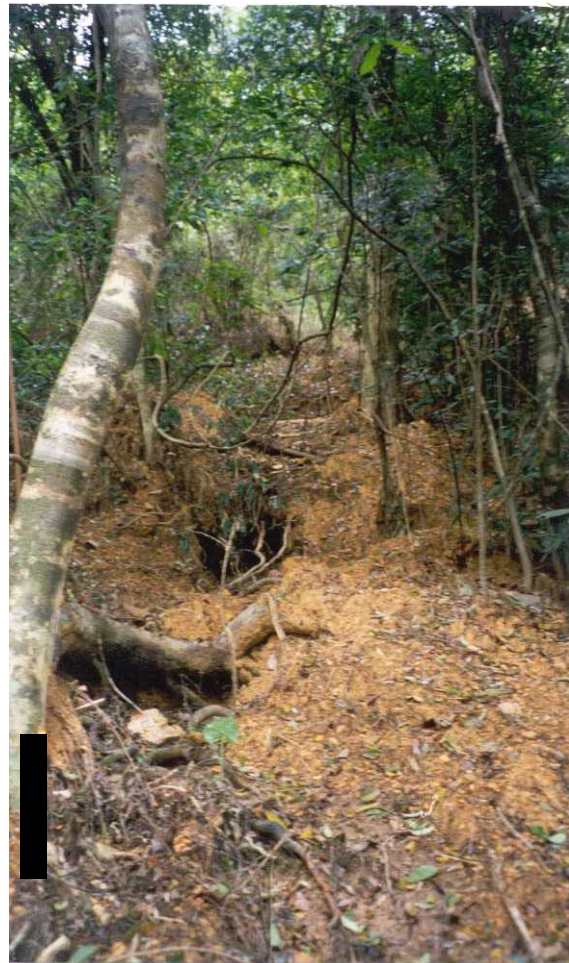
Evidence of past instability was also observed on the more gently inclined ground above slope No. 3NE-C/C161, where the debris had deposited over colluvium (Plate 8). The ground is hummocky in this area and minor scarps were observed within the colluvium giving a stepped appearance.

Plate 8 – Lower Portion of the Stream
Course Showing Small Debris
Lobes (Looking Upslope)
(Photograph taken on
17 June 1998)

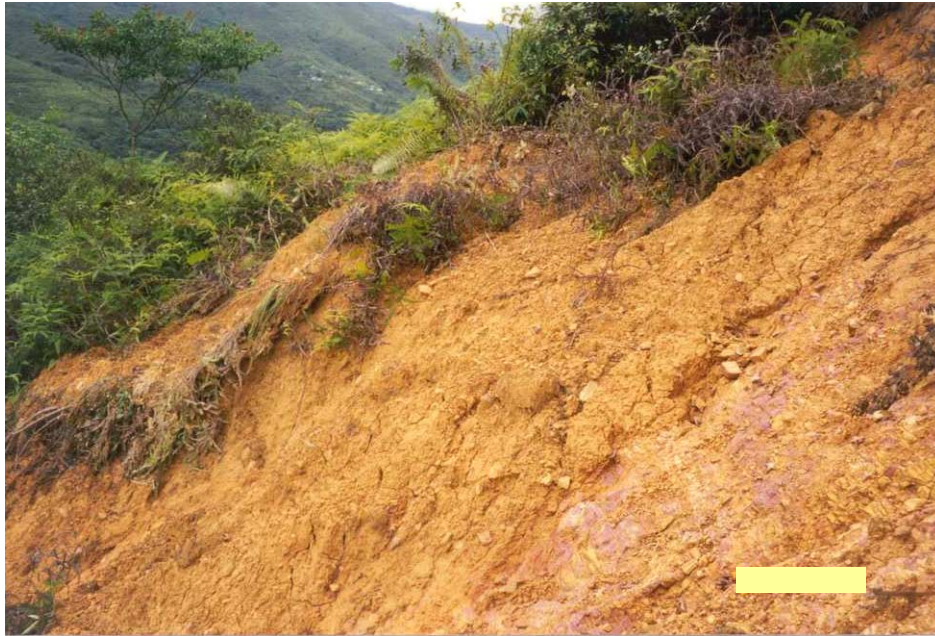
below. Material exposed on the surface of rupture comprised highly to completely decomposed siltstone, which was overlain by about 1 m of residual soil (Plate 9). Local planar features were observed on the surface of rupture and a quantity of debris and occasional rafts of relatively intact displaced material (Plates 5 and 6) remained within the source area. Details of the geological mapping are presented in Section 5.

Plate 9 – Part of the Surface of Rupture
(Photograph taken on 17 June 1998)

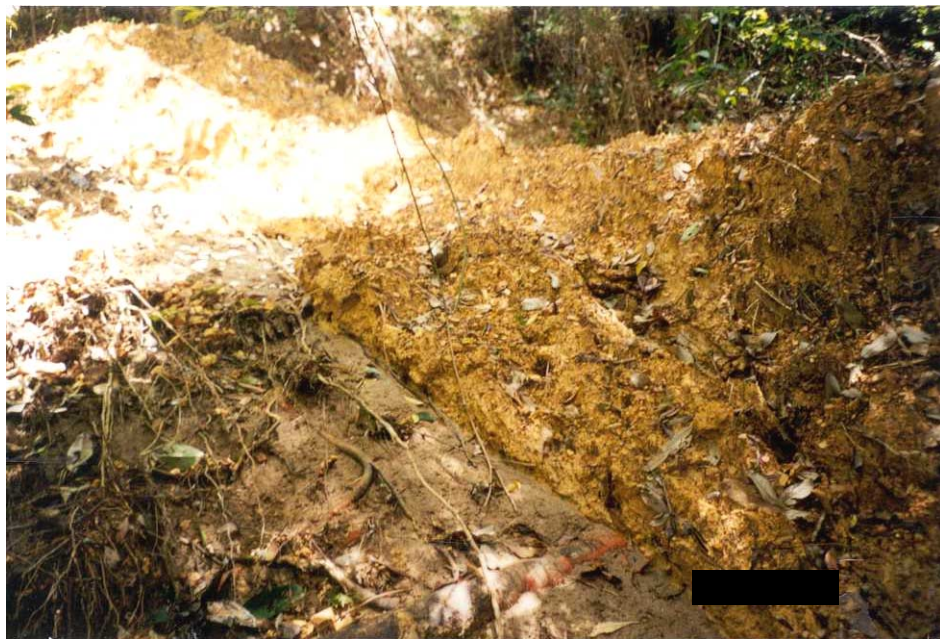
Plate10 – Landslide Debris Overlying Colluvium in Zone of Accumulation
(Photograph taken on 17 June 1998)

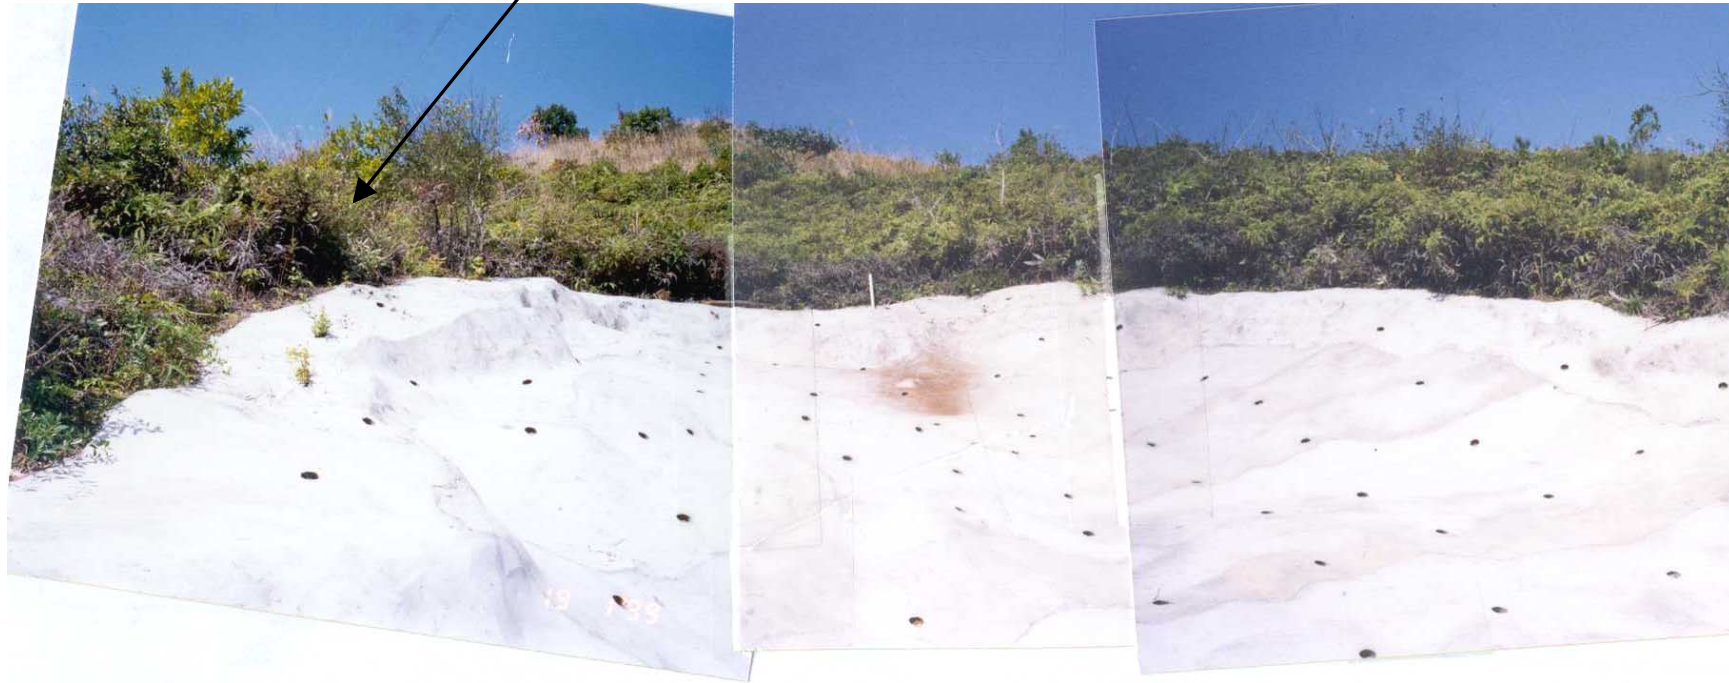
**Approximate location
of tension crack**

Plate 11 – Top of the Landslide Scar Following the Application of Chunum Surface Protection
(Photograph taken on 19 January 1998)

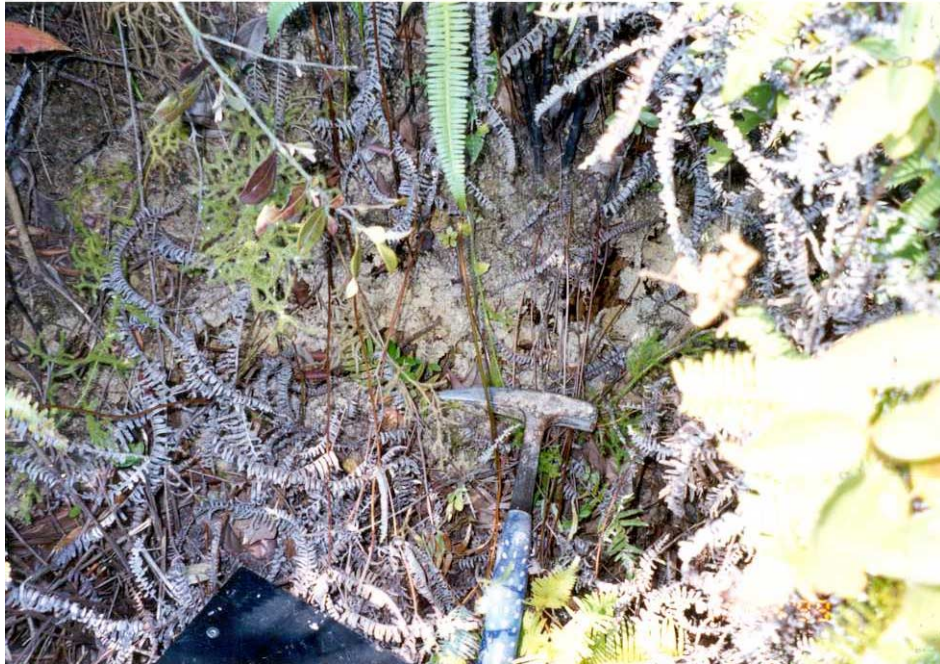
A second site visit was made by FSW on 19 January 1999, when the seasonally less dense vegetation cover permitted a more detailed inspection of the hillside surrounding the source area. At this time, the landslide scar at the source area had been partly covered by chunam. A crack was observed above the scar, without infilling and about 12 m from the crown of the recent failure towards the ridge (Plates 11 to 13). The crack, orientated in a north-south direction and about 50 mm to 200 mm wide, could be traced laterally for 3 m to 4 m.

Plate 12 – Tension Crack Located Above the 1998 Landslide Scar
(Photograph taken on 19 January 1999)

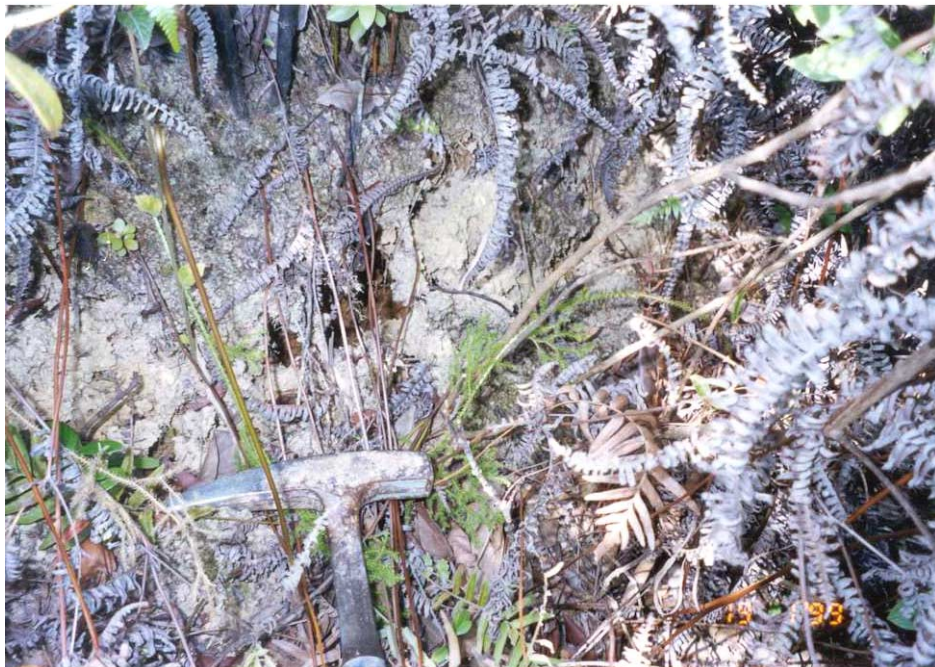
Plate 13 – Close-Up of Tension Crack
(Photograph taken on 19 January 1999)

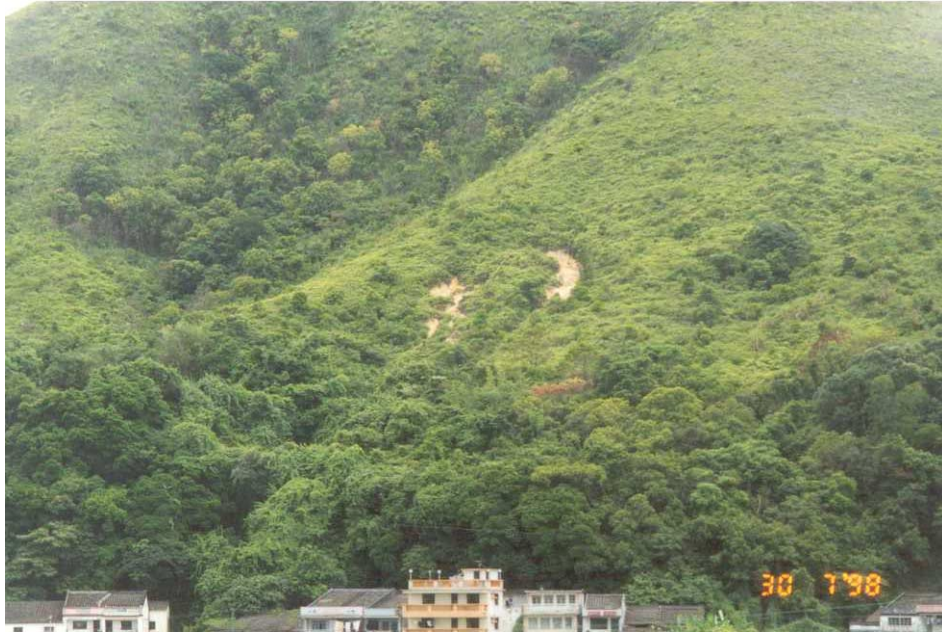
During the field inspection on 17 June 1998, three neighbouring pre-existing landslide scars were also examined on the eastern side of the hill (Nos. 2, 3 and 4 on Figure 2). All involved instability in the insitu weathering profile of the meta-sedimentary rock mass, as with the present failure. Landslide scar No. 2 occurred on hillside inclined at about 25° to 30° and involved a large raft of material that appeared to have slumped with limited downslope movement of about 1 m (Plate 14). The failure appeared to be shallow in nature (less than

2 m deep) and involved about 400 m³ of material. Erosion had also occurred on the edges of the displaced mass.

Plate 14 – View South West Towards Landslide No. 2
(Photograph taken on 17 June 1998)

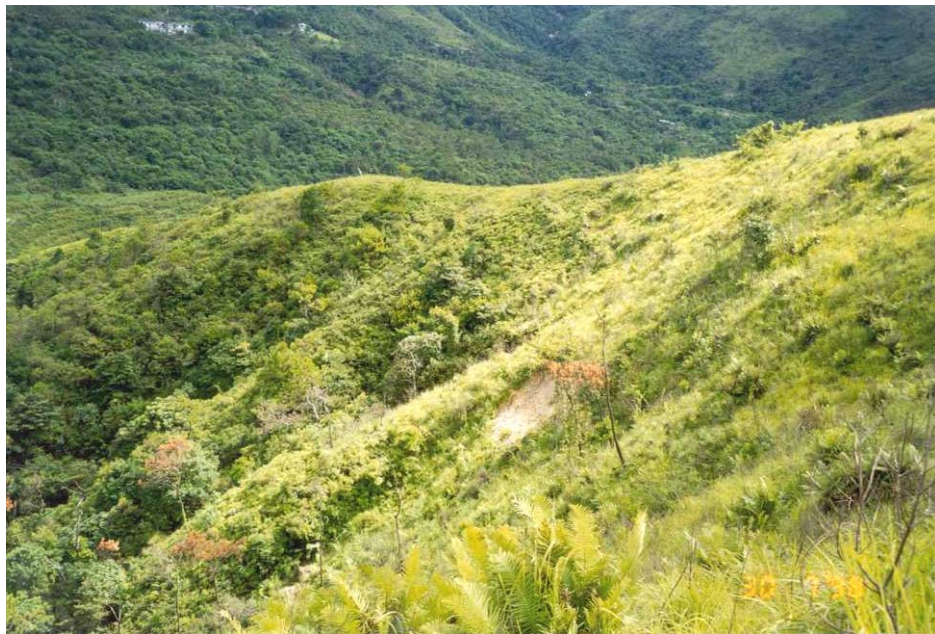
Landslide scars No. 3 and 4 were smaller features, involving about 50 m³ and 40 m³ of material respectively and occurred on hillside inclined at about 40° to 45° (Plates 15 to 17). Both scars are shallow in nature (<1 m deep). Landslide scar No. 4 has a trail of about 20 m, whereas landslide scar No. 3 is less elongate in shape with most of the debris located close to the source.

Plate 15 – View of Landslide Scar No. 3
(Photograph taken on 17 June 1998)

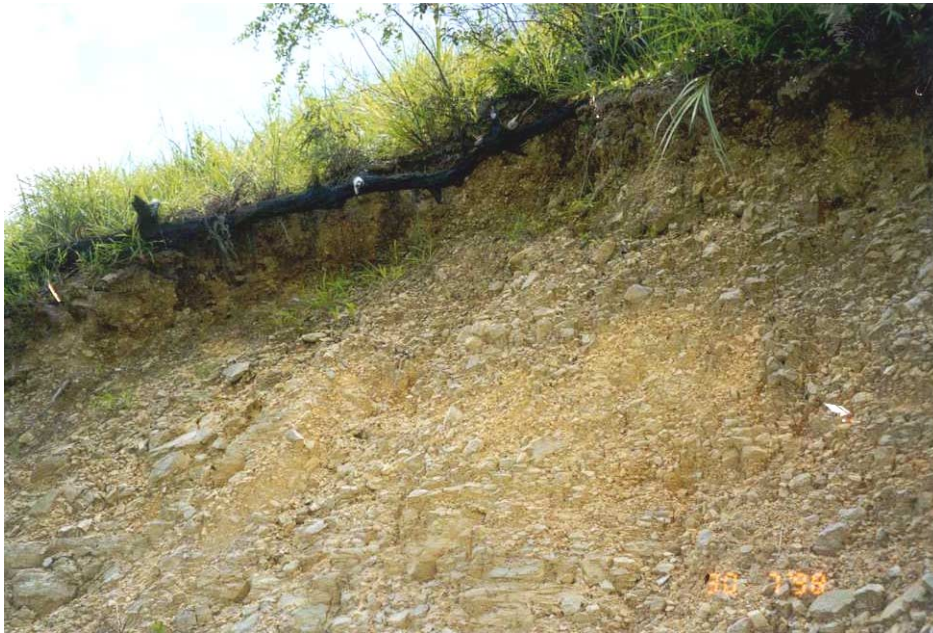
Plate 16 – Close-Up of Landslide Scar No. 3
(Photograph taken on 17 June 1998)

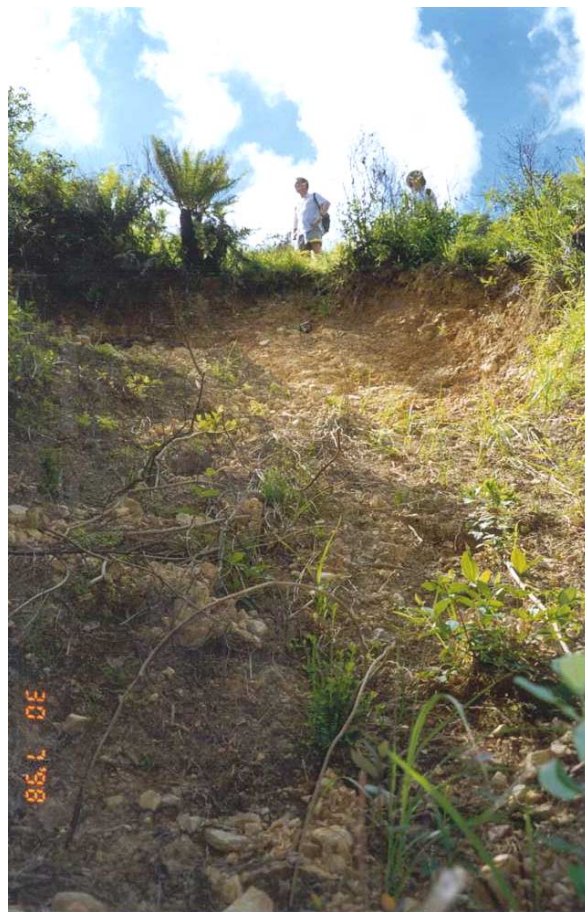
Plate 17 – View of Looking Upslope
Towards Landslide Scar No. 4
(Photograph taken on
17 June 1998)
