# **INVESTIGATION OF SOME SELECTED LANDSLIDES IN 1998 (VOLUME 2)**

**GEO REPORT No. 109**

**SECTION 1 :  
DETAILED STUDY OF THE  
DISTRESS OBSERVED IN  
SLOPE NO. 11NE-D/F10 BELOW  
HIU KWONG STREET,  
SAU MAU PING  
ON 9 APRIL 1998**

This report presents the findings of a detailed study of distress observed in fill slope No. 11NE-D/F10 located below Hiu Kwong Street, Sau Mau Ping, on 9 April 1998. The distress comprised cracking, displacement and bulging of the shotcrete cover to the upper batter of the slope, and was observed following the reporting of seepage from the toe of the slope.

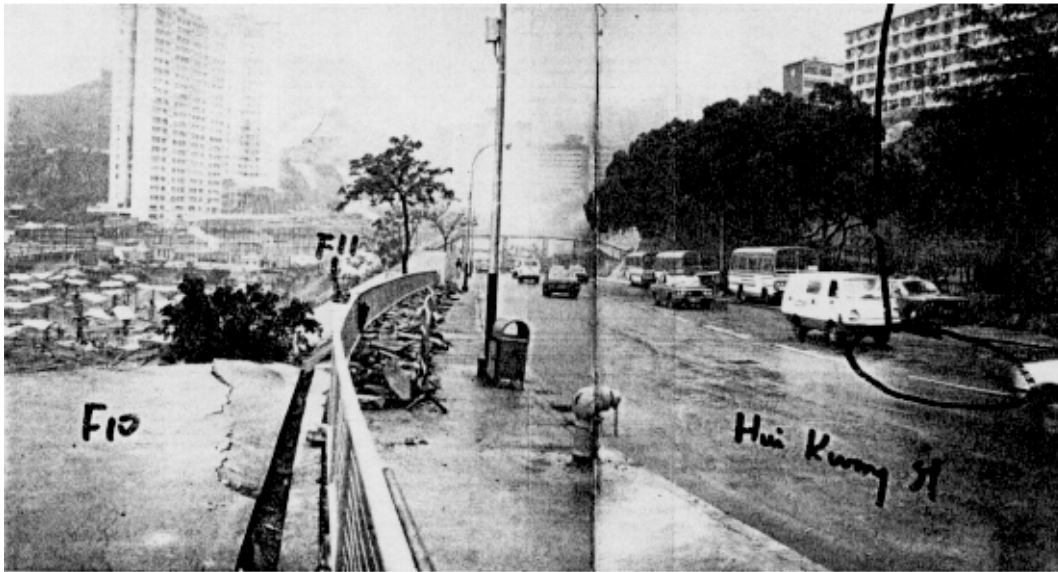
On 3 April 1984, a slope failure occurred on the north-western portion of the upper batter of slope No. 11NE-D/F10 (GCO, 1984), which was described as a “washout failure” and attributed to a leaking water main at the slope crest, though available documentation does not positively identify the source of the leakage. The damage to the slope is shown in Plates 6 to 9, which suggests fill material having been removed from the slope, creating a void into which the hard surfacing collapsed. There appeared to be significant undermining of the hard surfacing, given the extent of the cracking, which extends beyond the crest of the slope (Plate 6). An area of subsidence in the eastbound lane of the Hiu Kwong Street carriageway is also indicated in Plate 6. Available records indicate that the volume of the failed material was of between 50 m<sup>3</sup> and 160 m<sup>3</sup>.

Plate 6 – View North-west Along Crest of Slope No. 11NE-D/F10 Following "Washout" of Fill Reportedly by Leaking Water Main (Photograph Taken on 5 April 1984)

The damage resulting from the 3 April 1984 incident was repaired by removal of the affected material (as determined by GCO probing – locations indicated on Figure 8) and the replacement and recompaction of fill in the excavated area (including the replacement of the filter layer, where encountered), and replacement of the hard surface cover. The remedial works are shown in Plate 10. The presence of surface drainage and hard surfacing from the pre-1977 slope formation beneath the excavated fill at the edge of the feature, as can be seen in Plate 9, suggests that these may have been left in place beneath the 1977 reconstruction works.

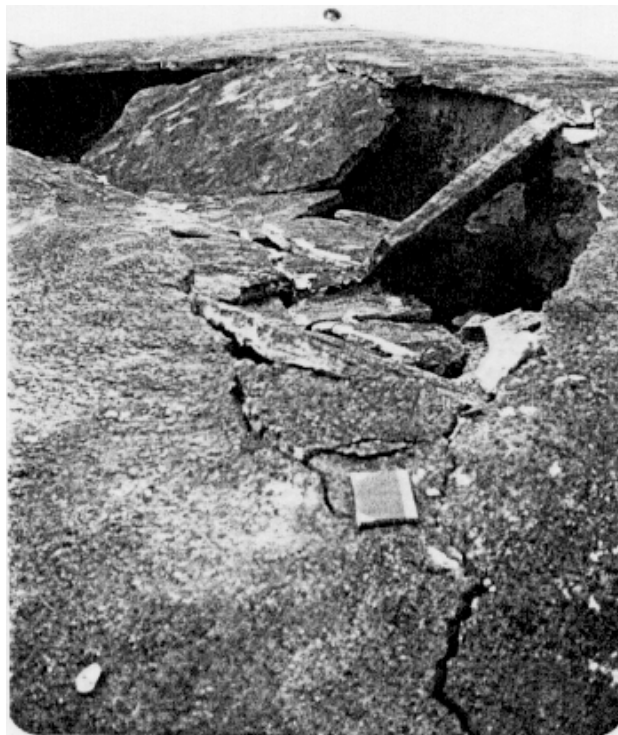
Plate 7 – Close-Up of Zone of "Washout" (Photograph Taken on 6 April 1984)

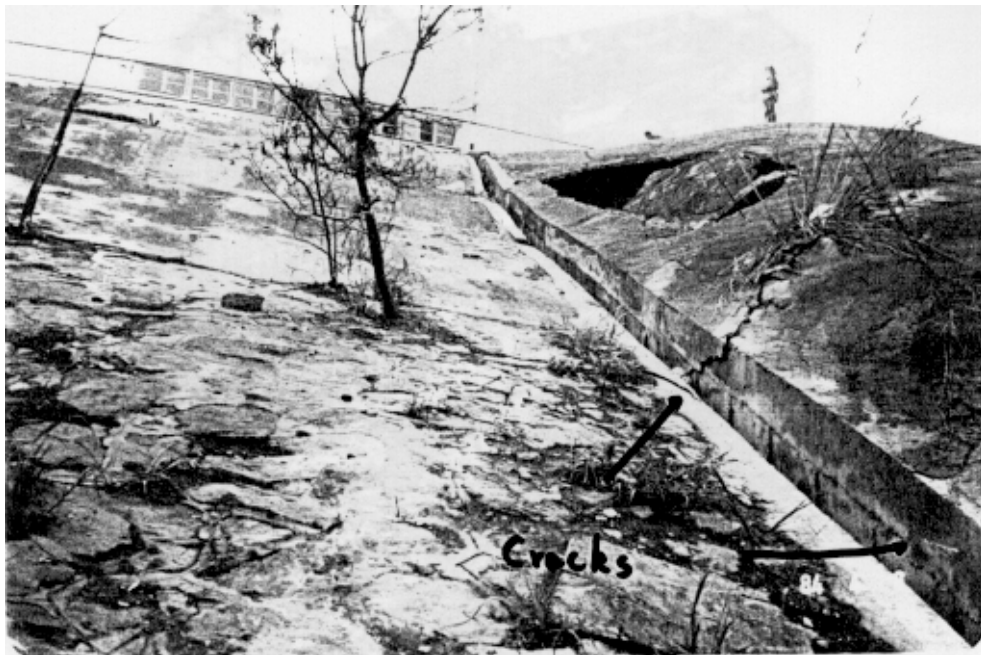
Plate 8 – View North-east Towards Zone of "Washout". Cracks in Hard Surfacing Below "Washout" also Indicated (Photograph Taken on 6 April 1984)

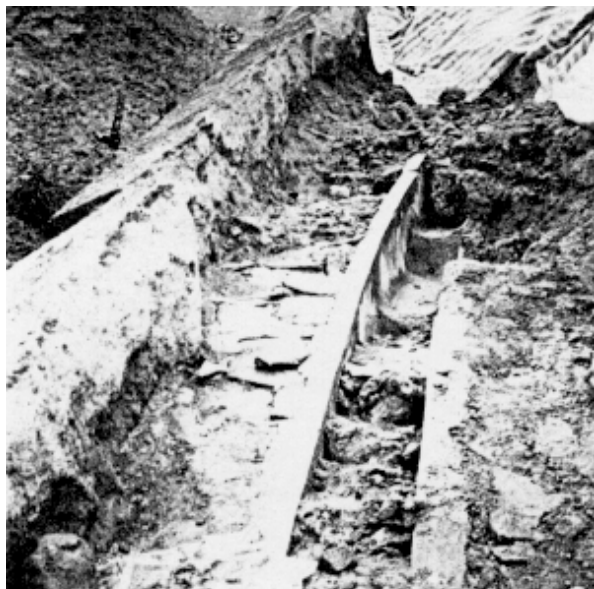
Plate 9 – View North-east Towards Crest of Slope at Location of "Washout" Indicating Old Surface Channel and Hard Surfacing Below 1977 Remedial Works Revealed During 1984 Remedial Works (Photograph Taken on 25 April 1984)

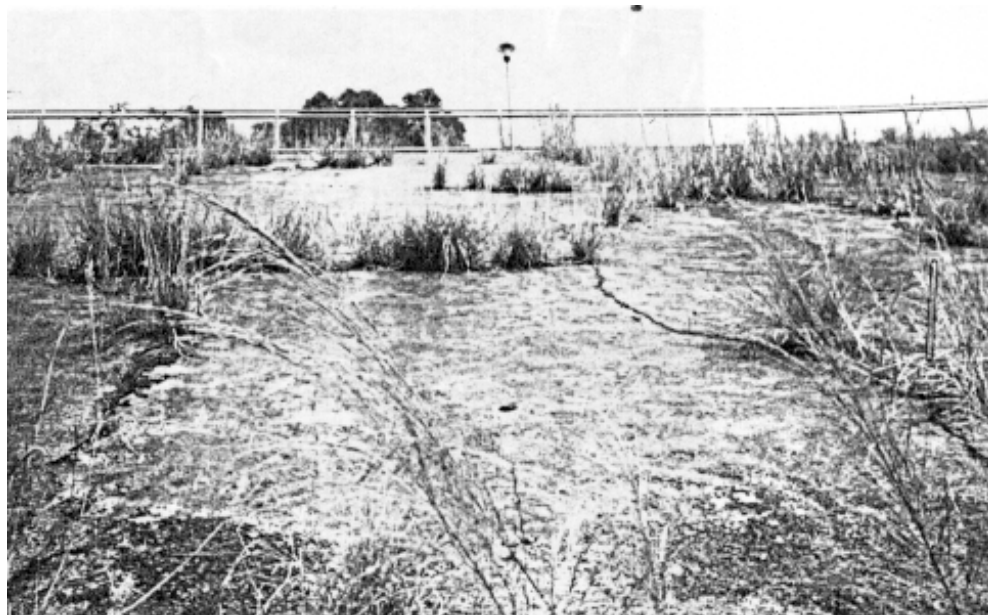
The condition of the upper batter in February 1994 is shown in Plates 11 to 13, which indicate vegetation and cracking in the hard surfacing (with repairs). Possible distortion in the hand railing at the slope crest is evident in Plate 13. A small patch of what appears to be erosion is visible on the upper batter, near the location of "bulging" described by the GEO in 1998 (see Section 4 and Figure 7), in the May 1994 aerial photographs. The patch is darker than the rest of the slope, the cause of which is not known. The October 1994 aerial photographs indicate noticeably heavier vegetation in this area.

Plate 11 – View North-east From Toe of Slope Indicating Vegetation and Cracking on Hard Surfacing (Photograph Taken on 17 February 1994)

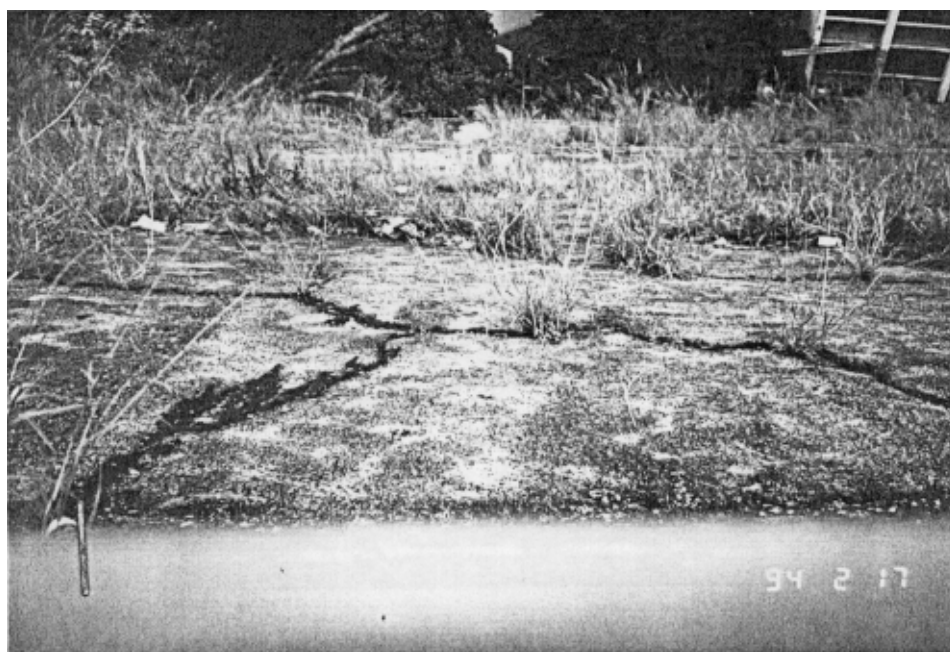
Plate 12 – View South-west From Crest of Slope Indicating Vegetation and Cracking on Hard Surfacing (Photograph Taken on 17 February 1994)

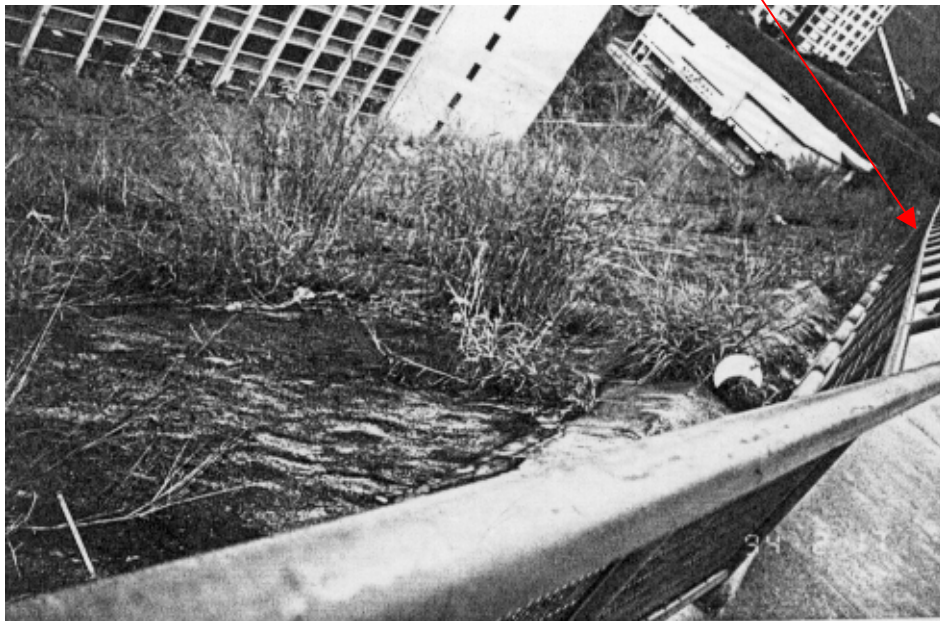
Slight Distortion on Hand Railing

Plate 13 – View North-west From Slope Crest Indicating Vegetation on Hard Surfacing. Note Also Slight Distortion in Hand Railing on Right (Middle Distance) (Photograph Taken on 17 February 1994)

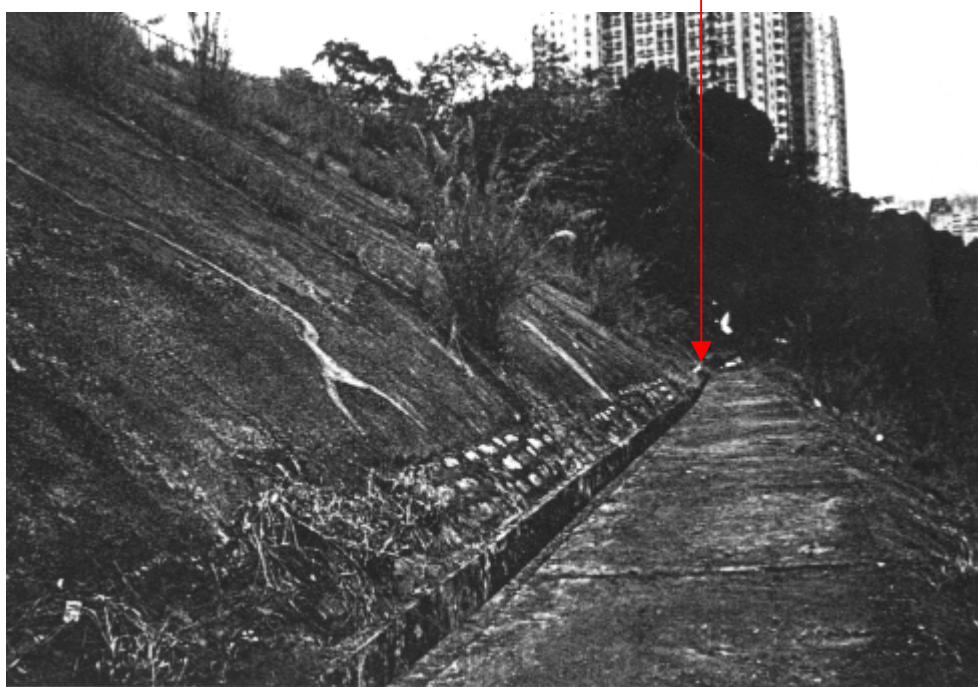
The condition of the slope approximately one year later, in March 1995, is presented in Plates 14 and 15. Of note is the apparent convex deformation of the lower portion of the slope face of the upper batter at the interface between the hard surfacing and stone pitching (Plate 14) and the cracking along the interface (Plate 15).

Apparent Distortion of Berm Channel

Plate 14 – View South-east Along Upper Berm. Note Repaired Cracking, Stone Pitching Above Berm Channel and Convex Shape of Lower Portion of Slope. Note Also Apparent Distortion of Berm Channel (Photograph Taken on 20 March 1995)

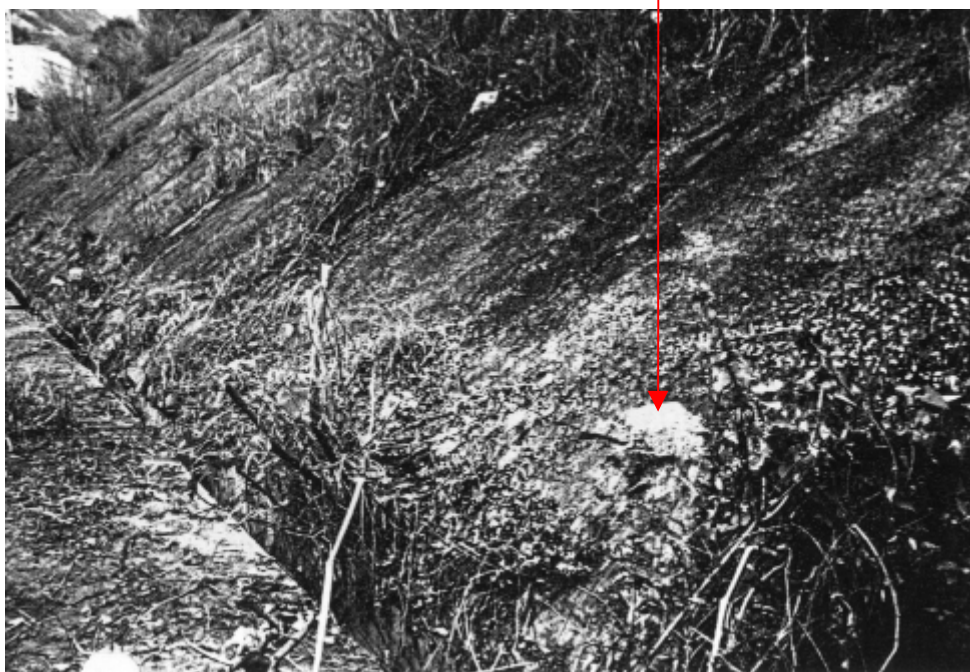
Crack Between Hard Surfacing and Stone Pitching

Plate 15 – View North-west Along Upper Berm. Note Vegetation on Slope Face and Apparent Crack Between Hard Surfacing and Stone Pitching in Foreground (Photograph Taken on 20 March 1995)

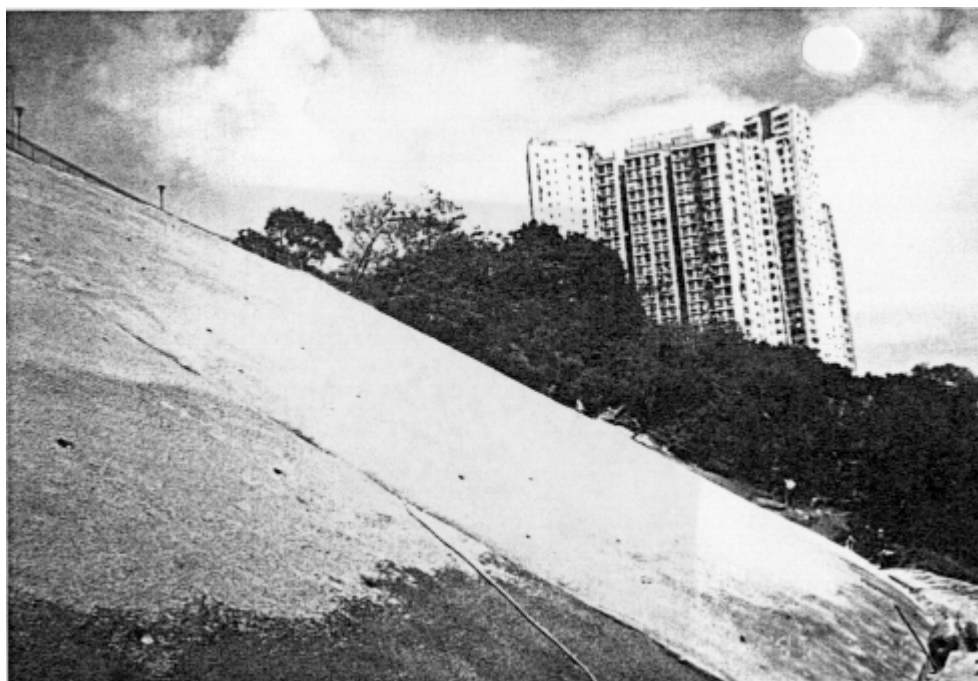
Plate 17 – View South-east Along Lower Berm. Re-Surfacing Works in Progress.  
Note Slight Convex Shape of Slope at Toe in Profile (Photograph  
Taken on 26 May 1995)

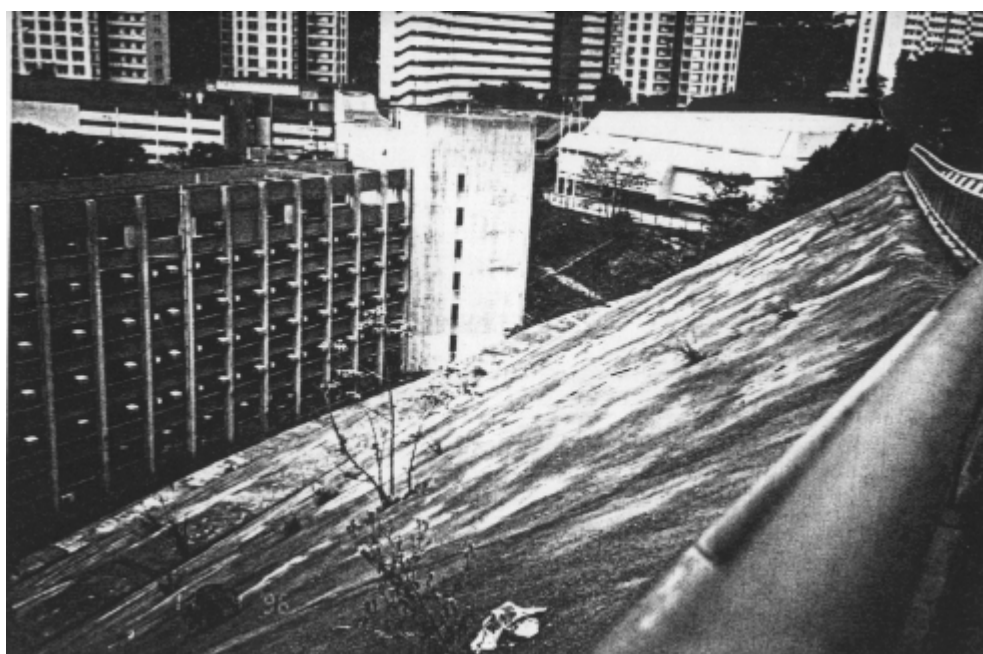
Plate 19 – View North-west Along Crest of Slope. Note Possible Cracking in Foreground. Note Also Distortion in Hand Railing at Crest on Right (Photograph Taken on 11 April 1996)

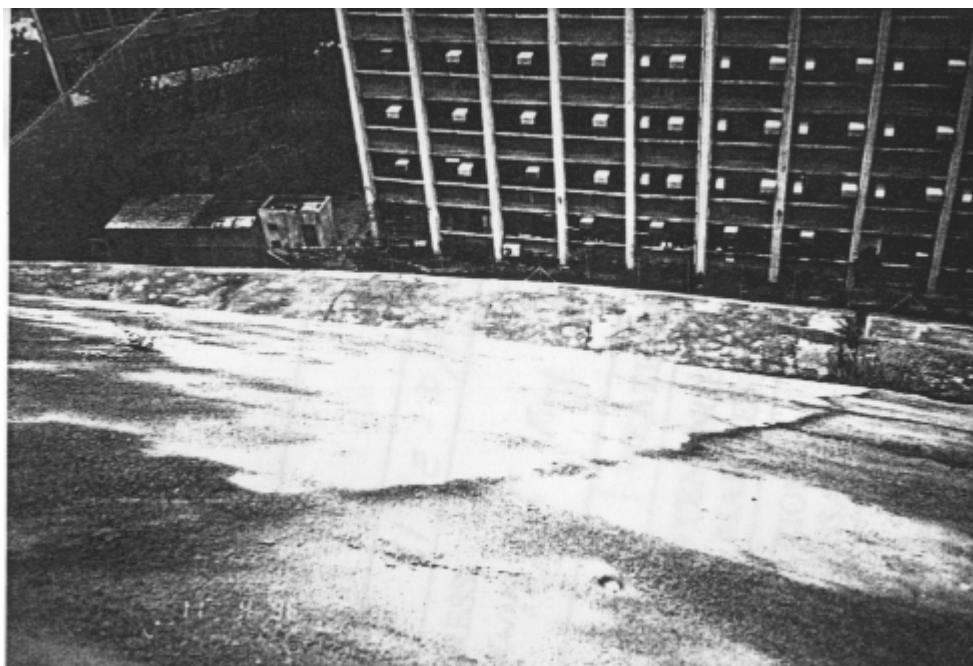
Plate 20 – View South-west Down Slope Face From Crest. Note Vertical Line Down Slope Face with Step Across, Indicating Previous Partial Removal of Surfacing Prior to Present Application (Photograph Taken on 11 April 1996)

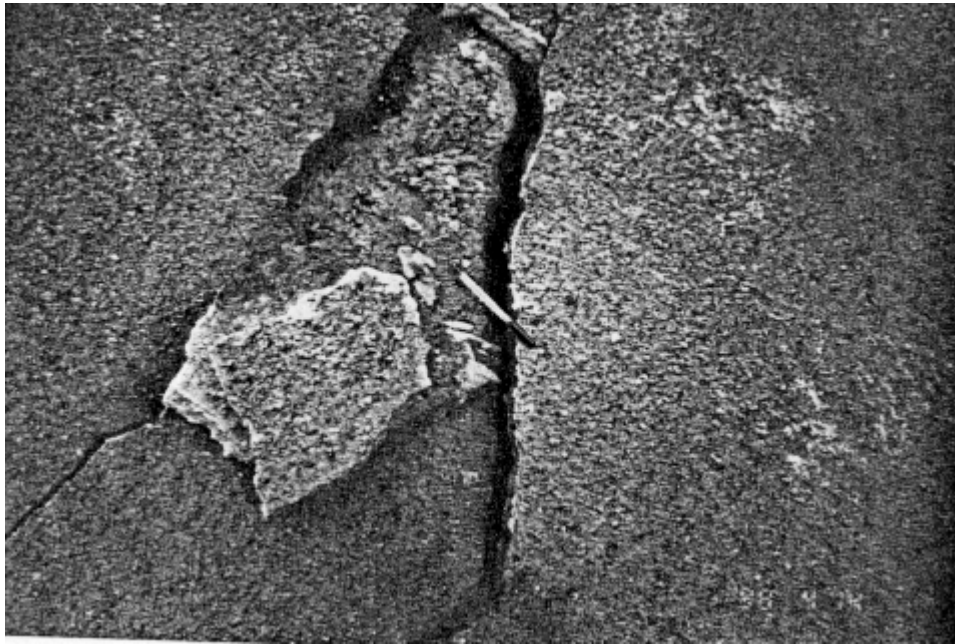
Plate 22 – Cracking in Shotcrete at North-western Zone of Bulging  
(Photograph Taken on 14 April 1998)

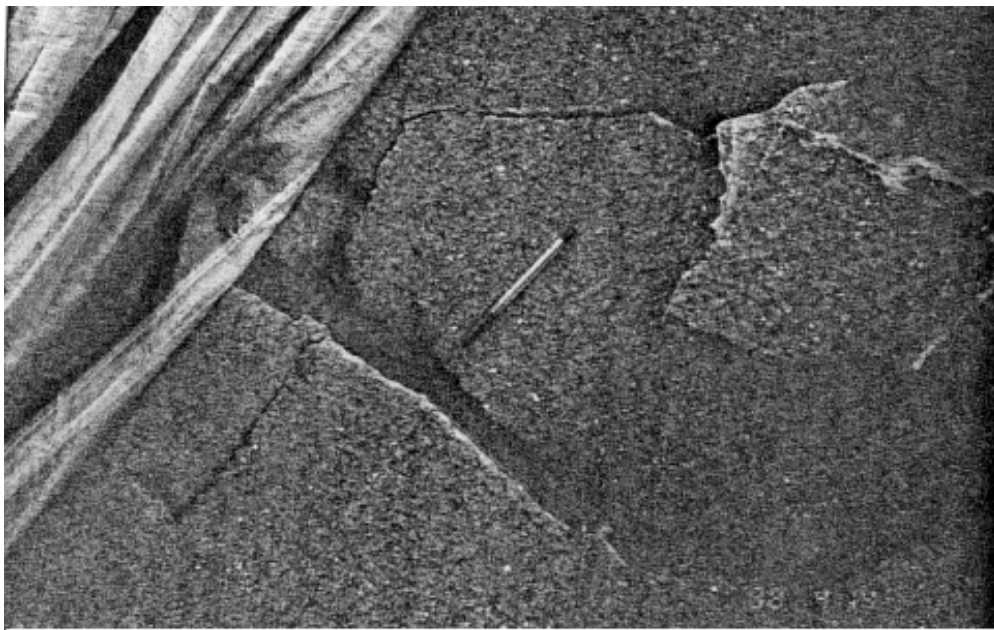
Plate 23 – Cracking in Shotcrete at North-western Zone of Bulging  
(Photograph Taken on 14 April 1998)

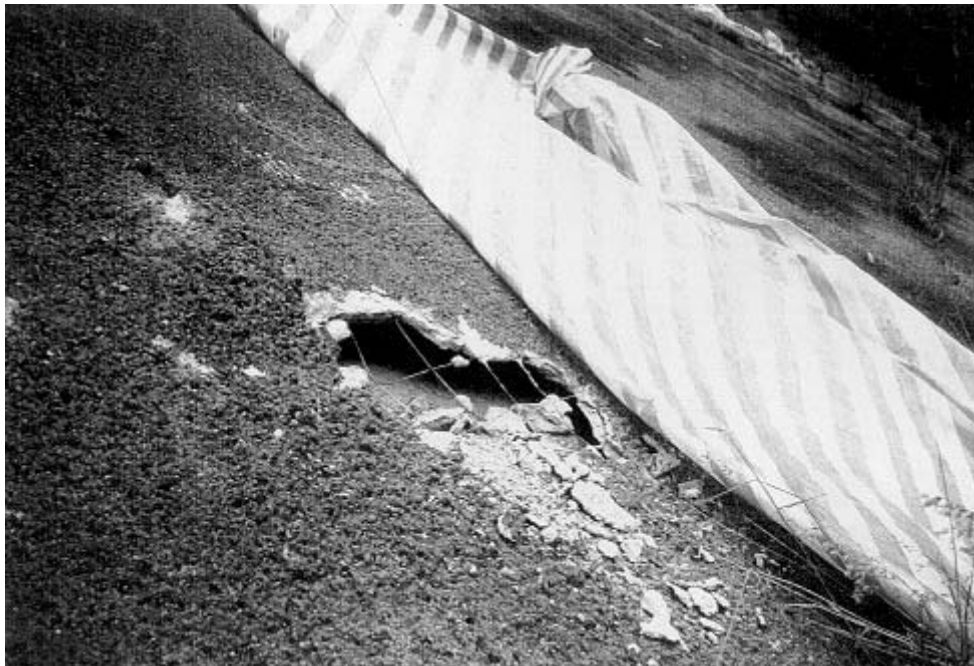
Plate 24 – View of North-western Zone of Bulging in Shotcrete with Inspection Hole Broken in. Note Absence of Free Water (Photograph Taken on 14 April 1998)

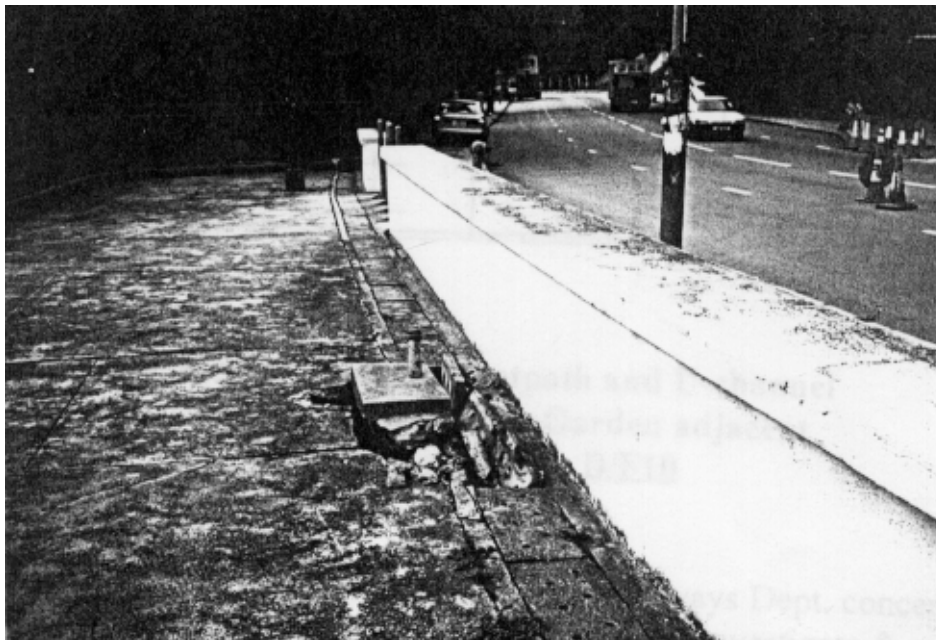
Plate 25 – View North-west Along USD "Open Space" Behind Crest of Slope at North-western End Indicating Concrete Plinth Standing Proud of Surrounding Pavement (Photograph Taken on 14 April 1998)

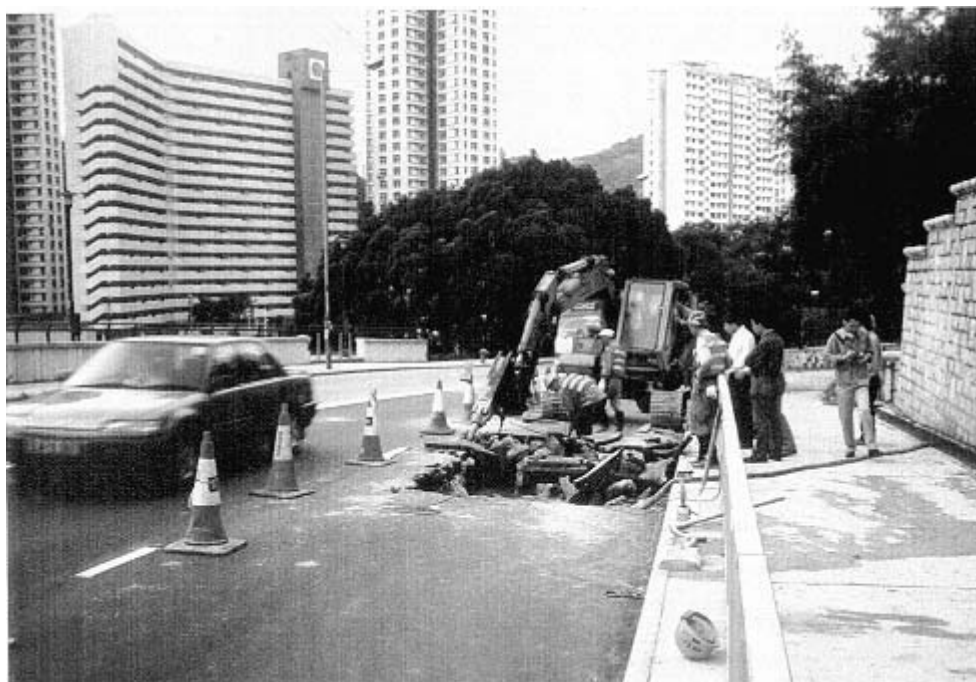
Plate 26 – View North-west Along Northern Side of Hiu Kwong Street. Exploratory Pit Open at Location of Leak in Water Main. Note Free Water Visible in Pit and Blue Hose Pipe for De-Watering (Photograph Taken on 14 April 1998)

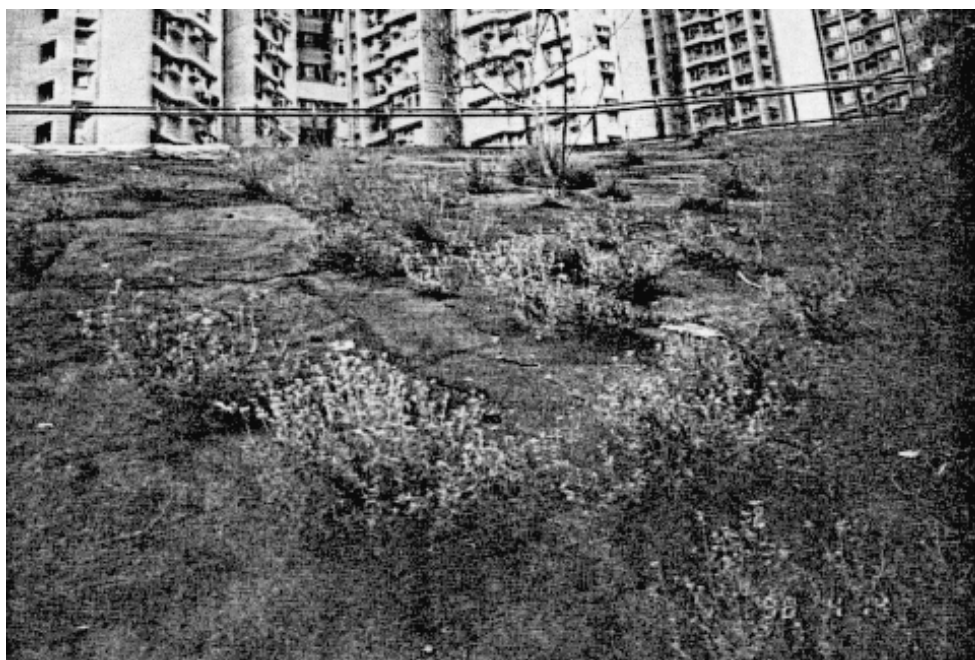
Plate 27 – View North-east From Upper Berm at Location of South-eastern Zone of Cracking and Bulging in Shotcrete (Photograph Taken on 14 April 1998)

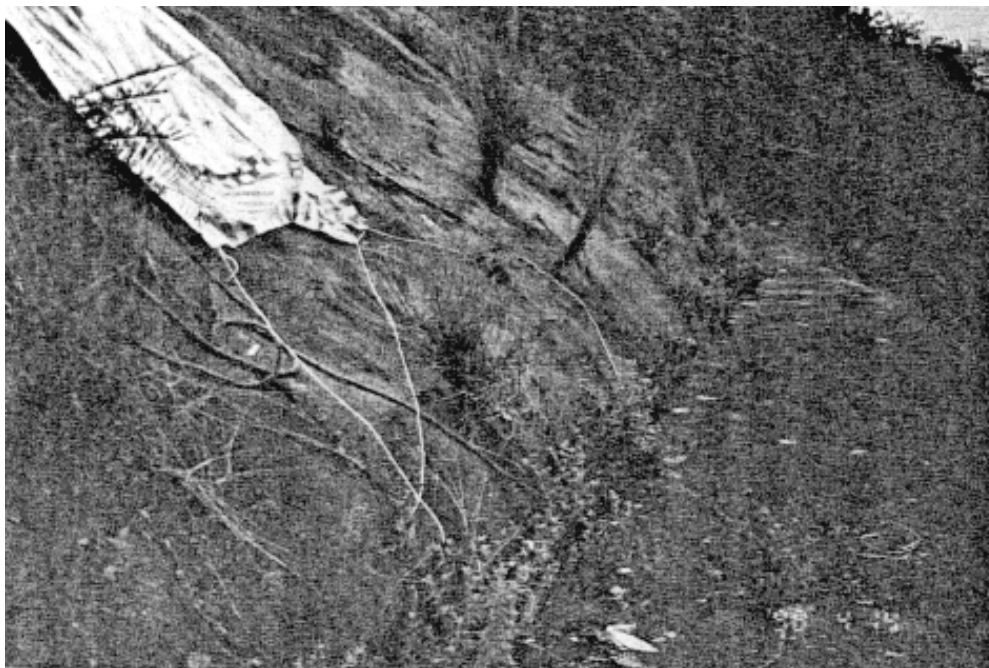
Plate 28 – View South-east Along Upper Berm. Note Break in Slope Angle and Cracking Along Break (Photograph Taken on 14 April 1998)

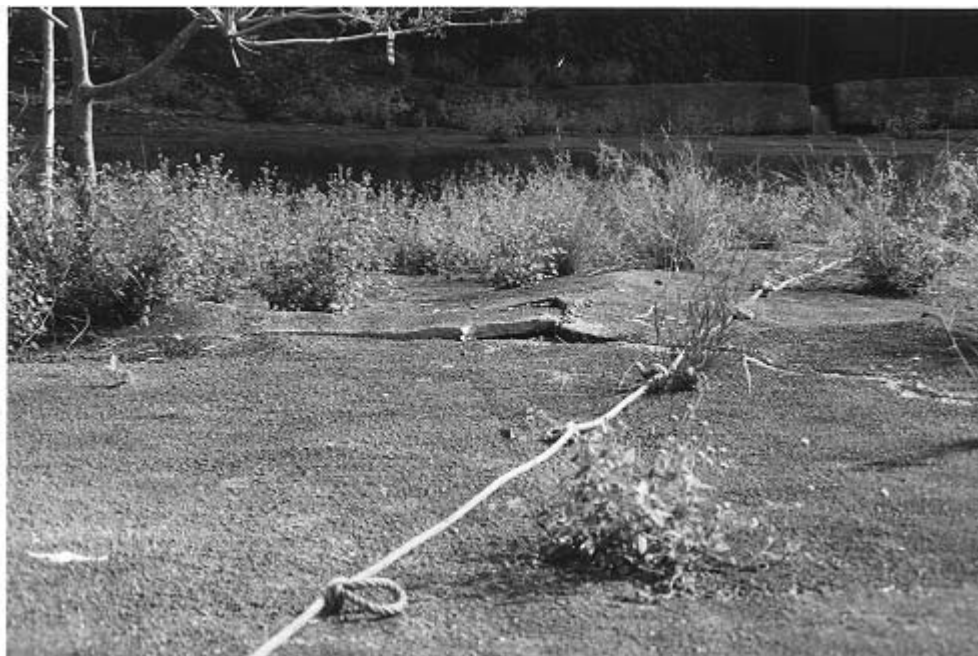
Plate 29 – View South-west Down Face of Upper Batter at Location of Bulging, South-eastern End of Feature (Photograph Taken on 5 May 1998)

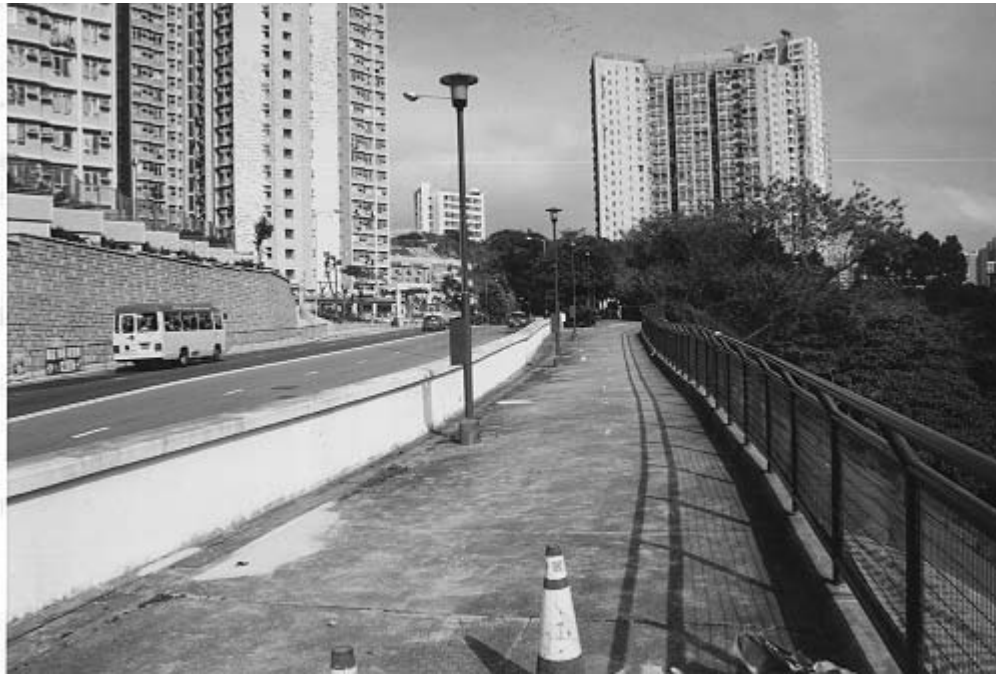
Plate 32 – View South-east Along Open Space Behind Crest. Note Distortion in Hand Railing and Concrete Parapet Wall. Repaired Location of Concrete Plinth Visible in Left Foreground. Repaired Road Pavement at Location of Leaking Main Visible Behind PLB in Left Middle Ground (Photograph Taken on 5 May 1998)

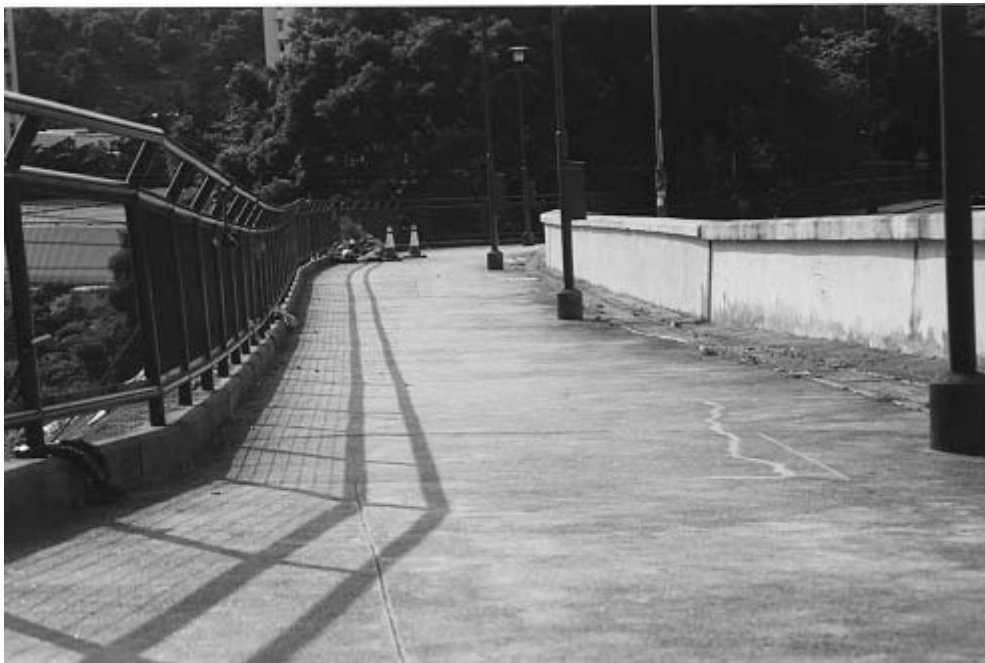
Plate 33 – View North-west Along USD "Open Space" Behind Crest. Note Distortion in Hand Railing and Concrete Parapet Wall. Note Also Repaired Cracking in Pavement in Right Foreground (Photograph Taken on 5 May 1998)

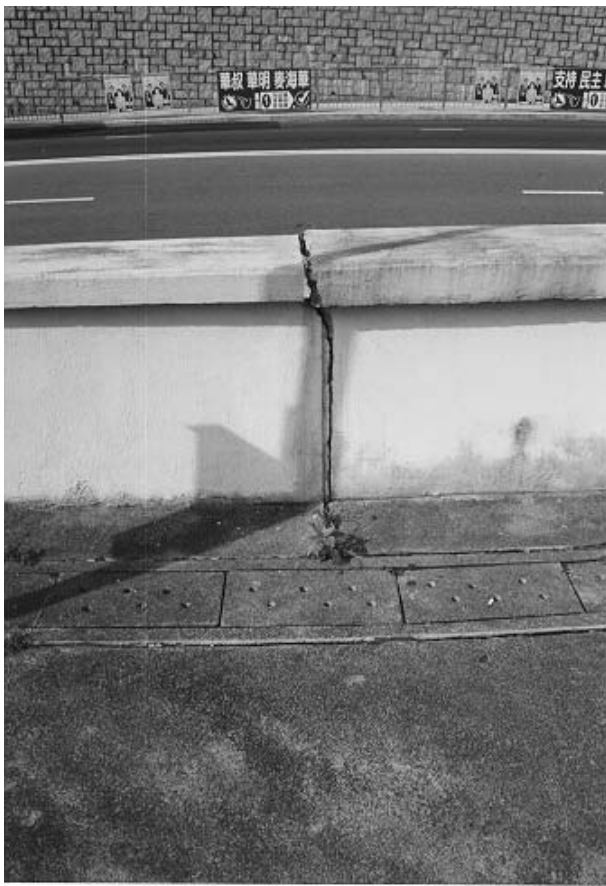
Plate 34 –  
Cracking at Construction Joint in  
Parapet Wall (Visible in Plate 33)  
(Photograph Taken on 5 May 1998)

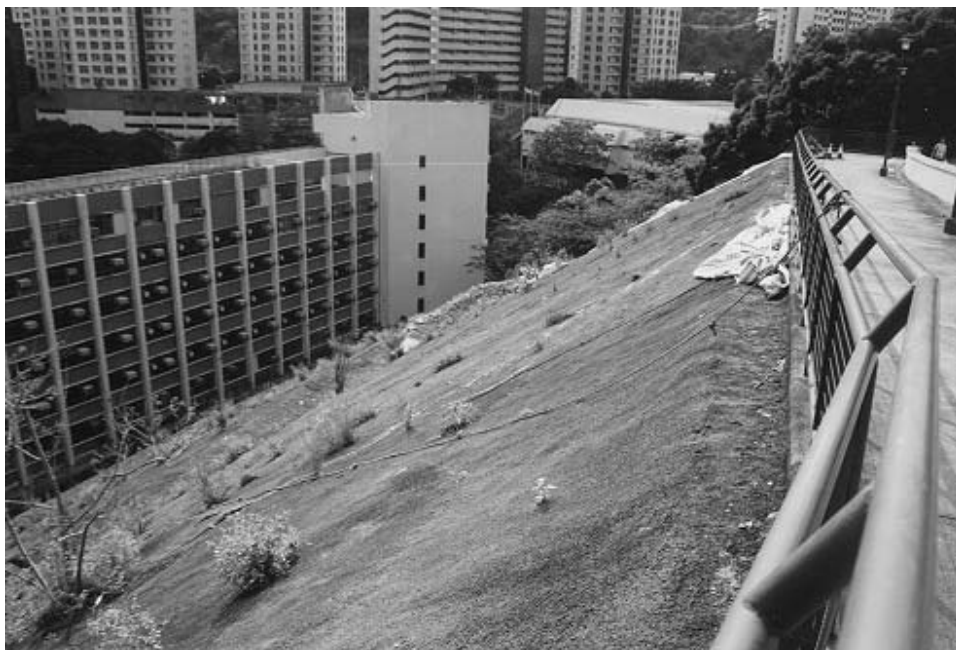
Plate 35 – View North-west Across Upper Batter. Note Cracking on Slope Face  
and Distortion in Hand Rail (Photograph Taken on 5 May 1998)

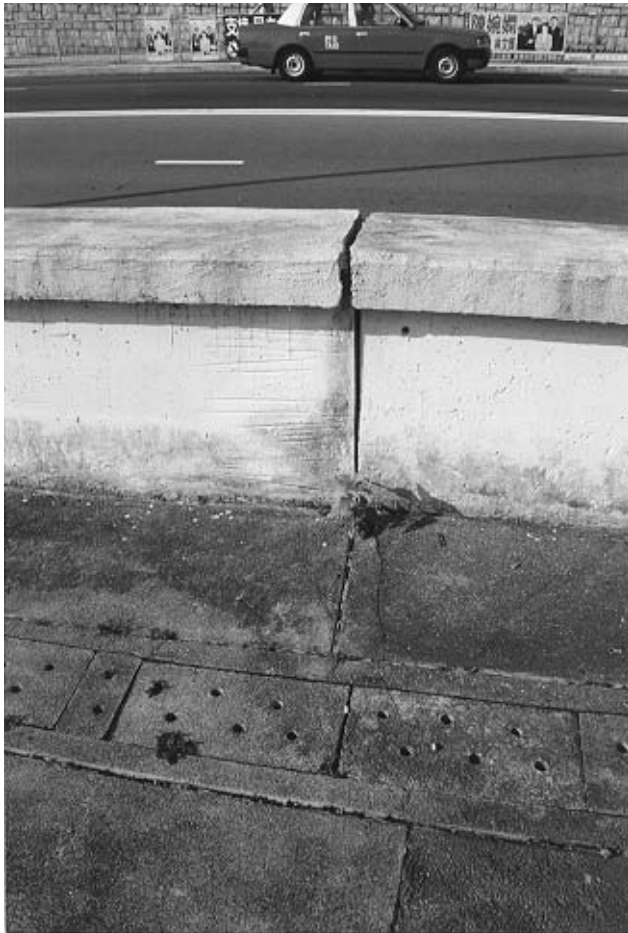
Plate 36 –  
Cracking at Construction Joint in  
Parapet Wall (Photograph Taken  
on 5 May 1998)

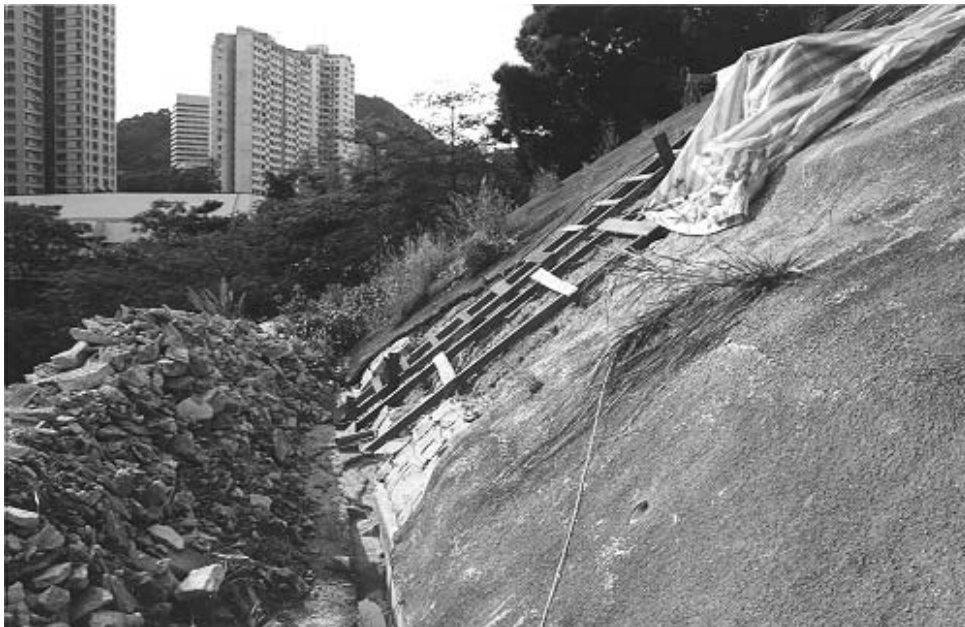
Plate 37 – View North-west Along Upper Batter Across Shotcrete Strip, North-western  
End of Feature. Note Stone Pitching Exposed and Cracking in Shotcrete  
Along Break in Slope. Note Also Convex Form of Stone Pitching and Void  
Between Shotcrete and Stone Pitching (Photograph Taken on 5 May 1998)

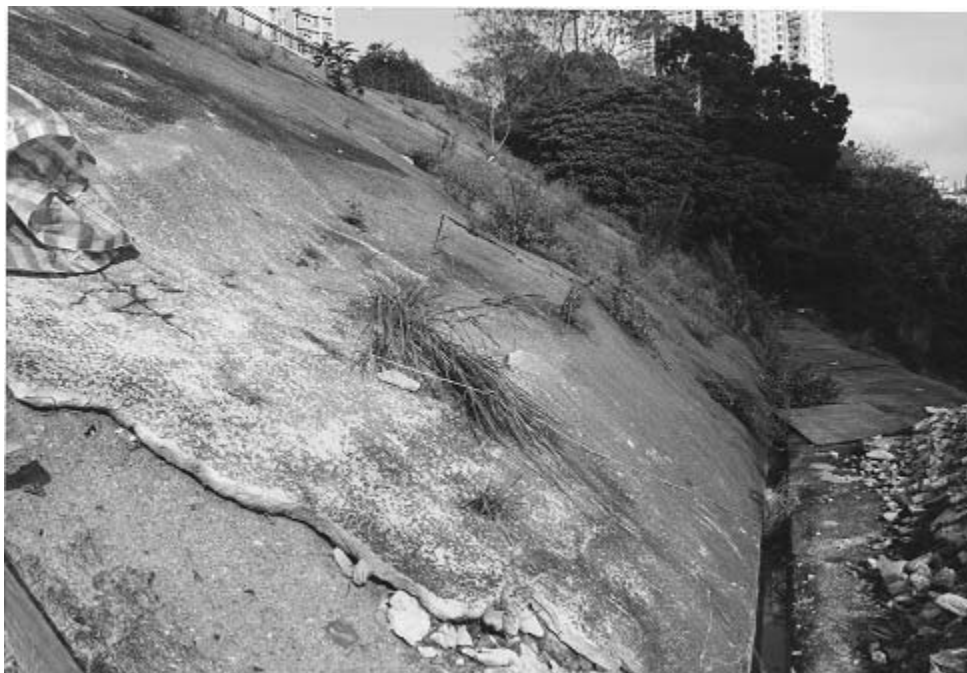
Plate 38 – View South-east Along Upper Berm. Shotcrete Strip Visible in Foreground. Note Break in Slope Angle and Uneven Form of Shotcrete. Note Also Shotcrete Directly Overlying Fill (Photograph Taken on 5 May 1998)

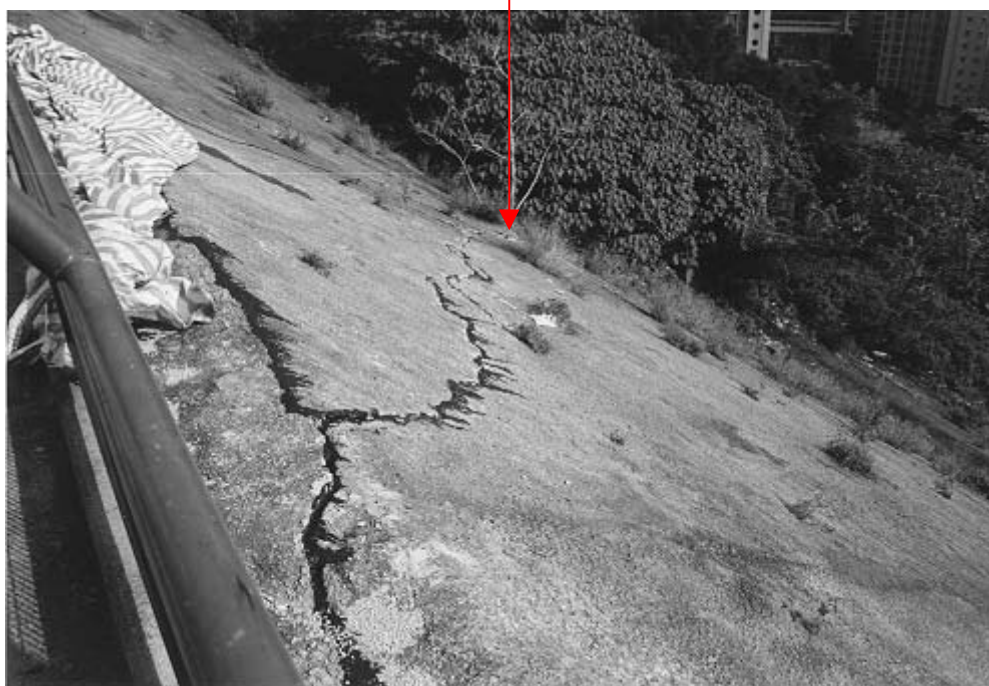
Plate 40 – View South Along Line of Cracking in Upper Batter at South-eastern End of Feature. Crack Has Been Filled. Zone of Bulging Visible in Distance (Photograph Taken on 5 May 1998)

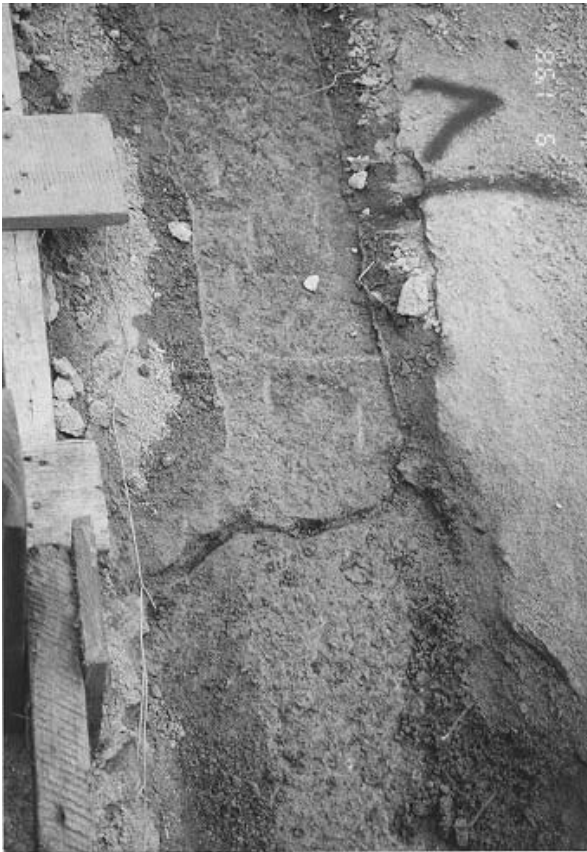
Plate 42 –  
Strip S1 Showing Cracking in  
Previous Hard Surfacing 7.5 m Down  
Face From Crest (Photograph Taken  
on 1 September 1998)

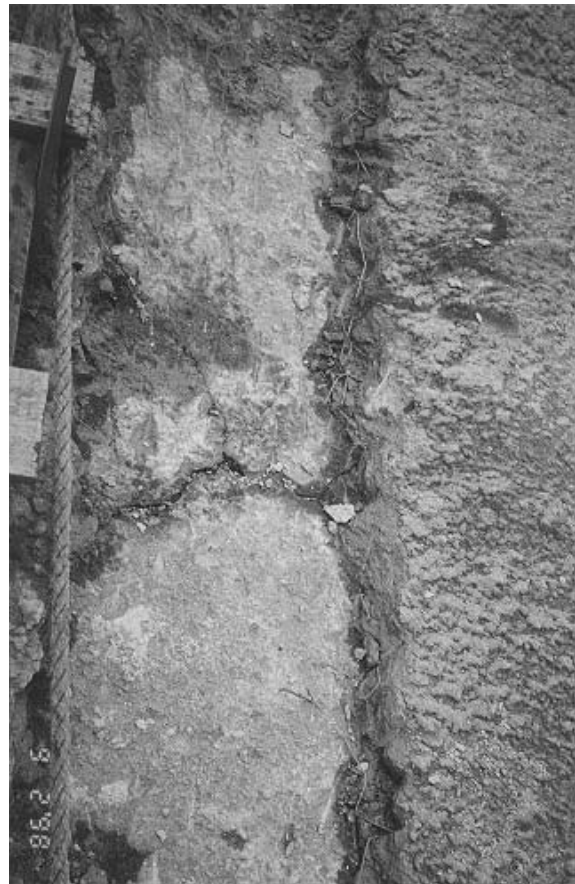
Plate 43 –  
Strip S1 Showing Cracking in  
Previous Hard Surfacing 2 m Down  
Face From Crest (Photograph Taken  
on 2 September 1998)

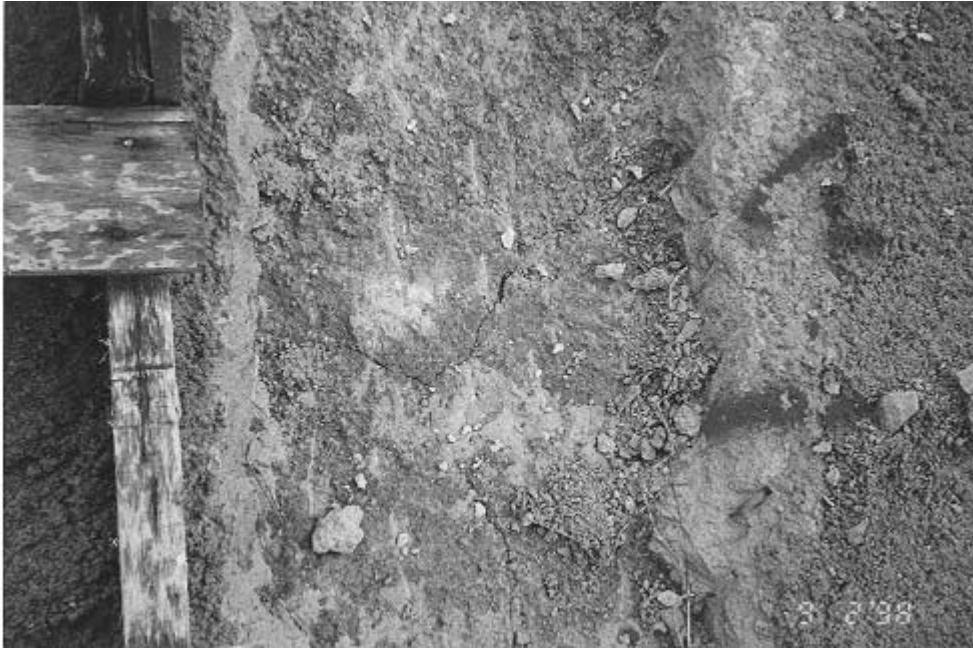
Plate 44 – Strip S1 Showing Cracking in Previous Hard Surfacing 4 m Down Face From Crest (Photograph Taken on 2 September 1998)

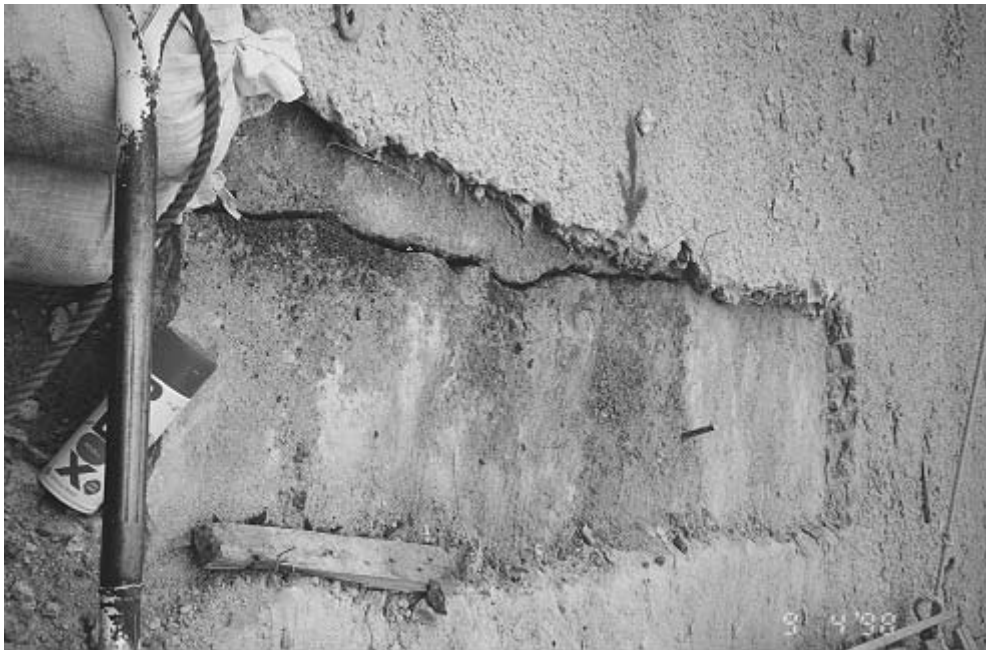
Plate 46 – Strip S1(A) Showing Crack Exposed in Horizontal Strip Extended Across Slope From Strip S1 7.5 m Below Crest (Photograph Taken on 4 September 1998)

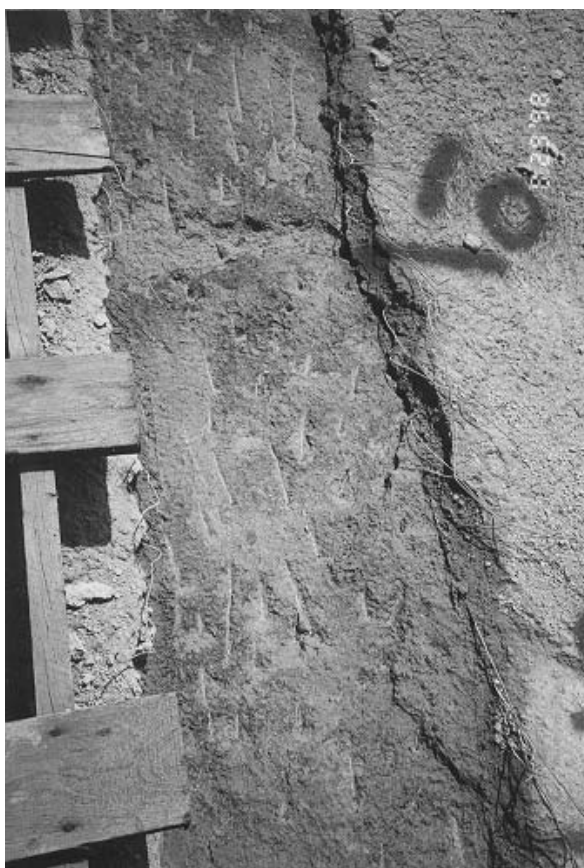
Plate 50 –  
Strip S2 Showing Crack in  
Previous Hard Surfacing 10 m  
Above Upper Berm (Photograph  
Taken on 29 August 1998)

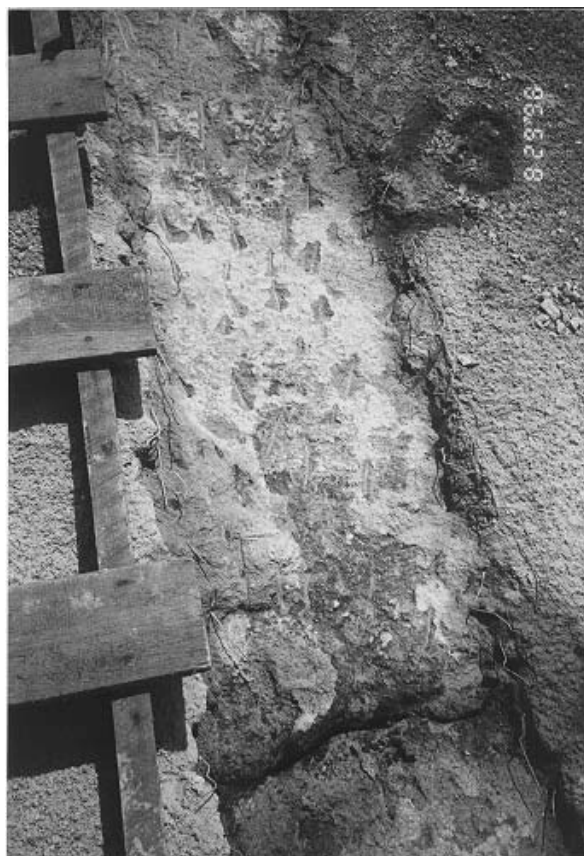
Plate 51 –  
Strip S2 Showing Crack in  
Previous Hard Surfacing 17 m  
Above Upper Berm (Photograph  
Taken on 29 August 1998)
