# **INVESTIGATION OF SOME SELECTED LANDSLIDES IN 1998 (VOLUME 2)**

**GEO REPORT No. 109**

**SECTION 1 :  
DETAILED STUDY OF THE  
DISTRESS OBSERVED IN  
SLOPE NO. 11NE-D/F10 BELOW  
HIU KWONG STREET,  
SAU MAU PING  
ON 9 APRIL 1998**

This report presents the findings of a detailed study of distress observed in fill slope No. 11NE-D/F10 located below Hiu Kwong Street, Sau Mau Ping, on 9 April 1998. The distress comprised cracking, displacement and bulging of the shotcrete cover to the upper batter of the slope, and was observed following the reporting of seepage from the toe of the slope.

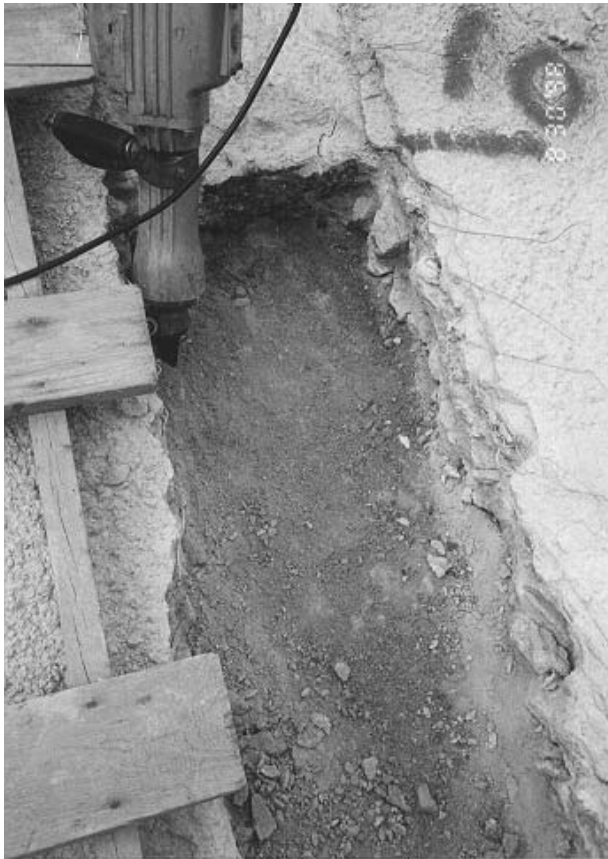
Plate 52 –  
Strip S2 Showing Fill Exposed Below  
Hard Surfacing 10 m Above Upper  
Berm. Note Numerous Layers of  
Hard Surfacing and Organic Deposit  
on Upper Face of Crack (Photograph  
Taken on 30 August 1998)

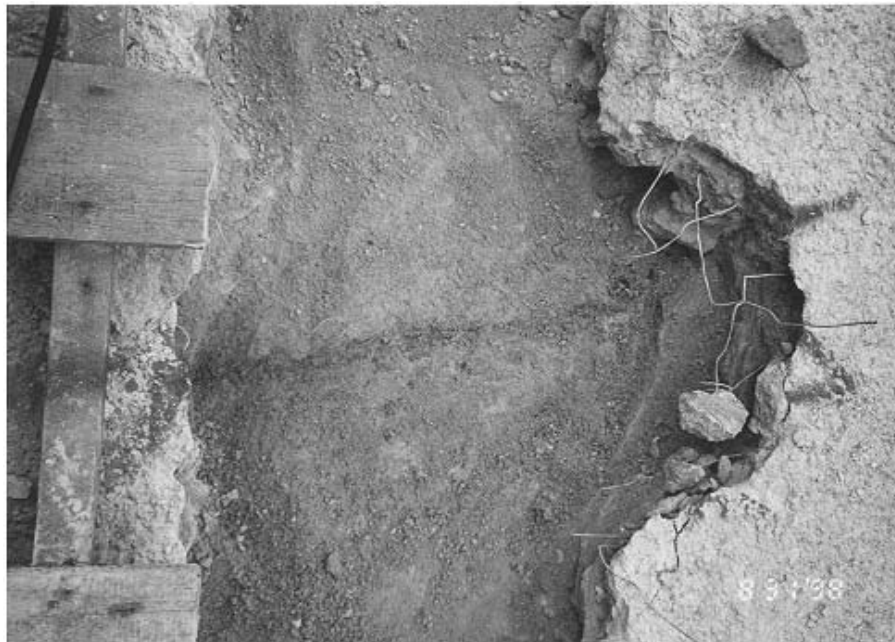
Plate 53 – Strip S2 Showing Fill Exposed Beneath Hard Surfacing, 17 m Above  
Upper Berm. Note Apparent Extension of Crack into Fill (Area  
Chased, But No Sign of Cracking in Fill Observed) (Photograph Taken  
on 31 August 1998)

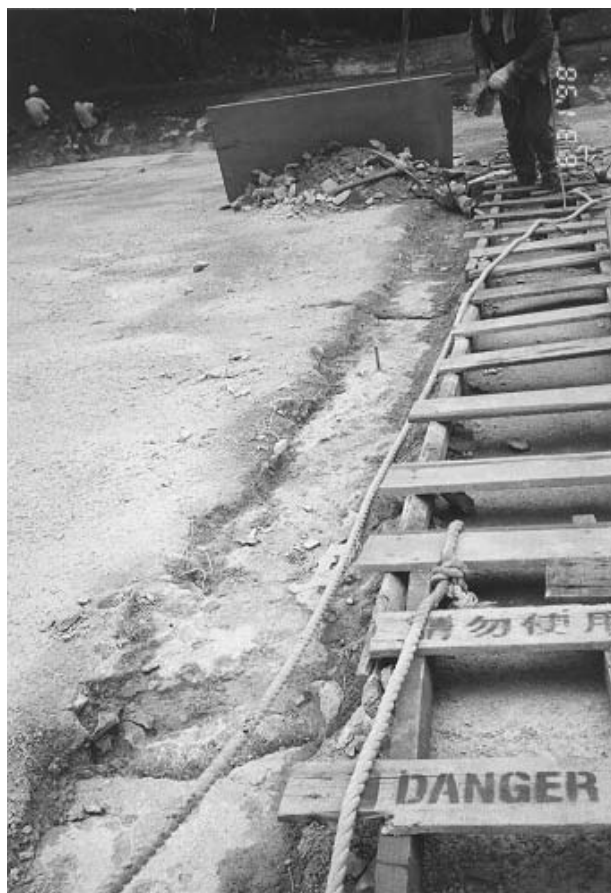
Plate 54 –  
Strip S3 Showing Cracking Exposed in  
Previous Hard Surfacing. Crack in  
Foreground Approximately 0.2 m  
Below Crest. Crack in Middle Ground  
Approximately 4 m Below Crest  
(Photograph Taken on 31 August 1998)

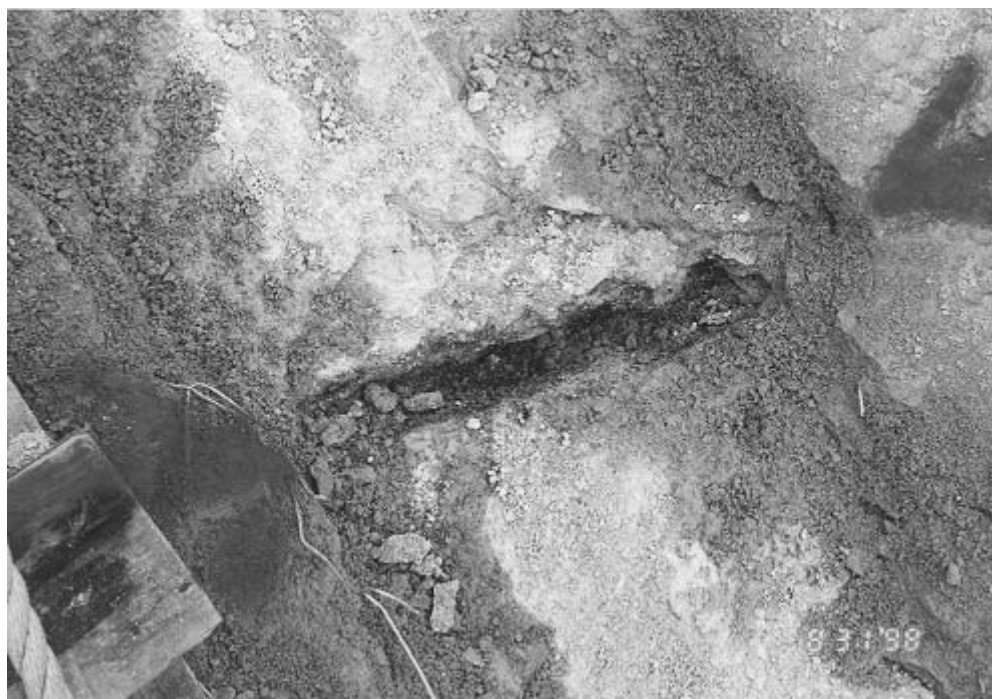
Plate 55 – Strip S3 Showing Cracking Exposed in Previous Hard Surfacing  
Approximately 4 m Below Crest. Note Darker Organic Fill in  
Middle Ground (Photograph Taken on 31 August 1998)

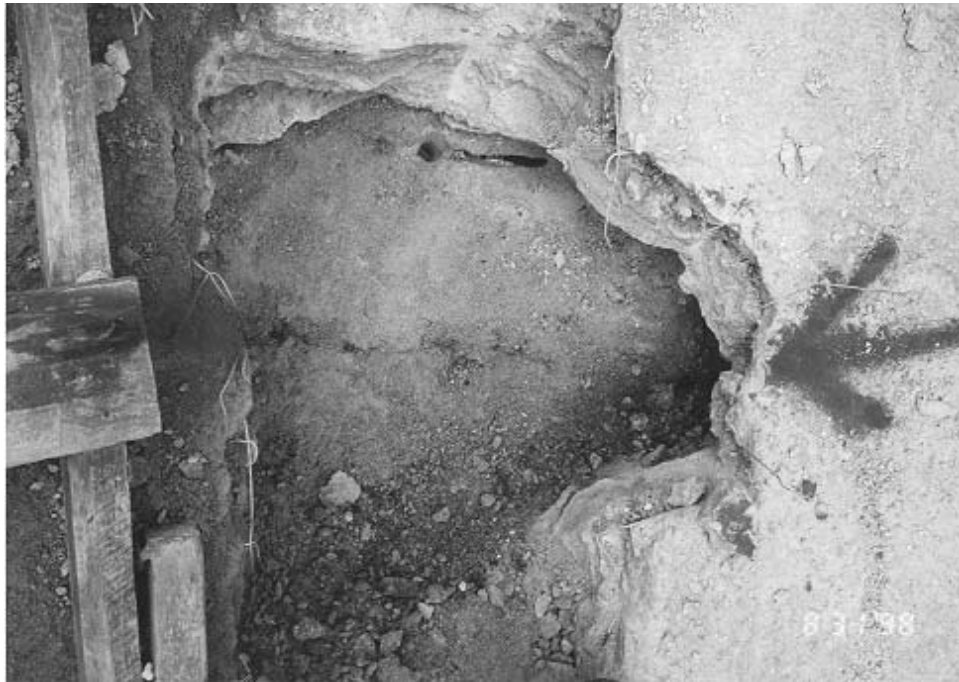
Plate 56 – Strip S3 Showing Fill Exposed Behind Hard Surfacing at Crack Location. Note Staining of Fill Along Line of Crack in Hard Surfacing. Note Void Beneath Surfacing on Right Hand Side. Slot at Top of Exposure is Crack Infill (Photograph Taken on 31 August 1998)

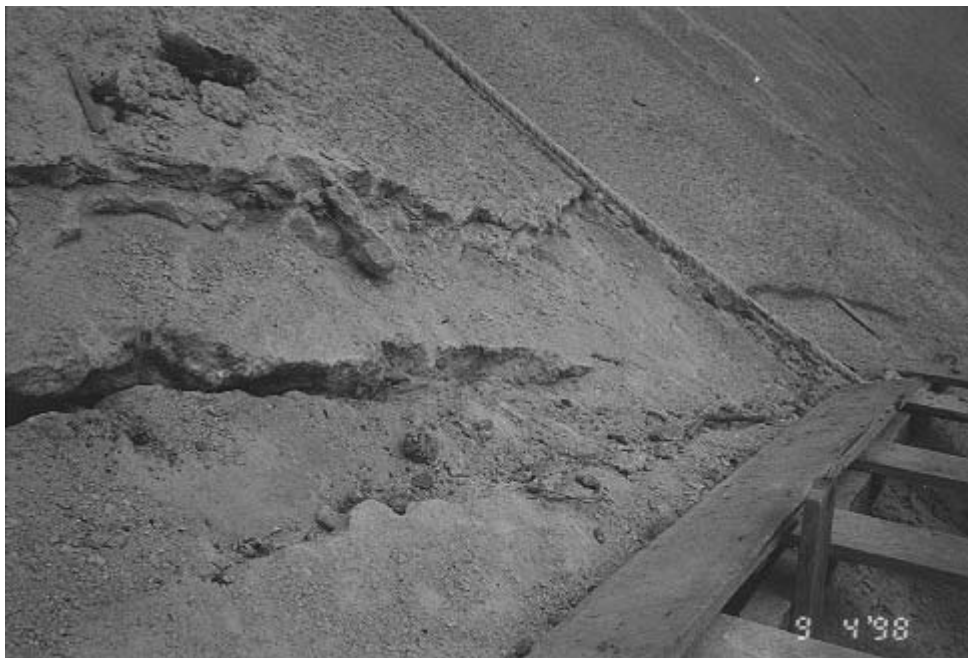
Plate 57 – Strip S3(A) Showing Cracking in Previous Hard Surfacing and Voiding Beneath Exposed Below 1998 Application of Shotcrete, Approximately 4 m Below Crest (Photograph Taken on 4 September 1998)

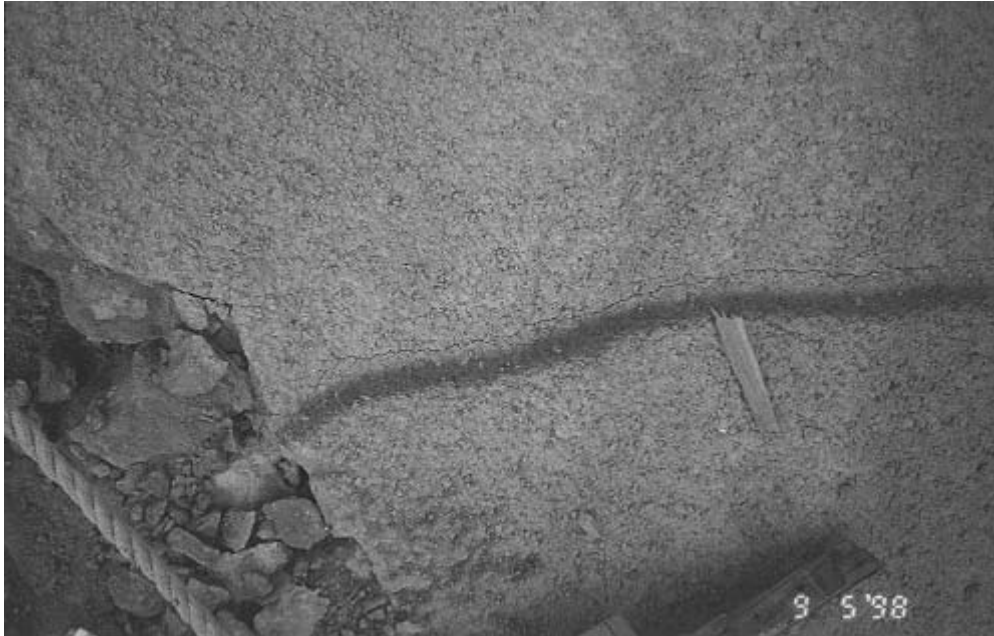
Plate 58 – Strip S3(A) Showing Cracking in 1998 Application of Shotcrete Beyond Extent of Strip (Photograph Taken on 5 September 1998)

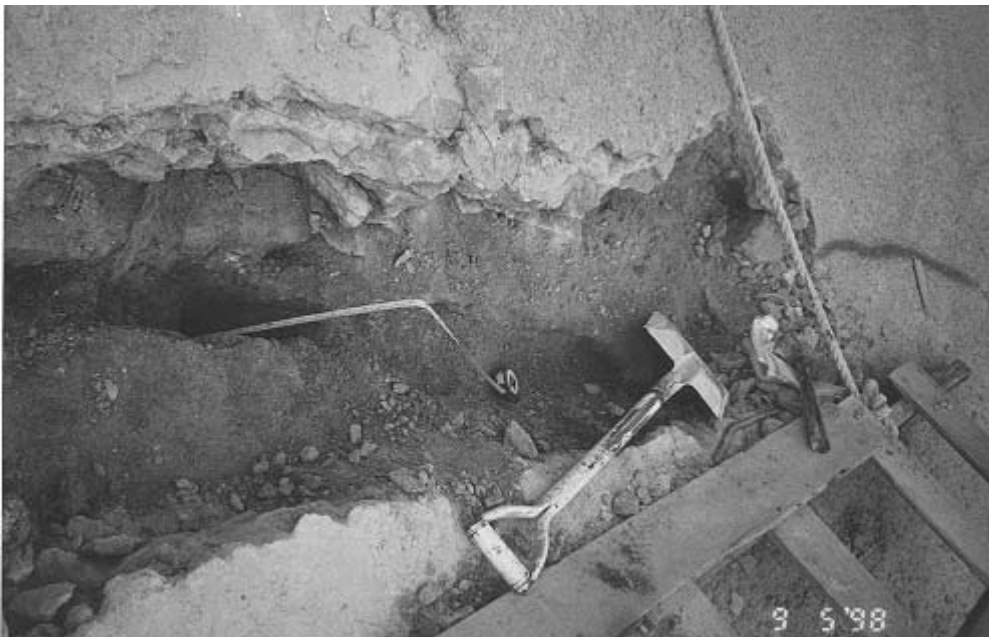
Plate 59 – Strip S3(A) Showing Voiding in Fill Exposed Beneath Hard Surfacing. Crack Width Approximately 100 mm Throughout, Soft Infill Between Voids (Note Multiple Layers of Hard Surfacing) (Photograph Taken on 5 September 1998)

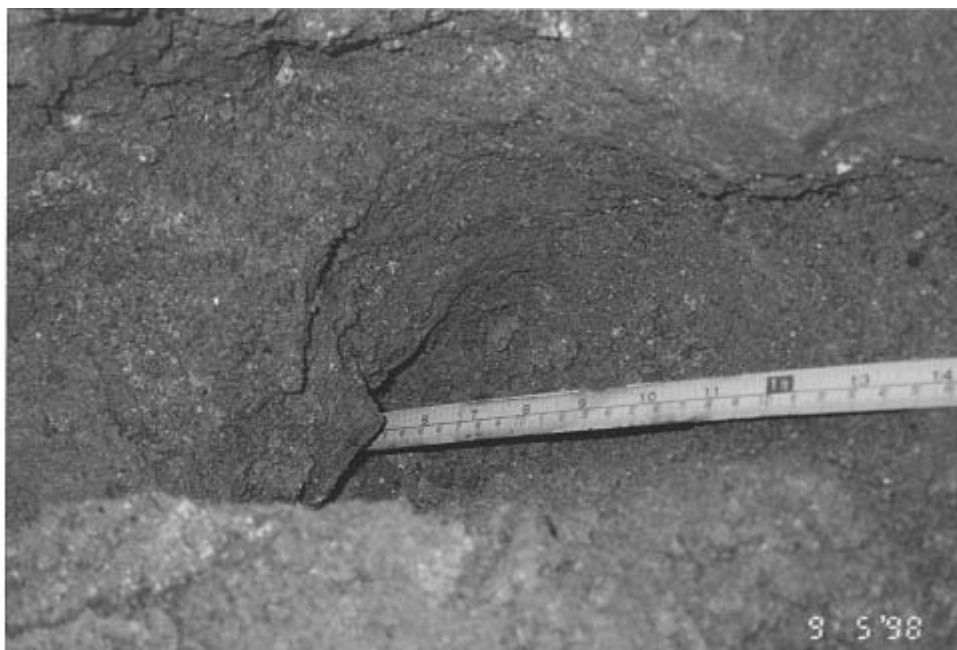
Plate 60 – Strip S3(A) Showing Close-Up of Void. Tape Measure Reads Approximately 300 mm (Photograph Taken on 5 September 1998)

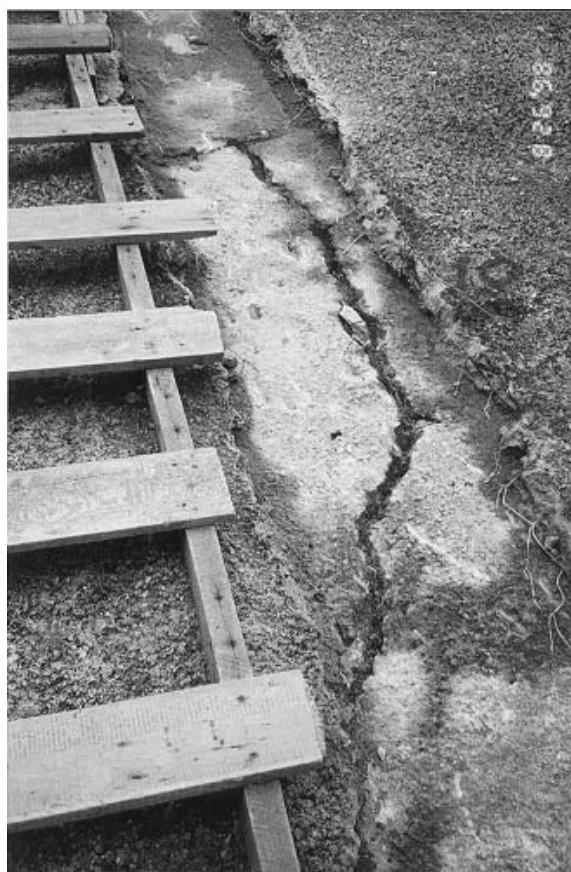
Plate 63 –  
Strip S4 (Middle Batter) Showing  
Cracking in Previous Hard Surfacing  
Below 1995 Application of Shotcrete  
Approximately 16 m Above Lower  
Berm. Note Organic Infill and Rootlets  
(Photograph Taken on 26 August 1998)

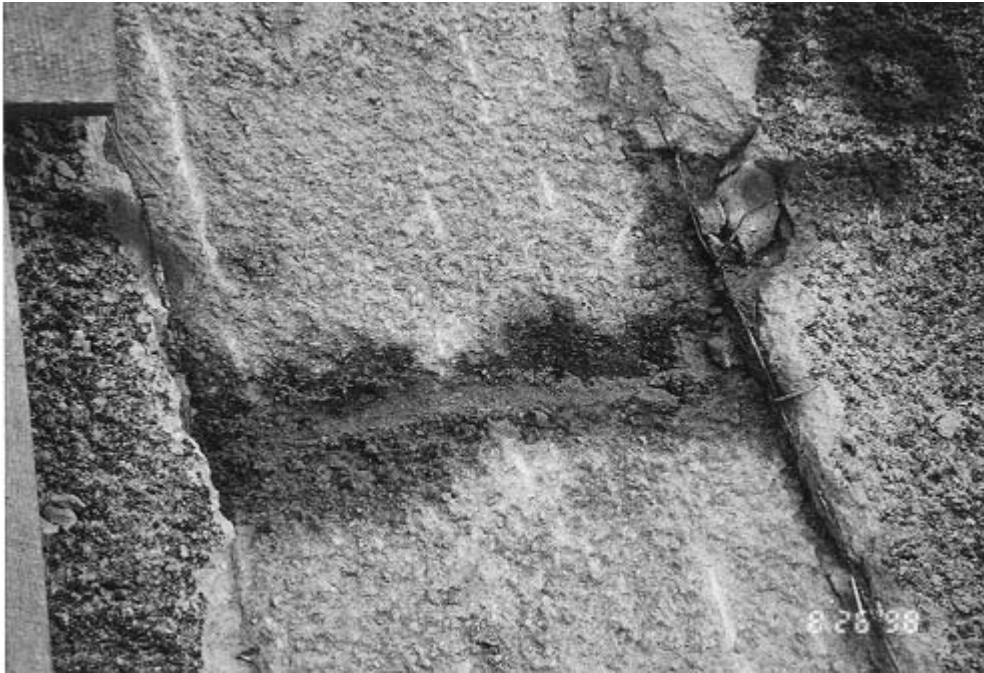
Plate 64 – Strip S4 (Middle Batter) Showing Cracking in Previous Hard Surfacing Approximately 16 m Above Lower Berm. Note Organic Fill and Rootlets (Photograph Taken on 26 August 1998)
