**SECTION 2 :
DETAILED STUDY OF THE
LANDSLIDE BELOW
AU TAU VILLAGE ROAD,
TSEUNG KWAN O
ON 9 JUNE 1998**

Fugro Scott Wilson Joint Venture

**This report was originally produced in October 1999
as GEO Landslide Study Report No. LSR 6/99**

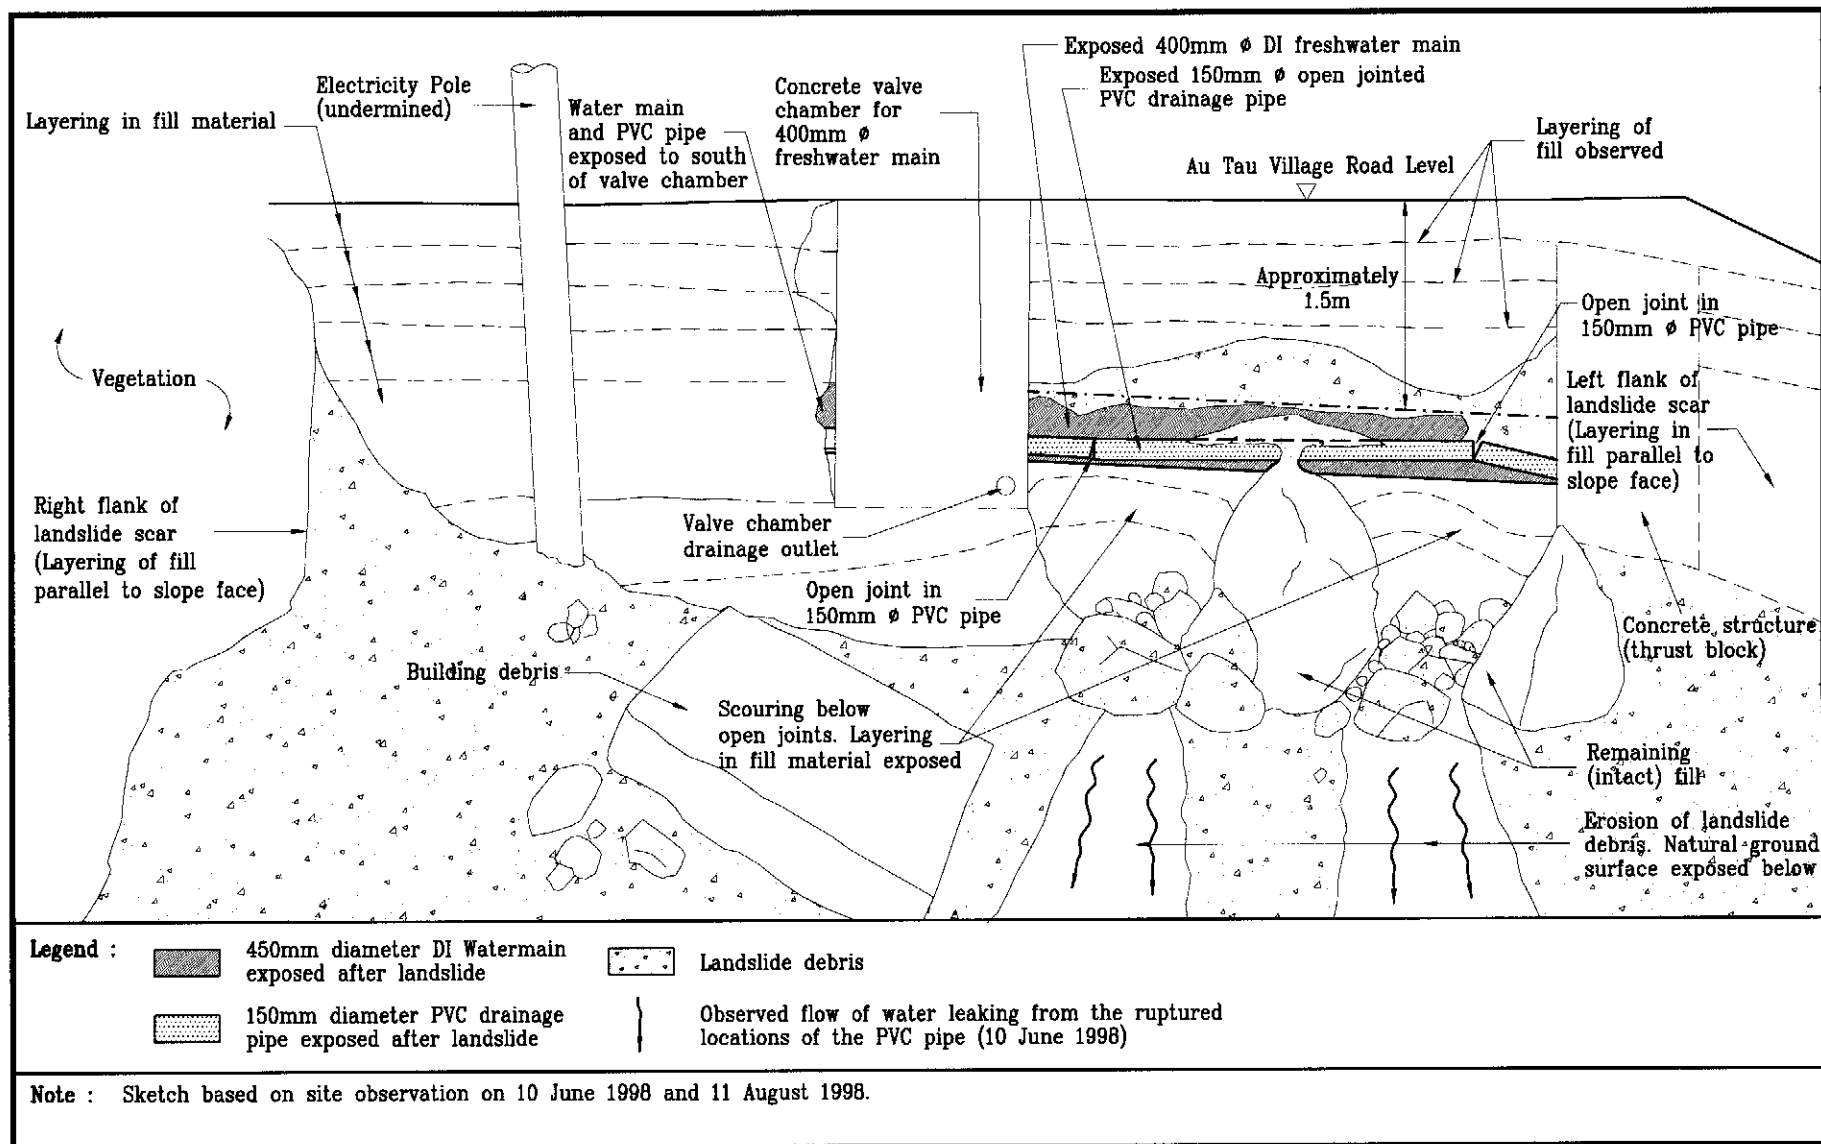
Figure 7 - Local Arrangement of Services Exposed in the Main Scarp

exposed in the main scarp comprised an intact 400 mm diameter ductile iron water main extending north from a concrete valve chamber and a 150 mm diameter PVC pipe aligned parallel and close to the water main which also extended north from the valve chamber. No leakage from the 400 mm water main was observed. A concrete thrust block was exposed in the scarp approximately 3 m north of the valve chamber, through which both pipelines passed (Figure 7).

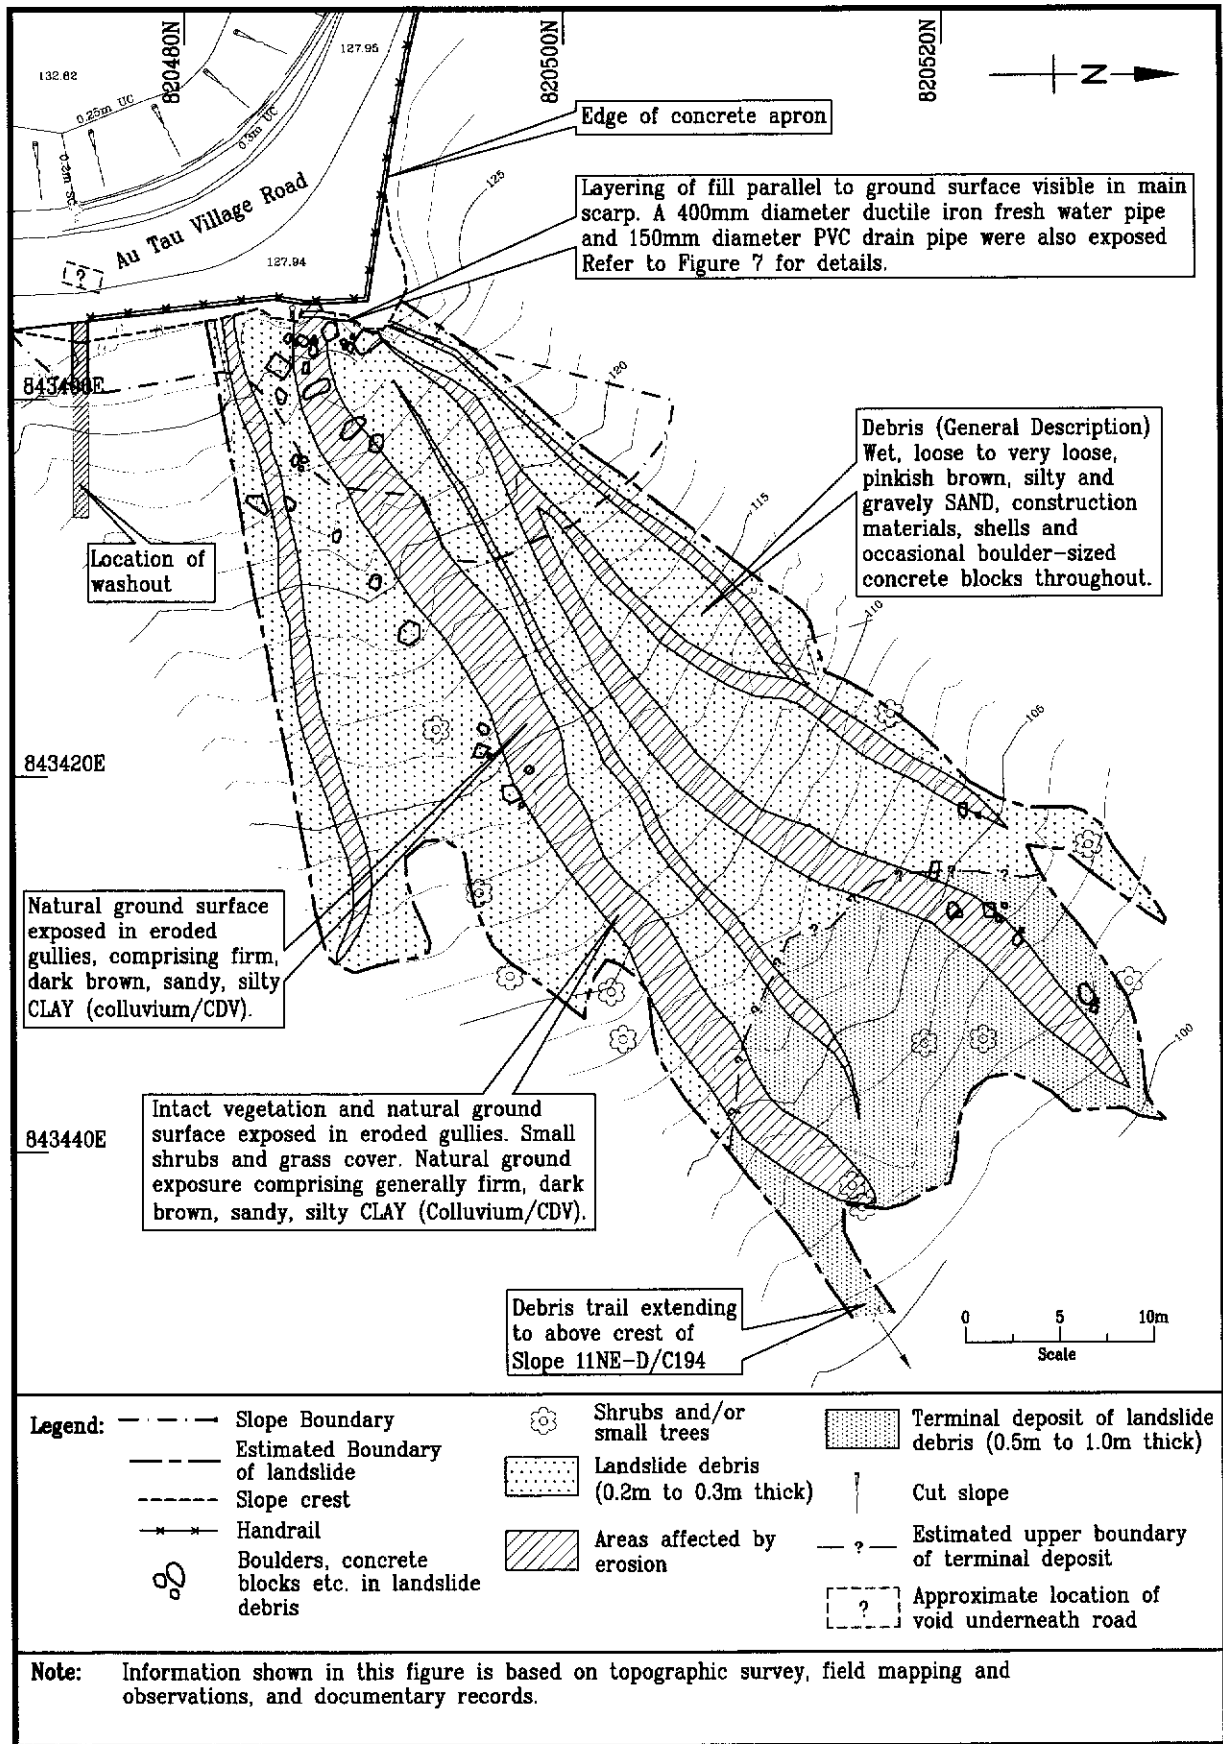
Figure 9 - Mapping of the Landslide Scar

The CCTV survey found that the PVC pipe extended upstream to the south by approximately 8 m beyond the extent of the WSD diversion trench and remained beneath the road and within the WSD pipeline trench. Open butt joints between lengths of pipes (as exposed in the main scarp) and major deformation of the pipe were observed. The pipe terminated at a large void underneath the road surrounding the water main. At this point, the survey could not proceed further due to the oblique entry of the pipe into the void preventing further advance. However, it could be seen that the void was of a similar size to the trench excavation (about 1 m wide) for the original 400 mm water main installation (i.e. the granular surround to pipeline was apparently lost). The length of the void could not be determined. The floor of the void appeared to consist of a silty deposit, consistent with a sediment deposited following passage of water. The approximate location of the void is shown in Figure 9.

It is noted that the location of the void is adjacent to the narrow failure scar described earlier (Figure 9), although no direct link between these features can be established. It is not certain how the void was formed. Other significant unknowns are the purpose of the PVC pipe and the source of the water observed flowing from the pipe in the landslide scar.

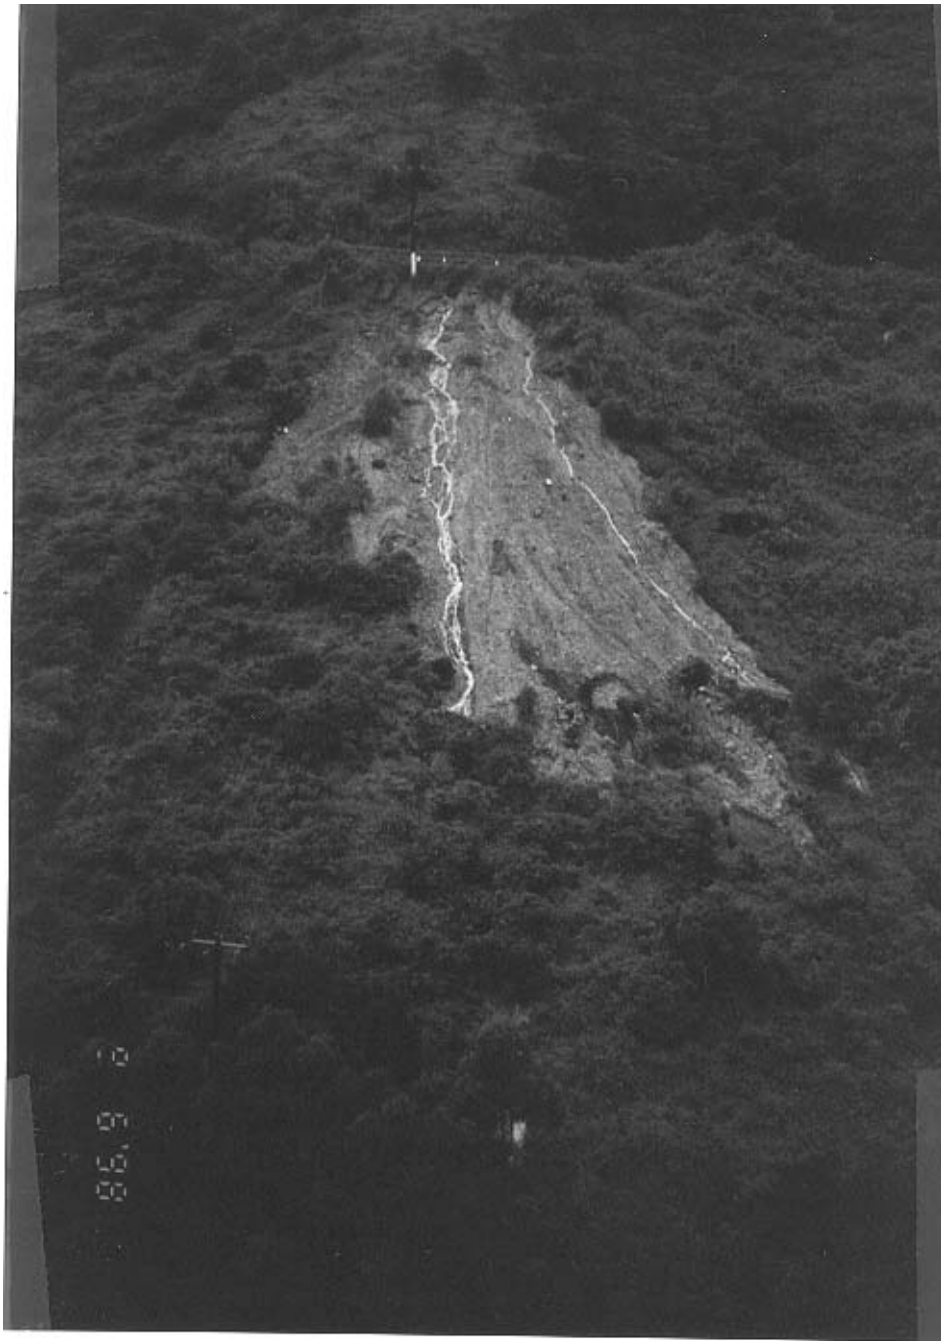
- (c) Heavy scouring had occurred beneath the pipelines at the locations of the gaps in the PVC pipe. The locations of the gaps are consistent with the main flow of water observed to be issuing from the scarp in Plate 3.

Plate 3 – View West from Choi Lam House, Tsui Lam Estate, Indicating Landslide Scar and Debris Runout. Note Heavy Flow of Water From Two Sources in Main Scarp. Poor Quality of Image Noted. (Photograph Taken Around 17:30 Hours on 9 June 1998)

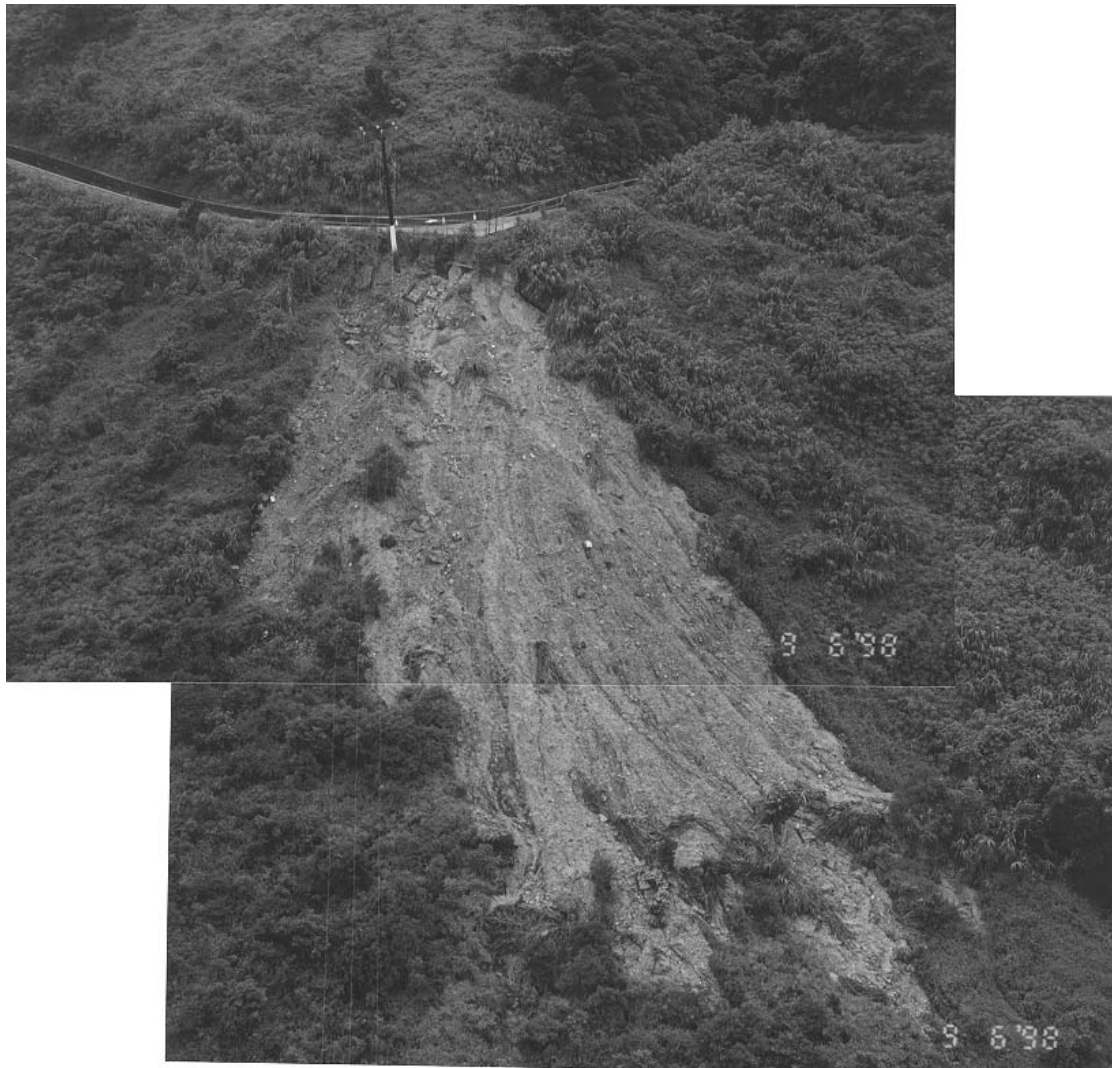
Plate 4 – View West from Choi Lam House, Tsui Lam Estate, Indicating Landslide Scar and Debris Runout. Note Pipework Exposed in Main Scarp. Note Also Apparent Fluid Appearance of Debris Deposition and Secondary Gully Erosion through Debris. (Photograph Taken on Morning of 10 June 1998)

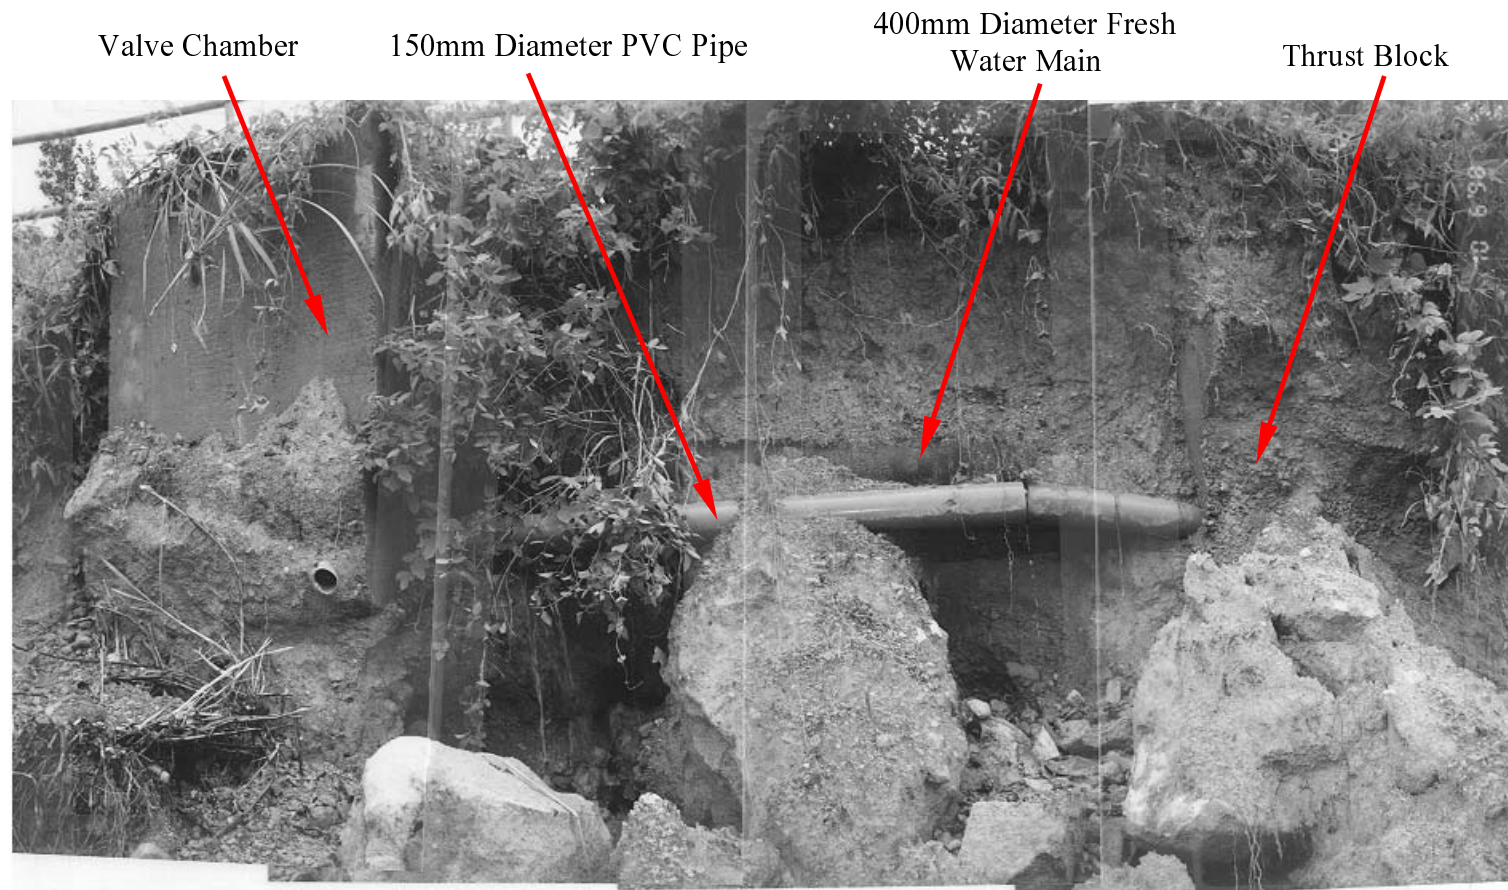
- (b) The PVC pipe, where exposed, comprised a series of 2 m to 3 m long sections placed end to end (i.e. no joints) from which water was continuing to flow at the gaps between individual sections of the pipe (Plate 7). The heaviest flow was occurring from the gap nearest the valve chamber, with the through-flow at this location causing leakage at the next gap to the north.

Plate 7 – View of Pipework Exposed in Main Scarp of Landslide Indicating Valve Chamber on Left of Frame, 400 mm Diameter Water Main and 150 mm Diameter PVC Pipe in Centre of Frame and Mass Concrete Structure on Right of Frame. Note Open Butt Joints in PVC Pipe (Water Still Flowing From Pipe) and Heavy Gully Erosion in Scarp Below. (Photograph Taken on 10 June 1998)

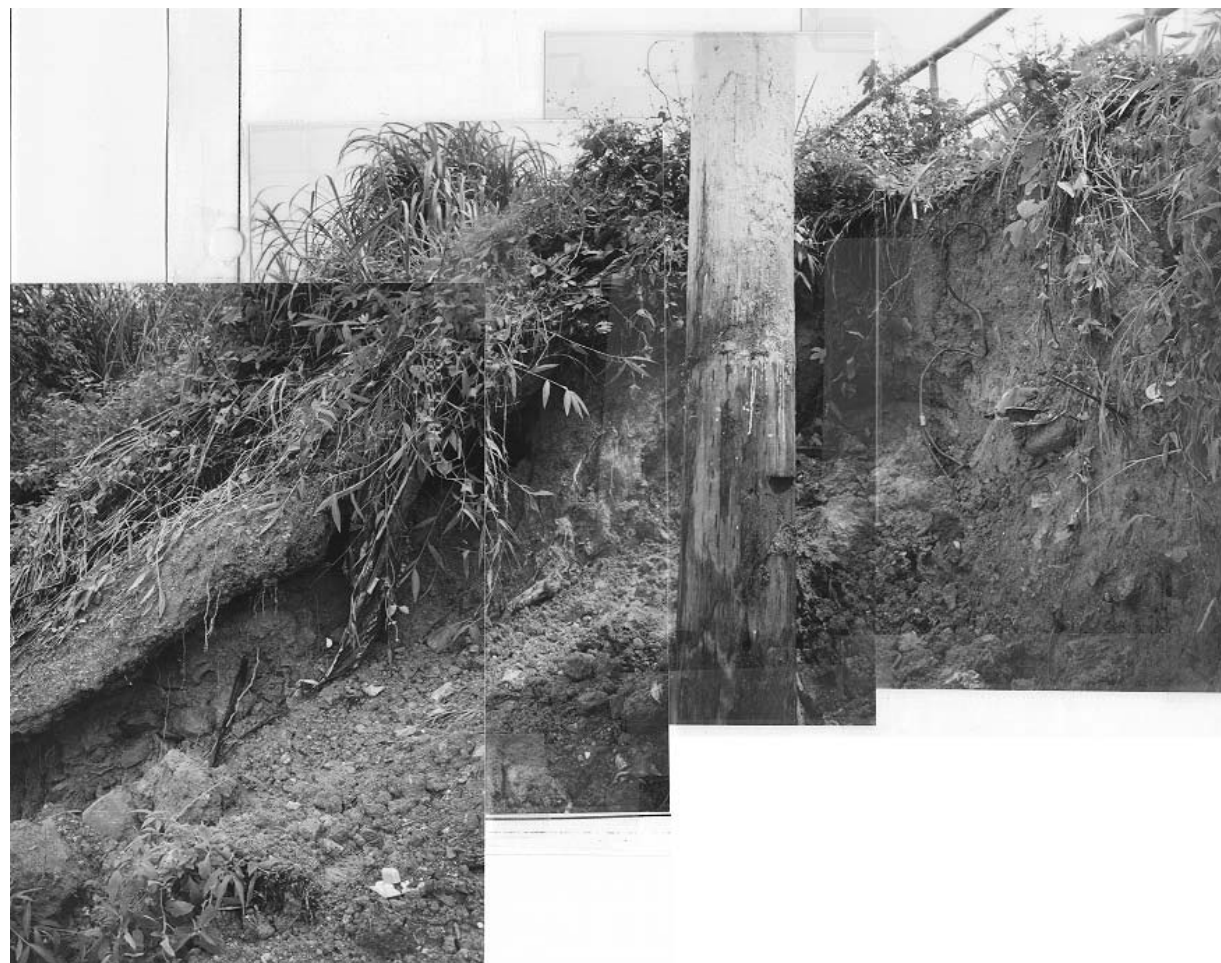
Plate 8 – View of Southern Flank of Landslide Near Main Scarp Indicating Loose Nature of Fill Material and Layering Parallel to Slope Face. (Photograph Taken on 10 June 1998)

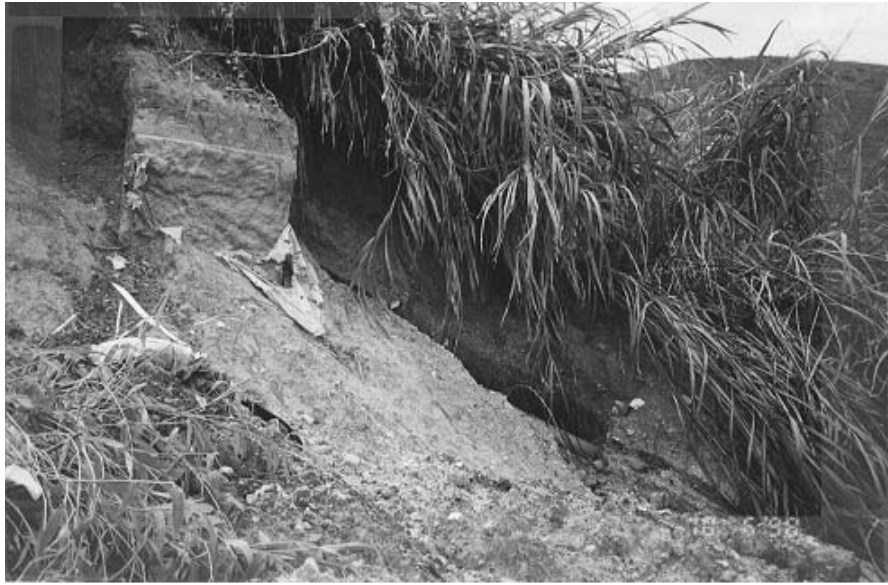
- (d) The pipelines described in (a) above were also exposed in the northern flank of the landslide scar (Plate 9), extending downslope at less than approximately 1 m below the slope face. The 400 mm water main was intact and the PVC pipe was observed to be broken in the exposure at a location which appears to be consistent with a source of water flow in Plate 3.

Plate 9 – View of Exposed Pipework on Northern Flank of Landslide Scar. 400 mm Diameter Water Main and 150 mm Diameter PVC Pipes Visible. Broken Section of PVC Pipe Leaking Water Obscured. (Photograph Taken on 10 June 1998)

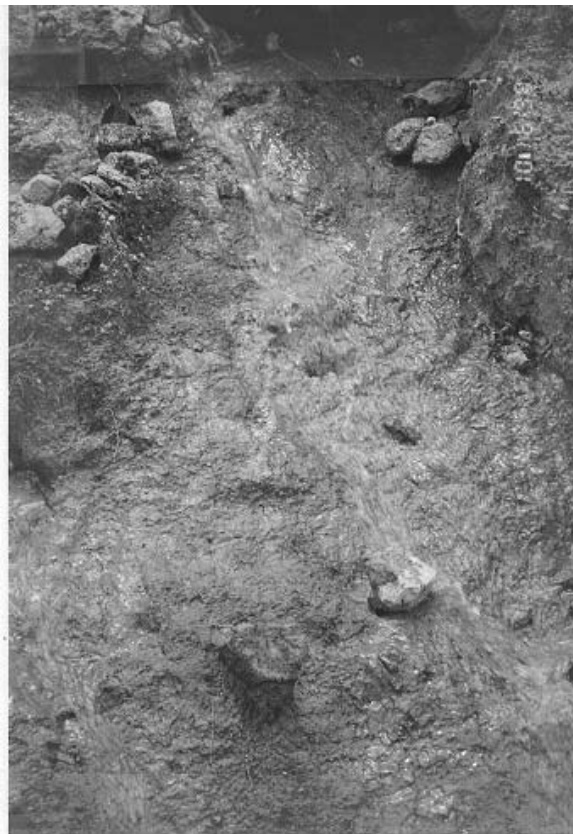
Plate 10 – Close-Up of Exposed Insitu Material in Landslide Scar. Note Water (From PVC Pipe - Plate 7) Flowing Across Exposure. (Photograph Taken on 10 June 1998)

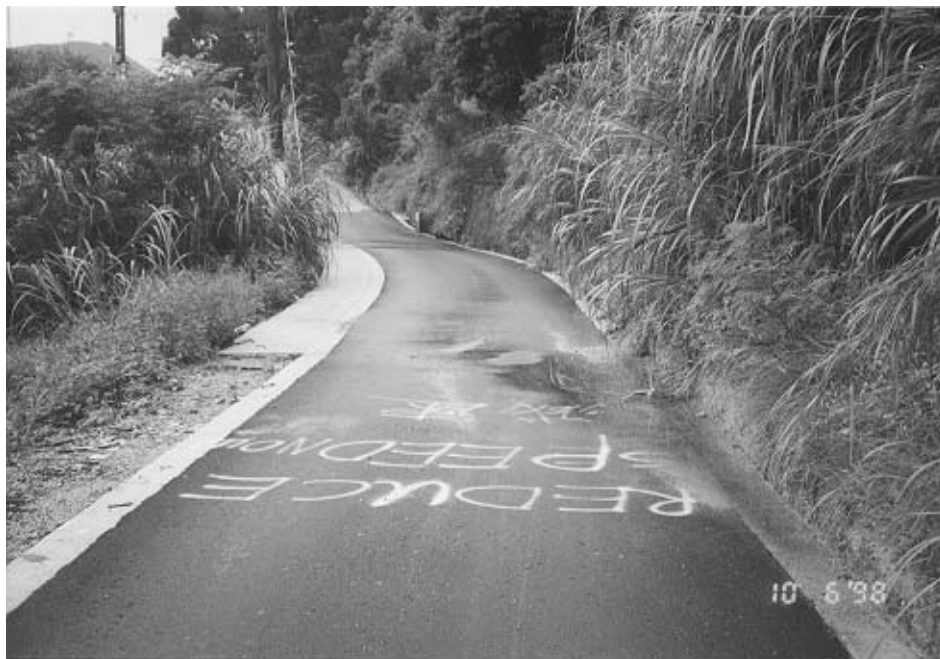
Plate 16 – View South Along Au Tau Village Road From Above Main Scarp. Note Poned Water on Right of Frame. (Photograph Taken on 10 June 1998)

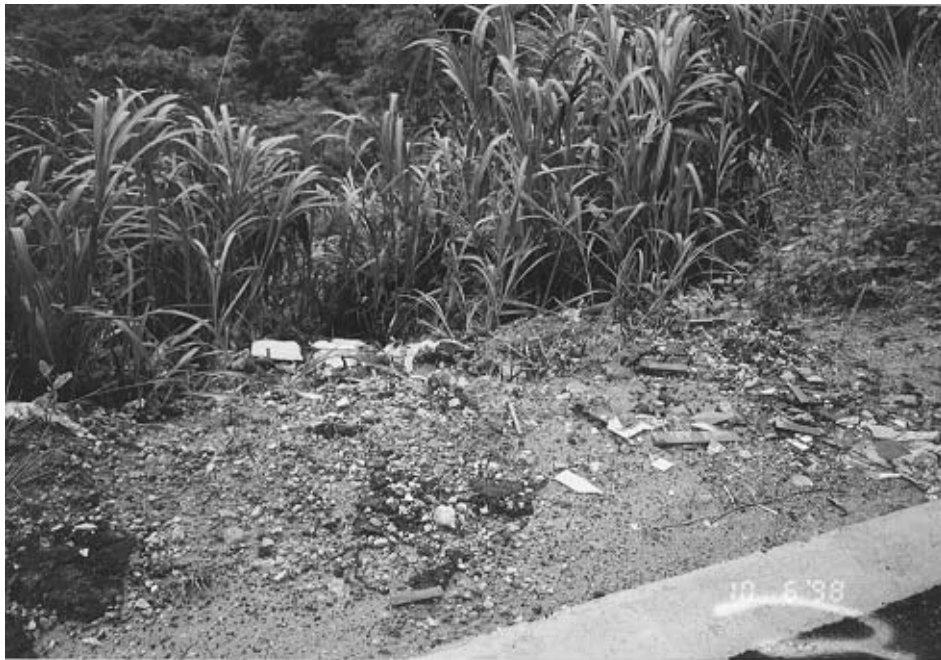
Plate 17 – View East Over Crest of Fill Slope to South of Landslide Scar. Warning Lettering on Pavement (Refer Plate 16) Visible in Lower Right of Frame. Note Appearance of Recent Overland Flow on Soft Verge. (Photograph Taken on 10 June 1998)

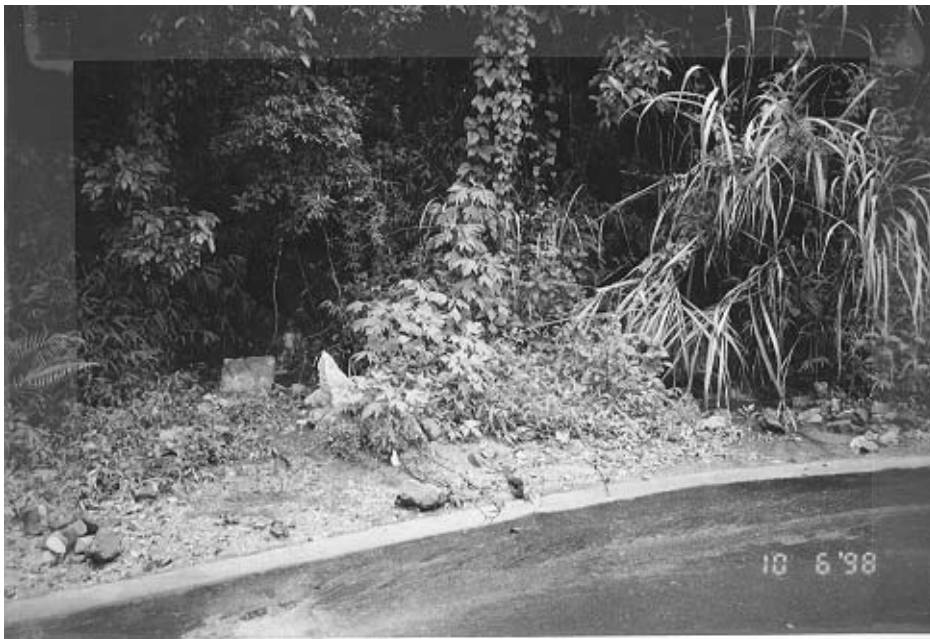
Plate 20 – Over-Flow From “Soak-aways” Located on West Side of Au Tau Village Road at Stream Course “A”. (Photograph Taken on 10 June 1998)

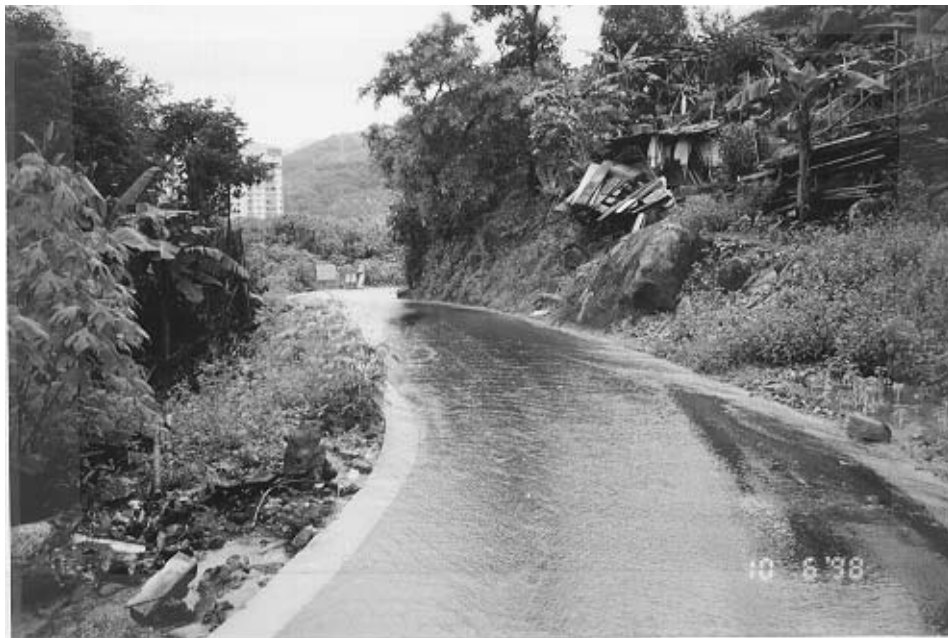
Plate 22 – View South-East Along Au Tau Village Road From Intersection of Road and Stream Course “B”. Note Substantial Overland Flow Along Road. (Photograph Taken on 10 June 1998)

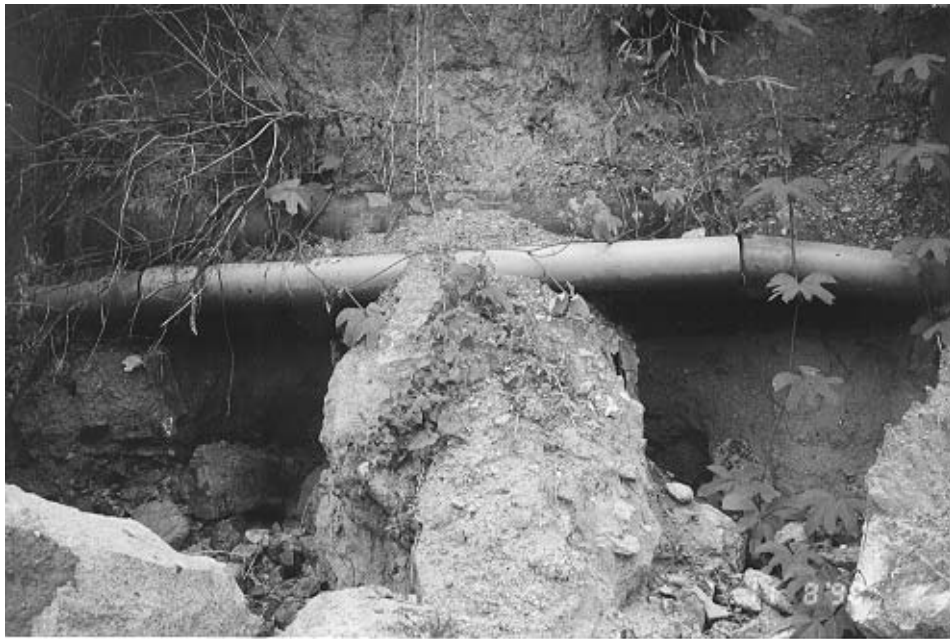
Plate 23 – View of Pipework Exposed in Main Scarp. Note Open Butt-Jointed Placement of 150 mm Diameter PVC Pipe (Refer Plate 7). (Photograph Taken on August 1998)

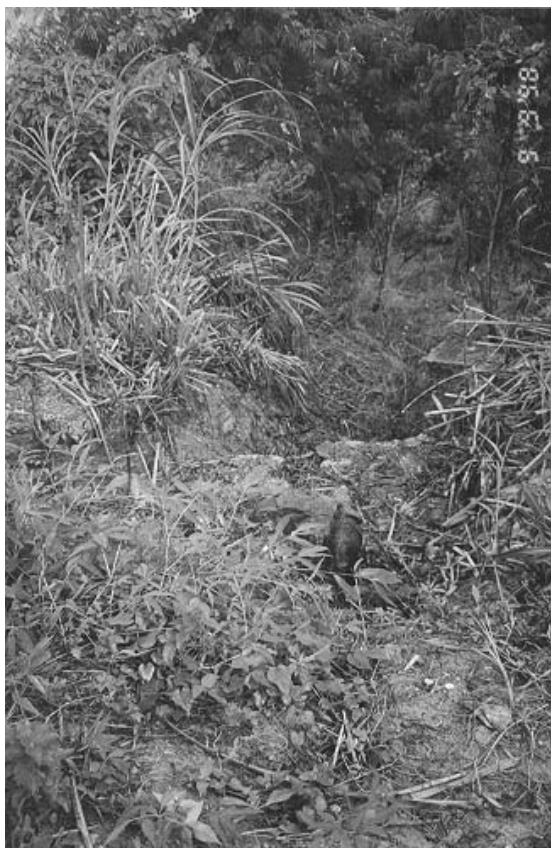
Plate 25 – View East Down Cleared Section of Slope to South of Landslide Scar (refer Plate 17) Exposing Narrow Washout. Note Vegetation Cover Suggests Washout is a Historic Feature. Note Also Concrete Slab and Tree with Broken Limb as Reference for Plate 26. (Photograph Taken on 9 September 1998)

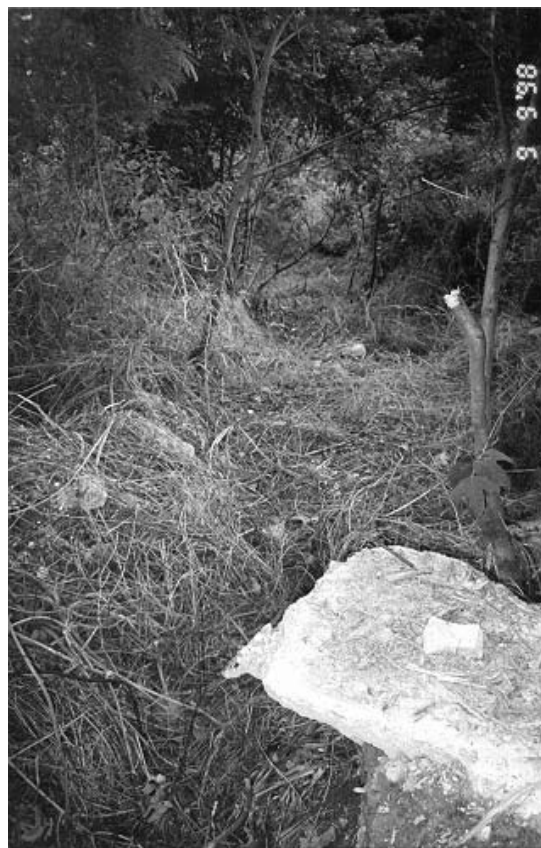
Plate 26 – View East Down Cleared Section of Slope Exposing Narrow Washout (Refer Plate 25). Note Vegetation Growth in Gully Erosion, Suggesting Historic Feature. (Photograph Taken on 9 September 1998)

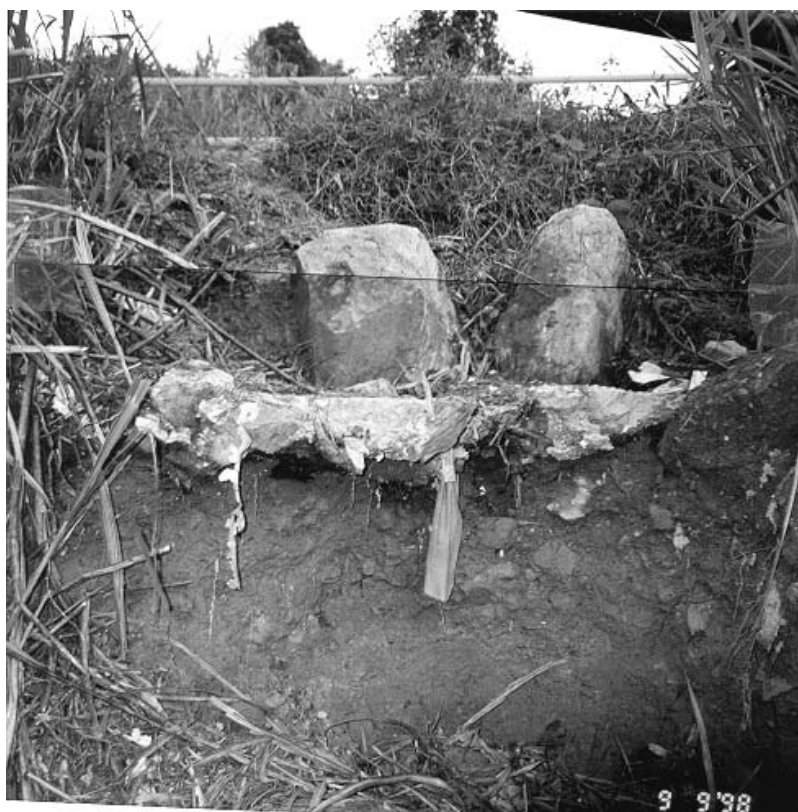
FSW organised site clearance work in early September 1998 to permit survey works and investigation of certain portions of the landslide site to be undertaken. During these works, the upper portion of the slope formation resulting from the water main installation in 1991-1993 (Sections 3.2 and 3.3) was observed north of the apron. Also of interest was a narrow failure scar located around 10 m south of the south flank of the landslide (Plates 25 to 27 and Figure 9). The scar was of the order of 1 m to 2 m wide and extended some 10 m to 15 m downslope. The scar had been heavily vegetated prior to clearance, indicating that it was a pre-existing feature. The geometry of the scar near the road level was complicated by a random assortment of concrete slabs which had been (apparently recently) undermined (Plate 27), exposing layers of fill beneath.

Plate 27 – Close-Up of Main Scarp of Narrow Washout to South of Landslide Scar (Refer Plate 17). Purpose of Concrete Slab is Unknown. Note Undermining Beneath. (Photograph Taken on 9 September 1998)
