**SECTION 3 :
DETAILED STUDY OF THE
LANDSLIDE AT A
PFA FILL SLOPE AT
SIU LANG SHUI,
TUEN MUN ON 9 JUNE 1998**

Fugro Scott Wilson Joint Venture

**This report was originally produced in October 1999
as GEO Landslide Study Report No. LSR 11/99**

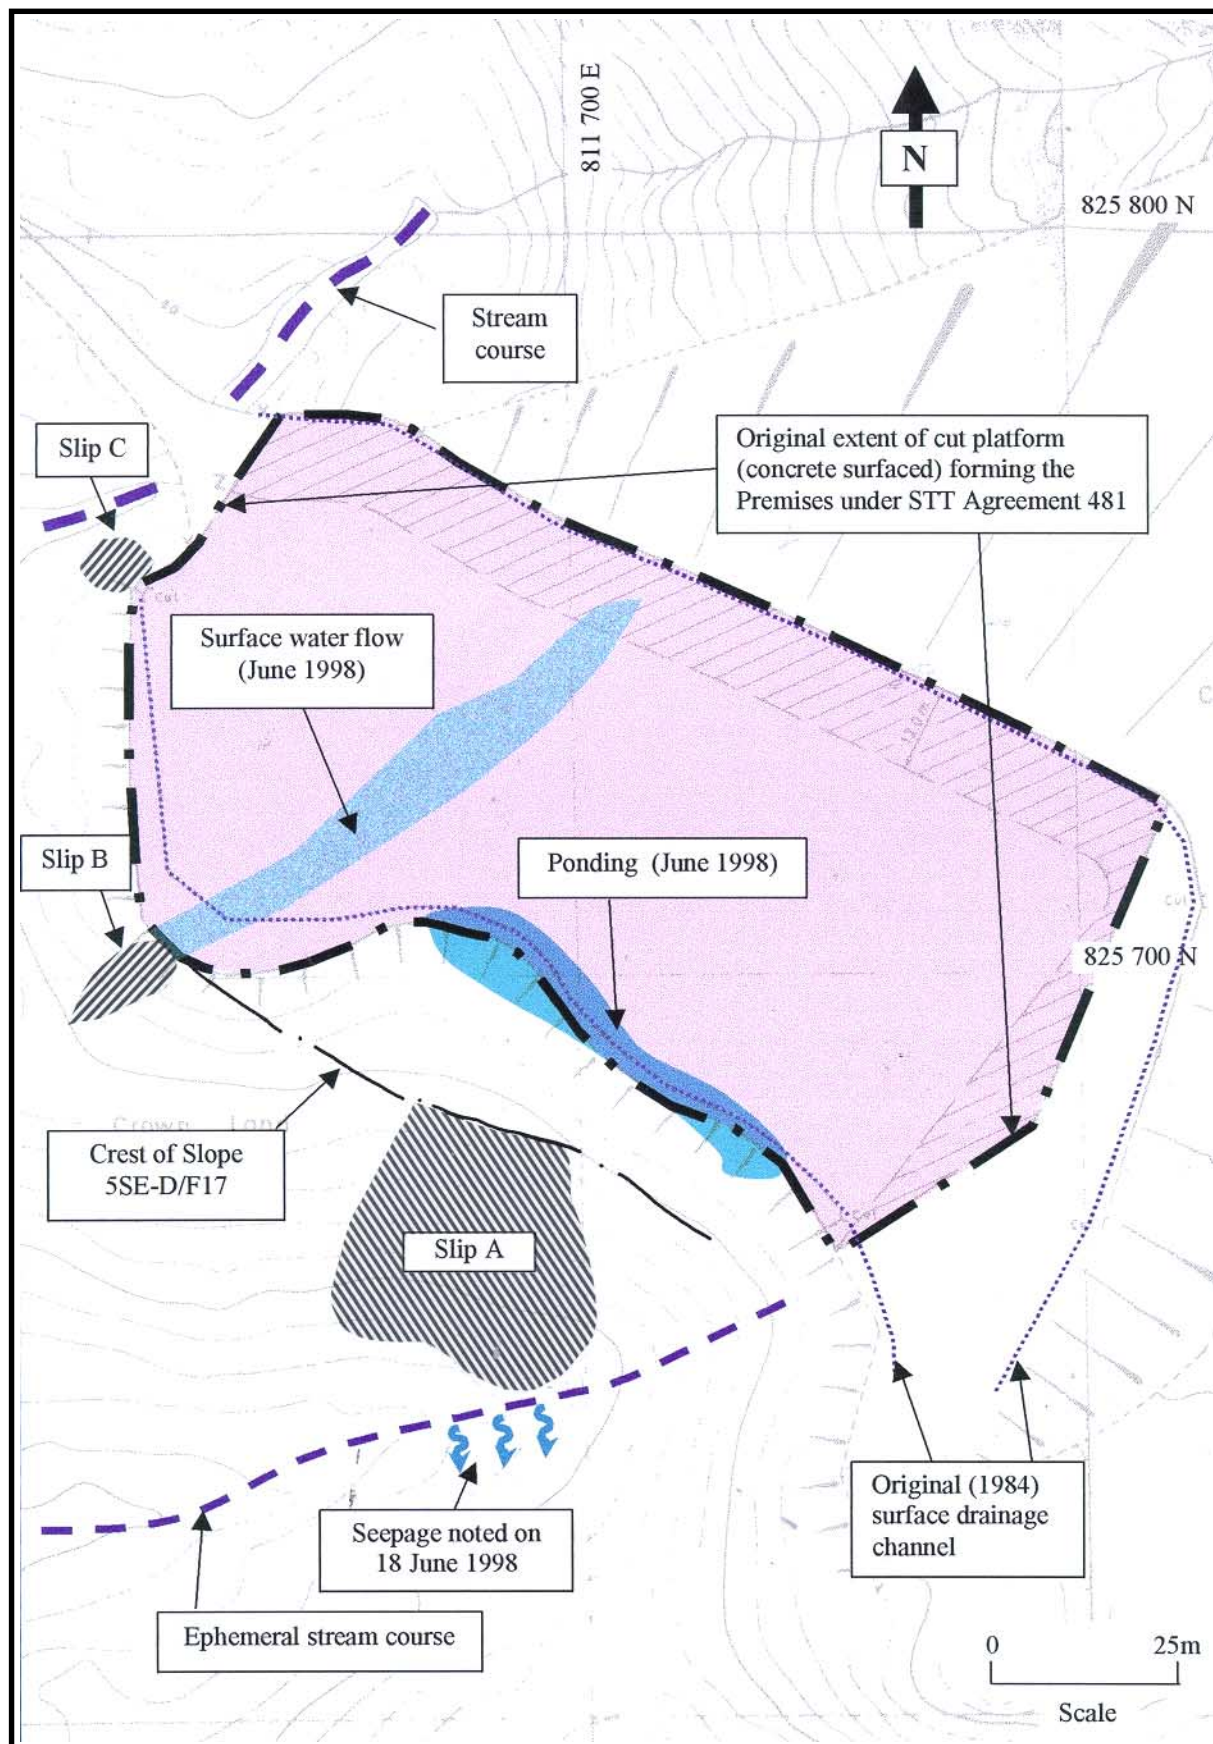
Figure 2 – Site Plan

The extent and profile of Slips A, B and C were determined by field inspection by FSW staff on 18 June 1998. The extent of the landsliding is shown in Figure 2, and a cross-section through the main landslide (i.e. Slip A) is given in Figure 4c. General views of the landslide site are shown in Plates 1 to 6.

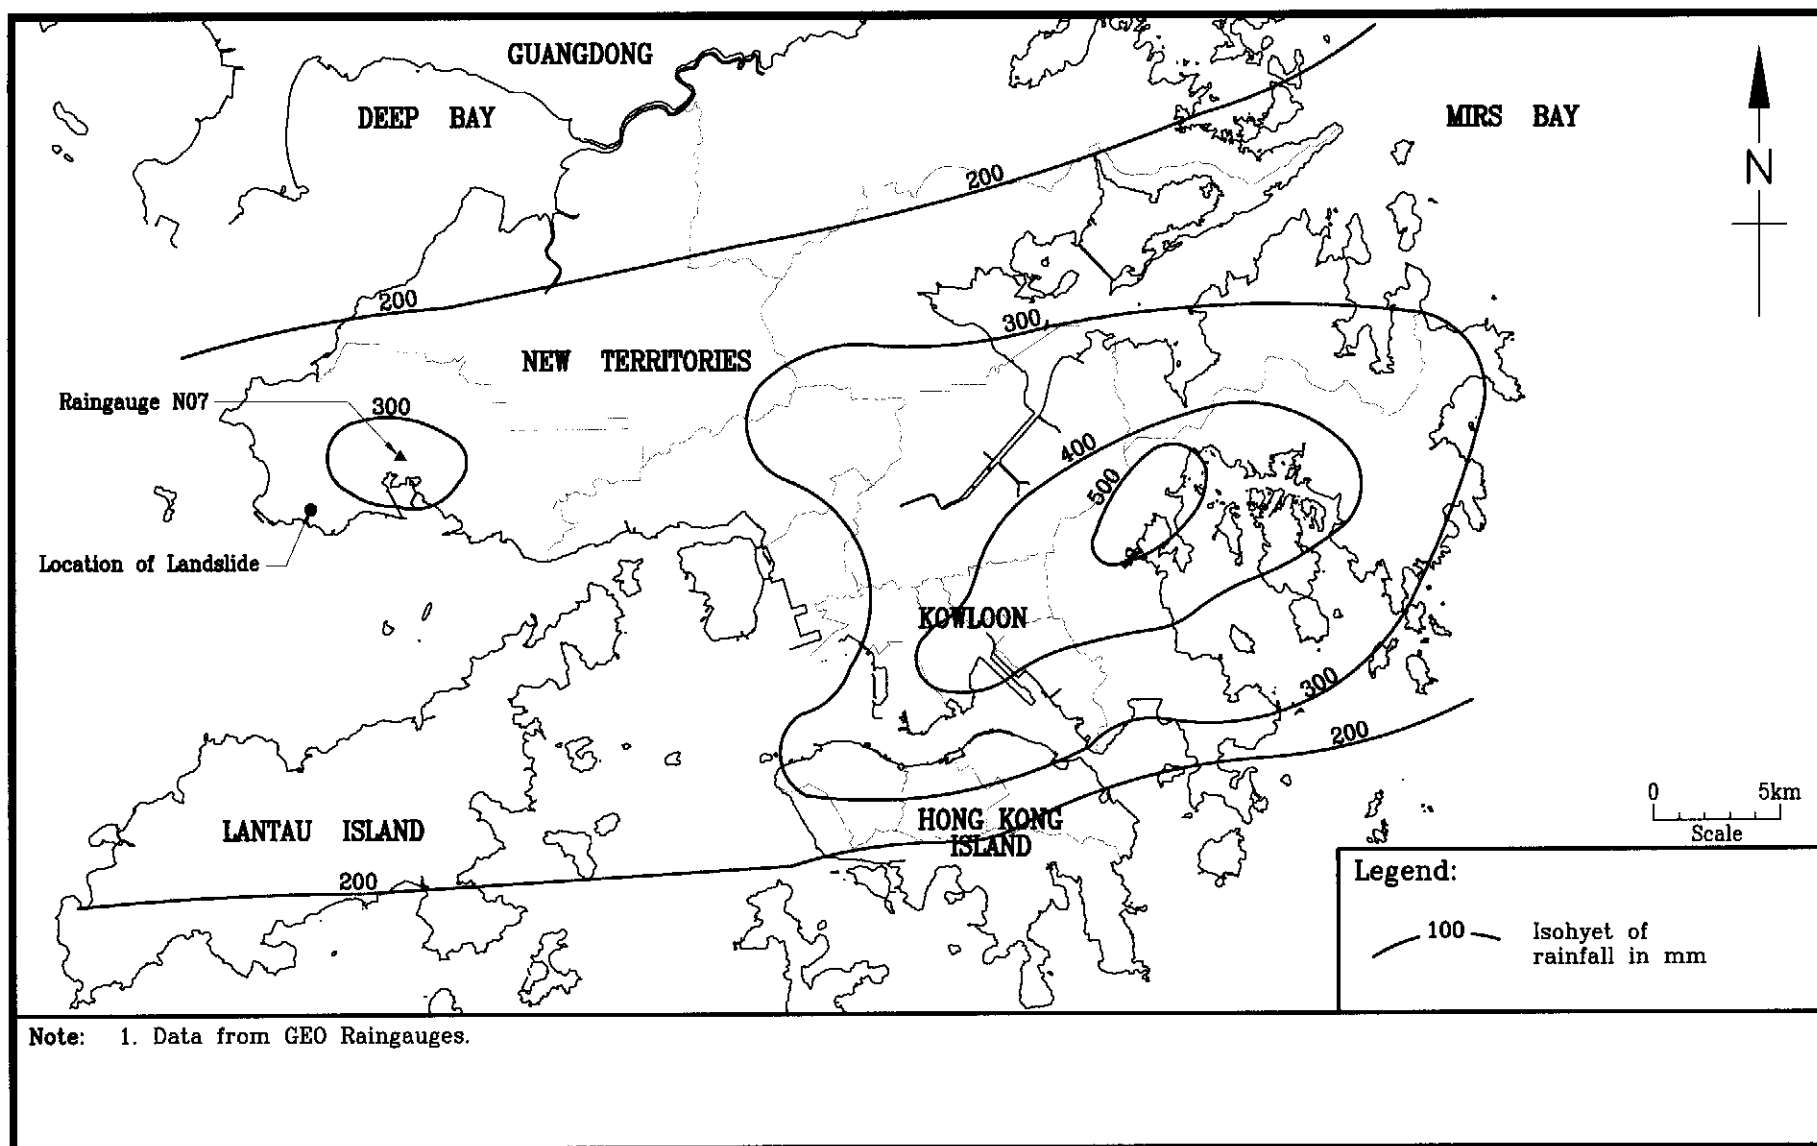
Figure 6 - Isohyets of Rainfall from 00:00 to 24:00 Hours on 9 June 1998

Isohyets of rainfall for the 24-hour period preceding the landslides are shown in Figure 6, based on an assumed failure time of midnight on 9 June 1999.

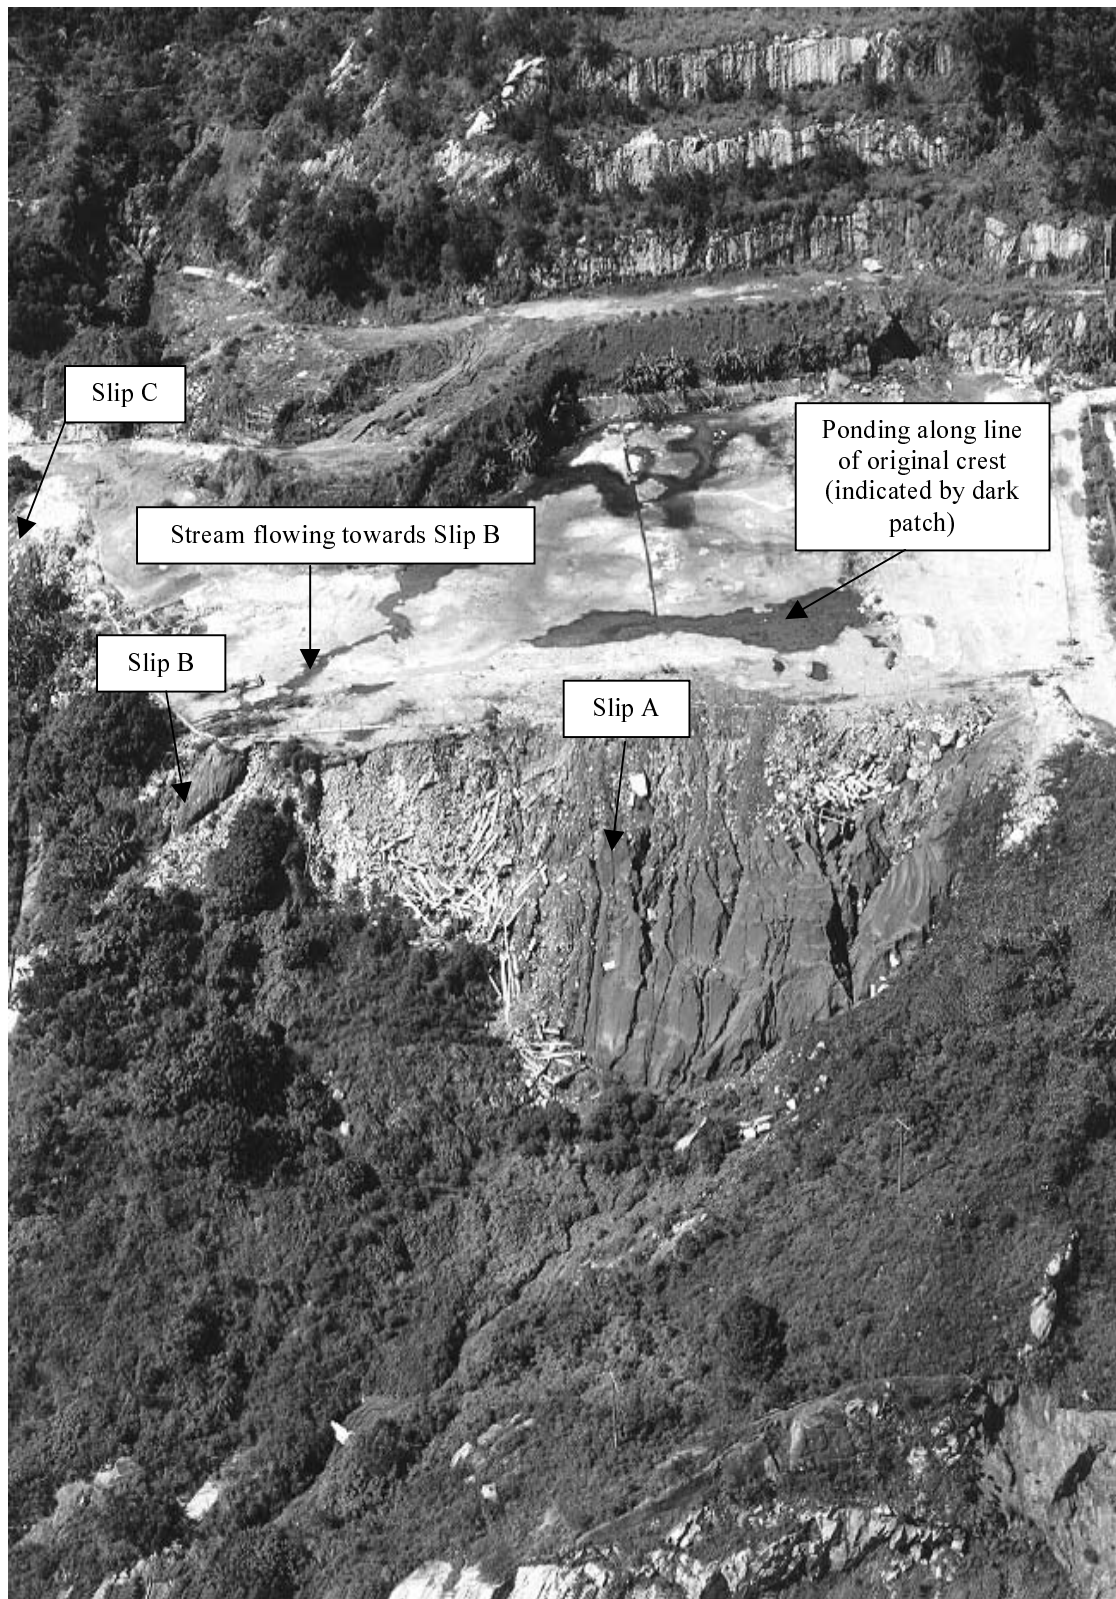
Plate 1 – Aerial View of Landslides (Photograph taken on 29 June 1998)

In the oblique aerial photographs taken on 29 June 1998 (Plate 1), it is apparent that a low area exists on the site platform, around the line of the original slope crest, some 25 m back from the crest of the main slope, above Slip A. This area was seen to be ponded on the oblique aerial photographs (Plate 1). The photograph also shows a stream of water, emanating from the cut slope at the back of the platform, running towards the location of Slip B.

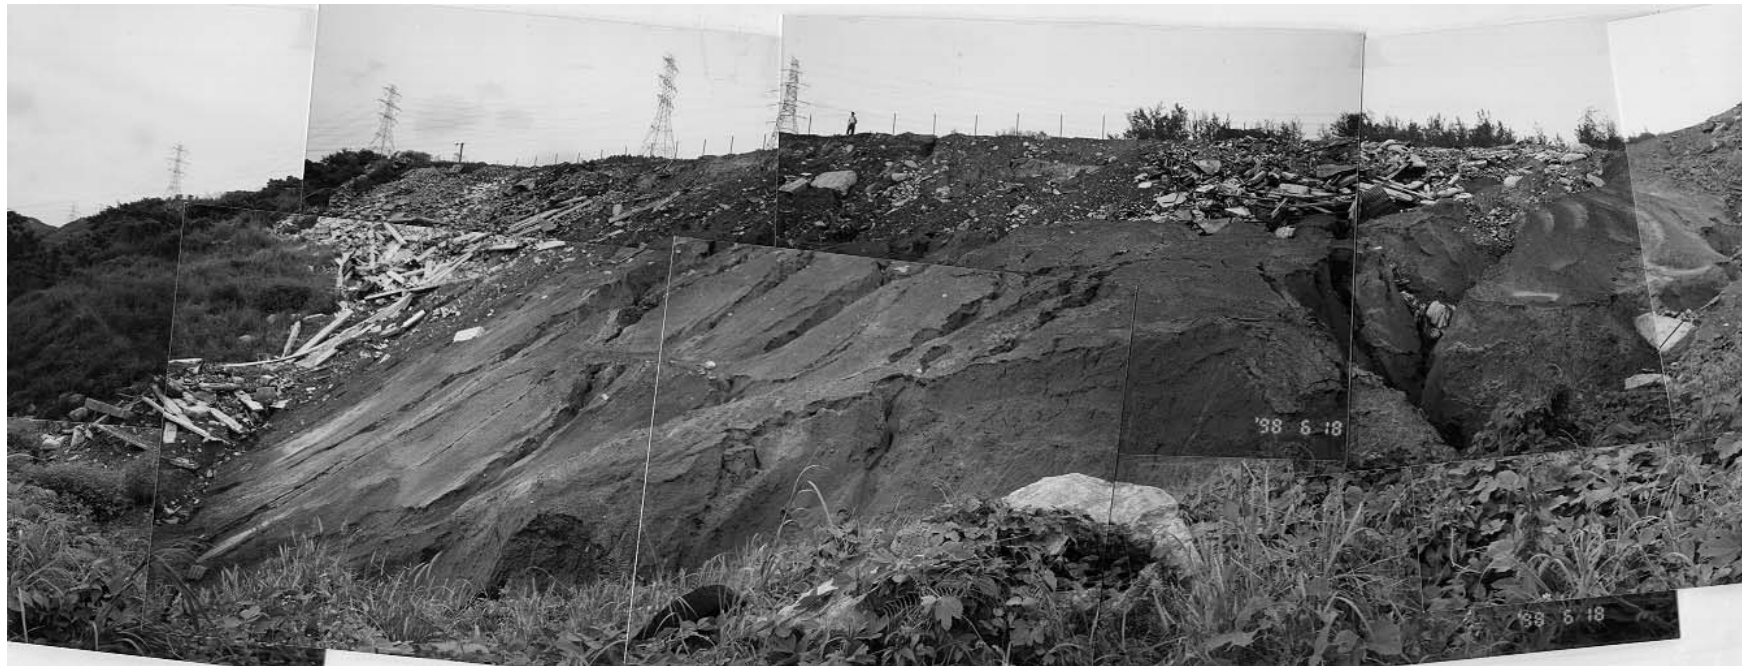
Plate 2 – View of Slip A from Slope Toe (Photograph taken on 18 June 1998)

The largest landslide (Slip A) occurred within the main body of end-tipped PFA on the south-facing embankment. It comprised an approximately 60 m wide, 30 m long and 2 m deep mass with an estimated volume of about $1,000 \text{ m}^3$ (Plates 1 and 2). The mode of debris movement involved a sliding failure. The failed mass comprised a number of bulging and discrete blocks, which were typically 6 m wide and 10 m long in a downslope direction. Erosion gullies up to 2 m deep had formed, probably due to the action of concentrated surface water flow between the blocks (Plate 2). PFA debris had been washed out along the stream

course as far as the Lung Mun Road and attained an average thickness of around 0.5 m along the stream course.

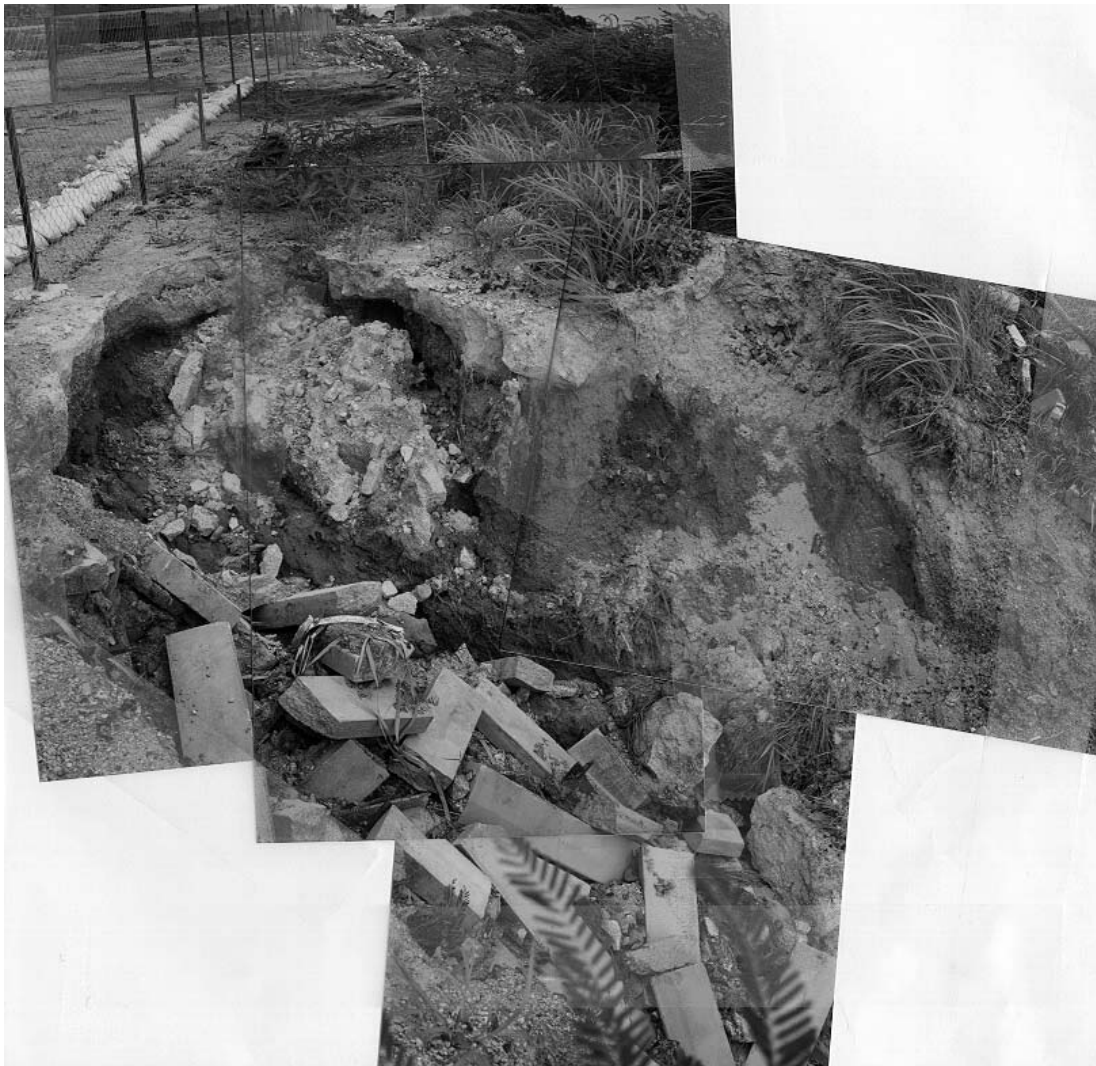
Plate 3 – View of Slip B from North (Photograph taken on 18 June 1998)

The two smaller landslides (Slips B and C) occurred in the western section of the slope. Slip B occurred at the southwestern corner of the platform and the scar was 8 m wide, 10 m long and 4 m (maximum) deep, corresponding to a volume of approximately 80 m³ (Plates 3, 4 and 5). Severe erosion was apparent around the crest and margins of this slip suggesting that washout by surface water flows had occurred.

The main cause of Slip B was predominantly concentrated surface water flow which, based on site observations, was channelised towards this area resulting in surface erosion.

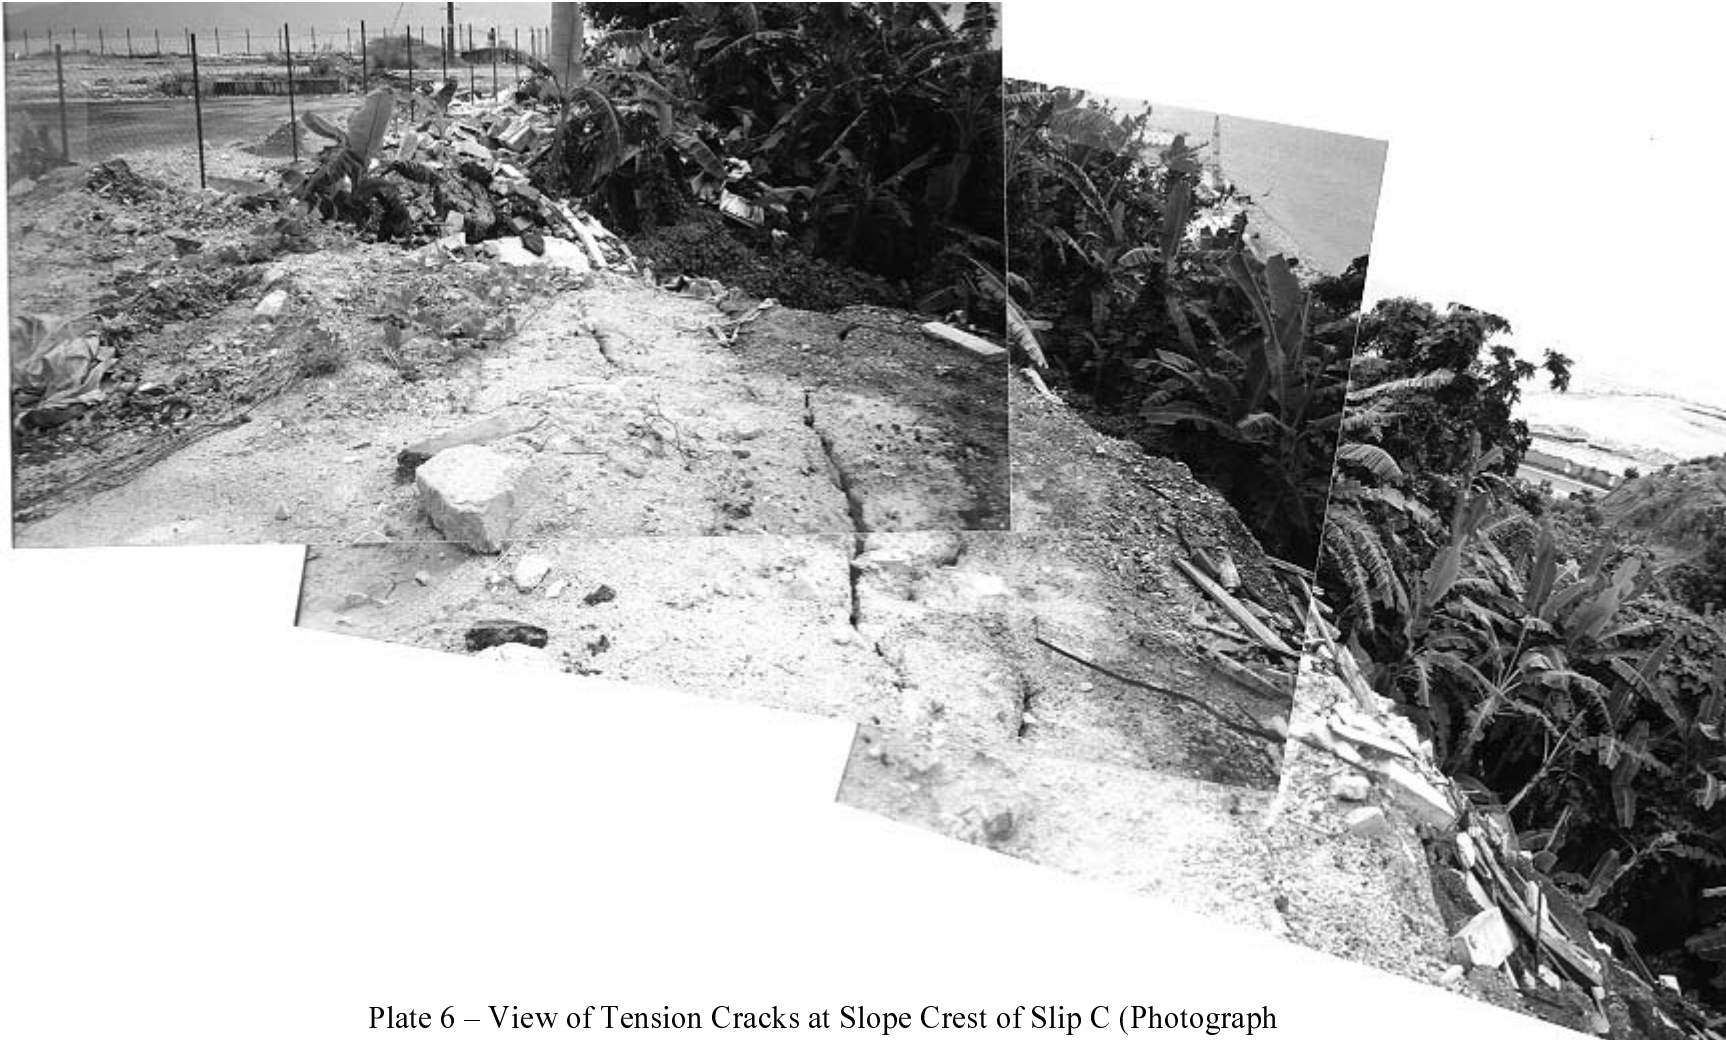
Plate 6 – View of Tension Cracks at Slope Crest of Slip C (Photograph taken on 18 June 1998)

Slip C occurred at the northern end of the western section. This part of the slope exhibited sign of distress with severe settlement in the order of 500 mm together with numerous tension cracks at the slope crest (Plate 6). The disturbed area measured about 7 m wide and 10 m long, involving a volume of about 20 m³.

The main cause of Slip C was probably the wetting up of loose PFA fill and building debris resulting in localised slope movement and erosion of the loose fill.
