INVESTIGATION OF SOME SELECTED LANDSLIDES IN 1998 (VOLUME 3)

GEO REPORT No. 110

**SECTION 1 :
DETAILED STUDY OF THE
LANDSLIDE AT SUNNY VILLA,
218 CASTLE PEAK ROAD
ON 9 JUNE 1998**

**This report was originally produced in July 1999
as GEO Landslide Study Report No. LSR 3/99**

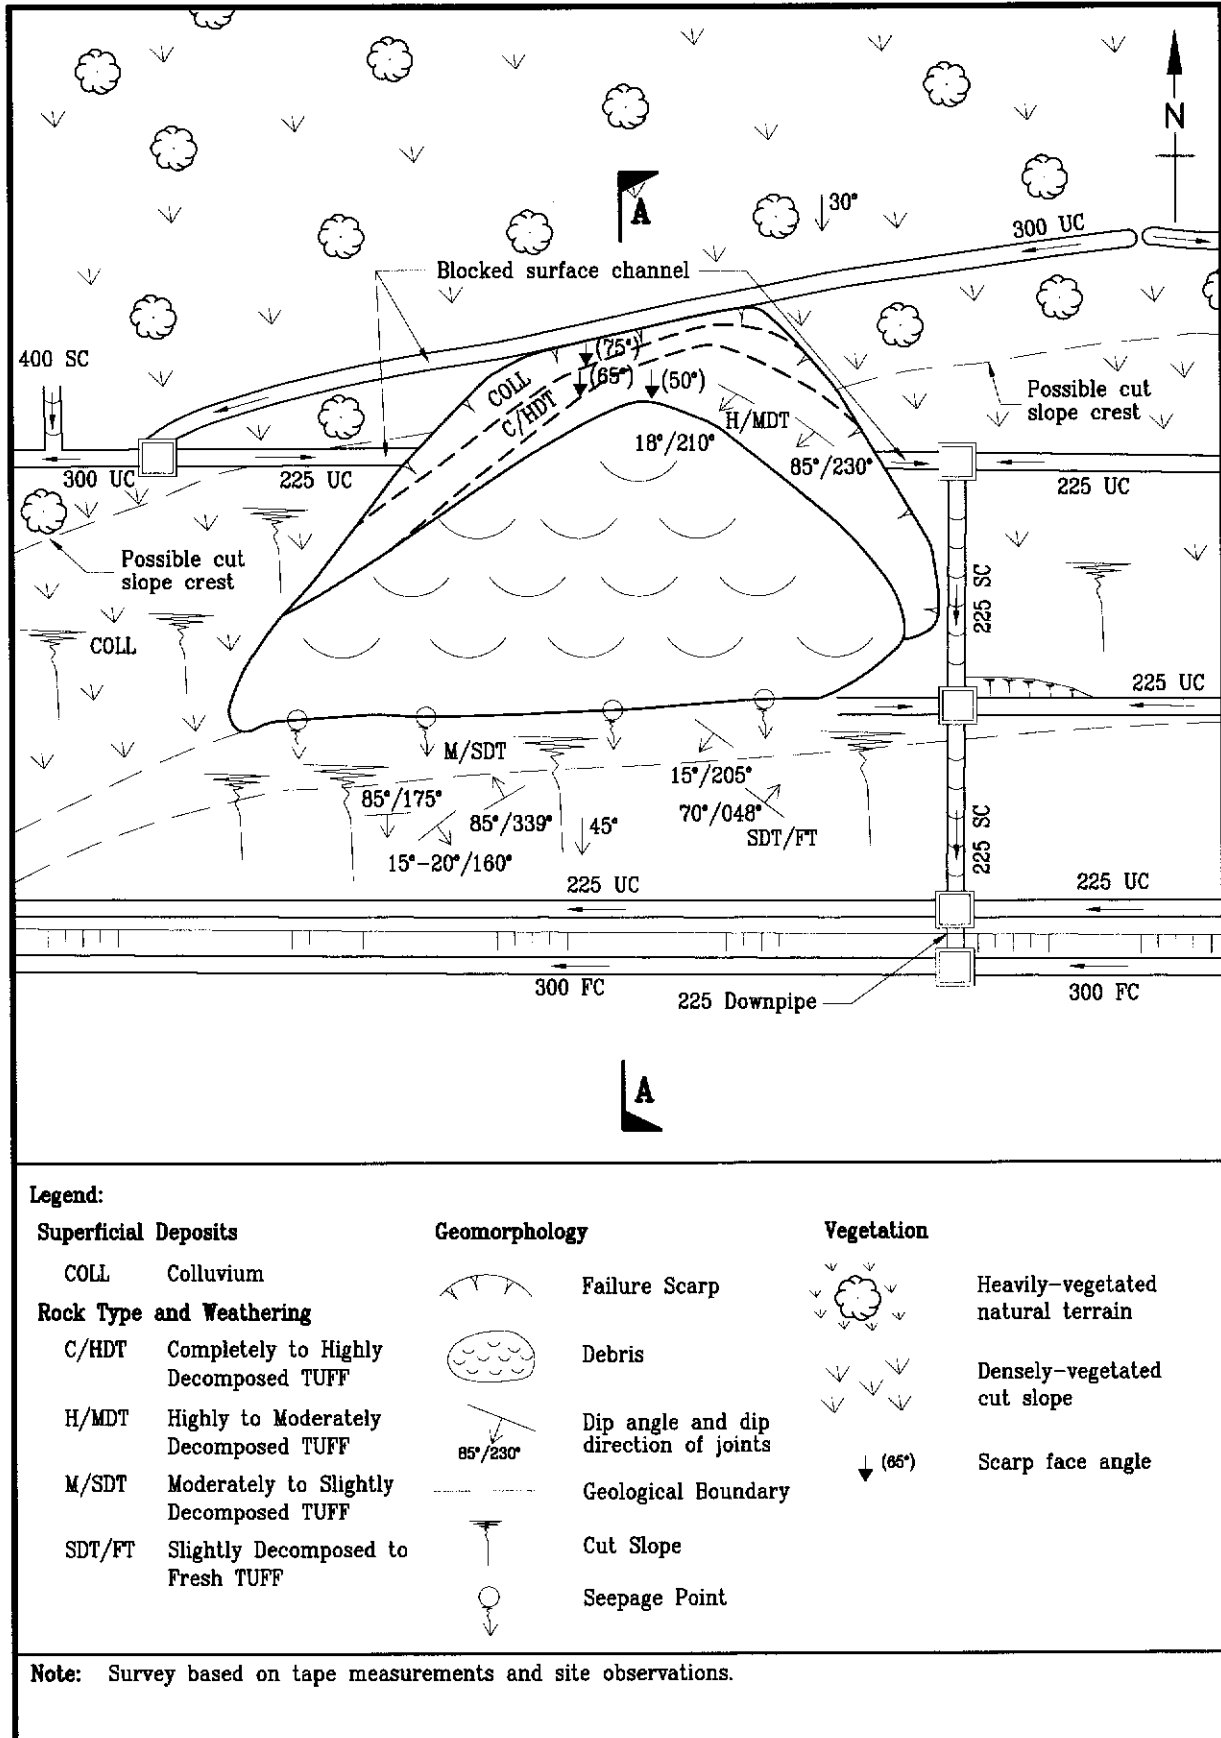
Figure 3 - Geological Map of the Landslide Site

The landslide scar was located immediately below a 300 mm crest U-channel, which was almost completely blocked with vegetation (Figure 3). Most of the surface U-channels on the slope were also covered with vegetation and blocked (Plate 6), indicating inadequate maintenance. A dislocated berm U-channel was observed on both flanks of the scar, the remains of which were noted in the debris along the access road.

During the inspection carried out by FSW in the morning of 10 June 1998, a lot of water was noted emanating from four locations of the failure scar (Figure 3). However, no surface runoff was observed, suggesting that sub-surface water may be the source of the observed seepage. No signs of erosion by surface water were noted, indicating that the landslide was unlikely to have involved a washout failure caused by the action of external surface water flow.

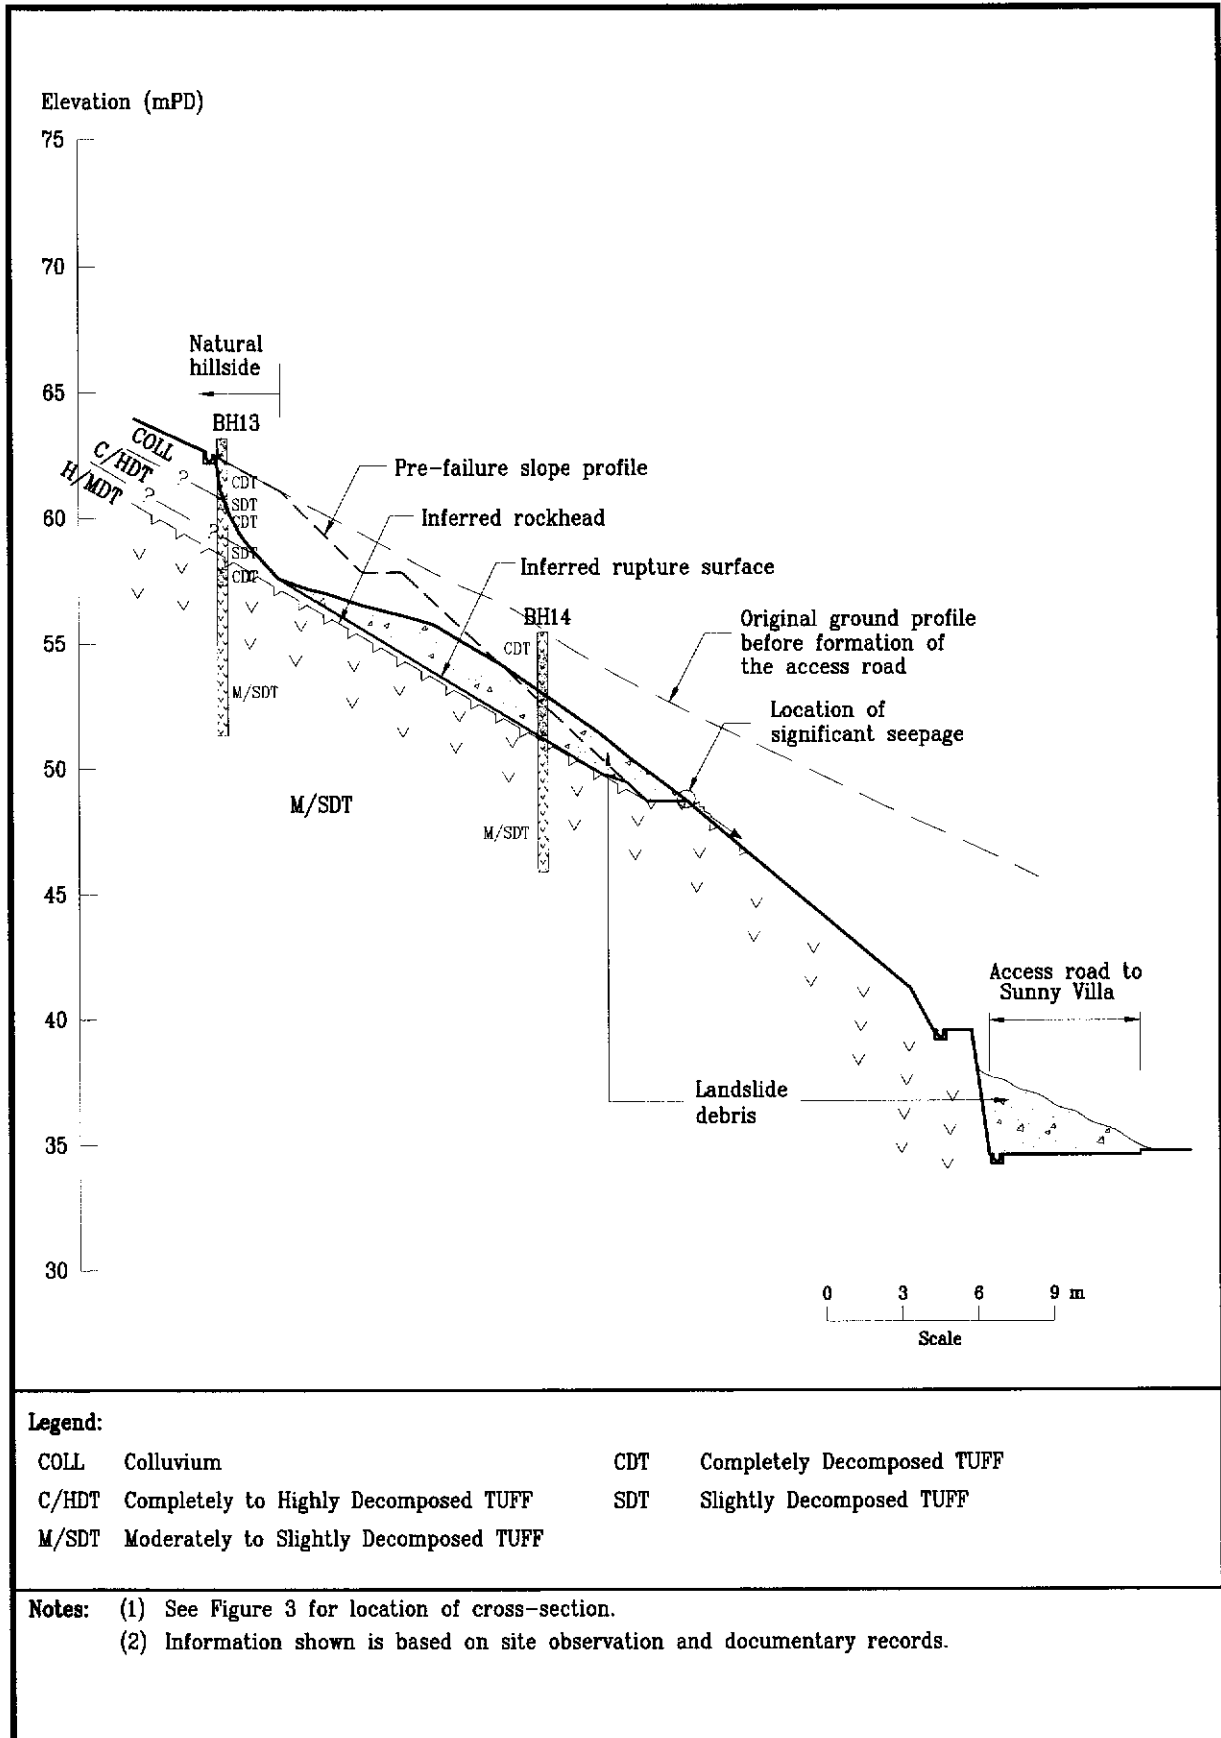
Figure 4 - Cross Section A-A through the Landslide

Based on the post-failure site inspections and the information from the previous ground investigation, a representative geological section of the landslide site has been prepared as shown in Figure 4. The vegetated slope with a relatively shallow soil mantle of colluvium and saprolite would be favourable to the development of perched water table above the Grade III or less decomposed rock.

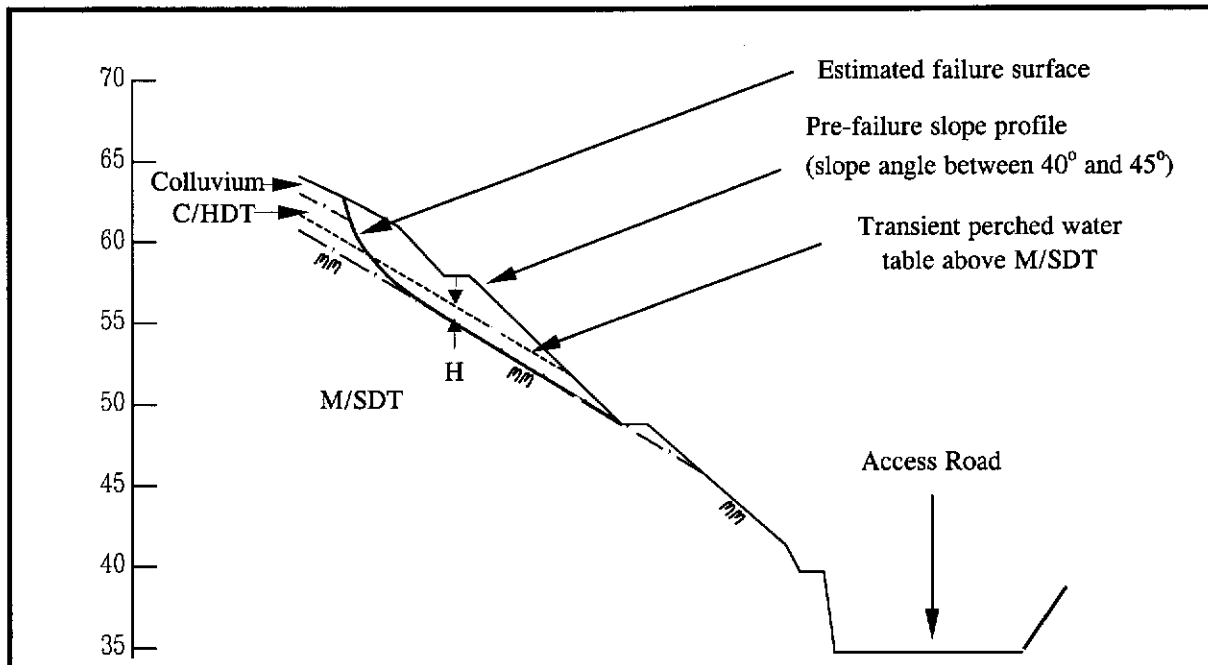
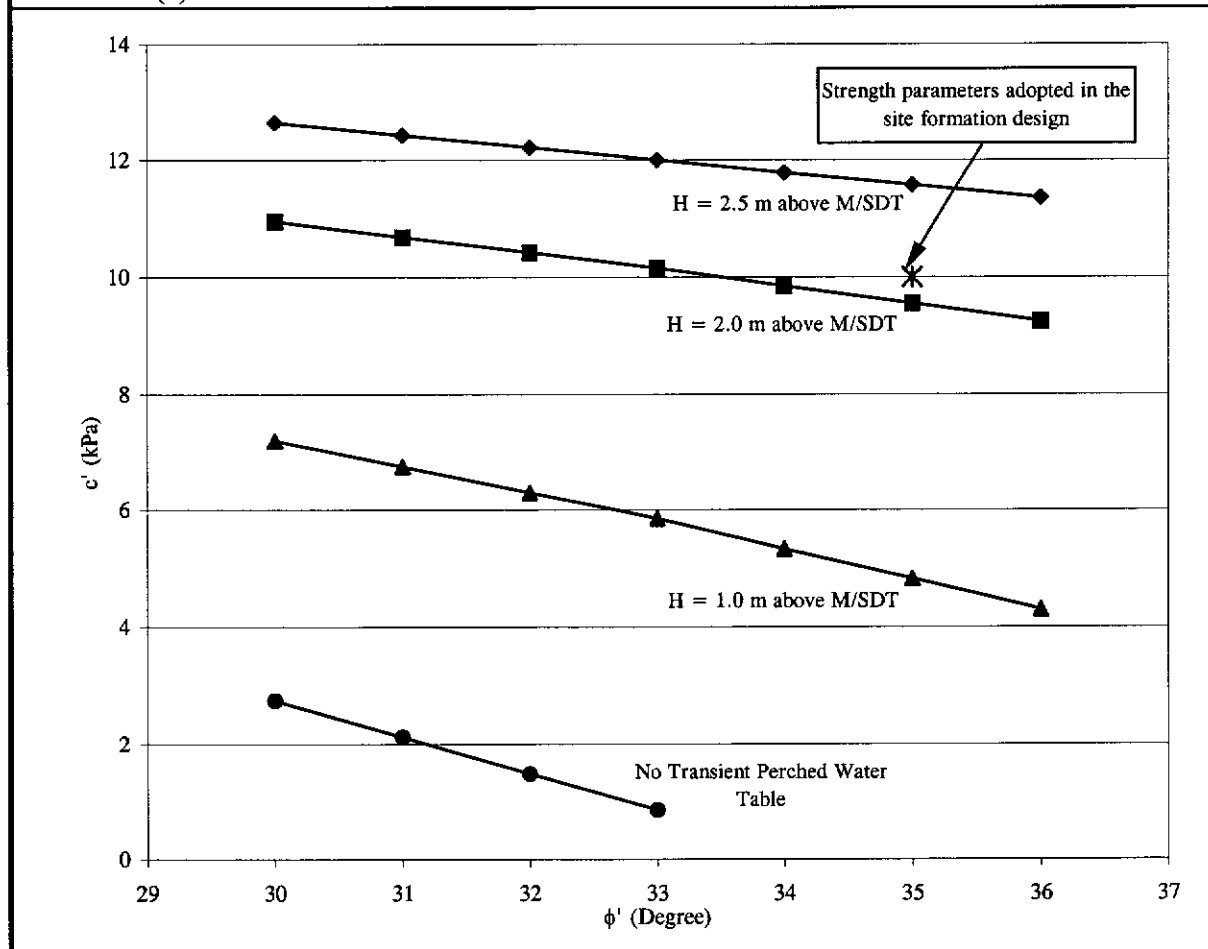
Figure 8 - Results of Theoretical Stability Analysis

A representative cross-section of the landslide site along which stability analyses have been carried out is presented in Figure 8. The pre-failure slope profile was established from the approved site formation plans, whereas the geometry of the landslide surface was based on post-failure field mapping and site measurements made by FSW. The relationship between probable groundwater levels and shear strength parameters corresponding to a factor of safety of unity for the observed failure surface is given in Figure 8.

strength parameters were appropriate for the observed failure, the groundwater level would have to be at about 2 m above rockhead. On the other hand, if there was no build-up of positive water pressure at the time of failure except for saturation of the failed material, as assumed in the site formation design, the operational shear strength parameters of the near-surface materials involved in the failure would be in the range of about $c' = 1$ kPa and $\phi' = 33^\circ$ to $c' = 3$ kPa and $\phi' = 30^\circ$.

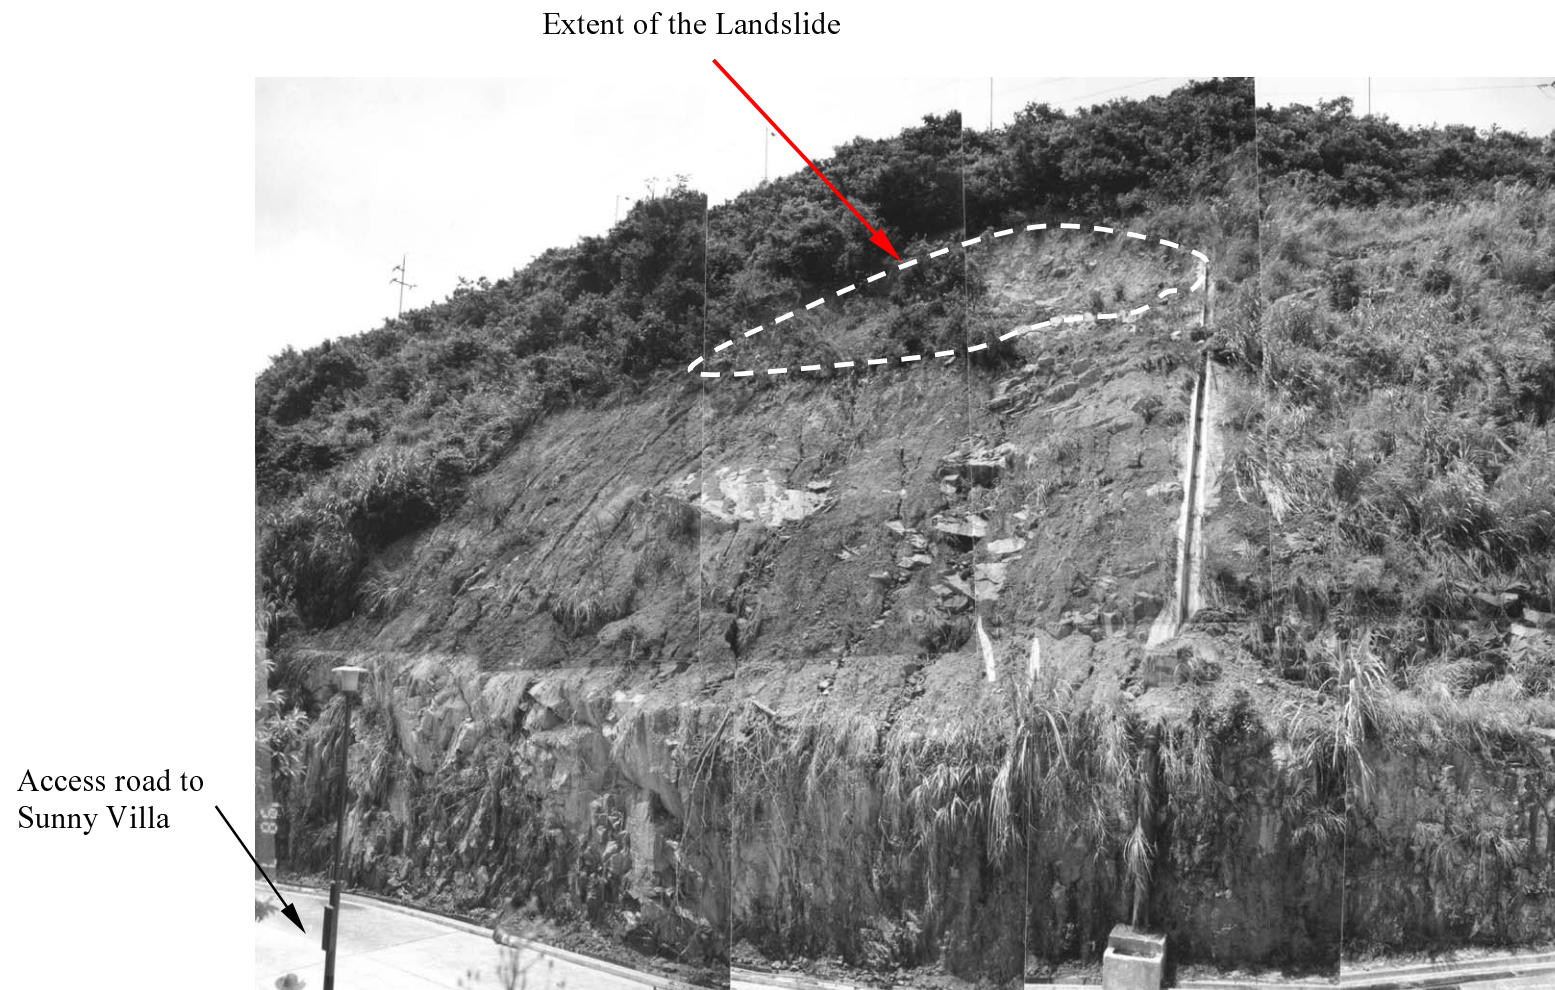
The landslide released about 200 m³ of debris from the upper part of the eastern portion of slope No. 6SE-D/C304, which completely blocked the access road to Sunny Villa. The majority of the landslide debris comprised very loose, very wet silty sand with gravel, cobbles and occasional boulders of highly to moderately decomposed coarse ash tuff. Remnants of concrete drainage channels were also found in the debris and intact raft of vegetation were located below the main scarp. The landslide debris was mainly from the cut slope with a small portion from the natural hillside above the slope crest. As the landslide debris was constrained by the bank at the far side of the access road, the travel angle of the landslide debris cannot be determined reliably.

Plate 2 - General View of the Landslide Scar
(Photograph taken on 29 July 1998. See Figure 2 for Location of Photograph)

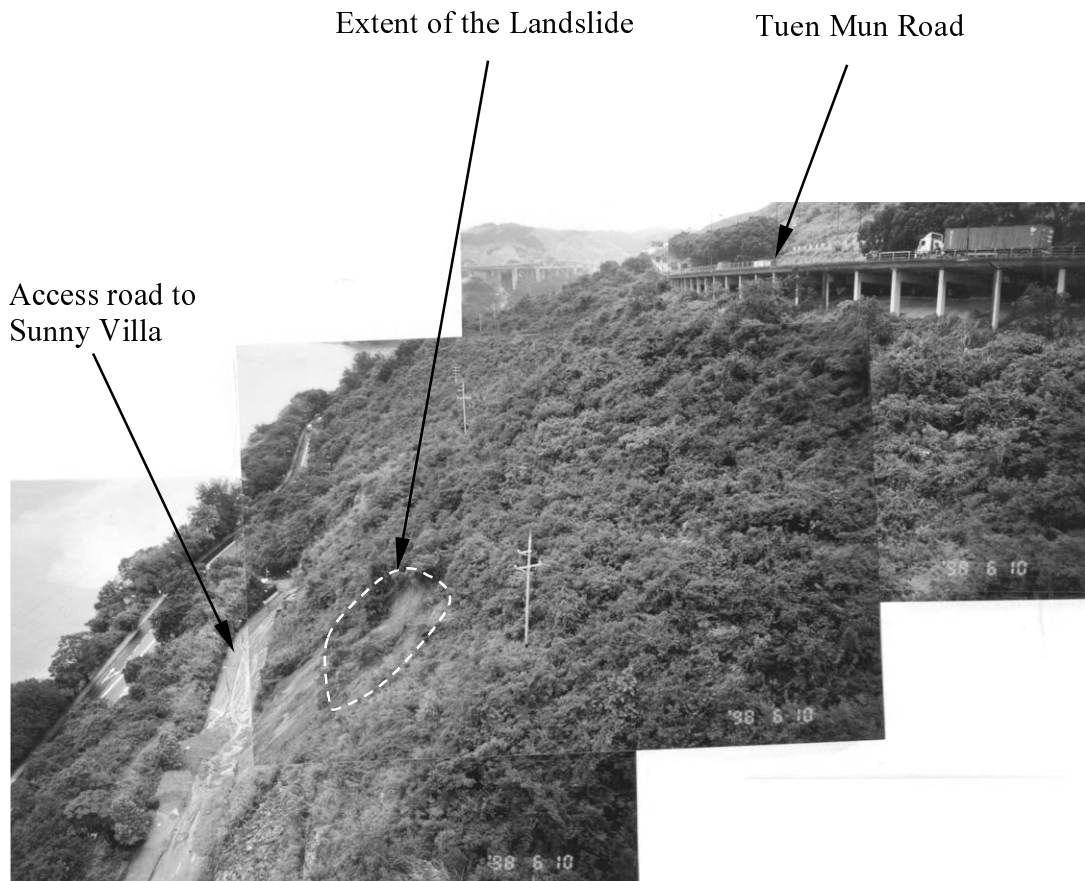
The main scarp of the landslide was about 28 m wide and 4.5 m high as measured at the middle section of the scarp. The height of the main scarp reduced to about 0.5 m towards its flanks. The inclination of the scarp varied between about 75° near the crown and about 50° along the surface of rupture. The surface of rupture was about 2 m deep and 15 m long, with the lower three quarters covered by detached materials. In the main scarp, highly to completely decomposed tuff (about 3 m thick) was overlain by a layer of colluvium (about 1 m thick) (Figure 4). Moderately to slightly decomposed tuff overlying slightly decomposed to fresh tuff was exposed in the slope immediately below the toe of the surface of rupture. No signs of distress were observed in the area adjacent to the landslide site.

Plate 3 - Side View of the Landslide Scar
(Photograph taken on 10 June 1998.
See Figure 2 for Location of Photograph)

After the landslide, the GEO recommended urgent repair works which included the cutting back of the sub-vertical back scarp to an inclination of 45° and the provision of a 75 mm-thick sprayed concrete cover. The urgent repair works were carried out in October 1998.

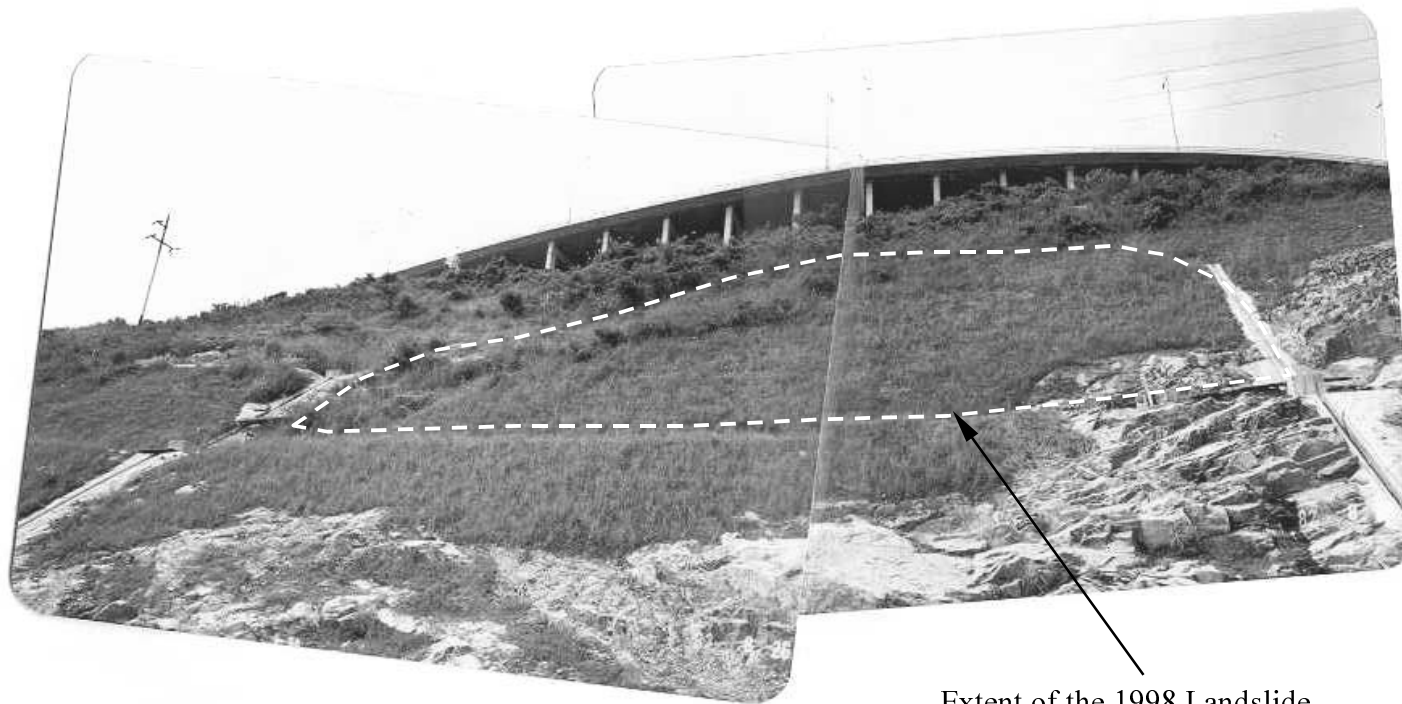
Extent of the 1998 Landslide

No as-built records of the constructed cut slope have been found in the available documents. A photograph taken by ESA at the location of the present failure in late 1982 is shown in Plate 4.

Plate 4 - Front View of the Cut Slope at the Location of the 1998 Landslide
(Photograph reproduced from ESA's Geotechnical Report dated October 1982.
See Figure 2 for Location of Photograph)

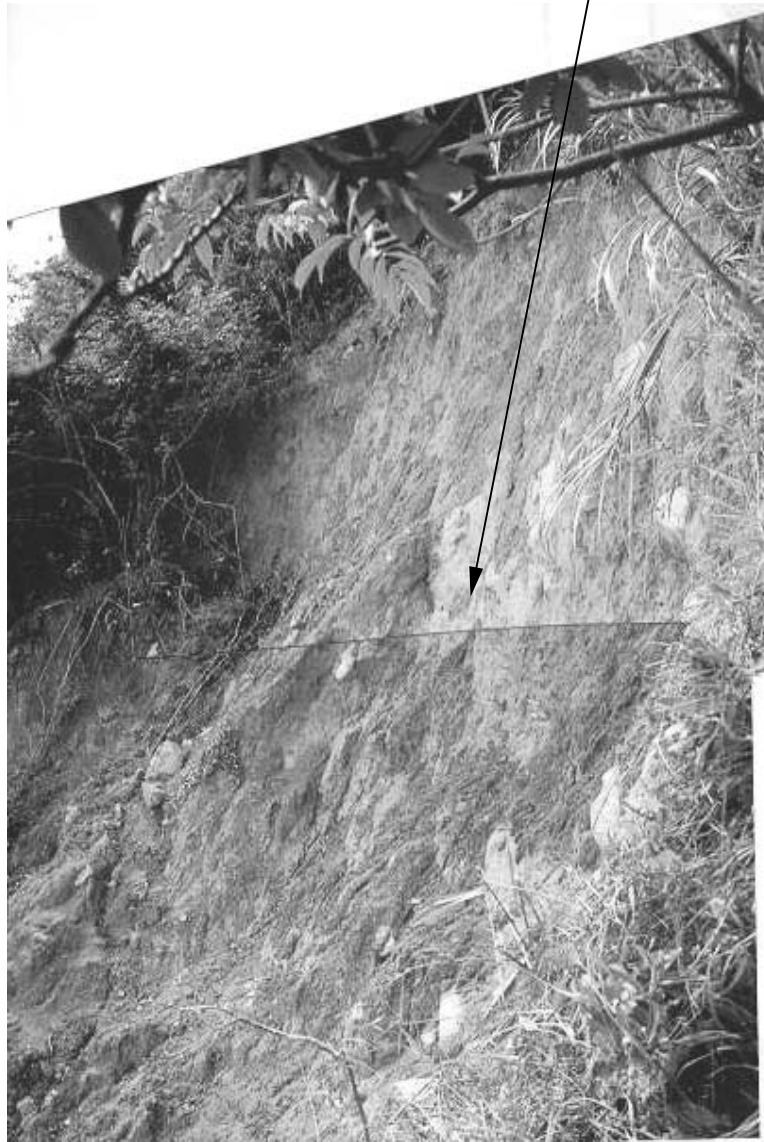
Kaolin-coated Relict Joint

Steeply-dipping, close to medium spaced relict joints of persistence of about 1 m to 2 m, which were generally infilled with kaolin (about 2 mm to 5 mm thick) and occasionally stained with manganese and iron oxides, were observed along the middle and eastern portions of the main scarp of the landslide within completely decomposed volcanics (Plate 5).

Examination of the landslide scar revealed the presence of adversely orientated kaolin-infilled relict joints in the weathered tuff of the slope. These form planes of weakness in the soil mass and affect the mass strength of the soil. Hence, the operational shear strength of the weathered tuff is likely to be weaker than that assumed in the site formation design (viz. $c' = 10$ kPa and $\phi' = 35^\circ$). It would appear that the kaolin-infilled relict joints that controlled the failure scar were not specifically considered in the site formation design.

Plate 5 - Kaolin-coated Relict Joints at the Landslide Scar
(Photograph taken on 23 July 1998.
See Figure 2 for Location of Photograph)

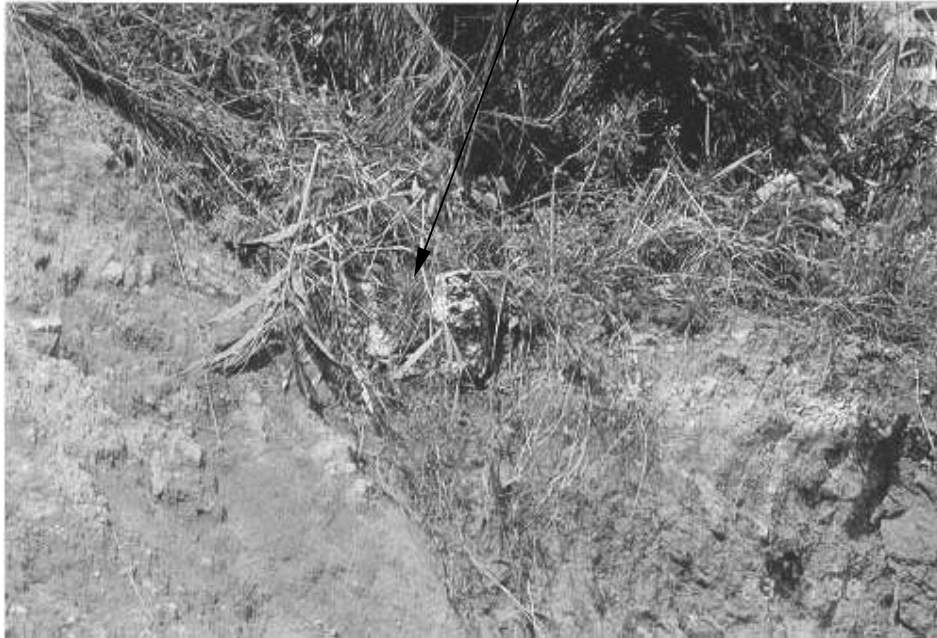
U-channel blocked by vegetation

The failure occurred during a rainstorm that was not particularly severe. The fact that the slope had previously been exposed to more severe rainstorms in 1986, 1994 and 1996 without failures suggests that inadequate slope maintenance (e.g. blocked crest drainage channels), possibly exacerbated by progressive deterioration of the slope condition, might have been a significant contributory factor to the failure.

Plate 6 – U-channel Blocked by Vegetation (Photograph taken on 23 July 1998. See Figure 2 for Location of Photograph)
