SECTION 2 : DETAILED STUDY OF THE LANDSLIDE AT FUNG WONG SERVICE RESERVOIR ON 9 JUNE 1998

Fugro Scott Wilson Joint Venture

**This report was originally produced in August 1999
as GEO Landslide Study Report No. LSR 5/99**

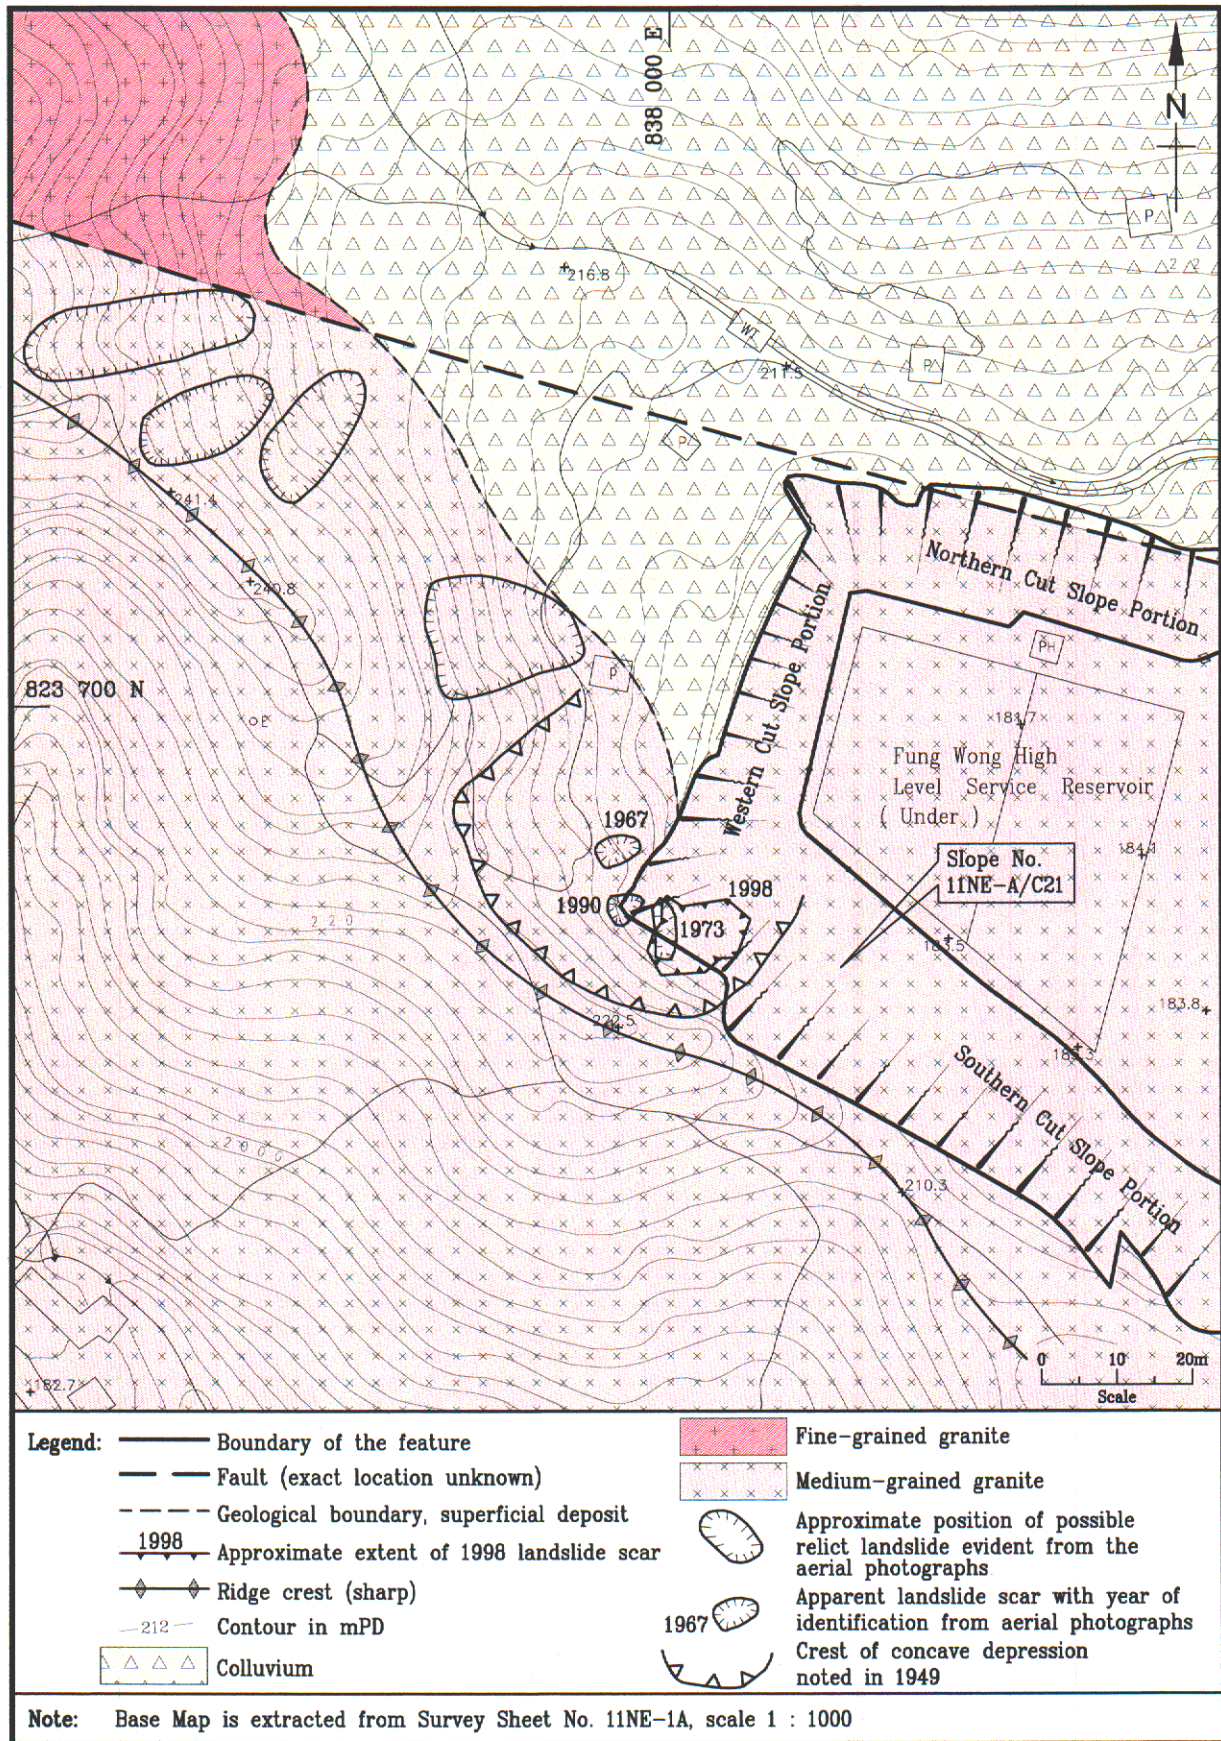
Figure 4 - Geological and Geomorphological Map of the Landslide Site

When looking at the valley in which the reservoir was formed, it can be seen that a number of failure scars are evident along the ridgeline that forms the southern slope (Figure 4). In particular, a concave depression is evident at the southwestern corner of the reservoir where the current landslide occurred. Aerial photographs taken prior to formation of the reservoir show that a lobe of material is apparent in the drainage line at the toe of the depression, suggesting that this feature marks the scar of a past landslide. Larger fans of what appear to be colluvium are also evident to the northwest of the reservoir.

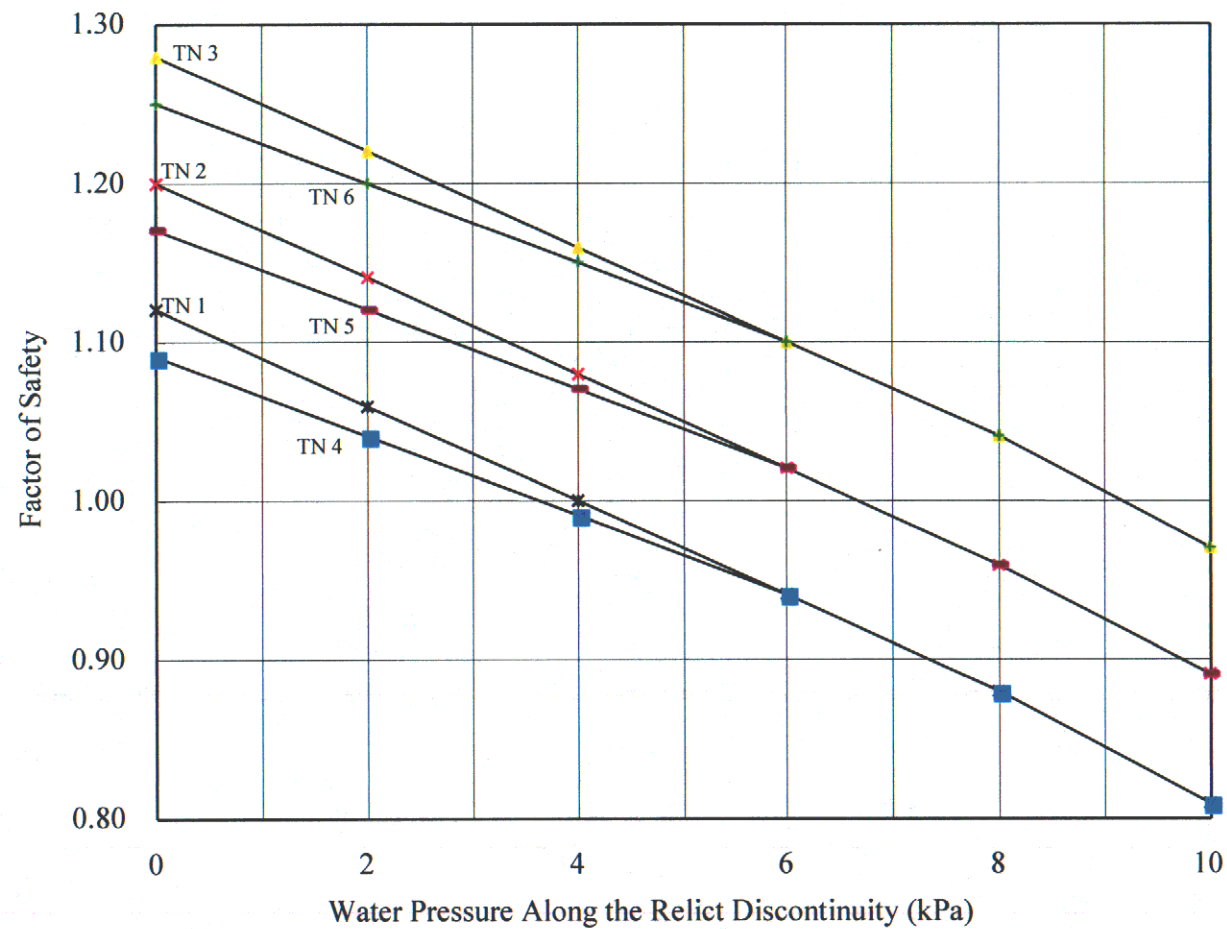
Figure 9 – Summary of Results of Stability Analyses

The results of the analysis are summarised in Figure 9. These show that the wedge is stable in dry conditions for the range of shear strength parameters adopted. However, as water pressure builds-up along the relict discontinuity the factor of safety falls below unity.

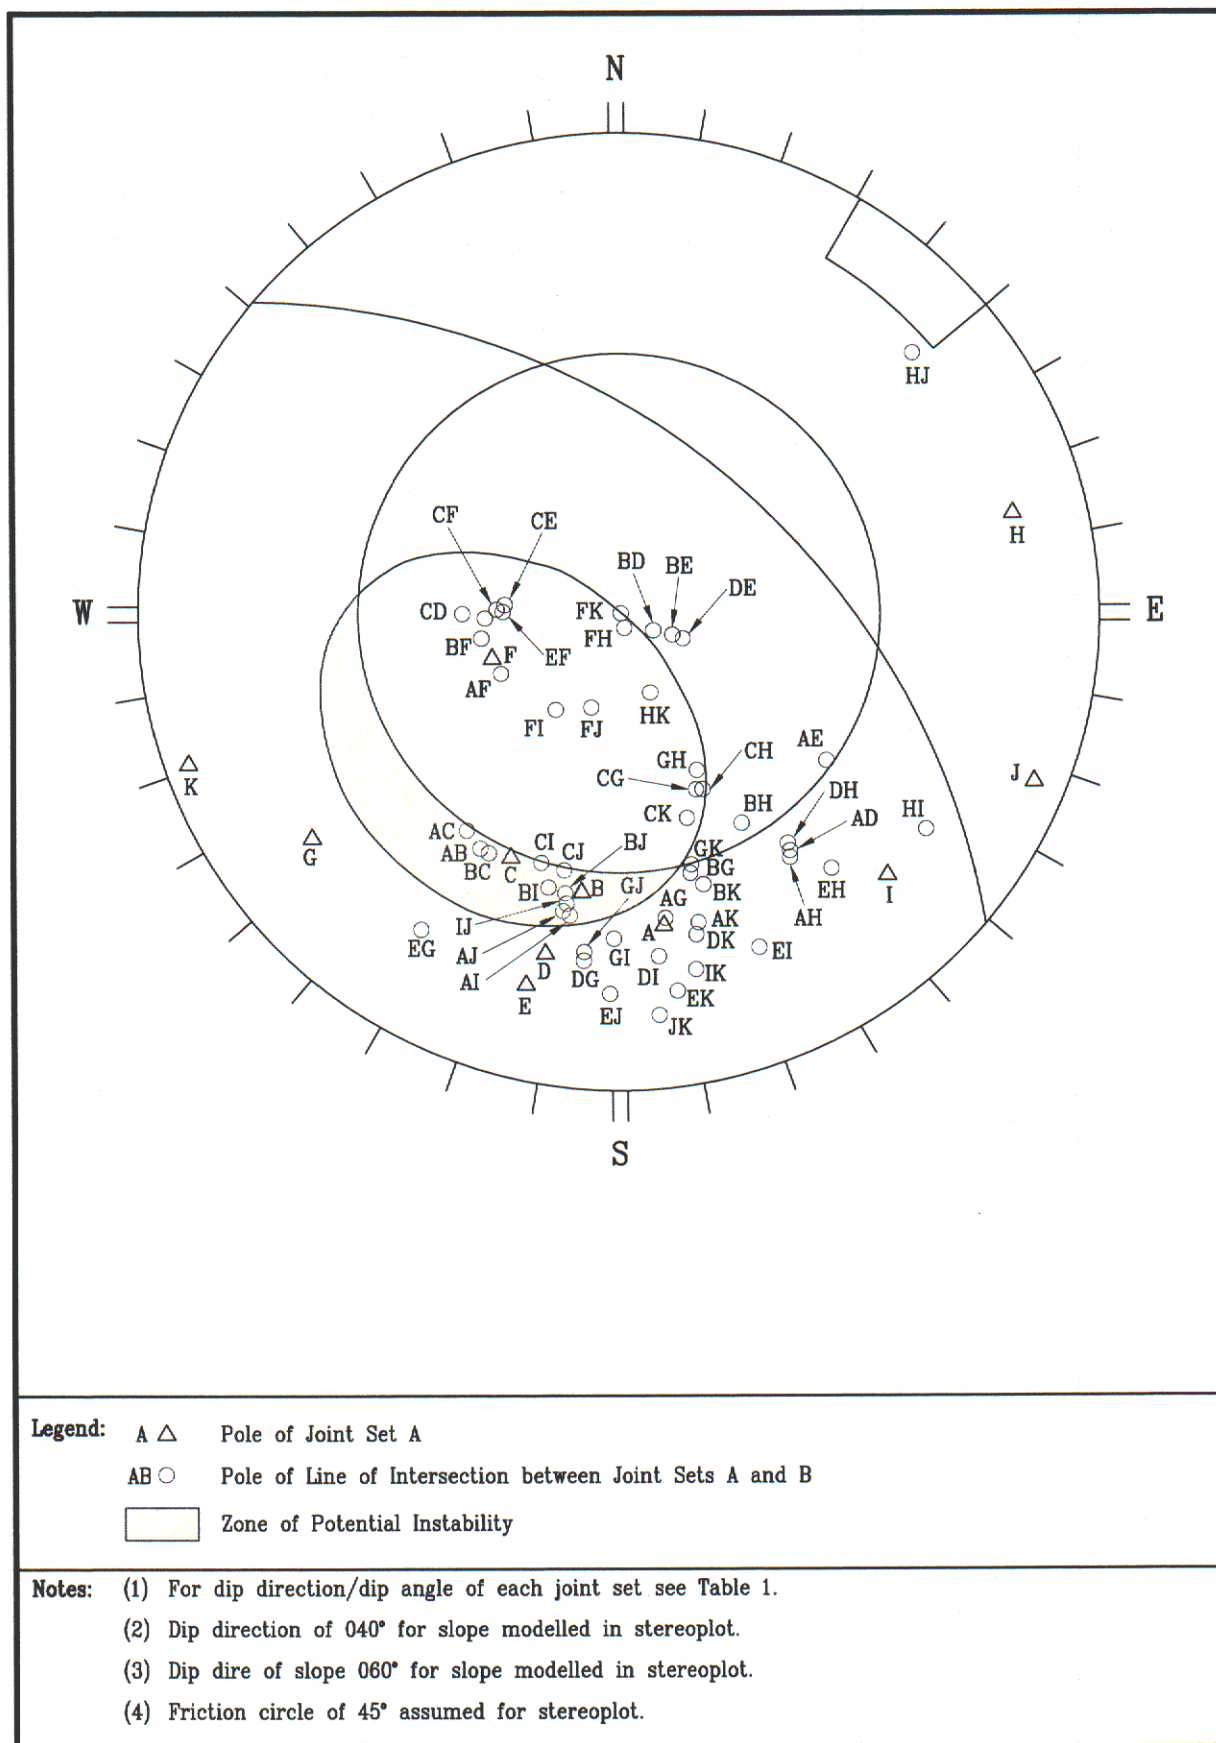
Figure 10 - Summary of Kinematic Analyses

Kinematic analyses were also undertaken for the range of joint measurements taken along the southern slope (Figure 5 and Table 1). These measurements are plotted on an equatorial equal-area stereonet. This showed that even given a high angle of friction ($\phi' = 45^\circ$) along the joint planes there would still be the potential for plane and wedge failures (Figure 10).

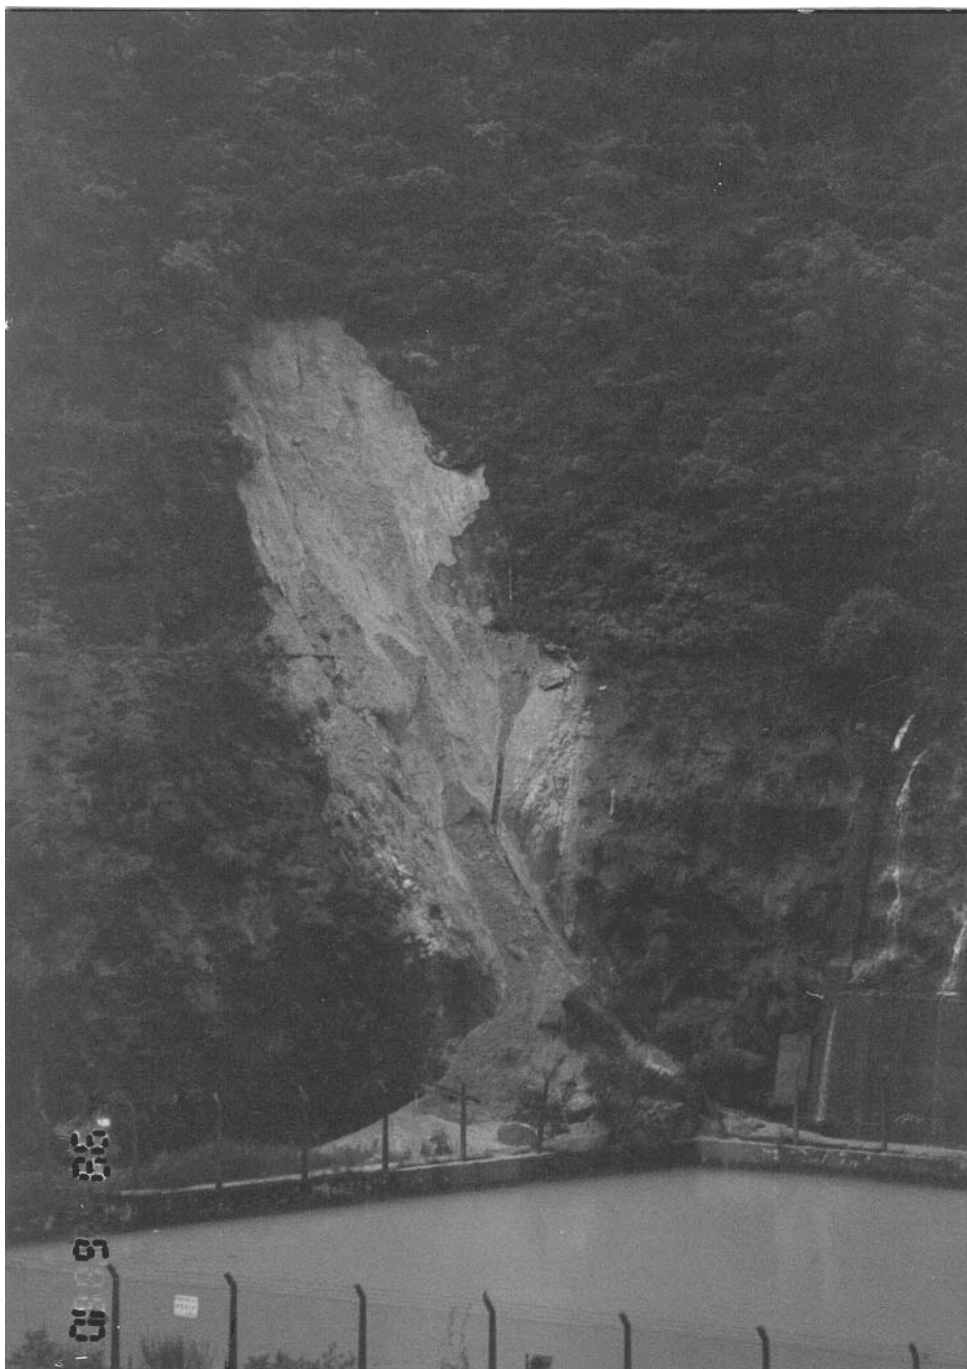
Plate 1 – General View of the Landslide
(Photograph taken on 10 June 1998)

The landslide produced a wedge-shaped scar of about 19 m in length and 12 m in width, with a maximum depth of about 2.5 m (Plates 1 to 3). Due to the height of the failed section (between 16 m and 30 m above ground level), a detailed inspection of the failure scar could not be undertaken until a scaffold access had been erected. This was not completed until September 1998 and therefore objective observations regarding seepage and water flows could not be made shortly after the failure. However, no soil pipes were observed upon inspection of the back scar and there were no obvious signs of significant vegetation disturbance or erosion.

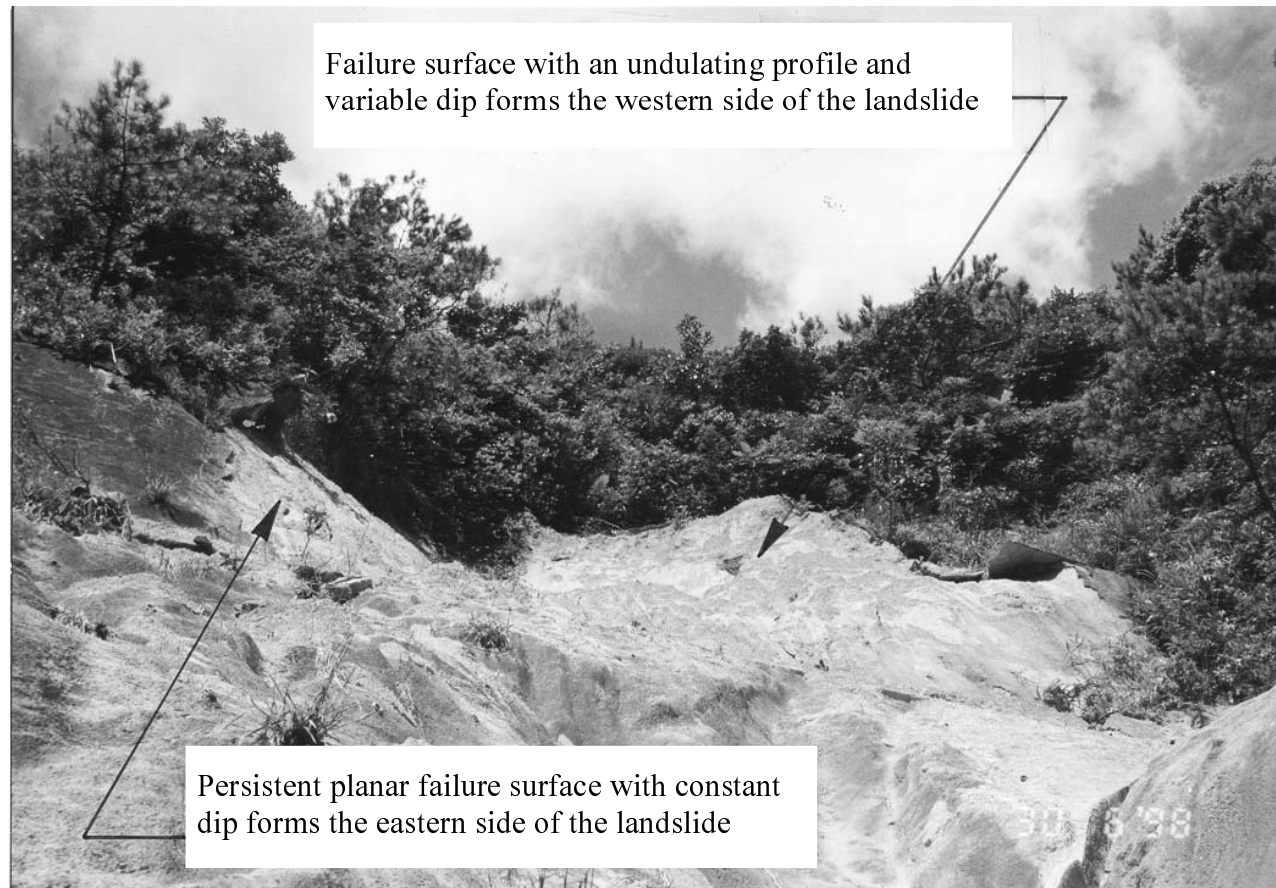
Plate 3 – Up-slope View of the Landslide
(Photograph taken on 30 June 1998)

Detailed inspection of the rupture surface revealed that the eastern side of the wedge failure was formed by a persistent, essentially planar surface believed to be a relict discontinuity (Plates 3 to 5). This plane had a slightly convex profile with an overall dip in a

Changing inslope angle is noticeable
in upper soil cut slope
(Possible interface between
cut slope and natural terrain)

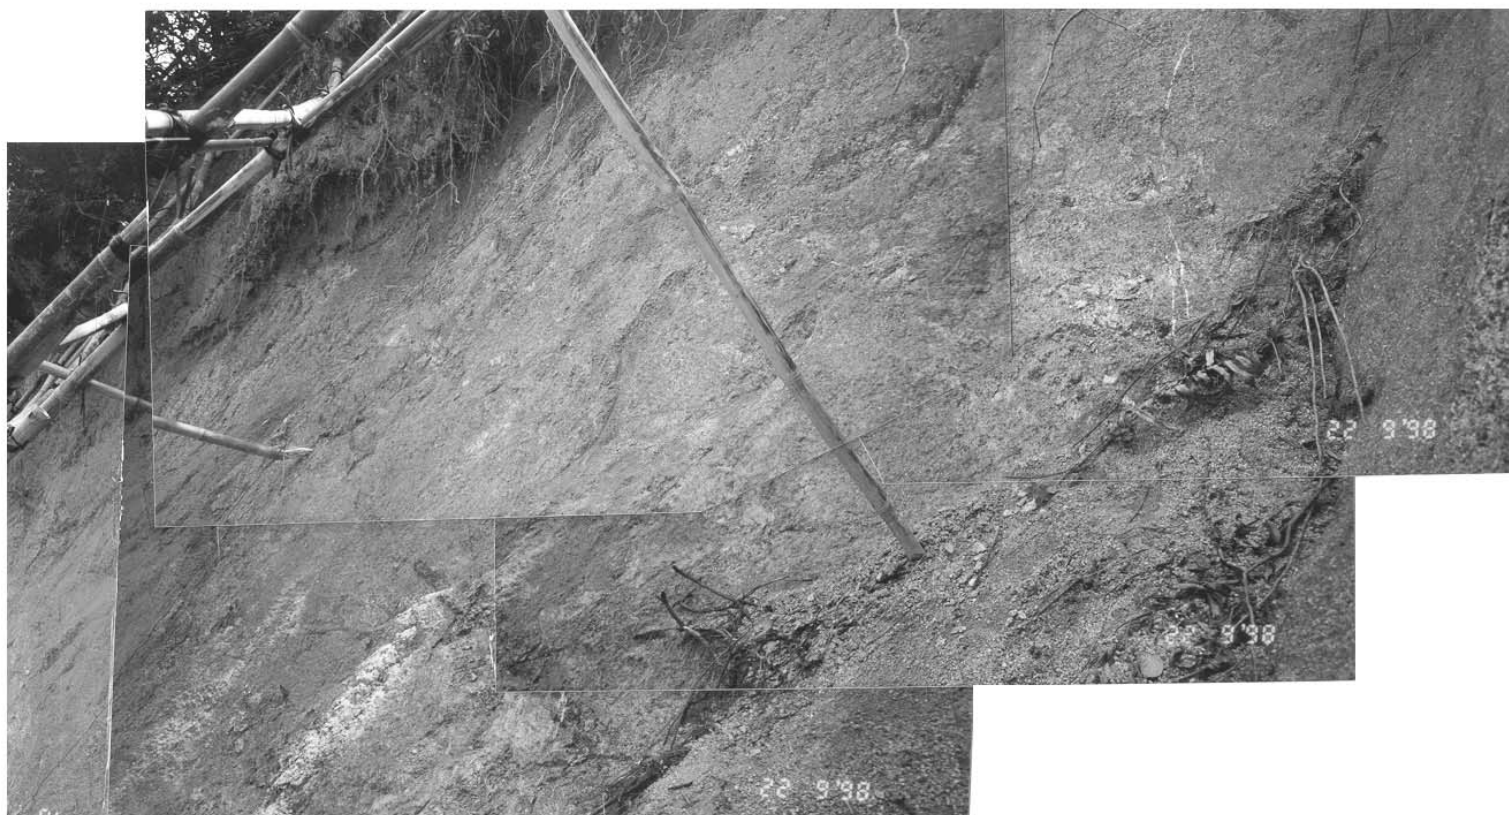
Plate 5 – Close-up View of the Eastern Failure Plane
(Photograph taken on 22 Septembe 1998)

northerly direction of between 50° and 55° to the horizontal. The material forming this face comprised completely decomposed granite, with evidence of kaolin over portions of the failure surface (Plates 5 and 6).

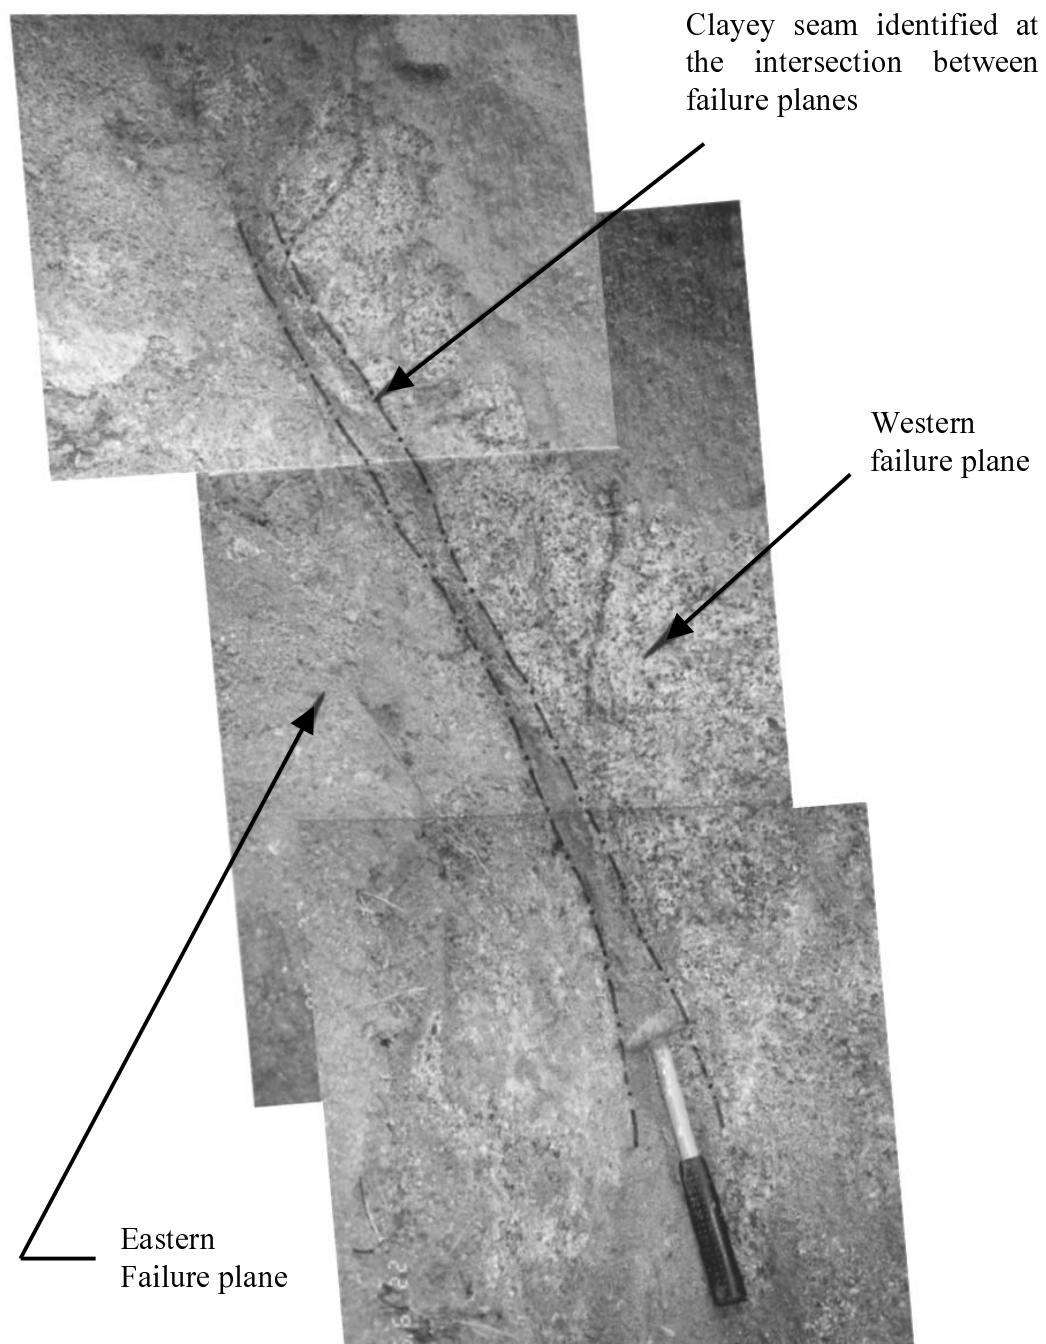
Plate 7 – View of Clayey Seam at the Intersection between Failure Planes
(Photograph taken on 22 September 1998)

At the interface between the planes it was noticeable that a clayey seam had developed. This seam had the same dip and orientation as the easterly failure plane and was 10 mm to 20 mm thick (Plate 7).

At the interface between these two planes a zone of more decomposed material, comprising a brown clayey silty sand, typically 10 mm to 20 mm thick, was present. This seam is evidence of preferential decomposition along the relict discontinuity, probably caused by infiltrating surface water.

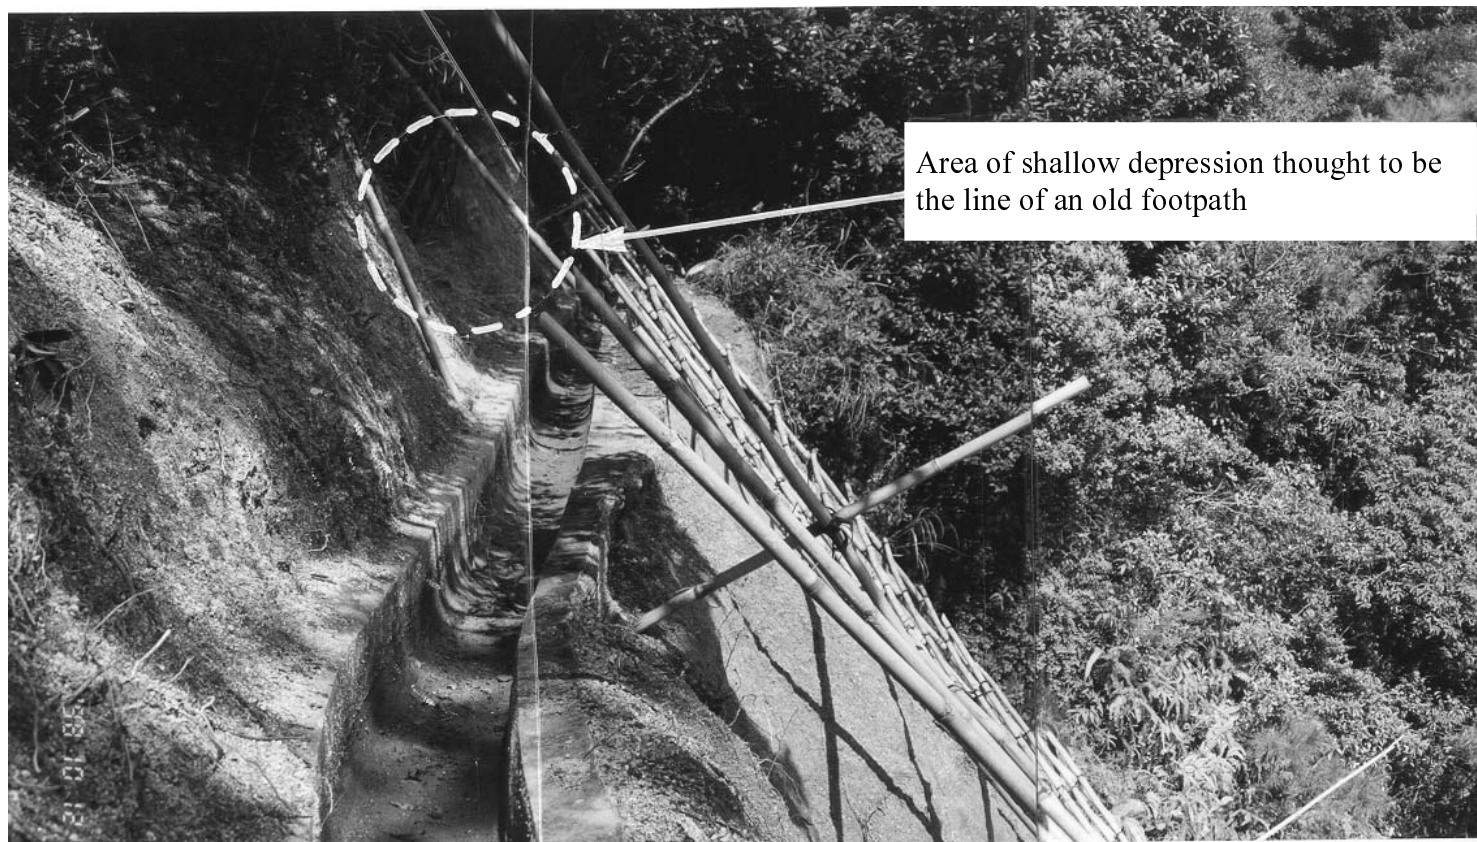
Plate 10 – View of the Drainage Channel above the Crown of the Landslide
(Photograph taken on 12 October 1998)

The crest channel directly above the crown of the landslide, which starts at approximately the upper eastern corner of the rupture surface, was completely blocked at a distance of about 12 m from its starting point (Plates 10 and 11). The debris blocking the 300 mm-wide channel appeared to be slope wash material transported from the higher ground above. Further investigation showed that the channel connected into the main drainage line above the northern boundary of the reservoir, but that a considerable section (approximately 20 m to 30 m) had become completely filled with debris. Consequently, surface water flowing into this section of the channel could not drain away along its intended route. Instead, it would overtop the channel once sufficient water had entered this blocked section of surface drainage.

A further contributory factor to the failure is inadequate slope maintenance, as evidenced by the completely blocked drainage channel at the crest of the failure.

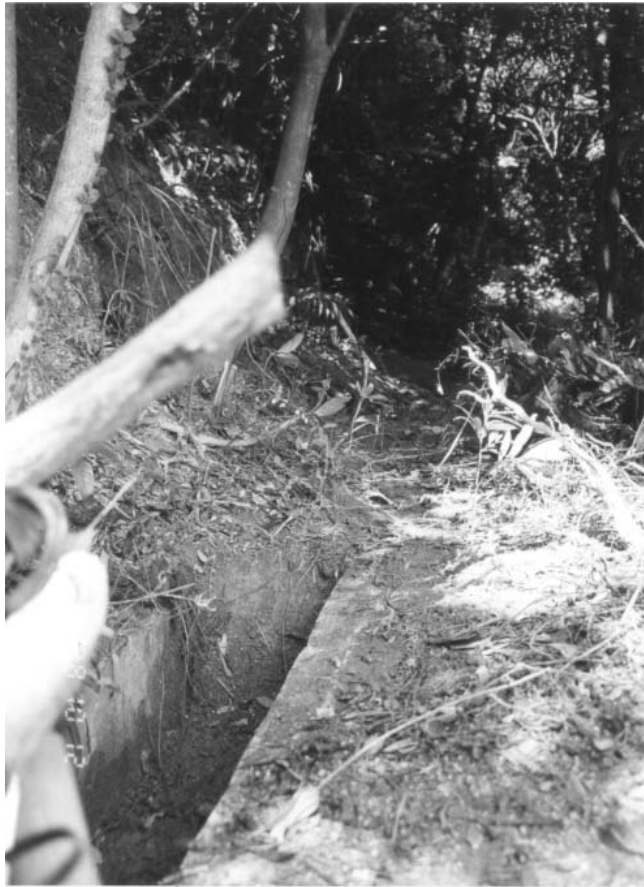
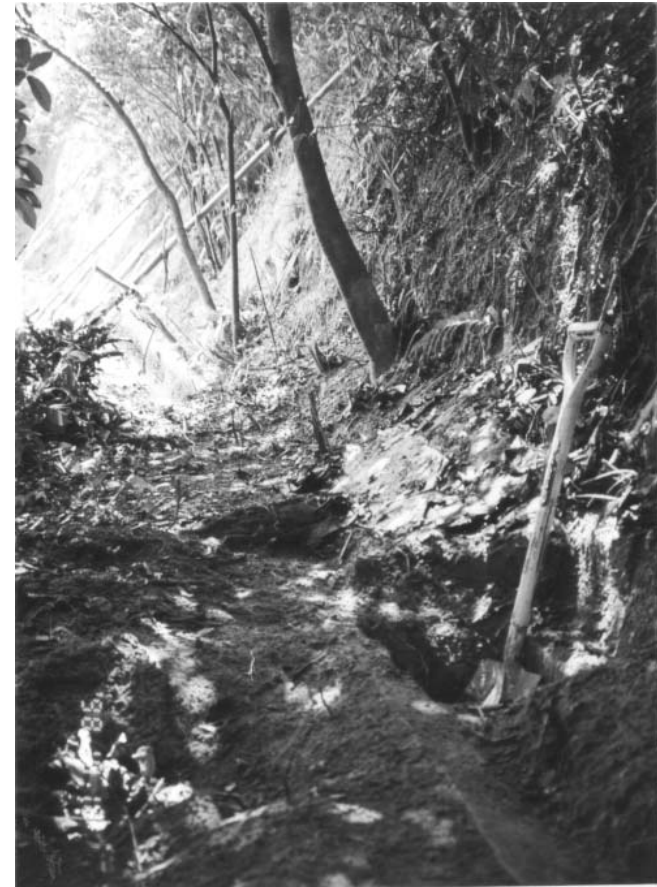
Plate 11 – View of the Drainage Channel above the Western Side of the Landslide
(Photographs taken on 12 October 1998)

Channel has been completely blocked and totally obscured over a length of between 20 m and 30 m by what appears to be slope wash material

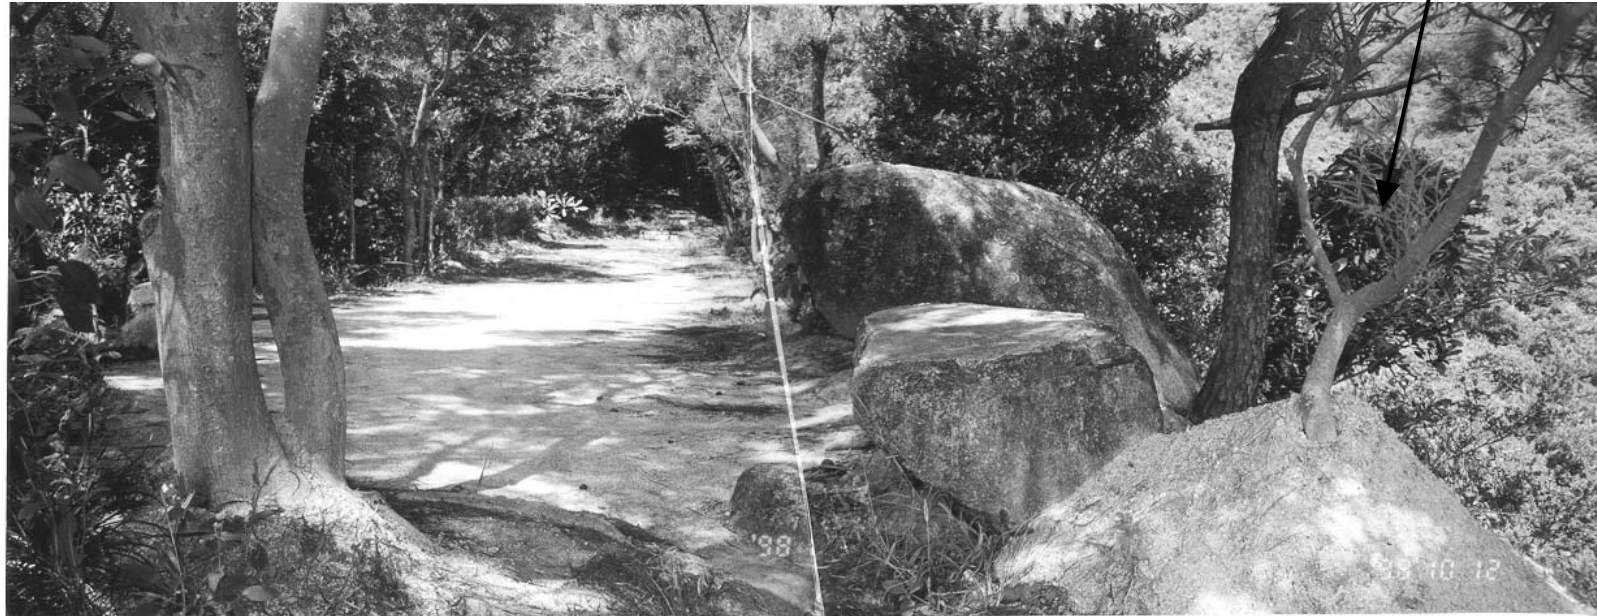
Plate 12 – View of Area above the Landslide Site
(Photograph taken on 12 October 1998)

It was also noted that an area of open ground has been formed along the ridgeline directly above the landslide, which based on API was formed some time between 1981 and 1982 (Figure 2 and Plate 12). This area has been levelled to form a platform about 30 m long by 5 m wide and is unprotected, being open to infiltration and could provide a source for rainwater runoff.

Natural terrain descends relatively steeply towards the cut slope and area of the landslide below

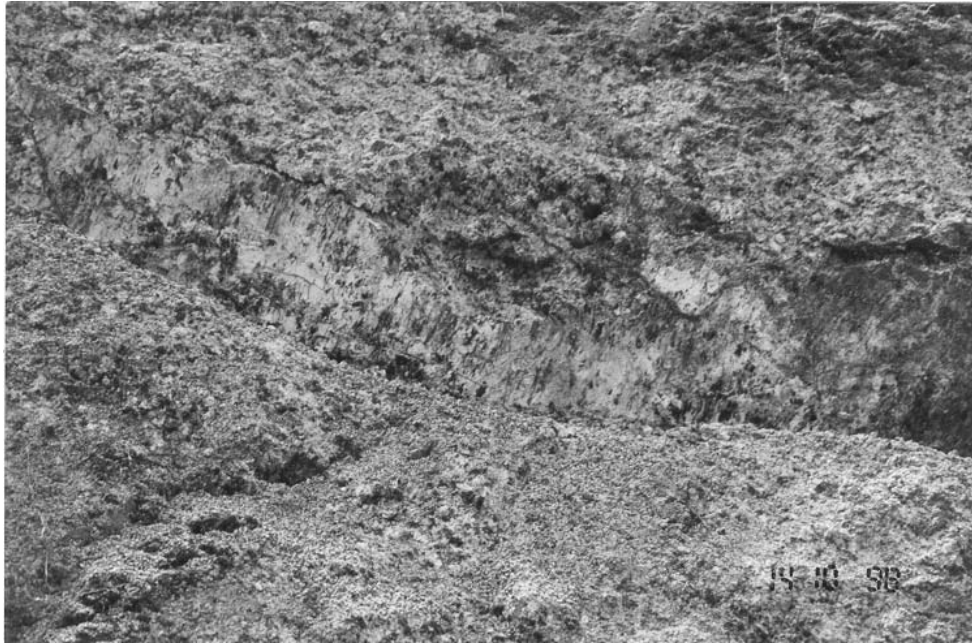
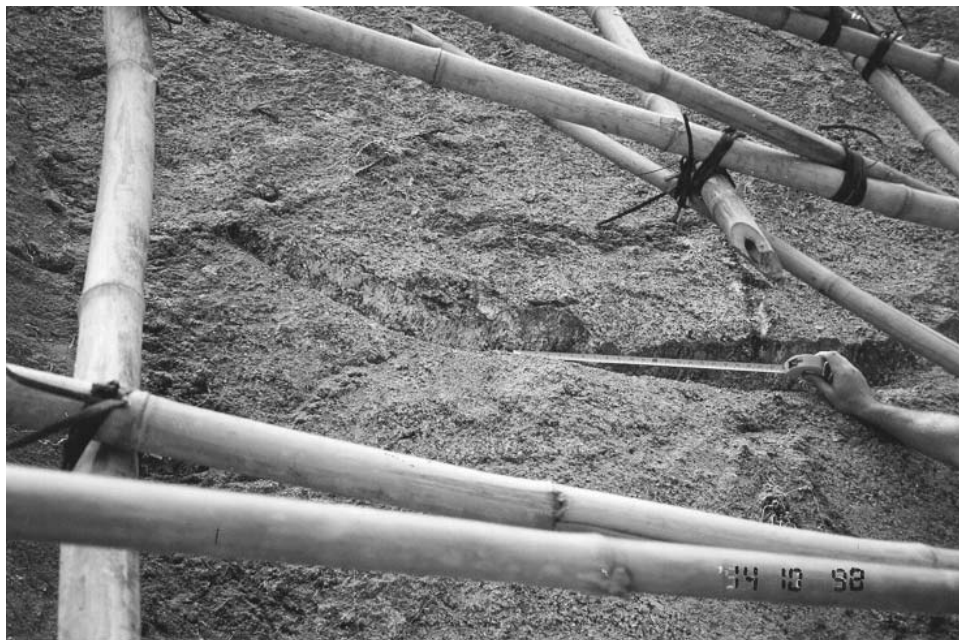
Plate 15 – View of Kaolin Infilled Joint Surfaces Exposed in the Soil Cut Slope
(Photographs taken on 14 October 1998)

Mapping of the remaining portion of the southern cut slope revealed discontinuity surfaces dipping in a similar direction and at a similar angle to that of the relict discontinuity exposed in the failure scar (Figure 5 and Table 1). These discontinuities occurred at regular intervals along the southern slope portion in both soil and rock slope portions (Plates 13 and 14), and were typically widely to very widely spaced. One such discontinuity forms a prominent exposure in the lower batter (Figure 5). It is thought that these discontinuities probably represent sheeting joints, possibly formed following erosion of surface material over the years. Along the soil slope portion of the southern cut slope the surface of the discontinuities inspected were found to be infilled with kaolin, which in places was about 2 mm to 3 mm thick. Furthermore, there was evidence of slickensiding along one of these discontinuities that dipped steeply into the slope in a southwesterly direction (Plate 15).

Kaolin infilled discontinuity dipping steeply into the slope in a southwesterly direction. Note the presence of slickensiding along the surface of the kaolin.
