SECTION 3 : DETAILED STUDY OF THE LANDSLIDE AT YUE SUN GARDEN, WO MEI ON 9 JUNE 1998

Fugro Scott Wilson Joint Venture

**This report was originally produced in October 1999
as GEO Landslide Study Report No. LSR 8/99**

This report presents the findings of a detailed study of the landslides (GEO Incident No. ME 98/6/36) that occurred within the L-shaped cut slope No. 11NE-B/C513 at Yue Sun Garden, Wo Mei, adjacent to Hiram's Highway near Sai Kung on 9 June 1998. Three landslide incidents occurred within the main southwest-facing slope of the feature and involved the failure of approximately 50 m of the slope. The resulting debris, estimated at a total volume of about 1,350 m³, inundated part of the garden nursery below, damaging a storage building, which is within a licensed area. No fatalities or injuries were reported following the landslide.

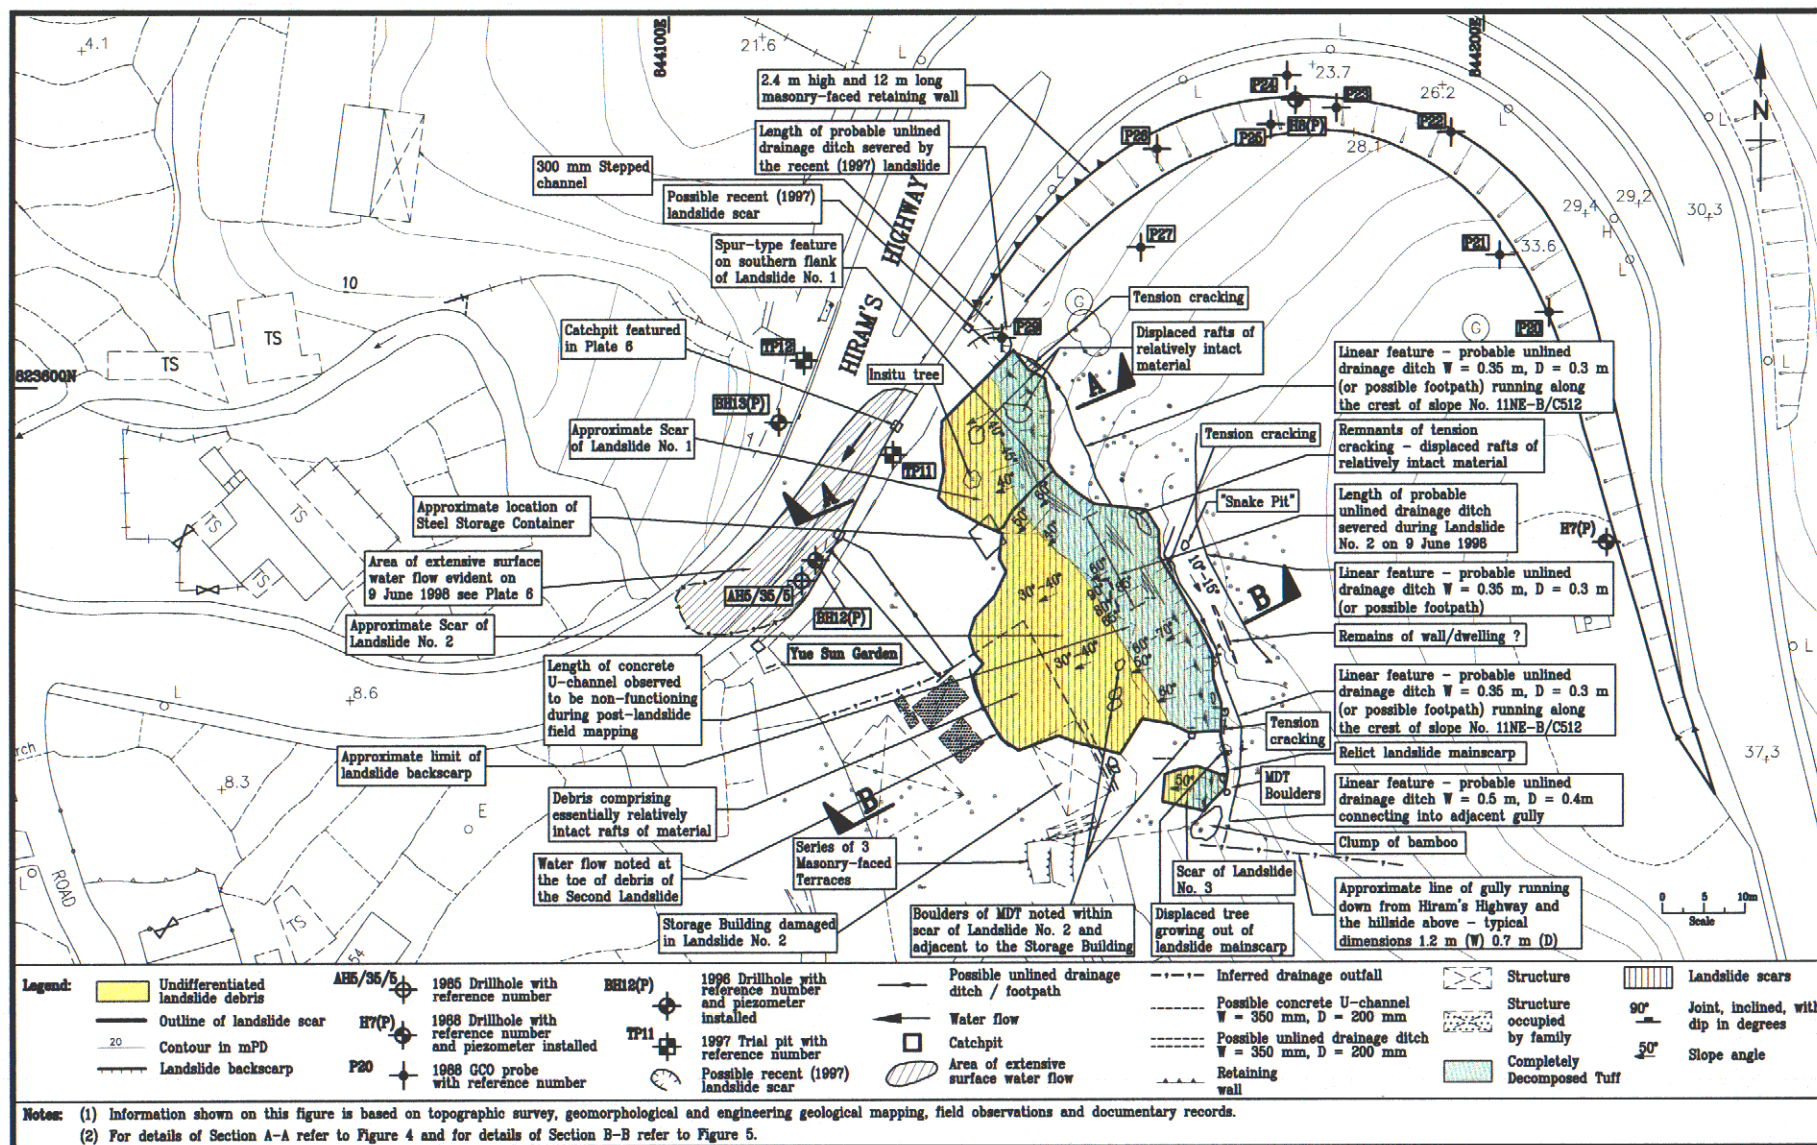
Figure 2 - Plan of the Landslides

The three landslides were all located within the main southwest-facing slope of the “L-shaped” feature, No. 11NE-B/C513 (Figure 2). The landslides comprised the failure of approximately 50 m of the slope and involved a total of about 1,350 m³ of decomposed tuff. The debris inundated the eastern half of the Yue Sun Garden Nursery below, damaging a storage building and adjacent shade racks and covering a steel storage container (Plates 3 and 4). The storage building, which was not occupied at the time of the landslides, was subsequently dismantled. The steel storage container has also been removed to another part of the site. A plan of the landslide site and two typical cross-sections through the landslide scars, corresponding to the first and second landslides, are given in Figures 2, 5 and 6 respectively.

The remains of a “spur-type” feature were noted on the southern flank of the scar of Landslide No. 1, delineating it from the adjacent landslide scar (Landslide No. 2, Plate 4). The side slopes of this “spur-type” feature varied from 50° to 60° adjacent to the mainscarp of Landslide No. 1, 40° to 50° within the mid-portion of the scar and 30° to 35° at the base of the scar. A further less pronounced “spur-type” feature, with side slopes varying between 40° and 50°, was observed immediately to the south of this feature (Figure 2).

Several boulders of Moderately Decomposed Tuff (MDT) with dimensions approximately 1 m x 1 m x 1.2 m were also noted within the lower half of this landslide scar adjacent to the damaged storage building (Figure 2).

The narrow strip of slope, about 5 m wide, separating the second and third landslides was not involved in the current incident although it has failed in the past (Figure 2). Relict tension cracking as well as a relict landslide mainscarp, moss covered and overgrown with other vegetation, were observed within this densely-vegetated area, and a boulder of MDT with dimensions approximately 1 m x 1 m x 1.5 m was noted lodged between trees at about mid-slope (Plate 10).

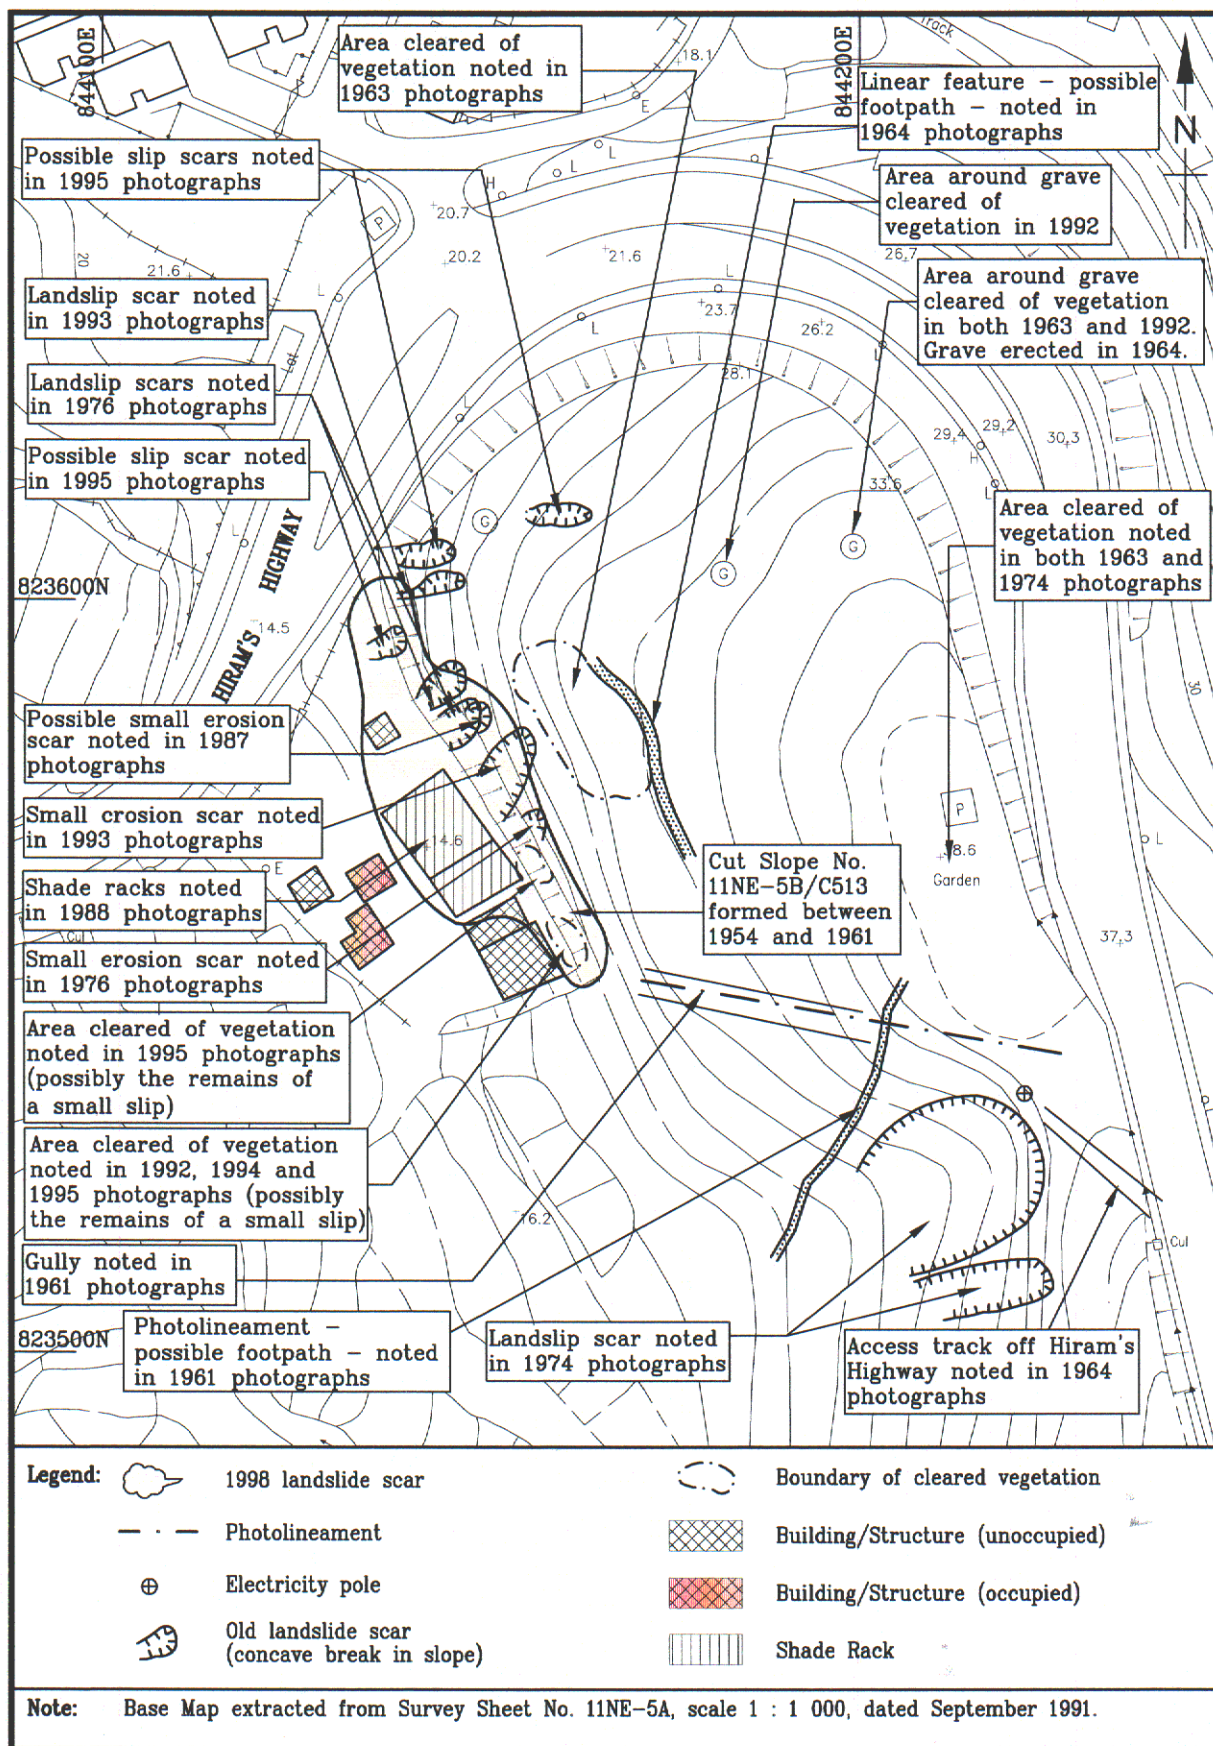
Figure 3 - History of Site Development

Several relict landslides have been identified, from low level aerial photographs, within the main southwest-facing slope of feature No. 11NE-B/C513 (Figure 3), most notably in 1976 (two locations) and 1993 (one location) when significant failures (likely to be in excess of 50 m³) occurred. In all three cases, landsliding appears to have involved the hillside above. Additionally, numerous other possible erosion/landslide scars have been noted from API within this part of the feature in the past 20 years – in 1976, 1977, 1987, 1992, 1993, 1994 and 1995 (all singular incidents with the exception of the last case when four separate incidents were noted). This history of past instability has been confirmed during interviews with longstanding members of staff at Yue Sun Garden and residents of the area. Furthermore, it is understood from discussions with members of staff of Yue Sun Garden that no formal repairs were carried out to these landslide scars. It appears that the landslide scars were simply allowed to re-vegetate, except those close to the toe of the slope which were worked to form platforms and were subsequently incorporated into the garden nursery (additional “terraces” for the plants).

In 1995, the GEO commenced the Natural Terrain Landslide Study (NTLS) as part of a series of studies to investigate the landslide hazards associated with natural terrain in Hong Kong. Phase I of the NTLS comprised the establishment of an inventory of landslides on natural terrain, the Natural Terrain Landslide Inventory (NTLI), from the interpretation of high level aerial photographs dating from 1945 to 1994 (King, 1997). In the NTLI, no relict landslide scars were identified on the hillside between the ridgeline and slope No. 11NE-B/C513. The API carried out as part of this study has confirmed these observations with the exception of the relict landslide scar to the southeast of slope No. 11NE-B/C513, in a depression on the western face of the ridge (Figure 3).

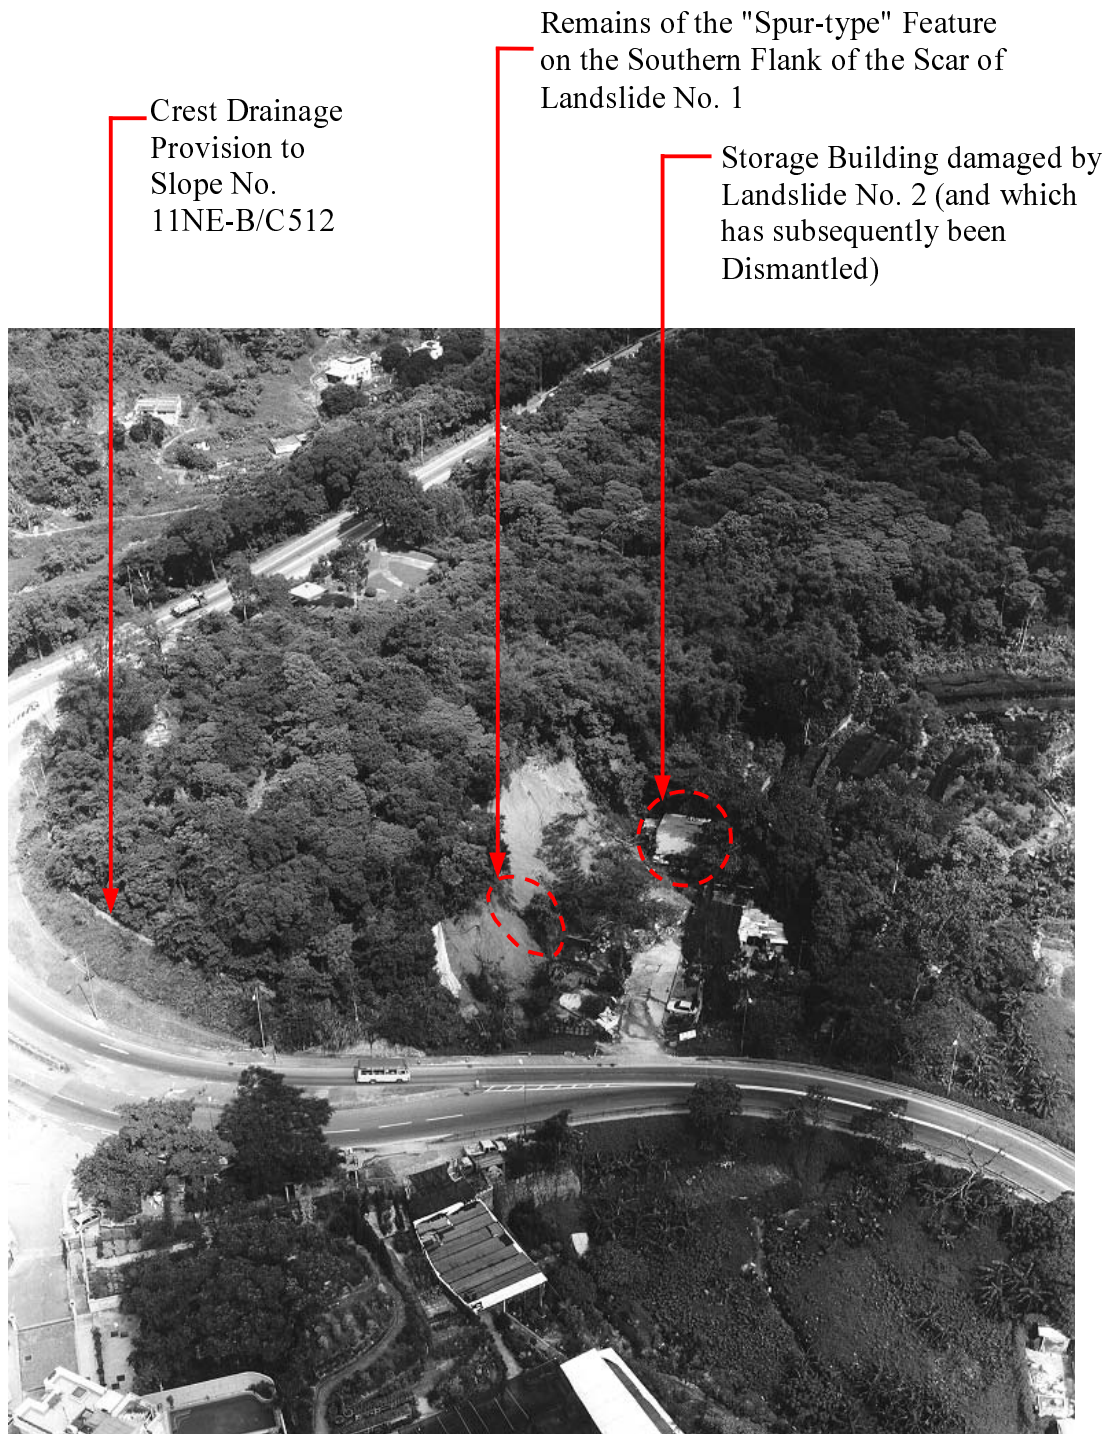
Plate 1 – The Landslides of 9 June 1998
(Photograph taken on 29 June 1998)

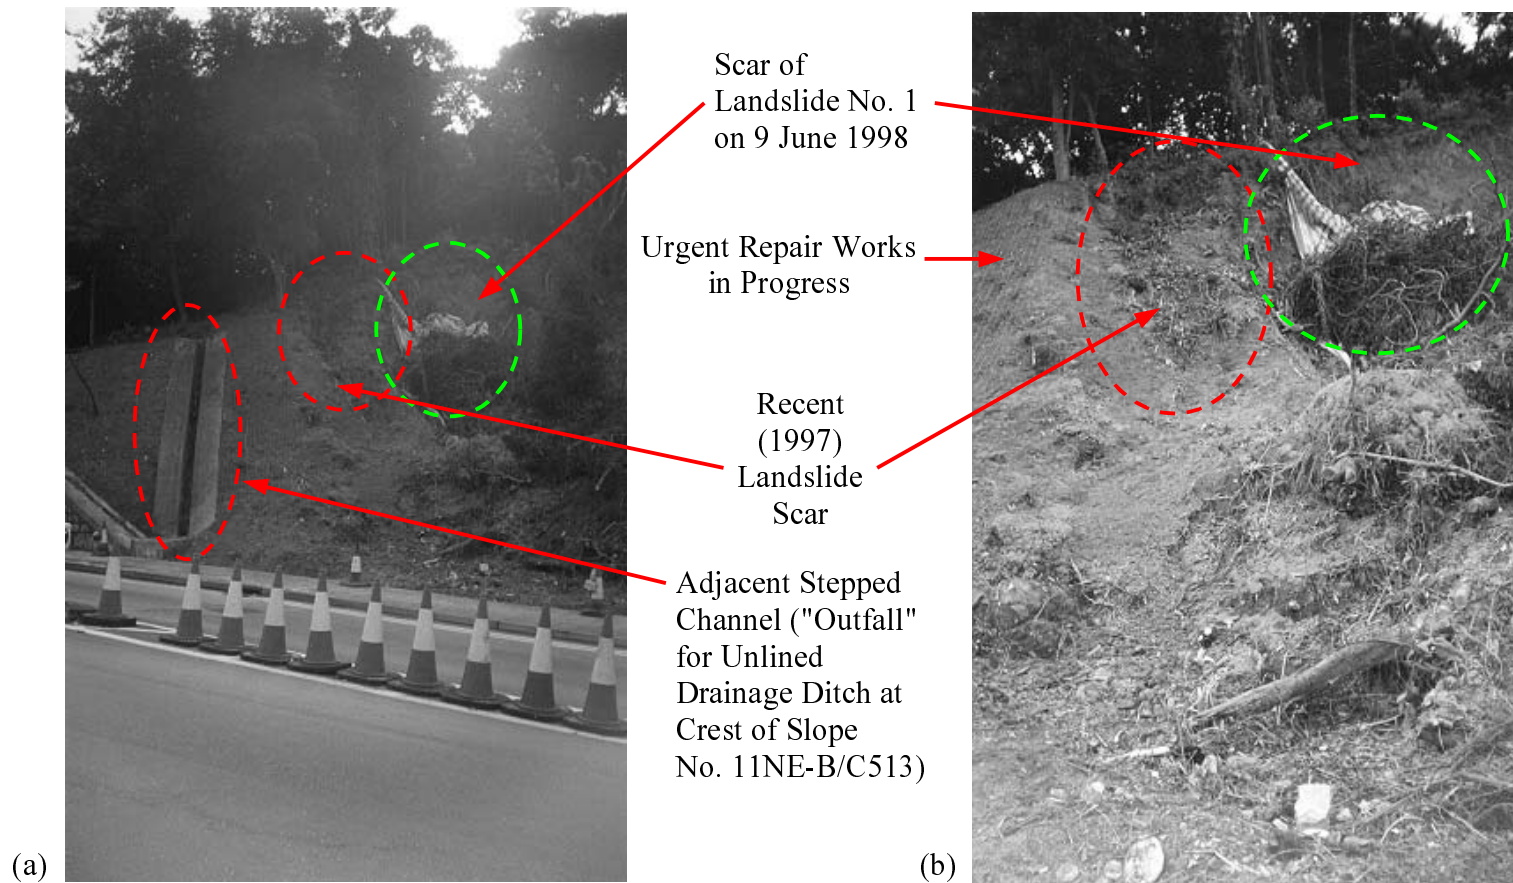
In addition, a GEO staff member indicated that a minor landslide occurred within the main southwest-facing slope of feature No. 11NE-B/C513 adjacent to Hiram's Highway following heavy rainfall at the beginning of July 1997. Vegetation clearance associated with urgent repair works carried out in August 1998 following the current landslides revealed a relict landslide scar, which coincided with the above indicated location of the 1997 failure (Plate 2).

Plate 2 – General Views of a Possible Recent (1997) Landslide Scar adjacent to Hiram's Highway
(Photographs taken on 28 August 1998)

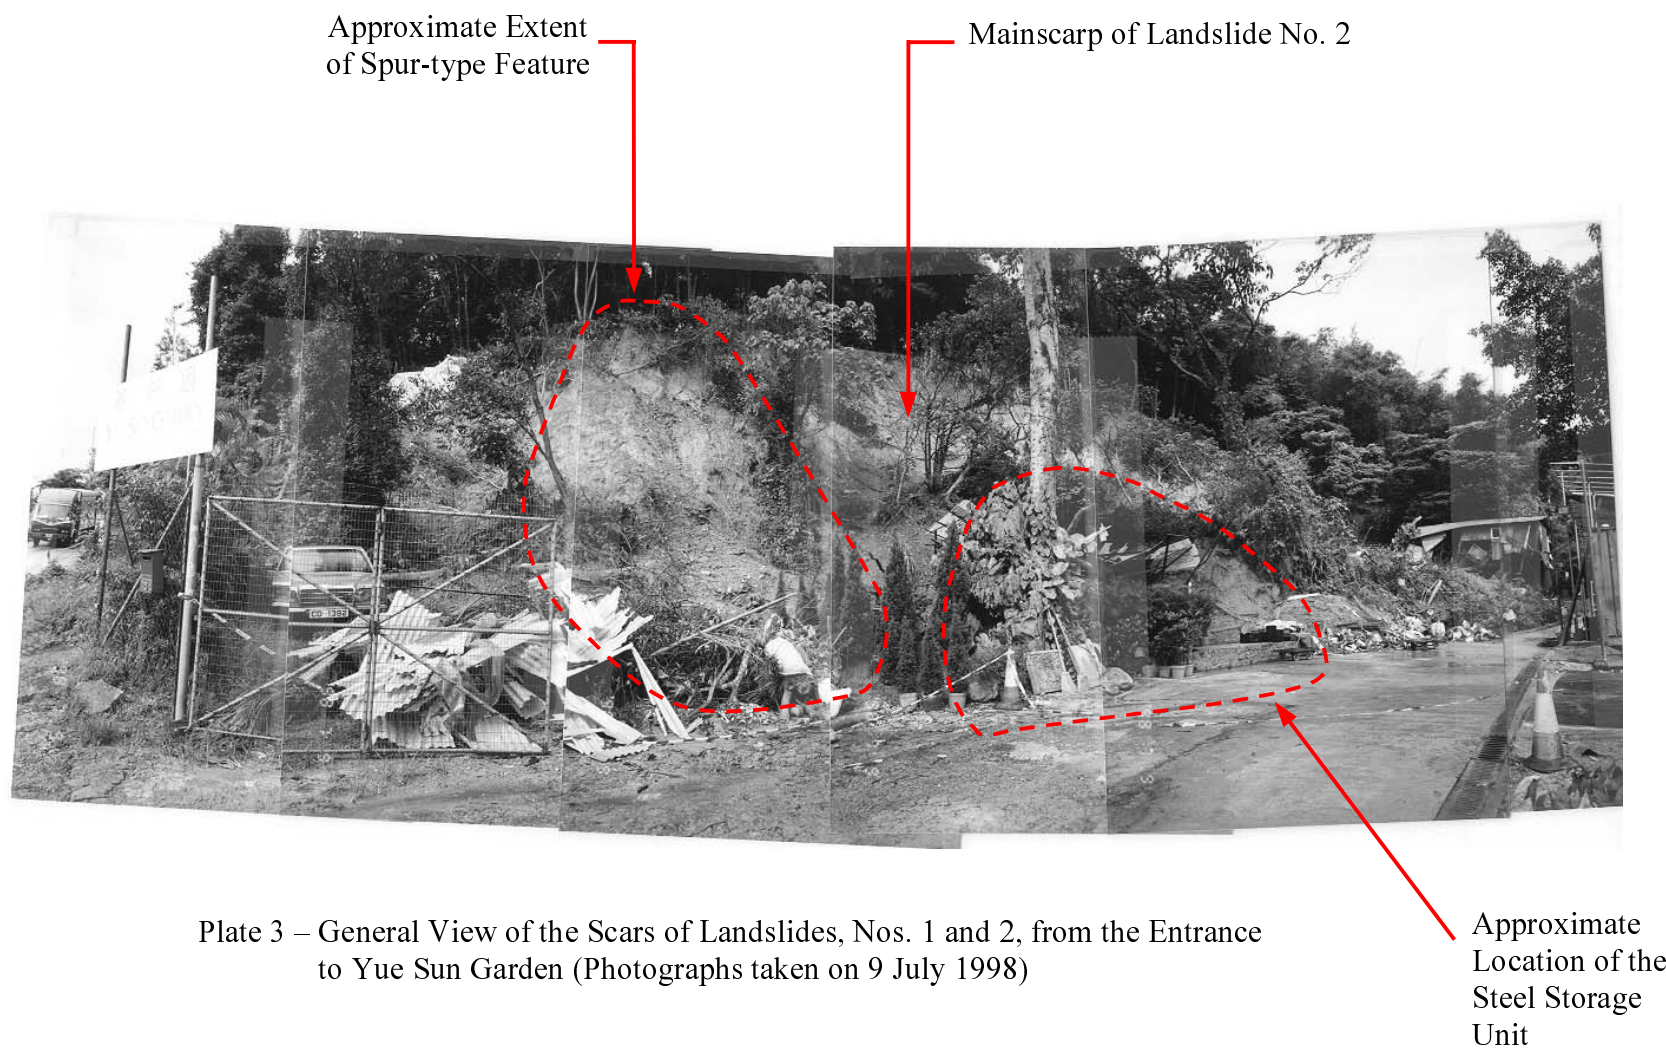
Plate 3 – General View of the Scars of Landslides, Nos. 1 and 2, from the Entrance to Yue Sun Garden (Photographs taken on 9 July 1998)

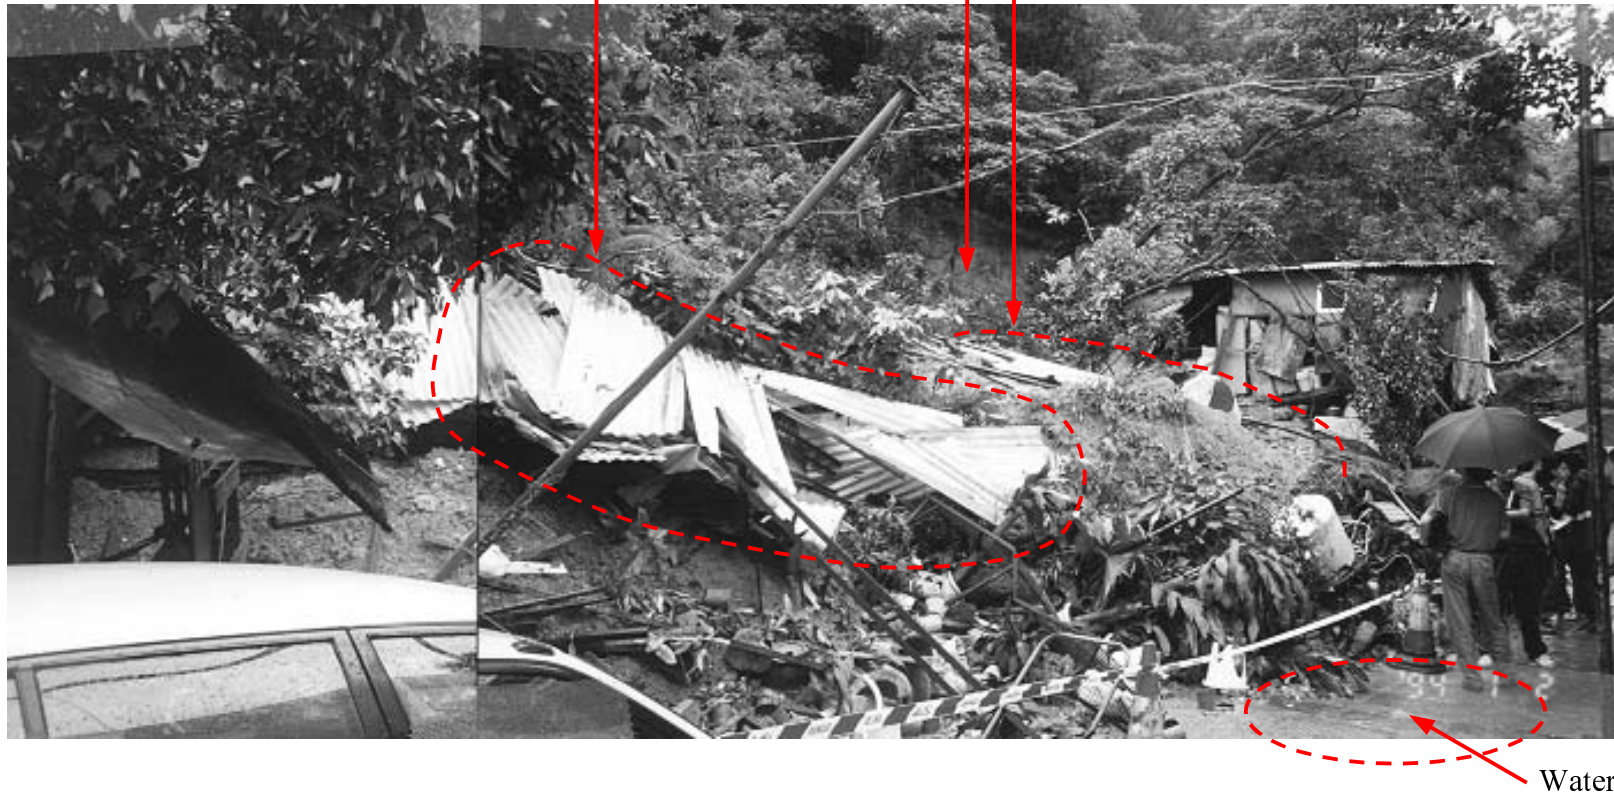
Plate 4a – General View at the Toe of the Scar of Landslide No. 2 showing the Damaged Storage Building.
Note the Water at the Toe of the Debris (Photographs taken on 11 June 1998)

Approximate Extent of
the Relatively Intact
Slab of Decomposed
Material which resulted
from Landslide No. 2

Storage Building
damaged in
Landslide No. 2
(and which has
subsequently been
Dismantled)

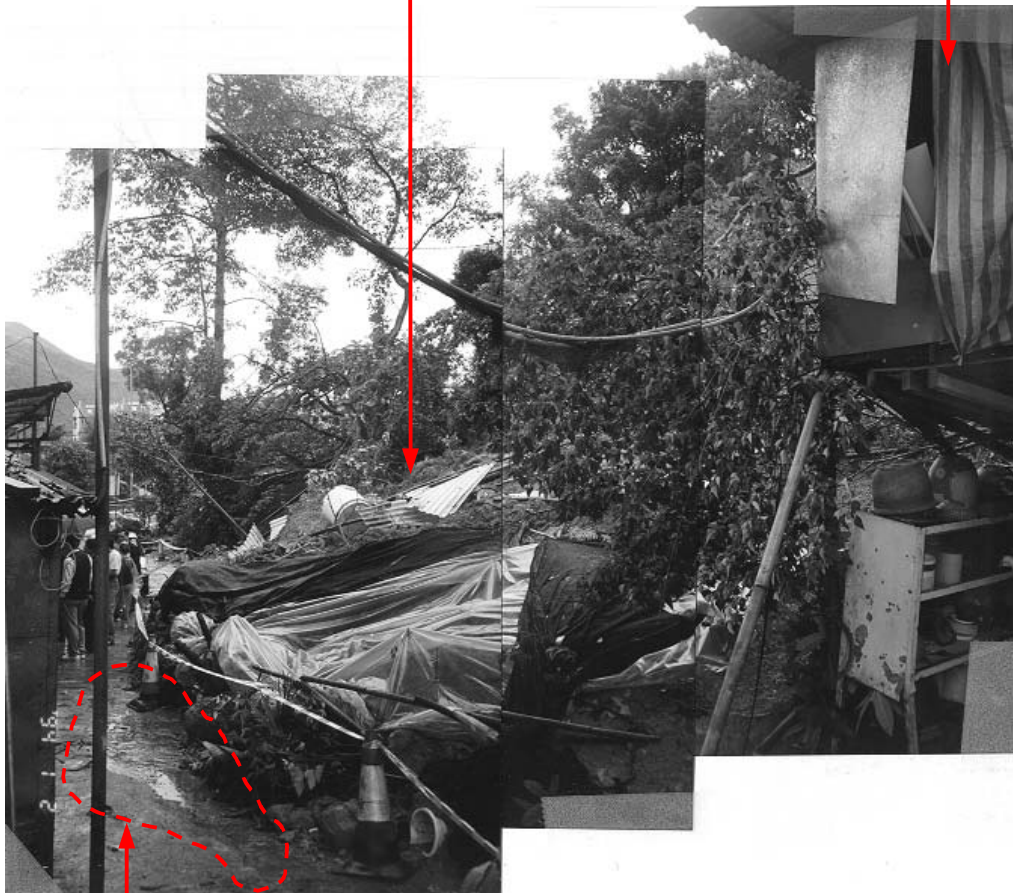
Water Observed Flowing in a South-North Direction at the
Toe of the Debris which resulted from Landslide No. 2

Plate 4b - General View at the Toe of the Scar of Landslide No. 2 showing
the Damaged Storage Building. Note the Water at the Toe of the
Debris (Photographs taken on 11 June 1998)

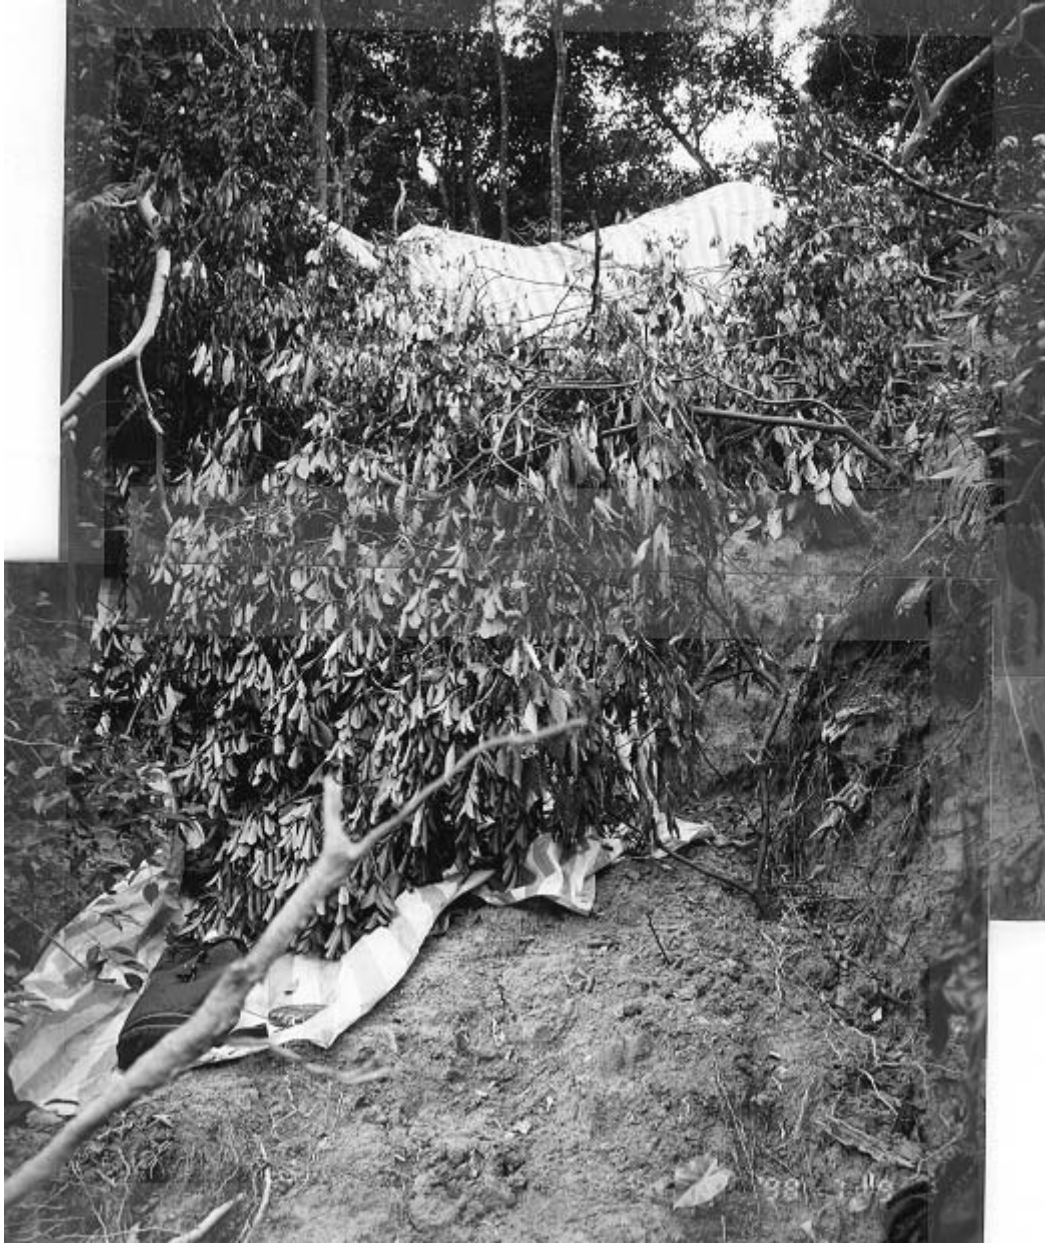
Plate 5 – General View of the Scar resulting from Landslide No. 1
(Photographs taken on 9 July 1998)

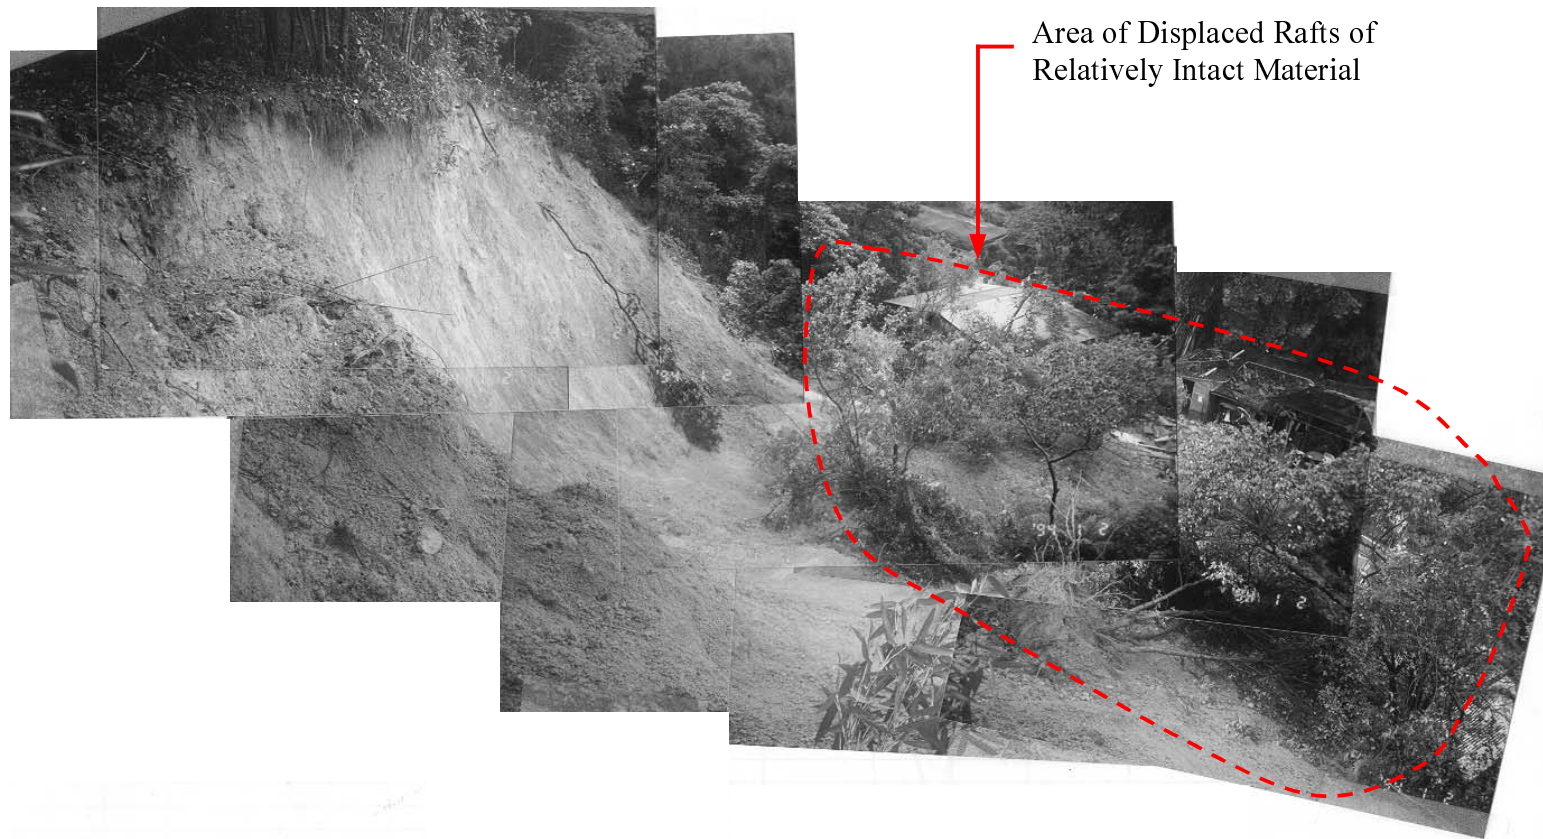
Plate 7a – General View of the Scar resulting from Landslide No. 2
(Photographs taken on 11 June 1998)

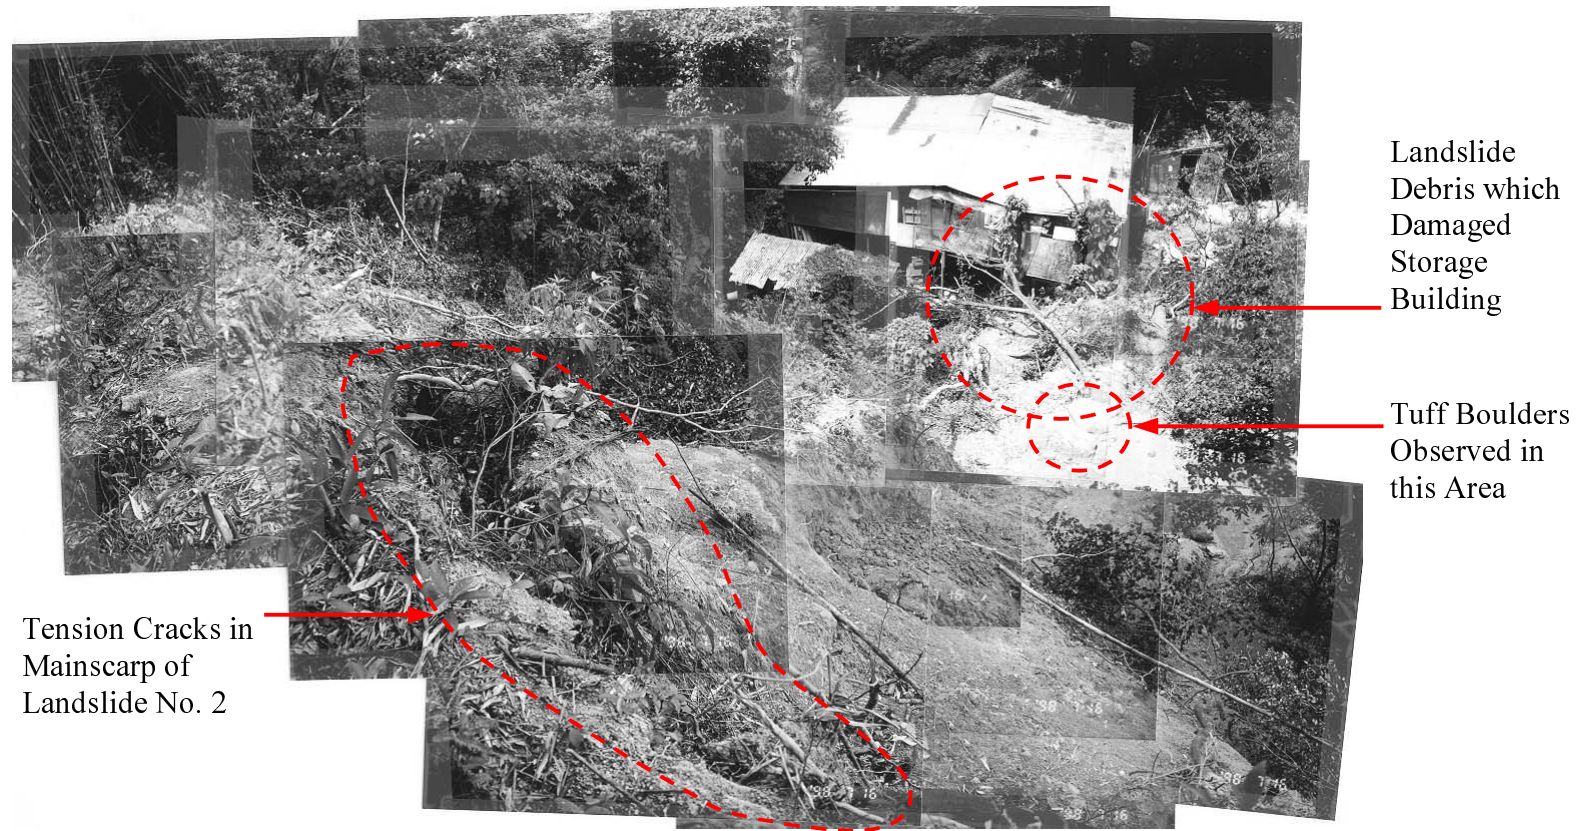
Plate 7b – General View of the Scar resulting from Landslide No. 2
(Photographs taken on 16 July 1998)

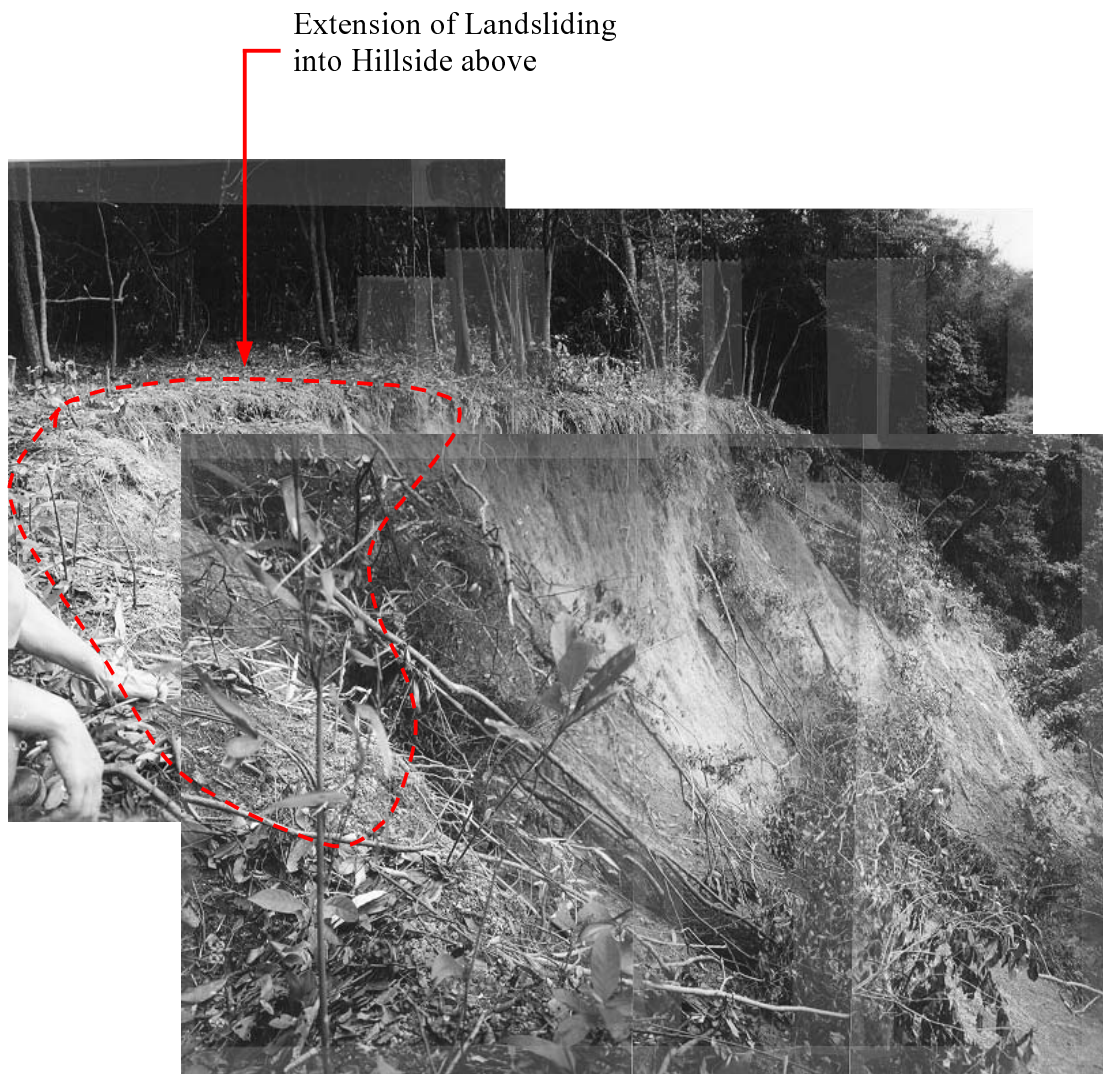
Plate 8 – General View of the Mainscarp resulting from Landslide No. 2
(Photographs taken on 9 July 1998)

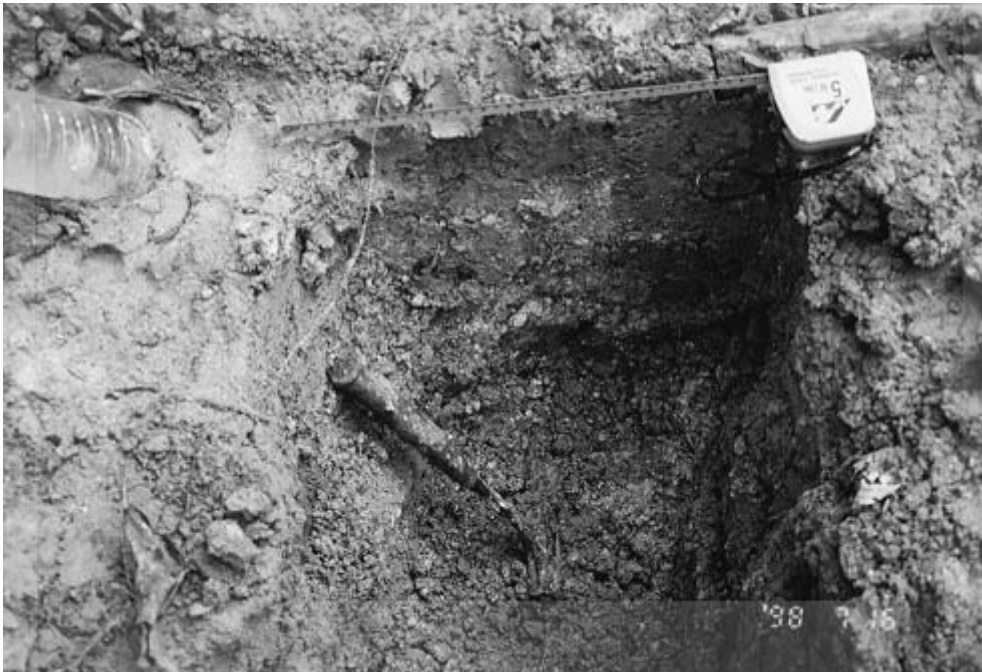
Plate 9 – Intact Nature of the Slab of Debris at the Toe of the Slope
resulting from Landslide No. 2
(Photograph taken on 16 July 1998)

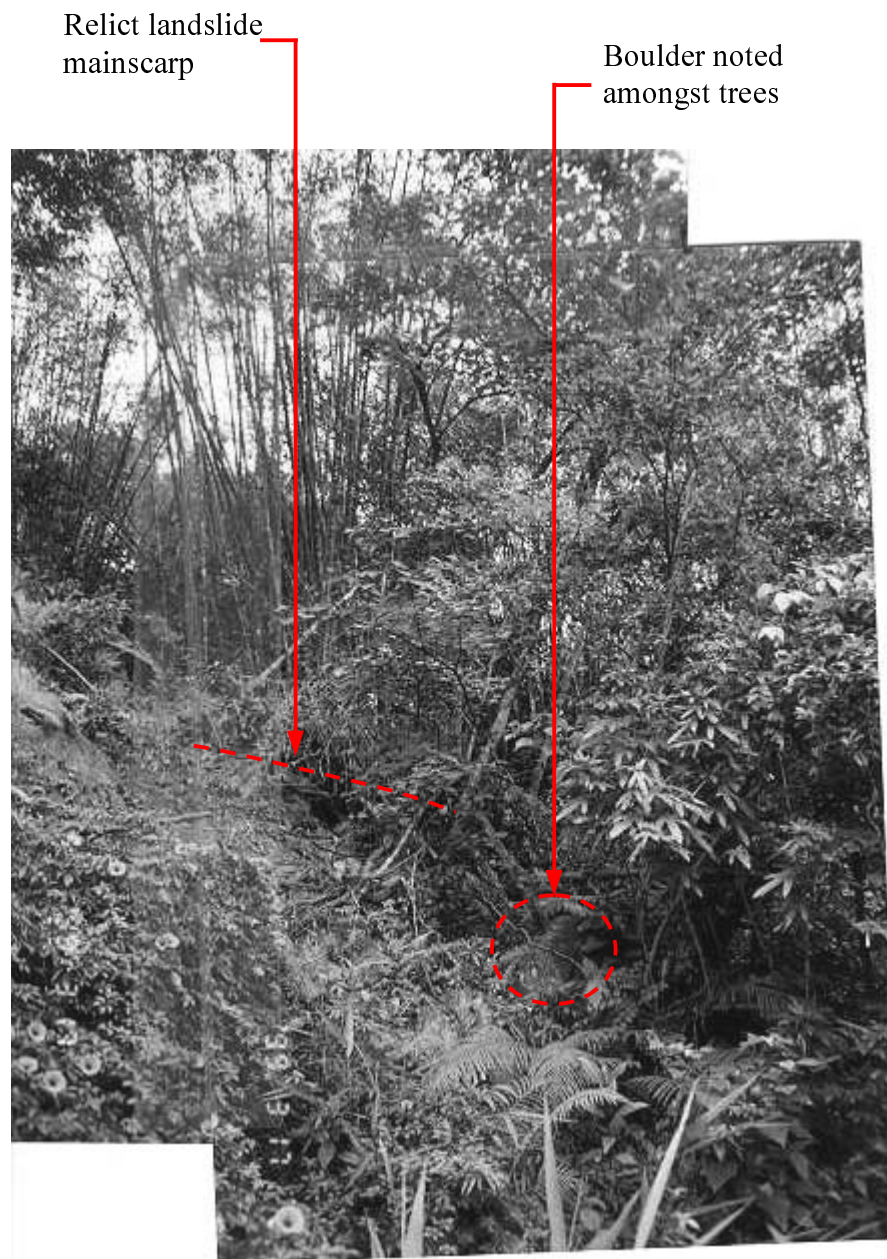
Plate 10 – The "Stable" Portion of the Main Southwest-facing Slope of the Feature between Landslides Nos. 2 and 3. The Boulder is considered indicative of Previous Instability within this part of the Slope (Photographs taken on 17 March 1999)

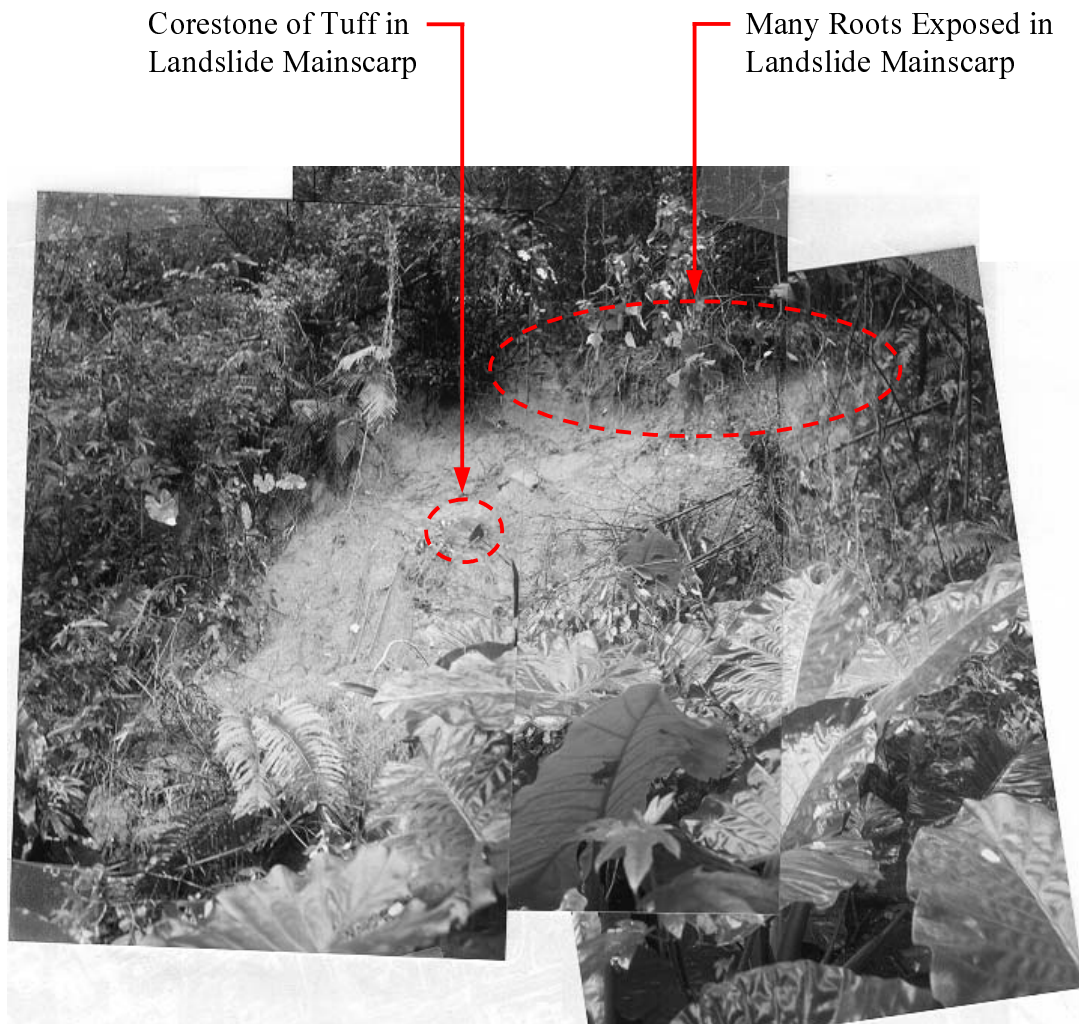
Landslide No. 3 took place at the junction between the main and subsidiary slopes of the feature (Plate 11) and involved approximately 50 m³ of material. This, the final landslide does not appear to have been directly connected to the first two incidents as a portion of "intact" slope (see above) was observed between this failed area and the two earlier areas of collapsed ground during FSW's post-landslide field mapping. The scar of this landslide was approximately 10 m wide and 8 m long with a maximum depth of about 1 m. The sub-vertical mainscarp, with a slope angle of about 80°, was typically 2 m deep. The remainder of the landslide scar had slope angles typically of the order of 50°. The material

Plate 11a – General View of Scar resulting from Landslide No. 3
(Photographs taken on 11 June 1998)

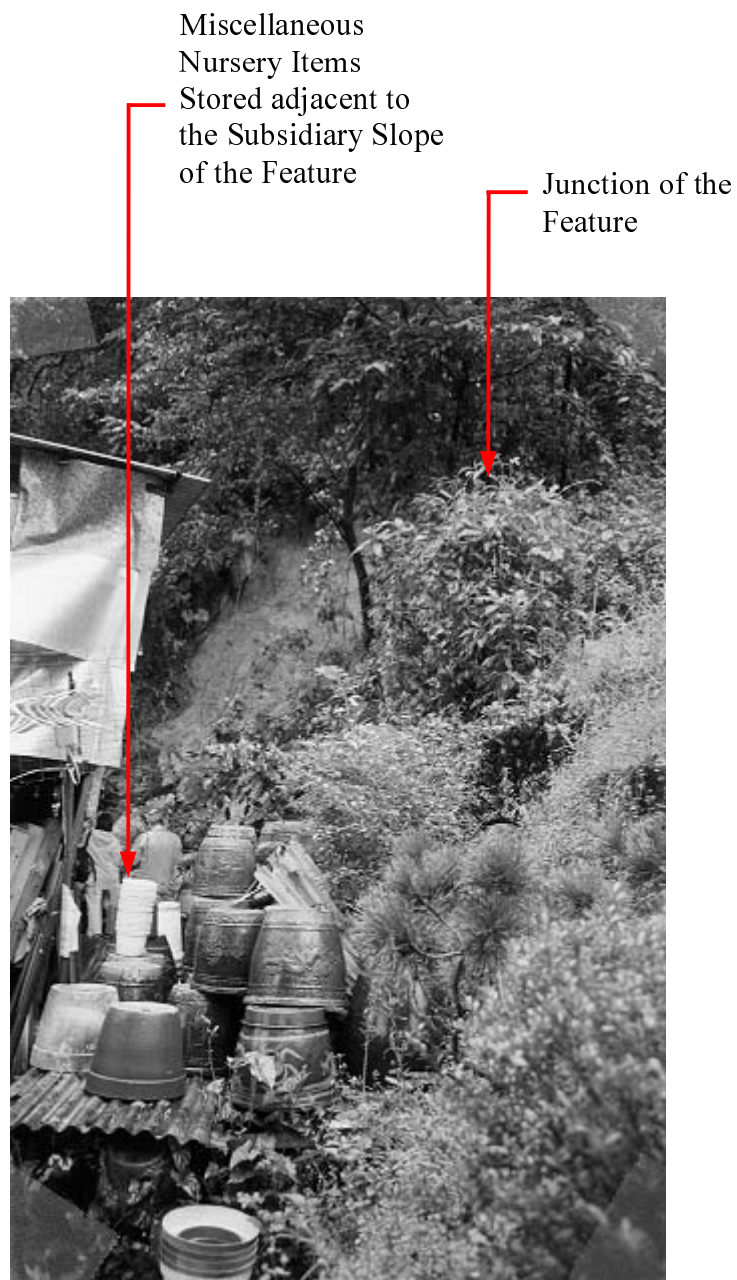
Plate 11b – General View of the Scar resulting from Landslide No. 3
(Photograph taken on 11 June 1998)
