SECTION 3 : DETAILED STUDY OF THE LANDSLIDE AT YUE SUN GARDEN, WO MEI ON 9 JUNE 1998

Fugro Scott Wilson Joint Venture

**This report was originally produced in October 1999
as GEO Landslide Study Report No. LSR 8/99**

This report presents the findings of a detailed study of the landslides (GEO Incident No. ME 98/6/36) that occurred within the L-shaped cut slope No. 11NE-B/C513 at Yue Sun Garden, Wo Mei, adjacent to Hiram's Highway near Sai Kung on 9 June 1998. Three landslide incidents occurred within the main southwest-facing slope of the feature and involved the failure of approximately 50 m of the slope. The resulting debris, estimated at a total volume of about 1,350 m³, inundated part of the garden nursery below, damaging a storage building, which is within a licensed area. No fatalities or injuries were reported following the landslide.

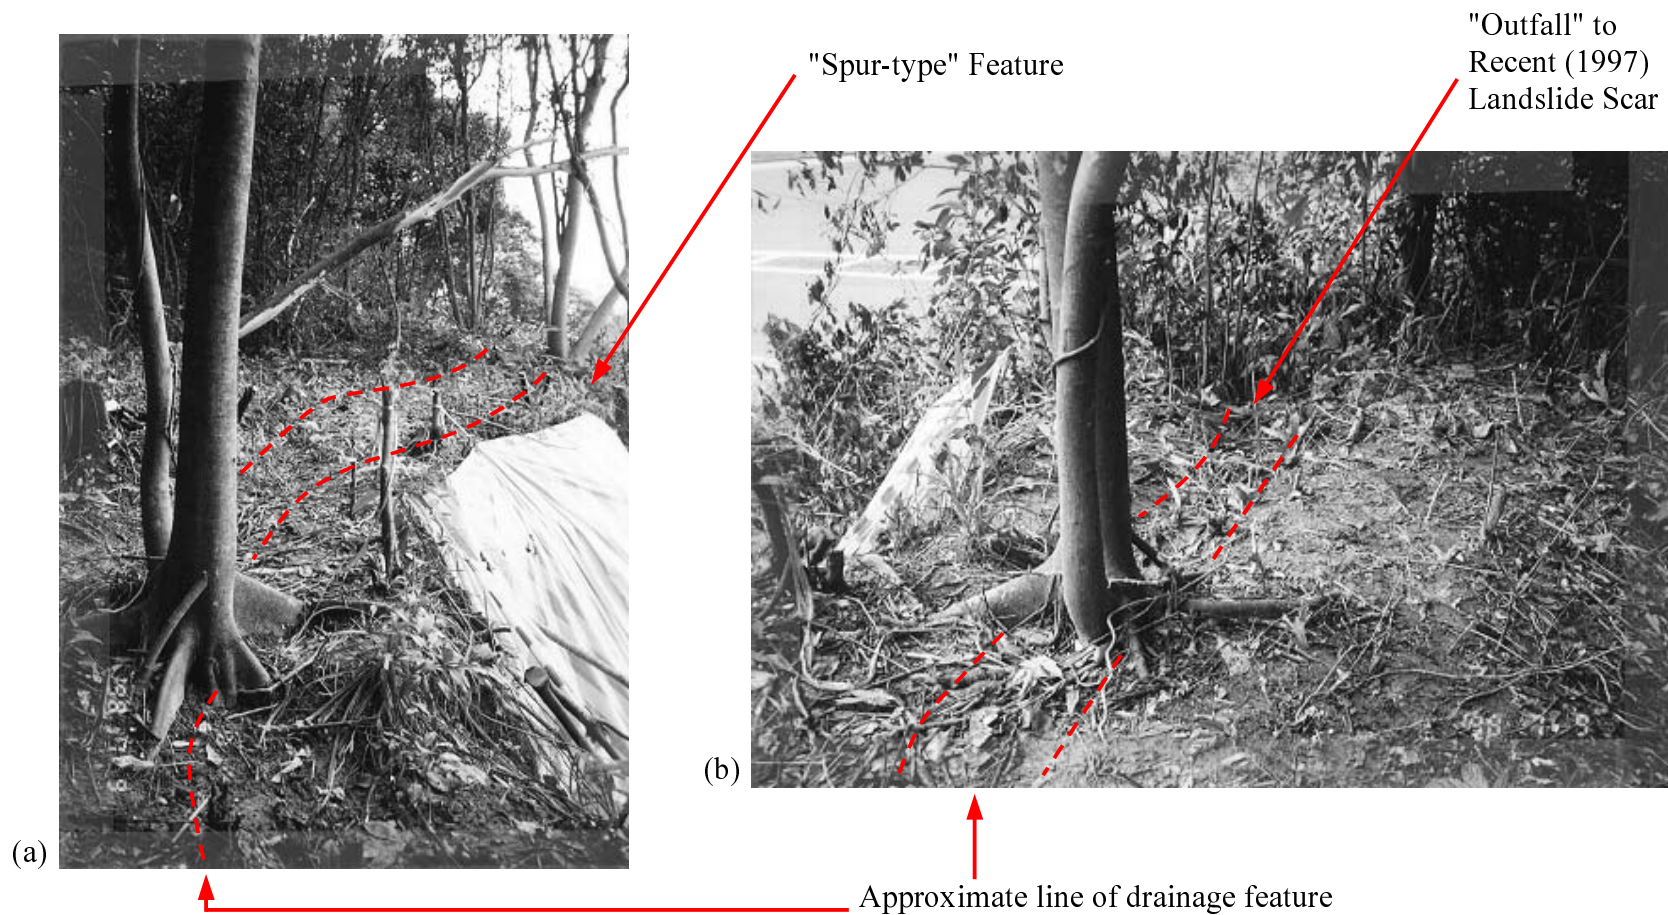
Plate 12 – Possible Footpath/Drainage Ditch running along the Crest of the Main Southwest-facing Slope of the Feature.
The Drainage Ditch appears to "outfall" to the adjacent roadside slope (Photographs taken on 9 July 1998)

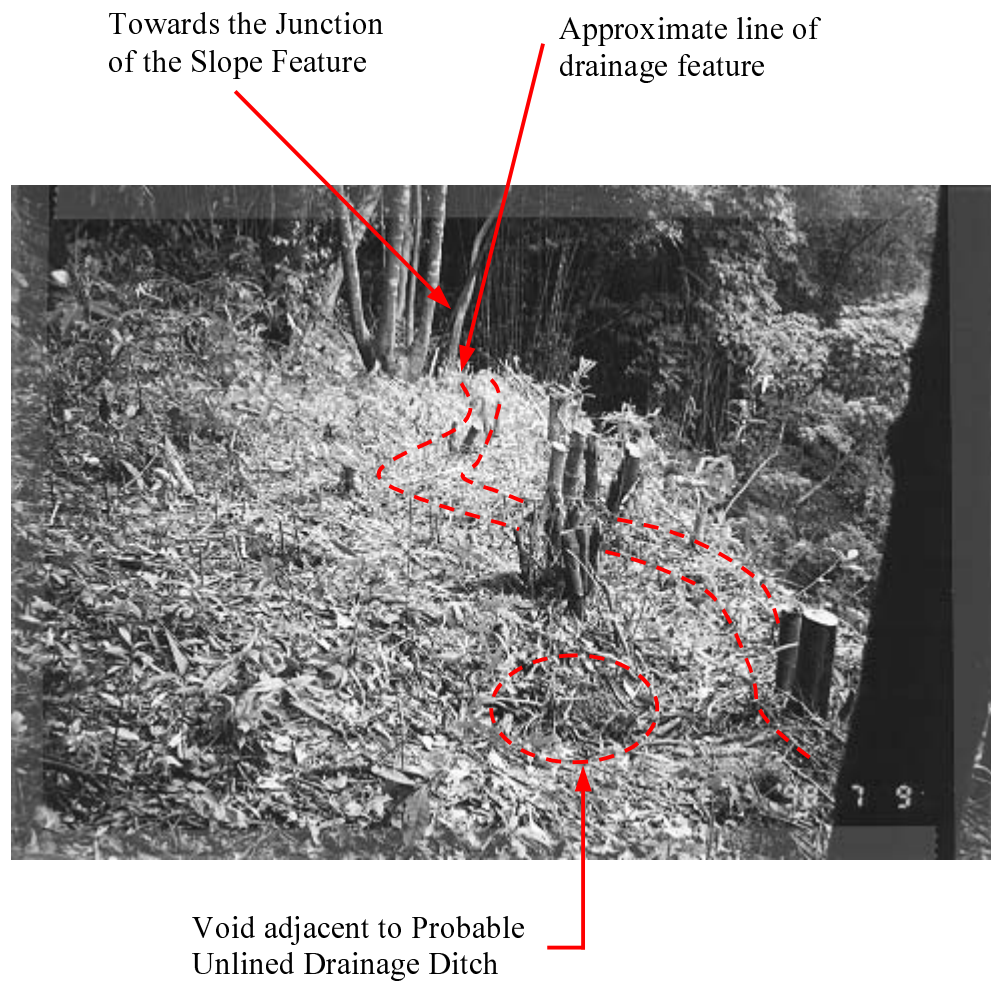
Plate 13 – Possible Footpath/Drainage Ditch running along the Crest of the
Main Slope of the Feature (Photograph taken on 9 July 1998)

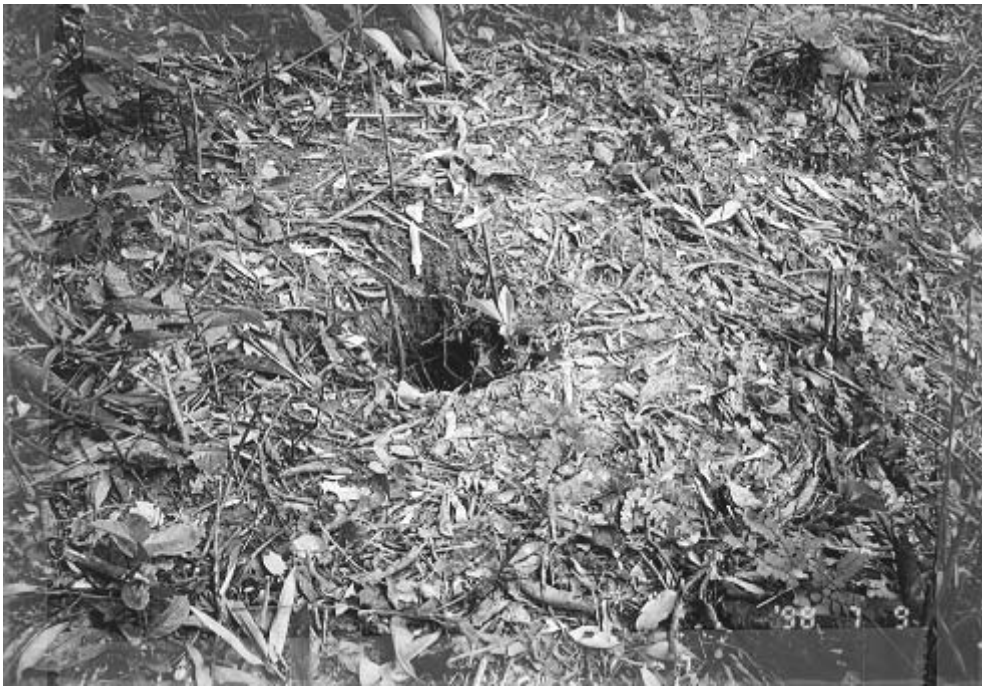
Plate 14 – Possible Snake Pit at the Crest of the Main Slope of the Feature, mid-way along its length (Photograph taken on 9 July 1998)

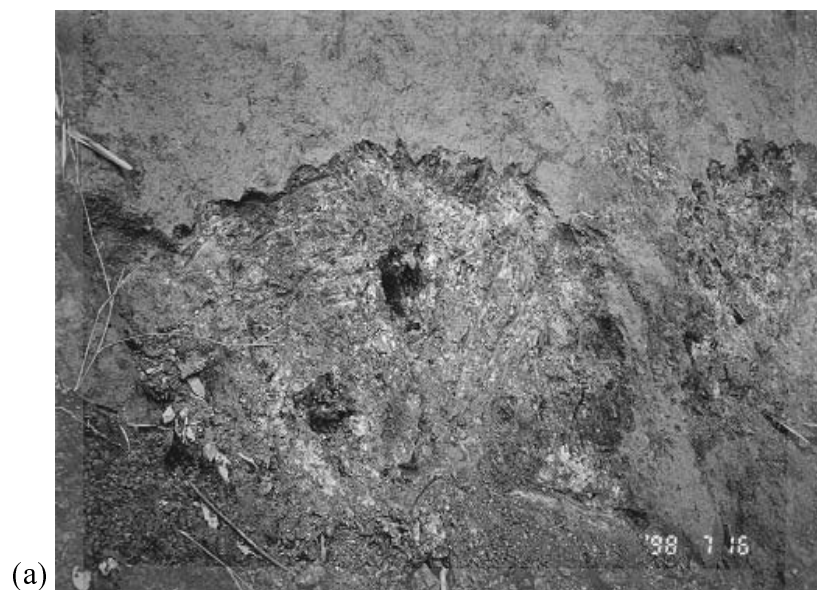
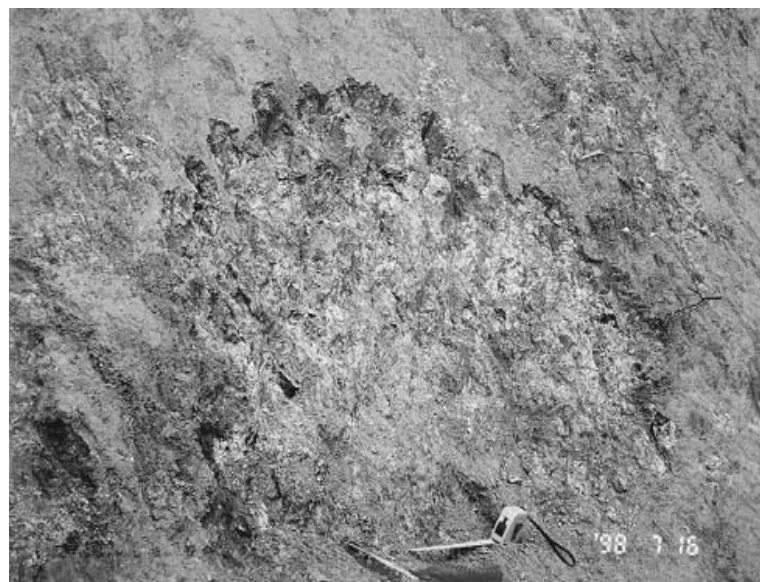
Plate 15 – Exposures of the Decomposed Tuff in the Mainscarp of Landslide No. 2. Typical Spheroidal Weathering Profile Evident (Photographs taken on 16 July 1998)

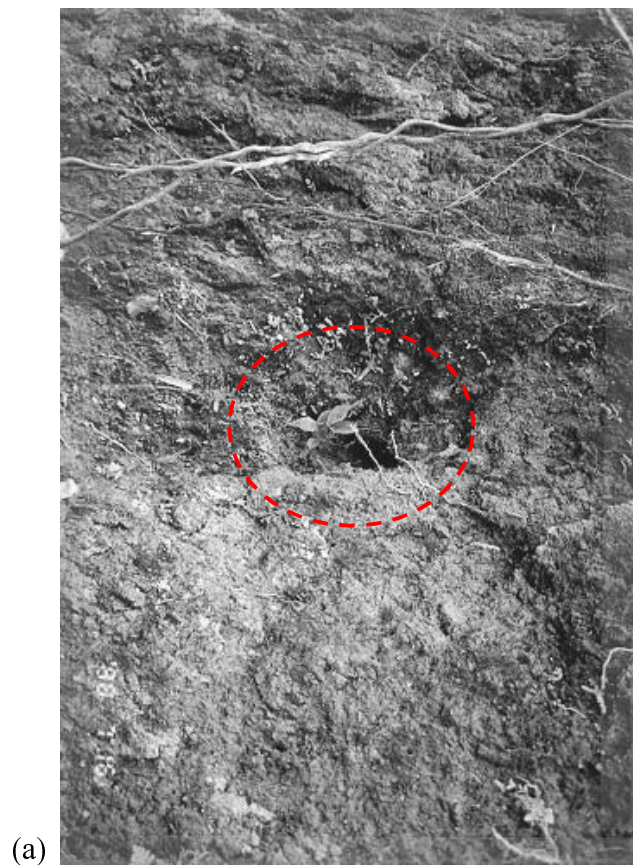
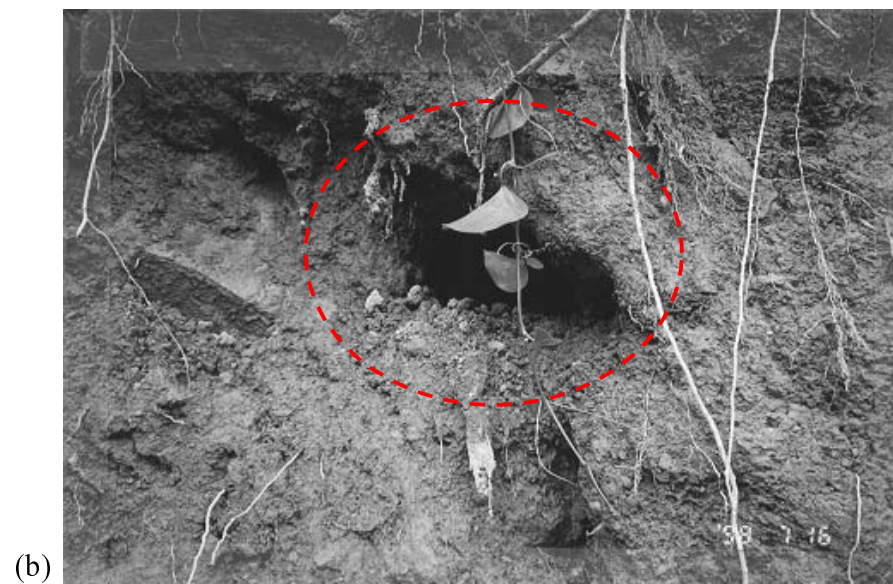
No seepages were noted during the inspections by FSW of each of the three landslide mainscarps, although it should be noted that these inspections were some time after the landslides occurred. Numerous possible erosion pipes, typically less than 5 mm in diameter, were, however, observed in the upper few metres of the landslide mainscarps. In addition, two such features with diameters in excess of 100 mm were noted. All these features were dormant during FSW's post-landslide site inspections.

Plate 16 – Possible Erosion Pipes Observed on the Southern Flank of the Mainscarp of Landslide No. 2
(Photographs taken on 16 July 1998)

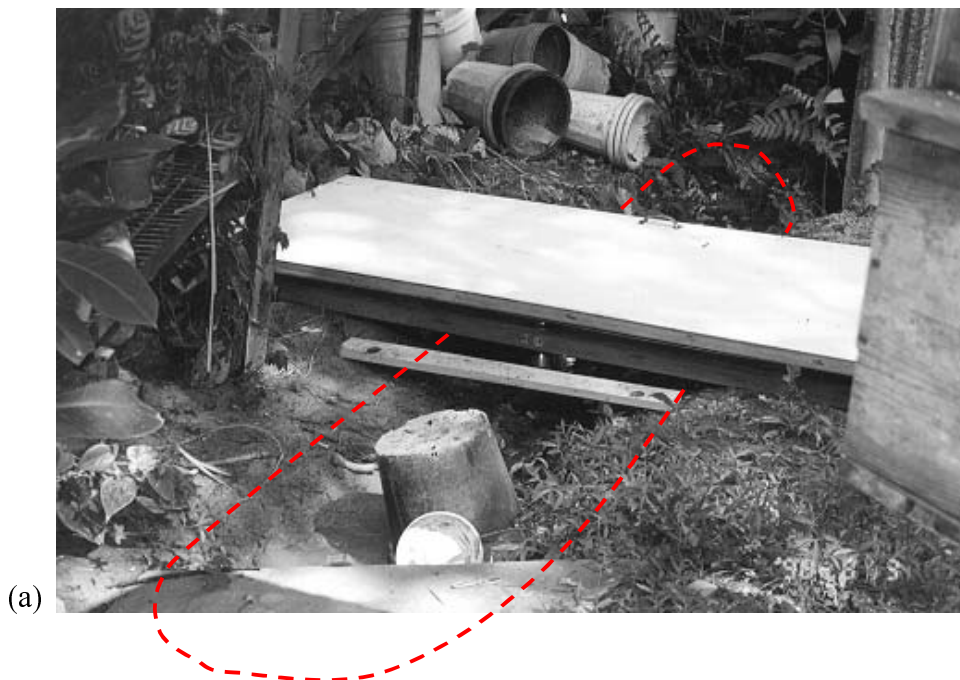
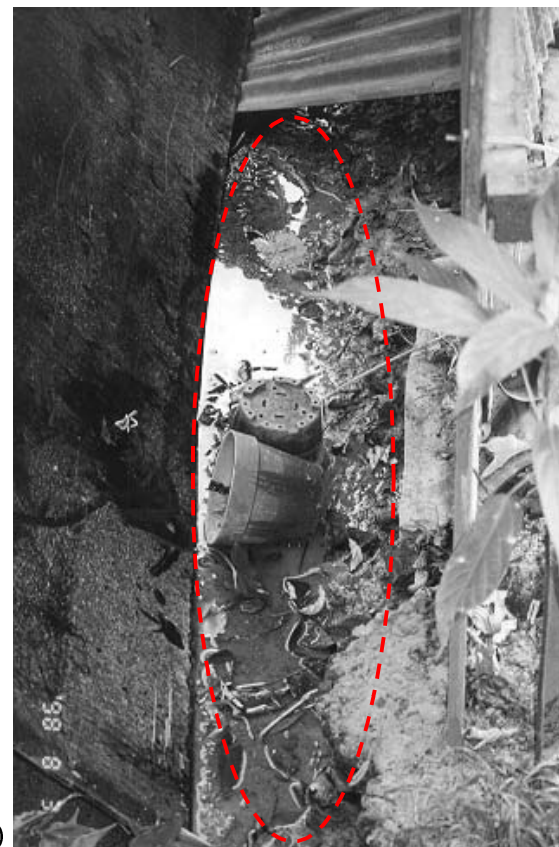
Plate 17 – Water at the Toe of the Slope, adjacent to the Junction of the Feature, behind the Damaged Storage Building
(Photograph taken on 3 August 1998)
