INVESTIGATION OF SOME SELECTED LANDSLIDES IN 1998 (VOLUME 4)

GEO REPORT No. 111

SECTION 1 : DETAILED STUDY OF THE LANDSLIDE AT THE HONG KONG STADIUM ON 24 MAY 1998

This report presents the findings of a detailed study of the landslide (GEO Incident No. HK 98/5/2) that occurred on the northeast-facing slopes bounding the Hong Kong Stadium on 24 May 1998. Debris from the landslide was deposited primarily onto the stadium perimeter access road below although some debris was also noted on the adjacent Level 3 podium of the stadium. No fatalities or injuries were reported following the landslide.

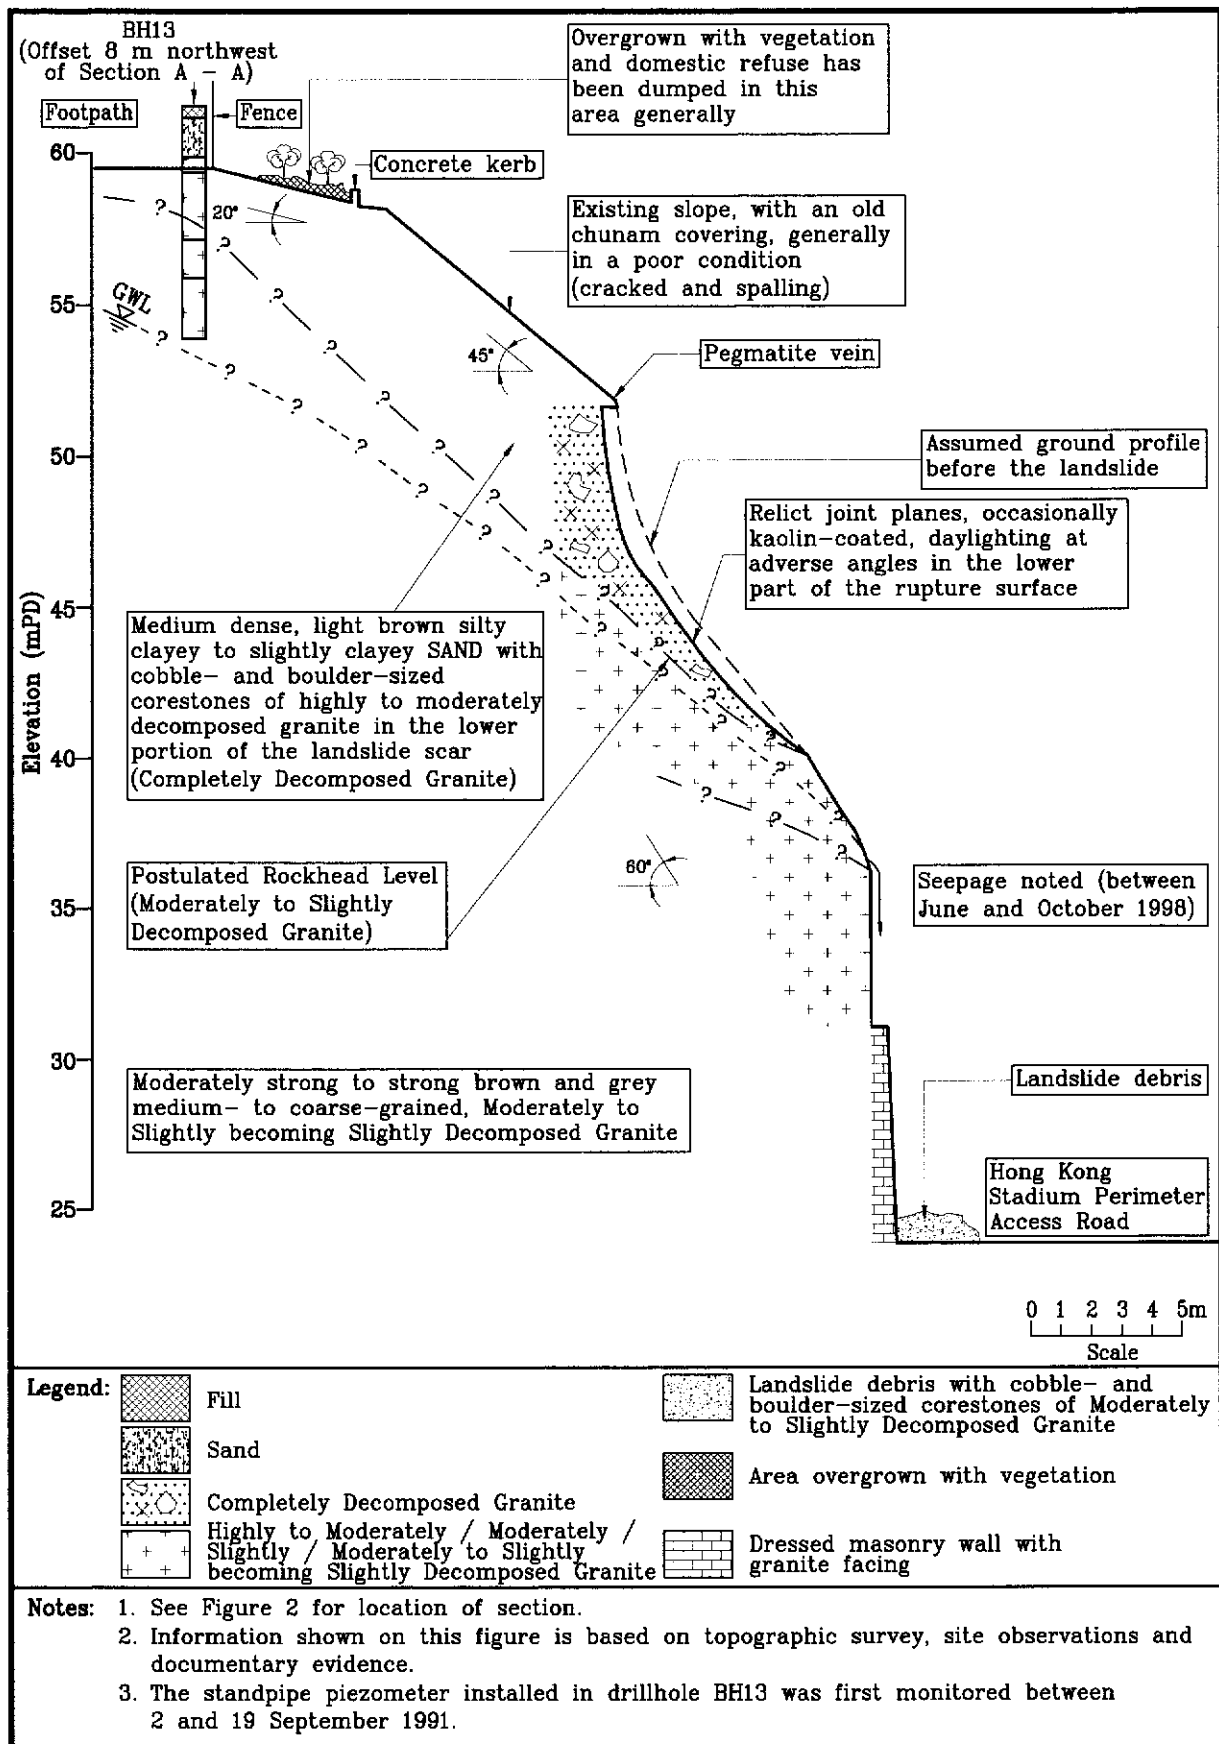
Figure 4 - Section A - A Through the Landslide

There have been two ground investigations in the general vicinity of the failed slope (Bachy Soletanche, 1983 and Lam Geotechnics, 1991). FSW have used information from these investigations, together with post-failure site observations to prepare a geological section through the landslide site (Figures 2 and 4).

The available groundwater monitoring records together with post-failure field observations indicate that, in general, within the vicinity of the landslide, there is no permanent high groundwater table within the slope (Figure 4).

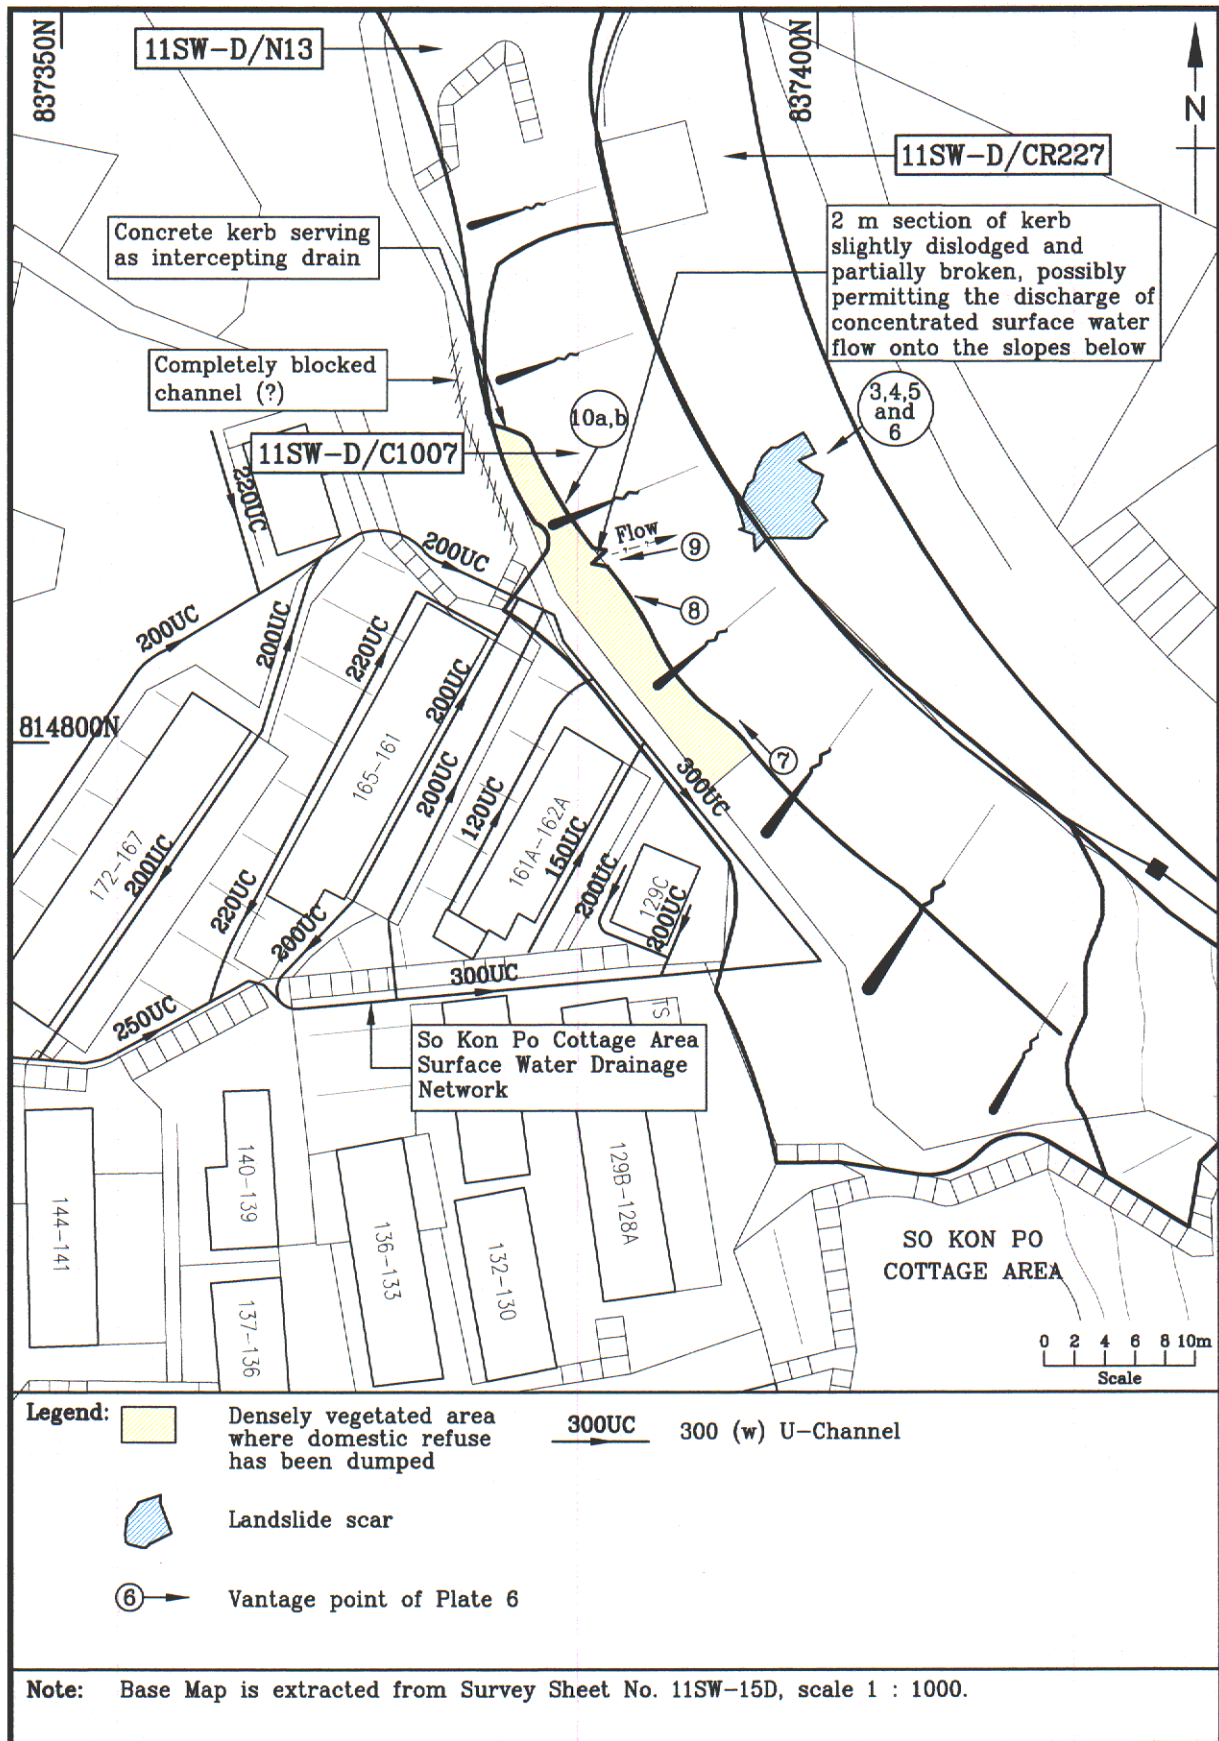
Figure 5 - Surface Water Drainage Networks

A system of surface channels, carrying both storm and foul water, is present in the So Kon Po Cottage Area above (Figure 5). Whilst generally in a good condition, apart from one section that was blocked by leaves along the footpath outside cottages 161-165, these drains have sharp bends at certain locations which may lead to overtopping during intense rainstorms.

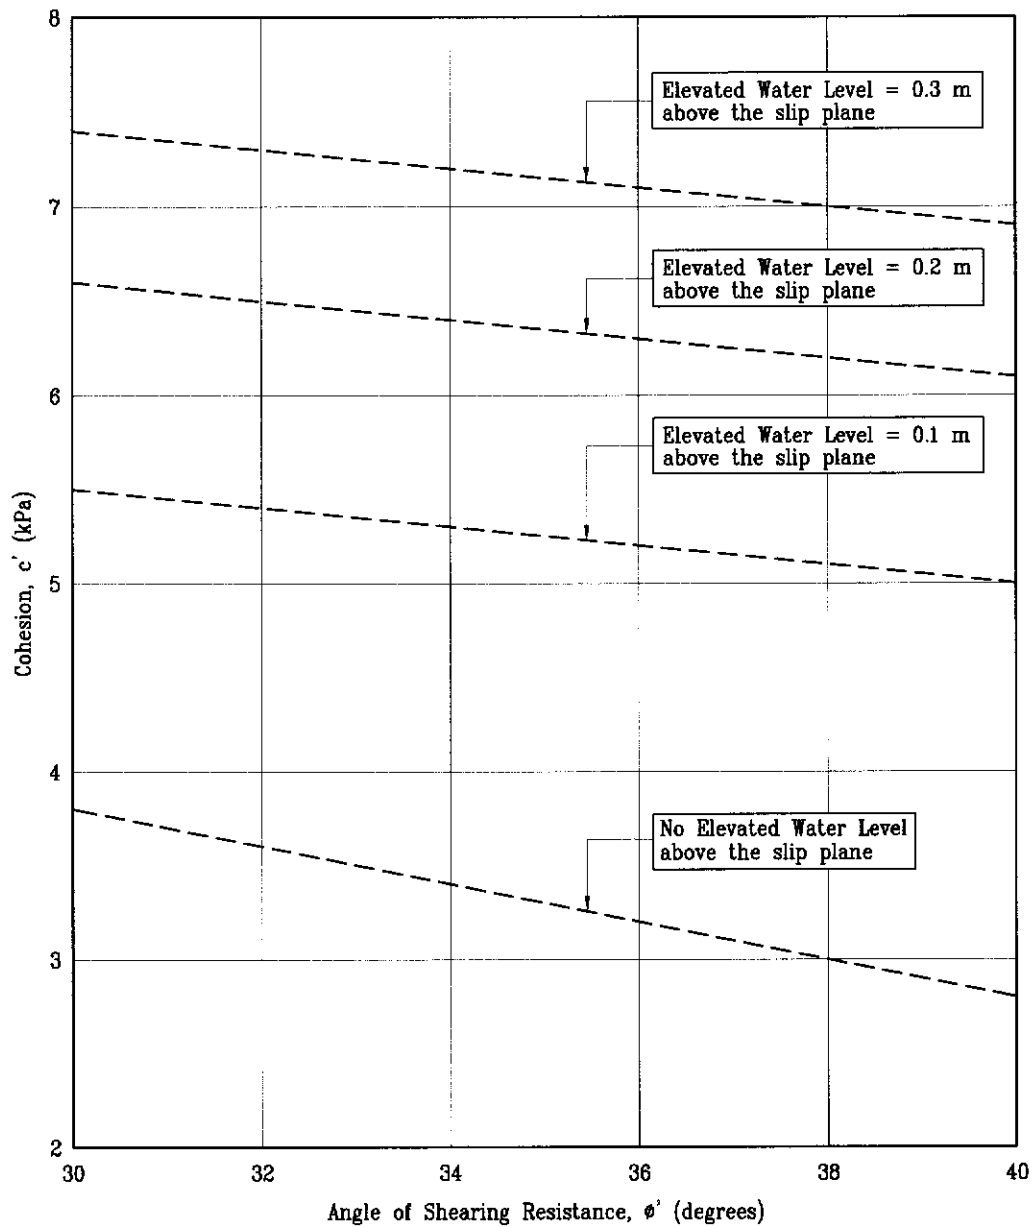
Figure 10 - Summary of Theoretical Stability Analyses

The results of the stability analyses are summarised in Figure 10. The presence of an adversely orientated, locally kaolin-coated, relict joint plane, which partly controlled the failure, suggests that the likely operational value of c' along the observed surface of rupture was relatively low. Given this, it is also likely that a relatively modest increase in water pressure would have been sufficient to initiate failure.

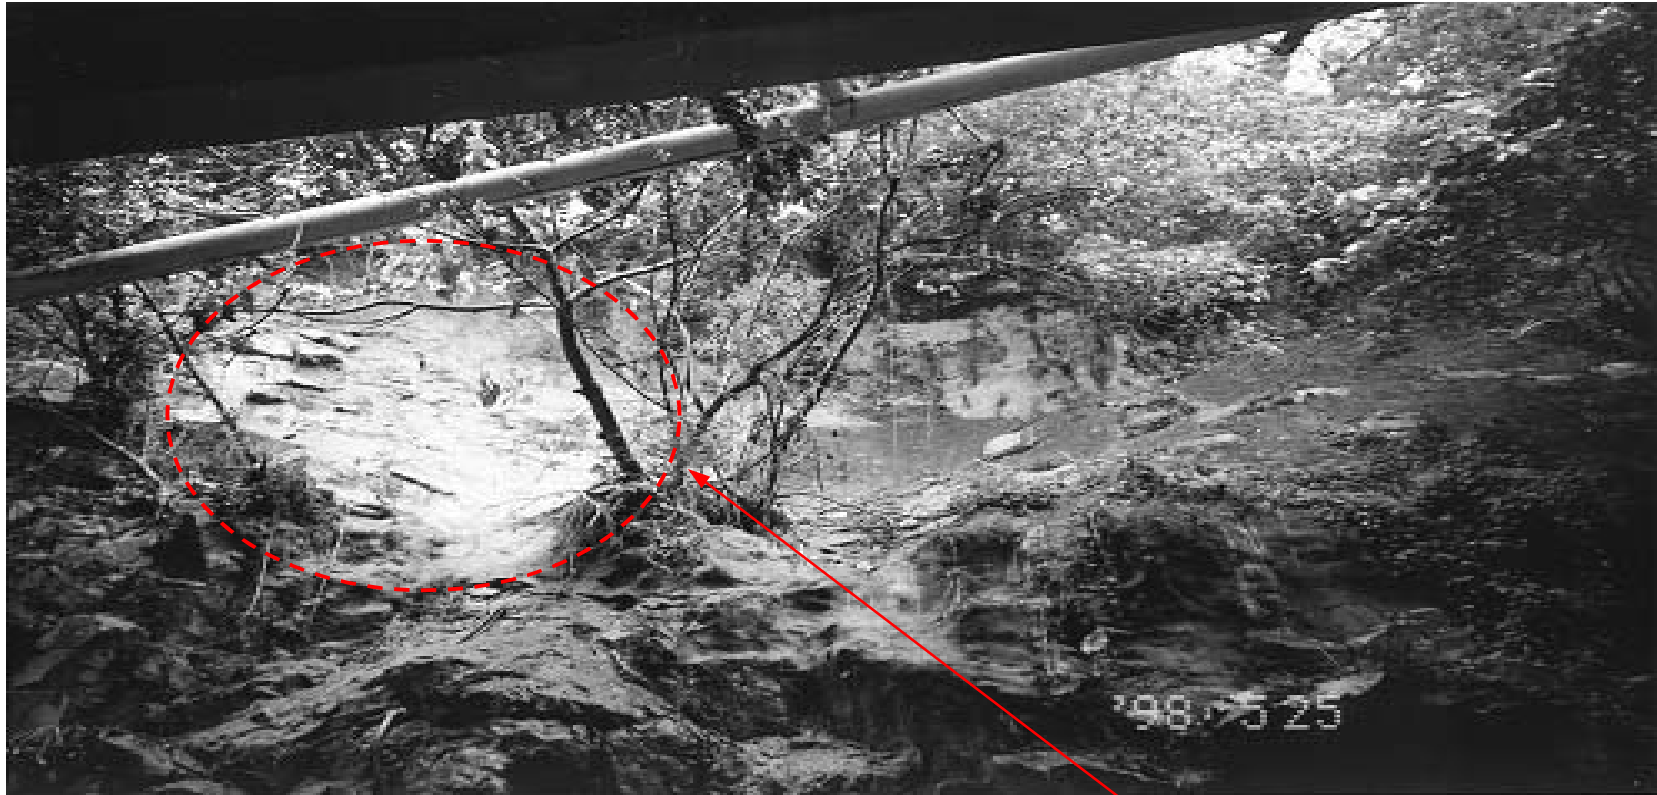
The present failure occurred in a concave portion of the slope in the weathered profile near the soil/rock interface, at the junction between the above registered slope features (Plate 1).

The landslide was located in a concave depression towards the crest of Slope No. 11SW-D/CR227 (Plates 1 and 2). The landslide involved the failure of about 5 m³ of decomposed material near the soil/rock interface. The majority of the debris was deposited on the stadium perimeter access road some 25 m below. However, a small amount of debris landed on the pedestrian walkway of the Level 3 podium of the stadium.

Plate 1 – The Landslide of 24 May 1998
(Photograph taken on 25 May 1998)

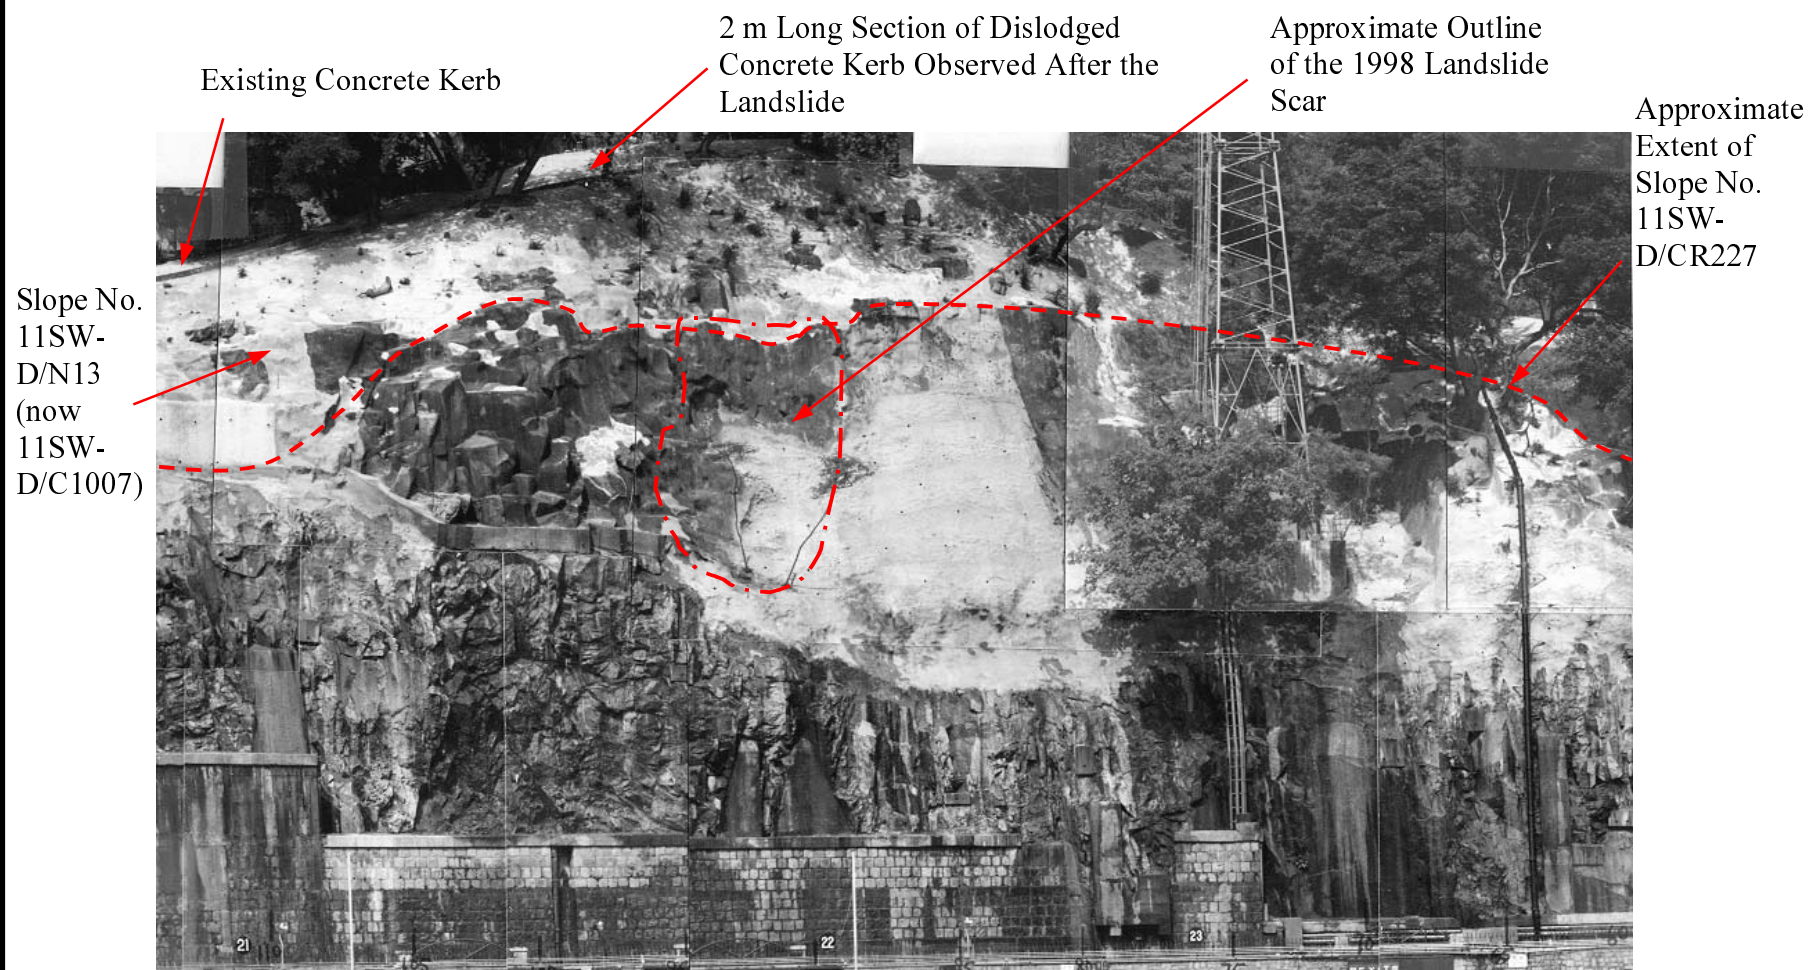
Plate 2 – Front View of the Slopes in 1985
 (Photographs reproduced from Fugro (HK) Ltd's As-built
 Record Report dated June 1985)

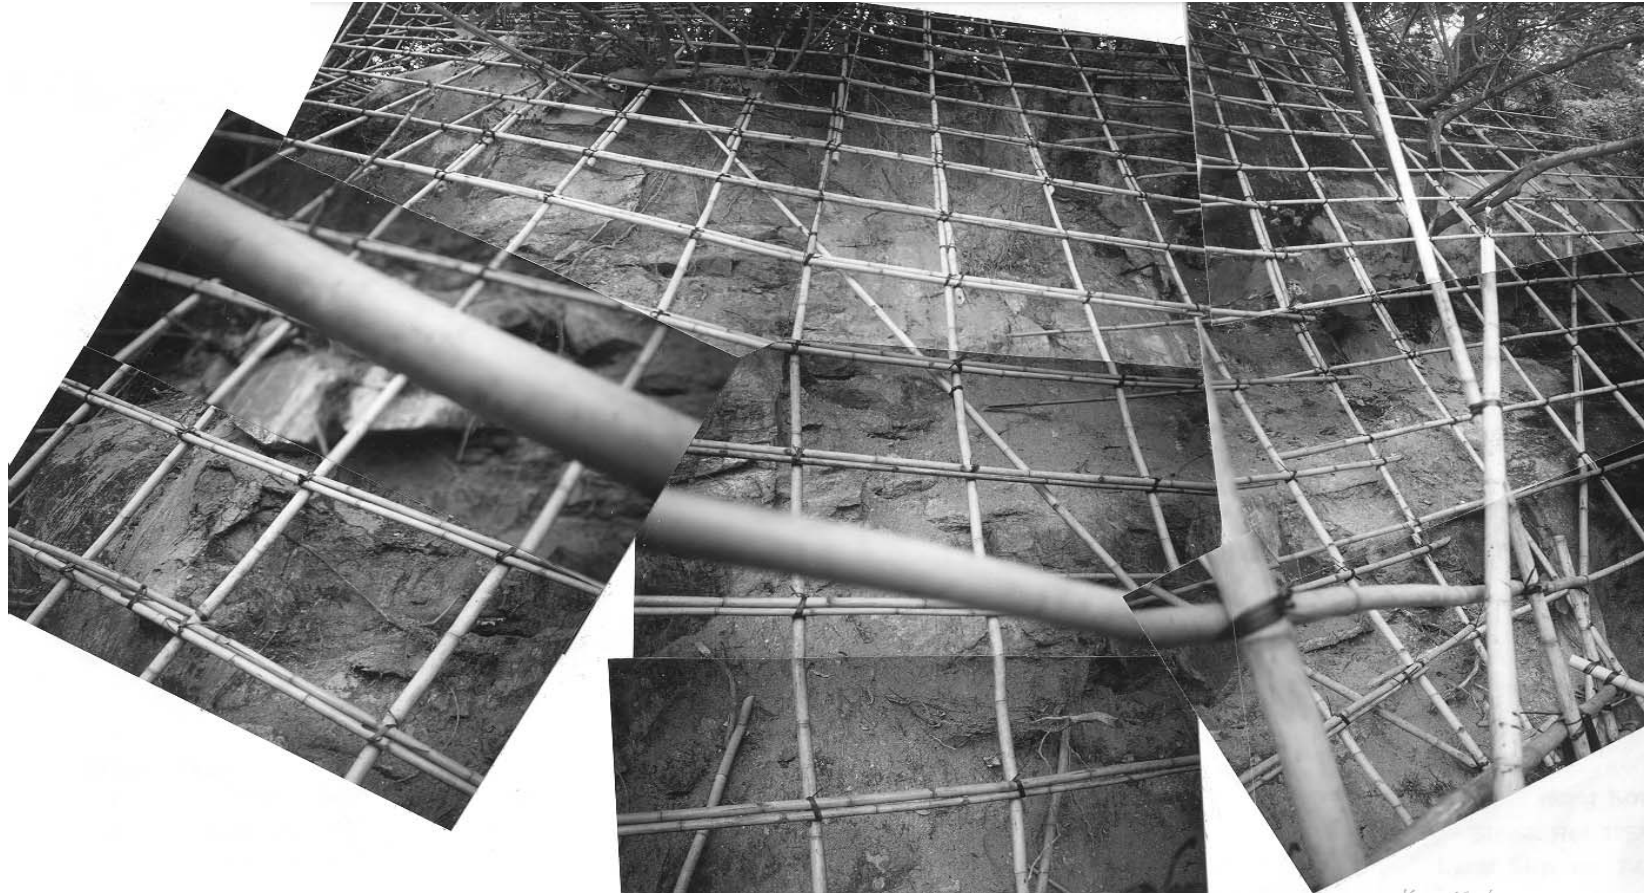
The landslide scar was approximately 6 m wide and 6 m long, with a maximum depth of about 0.5 m. The profile of the scar varied from sub-vertical in the upper portion to an inclination of approximately 45° in the lower half of the scar (Figure 4 and Plate 3). Two sub-vertical relict joint planes, orientated parallel and normal to the strike of the slope face with strike and dip of typically 014°-039°/60°-75° and 308°-355°/75°-86° respectively, were observed. In addition, an adversely orientated relict joint plane was mapped in the lower portion of the landslide scar with a dip angle of typically between 35° and 45° and a generally northeasterly orientation. This adversely orientated relict joint plane was occasionally kaolin-coated (Plate 4).

Plate 3 – General View of Landslide Scar
(Photographs taken on 24 May 1998)

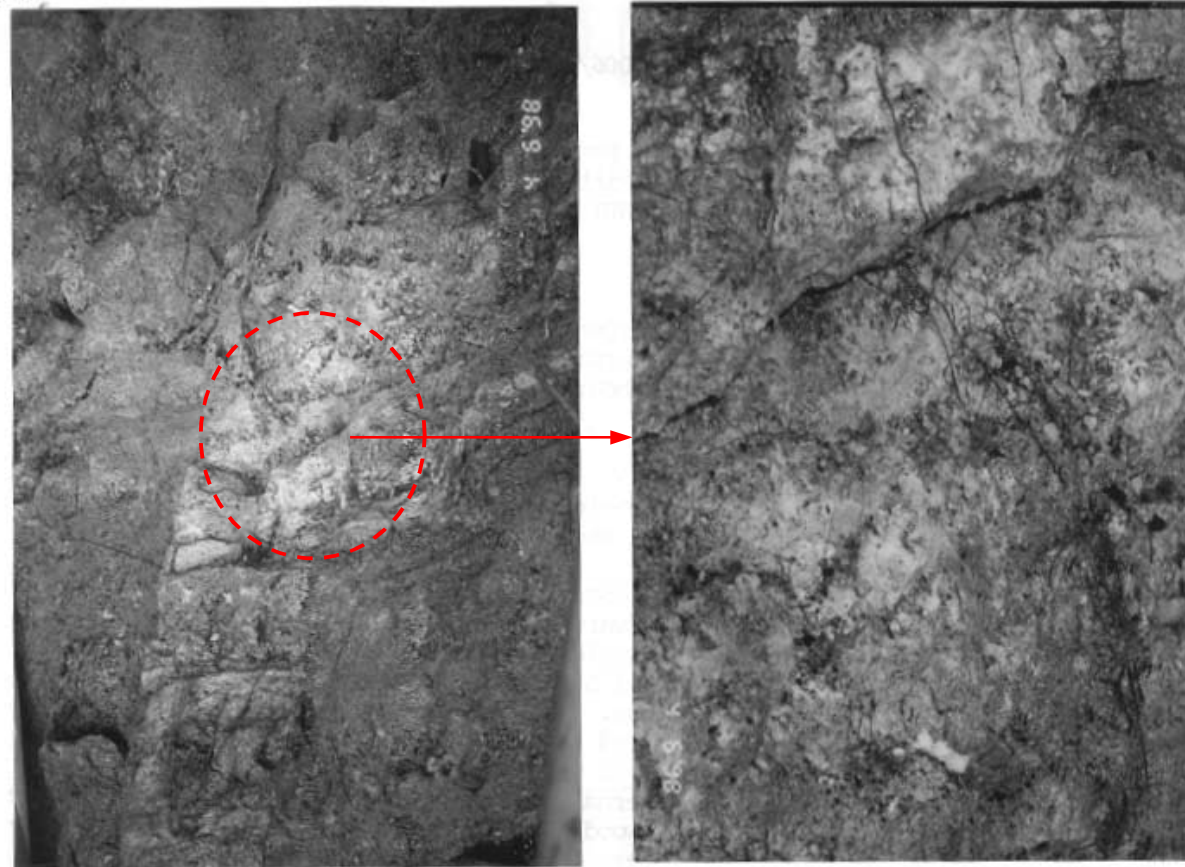
Plate 4 – Kaolin Patches Noted on Joint Planes within the Completely Decomposed Granite
(Photographs taken on 4 June 1998)

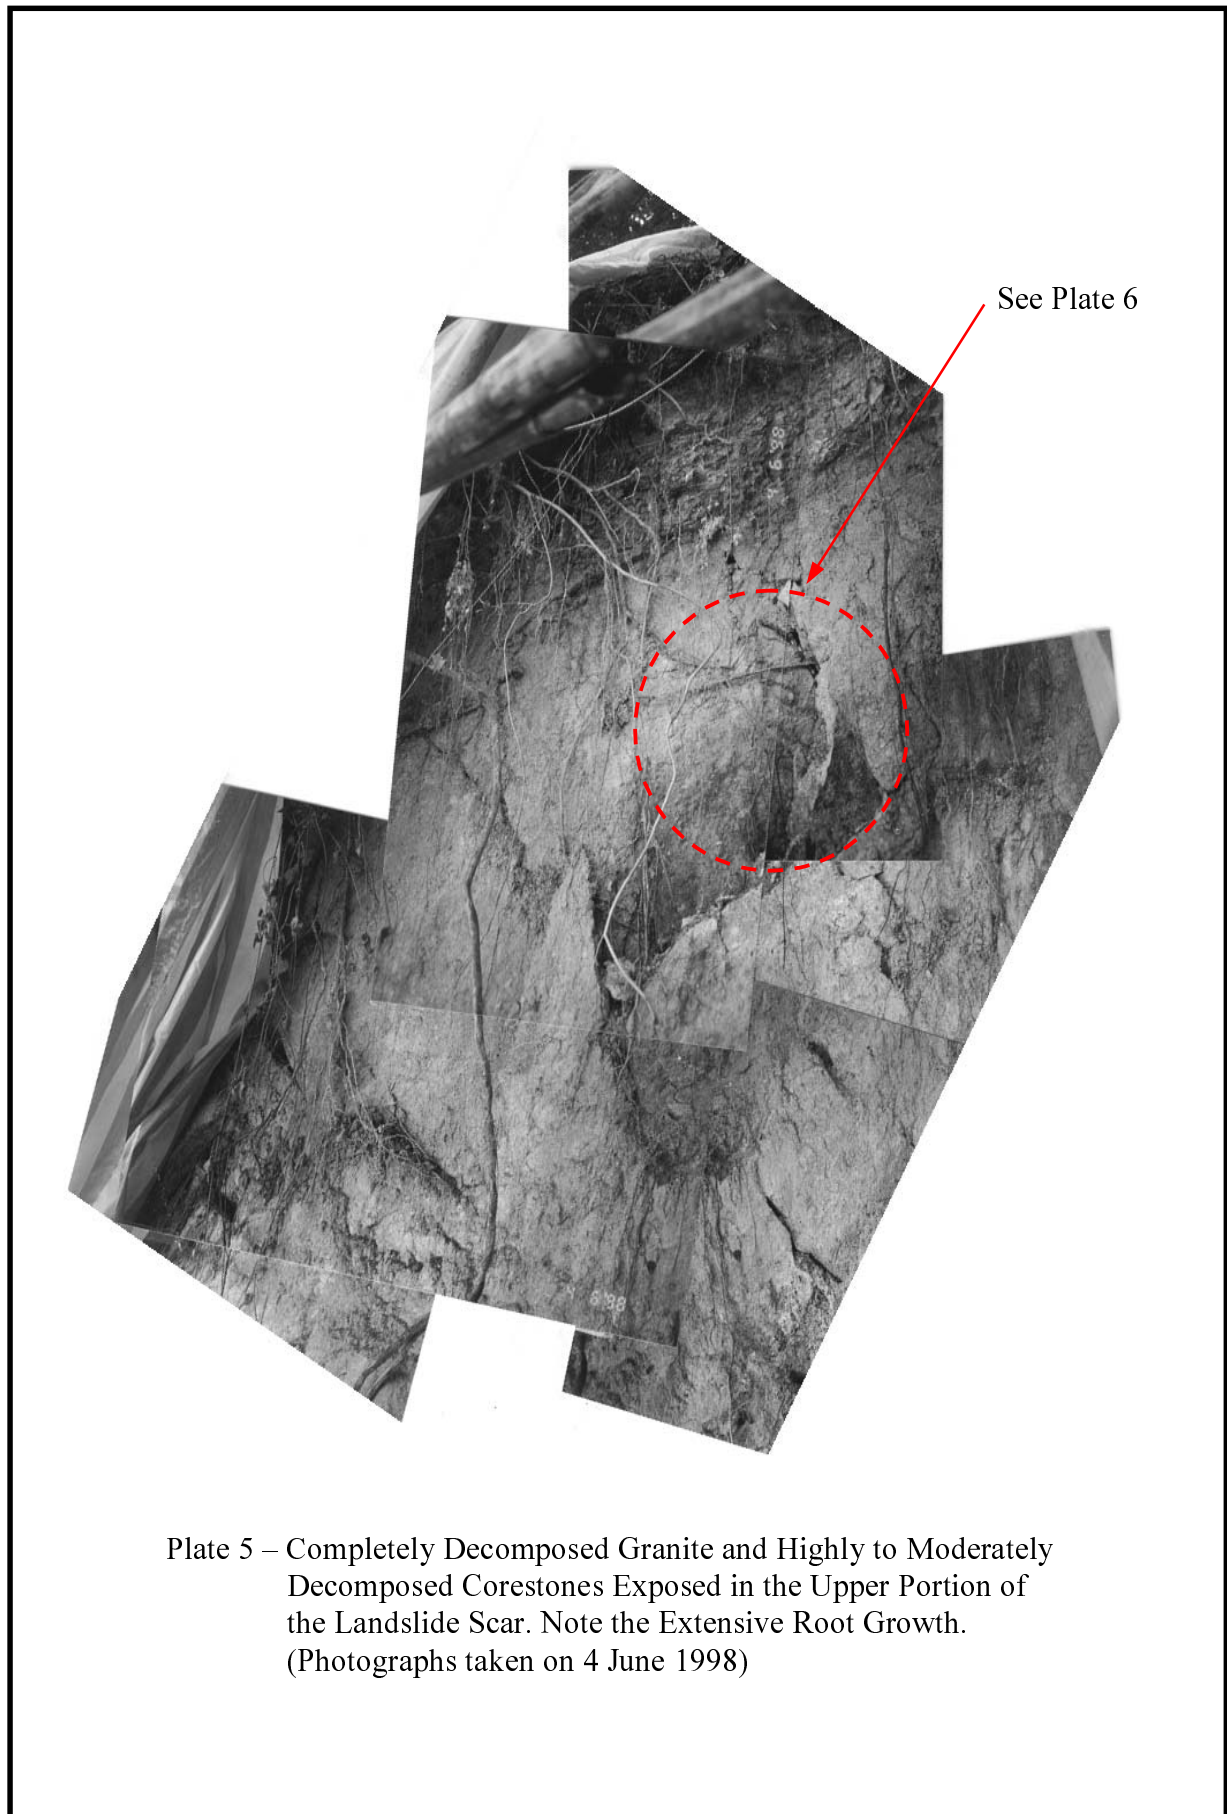
Extensive root growth from trees located at the slope crest was also observed along the surface of rupture in the upper portion of the landslide scar (Plates 5 and 6).

The landslide occurred in corestone-bearing decomposed granite standing at an angle of between 65° and 75° in an area with a history of past instability. The generally poor condition of the chunam cover (See Section 2.1) would have rendered the slope more susceptible to direct infiltration (Plate 10). The extensive tree root growth evident could also have wedged open the soil mass, particularly the adversely orientated relict joint (Plates 5 and 6).

Plate 5 – Completely Decomposed Granite and Highly to Moderately Decomposed Corestones Exposed in the Upper Portion of the Landslide Scar. Note the Extensive Root Growth. (Photographs taken on 4 June 1998)

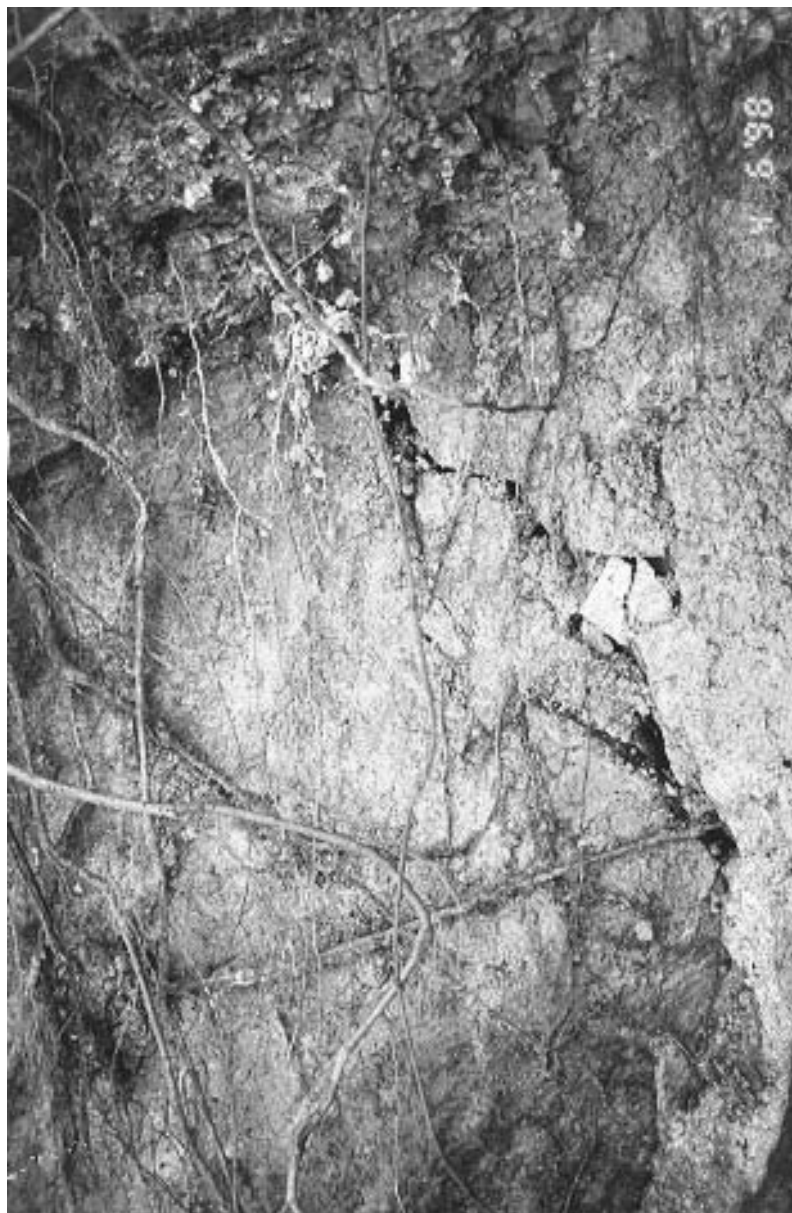
Plate 6 – View of Root Growth within the Landslide Backscarp
and a Manganese-stained Relict Joint (Photograph
taken on 4 June 1998)

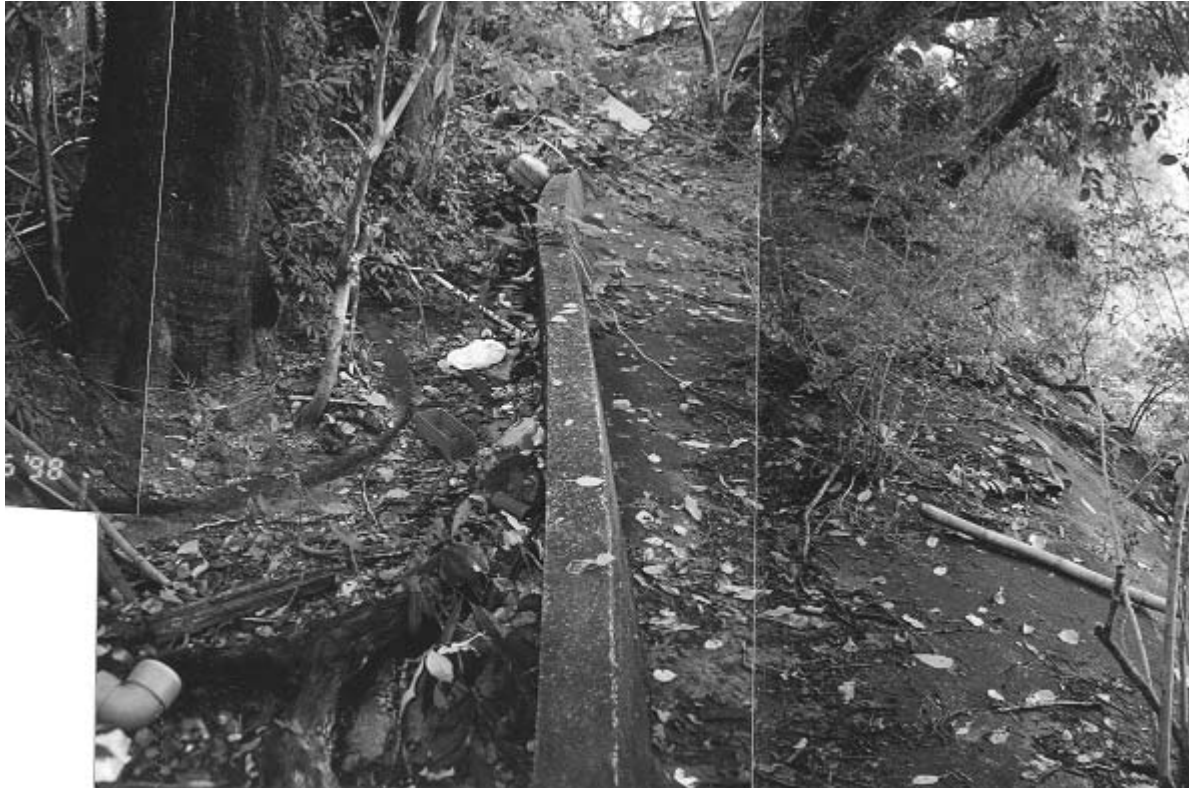
General blockage of the intercepting drain near the slope crest due to inadequate maintenance could have resulted in an increased discharge onto the slope below and provided an additional source of water (Plate 7). In addition, the dislodged and locally broken concrete kerb, part of the intercepting drain above the backscarp of the present failure, may have directed surface water flow onto the landslide site, further promoting water ingress (Plates 8 and 9).

Plate 7 – Blocked Drainage 8 m above Slope No. 11SW-D/C1007
(Photographs taken on 5 June 1998)

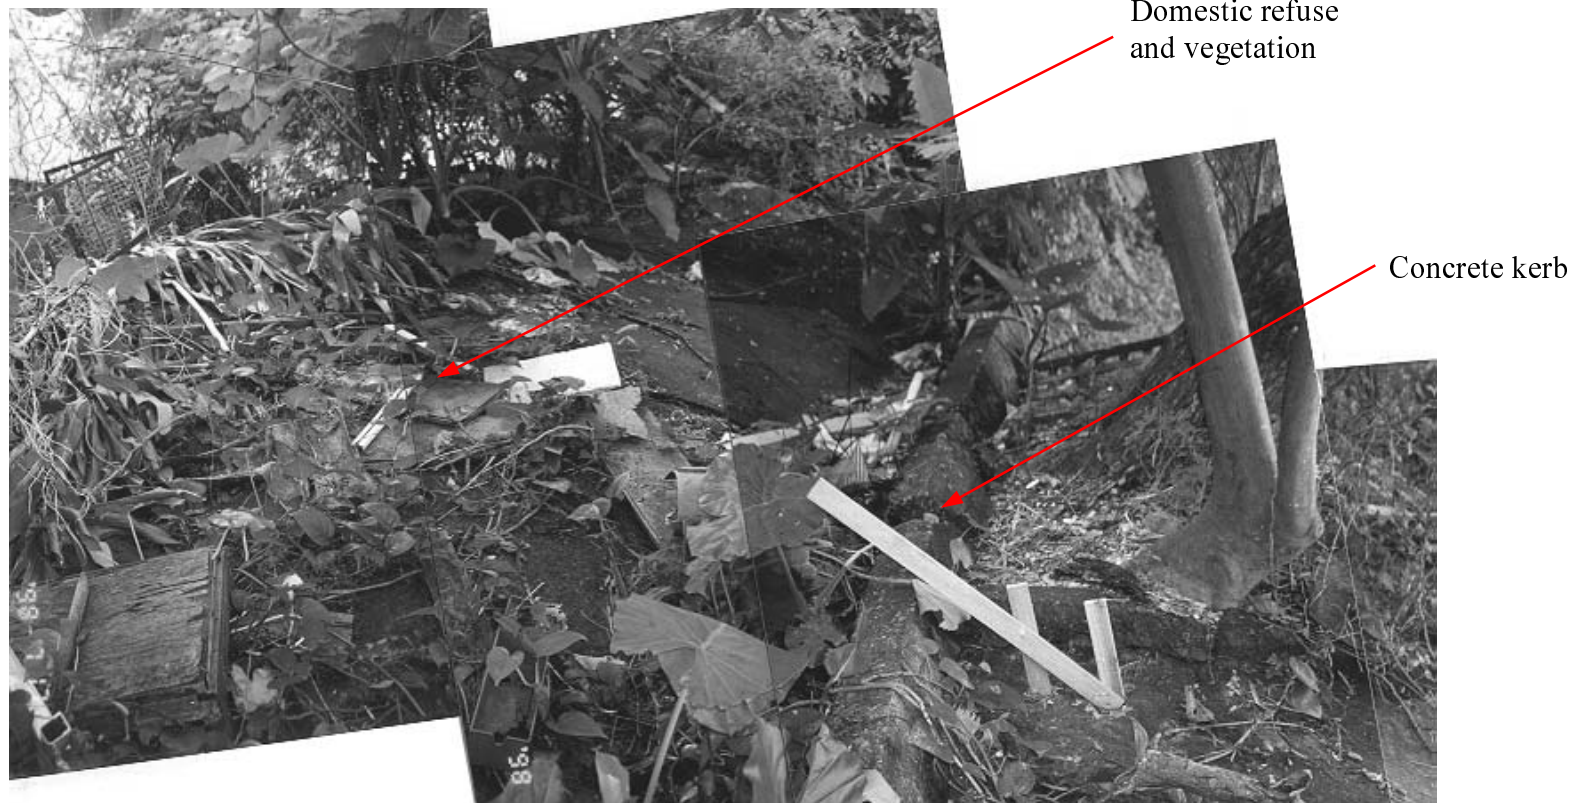
No surface drainage channels exist within the immediate vicinity of the landslide scar. However, an old concrete kerb, apparently constructed as an intercepting drain, is located approximately 8 m above the backscarp of the landslide (Plate 7). This drain and the area immediately behind were noted as being overgrown with vegetation during FSW's post-landslide field inspections. Much domestic refuse has also been dumped in the area generally (Figures 4 and 5). In addition, a 2 m length of this intercepting drain, directly above the landslide scar, was noted by FSW as being slightly dislodged and partially broken, possibly providing a means for overland flow to get onto the slope below during rainstorms (Figure 5, and Plates 8 and 9).

Plate 8 – Dislodged and Partially Broken Section of Concrete Kerb
(Photographs taken on 17 July 1998)

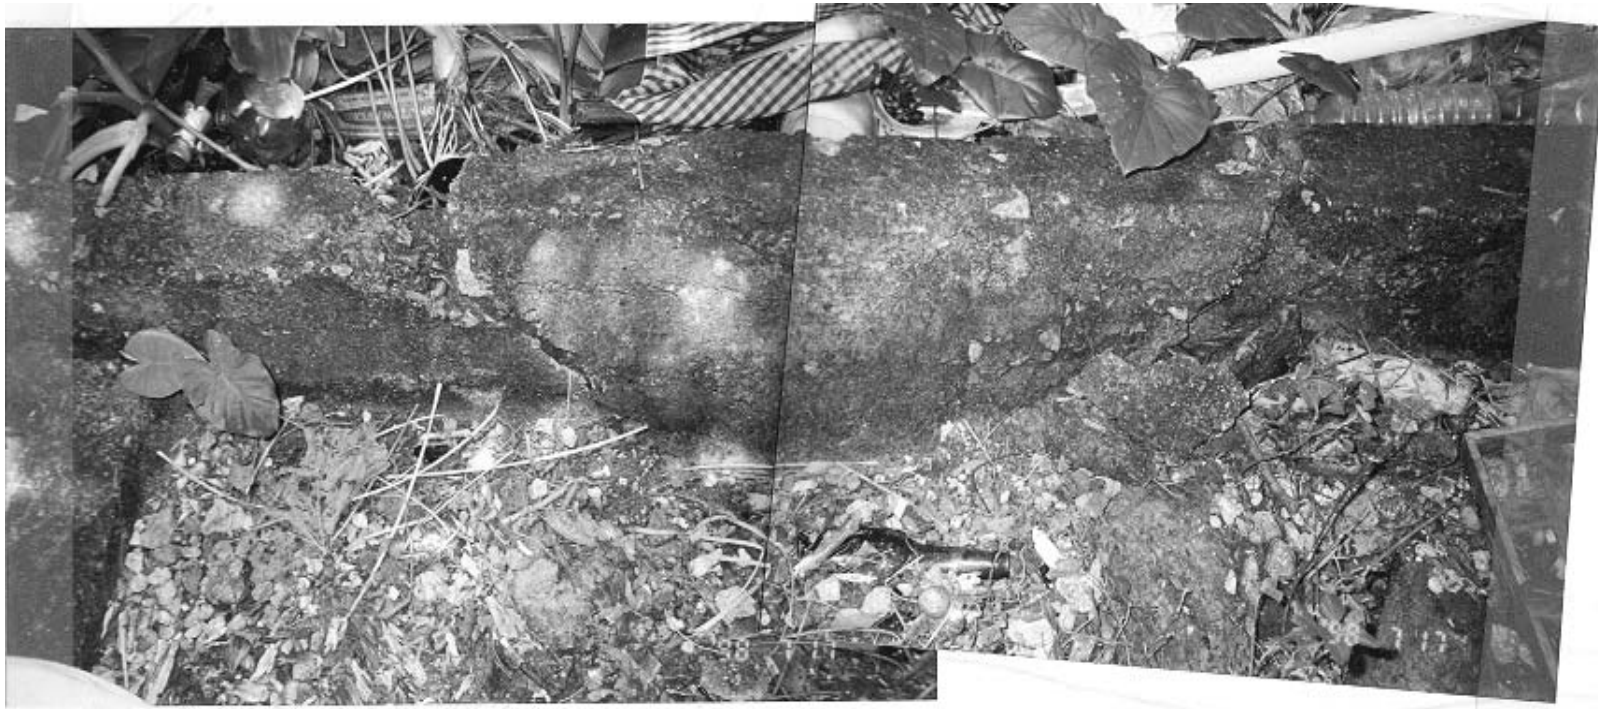
Plate 9 – Close-up View of Dislodged and Partially Broken Section of Concrete Kerb
(Photographs taken on 17 July 1998)

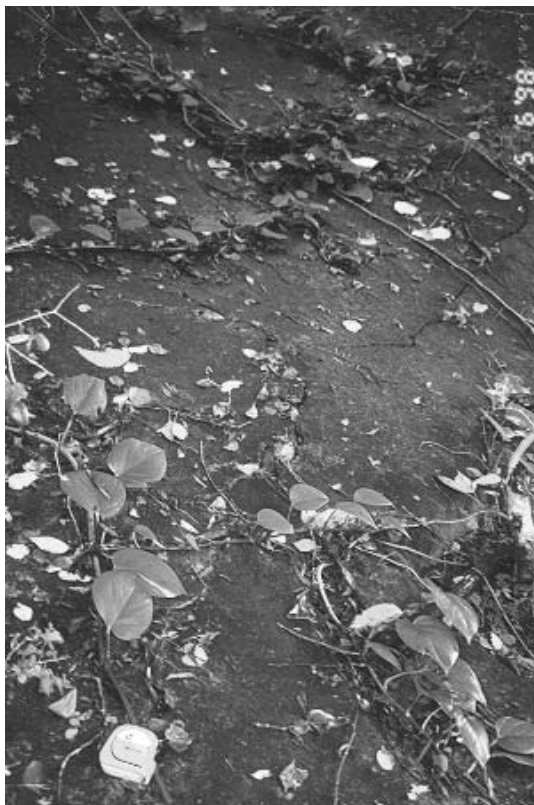
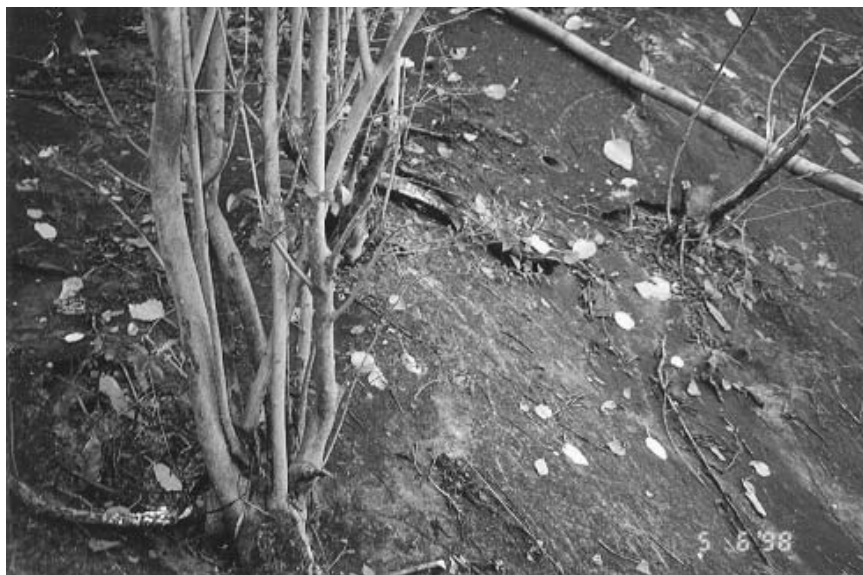
Plate 10 – General Views of Surface Covering to Slope above the Landslide Scar
(Photographs taken on 5 June 1998)
