**SECTION 2 :
DETAILED STUDY OF THE
LANDSLIDES AT THE
JUNCTION OF SAI SHA ROAD
AND TAI MONG TSAI ROAD
IN JUNE 1998**

Fugro Scott Wilson Joint Venture

**This report was originally produced in November 1999
as GEO Landslide Study Report No. LSR 13/99**

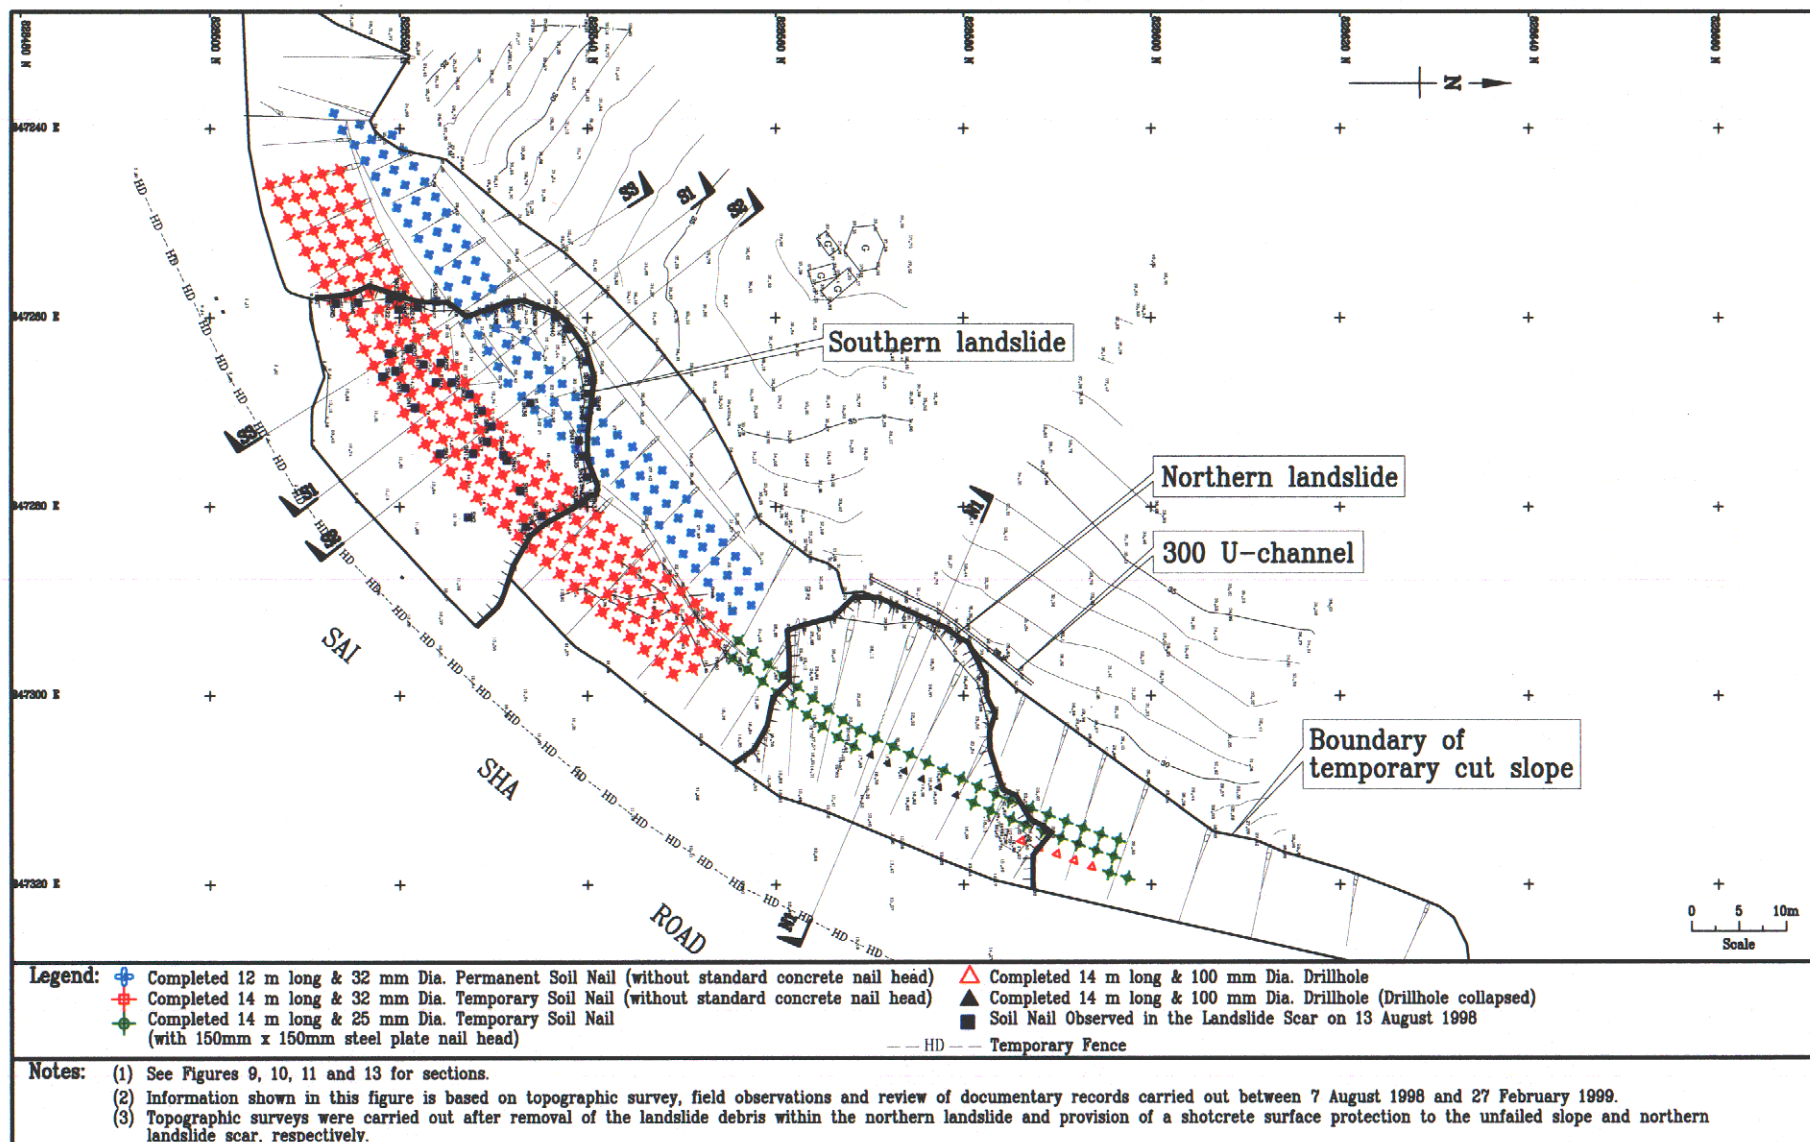
Figure 2 - Plan of the Landslides

In the area of the northern landslide, the temporary cut before the failure was about 18 m in height, with the lower 12 m sloping at a gradient of about 50° to the horizontal and the upper 6 m at about 30° to the horizontal. At the time of the failure, 24 nos. temporary soil nails had been installed within the ground that failed (Figure 2).

In the area of the southern landslide, the temporary cut before the failure comprised 3 batters with a total height of about 24 m and an overall gradient of about 42° to the horizontal. Prior to the excavation of the temporary cut, 28 nos. permanent and 80 nos. temporary soil nails were installed within the ground that subsequently failed. The layout of the soil nails is shown in Figure 2.

Prior to the failures, construction of the crest drainage channel was in progress. About 20 m of the crest channel had been completed in the northern portion of the temporary cut where the landslide occurred. No surface drainage channels were provided on the southern portion of the temporary cut at the time of the failure (Figure 2).

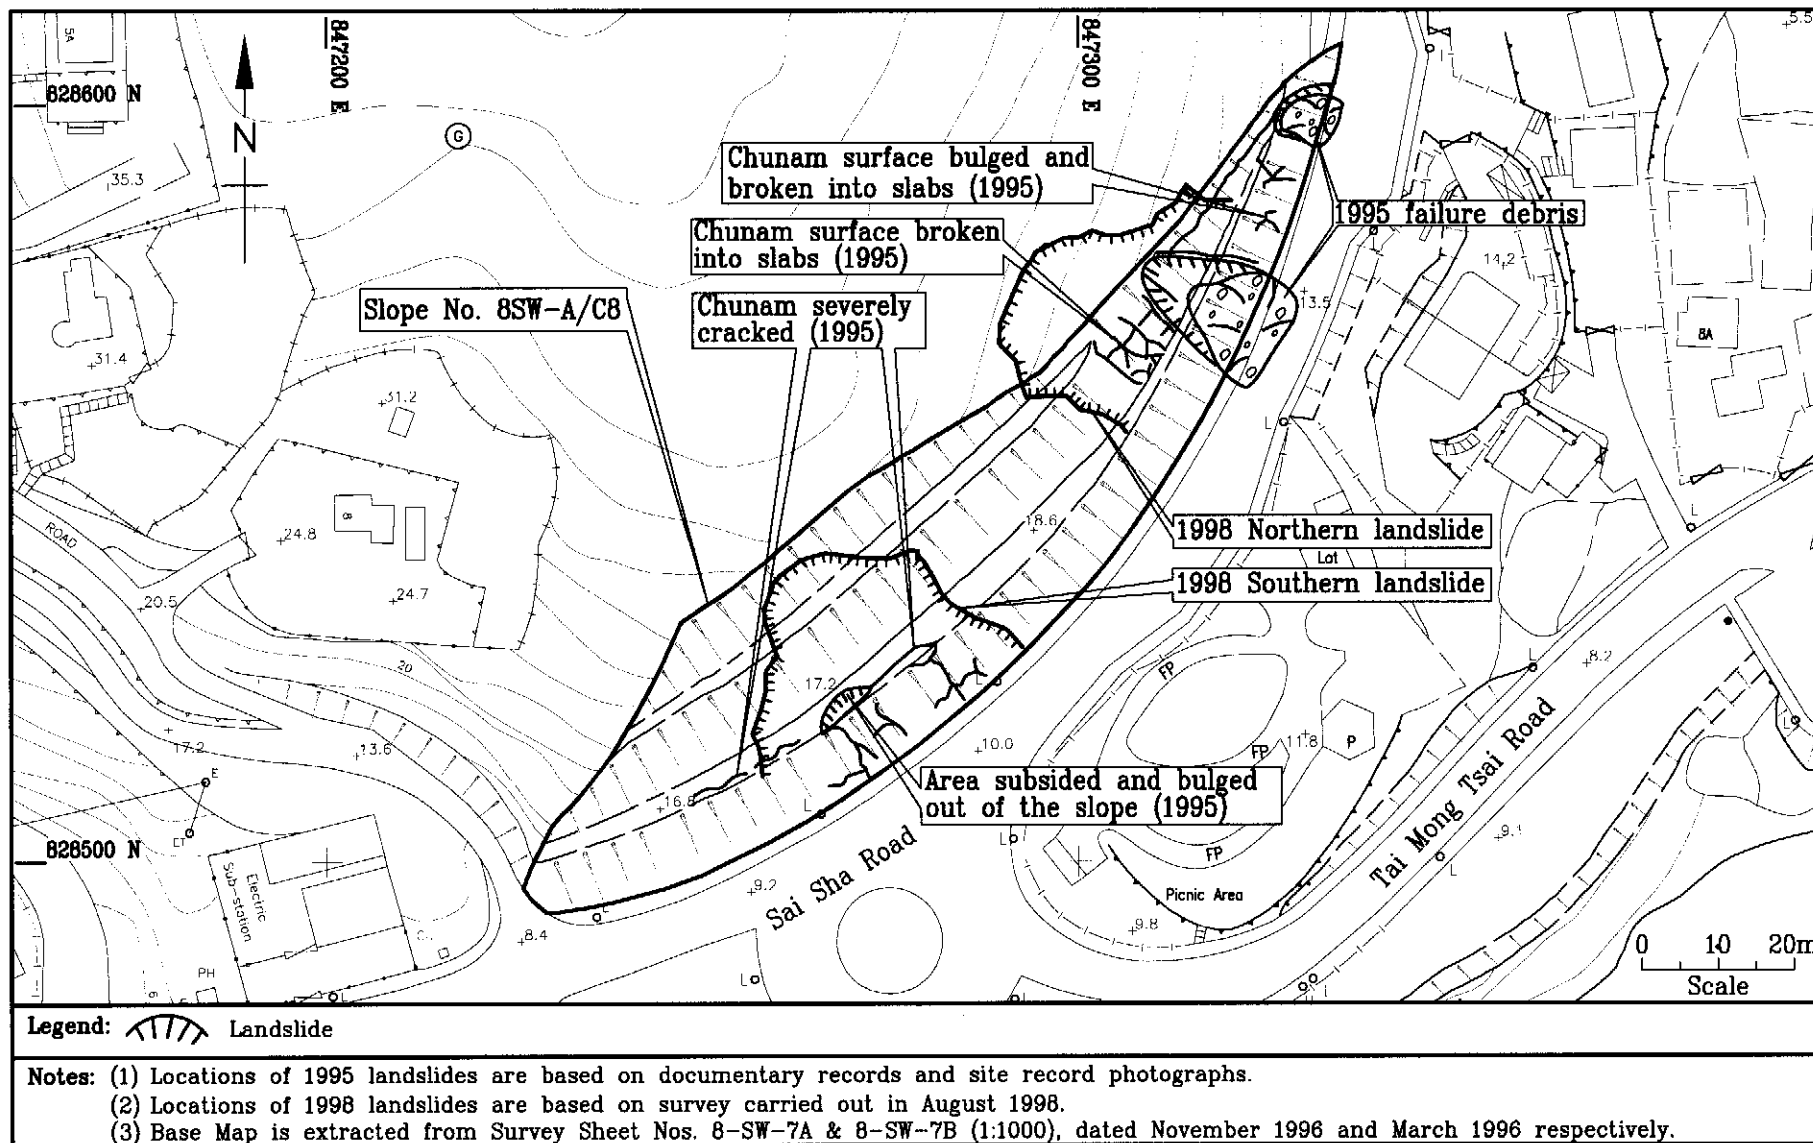
Figure 4 - Locations of 1995 and 1998 Landslides

During torrential rain associated with Typhoon Helen on 14 August 1995, landslides and significant cracking of the chunam occurred on cut slope No. 8SW-A/C8. The locations of the instabilities are shown in Figure 4. The total volume of the landslide debris was estimated by the GEO (1995) to be about 2,000 m³.

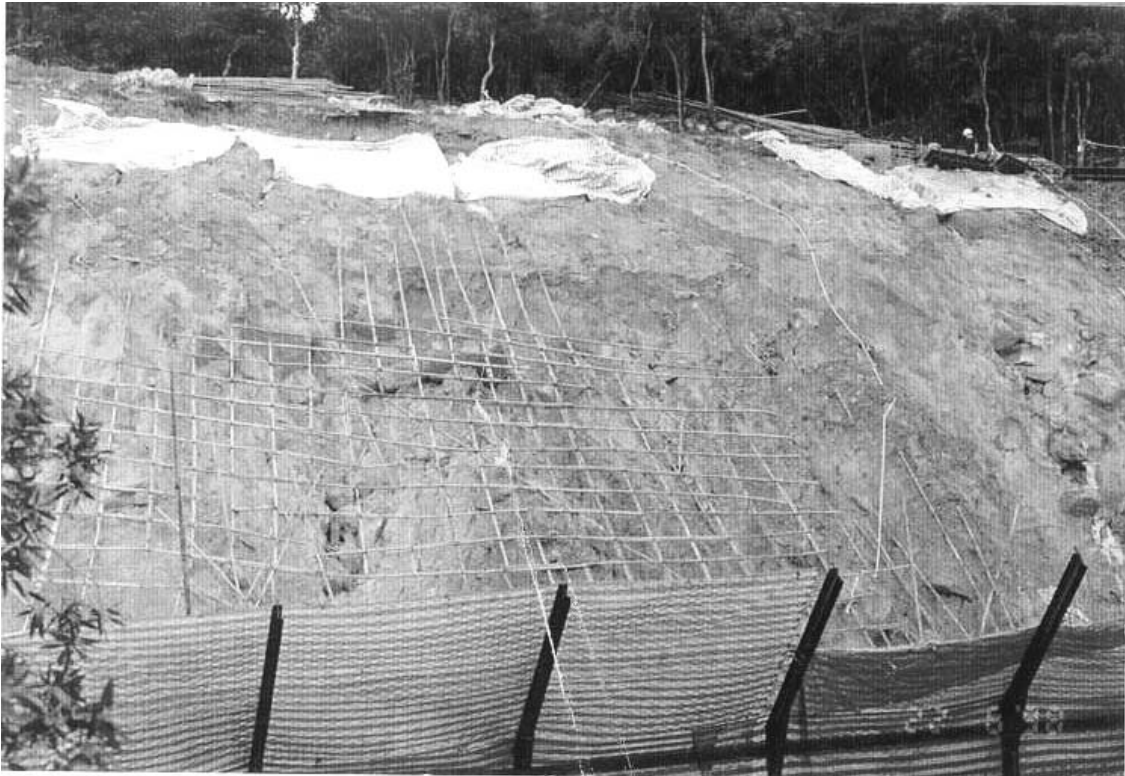
The extent and profile of the northern landslide, shown in Figures 2 and 9 respectively, were estimated by the Design and Works Divisions of the GEO following removal of the landslide debris during site clearance works. The landslide resulted in a 13 m high and 35 m wide failure scar. The average depth of the landslide was about 3 m and the surface of rupture was generally concave in shape. A general view of the northern landslide is shown in Plate 1.

The northern portion of the cut slope, at the time of failure on 9 June 1998, was covered with sheeting on the upper slope area, and a scaffolding platform had been erected for soil nail and raking drain installation. Landslide debris, comprising corestones, collided with and damaged some of the scaffolding. Several temporary soil nails with 150 mm square steel plate heads protruded from the middle portion of the cut slope affected by the landslide. The landslide created a 1 m to 2 m high main scarp. Relatively intact debris, comprising blocks of CDT up to about 10 m³, was located immediately below the main scarp.

Plate 1 – General View of the Northern Landslide
(Photograph taken on 22 June 1998 and Reproduced
from GEO Site Record. See Figure 32 for Location.)

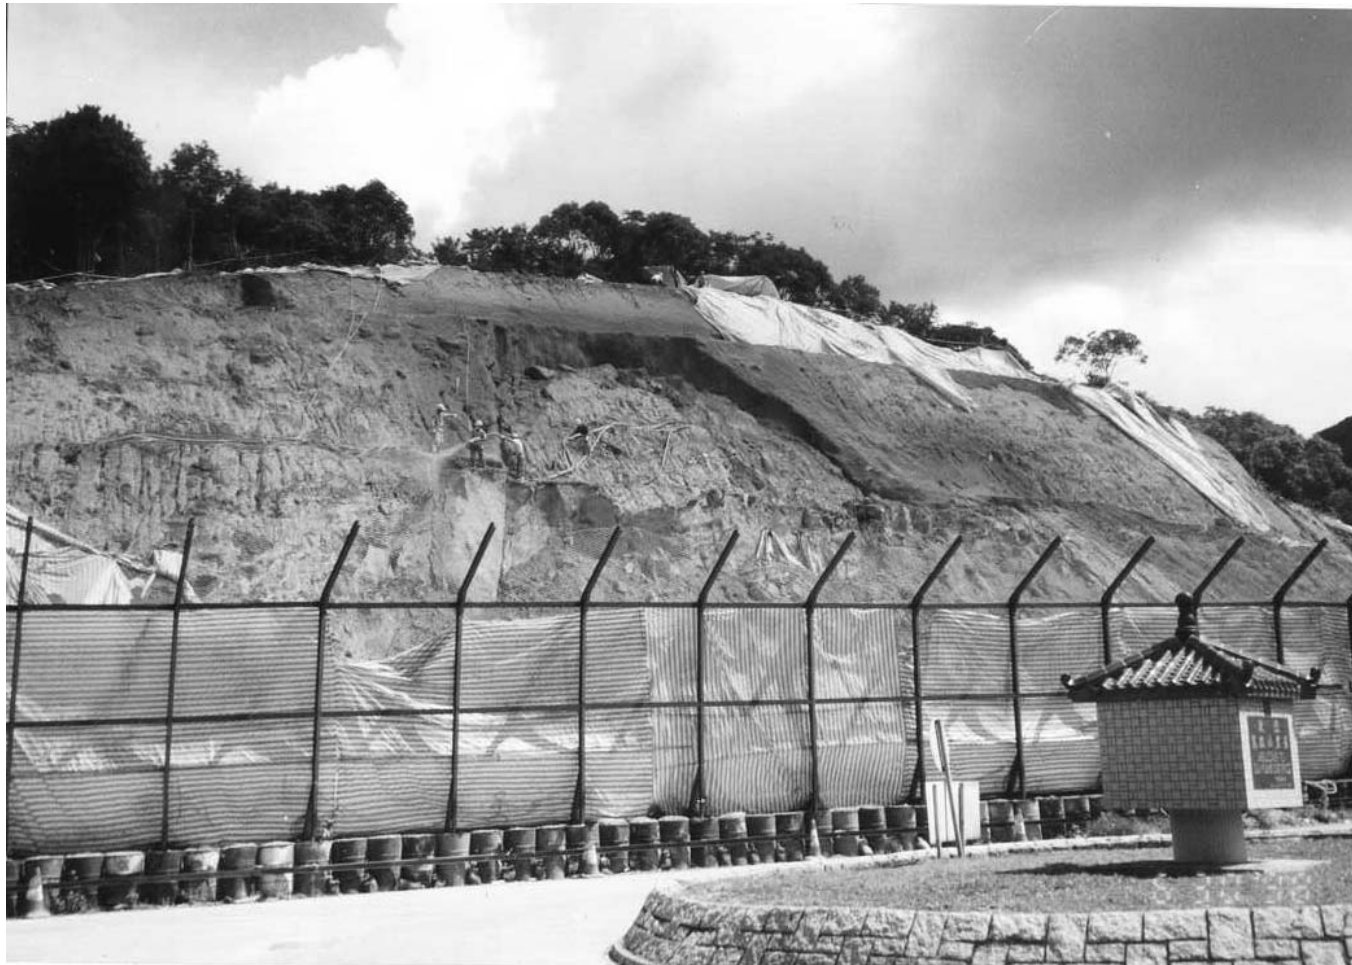
In the southern landslide, the crown was located at the upper-most berm, and both the lower and middle batters were affected by the instability. The main scarp (about 1 m to 2 m high) and parts of the flanks of the landslide were shotcreted at the end of June 1998 as part of the urgent repair works. Despite these works, downward movement of the disturbed material still continued. In August 1998, the main scarp was observed to have enlarged to about 4 m high, the upper half of which remained covered with shotcrete (Plates 2 and 7).

Plate 2 – General View of the Southern Landslide
(Photograph taken on 30 June 1998 and Reproduced
from GEO Site Record. See Figure 32 for Location.)

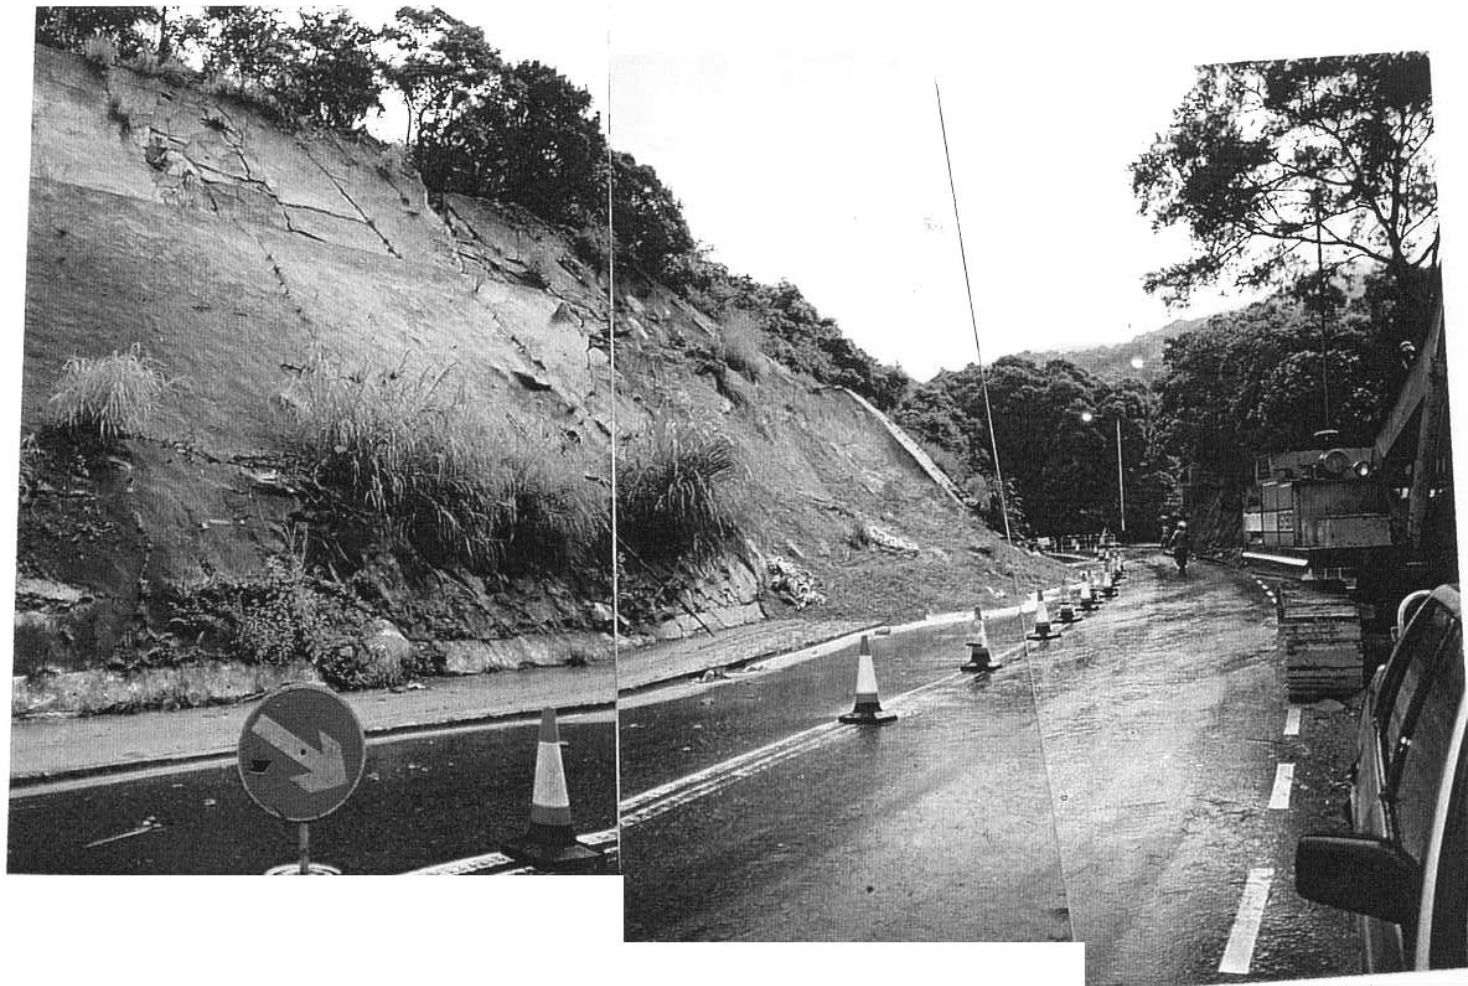
height of about 10 m. The failure debris buried the footpath along the slope toe and blocked one lane of Sai Sha Road. The chunam surfaces over the ground immediately adjacent to these landslides were severely cracked, broken into slabs and locally severely crushed. This possibly indicates that the slope at these areas was also close to failure (Plate 3 and Figure 4).

Plate 3 – General View of the 1995 Landslide in the Northern Portion of the Slope
(Photograph taken on 14 August 1995. See Figure 32 for Location.)

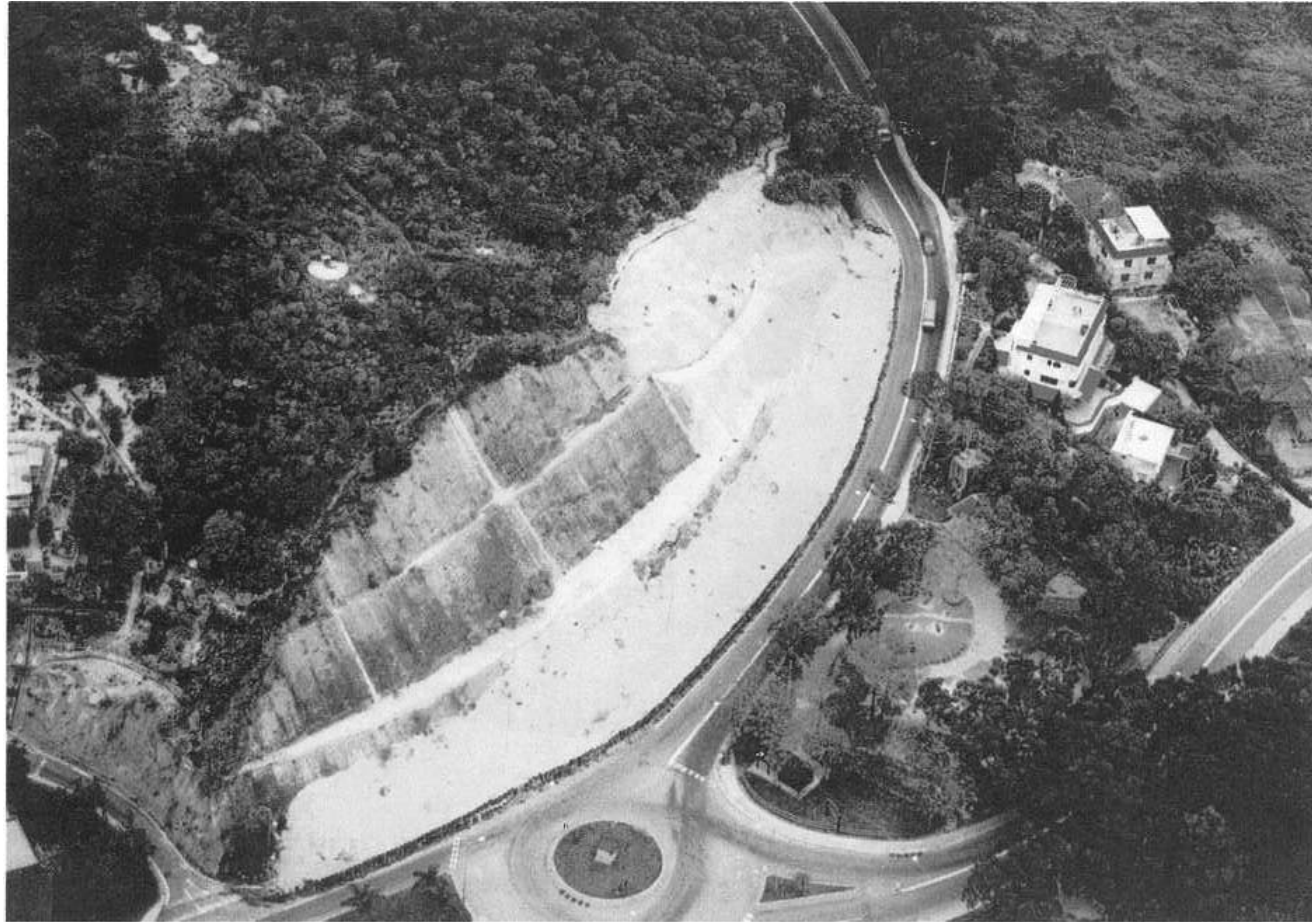
Plate 4 – Aerial View of the Slope after Completion of Emergency
Repair Works Subsequent to the 1995 Failure

Based on the recommendations of the GEO, the contractor of HyD carried out urgent repair works which included removal of debris, trimming back of the landslide scars in the northern portion of the slope, provision of reinforced shotcrete surface to the trimmed area and construction of a temporary rockfill berm along the toe of the entire cut slope (Plate 4). Following the completion of the urgent repair works, HyD installed 30 settlement monitoring stations on the slope and monitored from February 1996 to May 1997. The monitoring results did not show any trend of significant ground movements.

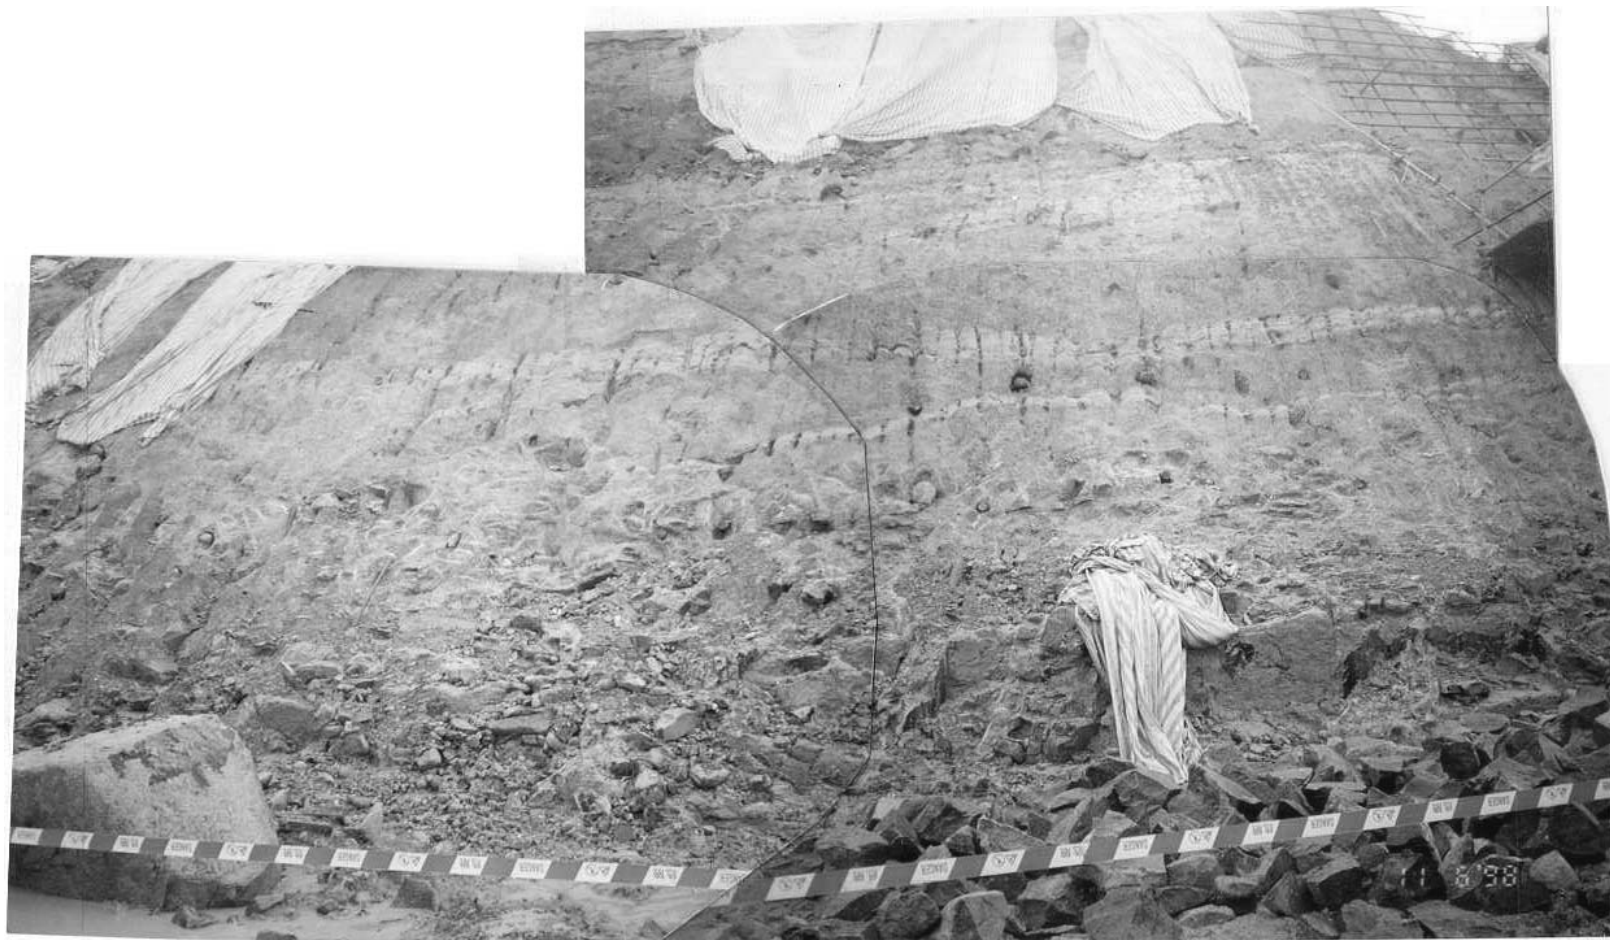
Plate 5 – View of Temporary Cut Slope Surface with Temporary Soil Nails without Nail Head
(Photograph taken on 11 June 1998 and Reproduced from GEO Site Record. See Figure 32 for Location.)

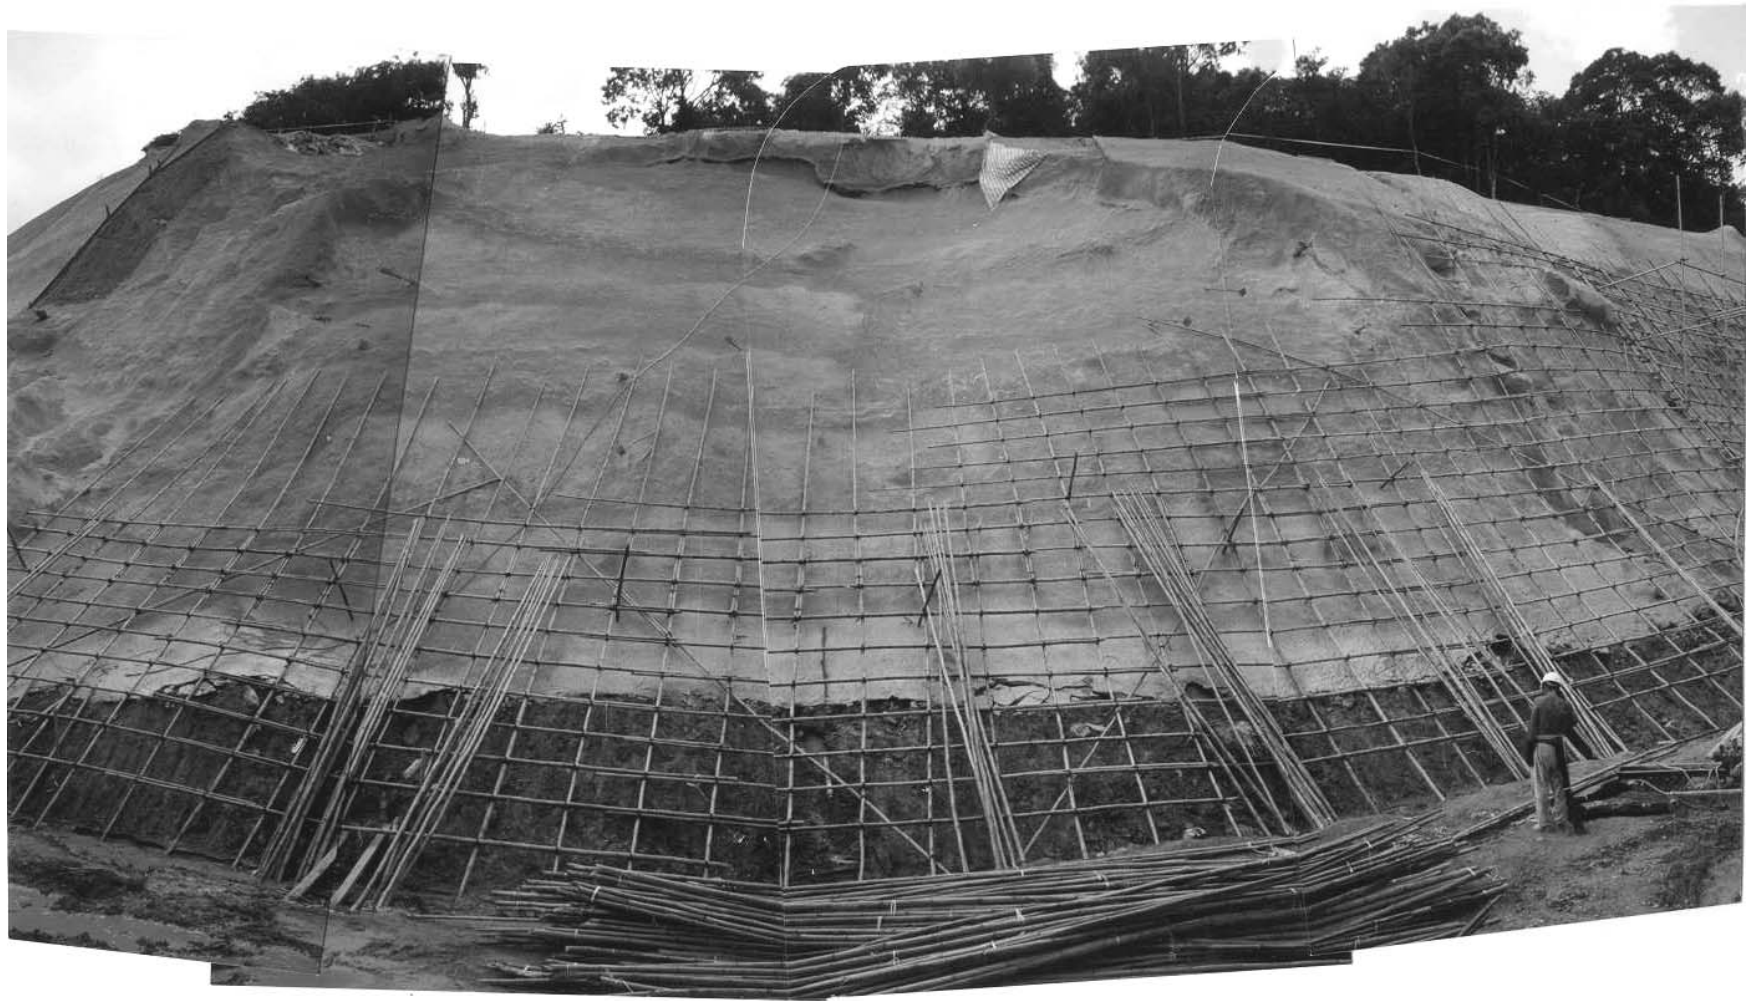
Plate 6 – General View of the Northern Landslide after Removal of Debris and Shotcreting
(Photograph taken on 13 August 1998. See Figure 32 for Location.)

Following the instabilities that occurred in June 1998, urgent repair works were completed between July and September 1998. These included the provision of a shotcrete cover to the surface of the unfailed portions of the cut slope and installation of raking drains in the areas adjacent to the landslide locations. According to the site supervisory staff, landslide debris had been removed from the northern landslide. In the portion of slope between the northern and southern landslides, according to the observations of the site staff, hair cracks up to about 1 mm wide were noted in early August at the lower portion of the newly applied shotcrete surface. By late August, the cracks here were noted to have progressively developed to a maximum width of about 10 mm, whereas new cracks were seen at the upper shotcreted surface. In places, the cracks were noted to extend into the soil and were not confined only to the shotcreted surface. In view of the observed distress in this area, a concrete buttress was constructed in September along the toe of this portion of slope, and an additional layer of shotcrete was applied on the surface.

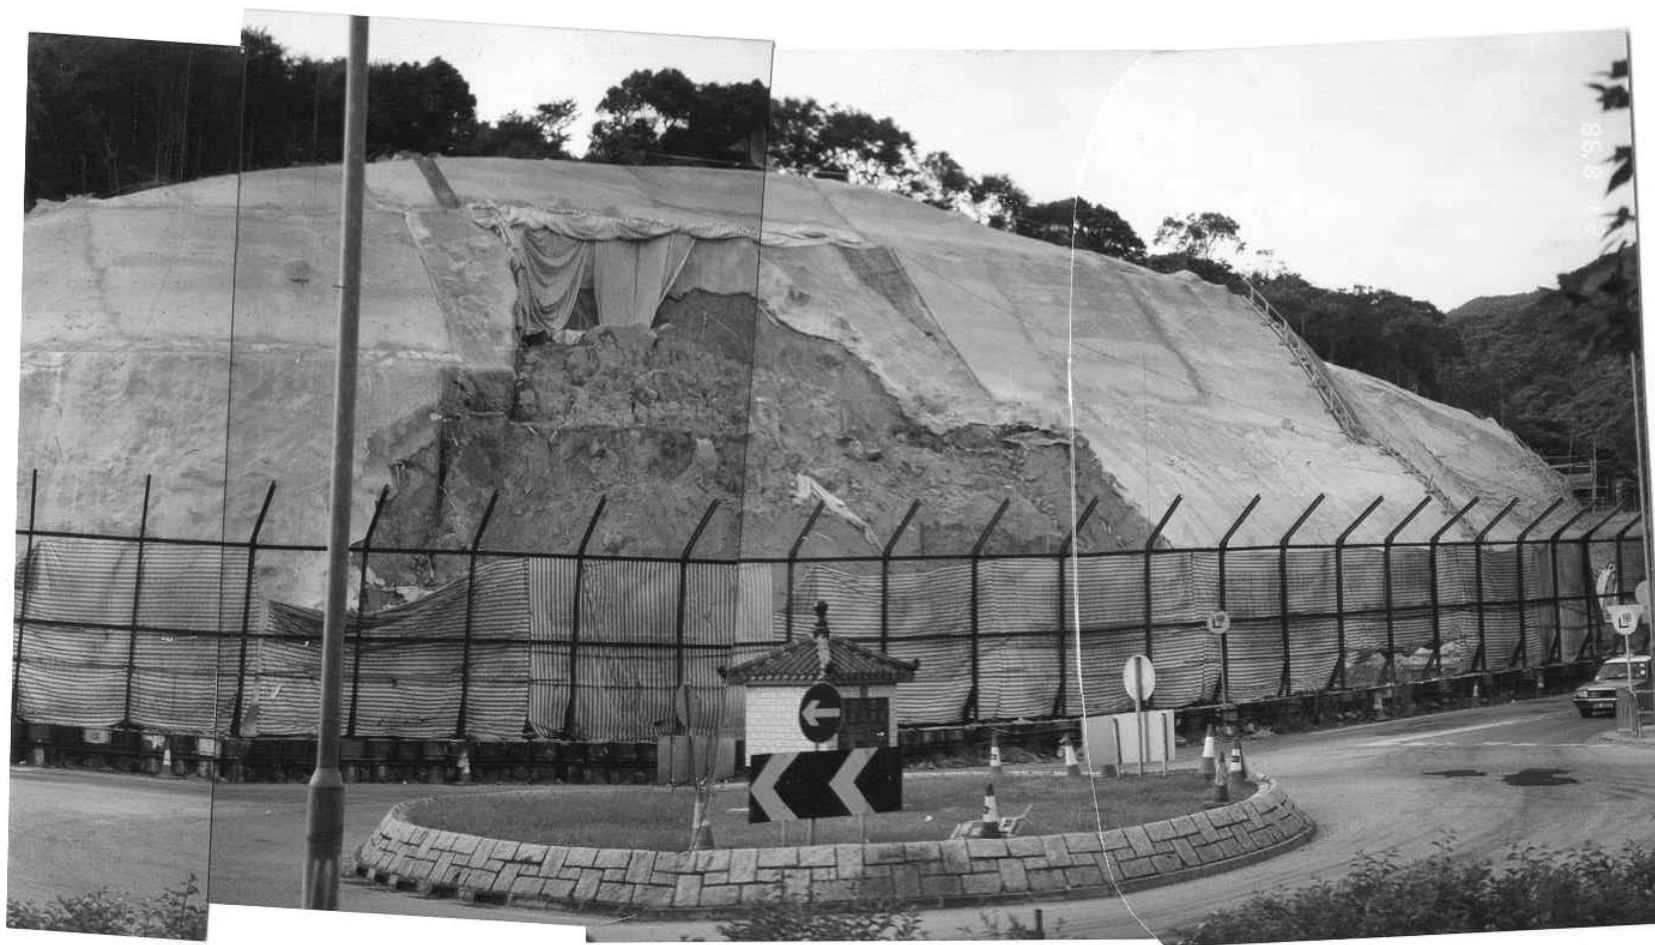
The landslides were first brought to the attention of the Landslip Investigation Division of the GEO in early August 1998. FSW first visited the site on 7 August 1998. During site inspections in August 1998, it was noted that urgent repair works comprising slope trimming and shotcreting of the northern landslide location had been completed (Plate 6). Part of the upper portion of the main scarp and the flanks of the southern landslide had been sprayed with shotcrete (Plate 7).

Plate 7 – General View of the Southern Landslide after Shotcreting the Adjacent Areas
(Photograph taken on 27 August 1998. See Figure 32 for Location.)

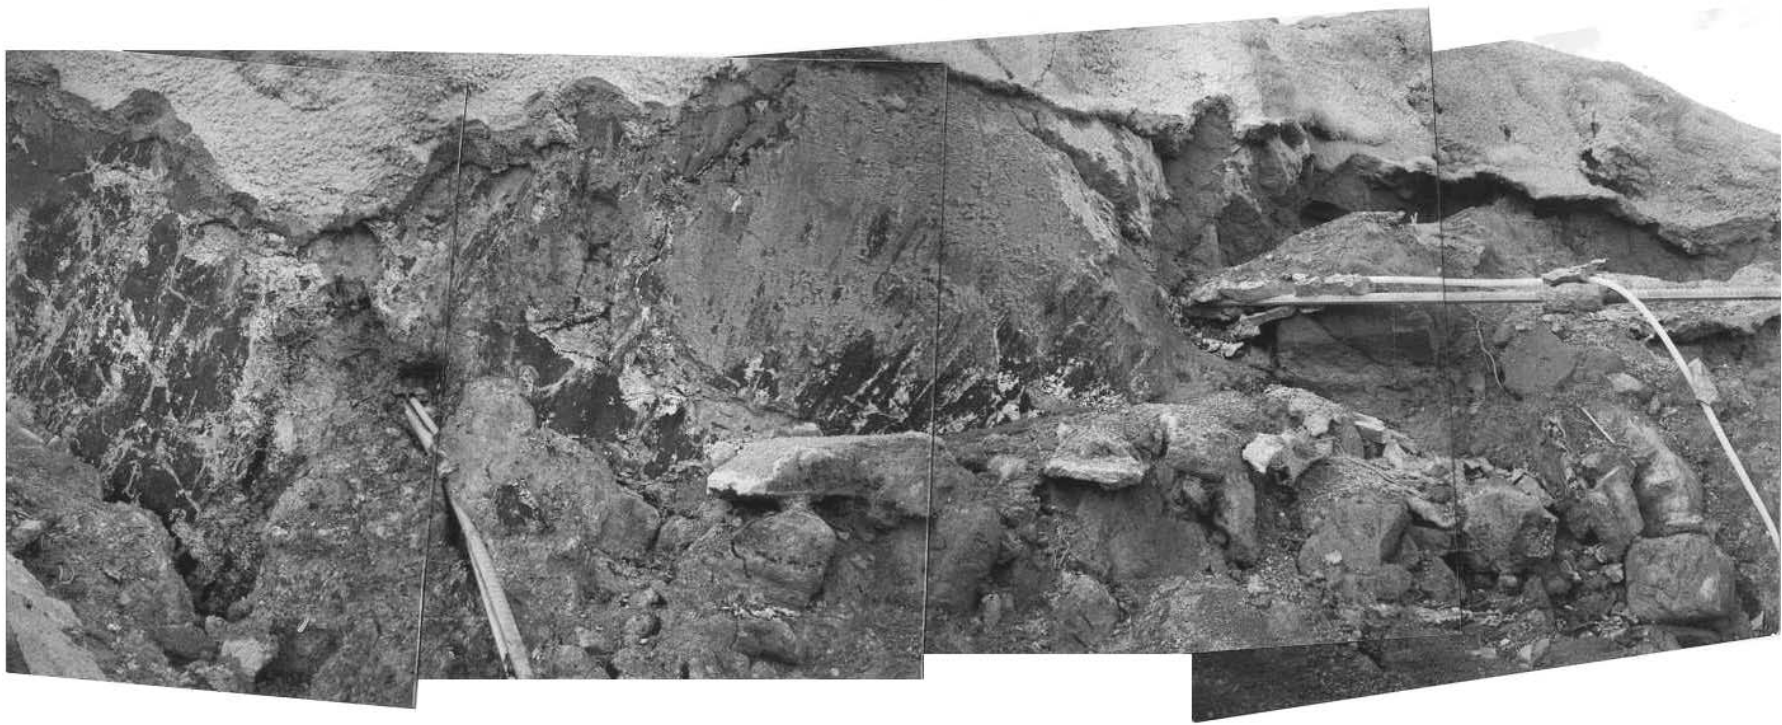
with a thickness of upto about 2 mm (Plate 8). Several open relict joints, some of which were partially infilled with clay and silt deposits, were observed in and below the disturbed material dipping steeply (75° to 85°) into the slope (Plate 9).

Plate 8 – Sub-vertical, Slickensided, Manganese Infilled Relict Joints
Forming Part of the Release Plane of the Southern Landslide
(Photograph taken on 12 August 1998. See Figure 32 for Location.)

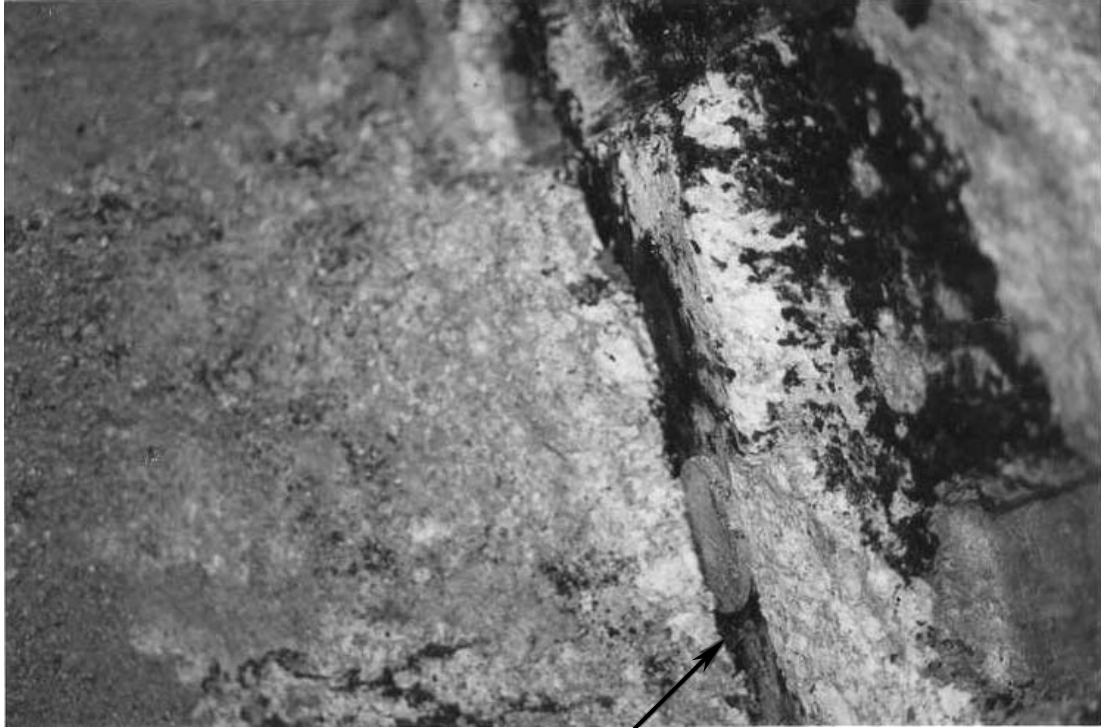
Plate 9 – Opened Relict Joint (Dipping into the Slope) within the Slipped Mass of Southern Landslide (Photograph taken on 9 February 1999. See Figure 32 for Location.)

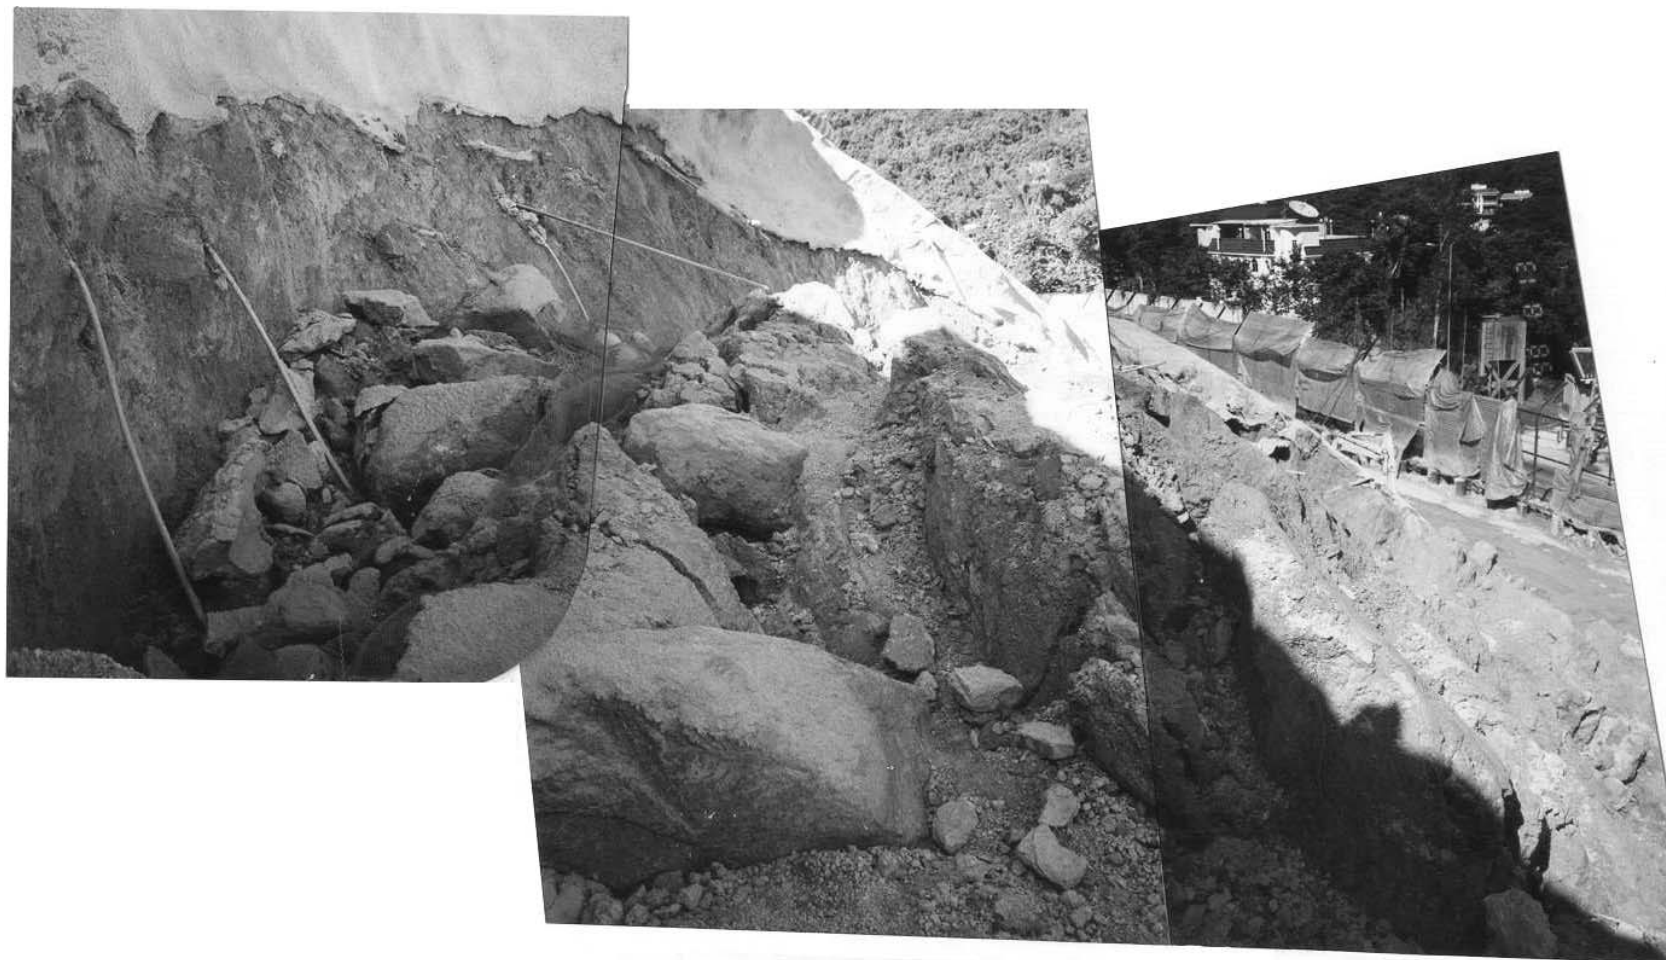
In the southern landslide, relatively intact blocks of CDT, including part of the failed lower berm, were noted in the landslide debris. Several deformed soil nail bars (nail heads not yet installed), sections of grout, and plastic grout tubes (originally inserted into the drillholes with the soil nails) protruded from the main scarp, along the flanks of the landslide and within the debris (Plates 8 and 10). The deformed soil nail bars were generally inclined downslope.

Plate 10 – Close-up View of Deformed Soil Nails Protruding from the Main Scarp of Southern Landslide
(Photograph taken on 13 August 1998. See Figure 32 for Location.)

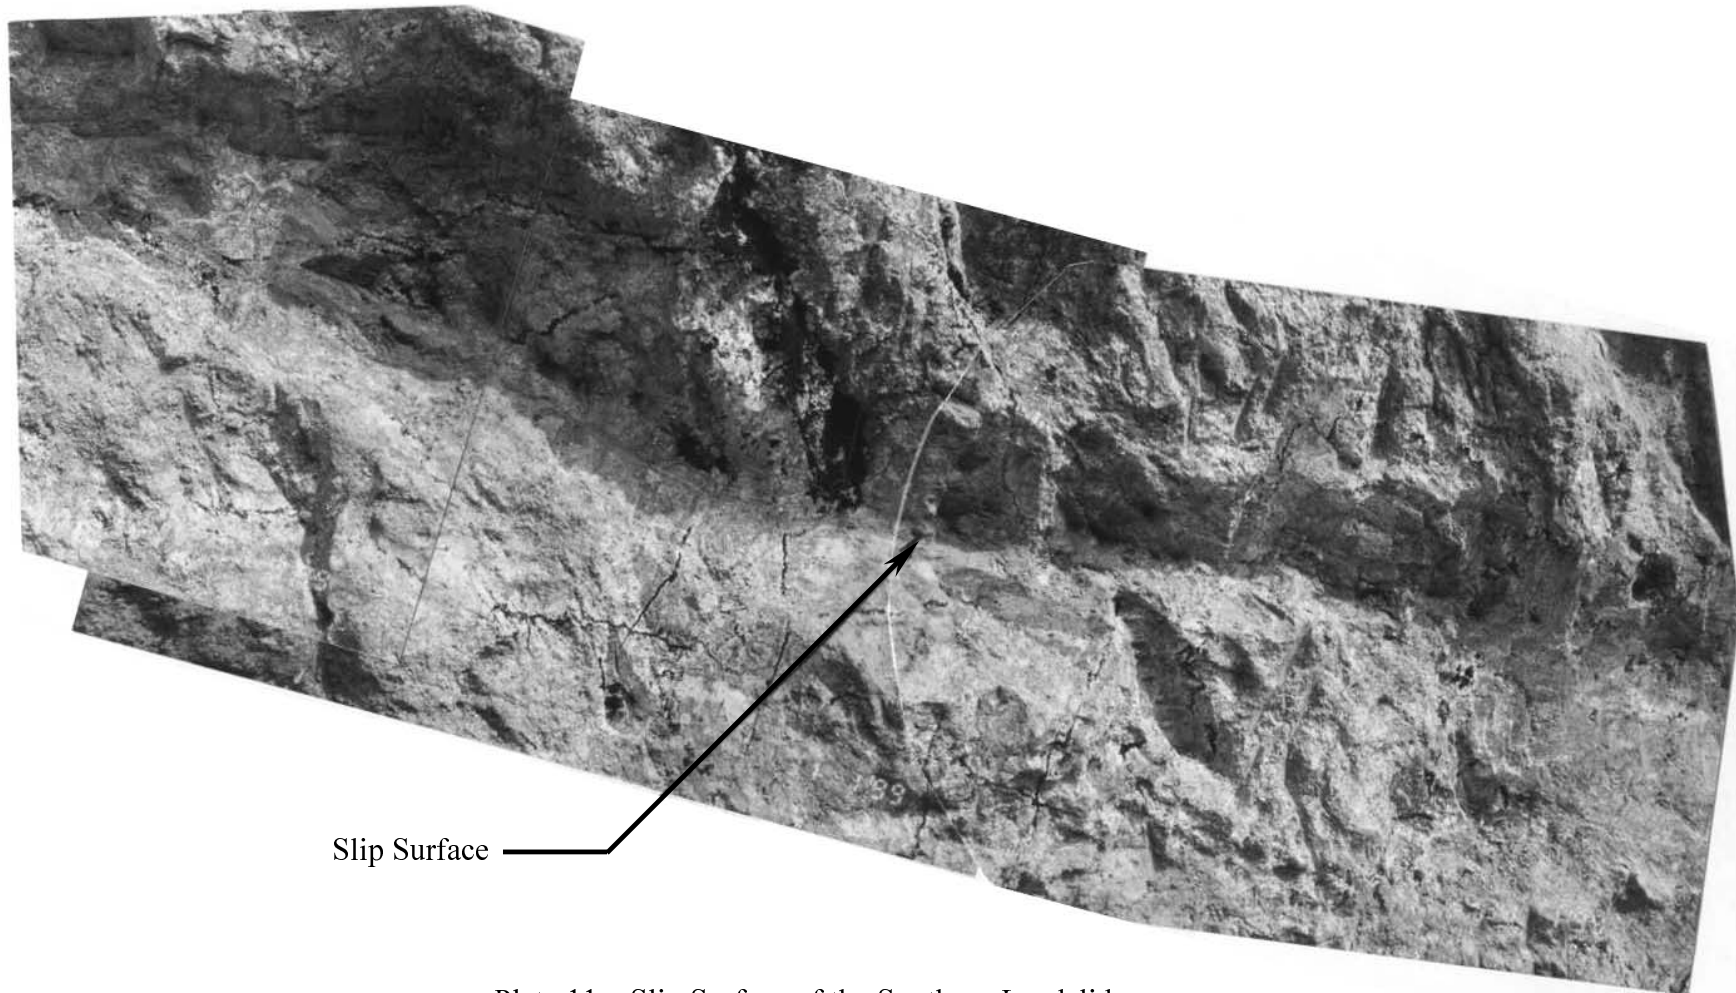
Plate 11 – Slip Surface of the Southern Landslide
(Photograph taken on 31 January 1999.
See Figure 32 for Location.)
