**SECTION 2 :
DETAILED STUDY OF THE
LANDSLIDES AT THE
JUNCTION OF SAI SHA ROAD
AND TAI MONG TSAI ROAD
IN JUNE 1998**

Fugro Scott Wilson Joint Venture

**This report was originally produced in November 1999
as GEO Landslide Study Report No. LSR 13/99**

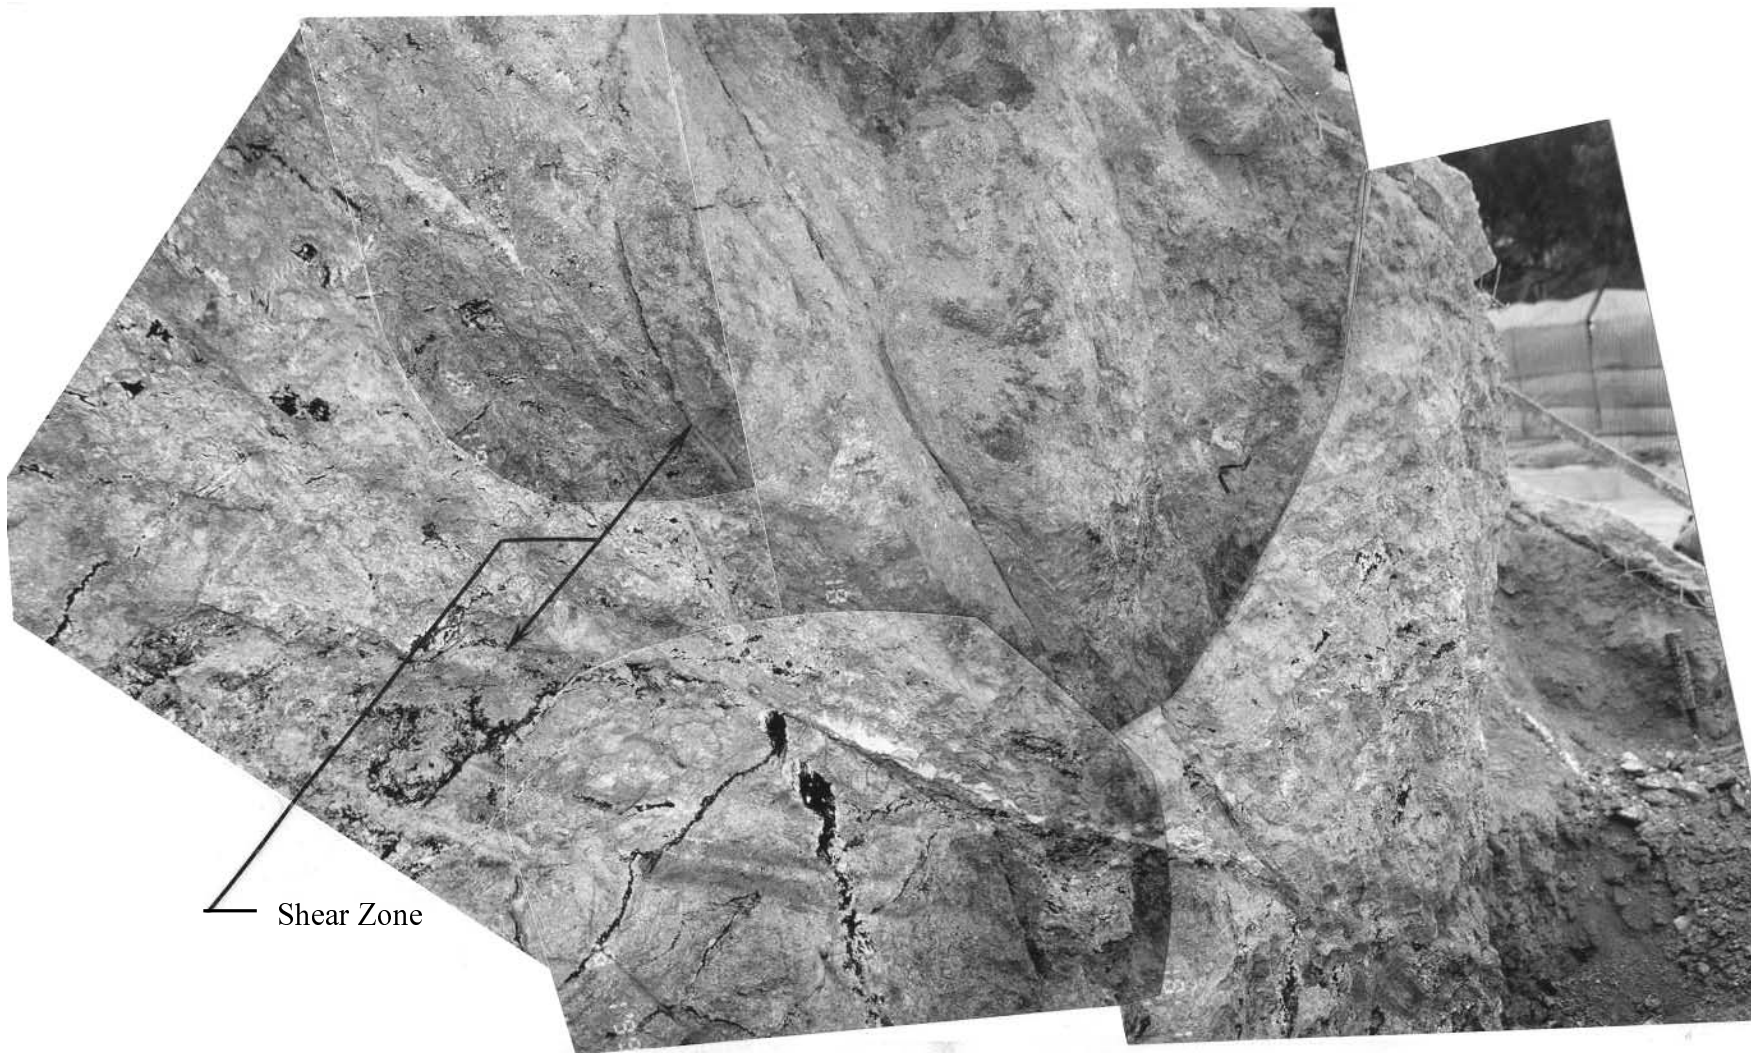
Plate 12 – Slip Surface of the Southern Landslide in the Form of Shear Zone
(Photograph taken on 18 January 1999. See Figure 32 for Location.)

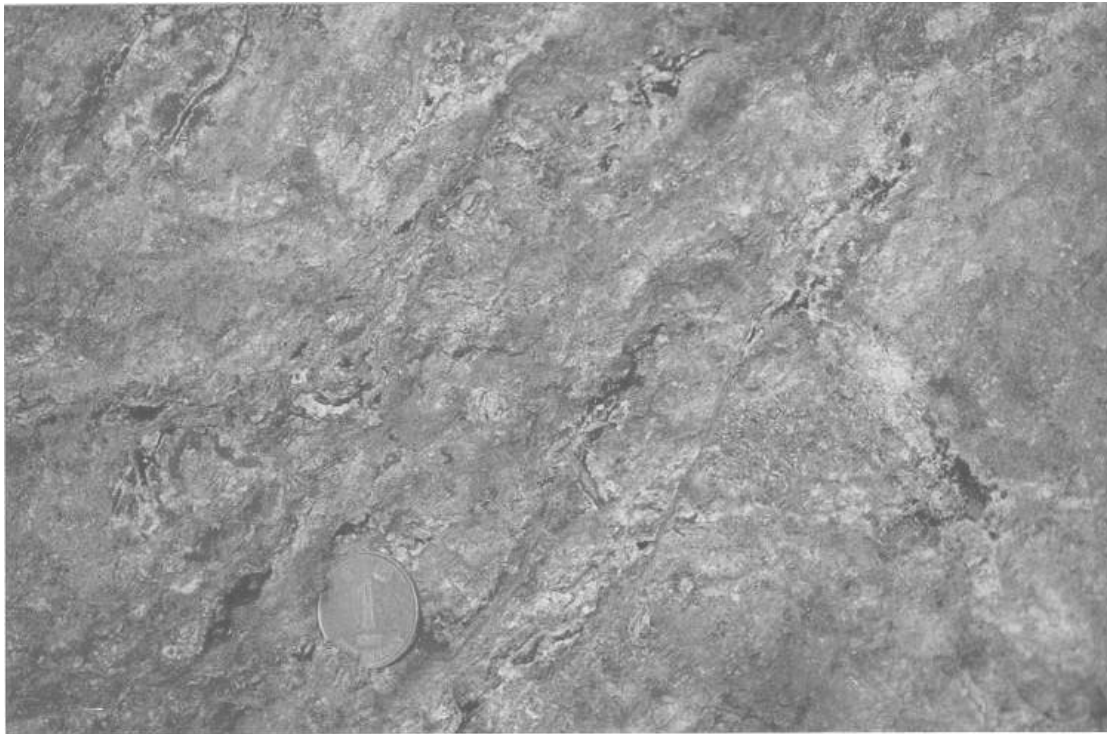
Plate 13 – Close-up View of Sigmoidal S-C Fabrics within Shear Zone above the Slip Surface of Southern Landslide (Photograph taken on 9 February 1999. See Figure 32 for Location.)

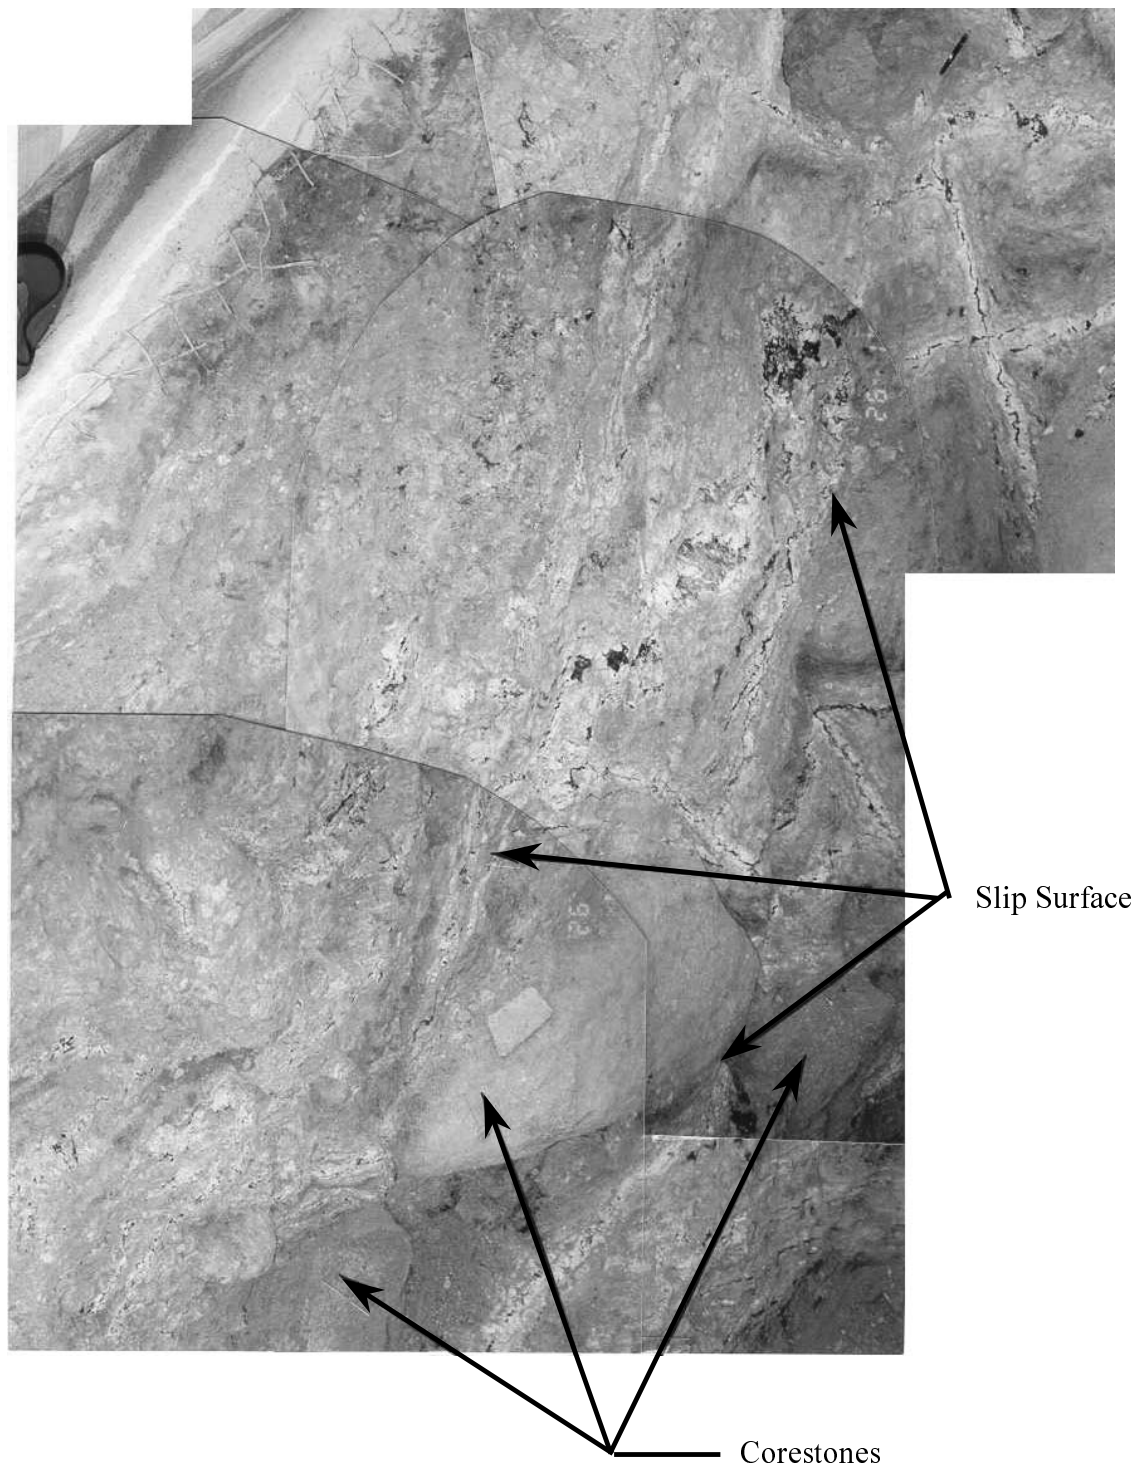
Plate 14 – Slip Surface of the Southern Landslide Deflected around Corestones
(Photograph taken on 31 January 1999. See Figure 32 for Location.)

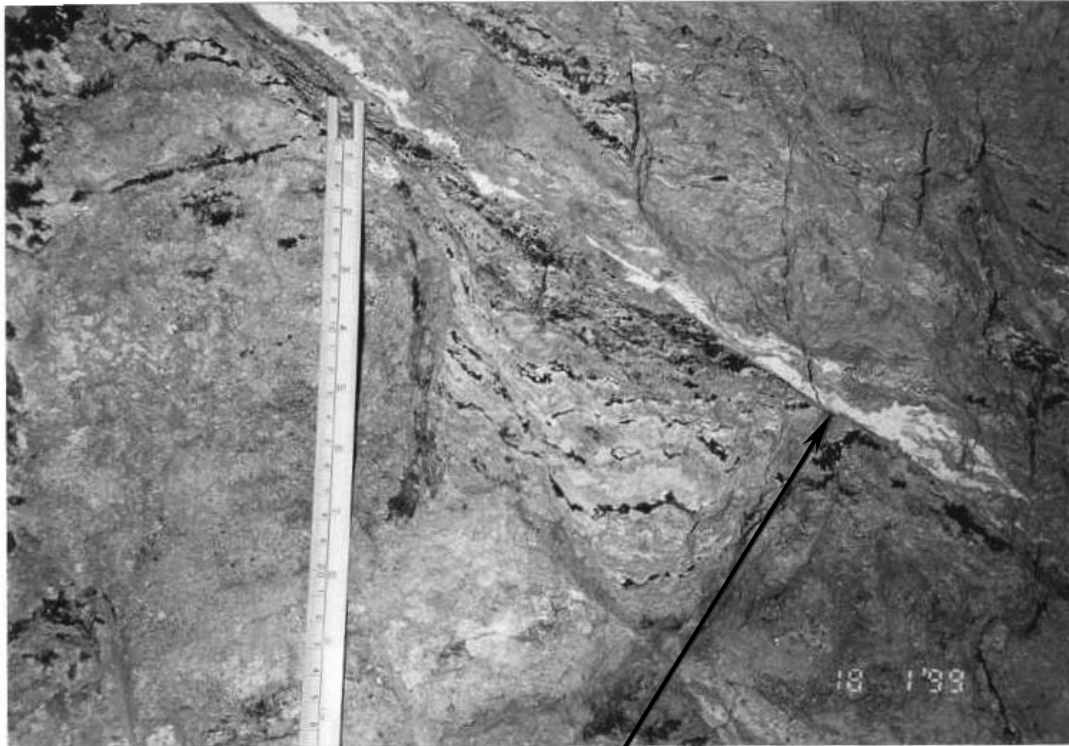
Plate 15 – Slip Surface of the Southern Landslide along Kaolin Infilled and Manganese Oxide Stained Relict Joint. (Photograph taken on 18 January 1999. See Figure 32 for Location.)

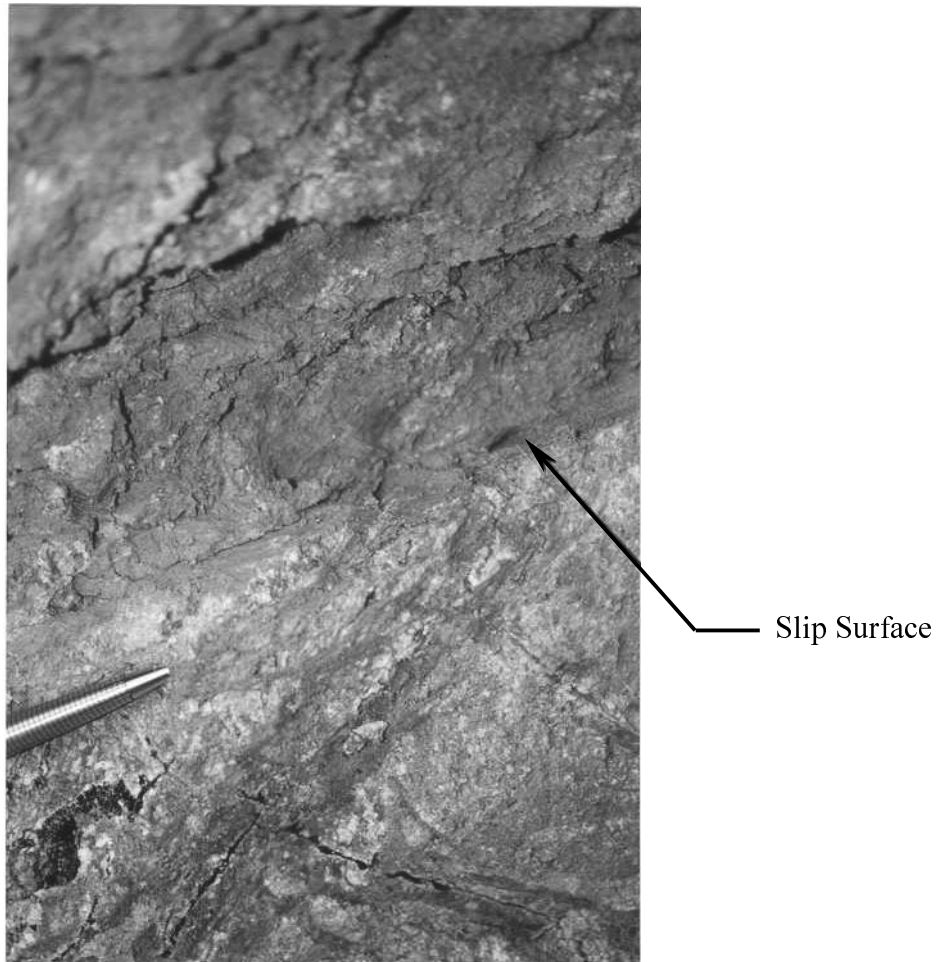
Plate 16 – Close-up View of the Southern Landslide Slip Surface with Destroyed Fabric above and Intact Fabric below the Slip Surface (Photograph taken on 9 February 1999. See Figure 32 for Location.)

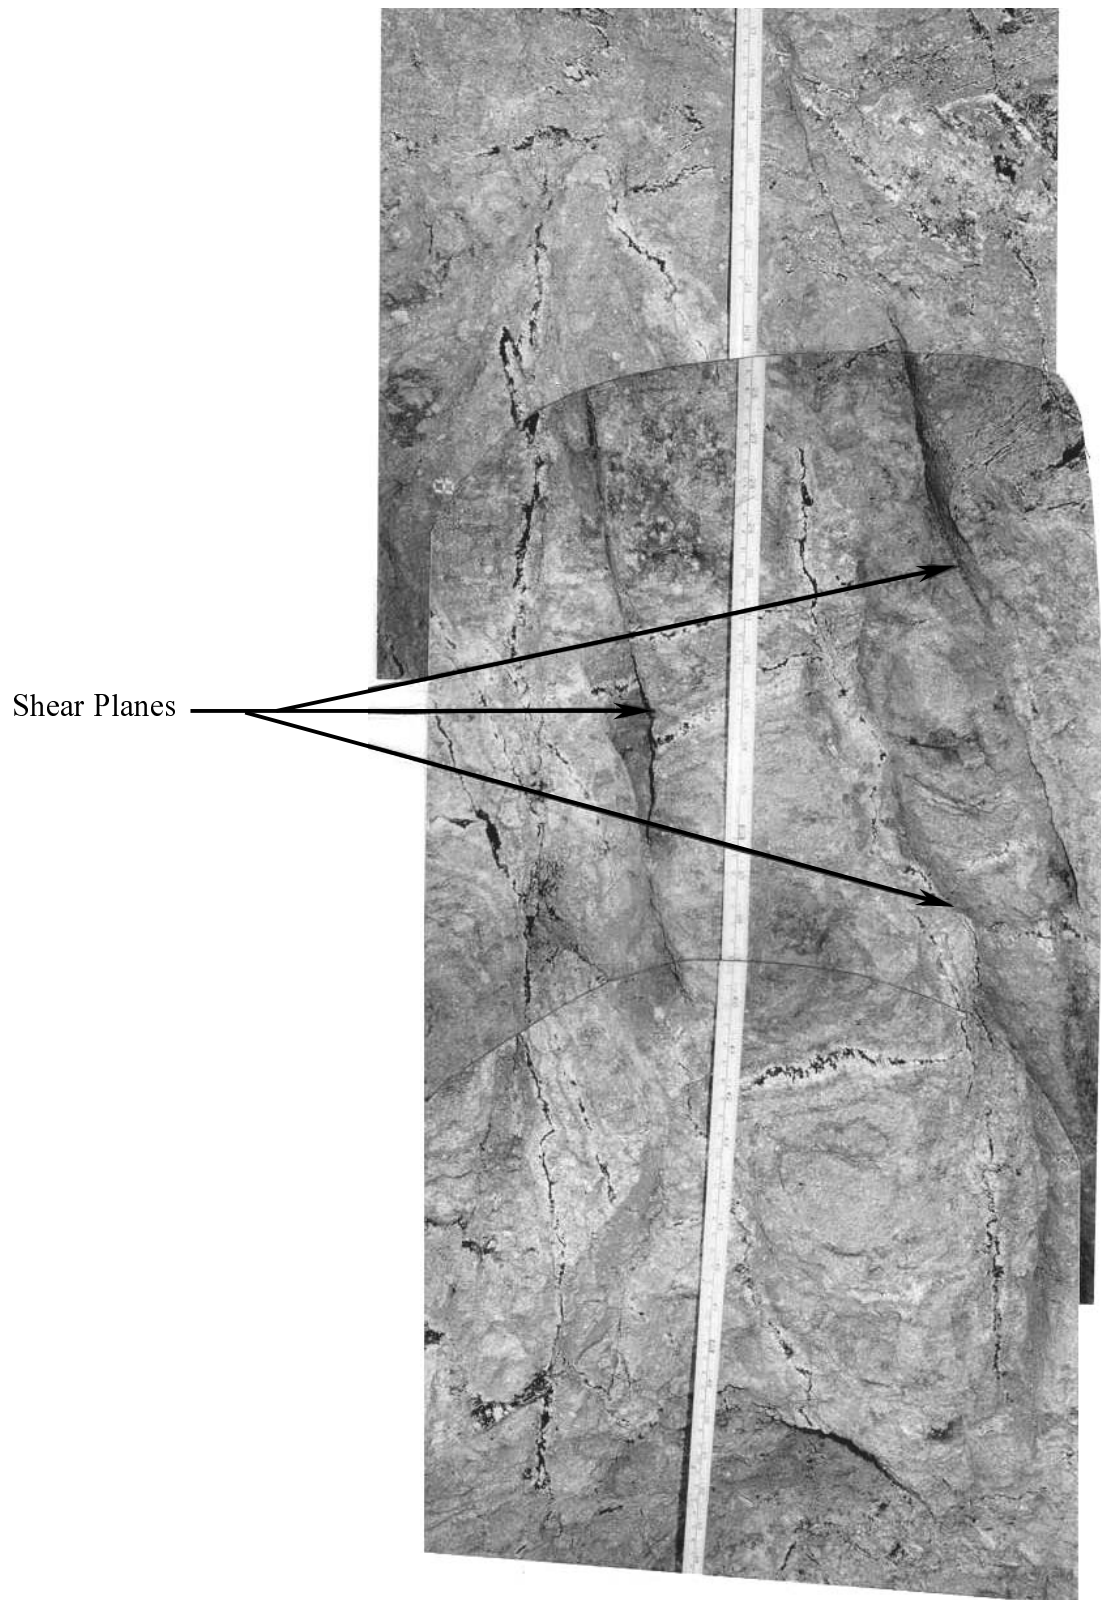
Plate 17 – Localised Sub-vertical Shear Planes within the Slipped Mass of Southern Landslide (Photograph taken on 8 January 1999. See Figure 32 for Location.)

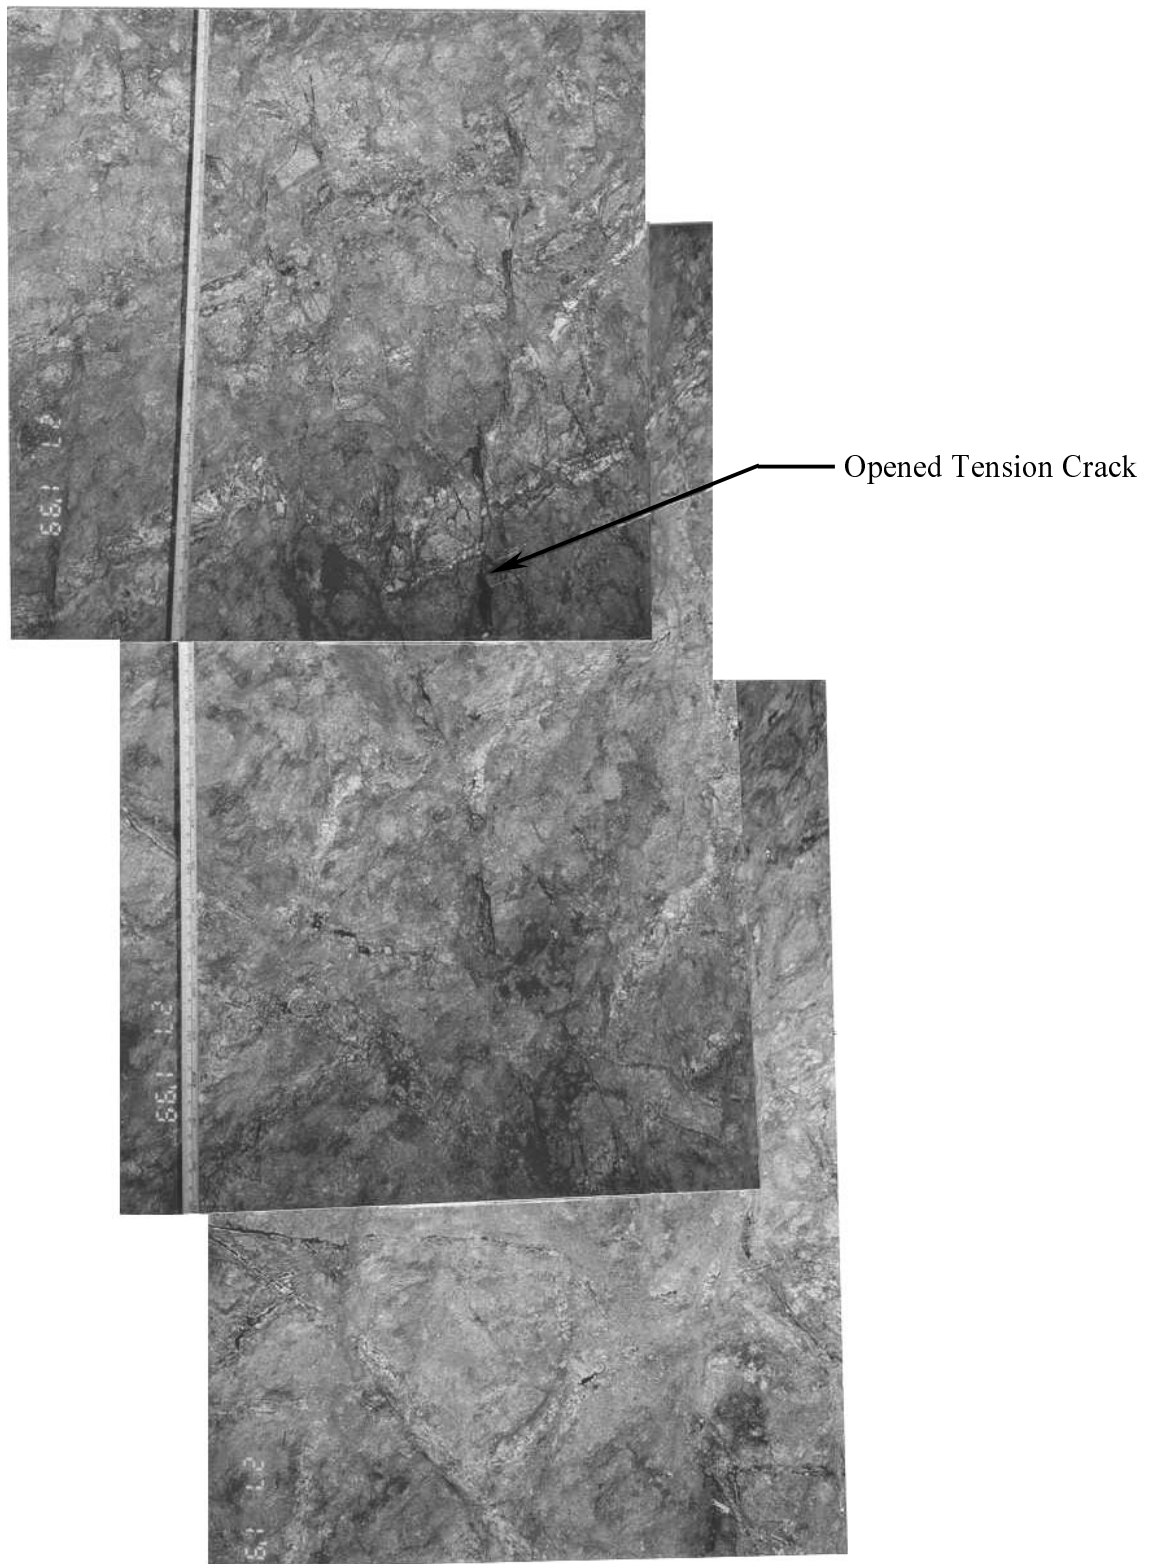
Plate 18 – Opened Tension Cracks within the Slipped Mass of
Southern Landslide (Photograph taken on 27 January 1999
See Figure 32 for Location.)

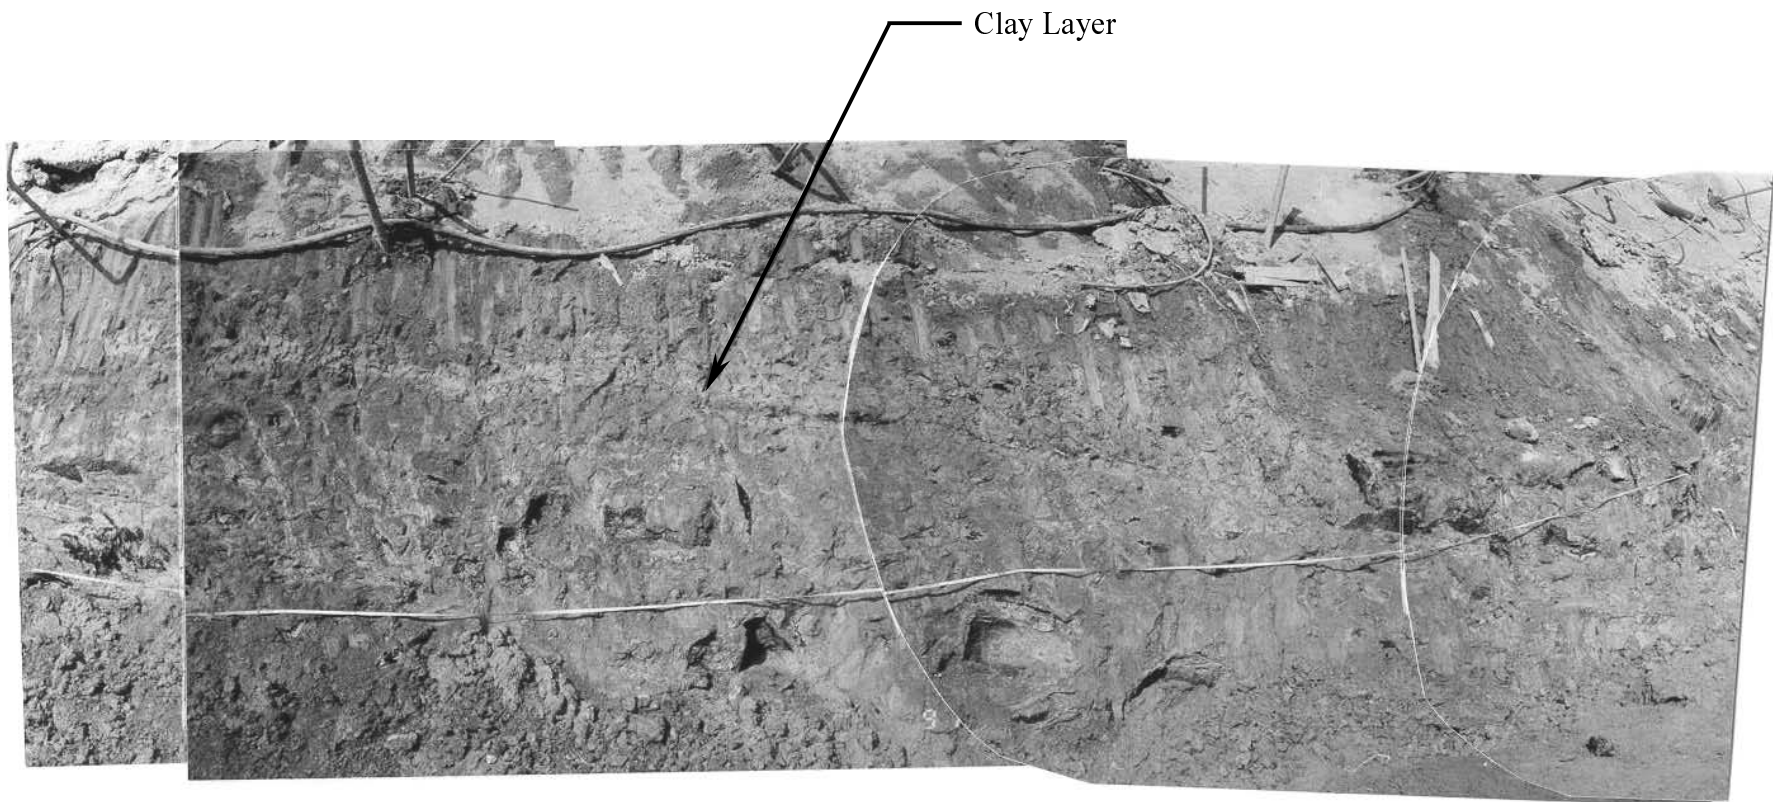
Plate 19 – Clay Layer along the Toe of Temporary Cut Slope
(Photograph taken on 9 December 1998. See Figure 32 for Location.)

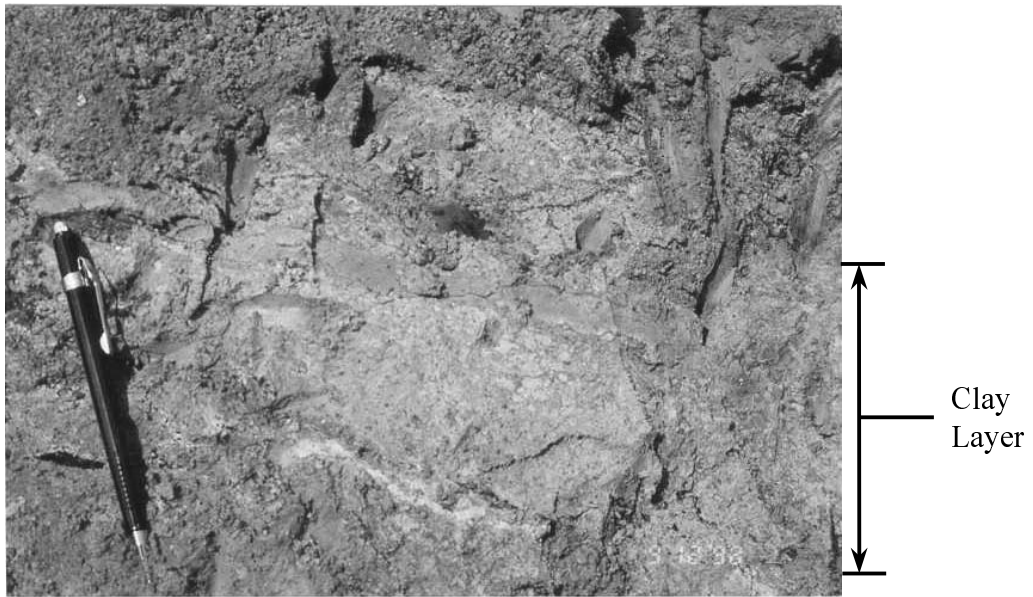
Plate 20 – Close-up View of the Clay Layer
(Photograph taken on 9 December 1998.
See Figure 32 for Location.)

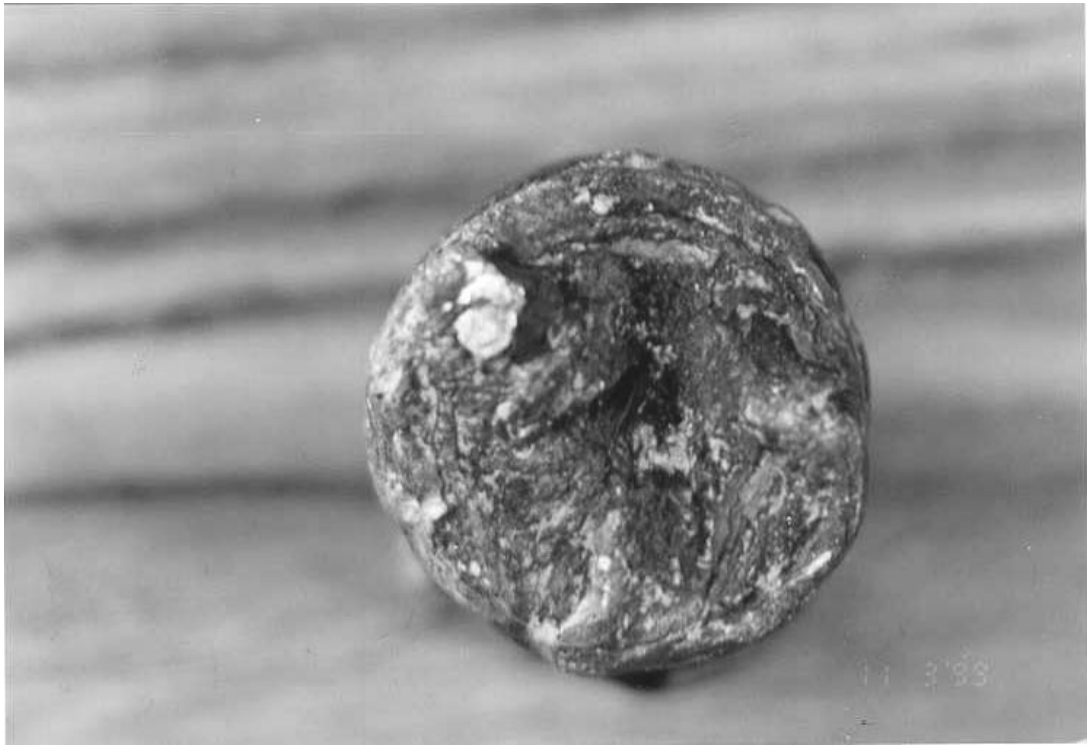
Plate 21 – Close-up View of Fractured Soil Nail Bar

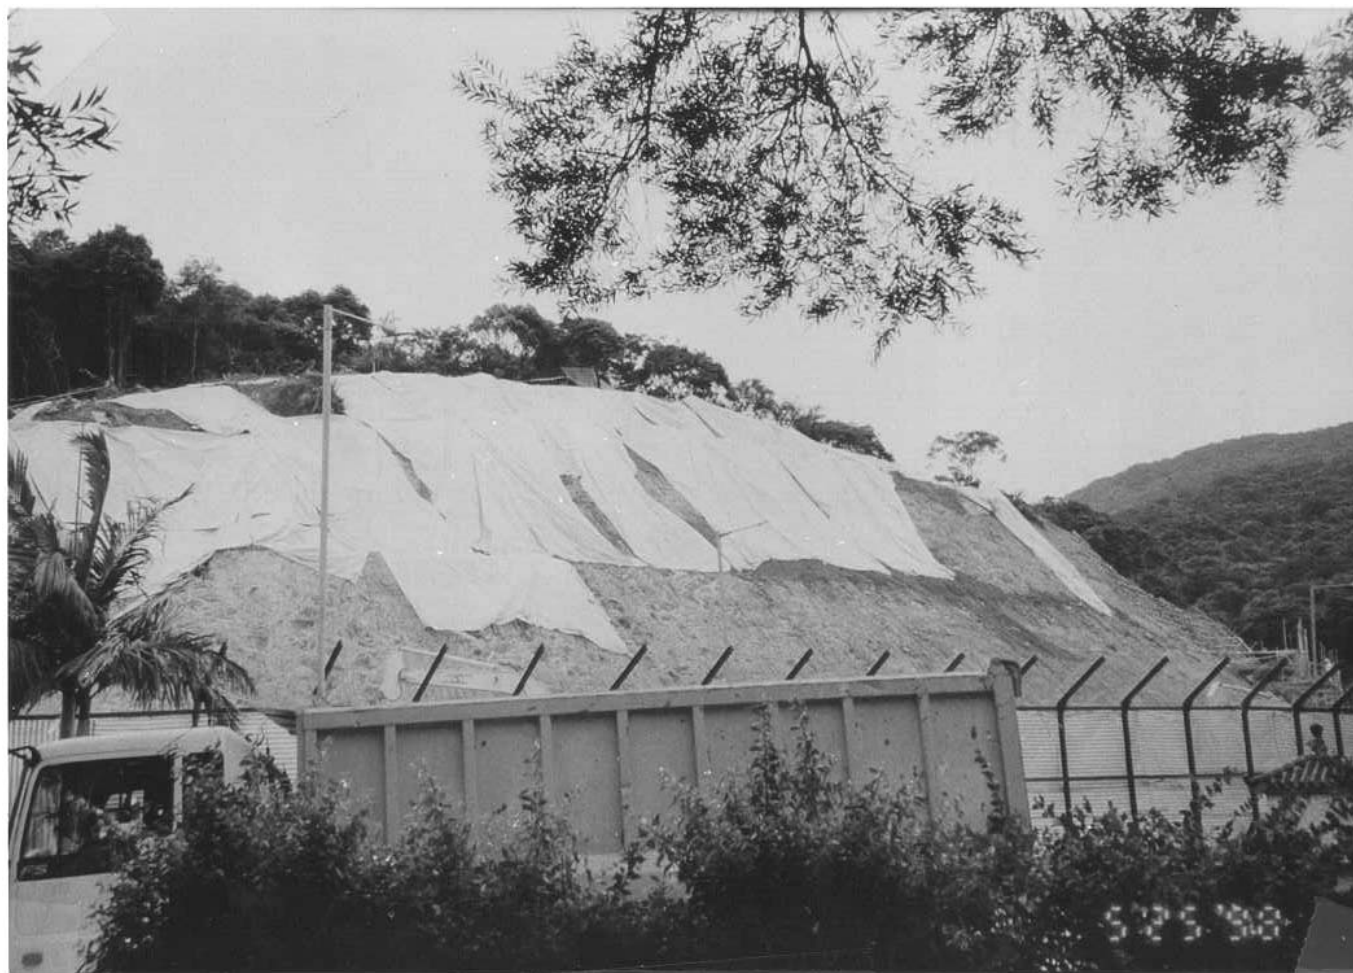
Plate 22 – General View of the Temporary Cut Slope after Removal of Chunam Surface Protection
(Photograph taken on 25 May 1998 and Reproduced from GEO Site Record. See Figure 32 for Location.)
