INVESTIGATION OF SOME SELECTED LANDSLIDES IN 1998 (VOLUME 5)

GEO REPORT No. 112

Fugro Scott Wilson Joint Venture

SECTION 1 : DETAILED STUDY OF SLOPE DISTRESS AT QUEEN'S HILL, BURMA LINES CAMP, FANLING

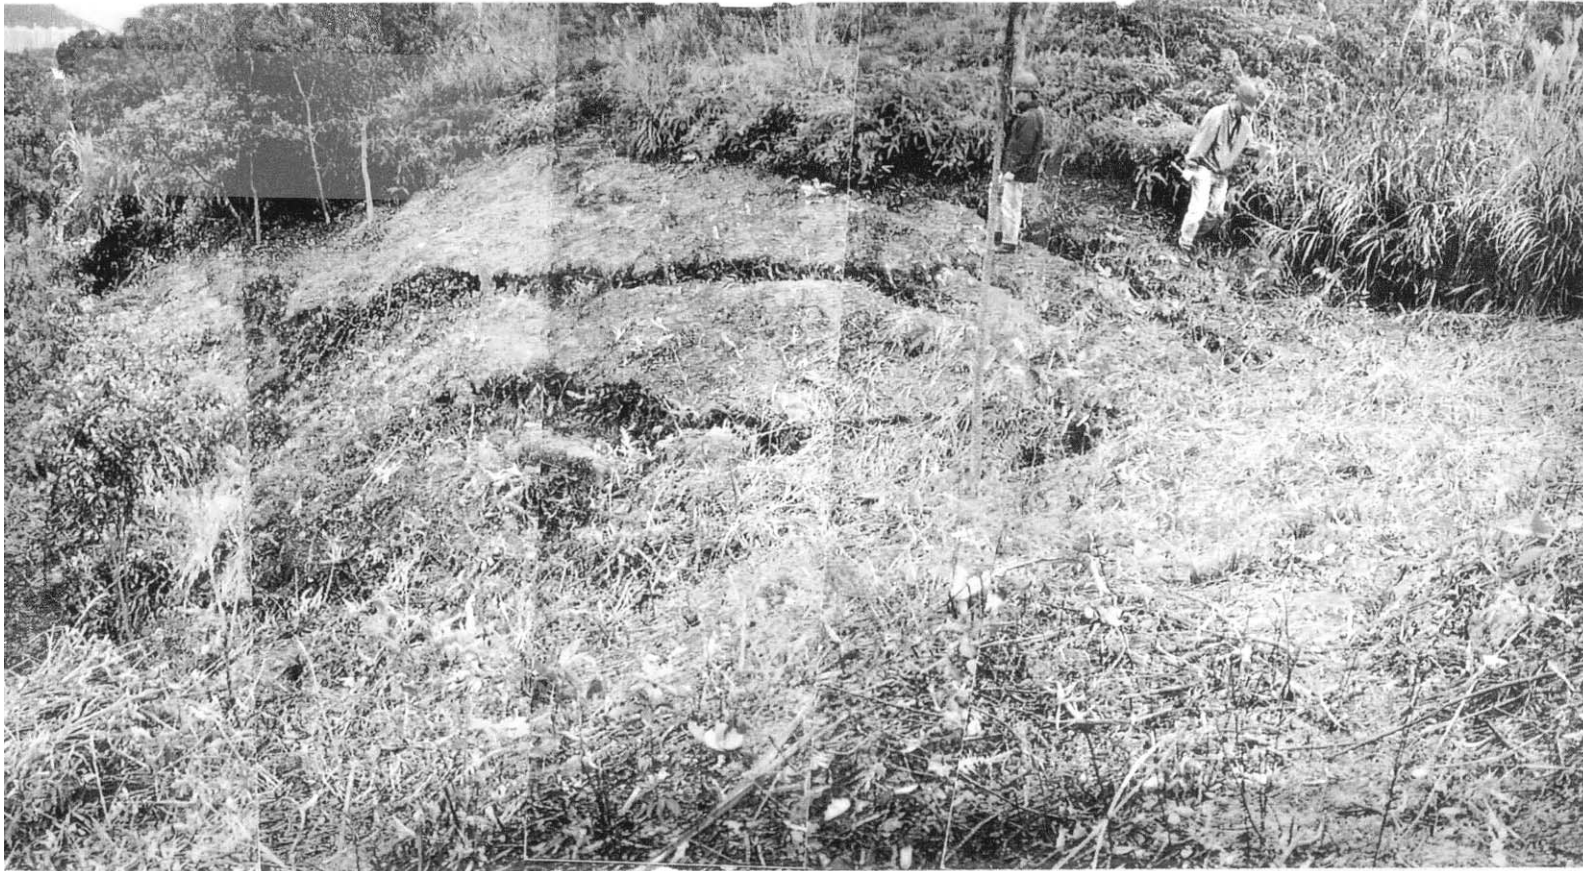
Much of the depression was covered by mesh reinforced shotcrete following the observation of distress in this area during the LPM works. Site inspections undertaken by FSW in August 1998 noted cracks through the shotcrete (that was applied to the unstable portion of the depression in about May/June 1998). In general these are hairline cracks, but over the mid to upper eastern side of the depression, below the prominent backscar, the hairline cracks have developed into 2 mm to 3 mm wide cracks, which indicates possible continued movement in this locality.

Plate 2 – View of Extensive Cracking and Bulging Visible in the Shallow Depression above Blocks 15 and 17
(Photographs taken on 23 January 1998)

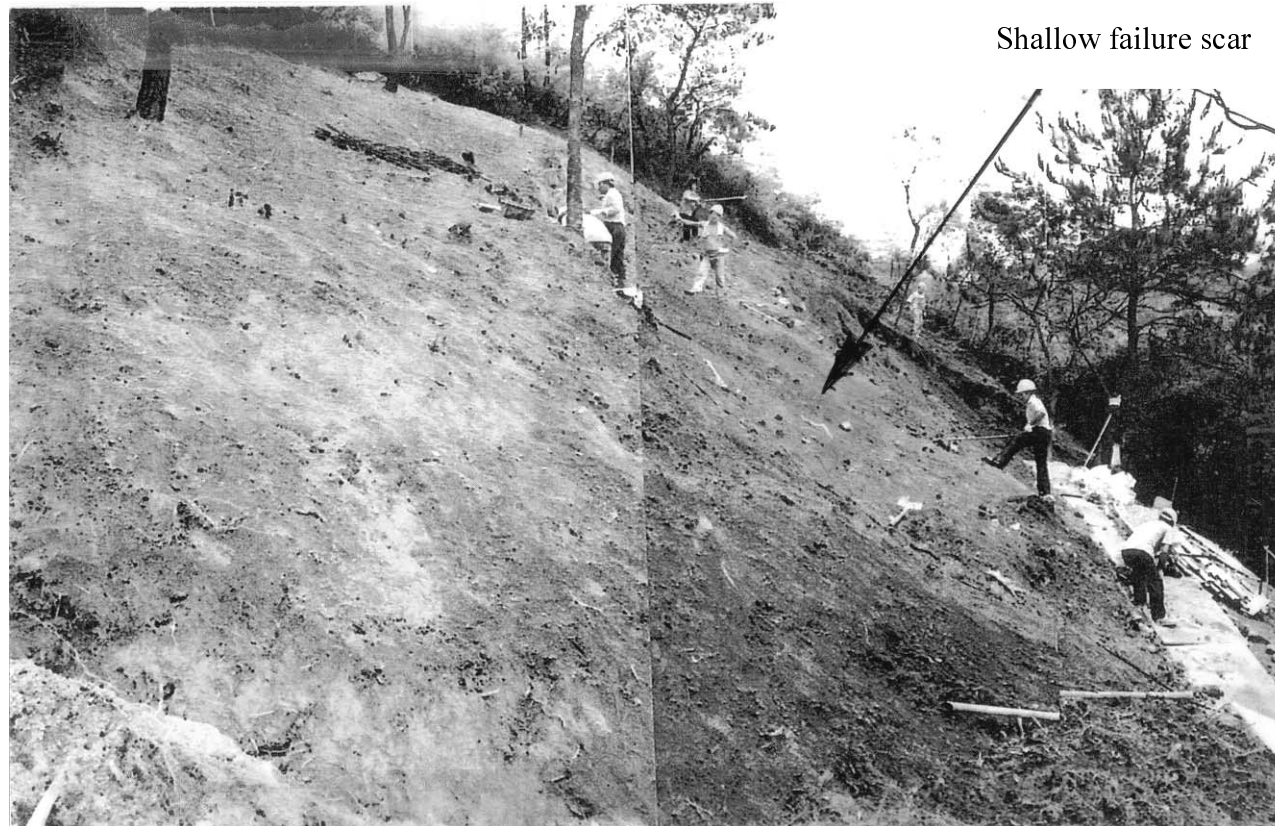
Another less prominent depression, which also appears to form an ephemeral drainage line, descends the eastern side of the hillside. In the vicinity of this depression are two landslide scars and disturbed ground with tension cracks (Plates 4, 11 and 12). The crown of the northernmost landslide scar lies approximately 15 m to 20 m downslope from the ridgeline and occurs in the vicinity of one of the prominent breaks in slope observed across the hillside. The scar is approximately L-shaped in plan with the landslide backscarp, which runs roughly parallel to the ridgeline, being about 20 m long, and varying in height up to a maximum of about 2.5 m. The estimated volume of this failure is of the order of 150 m^3 to 200 m^3 . A layer of colluvium of variable thickness overlying highly and highly to moderately decomposed tuff is exposed in the mainscarp. The corresponding debris trail extends downslope for a distance of about 25 m (Plates 11 and 13). The profile of the debris trail appears to have been accentuated by erosion.

Plate 3 – View of Shallow Failure Scar Identified in the Hillside above Block 13
(Photographs taken on 29 April 1998)

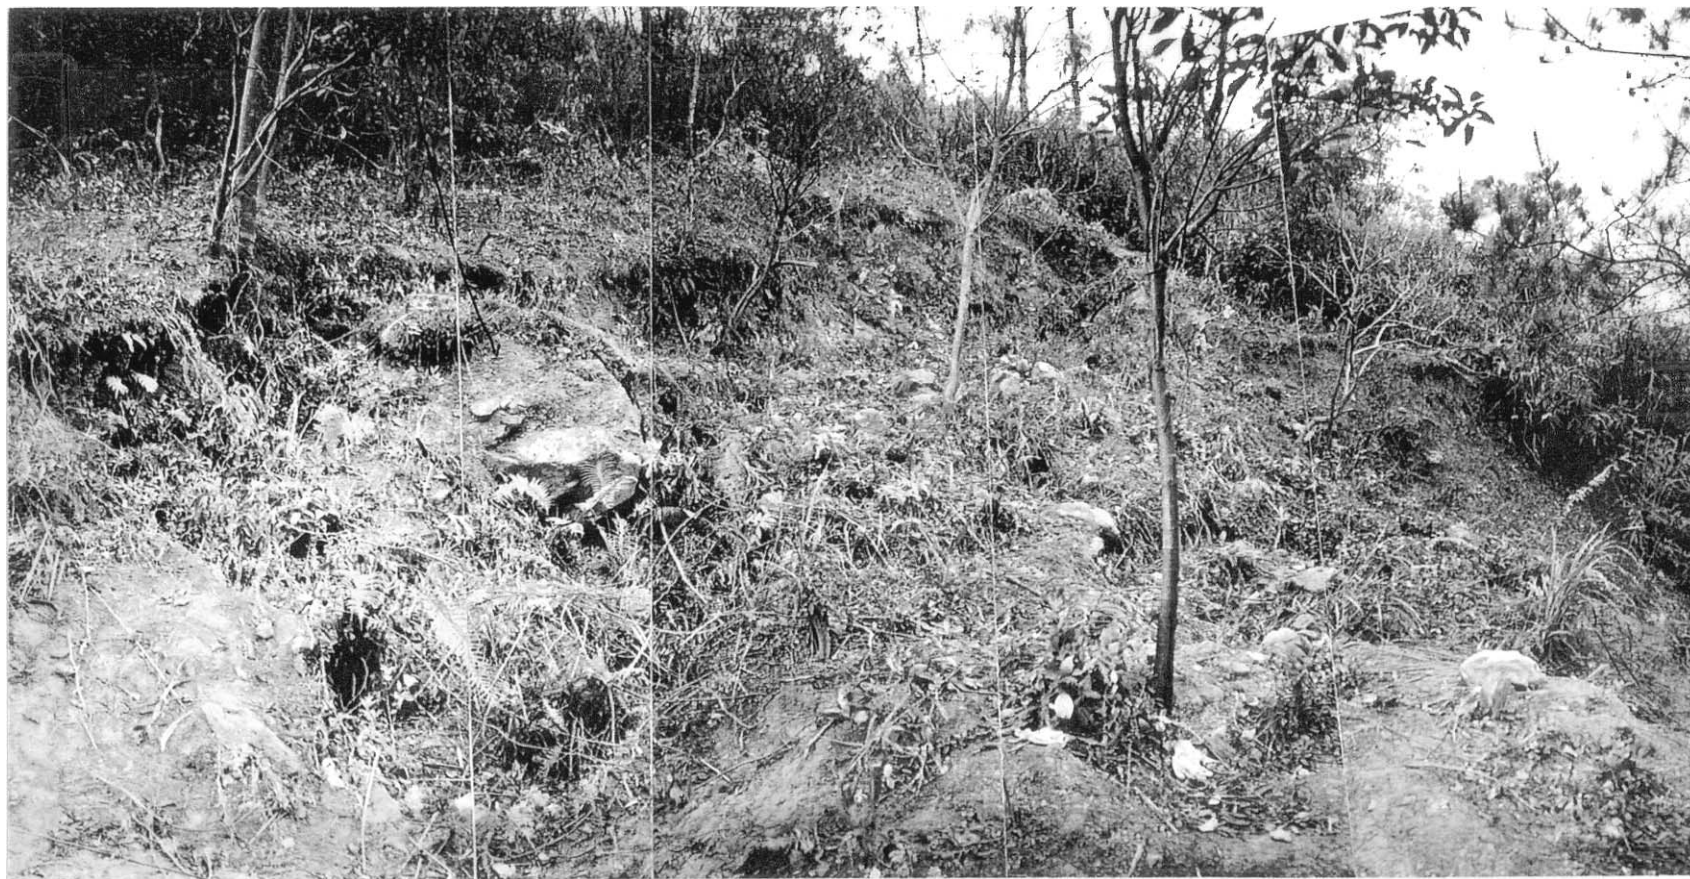
The second failure scar is located further downslope and was identified during the LPM works to Slope No. 3SW-B/C12 (Plate 4). This scar is about 10 m to 15 m wide with a semi-circular plan profile, and has been covered with shotcrete and surface water drainage provided. In addition, soil nails and raking drains have been installed locally in the landslide scar.

Plate 4 – View of Old Landslide Scar Identified above Block 13
(Photographs taken on 9 March 1998)

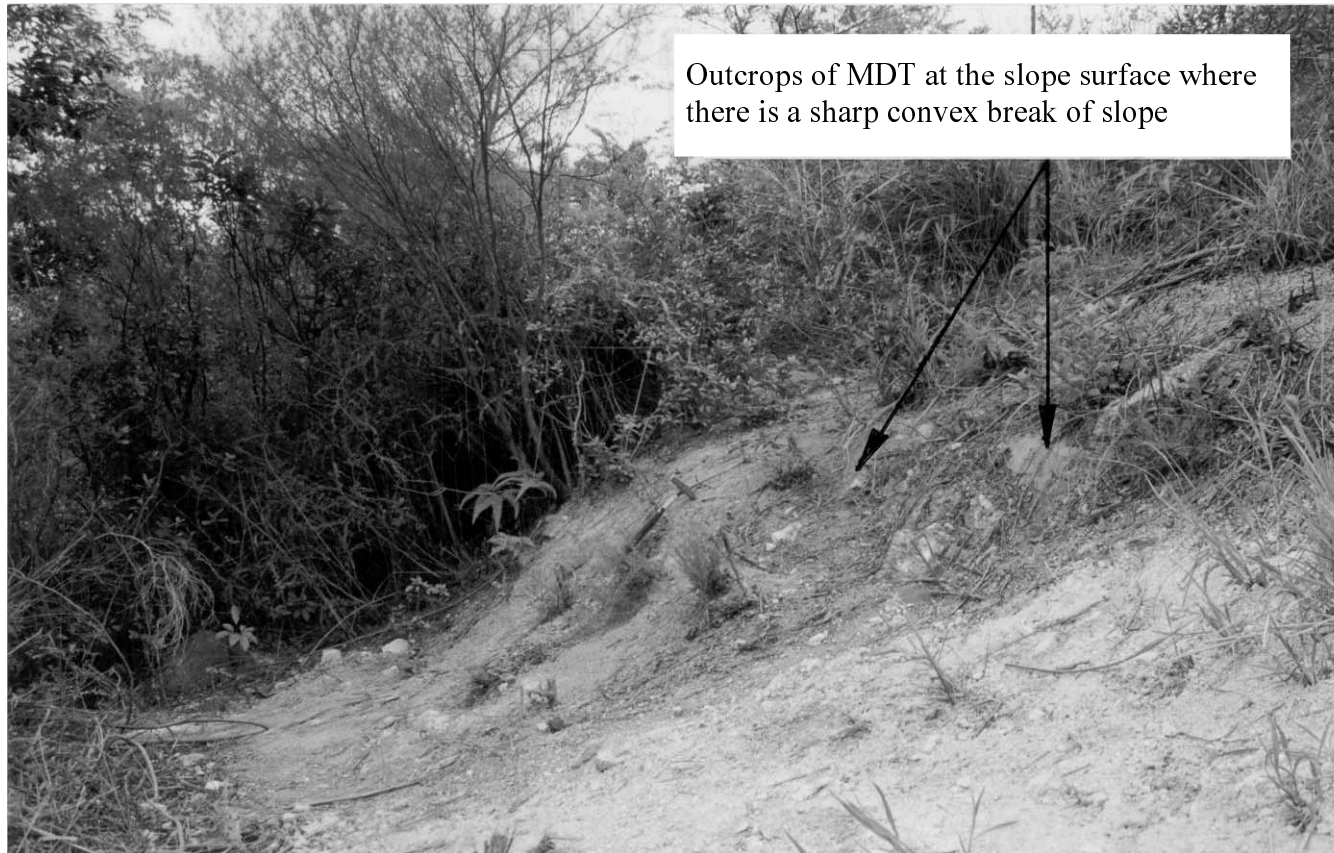
Outcrops of MDT at the slope surface where there is a sharp convex break of slope

Plate 5 – View of Prominent Convex Break of Slope
(Photograph taken on 14 April 1999)

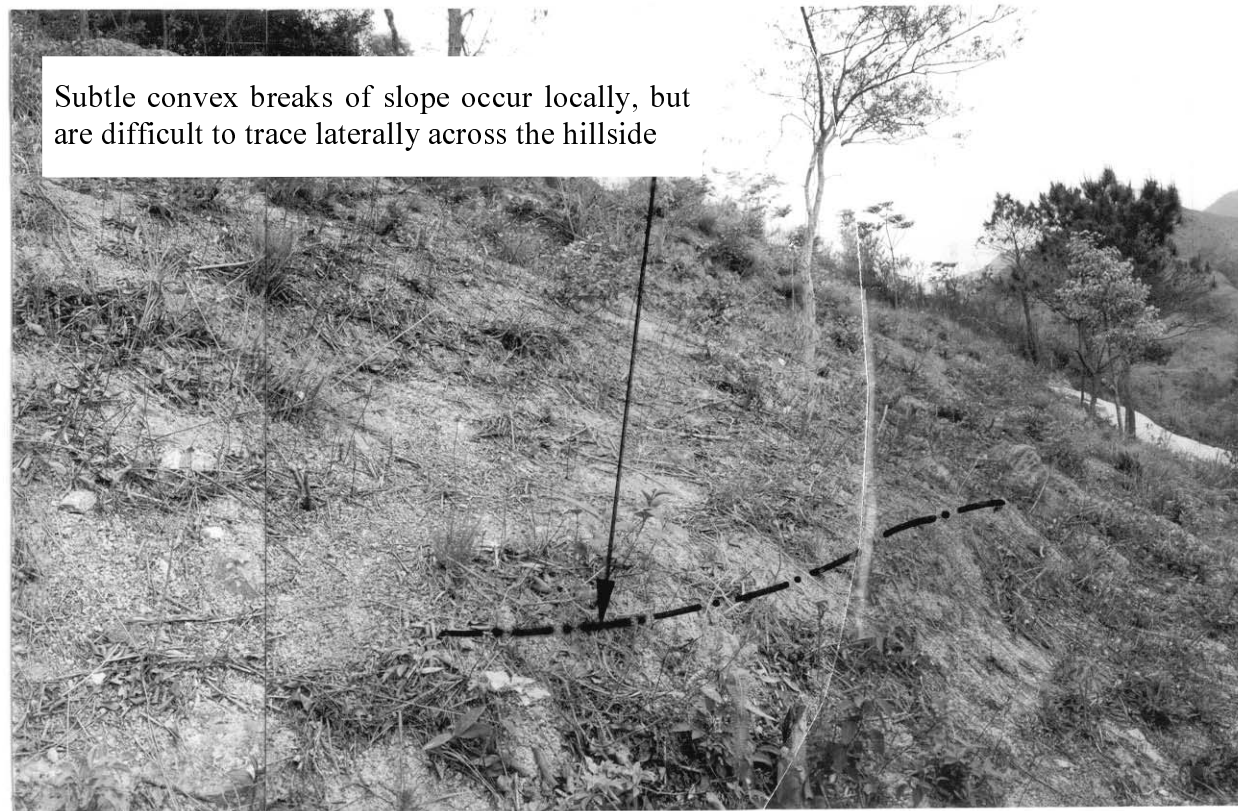
Subtle convex breaks of slope occur locally, but are difficult to trace laterally across the hillside

Plate 6 – View across the Lower Eastern Portion of the Site Showing the Hummocky Nature of the Ground
(Photographs taken on 14 April 1999)

Subtle convex breaks in slope easier to identify
along shotcreted portions of the slope

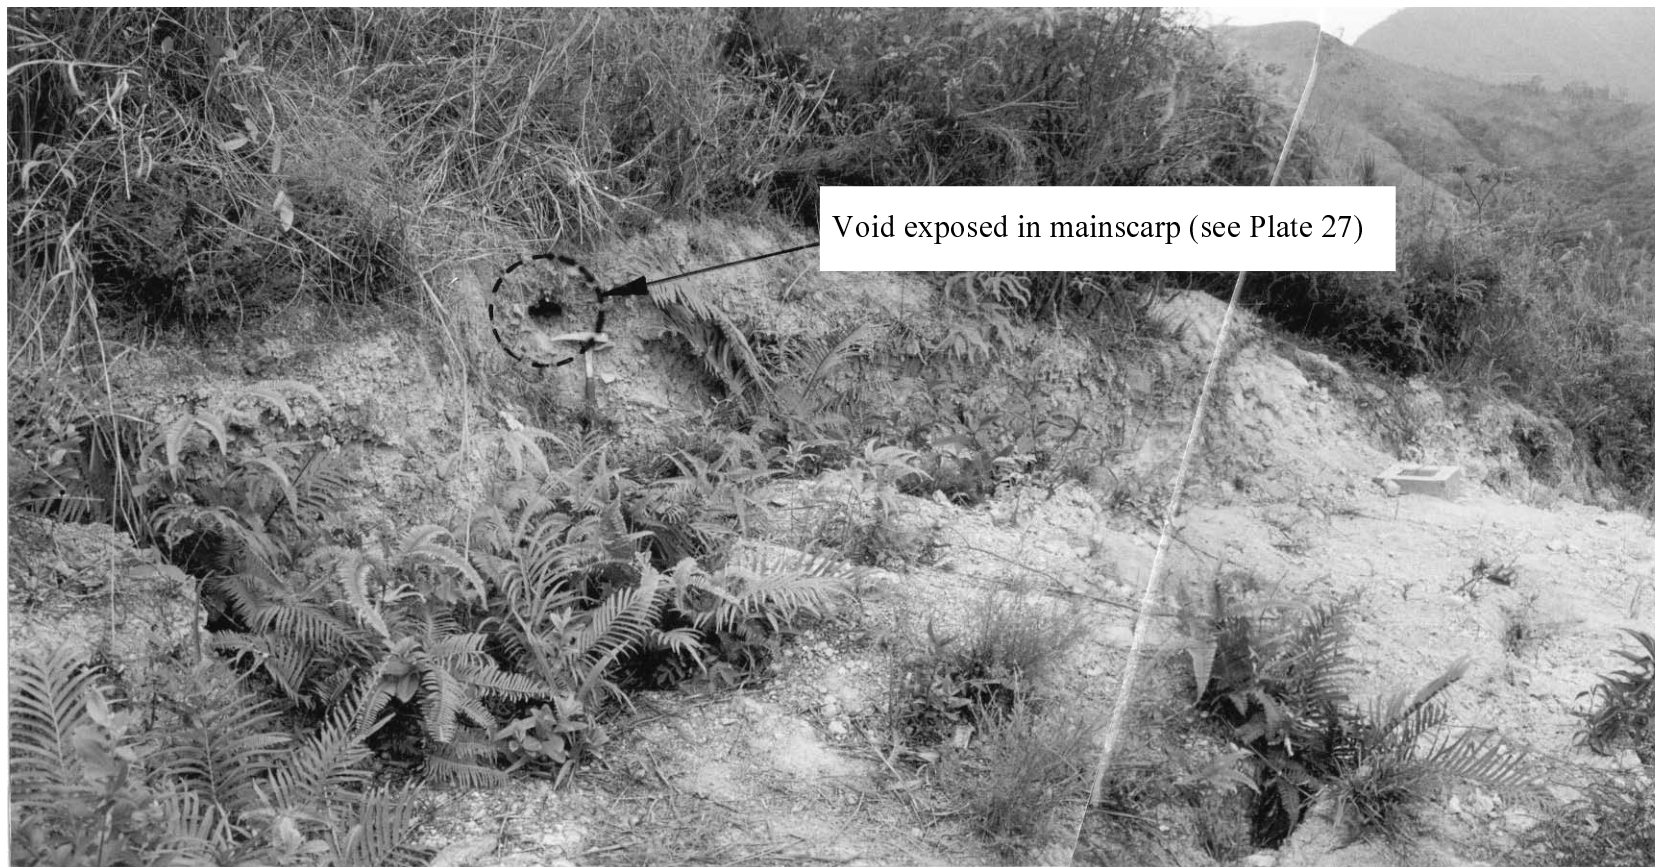
Plate 9 – View of Prominent Mainscarp in the Western Half of the Site
(Photographs taken on 14 April 1999)

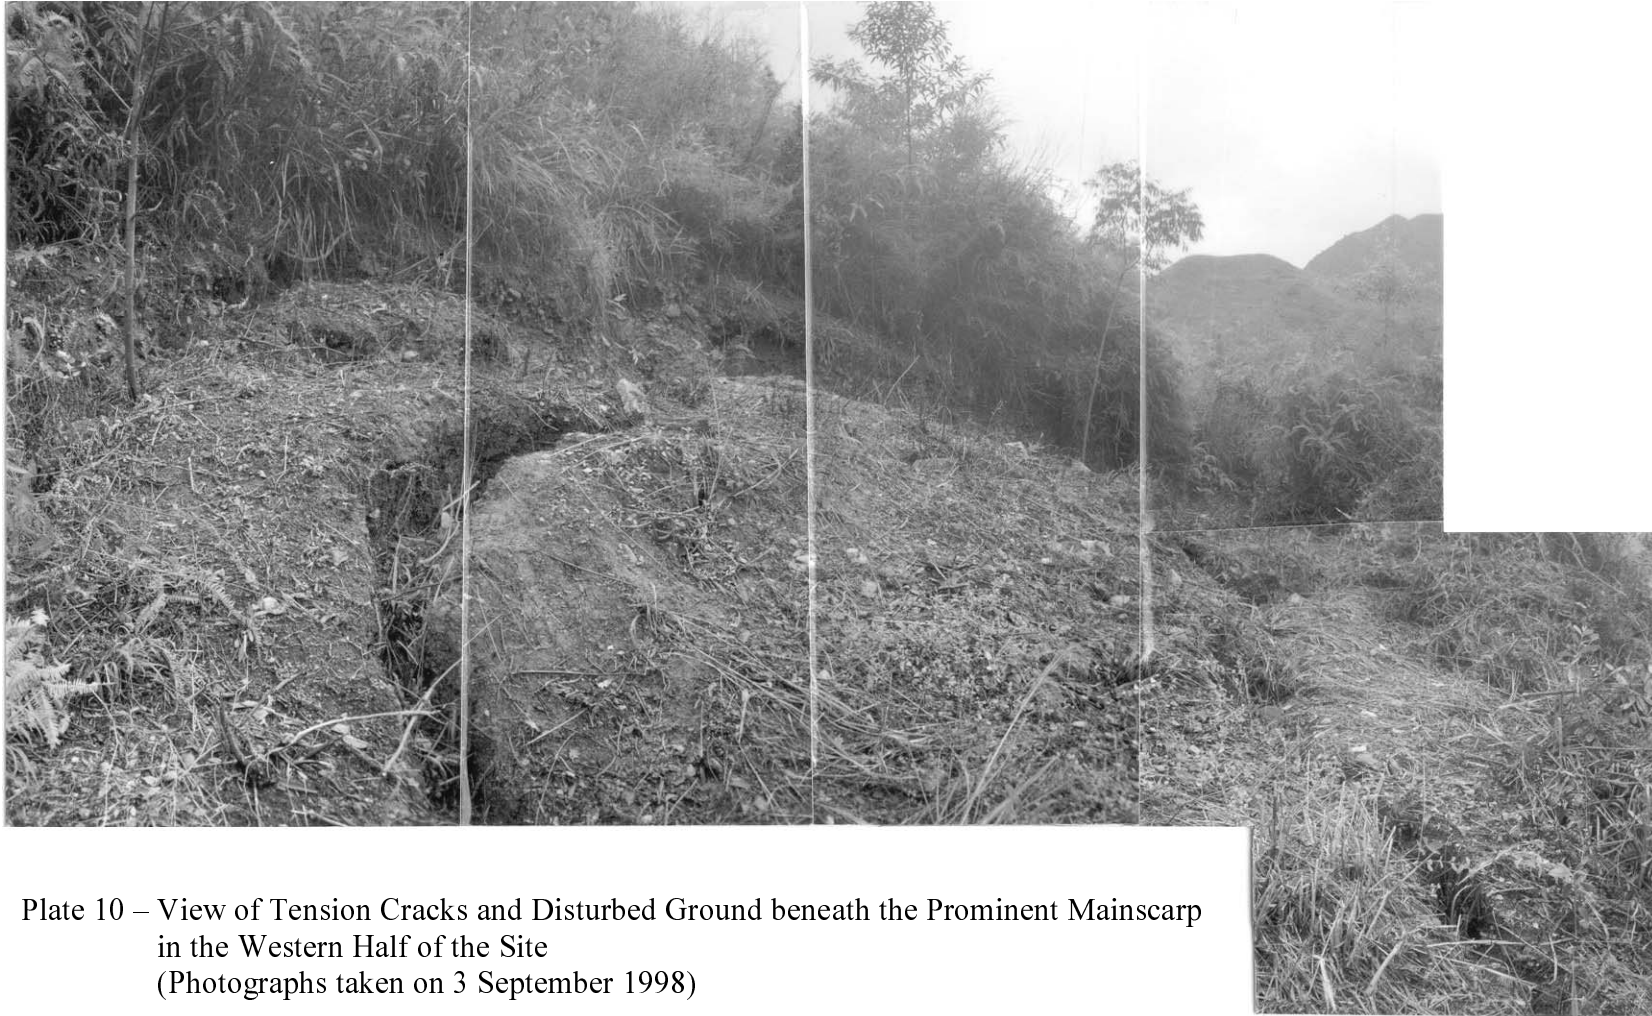
Plate 10 – View of Tension Cracks and Disturbed Ground beneath the Prominent Mainscarp
in the Western Half of the Site
(Photographs taken on 3 September 1998)

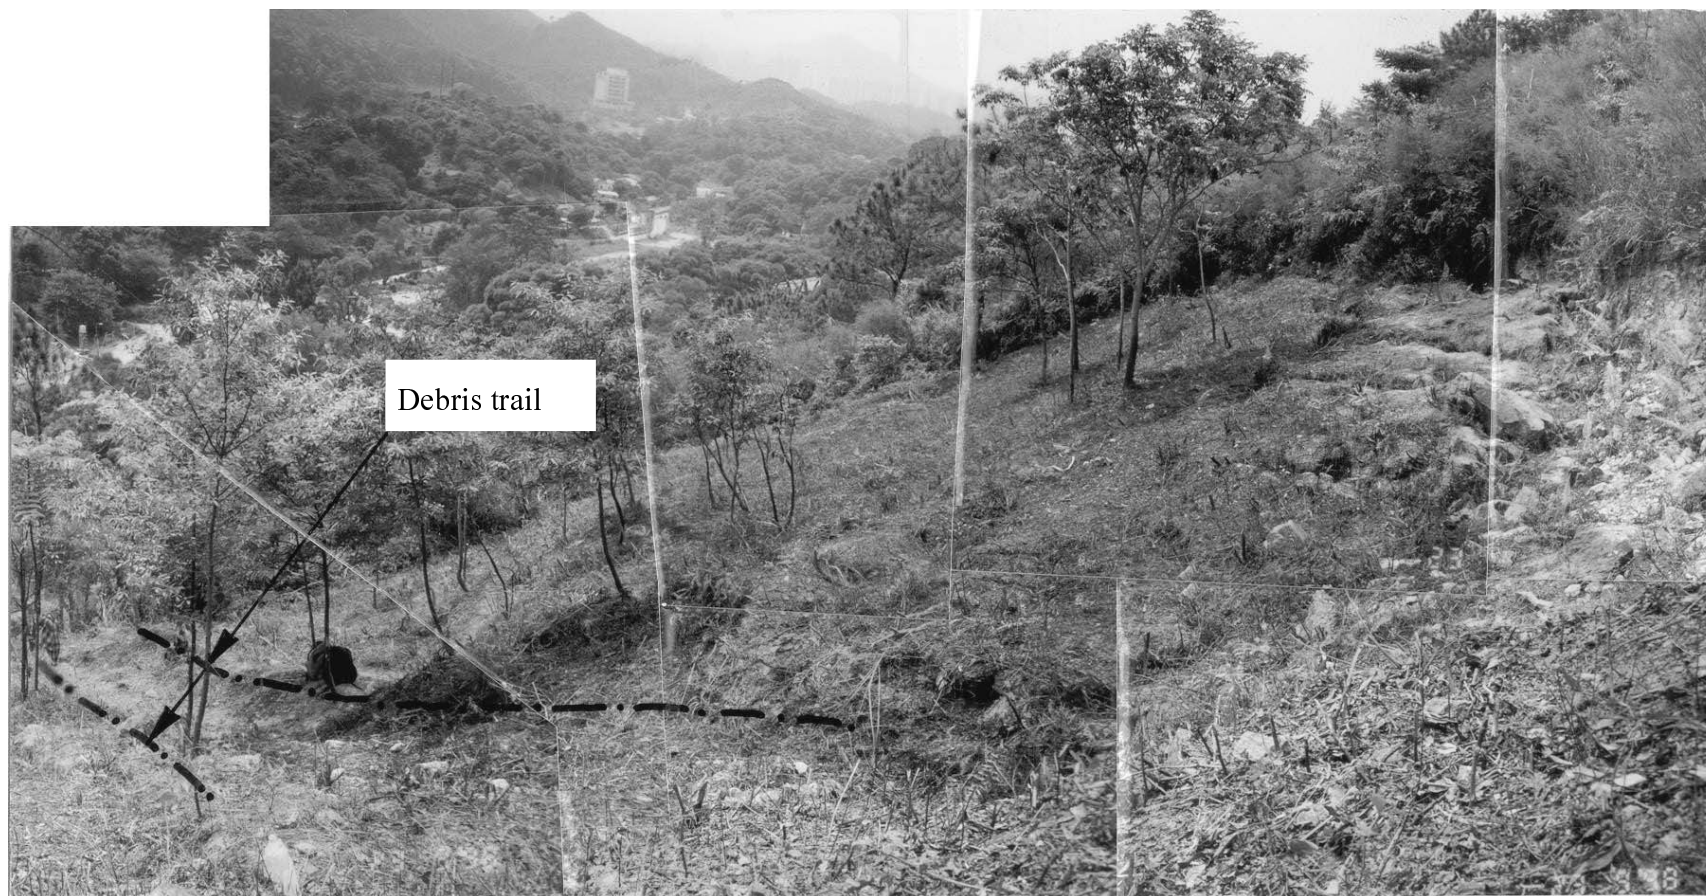
Plate 11 – General View of Mainscarp and Disturbed Ground in the Eastern Half (Upper Part) of the Site
(Photographs taken on 23 September 1998)

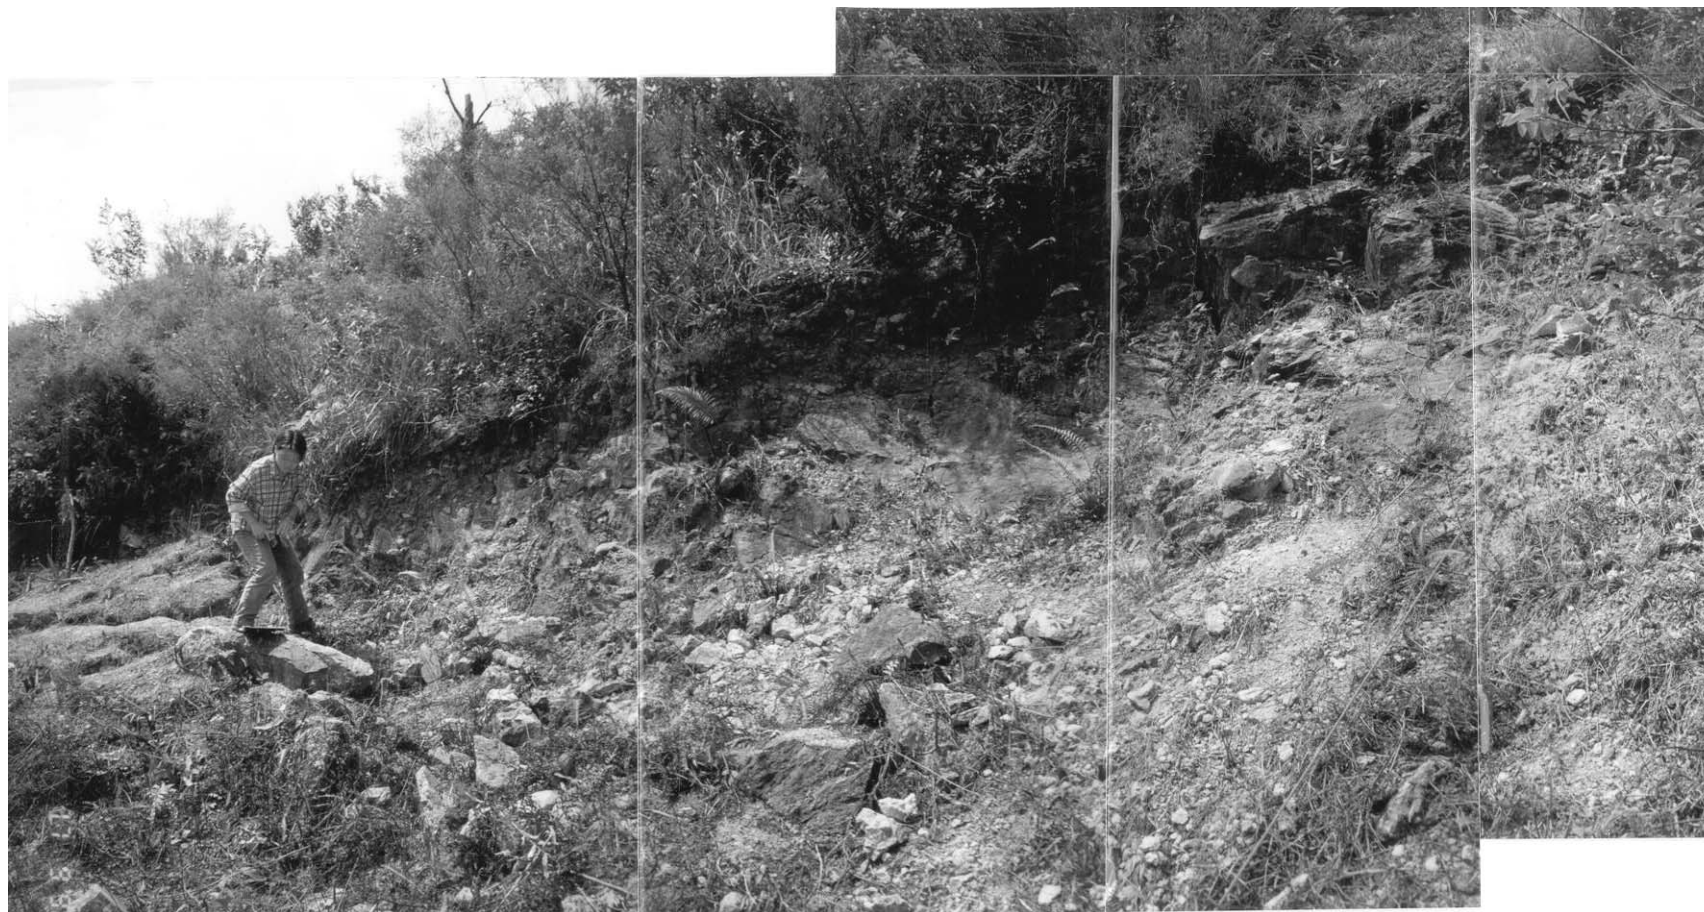
Plate 12 – View of Mainscarp in the Eastern Half (Upper Part) of the Site
(Photographs taken on 17 September 1998)

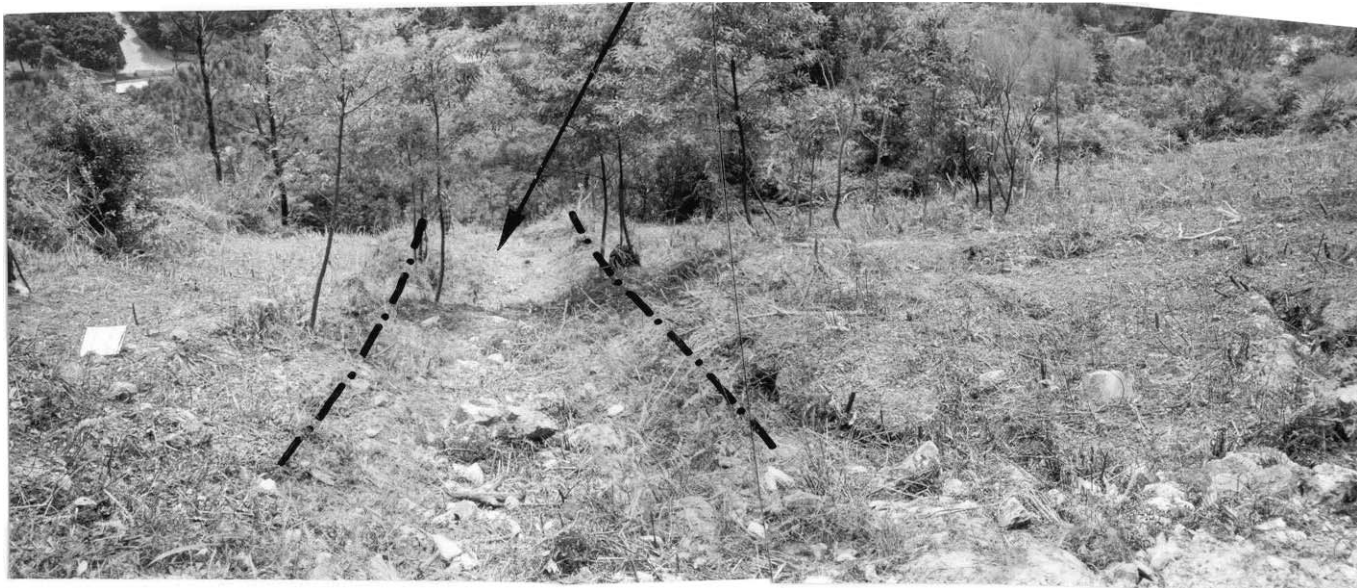
Erosion has excentuated the profile of
the debris trail below the mainscarp

Plate 13 – Debris Trail of L-shaped Landslide Scar
(Photographs taken on 23 September 1998)

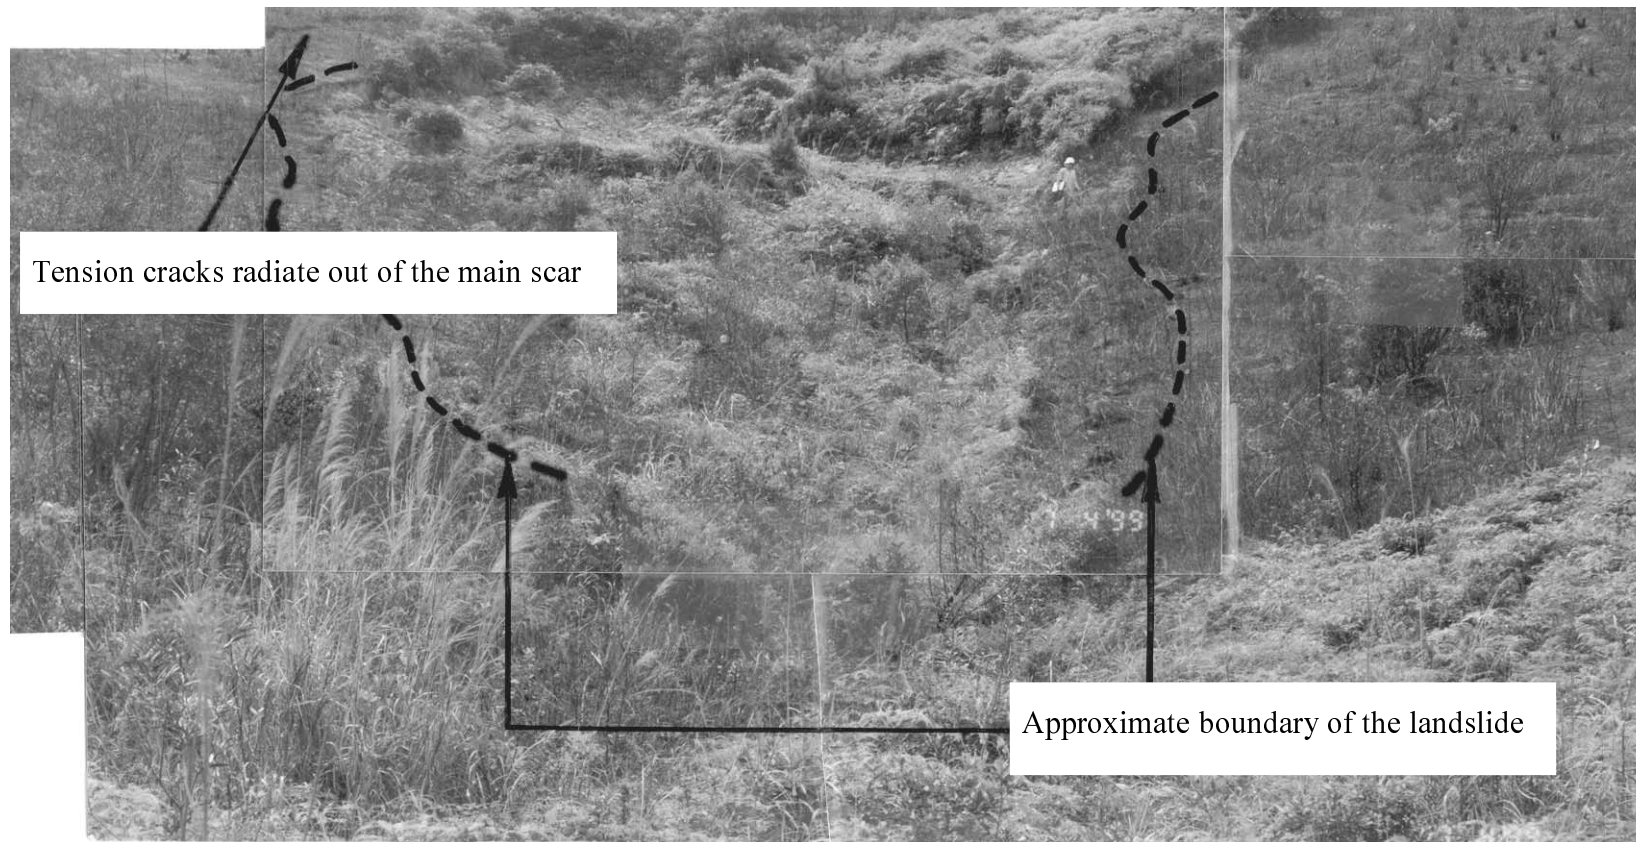
Evidence of instability is also present to the east of the study area as well as over the northern side of Queen's Hill. This takes the form of recent landslides and tension cracks within relict landslide scars (Figure 11 and Plates 14 to 18). Observations on site suggest that this instability involves a thin colluvial layer sliding on top of the underlying decomposed tuff.

Tension cracks radiate out of the main scar

Approximate boundary of the landslide

Plate 14 – General View of Apparently Recent Instability within a Relict Landslide Scar
on the Northern Side of Queen's Hill
(Photographs taken on 7 April 1999)

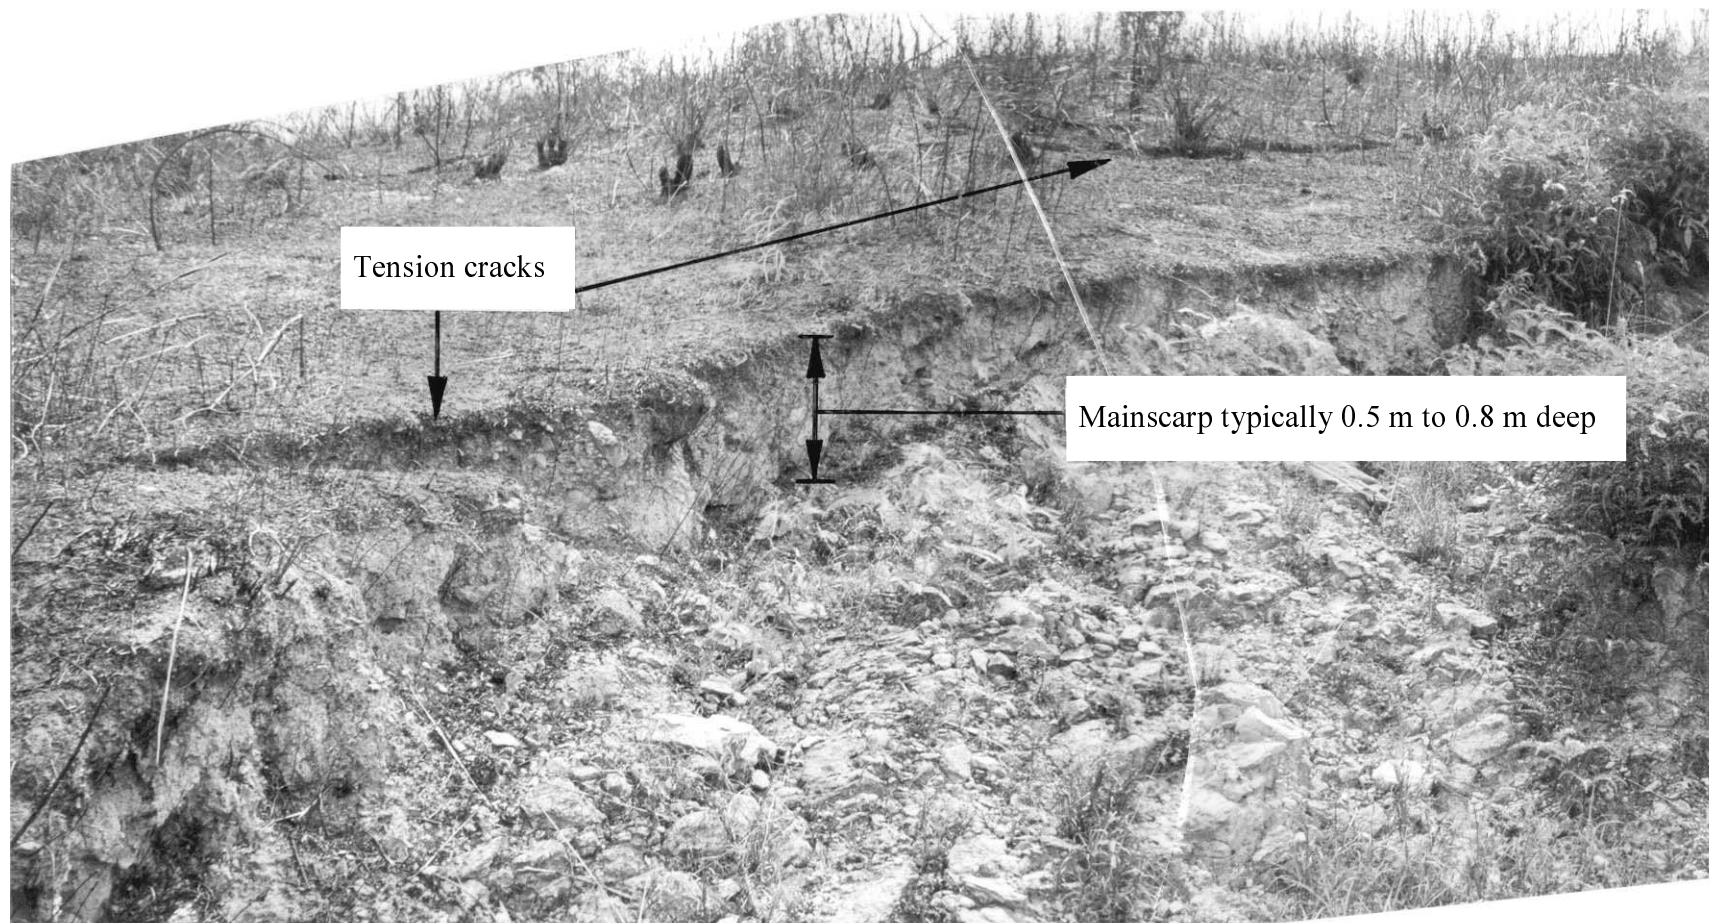
Plate 15 – Close-up View of Mainscarp from Plate 13 Showing the Shallow Nature of the Instability
(Photographs taken on 7 April 1999)

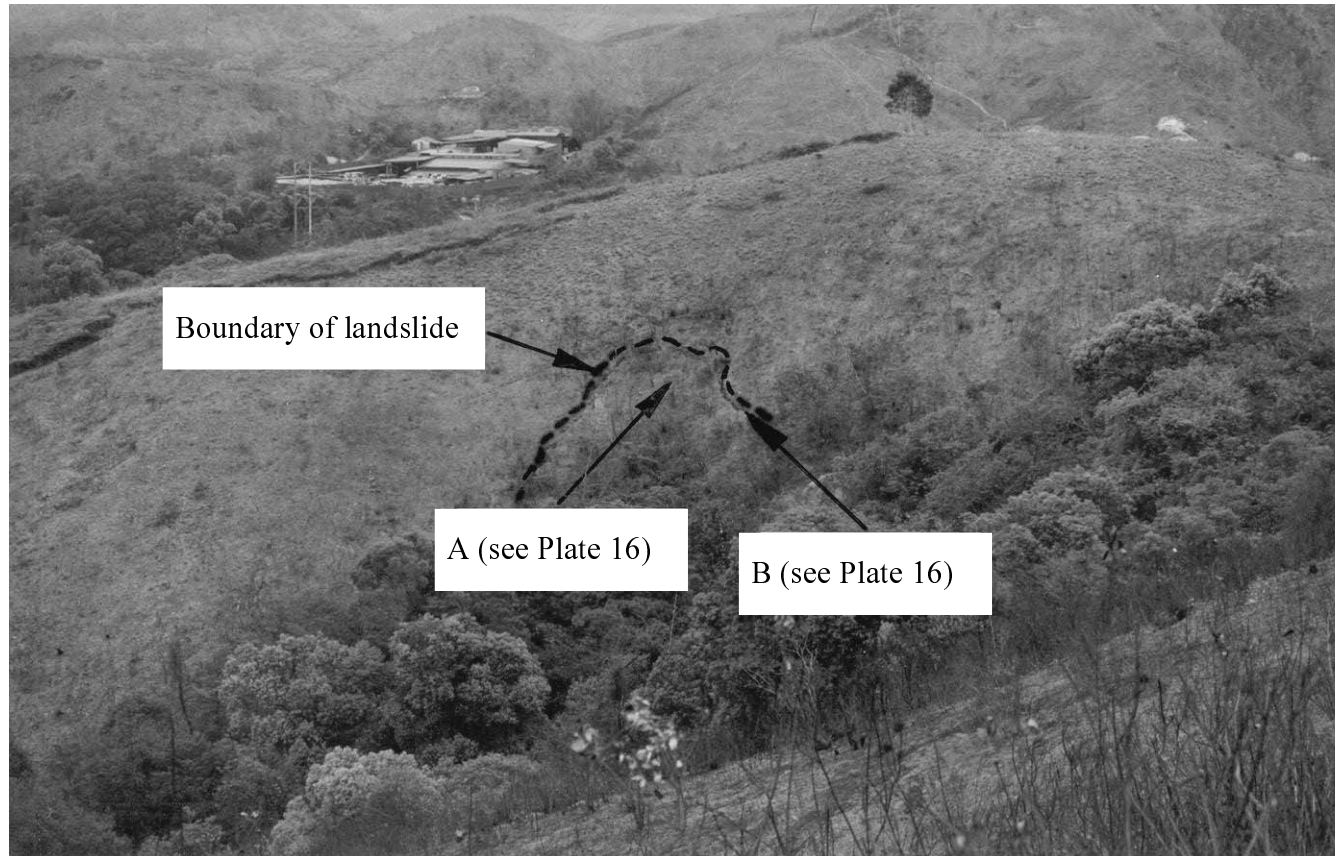
Plate 16 – View of Further Shallow Instability along the Flank of a Relict Landslide Scar on the Northern Side of Queen’s Hill (Sheet 1 of 2)
(Photographs taken on 14 April 1999)

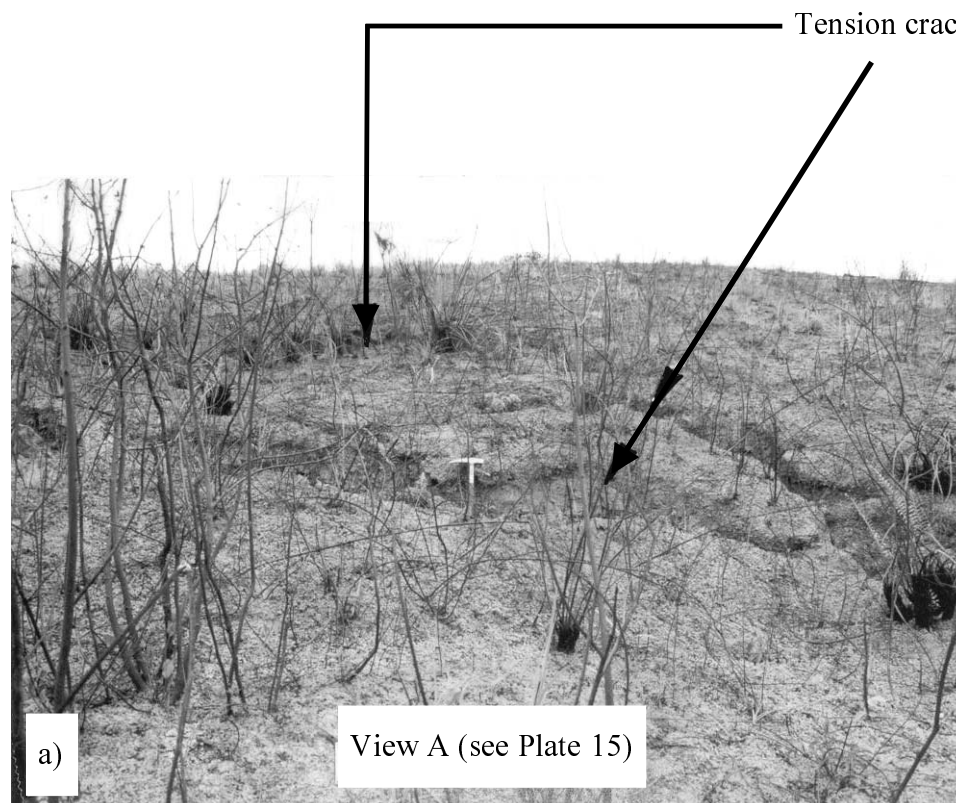
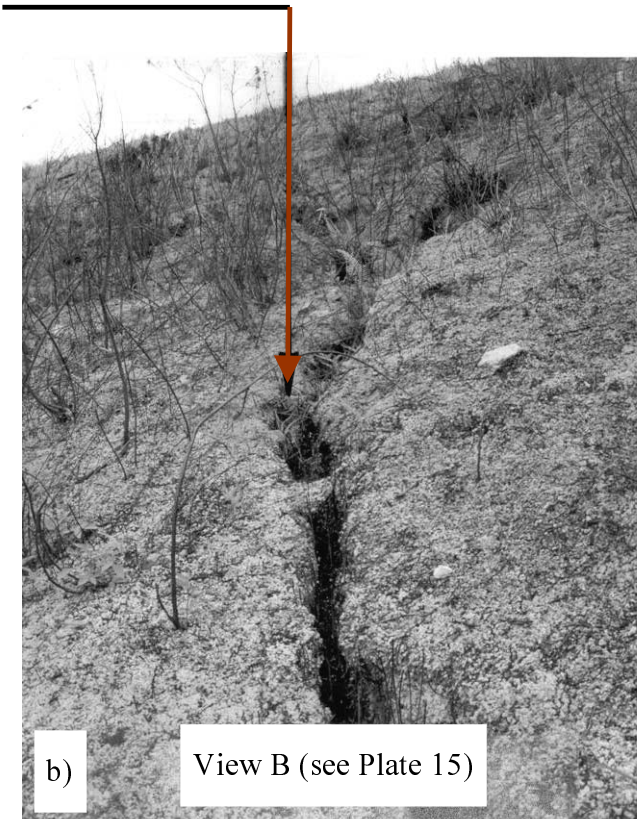
Plate 17– View of Further Shallow Instability along the Flank of a Relict Landslide Scar on the Northern Side of Queen’s Hill (Sheet 2 of 2)
(Photographs taken on 14 April 1999)

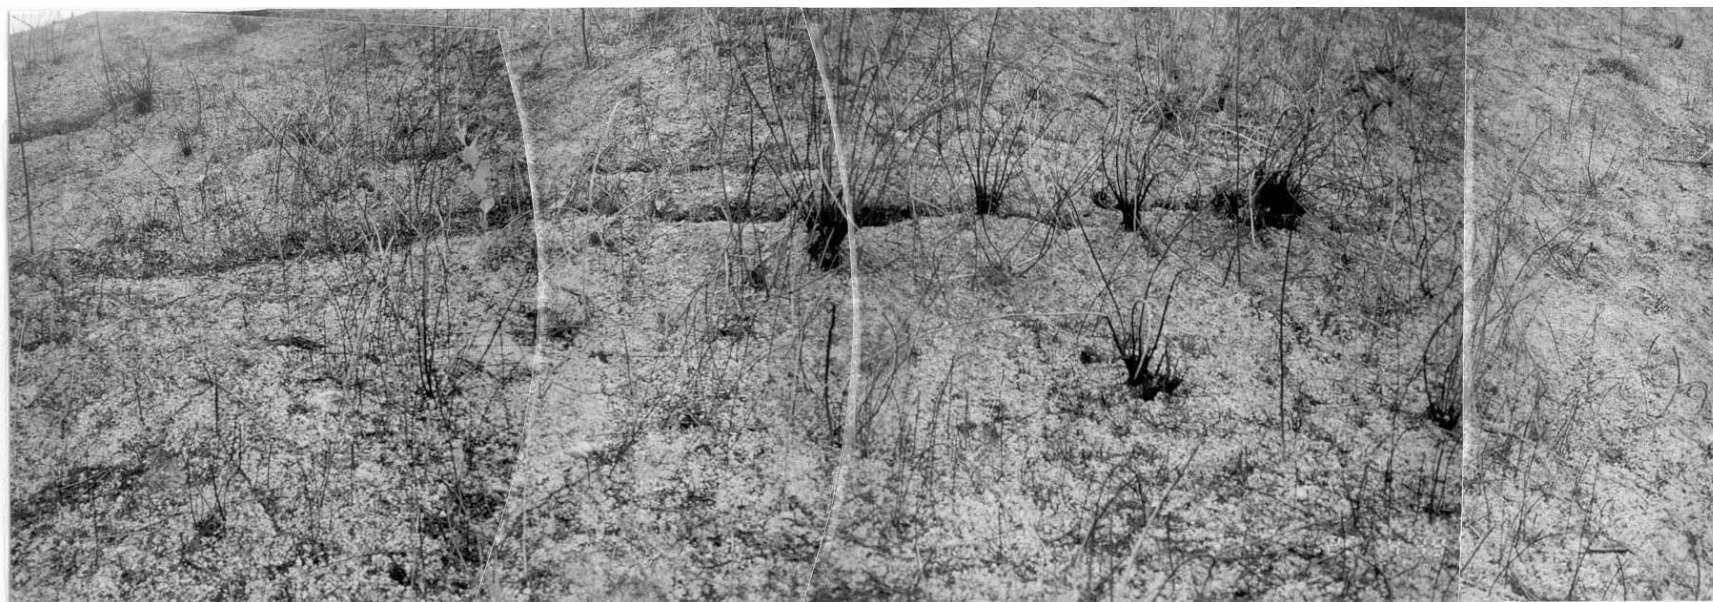
Recent hillfires (April 1999) across Queen's Hill have exposed some of the tension cracking, sharp breaks of slope and relict landslides observed during the API for the current study. Also, several discontinuous man-made trenches were observed along the ridgeline of Queen's Hill (Figure 8 and Plate 19). These occur in sections of varying length covering an overall distance of about 50 m and are between 0.65 m and 1.45 m deep, and 0.65 m and 2.3 m wide. There are also other smaller isolated man-made trenches elsewhere across the hillside. There is no apparent relationship between the trenches and the extensive instability identified across the hillside, although ponding within the trenches could have locally affected the stability of the hillside.

Plate 18 – Tension Cracking and Relict Landslides Observed on Western Side of Queen’s Hill Following Recent (April 1999) Hillfires
(Photographs taken on 27 April 1999)

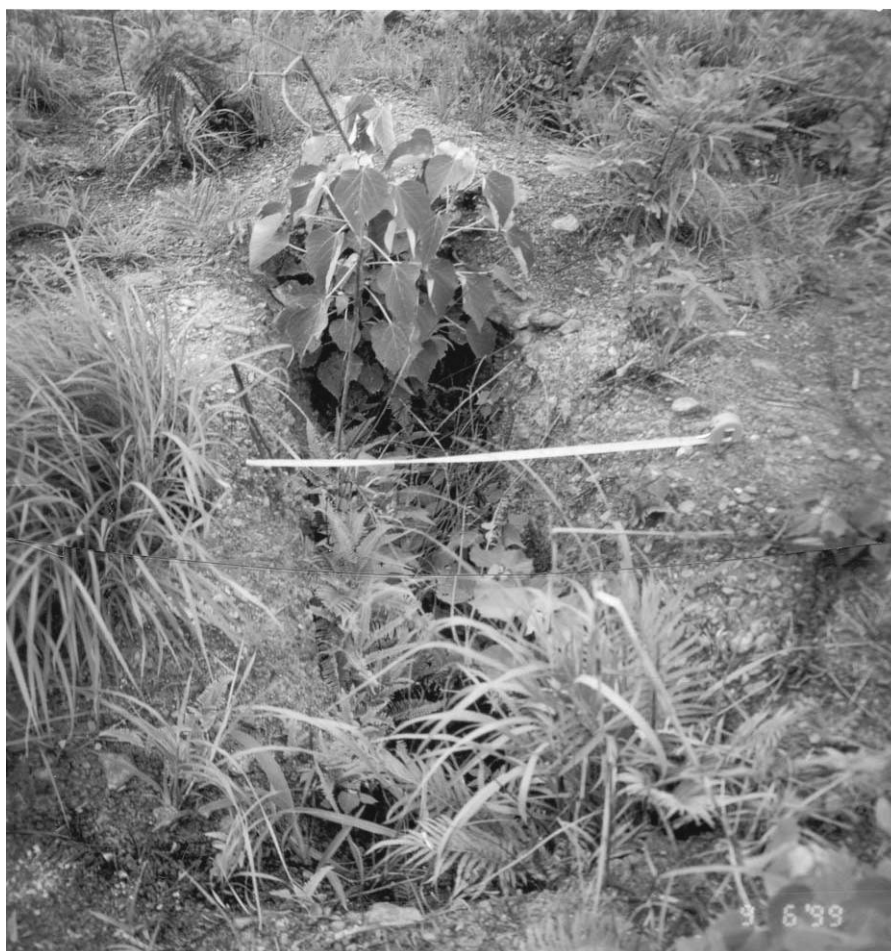
Plate 19 – Man-made Trench Running along Queen’s Hill Ridgeline
(Photographs taken on 9 June 1999)

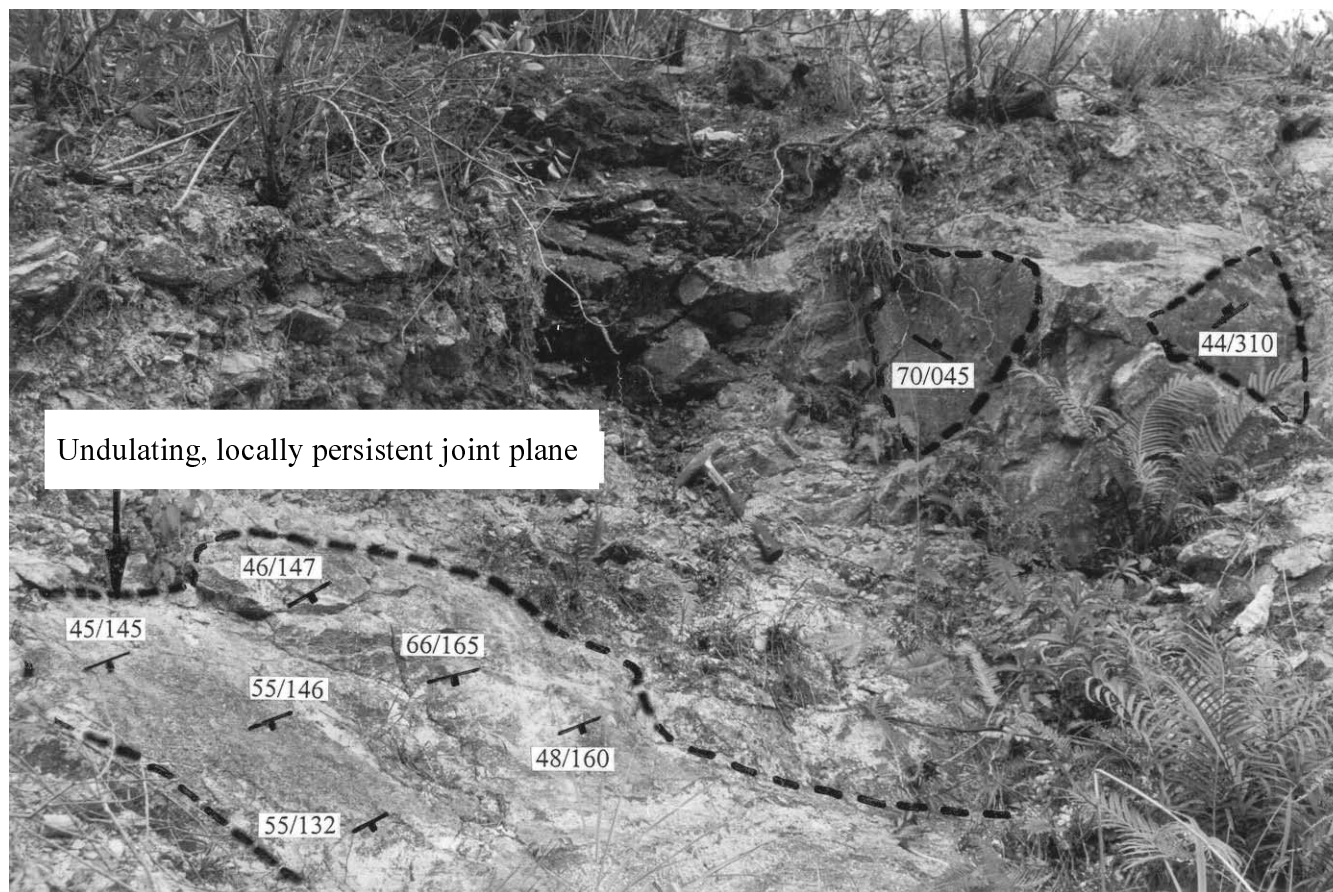
Plate 21 – View of Mainscarp Exposed in the Northeastern Corner of the Site Showing Adverse Jointing
 (Photograph taken on 14 April 1999)
