INVESTIGATION OF SOME SELECTED LANDSLIDES IN 1998 (VOLUME 5)

GEO REPORT No. 112

Fugro Scott Wilson Joint Venture

SECTION 1 : DETAILED STUDY OF SLOPE DISTRESS AT QUEEN'S HILL, BURMA LINES CAMP, FANLING

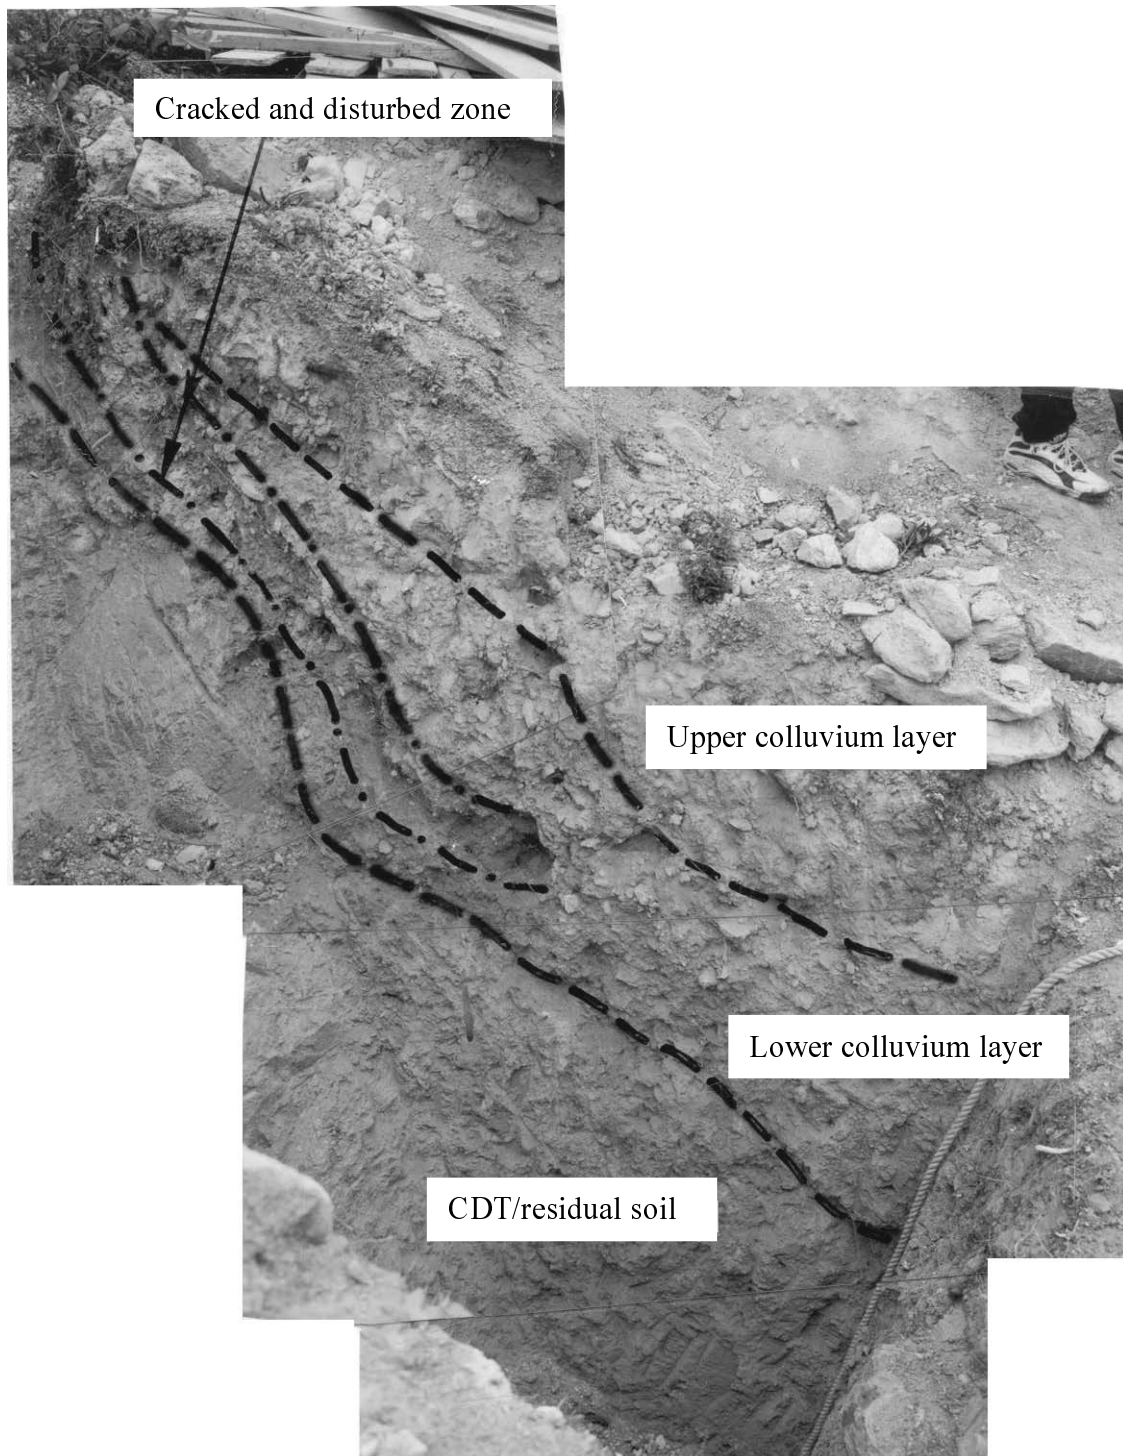
Plate 26 – View of Voided Shear Zone Exposed in Face A, Trial Trench TT8
(Photographs taken on 23 March 1999)

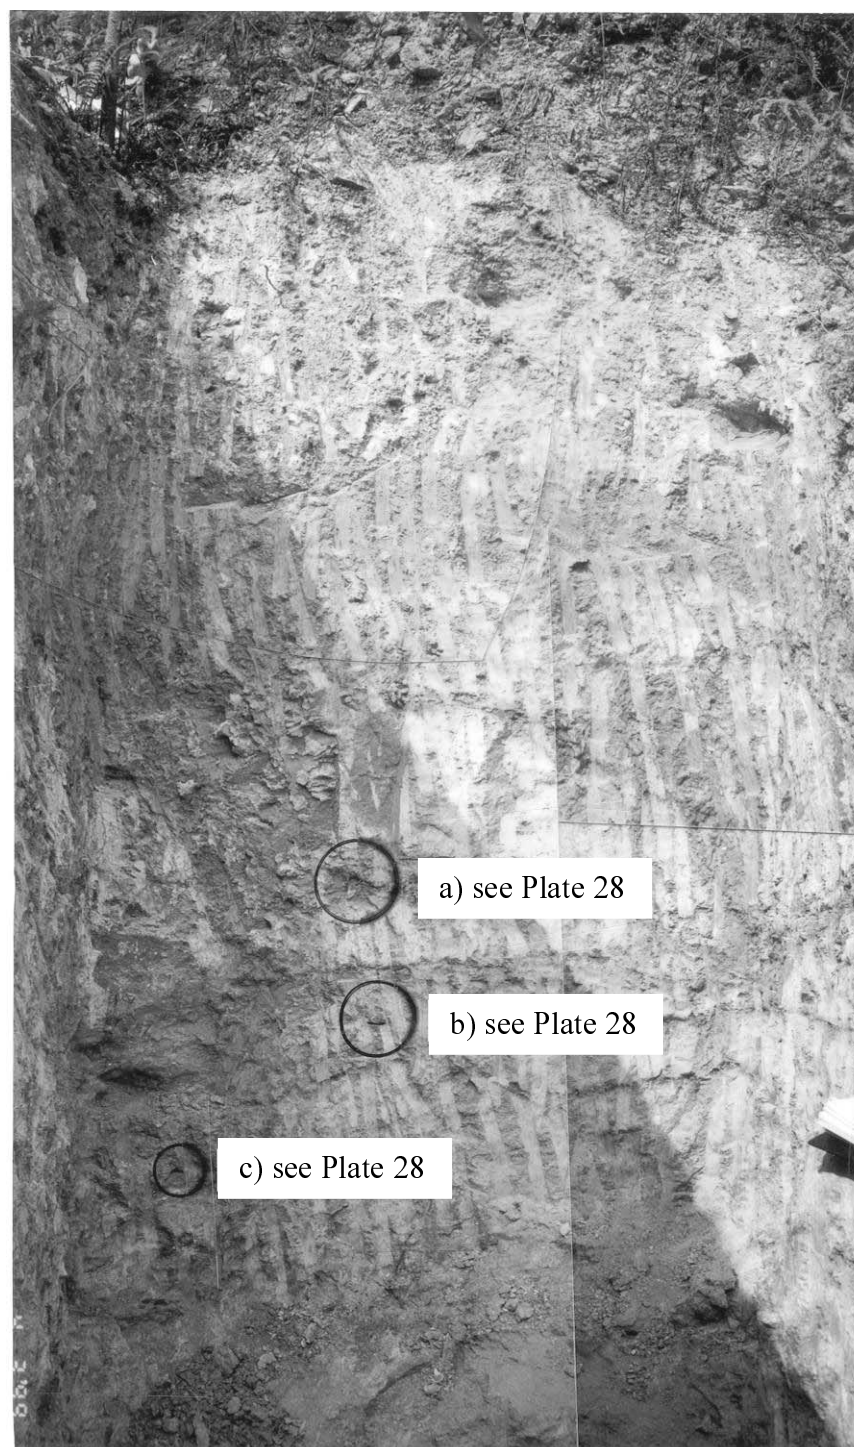
Plate 27 – View of Face A, Trial Trench TT1, Showing Location of Voids/Soil Pipes within the C-HDT
(Photographs taken on 4 March 1999)

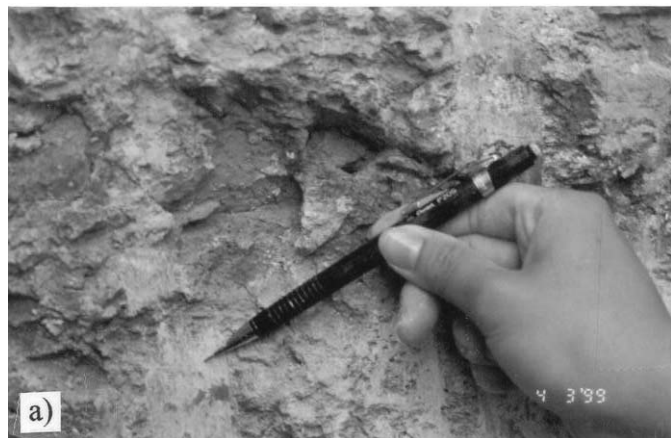
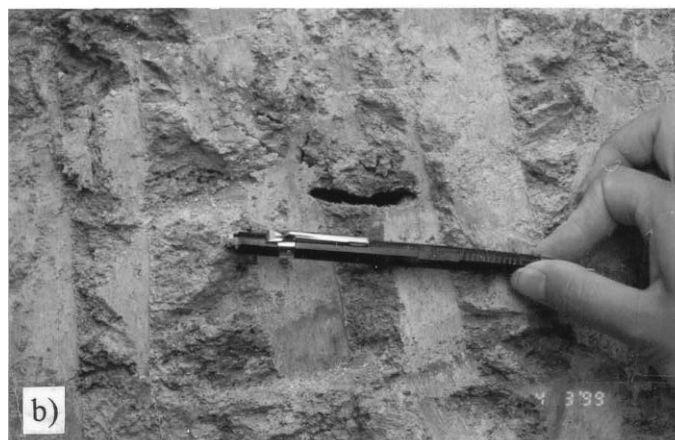
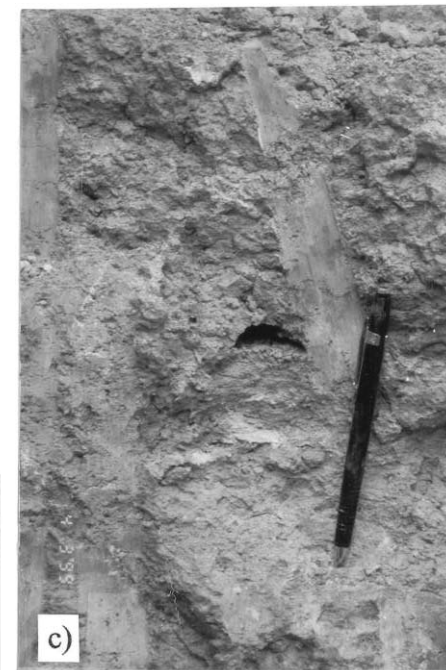
Plate 28 – Close-up Views of Voids/Soil Pipes Exposed in Trial Trench TT1
(Photographs taken on 4 March 1999 - see Plate 27 for locations)

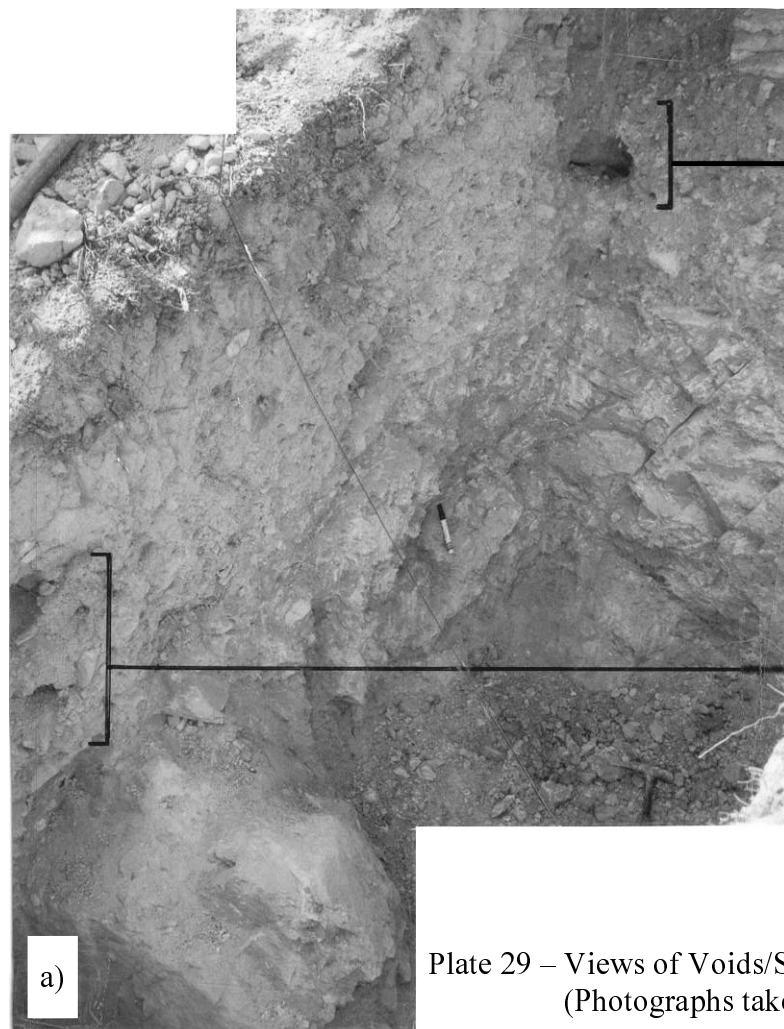
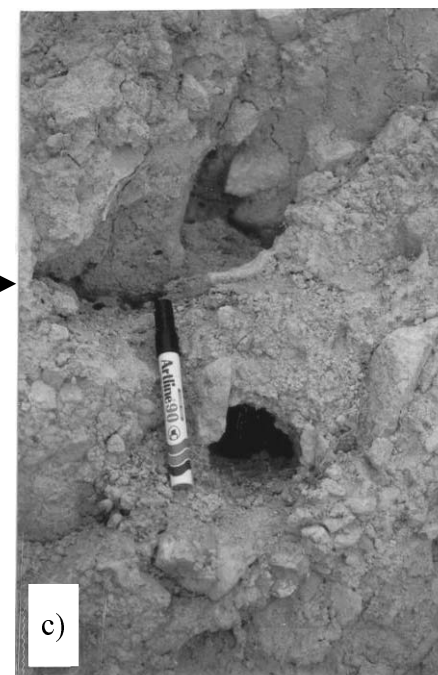
Plate 29 – Views of Voids/Soil Pipes Exposed in Trial Trench TT4
(Photographs taken on 4 March 1999)

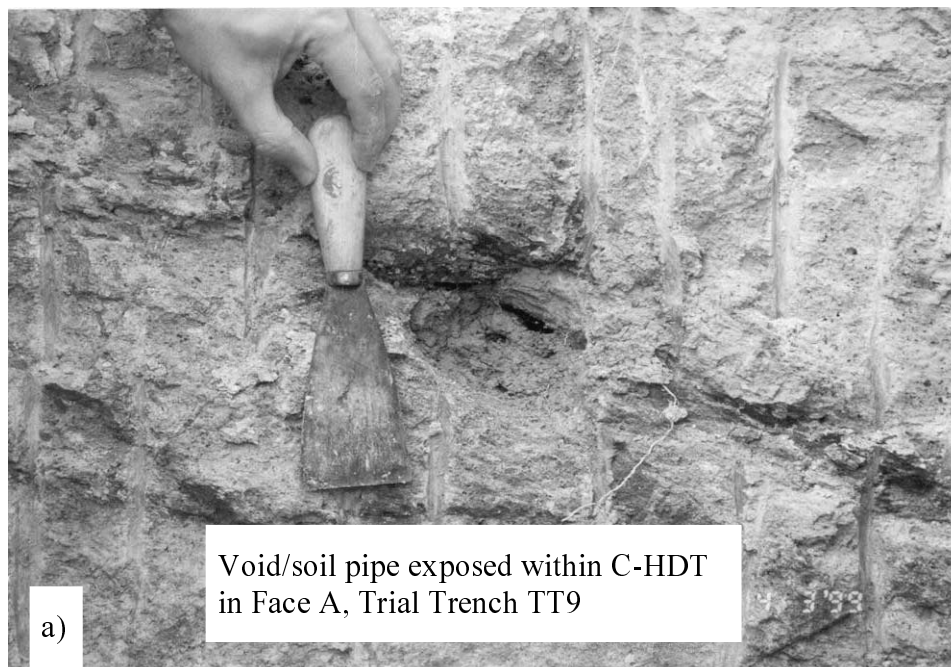
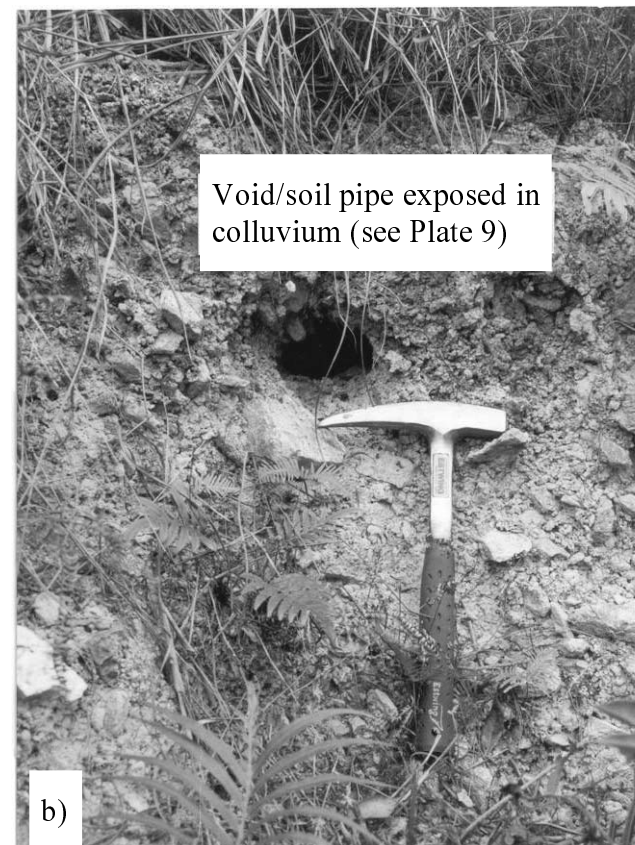
Plate 30 – Views of Voids/Soil Pipes Identified within the Site
(Photographs taken on 4 March 1999)

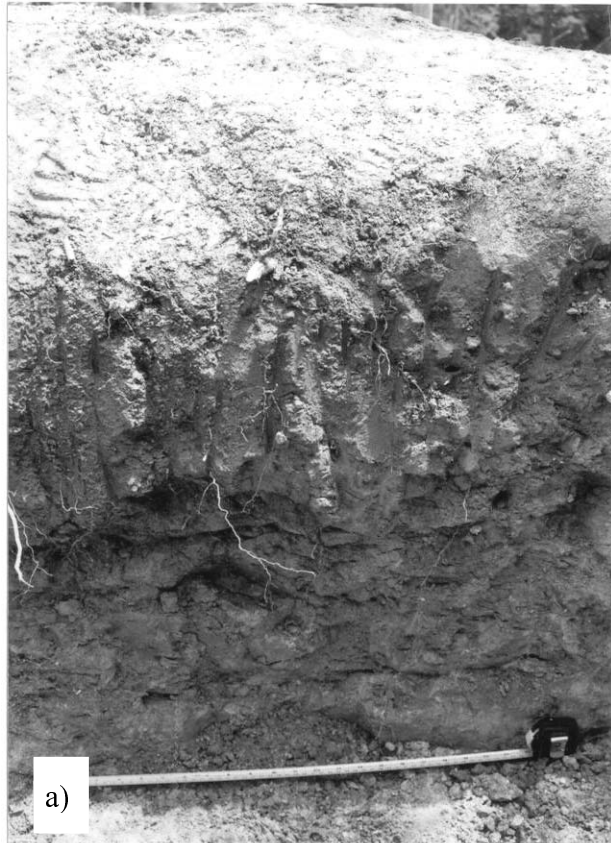
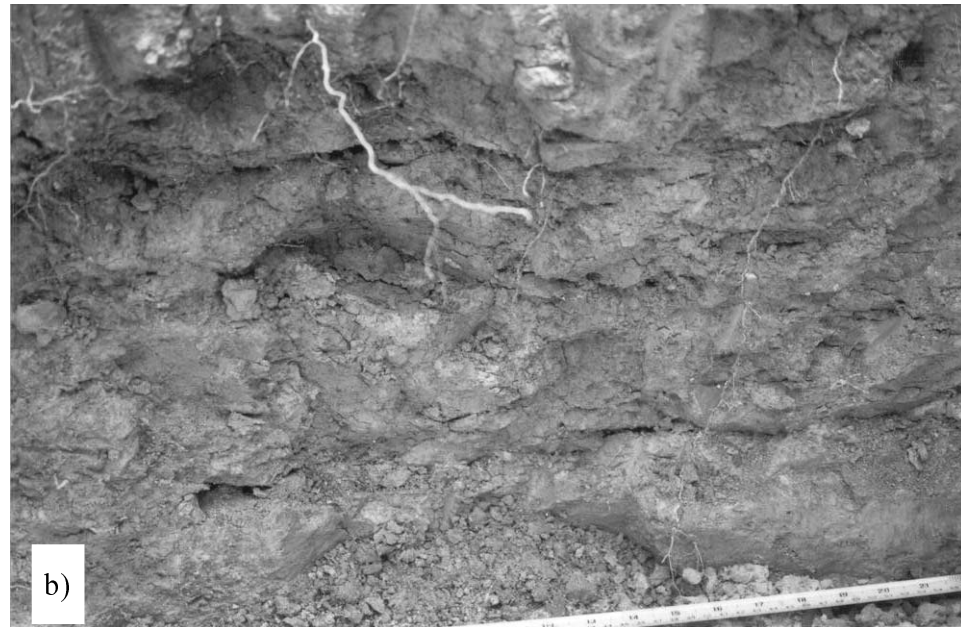
Plate 31 – Views of Face C, Trial Pit TP7 Showing Lateral Cracking/Voiding within CDT
(Photographs taken on 4 March 1999)

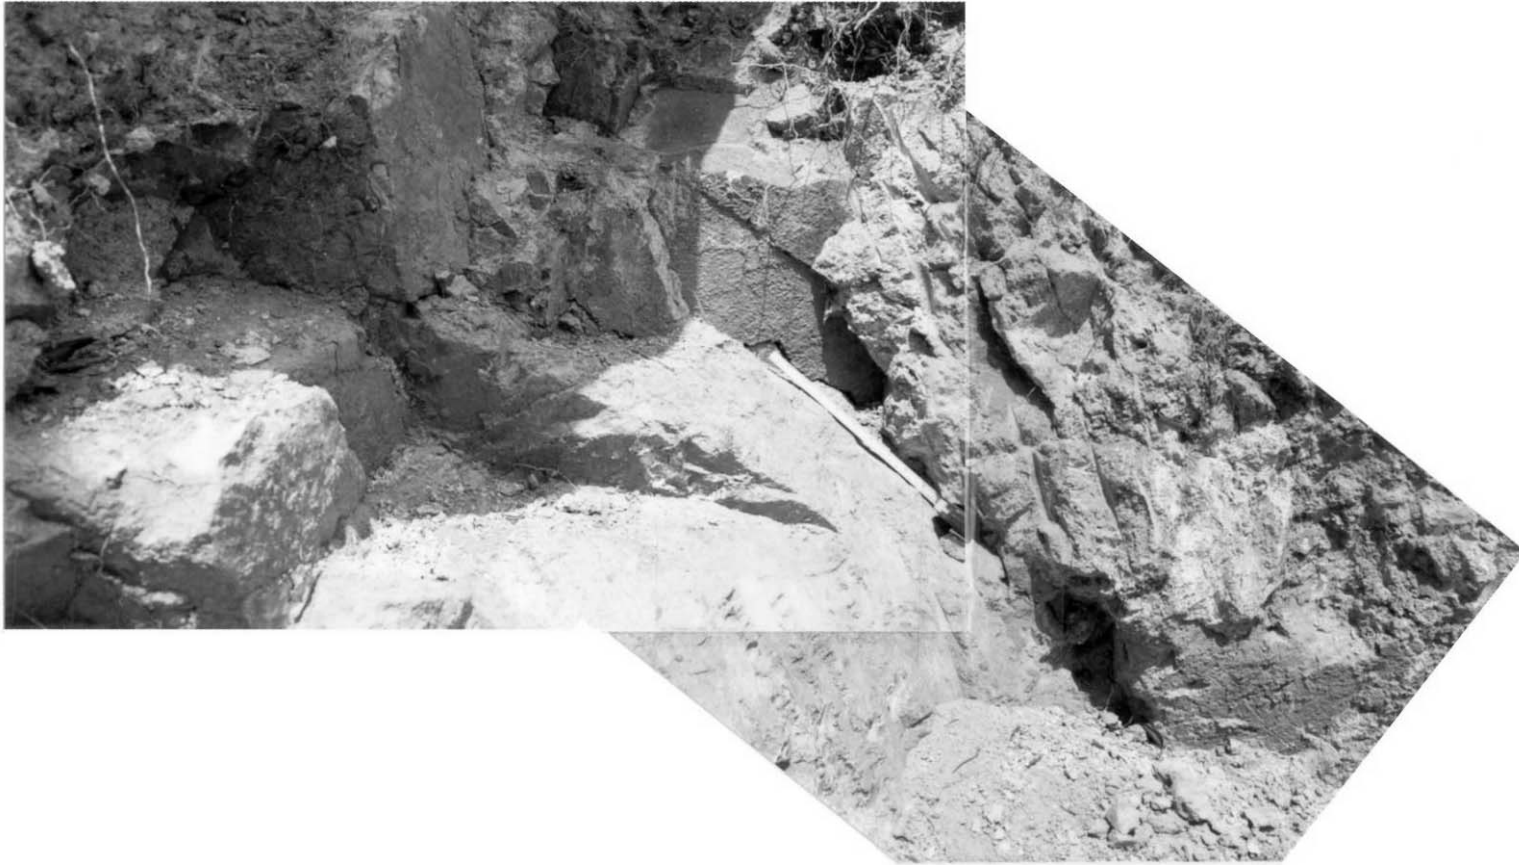
Plate 32 – View of Face B, Trial Pit TP7 Showing Cracking within H-MDT
(Photographs taken on 23 March 1999)

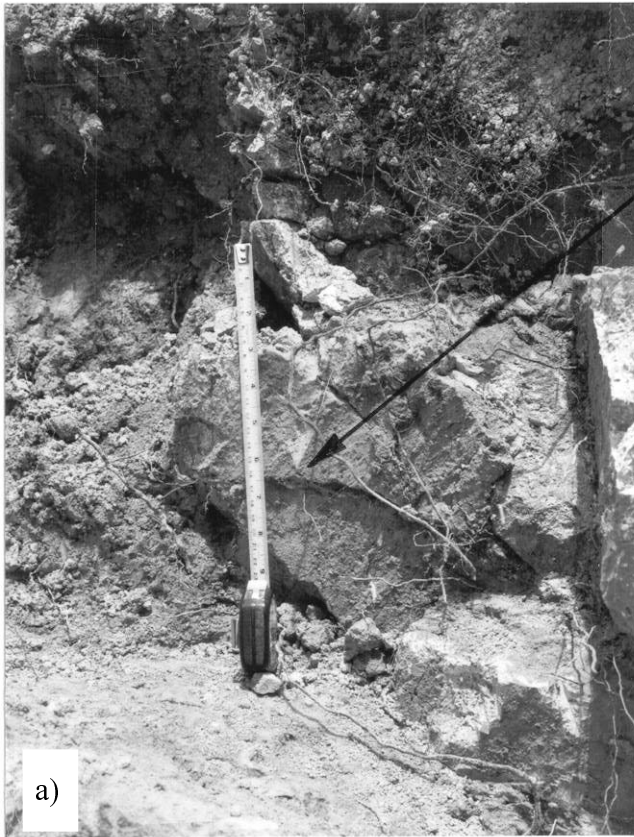
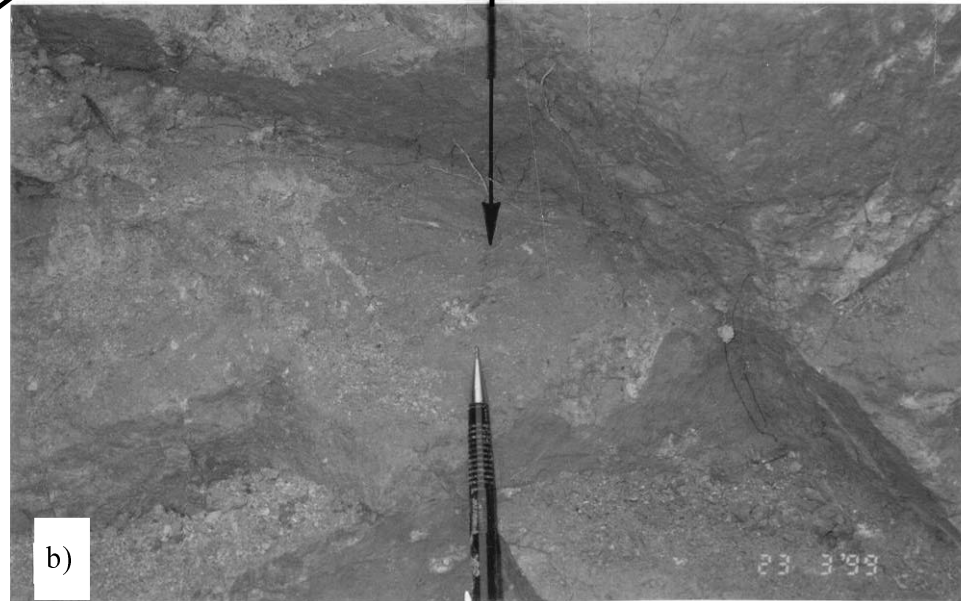
Clay infill and roots present along joints

Plate 33 – Views Showing Infilling to Joints/Cracks within H-MDT
(Photographs taken on 23 March 1999)

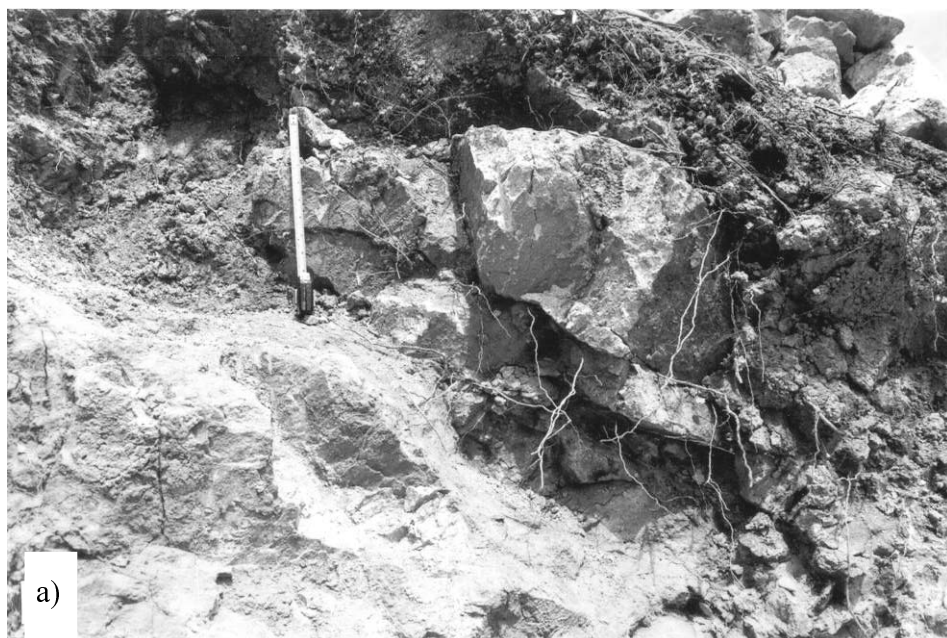
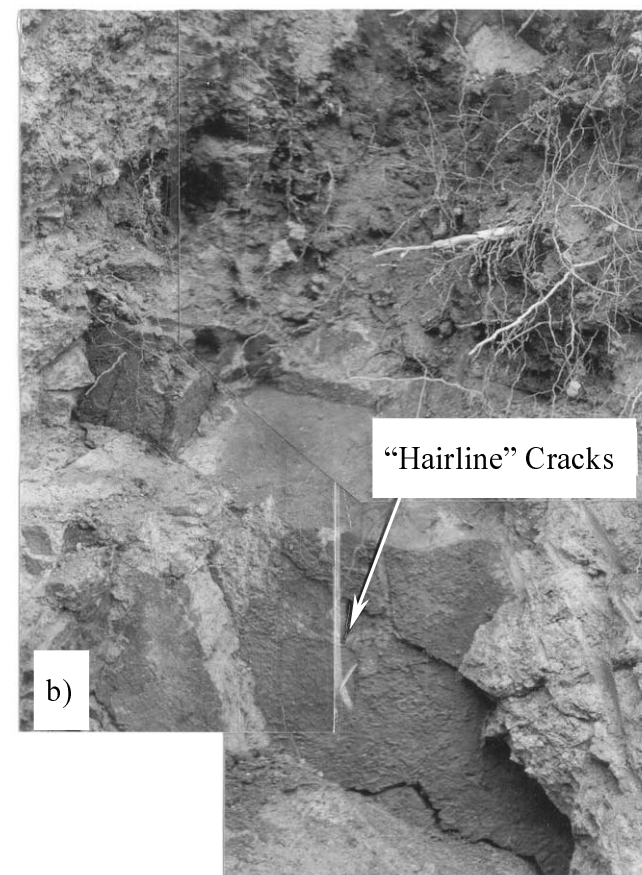
Plate 34 – Open Joints and “Hairline” Cracks Observed in the Tuff in Trial Trench TT6 and Trial Pit TP7
(Photographs taken on 23 March 1999)
