**SECTION 2 :  
DETAILED STUDY OF THE  
LANDSLIDE BEHIND  
7C BOWEN ROAD  
ON 11 JUNE 1998**

**Fugro Scott Wilson Joint Venture**

**This report was originally produced in November 1999  
as GEO Landslide Study Report No. LSR 19/99**

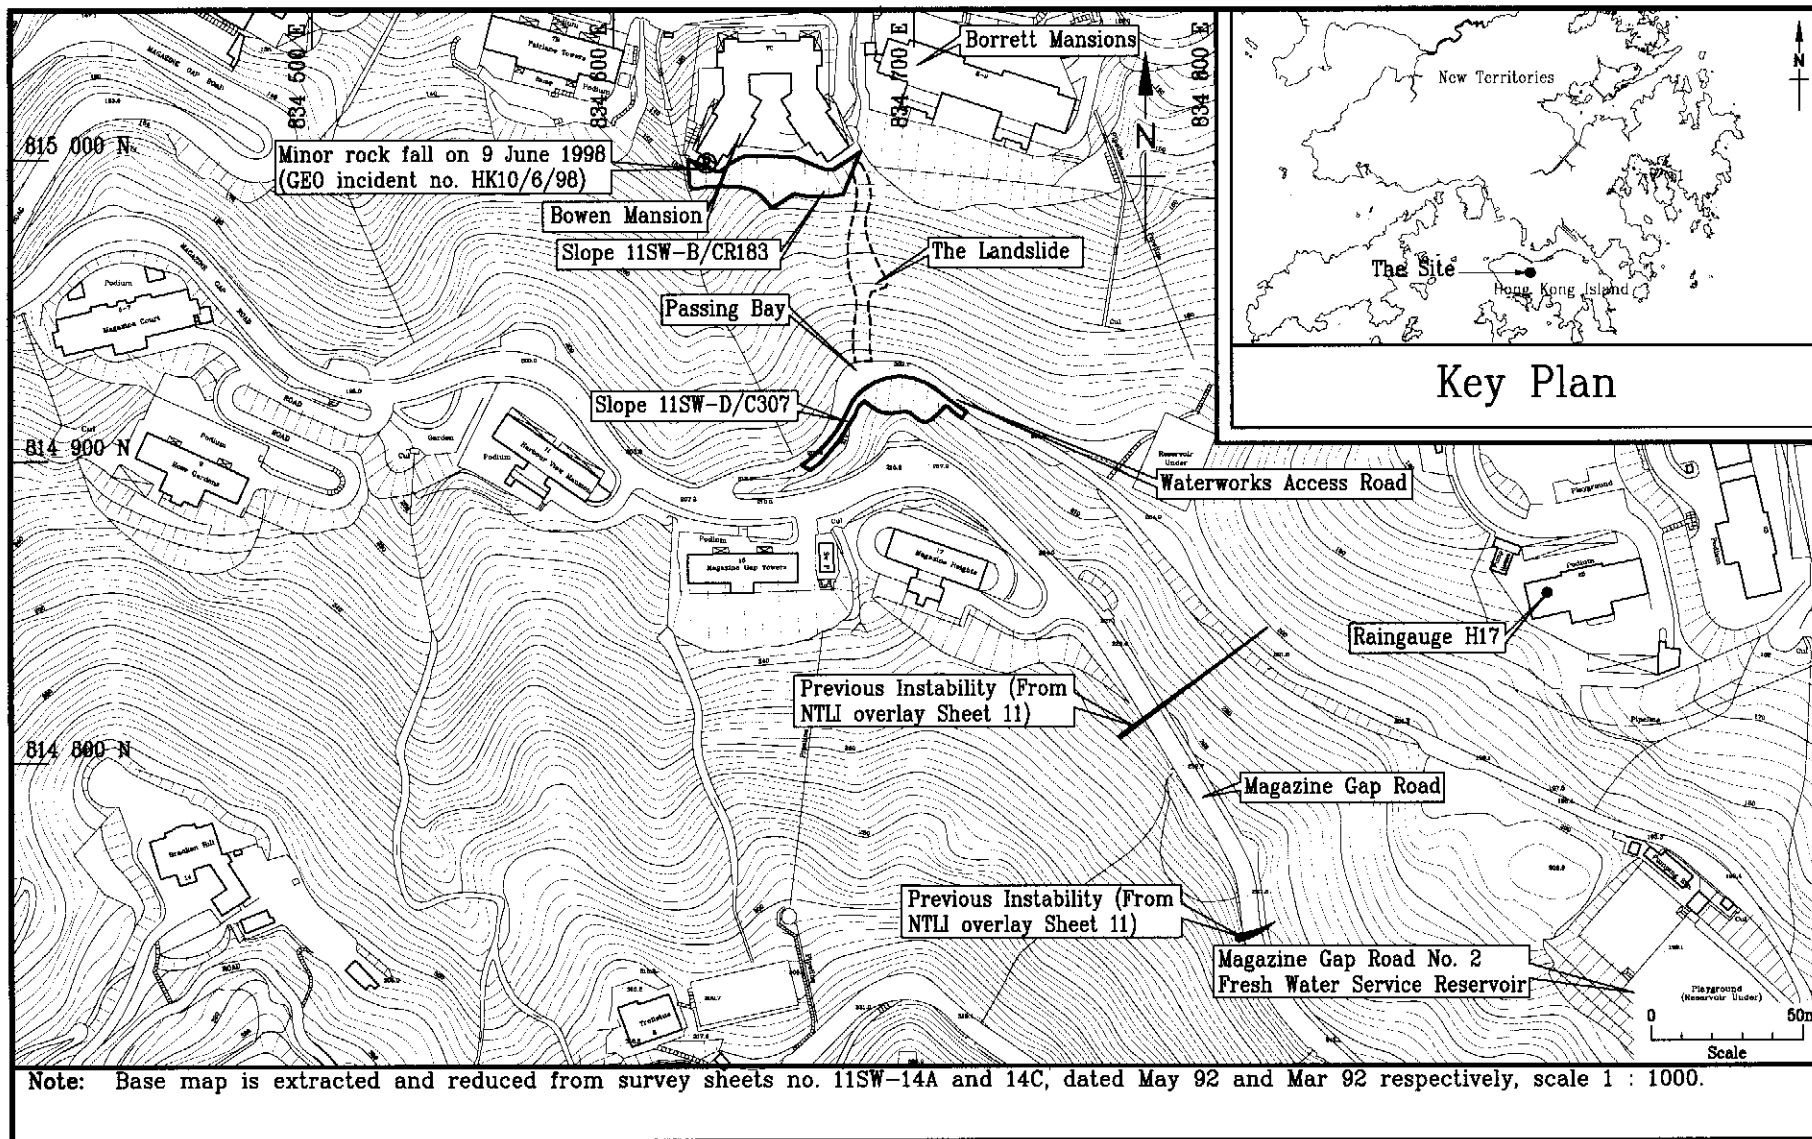
Figure 8 - Locations of Previous Instability

There are no past failures in the natural terrain in the proximity of the landslide site recorded in GEO's Natural Terrain Landslide Inventory (NTLI). This is consistent with the detailed API carried out by FSW. The nearest natural terrain landslide identified in the NTLI is located about 150 m to the southeast of the passing bay and above Magazine Gap Road (Figure 8).

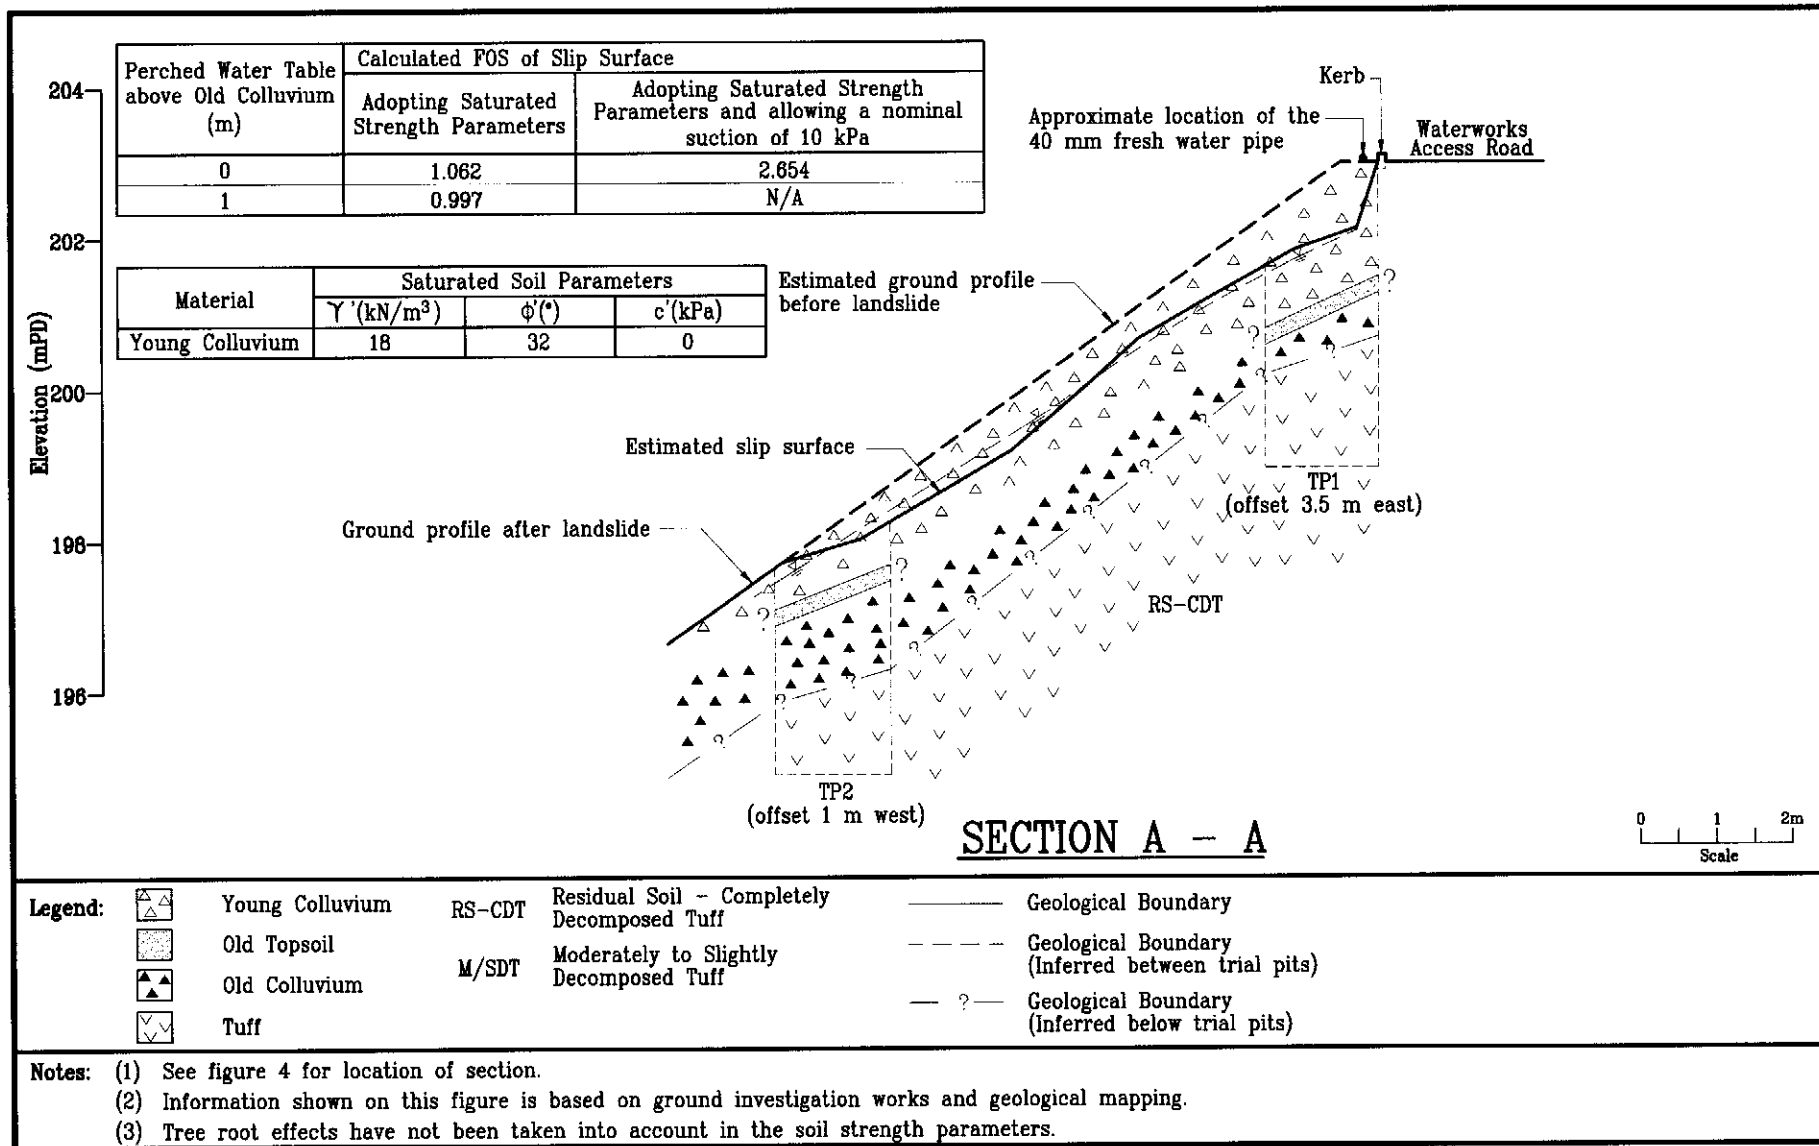
Figure 13 - Theoretical Slope Stability Analyses

The results of stability analyses are summarized in Figure 13. When the near-surface material is not fully saturated with a nominal suction prevailing in the young colluvium, the theoretical factor of safety for the failure surface is much greater than unity. The results also indicate that when the young colluvium becomes fully saturated with a perched water table at about 1 m above its base, the factor of safety of the failure surface would be below unity (i.e. failure will theoretically occur).

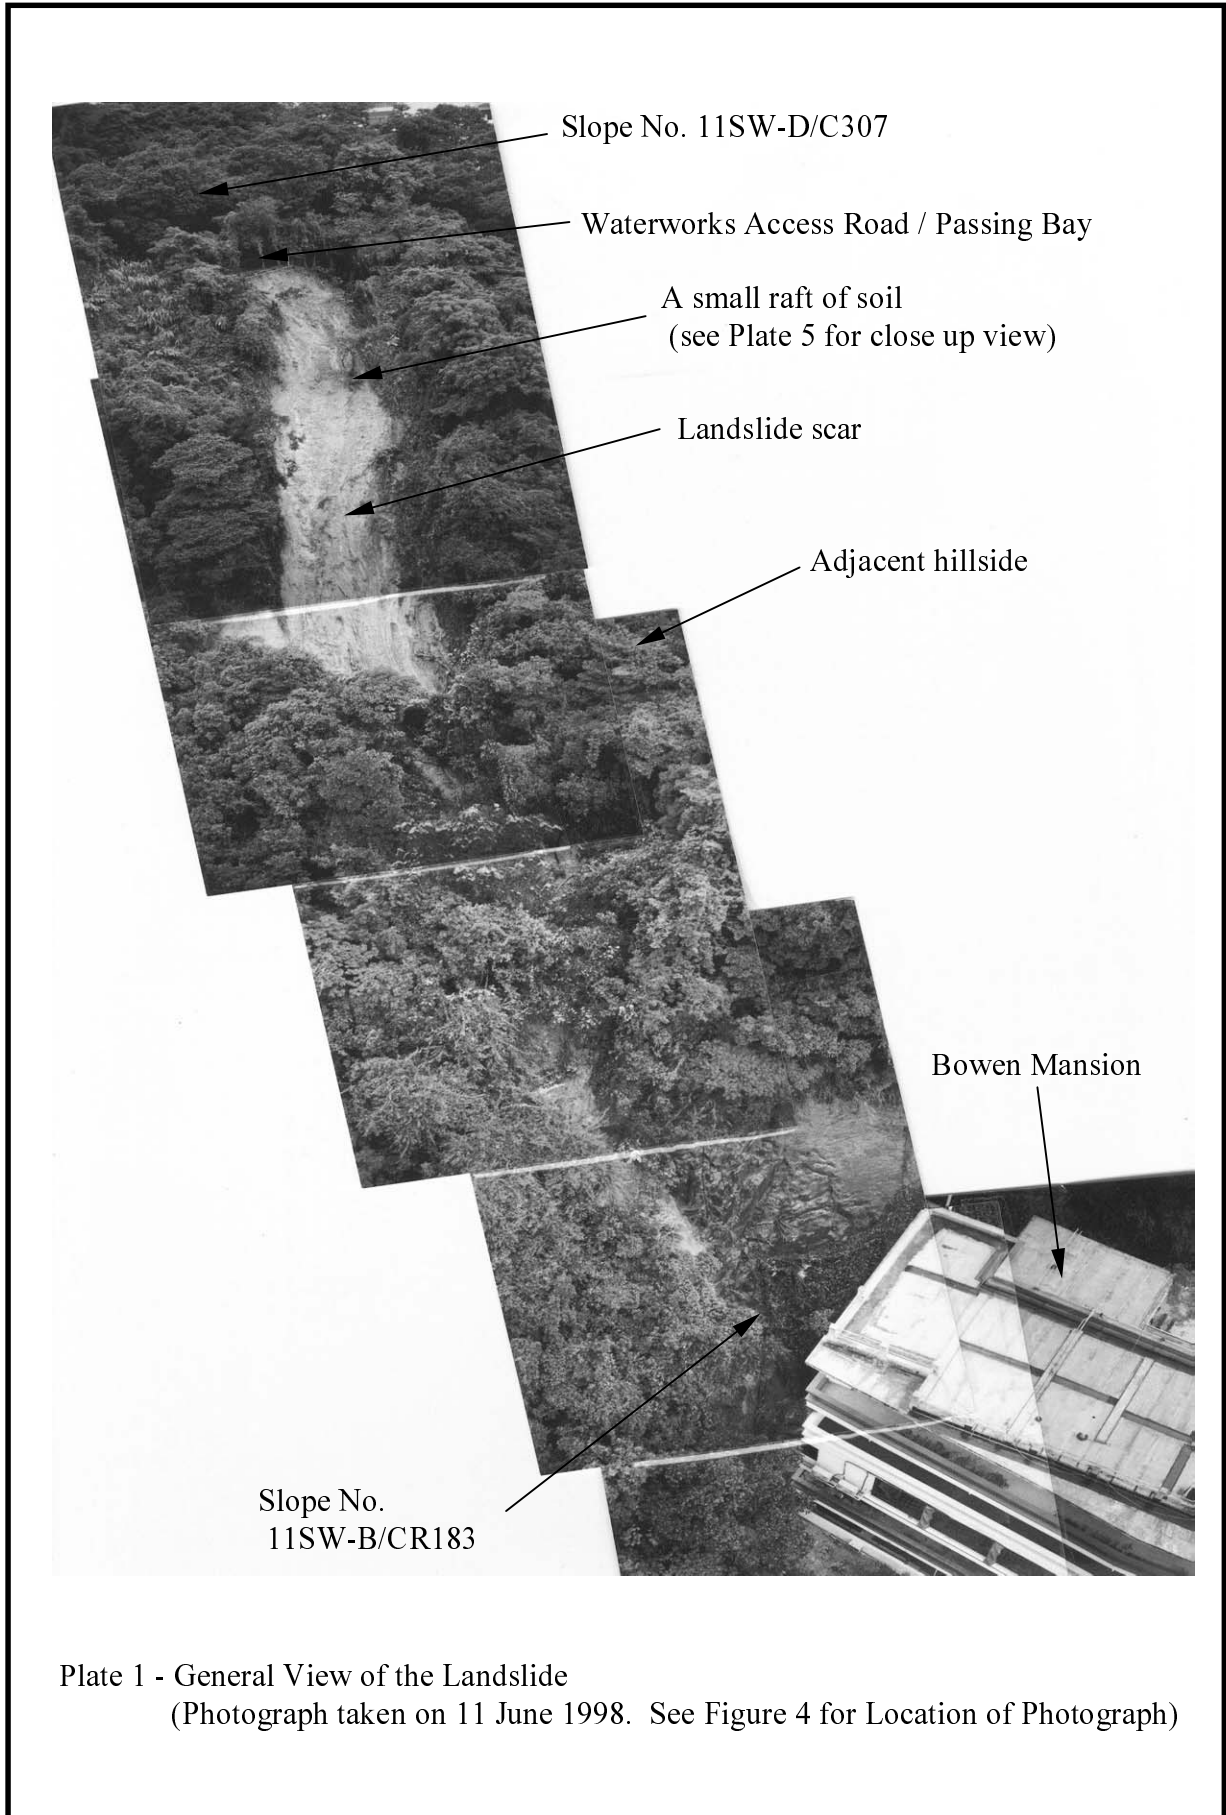
- (a) except for a few mature trees, most of the vegetation and trees originally on the hillside were either removed or knocked down from the crest to the toe of the failure scar (Plate 1),
- (b) very wet soil and localized ponding of water were noted on the failure scar surface (Plate 5),
- (c) a large amount of cobble-sized debris was found on the failure scar surface, especially in the area close to the crest (Plate 4), and
- (d) a small raft of soil knitted together by a mass of shallow and thin tree roots and on which a tree remained intact was found to have been displaced to a location about 7.5 m from the crest of the landslide scar (Plate 5).

Plate 1 - General View of the Landslide  
(Photograph taken on 11 June 1998. See Figure 4 for Location of Photograph)

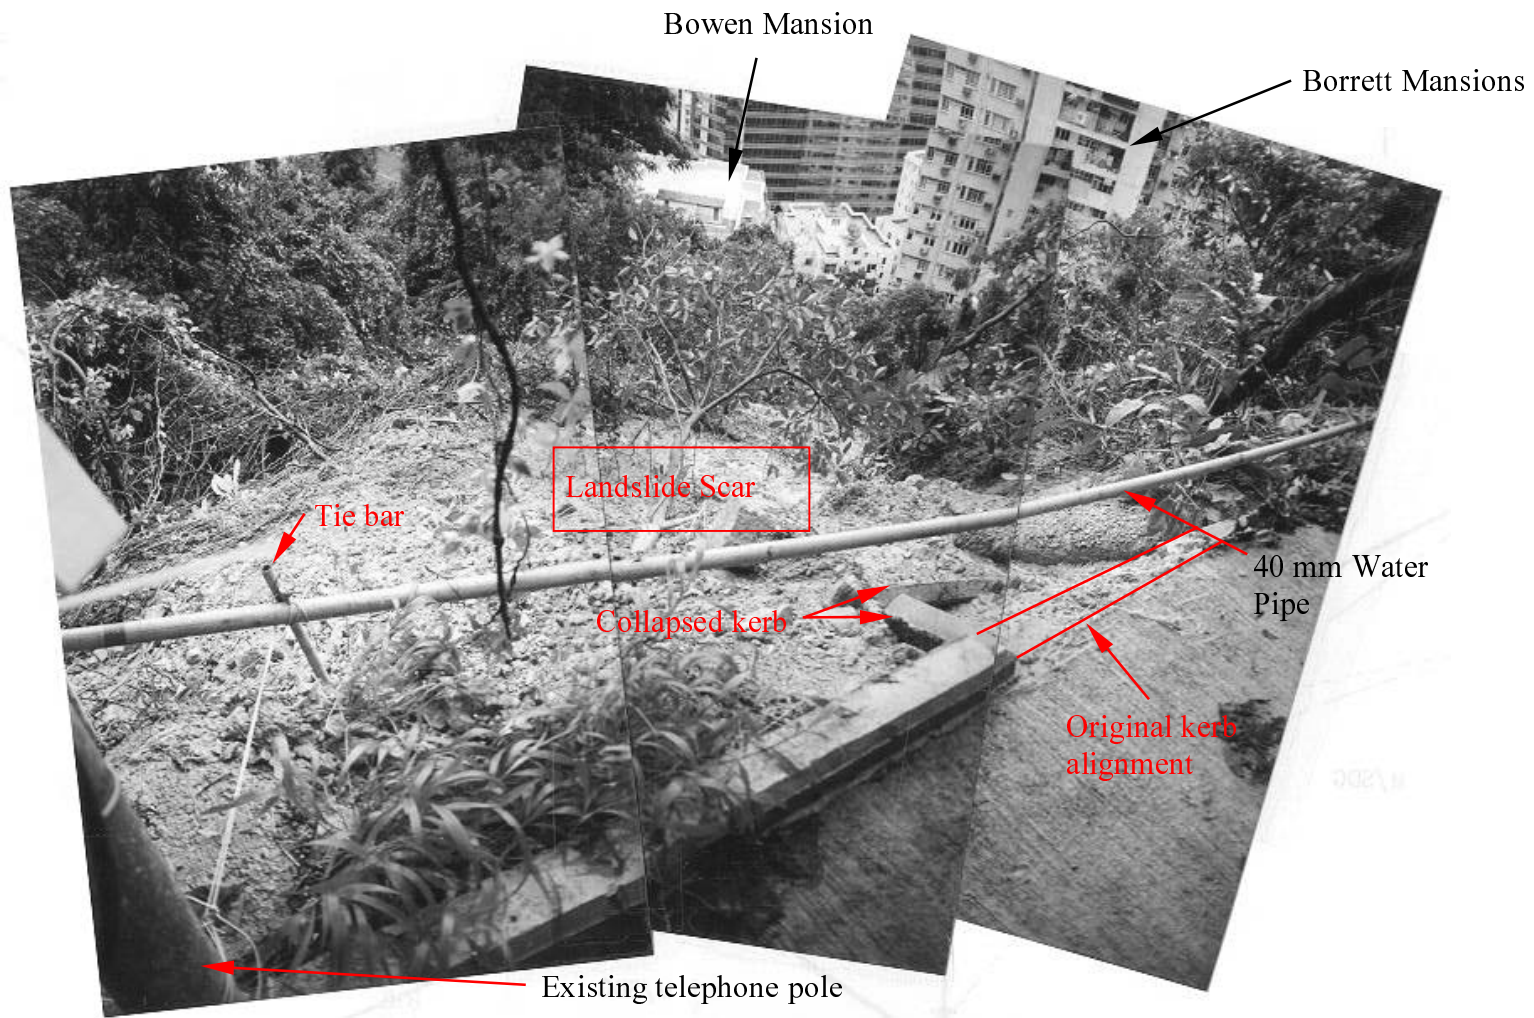
Plate 2 – General View of the Landslide Scar near the Crest  
(Photograph taken on 11 June 1998. See Figure 4 for Location of Photograph)

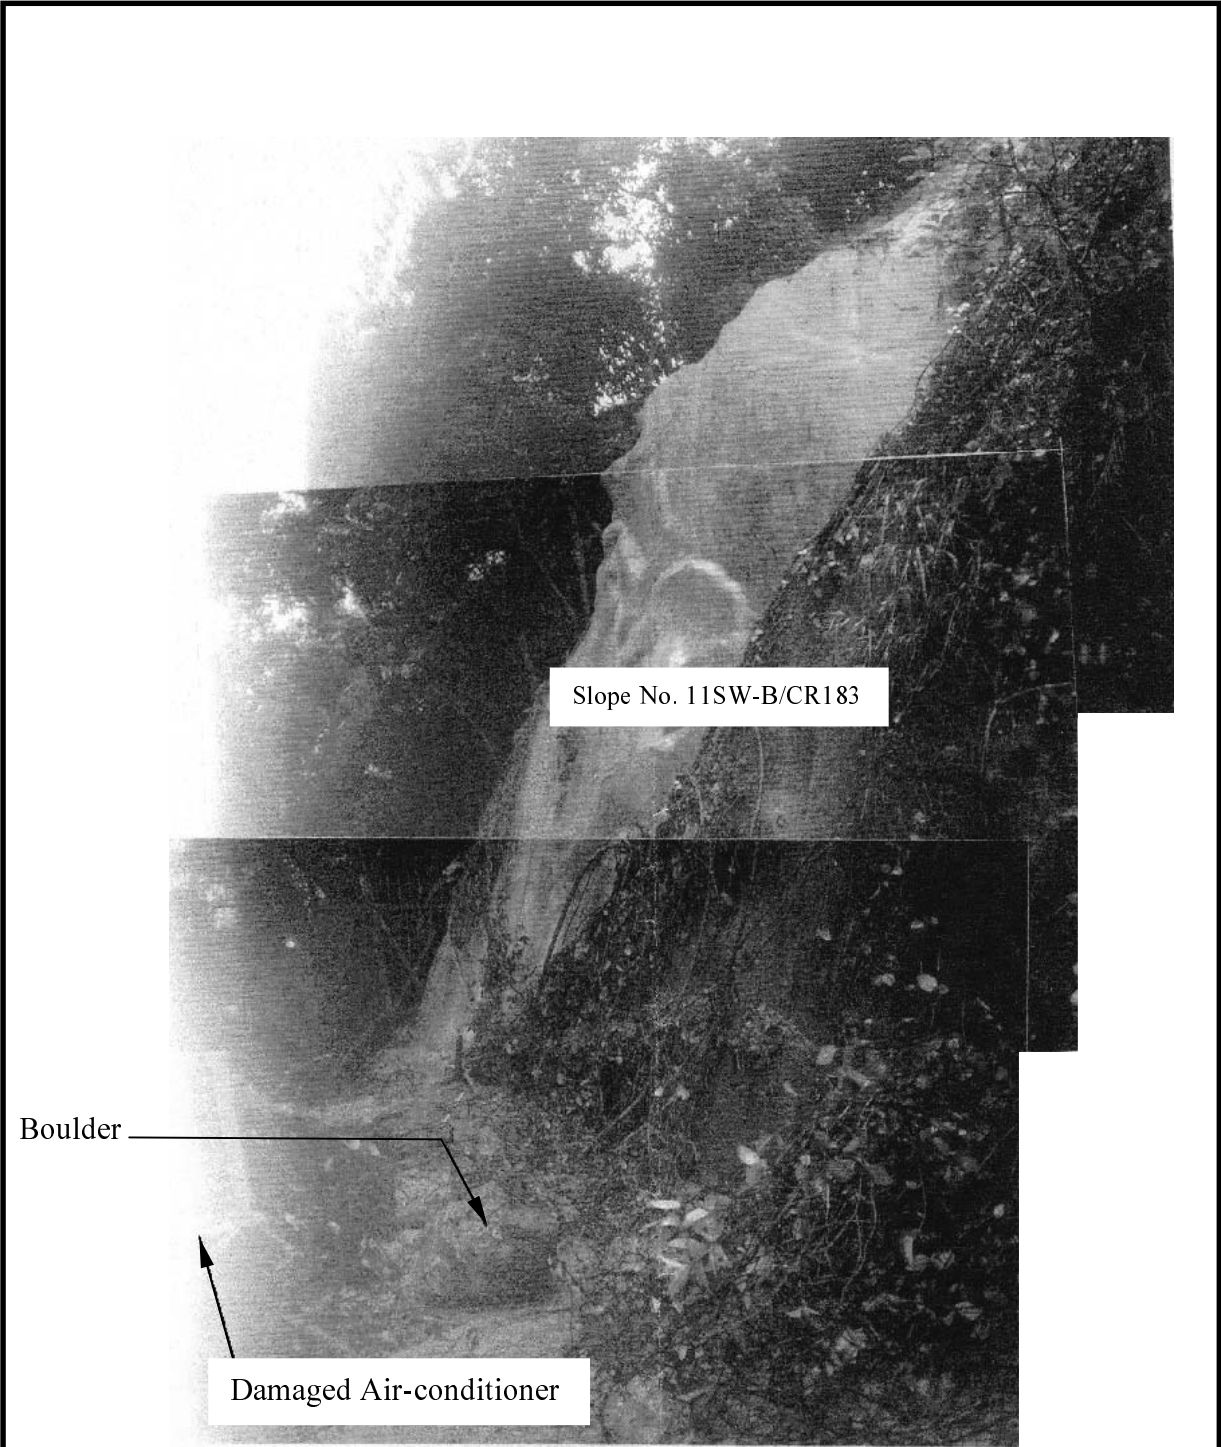
Examination of the landslide debris by FSW staff showed it to be composed of loose and wet clayey, sandy silt with cobbles, gravels and boulders, tree branches, and broken pieces of concrete kerb. As the landslide debris was constrained by the building in front of the hillside, the travel angle of the landslide debris cannot be determined reliably. Stains of muddy water splashes could be seen up to the third floor of the facade of the affected building.

Plate 3 - Landslide Debris deposited at the Rear Yard of Bowen Mansion  
(Photograph taken on 11 June 1998. See Figure 4 for Location  
of Photograph)

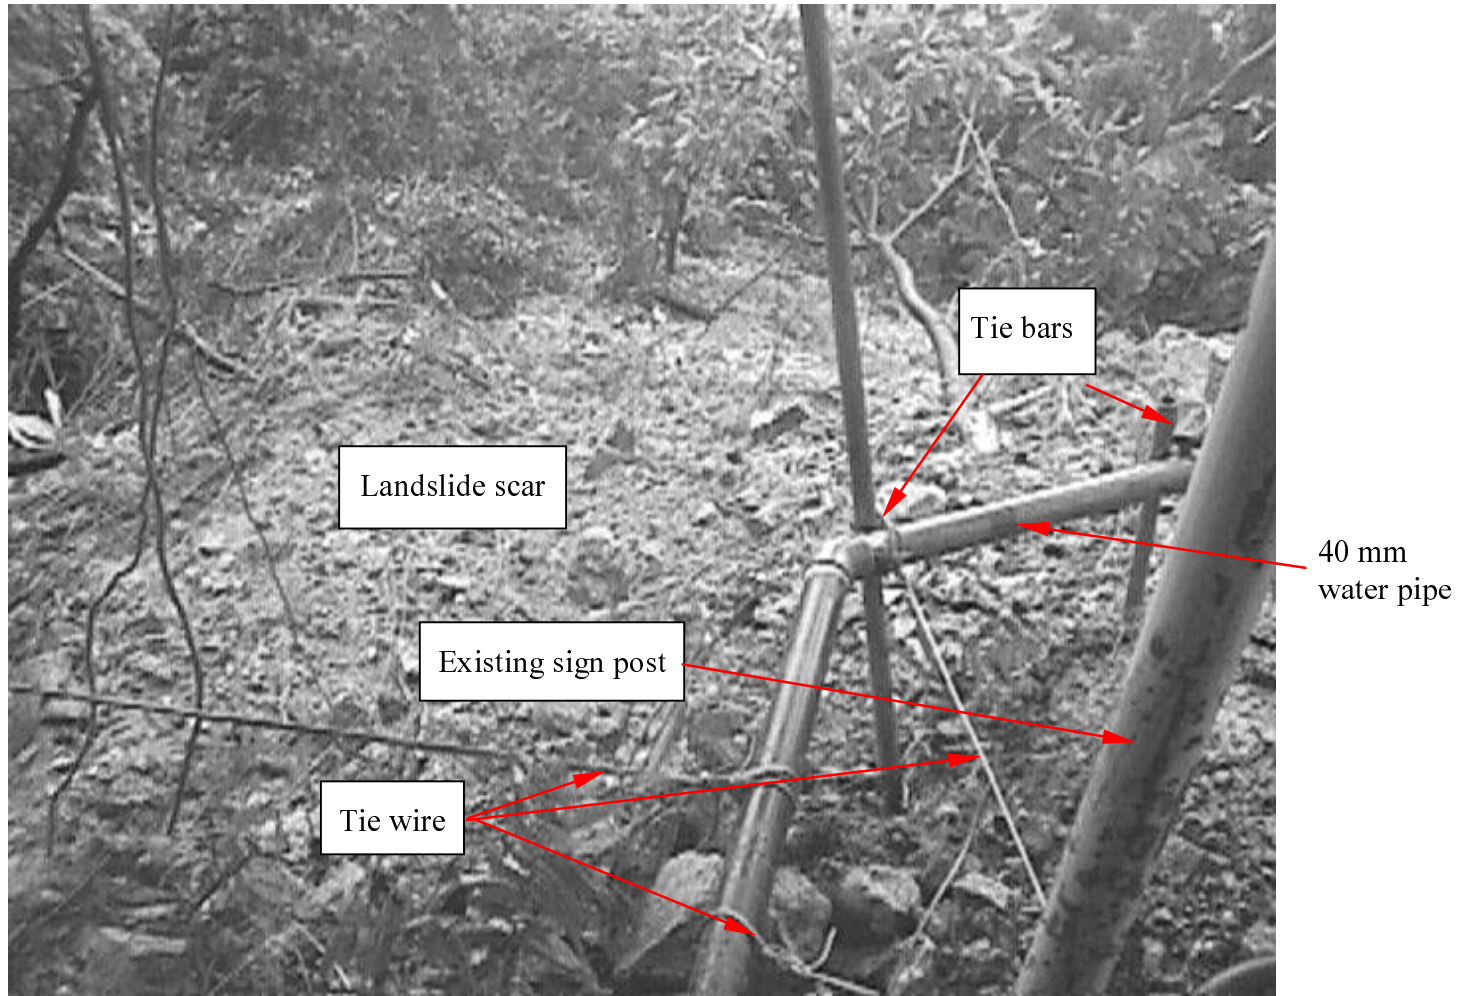
Plate 4 - Large Amount of Cobble-sized Debris Scattered near Slope Crest  
(Photograph taken on 11 June 1998. See Figure 4 for Location of Photograph)

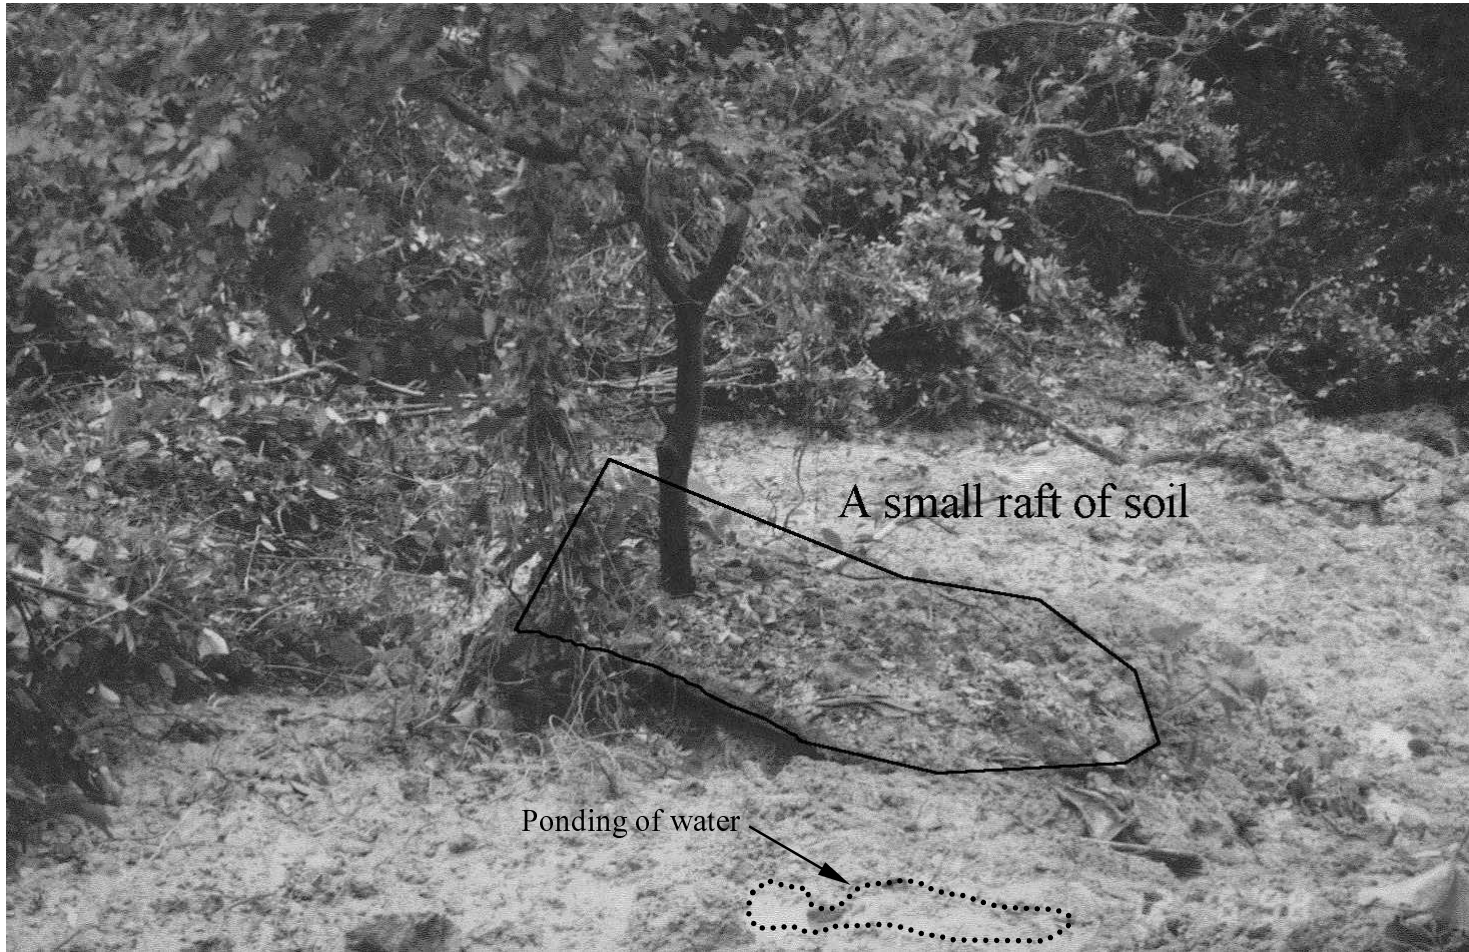
Plate 5 - A small Raft of Soil near Slope Crest  
(Photograph taken on 12 June 1998. See Figure 4 for Location of Photograph)

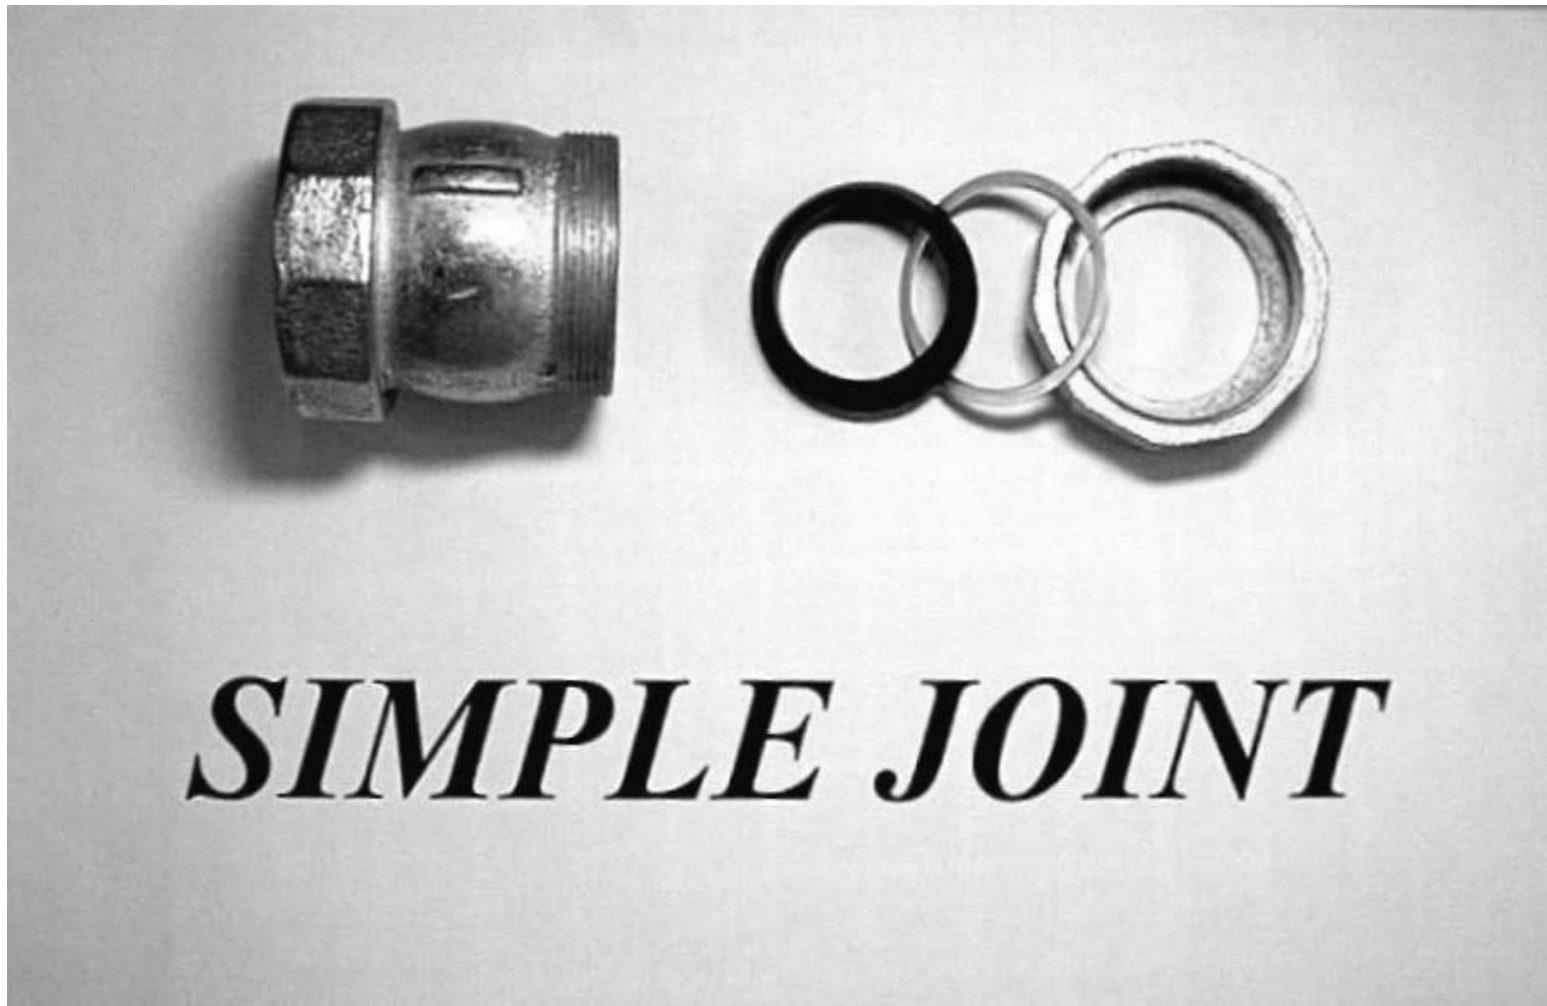
Plate 6 - Details of Simple Joint

The WSD advised that this joint is a 'simple joint' and that its use at the passing bay was necessary because curtailed sections of GI pipes were used at both sides of the joint. Although it is indicated in the WSD Manual of Mainlaying Practice (1997) that 'simple joints' shall be used for repair works to water mains, the use of 'simple joint' for permanent connection of small diameter GI pipes of less than the standard length is, according to the WSD, quite common. Based on a sample of the 'simple joint' provided by the WSD, this type of joint does not require threads to be formed at the end of pipes to be joined, and that the pipes are fixed in position by squeezing a rubber wedge in order to clamp the pipes together (Plate 6).

The leakage occurred at a 'simple joint' of the water main along the outward edge of the access road. Such joints do not require threads to be formed at the end of pipes to be joined, and the pipe sections are fixed in position by squeezing a rubber wedge ring to clamp them together (Plate 6). In comparison with a screw joint, this type of joint is more vulnerable to leakage when it is subjected to localised ground movement, or repeated tension/bending forces, particularly in the absence of adequate anchoring resistance from the support to take up the surge loading acting on the bend.

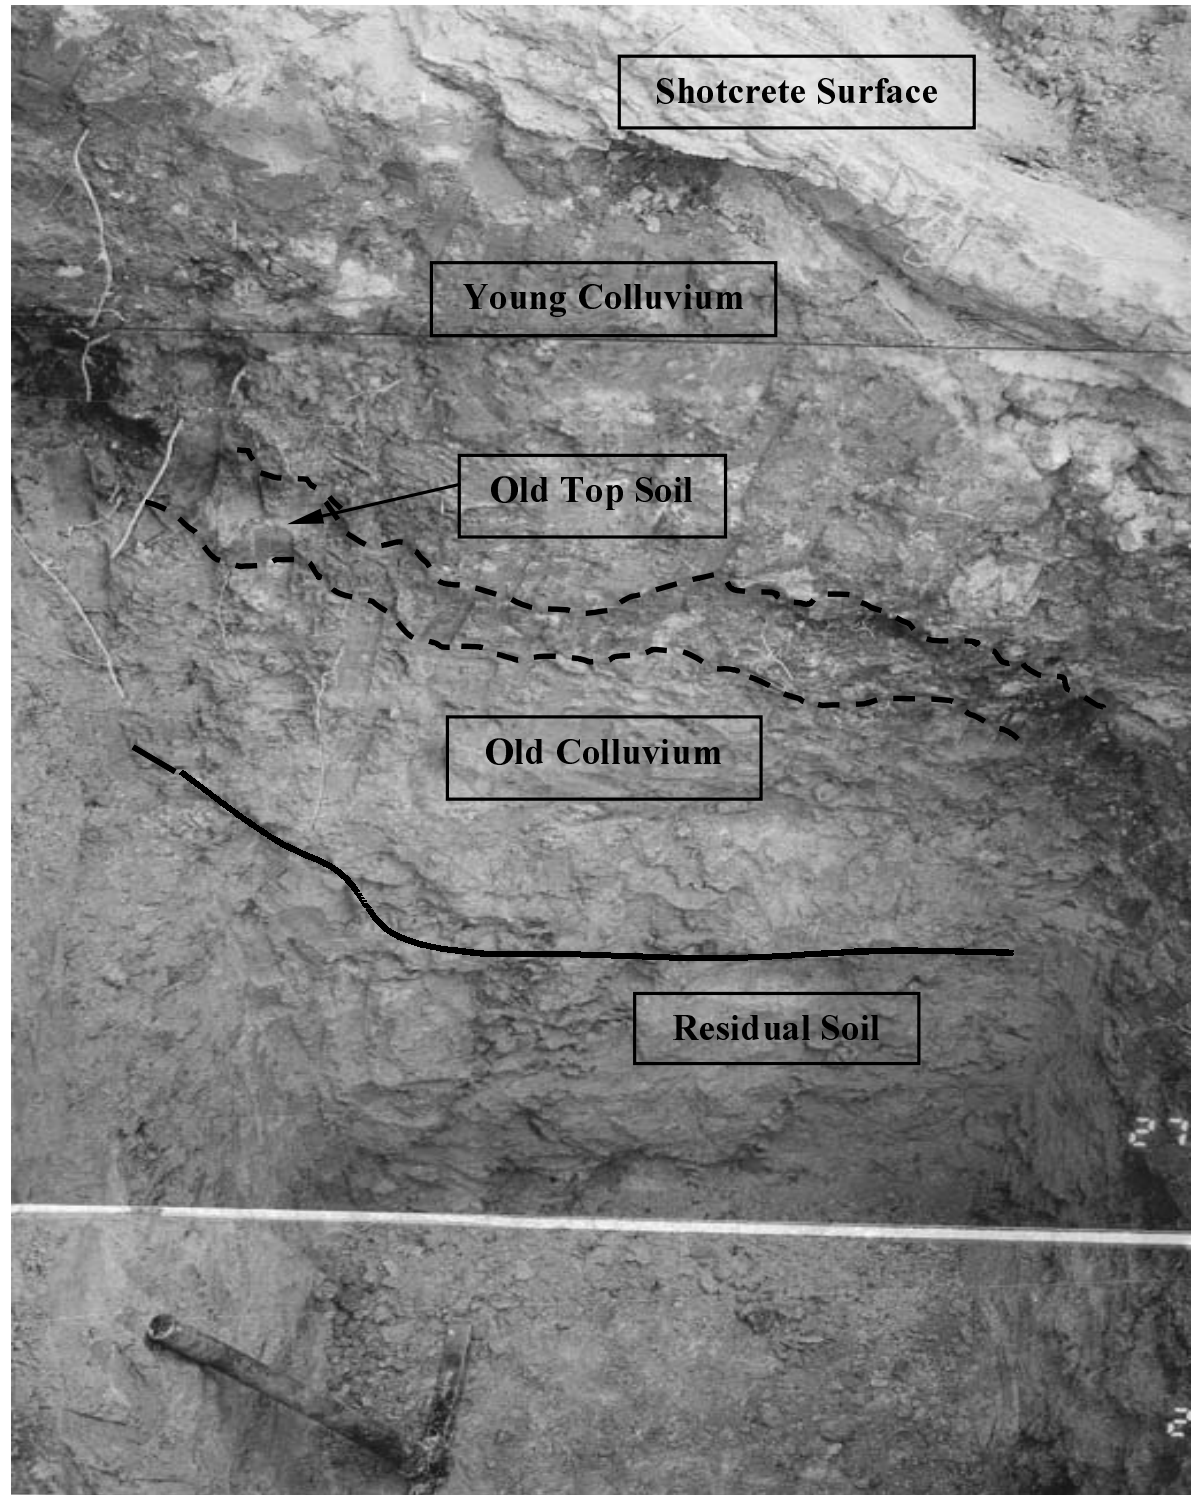
Trial pit TP1, which was excavated immediately below the passing bay, revealed a surface layer of colluvium (referred to as young colluvium) of composition similar to that noted in the lower part of the landslide scar (see Section 4.2 above) and of thickness ranging from 0.5 m to 1.3 m. The young colluvium is underlain by a layer of old top soil (maximum 0.3 m thick) comprising firm, dark grey, very silty, sandy clay, similar to that observed in the surface strips. A few isolated tree roots were found in the young colluvium and old top soil. The old top soil is underlain by another layer of colluvium (referred to as old colluvium), approximately 0.5 m thick and composed of firm, mottled brown, very silty, sandy clay with some angular gravel and cobble-sized rock fragments. The subsoil profile exposed in TP1 is shown in Plate 7. Trial pit TP2, which was excavated approximately 7 m downslope from TP1, revealed a similar sequence of colluvial layers divided by a layer of top soil as found in TP1. In TP2, the surface layer of colluvium (i.e. young colluvium) is approximately 0.2 m thick.

Plate 7 - Subsoil Profile Exposed in Trial Pit TP1  
(Photograph taken on 27 August 1998. See Figure 4 for Location of Photograph)
