**INVESTIGATION OF SOME
SELECTED LANDSLIDES
IN 1998
(VOLUME 6)**

GEO REPORT No. 113

**GEOTECHNICAL ENGINEERING OFFICE
CIVIL ENGINEERING DEPARTMENT
THE GOVERNMENT OF THE HONG KONG
SPECIAL ADMINISTRATIVE REGION**

**SECTION 1 :
DETAILED STUDY OF
THE LANDSLIDE AT
TATE'S RIDGE,
FEI NGO SHAN ROAD
ON 9 JUNE 1998**

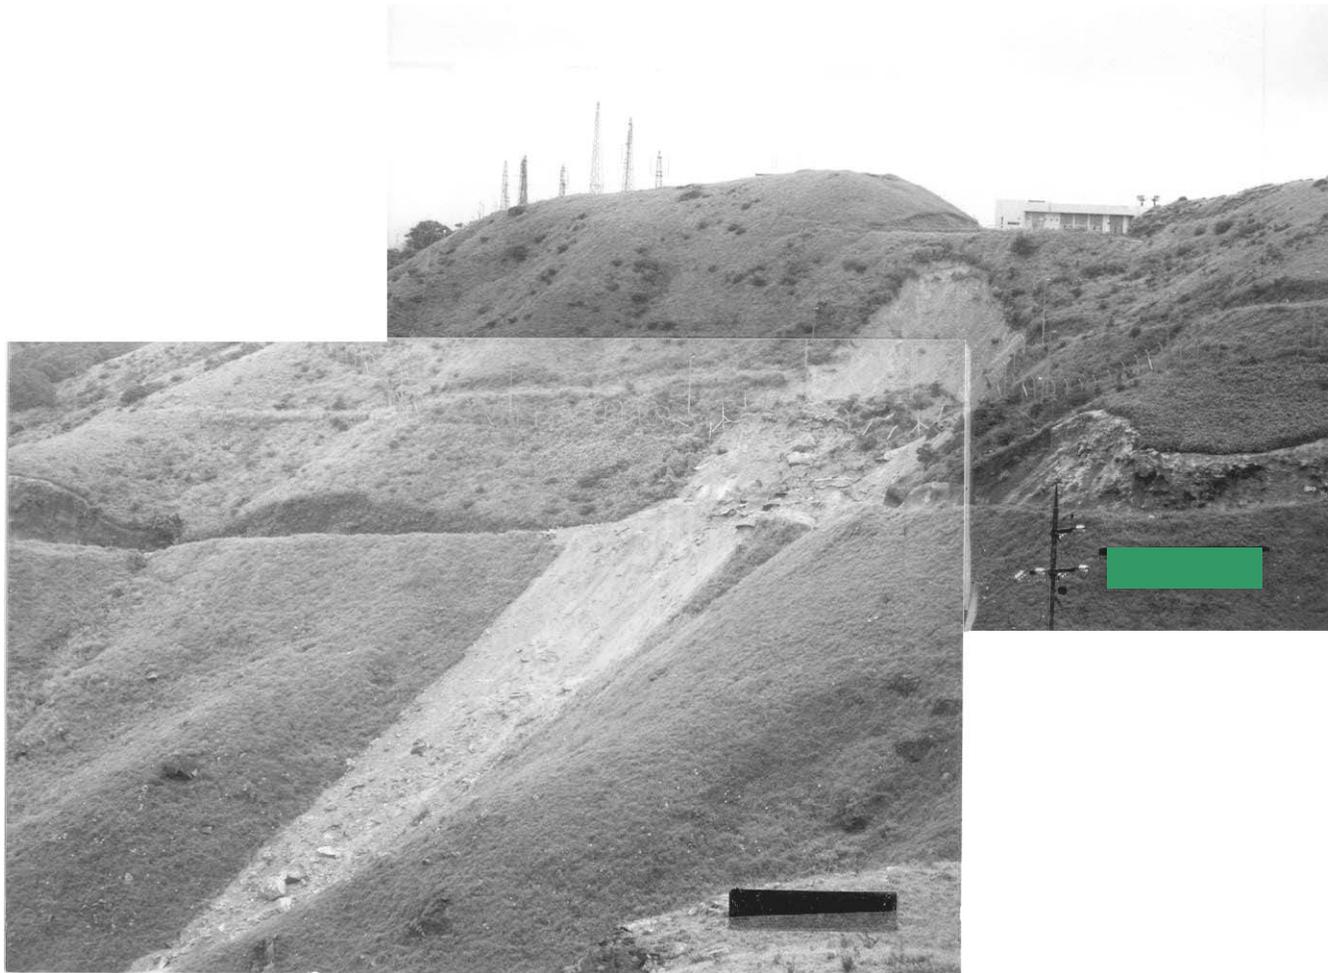
Plate 1 – Front View of 9 June 1998 Landslide
(Photographs taken on 12 June 1998)

At sometime between the early morning and 12:30 p.m. on 9 June 1998, a landslide (GEO Incident No. K 98/6/5) occurred at Slope No. 7SE-C/C42 below the Police Post at Tate's Ridge, Fei Ngo Shan Road, Kowloon (Figure 1 and Plates 1 and 2). Debris from the landslide travelled downslope for a horizontal distance of about 170 m from the crown of the failure, completely blocking Fei Ngo Shan Road. There were no casualties as a result of the landslide.

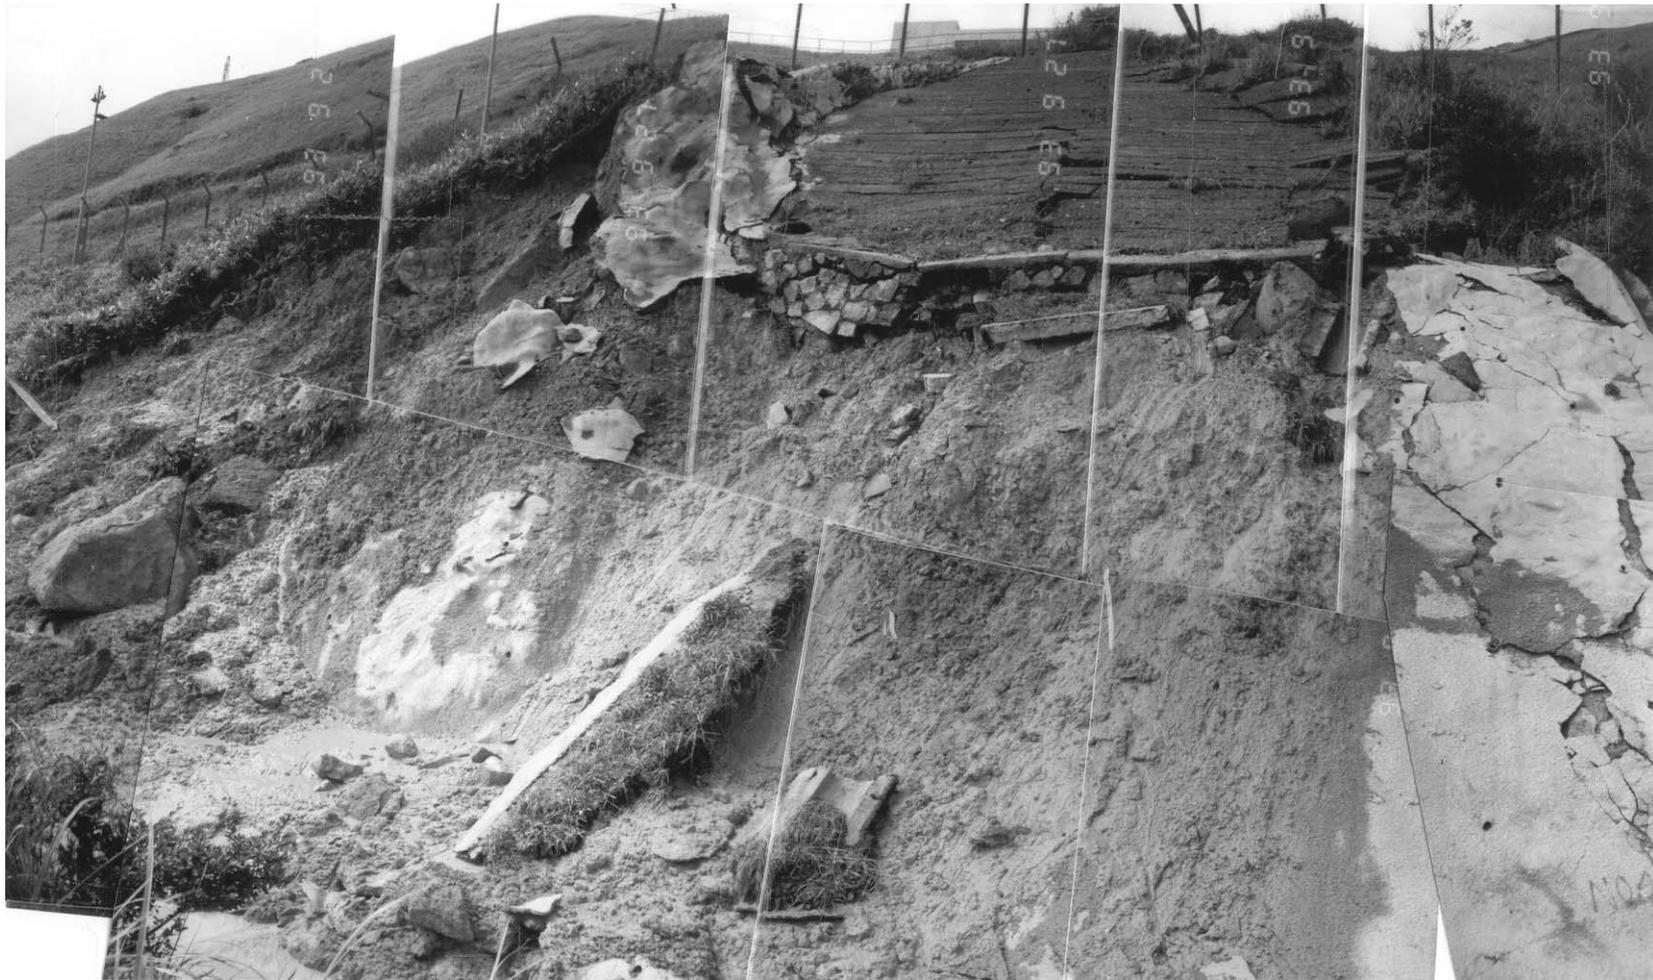
Plate 3 – General View of the September 1993 Landslide
(Photographs taken on 27 September 1993)

The earliest recorded incidence of failure was that on 27 September 1993, when a major landslide occurred in the vicinity of the upper cut slope (GEO, 1993) following a rainstorm. The recorded volume of the failure was 1000 m³, and debris from the landslide blocked Fei Ngo Shan Road (Plate 3). Following the incident a tension crack bounding the upper portion of the landslide was identified in the natural ground approximately 5 m to 10 m above the upper cut slope (Figure 5 and Plate 4). No interpretation as to whether the crack was new or old or details regarding the depth and extent of the tension crack were recorded in the incident report or GEO's files. However, from photographs it is estimated that the maximum movement of the main body of material was less than 0.5 m both horizontally and vertically (Plate 4), although the western side of the landslide appeared to have displaced by a greater extent (Plate 3).

Remedial works recommended by the Mainland East Division of the GEO following the failure comprised cutting back the lower slope to a gradient of 1:2, covering the area with surface protection and construction of new surface drainage. Also, a 300 mm U-channel was to be installed on the uphill side of the tension crack (Plate 5). Additionally, control points were to be installed to monitor the movement of the tension crack during construction of the remedial works. A memo from the GEO to the Highways Department, dated 6 October 1993, stated that "As your monitoring indicates no further movement at the upper part of the slope please fill the tension cracks with well rammed soil to prevent surface water ingress".

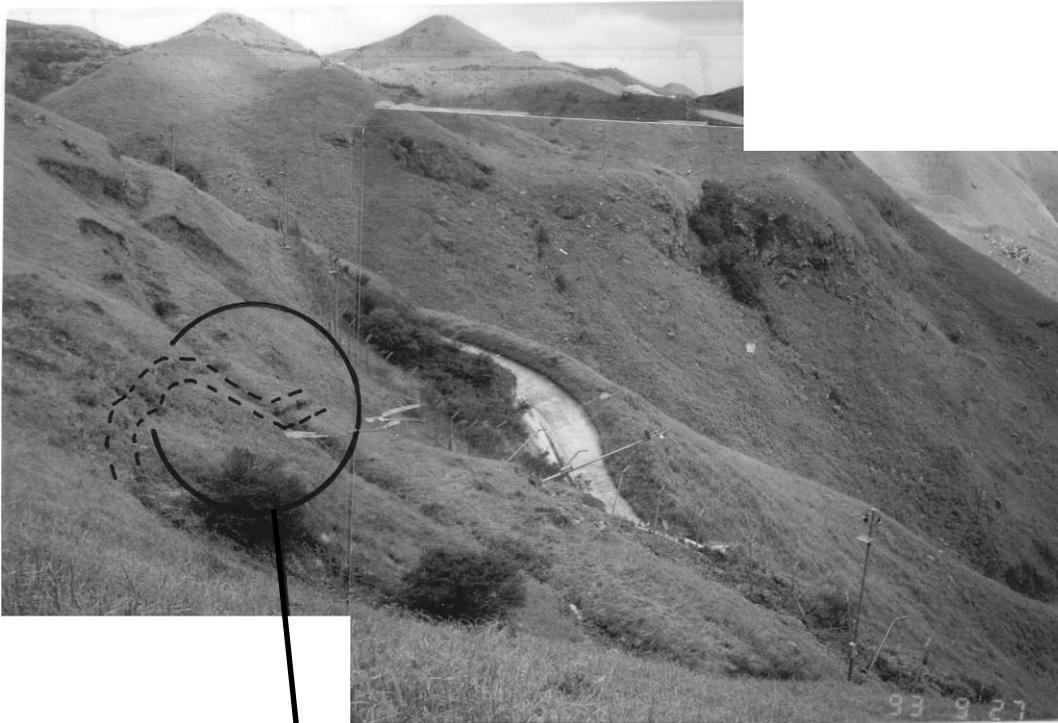
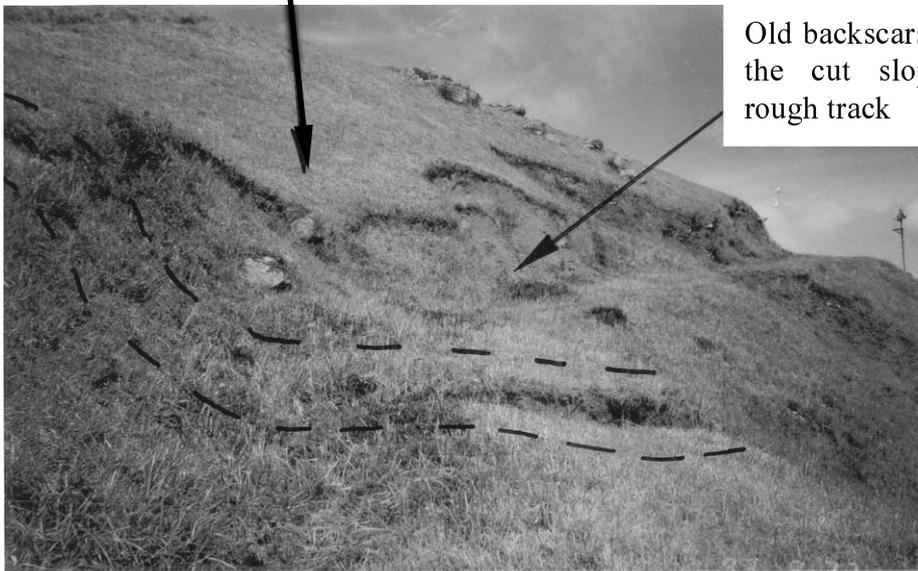
Plate 4 – View of the Tension Crack Following the 1993 Landslide
(Photographs taken on 27 September 1998)

Location of tension crack noted in the natural slope following the 1993 landslide. The crack descends through the upper cut slope into the area of natural ground below

Old backscars are evident in the cut slope above the rough track

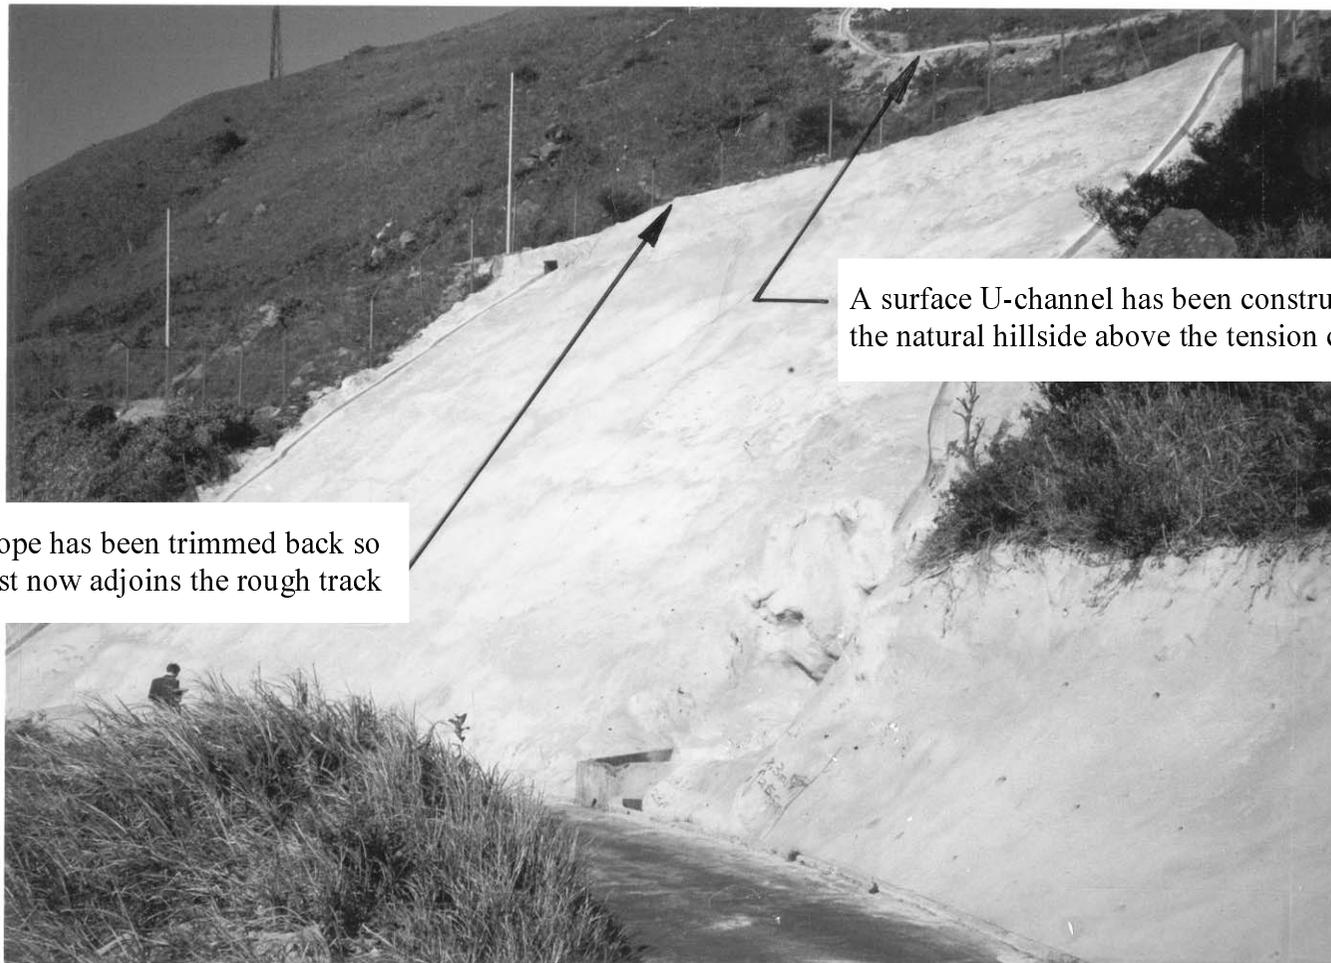
Plate 5 – View of Slope Following Remedial Works in 1993
(Photographs taken on 21 December 1993)

Lower cut slope has been trimmed back so the slope crest now adjoins the rough track

A surface U-channel has been constructed across the natural hillside above the tension crack

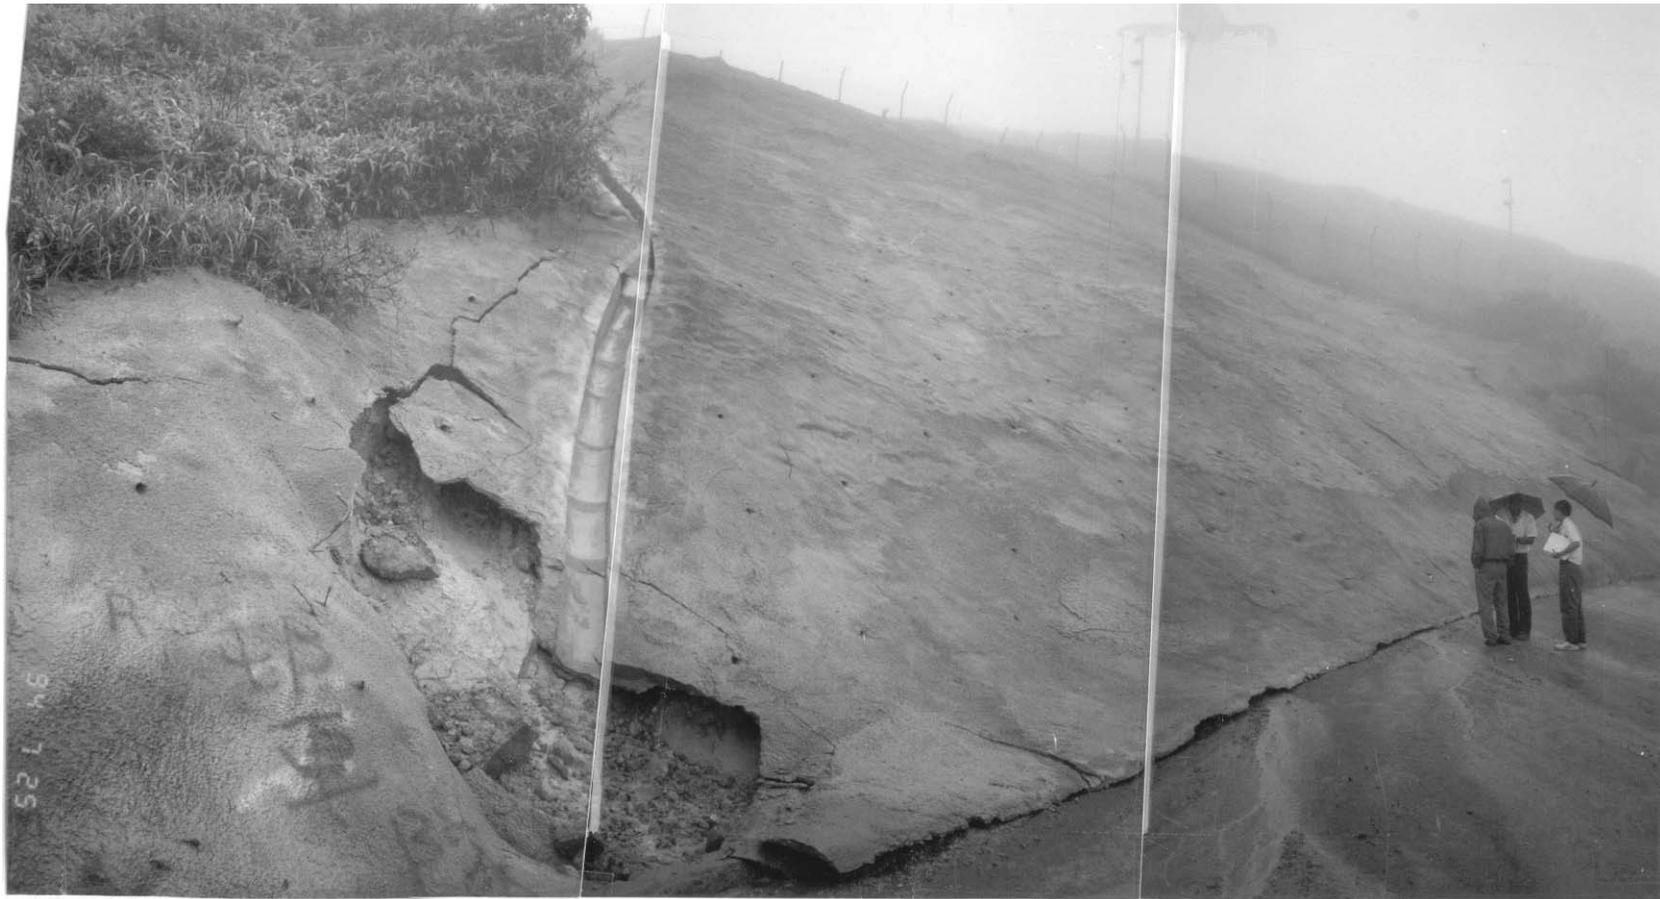
Plate 6 – View of Slope Distress in July 1994
(Photographs taken on 25 July 1994)

In July 1994, further instability in the form of extensive cracking and slope movement was noted at the toe of the cut slope directly above Fei Ngo Shan Road (GEO, 1994). Cracking was most notable at the corners of the slope and there was also some spalling of the shotcrete at the western side (Plate 6). In the central portion of the slope, the shotcrete cover was recorded as having moved out by some 100 mm, and steady seepage was noted along the toe. Remedial measures recommended by the Mainland East Division involved the removal of the existing surface protection and any loose material below, followed by the application of a new shotcrete layer.

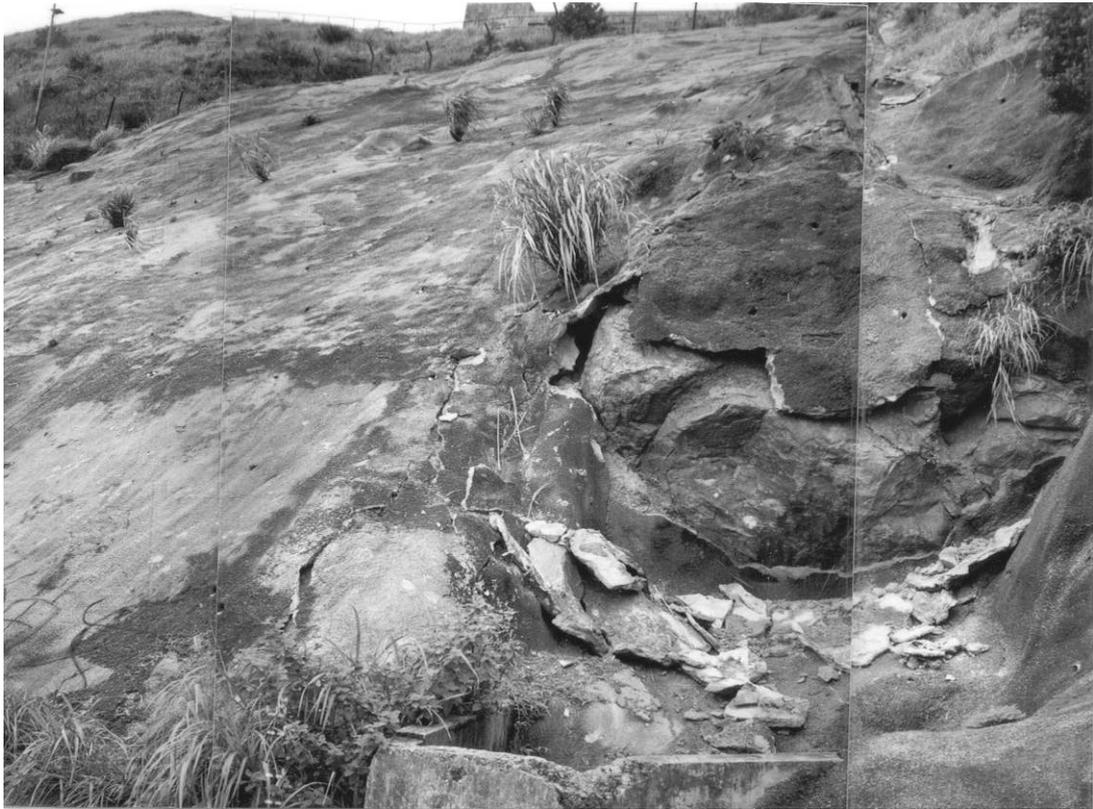
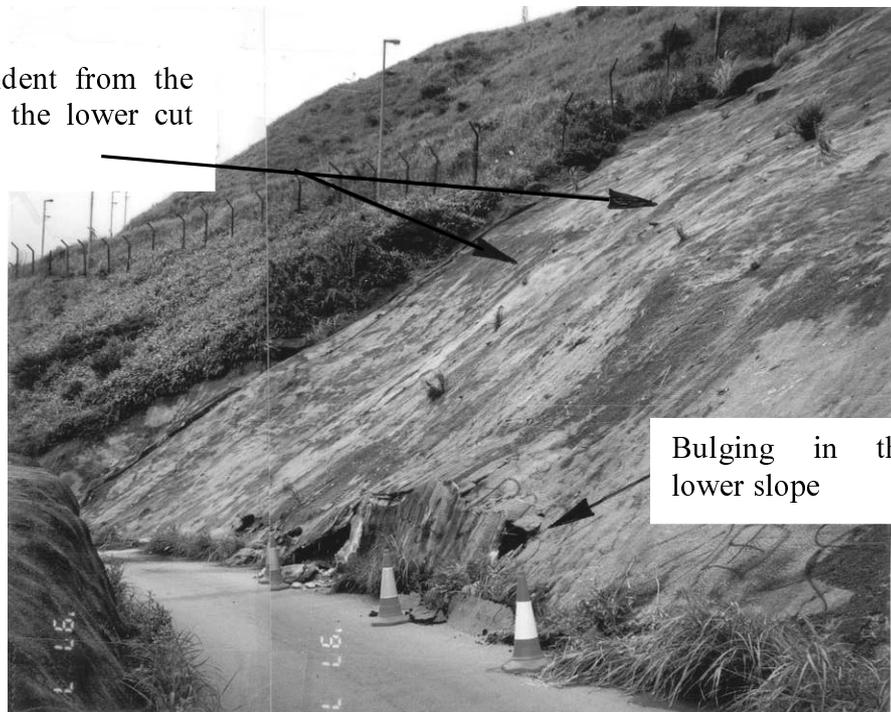
Plate 7 – View of Slope Distress in July 1997
(Photographs taken on 11 July 1997)

In July 1997, cracking and bulging was again observed at the toe of the cut slope directly above Fei Ngo Shan Road with water seeping out from the weepholes about 10 m upslope from the road (GEO, 1997). Also, extensive cracking and spalling of the shotcrete was present at the eastern corner (Plate 7). Two sets of tension cracks were recorded in the

Seepage is evident from the mid-portion of the lower cut slope

Bulging in the lower slope

Following these observations, more extensive remedial measures were recommended by the Mainland East Division. The 18 m-high section of slope directly above Fei Ngo Shan Road was to be formed into two batters (35° for the lower portion and 40° for the upper portion) separated at the mid-point by a 1 m-wide berm. A new layer of shotcrete was to be applied to the trimmed slope, and three rows of 12 m-long soil nails and eleven 10 m-long horizontal drains were to be installed in the lower 6 m of the slope (Figure 6).

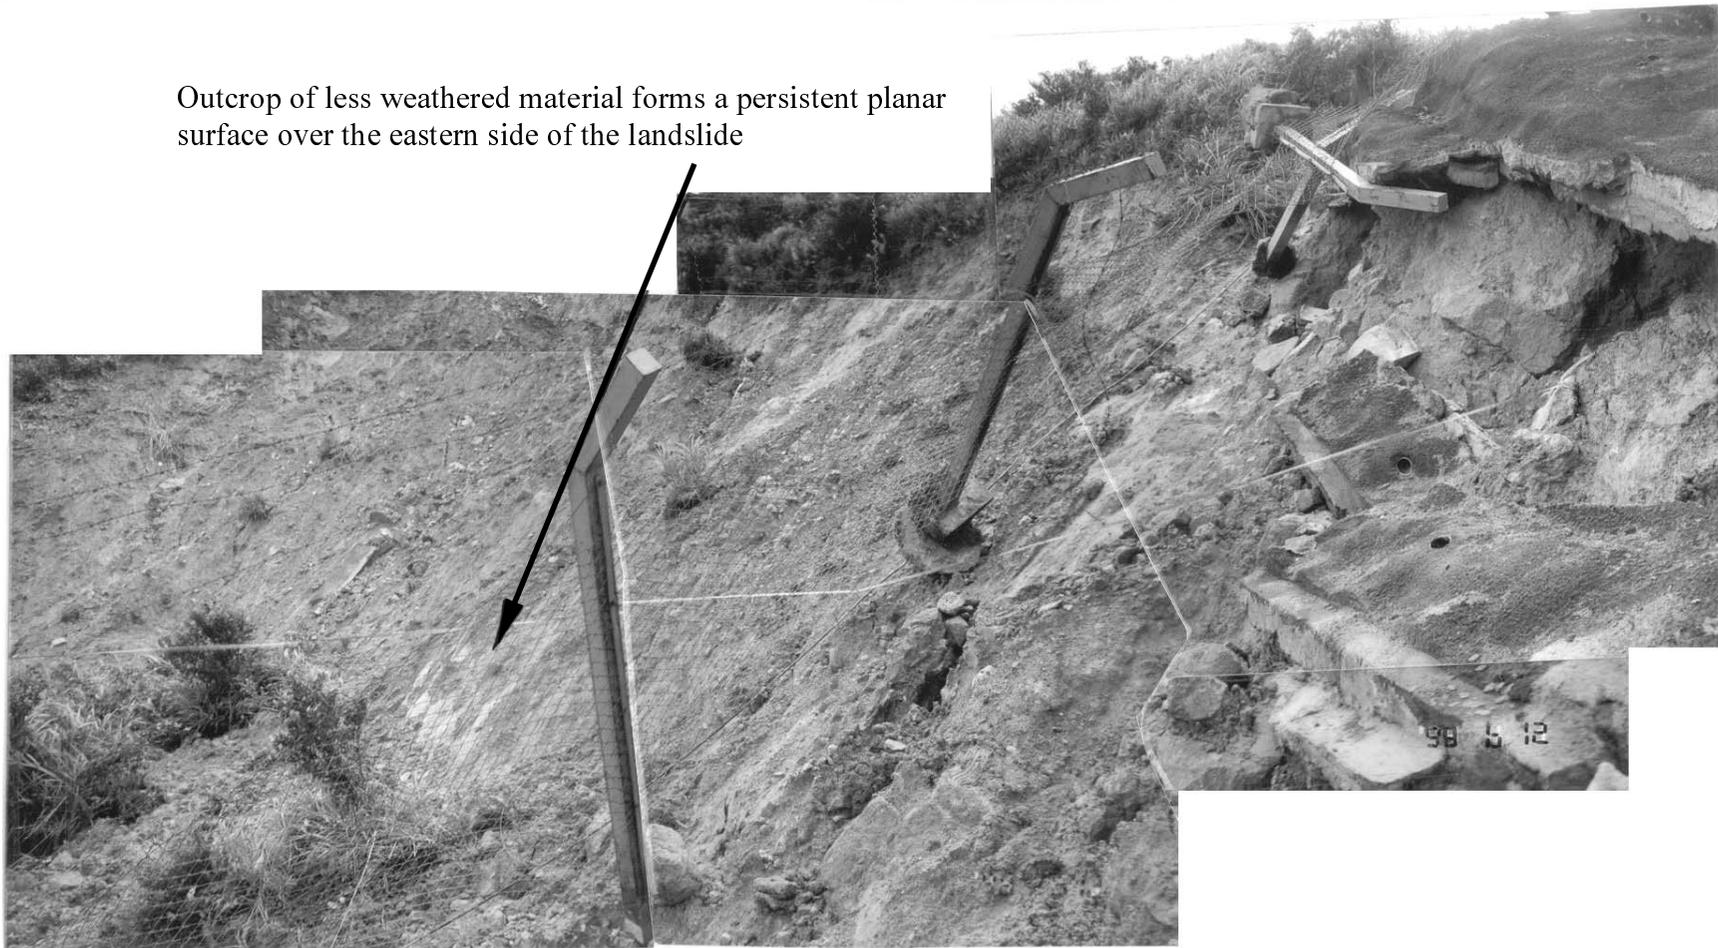
Plate 9 – View of the Planar Discontinuity along the Eastern Side of the Landslide
(Photographs taken on 12 June 1998)

Outcrops of dark blue grey, moderately and moderately-to-slightly decomposed tuff (MDT and M-SDT respectively) were irregularly spaced within the more weathered matrix. These appeared to be more prominent over the eastern portion of the rupture surface, and over the lower eastern portion an area of M-SDT formed a locally persistent outcrop with a planar surface that dipped at an angle of 50° approximately due south (Plates 9 and 12). A slickensided black manganiferous deposit was observed over parts of this outcrop. This plane appears to have partially controlled the eastern side of the landslide in this area.

Outcrop of less weathered material forms a persistent planar surface over the eastern side of the landslide

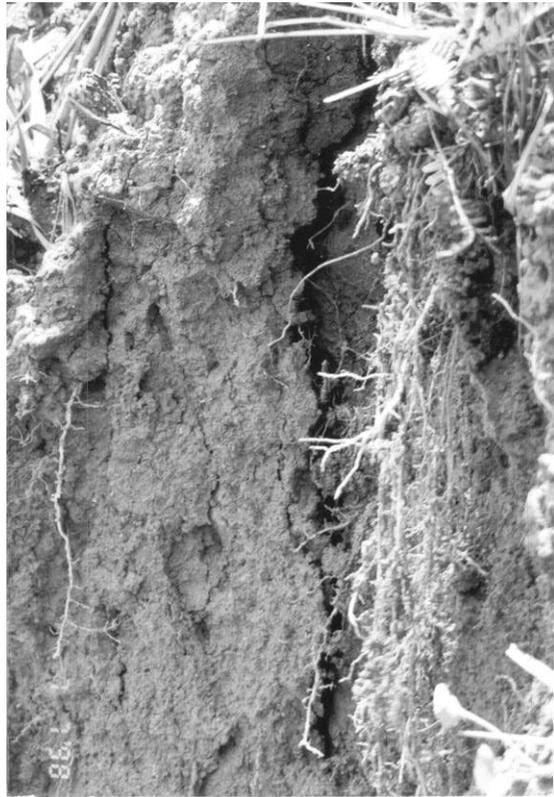
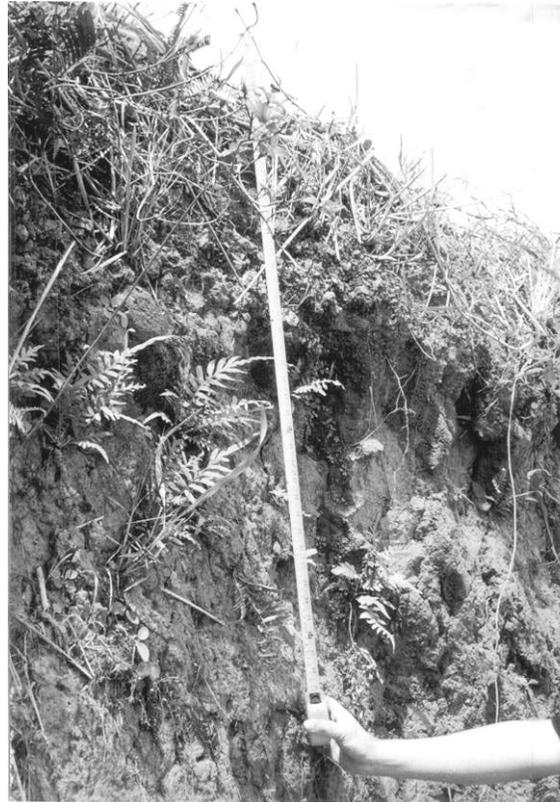
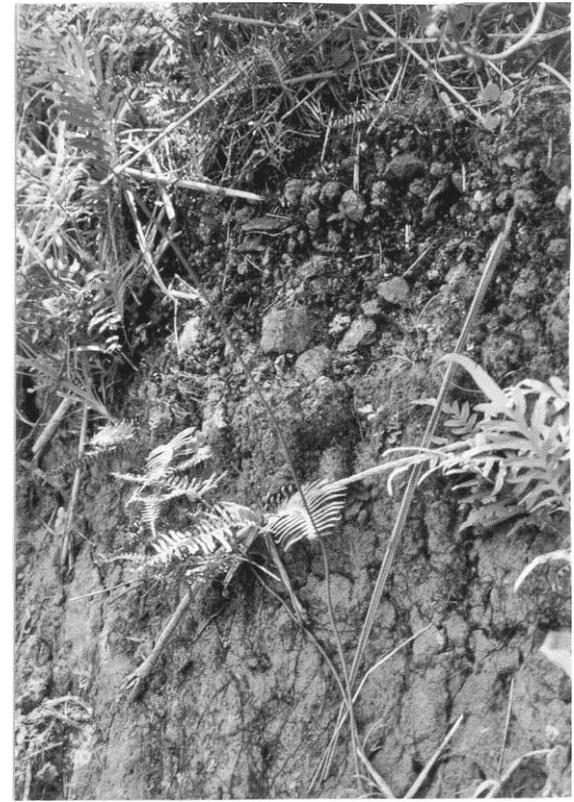
Plate 10 – View of Tension Crack Formed prior to the Landslide on 9 June 1998
(Photographs taken on 7 July 1998)

a) In-part the 1998 landslide failed along the existing tension crack formed following the 1993 landslide

b) The depth of the tension crack appears to be about 1 m deep

c) In-part the tension crack was filled with granular material

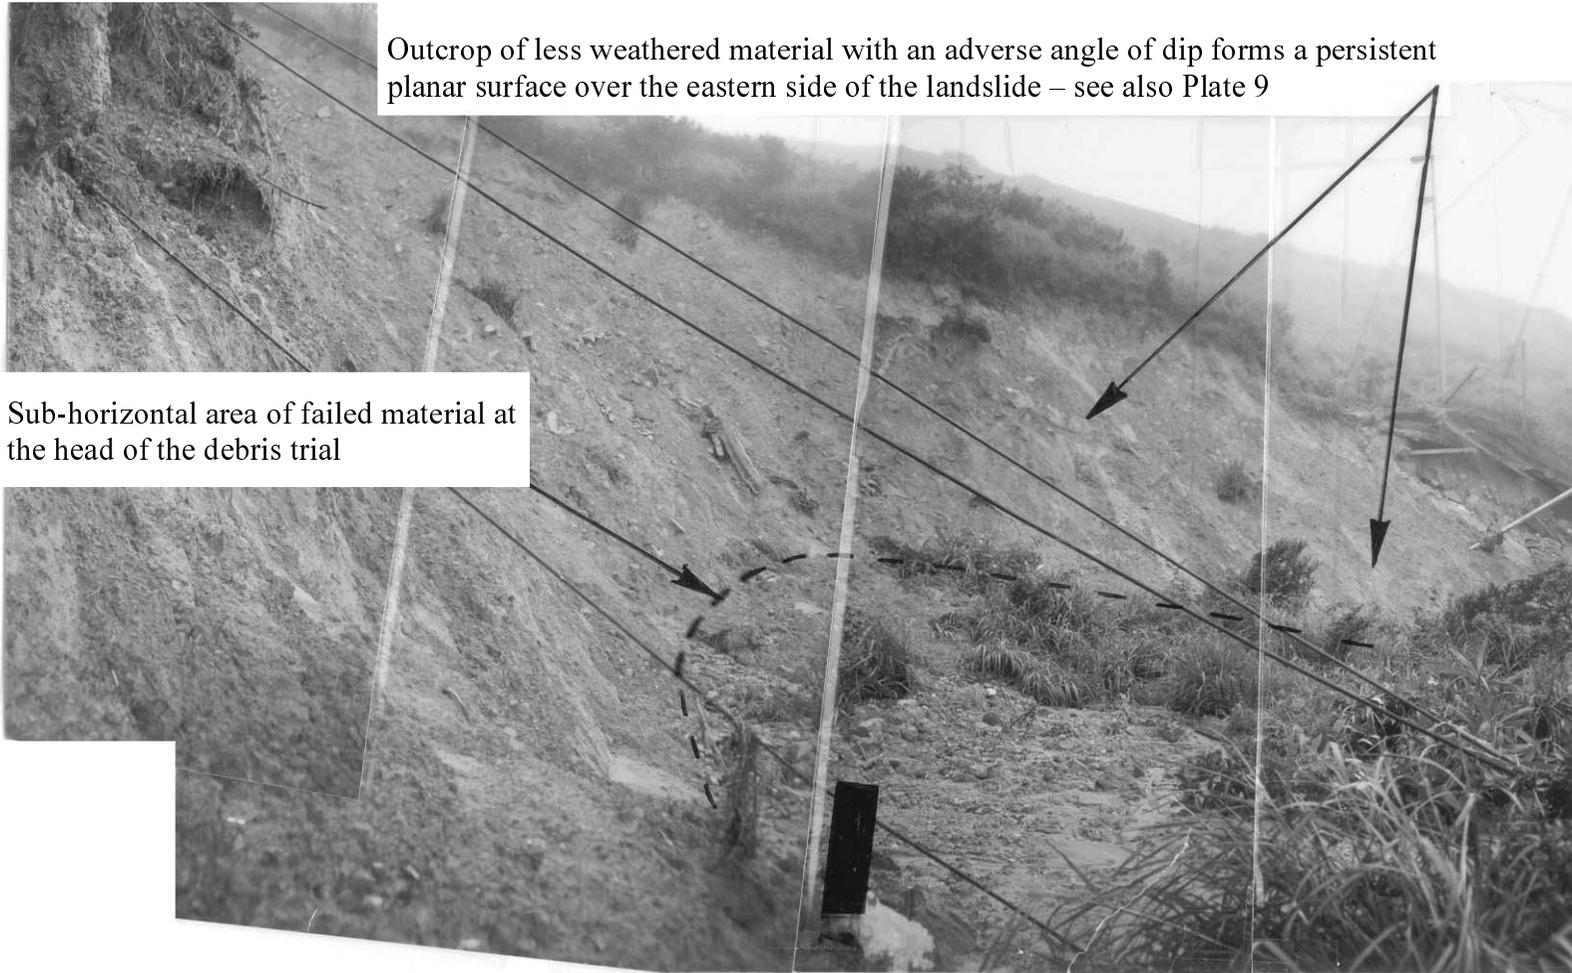
Plate 12 – View of Head of Failed Material Following 9 June 1998 Landslide
(Photographs taken on 10 June 1998)

Debris from the landslide formed a sub-horizontal deposit at the head of the debris trail approximately 20 m to 25 m from the crown. Material in this area was thought to be approximately 2 m to 3 m thick and was very wet and covered by displaced vegetation (Plates 2 and 12). The vegetation appeared largely intact giving the impression that this section of the slope failed as an intact raft that broke up slightly under movement. Occasional large boulders and broken U-channel sections were evident over the surface.

Outcrop of less weathered material with an adverse angle of dip forms a persistent planar surface over the eastern side of the landslide – see also Plate 9

Sub-horizontal area of failed material at the head of the debris trail

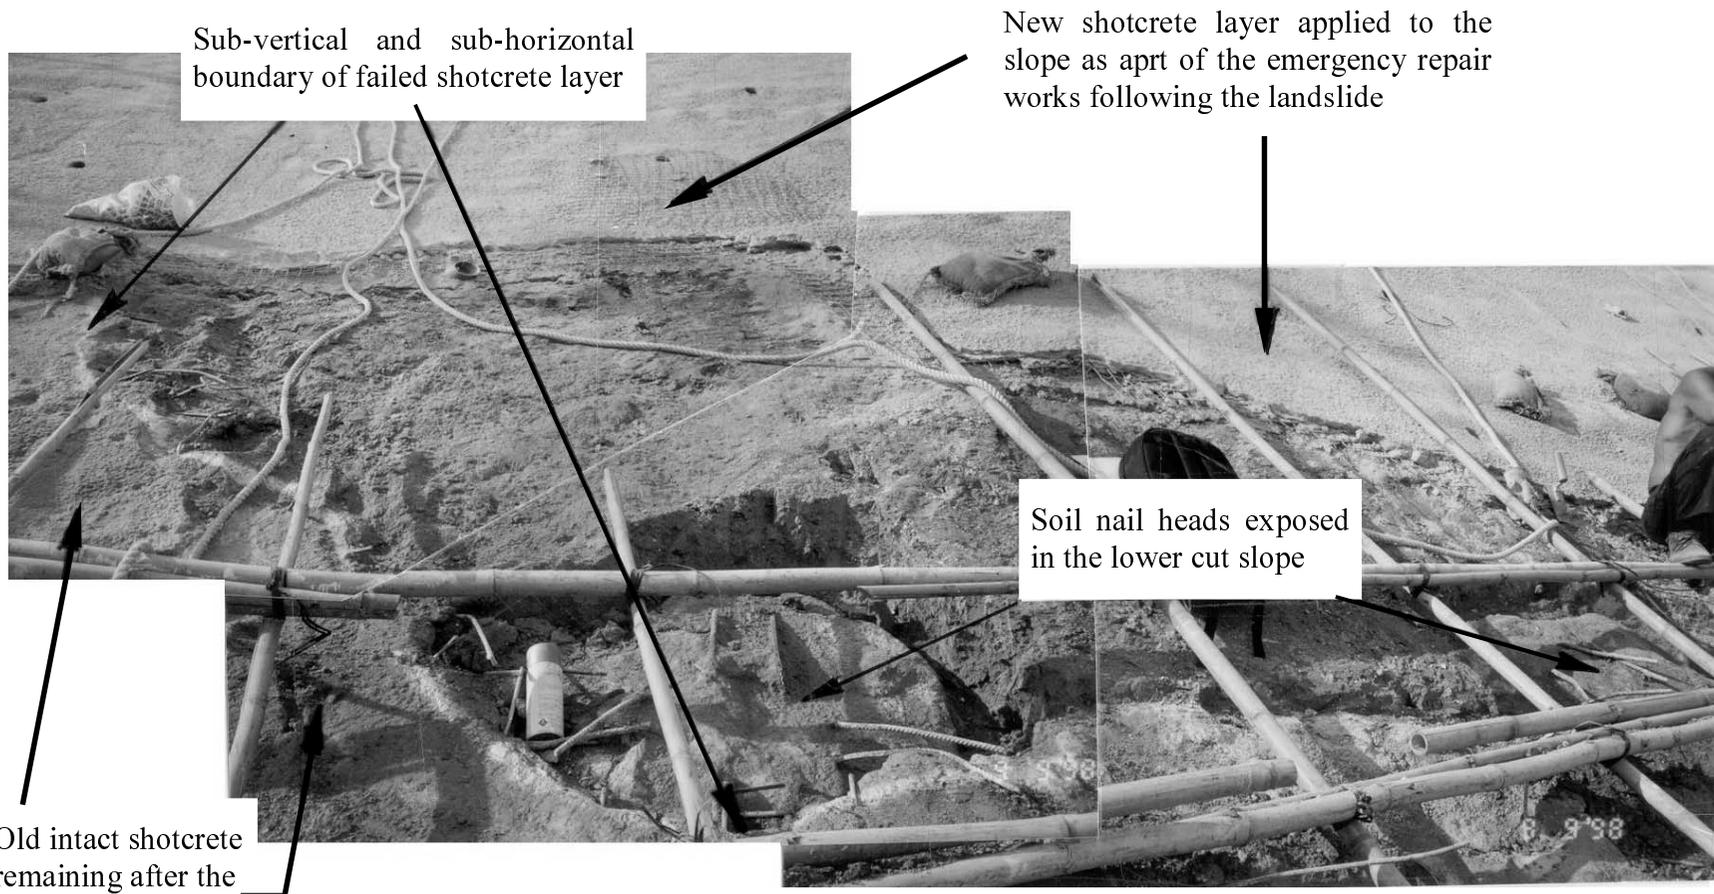
Plate 15 – View of Soil Nail Heads Exposed in the Lower Cut Slope Following 9 June 1998 Landslide
 (Photographs taken on 10 June 1998)

Directly below the nail heads the shotcrete had failed sub-horizontally creating a boundary above which there was no shotcrete and below which the shotcrete remained intact. Adjacent to the westernmost nail head, this boundary arced upwards sub-vertically, and similarly formed a boundary to the east of which was no shotcrete, but to the west of which was intact shotcrete (Plate 15).

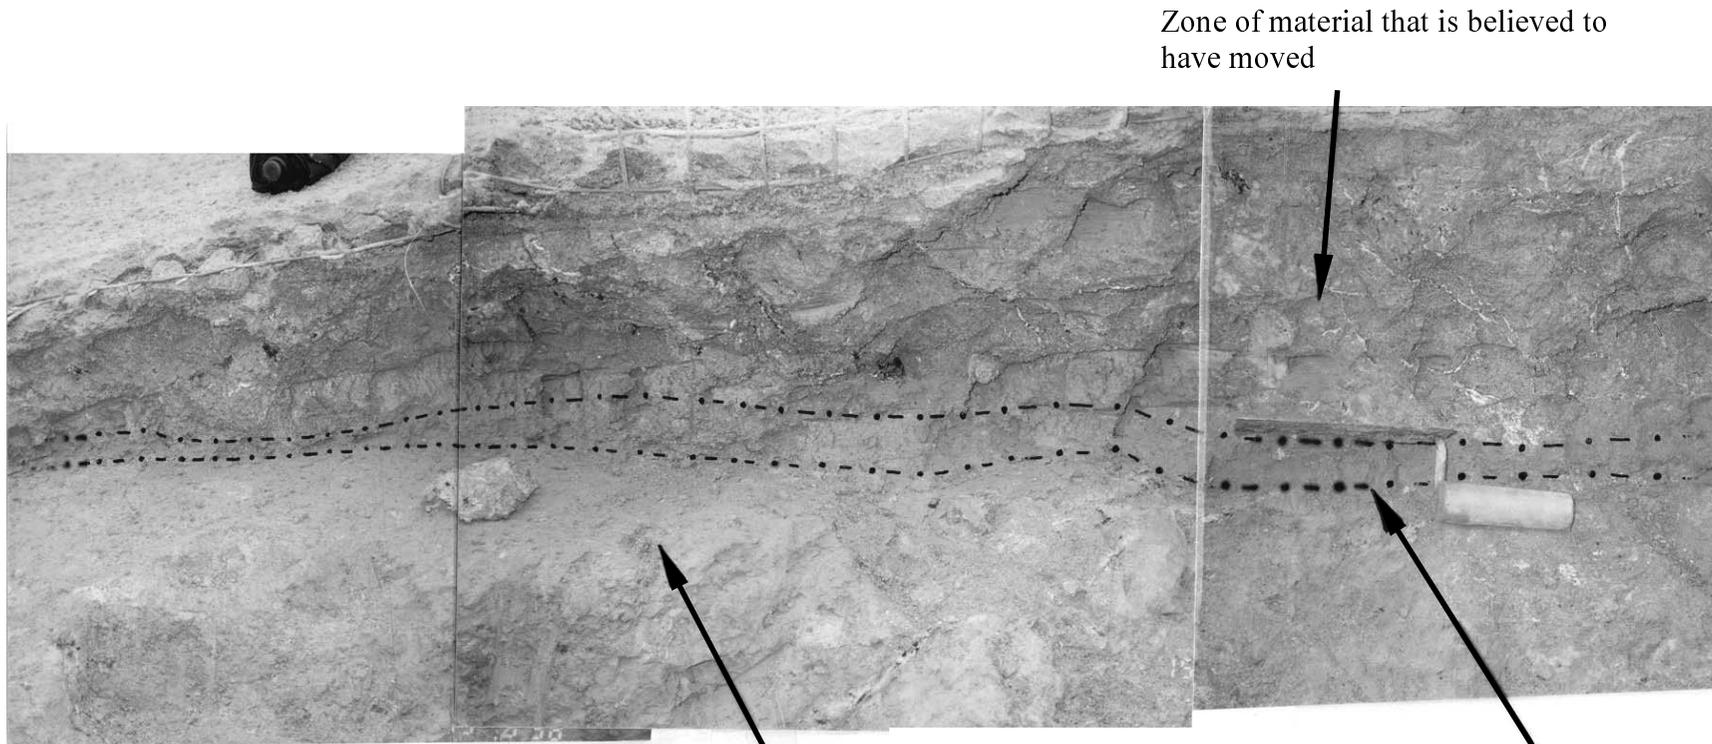
Plate 17 – View of Disturbed Seam Exposed in the Trial Pit (TP1)
(Photographs taken on 9 September 1998)

Intact material that is not believed to have moved as a result of the current landslide

Zone of apparently reworked material that lacks structure – possible movement plane
