INVESTIGATION OF SOME SELECTED LANDSLIDES IN 1998 (VOLUME 7)

GEO REPORT No. 114

Fugro Scott Wilson Joint Venture

**GEOTECHNICAL ENGINEERING OFFICE
CIVIL ENGINEERING DEPARTMENT
THE GOVERNMENT OF THE HONG KONG
SPECIAL ADMINISTRATIVE REGION**

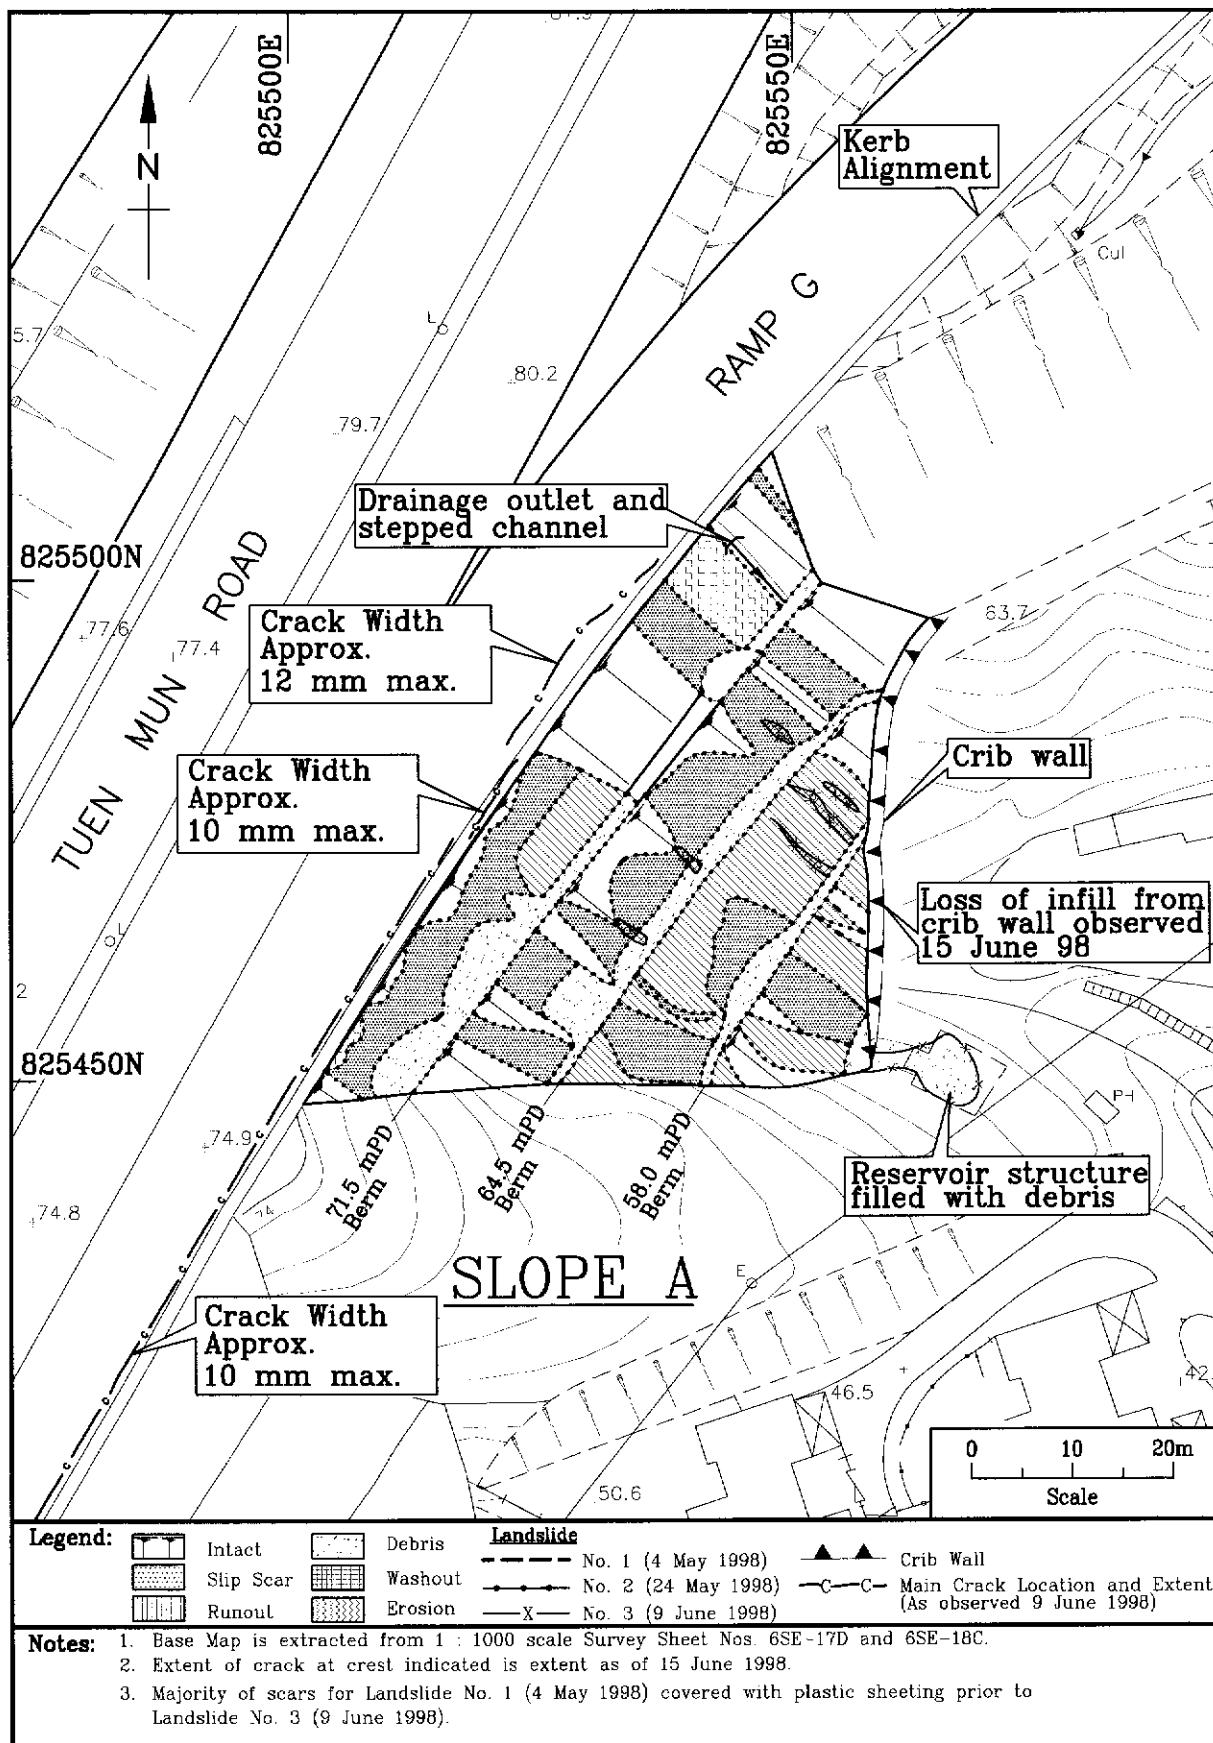
Figure 5 - Completed Formation (Slope A) Showing Observations after Failure

Failures occurred mainly in Slope A (Plate 19) with an estimated total volume of about 400 m³ (Figure 5). The mode of failure comprised shallow sliding along a surface of rupture about 0.3 m to 0.4 m below and parallel to the slope face (Figure 7).

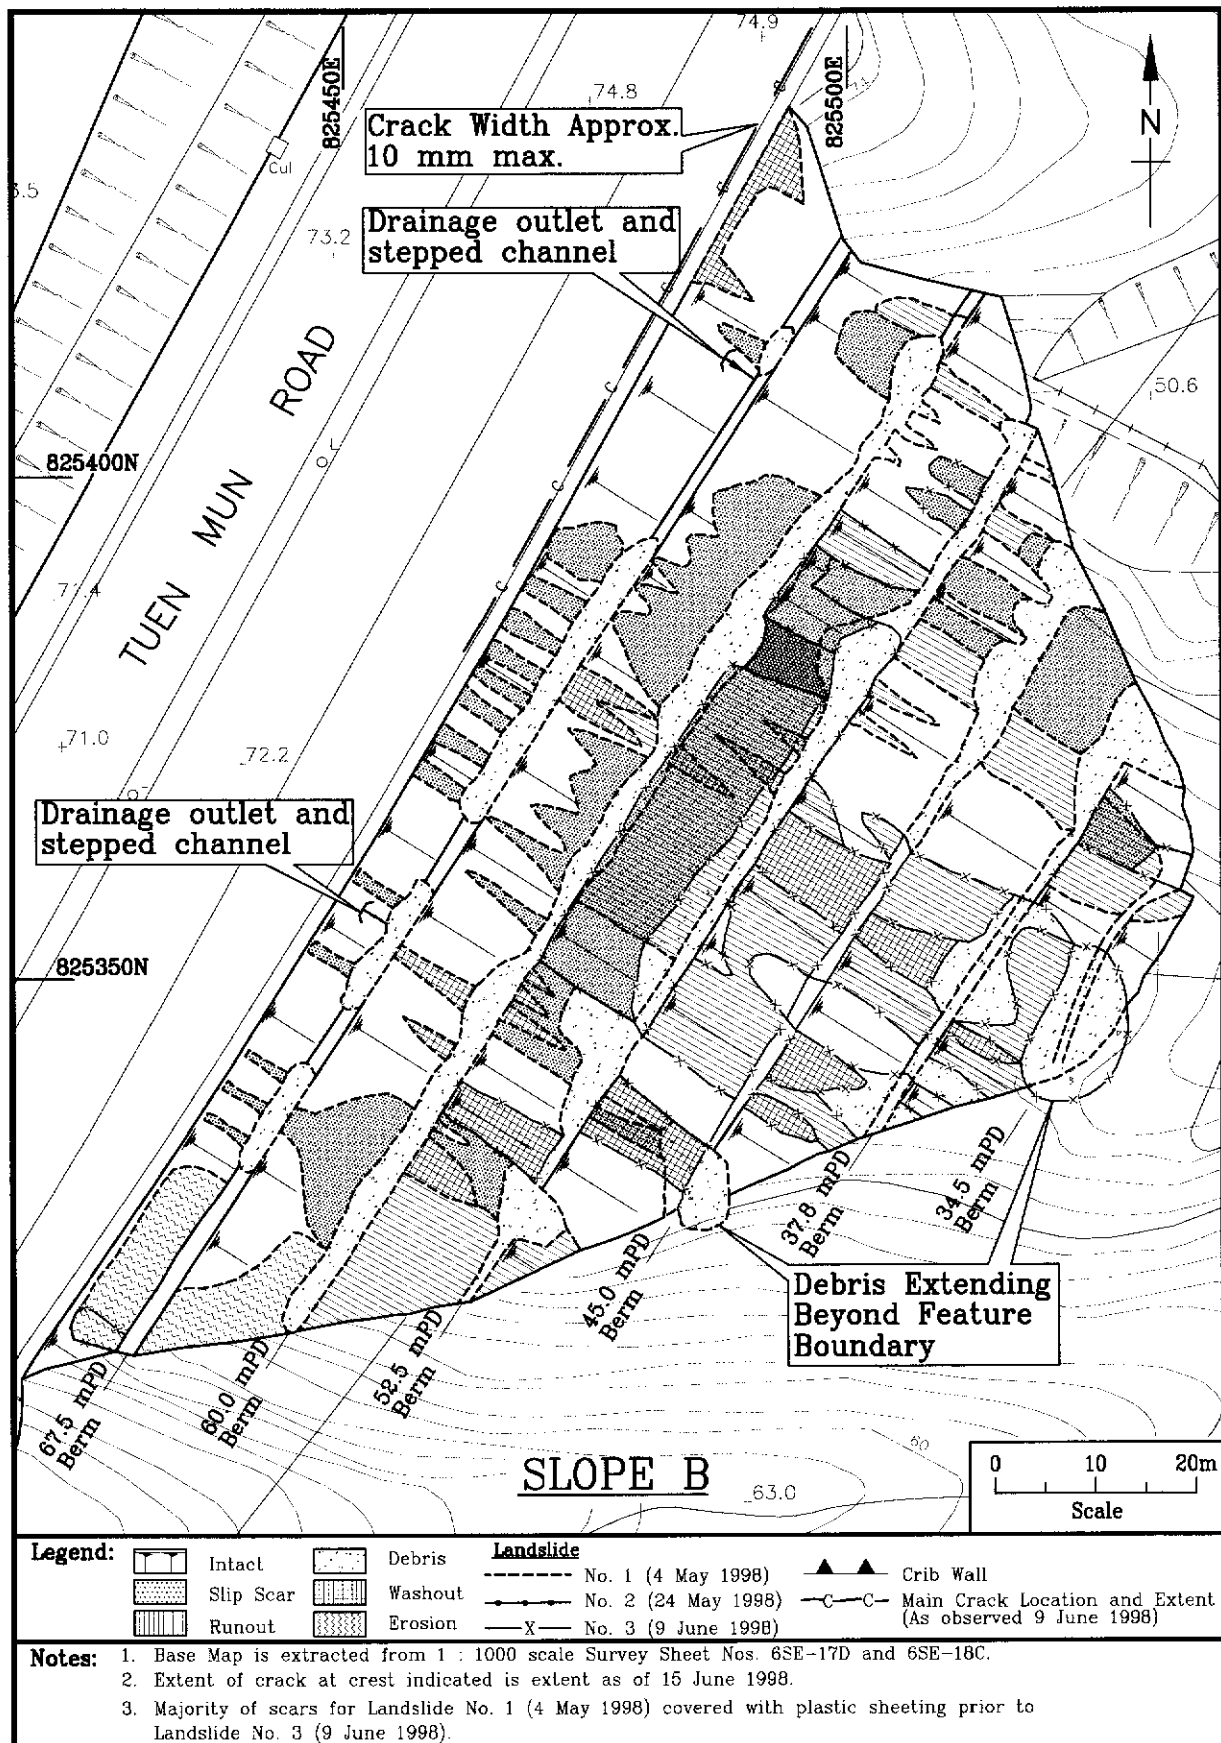
Figure 6 - Completed Formation (Slope B) Showing Observations after Failure

Failures occurred mainly in Slope B with an estimated failure volume of about 500 m³ (Figure 6 and Plates 6, 7 and 15). The individual landslide scars were generally confined to the batters (Figure 7). The surface of rupture was typically 0.3 m to 0.4 m below, and approximately parallel to, the slope face, with fairly well-defined sub-vertical flanks. The mode of failure involved principally a shallow planar slide of the near-surface material (Plates 8 to 11 and Plate 15). Secondary outwash was also observed at isolated locations (Plates 9 to 14).

The failures were generally limited to Slope B with an estimated combined volume of about 400 m³ and affected previously intact areas of the slope. The mapped extent of the failures and the condition of existing landslide features are indicated on Figure 6.

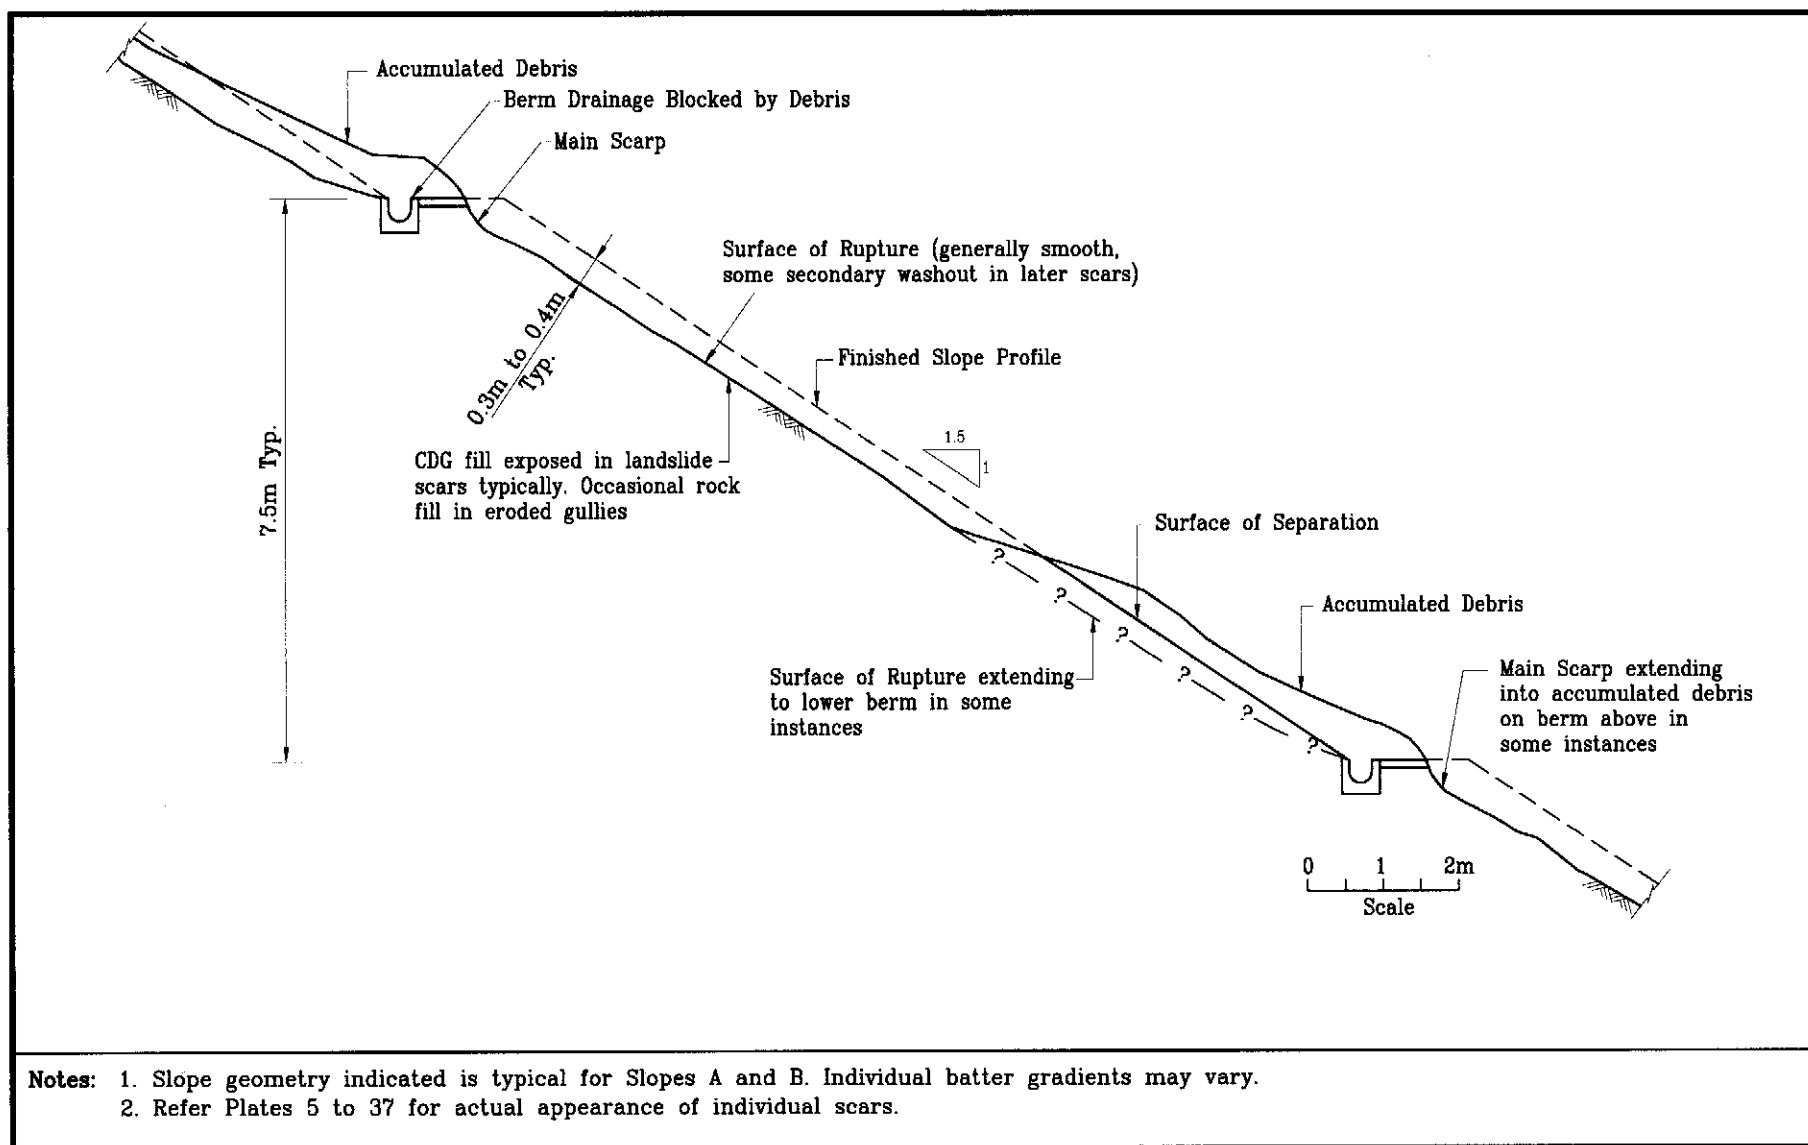
Figure 7 - Typical Section through Landslides

The mode of failure comprised shallow sliding along a surface of rupture located 0.3 m to 0.4 m below and parallel to the slope face (Figure 7 and Plate 25). Secondary outwash of the scars was observed, cutting sharp channels and exposing rock fill material beneath a thin (200 mm to 300 mm) layer of finer material (Plate 27). Debris runout extended

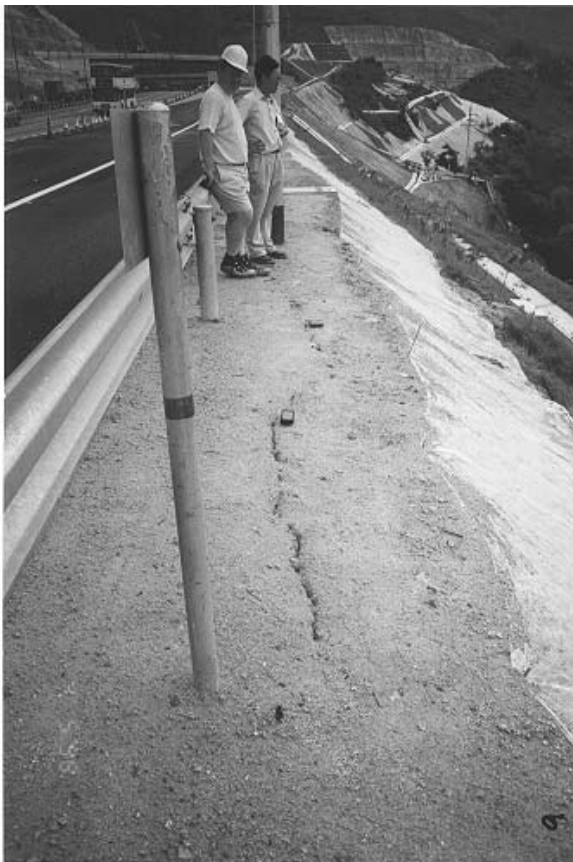
Following the landslides, cracking was observed at the crest of Slope B (Plate 5) and between the crest of the Slope A and the kerb (Plate 18). Separation between berm apron slabs and U-channels was also noted on Slope B (Plate 16).

Plate 5 - Event No. 1: 4 May 1998.
View North-East Along
Crest of Slope B Indicating
Tension Cracking South of
Road Drainage Outlet on
Slope (Outlet Visible on
Right of Frame).
(Photograph Taken on
4 May 1998)

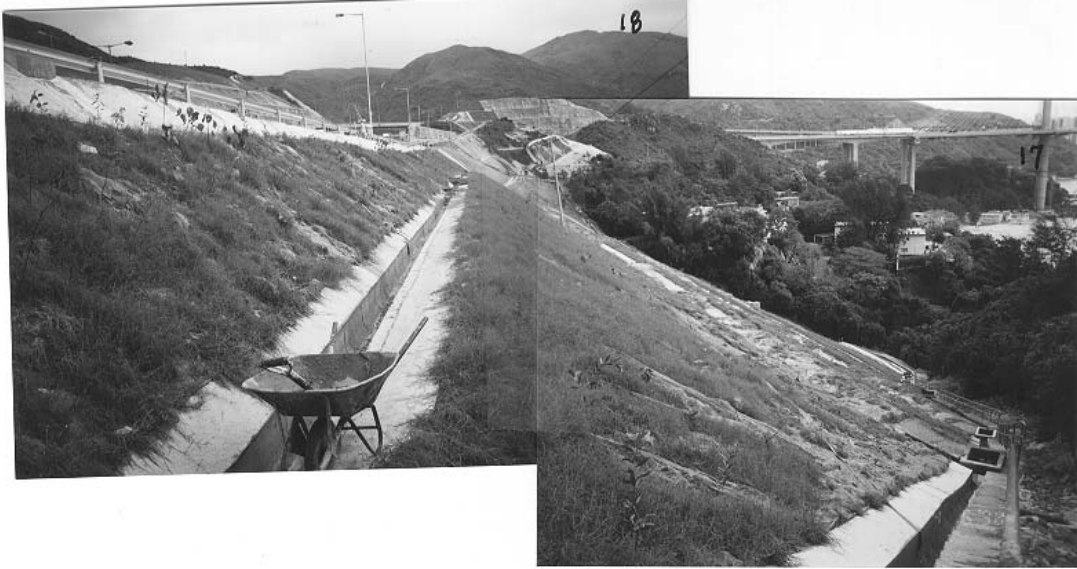
Plate 6 – Event No. 1: 4 May 1998. View North-East Along 67.5 mPD (Uppermost) Berm of Slope B and Lower Batters from Southern End of Slope. Note Extensive Blockage of 67.5 mPD Berm Drainage and Failed Areas of Slope on Right of Frame. (Photograph Taken on 4 May 1995)

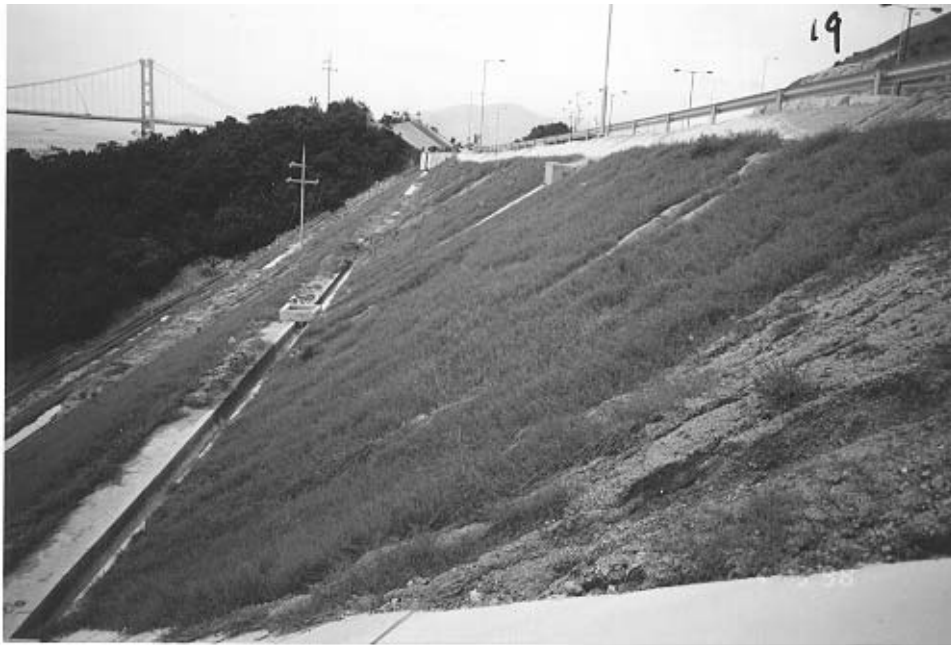
Plate 7 – Event No. 1: 4 May 1998. View South-West Along Upper Batter of Slope B and 67.5 mPD Berm from Northern End. Note Road Drainage Discharge into Slope Drainage in Middle-Ground and Debris from Landslides Blocking Berm Drainage Channel on Either Side of Catchpit. (Photograph taken on 4 May 1998)

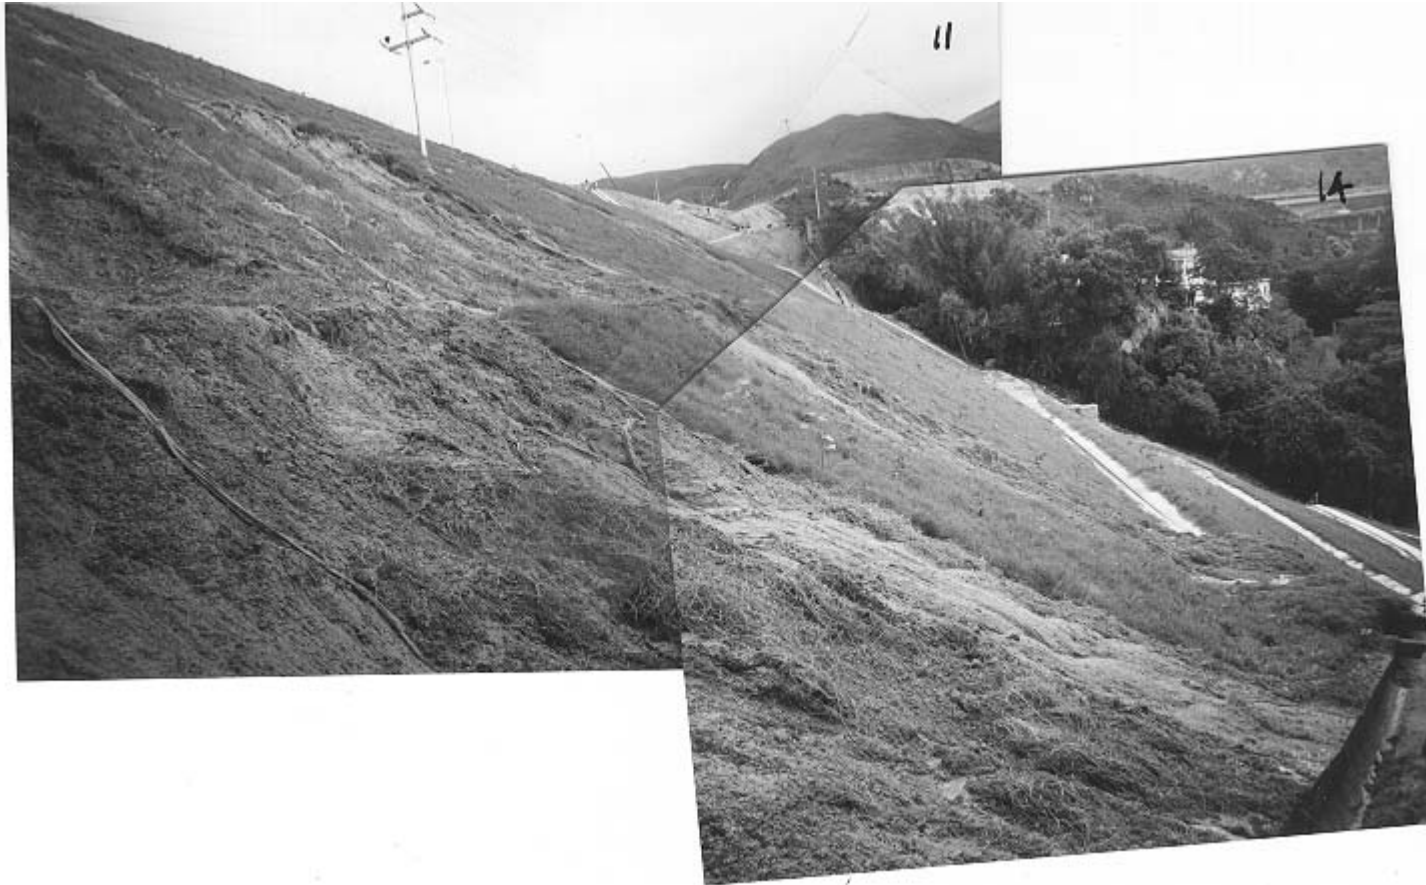
Plate 11 – Event No. 1: 4 May 1998. View North-East Along Batter Between 45 mPD and 52.5 mPD Berms from South End of Slope B. Note accumulated Debris in Foreground, with Scar Extending from Batter Above 52.5 mPD Berm to 45 mPD Berm and Debris Accumulation on Berm. (Photograph Taken on 4 May 1998)

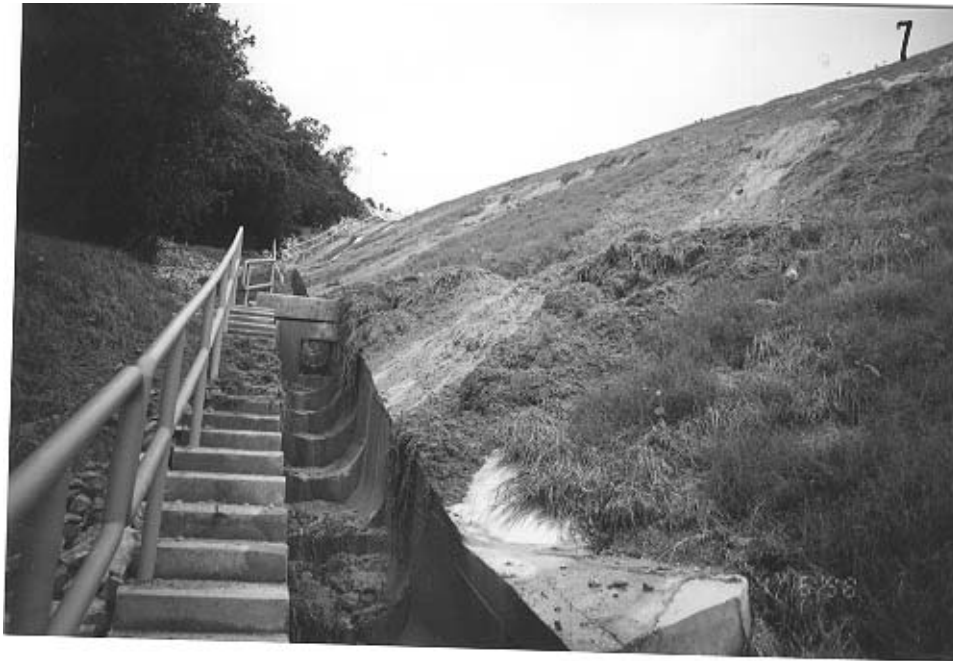
Plate 14 – Event No. 1: 4 May 1998. View West Along Perimeter Drainage at South End of Slope B from Outlet of Culvert No. P044 Below 45 mPD Berm (Berm is Level with Catchpit). Note Scars and Debris Runout and Deposition on Batters Above. (Photograph Taken on 4 May 1998).

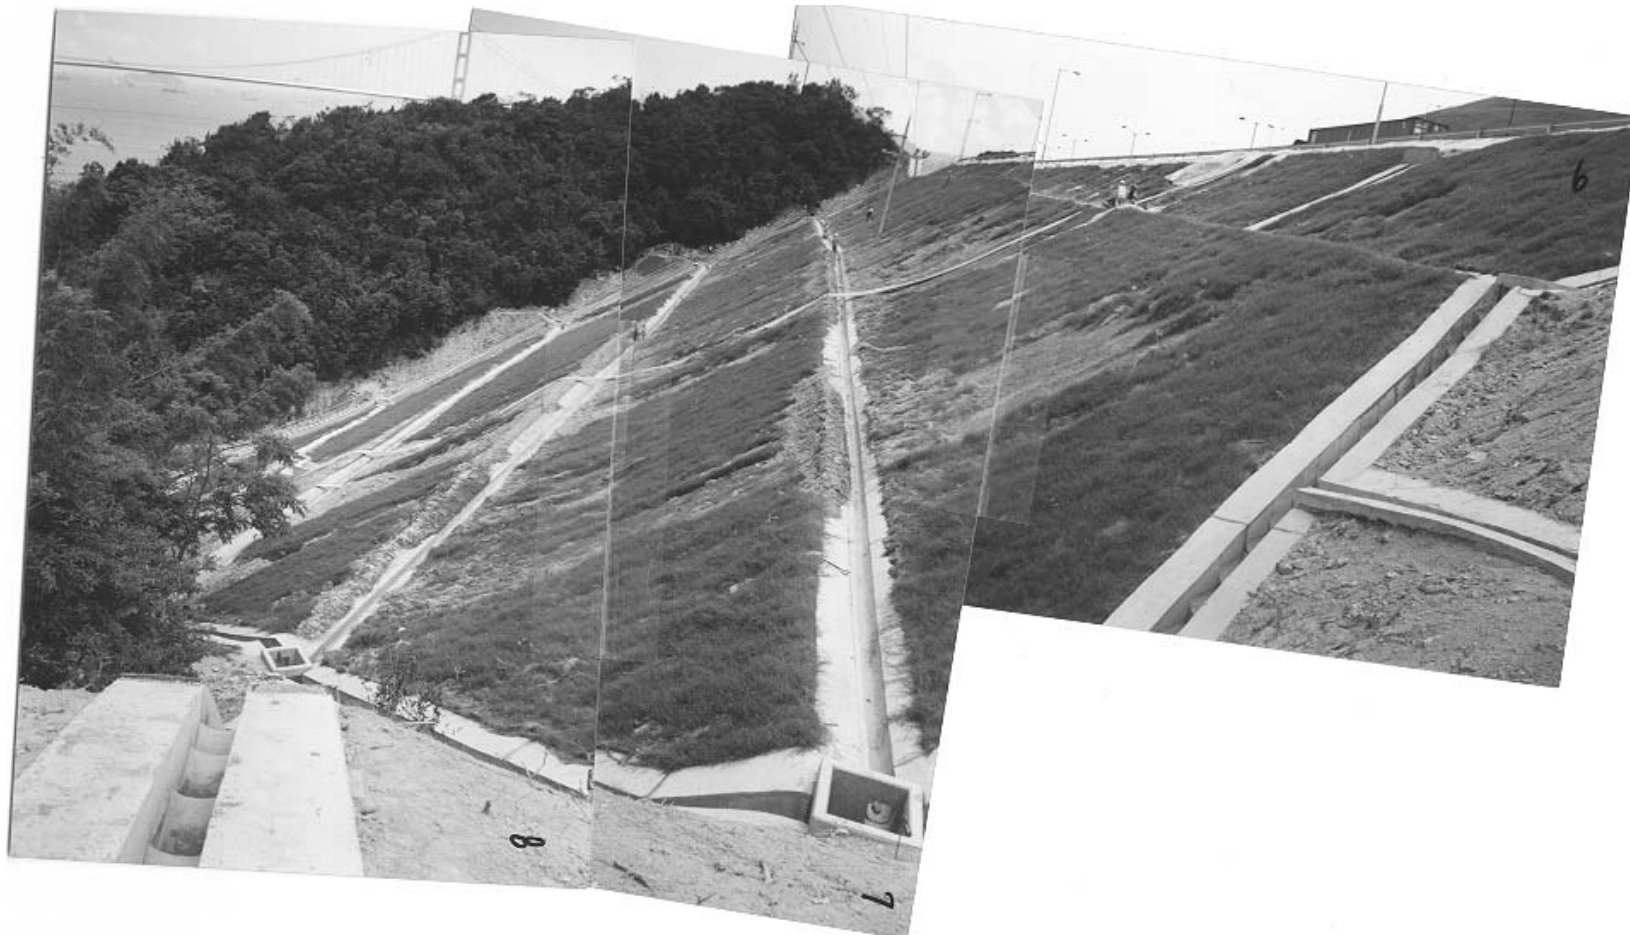
Plate 15 – Event No. 1: 4 May 1998. View South-West Across Slope B from Natural Spur Separating Slopes A and B. 60 mPD Berm in Centre of Frame. Note Extent of Scars in Slope Face. Note also Clearance of Berm Channels and Stock piling of Debris on Berm Apron. (Photographs Taken on 8 May 1998)

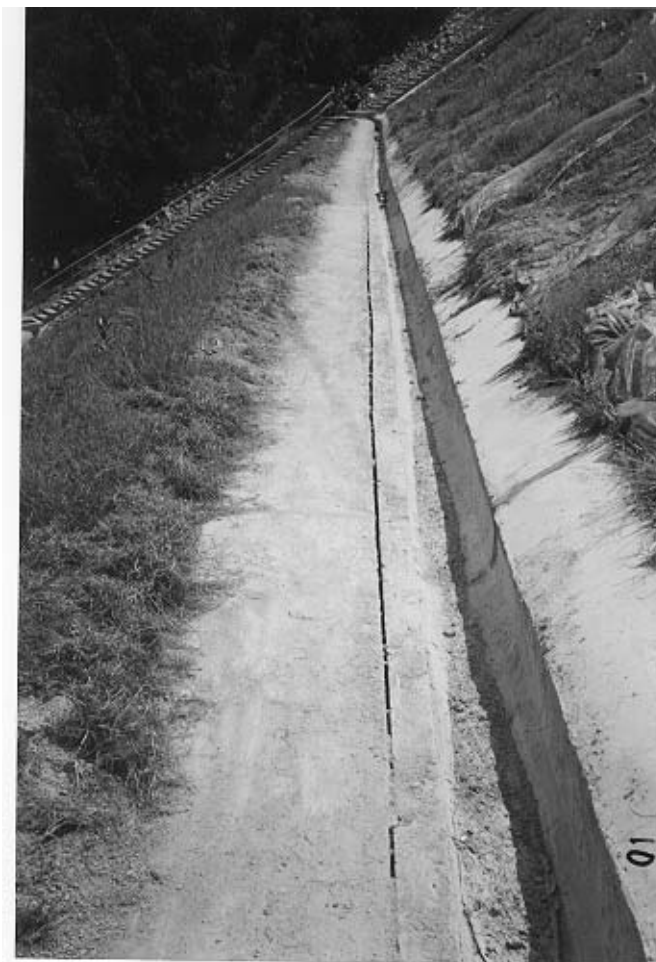
Plate 16 – Event No. 1: 4 May 1998. View South-West Along 60 mPD Berm Towards South End of Slope B. Note Separation of Apron Slab from Berm U-Channel. (Photograph Taken on 8 May 1998)

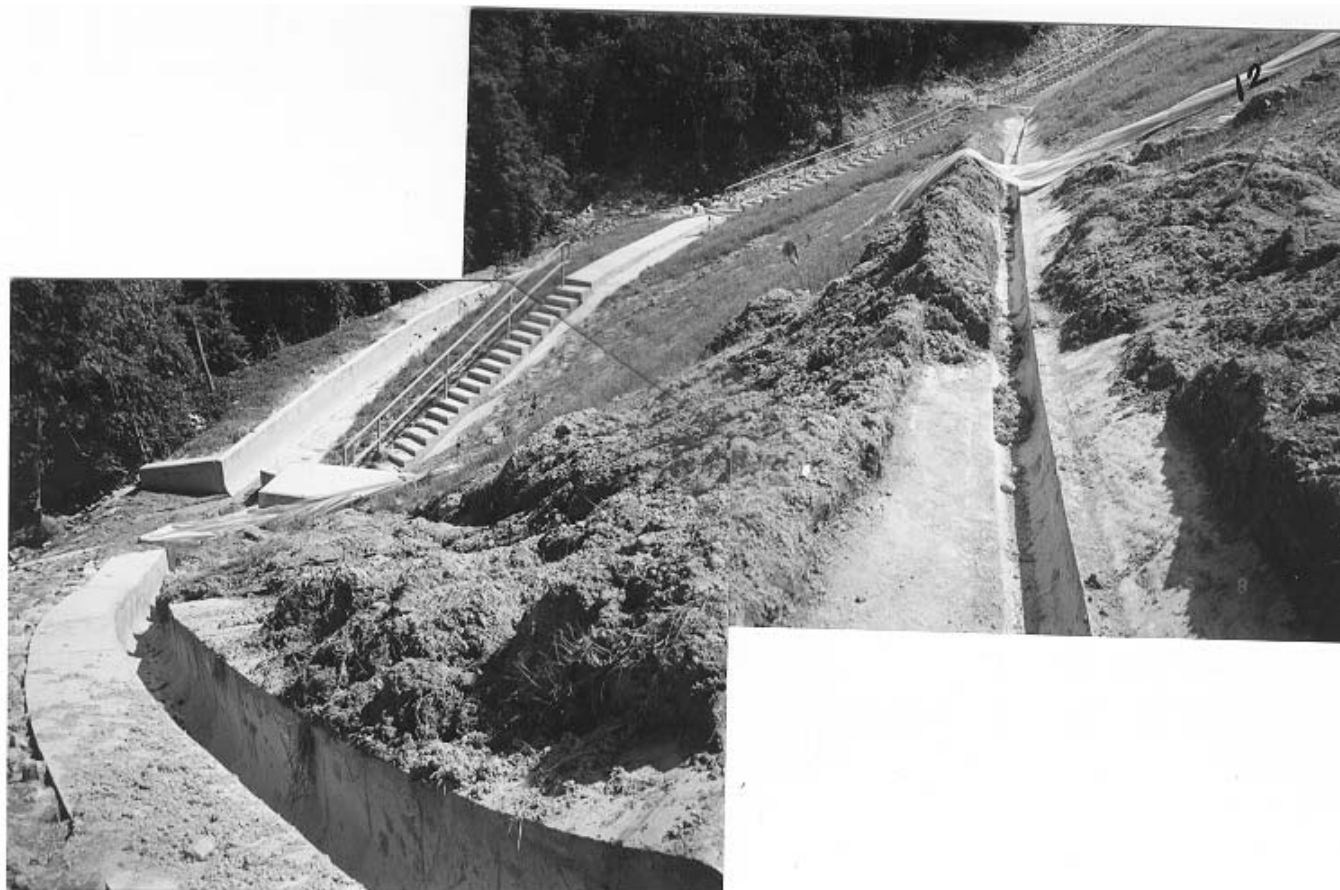
Debris from the landslides was deposited on berms, blocking the berm channels, and in many cases flowed down onto the batter below (Plates 10, 13 and 17). The debris comprised material of a silt/sand particle size and was in a relatively wet state (Plates 8, 9 and 11) immediately following failure. In some instances (Plate 9) the hydroseeding, although disturbed, gives the appearance of debris having moved down-slope as discrete units or slabs. The travel angle of the debris (Wong & Ho, 1996) was about 33°, which is within the typical range for rain-induced sliding failures of fill slopes.

Plate 17 - Event No. 1: 4 May 1998. View South-West Along 37.5 mPD Berm Towards South End of Slope B Indicating Debris Deposition on Slope Face. Clearance of Berm Drainage in Progress. Note Also Apparent Runout Over Batter Below Berm in Middle Distance Indicated by Flattened Hydroseeding. Outlet for Culvert P043 Visible at Toe of Slope on Left of Frame. (Photograph Taken on 8 May 1998)

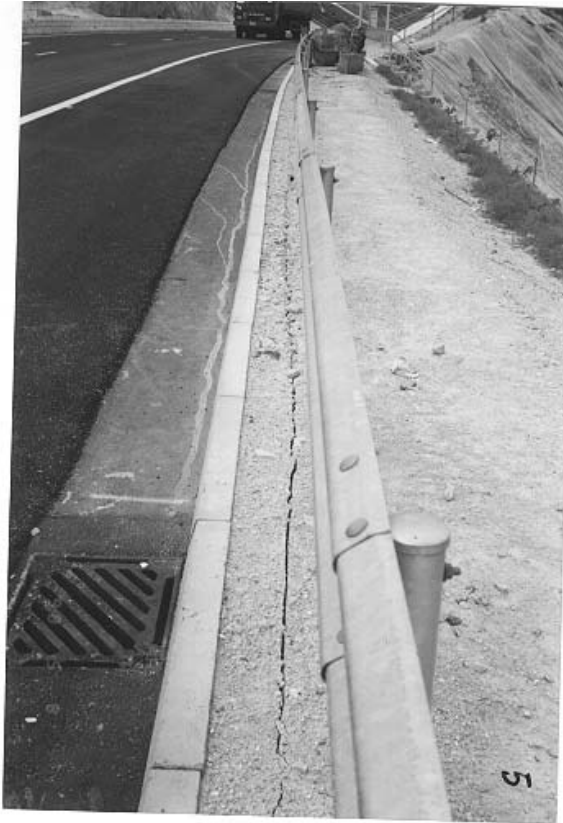
Plate 18 – Event No. 1: 4 May 1998.
View North-East Along
Crest of Slope A
Indicating Cracking
Behind Kerb Beam.
(Photograph Taken on 8
May 1998)

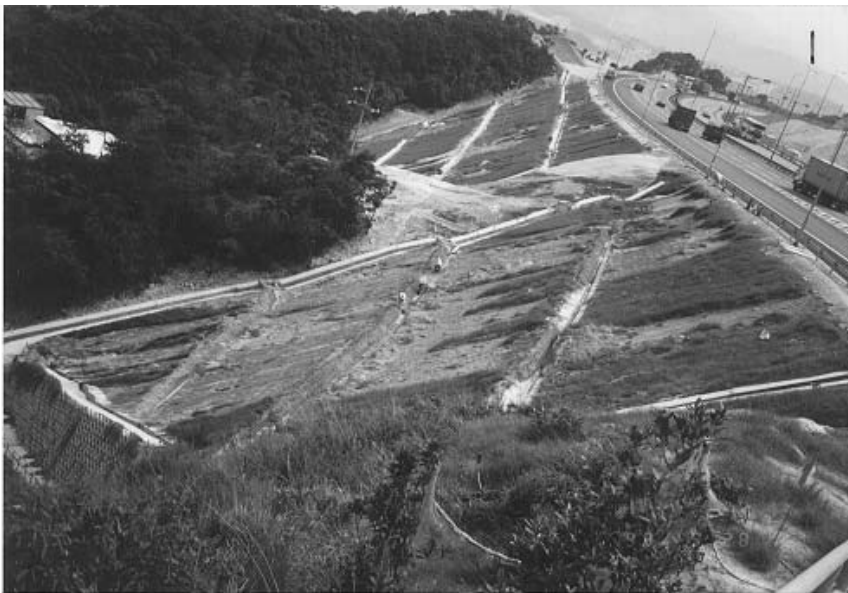
Plate 19 – Event No. 2: 24 May 1998. View South-West Across Slope A and Slope B, Indicating Extensive Failure in Upper Two Batters of Slope A, with Runout of Debris and Additional Failures on Third and Fourth Batters (Below 64.5 mPD and 58 mPD Berms, Respectively). Clearance of Berm Drainage Channels Underway. Note Stockpiling of Debris on Berm Aprons. Note Also Little Change to Appearance of Slope B Since 8 May 1998 (Refer Plate 15). (Photograph Taken on 28 May 1998)

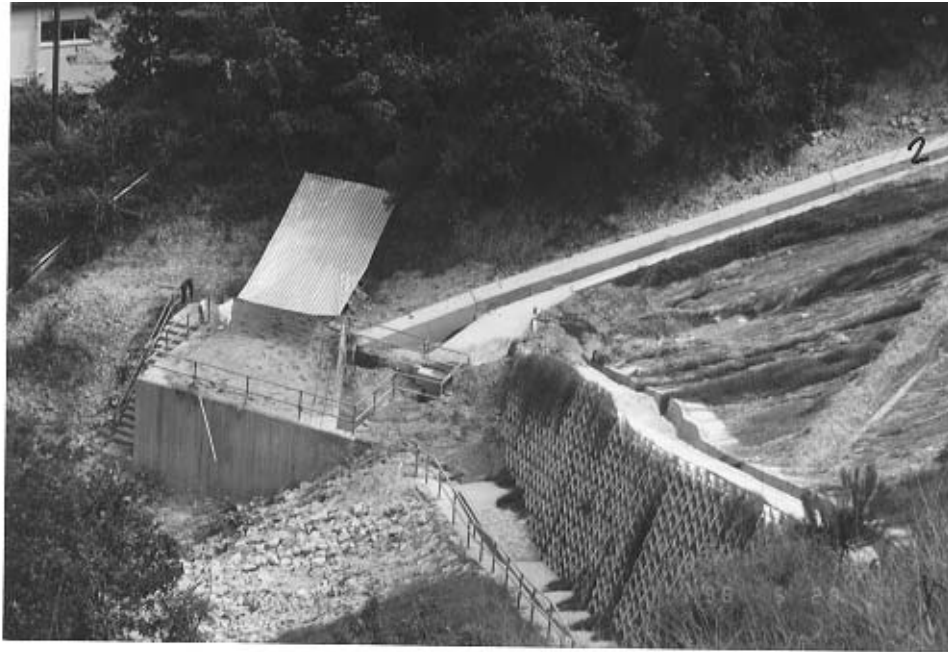
Debris from the landslides comprised essentially fine material deposited on berms, blocking the berm channels, and in many cases flowed down onto the batters below. A succession of scars/runouts was observed over almost the full height of the slope. The debris deposition zone extended beyond the toe of the slope (Plate 20), with a travel angle of about 33°.

The photographic records suggest that the cribwall at the toe of Slope A (Plates 20 & 22) was not significantly affected by the landslides, when compared to the initial condition (Plate 49), except for the undermining of the access stairway at the toe of the wall (Plate 23).

Plate 20 – Event No. 2: 24 May 1998. View South Towards Toe of Slope A Indicating Debris Deposition on Slope Face, with Over-spill onto Concrete Apron at Toe of Crib Wall and Reservoir Structure. (Photograph Taken on 28 May 1998)

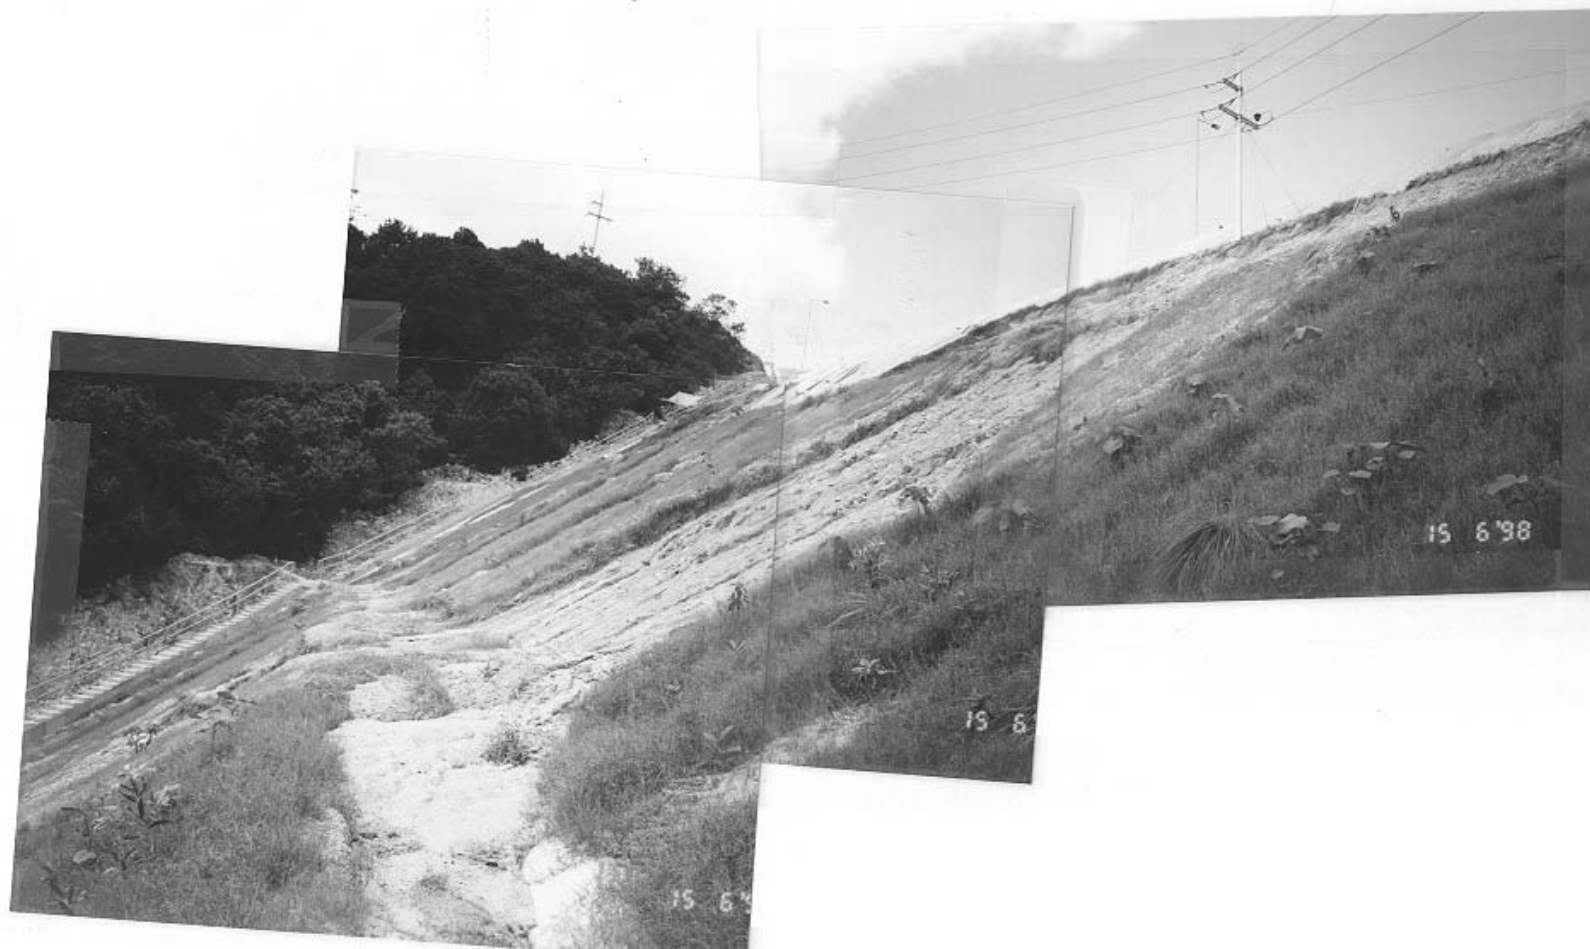
The landslides generally occurred in the third batter (52 mPD to 60 mPD) below the slope crest (Plate 25) with an approximately 30 m wide progression of failures and debris runout in lower batters to the slope toe from the 52.5 mPD berm (Plate 26). A failure was also noted at the northern end of the slope below the 37.5 mPD berm (Plate 28).

Plate 25 – Event No. 3: 9 June 1998. View South-West Along 45 mPD Berm on Slope B Indicating New Failures in Slope B Affecting Batter Above 52.5 mPD Berm (Right of Frame). Note Debris Over-Spill onto Batter Below 45 mPD Berm and Blockage of Berm Drainage. (Photograph Taken on 15 June 1998)

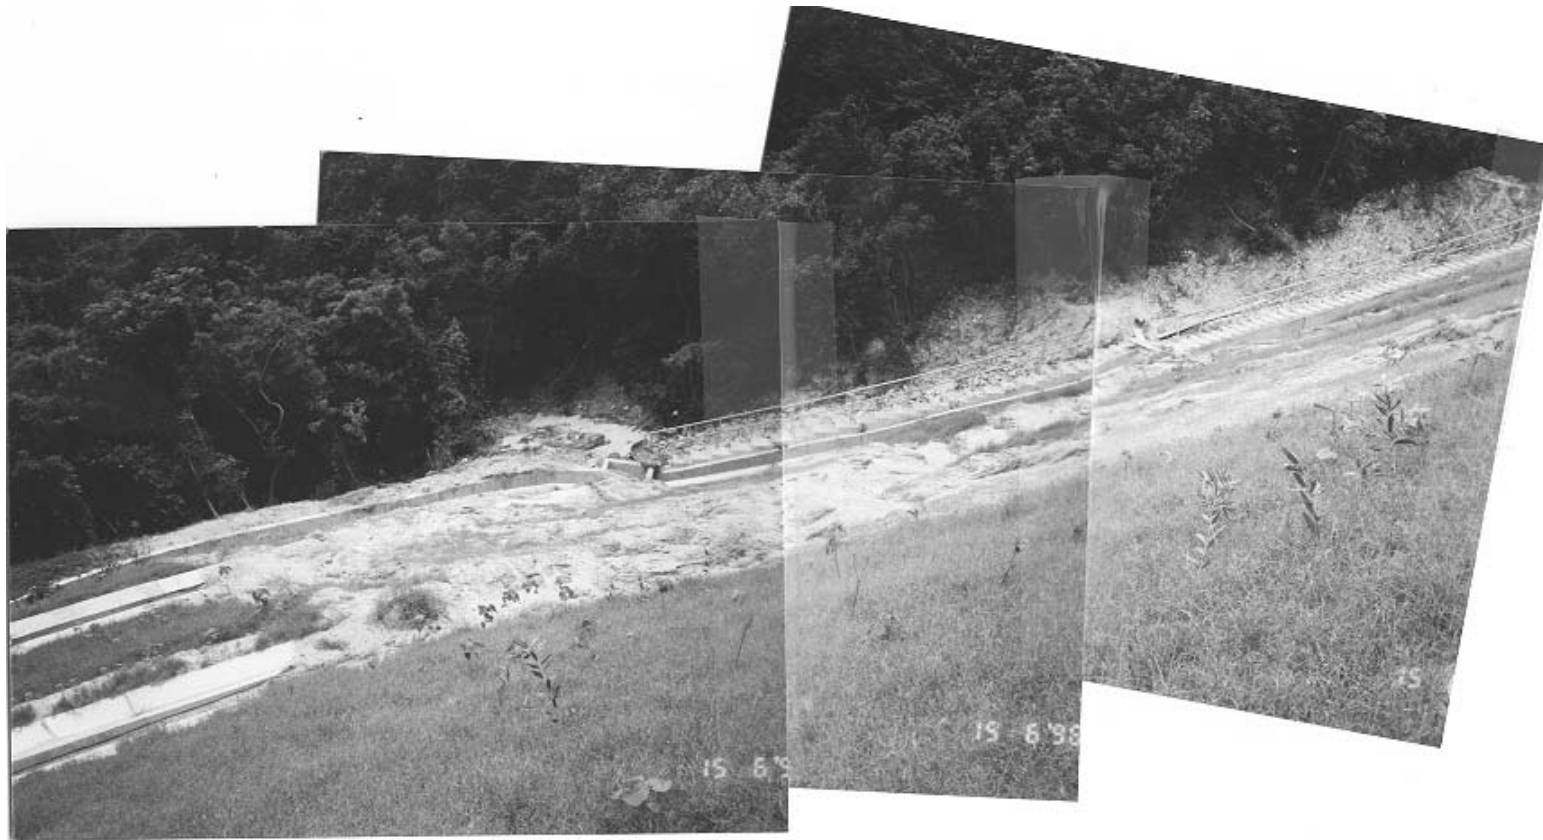
Plate 26 – Event No. 3: 9 June 1998. View South from 45 mPD Berm on Slope B Indicating Debris Runout from New Failure in Batter Above 37.5 mPD Berm to Batter Below and Beyond Toe of Slope. (Photograph Taken on 15 June 1998)

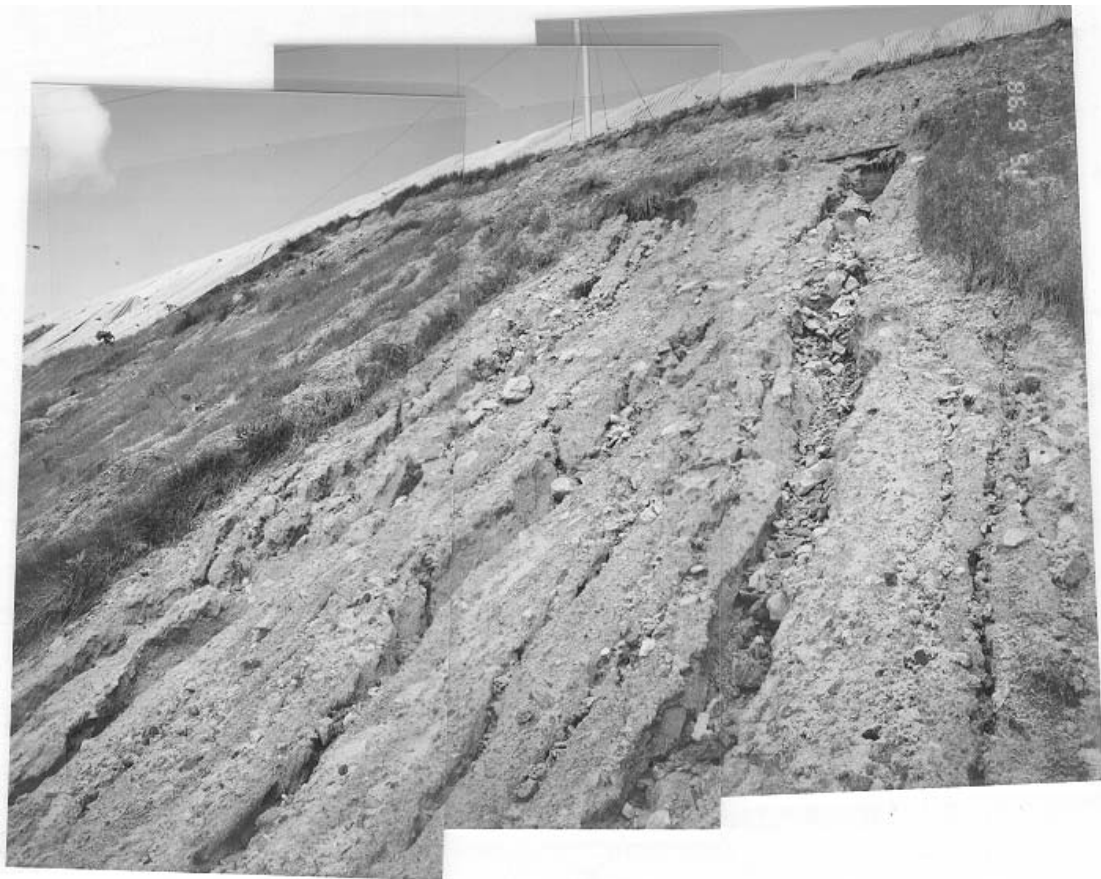
Plate 27 – Event No. 3: 9 June 1998. View Towards Crest of Slope B From 45 mPD Berm Indicating Scars of New Failures. Note Secondary Washout of Scars Exposing Rock Fill Beneath. (Photograph Taken on 15 June 1998)

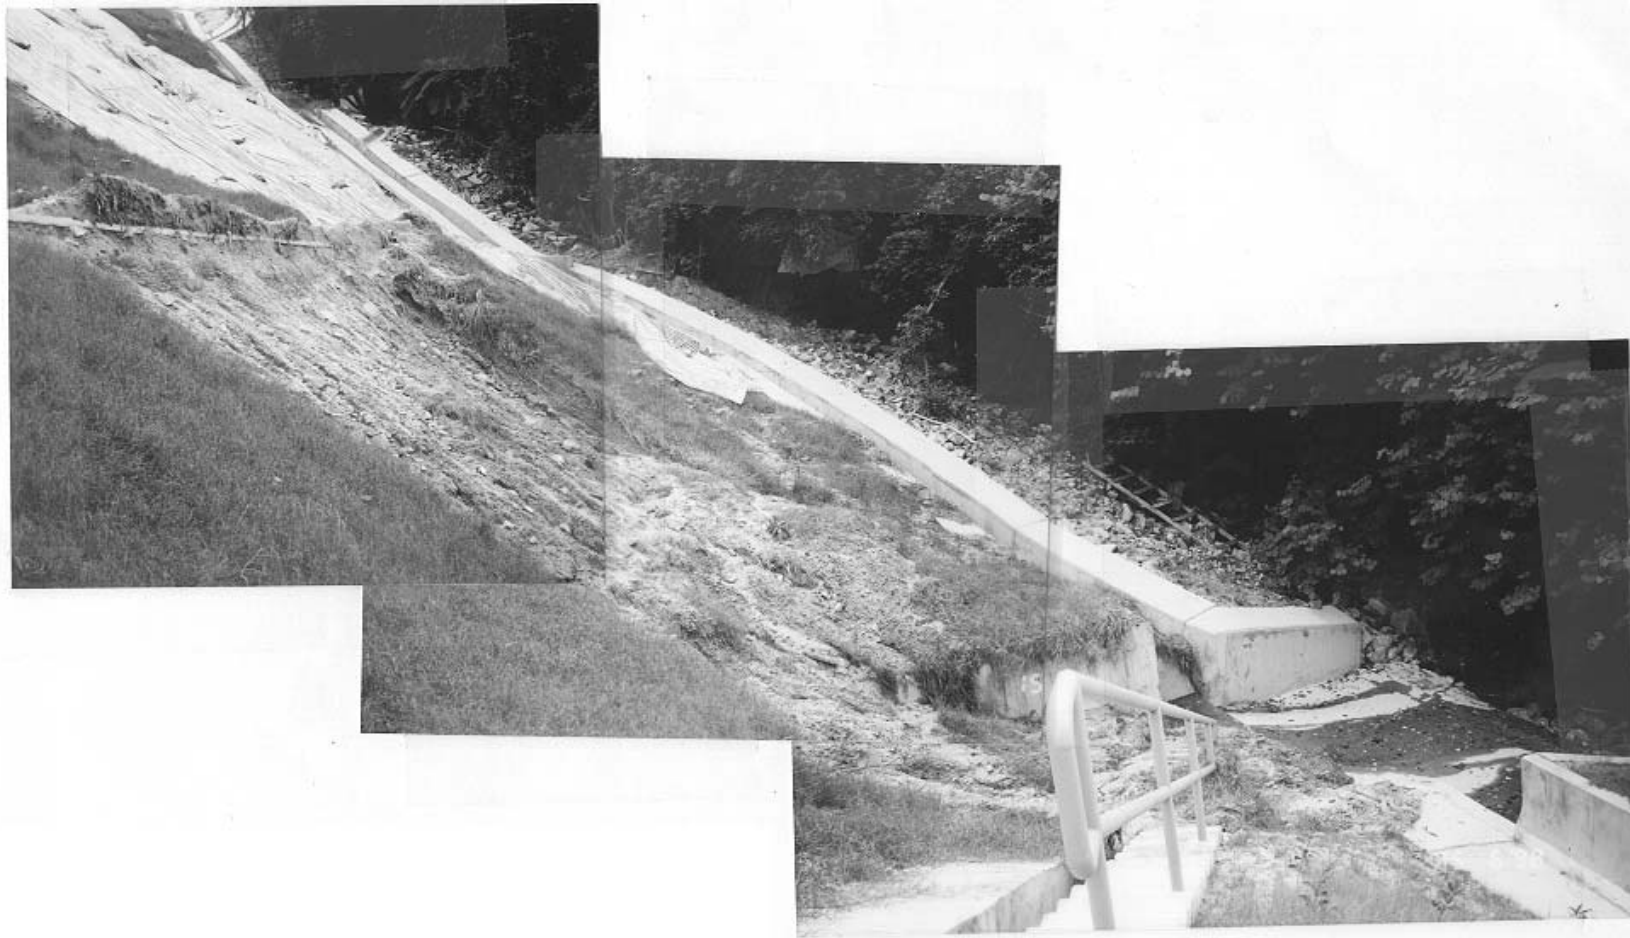
Plate 28 – Event No. 3: 9 June 1998. View North from 34.5 mPD Berm Towards New Failure in Batter Below 37.5 mPD Berm.
Note Rock Fill Exposed in Scar and Main Scarp in Debris on Berm. (Photograph Taken on 15 June 1998)
