INVESTIGATION OF SOME SELECTED LANDSLIDES IN 1998 (VOLUME 7)

GEO REPORT No. 114

Fugro Scott Wilson Joint Venture

**GEOTECHNICAL ENGINEERING OFFICE
CIVIL ENGINEERING DEPARTMENT
THE GOVERNMENT OF THE HONG KONG
SPECIAL ADMINISTRATIVE REGION**

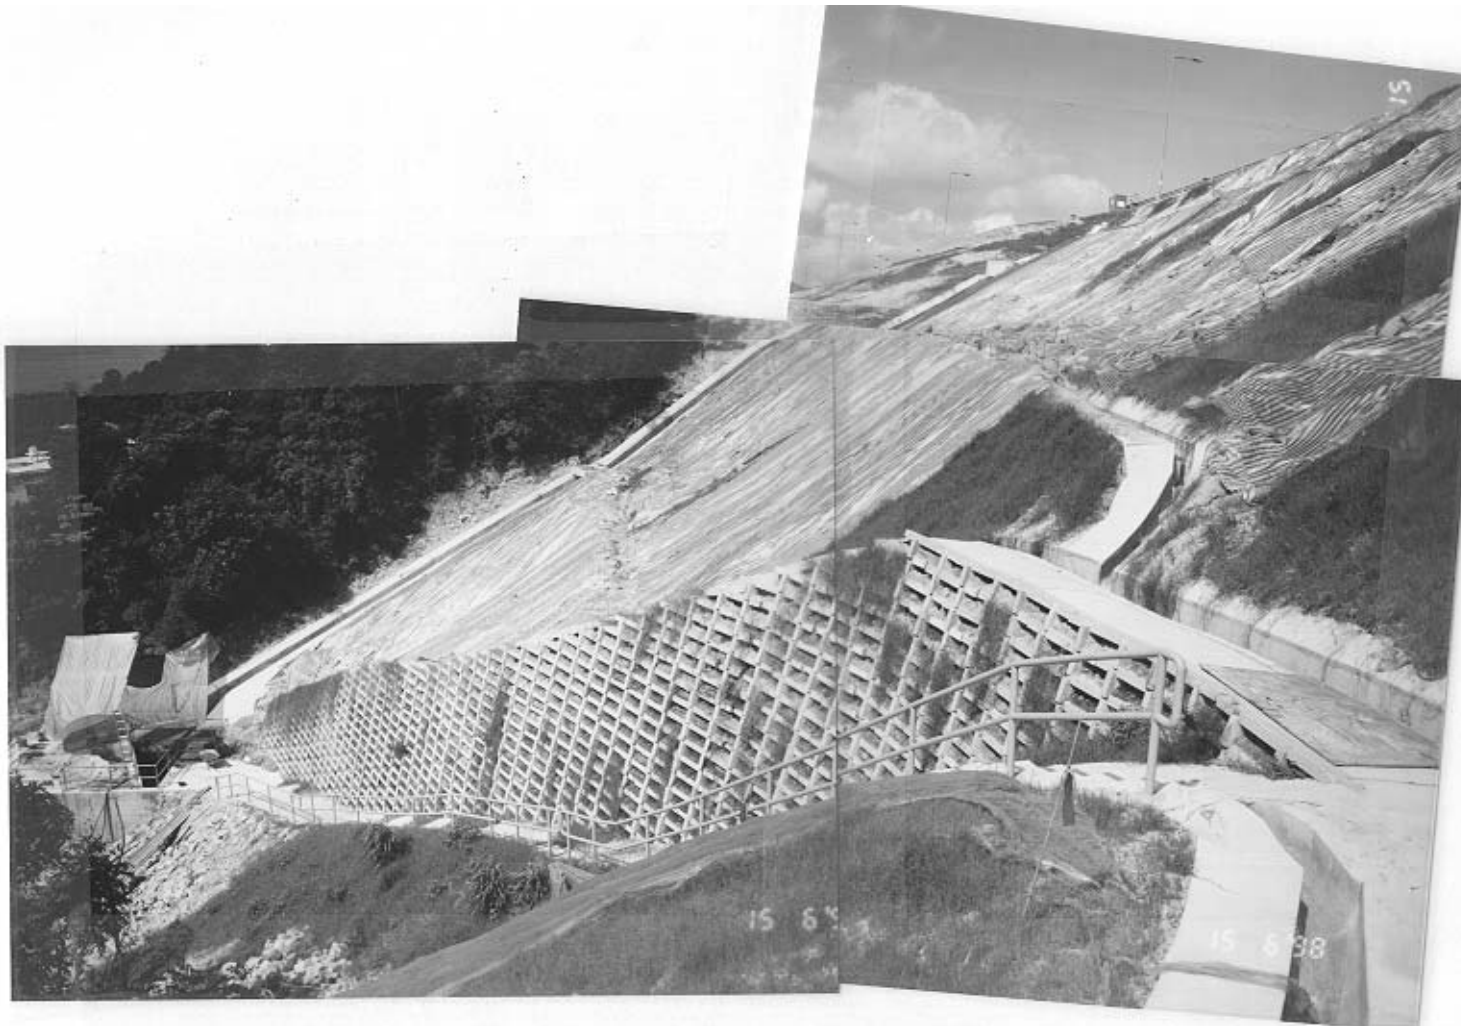
Plate 29 – Event No. 3: 9 June 1998. View South-West Across Slope A. Note Extensive Coverage of Slope Face with Plastic Sheeting and only Minor Washout of Debris at Joins in Sheeting. Note Also Blocked Drainage on 58 mPD Berm in Centre of Frame. (Photograph Taken on 15 June 1998)

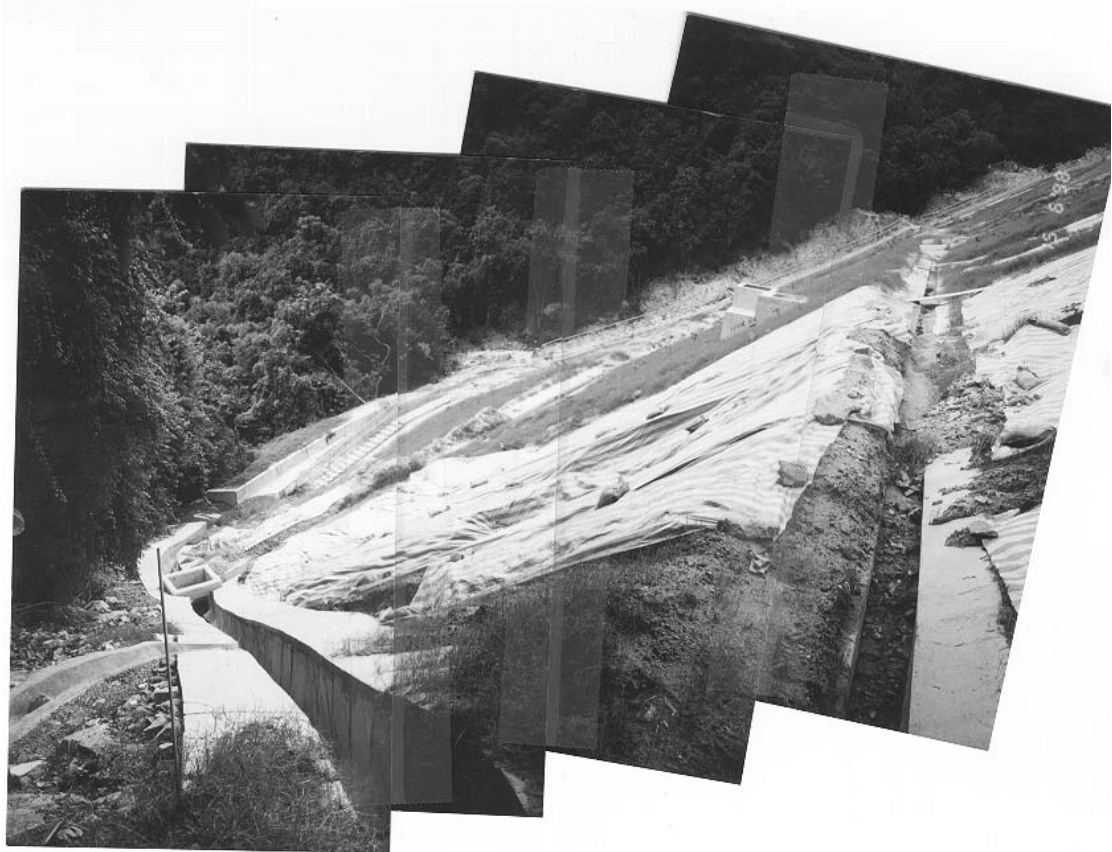
Plate 33 – Event No. 3: 9 June 1998. View South Across Lower Portion of Slope B from 45 mPD. Note Blockage of Surface Drainage by Debris Stockpiled on Berms and Debris from New Failure in Batter Above 37 mPD Berm in Distance. (Photograph Taken on 15 June 1998)

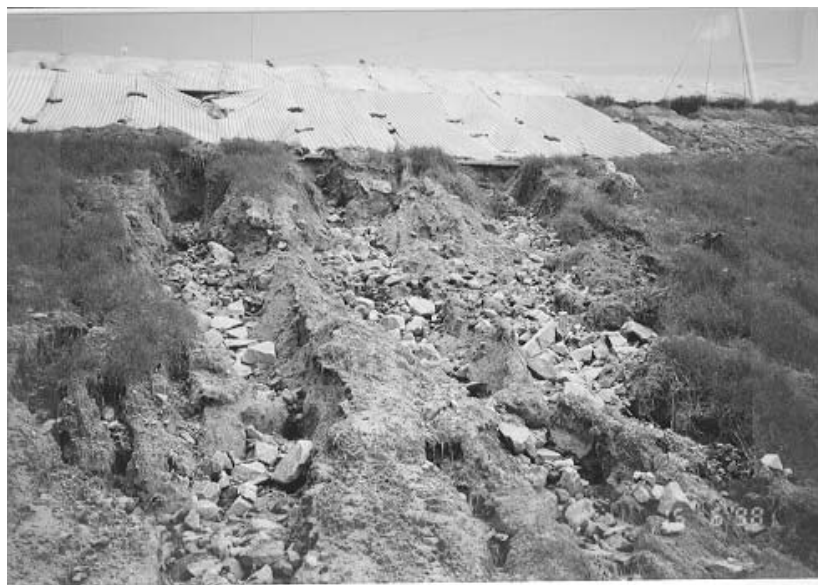
Plate 34 – Event No. 3: 9 June 1998. View Towards Crest of Slope B From 45 mPD Berm Indicating Secondary Washout of Existing Scar. Note Plastic Sheetting on Slope Above and Thin Layer of Rock Fill Exposed Beneath DG Fill, with Existing Fill Visible Behind Rock Fill. (Photograph Taken on 15 June 1998)

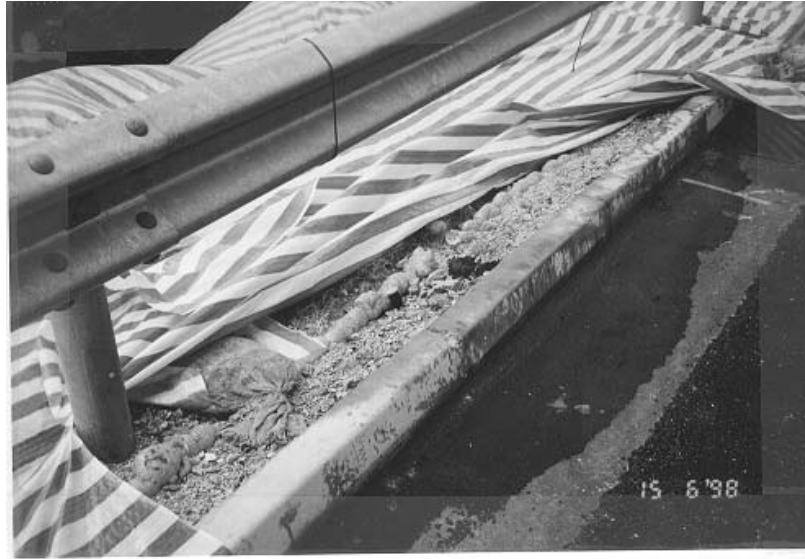
Plate 36 – Event No. 3: 9 June 1998. Close-up of Filled Cracking Behind Kerb Beam Approximately Mid-Way Along Crest of Slope A. Note Also, Separation of Kerb Beam from Pavement. (Photograph Taken on 15 June 1998)

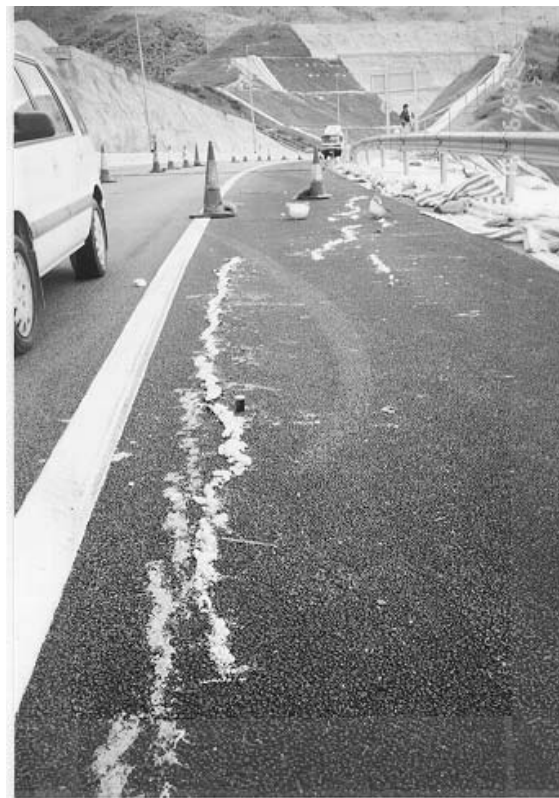
Plate 37 – Event No. 3: 9 June 1998. View North-East Along Hard Shoulder at Crest of Slope A Approximately 35 m from North End Indicating Cracking in Pavement. Cracking Filled with Expanding Foam. (Photograph Taken on 15 June 1998)

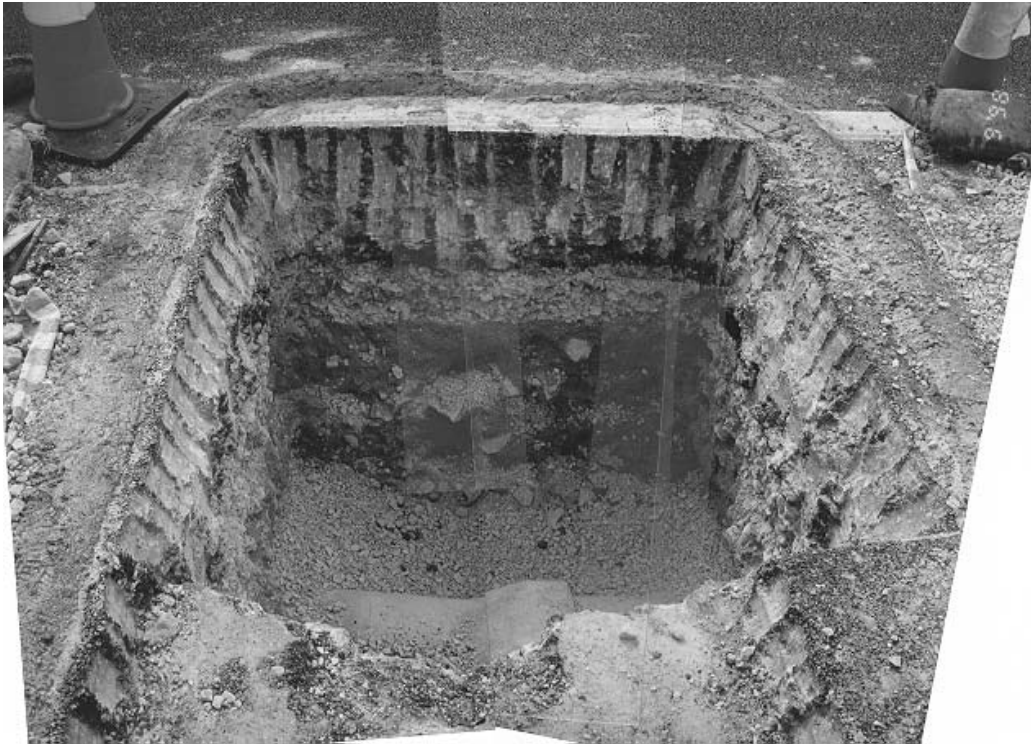
Plate 38 – Trial Pit ATP1 Excavation at Crest of Slope A. Note Line of Cracking Across Far Side of Pit Indicated by Yellow Foam on Either Side. Pavement Layers and Stormwater Drain Exposed in Pit. (Photograph Taken on 9 July 1998).

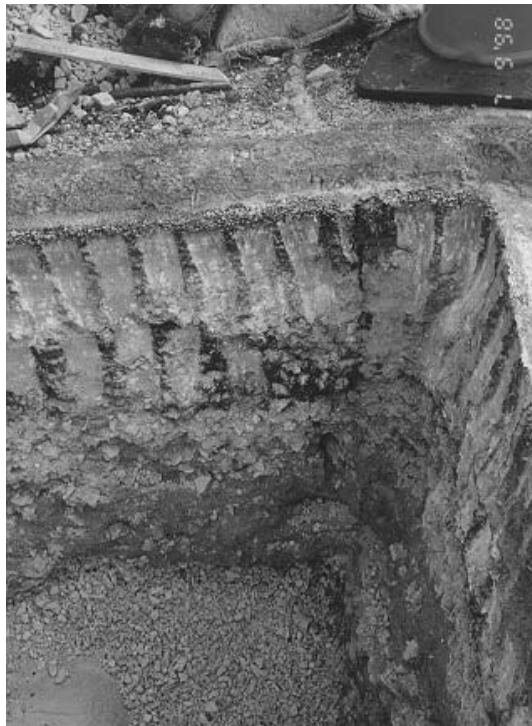
Plate 39 – Close-Up of Cracking Extending Vertically Beyond Base of Trial Pit ATP1. (Photograph Taken on 9 July 1998)
