**SECTION 2 :
DETAILED STUDY OF
THE LANDSLIDE AT
FUNG SHING STREET,
NGAU CHI WAN,
KWUN TONG ON 9 JUNE 1998**

Fugro Scott Wilson Joint Venture

**This report was originally produced in December 1999
as GEO Landslide Study Report No. LSR 21/99**

This report presents the findings of a detailed study of the landslide (GEO Incident No. K 98/6/1) that occurred within fill slope No. 11NE-A/F116 at Fung Shing Street, Ngau Chi Wan, Kwun Tong on 9 June 1998. An approximately 15 m length of this fill slope adjacent to Fung Shing Street failed resulting in the release of about 250 m³ of debris. The debris inundated a wooden watchmen's hut at the toe of the slope before continuing onto Fung Shing Street and partially blocking the northbound lane of the road. The subsequent alluvial outwash from the landslide debris travelled a further 250 m or so down Fung Shing Street towards its junction with Clear Water Bay Road. No fatalities or injuries were reported following the landslide.

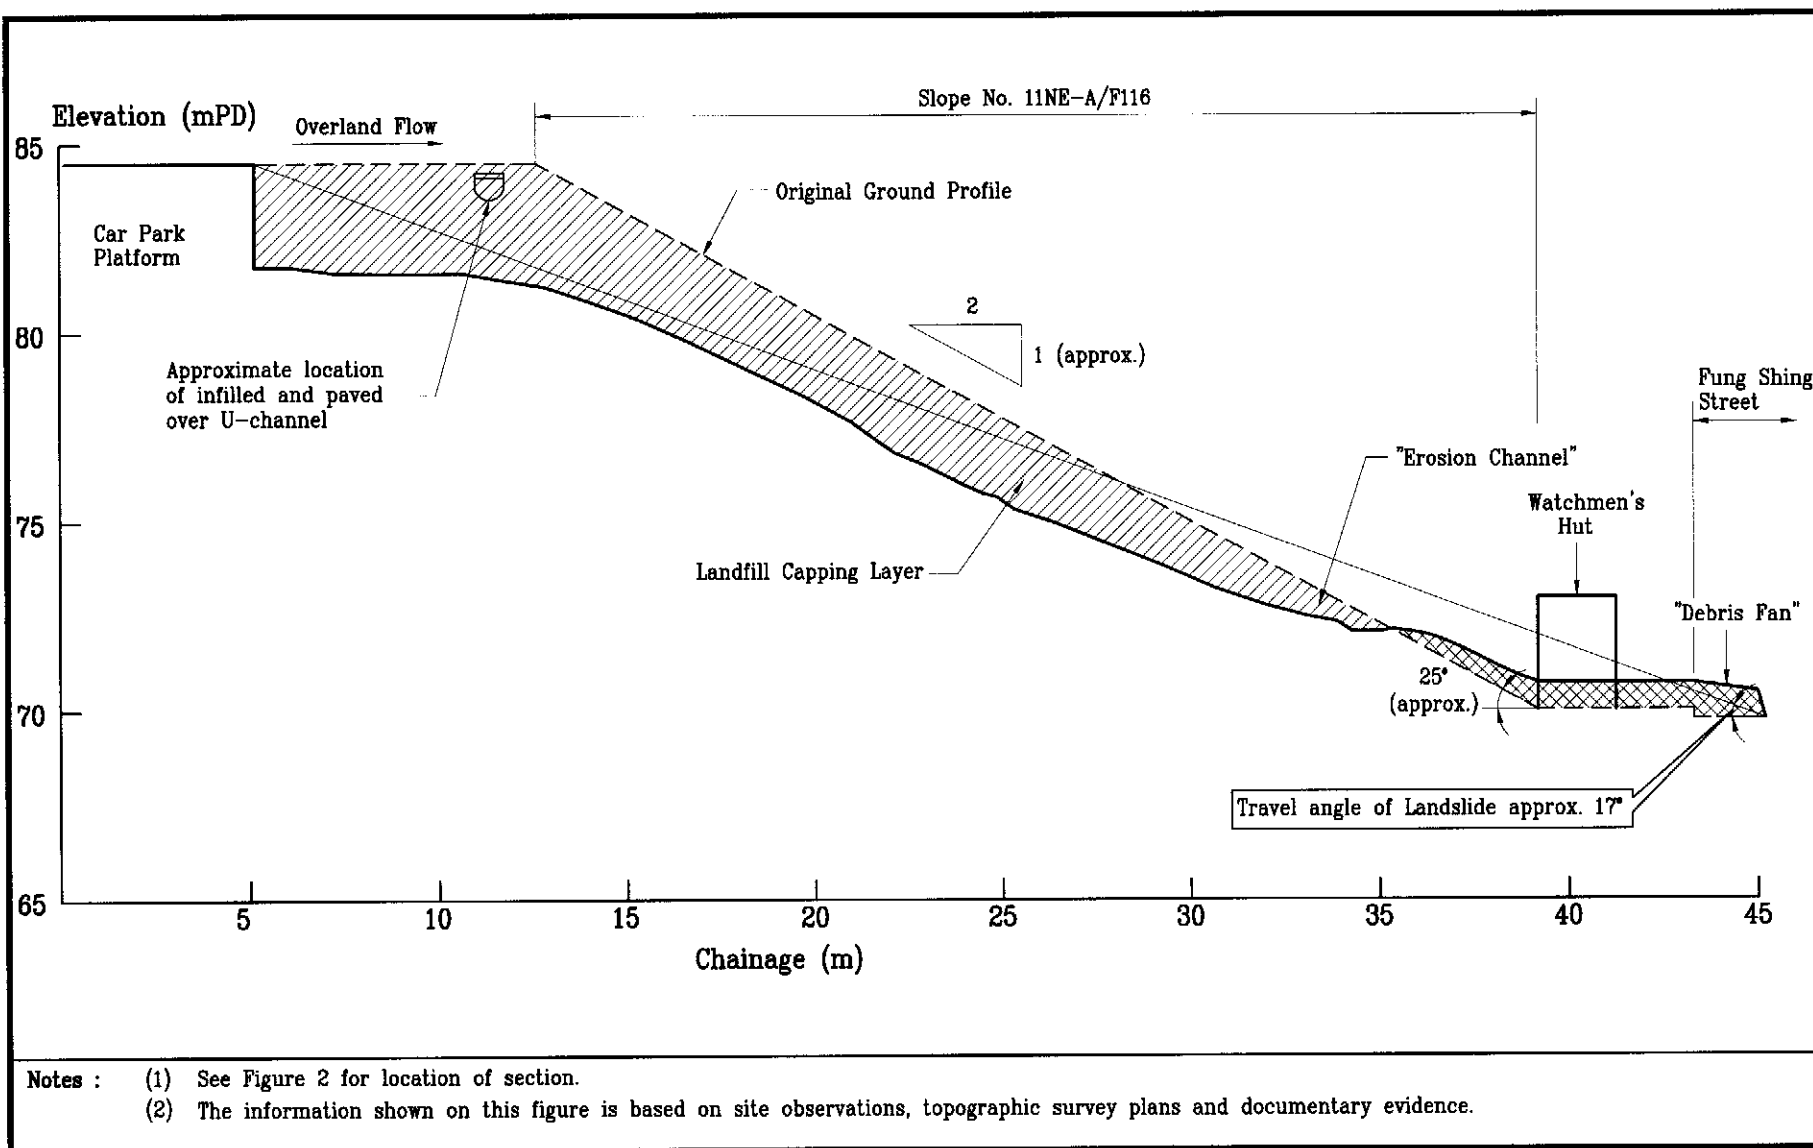
Figure 8 - Section A-A Through the Landslide

A plan of the landslide is shown in Figure 2 whilst a section through the failed part of the slope, based on the results of field examination and topographical survey plans, is shown in Figure 8.

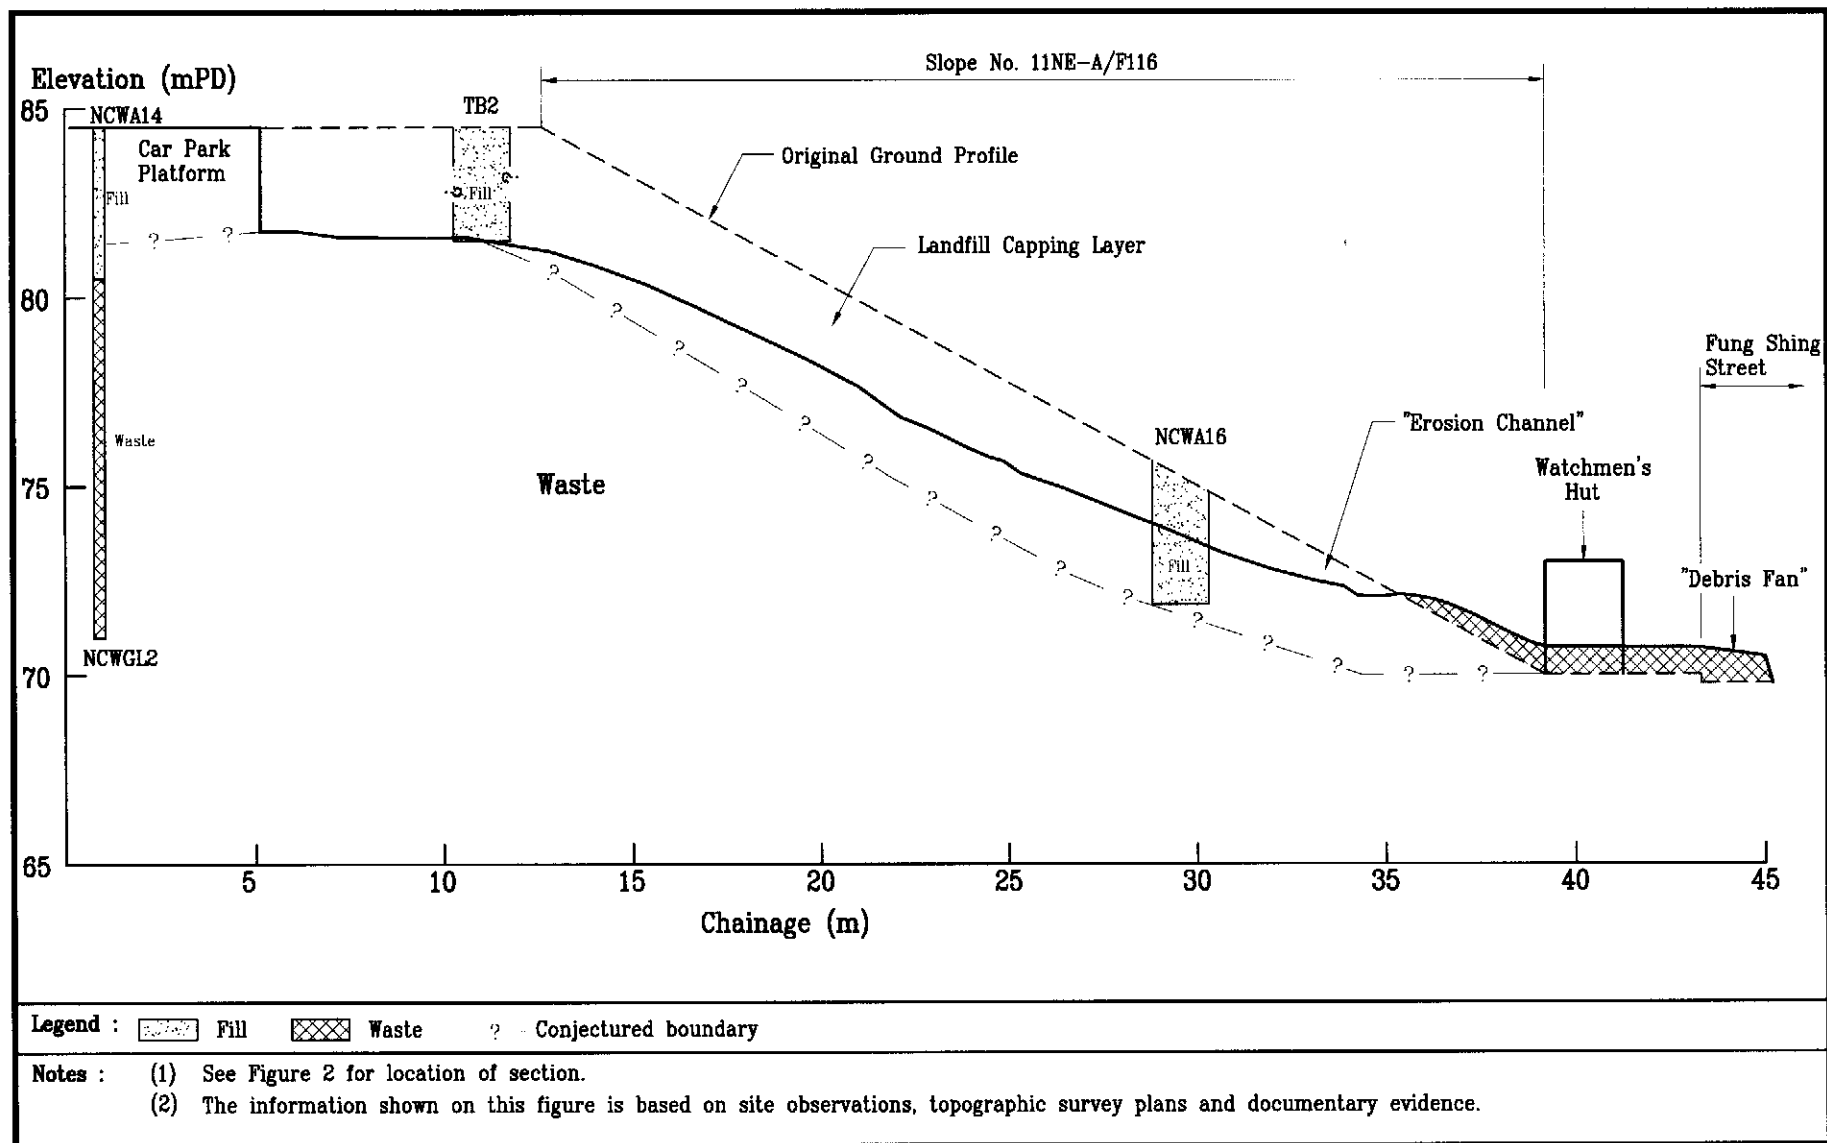
Figure 9 - Section Showing the Inferred Ground Conditions at the Landslide Site

The features mapped at the site by FSW following the 1998 landslide are shown in Figures 2 and 8 whilst a section through the landslide scar showing the inferred ground conditions is given in Figure 9.

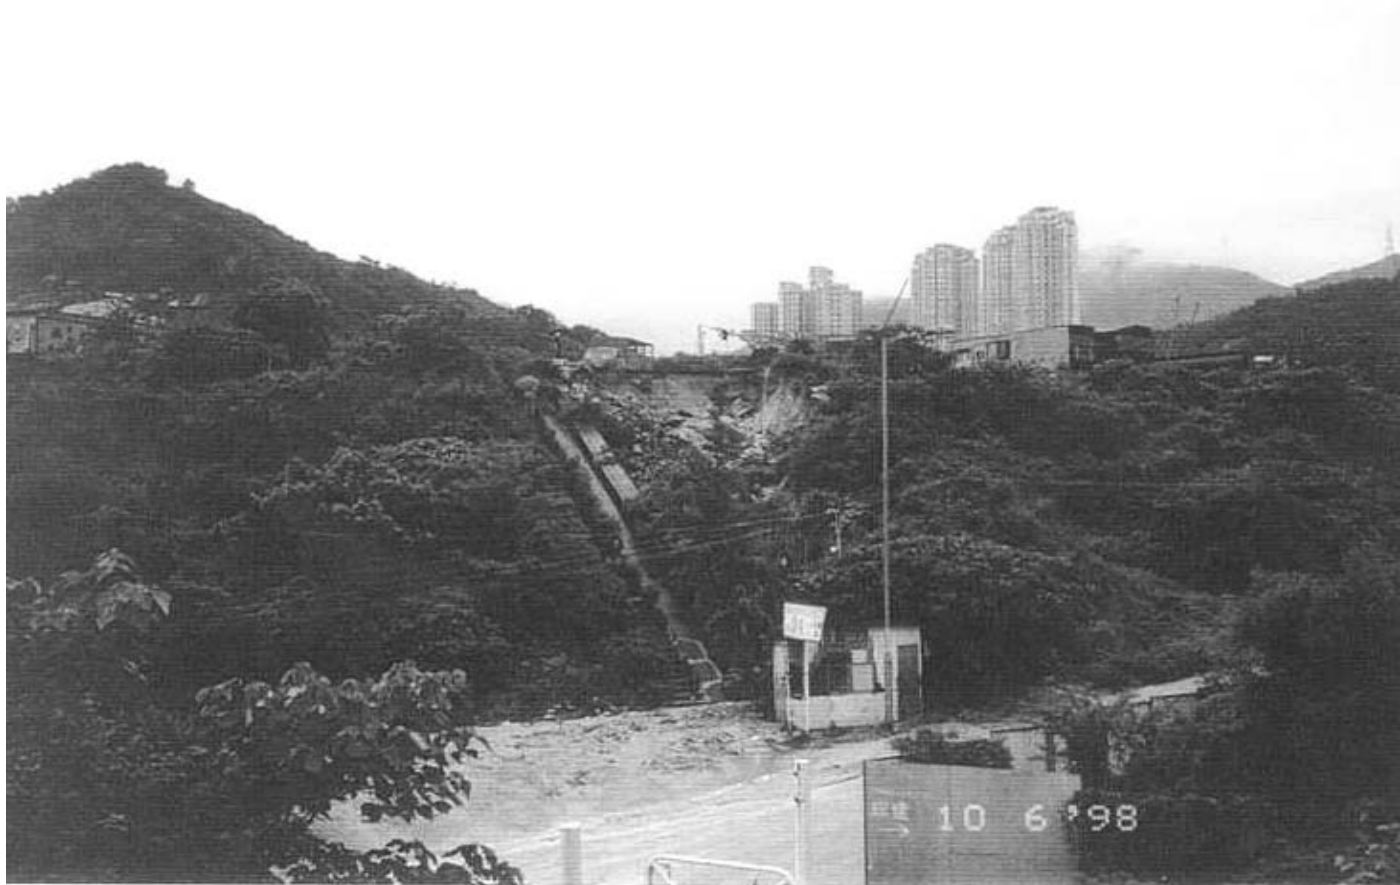
An inspection of the landslide site was carried out by representatives of both HyD and Environmental Protection Department (EPD) on 10 June 1998. Water was evident discharging into the landslide scar from the platform above (Plates 1, 2 and 3). The remains of the debris fan at the toe of the slope were also apparent (Plate 1). In addition, areas where water had caused the wetting-up of the capping layer material within the landslide scar, forming erosion channels, were evident (Plate 3). The densely-vegetated nature of the slopes in the vicinity of the landslide was also apparent during this inspection (Plates 1 and 2).

The landslide comprised the failure of an approximately 15 m wide section of the landfill slope adjacent to an existing stepped channel at the junction between the main and subsidiary slopes of the feature, and resulted in the release of about 250 m³ of debris (Plates 11, 12 and 13). The upper part of the landslide scar was generally “L-shaped” in plan, approximately 15 m wide at the crest of the slope reducing to about 5 m in width, some 5 m downslope (Figure 2). The scar remained at this relatively constant width for a further 18 m. At this point, near the toe of the slope, an “erosion channel”, approximately 0.5 m wide, 1.0 m deep and 2.0 m in length, was evident within the landslide scar (Plate 14). The sides of both the landslide scar and “erosion channel” were generally sub-vertical whilst the base of the scar was generally inclined at an angle of about 20°. The landslide scar was about 2 m deep generally, and up to 2.5 m deep locally. Based on site observations and accounts by witnesses the debris is considered to have formed a fan below the “erosion channel”, which spread out onto Fung Shing Street below this channel (Figure 2 and Plate 1).

The debris fan is understood to have had the general areal extent shown in Figure 2. This is partly corroborated by the remnants of this feature shown in Plate 1. The debris fan is thought to have been of the order of 0.5 m in depth maximum (Plates 19 and 20). The remains of the fan that were inspected by FSW on 16 June 1998 comprised generally a loose light brown slightly gravelly silty fine- to coarse-grained sand with some cobbles and boulders. No construction waste was identified in the remains of the debris fan.

Plate 1 – General View of Landslide Scar and Remnants of Debris Fan
(Photograph taken on 10 June 1998)

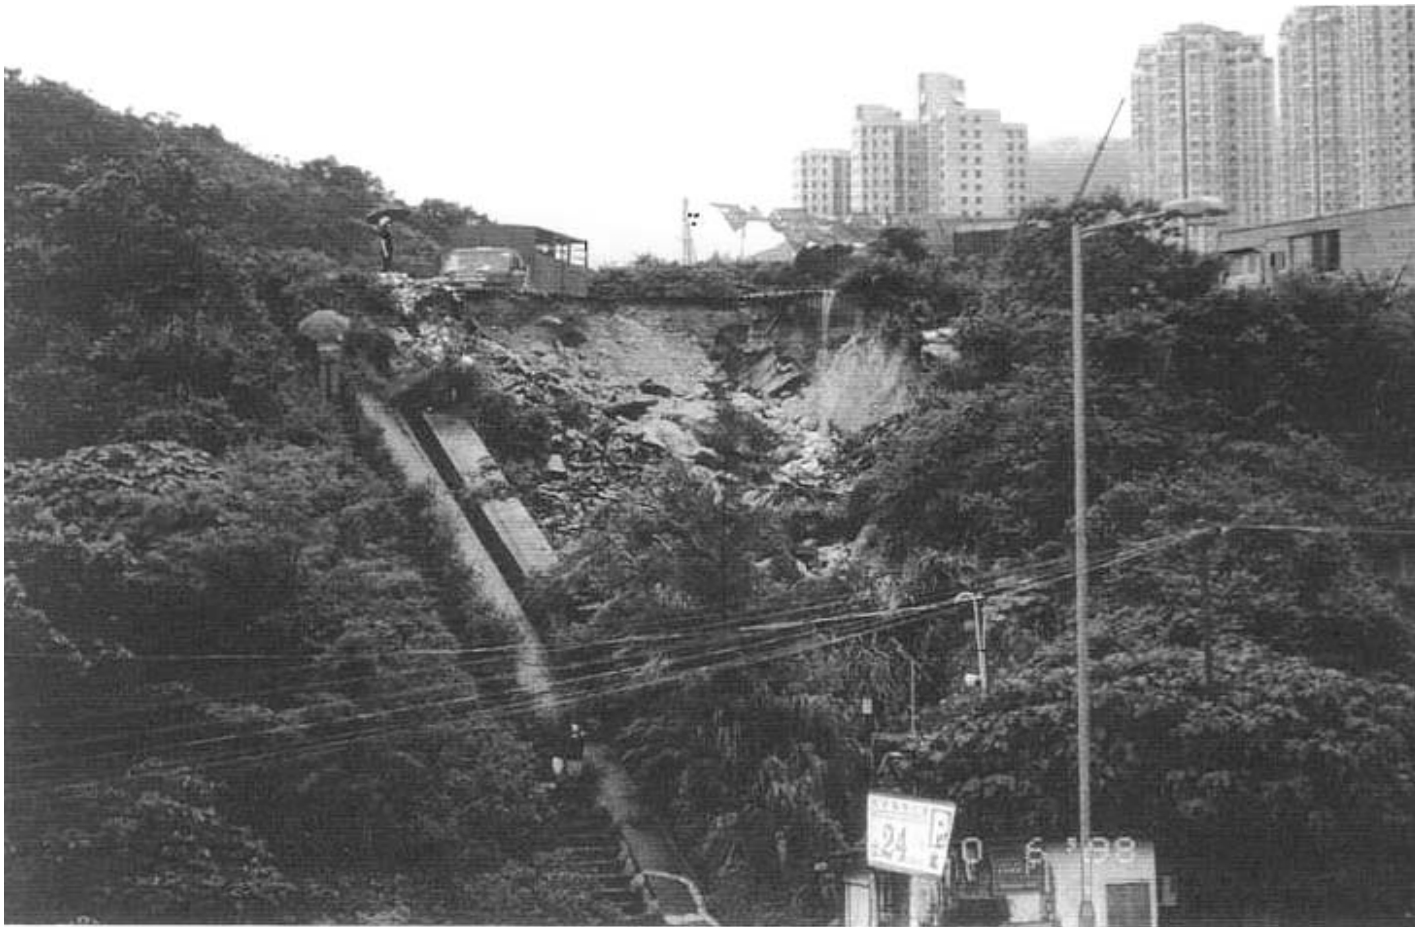
Plate 2 – View of Landslide Scar. Note Water still Discharging into Landslide Scar
(Photograph taken on 10 June 1998)

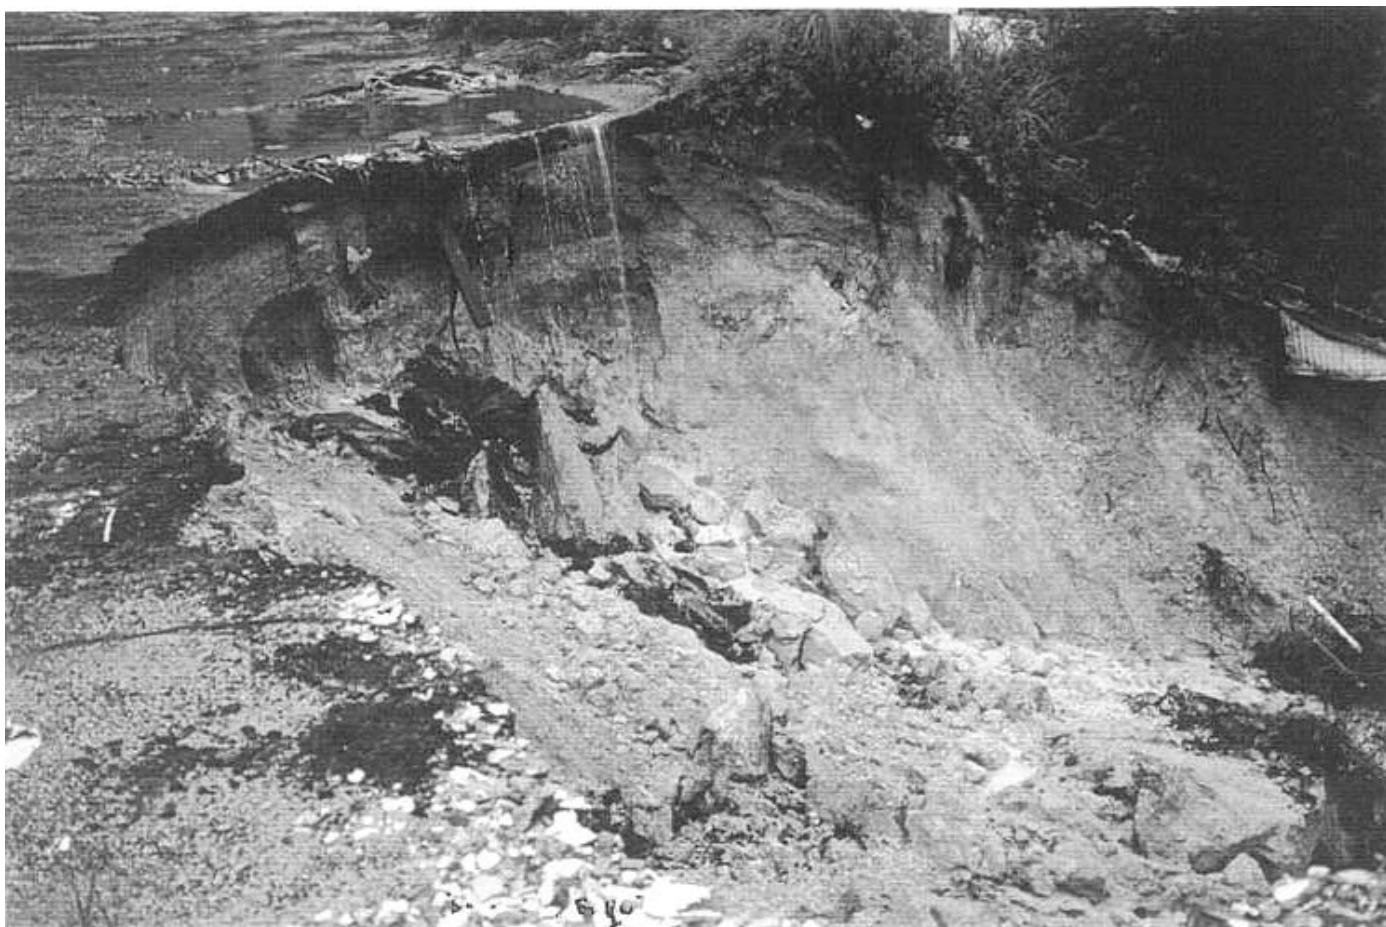
Plate 3 – Close-up View of Landslide Mainscarp
(Photograph taken on 10 June 1998)

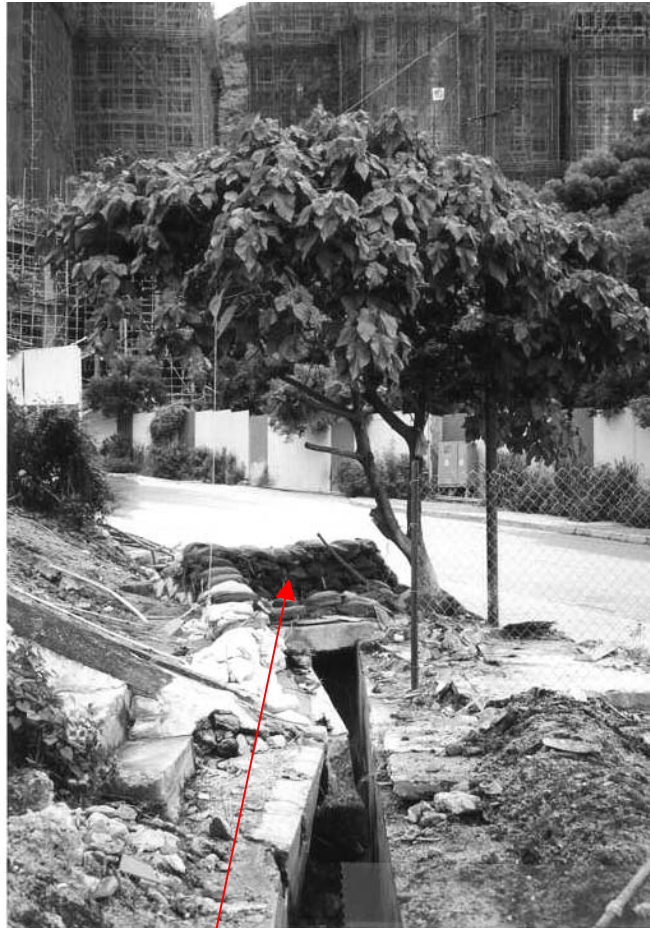
Sand bags indicate previous Location of Watchmen's Hut.

Plate 4 – View at the Toe of the Slope following the Removal of the Watchmen's Hut. Note Deformation of Upslope Wall of U-channel. (Photograph taken on 8 July 1998)

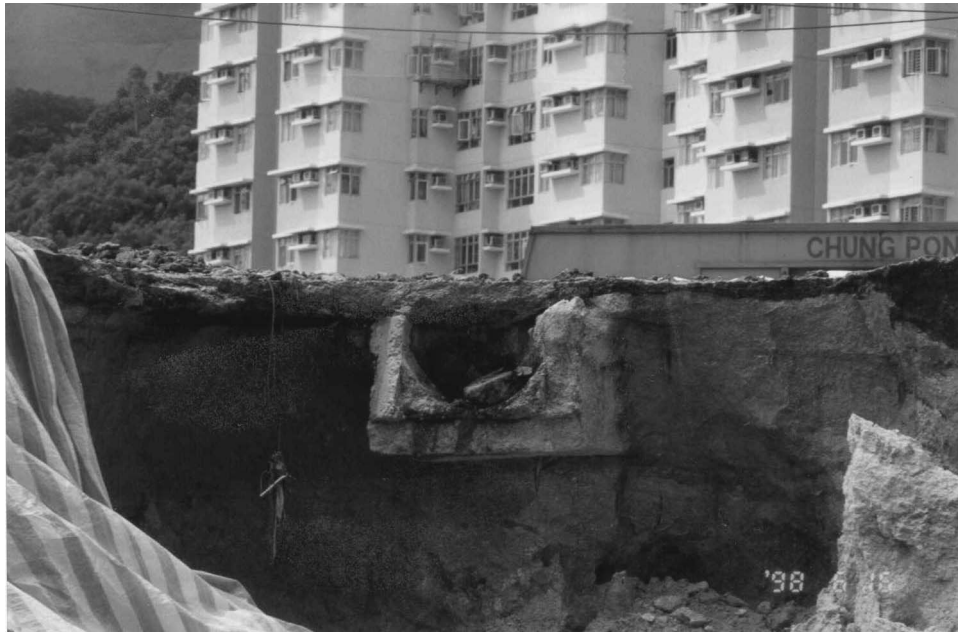
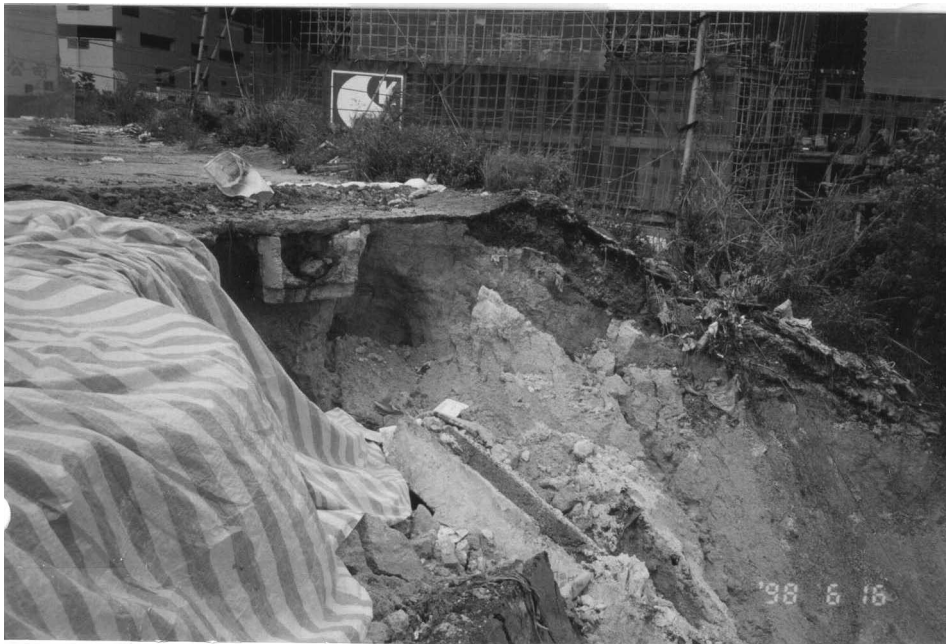
The first indications that the U-channel at the crest of the main slope of the feature had been filled over were noted on the 1990 aerial photographs. Site inspection by FSW in June 1998 revealed that this U-channel was infilled and an asphalt layer laid over the infilled U-channel (Plates 7 and 8).

Plate 7 – Views of "Infilled" Concrete U-channel at Crest of Slope.
Layering of Fill Capping to Landfill evident as is Erosion around
U-channel (Photographs taken on 16 June 1998)

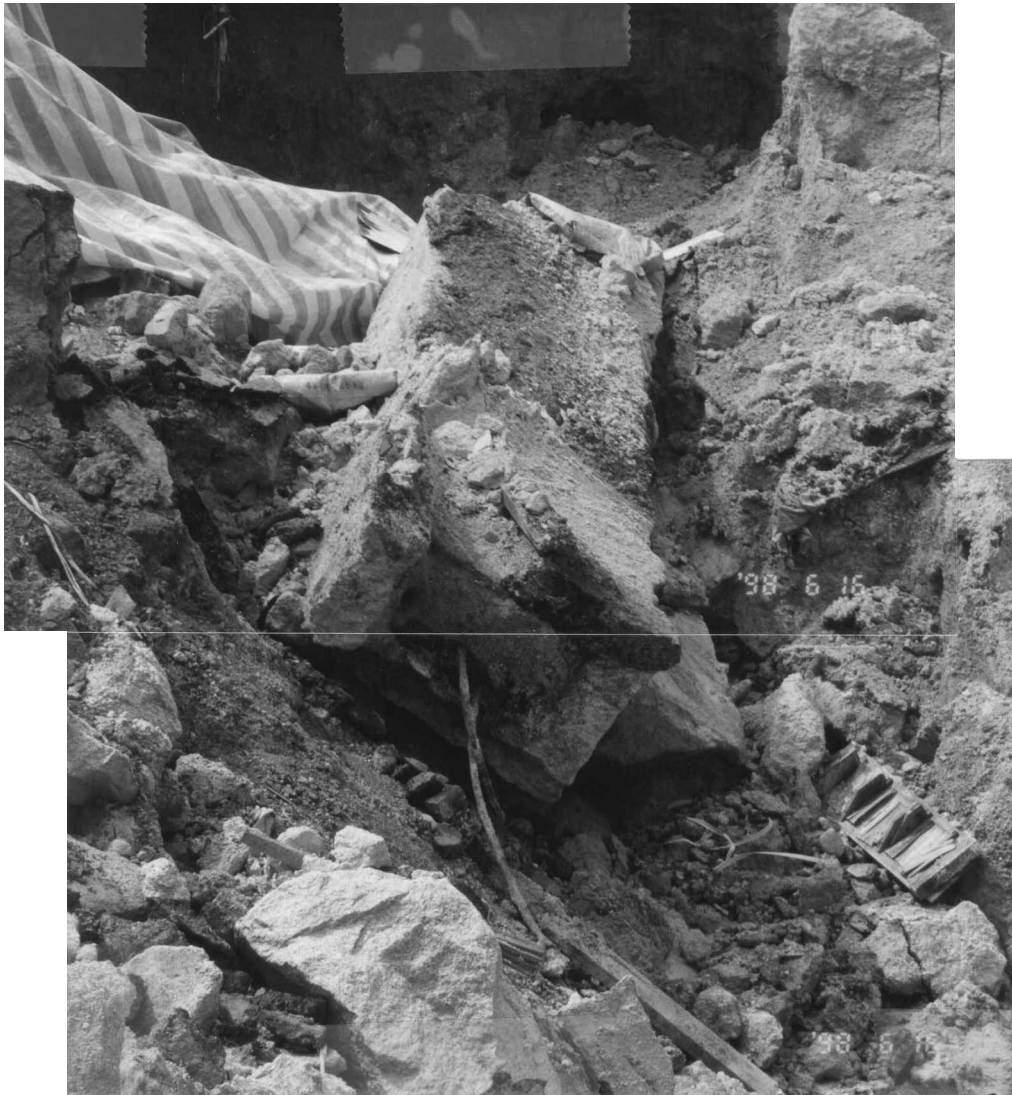
Plate 8 – View of "Infilled" Concrete U-channel within Landslide Scar.
Asphalt Overlay to U-channel also clearly evident (Photographs
taken on 16 June 1998)

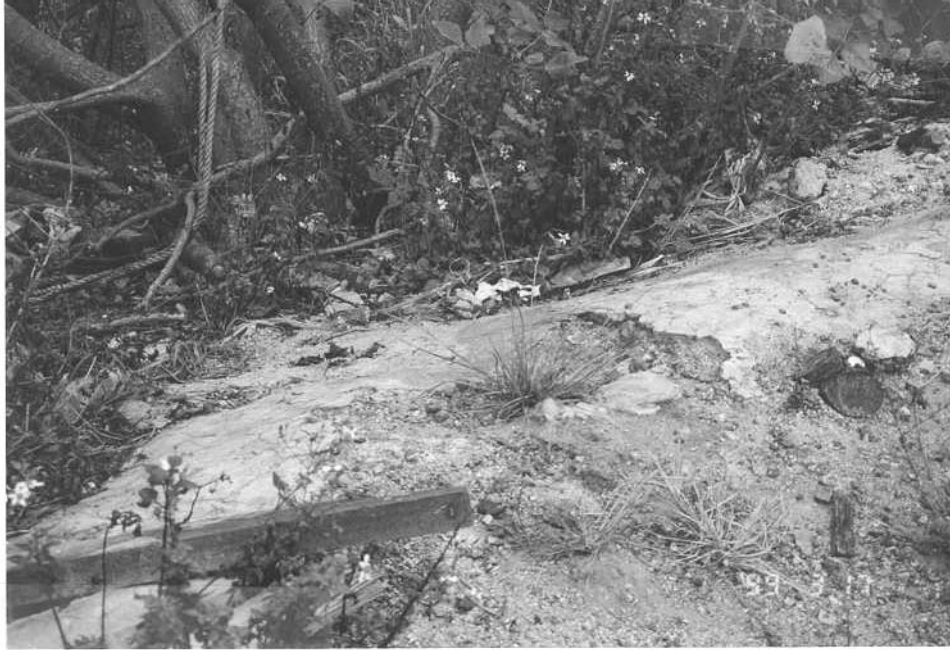
Plate 9 – Chunam Cover at Crest of Main Slope of Feature
No. 11NE-A/F116 (Photograph taken on 17 March 1999)

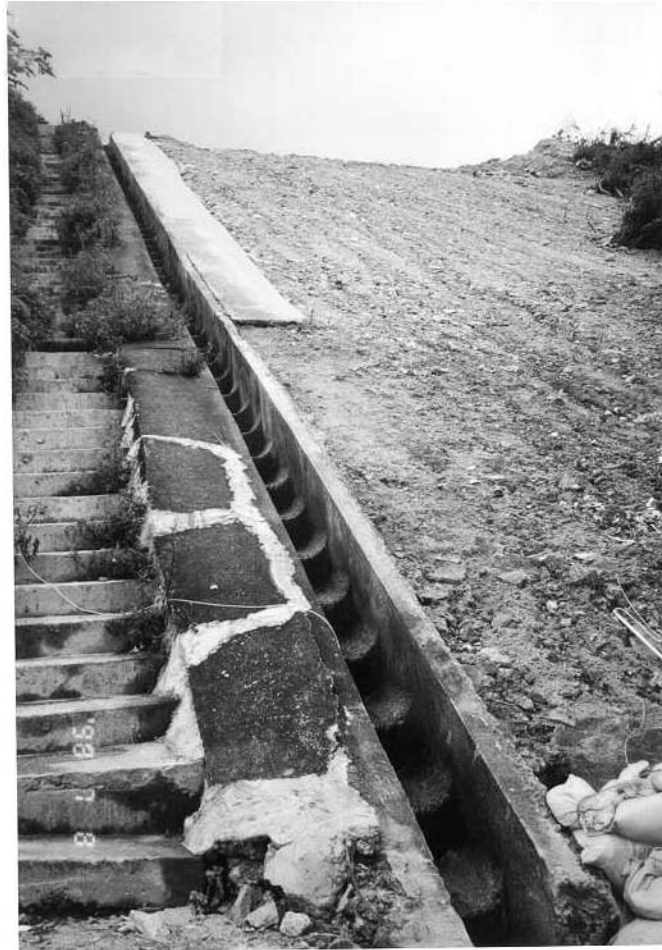
Plate 10 – View of Stepped Channel. Note Repairs to Channel and adjacent Steps (Photograph taken on 8 July 1998)

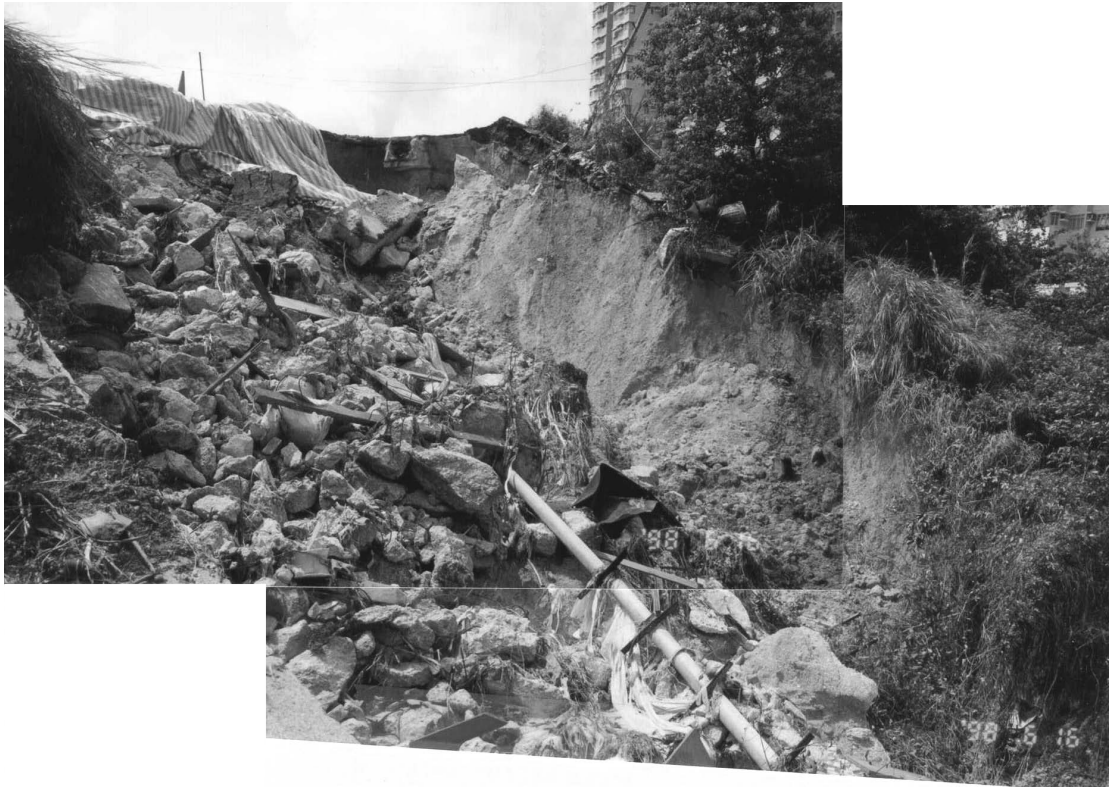
Plate 11 – General View looking up the Landslide Scar and Debris Trail. General Fill Capping Layer, in excess of 2 m thick, exposed in left flank of Landslide Scar. Note the Lighting Column within the Landslide Scar. Landfill Material exposed in scar includes Concrete, Wood and Stone Rubble. "Infilled" Concrete U-channel evident within Landslide Mainscarp (Photographs taken on 16 June 1998)

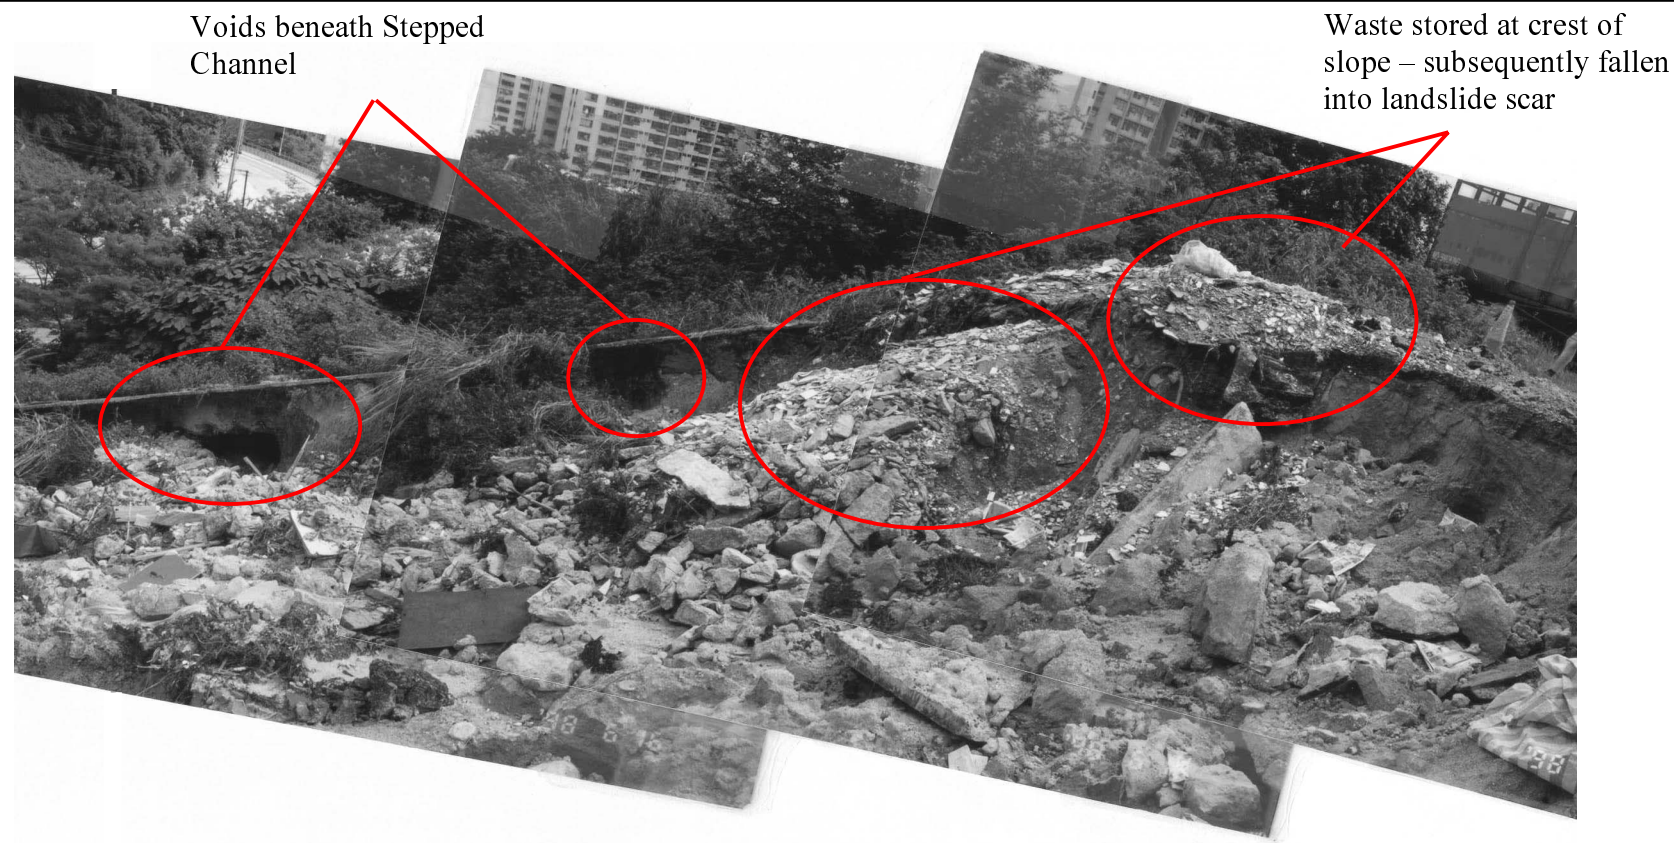
A stepped channel, 400 mm wide and 600 mm deep, was located adjacent to the landslide scar, and several significant voids (maximum dimension in excess of 0.5 m) were observed in the fill underlying the channel (Plates 12, 17 and 18). Although surface water runoff appeared to be concentrated towards the stepped channel at the crest of the slope no drainage connections were observed between the crest U-channel and the stepped channel.

Plate 12 – General View looking across and down the Landslide Scar. Undermining of the Stepped Channel clearly evident. Note the Nature of the Material within the Landslide Scar – Heterogeneous Construction Waste and a Fill Capping. Layering of Capping clearly evident. Construction Waste also appears to have been stored at the Crest of the Slope adjacent to the Stepped Channel. Some of this Waste appears to have subsequently fallen into the Landslide Scar (Photographs taken on 16 June 1998)

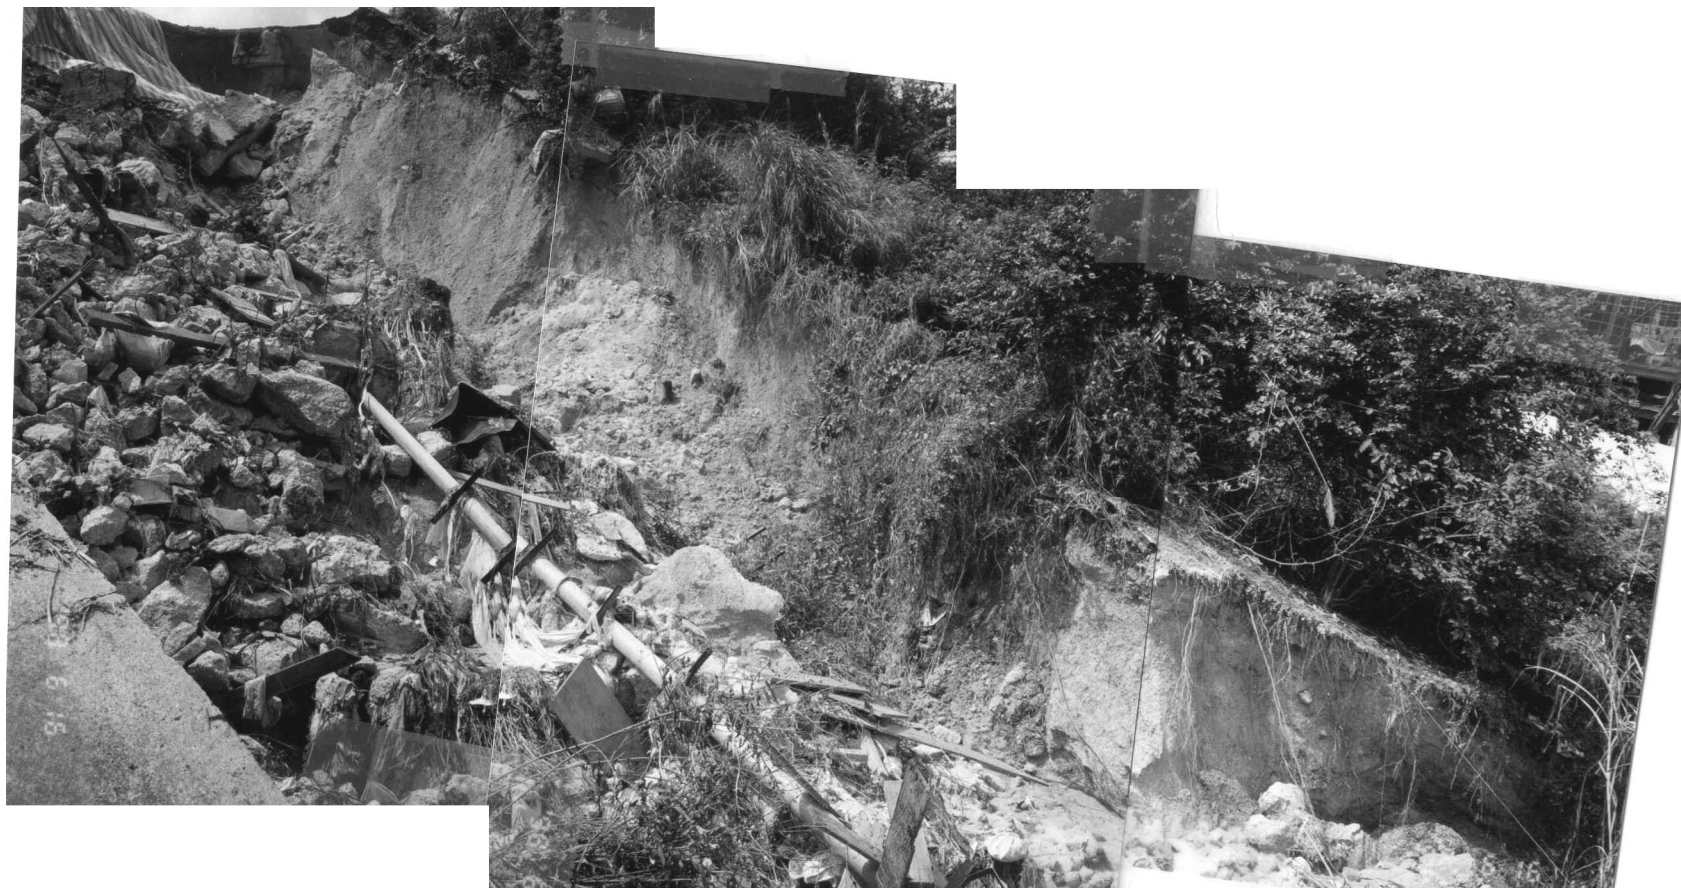
Plate 13 – General View looking up and across the Landslide Scar. Note "Erosion Channel" in bottom right hand side of picture (Photographs taken on 16 June 1998)

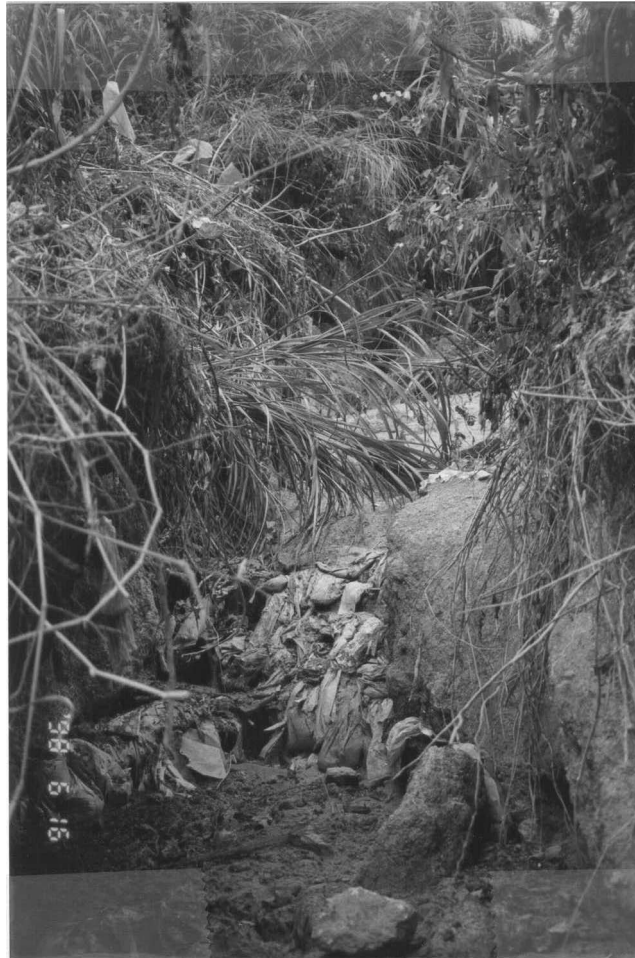
Plate 14 – View of the "Erosion Channel" at the Toe of the Slope
(Photograph taken on 16 July 1998)

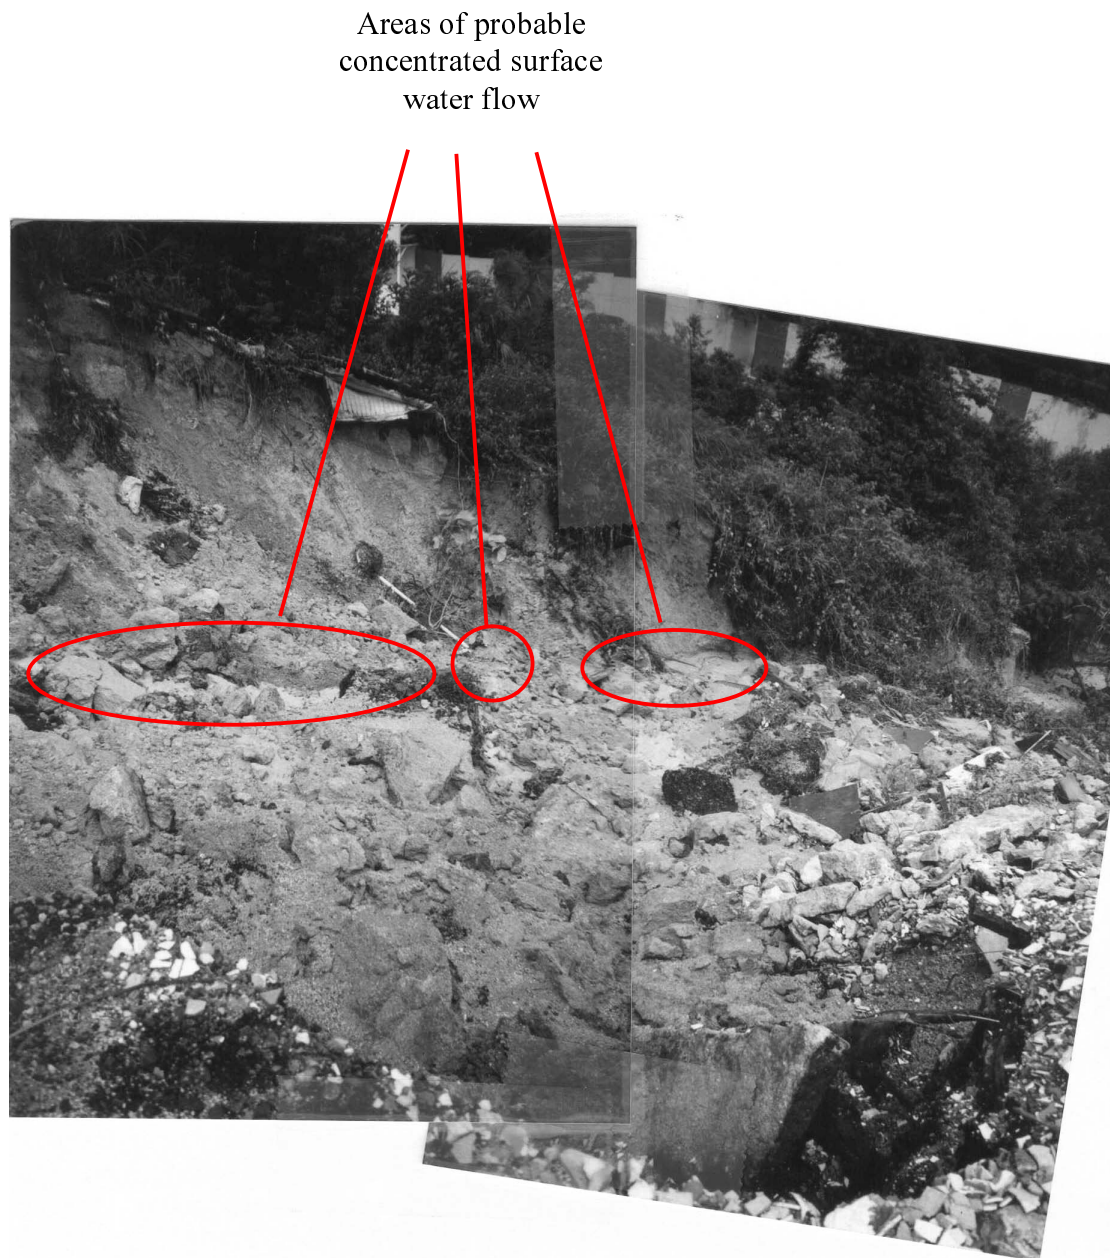
Examination of the landslide scar revealed that the failure was confined essentially to the capping layer of the landfill. This capping layer was typically 2 m deep and comprised a medium dense light brown slightly gravelly silty fine- to coarse-grained sand with some cobbles and occasional boulders. Layering was evident within the capping layer (Plate 7) as were probable erosion channels within the base of the scar (Plates 15 and 16).

Plate 15 – View of Landslide Scar looking down from Stepped Channel.
Note Lighter Coloured Areas in the Scar – Probable Areas of
Concentrated Surface Water Flow/Erosion Gullies during
Failure (Photographs taken on 10 June 1998)

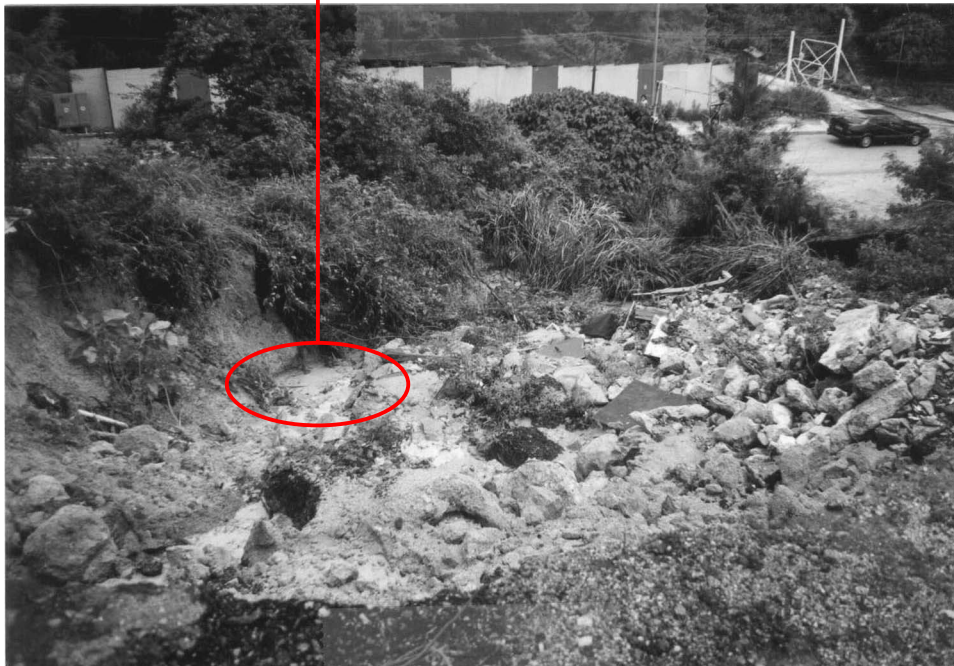
Areas of probable
"slurry-like" material

Plate 16 – General View of Landslide Scar Showing Nature of Landfill.
Note Lighter Coloured Area within the Scar – suggesting a
"Slurry-like" Material during Failure (Photograph taken on
10 June 1998)

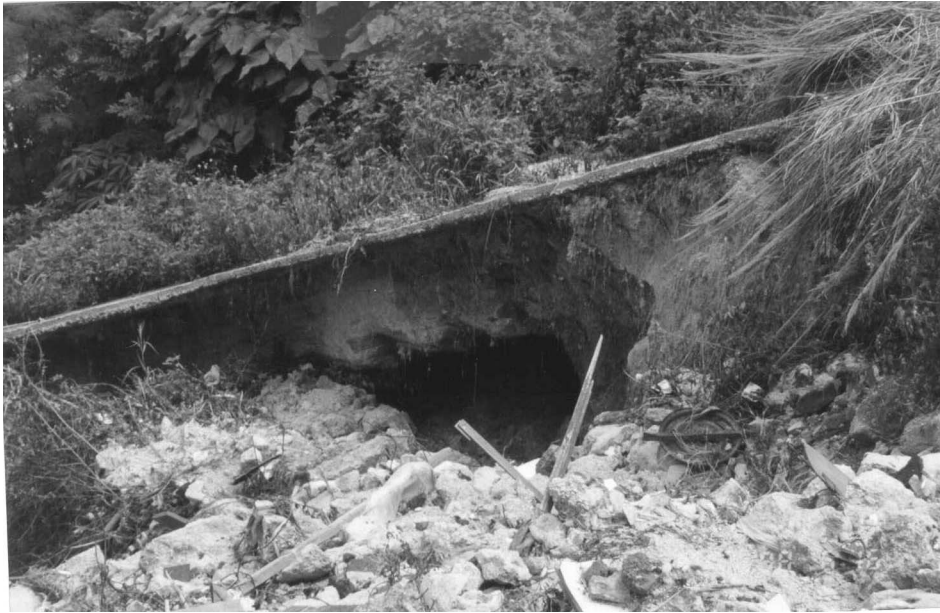
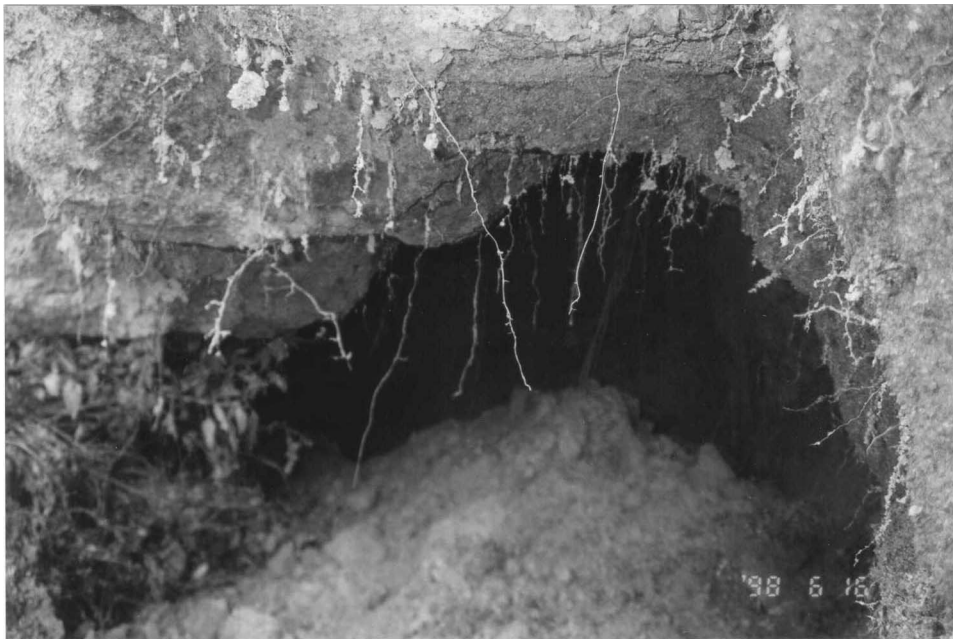
Plate 17 – Views of a Void beneath the Stepped Channel. Maximum Dimension in excess of 0.5 m (Photographs taken on 16 June 1998)

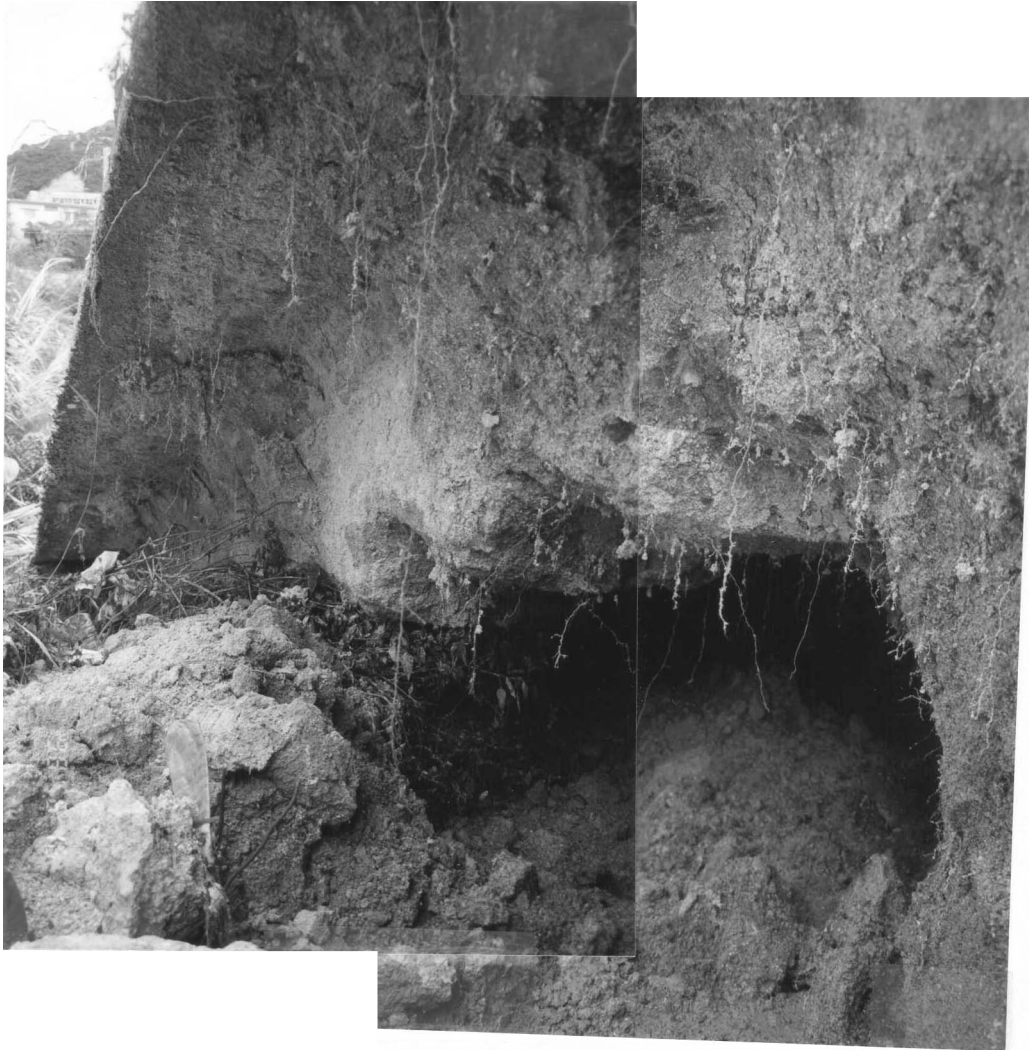
Plate 18 – Further View of a Void beneath the Stepped Channel
(Photograph taken on 16 June 1998)
