**SECTION 2 :
DETAILED STUDY OF
THE LANDSLIDE AT
FUNG SHING STREET,
NGAU CHI WAN,
KWUN TONG ON 9 JUNE 1998**

Fugro Scott Wilson Joint Venture

**This report was originally produced in December 1999
as GEO Landslide Study Report No. LSR 21/99**

This report presents the findings of a detailed study of the landslide (GEO Incident No. K 98/6/1) that occurred within fill slope No. 11NE-A/F116 at Fung Shing Street, Ngau Chi Wan, Kwun Tong on 9 June 1998. An approximately 15 m length of this fill slope adjacent to Fung Shing Street failed resulting in the release of about 250 m³ of debris. The debris inundated a wooden watchmen's hut at the toe of the slope before continuing onto Fung Shing Street and partially blocking the northbound lane of the road. The subsequent alluvial outwash from the landslide debris travelled a further 250 m or so down Fung Shing Street towards its junction with Clear Water Bay Road. No fatalities or injuries were reported following the landslide.

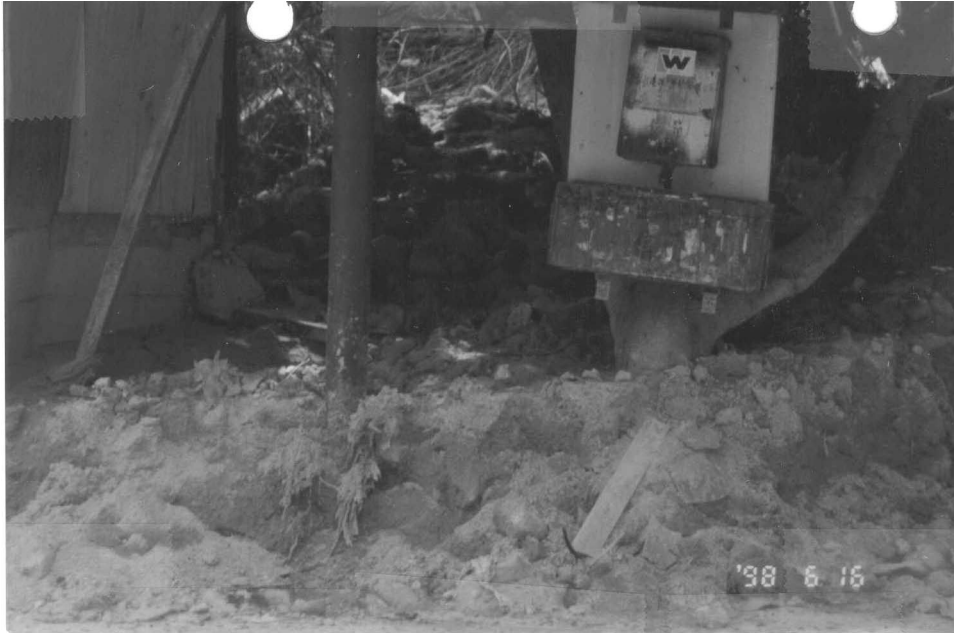
The debris fan is understood to have had the general areal extent shown in Figure 2. This is partly corroborated by the remnants of this feature shown in Plate 1. The debris fan is thought to have been of the order of 0.5 m in depth maximum (Plates 19 and 20). The remains of the fan that were inspected by FSW on 16 June 1998 comprised generally a loose light brown slightly gravelly silty fine- to coarse-grained sand with some cobbles and boulders. No construction waste was identified in the remains of the debris fan.

Plate 20 – View of the Remains of the Debris deposited at the Toe of the Slope. Depth of Debris up to 0.5 m (Photograph taken on 16 June 1998)

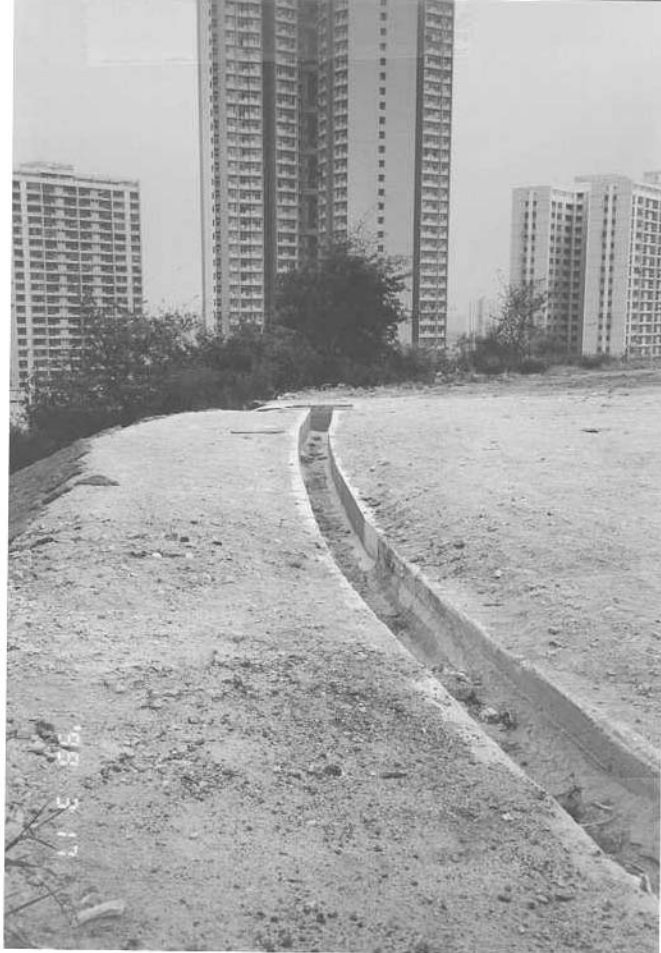
Plate 21 – View Looking towards Southeast Corner of Platform and Stepped Channel following completion of Remedial Works. Note Catchpit at Head of Slope (Photograph taken on 17 March 1999)

Following these initial remedial works further remedial works proposals were prepared by Au Posford Consultants Ltd on behalf of WCI (Au Posford, 1998). These works, comprising the removal of the uncontrolled sandfill and replacement with compacted general fill, and reinstatement of the surface drainage network in the vicinity of the 1998 landslide, were implemented between 4 January and 5 February 1999 (Plates 21, 22 and 23, Au Posford, 1999).

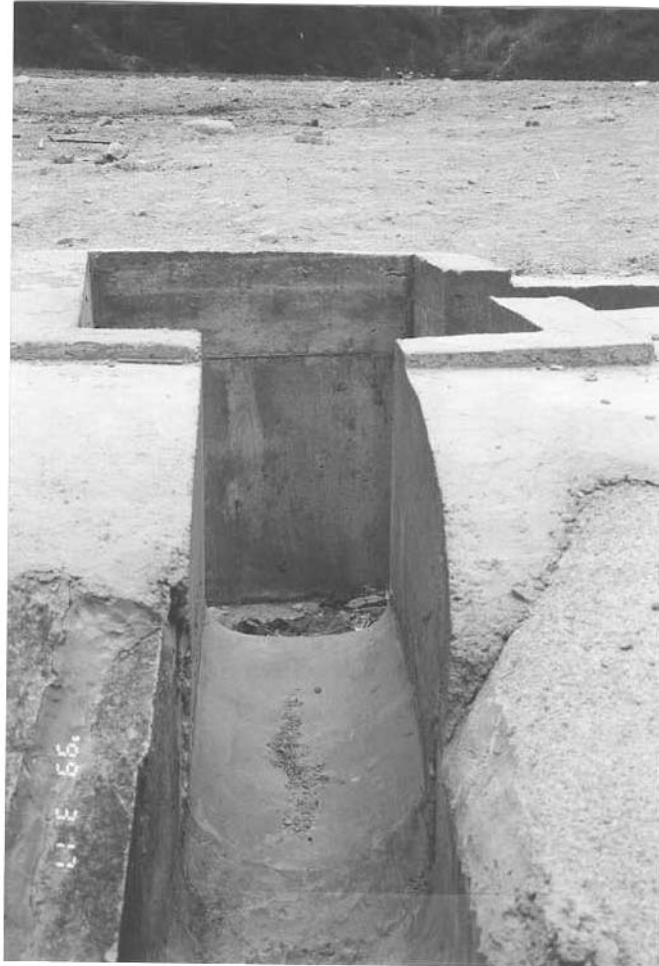
Plate 22 – View of Catchpit at Head of Stepped Channel
(Photograph taken on 17 March 1999)

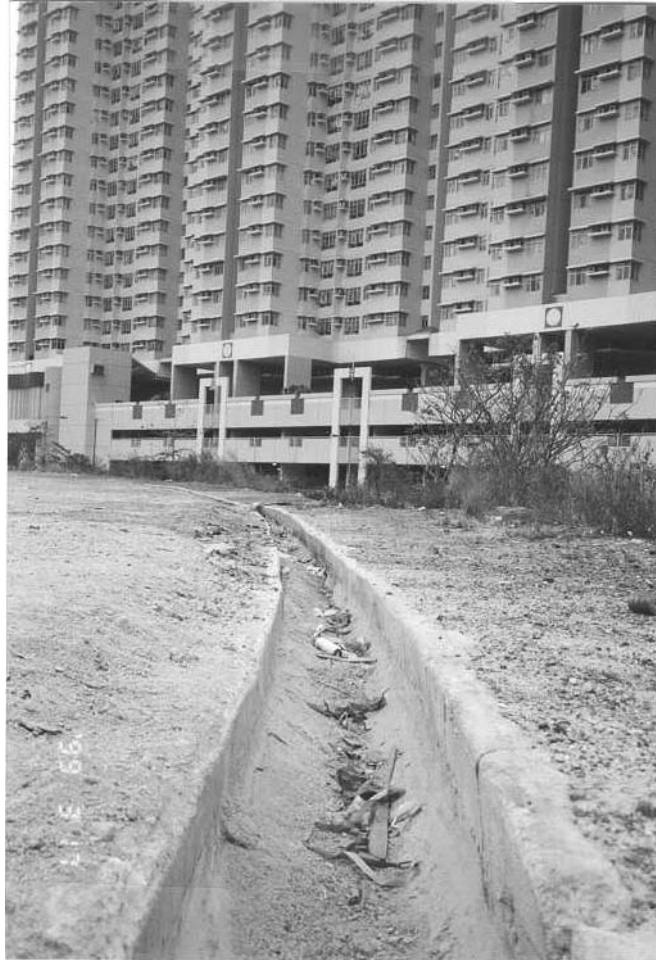
Plate 23 – General View of Reinstated Crest Channel
(Photograph taken on 17 March 1999)

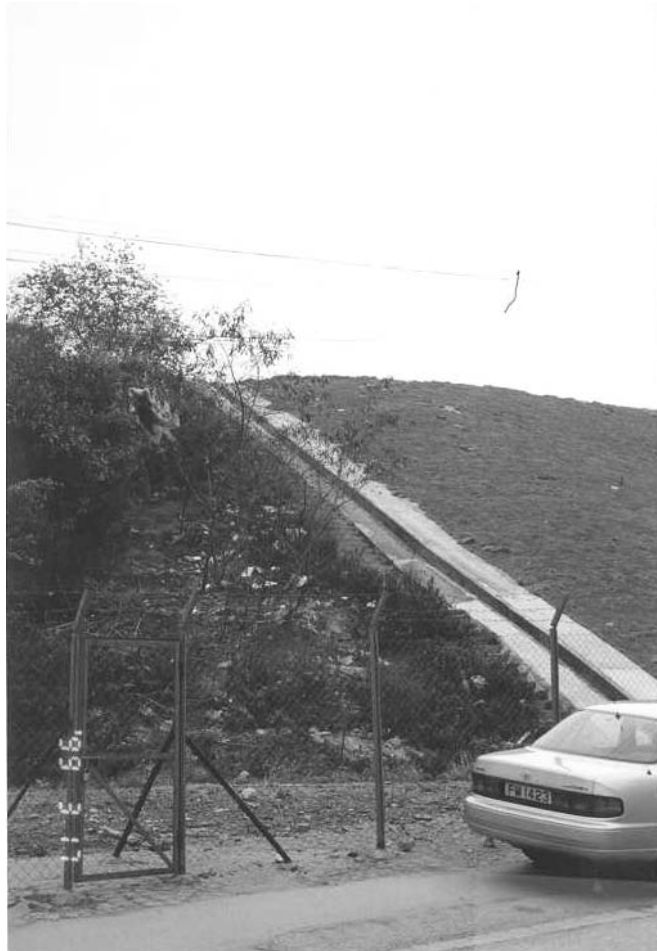
The API, desk studies and field inspections carried out as part of this study have revealed a history of past instability, primarily in the form of erosion scars and gullies, within the vicinity of the 1998 landslide. These instabilities may have caused local weakening of the landfill capping layer. It appears that these past incidents of erosion had not been reported to the GEO and that no proper repair works were carried out. It is therefore possible that the previously failed areas of the slope contain loose disturbed material (Plates 24 and 25).

Plate 24 – General View of Slopes at Southeast Corner of Middle Fill Platform (Photograph taken on 17 March 1999)

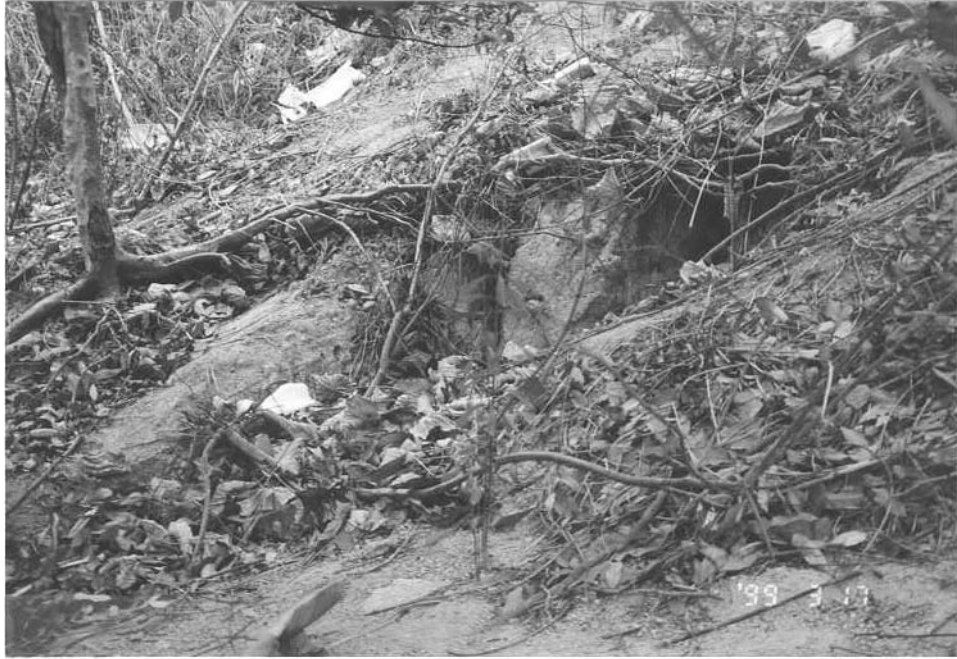
Plate 25 – View of Erosion Gullying on Fill Slope adjacent to
1998 Landslide (Photograph taken on 17 March 1999)

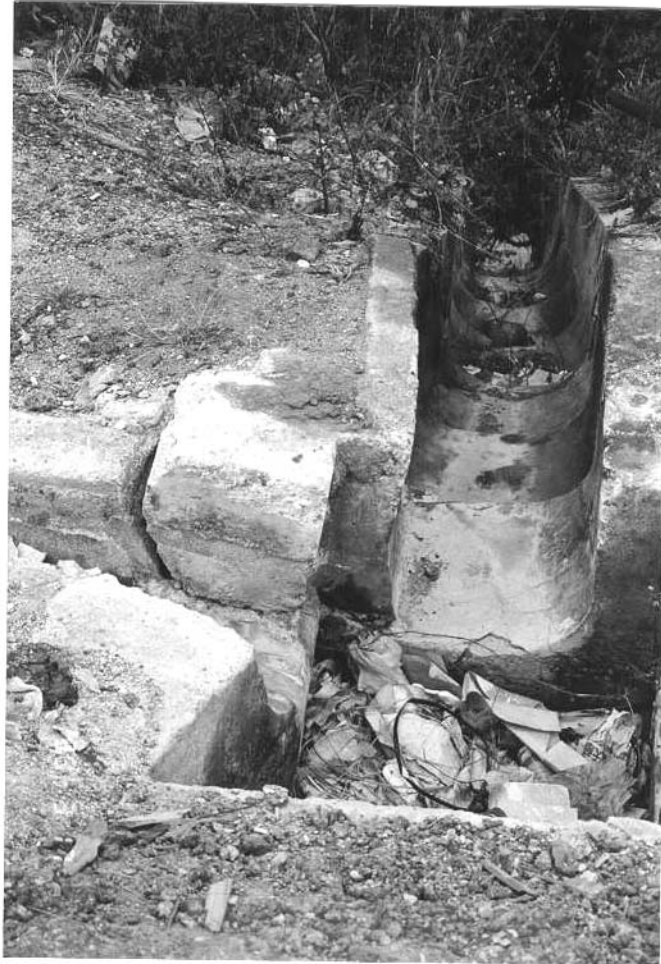
Plate 26 – View of Catchpit and Stepped Channel to the North of the 1998 Landslide Site. Note Deformation and Rubbish blocking the Flowpath (Photograph taken on 17 March 1999)

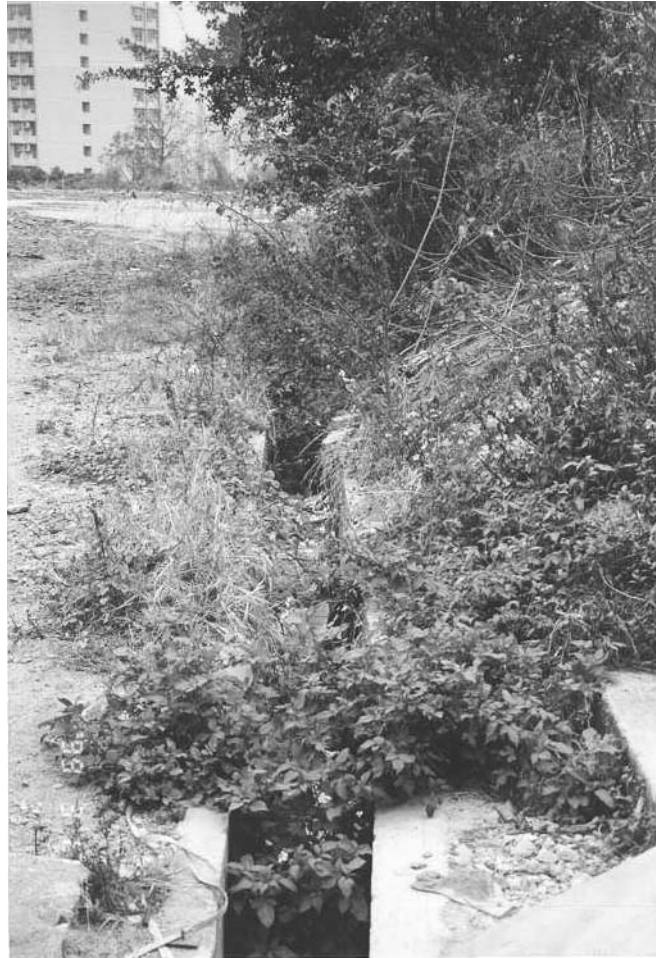
Plate 27 – View of U-Channel at Toe of Subsidiary Slope of Feature No. 11NE-A/F116 adjacent to Stepped Channel and 1998 Landslide (Photograph taken on 17 March 1999)
