# **INVESTIGATION OF SOME SELECTED LANDSLIDES IN 1999 (VOLUME 1)**

**GEO REPORT No. 120**

**Fugro Maunsell Scott Wilson Joint Venture**

**GEOTECHNICAL ENGINEERING OFFICE  
CIVIL ENGINEERING DEPARTMENT  
THE GOVERNMENT OF THE HONG KONG  
SPECIAL ADMINISTRATIVE REGION**

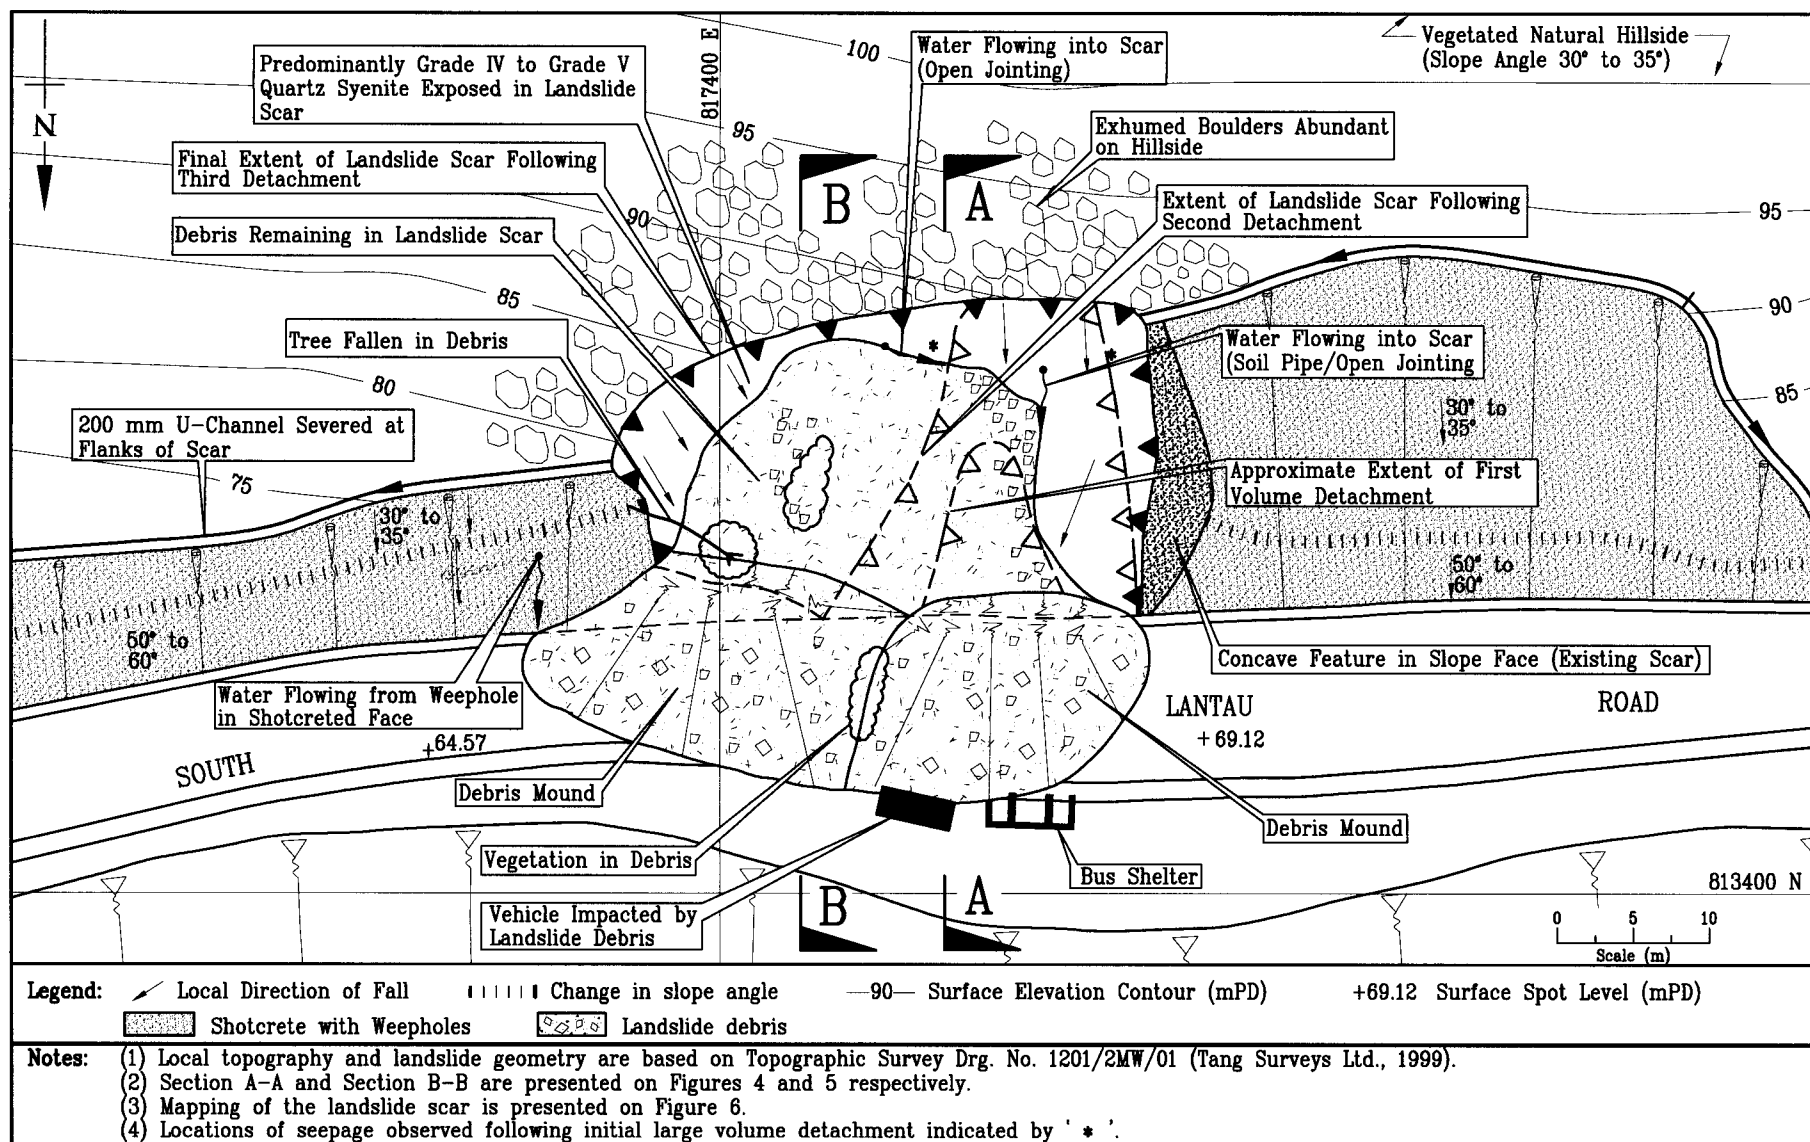
Figure 3 - Plan View of the Landslide

The eye-witness continued to observe the landslide scar following the major detachment of debris and noted that water was flowing from two locations adjacent to the scar, high up on the slope face (Figure 3). On the eastern side of the scar, water was flowing under some pressure from a weephole in the shotcrete surfacing, while to the west, water was entering the scar from beneath the cracked shotcrete.

Based on the eye-witness account, an estimate has been made of the extent of the landslide scar and the sources of water flow, which are indicated on Figure 3. According to the eye-witness, about 50% of the debris detached from the slope during the initial failure, involving the two separate phases of movement (Section 4.1), with the remaining detachment occurring subsequently within the following half hour at most.

- (b) A light brown, plastic silty clay deposit was observed as a coating on several of the boulders present in the debris. This material differed from the predominantly reddish-brown saprolite in the debris mass (Plate 9).
- (c) Muddy water was observed flowing from a weephole in the shotcrete surfacing adjacent to the eastern flank of the scar (Plate 10).
- (d) Adverse joint orientations were present in exposures of moderately decomposed bedrock within the scar (Plate 11).
- (e) Water was flowing into the scar at the base of the main scarp (Figure 3 and Plates 7 & 11).

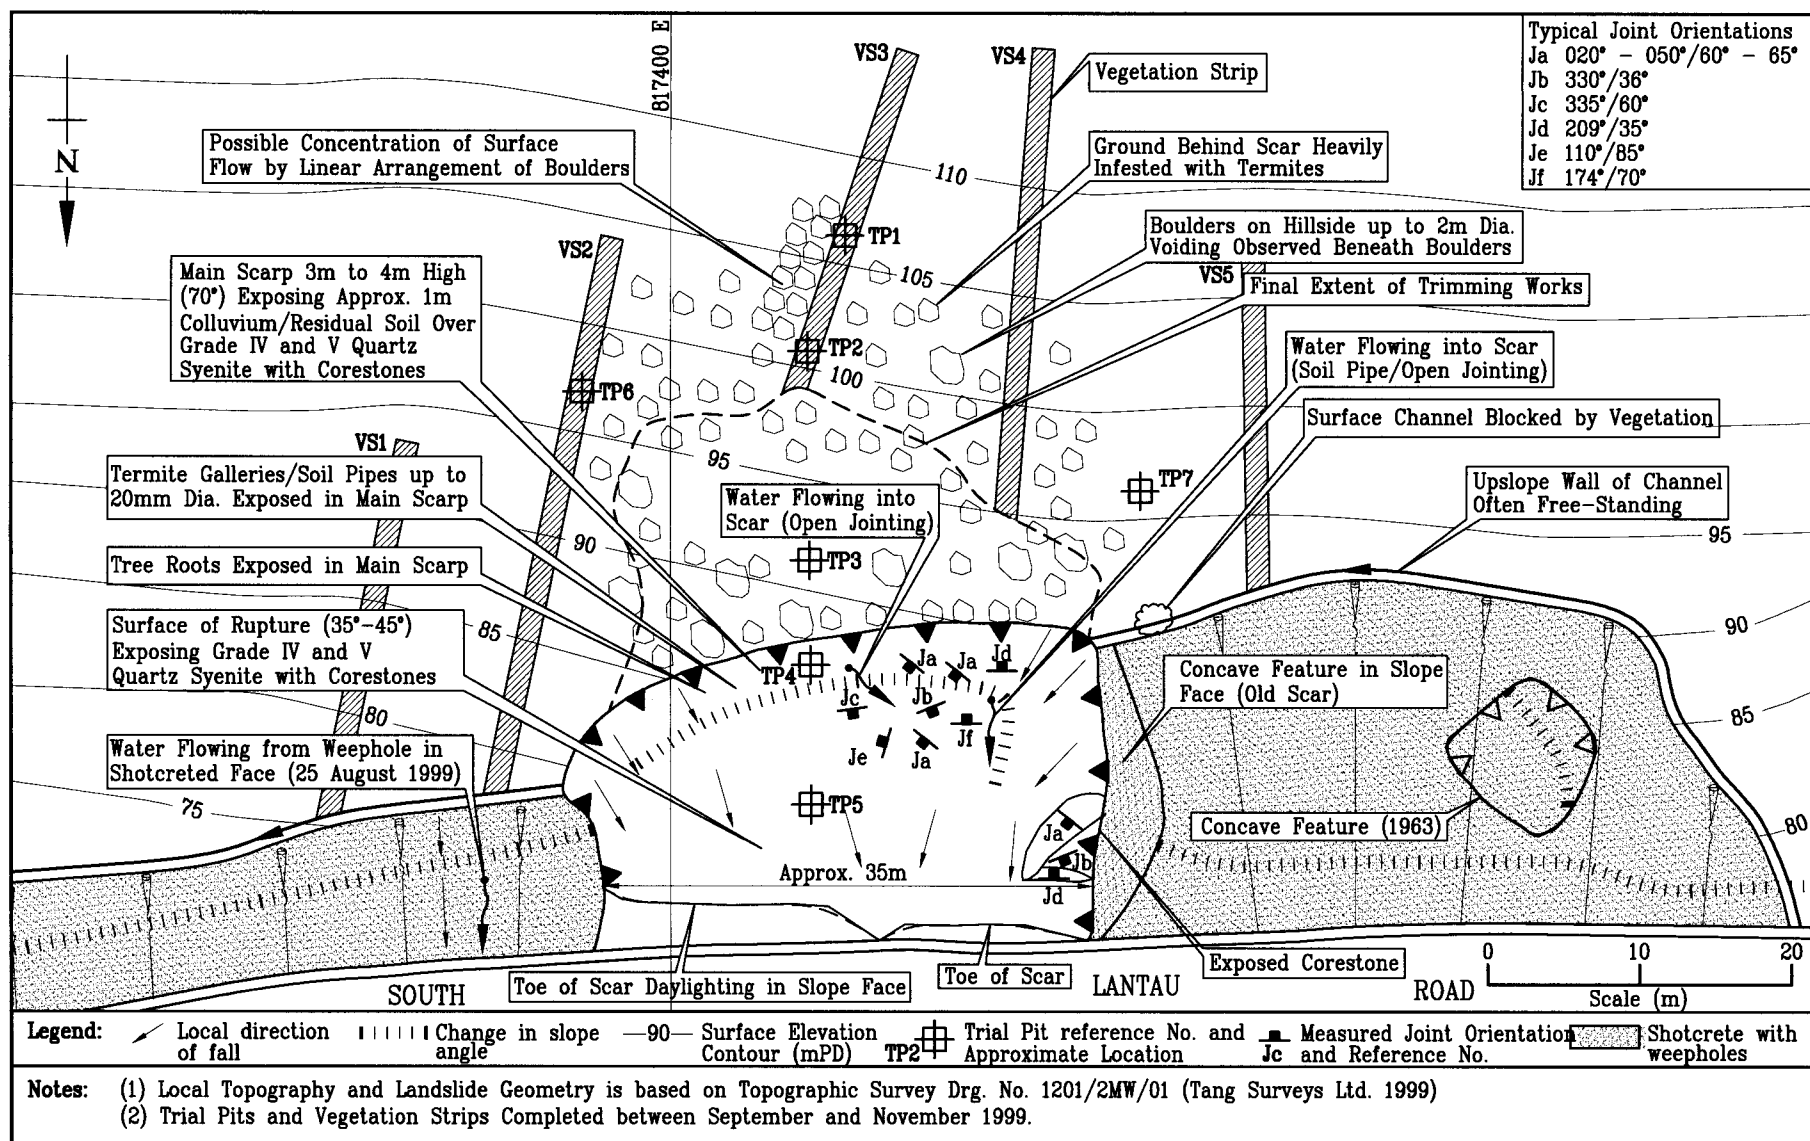
Figure 6 - Mapping of the Landslide Scar

Geological mapping of the exposed landslide scar was carried out by FMSW in the week following the failure and was completed on 29 August 1999. The major observations made during this exercise are presented on Figure 6.

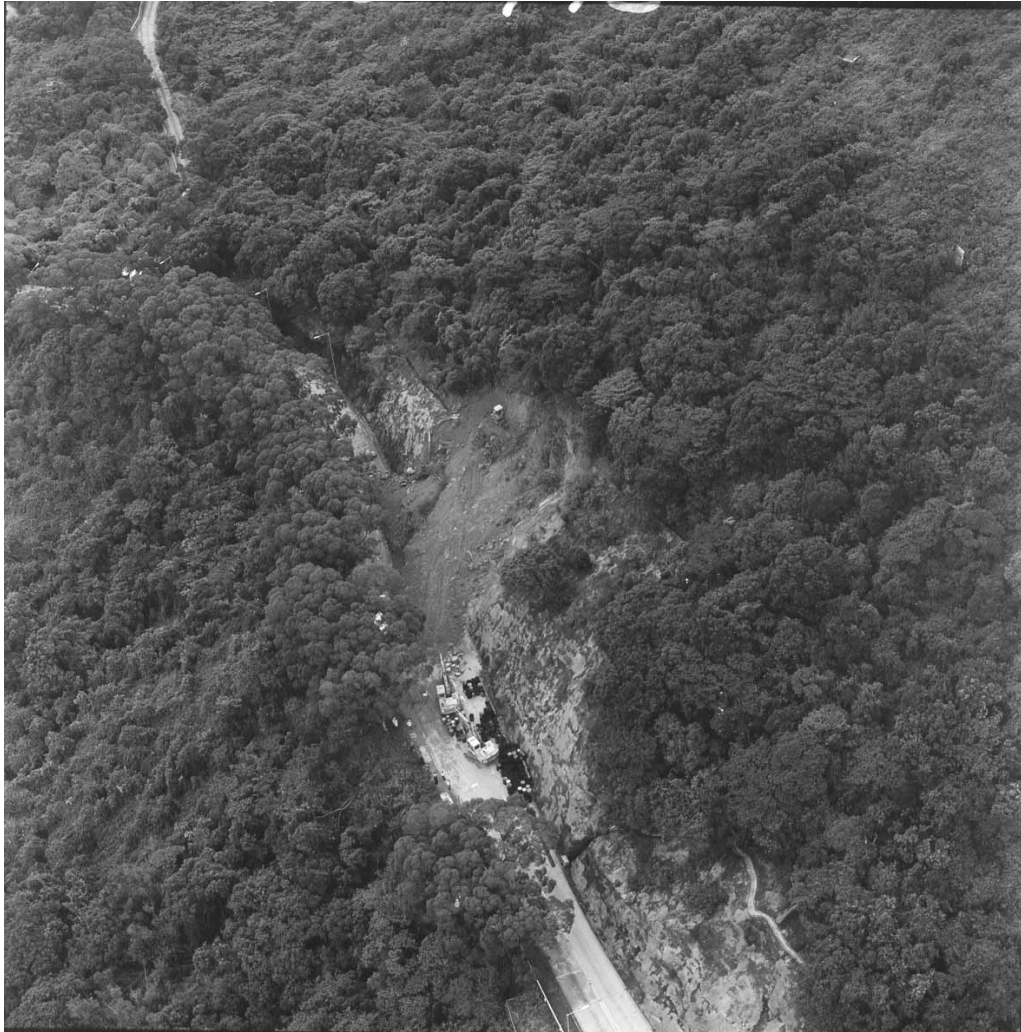
Plate 1 – Oblique View of the Landslide Site (Photograph Taken on  
25 August 1999)

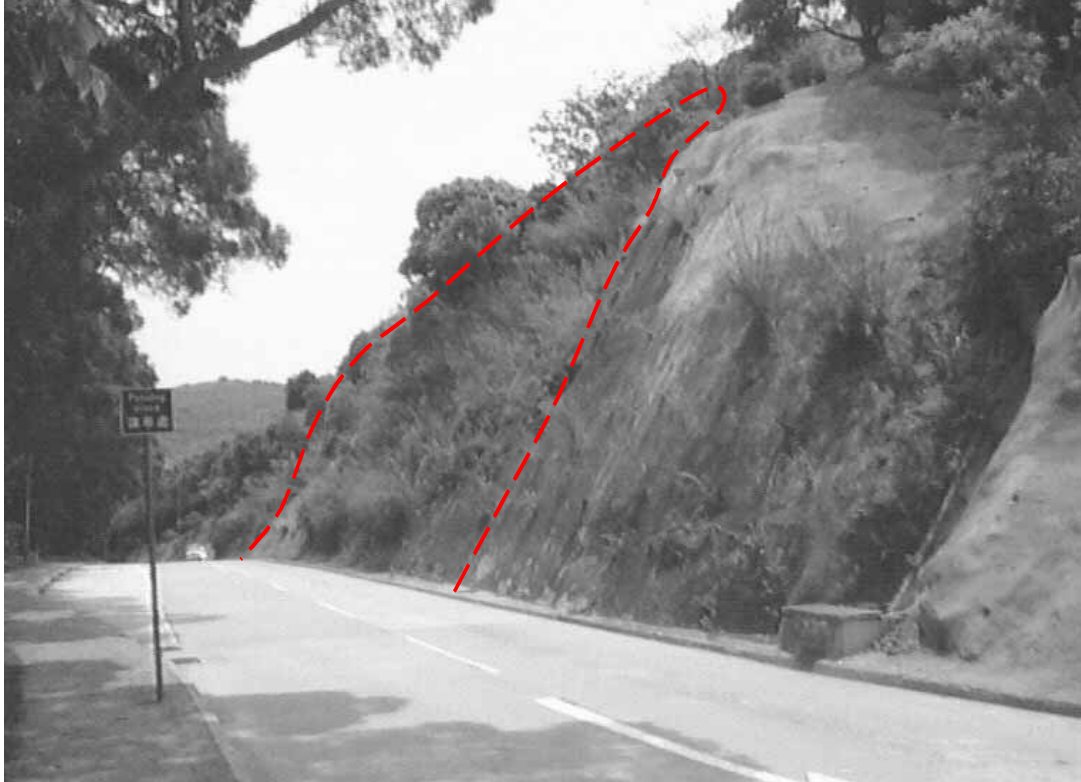
In April 1995, slope No. 10SW-C/C20 was inspected by consultants appointed by HyD under the project "Roadside Slope Inventory and Inspections". The Engineer Inspection Records (FMR Consultants, 1995) indicate the overall state of maintenance as "Fair" and notes moderate seepage from the slope toe at the same location as the western flank of the 1999 landslide scar. Cracking of the hard surfacing was also recorded. Photographs attached to the records show vegetation growing through the hard surfacing at the location of the 1999 landslide scar (Plate 3).

Plate 3 - View South-East across Western Portion of Slope No. 10SW-C/C20 on 26 April 1995. 1999 Landslide Site Indicated. Note Vegetation Growing through Hard Surfacing (Photograph Taken by FMR Consultant)

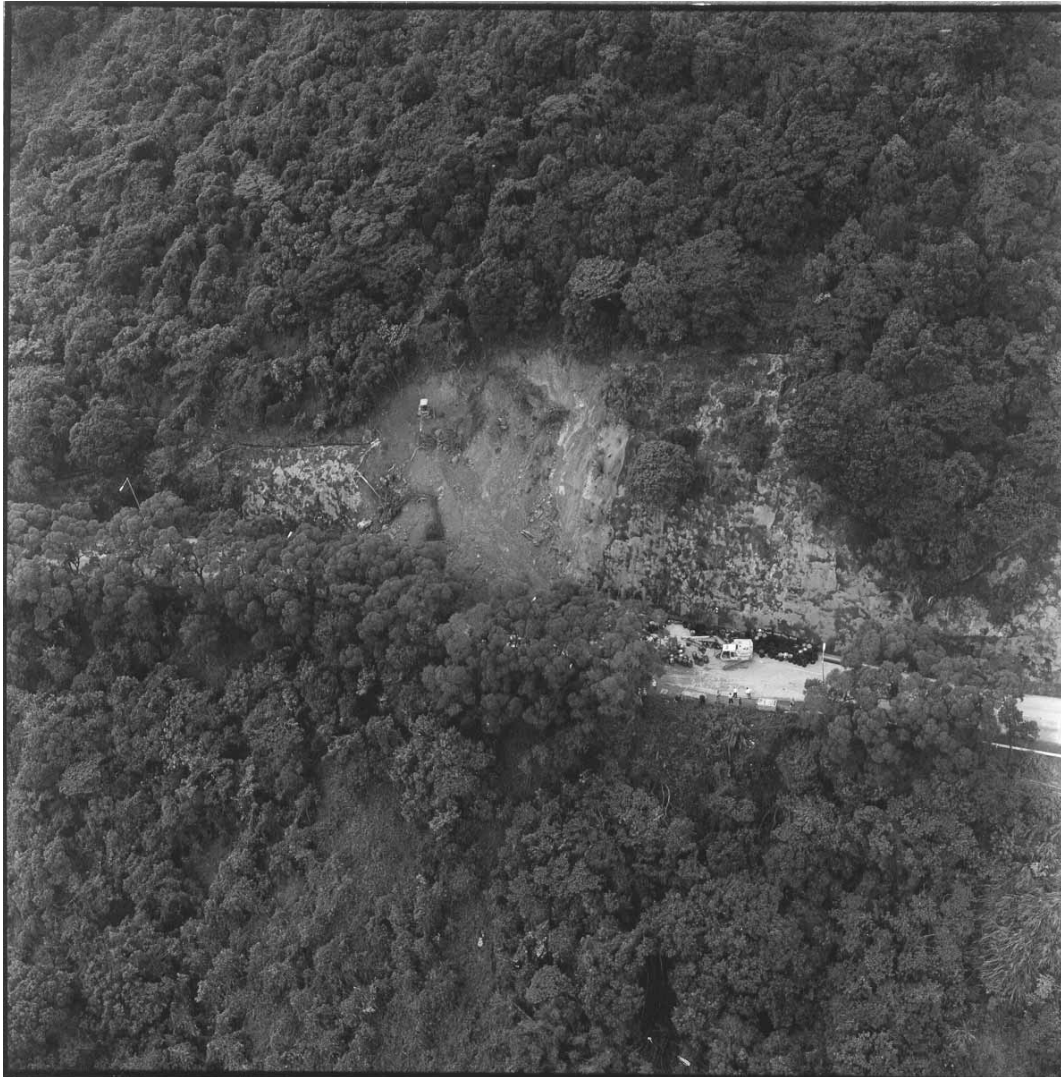
Plate 4 - General View of the Landslide Scar (Photograph Taken on  
25 August 1999)

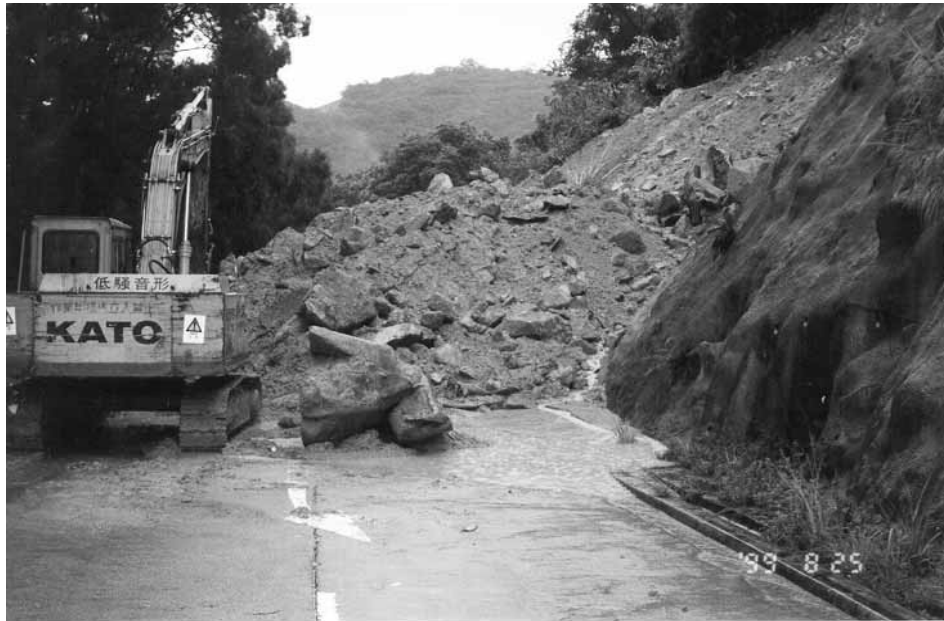
Plate 5 - View East along South Lantau Road towards Debris Mound.  
Note Boulder and Cobble Content of Debris and Angle of  
Repose ( $20^{\circ}$  to  $25^{\circ}$ ) (Photograph Taken on 25 August 1999)

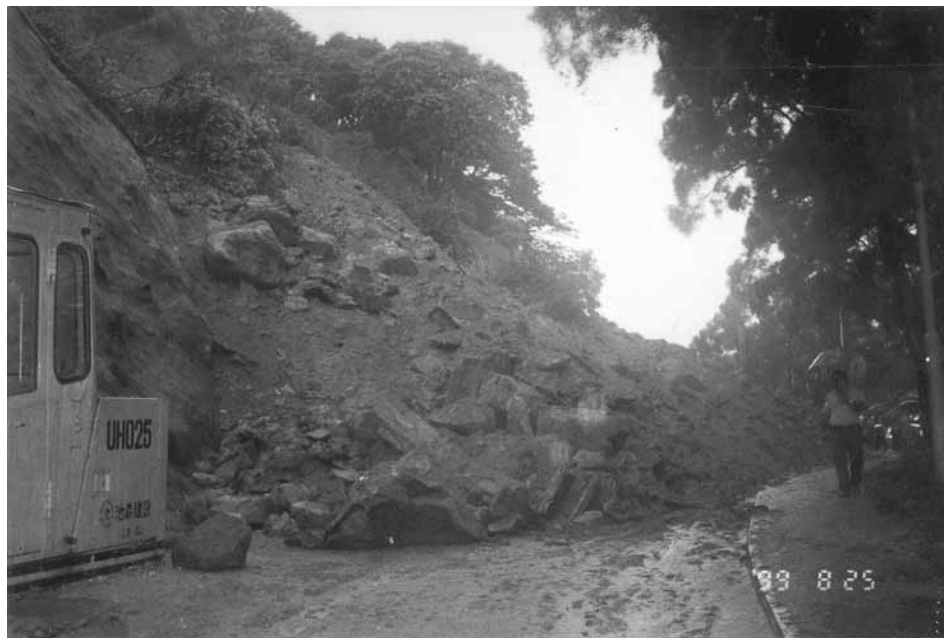
Plate 6 - View West along South Lantau Road. Debris Reposed at  
Approximately  $20^{\circ}$  to  $25^{\circ}$  (Photograph Taken on 25 August 1999)

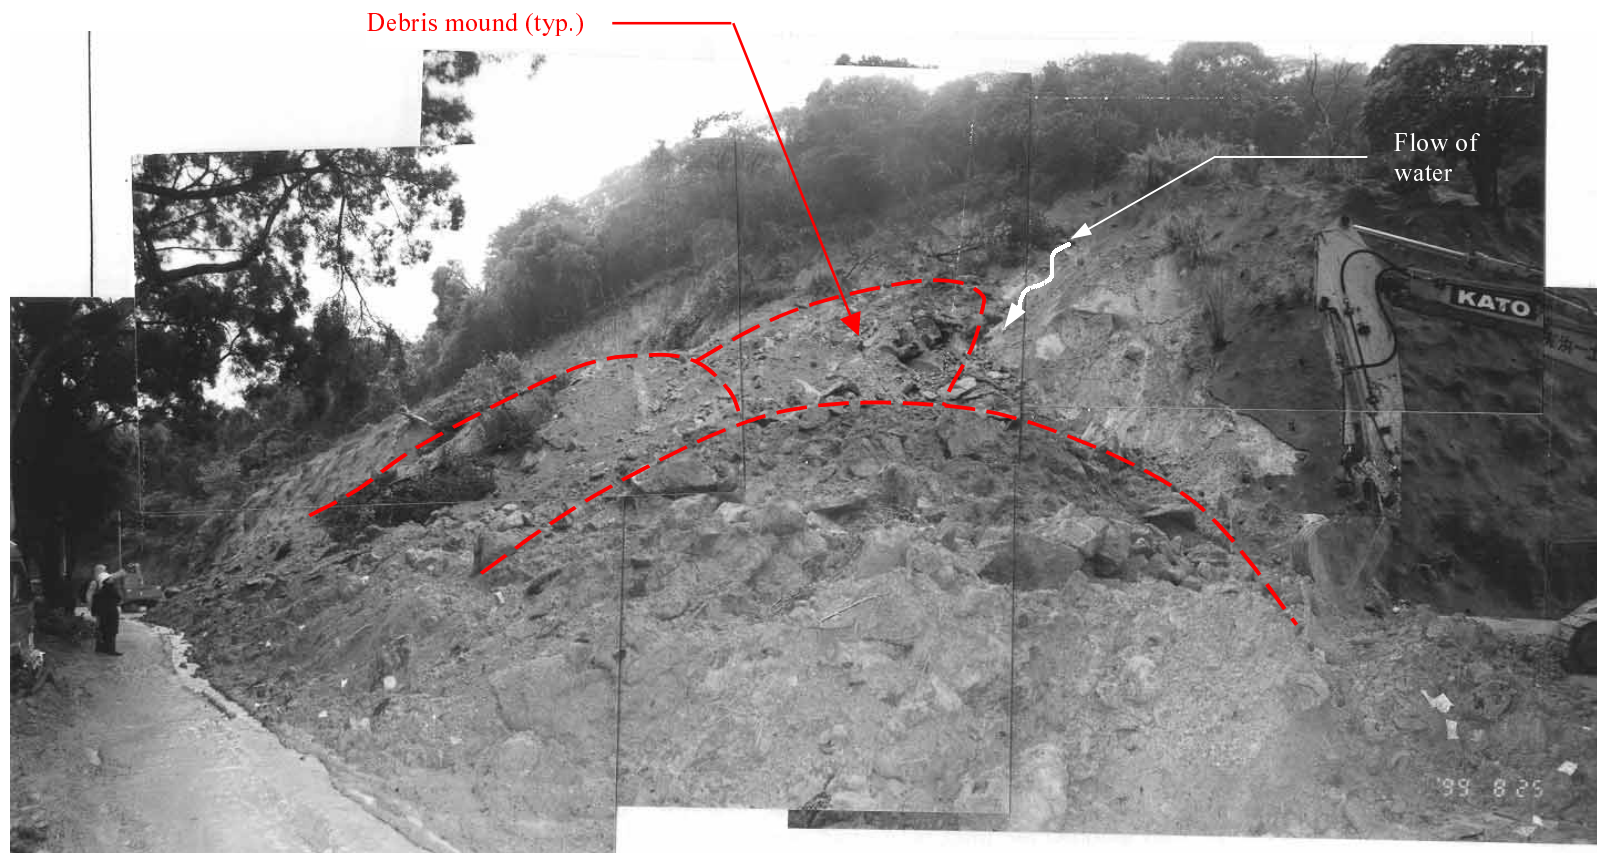
Plate 7 – General View South-East towards Landslide Scar. Note Form of Debris as a Number of Semi-Discrete Mounds (Indicated). Flow of Water Into Scar at Location Indicated. South Lantau Road Footpath Has Been Cleared of Debris (Photograph Taken on 25 August 1999)

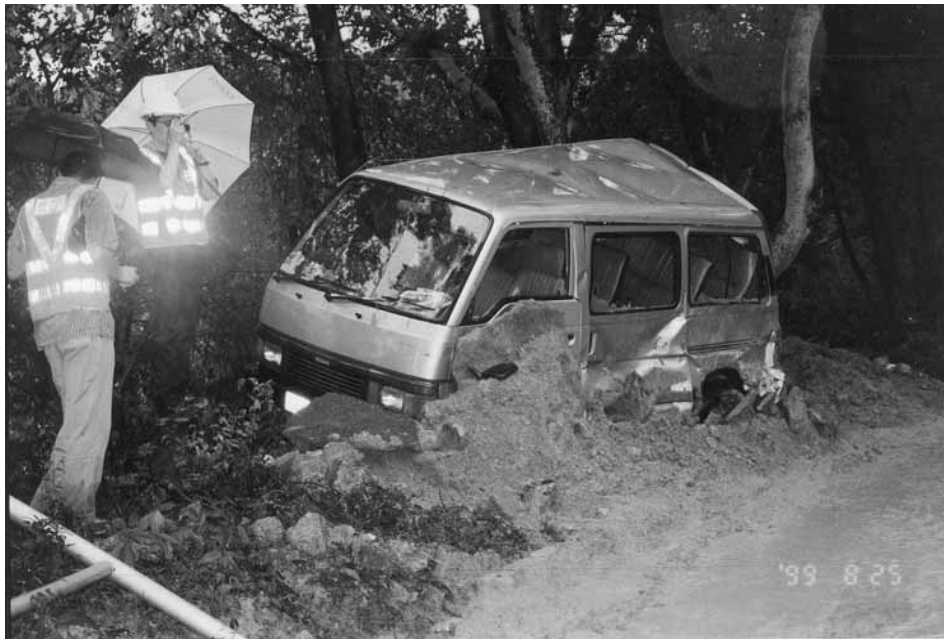
The landslide site was inspected by representatives of the GEO and HyD at about 3:00 p.m. on 24 August 1999. The GEO Incident Report noted blocked/broken drains at the slope crest and groundwater seepage at the failure location. The FMSW inspection team visited the site at about 11:00 a.m. on 25 August 1999. At this time, a temporary track had been cleared through the debris along the toe of the mound to permit the passage of vehicles, initial trimming works were being carried out at the main scarp and excavation plant had been assembled for further clearance works (Plate 7). The damaged vehicle is shown in Plate 8. The damage caused by the landslide to the bus shelter is less certain, as the observed condition (Plate 8) may have been caused by excavation plant.

Plate 8 - Vehicle Impacted by Landslide Debris. Bus-Stop Shelter  
Damaged by Landslide Visible in Foreground (Photograph  
Taken on 25 August 1999)

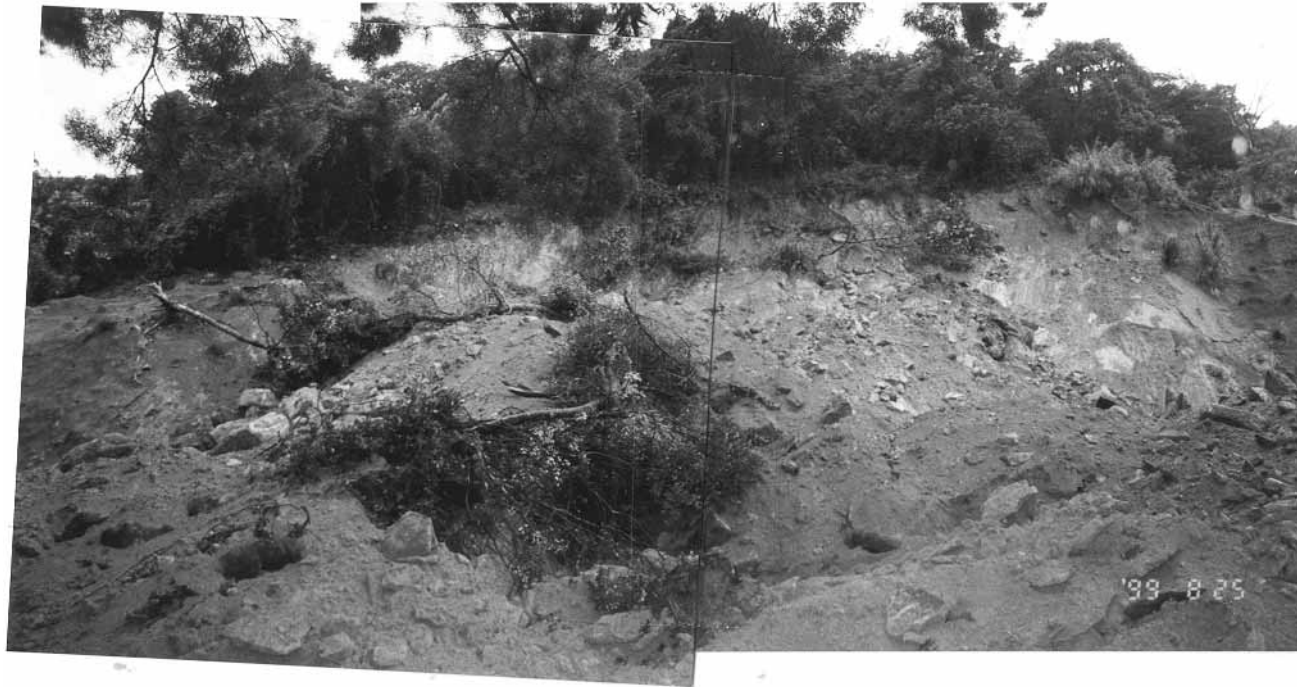
Plate 9 – View South towards Landslide Scar. Note Semi-Discrete Debris Mounds Comprising Predominantly Reddish-Brown Saprolite (Photograph Taken on 25 August 1999)

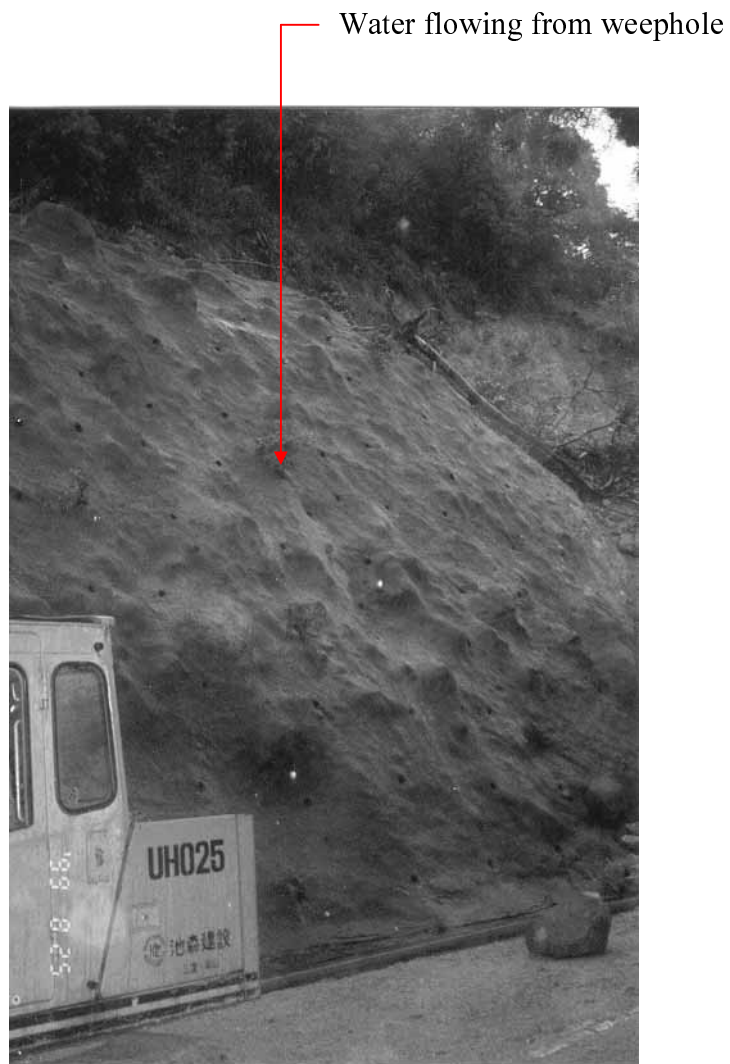
Plate 10 - Intact Portion of Shotcreted Slope beyond Eastern Flank of Scar.  
Note Muddy Water Flowing from Weephole (Indicated)  
(Photograph Taken on 25 August 1999)

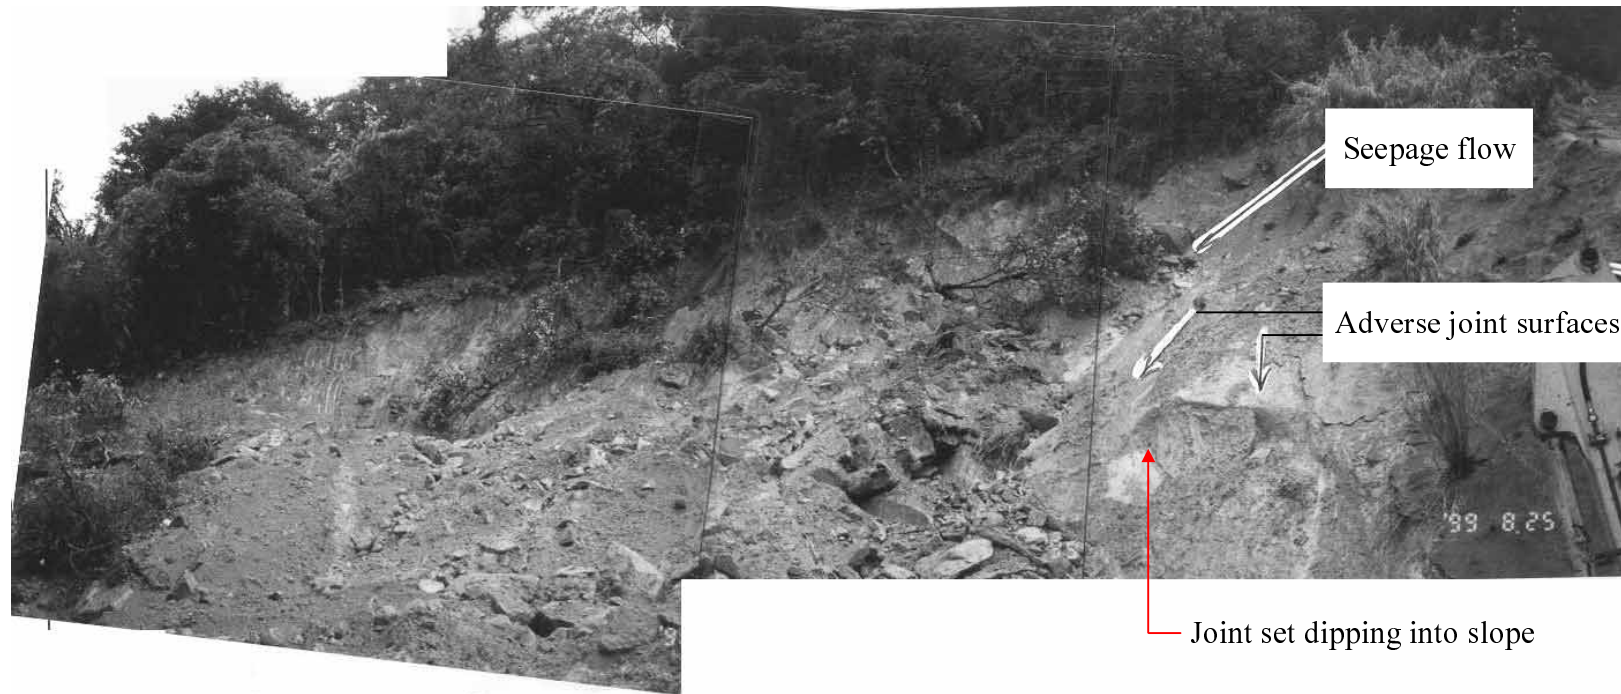
Plate 11 – View South-East towards Upper Portion of Landslide Scar and Main Scarp. Note Adverse Joint Surfaces on Corestone Exposed beneath Shotcrete on Right of Frame. Note also Joint Set Dipping into Slope Face Providing Release Plane. Flow of Water into Scar at Location Indicated (Photograph Taken on 25 August 1999)

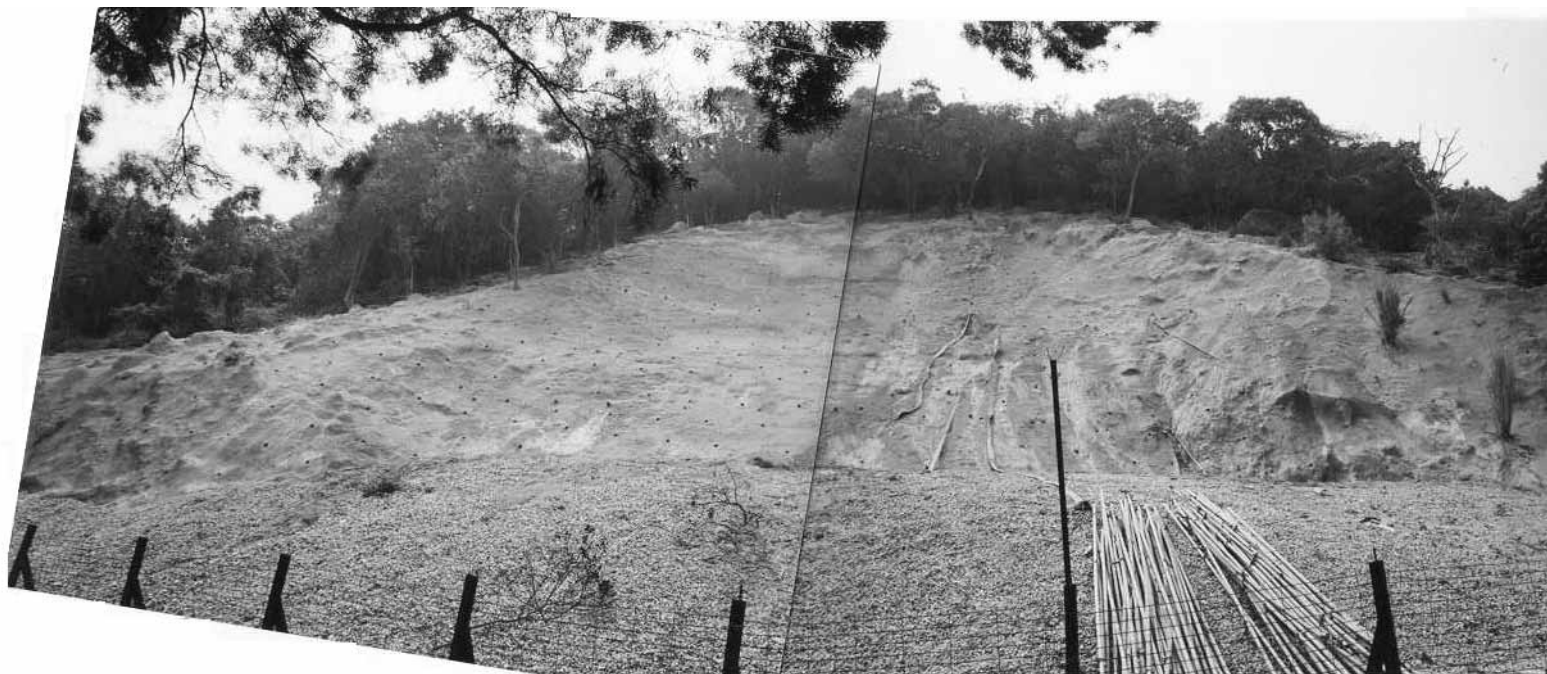
It is noteworthy that the seepage from the scar continued following the failure (Plate 12) and was still present at the completion of the post-landslide ground investigation in mid-November 1999.

Plate 12 – View South towards Shotcreted Landslide Scar. Note Continued Seepage of Water from Weepholes and Horizontal Drains (Photograph Taken on 20 September 1999)

Urgent repair works carried out by HyD at the recommendation of the GEO included trimming of the main scarp, which extended the scar a further 10 m upslope, removal of debris and application of a shotcrete surfacing with weepholes. A surface drainage channel was constructed along the slope crest and a rockfill toe berm was provided to a height of about 7 m along the slope toe over a distance of 110 m. Following completion of these works, the east-bound lane of South Lantau Road was opened to traffic on 4 September 1999.

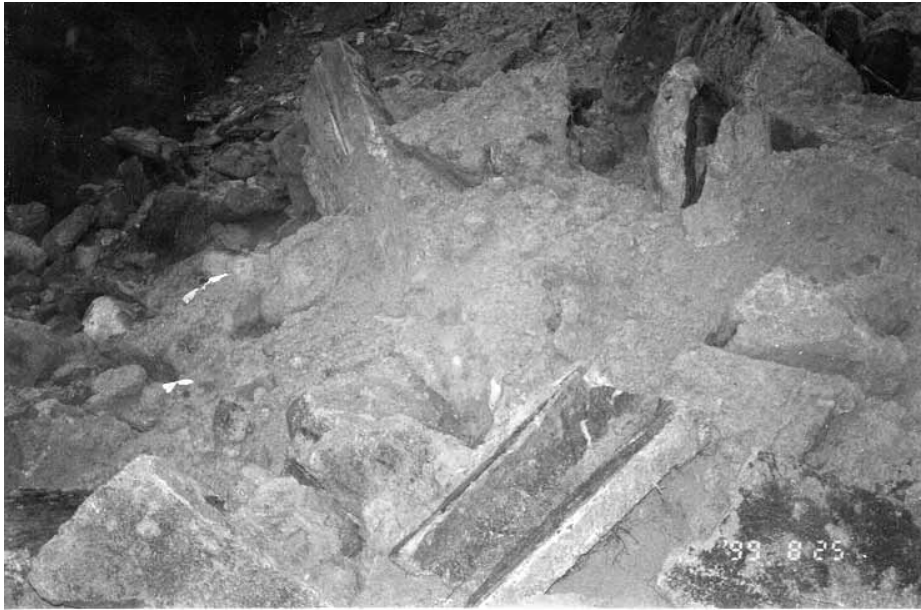
Plate 13 - Close-up of Debris at Eastern End of Mound Showing Broken Sections of U-Channel and Hard Surfacing (Photograph Taken on 25 August 1999)

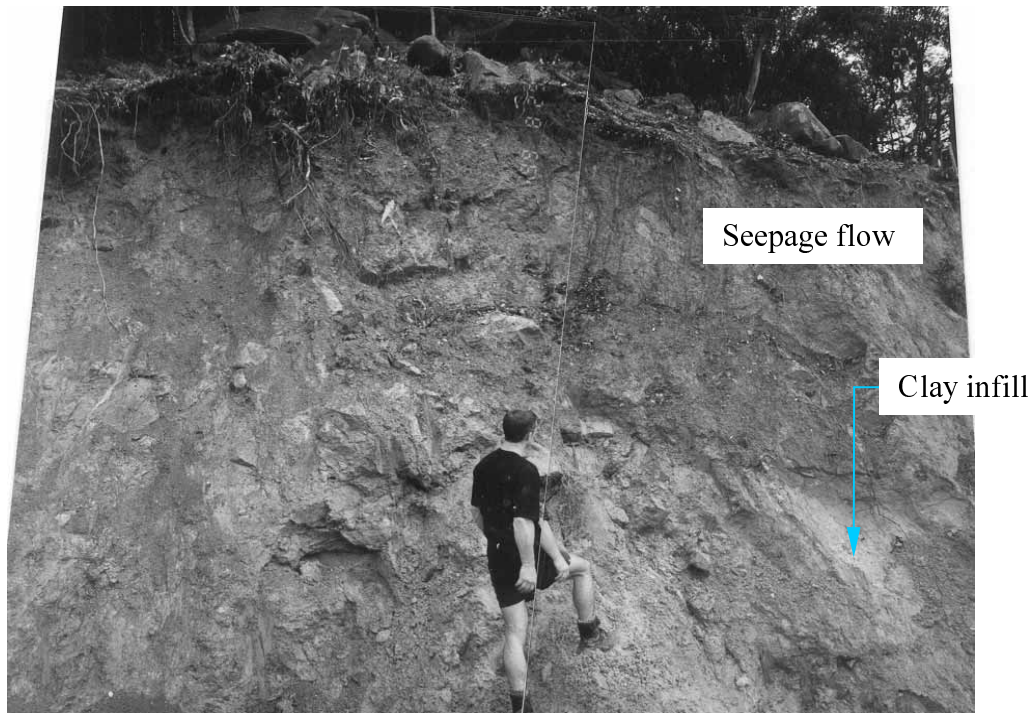
Light brown silty clay infill was observed on a number of relic joint surfaces exposed in the scar (Plates 14, 15 and 17), as well as on boulders contained in the landslide debris (Section 4.3). This material had a soft to firm consistency at the time of inspection.

Plate 14 - View of Central Portion of Main Scarp. Seepage at Location Indicated. Clay Infilled Joint Visible on Right of Frame (Photograph Taken on 29 August 1999)

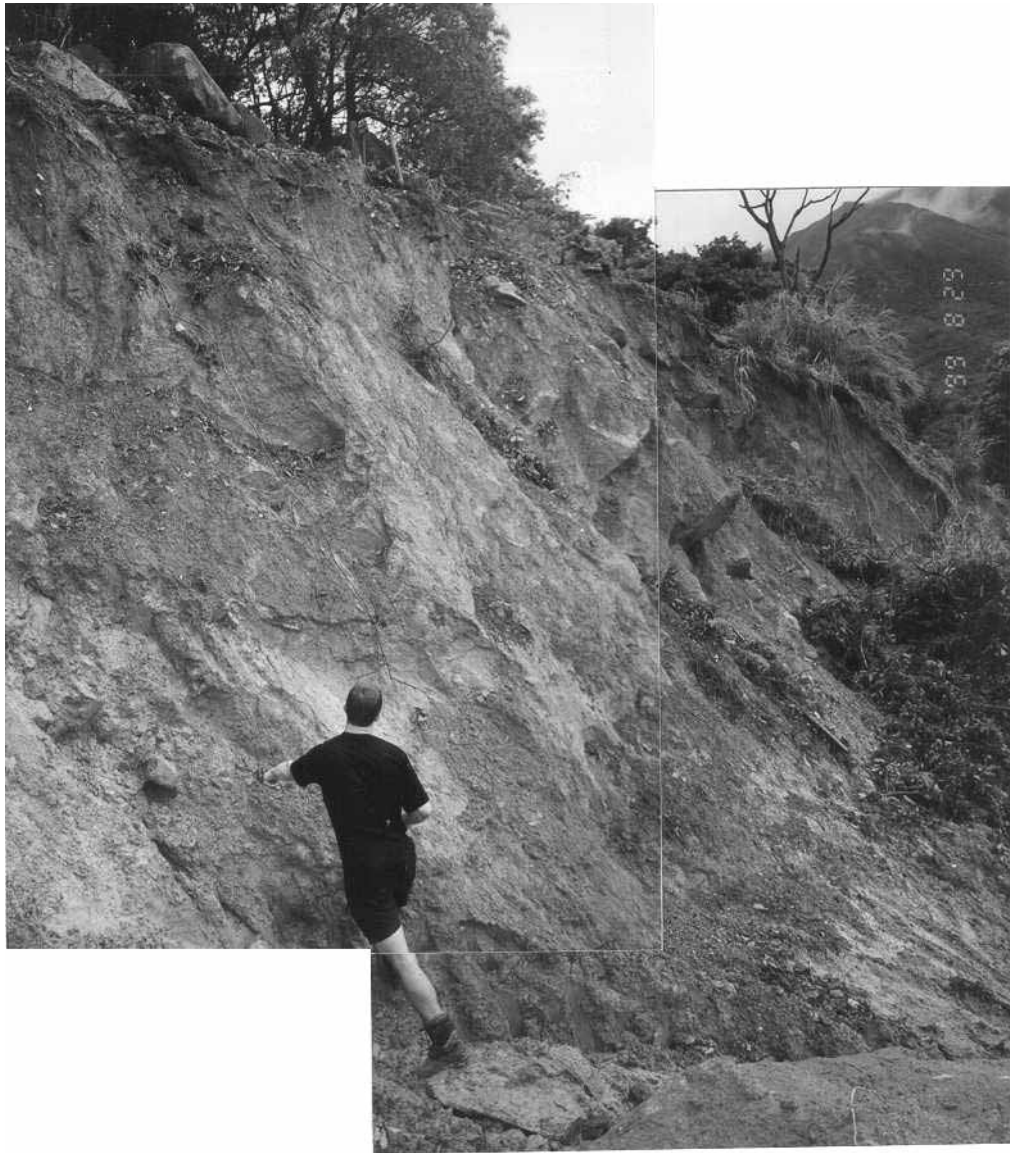
Plate 15 - View of Western Portion of Main Scarp. Adverse Relic Jointing and Light-Brown Clay Infill on Exposed Joints Visible (Photograph Taken on 29 August 1999)

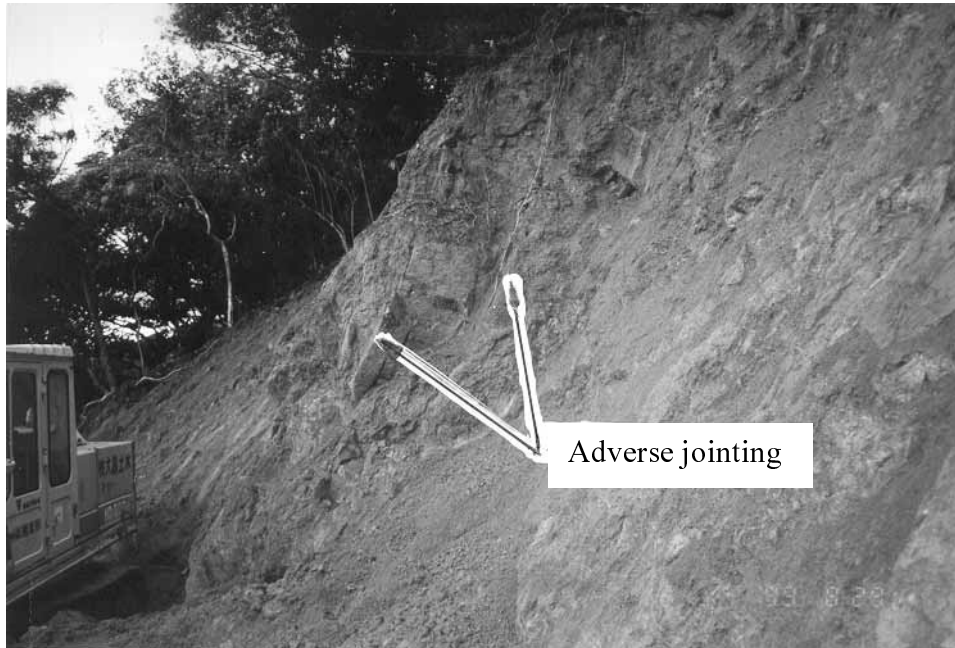
Plate 16 – View of Eastern Portion of Trimmed Main Scarp. Steep Adverse Joint Surfaces Indicated (Photograph Taken on 29 August 1999)

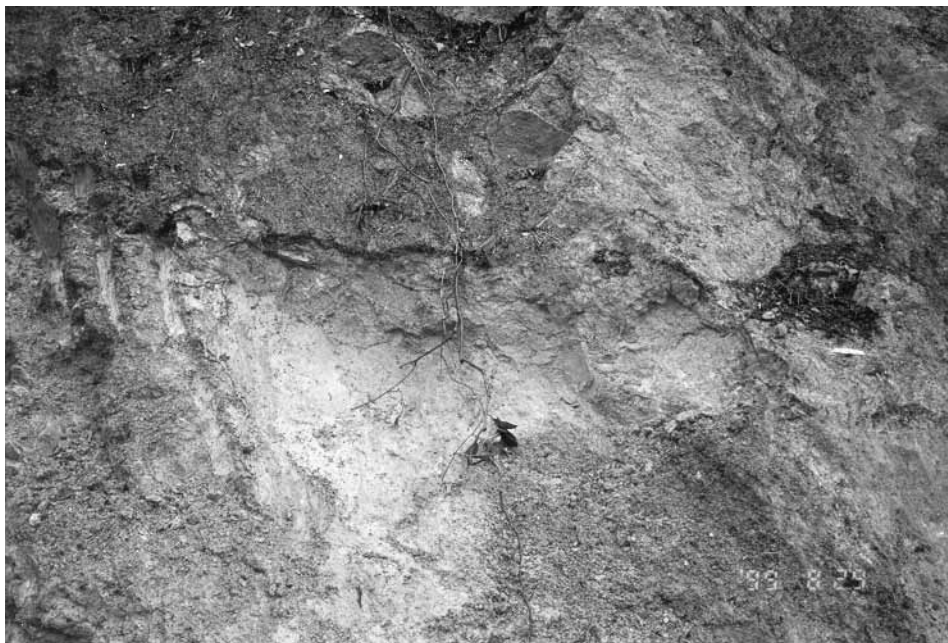
Plate 17 - Close-up of Clay Infilled Joint Exposed in Main Scarp (Photograph Taken on 29 August 1999)

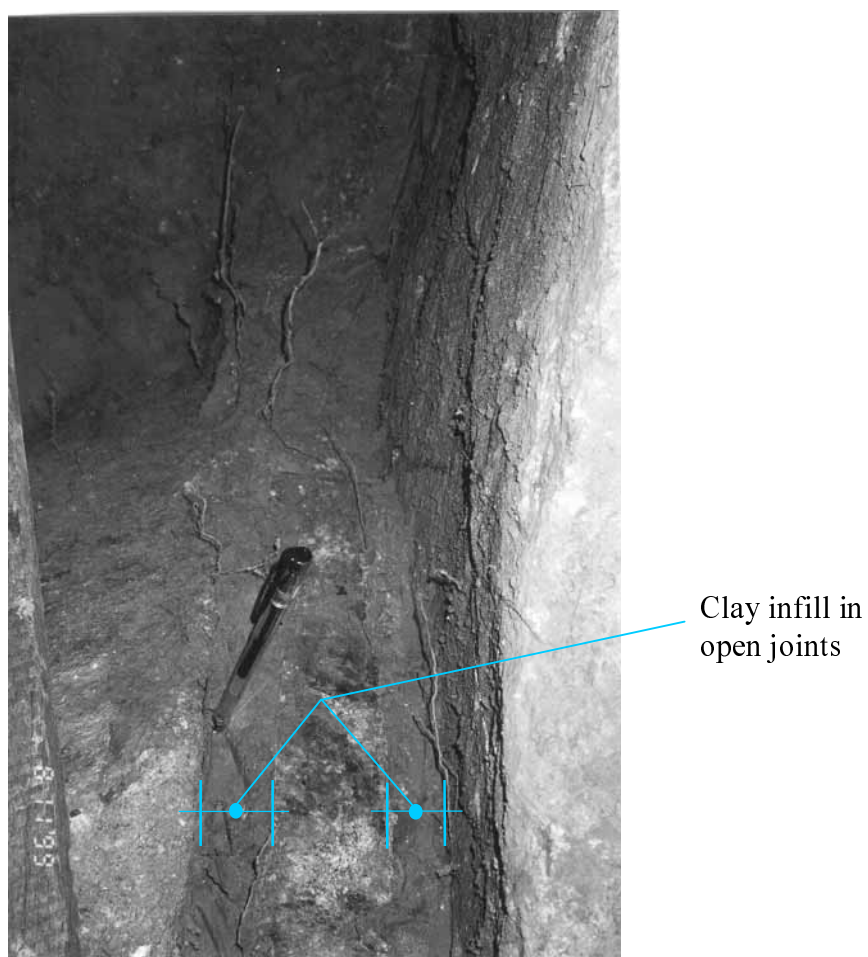
Plate 18 - Trial Pit TP2: Example of Clay Infill in Open Relic Joints (Possible Tension Features), Grade IV Quartz Syenite (Photograph Taken on 8 November 1999)

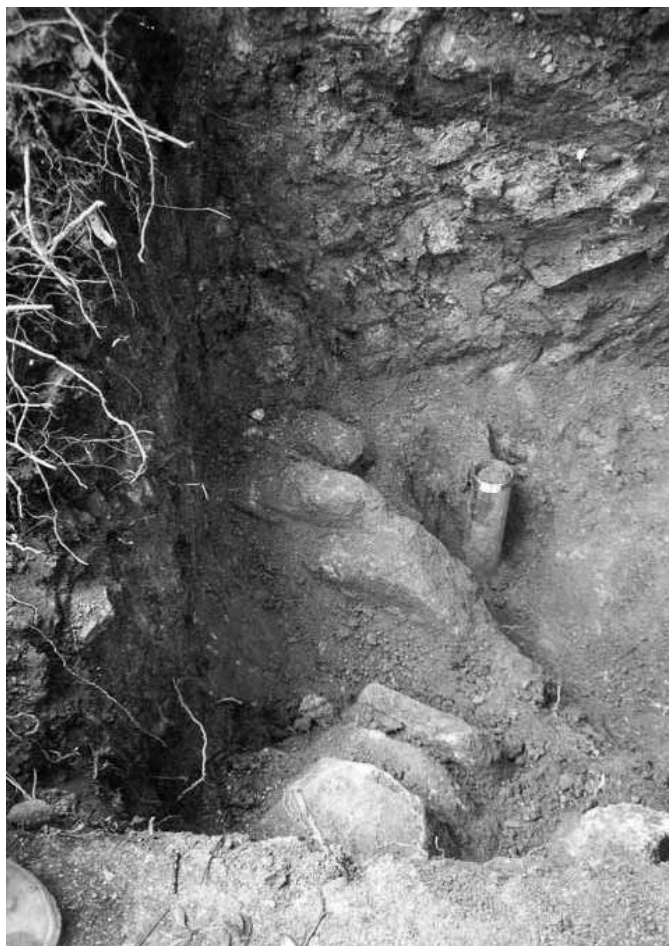
Plate 19 - Grade III/IV Quartz Syenite Exposed in Trial Pit TP2 with Closely to Very Closely Spaced, Saprolite Infilled Joints (Possible Tension Features) (Photograph Taken on 29 October 1999)

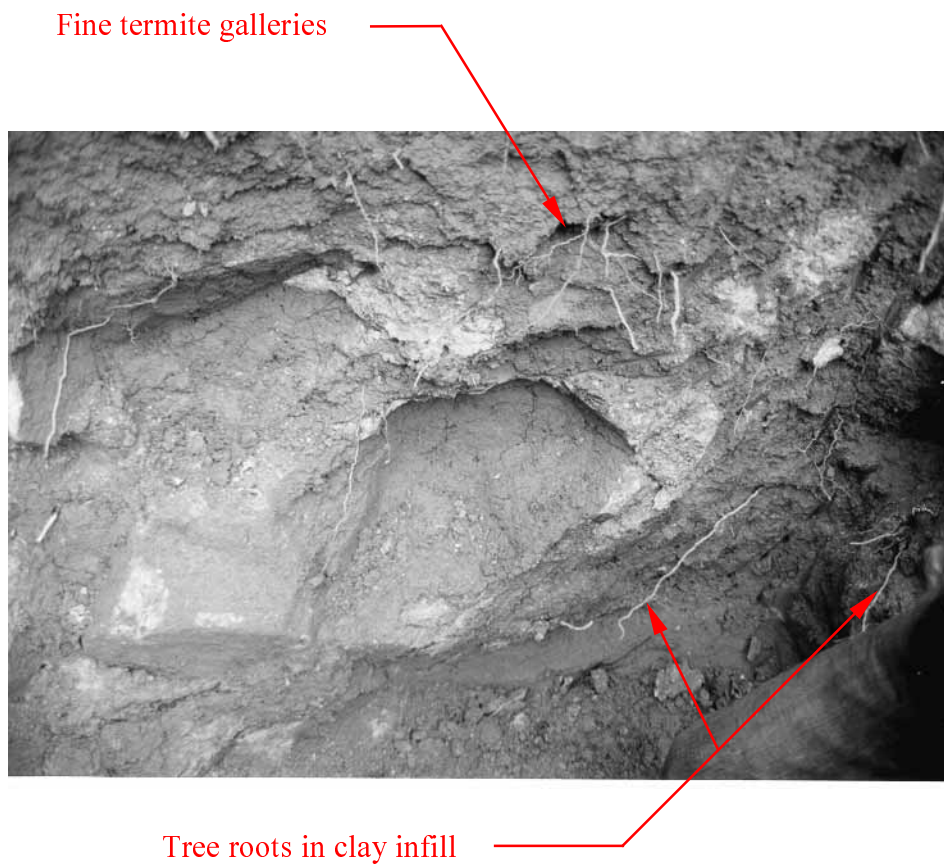
Plate 20 - Trial Pit TP5: Example of Clay Infill Surrounding Corestones in Weathered Rock Mass. Note also Fine Termite Galleries and Penetration of Tree Roots (Indicated) (Photograph Taken on 29 October 1999)

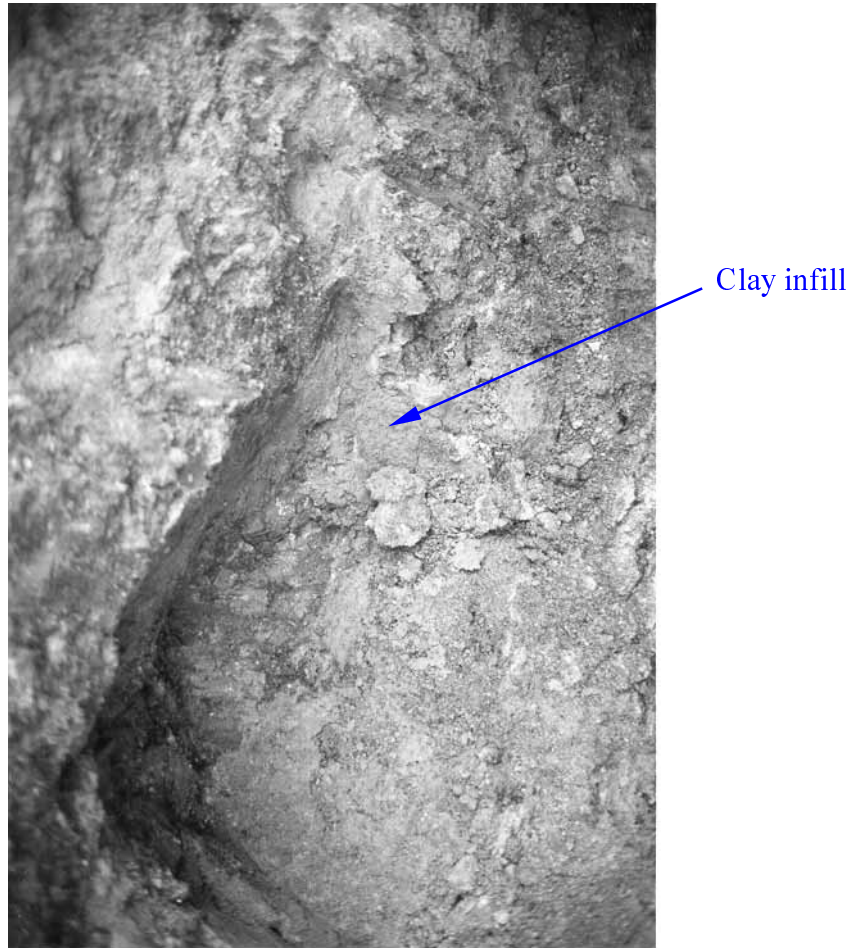
Plate 21 - Trial Pit TP4: Example of Light Brown Clay Infill Surrounding Corestones in Weathered Rock Mass (Indicated) (Photograph Taken on 29 October 1999)
