# **INVESTIGATION OF SOME SELECTED LANDSLIDES IN 1999 (VOLUME 1)**

**GEO REPORT No. 120**

**Fugro Maunsell Scott Wilson Joint Venture**

**GEOTECHNICAL ENGINEERING OFFICE  
CIVIL ENGINEERING DEPARTMENT  
THE GOVERNMENT OF THE HONG KONG  
SPECIAL ADMINISTRATIVE REGION**

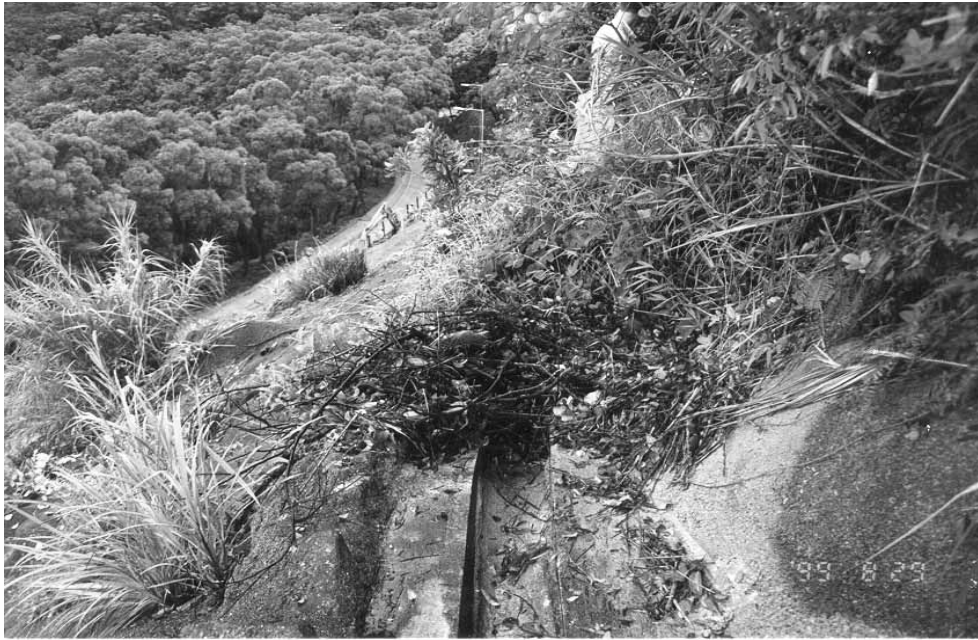
No obvious signs of further instability were observed in the hillside above the landslide scar. The crest drainage channel was totally blocked by dead vegetation a few metres to the west of the landslide scar (Plate 22). Instances of previous instability (see Section 3.2) were observed in the adjacent slope face (Plates 23 and 24).

Plate 22 - Vegetation Blocking Crest U-Channel beyond Western Flank of Scar. Fall of Channel is away from Camera (Photograph Taken on 29 August 1999)

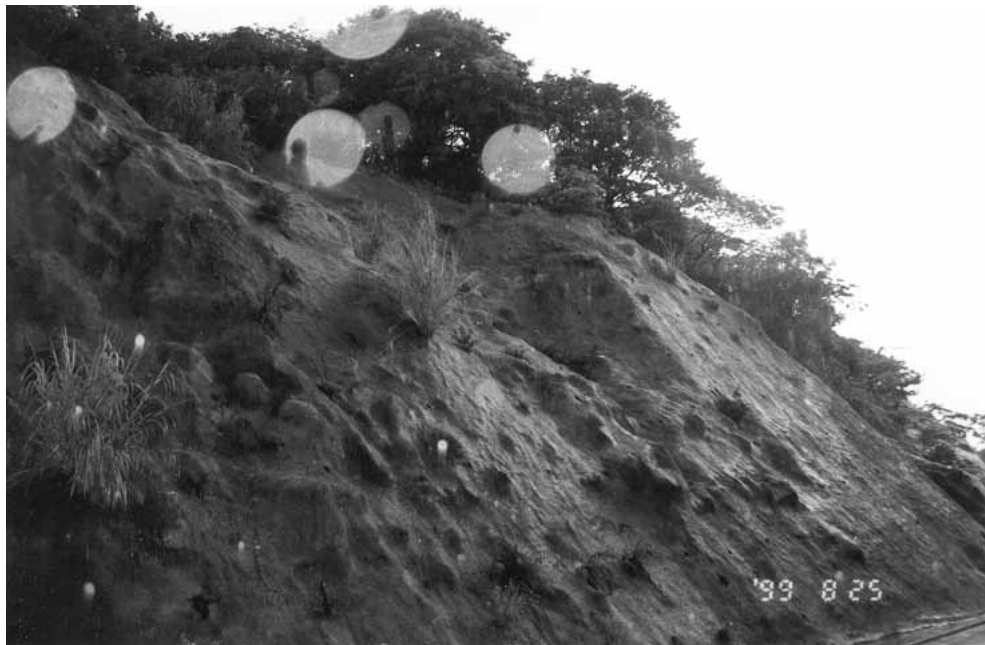
Plate 23 - View South-West towards Pre-Existing Wedge-Shaped Landslide Scar in Slope West of Present Failure. Note also Boulders and Cobbles Visible in Shotcreted Slope Face (Photograph Taken on 25 August 1999)

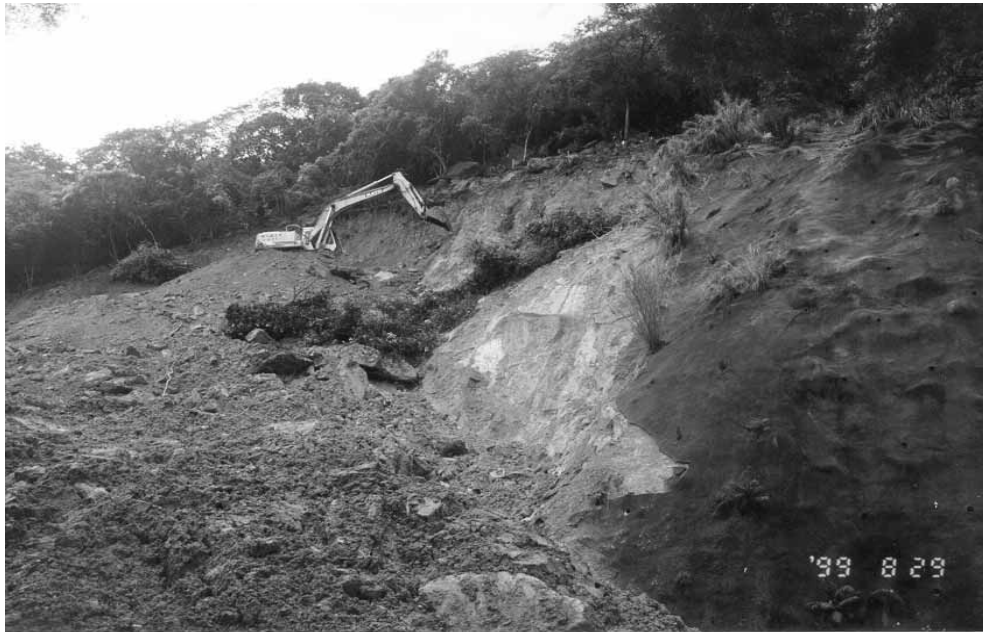
Plate 24 - View South-East along Western Flank of Scar. Adverse Joint Orientations Coincident with Previous Scar Visible in Centre-Right of Frame (Photograph Taken on 29 August 1999)

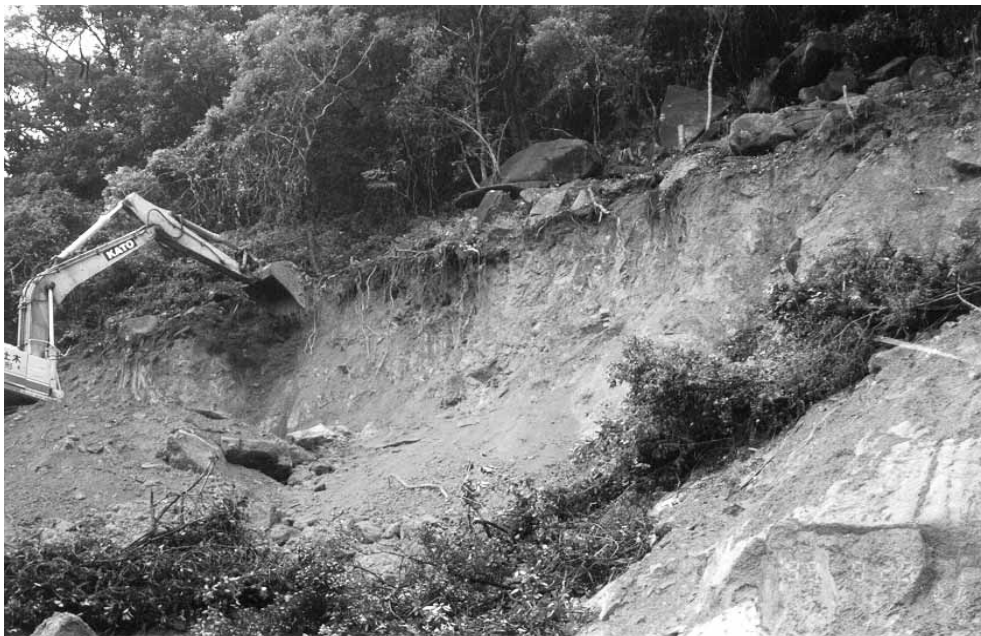
Plate 25 - View of Trimming Works in Eastern Portion of Scar. Note Large Number of Boulders Exposed on Hillside above (Photograph Taken on 29 August 1999)

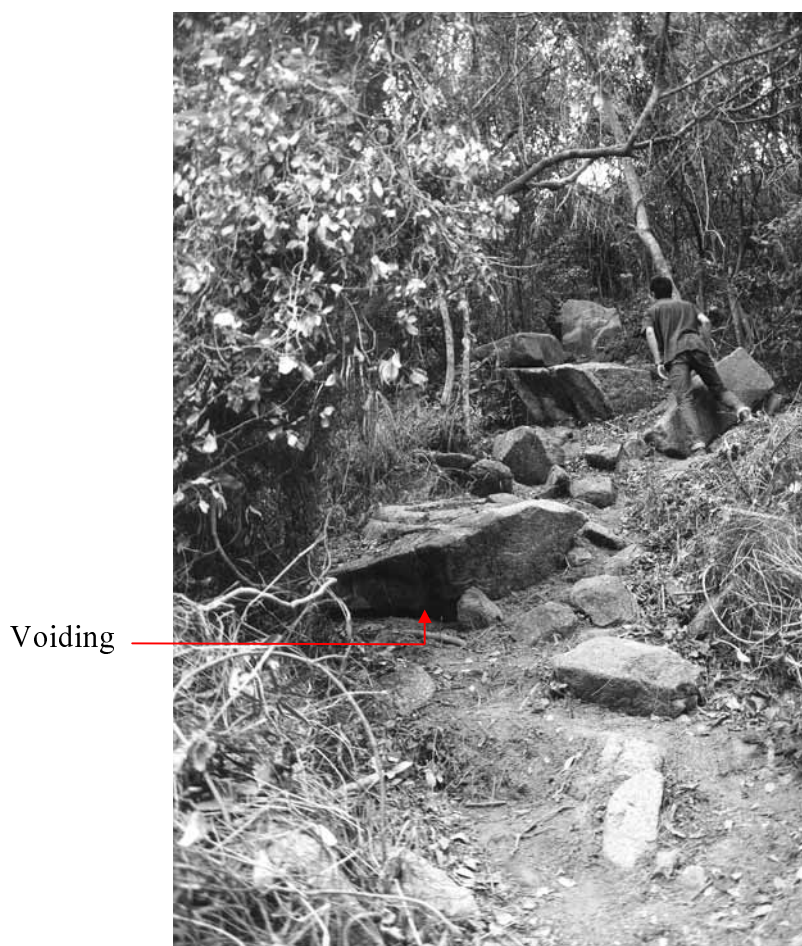
Plate 26 - Surface Strip SS2: Arrangement of Boulders and Cobbles on Natural Hillside above Landslide Scar. Note Void beneath Boulder in Foreground (Indicated) (Photograph Taken on 29 October 1999)

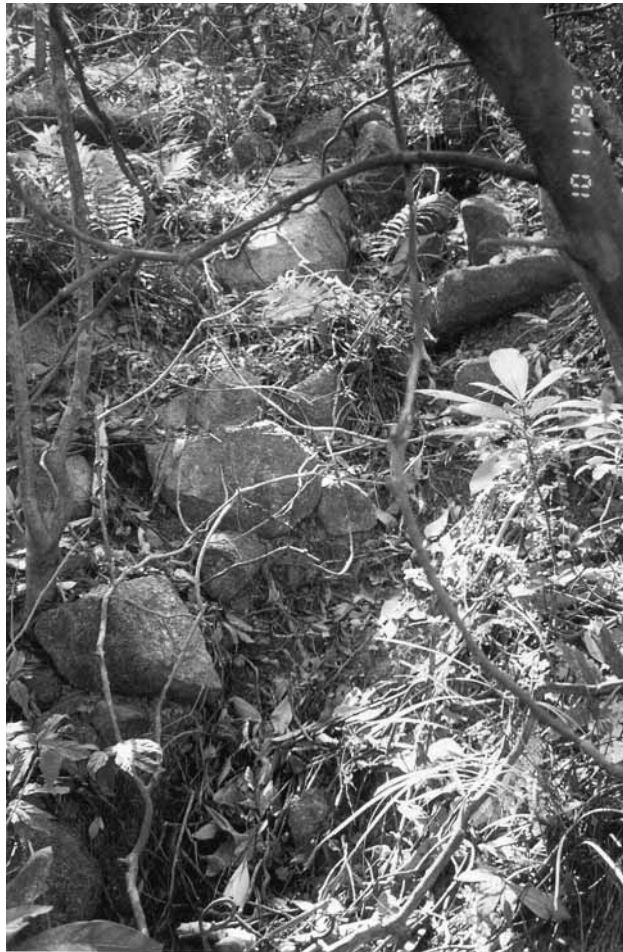
Plate 27 - Example of Erosion Channel around Boulders on Hillside above Scar (Photograph Taken on 20 November 1999)

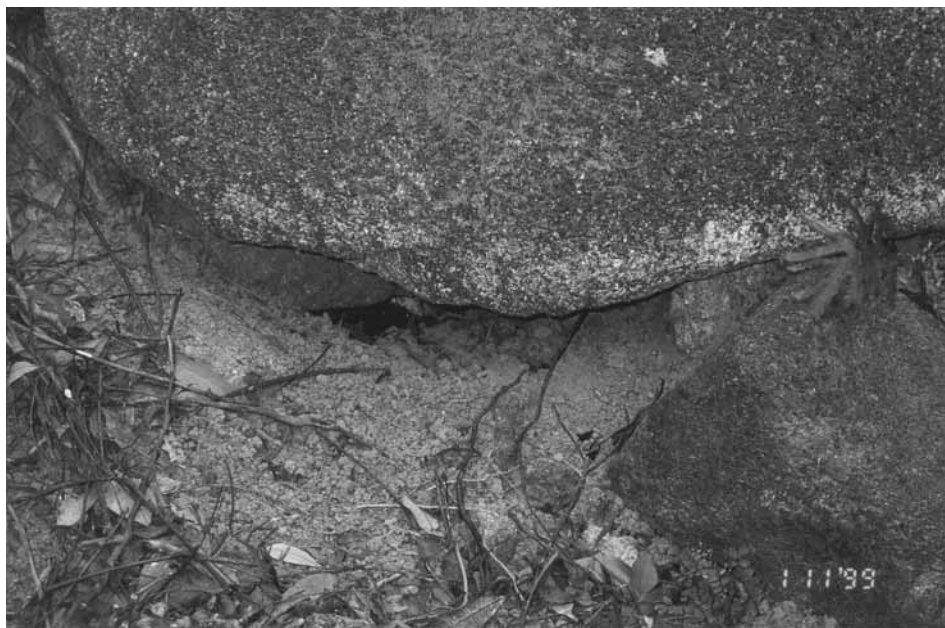
Plate 28 - Voiding beneath Exposed Boulder/Corestone on Hillside behind Scar (Photograph Taken on 1 November 1999)

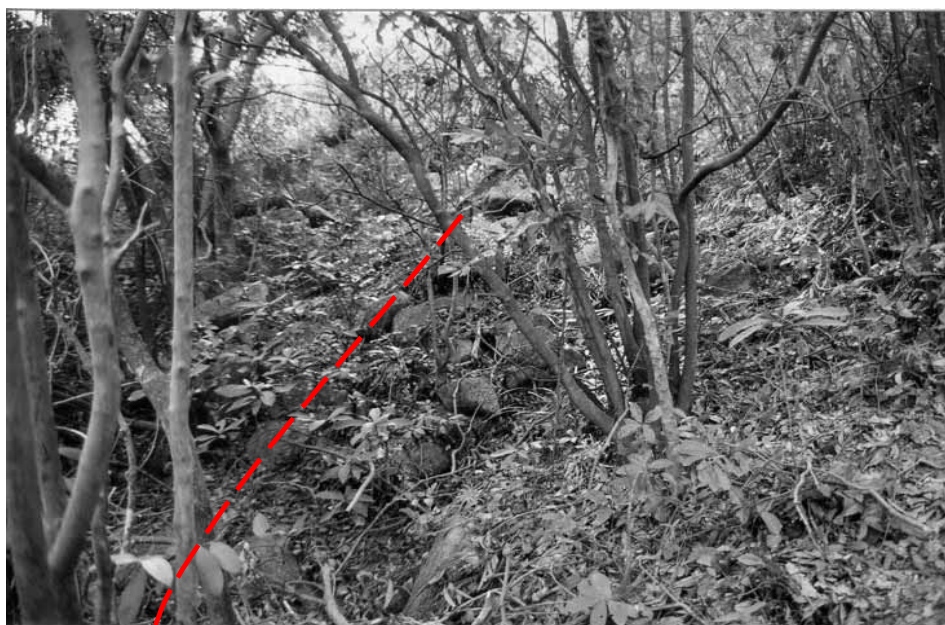
Plate 29 - Exposed Boulders on Natural Hillside above Landslide Scar. Possible Channel Indicated (Photograph Taken on 29 October 1999)

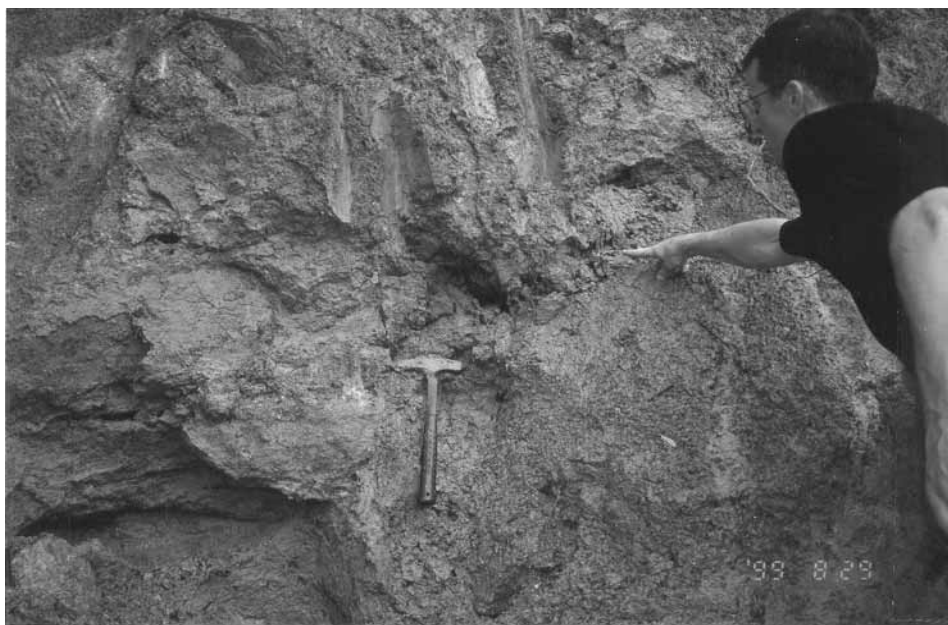
Plate 30 - Concentration of Termite Galleries/Erosion Pipes along Interface of Grade V Material with Underlying Corestone (Bedrock?) in Central Portion of Main Scarp (Photograph Taken on 29 August 1999)

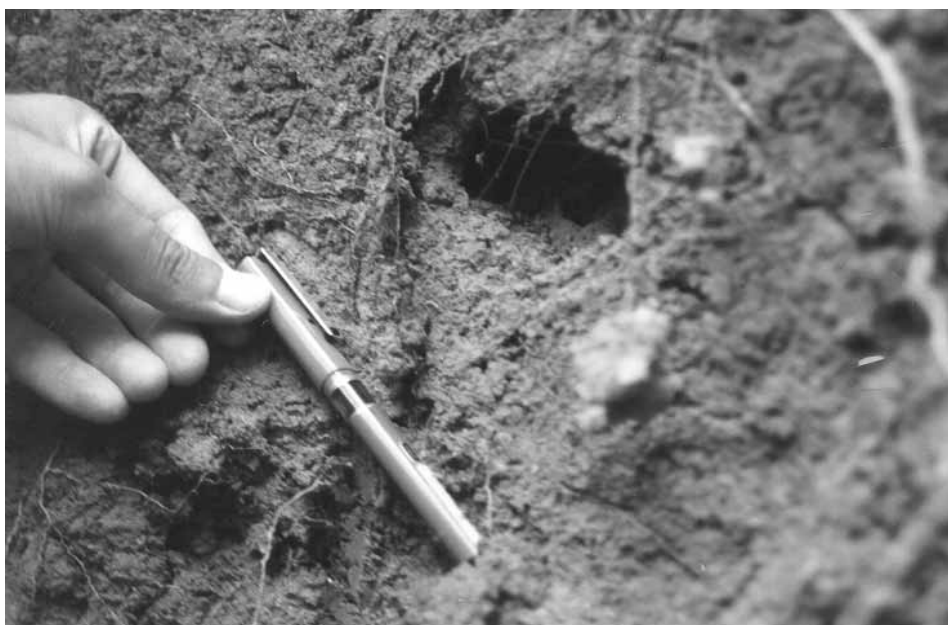
Plate 31 - Example of Termite Gallery/Erosion Pipe Exposed in Grade V Quartz Syenite (Photograph Taken on 29 October 1999)

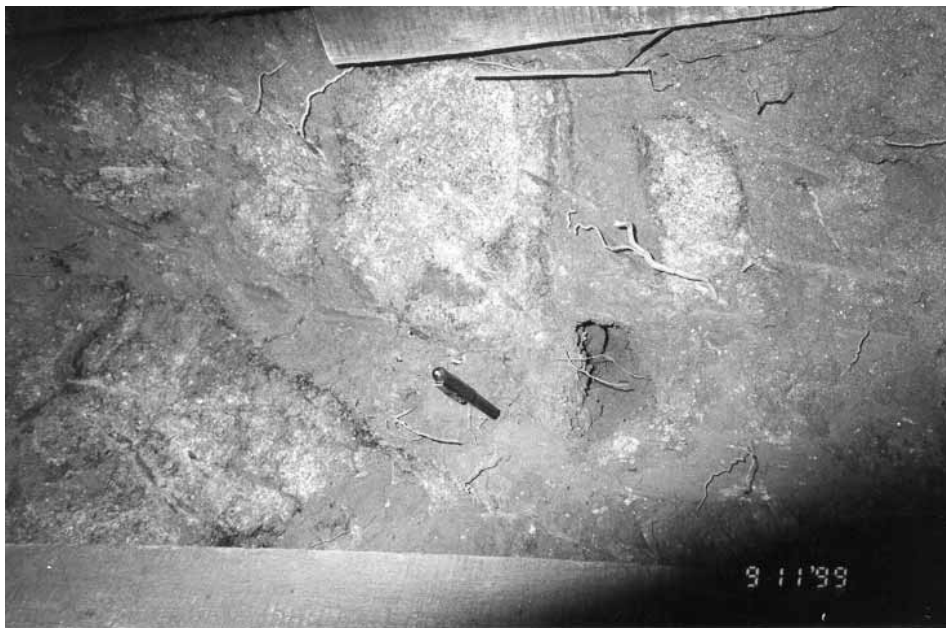
Plate 32 - Trial Pit TP1: Example of Clay Infill in Open Relic Joints with Large Termite Gallery/Erosion Pipe Exposed (Photograph Taken on 9 November 1999)

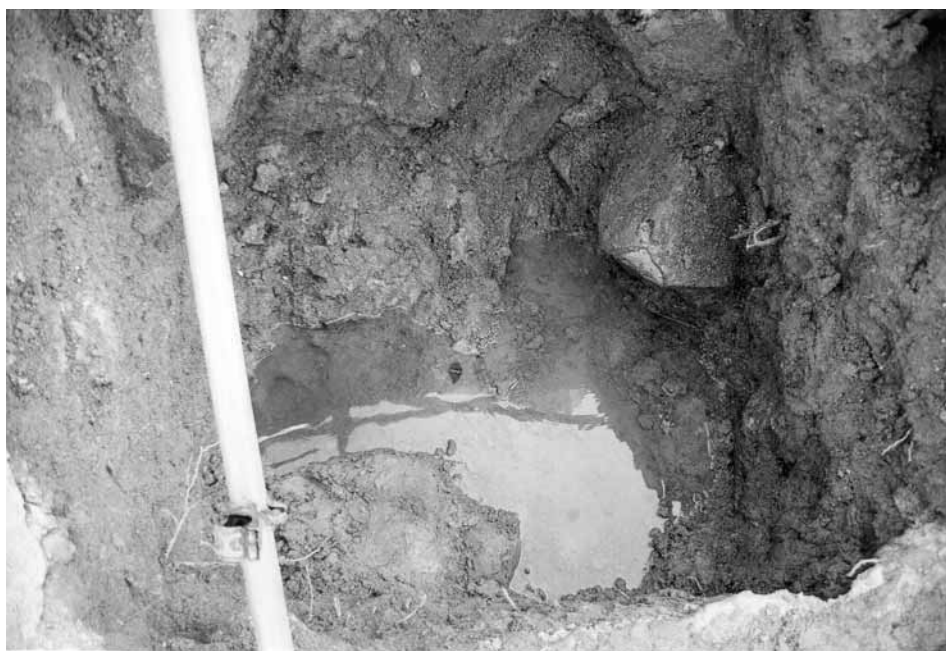
Plate 33 - Trial Pit TP4: Seepage Ponding in Base of Pit (Photograph Taken on 29 October 1999)
