**SECTION 2:  
DETAILED STUDY OF THE  
23 AUGUST 1999  
LANDSLIDE AT ROUTE TWISK  
OPPOSITE THE LOOKOUT  
POINT NEAR SHEK KONG**

**Fugro Maunsell Scott Wilson Joint Venture**

**This report was originally produced in August 2000  
as GEO Landslide Study Report No. LSR 5/2000**

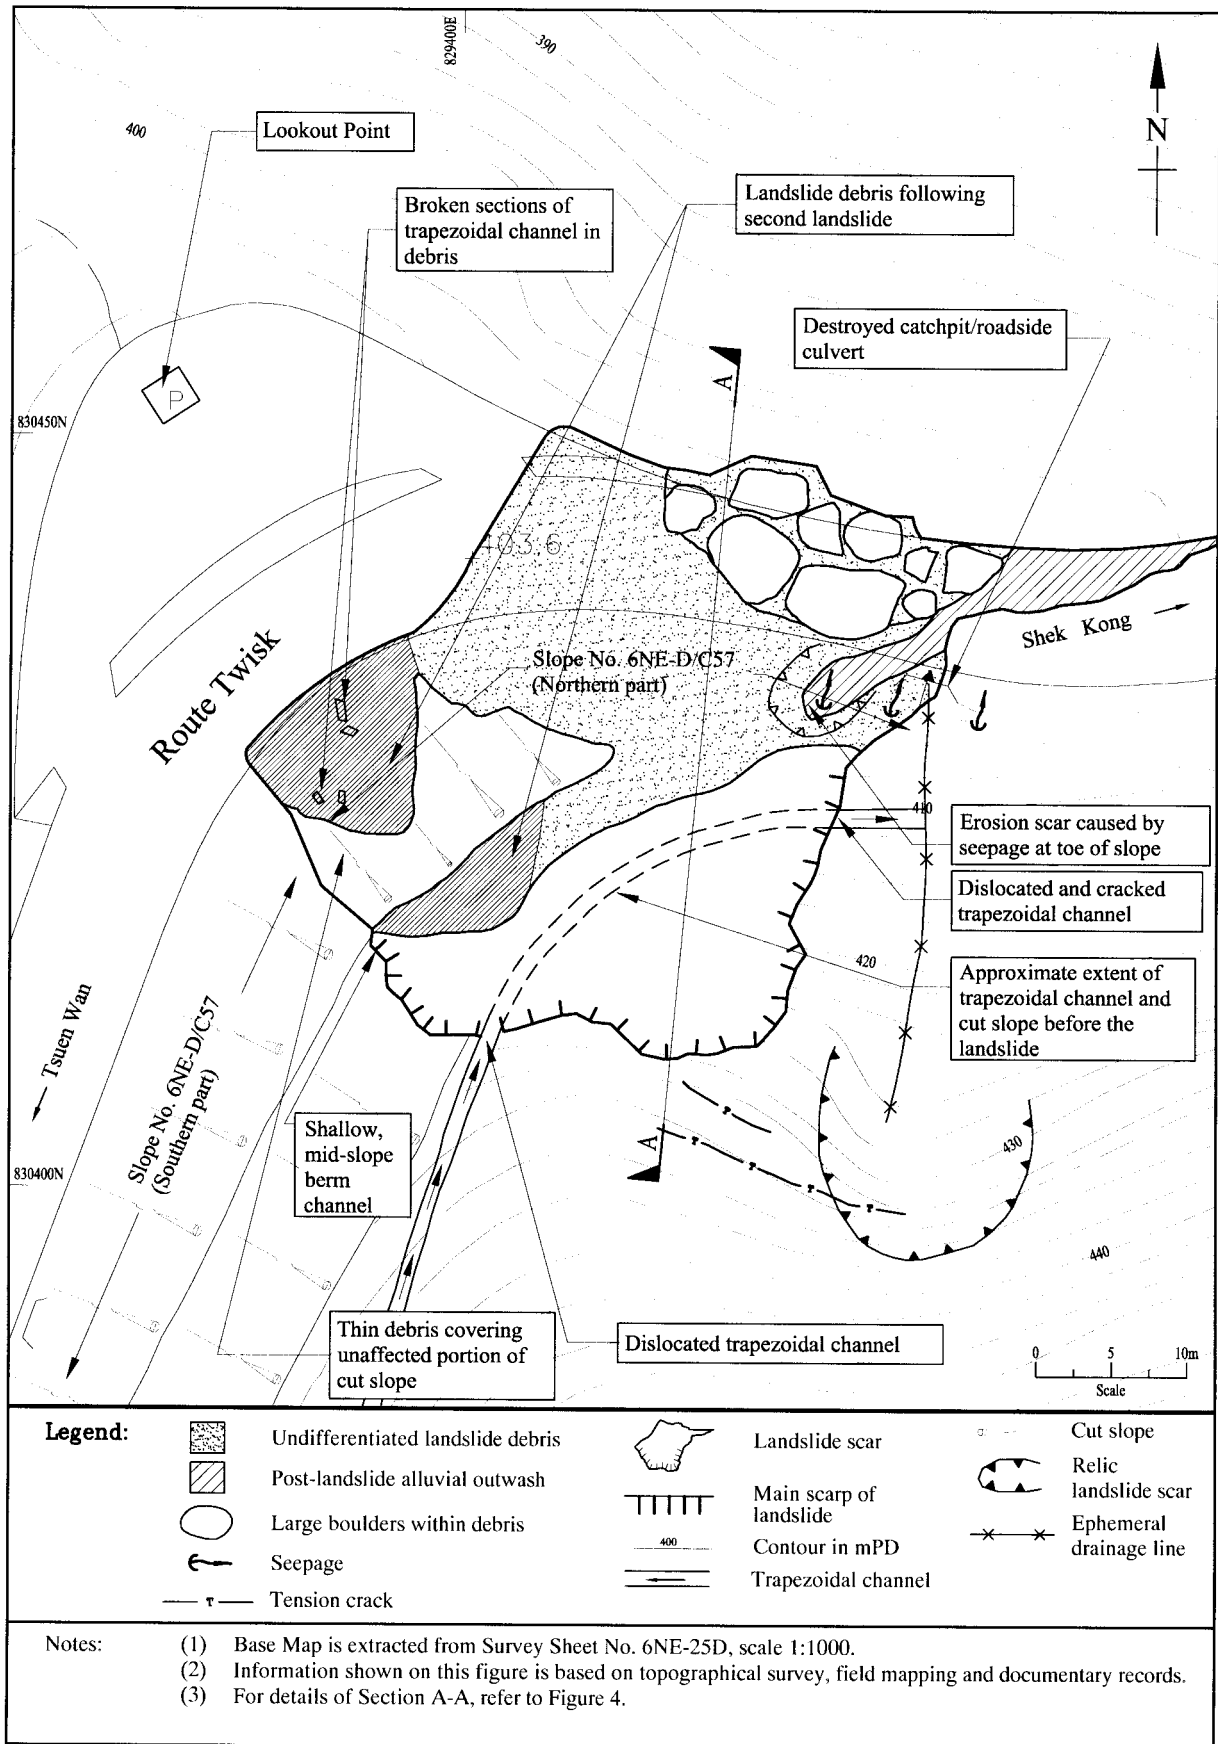
Figure 2 - Plan of the Landslide

A scar, formed by post-landslide erosion, was located on the lower eastern flank of the landslide adjacent to the roadside culvert (Figure 2). Seepage flows were observed by FMSW along joints in the rock mass (PW50/90) exposed within the erosion gully up to 4 m above the slope toe (Figure 2 and Plate 7). In addition, seepage flow was noted at the slope toe to the east of the gully (Figure 2). These seepages were observed over one week after the incident took place.

Two pre-existing tension cracks were observed above the eastern flank of the landslide scar (Figure 2 and Plate 8). The largest tension crack was about 16 m long, up to 200 mm wide and open, with vertical down-slope displacement of up to 400 mm (see also Section 5.2). The smaller tension crack was about 7 m long and up to about 20 mm wide. The depth of the tension crack and nature of infilling is not known. Both tension cracks were trending in a west northwest-east southeast direction, which indicates ground movement towards the north northeast. It is not certain whether these pre-existing tension cracks were associated with the relic landslide scar to the east of the 1999 landslide scar.

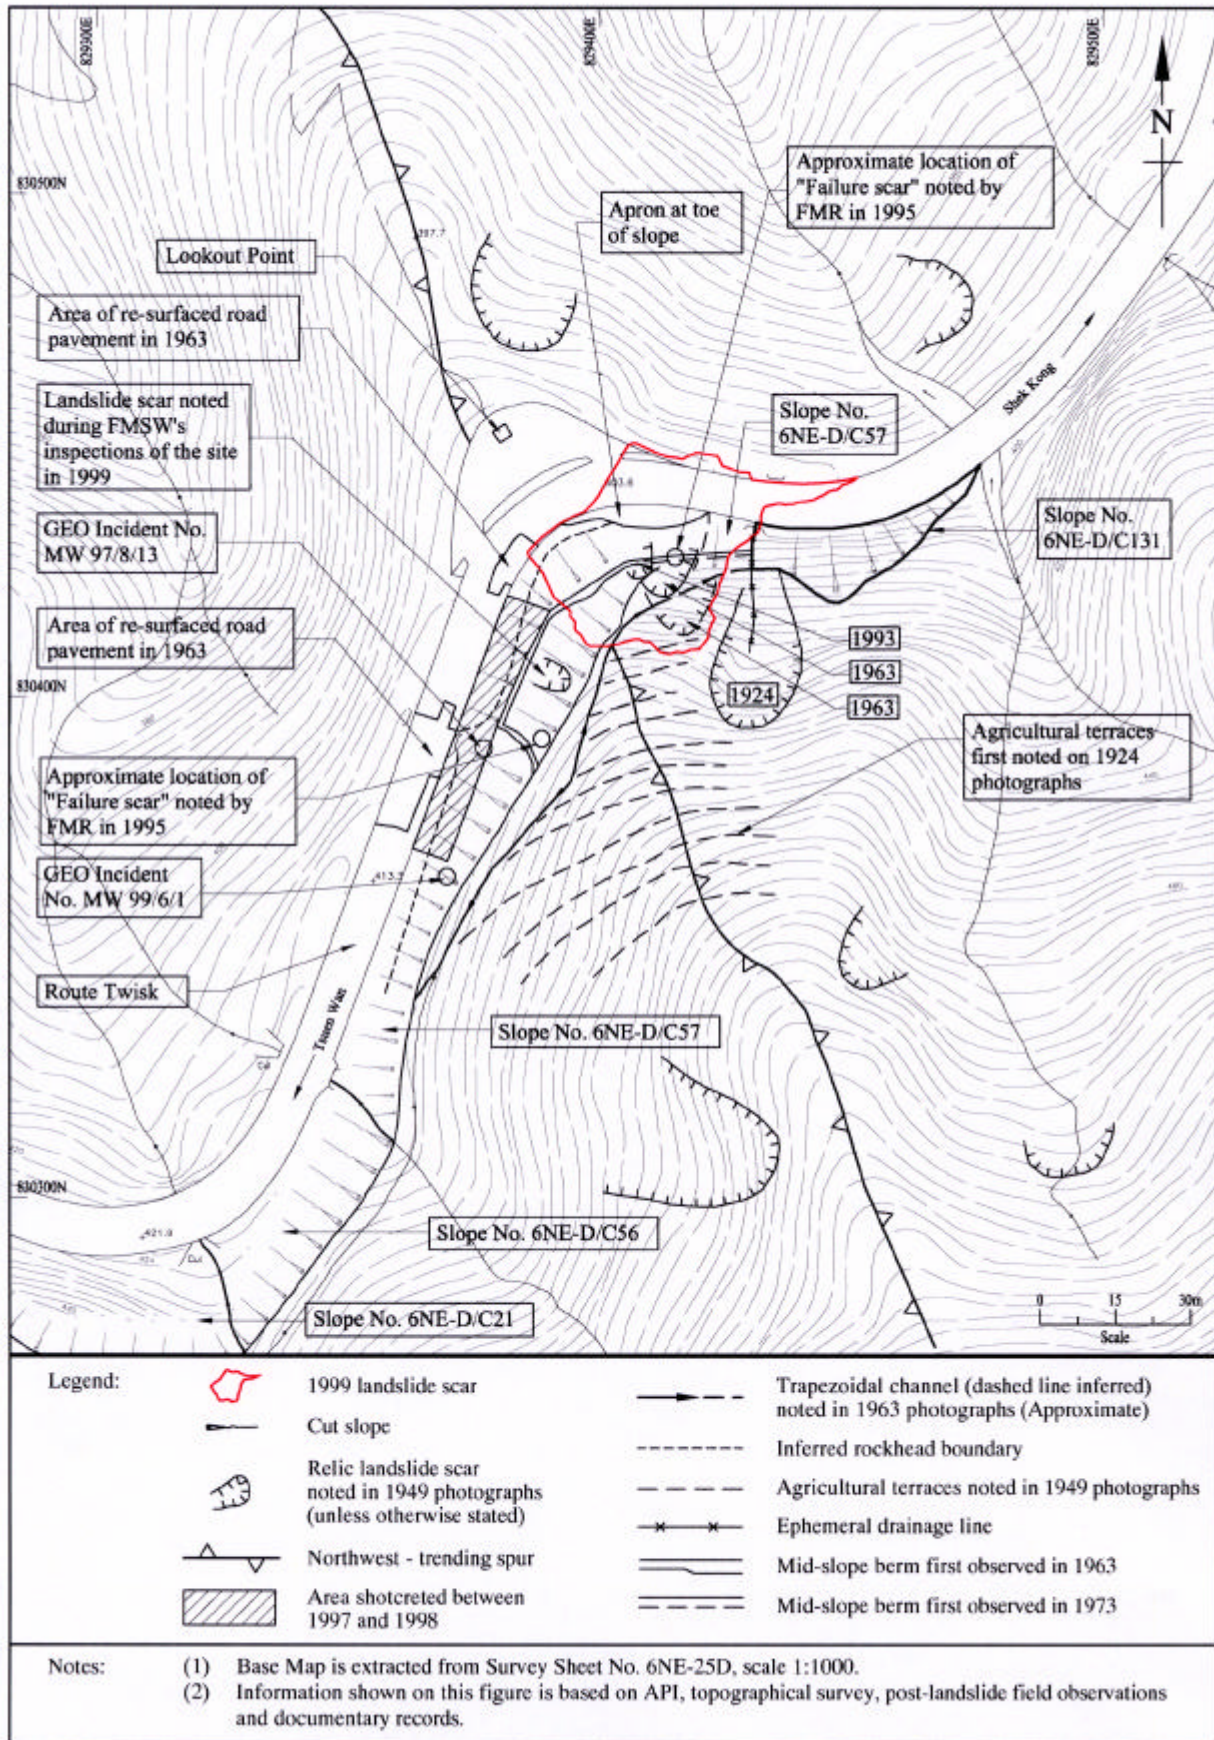
Figure 3 - History of Site Development and Past Instability

The GEO's landslide database has a record of two past landslide incidents within slope No. 6NE-D/C57. Incident No. MW 97/8/13 was located about 35 m to the southwest of the 1999 landslide (Figure 3), and comprised the failure of a moderately vegetated portion of the soil/rock cut slope, involving between 5 m<sup>3</sup> and 10 m<sup>3</sup> of partially weathered rock with rock mass weathering grade, PW 0/30. The possible cause of failure was considered to be "wash-out" as noted in the GEO Incident Report. One lane of Route Twisk was closed as a result of the landslide. The lower batter of the north portion of the southern part of slope No. 6NE-D/C57, including the 1997 failed area, was covered with shotcrete by 1998 (Figure 3).

Incident No. MW 99/6/1 was located about 50 m to the southwest of the 1999 landslide (Figure 3) within a moderately vegetated portion of the slope and comprised a minor rock fall, about 0.2 m<sup>3</sup> in volume and involving "about 10 pieces" of "maximum size about 0.25 m". Possible contributory factors to the failure included "weathering and unfavourable rock joints" as noted in the GEO Incident report.

Two landslide scars were also observed during an inspection of the slope by Fugro Mouchel Rendell Joint Venture (FMR) on 31 October 1995 under the HyD's Roadside Slope Inventory and Inspections consultancy (FMR, 1996) (see Section 3.4). The first scar was located close to the eastern flank of the 1999 landslide and was described as a shallow, soil slope failure about 0.5 m deep and 3 m wide (Figure 3). The second scar was located above the berm within the southern part of the slope (Figure 3). The dimensions of the second scar are not known.

In the 1924 and 1949 aerial photographs, several relic landslide scars are noted in the vicinity of the 1999 landslide site (Figure 3). In particular, a large scar is noted about 5 m to the east of the 1999 landslide above the boundary of slopes Nos. 6NE-D/C57 and 6NE-D/C131 (Figure 3). In 1963, following the formation of Route Twisk, two possible landslide scars are noted within the area affected by the 1999 landslide (Figure 3). The first scar appeared to be relatively shallow and its crest was located between the trapezoidal channel and the crest channel. The second scar was noted about 8 m above the first scar.

A small arcuate landslide scar was noted on the 1993 aerial photographs, close to the scars observed on the 1963 photographs (Figure 3).

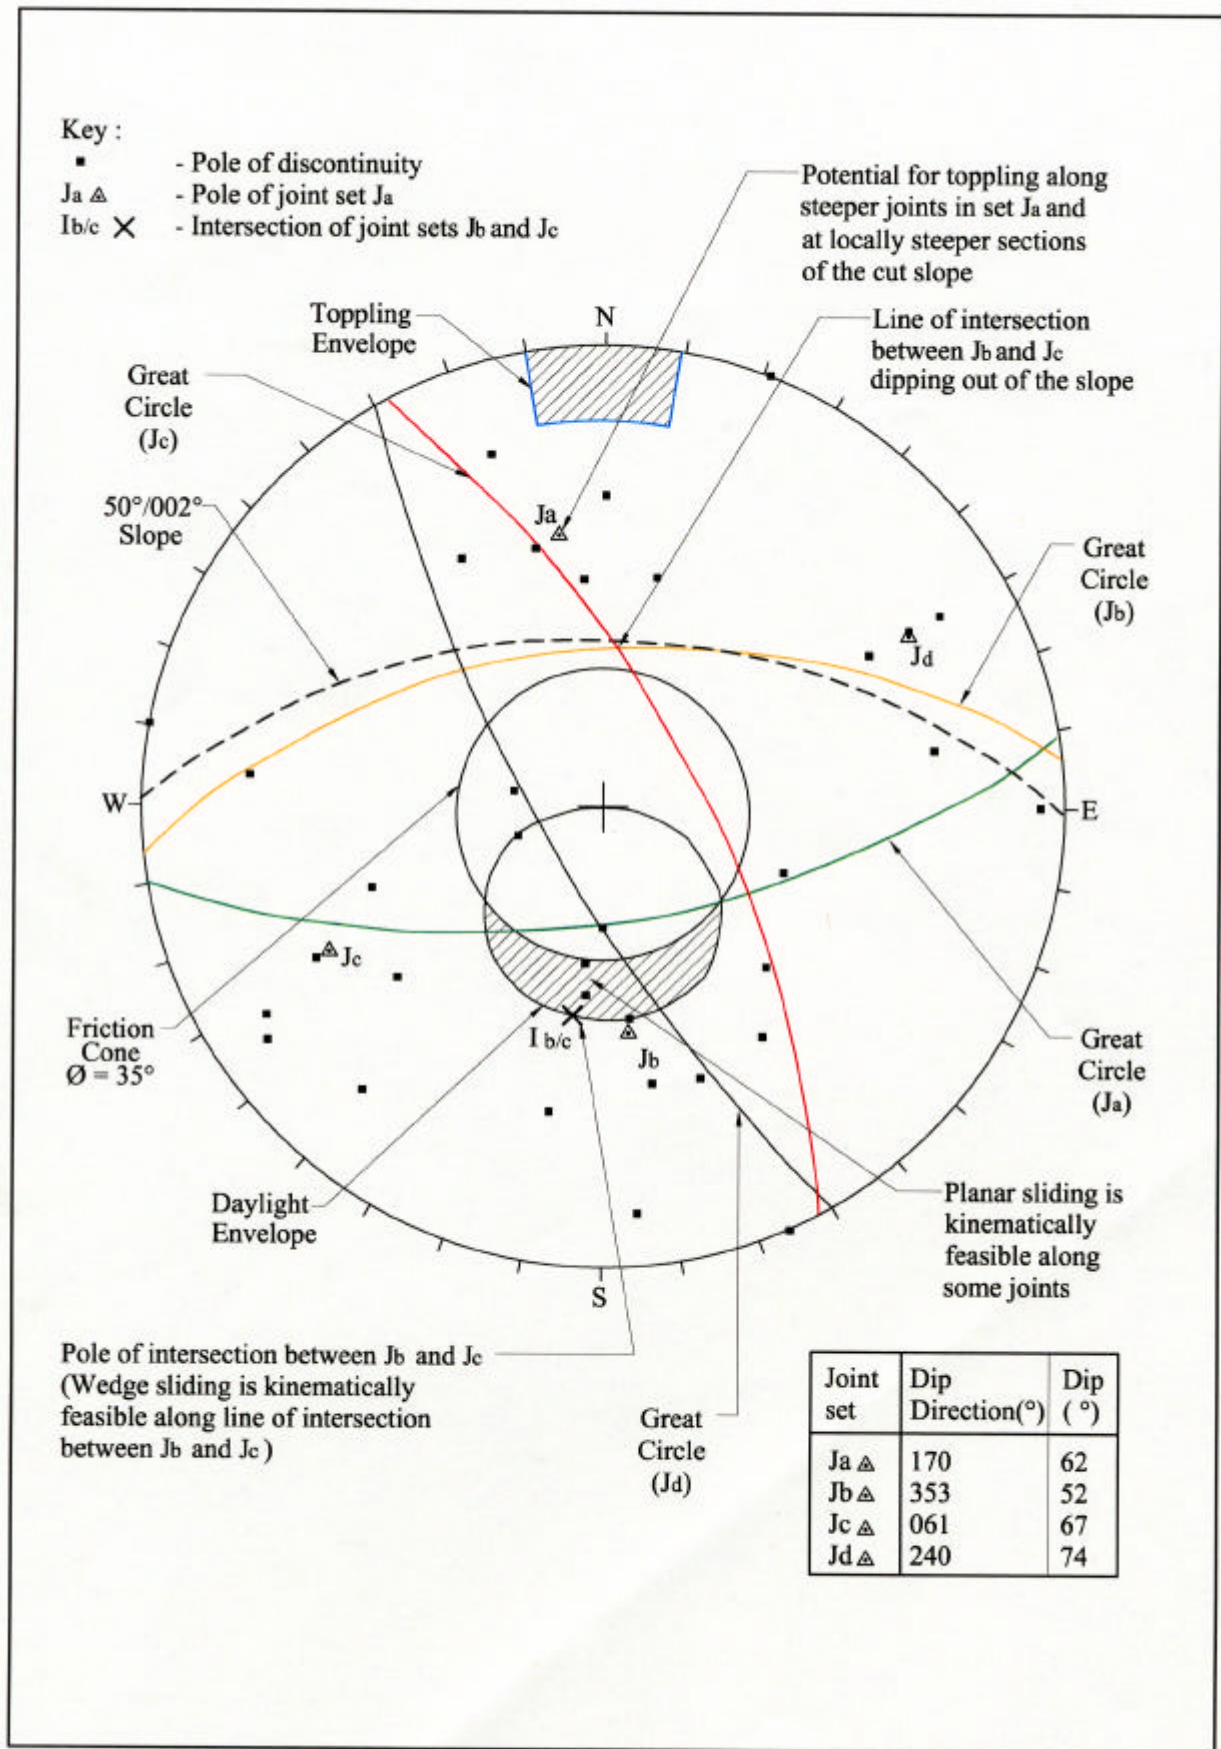
Figure 7 - Stereonet Plot of Discontinuity Data

Discontinuity data from the landslide site, together with the results of kinematic stability analyses, are presented on a stereoplot in Figure 7. Considering the four main joint sets (Joint Sets “Ja” to “Jd”), which were mapped at the site, a wedge failure along the intersection of joint sets “Jb” and “Jc” appears to be kinematically permissible given the steep slope angle prior to failure (about 50° at the eastern flank of the scar). This, plus the exposure of joint sets “Jb” and “Jc” on the flanks of the scar and the general north northeasterly trend of the scar and debris trail, which was slightly oblique to the slope direction, suggests a strong structural control to the failure. Localised planar sliding may also have occurred along joint set Jb (Figure 7).

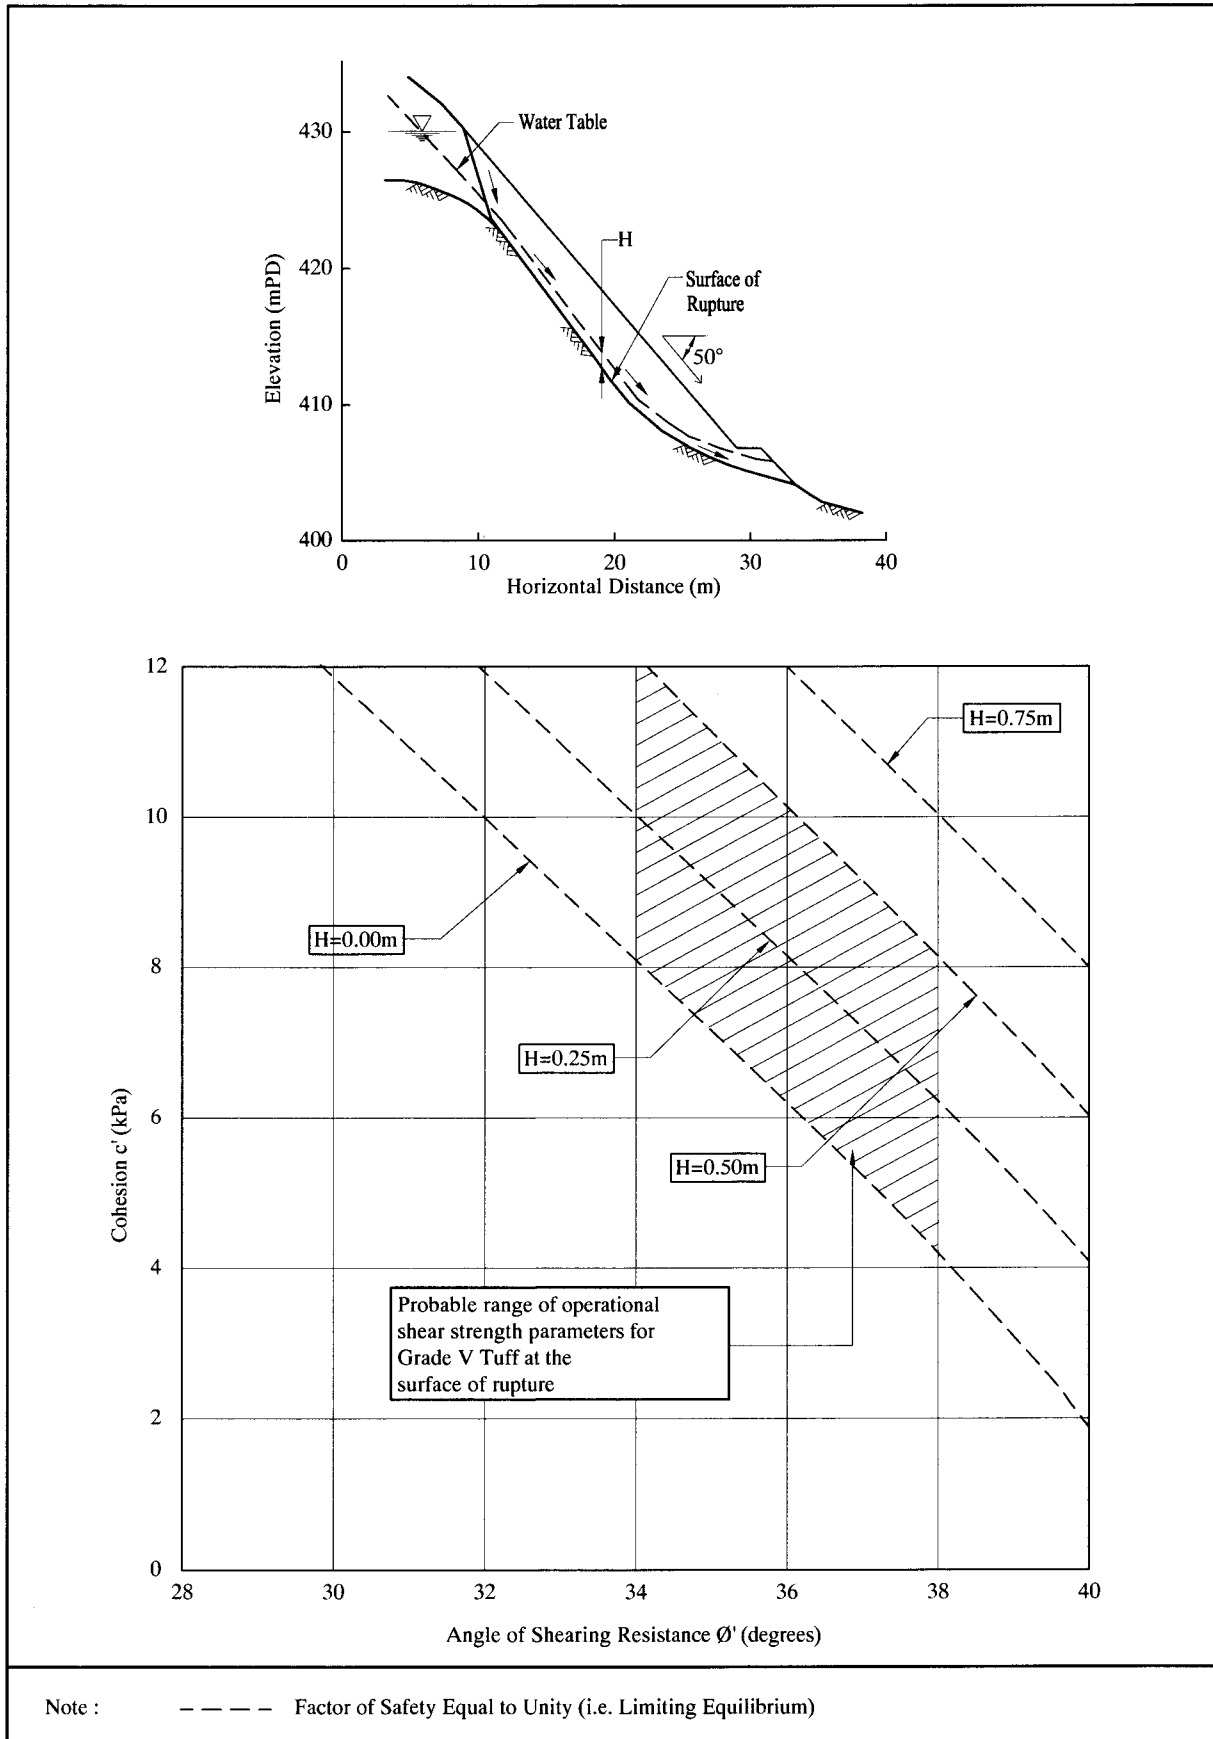
Figure 10 - Summary of Sensitivity Analyses

The results of the analyses are presented in Figure 10. These indicate that the development of an elevated groundwater pressure of about 0.25 m above the surface of rupture would be required to initiate failure in the slope.

Theoretical stability analyses indicate that relatively small increases in groundwater pressures above the surface of rupture are required to initiate the significant failure.

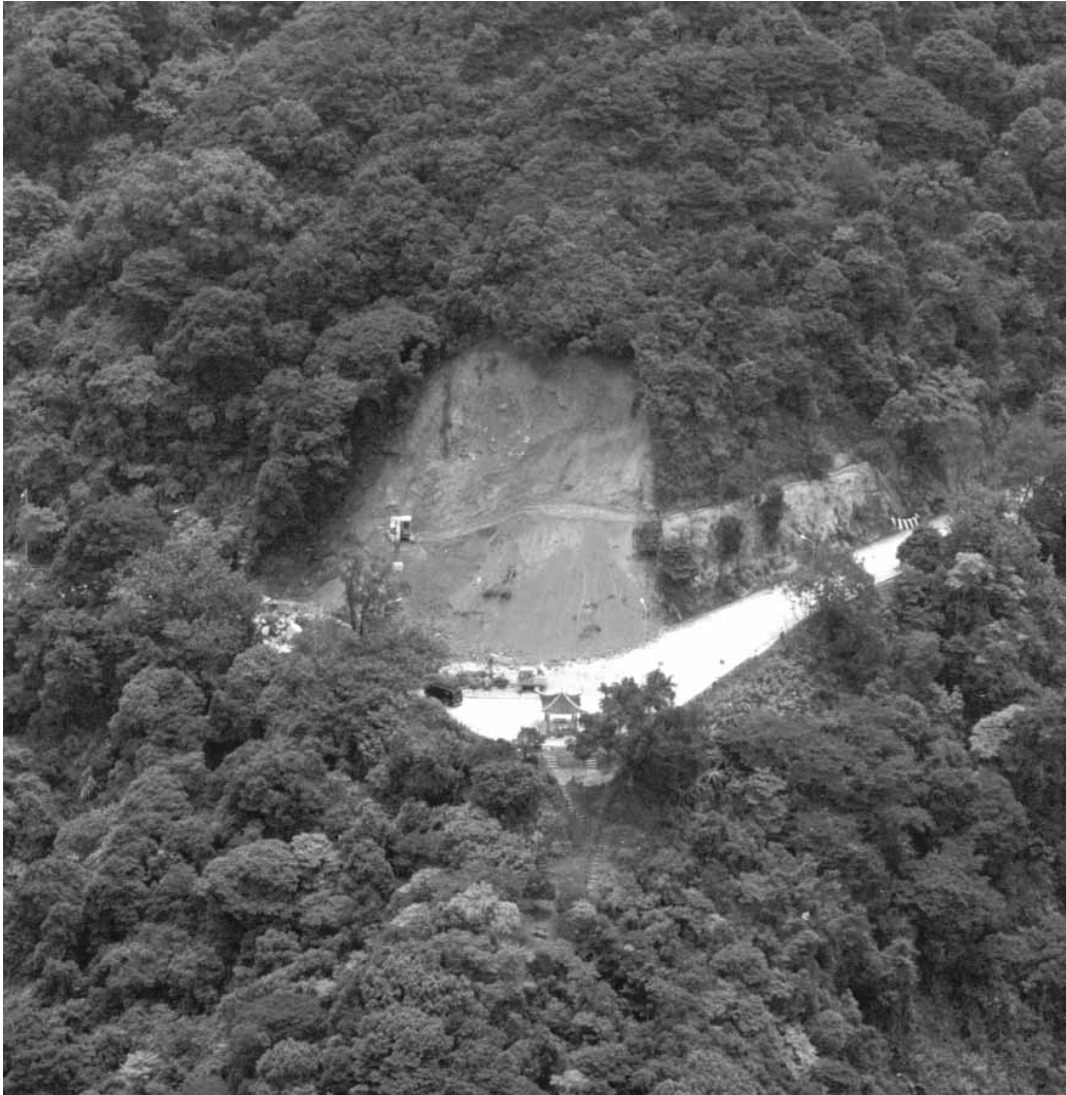
Plate 1 – Oblique Aerial View of the Landslide Site  
(Photograph Taken on 1 September 1999)

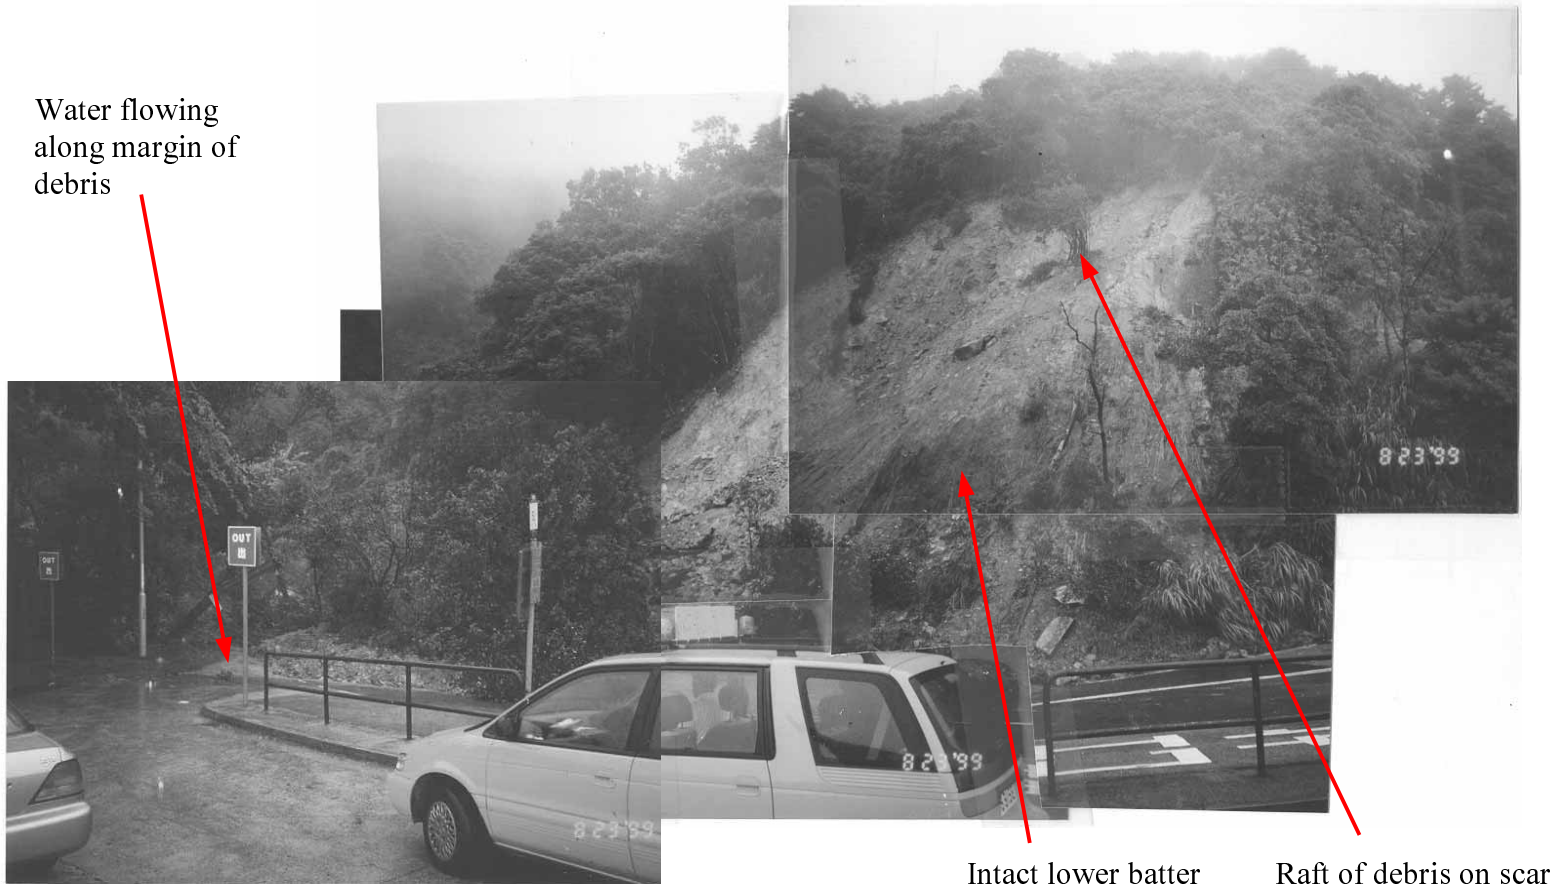
The landslide debris at the slope toe was saturated and water was flowing from the blocked toe channel towards the eastern flank of the scar (Plate 2). The debris comprised a large number of subangular to subrounded cobbles and boulders (up to 3 m x 3 m x 3 m in size), within a saturated structureless matrix of very soft reddish brown clayey very sandy silt (Plate 3). A large number of trees and bushes were also observed within the debris. The nature and extent of the debris suggests a fast-moving landslide.

Plate 2 – General View of Landslide Scar Shortly after Failure. Note Water on Margin of Debris Toe  
 (Photograph Taken on 23 August 1999. See Figure 11 for Location)

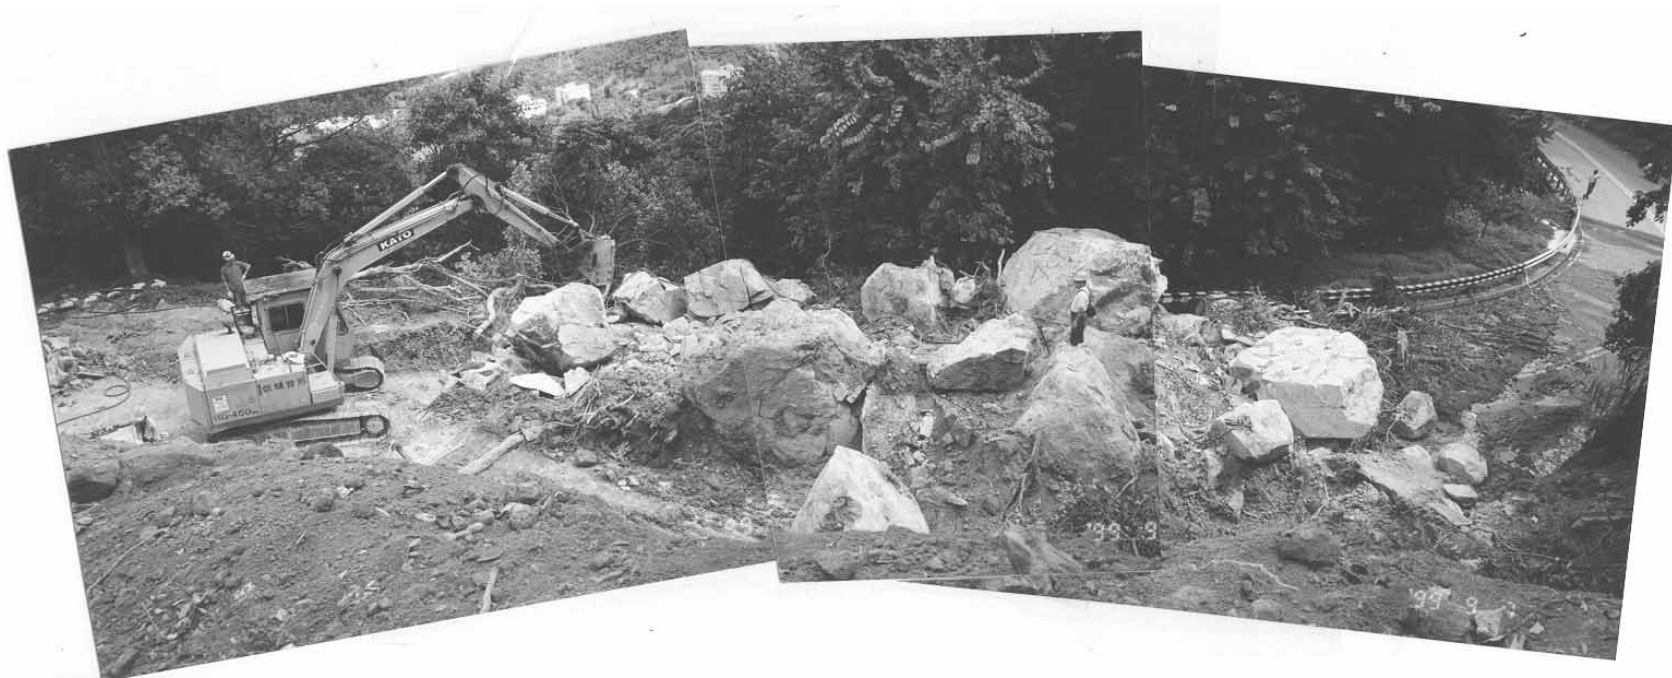
Plate 3 – Large Boulders within Debris Deposited on Route Twisk (Photograph Taken on 7 September 1999. See Figure 11 for Location)

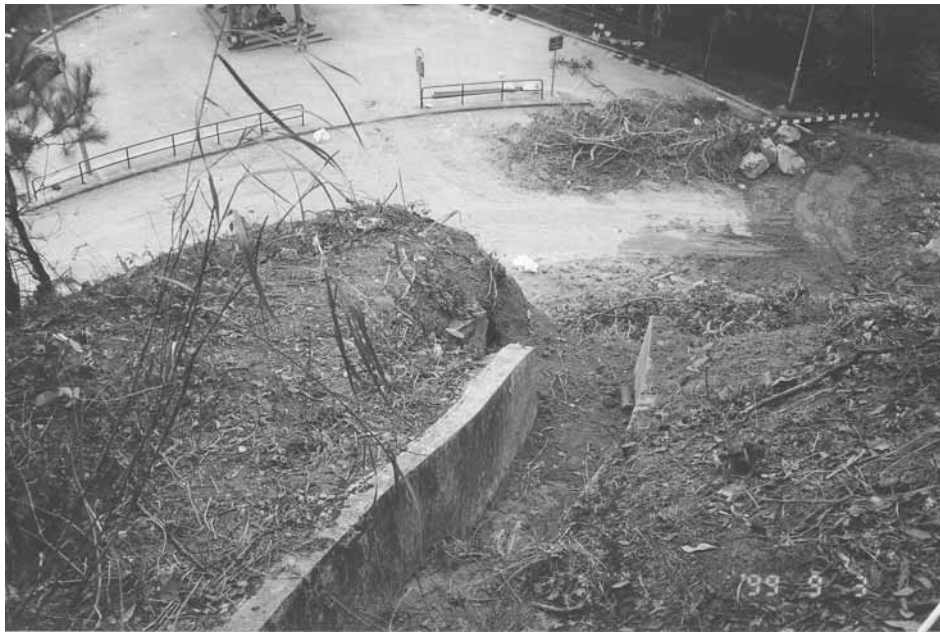
Plate 4 – Dislocated Trapezoidal Drainage Channel above the Western Flank of the Main Scarp (Photograph Taken on 3 September 1999. See Figure 11 for Location)

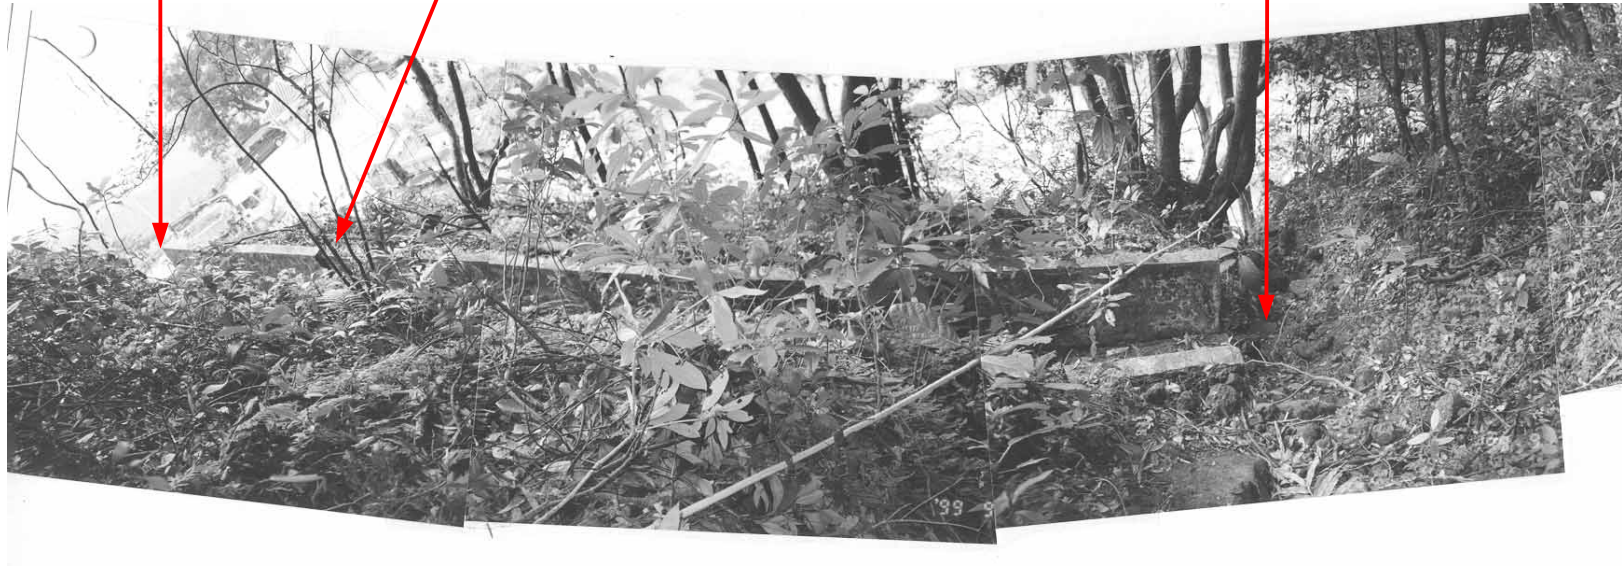
severed by the landslide, across the eastern flank and onto the debris. The trapezoidal channel on both the eastern (Plate 5) and western flanks was cracked and partially displaced in several locations. Some of these cracks appeared to have been repaired (with bitumen) and then reactivated, indicating past and more recent slope movement (Plate 6). Many of the cracks were covered with moss and contained roots indicating that they had been exposed for some time. It was also noted that the channel located above the main scarp along the western flank was blocked with vegetation.

Dislocated channel on eastern flank of the scar

Dislocated and cracked channel

Plate 5 – Lower Part of Trapezoidal Drainage Channel between the Eastern Flank of the Landslide Scar and the Ephemeral Drainage Line (Photograph Taken on 3 September 1999. See Figure 11 for Location)

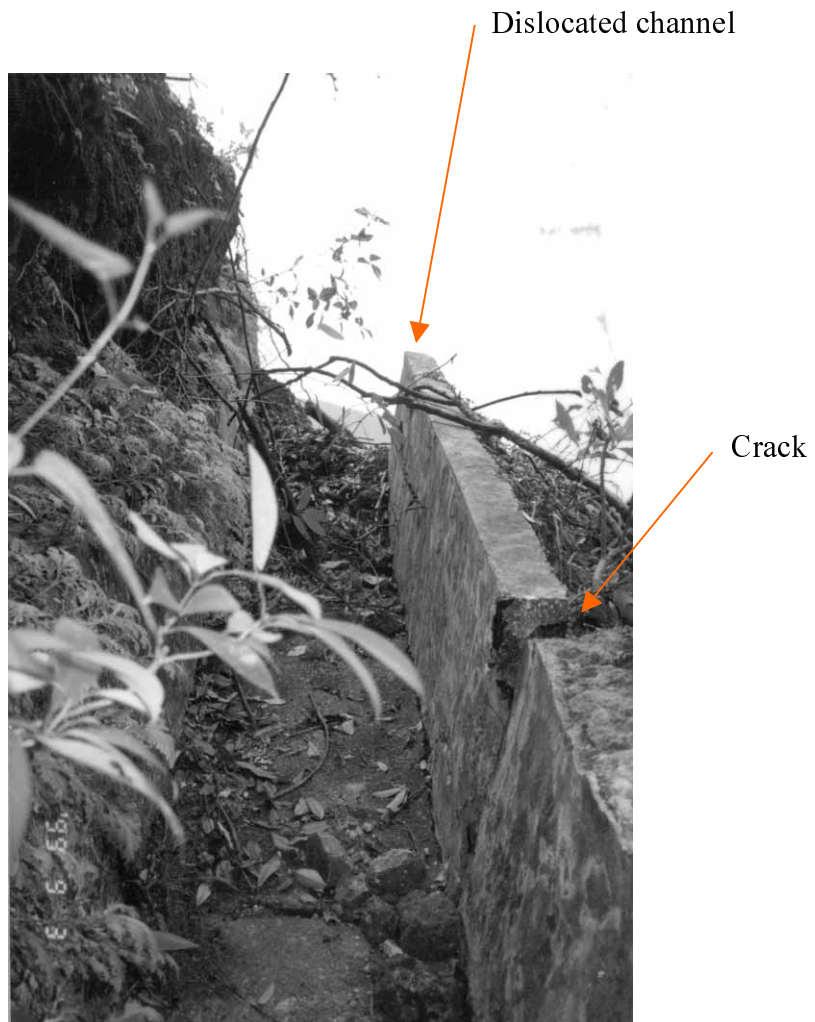
Plate 6 – Bitumen-coated, Reactivated Crack across the Trapezoidal Channel between the Eastern Flank and the Ephemeral Drainage Line (Photograph Taken on 3 September 1999. See Figure 11 for Location)

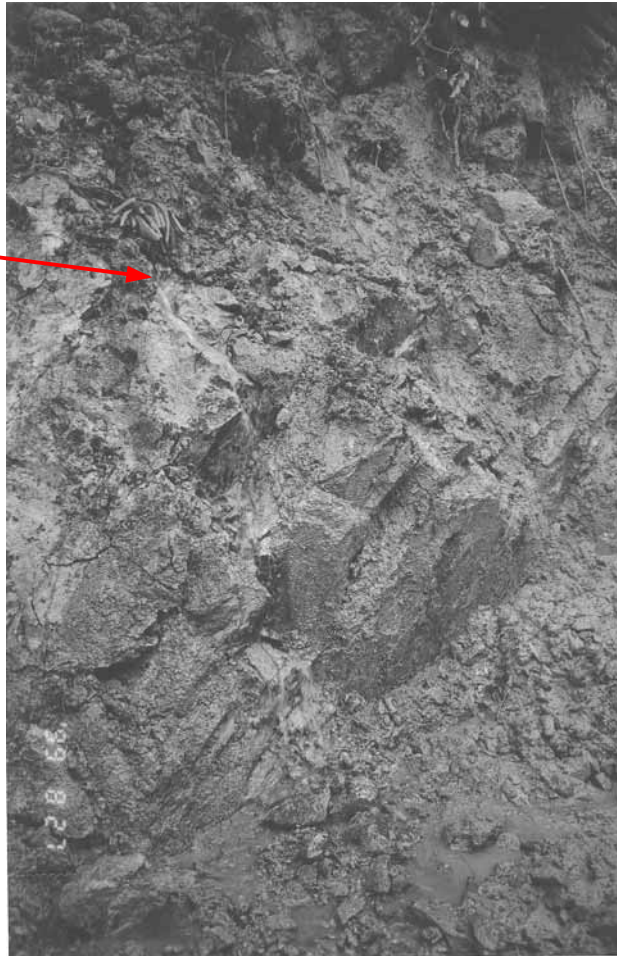
Seepage

Plate 7 – Seepages Observed along Joints within MDT Close to Rockhead at the Toe of the Eastern Flank of the Scar (Photograph Taken on 27 August 1999. See Figure 11 for Location)

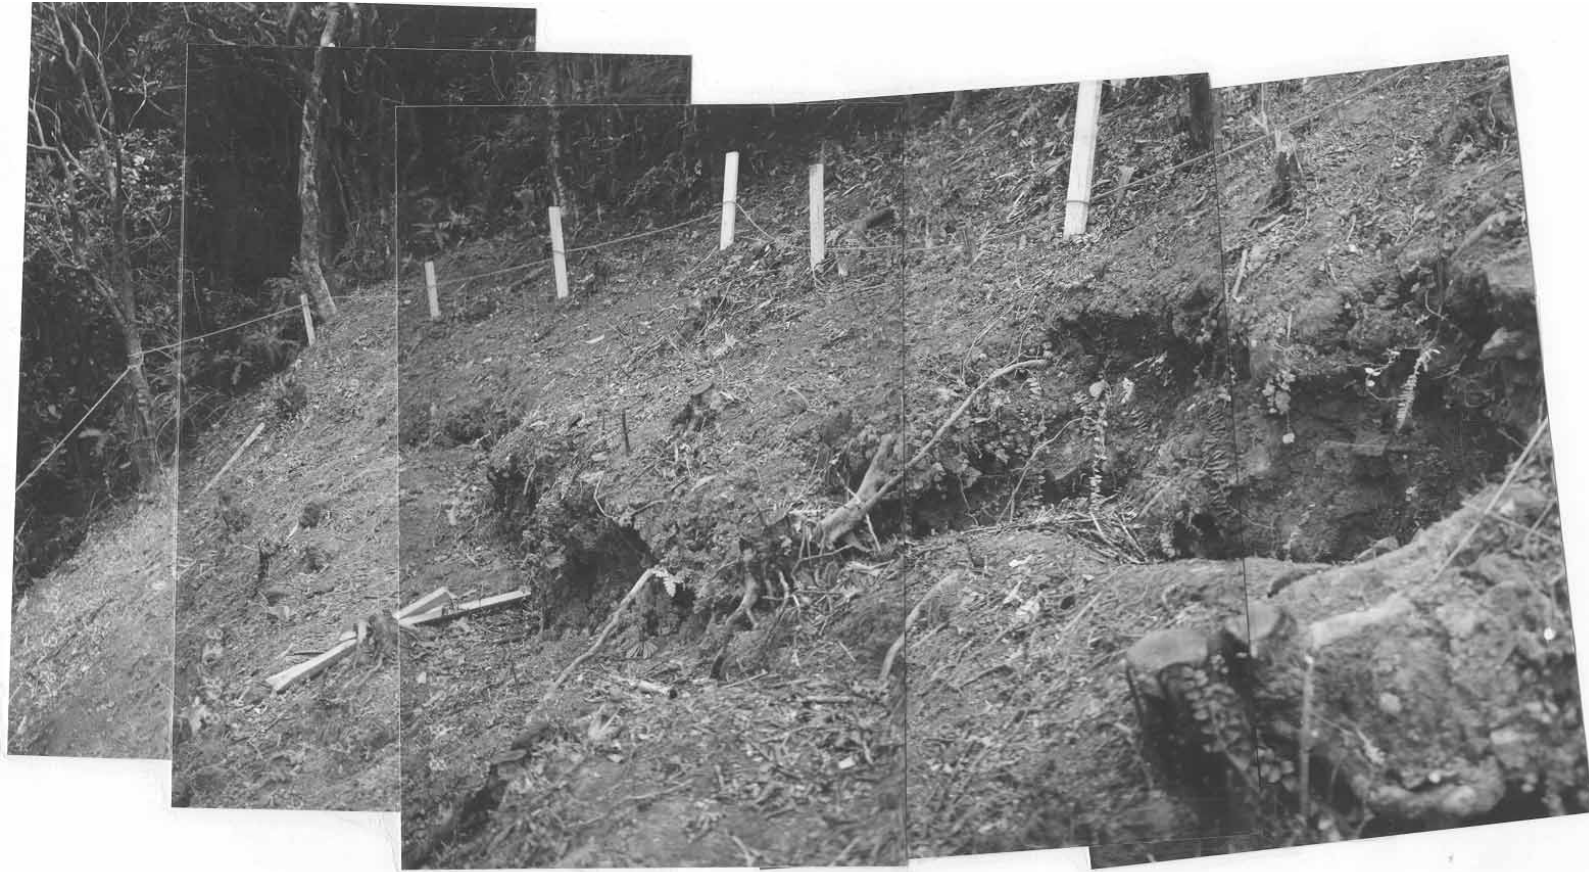
Seepages were noted up to 4 m above the toe of the slope, and along joints in the exposed rock mass on the eastern flank of the scar (Figure 2 and Plate 8). In addition, eye-witnesses observed a significant amount of water issuing from the slope shortly following further landsliding on 28 August 1999.

Plate 8 – Pre-existing Tension Crack Located on the Slope above the Crest of the Landslide Scar  
(Photograph Taken on 8 September 1999. See Figure 11 for Location)

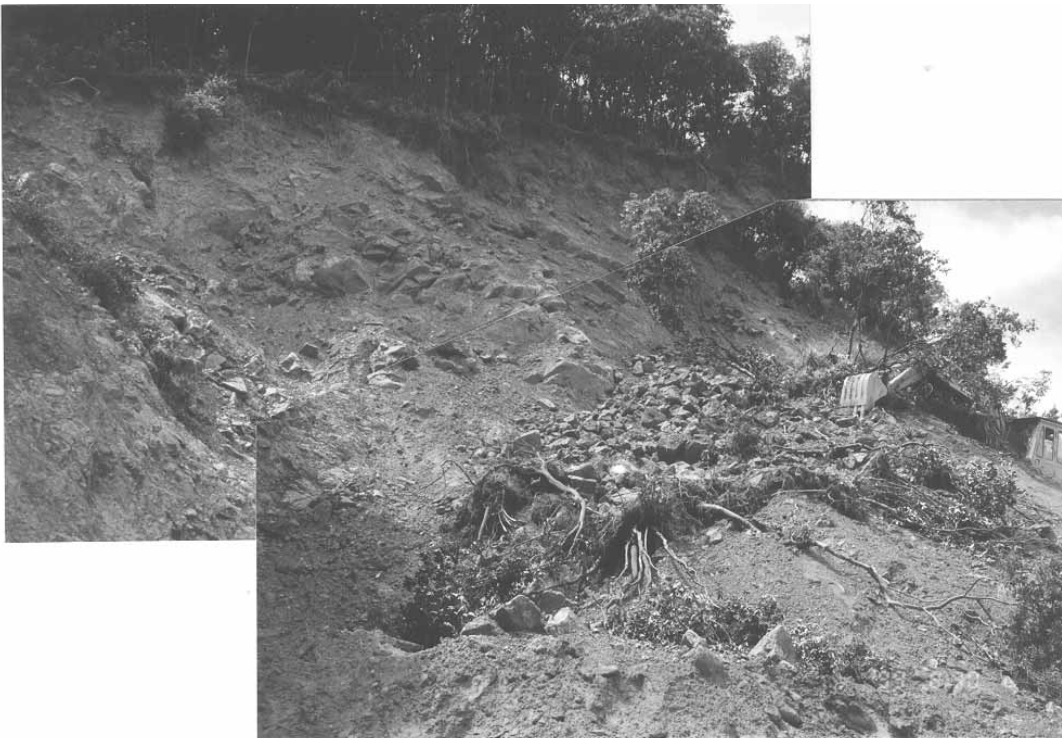
About 50 m<sup>3</sup> of debris was released during a later incident on 28 August 1999, which partially buried an excavator that was trimming back the slope as part of the urgent repair works at that time (Plate 9). Eye-witnesses reported that the trees at the crown of the landslide scar “slid down” undergoing a slow downward movement for about one metre before rapidly falling onto the mid-slope berm and excavator below. Following the failure, eye-witnesses observed a significant amount of water issuing from the toe of the failed slope, describing it as a “mud flow” with the “release of trapped water” from within the debris.

Plate 9 – Main Scarp Following Further Landsliding on 28 August 1999. Note Debris Covering Excavator (Photograph Taken on 30 August 1999. See Figure 11 for Location)

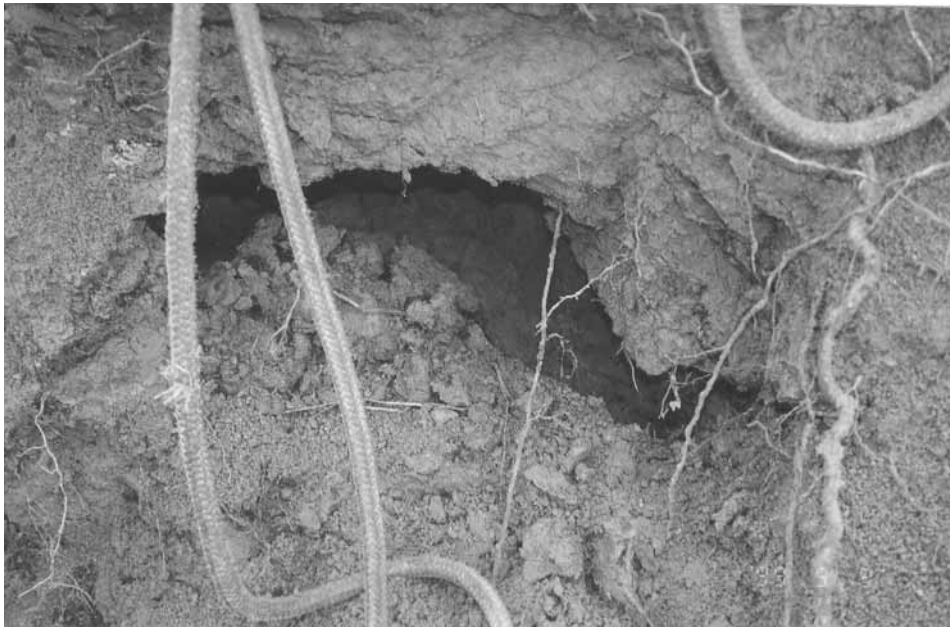
(Figure 5). A soil pipe up to 0.5 m wide was observed within the residual soil (and some CDT) following trimming of the main scarp (Plate 10).

Plate 10 – Soil Pipe Exposed behind the Main Scarp Following Trimming  
(Photograph Taken on 9 September 1999. See Figure 11 for  
Location)

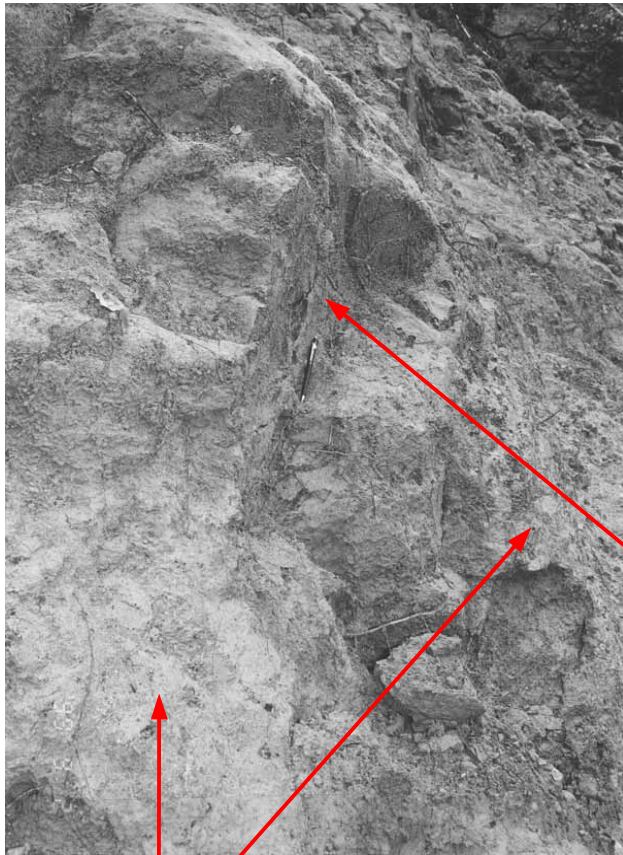
At the mid-section of the eastern flank of the scar, the slope comprised corestones of MDT within CDT (Plates 11 and 12). The CDT was typically moist soft reddish brown, slightly sandy clay/silt. The main release planes on the eastern flank were dominated by joints dipping at about 50° to the northwest and north (305° to 360°), respectively (Plates 11 and 12). The joints were typically closely to medium spaced, smooth, slightly undulating to planar, and infilled with slickensided (plunging at about 20° to southwest) kaolin (1 mm to 2 mm) and manganese oxide (< 1 mm thick) deposits. Some of the surfaces exposed on the eastern flank were covered with moist to wet, soft, yellowish brown, mottled reddish brown, fine sandy clay/silt up to 200 mm thick with rootlets (Plate 13). Many joints were infilled with similar material, which extended into the rock mass behind the scar (Plates 11 and 12). These relatively thick deposits were probably washed into persistent open discontinuities and possible deep (> 5 m) tension cracks exposed within the scar prior to the 1999 landslide.

Plate 11a – Release Planes within MDT. Note Infilling and Roots along Joint Planes (Photograph Taken on 2 September 1999. See Figure 11 for Location)

Release plane coated with clay/silt (joint/tension crack infilling)

Steeply-dipping release plane (joint)

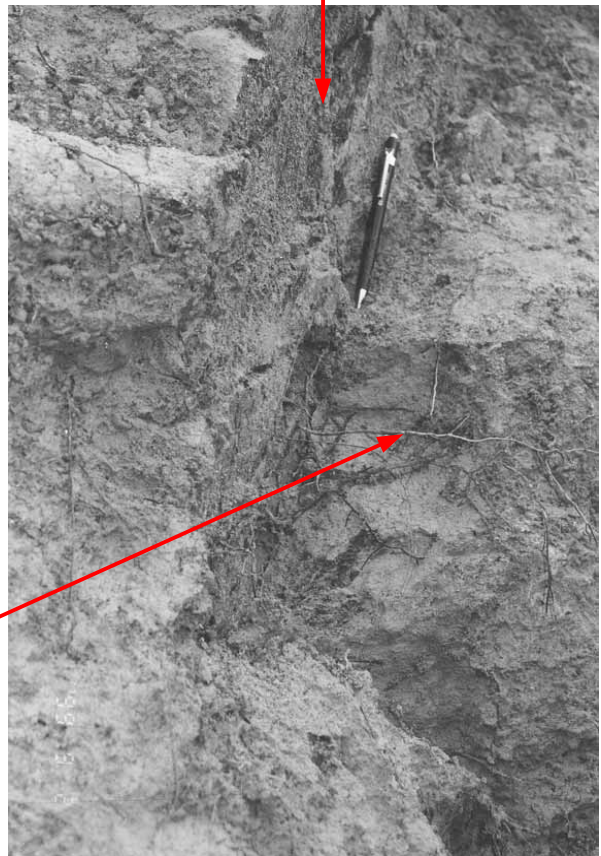
Plate 11b – Close-up View of Infilling with Roots along Release (Joint) Planes (Photograph Taken on 2 September 1999. See Figure 11 for Location)

Roots

Slickensided manganese oxide stained release plane

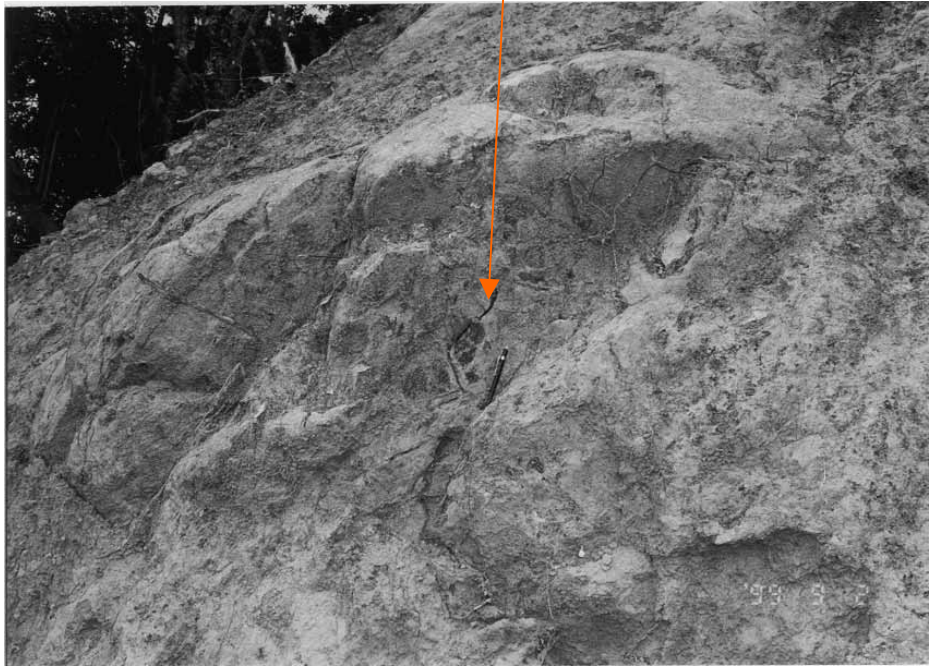
Plate 12a – MDT Corestone within CDT (Surface of CDT is Covered with Previous Tension Crack/Joint Infilling Material). Note Slickensided Manganese Oxide Stained Release Planes. (Photograph Taken on 2 September 1999. See Figure 11 for Location)
