**SECTION 2:  
DETAILED STUDY OF THE  
23 AUGUST 1999  
LANDSLIDE AT ROUTE TWISK  
OPPOSITE THE LOOKOUT  
POINT NEAR SHEK KONG**

**Fugro Maunsell Scott Wilson Joint Venture**

**This report was originally produced in August 2000  
as GEO Landslide Study Report No. LSR 5/2000**

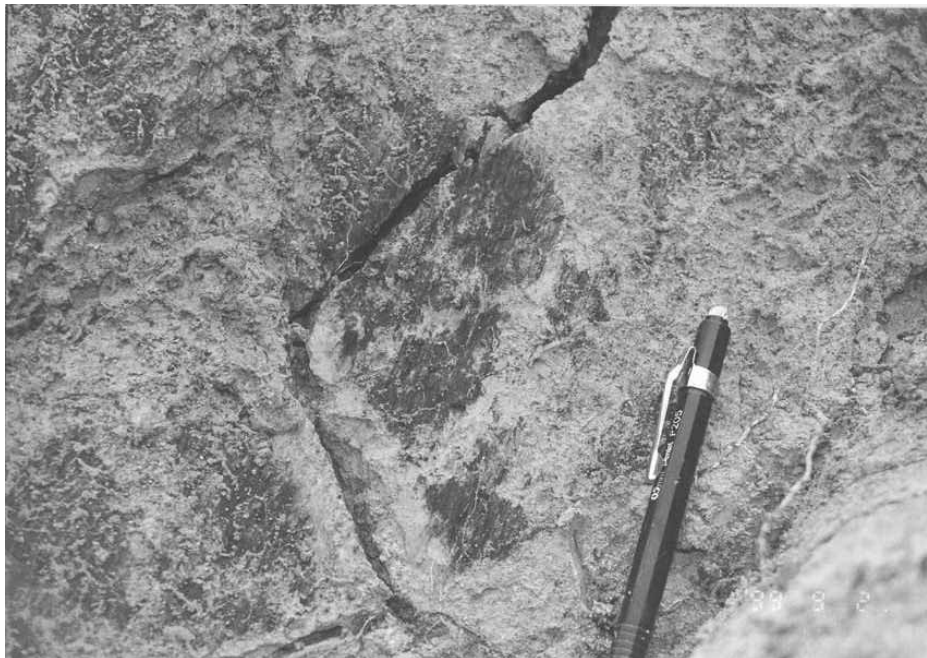
Plate 12b – Close-up View of Slickensided Manganese Oxide Stained Release Plane and Open Discontinuity (Photograph Taken on 2 September 1999. See Figure 11 for Location)

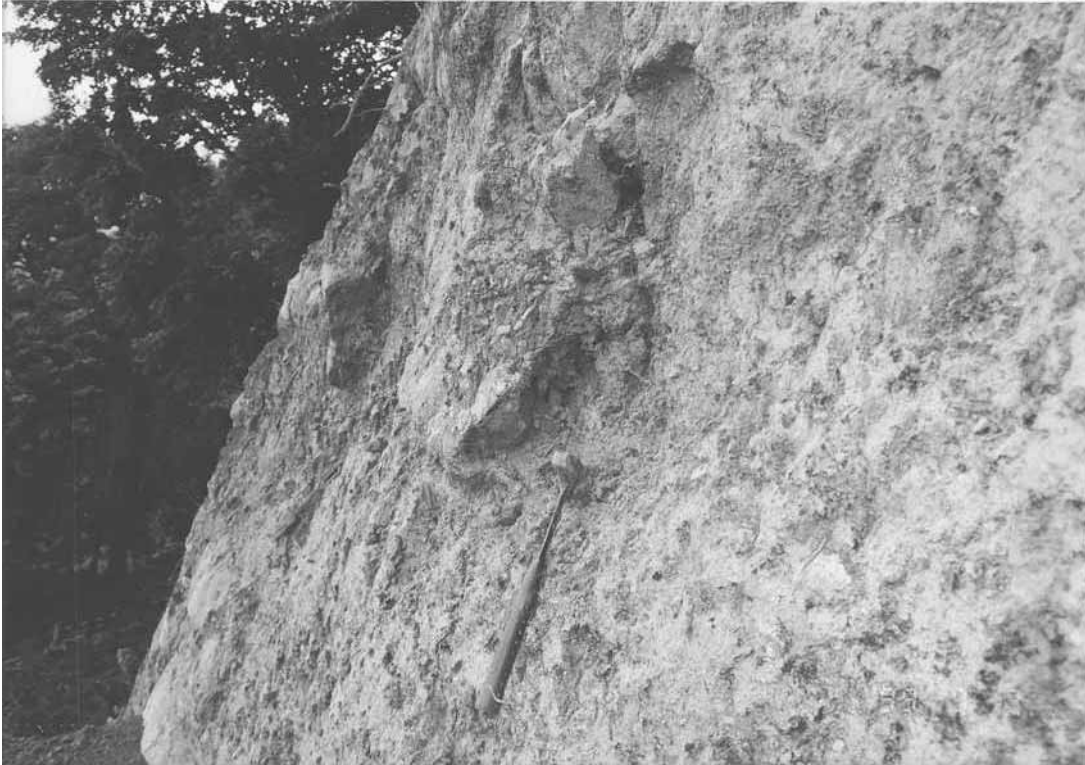
Plate 13 – Previous Tension Crack/Joint Infilling Exposed along Release Planes on Eastern Flank of the Scar (Photograph Taken on 2 September 1999. See Figure 11 for Location)

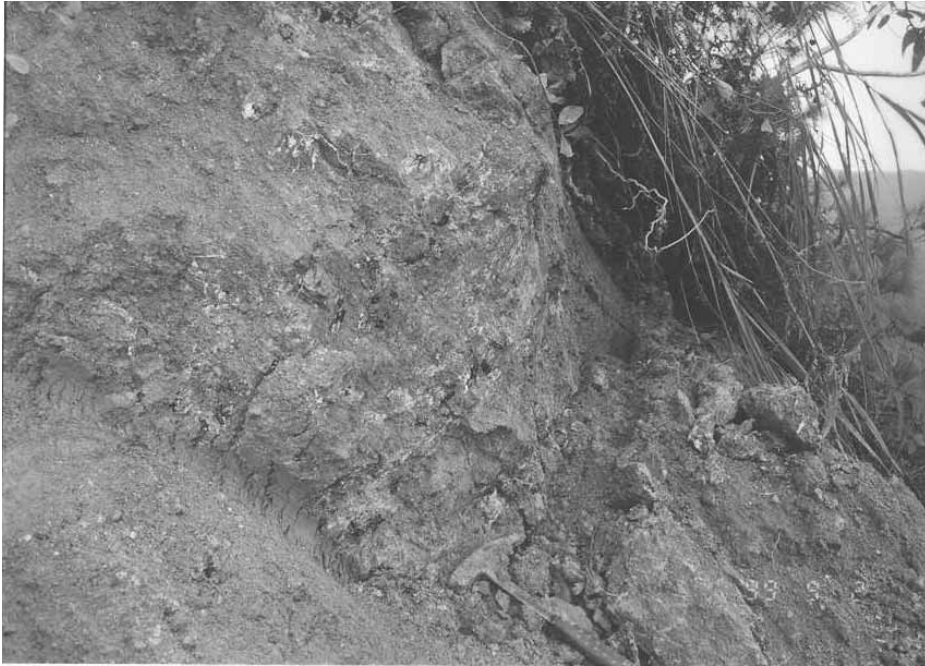
Plate 14a – CDT with Closely-Spaced Discontinuities along Western Flank of the Scar (Photograph Taken on 2 September 1999. See Figure 11 for Location)

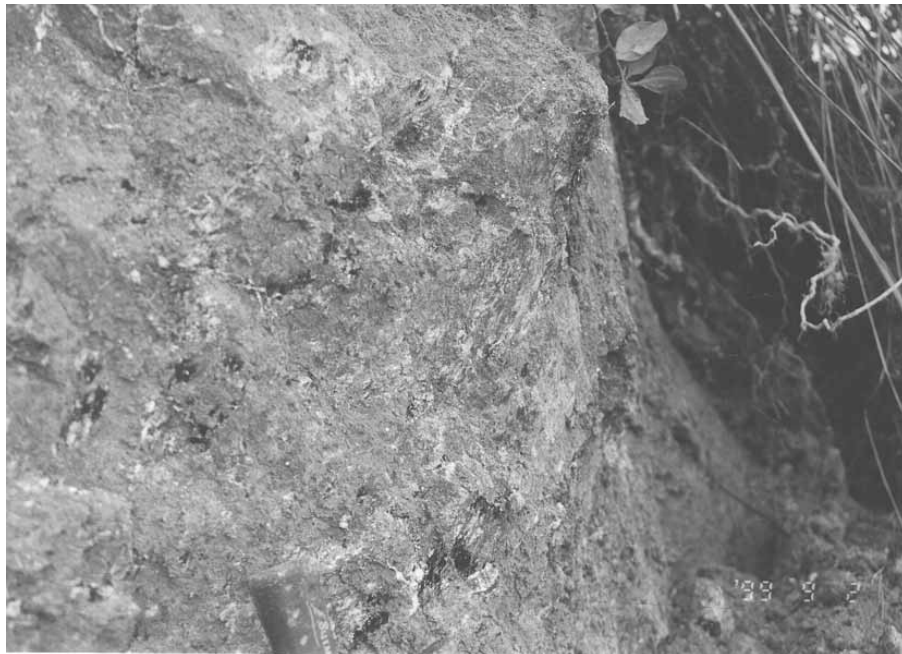
Plate 14b – Close-up View of Discontinuities Infilled with Kaolin and Manganese Oxide Deposits within CDT on Western Flank of the Scar (Photograph Taken on 2 September 1999. See Figure 11 for Location)

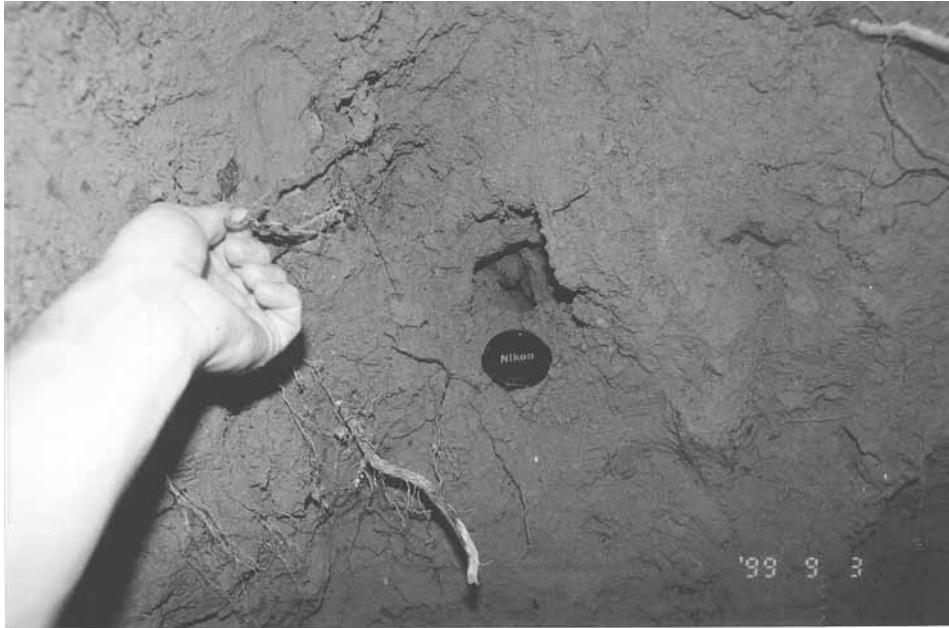
Trial pit No. TP1 encountered about 1 m to 1.5 m of soft to firm reddish brown sandy clayey silt (residual soil) above CDT and occasionally MDT. Soil pipes up to 200 mm in diameter were observed within the residual soil (Plate 15). They may have been formed by root action, bioturbation or erosion, or a combination of these processes. A pre-existing tension crack (up to 200 mm wide and over 2.8 m deep), which was infilled with loose, structureless, reddish brown, clayey sandy silt, was also noted within the residual soil (see Section 4.2). Trial pits Nos. TP2, TP3 and TP4 encountered up to 0.5 m of fill/reworked residual soil and CDT, above CDT.

Plate 15a – Soil Pipe within Residual Soil in Trial Pit No. TP1 (Photograph Taken on 3 September 1999. See Figure 11 for Location)

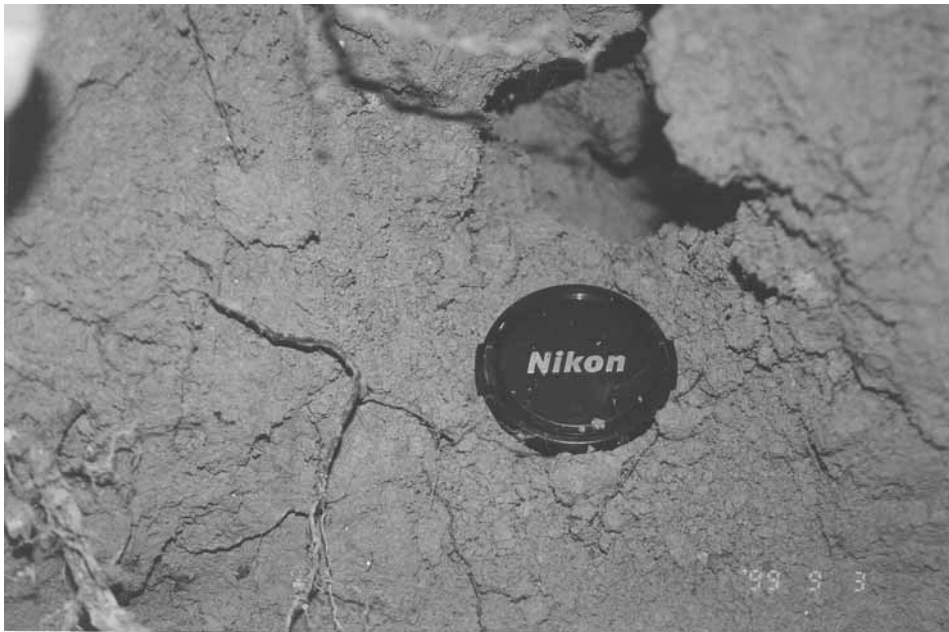
Plate 15b – Close-up View of Soil Pipe (Photograph Taken on 3 September 1999. See Figure 11 for Location)
