**INVESTIGATION OF SOME
SELECTED LANDSLIDES
IN 1999
(VOLUME 2)**

GEO REPORT No. 121

**GEOTECHNICAL ENGINEERING OFFICE
CIVIL ENGINEERING DEPARTMENT
THE GOVERNMENT OF THE HONG KONG
SPECIAL ADMINISTRATIVE REGION**

**SECTION 1:
DETAILED STUDY OF THE
LANDSLIDE ABOVE
KAP LUNG, SHEK KONG,
DURING THE SEVERE
RAINSTORMS BETWEEN
22 AND 24 AUGUST 1999**

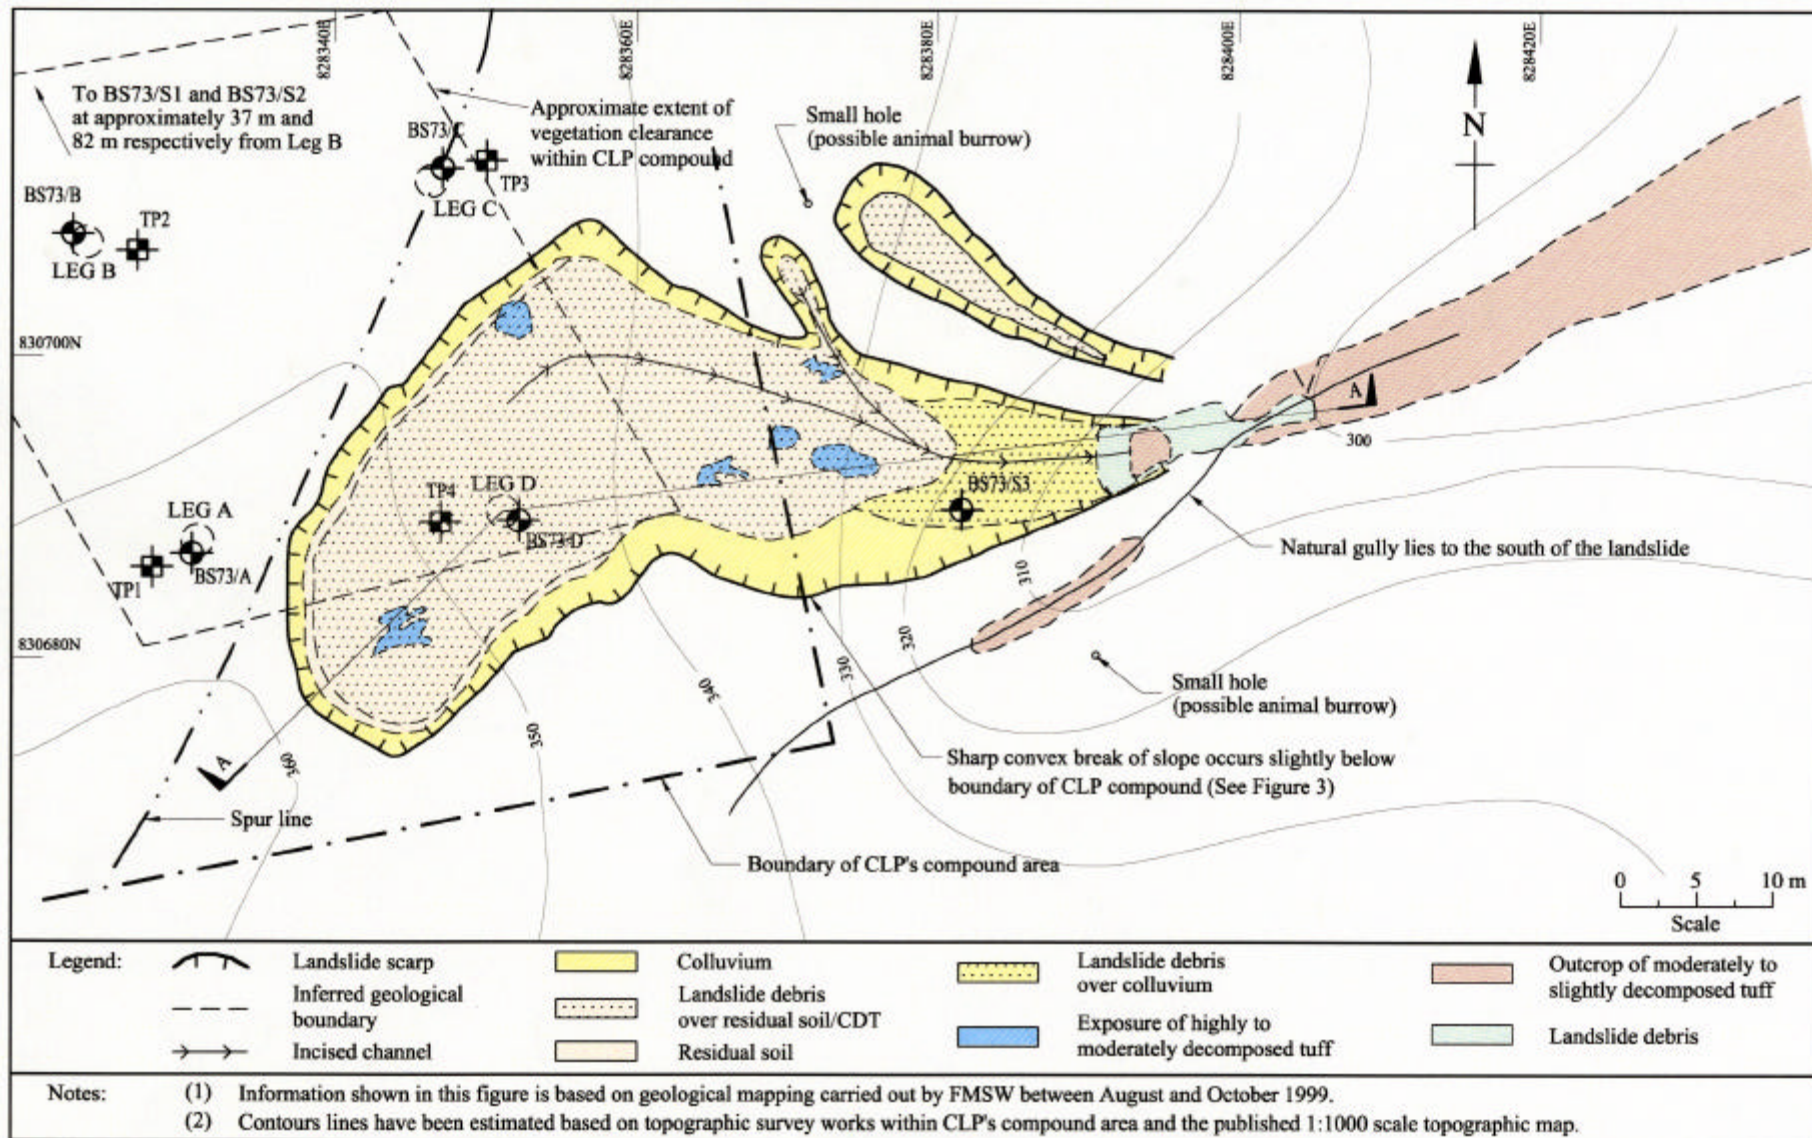
Figure 2 - Plan of the Landslide

The crown of the landslide was located about 18 m to the southwest of Leg D at an elevation of about 359 mPD. The surface of rupture was about 55 m long and 20 m wide, with an average depth of 2 m (Figures 2 & 3 and Plate 5). The failure occurred in colluvium. A sharp change in direction of the rupture surface occurred at approximately the mid-point of the scar, creating two distinct upper and lower portions (Figure 2).

Field mapping was carried out during a series of site inspections between August and October 1999 by FMSW. The geological features observed at the landslide site are shown in Figure 2. Based on the available ground investigation information (Section 4.3) and the results of the field mapping, a cross-section showing the inferred ground conditions through the landslide site is presented in Figure 3.

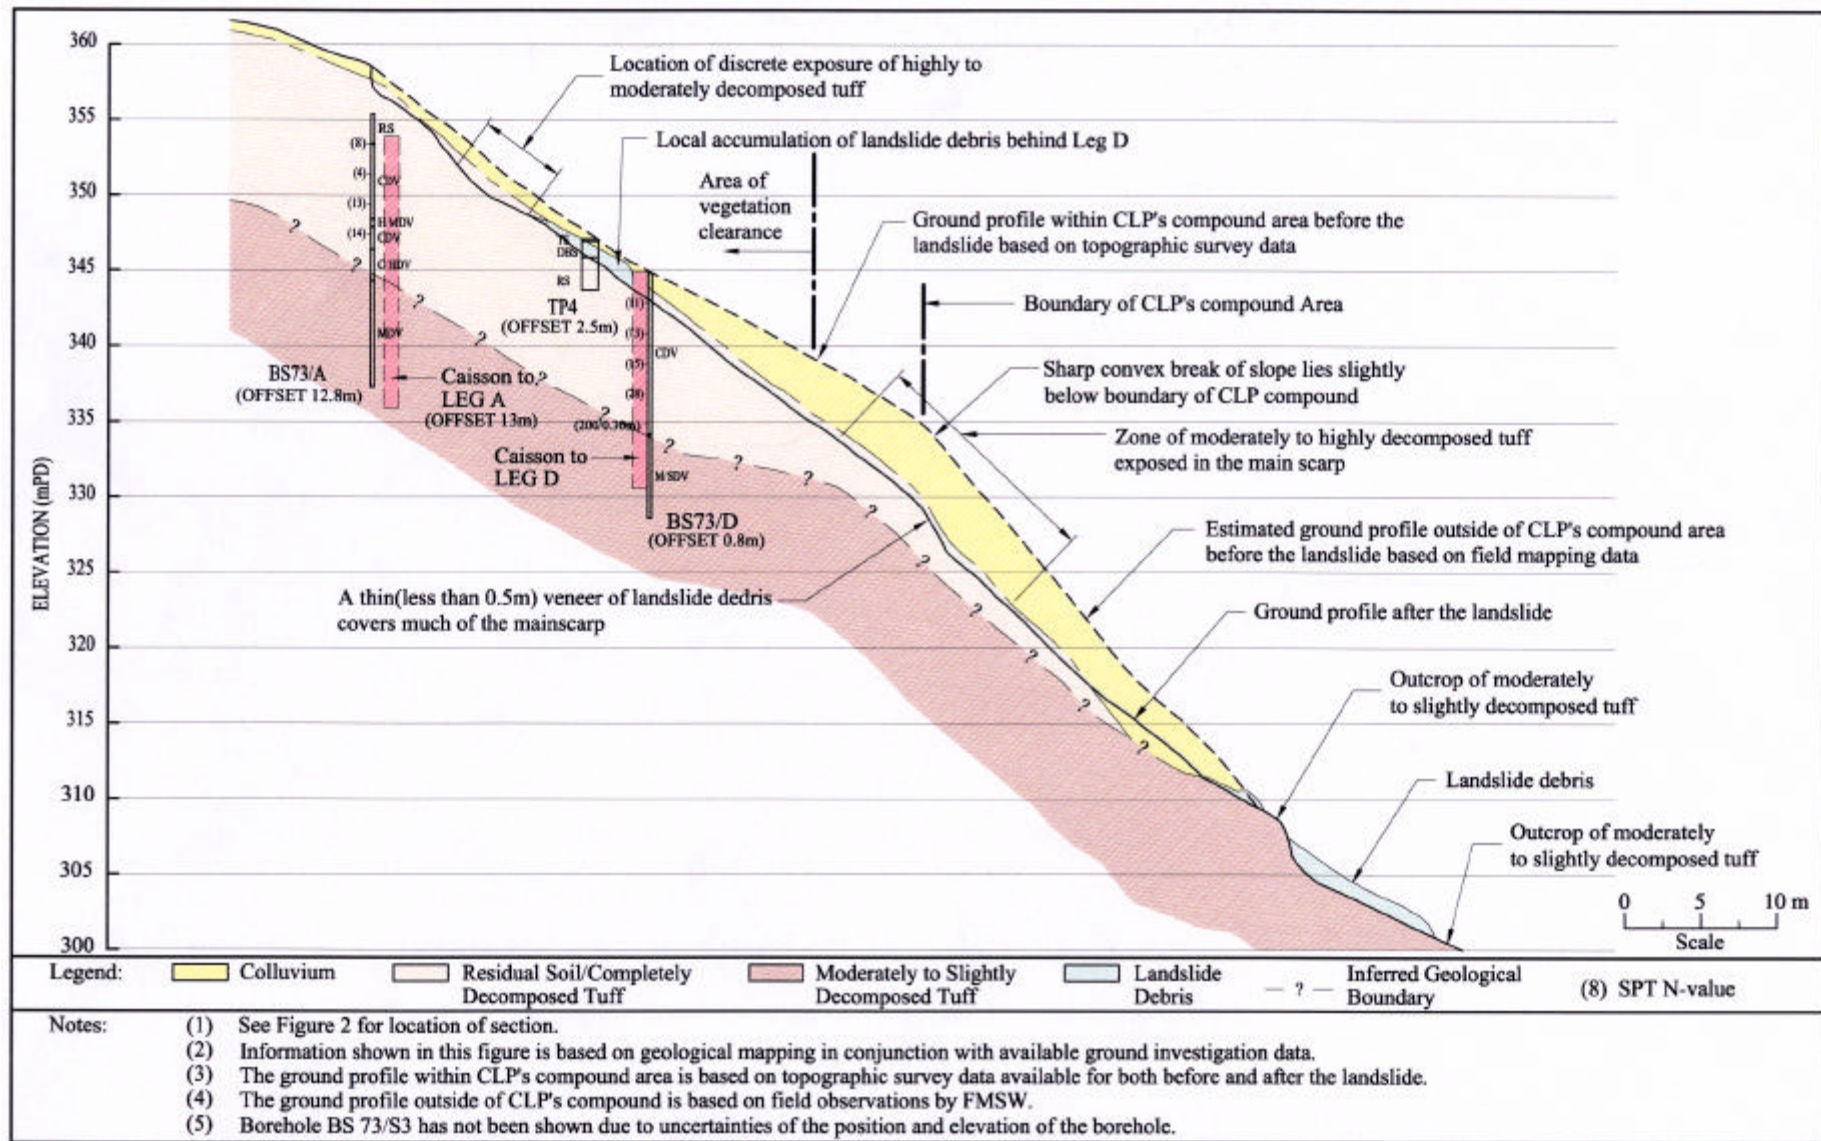
Figure 3 - Section A-A Showing the Inferred Geological Profile through the Landslide Site

It is noteworthy that the depth to rockhead in each of the analysed sections was at least 11 m. Therefore, under the assumed design groundwater conditions the slopes were effectively analysed under dry conditions for the slip surfaces considered. Furthermore, for each stability cross-section the ground profile beyond the CLP compound was determined by linear extrapolation. Consequently, the sharp convex break of slope and steeper ground profile across Leg D, as identified by post-failure mapping by FMSW (Section 2.1), were not accounted for (Figure 3 and Plate 4).

Localised outcrops of highly to moderately decomposed tuff (H-MDT) were exposed across the rupture surface (Figure 2 and Plate 10), and in the vicinity of the convex break of slope, several outcrops of H-MDT occurred in a cluster. Towards the toe of the landslide, outcrops of moderately to slightly and slightly decomposed tuff (M-SDT and SDT respectively) were observed (Plate 11). The outcrops of H-MDT observed in the main scarp could be isolated corestones, but towards the convex break of slope, where they occur in a cluster, they could be an indication of a shallower rockhead profile (Figure 3).

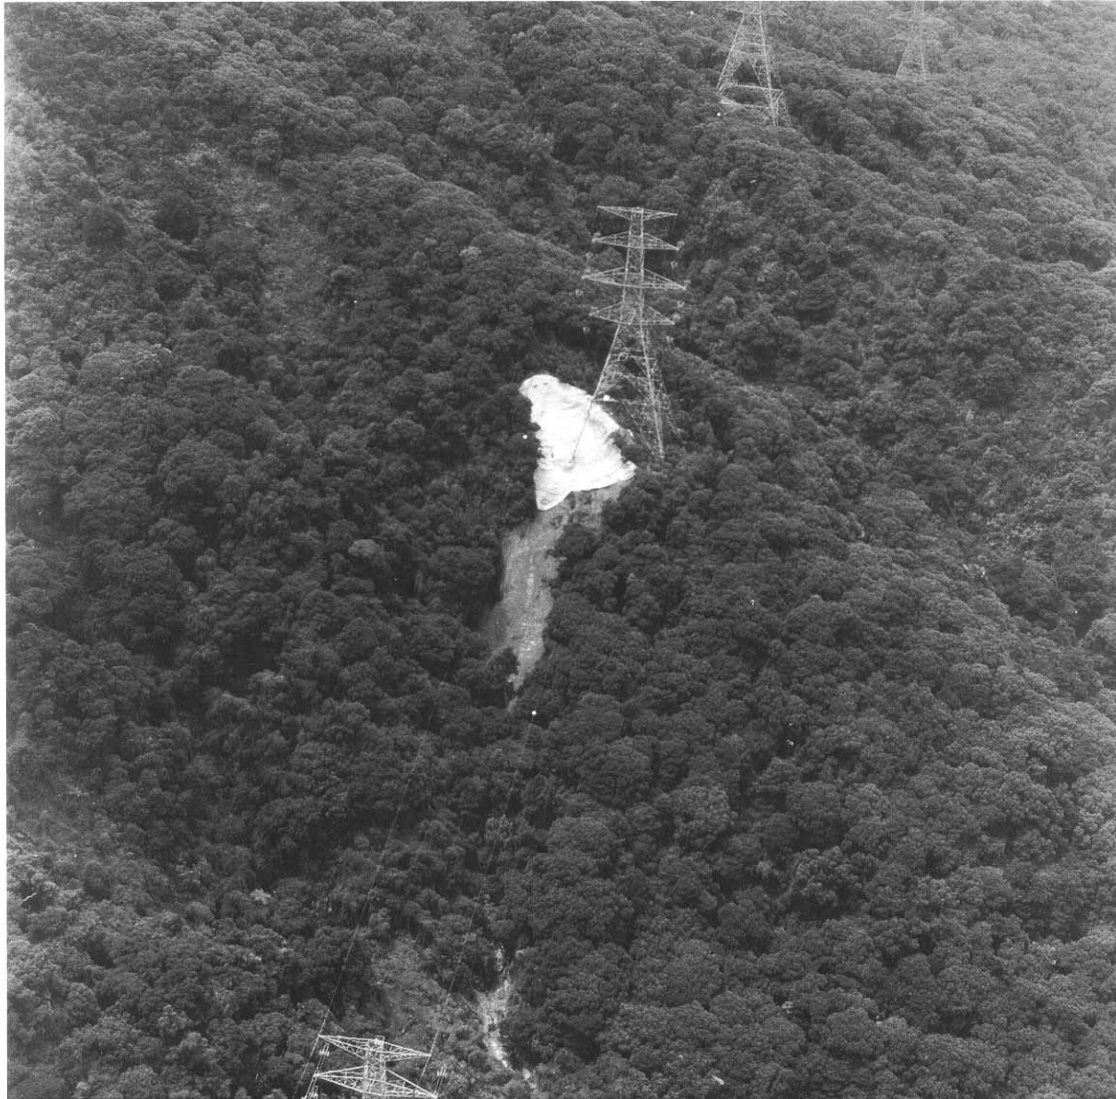
Plate 1 – Oblique Helicopter Photograph of the Landslide Looking West
(Ref. No. PS 1007-8) (Photograph Taken on 1 September 1999)

On 25 August 1999, a landslide was identified by the China Light and Power Company Limited (CLP) on the hillside above Kap Lung near Shek Kong in the New Territories (Figure 1 and Plate 1). The landslide was observed during CLP's aerial reconnaissance following the severe rainstorms between 22 and 24 August 1999. The incident was reported to the Mainland West Division of the Geotechnical Engineering Office (GEO) on 30 August 1999.

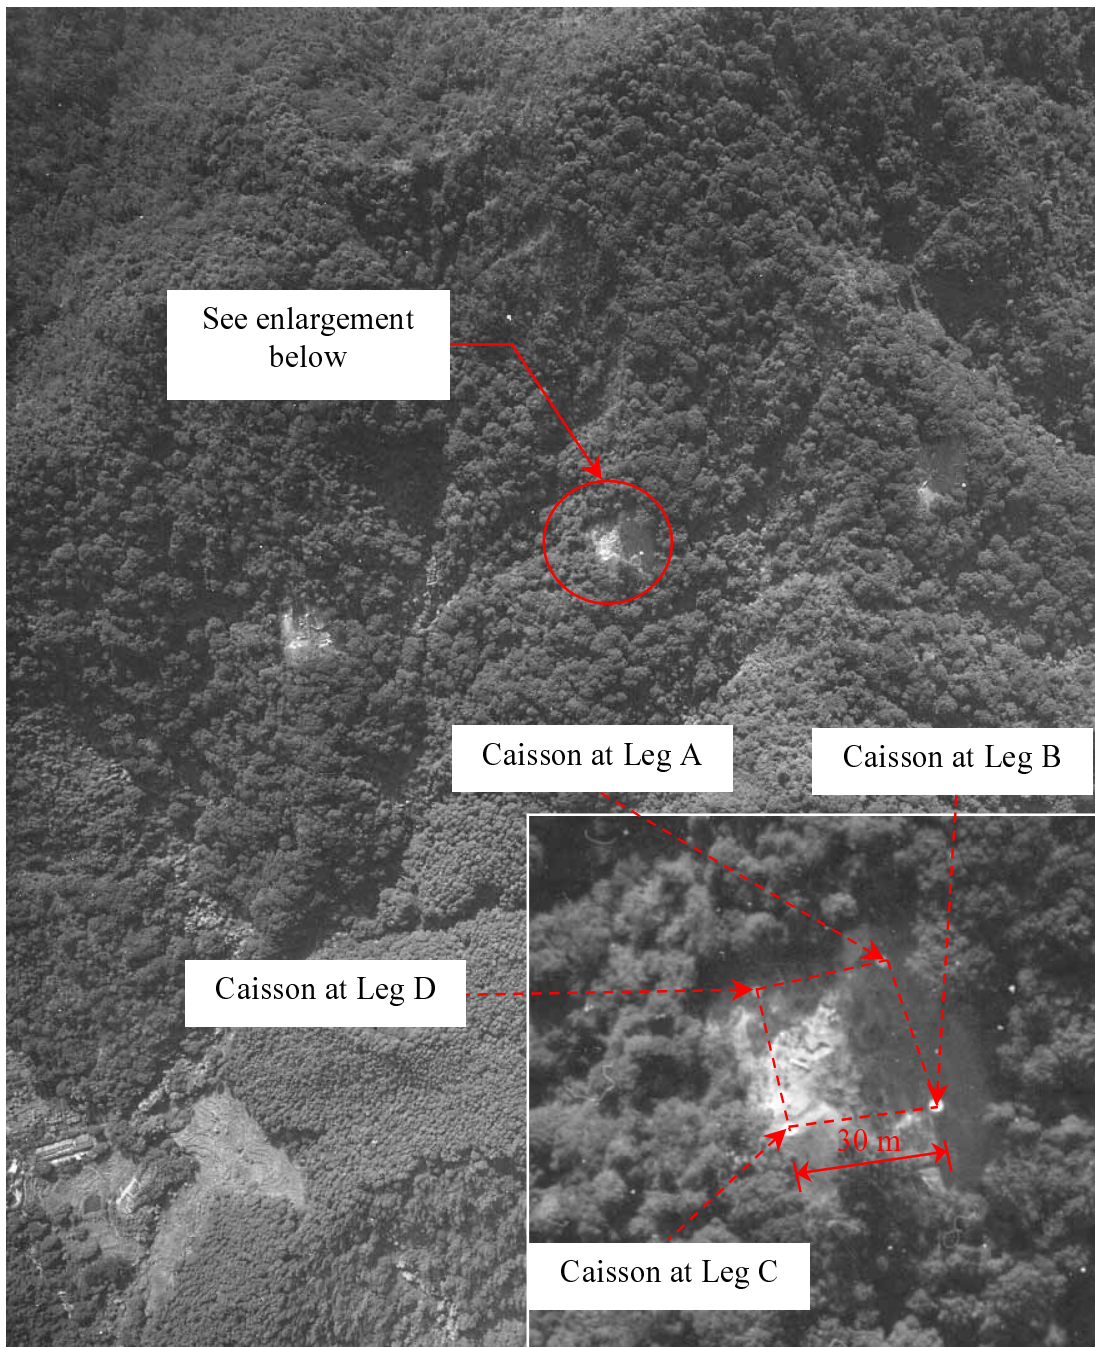
Plate 2 – Aerial Photograph of the Work Area of the Electricity Pylon
(Photograph Taken on 19 December 1995)

Vegetation clearance within the CLP compound over an area of about 1400 m² is clearly shown on the aerial photograph taken on 19 December 1995 (Plate 2). Little new vegetation growth was evident in the aerial photograph taken on 8 February 1999 (Plate 3). Post-failure site inspections have identified that the vegetation within the CLP compound remains sparse.

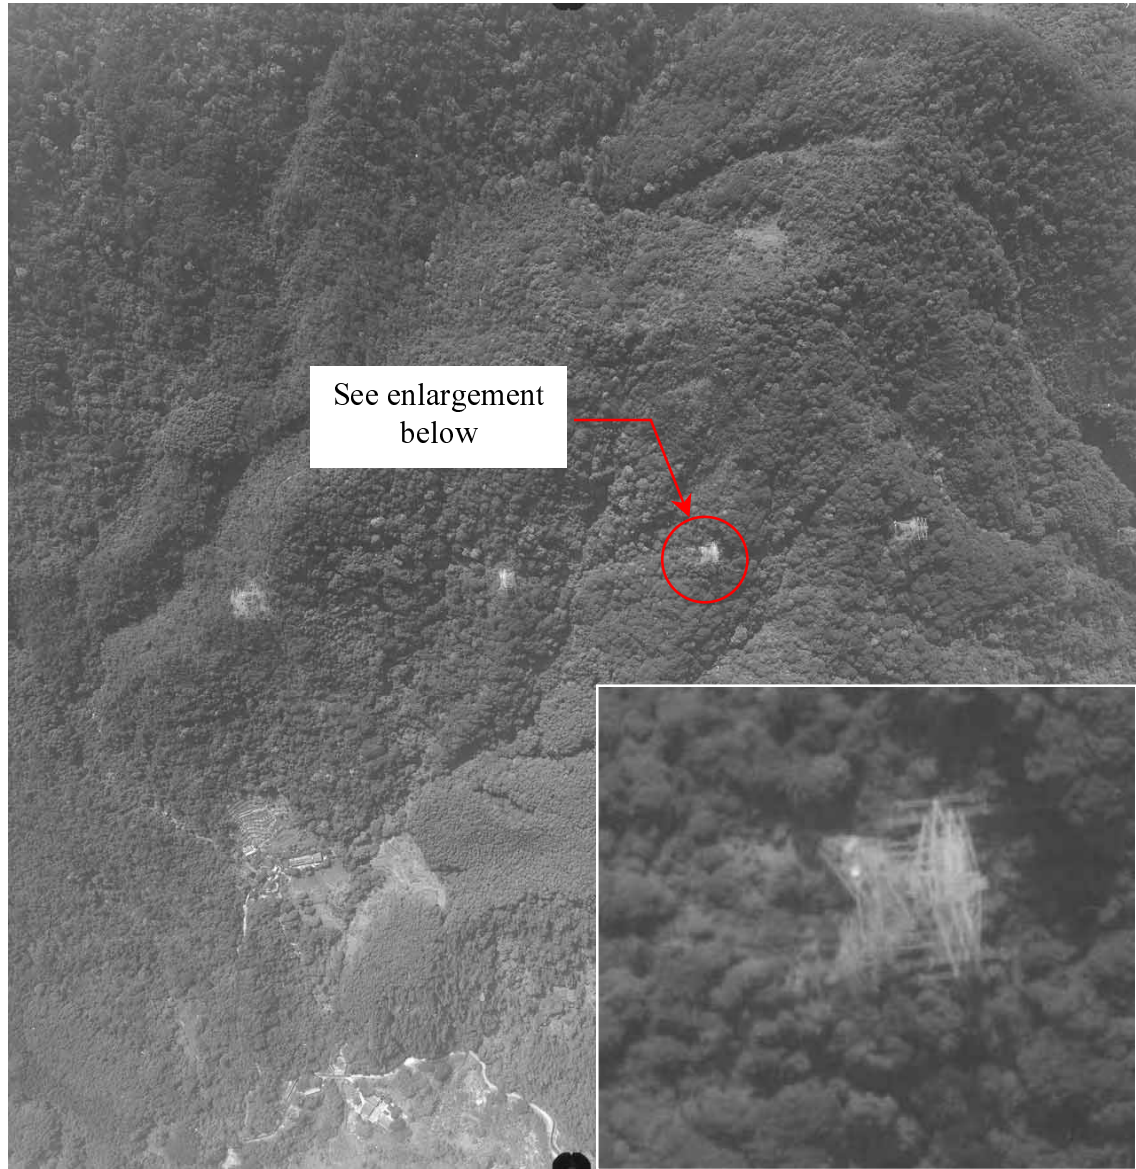
Plate 3 – Aerial Photograph of the Electricity Pylon
(Photograph Taken on 8 February 1999)

08/02/99	CN22578-CN22580	4,000	<ul style="list-style-type: none"> • At Electricity pylon 4BPB73, where vegetation clearance was noted in the 1995 aerial photograph, little new vegetation growth is evident. • No new landslide scars are noted in the immediate vicinity of the 1999 landslide site.

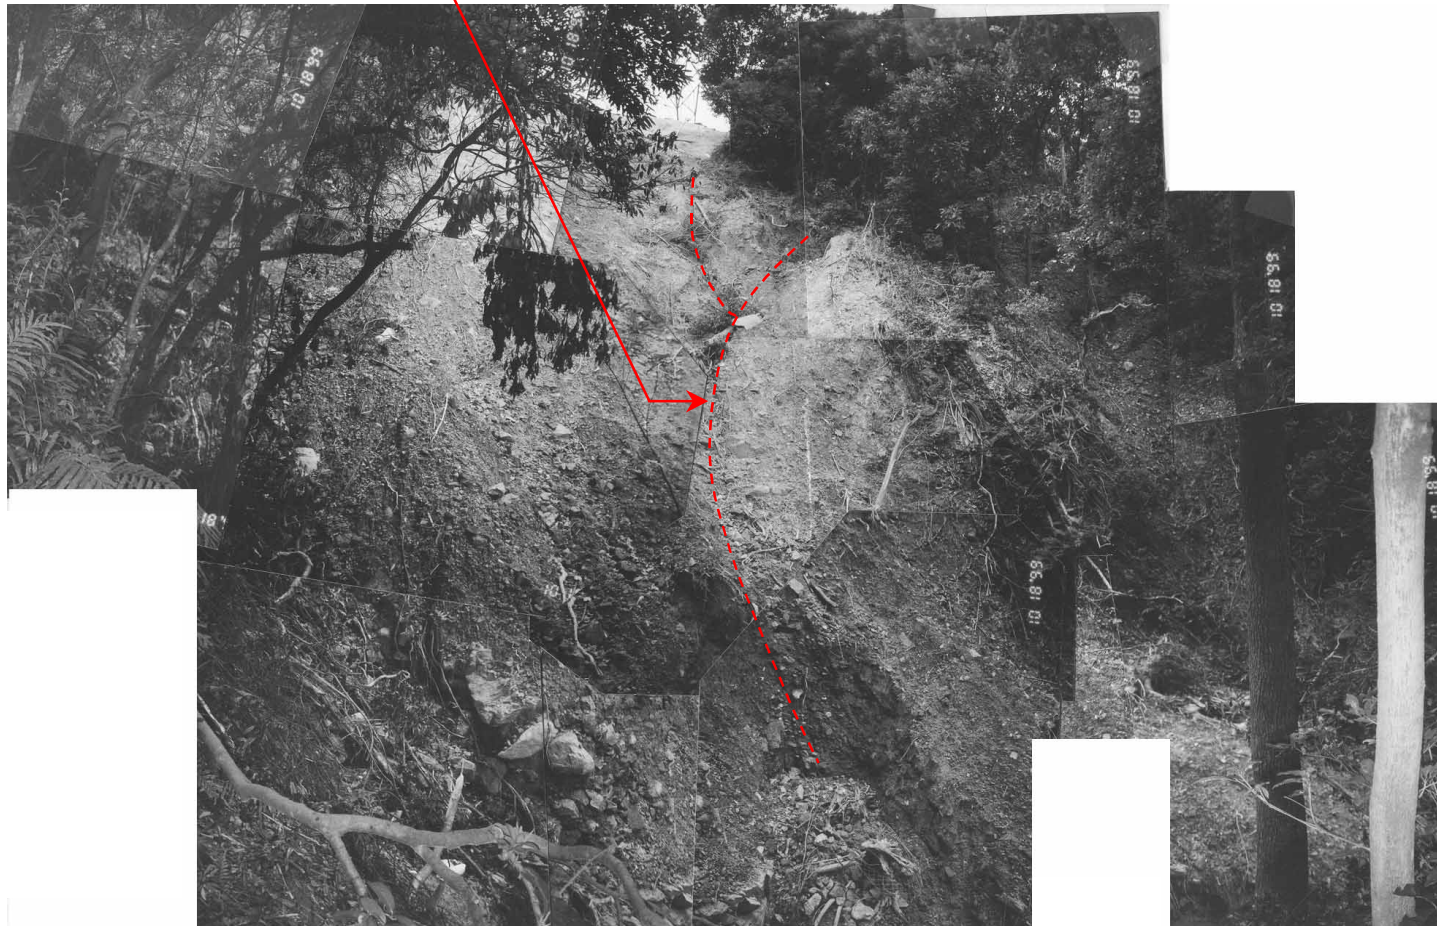
Plate 4 – General View of the Landslide Looking West (Photograph Taken on 18 October 1999)

Local accumulation of landslide debris
behind caisson forming Leg D

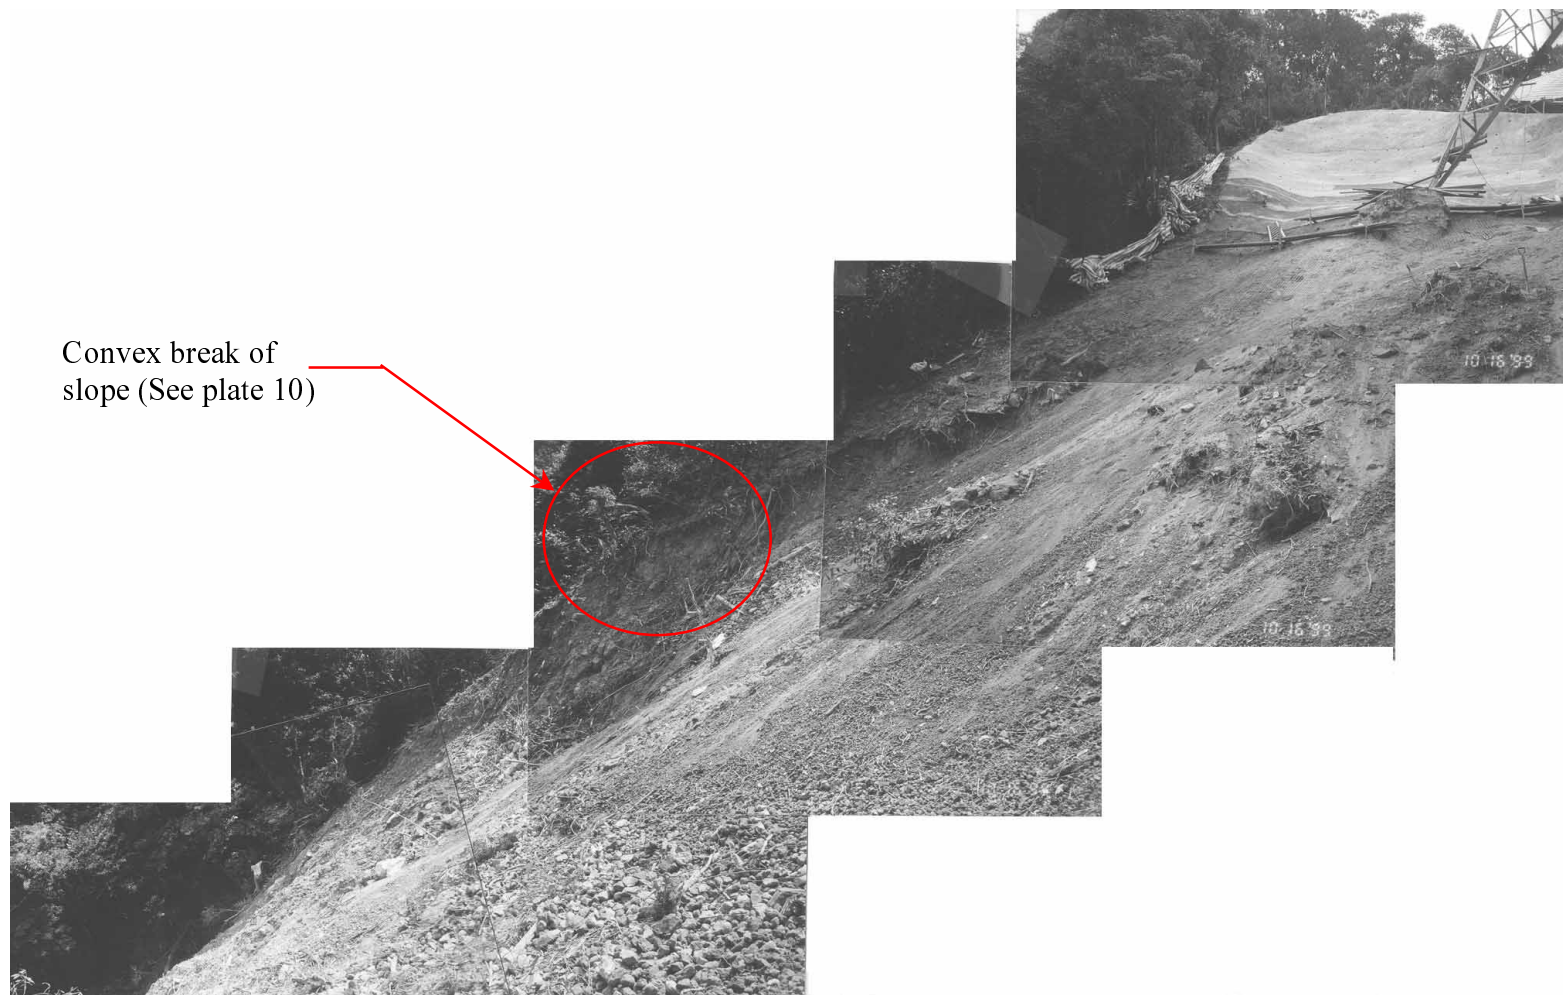
Plate 6 – General View of the Lower Portion of the Landslide Looking South
(Photograph Taken on 16 October 1999)

Convex break of slope (See plate 10)

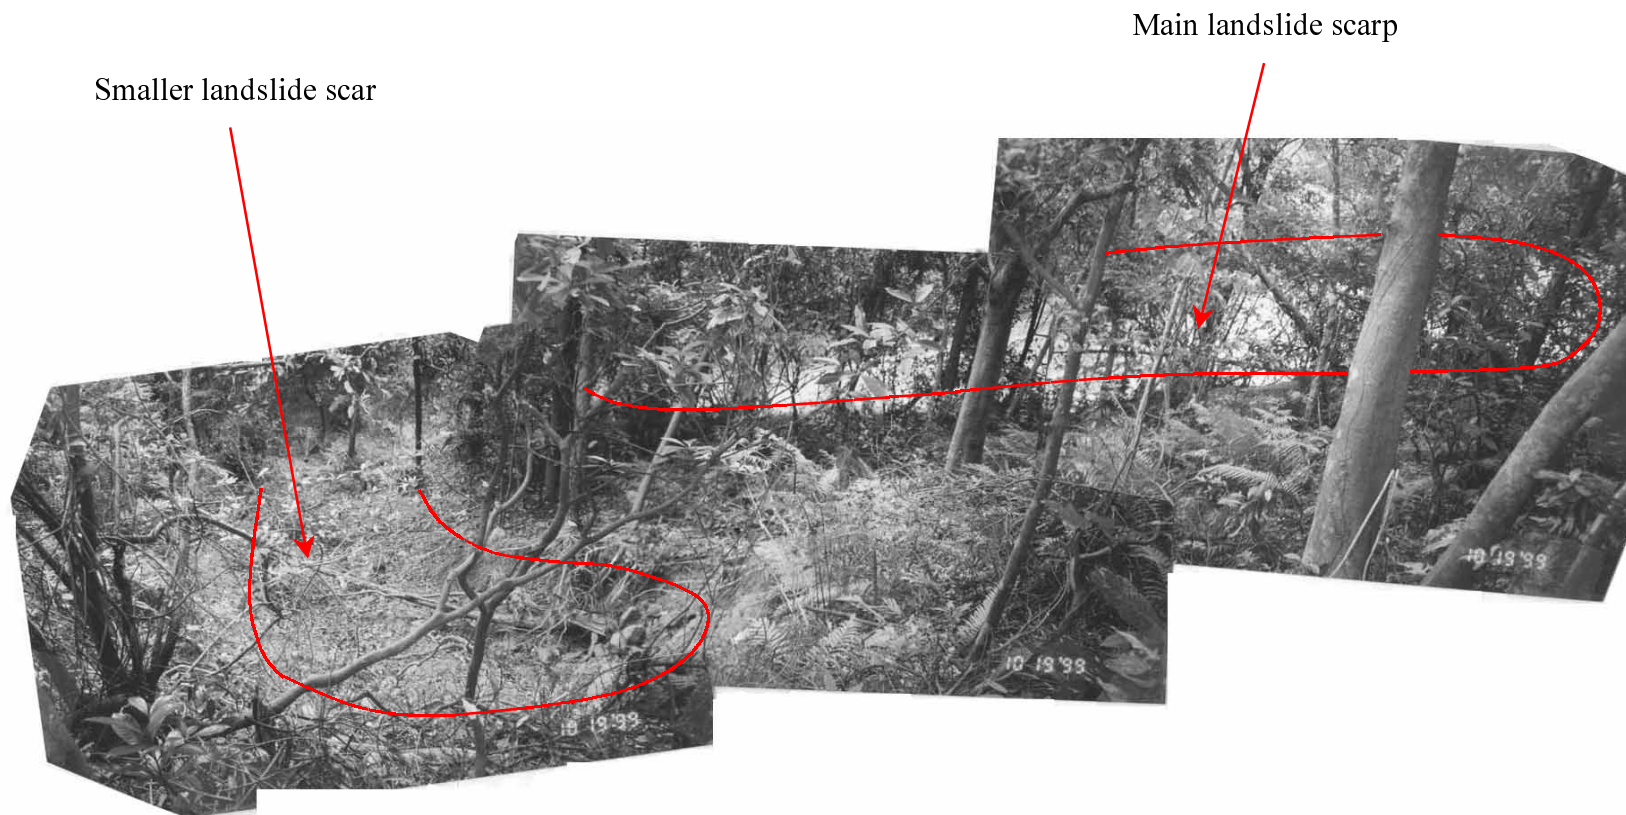
Plate 7 – View of the Smaller Landslide Scar Immediately North of the Main Landslide Scarp
(Photograph Taken on 19 October 1999)

Parallel and adjacent to the northern flank of the landslide, a smaller landslide scar, 6 m wide by 20 m long by 2 m deep, with a detached volume of about 50 m³ was observed (Figure 2 and Plate 7). This failure also occurred in colluvium and the failed material merged with debris from the main source area.

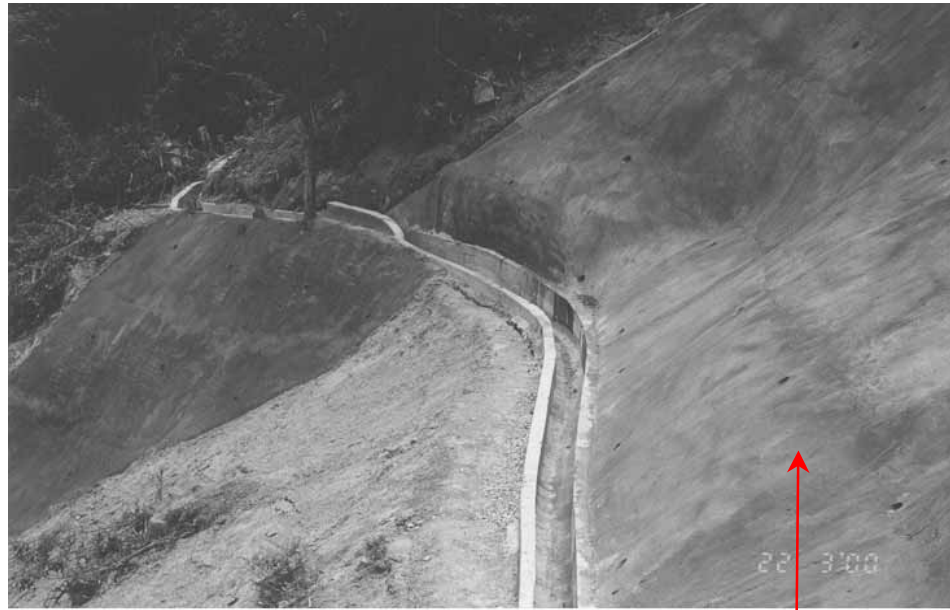
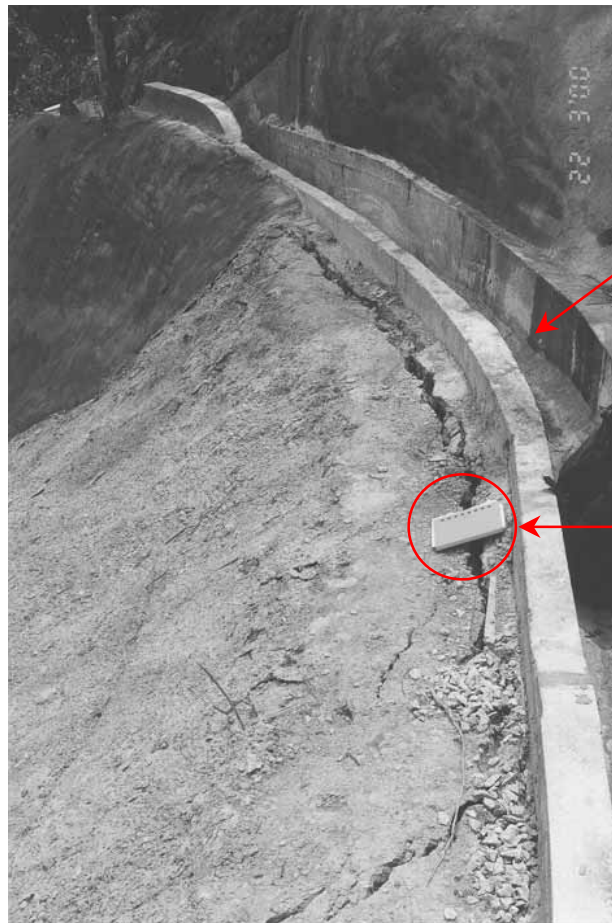
Plate 8 – View of Emergency Repair Works Following the Landslide
(Photographs Taken on 22 March 2000)

The emergency repair works were completed on 4 November 1999. A site inspection by FMSW on 22 March 2000 identified recent tension cracking, 20 mm to 30 mm wide, by 300 mm deep (maximum), by about 4 m long, directly below the treated area (Plate 8). This cracking appears to be associated with the thin superficial layer of 1999 landslide debris that had not yet been removed from the scar. Also, the drainage channel along the toe of the treated area had no upstand to it, such that water flowing from the steep shotcreted surface above may tend to over-shoot the channel and discharge onto the bare portion of the failed slope below.

Surface water runoff from the shotcreted portion of the slope may tend to overshoot the toe channel

Recent tension cracks, 20 mm to 30 mm wide by 300 mm deep by 4 m to 5 m long, were observed in the untreated portion of the landslide scarp

- (a) removal of loose debris and trimming of the over-steepened edges from the landslide scarp,
- (b) application of 75 mm thick shotcrete for protection against ingress of surface water and erosion, and
- (c) installation of weepholes at 2 m centres and peripheral surface channels.

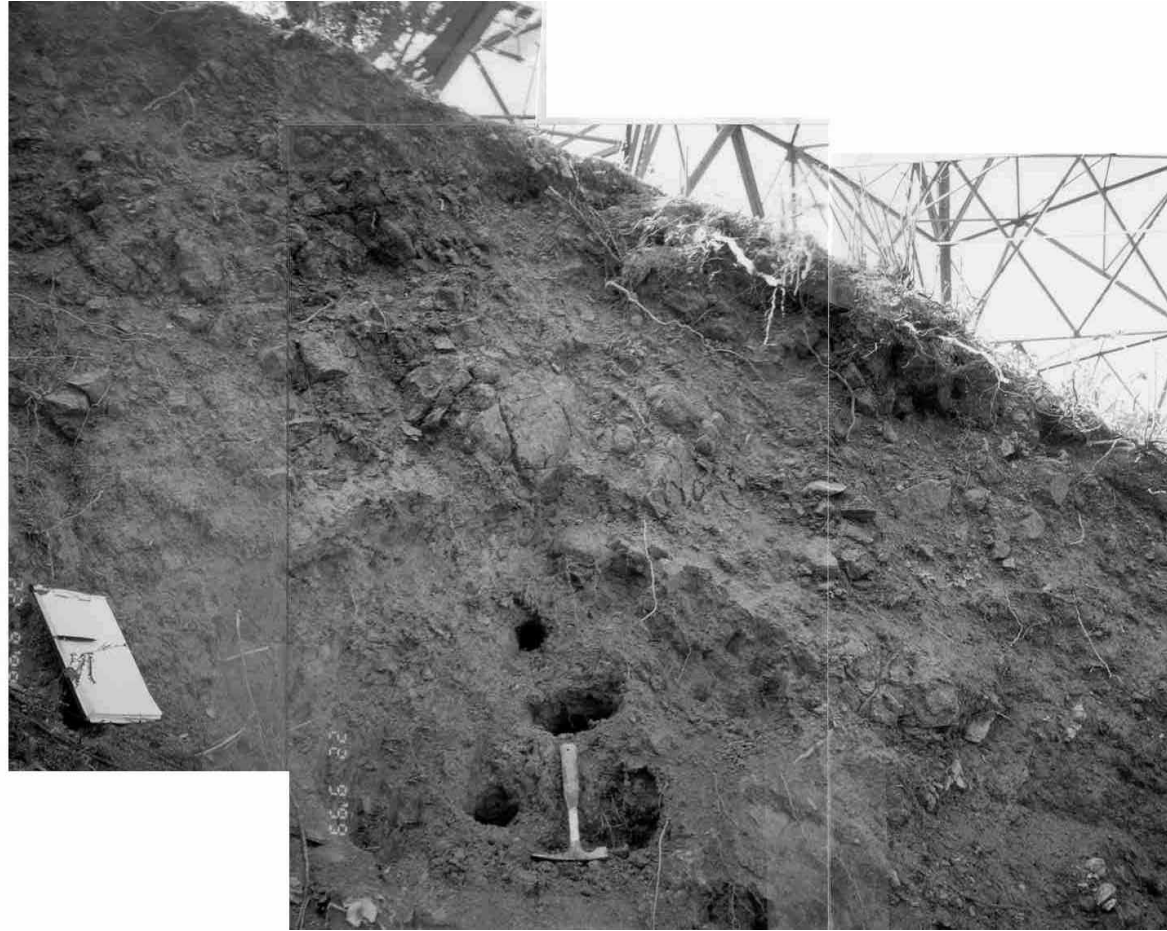
Plate 9 – View of Soil/Erosion Pipes Observed in the Upper Portion of the Landslide Main Scarp
(Photograph Taken on 22 September 1999)

Along the upper portion of the main scarp, the colluvium was underlain by residual soil and CDT. The thicknesses and lateral extent of these materials were very variable. The residual soil comprised a firm to stiff, brown, fine sandy, clayey silt up to a maximum thickness of about 2 m. A number of soil/erosion pipes were observed along the upper portion of the main scarp (Plate 9).

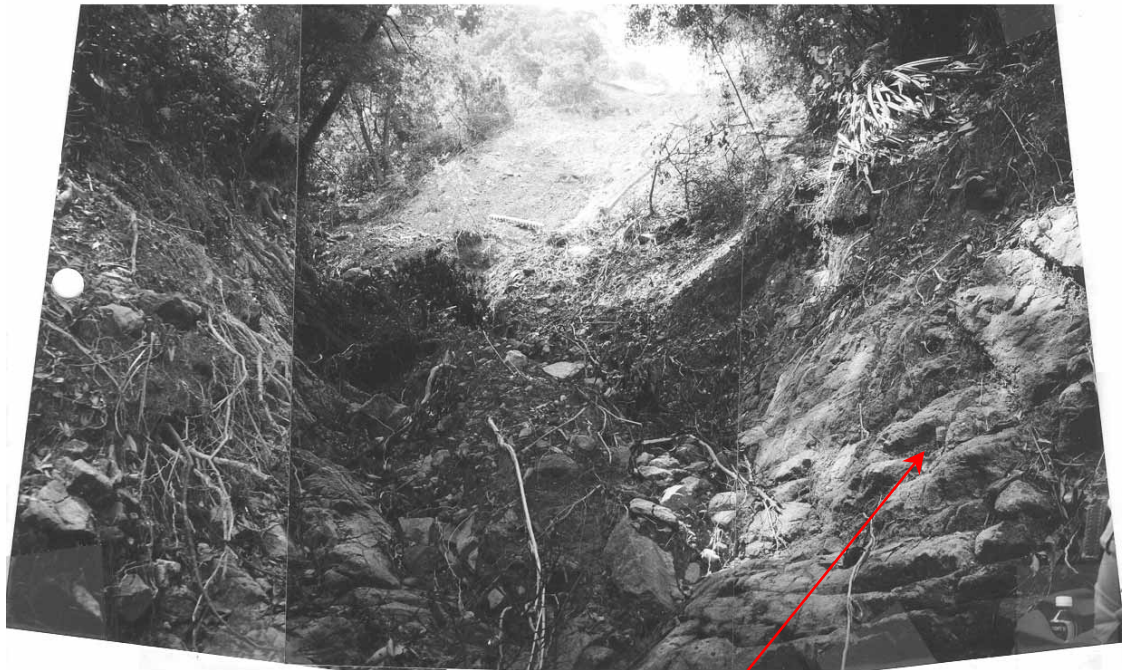
Plate 11 – View of Rock Outcrop in the Drainage Line at the Toe of the Landslide
(Photograph Taken on 24 September 1999)

Rock outcrop along natural gully

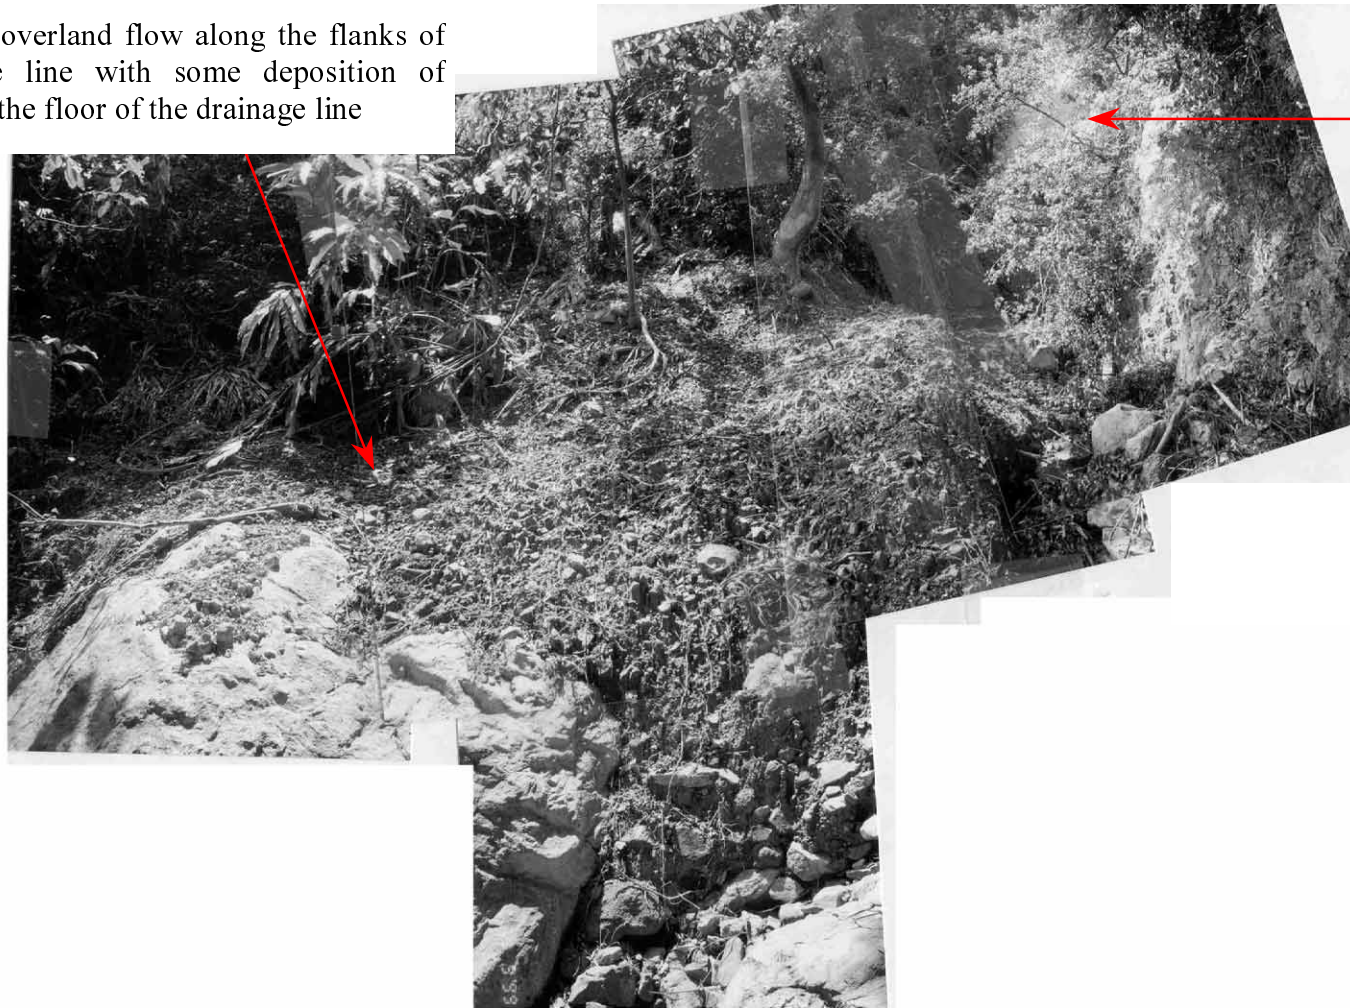
Plate A1 – View Looking Upslope of the Upper Portion of the Drainage Line below the Toe of the Landslide

Evidence of overland flow along the flanks of the drainage line with some deposition of debris along the floor of the drainage line

1999 landslide scar

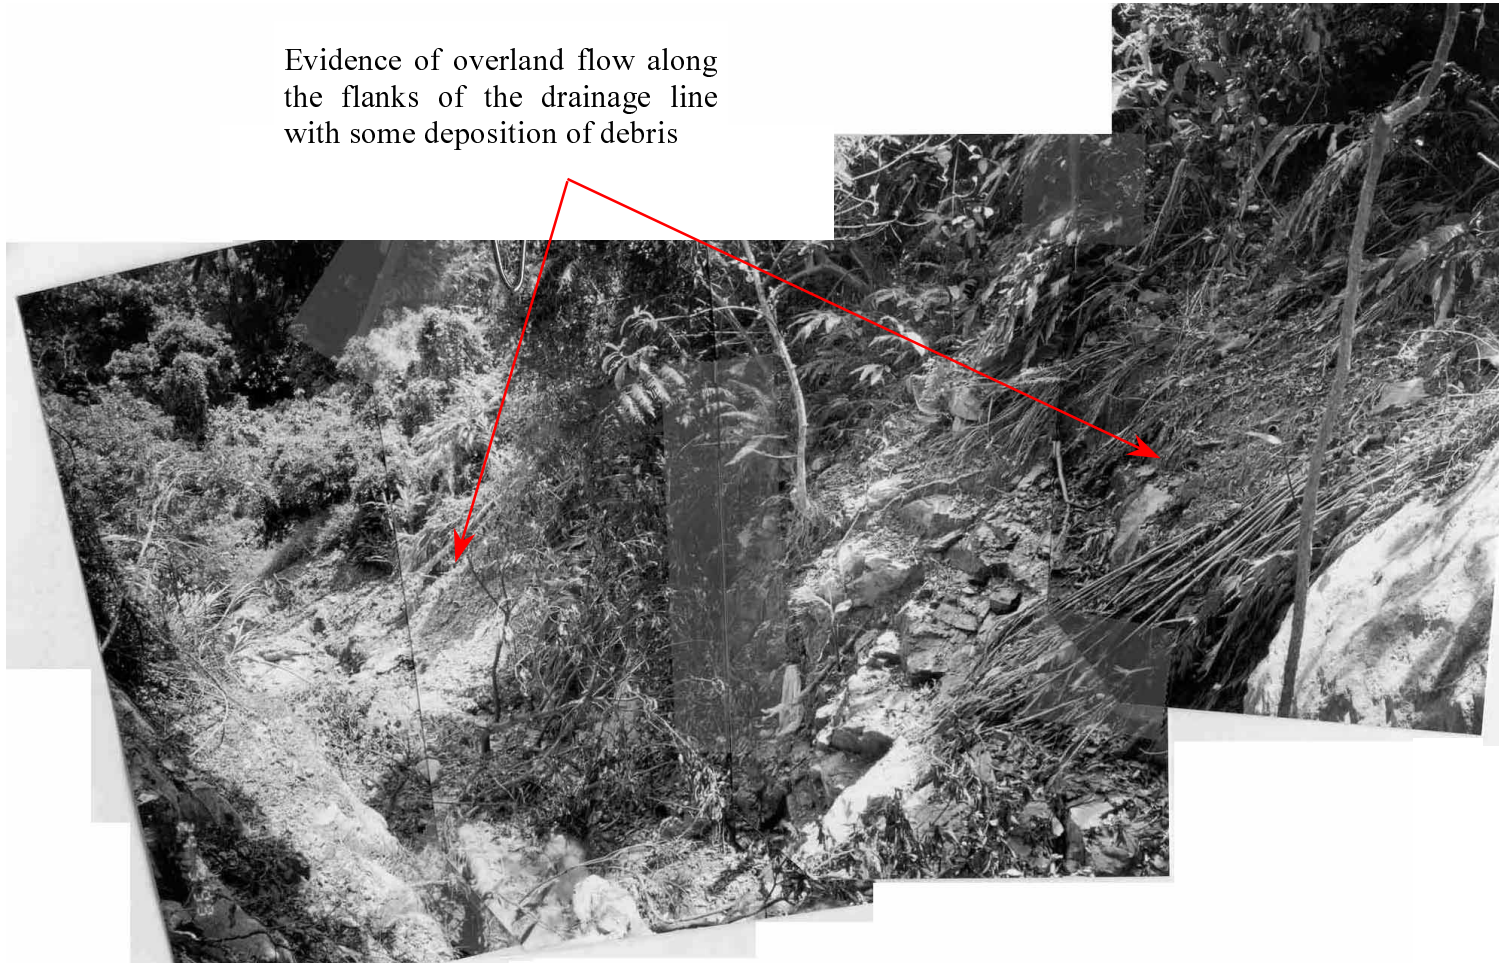
Plate A2 – View Looking Downslope of the Upper Portion of the Drainage Line below the Toe of the Landslide

Evidence of overland flow along
the flanks of the drainage line
with some deposition of debris

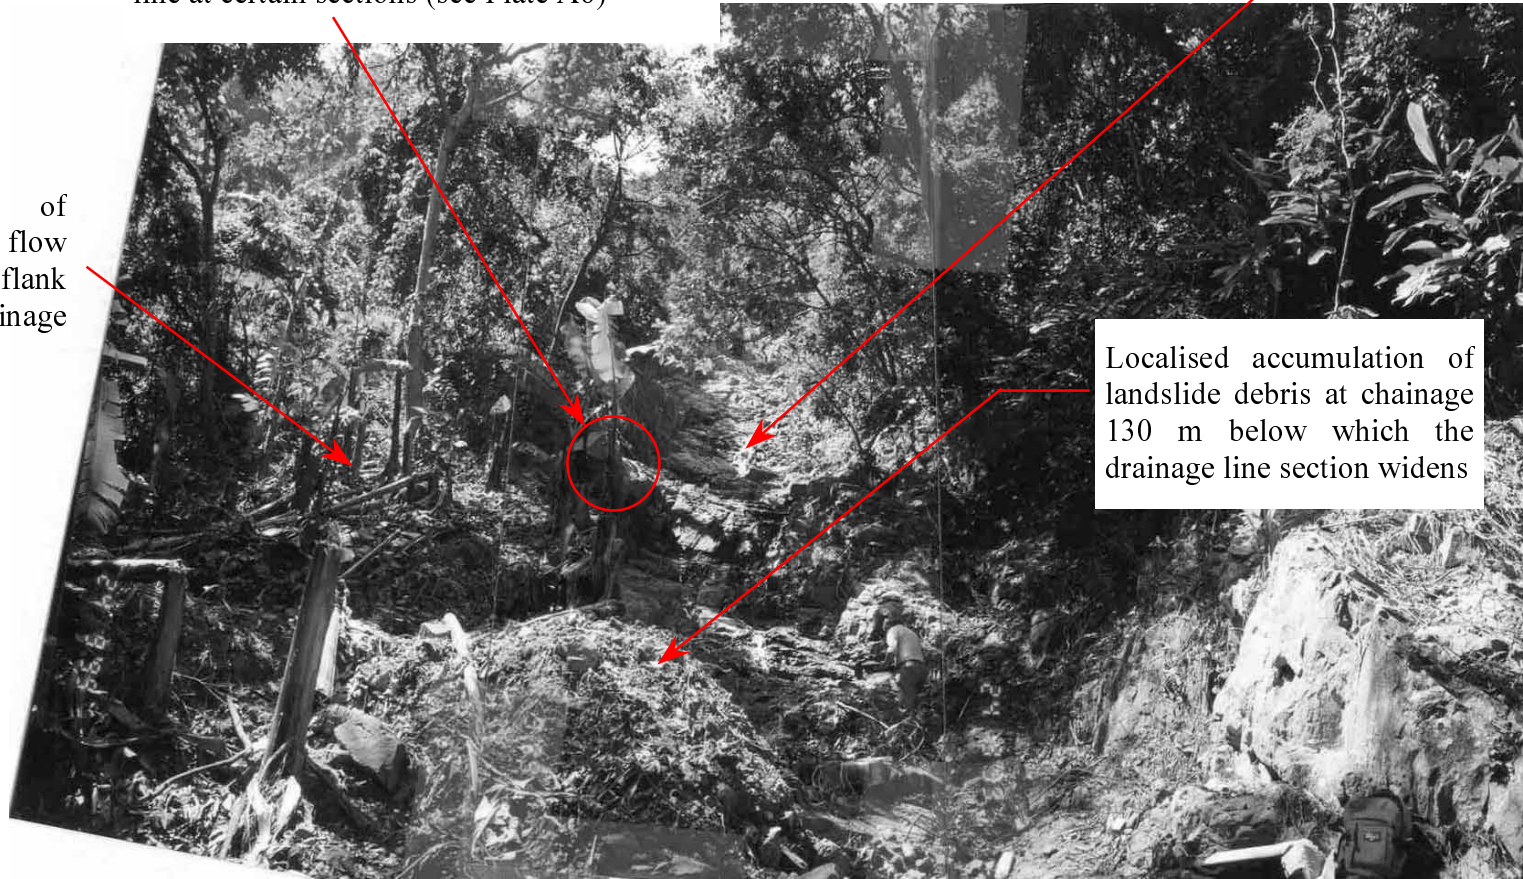
Plate A3 – View Looking Upslope of the Drainage Line at Chainage 130 m

Loose/voided colluvium overlying bedrock was observed in the flanks of the drainage line at certain sections (see Plate A6)

Floor of the drainage line exposes tuffaceous bedrock

Evidence of overland flow along the flank of the drainage line

Localised accumulation of landslide debris at chainage 130 m below which the drainage line section widens

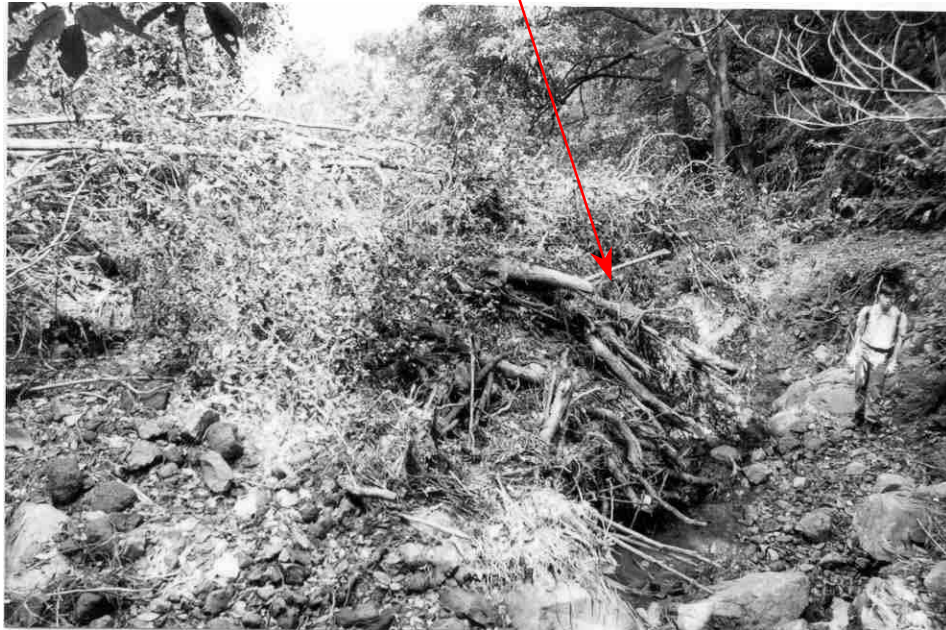
Plate A4 – View Looking Downslope of Localised Accumulation of Debris at Chainage 210 m

Large accumulation of vegetation and landslide debris partially blocking the drainage line
