**INVESTIGATION OF SOME
SELECTED LANDSLIDES
IN 1999
(VOLUME 2)**

GEO REPORT No. 121

**GEOTECHNICAL ENGINEERING OFFICE
CIVIL ENGINEERING DEPARTMENT
THE GOVERNMENT OF THE HONG KONG
SPECIAL ADMINISTRATIVE REGION**

**SECTION 1:
DETAILED STUDY OF THE
LANDSLIDE ABOVE
KAP LUNG, SHEK KONG,
DURING THE SEVERE
RAINSTORMS BETWEEN
22 AND 24 AUGUST 1999**

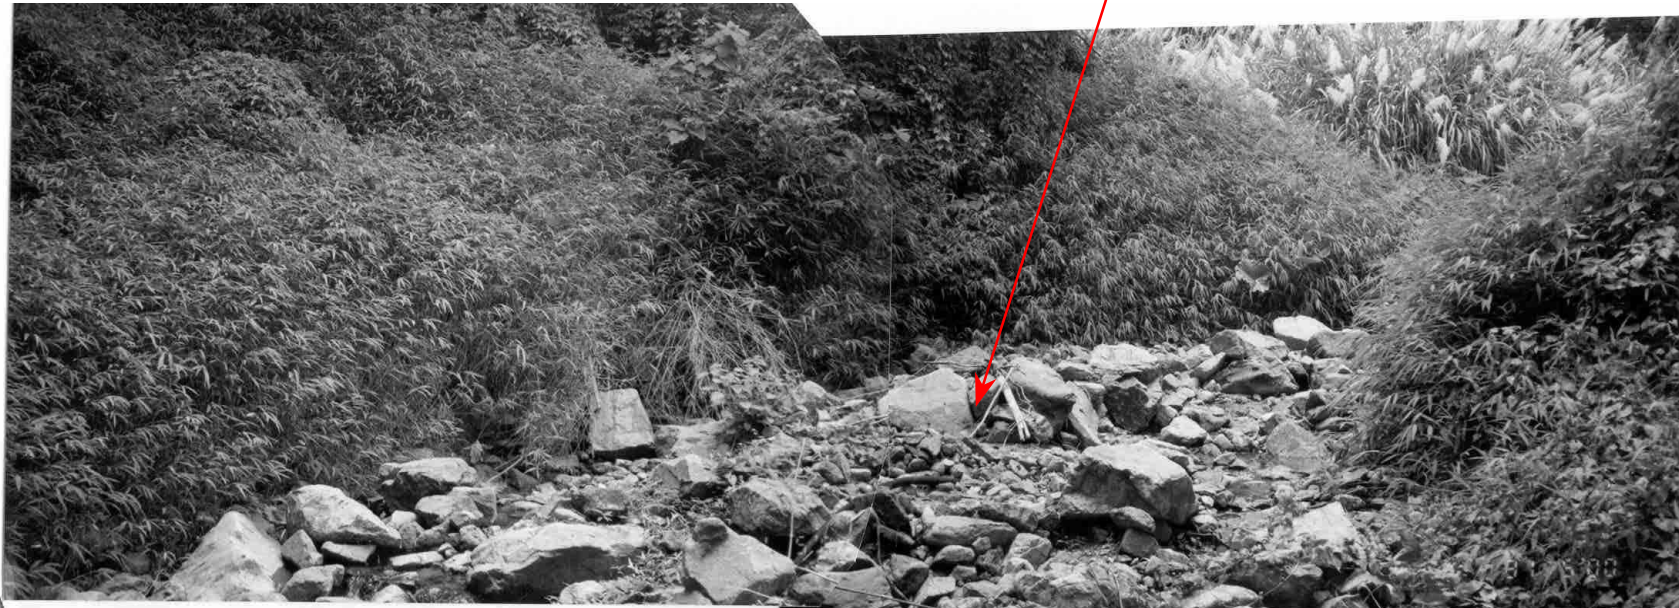
Plate A5 – View Looking Upslope of Area of Possible Deposition of 1999 Landslide Debris at Chainage 700 m

Area of bouldery deposition along the
centre line of the drainage line
considered to be 1999 landslide debris

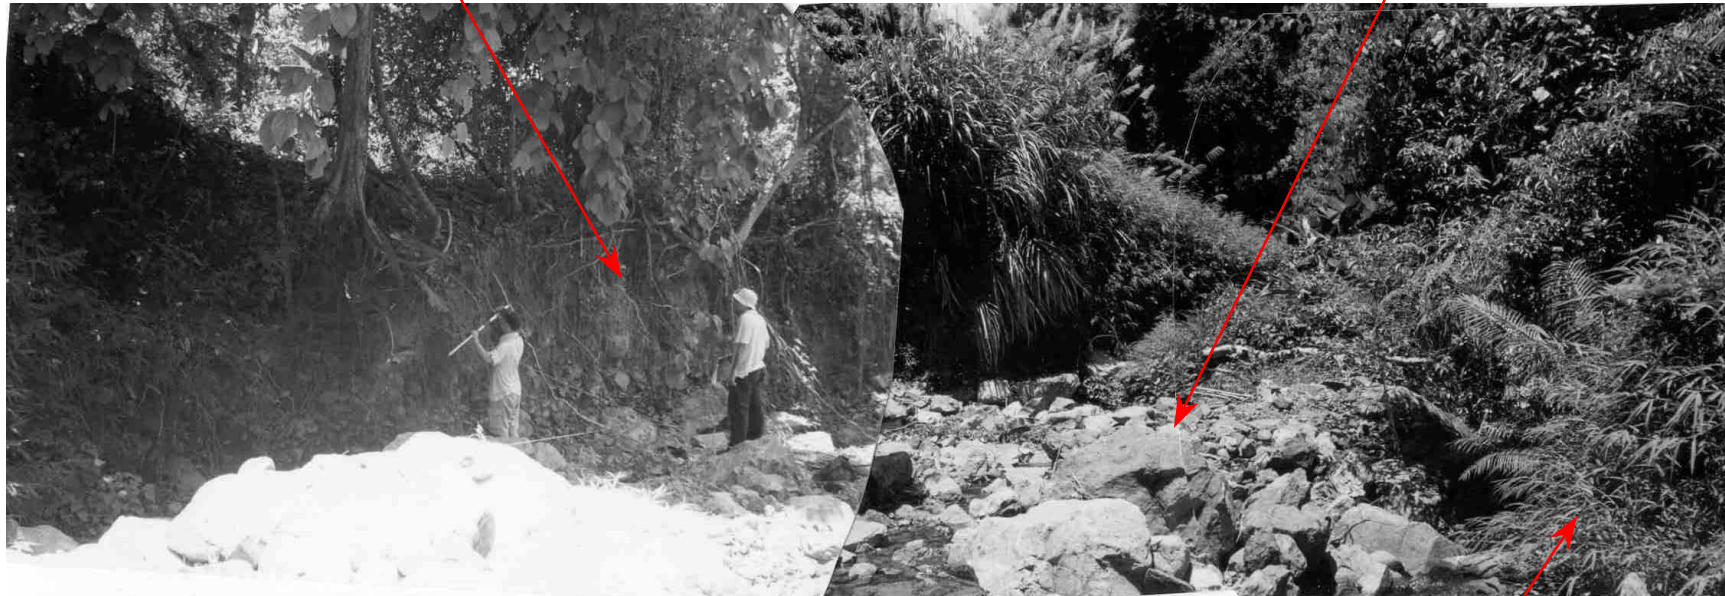
Plate A8 – View Looking Downslope Showing the Profile of the Lower Portion of the Drainage Line

Approximately 3 m of colluvium is exposed in the steep northern flank of the drainage line

Evidence of large volumes of deposition of 1999 landslide debris

Localised outcrop of bedrock in the southern flank of the drainage line

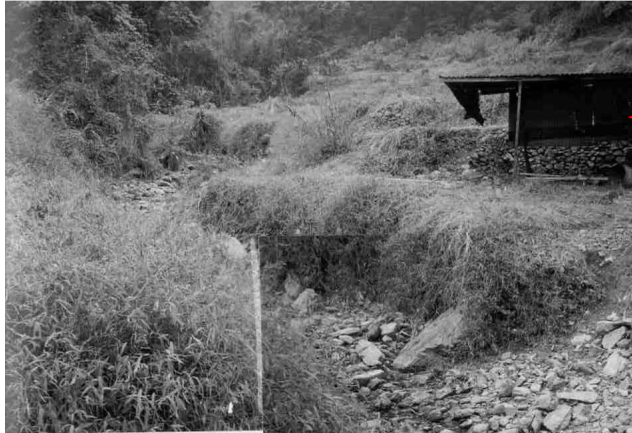
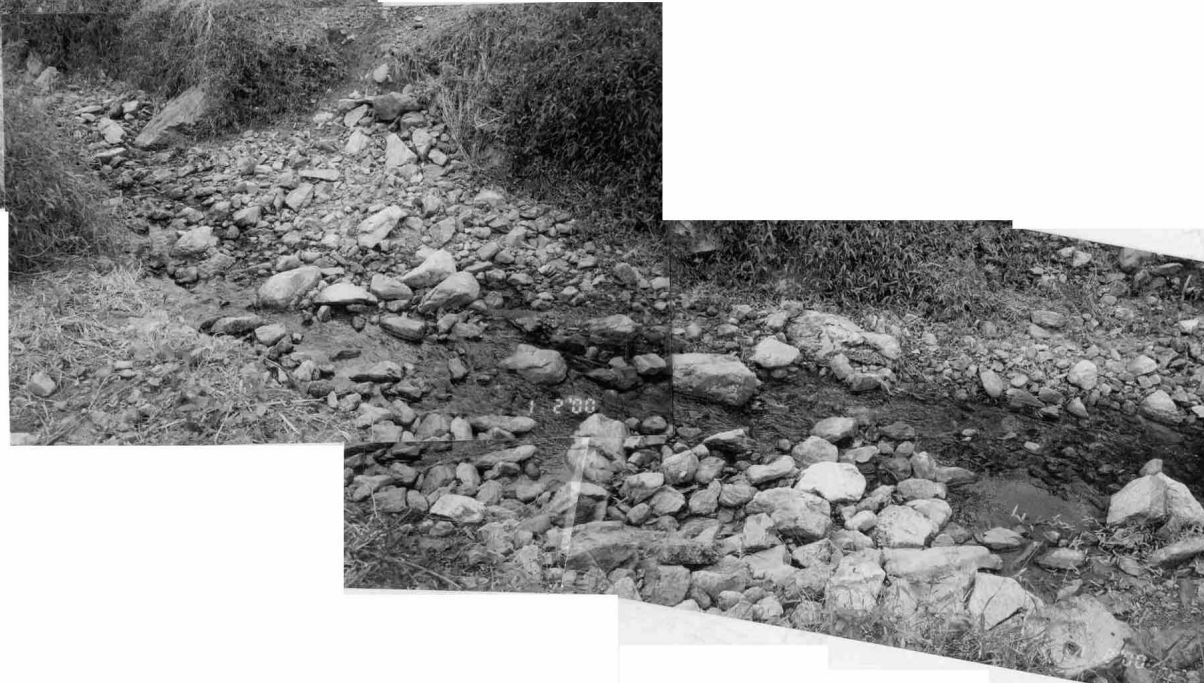
Plate A9 – View Showing the Topography and Nature of the Lower Portion of the Drainage Line

Gently sloping ground formed
in relic debris flow deposits
