**SECTION 2:
DETAILED STUDY OF THE
LANDSLIDES BELOW
VTC POKFULAM SKILLS
CENTRE, POKFULAM ROAD
ON 23 AUGUST 1999**

**This report was originally produced in October 2000
as GEO Landslide Study Report No. LSR 7/2000**

This report presents the findings of a detailed study of two landslides (GEO Incident No. HK 99/8/11) which occurred on 23 August 1999 in the hillside below the Vocational Training Council (VTC) Pokfulam Skills Centre on Pokfulam Road. Debris from the landslides, estimated at 100 m³ and 200 m³ respectively, was channelised in an ephemeral drainage line and reached Victoria Road, approximately 200 m west of the VTC facility on plan. No casualties were reported as a result of the incident.

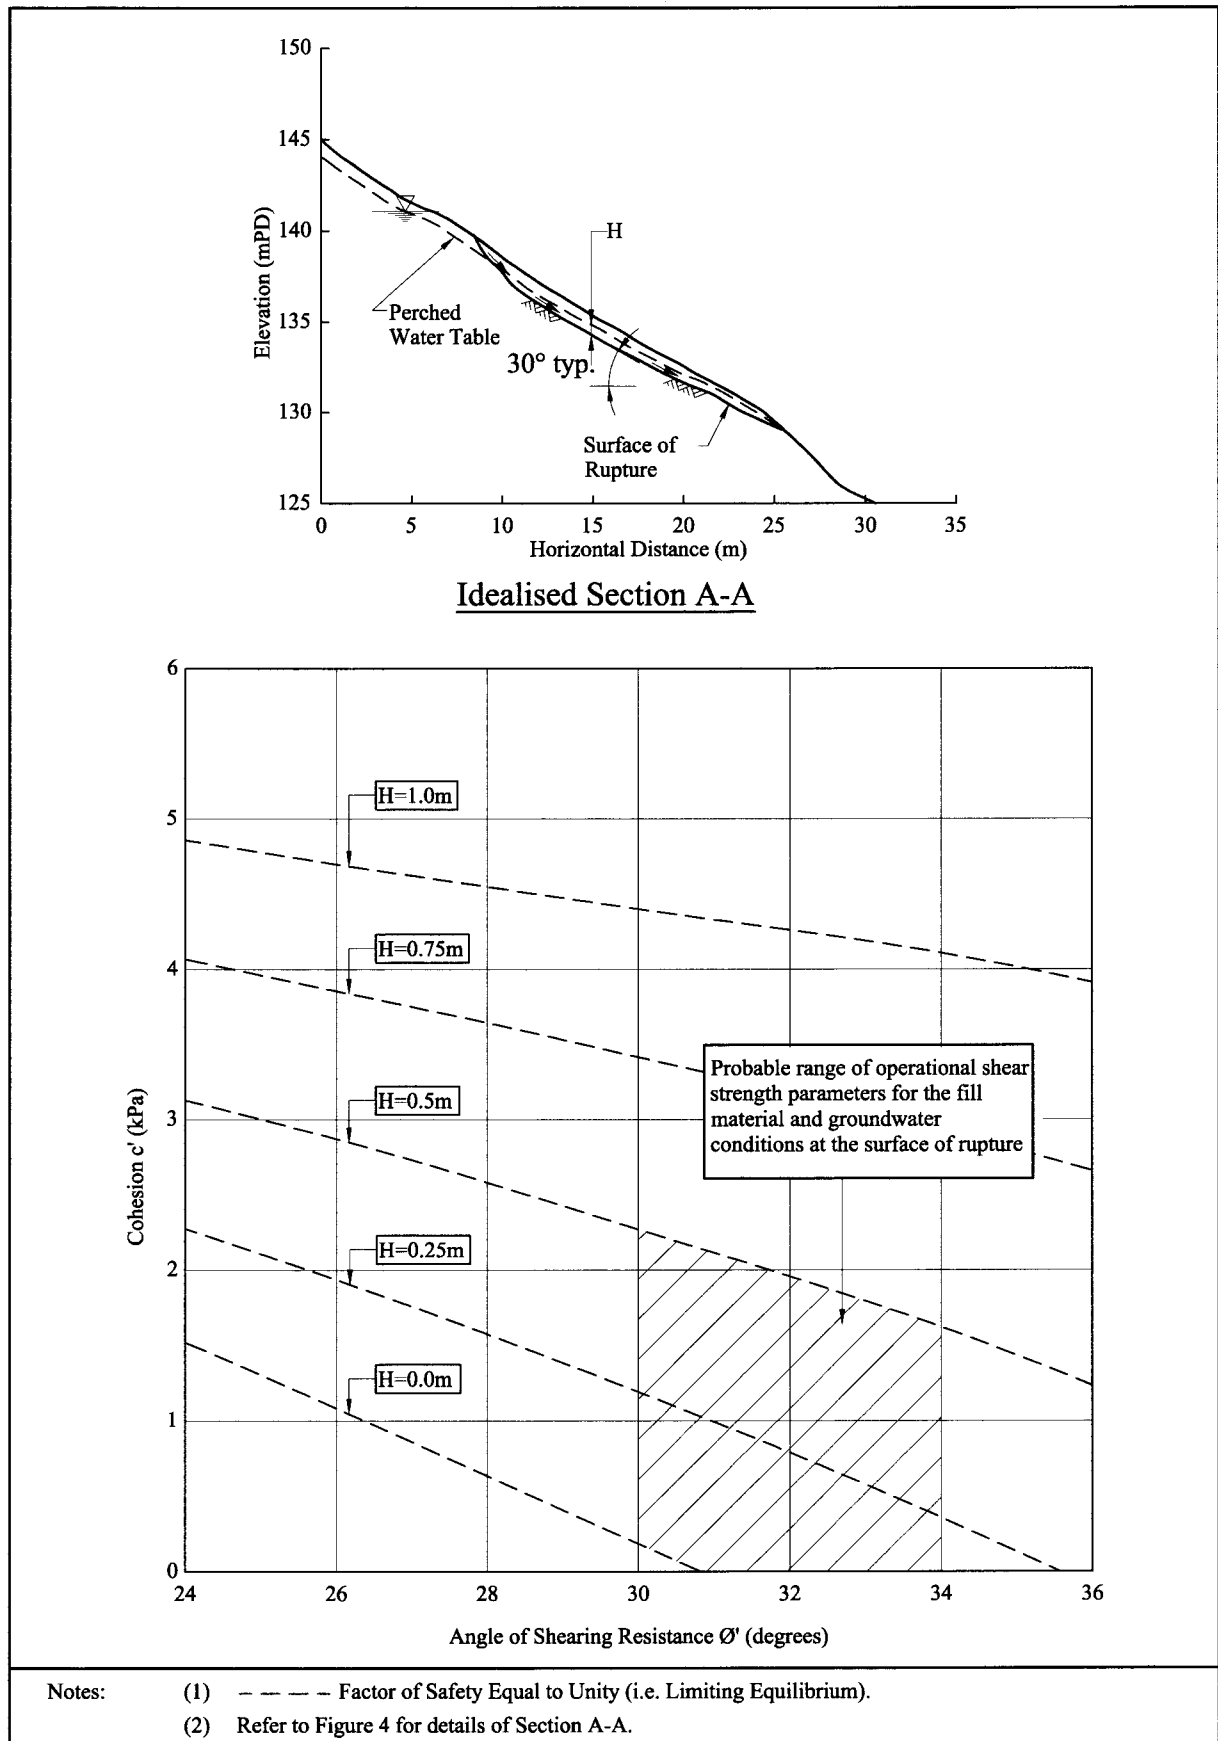
Figure 11 - Summary of Sensitivity Analyses (Landslide A)

The results of the analyses are presented in Figures 11 and 12 respectively. The results for Section A-A presented on Figure 11 indicate that elevated groundwater pressures of between 0.25 m to 0.5 m above the surface of rupture (fill/natural ground interface) would be required to initiate failure when effective cohesion corresponds to 1 kPa to 2 kPa. The fill was probably in a loose to medium dense state based on the interpretation of the available test results and site observations. This suggests that cohesion would be low.

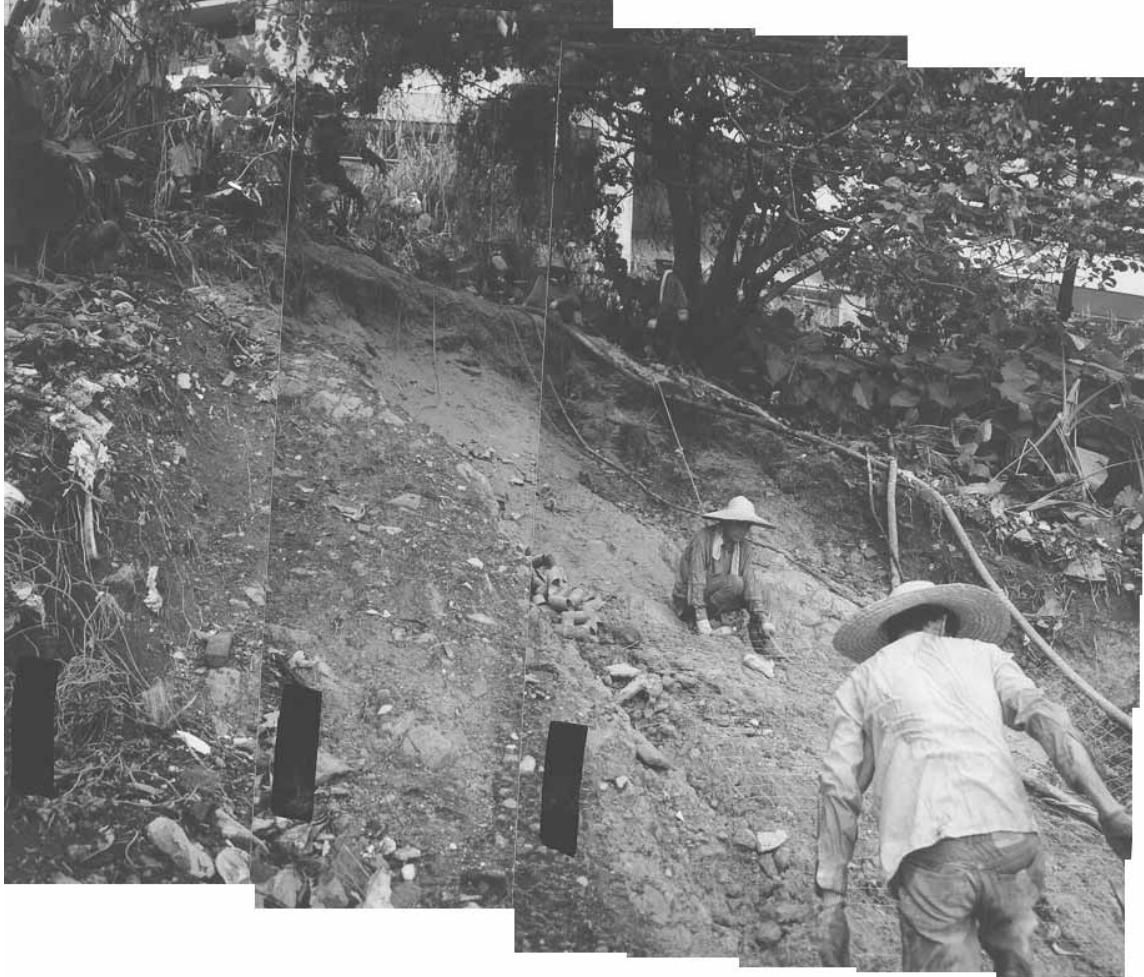
- (b) By comparison with drainage line No. 1, there was no significant flow of water from drainage line No. 2 (Plate 5), although seepage from rock outcrops within the debris trail of landslide A was observed (Plates 9 and 16). The source area of landslide A was also largely devoid of surface water.

Plate 5 – View East across Main Scarp and Southern Flank of Landslide A. Note Definition of Scarp and Flank, Exposed Fill in Flanks and Clear Line of Interface with Natural Ground Below. Note also Refuse Content of Fill (Photograph Taken on 26 August 1999)

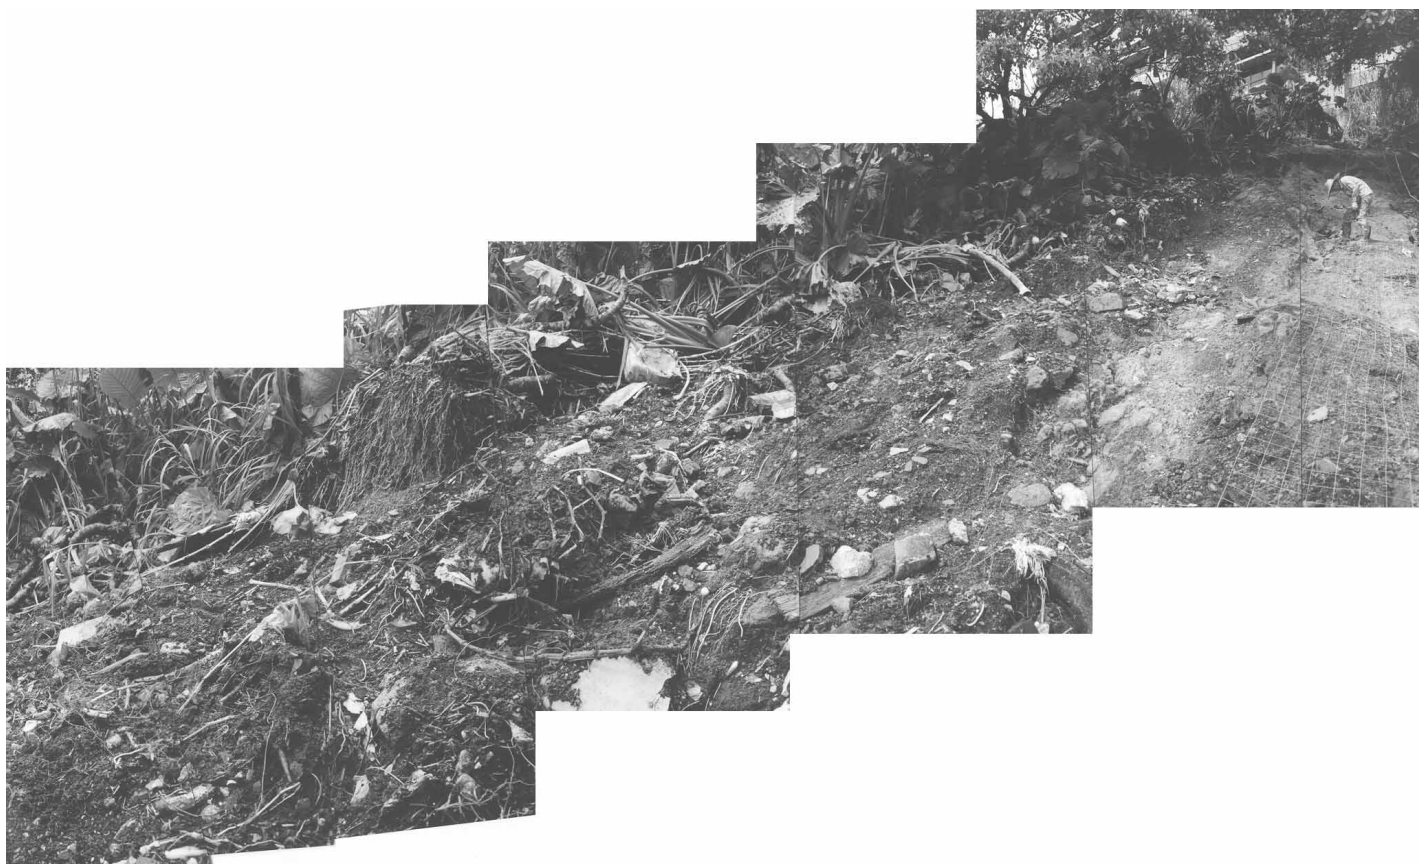
The scarp and flanks (Plates 6 and 7) exposed heterogeneous fill material comprising cobbles, boulders and assorted construction waste and refuse (e.g. tyres, pottery shards and domestic rubbish) in a soil matrix. The surface of rupture was roughly planar and inclined at about 30° to 40° to the horizontal, exposing fill, colluvium and Grades IV and V tuff. Corestones and rock outcrops were also observed. The exposure of insitu material along the surface of rupture and fill in the main scarp and flanks indicates that the surface of rupture was located at or near the fill/natural ground interface.

Plate 6 – View North-East along Northern Flank of Landslide A. Note Shallow Depth of Fill Overlying Natural Ground and Refuse Content of Fill (Photograph Taken on 26 August 1999)

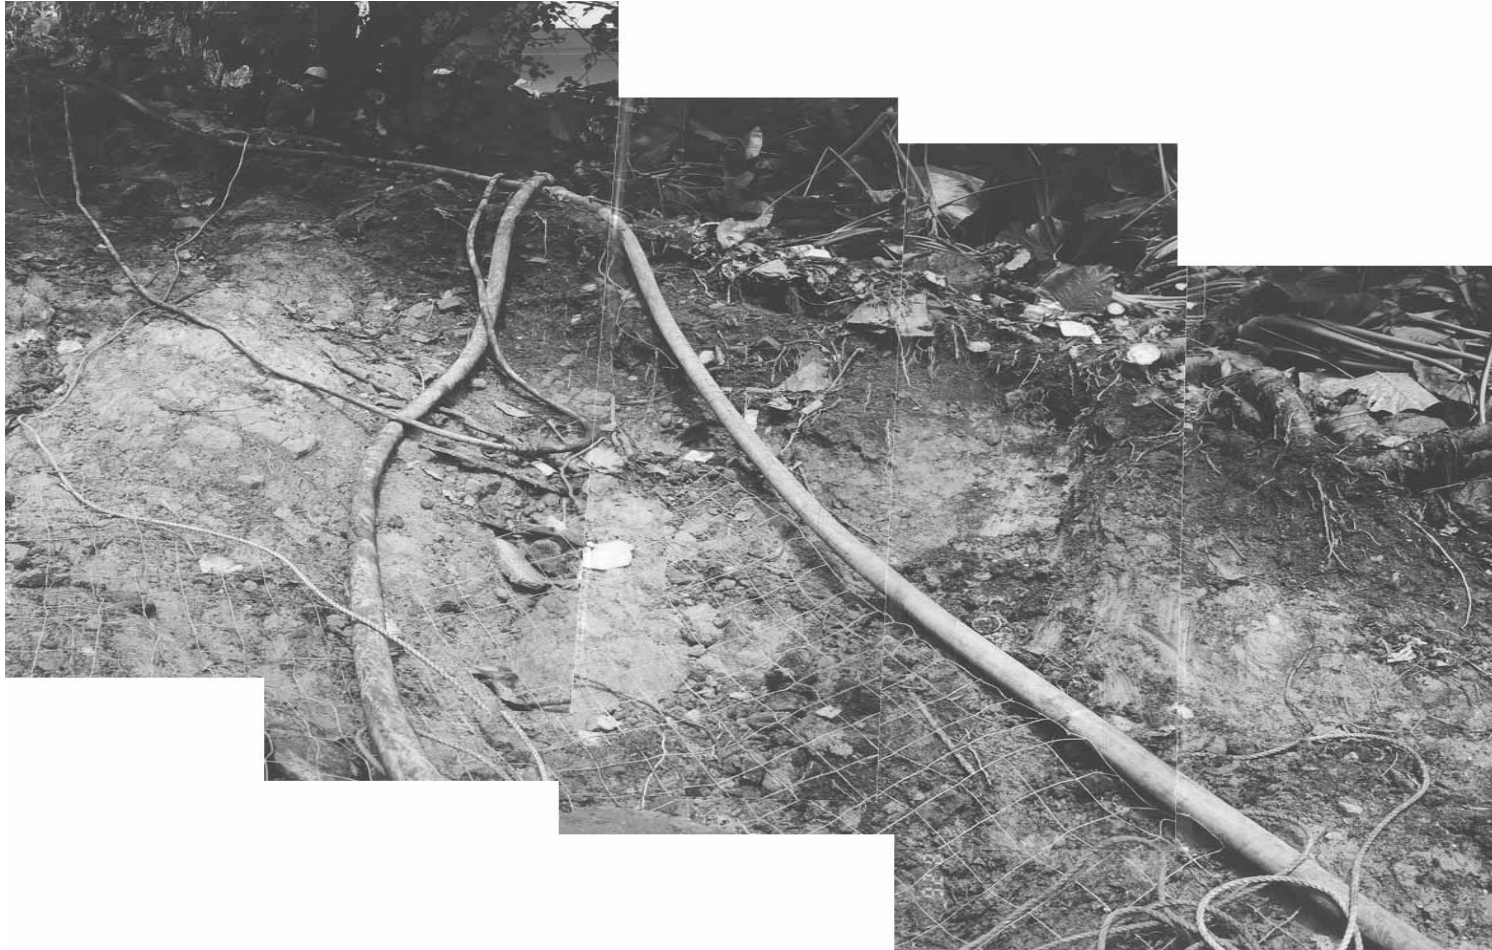
Plate 7 – View East across Southern Flank of Landslide A. Note Shallow Depth of Fill and Planar Exposure of Natural Ground in Scar. Note also Refuse Content of Fill (Photograph Taken on 26 August 1999)

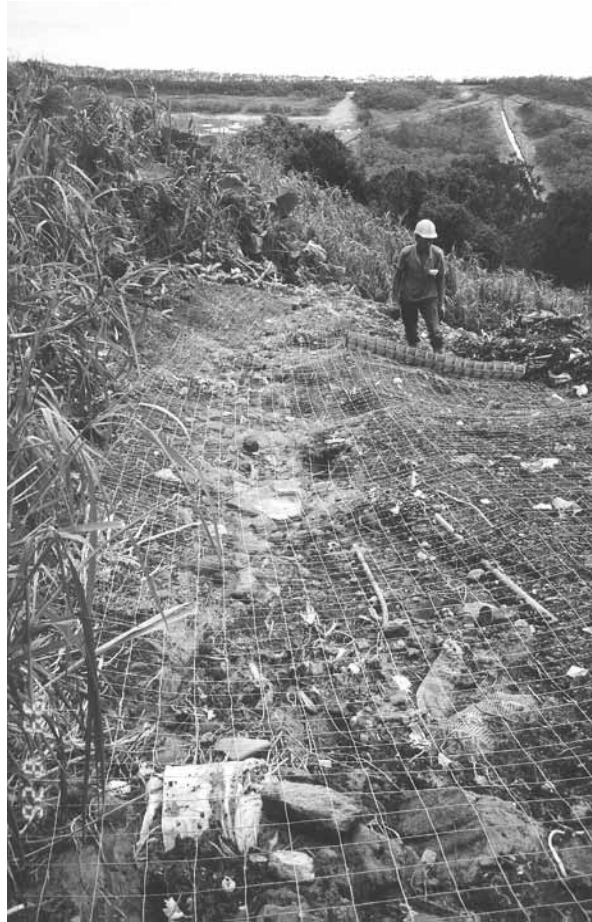
Plate 8 – View South-West down Landslide A. Note Shallow Sectional Geometry of Scar and Exposure of Natural Ground on Left of Frame (Photograph Taken on 26 August 1999)

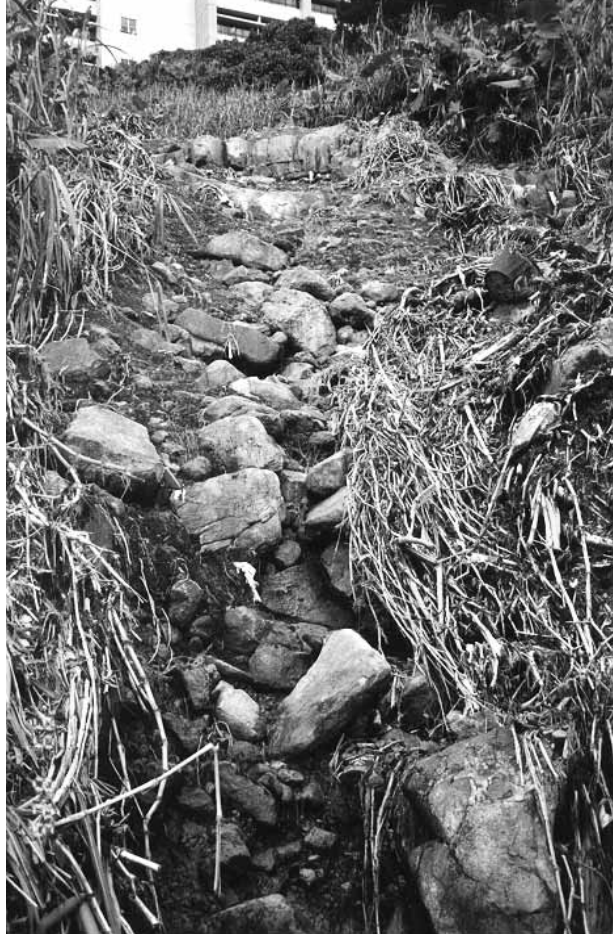
Plate 9 – View South-East up Landslide A from Point of Confluence of Drainage Lines Nos. 1 and 2 (Photograph Taken on 26 August 1999)

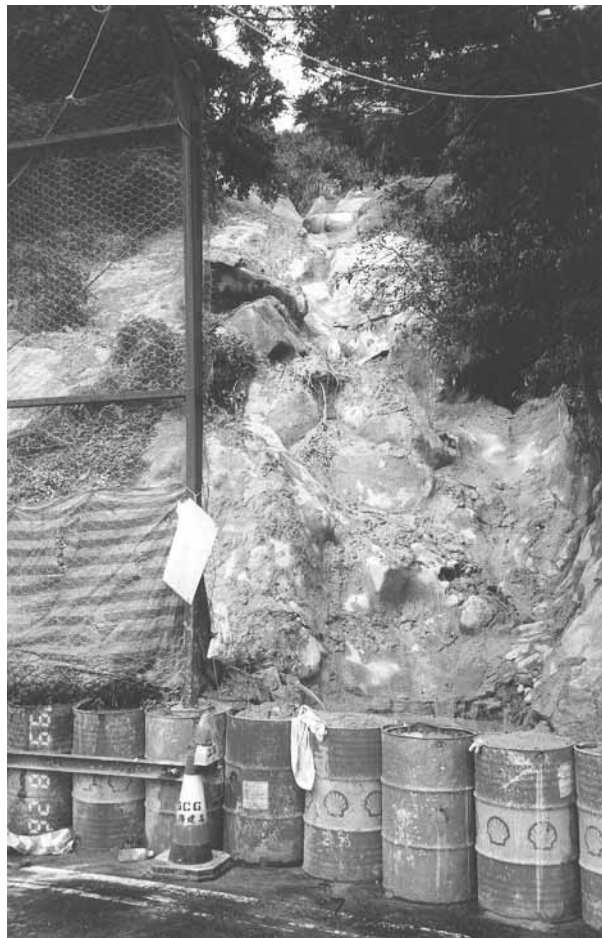
Plate 10 – View North–East up Landslide Scar from Victoria Road. Slope No. 11SW-C/C531 in Foreground. Note Random Orientation of Large Blocks in Slope to Suggest Previous Instability (Photograph Taken on 26 August 1999)

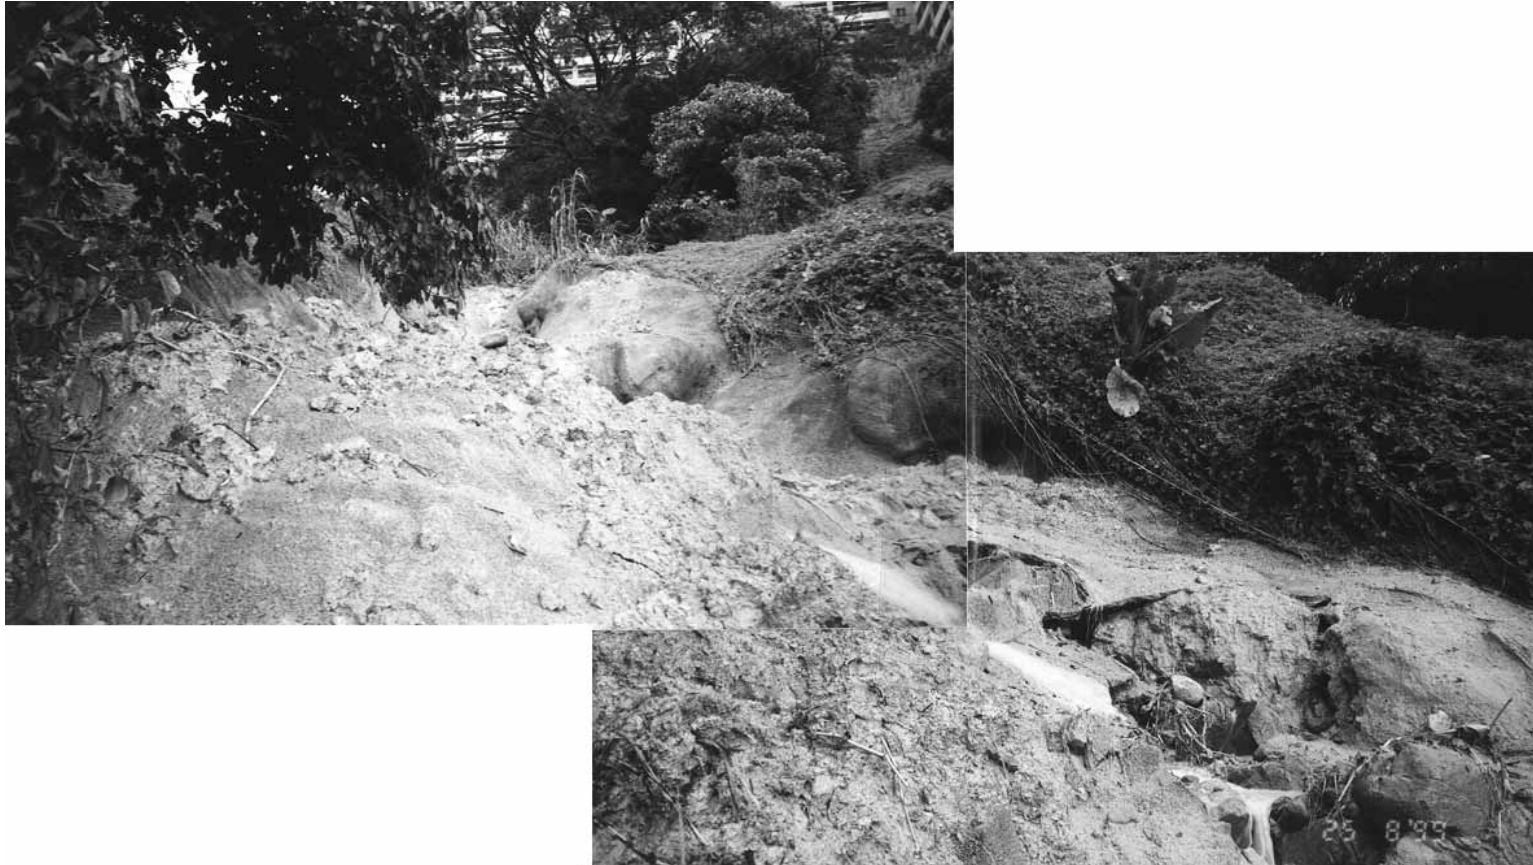
Plate 11 – View North-East up Landslide Scar from above Crest of Slope No. 11SW-C/C531 Exposing Previous Application of Shotcrete to Ephemeral Stream Course and Drainage Line No. 4 above Victoria Road (Photograph Taken on 25 August 1999)

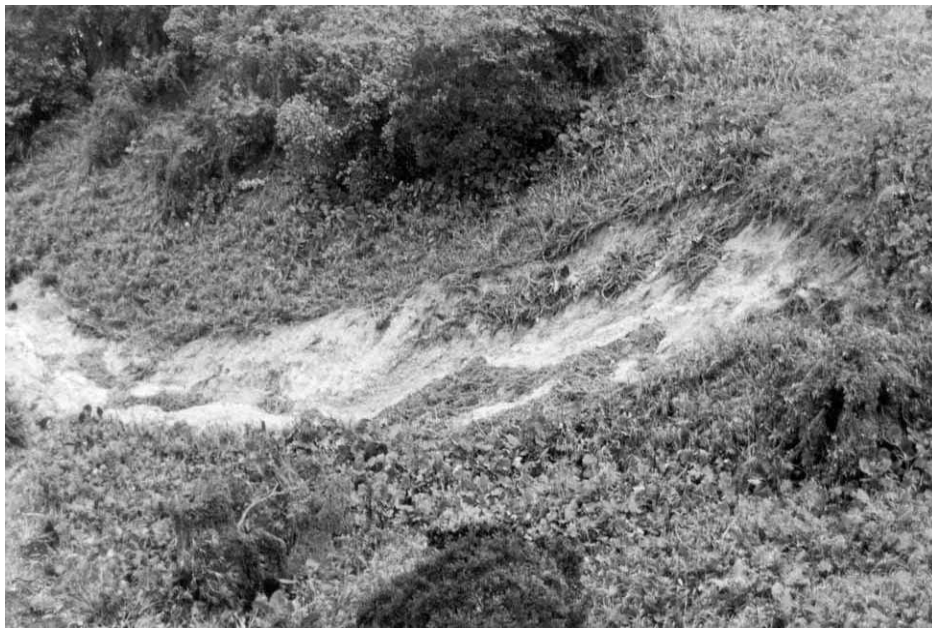
Plate 12 – View North–West across Landslide B. Landslide A Visible at Extreme Left of Frame. Note Rafts of Semi-Intact Material Remaining in Landslide B. Note also Light Colour of Material Exposed in Landslide B Compared to Landslide A (Photograph Taken by GEO on 24 August 1999)

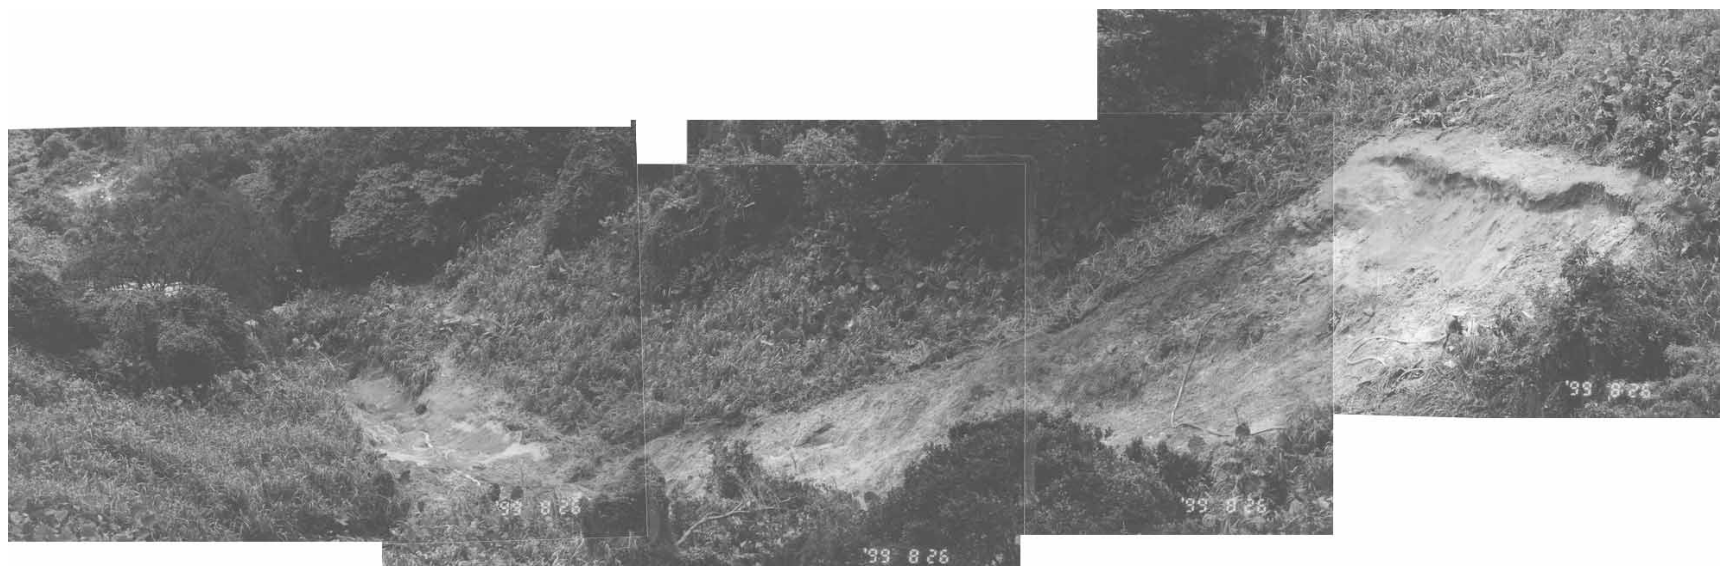
The landslide scars were first observed by a security guard from the VTC facility at about 7:00 a.m. on 23 August 1999. The witness advised that both landslide scars were present and were not significantly different in extent to that observed on 26 August 1999 by FMSW (Plate 13).

Plate 13 – View West across Landslide B from VTC Building. Shotcreting Works in Progress. Note Apparent Layer Separation in Main Scarp Producing Overhang. Note also Darker Superficial Material Remaining in Scar (Photograph Taken on 26 August 1999)

Urgent repair works recommended by the GEO and carried out by the HyD comprised trimming of loose material from the source area of both landslides and the application of shotcrete with weepholes over the full extent of the landslide scars. These works were completed within the week following the failures.

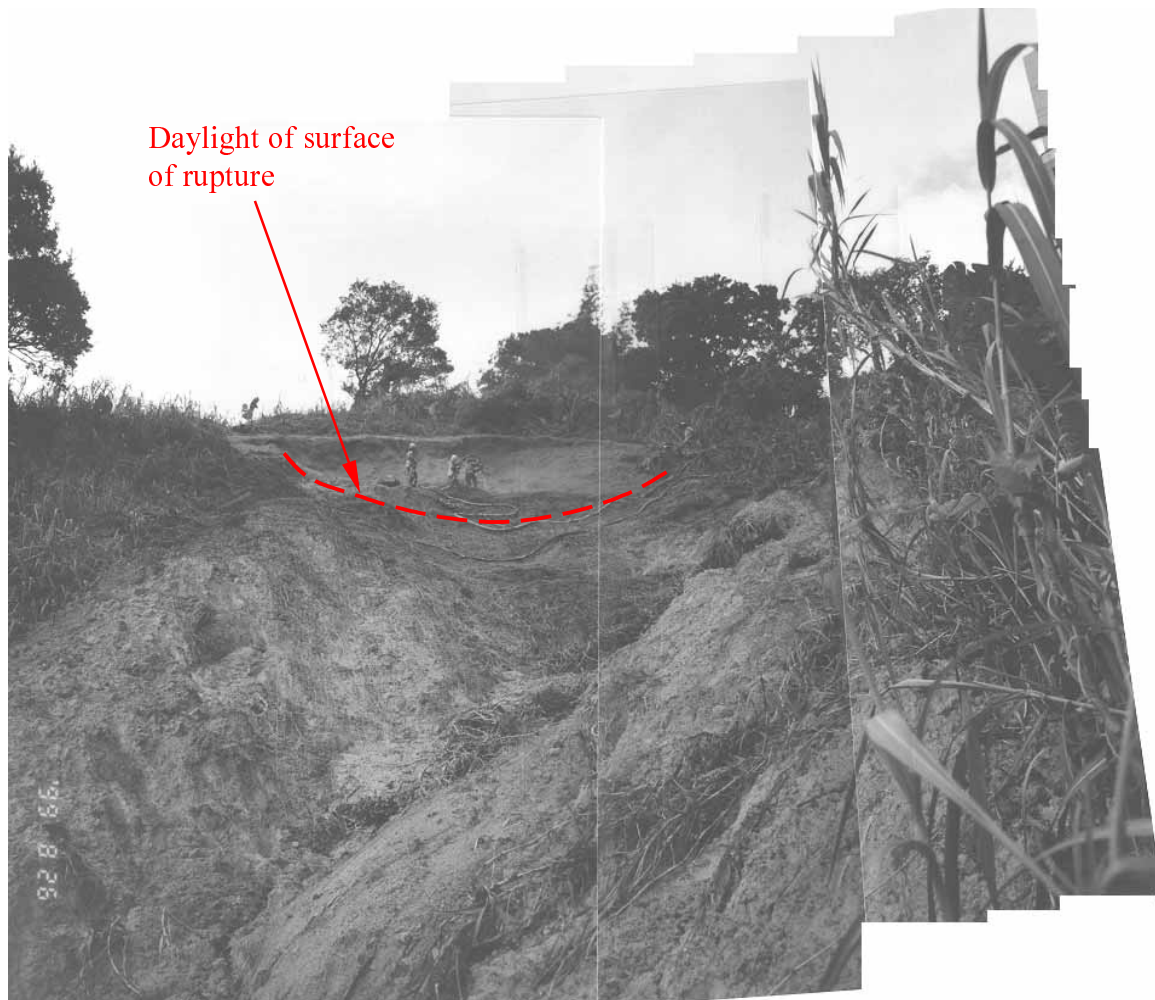
Plate 14 – View North up Landslide B from above Point of Confluence. Shotcreting Works Underway. Note Overhang of Main Scarp. Intact Vegetation in Scar in Foreground Suggests Source Area Largely Confined to Portion Already Shotcreted (Estimated Daylight Indicated). Note also Erosion Gully in Base of Drainage Line Traversing Scar in Foreground (Photograph Taken on 26 August 1999)

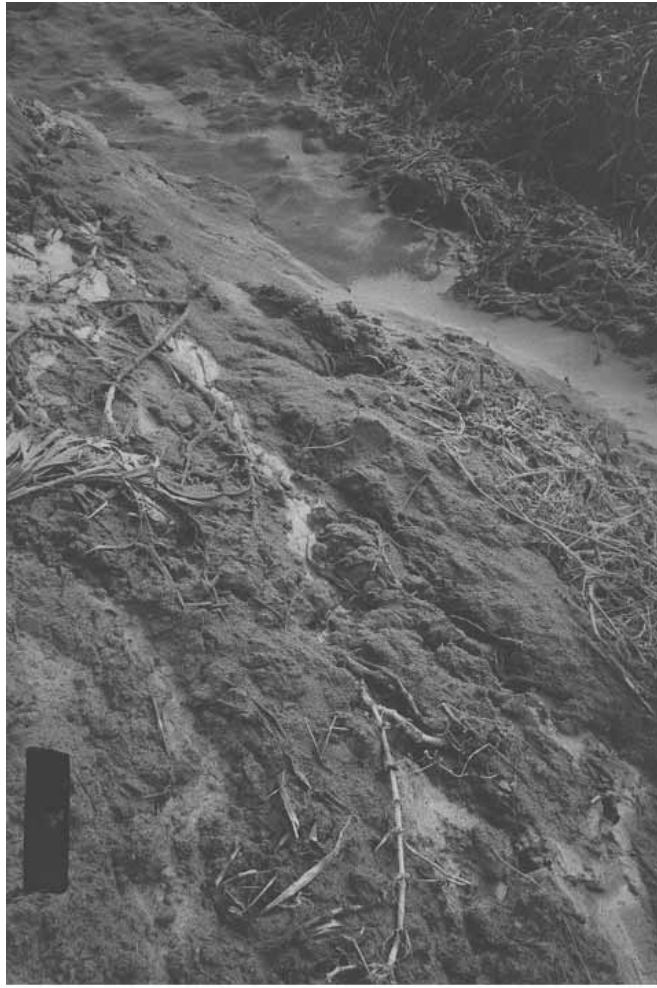
Plate 15 – Erosion Channels within Landslide Scar downslope of Point of Confluence (Photograph Taken on 26 August 1999)

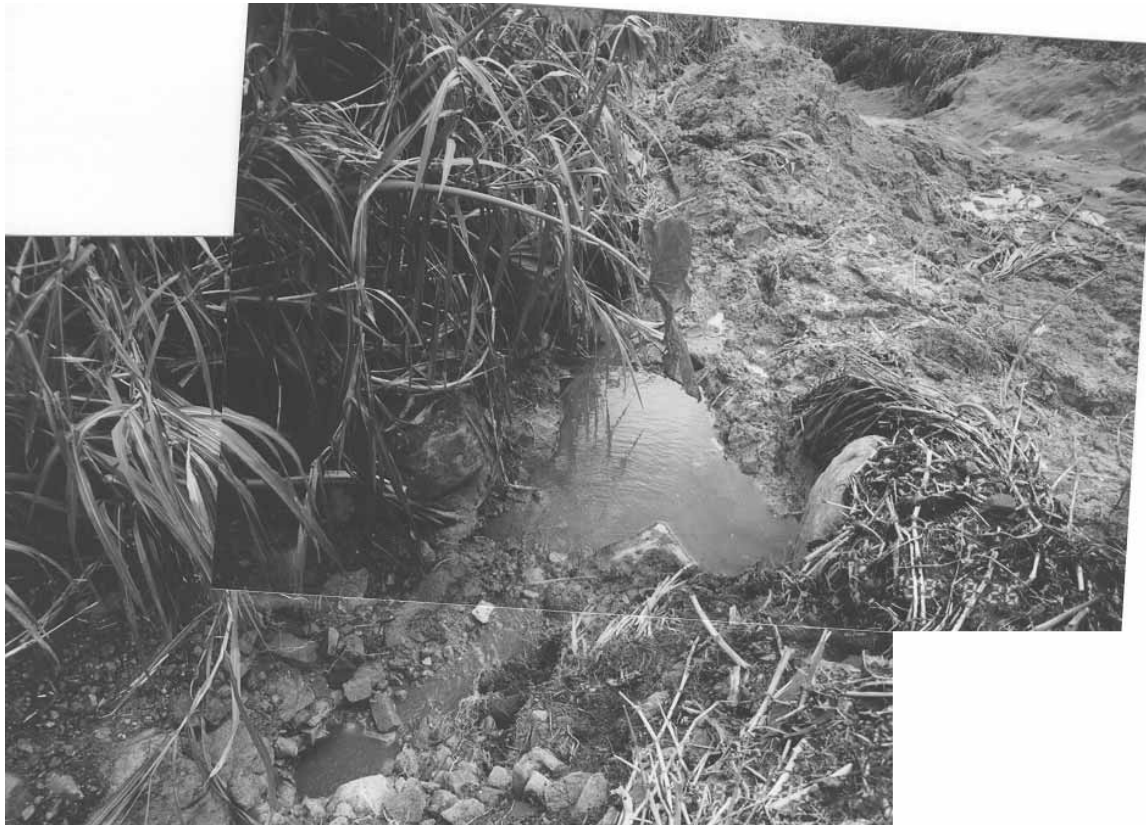
Plate 16 – View West down Landslide B at Point of Confluence. Note Poned Water from Continued Seepage along Drainage Line above
(Photograph Taken on 26 August 1999)

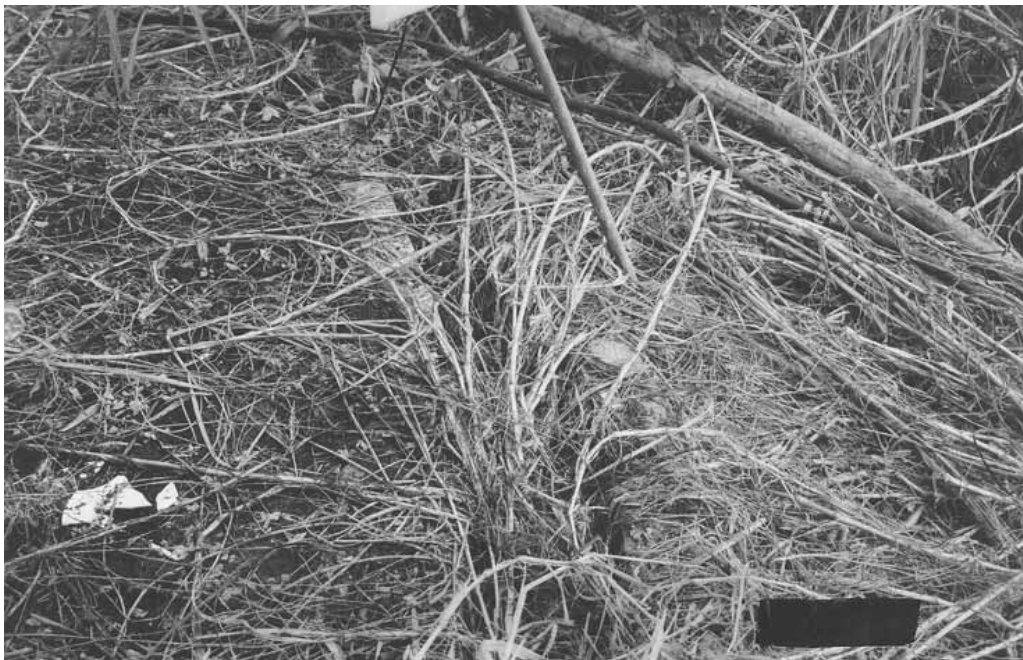
Plate 17 – 250 mm U-Channel Located above Main Scarp of Landslide A
Overgrown and Blocked by Vegetation (Photograph taken on
25 August 1999)

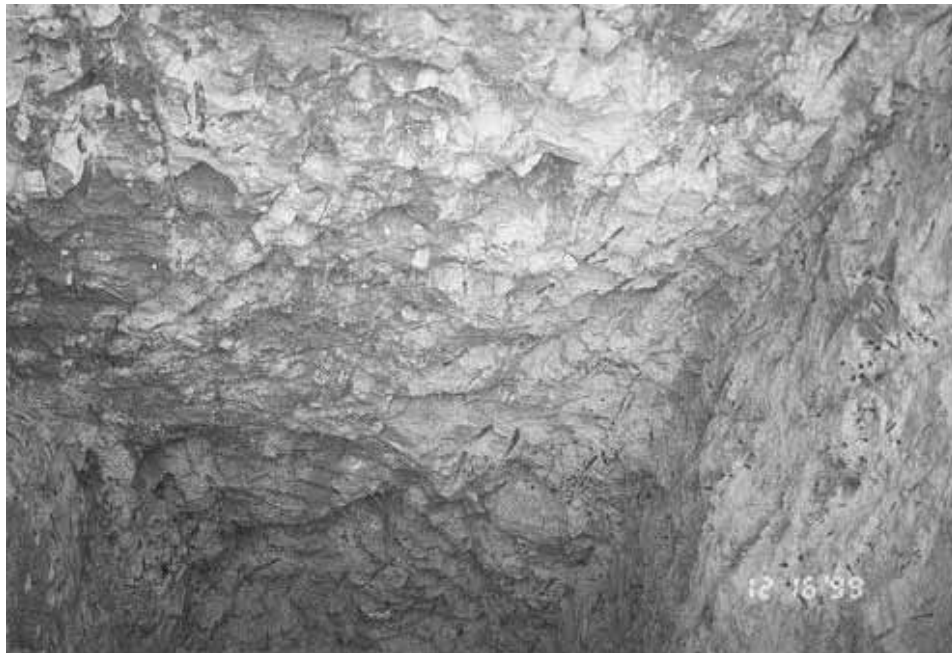
Trial pits excavated adjacent to the source area generally confirmed the ground profile described above (Plates 23 and 24), with Grade III/IV tuff also encountered in TP5. Trial pits excavated within the source area (Plates 25 and 26) exposed Grades IV and V tuff to the depth of investigation, indicating that the surface of rupture was not defined by a marked change in material.

Plate 23 – Trial Pit TP5: General View of Pit Showing Exposure of Grades IV and V Tuff (Photograph Taken on 16 December 1999)

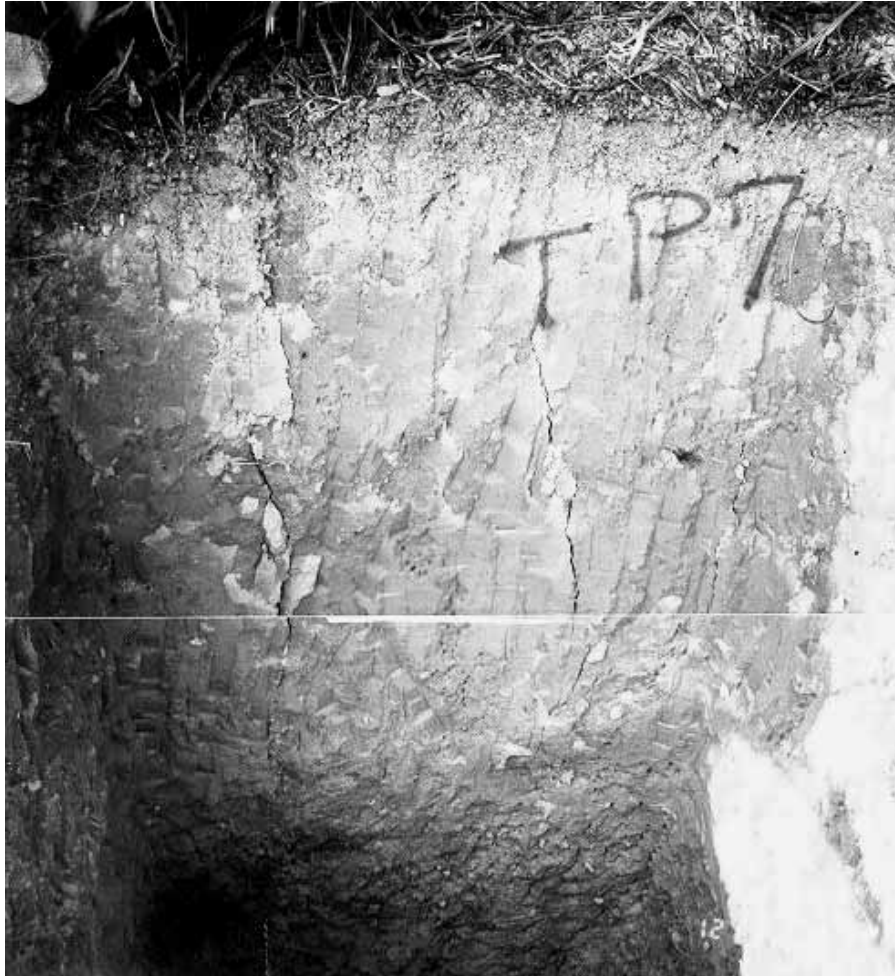
Plate 24 – Trial Pit TP7: General View of Pit Showing Exposure of Grade V Tuff.
Note also Cracks in Face of Pit (Photograph Taken on 15 December 1999)

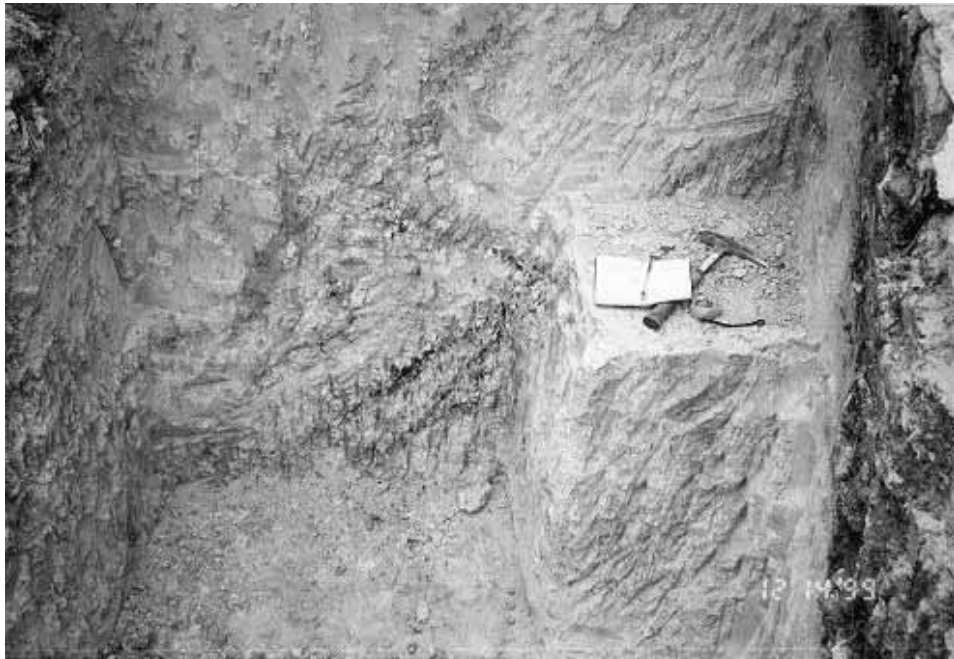
Plate 25 – Trial Pit TP6: General View of Pit Showing Exposure of Grades IV and V Tuff. Note Landslide Debris Remaining beneath Shotcrete on Right of Frame (Photograph Taken on 14 December 1999)

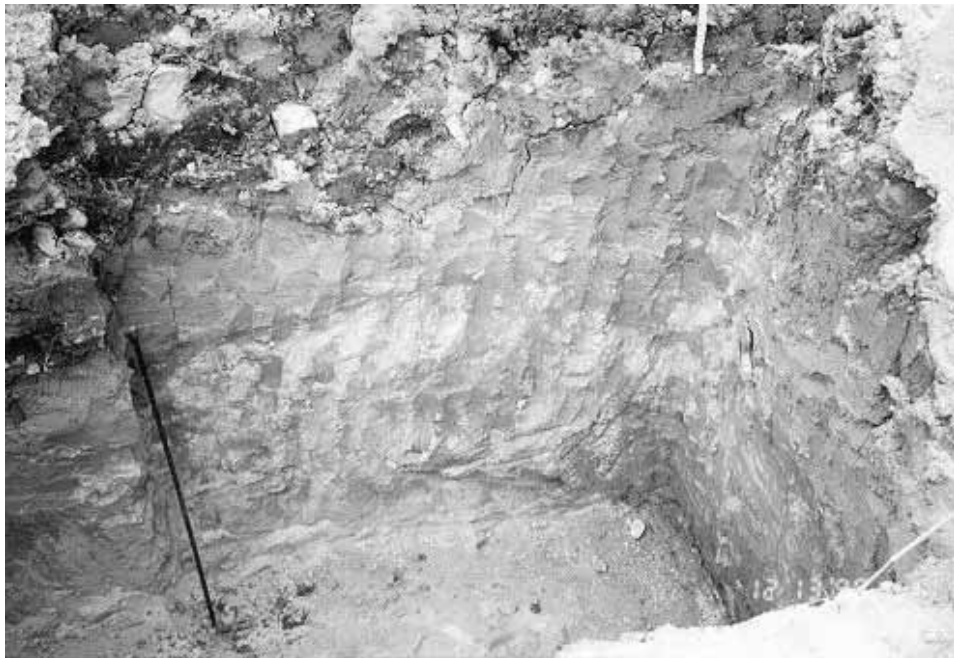
Plate 26 – Trial Pit TP8: General View of Pit Showing Exposure of Grades IV and V Tuff. Note Landslide Debris Remaining beneath Shotcrete at Top of Frame (Photograph Taken on 13 December 1999)

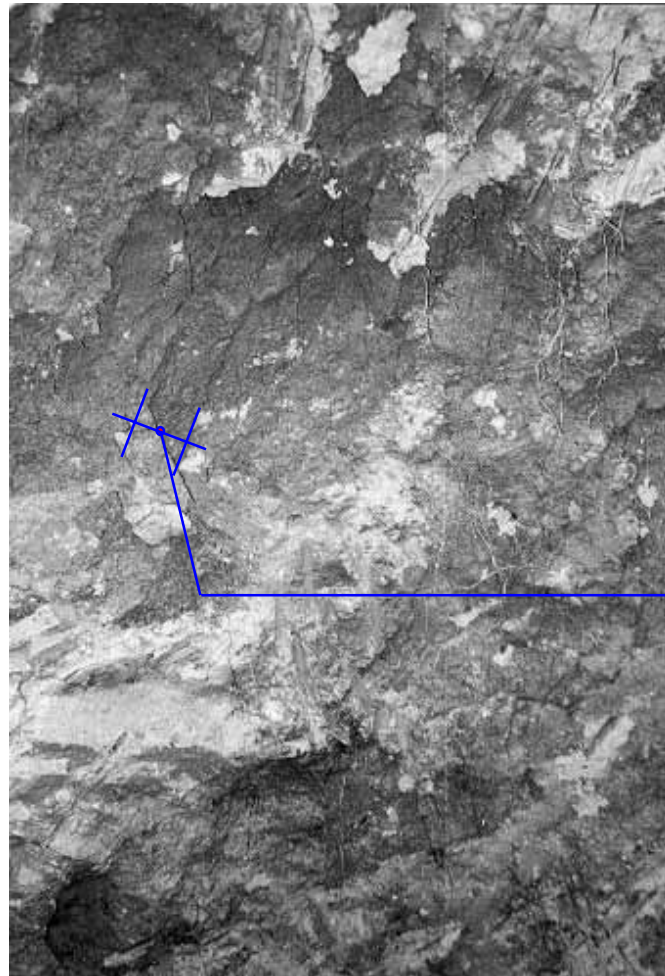
An infilled tension crack was observed in the western face of trial pit TP5, extending approximately 1 m below ground surface (Plate 28). The maximum aperture of the crack was about 30 mm to 40 mm. Infill material comprised the topsoil/colluvial layer. Cracking was also noted to develop in the eastern and southern faces of trial pit TP7 during the investigation (Plate 24). The cracks were a maximum of 5 mm in width and extended about 0.8 m below ground surface. It is noted that this trial pit was located a short distance from the flanks of a gully in the adjacent hillside (Section 3.2) and that the cracks may have formed as a result of reduced lateral support to the trial pit faces closest to the gully.

Infilled tension
crack (30 mm to
40 mm aperture)

Plate 28 – Trial Pit TP5: Infilled Tension Crack Exposed in Western Face of Pit
(Indicated) (Photograph Taken on 16 December 1999)
