**INVESTIGATION OF SOME
SELECTED LANDSLIDES
IN 1999
(VOLUME 3)**

GEO REPORT No. 122

Fugro Maunsell Scott Wilson Joint Venture

**SECTION 1:
DETAILED STUDY OF THE
24 AUGUST 1999 LANDSLIDE
AT TSING YI ROAD
TSING YI ISLAND**

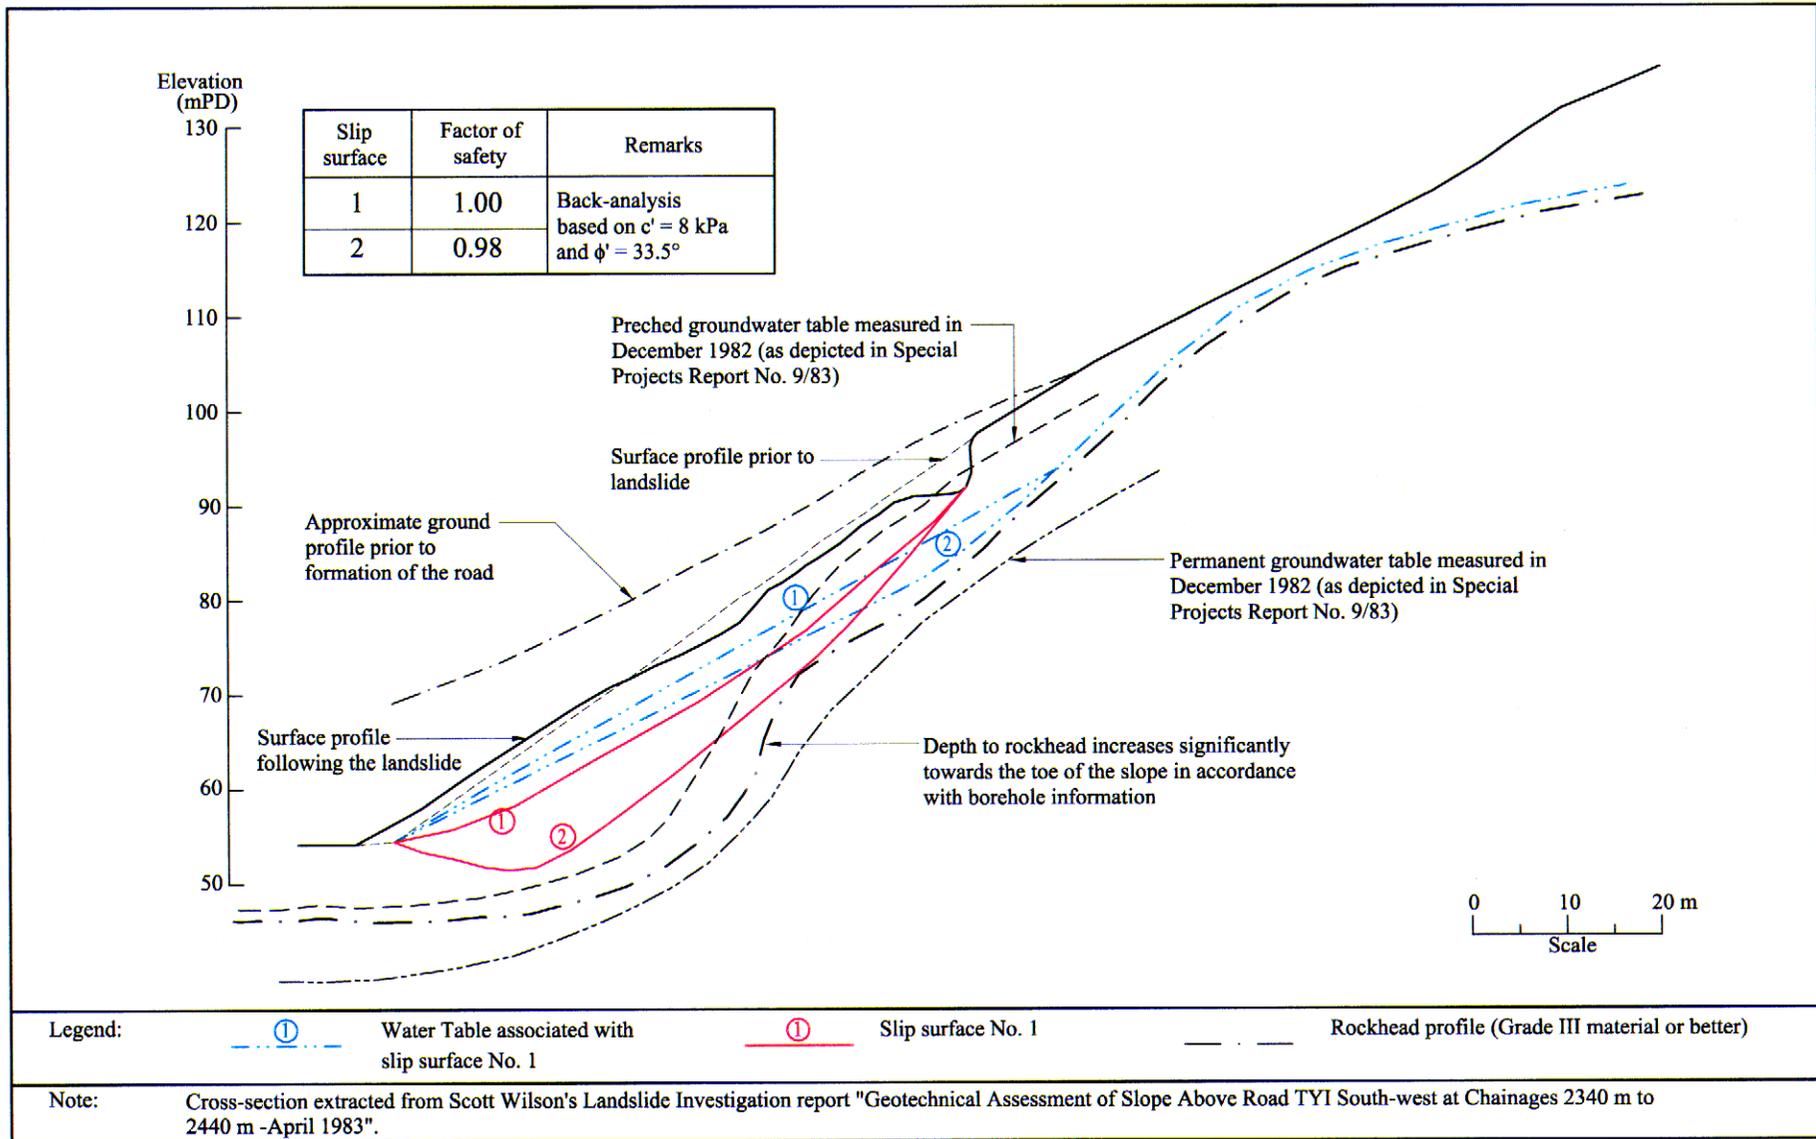
Figure 8 - Cross-section through the 1982 Landslide at Slope No. 10NE-B/C262

The geotechnical report prepared by SWKP following the 1982 landslide identified that the underlying geology of slope No. 10NE-B/C262 comprised granite that was intersected at about the slope's mid-point by a near-vertical feldspar porphyry dyke trending in an east-west direction. No adverse joint planes dipping out of the slope were identified. The depth to rockhead, defined as Grade III material or better, varied considerably across the failed slope, ranging from about 5 m to 10 m in the upper portion of the landslide to a maximum of about 20 m at the toe of the landslide. This was significantly deeper than that assumed in the original slope design, which assumed a maximum of 7 m below the finished cut slope profile.

Near the dyke, bands of completely to highly decomposed granite (C-HDG) or completely to highly decomposed feldspar porphyry (C-HDFP) alternate with less decomposed materials, forming alternating bands of loose and dense soil that are inferred as being sub-parallel to the slope surface. These alternating layers were not found in areas further away from the dyke. Above the failed section of the slope the depth to rockhead was shallower, being between 1 m and 5 m below ground level. A cross-section through the failed slope indicates a sharp drop in the rockhead profile at the toe of the slope (Figure 8).

No discussion was presented in SWKP's report about whether a perched groundwater table existed in the failed slope. However, according to Hencher (1983), "the groundwater table that saturated the slope is a perched groundwater table". The reason for perching was not certain as no aquaclude was recognised in any of the drillholes, but it was concluded that perching probably occurred at the soil/rock interface. A lower permanent groundwater table was identified within the underlying bedrock (Figure 8).

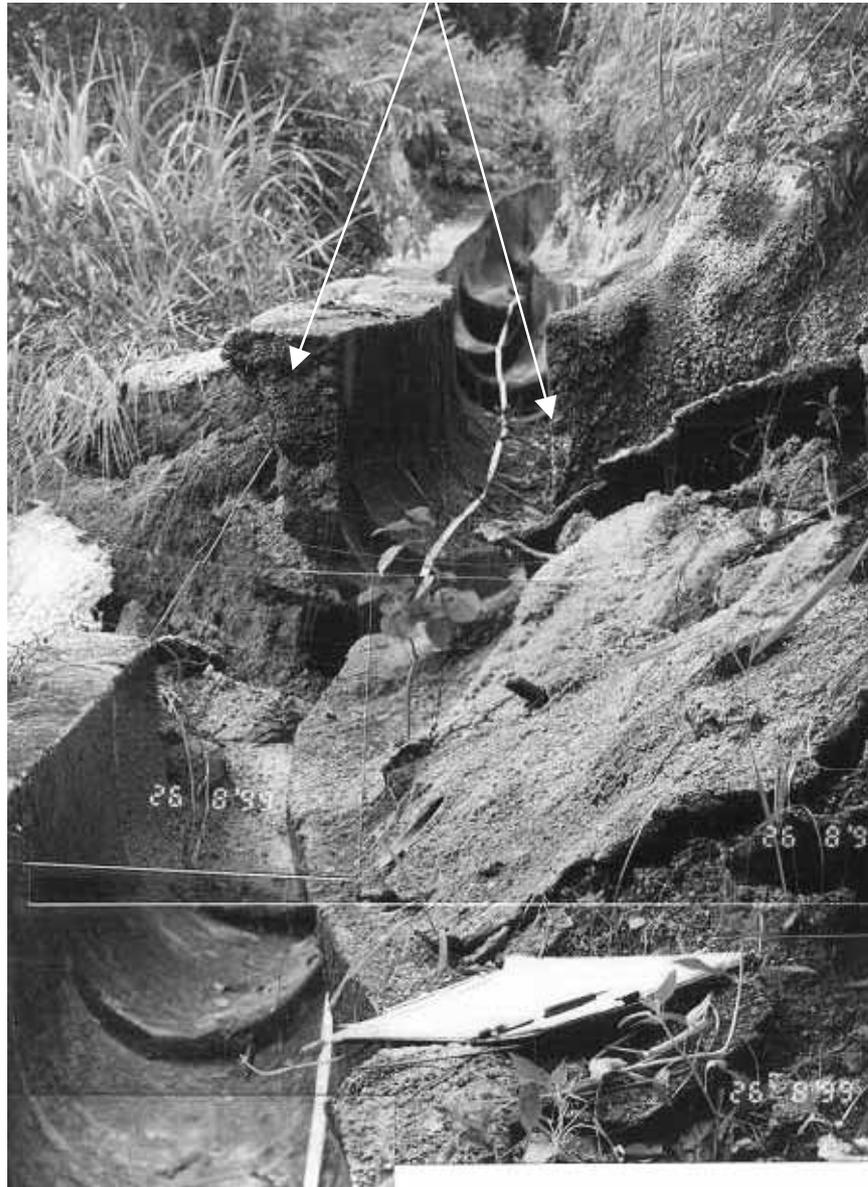
Plate 8 – View of Old Shotcrete Repair to Severed Crest Channel
(Photographs Taken on 26 August 1999)

Old shotcrete repair to severed crest channel indicates that about 400 mm of vertical displacement had occurred prior to movements associated with the 1999 landslide

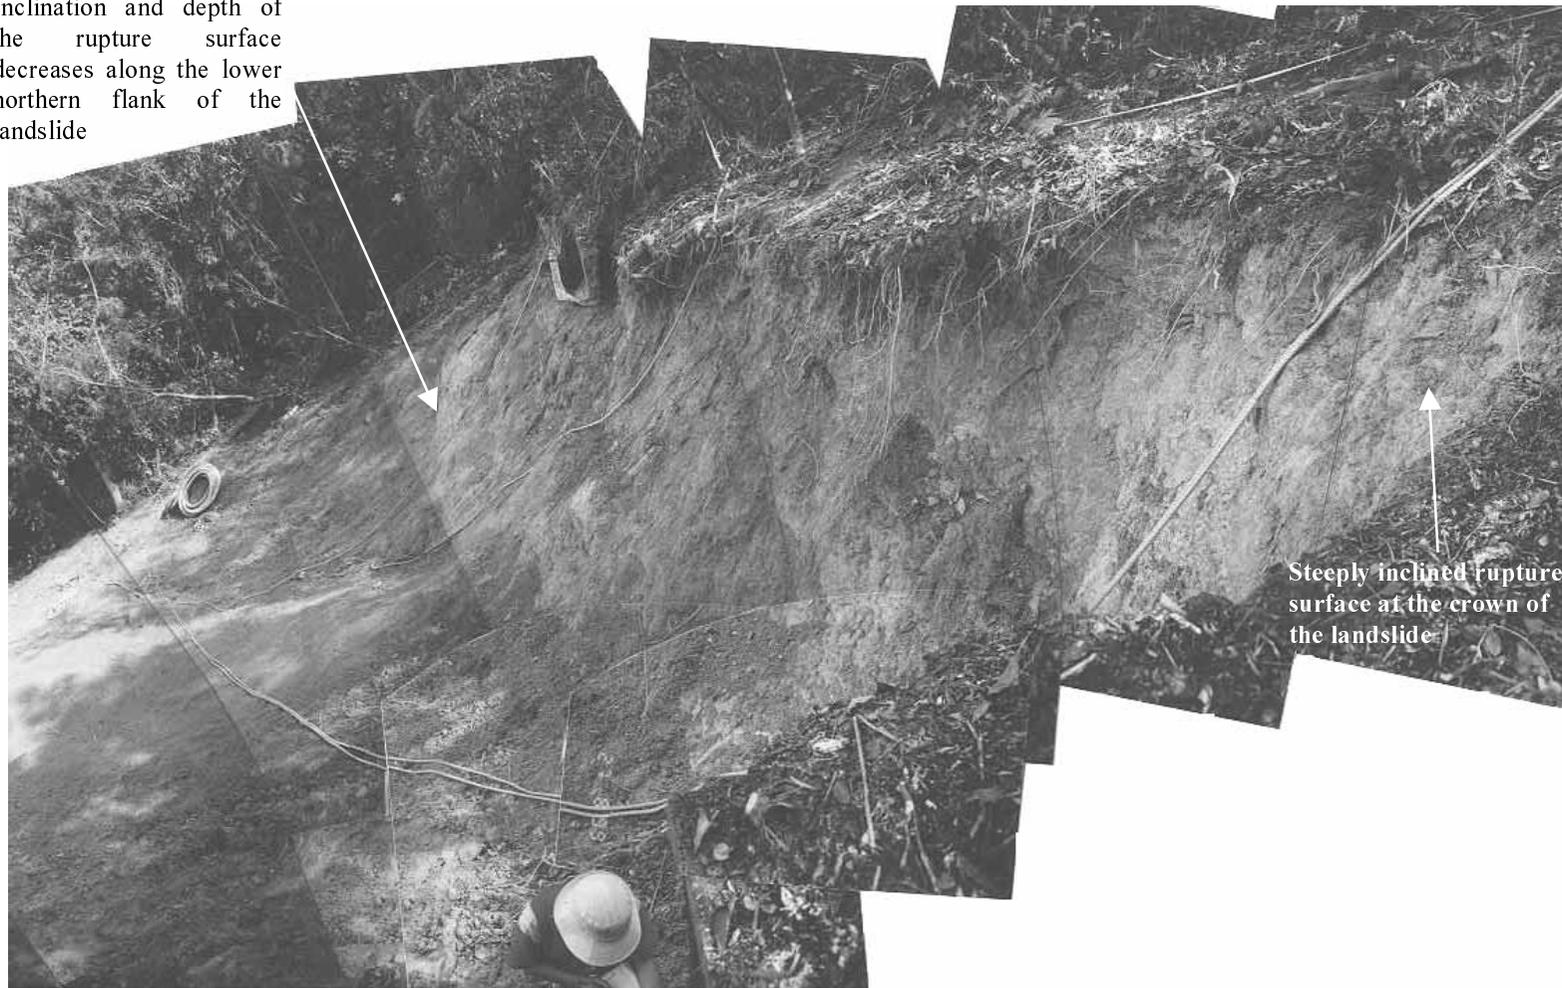
Plate 10 – View of the Northern Portion of the Main Scarp (Photographs Taken on 27 August 1999)

Inclination and depth of the rupture surface decreases along the lower northern flank of the landslide

Steeply inclined rupture surface at the crown of the landslide

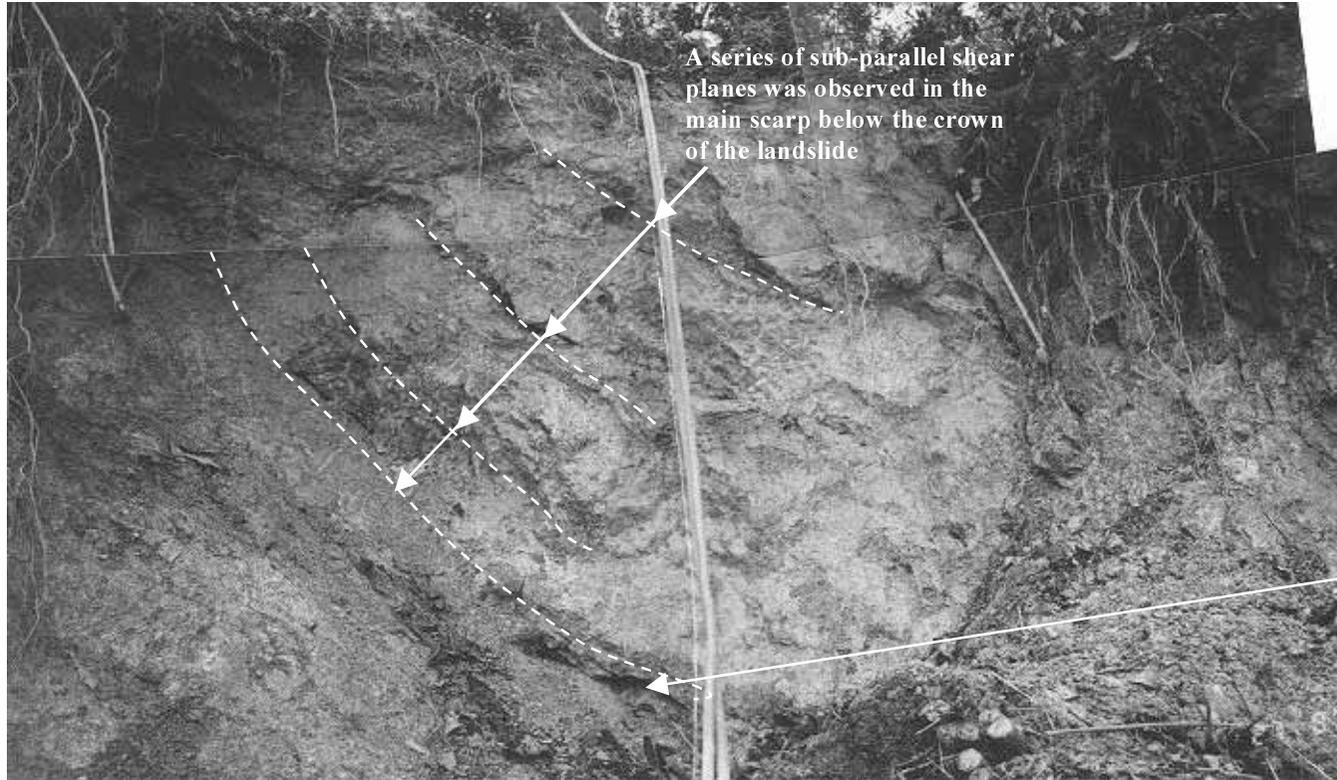
Plate 12 – View of the Main Scarp at the Crown of the Landslide
(Photographs Taken on 27 August 1999)

Ground water was seen flowing from the shear plane exposed at the base of the main scarp at the crown of the landslide on 25 August 1999

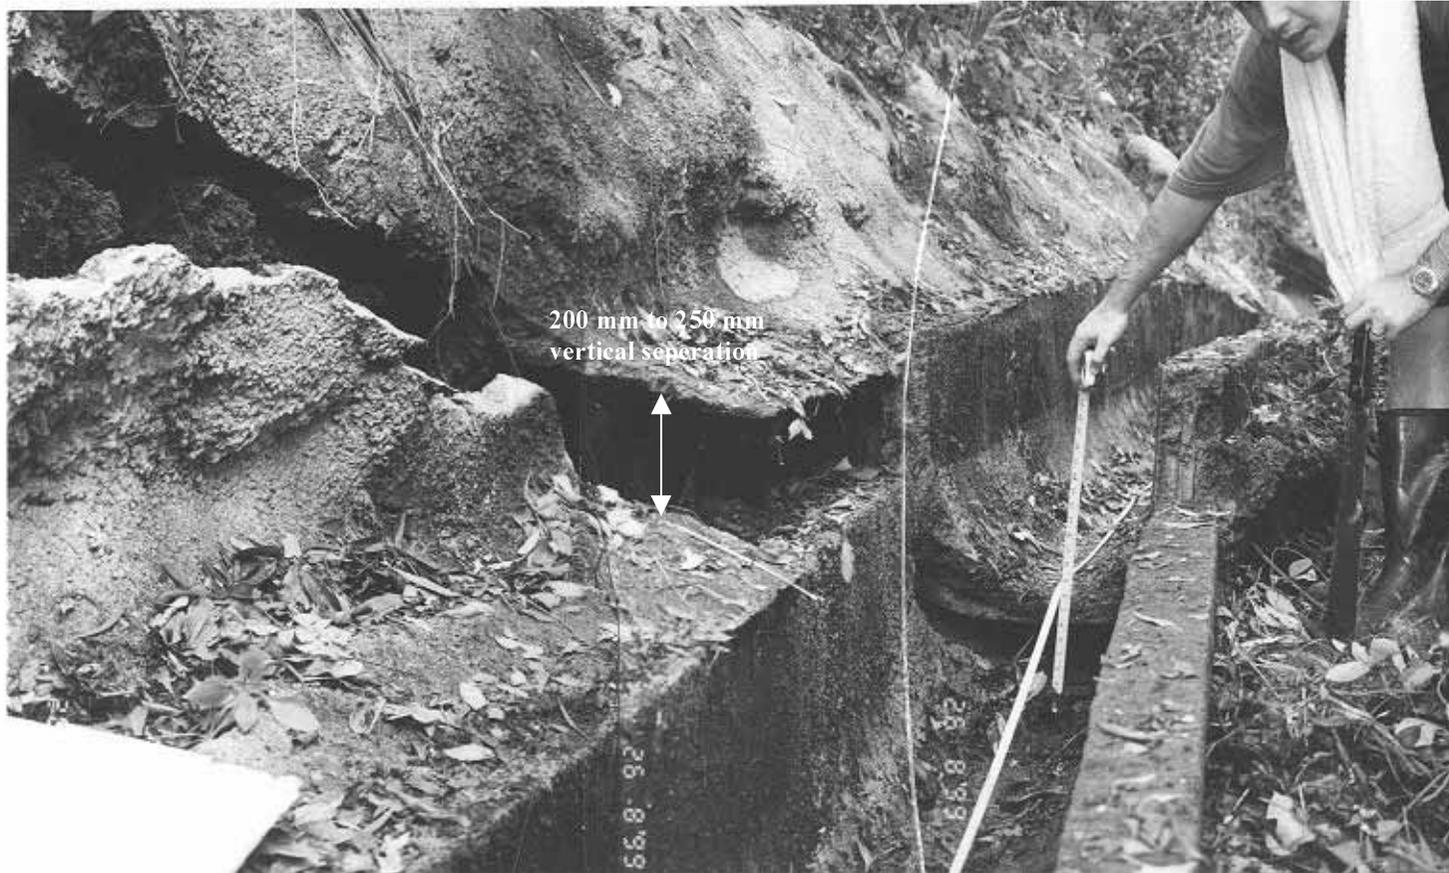
Plate 15 – View of Sheared and Dislocated Crest Channel
(Photographs Taken on 26 August 1999)

Tension crack extends northwards into the hillside

Crest channel has been severed and has moved downslope following progressive ground movement

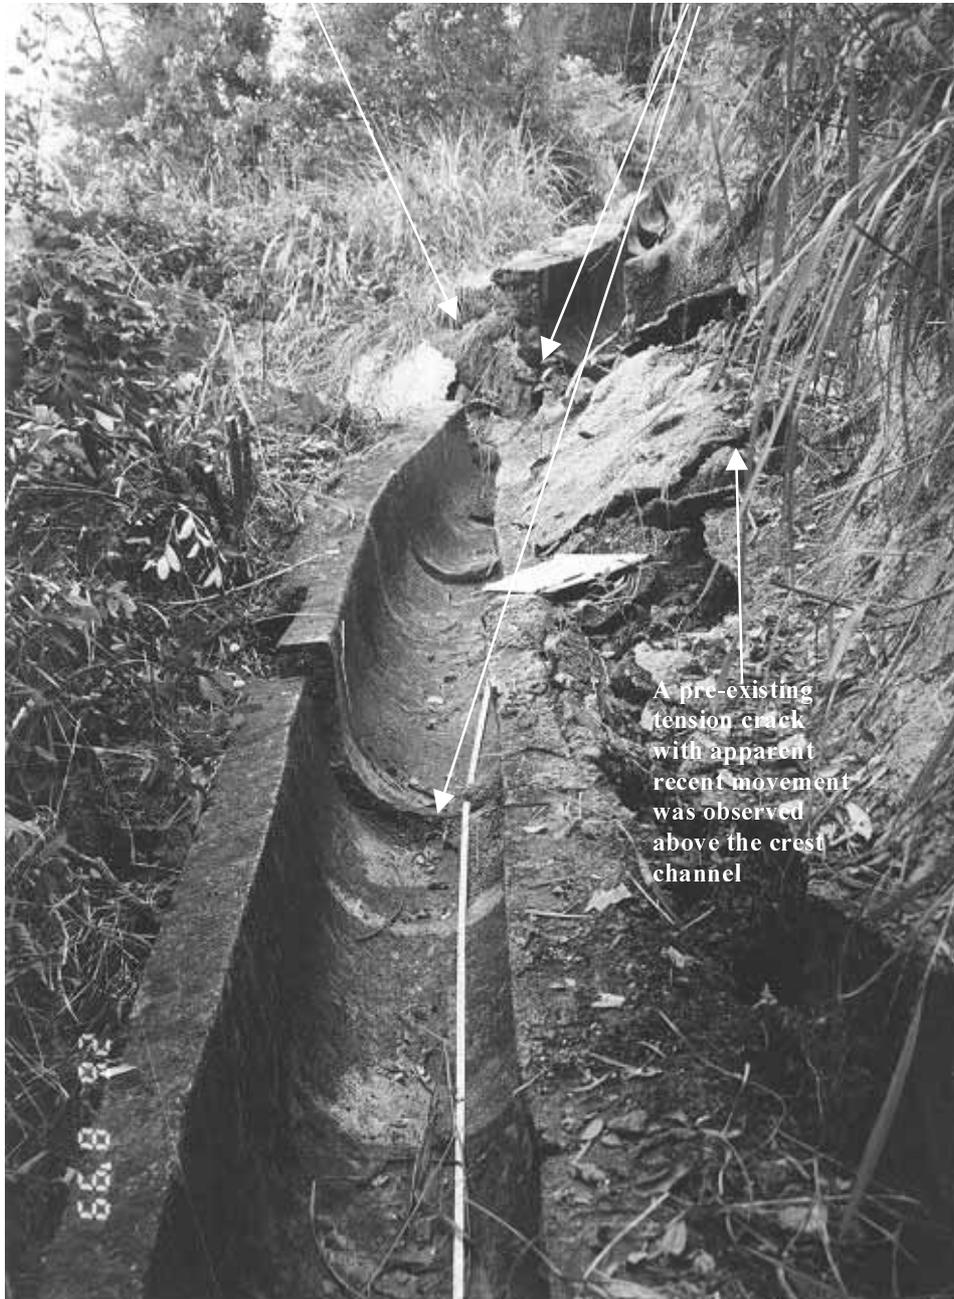
Plate 16 – View of Cracking and Distress along the Crest Channel
(Photograph Taken on 26 August 1999)

A pre-existing tension crack with apparent recent movement was observed above the crest channel

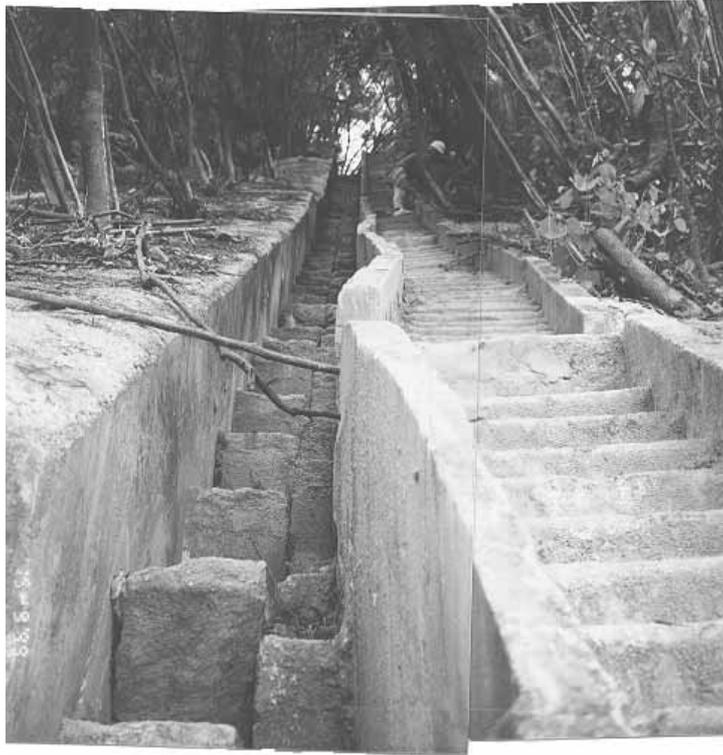
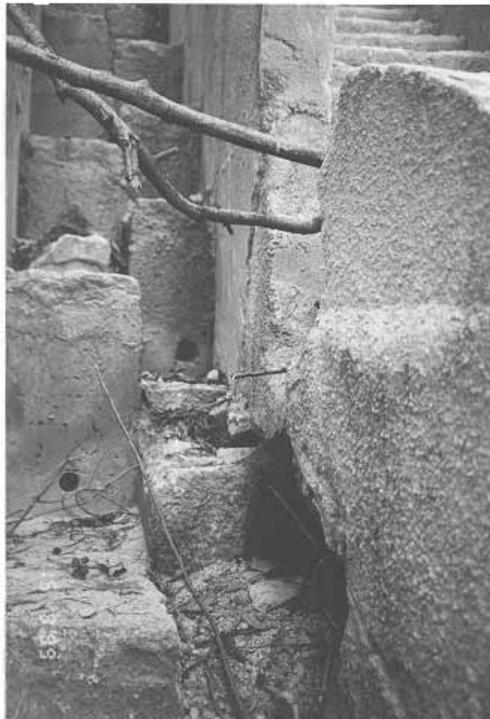
Plate 17 – View of Displaced Cascade Channel (Photographs Taken on 15 March 1999)

Sideways movement of about 250 mm is evident in the lower portion of the cascade channel

Recently repaired cascade channel had cracked again during the 1999 landslide

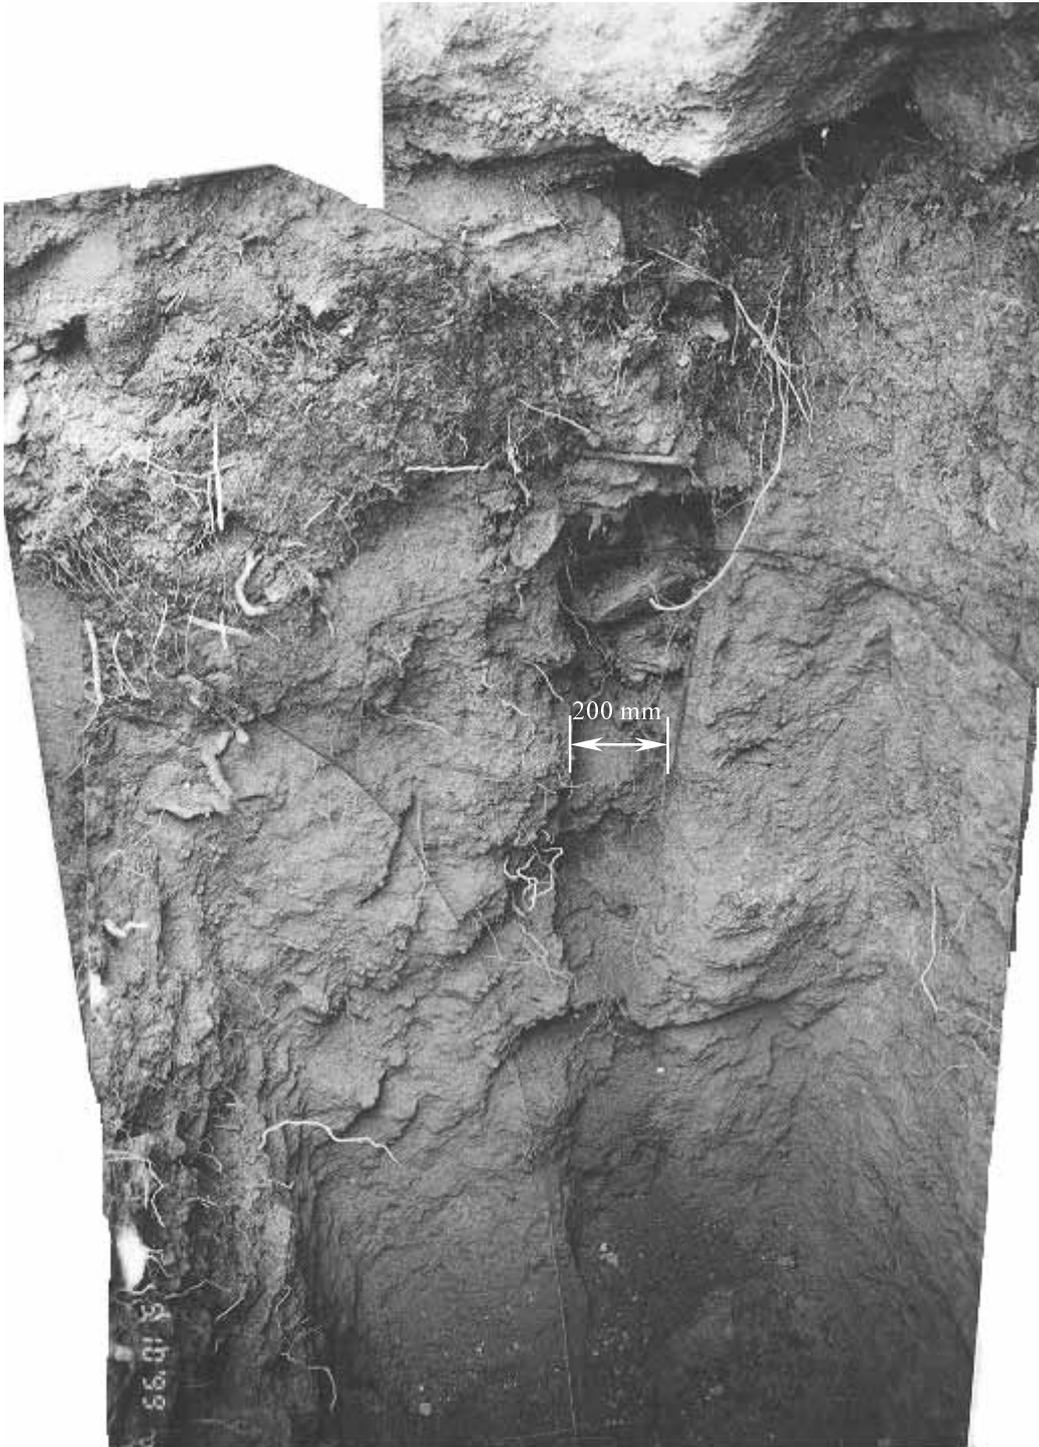
Plate 18 – View of Infilled Tension Crack Identified in Trial Pit TP2
(Photographs Taken on 9 October 1999)

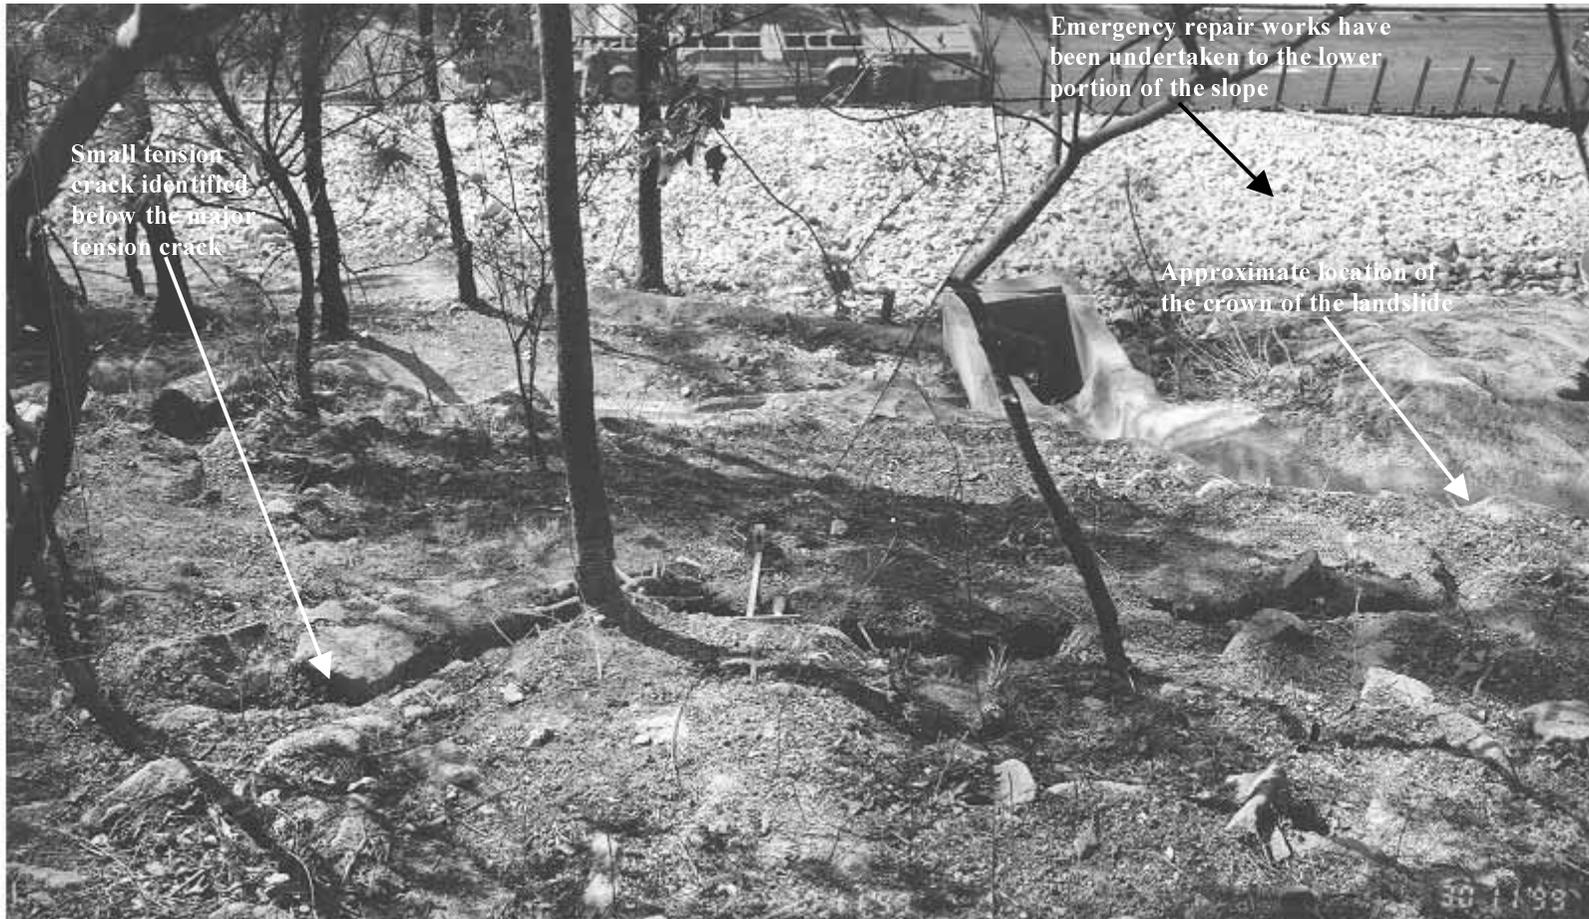
Plate 19 – View of Smaller Tension Crack Identified Following Vegetation Clearance Works
(Photographs Taken on 30 November 1999)

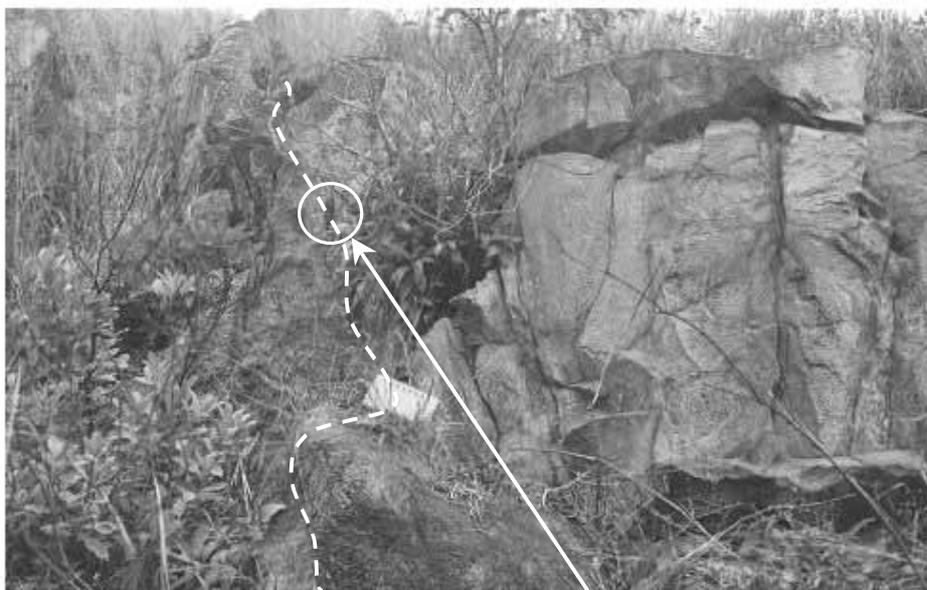
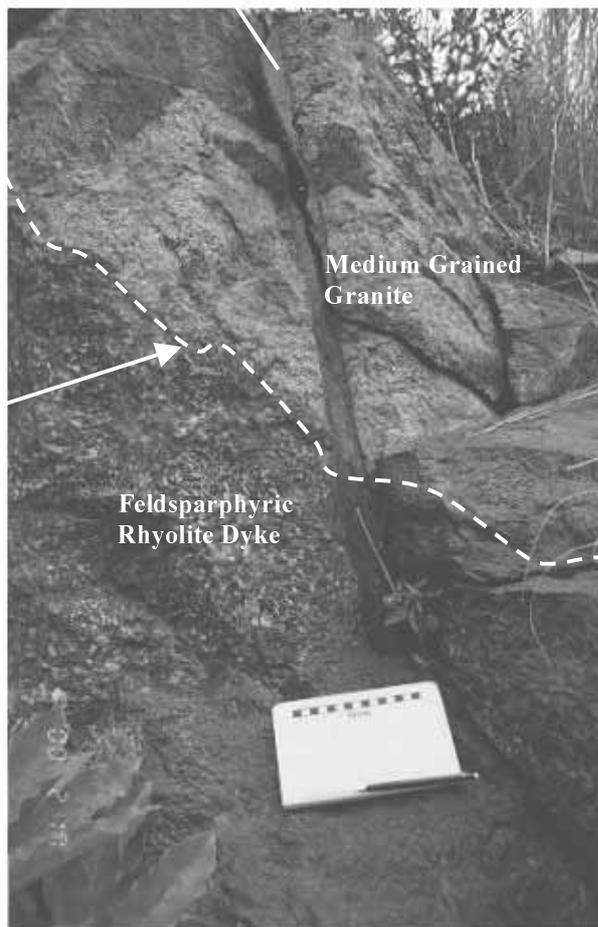
Plate 21 – View of Sharp Contact between Feldsparphyric Rhyolite Dyke and Medium Grained Granite (Photographs Taken on 10 February 2000)

The orientation of the contact is $72^{\circ}/176^{\circ}$ (dip and dip direction)

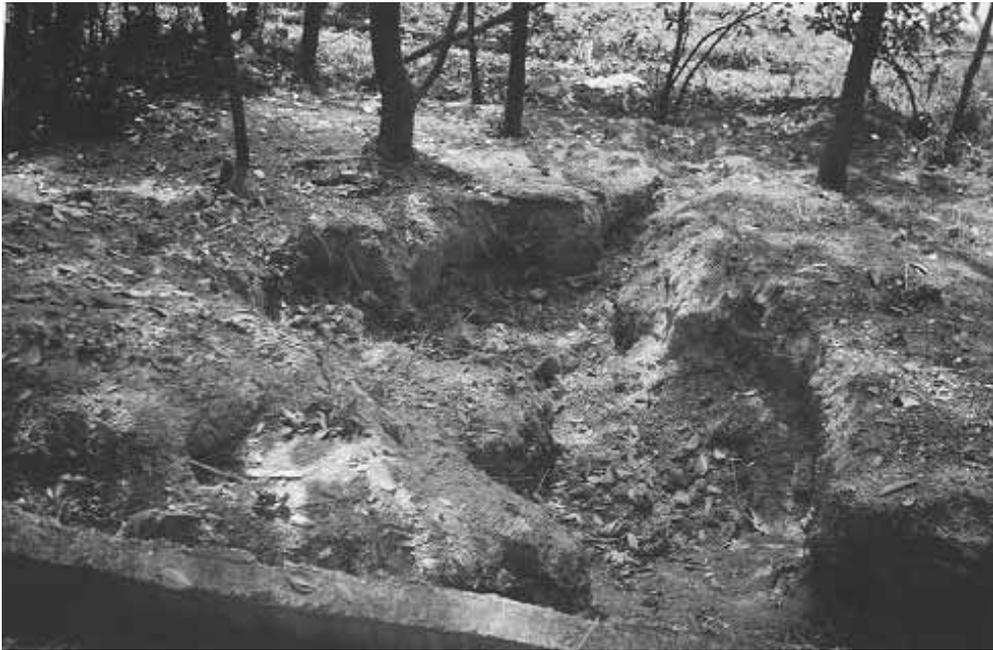
Plate A1 – View Looking Downslope of Erosion Scar in First Batter at the Northern End of Slope No. 10NE-B/C254 (Area 1)

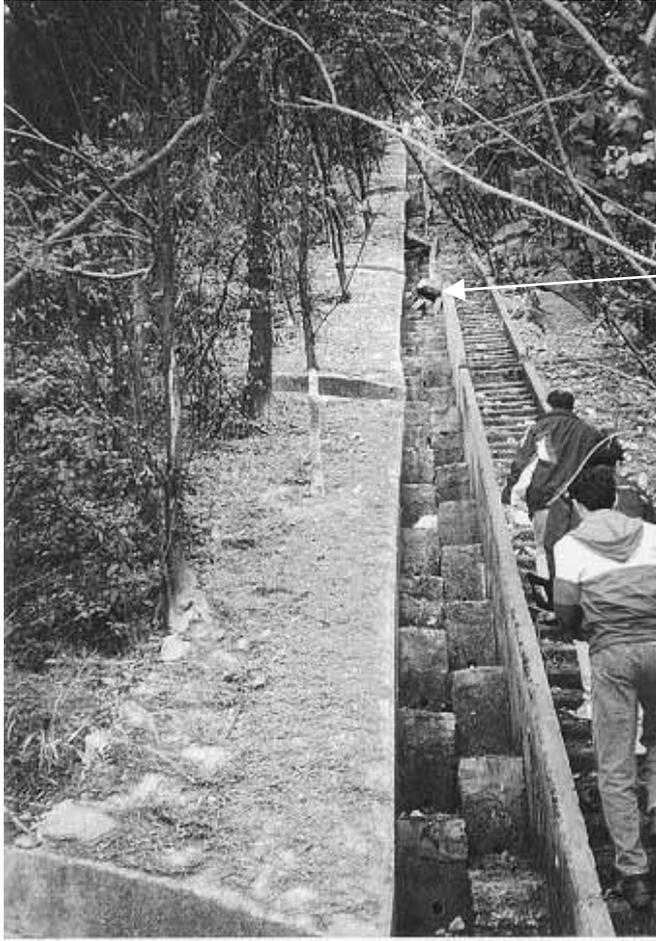
Plate A3 – General View Looking Westwards Up the Cascade Channel Separating Slope Nos. 10NE-B/C262 and 10NE-B/C254 (Area 1)

Side Wall to cascade channel has collapsed at the same elevation as the drainage channels above the second and third batter

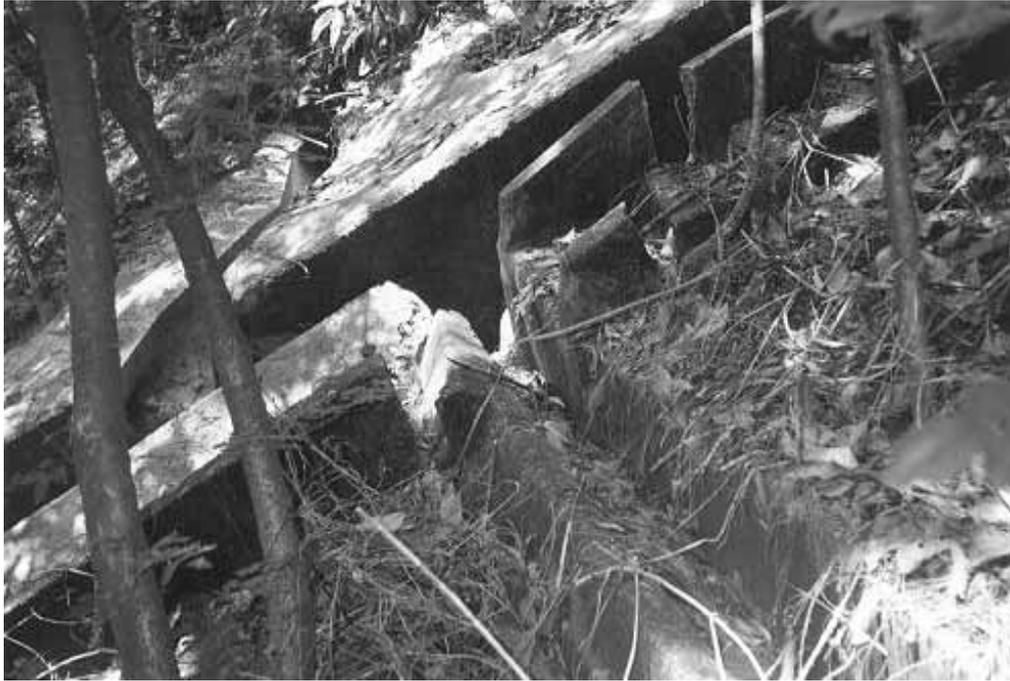
Plate A4 – Side View (Looking Northwards) of Cracking and Movement of Drainage Channel, Concrete Steps and Cascade Channel at an Elevation of the Drainage Channel above the Third Batter (Area 1)

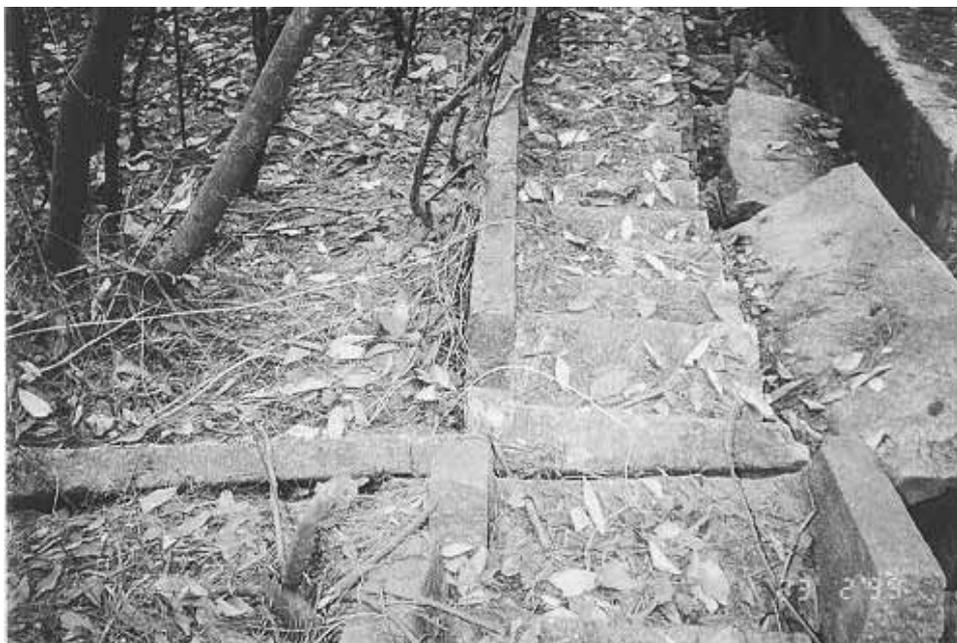
Plate A5 – View Downslope of Collapsed Side-wall to Cascade Channel at an Elevation of the Drainage Channel above the Third Batter (Area 1)

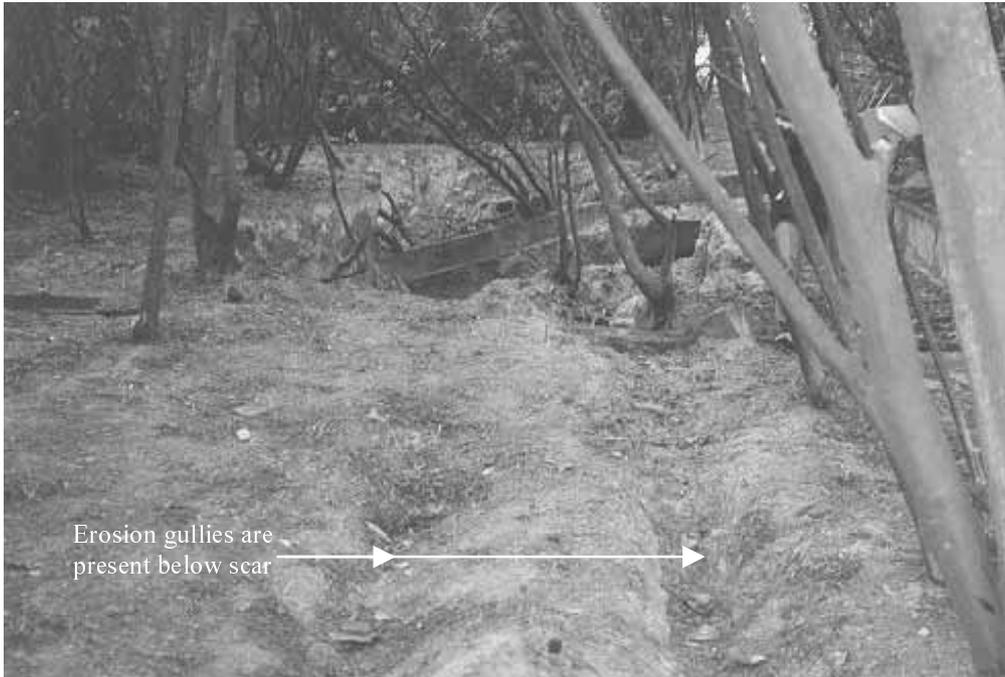
Plate A6 – View Looking Upslope of the Scar in the Fourth and Fifth Batter at the Southern End of Slope No. 10NE-B/C262 (Area 2)

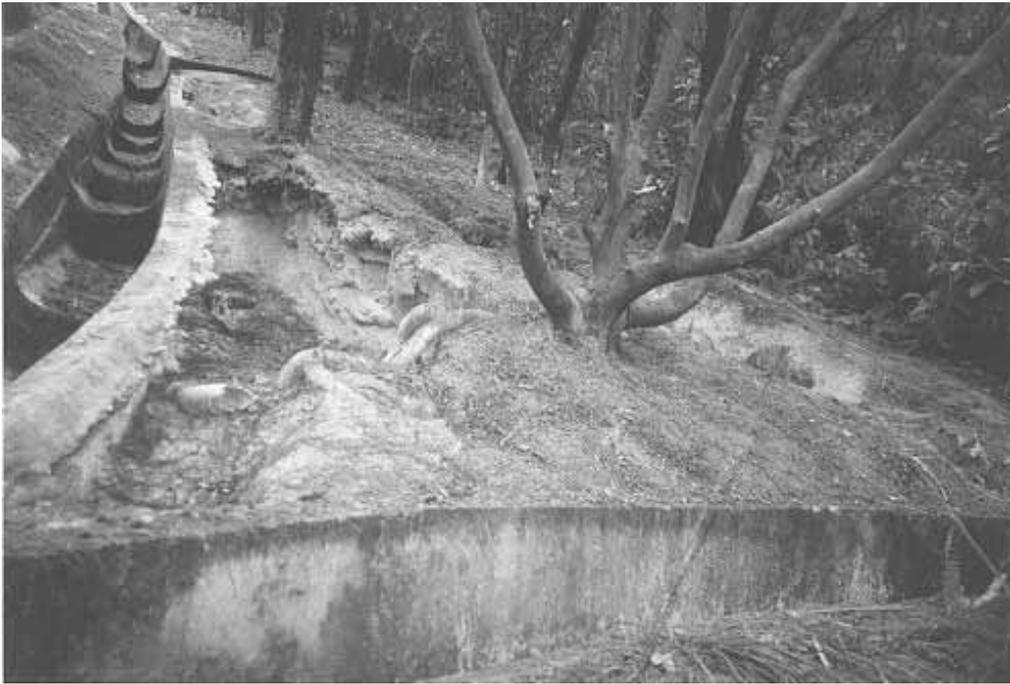
Plate A8 – View of Looking Upslope of the Erosion below the Crest Channel at the Northern End of Slope No. 10NE-B/C262 (Area 3)

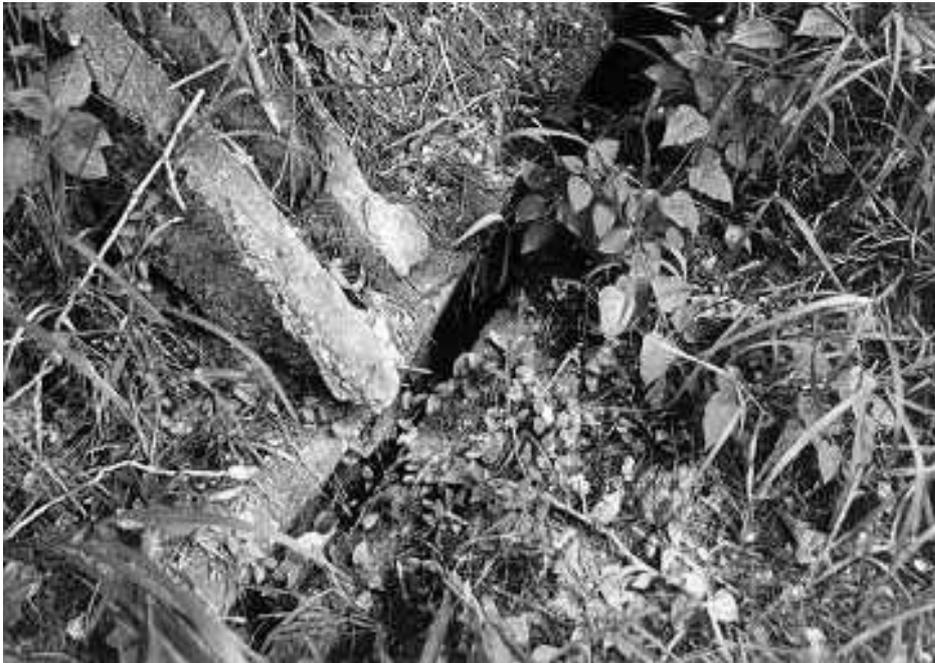
Plate A10 – View of Distressed Toe Channel Showing Significant Narrowing of the 300 mm Wide Channel

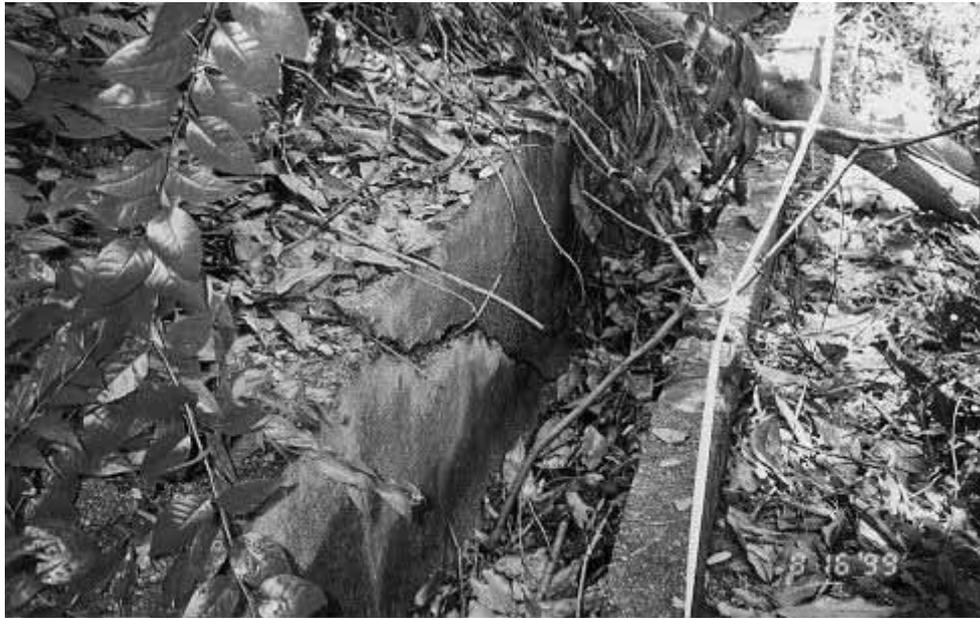
Plate B1 – View of Major Crack in Drainage Channel above Second Batter
at the Northern End of Slope No. 10NE-B/C254 (Area 1)

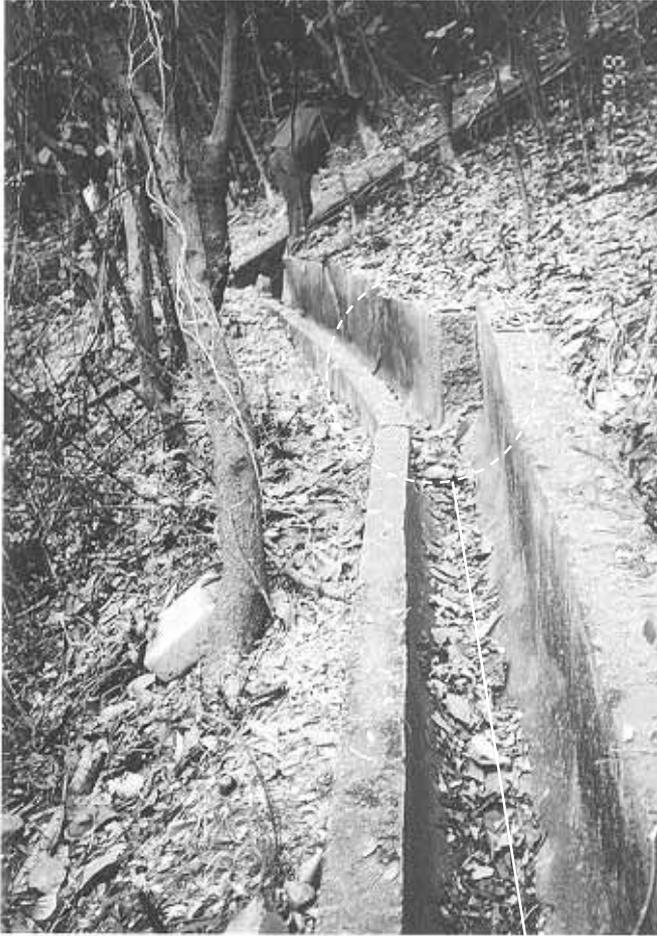
Plate B2 - View of Major Dislocation
in the Channel above the
Second Batter at the
Northern End of Slope
No. 10NE-B/C254
(Area 1)

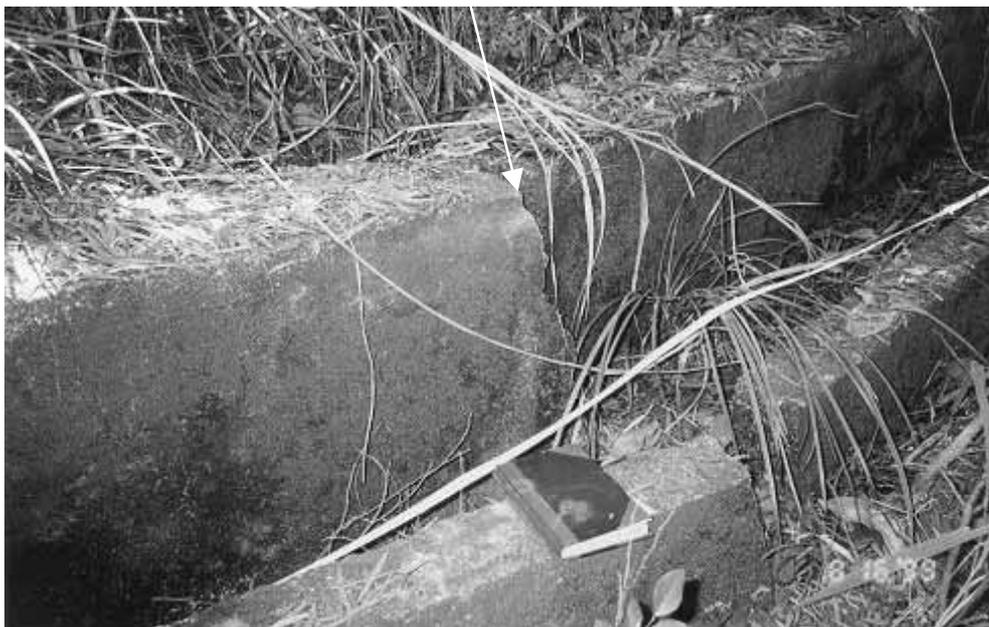
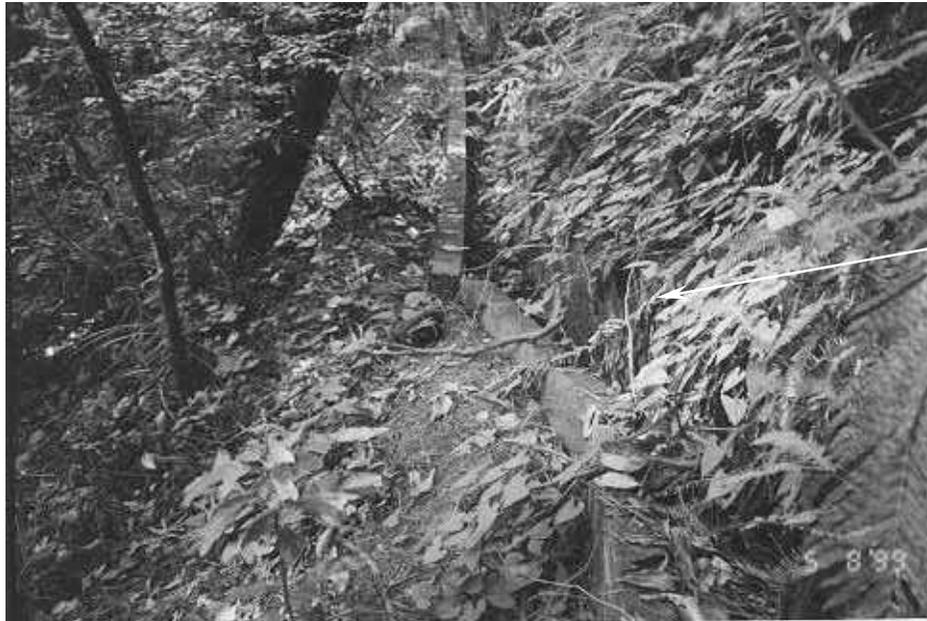
Plate B4 – View of Major Dislocation in the Channel above the Second Batter at the Northern End of Slope No. 10NE-B/C254 (Area 1)

Tension crack was identified in the third batter above one of the major dislocations in the drainage channel

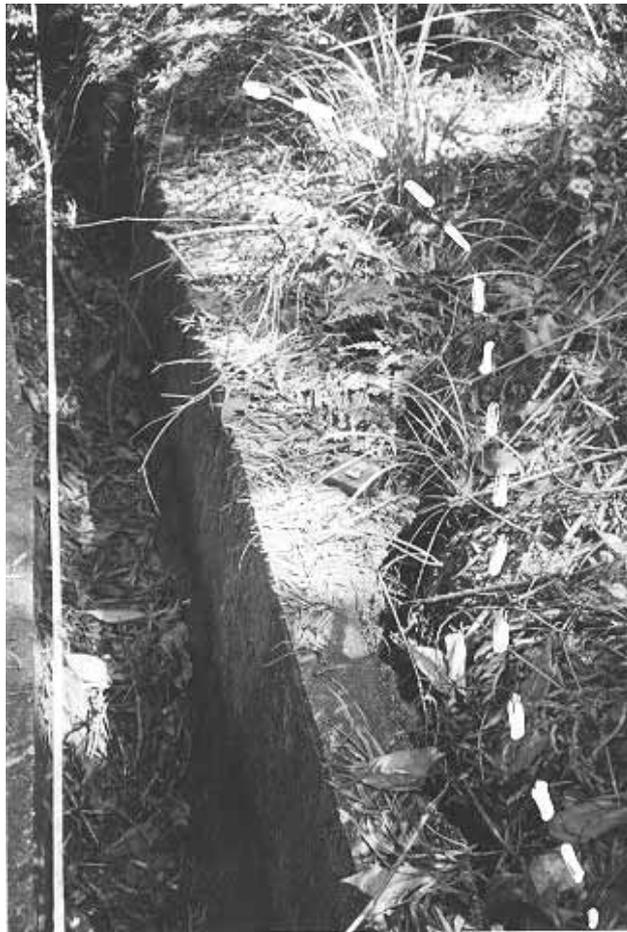
Plate B5 – View of Voided Area along the Upslope Side of the Drainage Channel above the Second Batter at the Northern End of Slope No. 10NE-B/C254 (Area 1)
