**INVESTIGATION OF SOME
SELECTED LANDSLIDES
IN 1999
(VOLUME 3)**

GEO REPORT No. 122

Fugro Maunsell Scott Wilson Joint Venture

**SECTION 1:
DETAILED STUDY OF THE
24 AUGUST 1999 LANDSLIDE
AT TSING YI ROAD
TSING YI ISLAND**

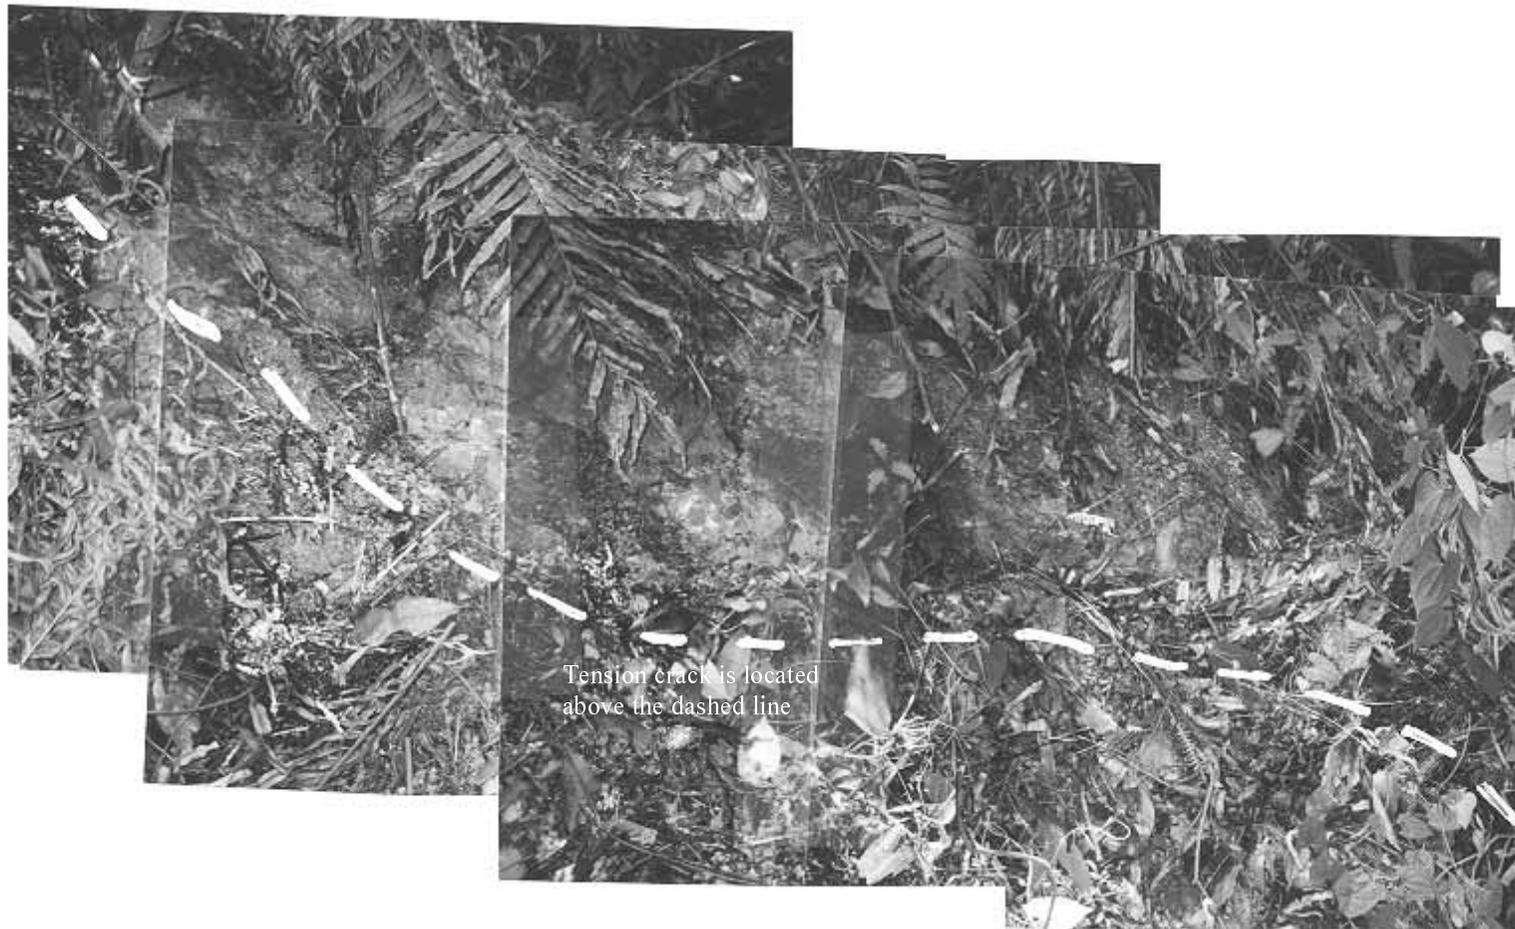
Plate B6 – View of Tension Crack in the Lower Portion of the Third Batter at the Northern End of Slope
No. 10NE-B/C254 (Area 1)

Tension crack is located
above the dashed line

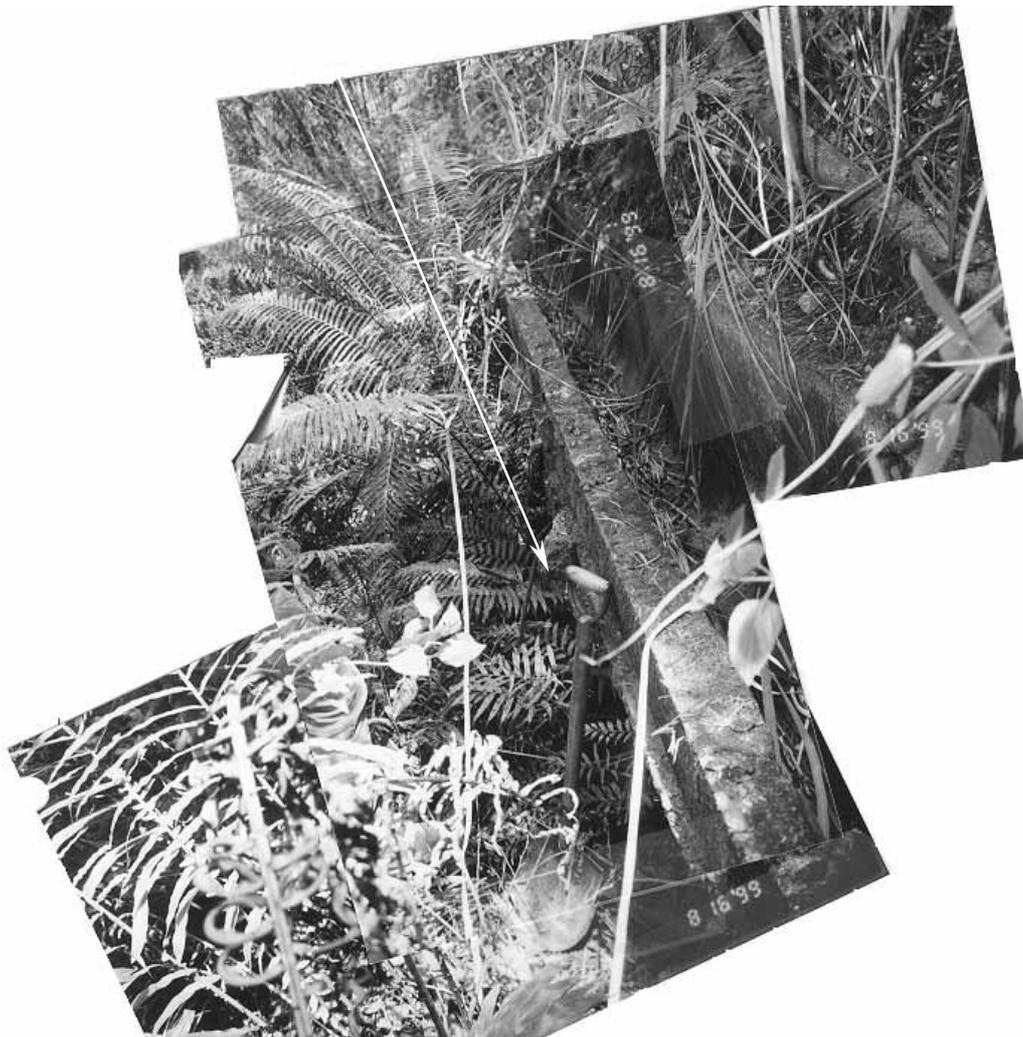
Plate B7 – View of Undermined Section of Drainage Channel above the Third Batter at the Northern End of Slope No. 10NE-B/C254 (Area 1)

Undermining / Slumping was identified to a depth of about 1 m below the drainage channel above the third batter

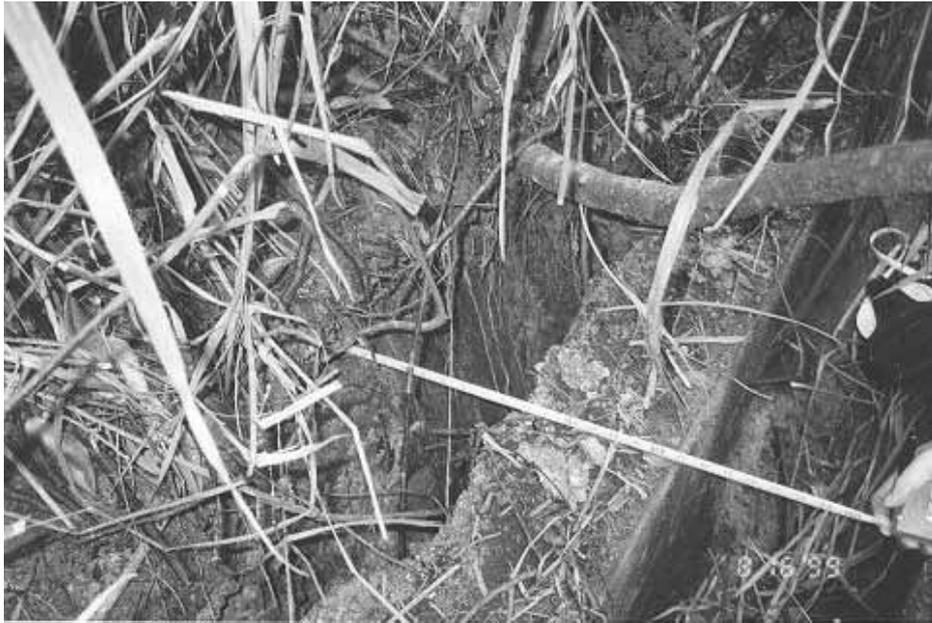
Plate B8 – View of Voiding along the Upslope Side of the Drainage Channel
above the Third Batter at the Northern End of Slope
No. 10NE-B/C 254 (Area 1)
