**SECTION 2:
DETAILED STUDY OF THE
24 AUGUST 1999 LANDSLIDE
AT SLOPES NOS. 9SW-D/C114
AND 9SW-D/C115
AT SHAM WAT ROAD
LANTAU ISLAND**

Fugro Maunsell Scott Wilson Joint Venture

**This report was originally produced in January 2001
as GEO Landslide Study Report No. LSR 1/2001**

This report presents the findings of a detailed study of the landslide (GEO Incident No. MW1999/8/107) that occurred on 24 August 1999 at slopes Nos. 9SW-D/C114 and 9SW-D/C115 located above Sham Wat Road, Lantau Island. The landslide blocked the single lane road that serves as the sole road access to Sham Wat Wan village. There were no casualties or damage to property as a result of the landslide.

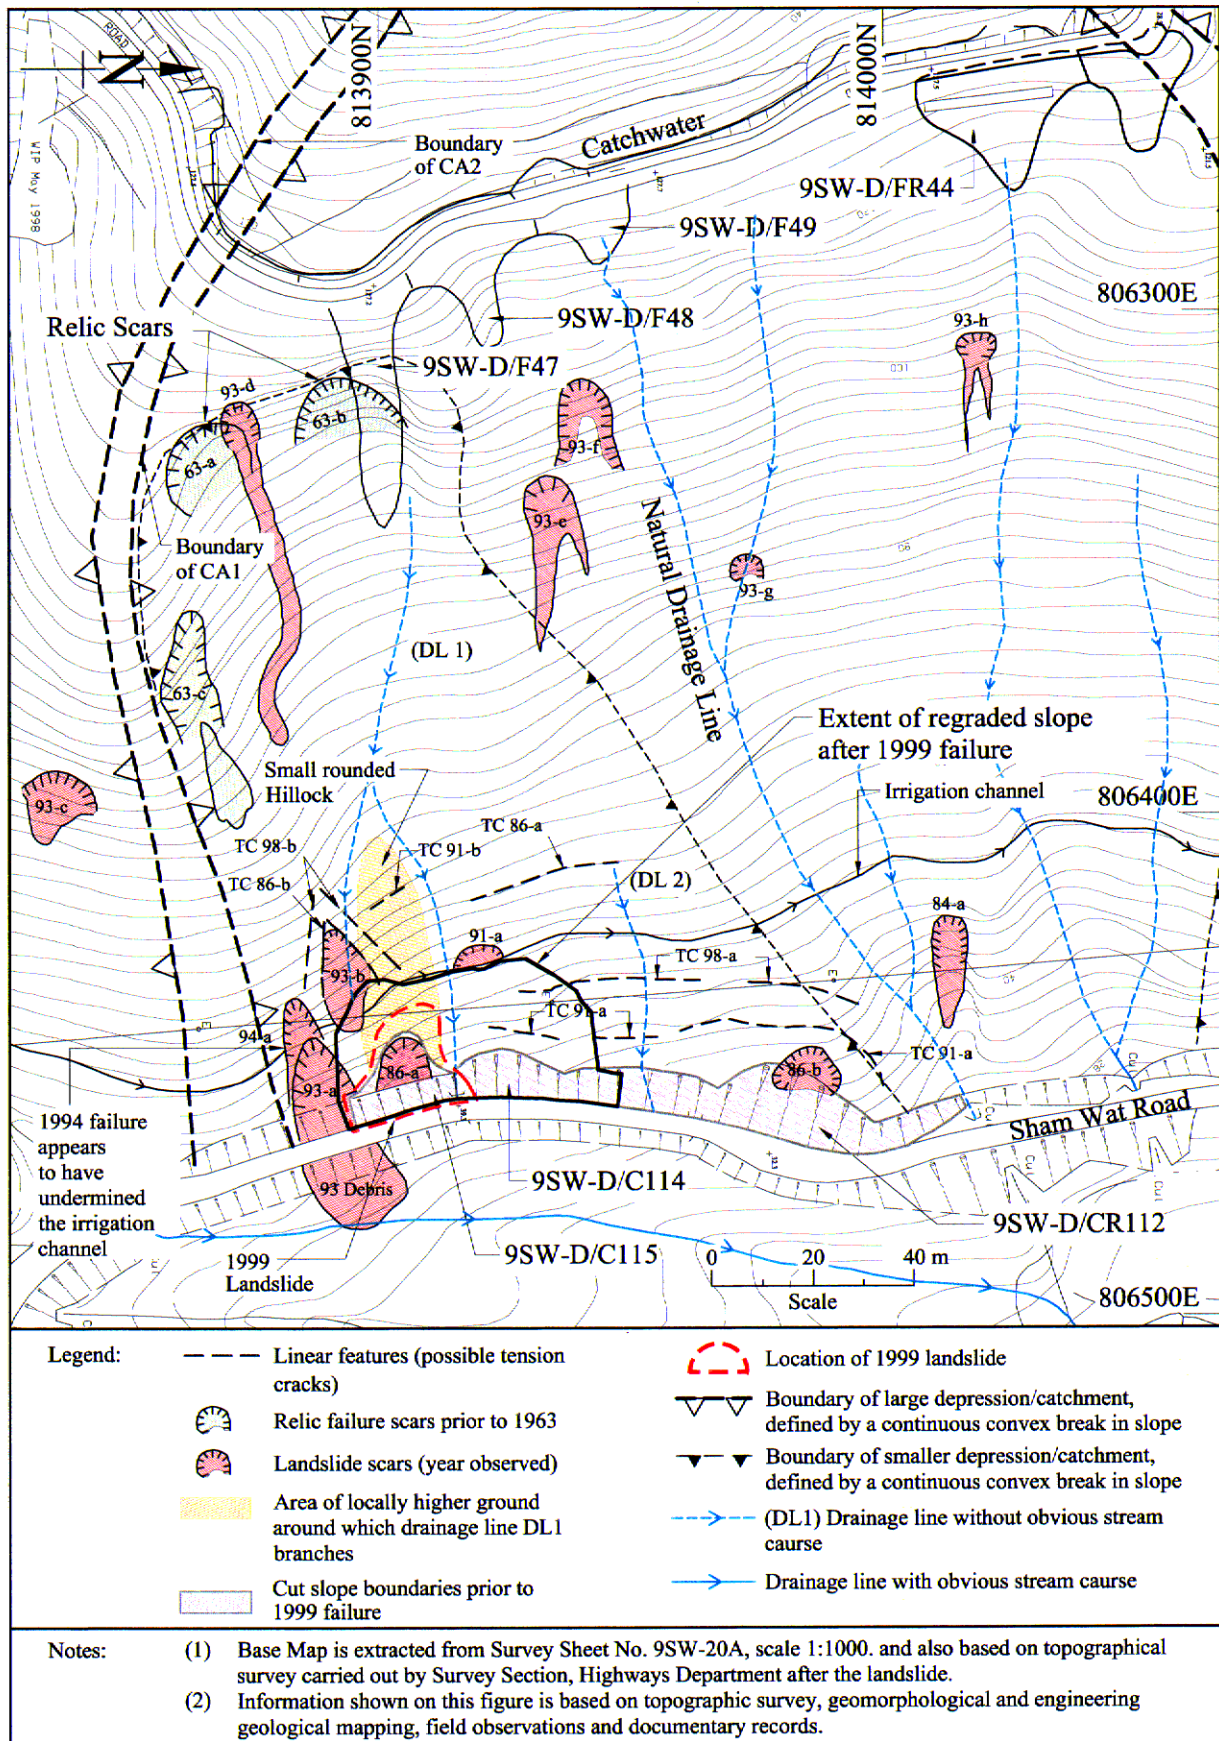
Figure 4 - Landslide and Slope Distress History Observed from API

In the 1963 aerial photographs, three concave depressions interpreted as relic failure scars (63-a to 63-c) are apparent approximately 100 m to 120 m east (upslope) of the 1999 landslide site (Figure 4). These relic failure scars are typically 20 m to 25 m wide and lie below a sharp convex break of slope, which defines the upper limit of a large depression that lies about 120 m east of the 1999 landslide site. This depression forms a sub-catchment (CA1), with an approximate surface area of 3 000 m², within a larger catchment (CA2), with an approximate surface area of 50 000 m² (Figure 5).

Further signs of instability, in the form of shallow depressions up to 15 m wide, were evident within CA1 in 1991, 1993 and 1994 (Figure 4). In particular, one of the failures in 1993 occurred in the same area as the washout failure scar adjoining the 1999 landslide observed by FMSW on 25 August 1999. This failure (93-b) retrogressed further up the hillside in 1994, with the crown of the landslide (94-a) located above the irrigation channel.

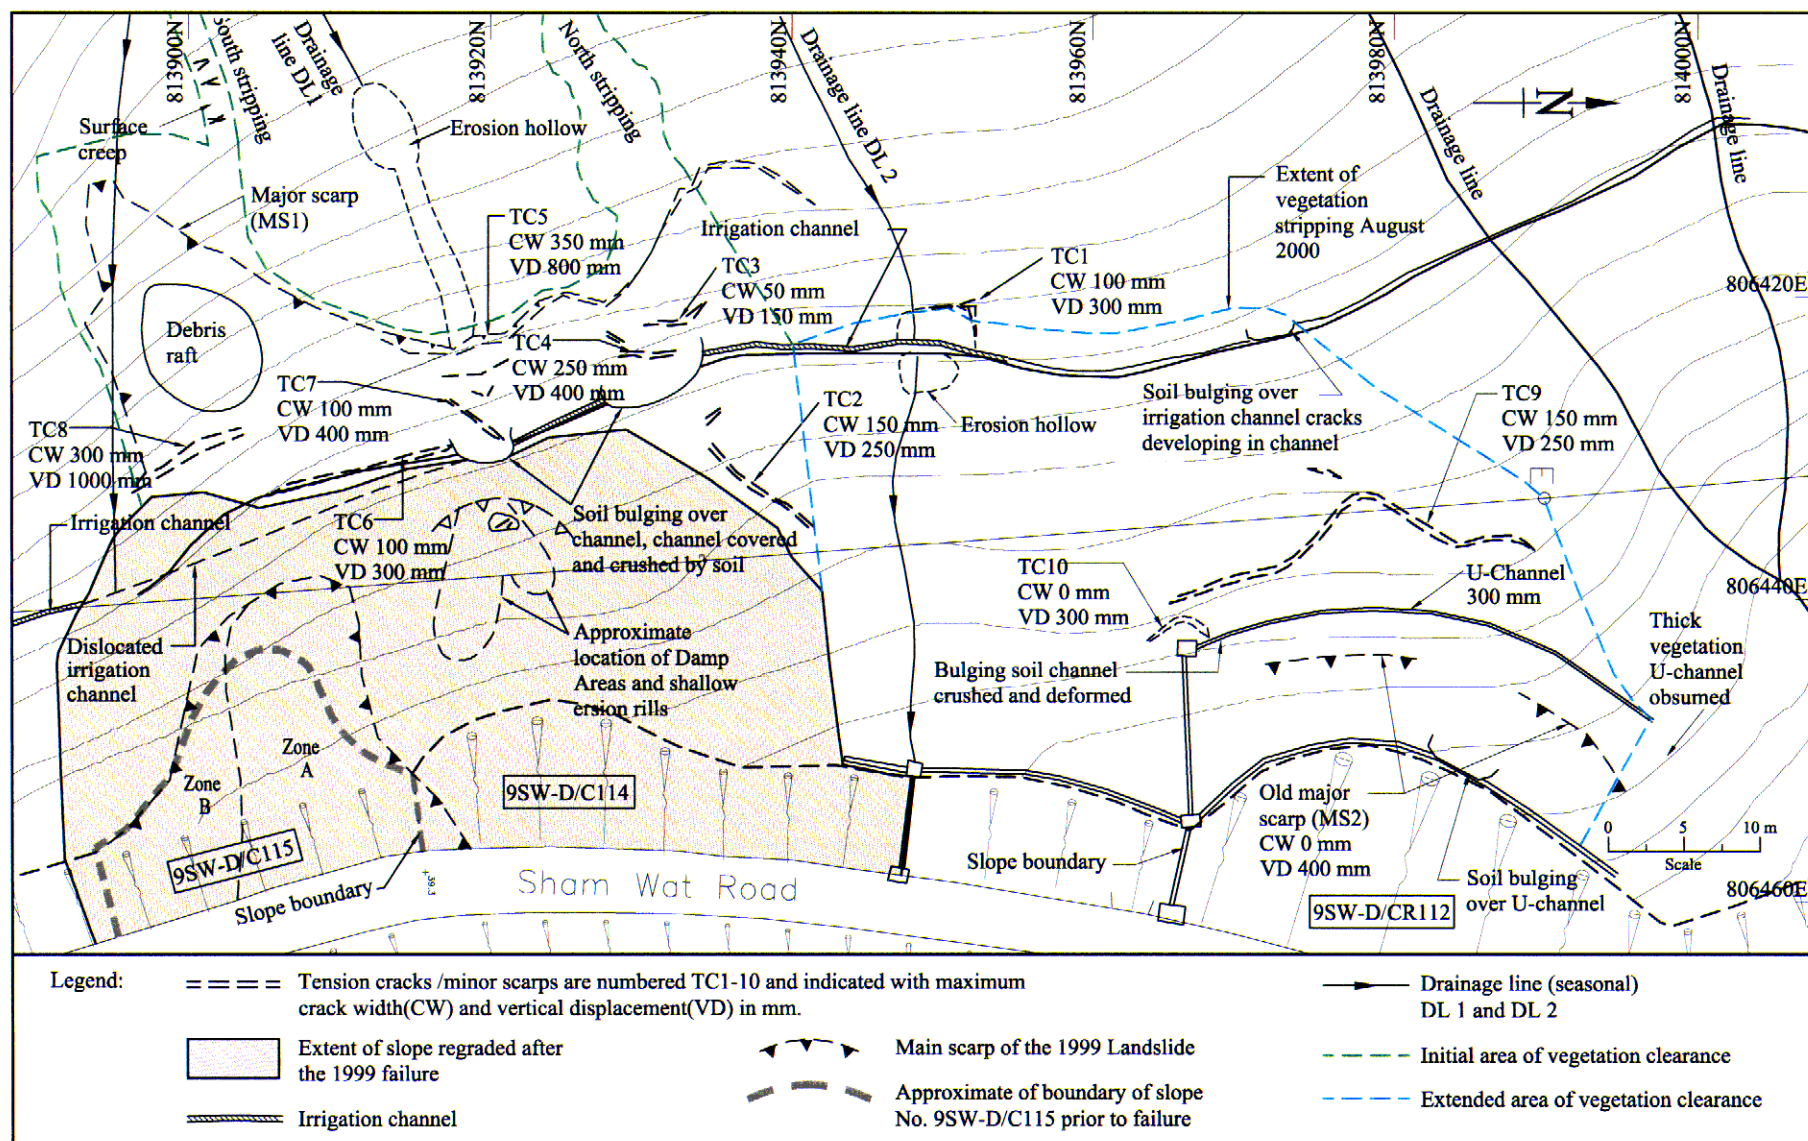
Figure 8 - Ground Movement and Distress Plan from Field Mapping

Detailed field mapping was undertaken by FMSW in November 1999, following the completion of slope trimming and the first phase of vegetation clearance works. Initial mapping identified a major scarp and a number of tension cracks/minor scarps, referenced MS1 and TC1 to TC8 respectively. Further vegetation clearance and mapping in August 2000 revealed another old main scarp and two further tension cracks/minor scarps, referenced MS2 and TC9 to TC10 respectively (Figure 8). The overall area of instability mapped by FMSW was about 100 m long and between 15 m and 20 m wide, with an estimated volume of displaced material of about 1 500 m³.

Further vegetation clearance was undertaken in August 2000 in the area to the north of the regraded slope in an attempt to confirm the existence of possible tension cracks/minor scarps observed from API (Figure 8). This work confirmed the presence of minor scarps, TC9 and TC10, in the area where possible distress (TC 98-a) was observed from API (Figure 4). TC9 was about 25 m long, with a horizontal separation of 150 mm and a vertical displacement of 250 mm. The back scarp of TC9 was slightly discoloured with no vegetation growth. TC10 was about 3.5 m long, with no horizontal separation and a vertical displacement of 250 mm. The back scarp to TC10 was discoloured with vegetation growth.

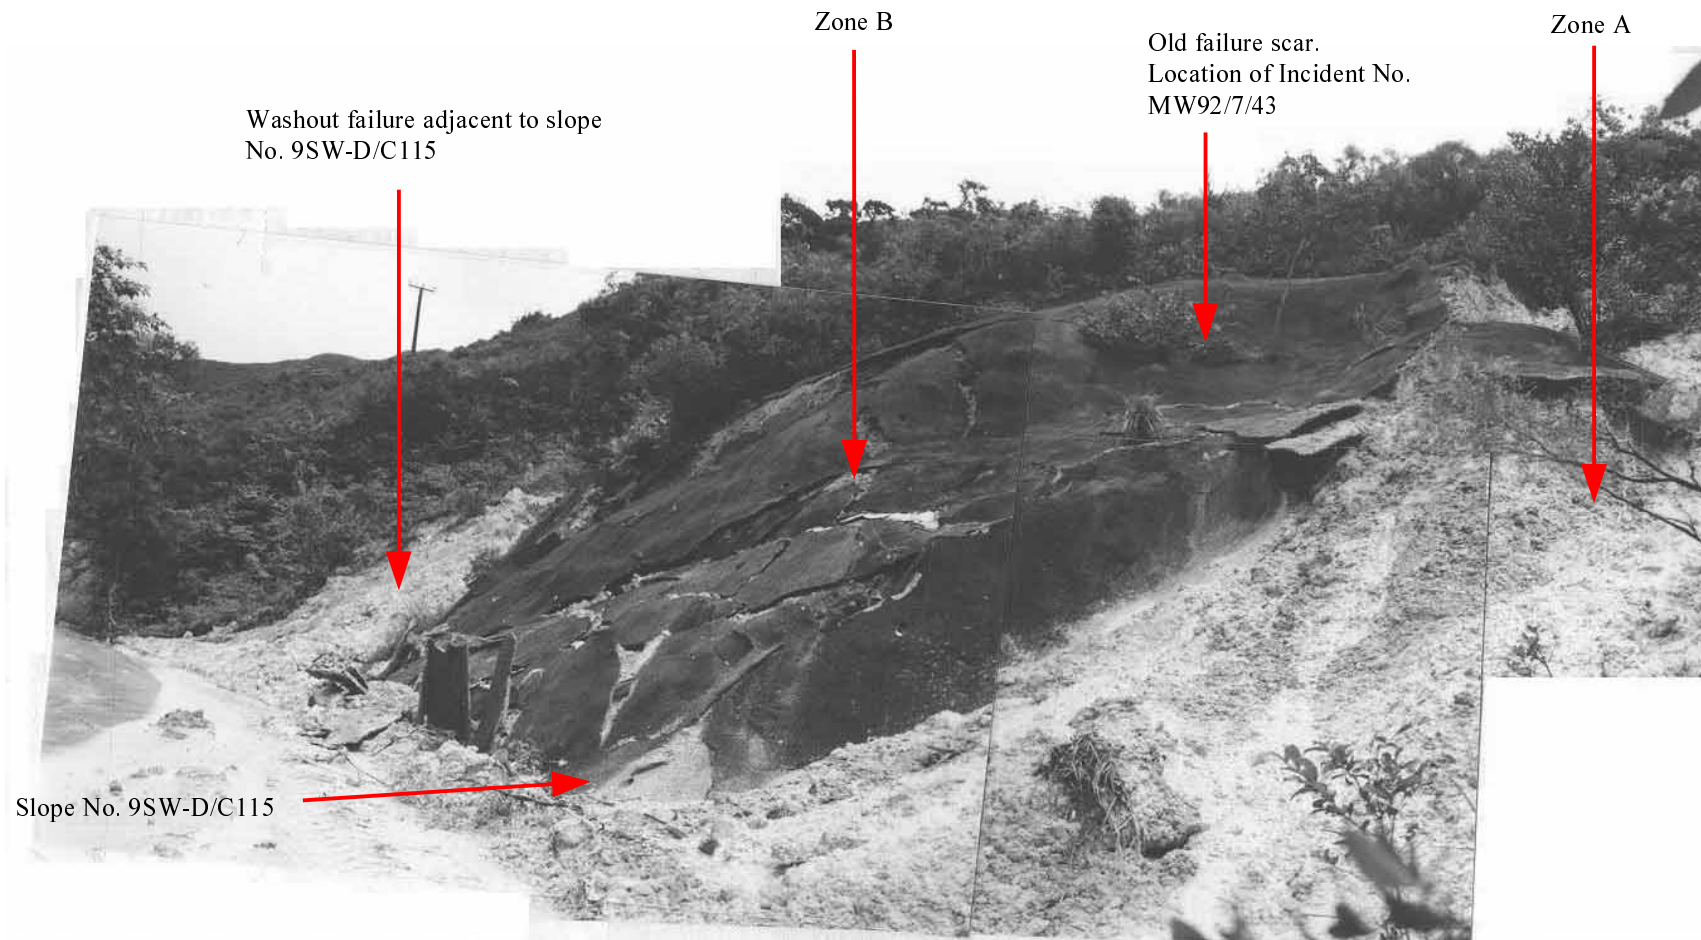
At about 12:00 p.m. on 24 August 1999, a landslide (GEO Incident No. MW1999/8/107) occurred on soil cut slopes Nos. 9SW-D/C114 and 9SW-D/C115 located above Sham Wat Road, Lantau Island (Figures 1 and 2 and Plates 1 to 3). The landslide blocked the single lane road that serves as the sole road access to Sham Wat Wan village. There were no casualties or damage to property as a result of the landslide.

The initial inspection of the landslide by FMSW on 25 August 1999 revealed that the failure affected the entire portion of slope No. 9SW-D/C115 as well as the hillside above and part of slope No. 9SW-D/C114 to the north (Figure 2 and Plates 1 and 2). It is estimated that the crown of the landslide had extended into the natural hillside above the slope to a height of about 12 m above Sham Wat Road.

Plate 1 – General View of the 1999 Landslide Looking Southwest
(Photograph Taken on 25 August 1999)

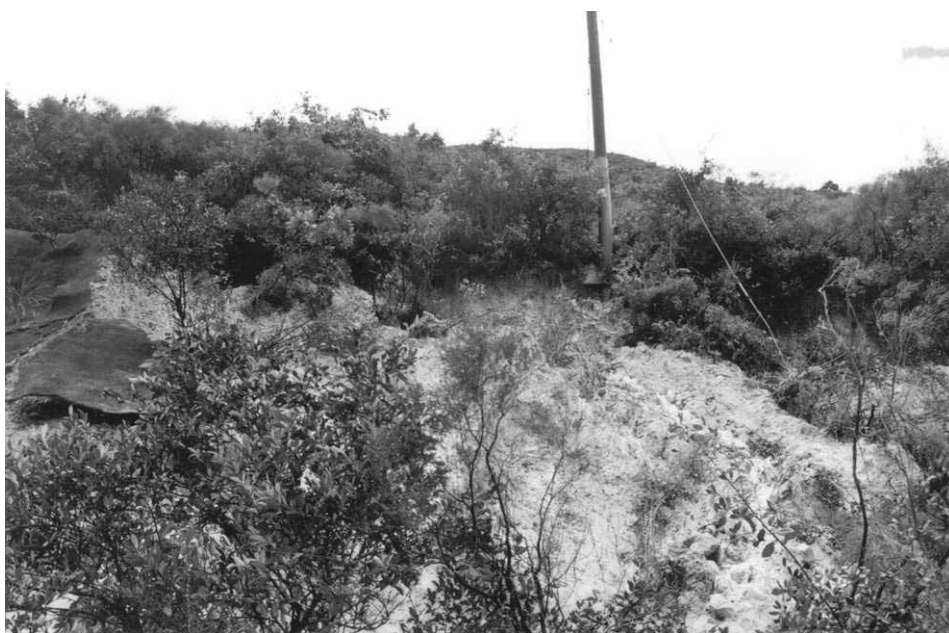
The failed area was about 30 m wide and could be divided into two distinct portions (Figure 2). The northern portion (Zone A) comprised an area of disturbed ground about 20 m wide by 18 m long with a maximum depth of about 1 m. Debris along the southern flank of

Zone A was more mobile and had inundated the single track road at the toe of the slope with a travel angle of the debris of about 30° (Wong & Ho, 1996). It is estimated that the failed volume in Zone A was between 75 m³ and 100 m³. The southern half of the landslide (Zone B) was less mobile involving about 0.5 m of vertical displacement and 1 m of outward horizontal movement without complete detachment of the unstable material from the surface of rupture. The failed area within Zone B was about 10 m wide by 18 m long, with an estimated volume of about 100 m³ (assuming the depth of failure to be 1 m). Following vegetation clearance and slope trimming undertaken by the HyD, more widespread instability with an estimated volume of displaced material of 1 500 m³ was observed above Sham Wat Road (Section 4.4.2).

Plate 2 – View of Northern Portion of Landslide (Zone A)
(Photograph Taken on 25 August 1999)

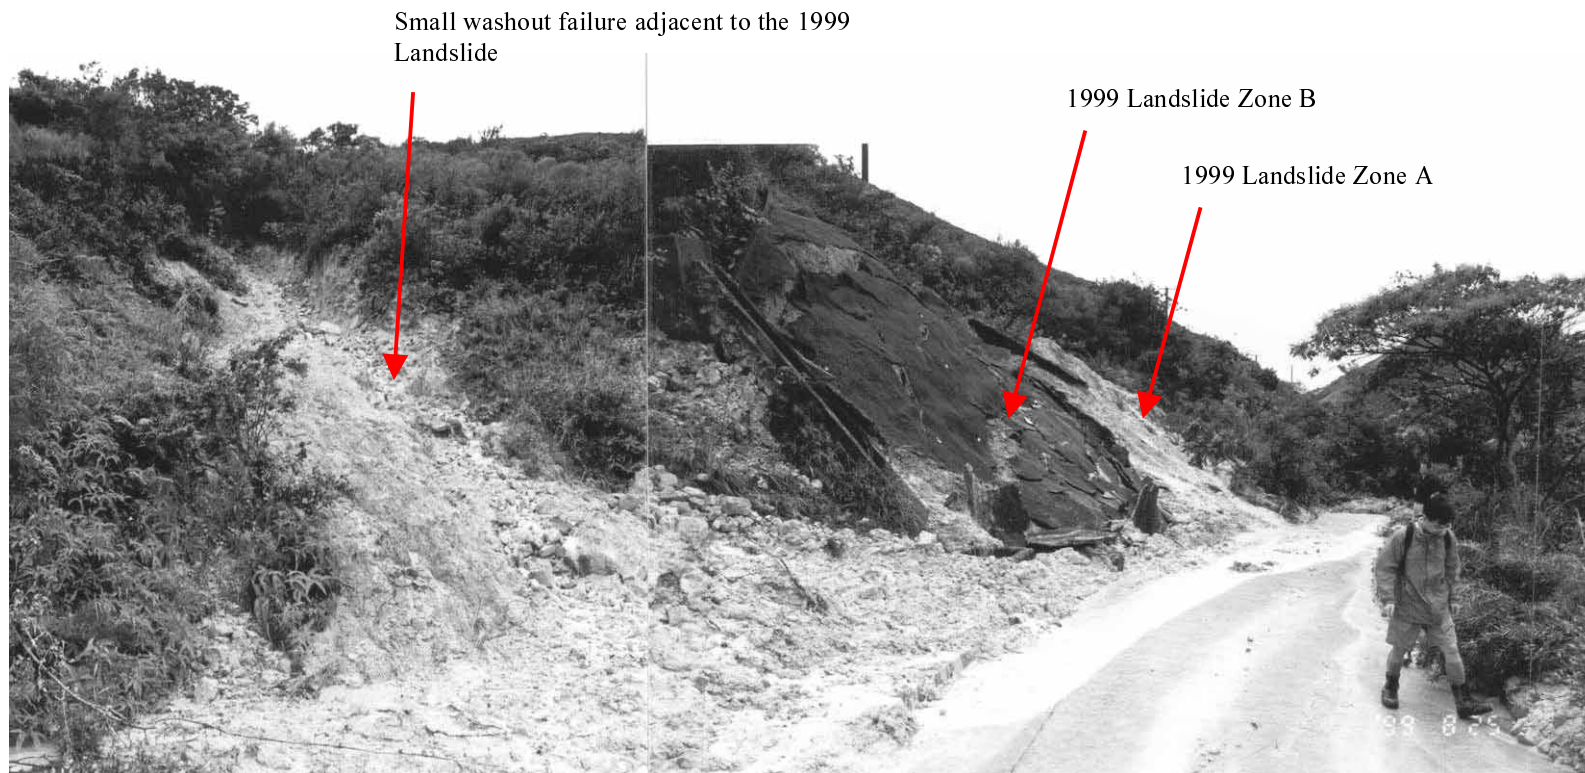
An old washout failure scar and erosion channel, along which there had been renewed movement of material, was observed to the south of Zone B (Plate 3). This failure scar corresponds to where instability was observed in 1993 and 1994 from the aerial photographs (Figure 4) and would appear to be separate from the 1999 landslide incident.

Plate 3 – View Looking North of the Small Washout Failure Adjoining the 1999 Landslide
(Photograph Taken on 25 August 1999)

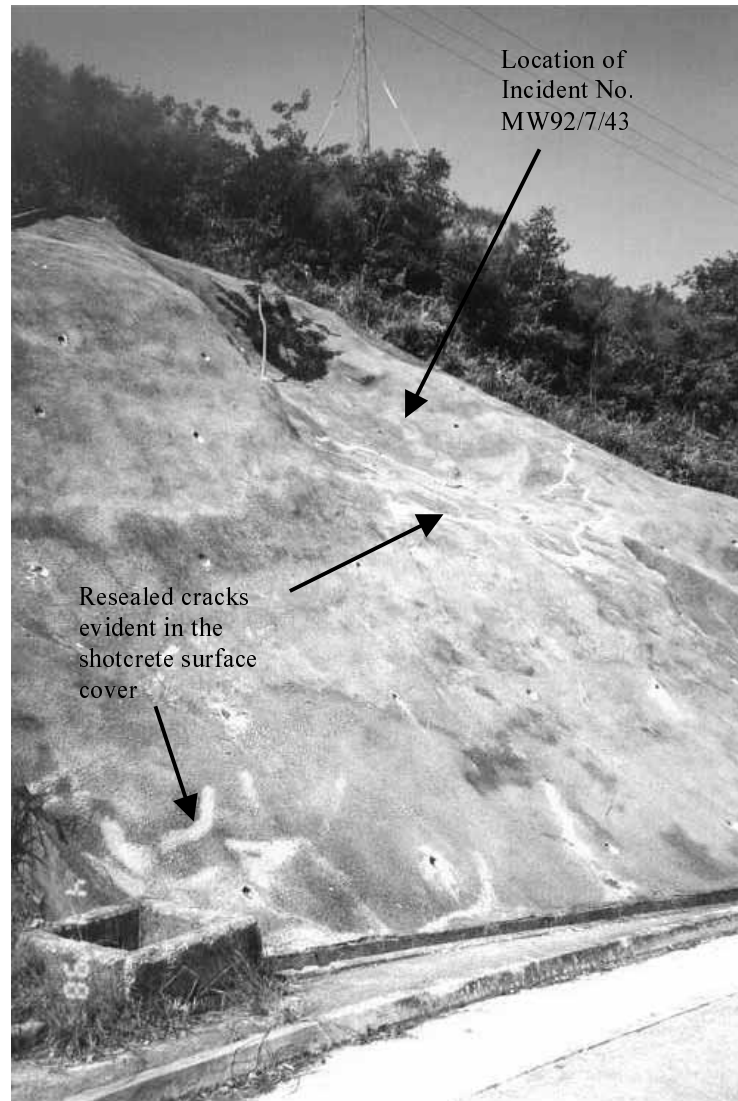
One landslide (GEO Incident No. MW92/7/43), was identified as having previously occurred at the same location of the 1999 landslide in the GEO landslide database (Plate 4). In accordance with the GEO Incident Report, the landslide occurred on 18 July 1992 and was recorded as having a failure volume of approximately 10 m³. The causes of failure were identified as groundwater perching and infiltration. “The landslide was about 20 m wide and affected the upper portion of the cut slope and extended about 10 m into the natural terrain above” (Figure 4). Based on photographs of the failure attached with the Incident Report, the failed volume is estimated to be about 25 m³ to 30 m³, which is greater than that quoted in the Incident Report (Plate 5). From the photograph of the landslide, the shotcrete cover to the failed slope was relatively new and appeared fresher than the rigid surface cover to the adjoining feature to the north, which is a possible indication of previous instability since formation of the slope in 1985.

Plate 4 – View of Slope No. 9SW-D/C115 Showing Concave Depression Following a Landslide in 1992 (GEO Incident No. MW1999/7/43) (Photograph Taken on 4 November 1998)

Rigid surface cover on the intact southern
portion of slope No. 9SW-D/C115 appears recent

Rigid surface cover on adjacent
slope No. 9SW-D/C114 Appears Old

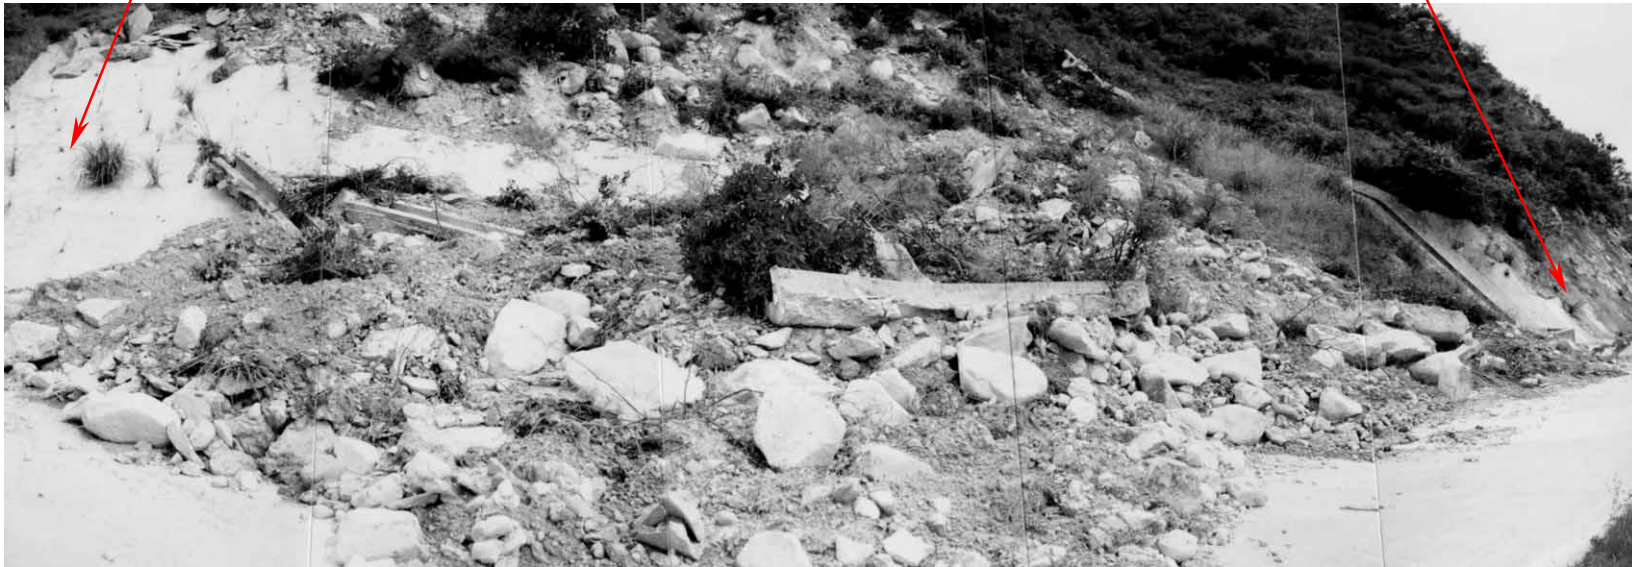
Plate 5 – View Looking Northwest of the 1992 Landslide (GEO Incident No. MW92/7/43)
(Photograph Extracted from GEO Incident Report No. MW 92/7/43) (Photograph
Taken on 21 July 1992)

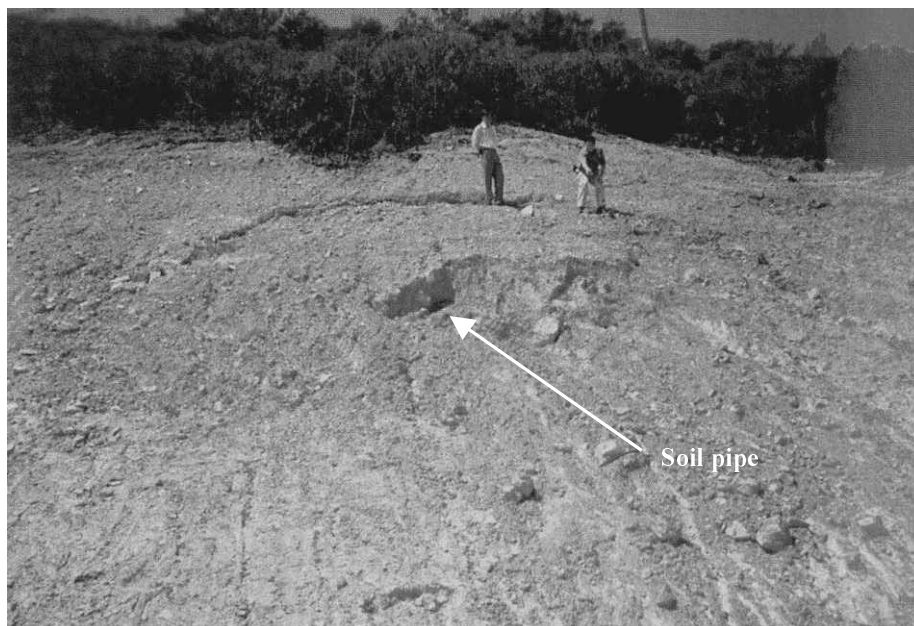
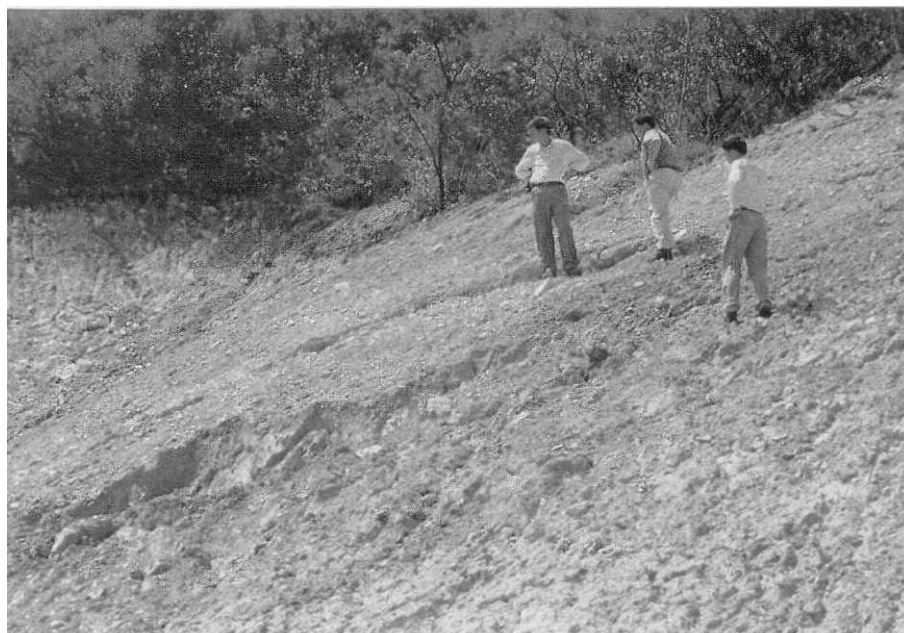
Plate 6 - View of Minor Failure and Exposed Soil Pipe in Reggraded Portion of Slope (Photograph Taken on 22 September 1992)

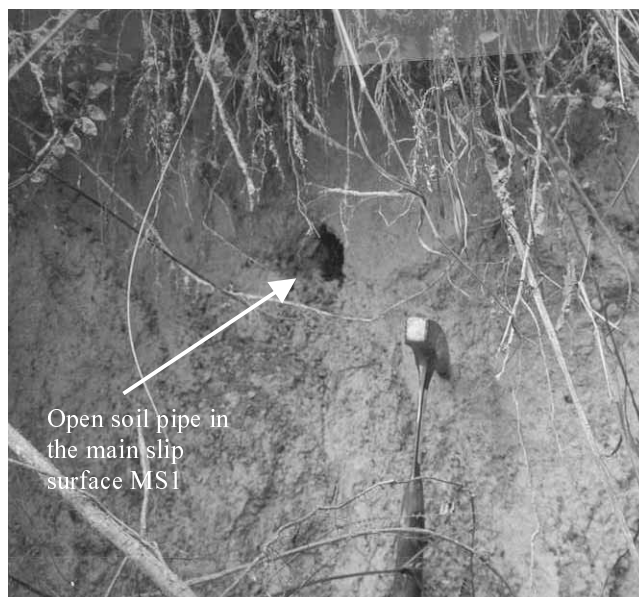
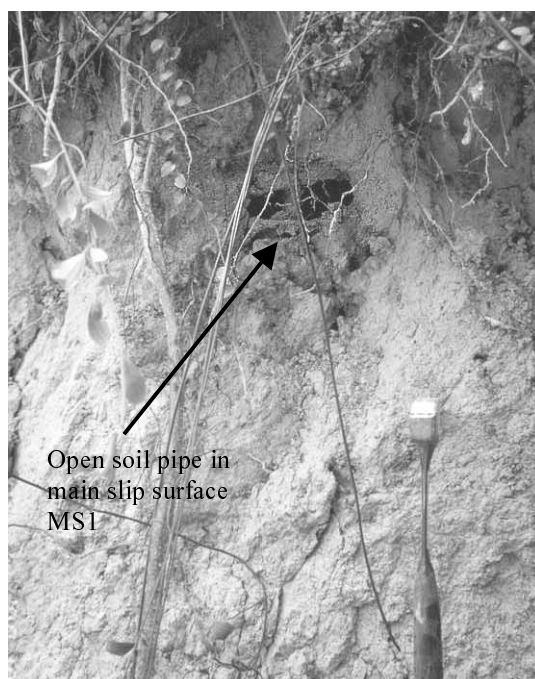
Plate 7 – View of Open Soil Pipes within the Colluvial Material
Exposed in the Main Scarp MS1 (Photograph Taken on
21 October 1999)

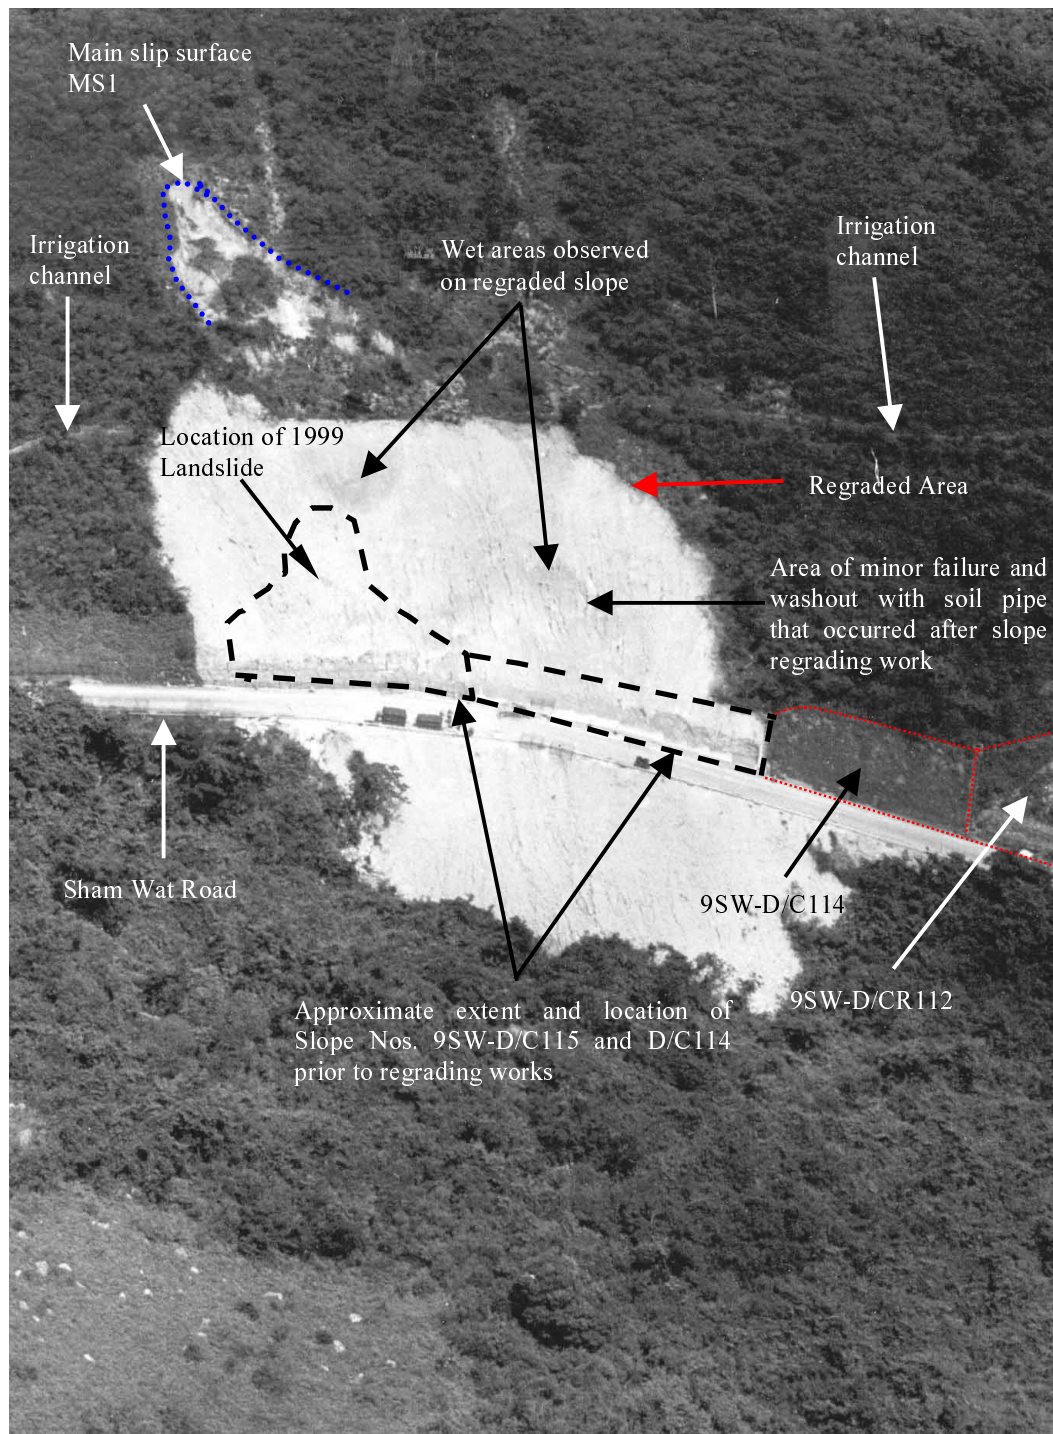
The major scarp MS1 was located to the west of the 1999 landslide and occurred in the same place as where API identified the presence of possible tension cracks/minor scarps in 1986 and 1998 (TC 86-b and TC 98-b) and a failure scar in 1993 (93-b), as shown in Figure 4. The failure scar was about 20 m long and increased in width in a downslope direction from about 2 m at the crown to 20 m at the toe. The main scarp was about 2 m high and exposed between 1 m and 1.5 m of colluvium overlying residual soil. Five open soil pipes, typically 50 mm to 150 mm wide, were observed with the thin colluvium mantel (Plate 7). An intact raft of debris, 7 m wide by 10 m long, remained within the central portion of the scar (Figure 8 and Plate 8).

Localised ground distress in the form of erosion hollows was also observed along both drainage lines DL1 and DL2. At the time of FMSW's inspection, these drainage lines were dry but there was a pronounced damp area within the upper section of the regraded slope below the northerly branch of DL1. This damp area is where a minor failure and soil pipe was observed in October 1999 following slope regrading works. A similar darker tone, possibly denoting another damp area, was observed below the major scarp MS1 (Plate 8).

Plate 8 – Oblique Aerial Photograph of the Urgent Repair Works Following the 1999 Landslide (Photograph Taken on 10 June 2000)

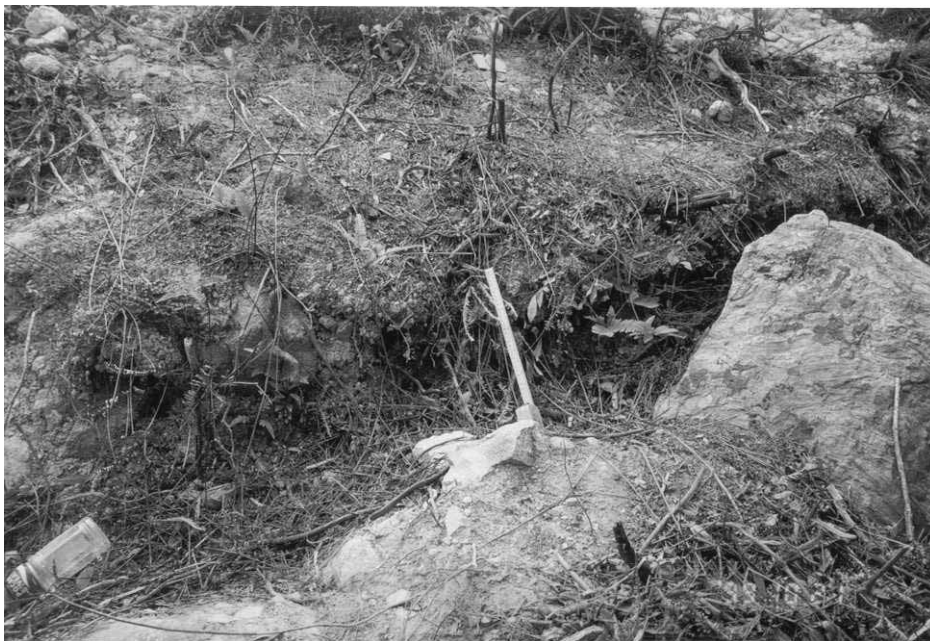
The tension cracks/minor scarps were typically discontinuous on the ground surface and were between 3 m and 10 m long with a horizontal separation between 50 mm and 350 mm and vertical displacements up to 1 m. In contrast, TC5 was laterally persistent and formed about a 30 m-long extension to the northerly flank of MS1. TC5 corresponds to the location of TC86-a observed from API. The minor scarps were typically orientated north to south, parallel to the line of cutting along Sham Wat Road. The exception to this was TC2, which trended northeast to southwest, parallel to the northern flank of the regraded cut slope. Minor scarps TC1 to TC 5 showed signs of discolouration, with some vegetation growth over the exposed back scarp of TC2, and were partly infilled with dead plant debris and slope wash

Plate 9 – View of Old Exposure of Colluvial Material in Minor Scarp TC4 (Photograph Taken on 21 October 1999)

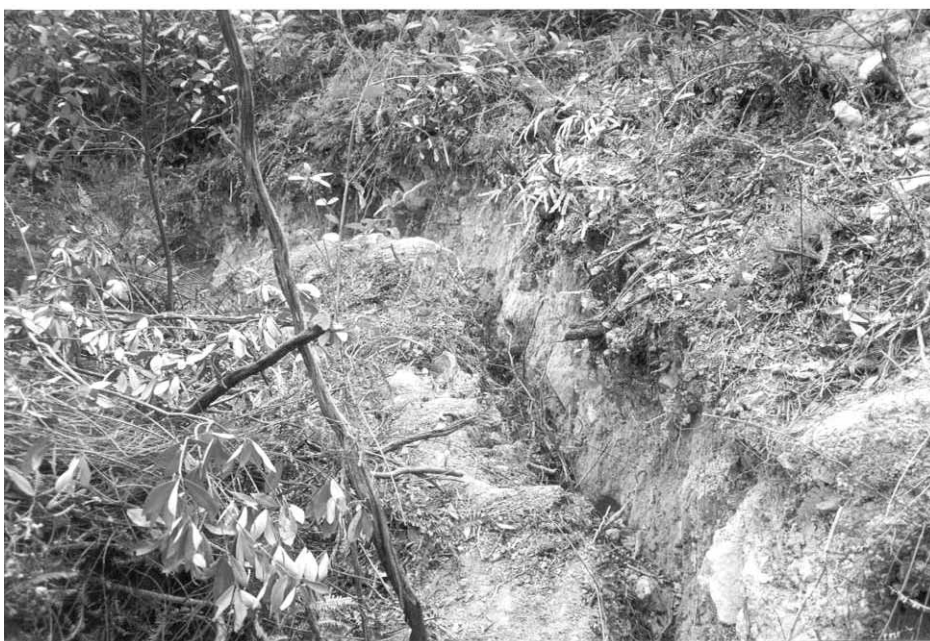
material (Plate 9). In contrast, there were no signs of infill material within minor scarps TC6 to TC8, and the back scarps exposed comparatively fresh material with no vegetation growth (Plate 10). Details of the tension cracks/minor scarps are summarised in Table 2.

Plate 10 – View of Recent Exposure of Colluvial Material in Minor Scarp TC5 (Photograph Taken on 21 October 1999)

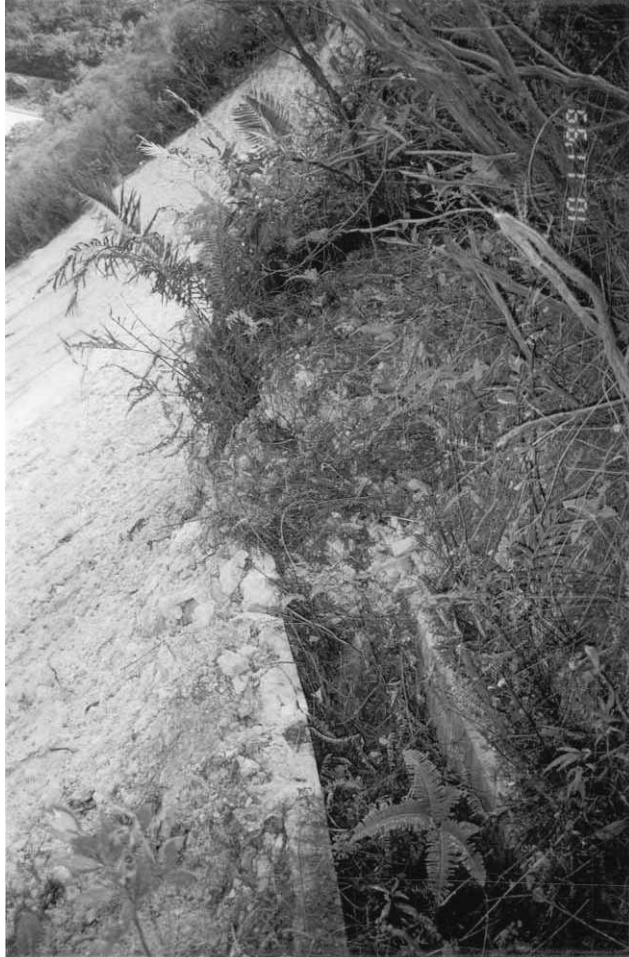
Local bulging and shallow ground movement were observed close to minor scarps TC3, TC4 and TC7, which had resulted in breaching of the irrigation channel, and blocking of the channel with debris in the process (Plate 11). These localised ground movements had also resulted in severe distress to the channel, which was crushed and severed at a number of locations (Plate 12). A section of channel above and to the northwest of the 1999 landslide was missing following slope regrading works (Figure 8). This section may have been removed as a result of the regrading works or, based on API, it is possible that this missing section may have been displaced/badly deformed by previous instability in the hillside above between 1993 and 1994. The observed condition of the adjoining section of channel (north of the regraded area) was cracked and appeared deformed. This provides further evidence to suggest that the missing channel section was also cracked and deformed prior to the 1999 landslide.

Plate 11 – View of Irrigation Channel Breached by Movement of Colluvium
(Photograph Taken on 10 November 1999)

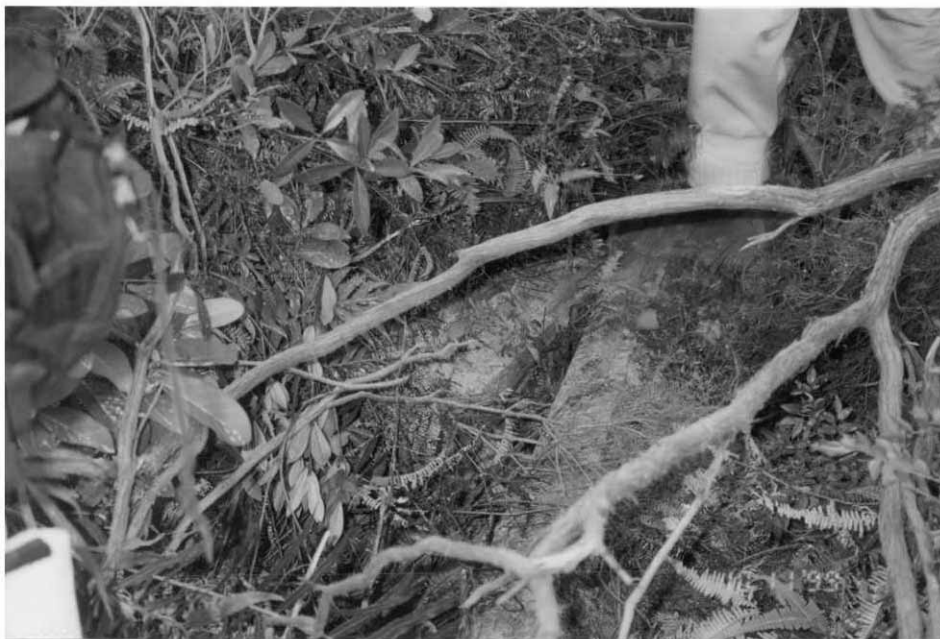
Plate 12 – View of Crushed Irrigation Channel (Photograph Taken on 10 November 1999)

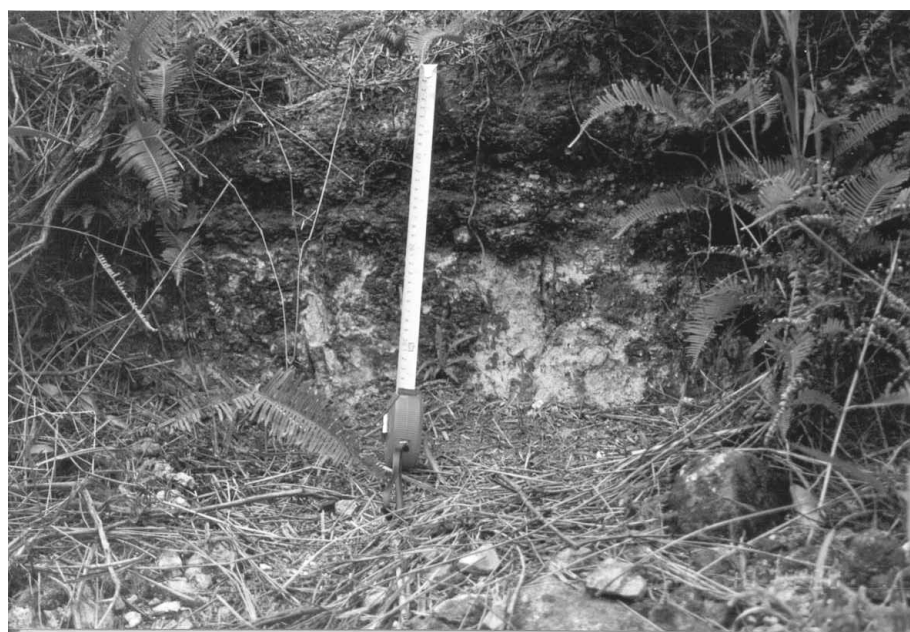
Remnants of an old major scarp, MS2, and evidence of ground bulging and shallow movement were identified above the crest of slope No. 9SW-D/CR112 (Figure 8). The main scarp of this failure, which was about 20 m long with no horizontal separation and a vertical displacement of 400 mm, was discoloured and had vegetation growth over it (Plate 13). The location and condition of the scarp indicate that it may have been linked to the instability recorded above this feature during the formation of the road in 1985/86.

Plate 13 – View of the Discoloured and Vegetated Main Scarp of MS2 (Photograph Taken on 30 August 1999)
