INVESTIGATION OF SOME SELECTED LANDSLIDES IN 1999 (VOLUME 4)

GEO REPORT No. 123

Fugro Maunsell Scott Wilson Joint Venture

**SECTION 1:
DETAILED STUDY OF THE
LANDSLIDE BELOW THE
BENJAMIN FRANKLIN CENTRE
CHINESE UNIVERSITY OF
HONG KONG
ON 7 JUNE 1999**

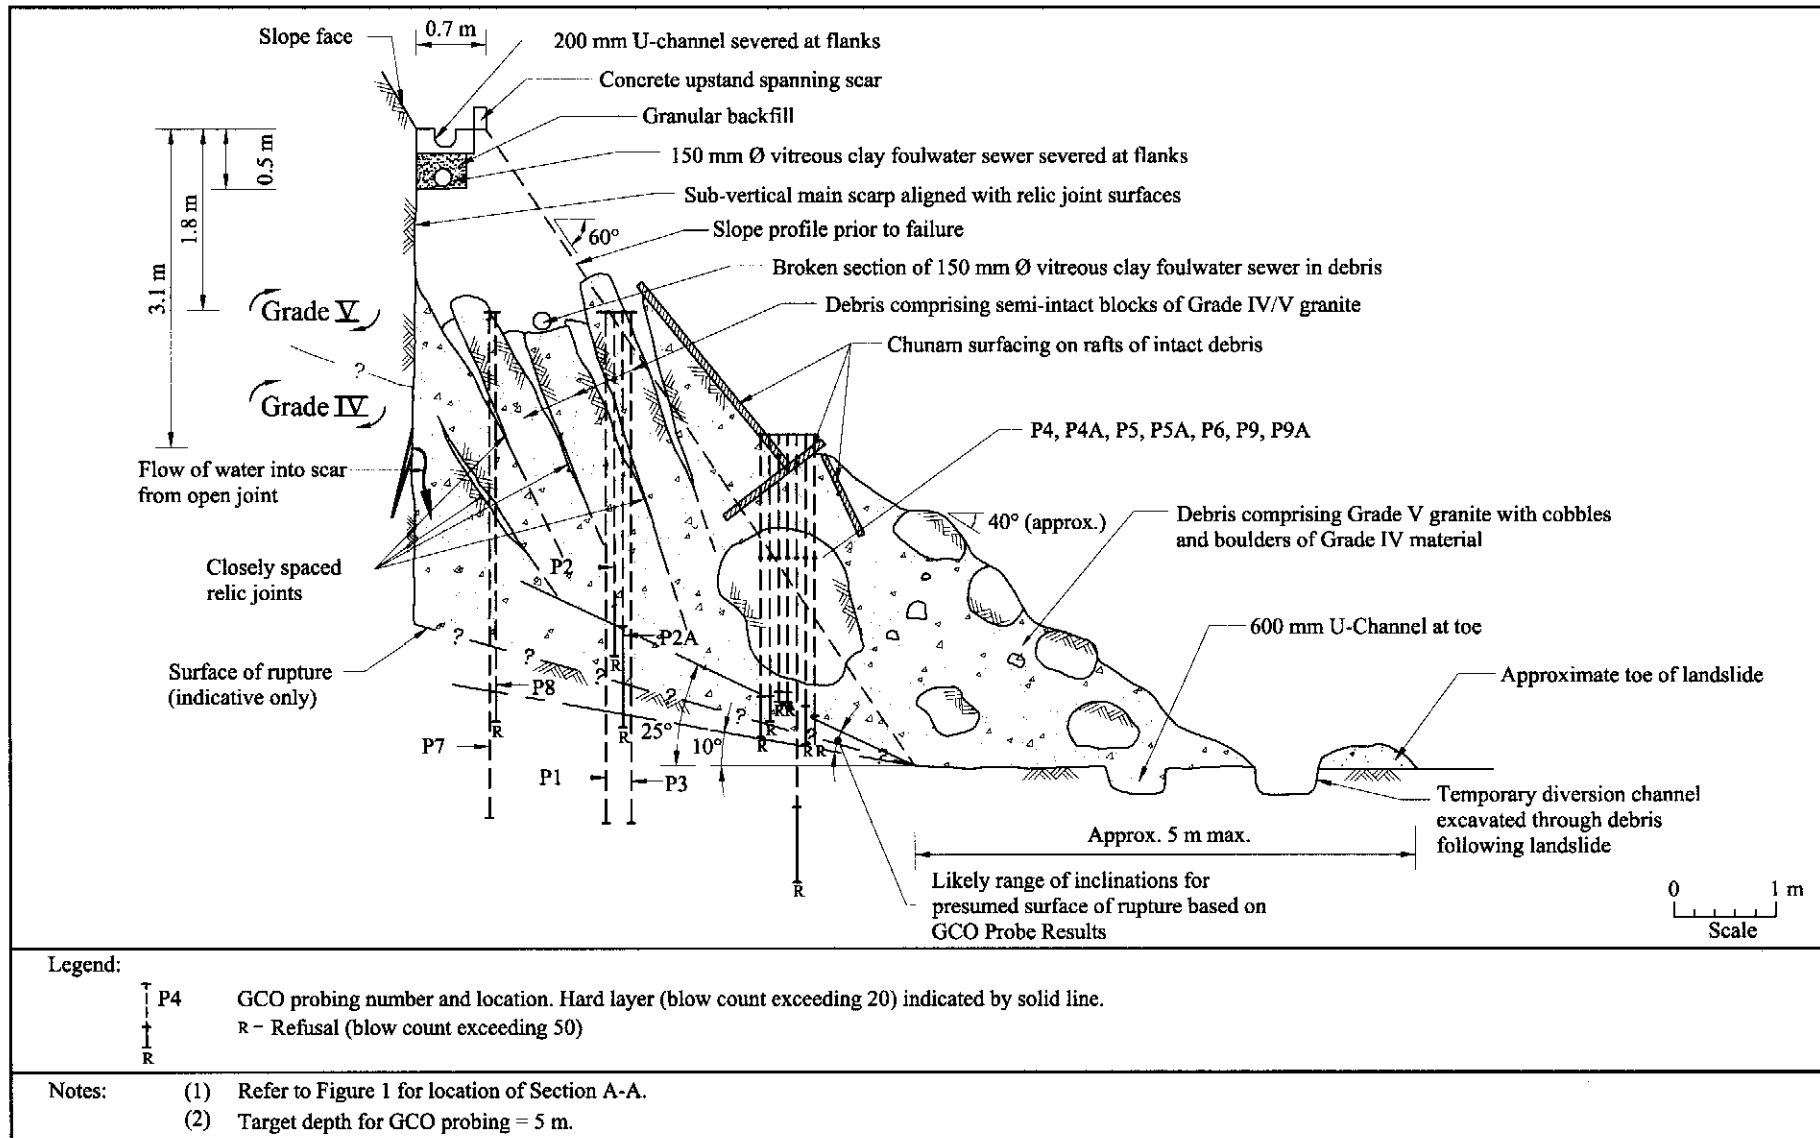
Figure 4 - Section A-A through the Landslide

The sub-vertical main scarp (Figure 4) aligned with the rear edge of the berm and followed persistent relic jointing within the weathered rock profile, providing a release surface to the failed mass. The maximum exposed height of the scarp above the debris was about 1.8 m. The remainder of the scarp was obscured by debris, as was the surface of rupture.

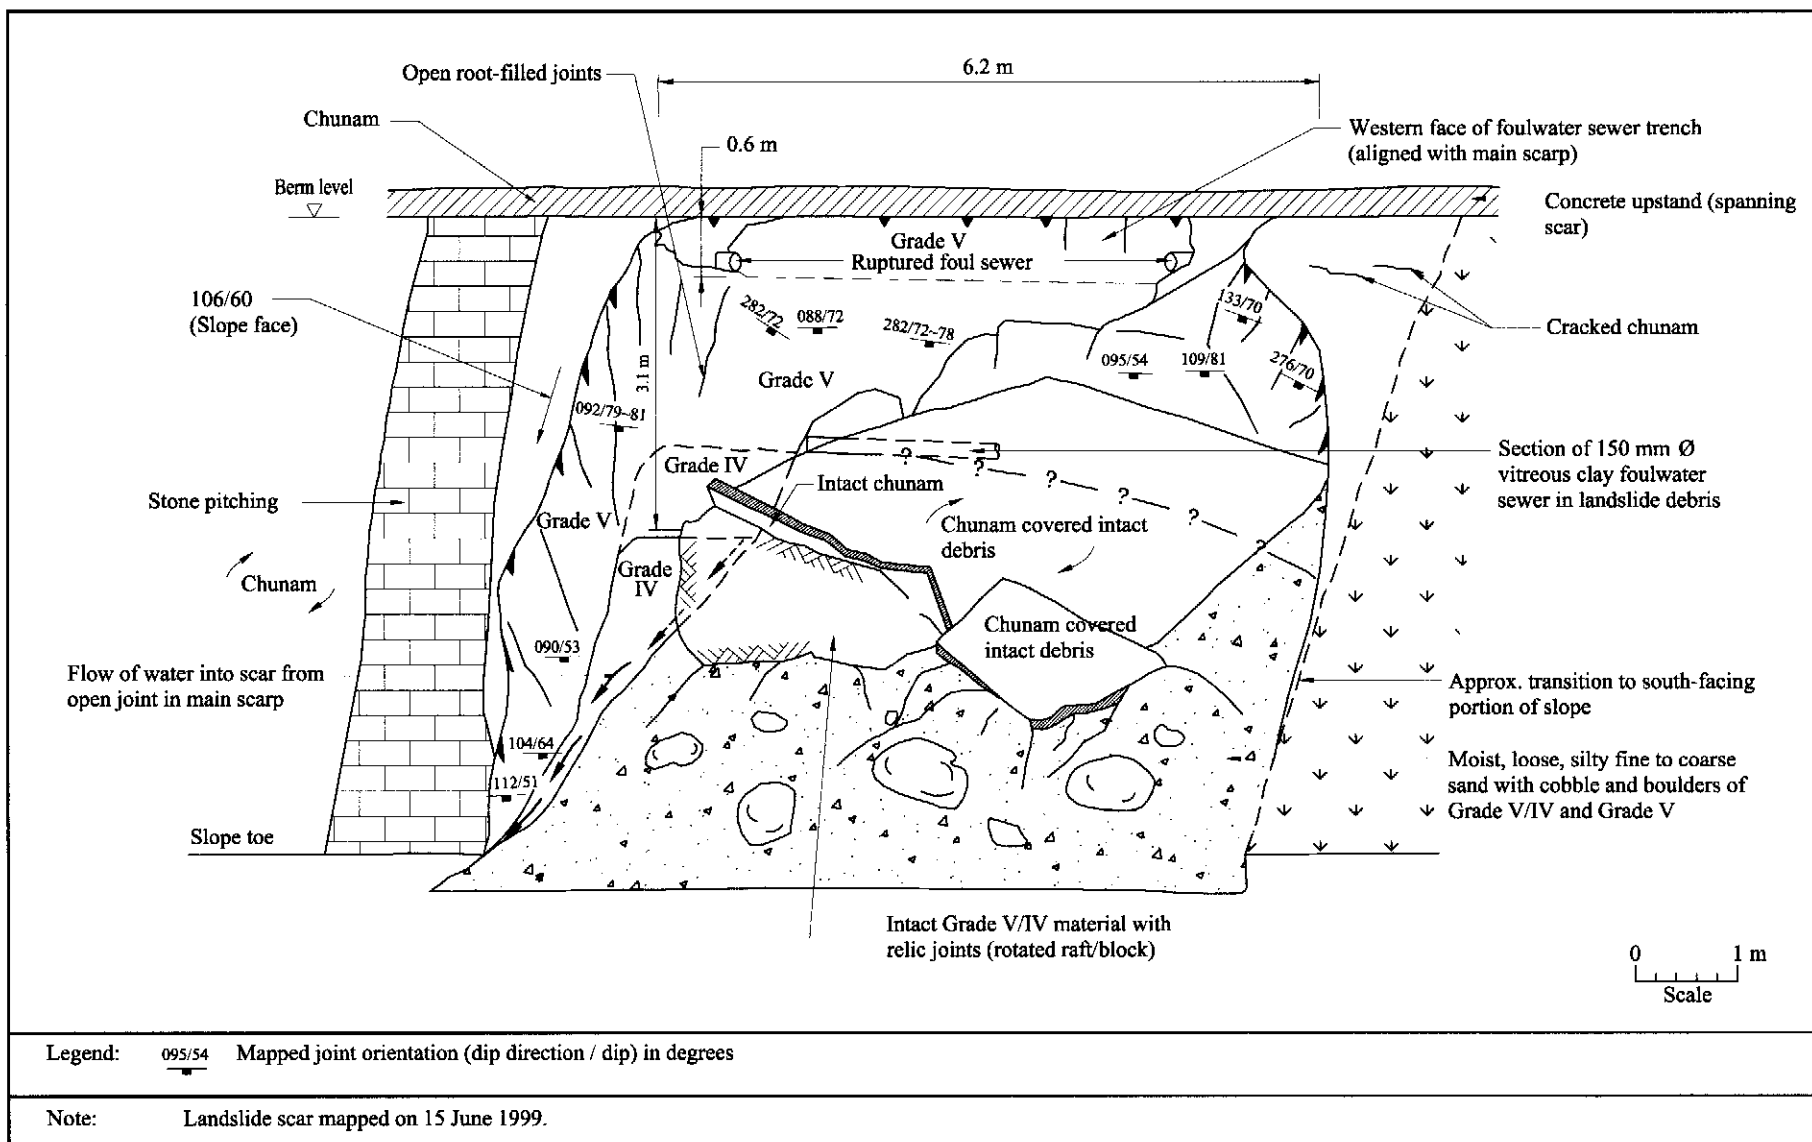
Figure 6 - Geological Mapping of the Landslide Scar

The landslide scar (Figures 4 and 6) exposed Grade IV and Grade V medium-grained granite (PW 0/30). Five predominant local joint orientations were observed in the landslide scar. These are: $280^\circ/75^\circ$ (Dip Direction/Dip Angle) and $088^\circ\text{--}092^\circ/72^\circ\text{--}81^\circ$ (main scarp), $030^\circ/75^\circ$ (southern flank), $133^\circ/70^\circ$ (northern flank) and $090^\circ\text{--}100^\circ/50^\circ$ (dipping out of the slope face). The contribution of this latter set to the failure geometry is not certain. GCO probing through the debris was not conclusive in defining the surface of rupture, indicating a best estimate of inclination in the range of 10° to 25° below horizontal, which is substantially lower than the dip angle of this set.

Joint sets forming the main scarp and those dipping out of the slope face (possible basal sliding plane/surface of rupture) are closely- to extremely closely-spaced with persistence in excess of 5 m to 7 m. The joint sets defining the flanks are closely- to widely-spaced, with observed persistence of about 1 m. Manganese oxide and kaolin infill up to 2 mm thickness were prevalent on joint surfaces. Evidence of past movement was observed in the form of open, root-filled joints in the main scarp (Figure 6) and in the

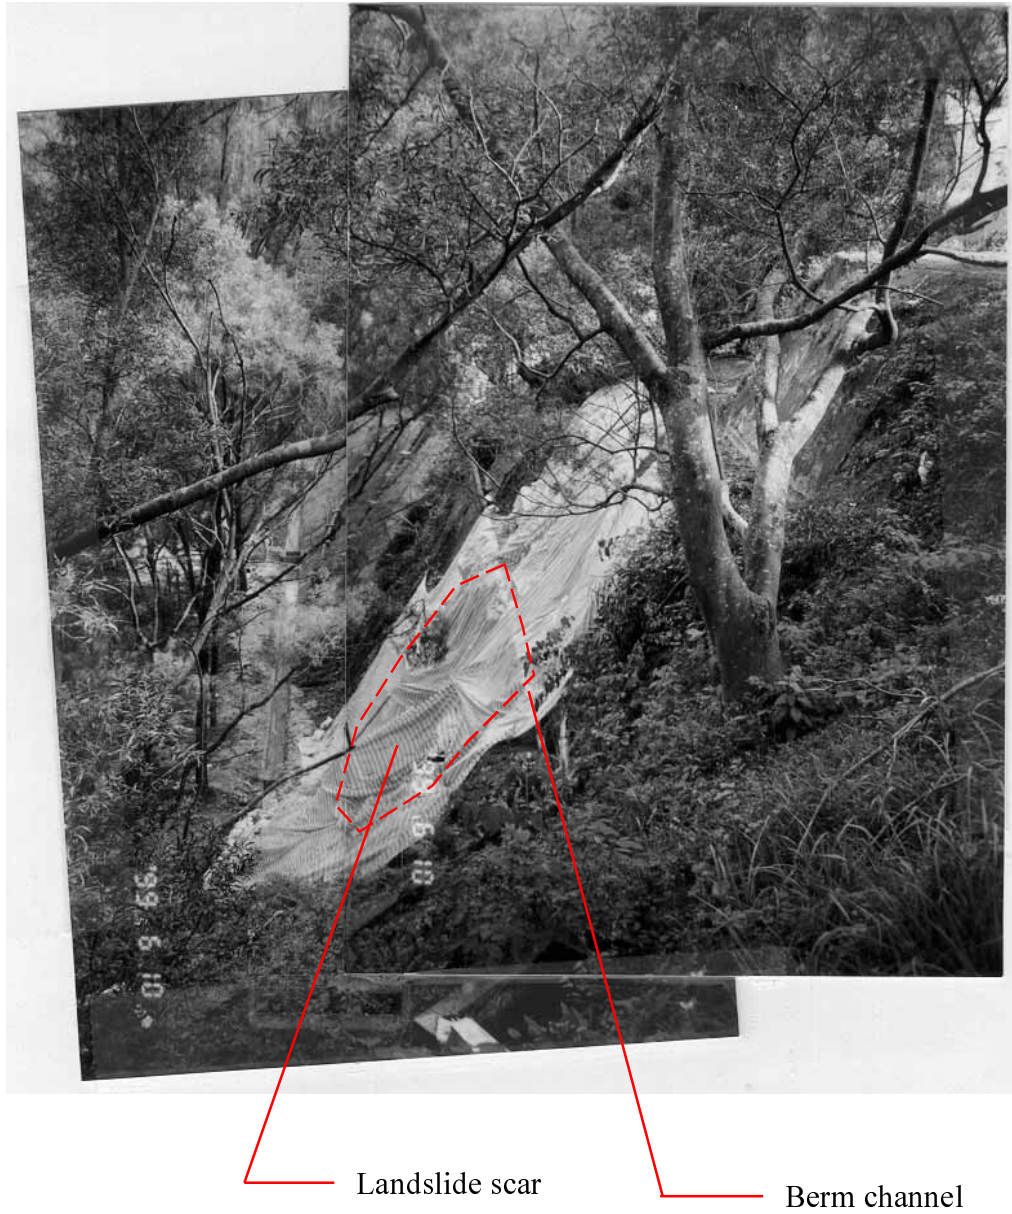
Plate 1 – General View South across Slope No. 7NE-C/C23 and Landslide Location, Obscured by Plastic Sheeting. Berm Channel at Main Scarp Indicated. Slope above Not Affected (Photograph Taken on 10 June 1999)

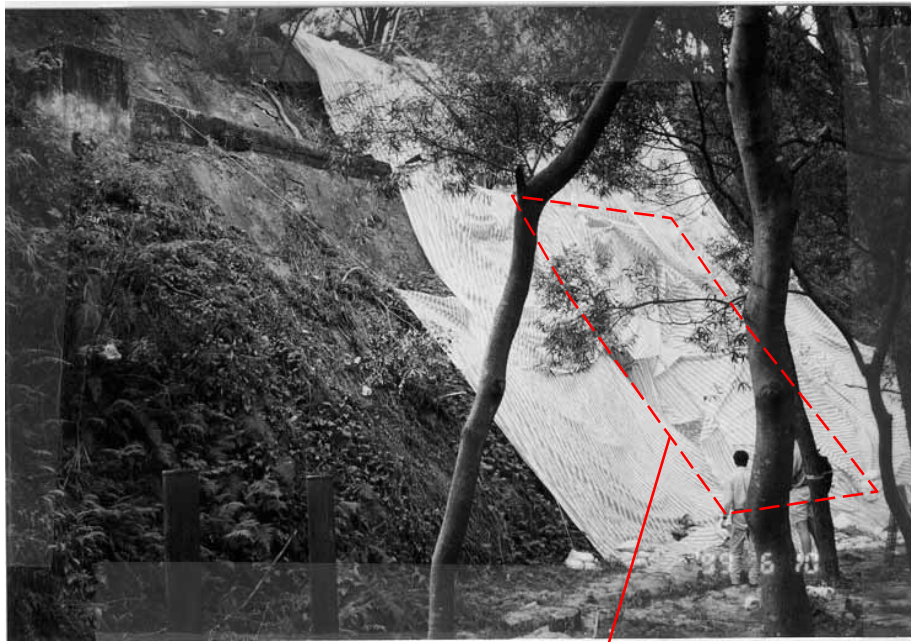
Plate 2 – View North-West across Slope from Toe. Slope Geometry (60°) and Generally Poor Condition of Chunam Surfacing Visible to Left of Plastic Sheeting (Photograph Taken on 10 June 1999)

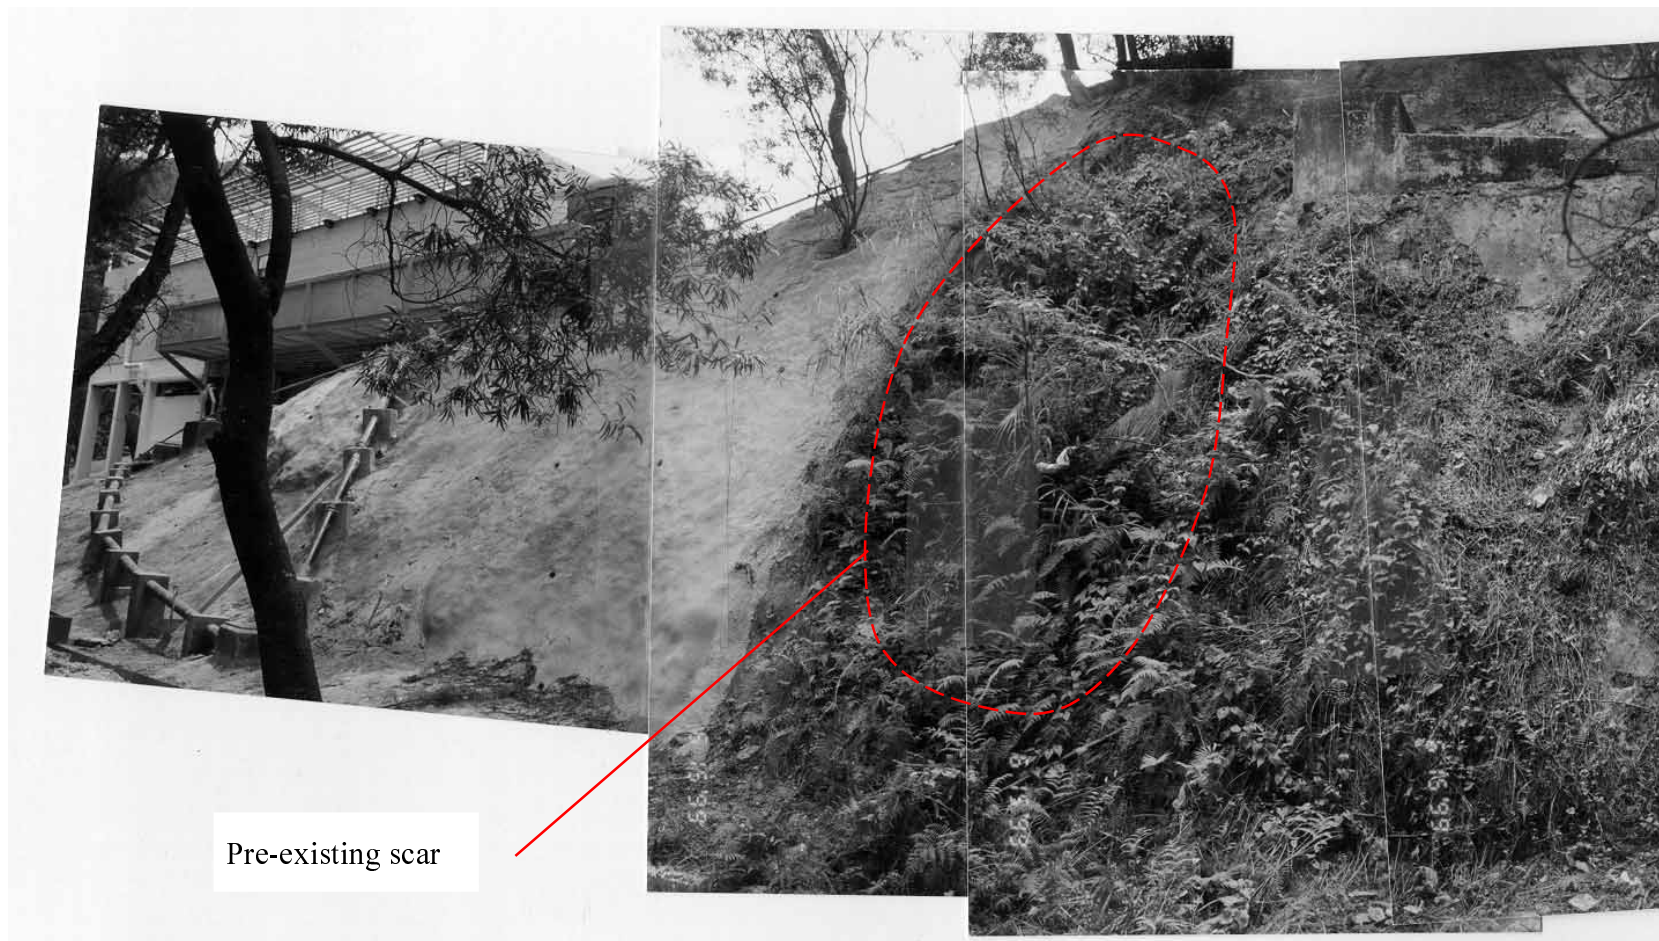
The 1994 aerial photographs show a part of the east-facing portion of the slope now located within slope No. 7NE-C/C160 to the south of slope No. 7NE-C/C23 to be much lighter in appearance than the surrounding slope and the platform at the toe of the slope to have been locally cleared of vegetation. This may indicate a past instability, the location of which corresponds to a possible shallow scar feature that was observed by FMSW (Section 3.4). No file records relating to this feature could be located.

Plate 4 – General View South-West of Northern Portion of Slope No. 7NE-C/C160. Note Condition of Surface Cover. Shallow Pre-Existing Landslide Scar in Centre of Frame. Southern Portion of Slope No. 7NE-C/C160 on Left of Frame Recently Shotcreted as Part of Swimming Pool Refurbishment (Photograph Taken on 15 June 1999)

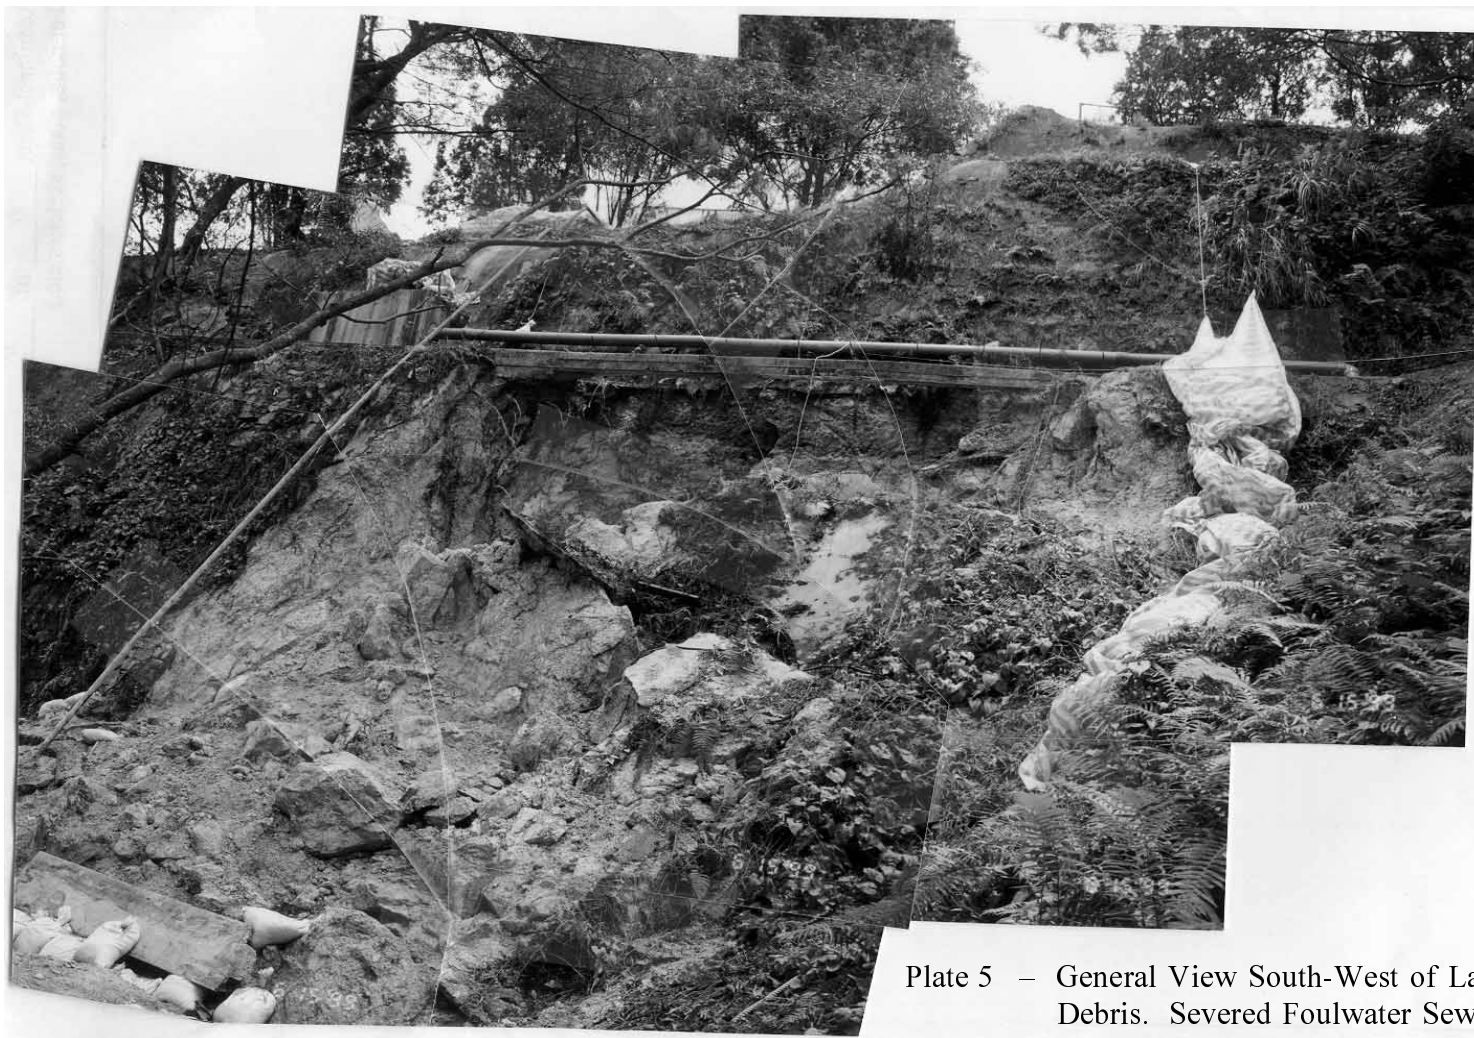
Plate 5 – General View South-West of Landslide Scar and Debris. Severed Foulwater Sewer Visible at Top Left of Main Scarp below Temporary Diversion Pipe (Photograph Taken on 15 June 1999)

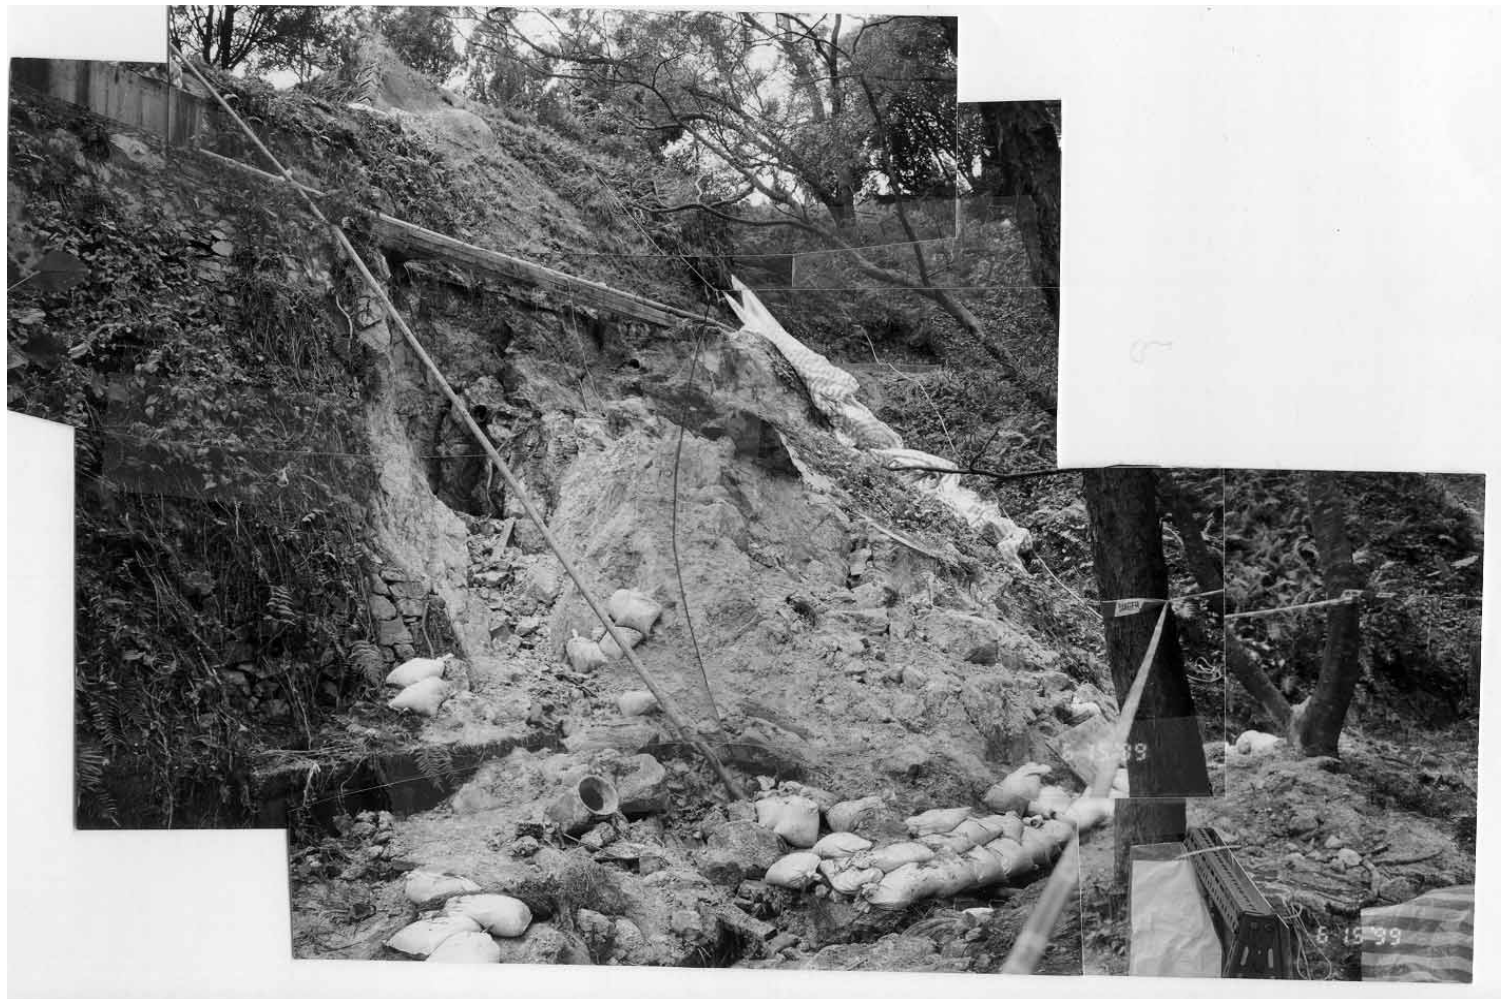
Plate 6 – General View North-West across Landslide Scar and Debris. Erosion Gully Cut by Continued Seepage Visible on Left of Scar (Photograph Taken on 15 June 1999)

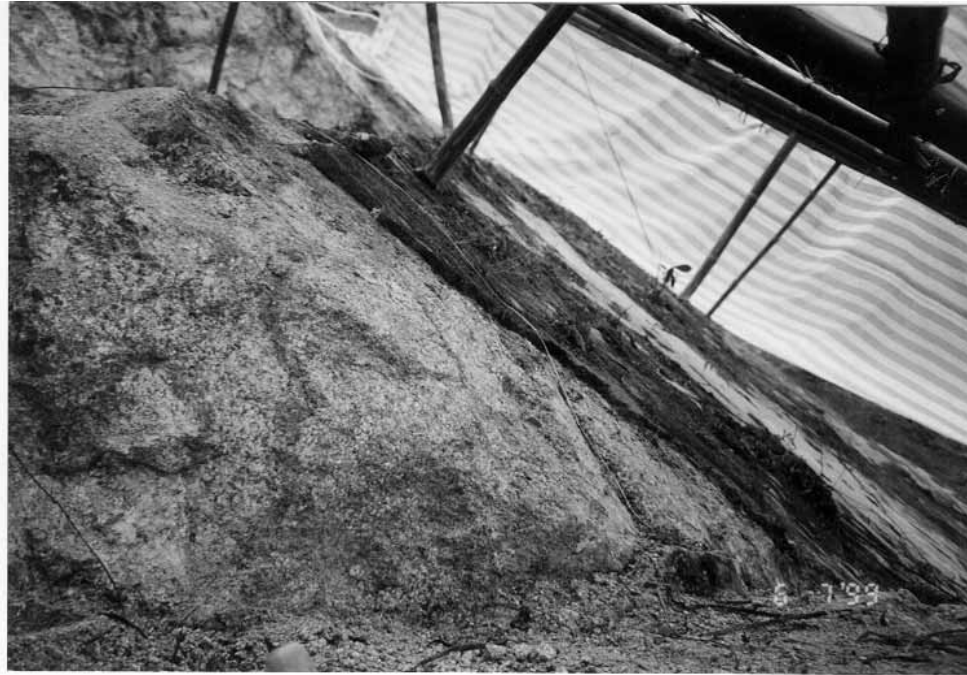
Debris deposited against the main scarp was largely intact, as evidenced by chunam surfacing maintaining original orientation (Plates 7 and 8). Debris extending beyond the slope toe was highly disturbed. Portions of chunam surfacing were observed to have rotated at the approximate transition from semi-intact to disturbed material. A 150 mm diameter foulwater drain (Plate 9) in a trench backfilled with granular material situated along the berm was severed at both flanks of the scar and continued to discharge sewage for a number of hours after the landslide, resulting in outwash of debris at the southern flank, until temporary diversion works were completed. The section of drain contained in the debris had a fresh break at one location (Plate 10). There were no obvious signs of prior leakage from the drain. The rear face of the trench containing the drain was coincident with the main scarp (Plate 9).

Plate 7 – Intact Portion of Chunam Surfacing on Displaced Debris Block
(Photograph Taken on 6 July 1999)

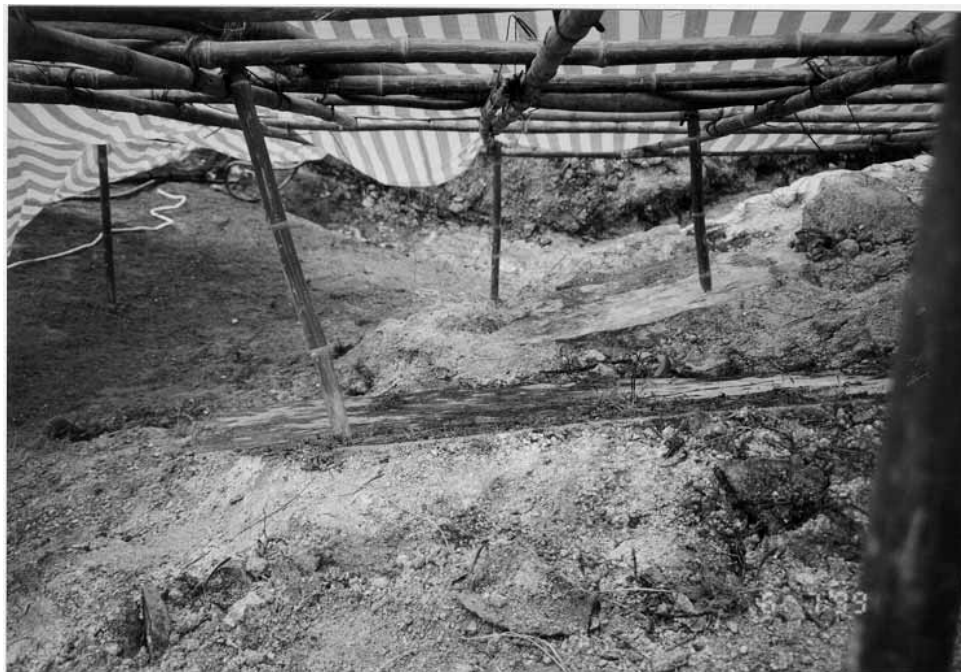
Plate 8 – Intact Portions of Chunam Surfacing on Displaced Blocks of Debris
near Northern Flank. Transition to Southern-Facing Portion of Slope
Visible on Left of Frame (Photograph Taken on
6 July 1999)

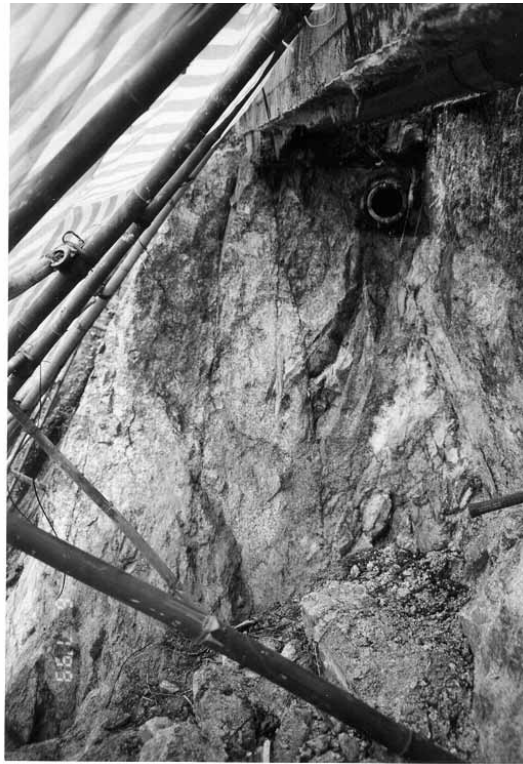
Plate 9 – Southern Flank of Scar Showing Sub-Vertical Main Scarp Coincident with Relic Joint Surfaces. Severed Foulwater Sewer Visible beneath Intact Berm U-Channel Upstand. Western Wall of Sewer Trench Coincident with Main Scarp. Kaolin-Rich Zone Visible in Centre-Right of Frame (Photograph Taken on 6 July 1999)

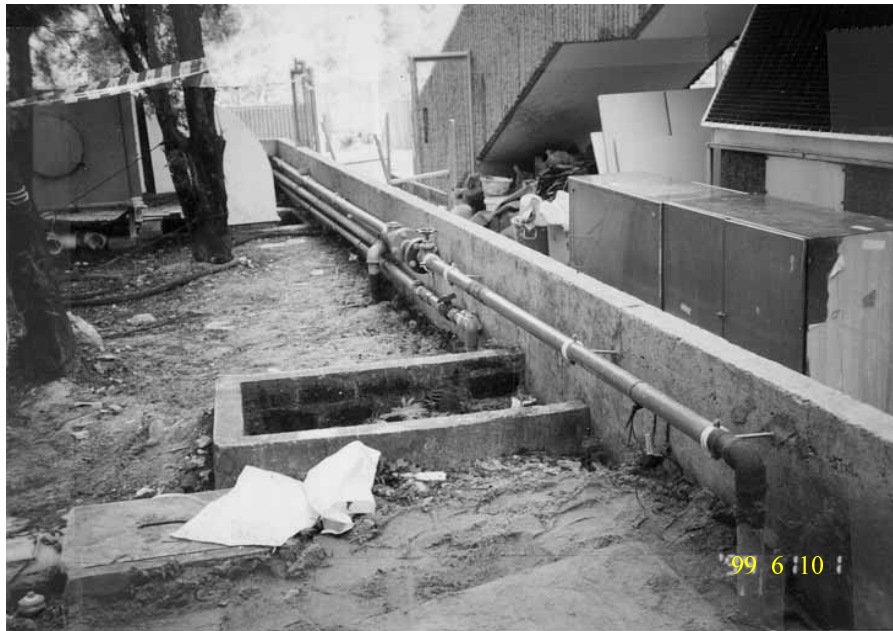
- (a) A number of exposed water-carrying services were present at the crest of the slope behind the landslide scar. A number of these appeared to have had works completed on them recently as indicated by the condition of fittings and presence of fresh sealant (Plate 11). A local arrangement of services was also observed (Plate 12) where temporary spigots and a metering system had been fitted to a water supply main.

Plate 11 – View South across Crest Area above Landslide Scar Indicating Arrangement of Pipework. Valves and Fittings Appear New (Photograph Taken on 10 June 1999)

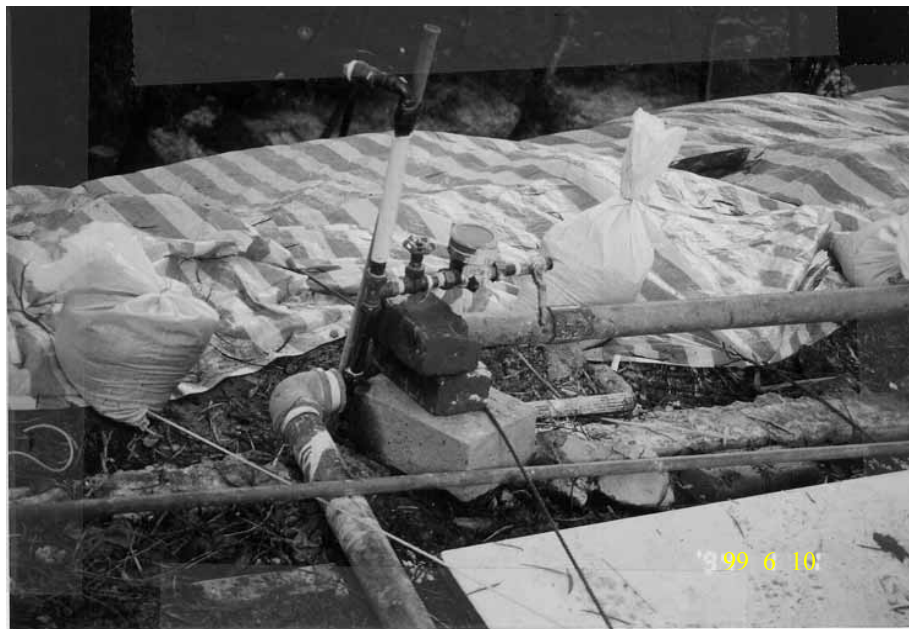
Plate 12 – Local Arrangement of Services at Slope Crest above Landslide. Note Temporary Spigots (Photograph Taken on 10 June 1999)

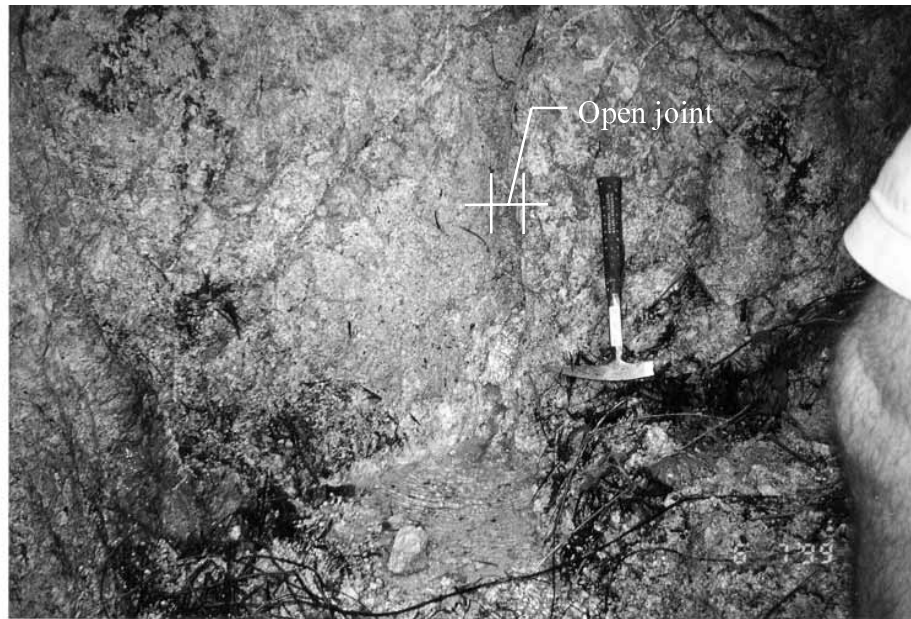
- (b) Seepage of water into the scar from a joint aperture ($282^{\circ}/75^{\circ}$ (Dip Direction/Dip Angle), 40 mm wide) in the main scarp approximately 3 m below berm level was observed near the southern flank (Plate 13). The water issuing from the joint was clear and the flow rate (estimated at 10 l/min) was steady.

Plate 13 – Seepage into Scar from Open Joint (Indicated) near Southern Flank. Note General Clarity of Water (Photograph Taken on 6 July 1999)

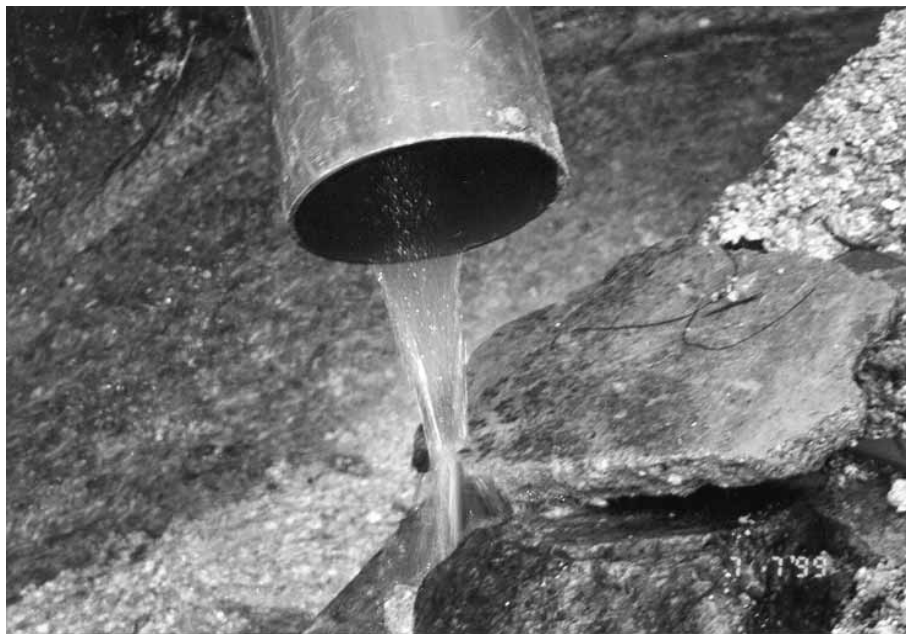
Plate 14 – Discharge of Water from Scar (Plate 13) through PVC Collection Pipe Providing Indication of Flow (Photograph Taken on 7 July 1999)

Urgent repair works were completed by the CUHK during this time and comprised shotcreting of the landslide scar and debris mass (not removed) and placement of rockfill against the slope up to berm level to act as a toe weight. These works were advised by Pypun Engineering Consultant Ltd (Pypun), who were engaged by CUHK for the design and supervision of permanent upgrading works for the package of slopes including slope No. 7NE-C/C23. Urgent repair works were agreed with the GEO. To facilitate monitoring of the flow of water from the scar after completion of these works, FMSW recommended that a PVC pipe be installed prior to shotcreting to collect seepage through the open joint and carry it to the drainage channel at the slope toe. A steady flow similar to that estimated in item (b) above was observed following completion of the urgent repair works (Plate 14).

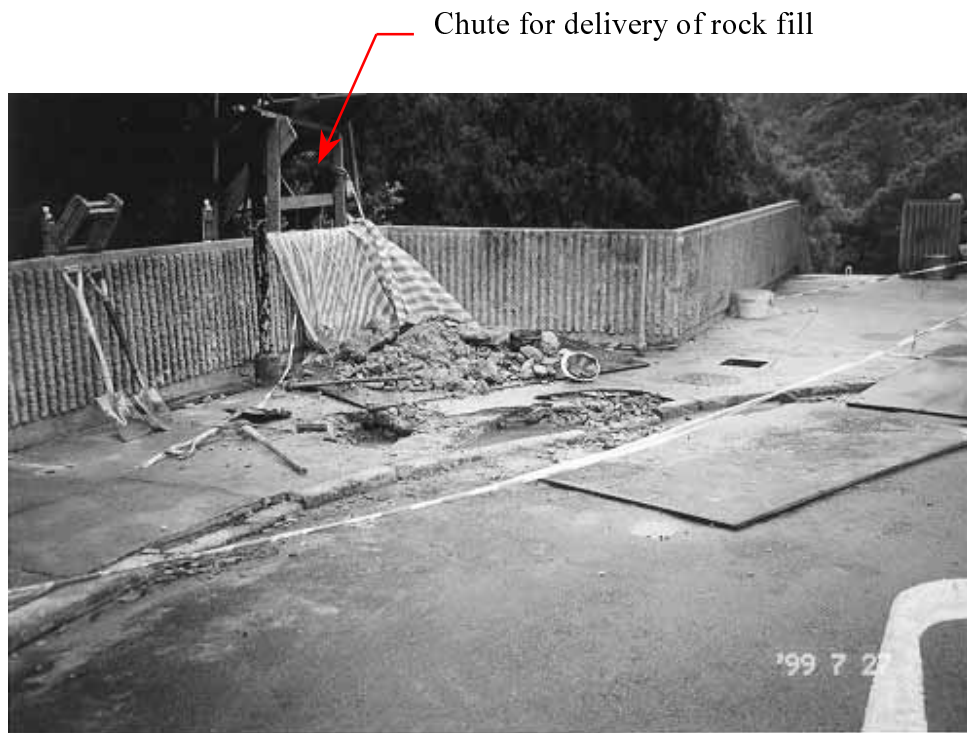
In late July 1999, CUHK staff observed damage to the carpark pavement behind the slope crest believed to be caused by trucks delivering rockfill to the landslide site (Plate 15). Repair works to the pavement exposed a 75 mm diameter fire services main in which a leak was identified (Plate 16). The section of main was isolated and repairs effected (Plate 17) during which time it was observed that flow from the PVC pipe had ceased. The flow resumed when the fire services main was re-pressurised following repair.

Plate 15 – View South-East across Driveway and Footpath at Crest of Slope above Landslide Location Showing Damage Caused by Heavy Vehicle. Chute for Delivery of Rock Fill to Toe of Slope Visible above Concrete Barrier Wall (Photograph Taken on 27 July 1999)

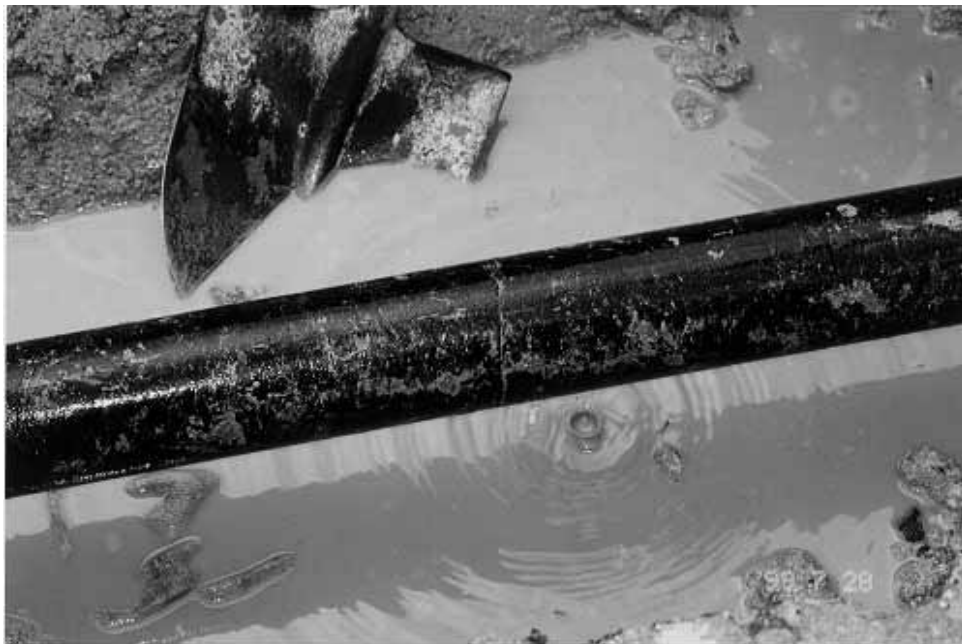
Plate 16 – Leak Identified in 75 mm Diameter Fire Services Main within Driveway at Slope Crest (Photograph Taken on 28 July 1999)

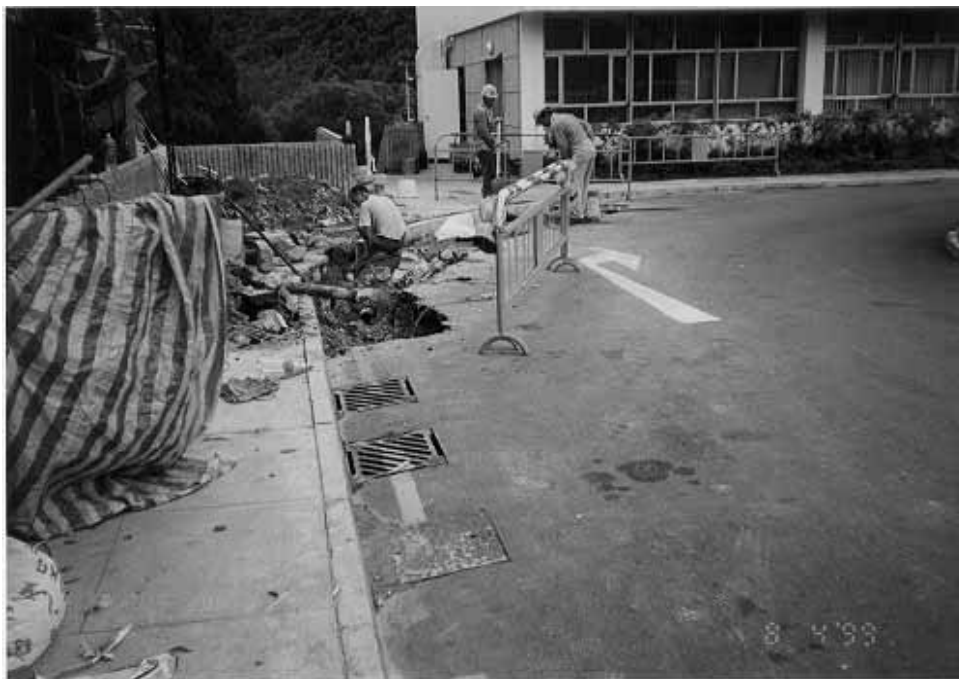
A short time later, further damage to the pavement at the same location was observed, also believed to have been caused by trucks delivering rockfill. Repair works were subsequently carried out (Plate 18), during which a second leak was identified in the 75 mm diameter fire services main. The main was again isolated and the leak repaired (Plate 19). Flow from the PVC pipe in the scar did not resume when the main was subsequently re-pressurised. Flow in the 600 mm stepped U-channel continued throughout this period. The source of flow in the channel could not be positively identified.

Plate 18 – Excavation of Driveway Pavement Following Second Incidence of
Damage by Heavy Vehicle. Additional Leak in 75 mm Diameter
Fire Services Main Identified During Pavement Repair Works
(Photograph Taken on 4 August 1999)

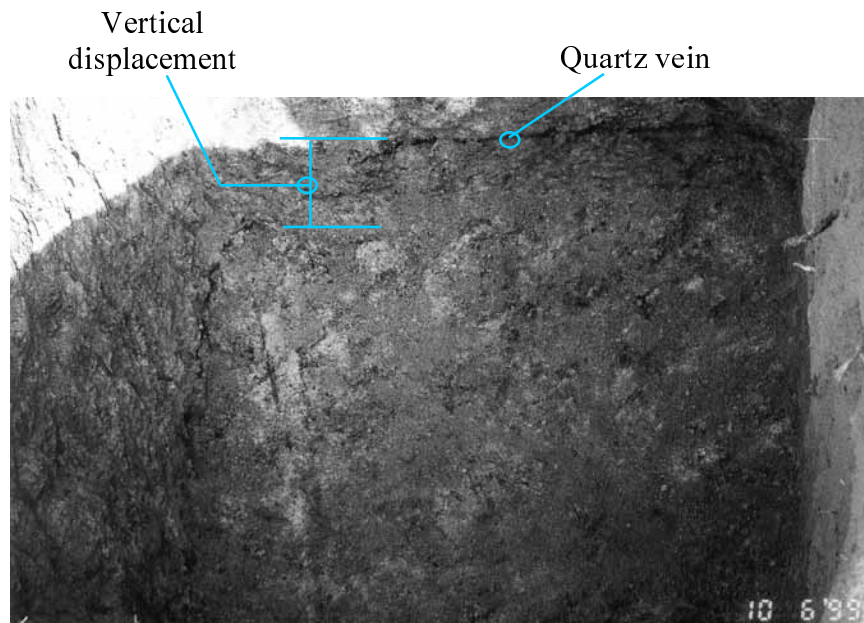
Jointing exposed in trial pits was often infilled with manganese oxide up to 2 mm in thickness and a number of quartz veins were observed, also with manganese oxide present (Plates 20, 21 & 23). Kaolin was also present as joint infill material, although not to the same extent as observed in the landslide scar. Joint infill surfaces were often slickensided and a further indication of past movement encountered in trial pit TP2 where about 200 mm of vertical displacement was indicated across a sub-horizontal quartz vein (Plate 23).

Plate 23 – Trial Pit TP2: Base of Pit Facing North. Sub-Horizontal Quartz Vein with Manganese Oxide Infill Visible near Base of Pit. Vertical Displacement across Vein Visible on Left of Frame (Photograph Taken on 6 October 1999)

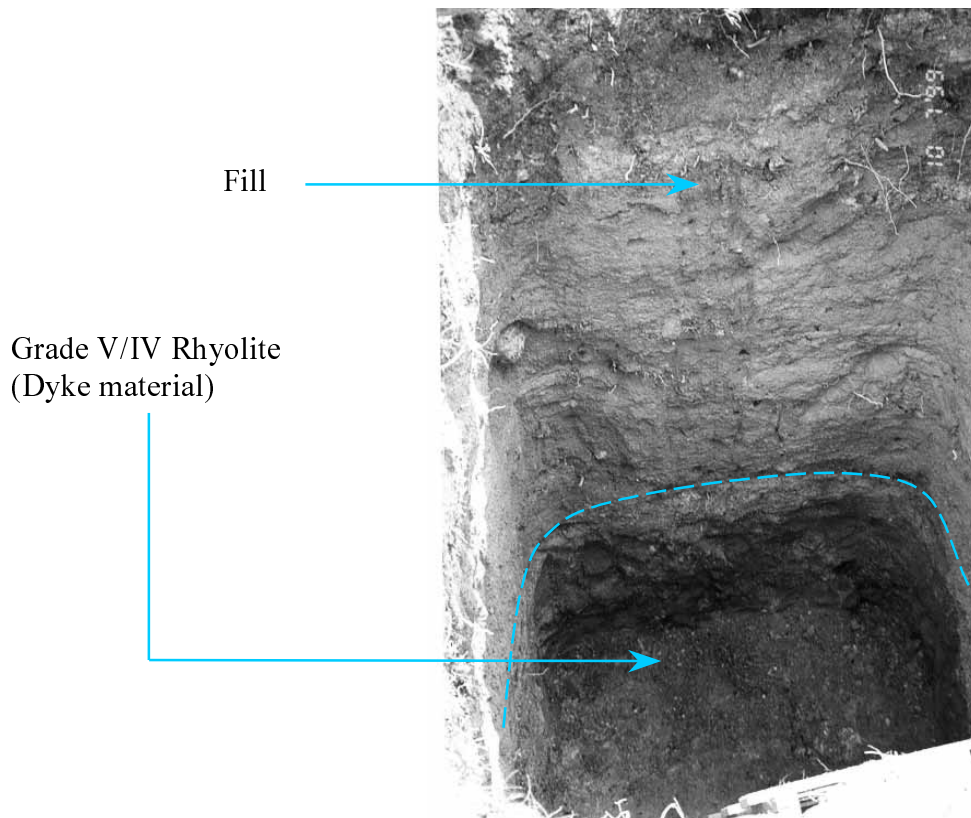
Dyke material (Grade V rhyolite) was encountered directly beneath the fill horizon in trial pit TP3 (Plates 24 and 25) at the contact with the weathered granite. It is noted that dyke material was also encountered during the previous investigation of slope No. 7NE-C/C22 (Compact, 1998). The orientation of the dyke could not be determined from the exposure in the trial pit.

Plate 24 – Trial Pit TP3: View of South Face and Base of Pit Showing Grade IV/V Rhyolite below Fill (Photograph Taken on 7 October 1999)

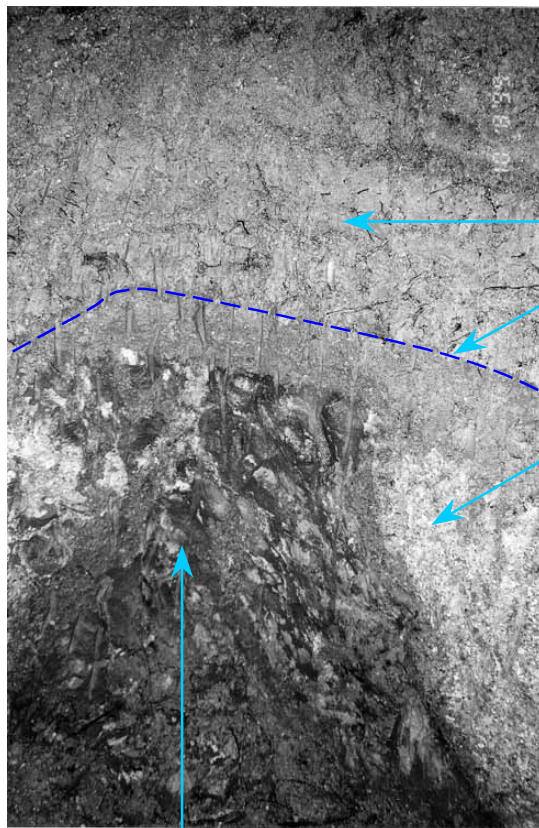
Plate 25 – Trial Pit TP3: View of Interface (Indicated) between Fill and Grade V/IV Rhyolite and Granite (Right of Frame) (Photograph Taken on 8 October 1999)

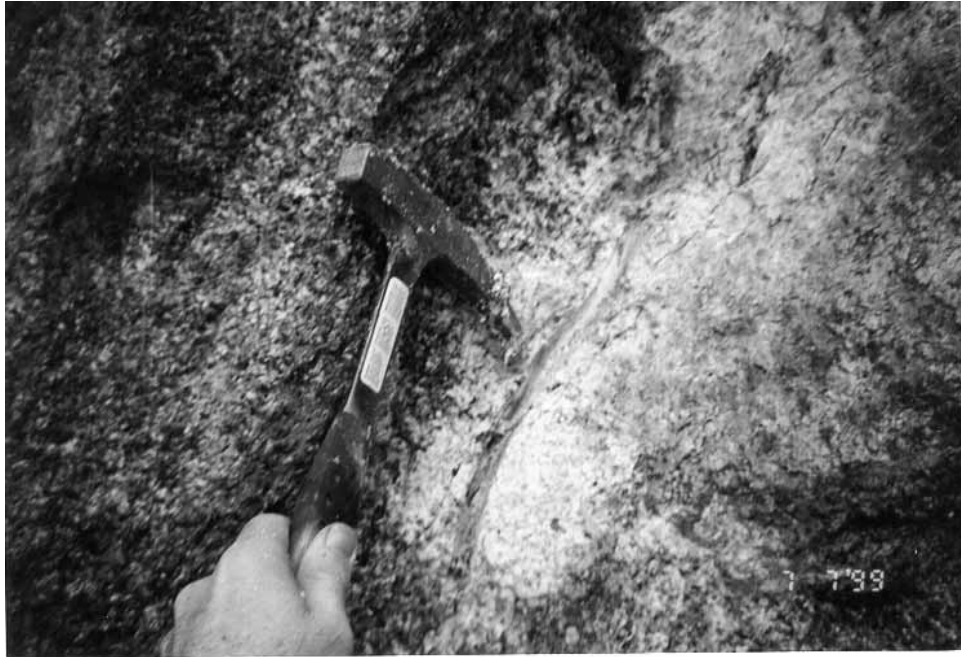
A thick (120 mm) lens of kaolin-rich material (Plate 27) in which relic joints were present was observed at the southern flank of the landslide scar. The completely decomposed granite matrix in adjacent exposures also contained significant quantities of kaolin. These two observations are suggestive of kaolinisation of the parent rock as a result of processes such as hydrothermal action, as opposed to kaolin deposition along joint surfaces resulting from groundwater flow. The limited extent of the ground investigation does not permit meaningful interpretation of the primary mechanism for the presence of kaolin at the site.

Plate 27 – Investigation of Kaolin-Rich Zone (Plate 9) (Photograph Taken on 7 July 1999)

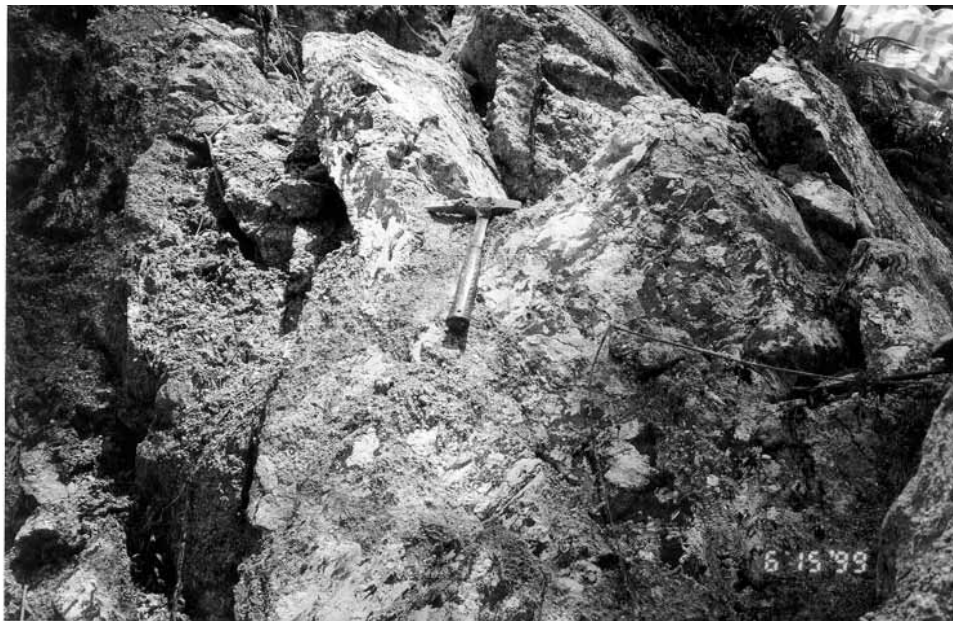
The landslide debris comprised a large raft/block of semi-intact Grades IV and V granite (Plate 28) towards the rear of the mass and more disturbed material towards the toe comprising predominantly sand-sized particles with cobble- and small boulder-sized blocks of intact material. Jointing within the semi-intact mass was broadly identifiable as comprising examples of the joint sets exposed in the scar, with similar infilling and appearance (polishing and slickensiding). Isolated blocks of kaolin-rich material were also observed in the landslide debris (Plate 29).

Plate 28 – Manganese Oxide (Black) Infill on Relic Joint Surfaces Exposed in Landslide Debris. Infill Thickness up to 2 mm (Photograph Taken on 15 June 1999)
