INVESTIGATION OF SOME SELECTED LANDSLIDES IN 1999 (VOLUME 4)

GEO REPORT No. 123

Fugro Maunsell Scott Wilson Joint Venture

**SECTION 1:
DETAILED STUDY OF THE
LANDSLIDE BELOW THE
BENJAMIN FRANKLIN CENTRE
CHINESE UNIVERSITY OF
HONG KONG
ON 7 JUNE 1999**

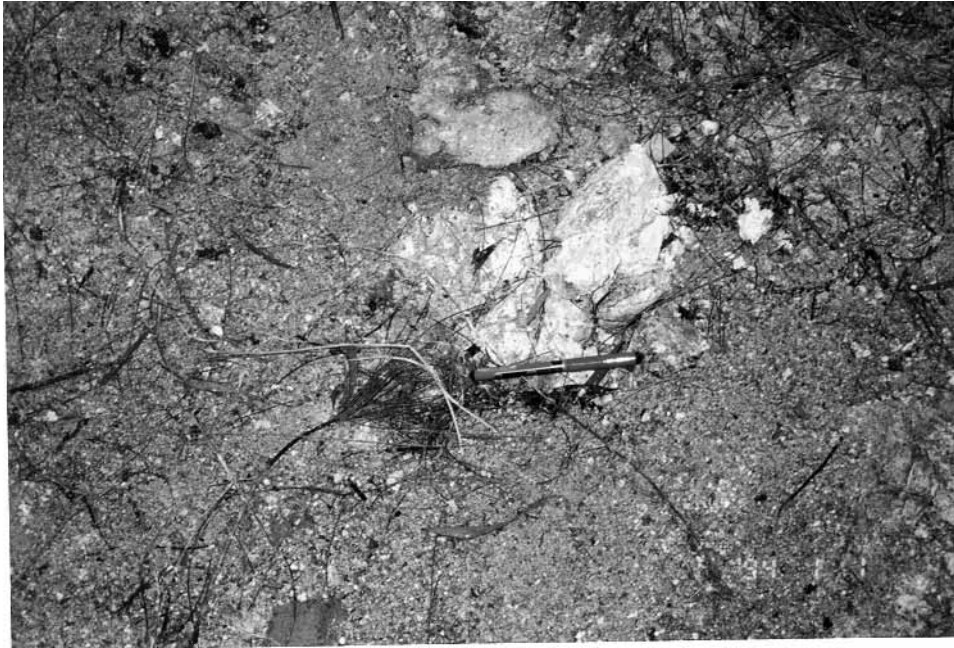
The landslide debris comprised a large raft/block of semi-intact Grades IV and V granite (Plate 28) towards the rear of the mass and more disturbed material towards the toe comprising predominantly sand-sized particles with cobble- and small boulder-sized blocks of intact material. Jointing within the semi-intact mass was broadly identifiable as comprising examples of the joint sets exposed in the scar, with similar infilling and appearance (polishing and slickensiding). Isolated blocks of kaolin-rich material were also observed in the landslide debris (Plate 29).

Plate 29 – Cobble-Sized Piece of Kaolin-Rich Material Observed in Landslide Debris (Photograph Taken on 10 June 1999)
