**SECTION 2:
DETAILED STUDY OF THE
LANDSLIDE ON SLOPE
No. 11NW-A/FR84
BELOW CASTLE PEAK ROAD
NEAR KAU WAH KENG
VILLAGE**

**This report was originally produced in October 2001
as GEO Landslide Study Report No. LSR 10/2001**

This report presents the findings of a detailed study of the landslide (GEO Incident No. MW 2000/01/07) on slope No. 11NW-A/FR84 above Kau Wah Keng Village, below Castle Peak Road, Kwai Chung, which was reported on 14 January 2000. Debris from the failure was transported along the natural stream course leading to the Kau Wah Keng Village. There were no casualties as a result of the slope failure.

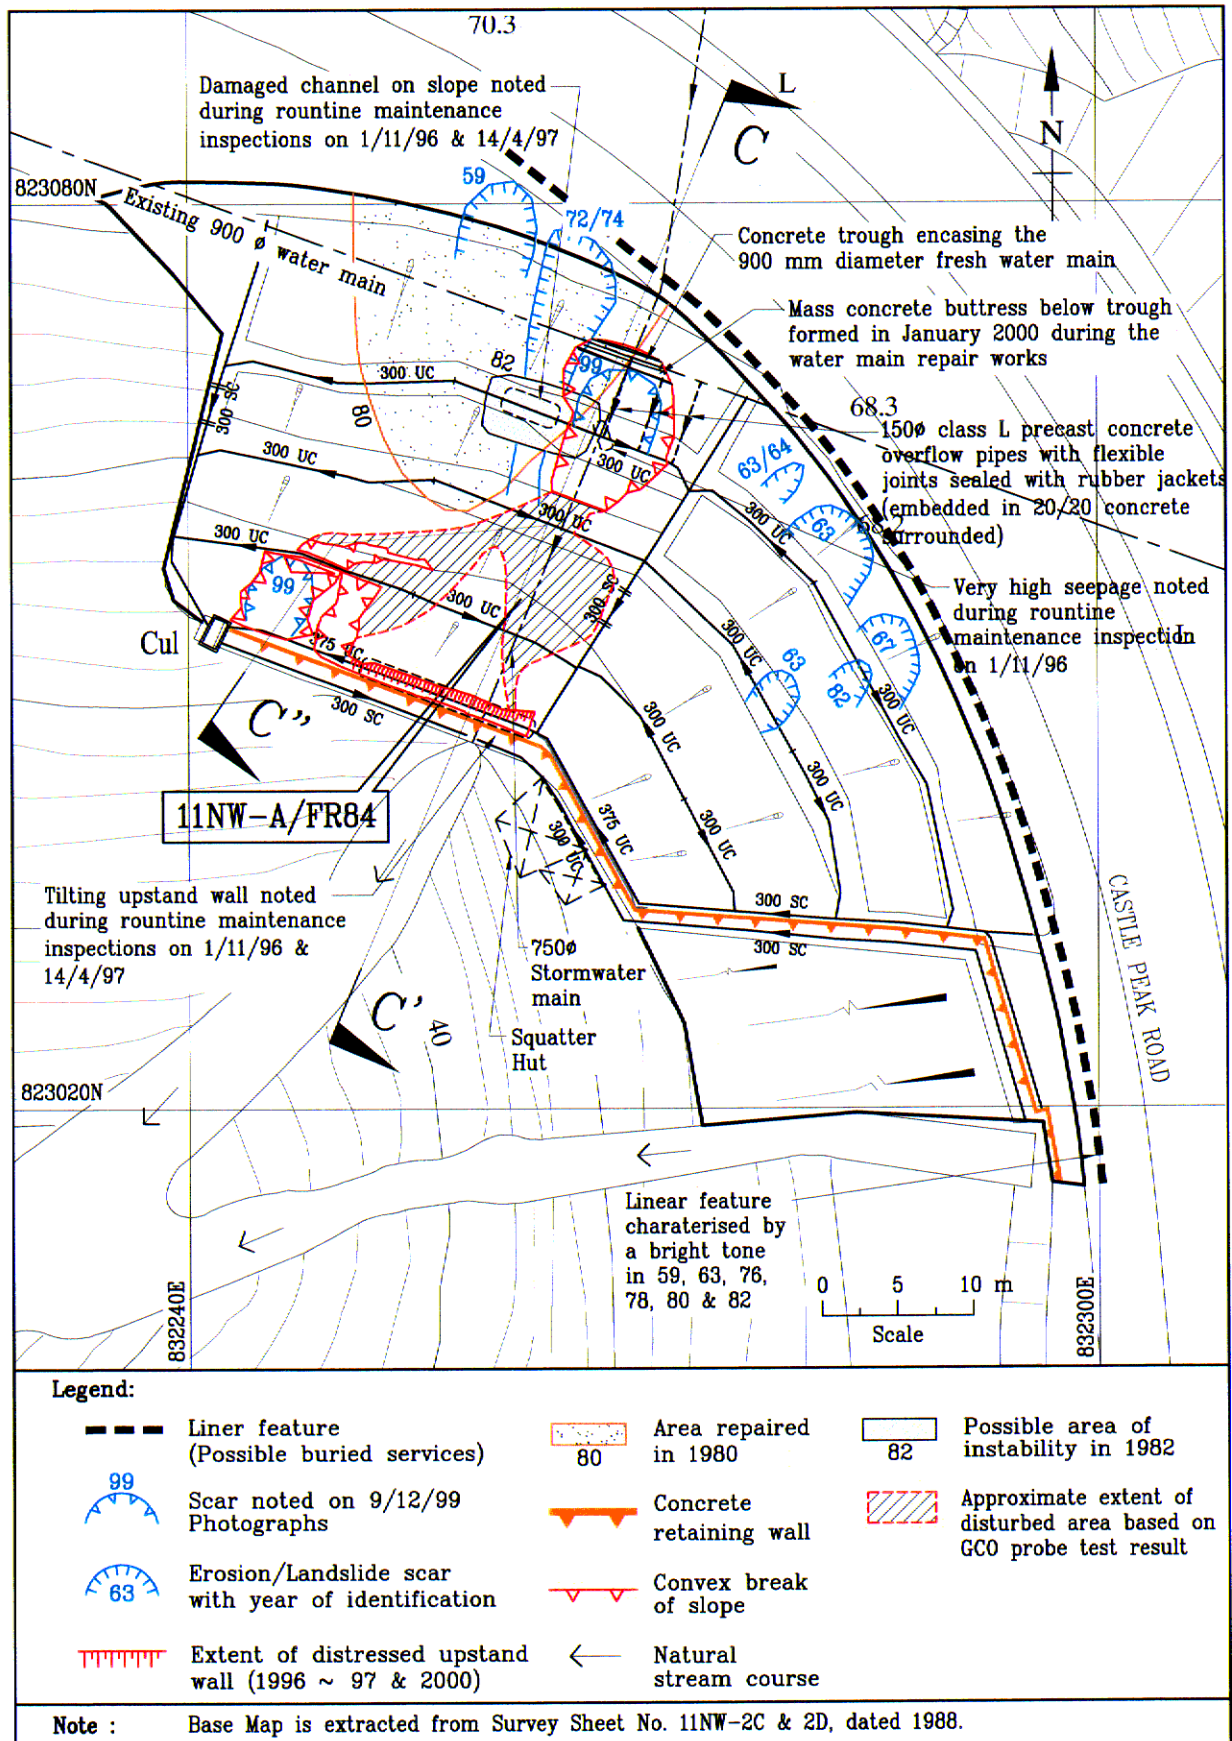
Figure 7 - Plan Showing Signs of Distress at the Landslide Site

The fill slope portion shows evidence of previous instability in the aerial photographs taken in 1959, 1963, 1967, 1972, 1974, 1980 and 1982 (Figure 7). Of these, the scars noted in 1959, 1963, 1967 and 1982 appear to be predominantly associated with erosion. However, the scar noted in the 1974 aerial photographs affected the western flank of the fill slope and may have involved a degree of mass displacement. The majority of the scars were located at the crest of the northwest and central portions of the fill slope.

Two distinct scars are noted on the aerial photographs taken on 9 December 1999 and on 11 December 1999 (Plates 2 & 3), which correspond to the main scar and lower scar observed by FMSW in January 2000 (Section 3.2 and Figure 7). These scars were not present in the aerial photographs taken on 8 February 1999, which indicates that the incident occurred sometime between February and December 1999. This is consistent with the squatter living below the fill slope, who stated that the failure occurred in early 1999 (Section 3.3). Based on the aerial photographs, the main scar appears to be limited in extent to the slope area between the berm and U-channel in the upper batter of the fill slope, which was severed by the time the slope was first inspected by FMSW in January 2000. This indicates that further significant instability could have occurred between December 1999 and January 2000.

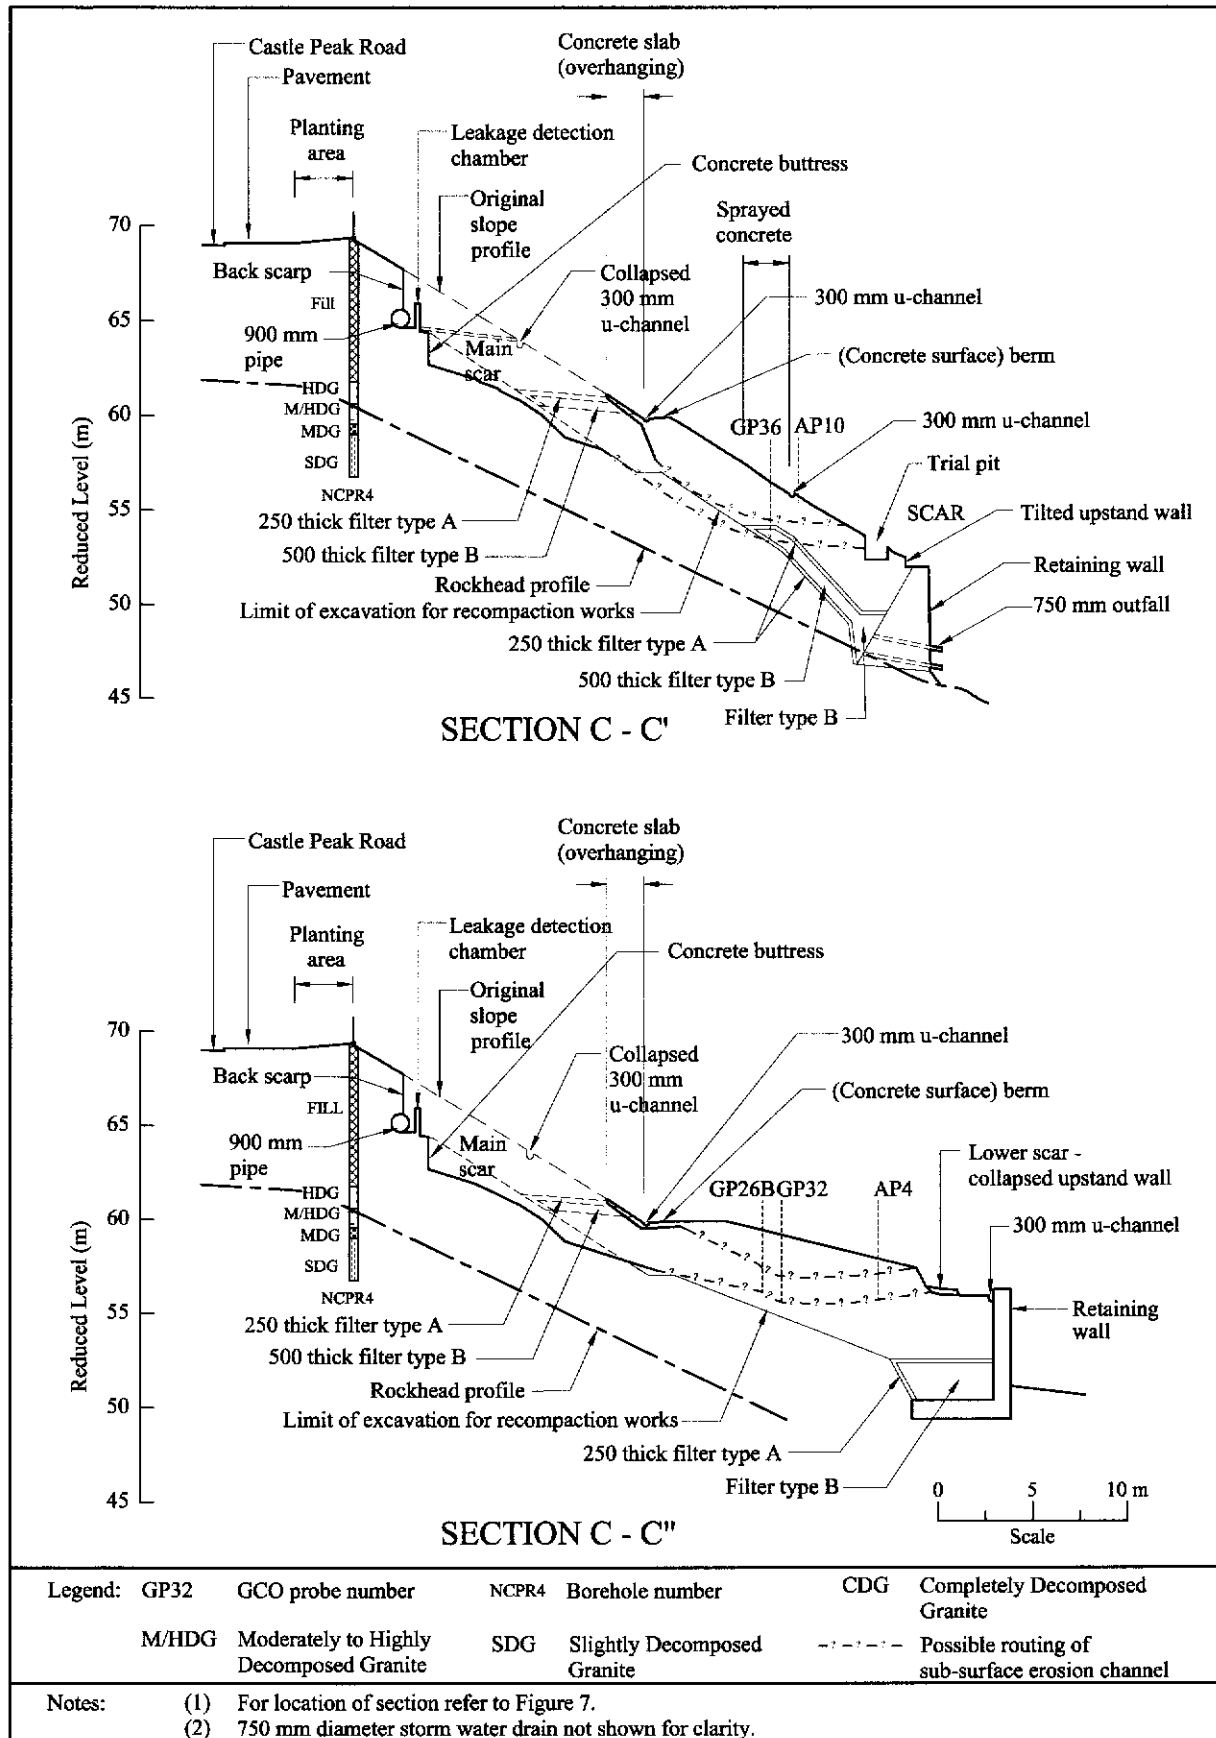
Figure 8 - Cross-sections through the Landslide

Based on the spatial relationship between the mouth of the void in the main scar and the voids and distress observed downslope, it is apparent that the two areas of distress are linked. On this basis, it is estimated that the total disturbed area measured 28 m long by 20 m wide with an overall disturbed volume of about 700 m³, assuming an average depth of between 2 m and 3 m. Cross-sections through the disturbed slope are presented in Figure 8.

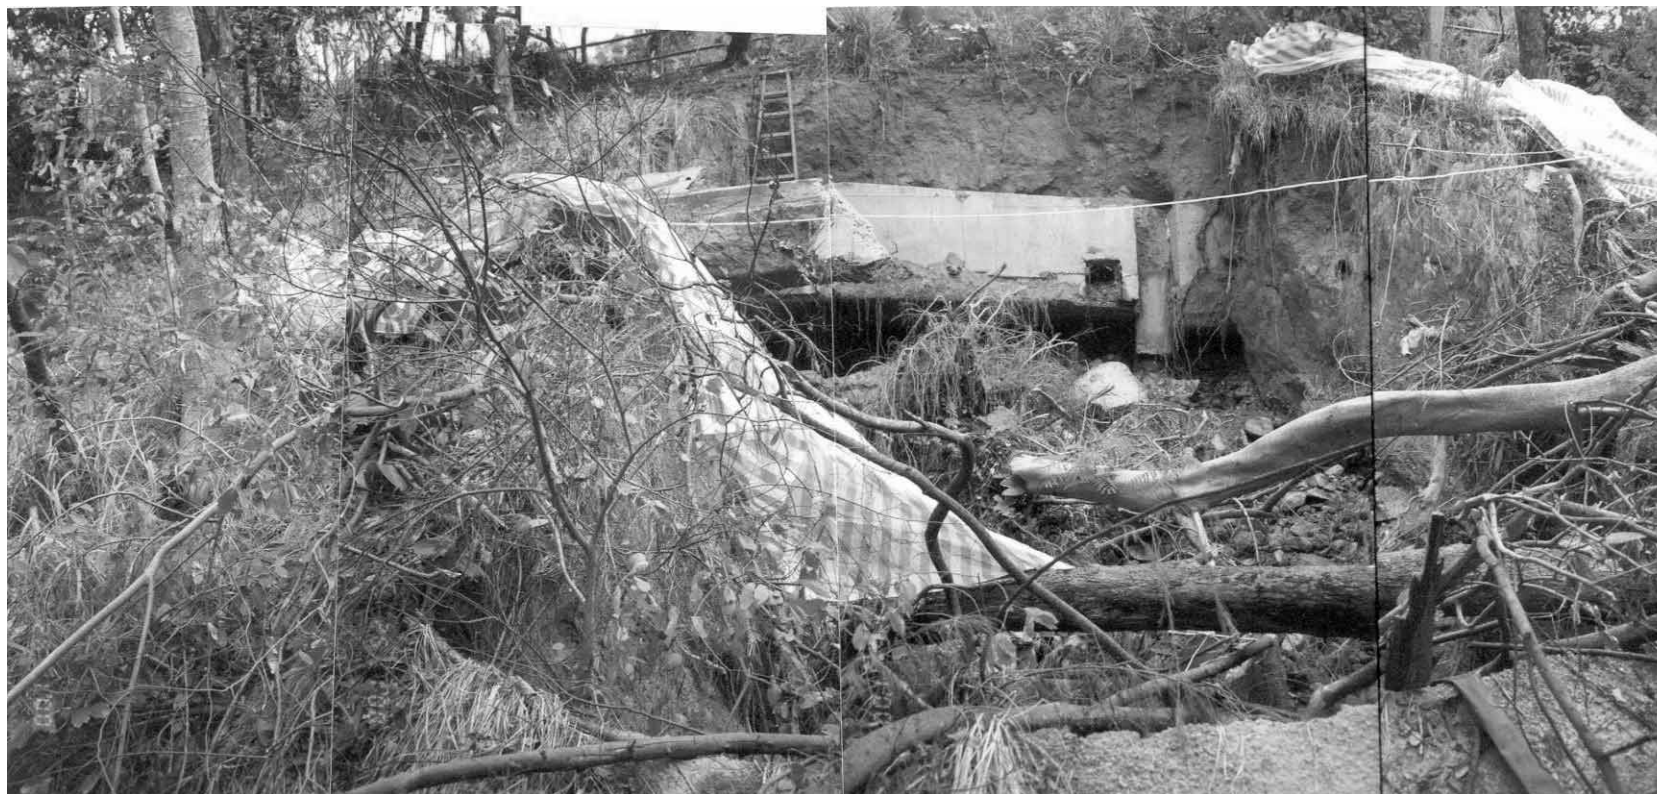
FMSW first inspected the site on 26 January 2000, at which time the 900 mm diameter watermain had been repaired. A further inspection was made on 9 March 2000, to undertake detailed mapping of the distressed slope. The details of field mapping are presented in Figures 7 and 8. Field mapping identified that the incident observed by SW comprised a large depression with steep sub-vertical sides (hereafter referred to as the main scar), that measured

17 m long by 8 m wide by 4 m deep (maximum), which indicates that the failure may have enlarged slightly since SW's original inspection on 14 January 2000. It is estimated that the volume of material originating from the main scar was about 300 m³.

Plate 1 – View of Main Scar (Photograph Taken on 26 January 2000)

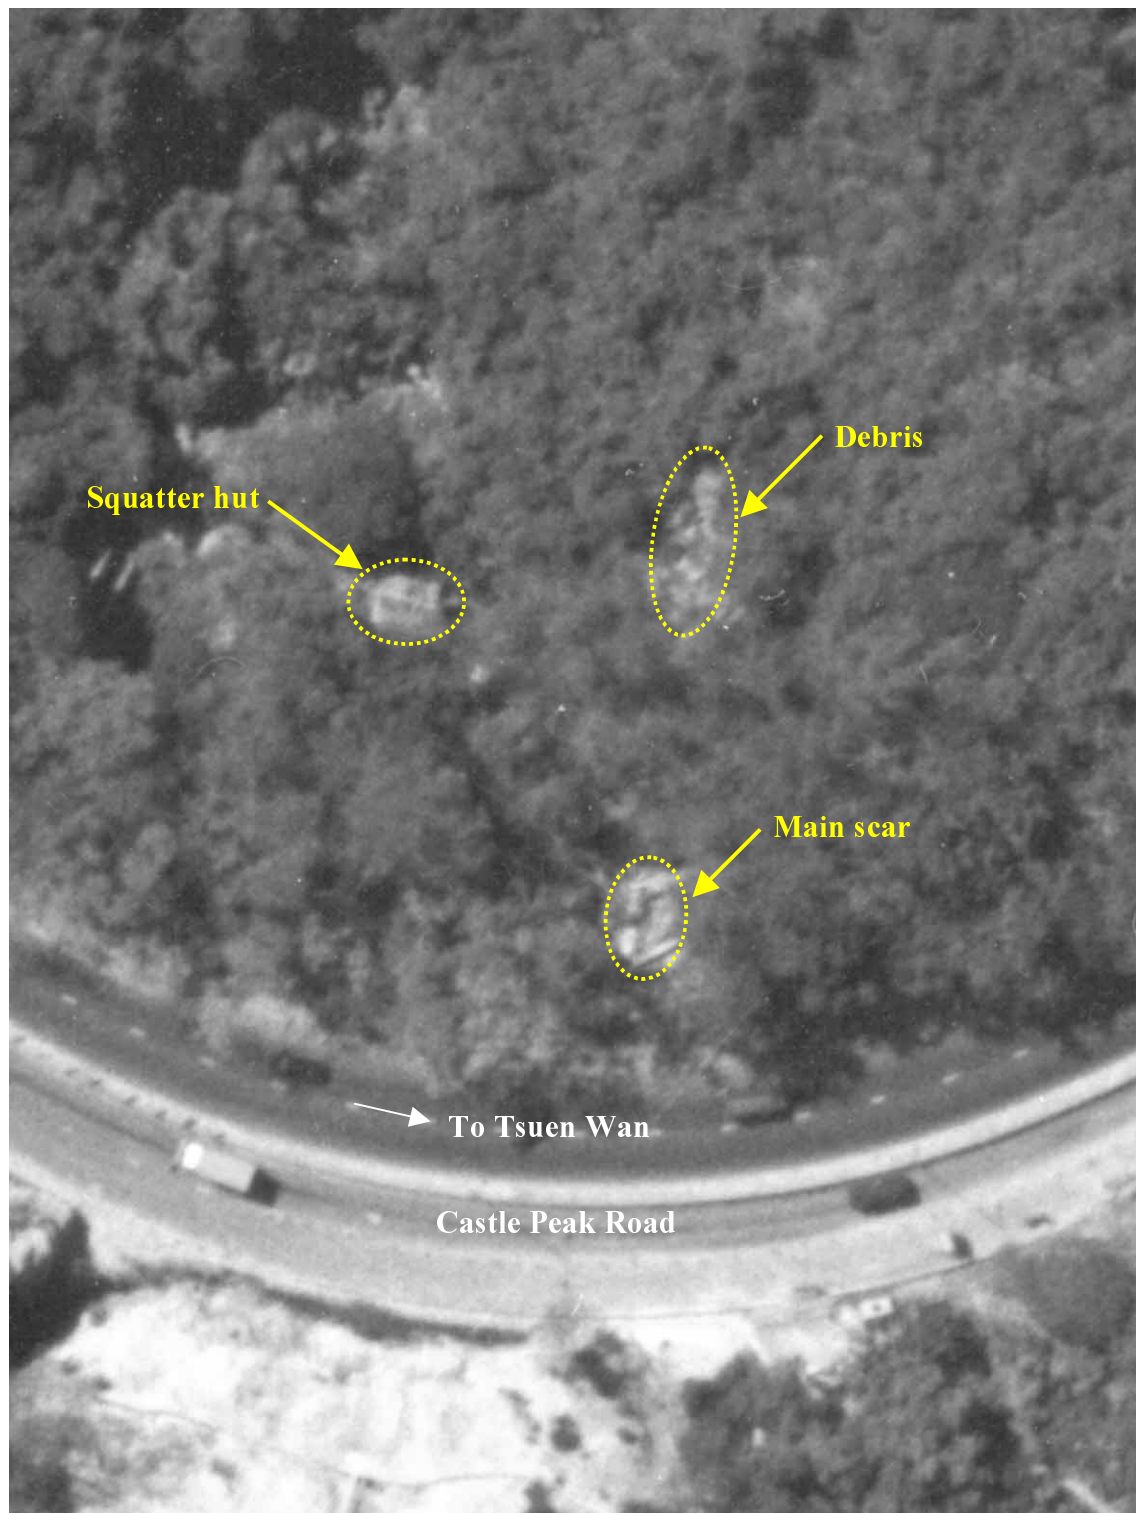
Plate 2 – Extract from Aerial Photograph CN 25421 Showing Slope Distress
(Photograph Taken on 9 December 1999)

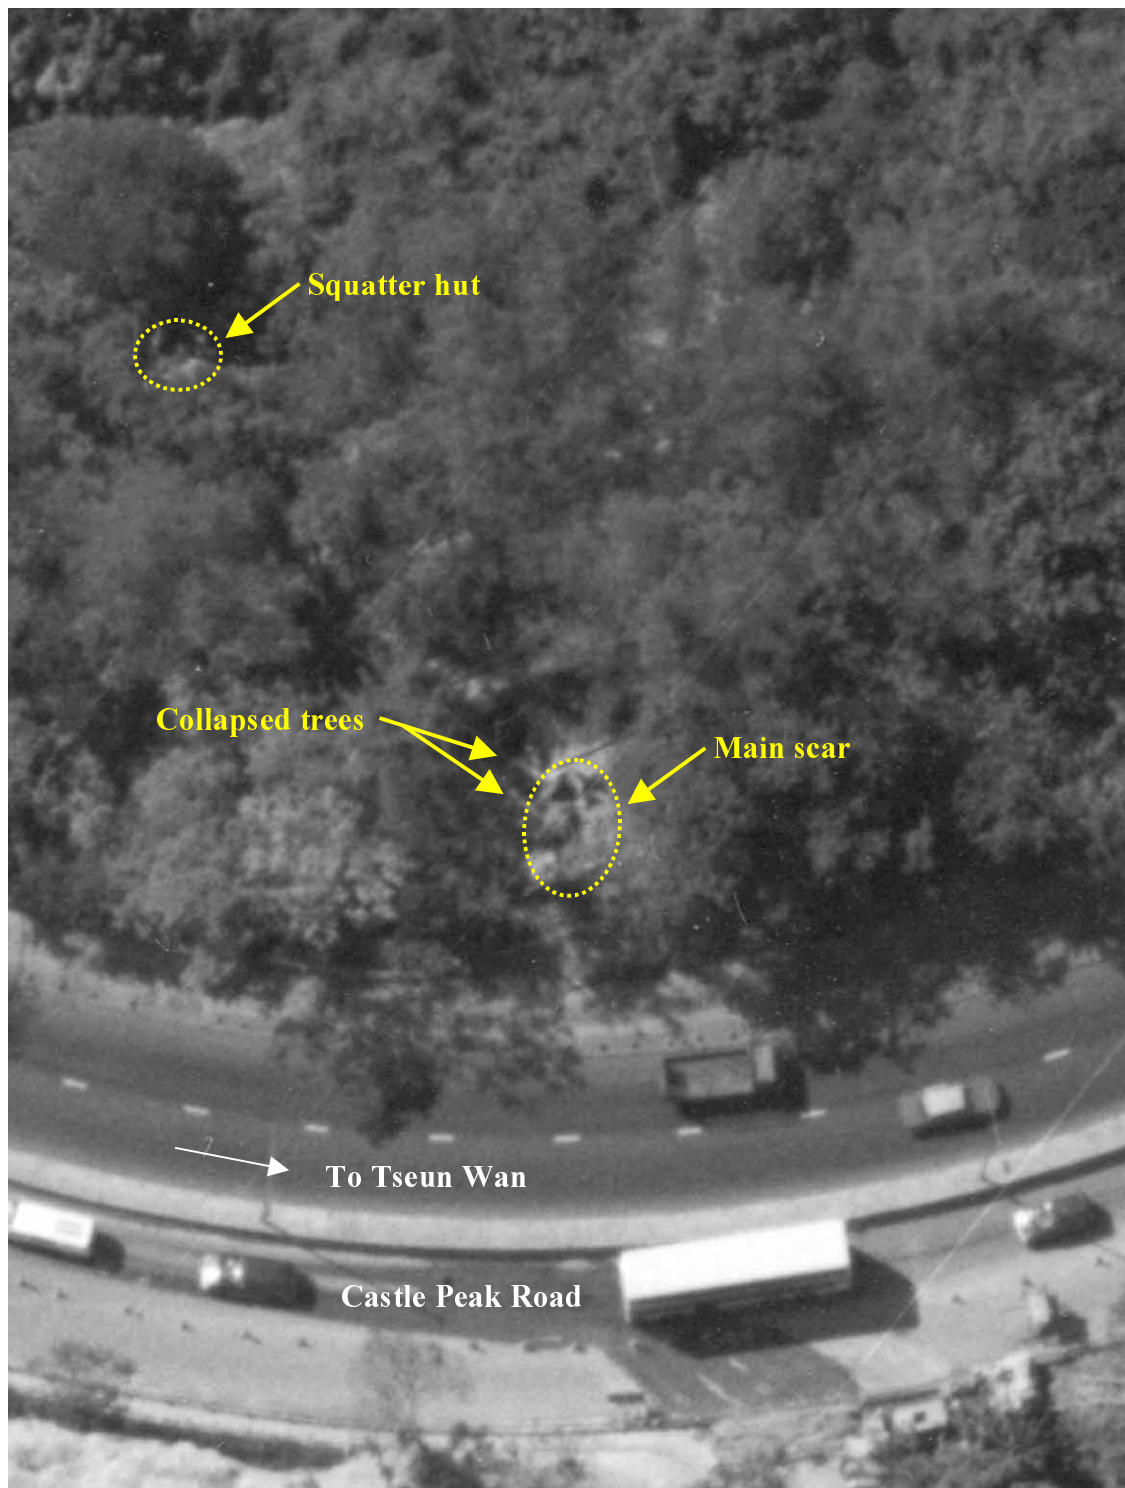
Plate 3 – Extract from Aerial Photograph CN 253 16 Showing Slope Distress
(Photograph Taken on 11 December 1999)

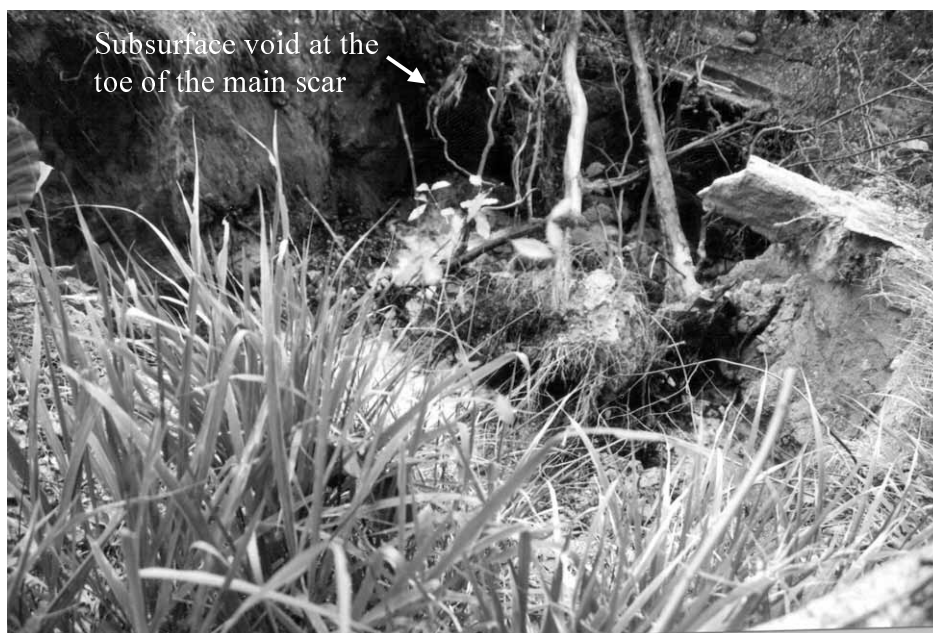
Plate 4 – View of Failed Slope as Observed by Scott Wilson (HK) Ltd.
(Photograph Taken on 14 January 2000 by Scott Wilson (HK) Ltd.)

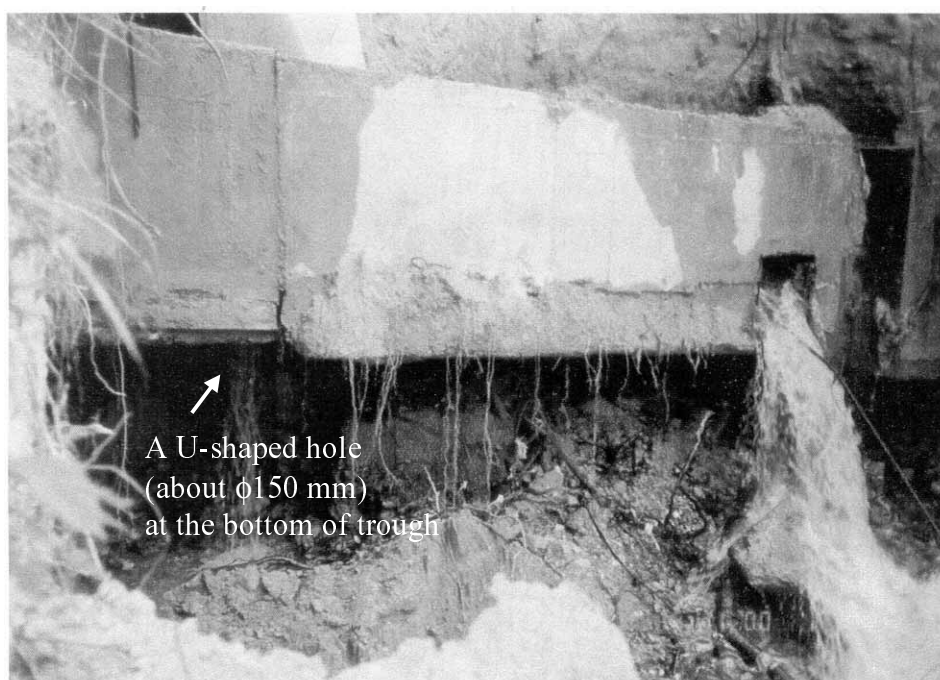
In late December 1999, the villagers of Kau Wah Keng Village observed an unusually high sediment content in the water flowing along the service channel through the village. This had led to an accumulation of sand and mud partly blocking the service channel. This issue was brought to the attention of the District Office of Kwai Tsing. The complaint was then forwarded to the Resident Site Staff for the LPM works being undertaken by Scott Wilson Hong Kong Limited (SW) under Contract No. GE/98/10 above Castle Peak Road (Figure 1). In response to the complaint, the upstream area of the Kau Wah Keng Village was inspected. During the inspection, which was undertaken on 14 January 2000, it was noted that the central portion of the upper batter of slope No. 11NW-A/FR84 had failed (Figure 2 and Plates 1 & 4). Based on observations made during SW’s inspection, the failed area was about 15 m long by 5 m wide by 2.5 m deep. At the time of inspection, it was noted that a large quantity of water was discharging into the failed portion of slope from the 900 mm diameter watermain exposed below the main scar (Plates 5 and 6).

Plate 5 – View of Water Discharging from Leakage Detection Trough in
Which the 900 mm Diameter Watermain was Housed (Photograph
Taken on 14 January 2000 by Scott Wilson (HK) Ltd.)

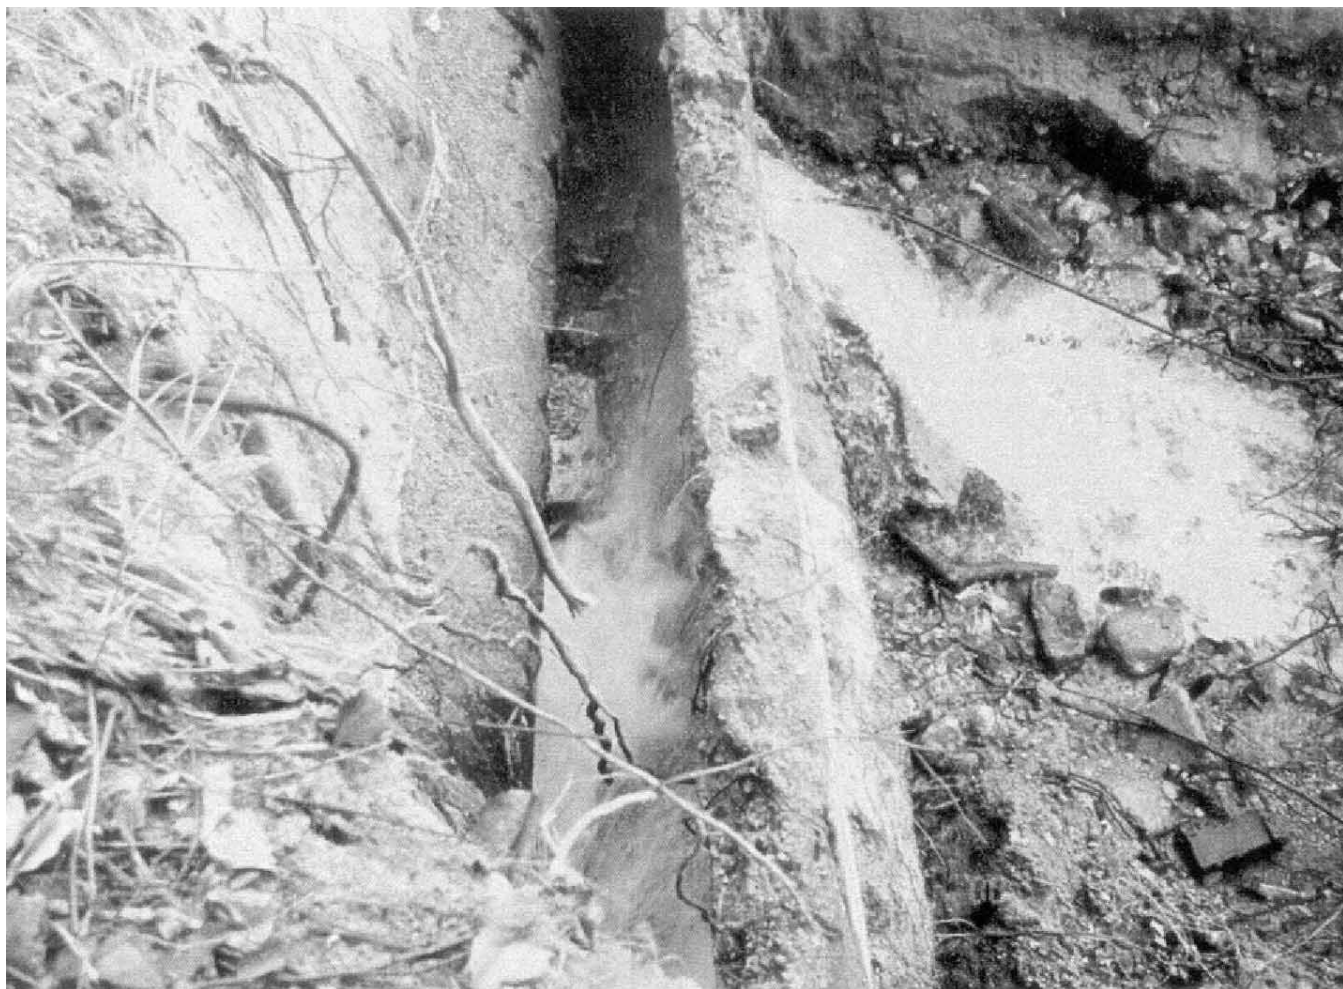
Plate 6 – View of Leaking Pipe at the Time of Inspection by WSD
(Photograph Taken on 15 January 2000)

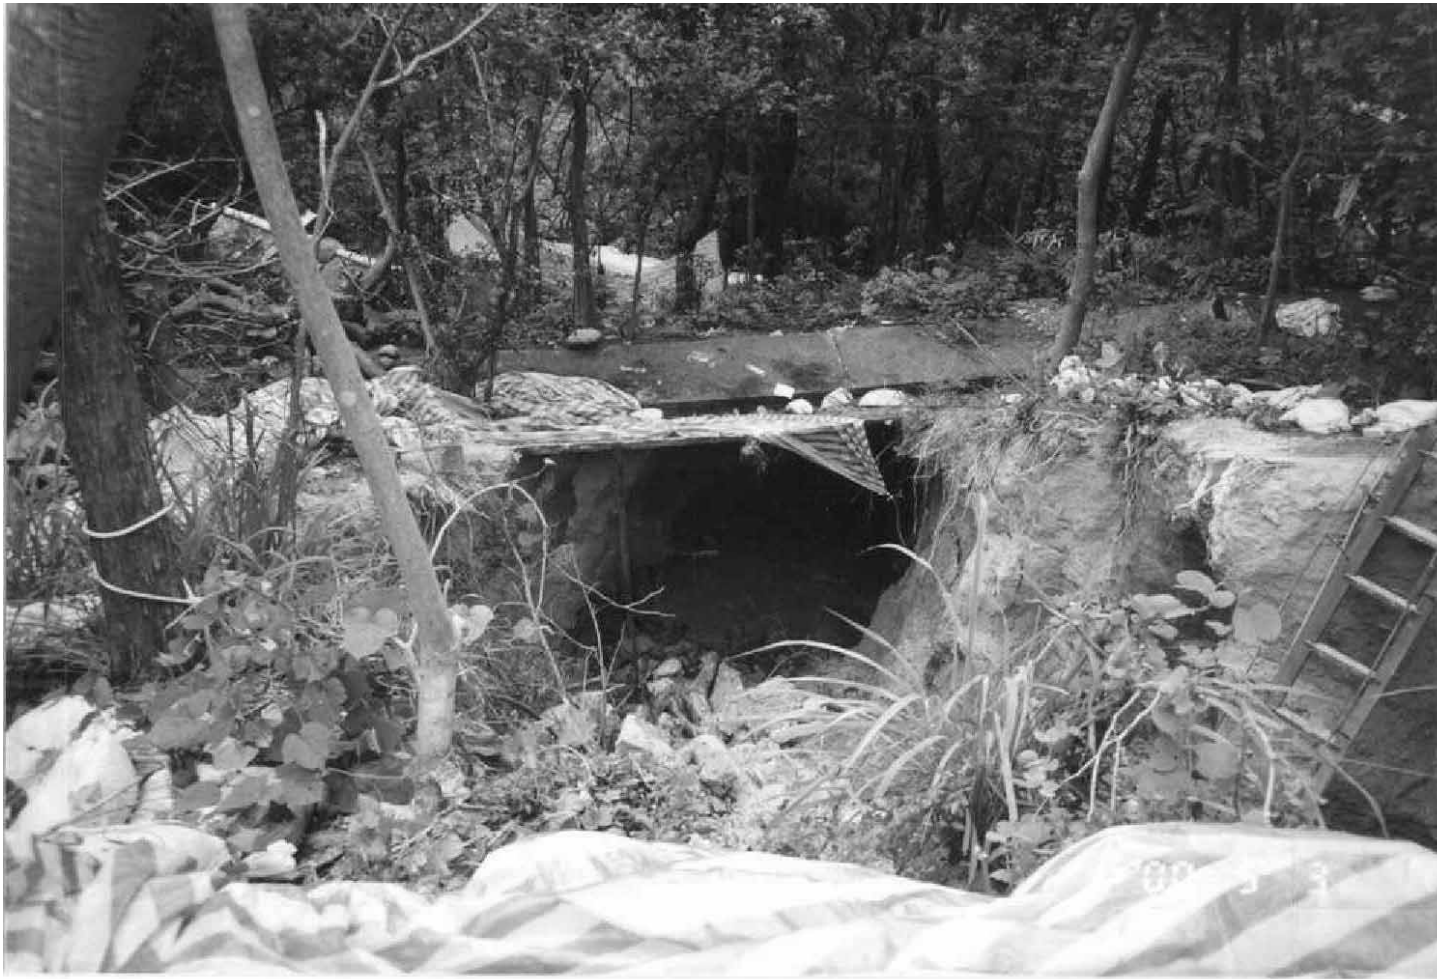
The width of the main scar narrowed towards the base, where a large subsurface void of about 1.5 m in diameter was identified (Plate 7). It was evident that the void extended further downslope and significant surface distress was noted along the base of the lower batter below and to the west of the main scar (Figure 7). This took the form of two voids and associated surface distress, one located below the main scar (Plate 8) and the other located some 15 m to the west (Plate 9). In the vicinity of these voids, there was evidence of surface washout/erosion. Also, the small upstand wall along the toe of the lower batter had tilted outwards over a length of about 15 m (Plate 10). Slope wash material had been deposited along the crest of the retaining wall indicating that large volumes of water had discharged from the surface voids and cascaded over the top of the wall, carrying material with it.

Plate 7 – View of the Void at the Toe of the Main Scar
(Photograph Taken on 3 May 2000)

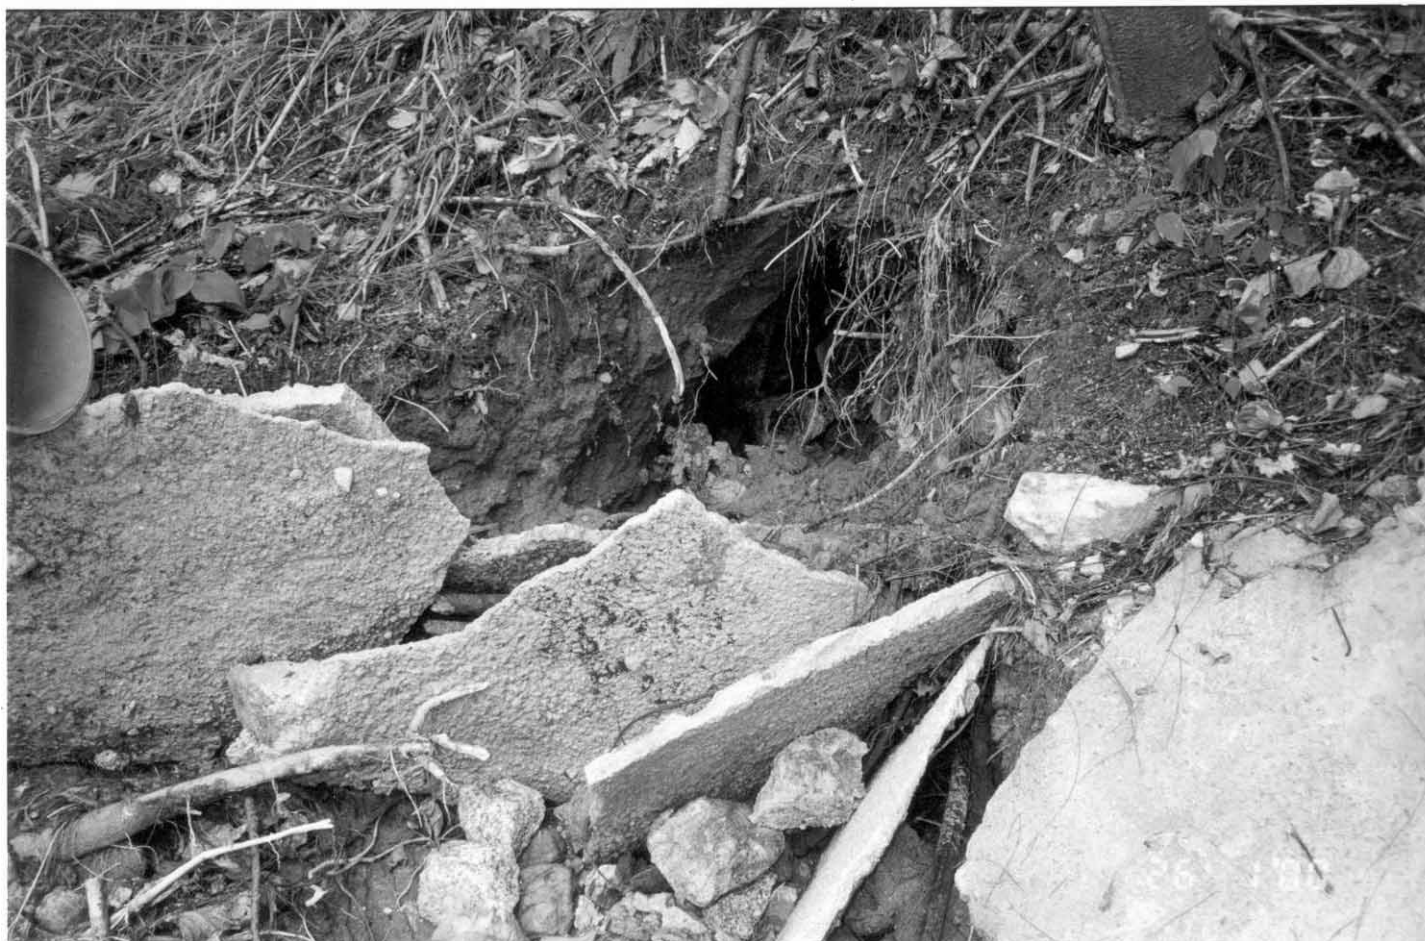
Plate 8 – Subsurface Void (approx. 0.6 m in diameter) in the Lowest Batter of the Slope below the Main Scar
(Photograph Taken on 26 January 2000)

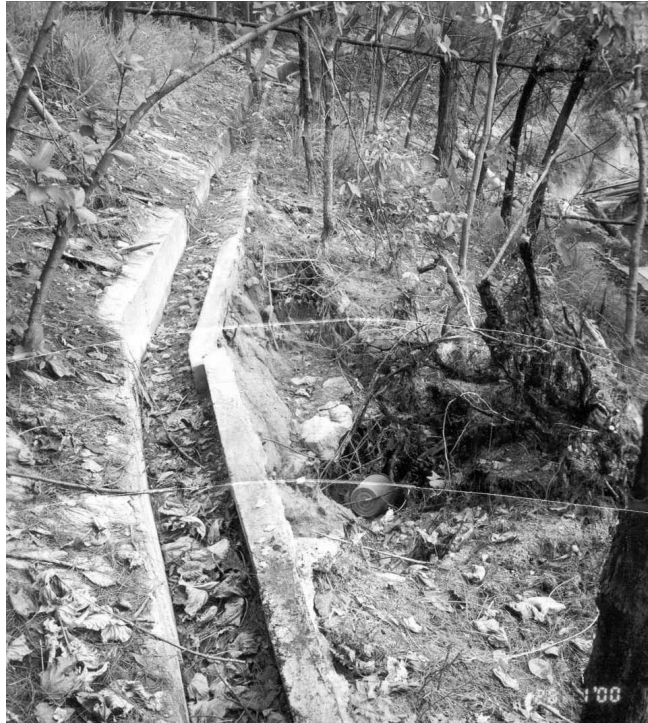
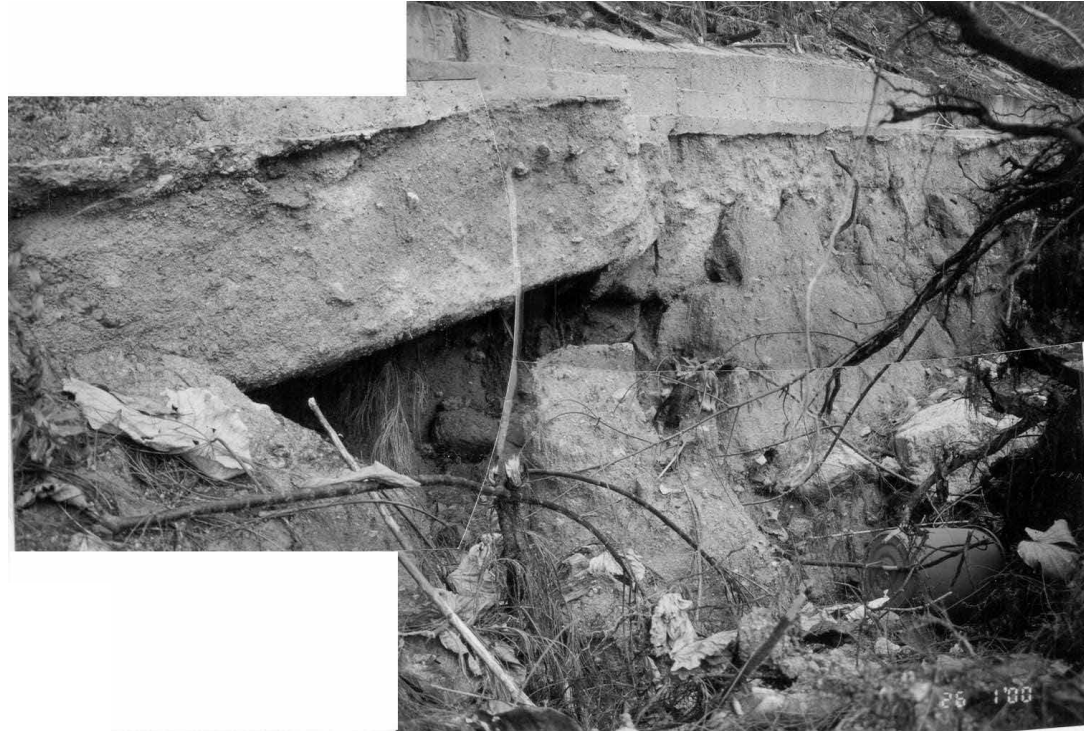
Plate 9 – Subsurface Void in the Lowest Batter to the Southwest of the Main Scar
(Photograph Taken on 26 January 2000)

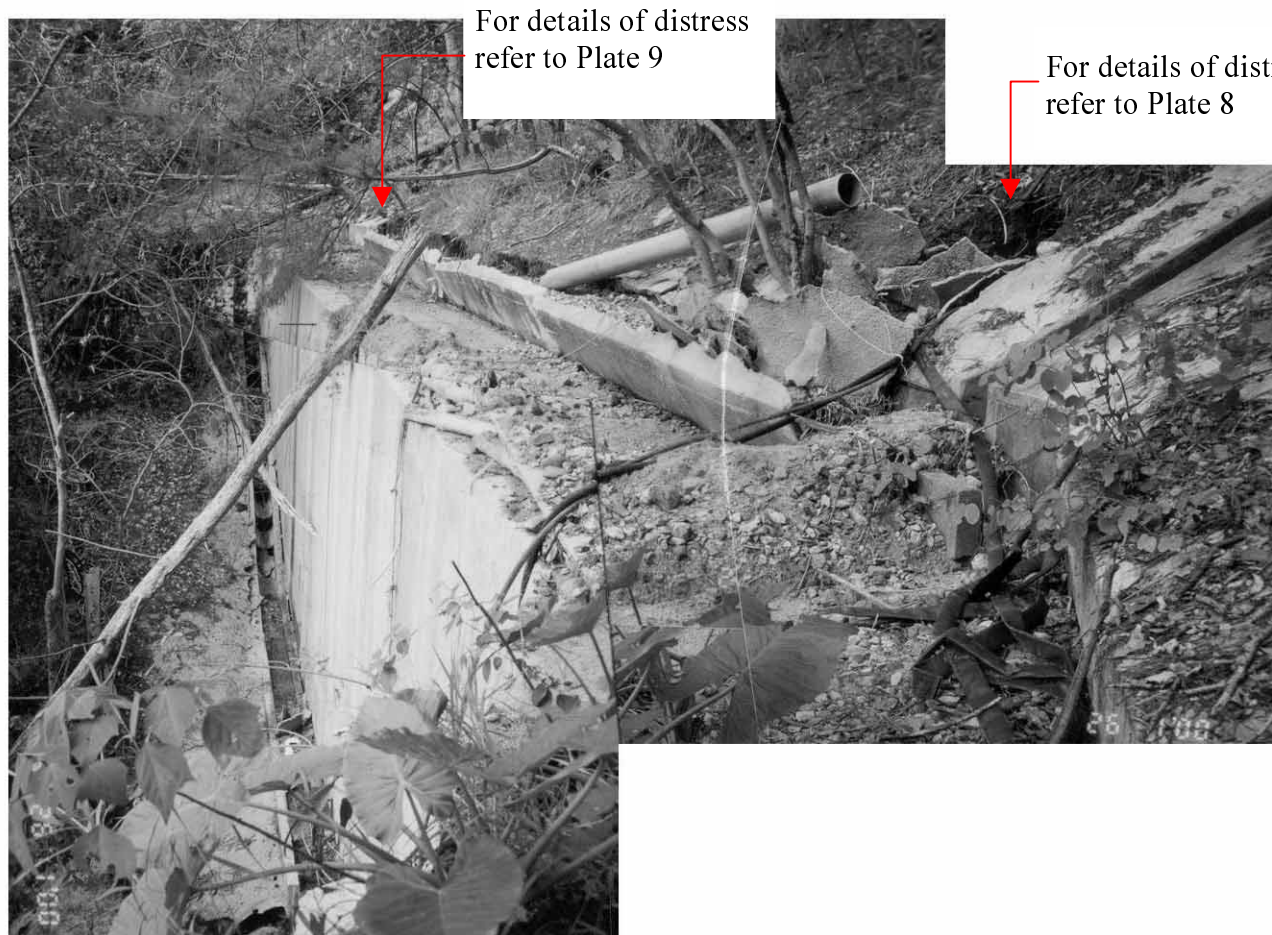
Plate 10 – Tilted Upstand Wall at the Toe of the Lowest Batter
(Photograph Taken on 26 January 2000)

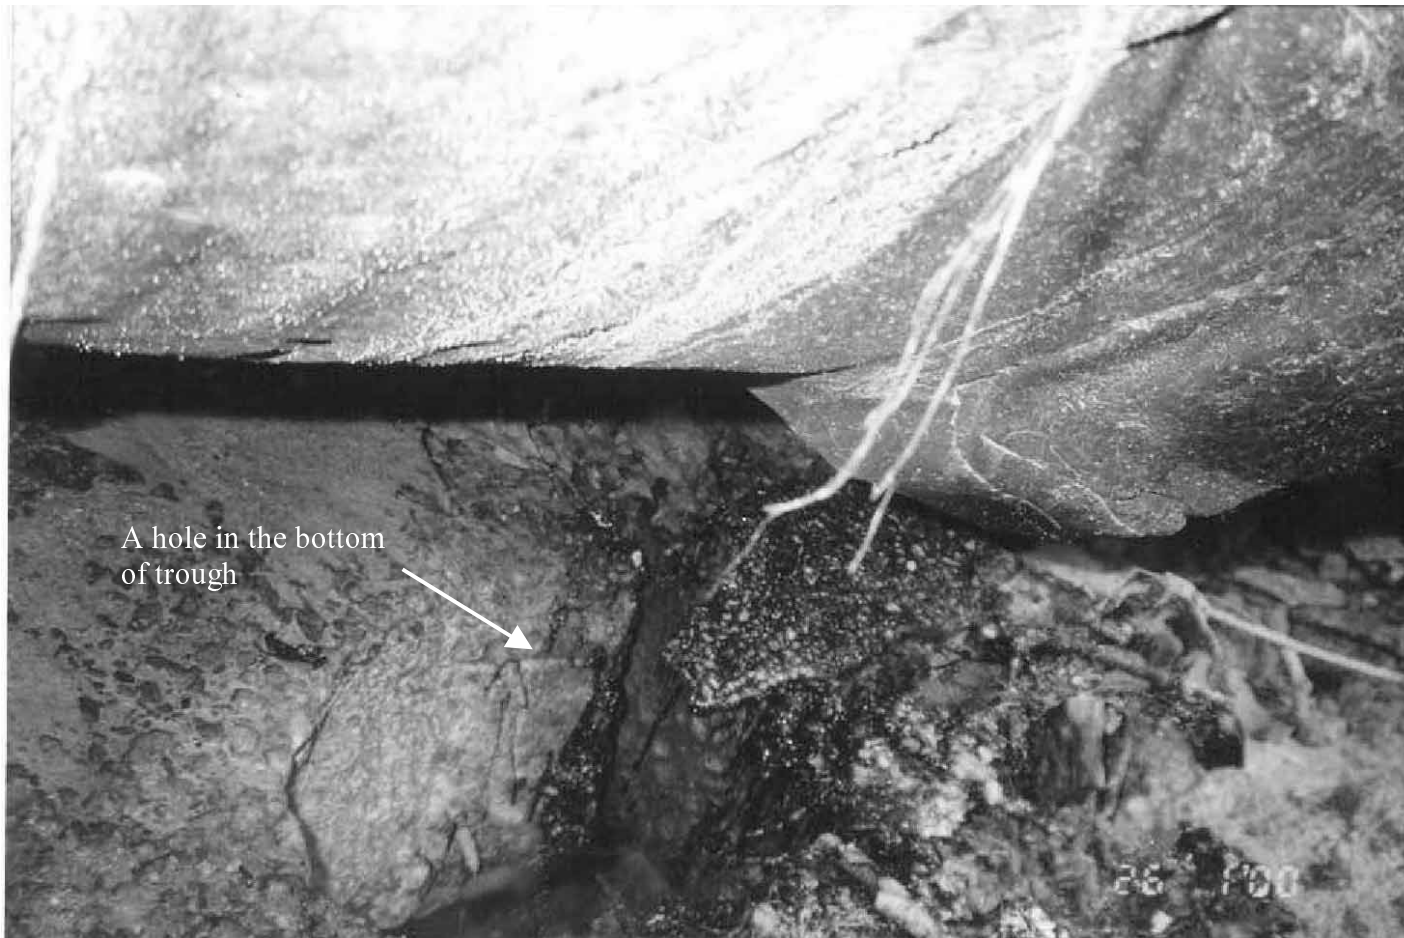
Inspection of the watermain and concrete trough exposed at the crown of the main scar showed that repair works had recently been carried out. A U-shaped hole of about 150 mm in diameter was present at the bottom of the trough (Plate 11). This hole is located at a construction joint in the trough approximately below the repaired portion of the watermain. The hole appeared old and exposed corroded reinforcement. Sub-vertical striations were evident on the exposed concrete surface of the hole, suggesting that mechanical action was probably used to form the hole.

FMSW were advised by the WSD that the U-shaped hole in the bottom of the concrete trough was present when they first inspected the site on 14 January 2000, following the report of the burst watermain. The WSD further noted that no complaints/reports on leakage of the 900 mm diameter watermain were received preceding the incident. No records were found in the WSD's files to show the construction details of the foundation to the watermain.

Plate 11 – View of the Hole at the Bottom of Trough
(Photograph Taken on 26 January 2000)

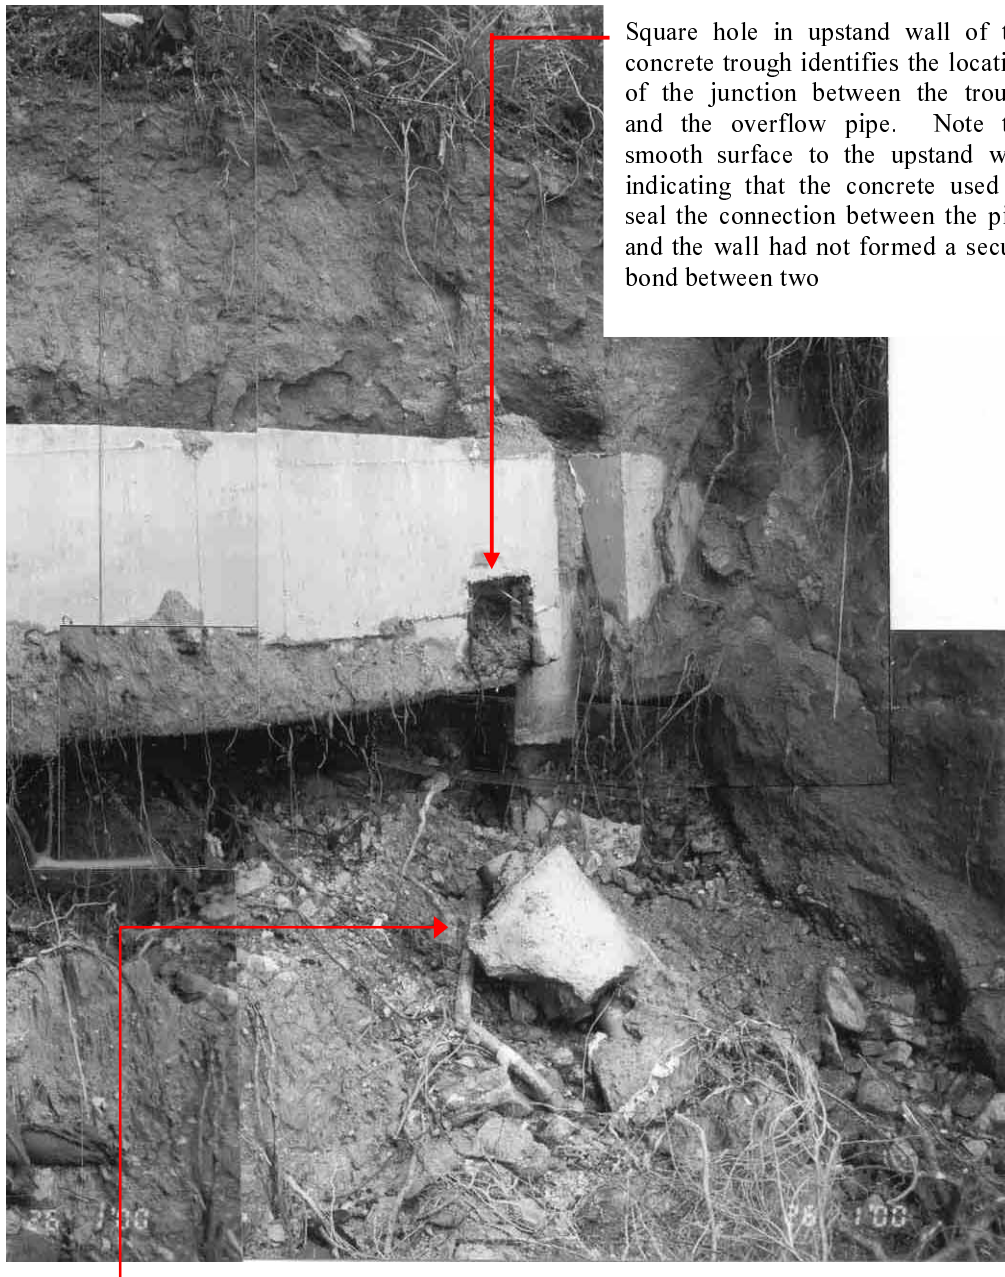
Another hole was observed at the eastern end of the concrete trough. This was a square hole about 250 mm wide that had been formed in the upstand wall to the concrete trough to provide an outlet connection to the overflow pipe (Plate 12). Inspection of the hole identified corroded reinforcement and that the internal sides of the hole were relatively smooth indicating that the hole had probably been formed by boxing out the section during

Square hole in upstand wall of the concrete trough identifies the location of the junction between the trough and the overflow pipe. Note the smooth surface to the upstand wall indicating that the concrete used to seal the connection between the pipe and the wall had not formed a secure bond between two

End of overflow pipe that was secured into the concrete trough. The end was intact indicating that it had been drawn out of the connection rather than being shear by vertical pressure from above

Plate 12 – View of Junction between the Outlet Hole in the Concrete Trough and the Overflow Pipe (Photograph Taken on 26 January 2000)
