**SECTION 2:
DETAILED STUDY OF THE
LANDSLIDE ON SLOPE
No. 11NW-A/FR84
BELOW CASTLE PEAK ROAD
NEAR KAU WAH KENG
VILLAGE**

**This report was originally produced in October 2001
as GEO Landslide Study Report No. LSR 10/2001**

This report presents the findings of a detailed study of the landslide (GEO Incident No. MW 2000/01/07) on slope No. 11NW-A/FR84 above Kau Wah Keng Village, below Castle Peak Road, Kwai Chung, which was reported on 14 January 2000. Debris from the failure was transported along the natural stream course leading to the Kau Wah Keng Village. There were no casualties as a result of the slope failure.

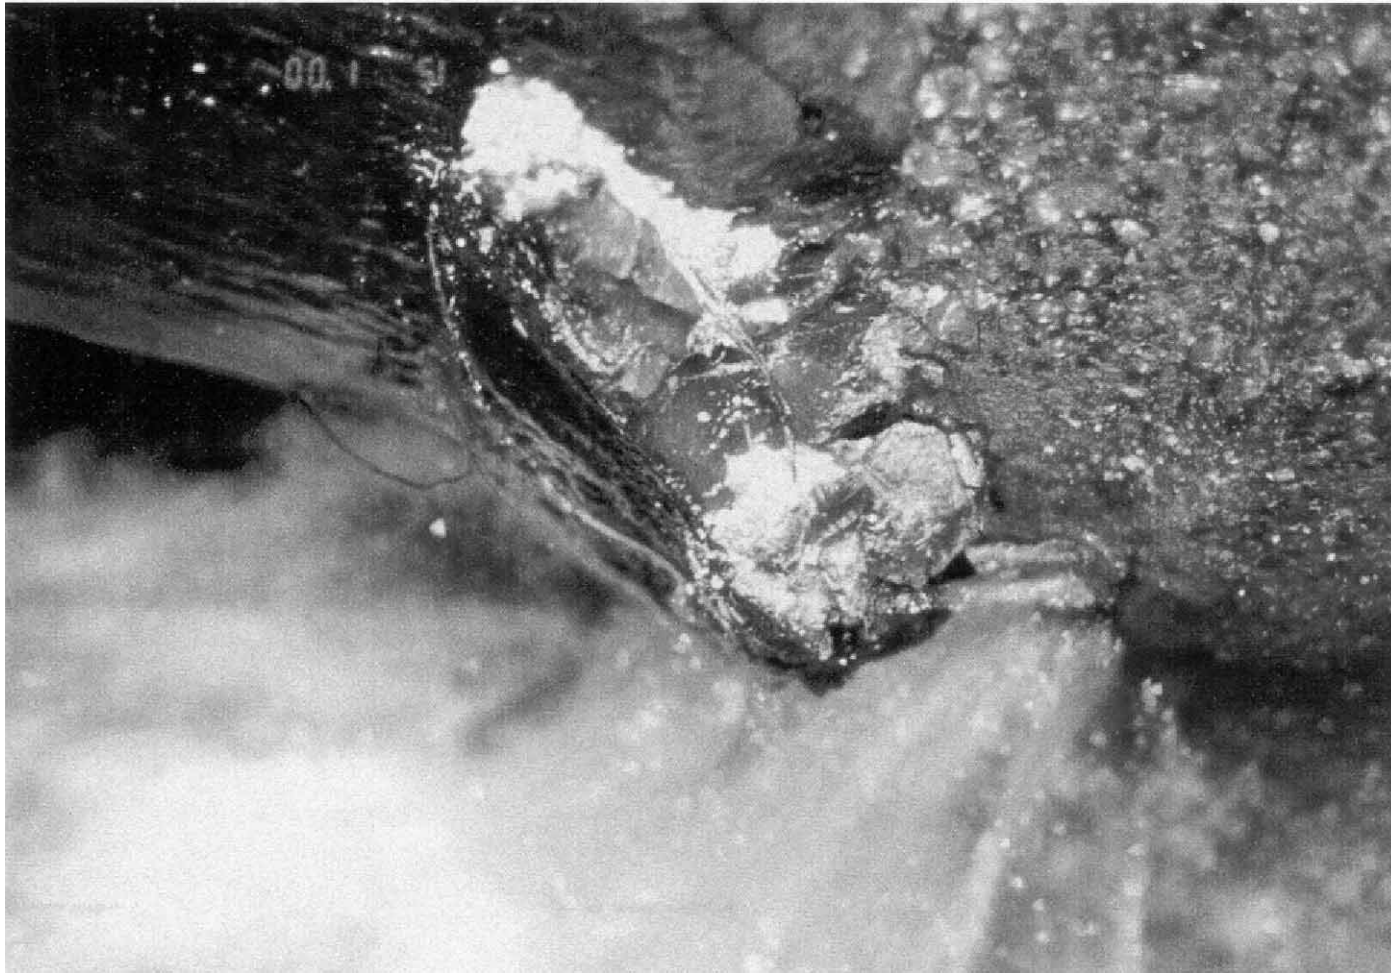
After identifying the incident, SW immediately reported the broken watermain to the WSD for urgent action. An inspection team from the WSD visited the site on 14 and 15 January 2000. They noted a 100 mm long crack along the edge of a welded joint in the lower quarter of the pipe on the downslope side of the watermain (Plates 13 and 14). The pipe was reported to be in sound working condition in general and the edges of the crack were recorded as being rough and relatively fresh. Remedial works, comprising the repair of the fracture and formation of a mass concrete buttress to support the concrete trough, were completed on 15 January 2000 (Plate 15).

Plate 13 – View of 100 mm Long Crack at the Welded Joint
(Photograph Taken by WSD on 15 January 2000)

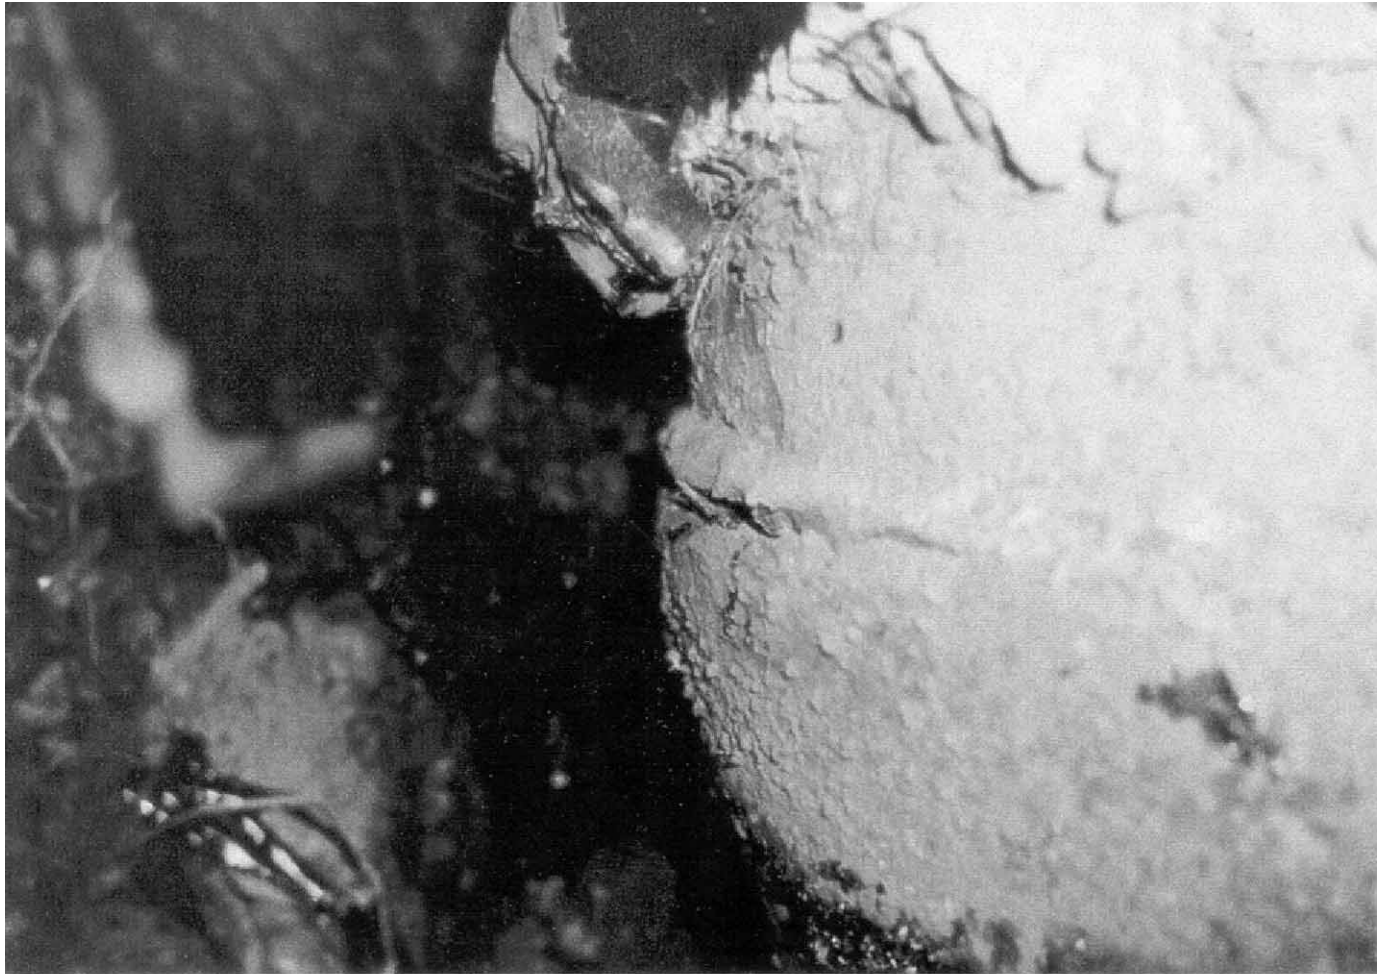
Plate 14 – Close-up View of the Crack along the Welded Joint
(Photograph Taken by WSD on 15 January 2000)

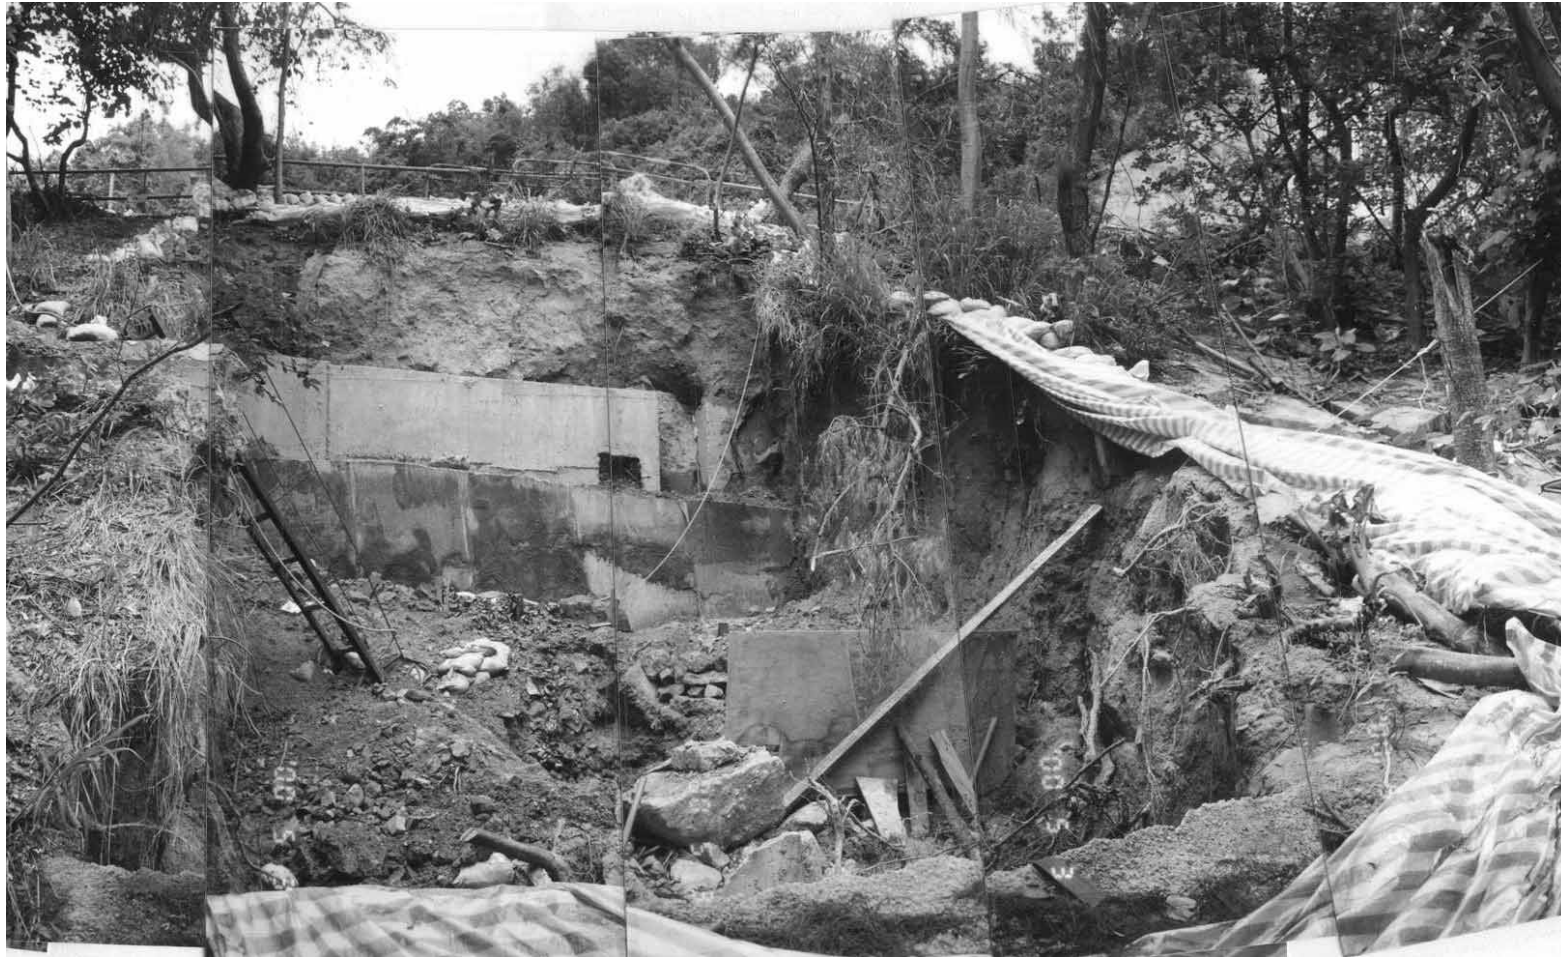
Plate 15 – View of Concrete Buttress Built to Support the Trough after the Incident
(Photograph Taken on 3 May 2000)

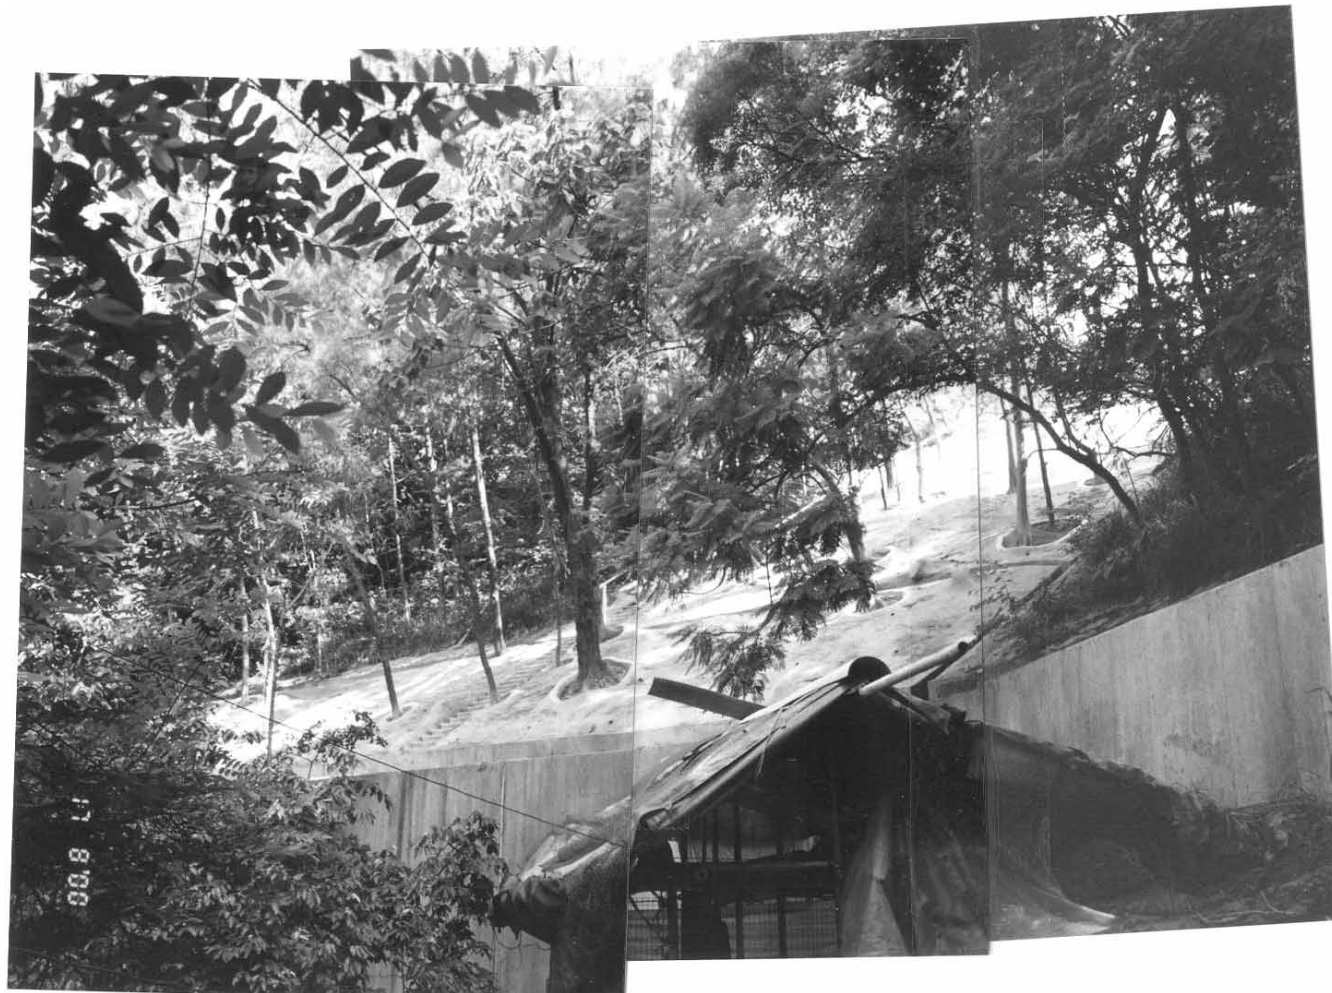
Plate 16 – General View of Slope after Repair Works by HyD
(Photograph Taken on 17 August 2000)

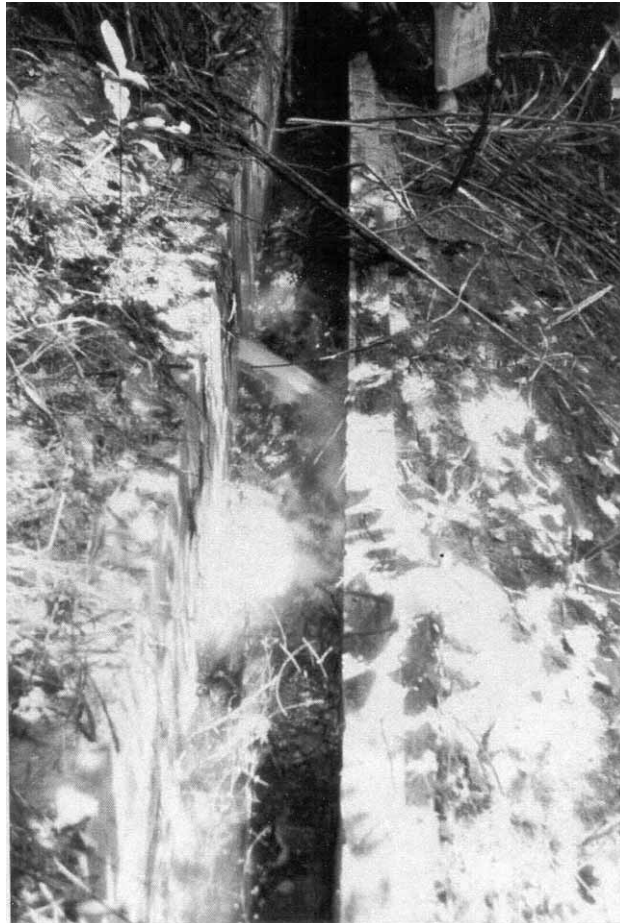
RMI and Routine Maintenance Works (RMW) have been undertaken at between six month and yearly intervals from 1996 onward. The first recorded RMI was undertaken on 1 November 1996, and record photographs attached to the inspection report showed strong water flow discharging from one of the overflow pipes connected to the leakage detection chamber (Appendix A, Plate A). The RMI report noted the following:

Plate A – View of Significant Discharge from Overflow Pipe Connecting to the Leakage Detection Chamber (Record Photograph Extracted from HyD Report on RMI of 1 November 1996)

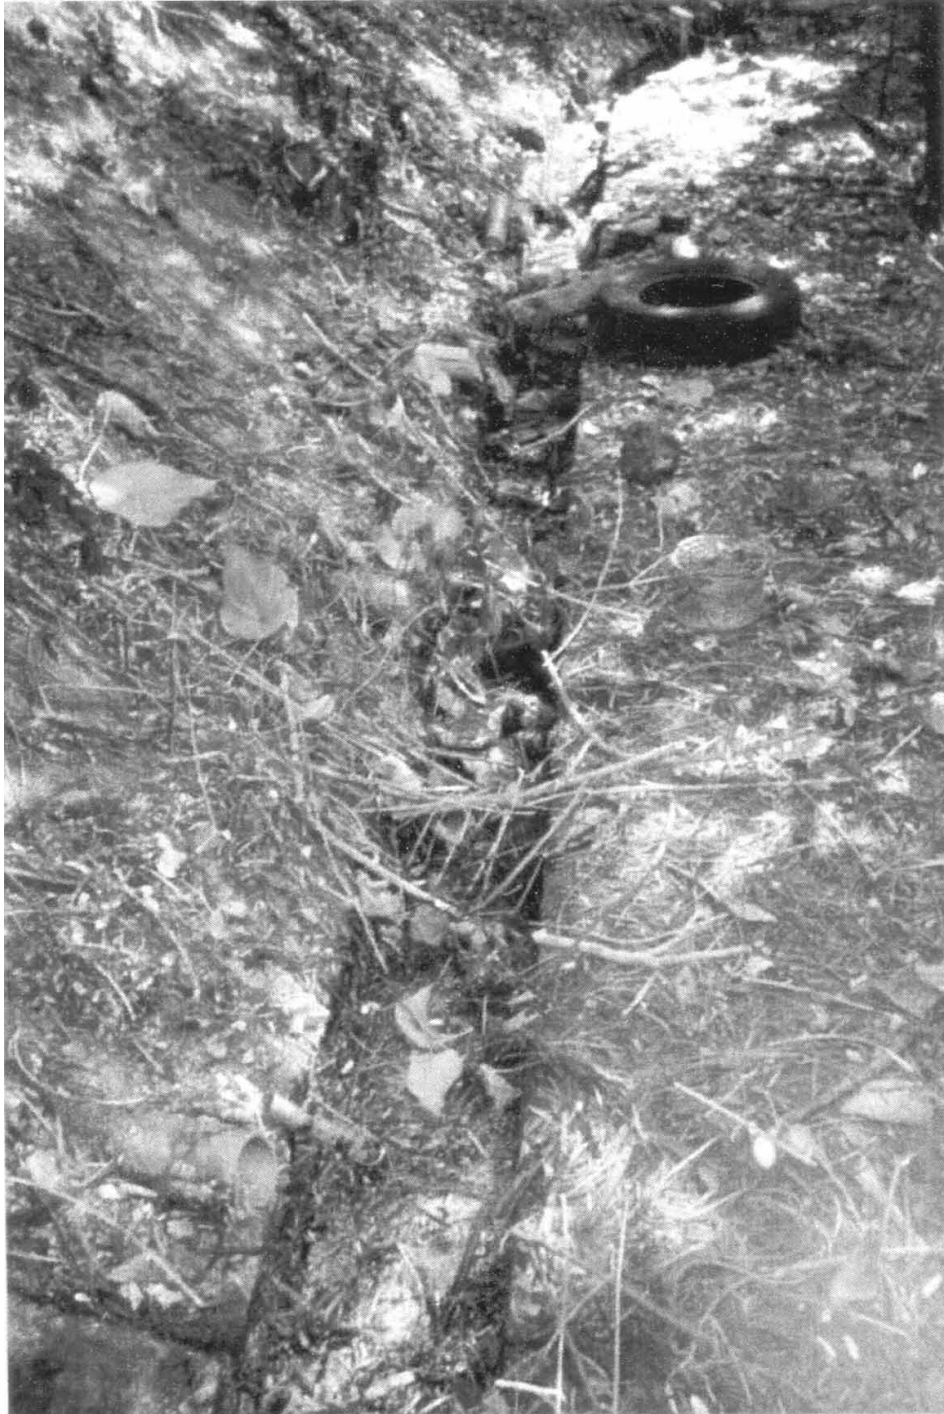
Plate B – View of Blocked Drainage Channel (Record Photograph Extracted from HyD Report on RMI of 1 November 1996)

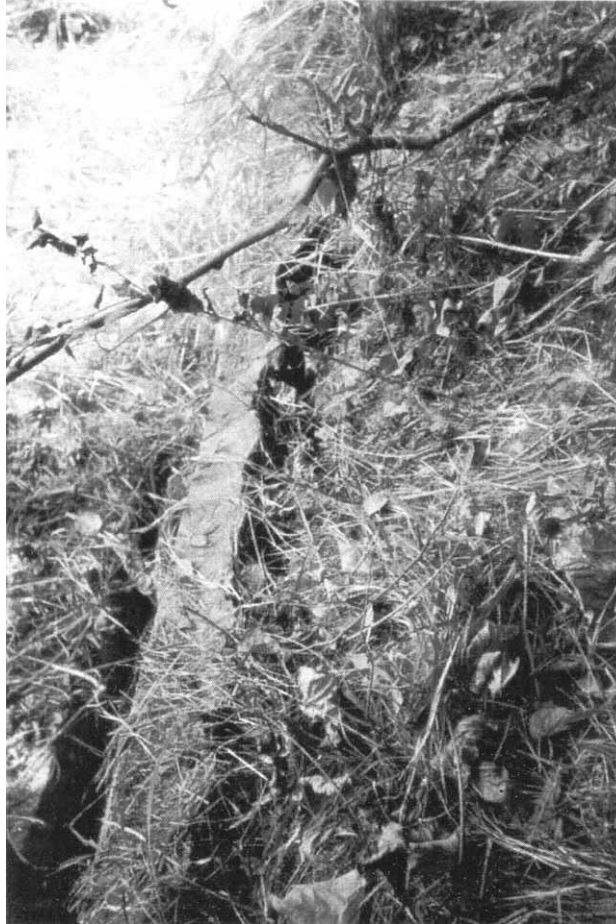
Plate C – View of Tilting Upstand Wall at the Toe of the Slope
(Record Photograph Extracted from HyD Report on RMI
of 1 November 1996)

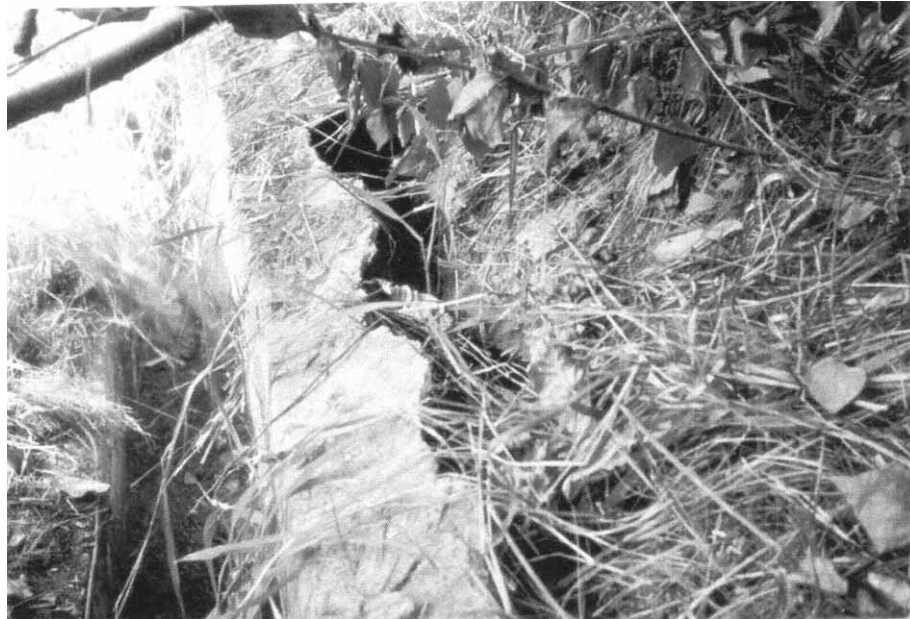
Plate D – View of Tilting Upstand Wall at the Toe of the Slope
(Record Photograph Extracted from HyD Report on RMI
of 1 November 1996)

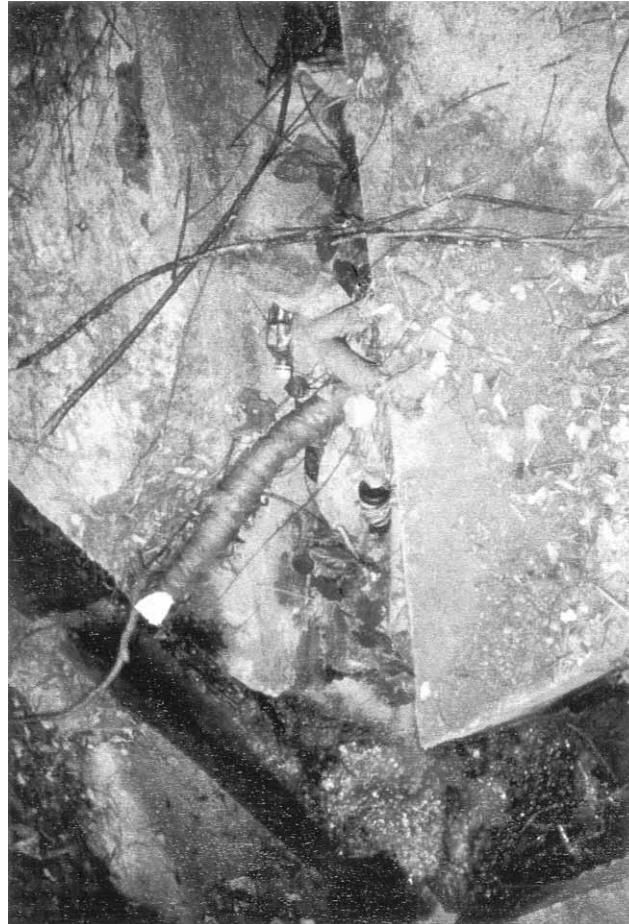
Plate E – View of Blocked Channel (Record Photograph Extracted from HyD Report on RMI of 1 November 1996)

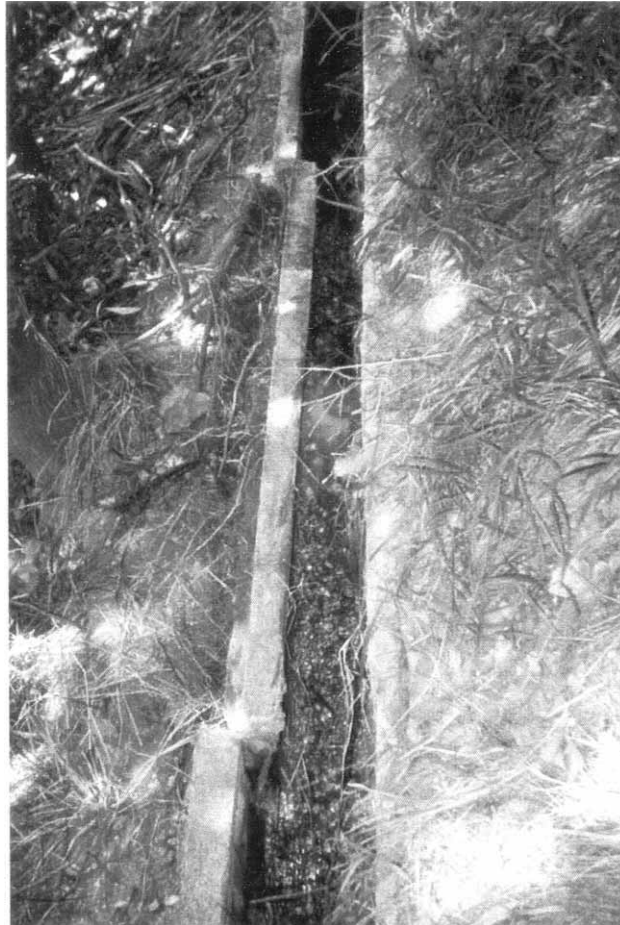
Plate F – View of Broken Channel (Record Photograph Extracted from HyD Report on RMI of 1 November 1996)

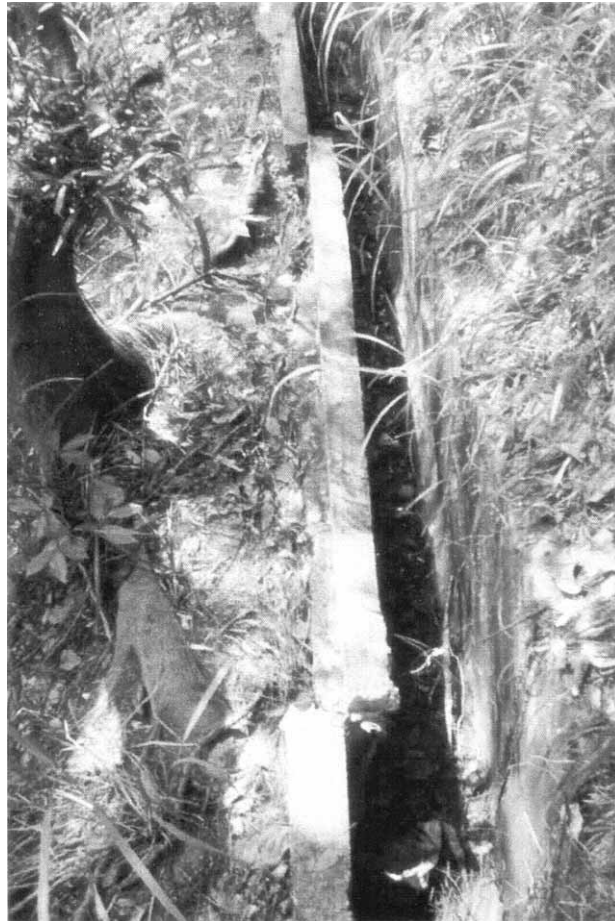
Plate G – View of Broken Channel (Record Photograph Extracted from HyD Report on RMI of 14 April 1997)

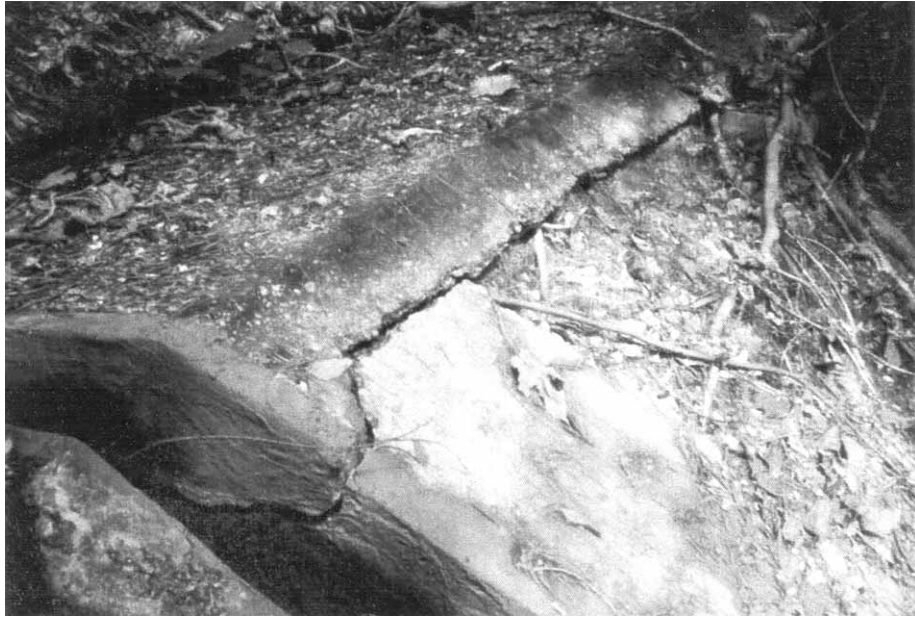
Plate H – View of Cracked Berm and Channel (Record
Photograph Extracted from HyD Report on RMI
of 14 April 1997)

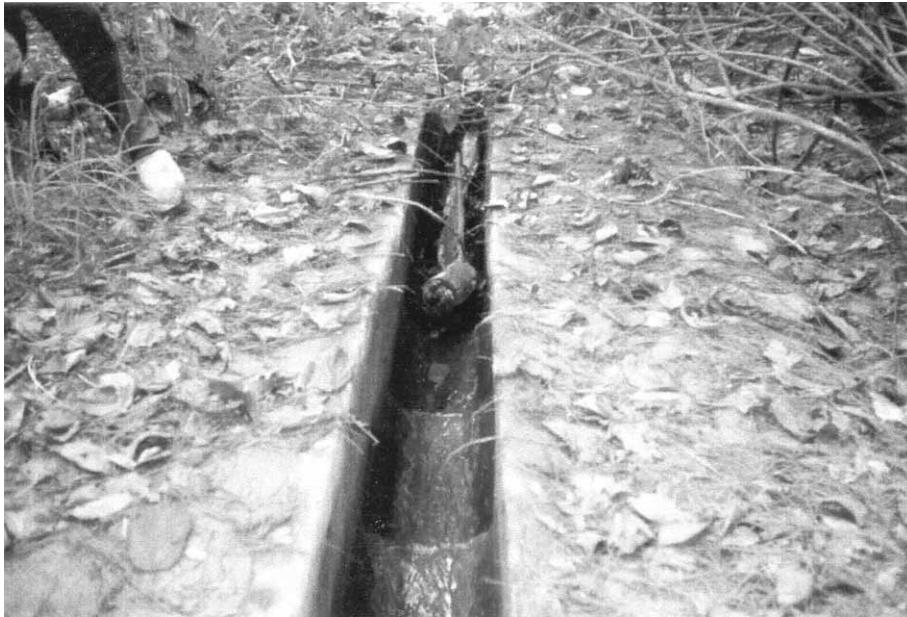
Plate I – View of Partly Blocked Channel (Record Photograph
Extracted from HyD Report on RMI of 14 April 1997)

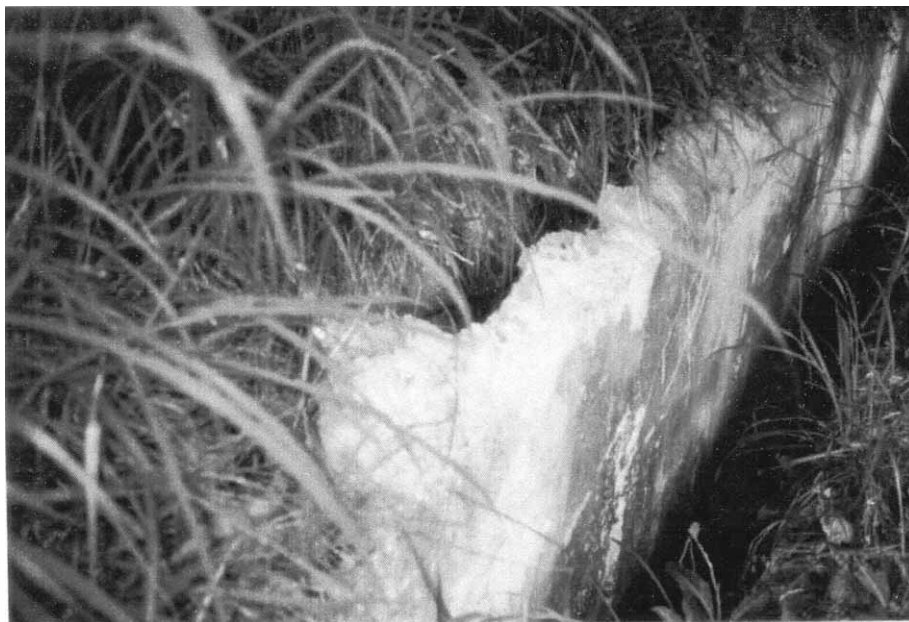
The next RMI in April 1997, identified very similar signs of distress across the feature as noted in the previous RMI. In particular, severed drainage channels and extensive voiding behind the upstand wall were still reported. There was no record of strong water flows discharging from the overflow pipe from the leakage detection chamber as noted in the previous RMI. The corresponding RMW to the observed distress was reported to have been completed by 23 September 1997.

Plate J – View of Tilting Upstand Wall at the Toe of the Slope
(Record Photograph Extracted from HyD Report on
RMI of 14 April 1997)

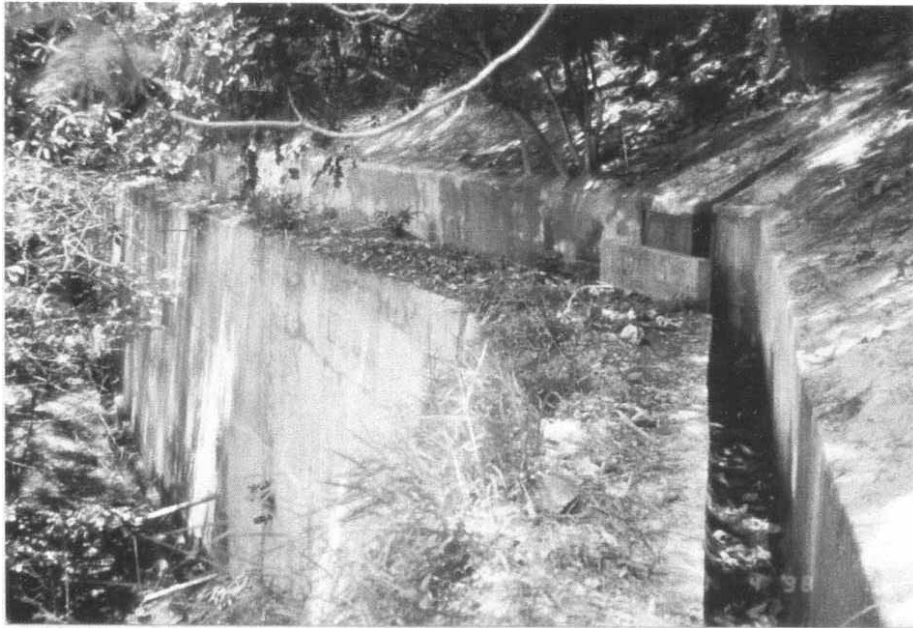
RMI undertaken in November 1997 and April 1998, again identified cracked and blocked channels. According to the recorded observations and photographs taken as part of these inspections, the defects observed in April 1997 had previously been repaired. In particular, the extensive voiding to the upstand wall had been backfilled and a shotcrete apron constructed at the upslope portion.

Plate K – View of Repaired Upstand Wall at the Toe of the Slope
(Record Photograph Extracted from HyD Report on RMI of
17 April 1998)

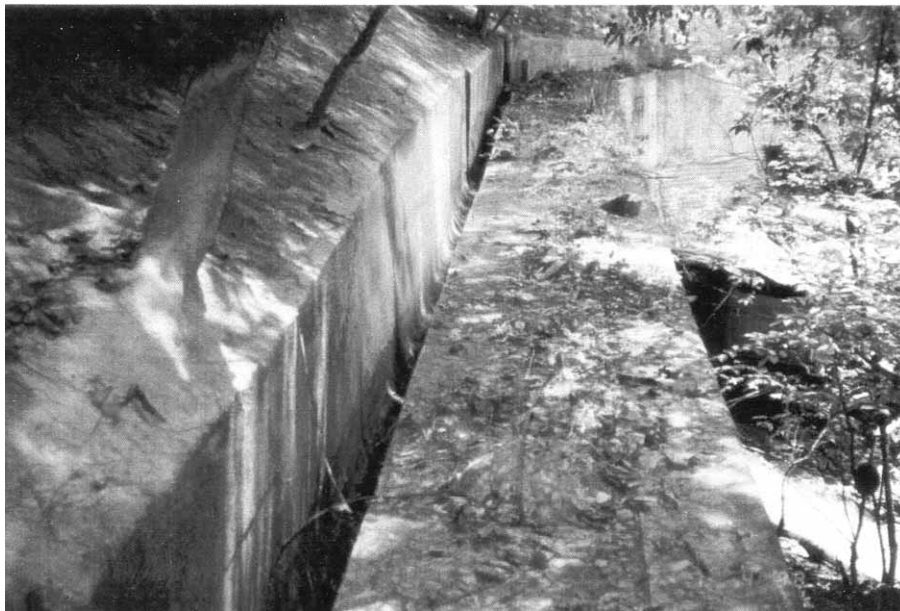
Plate L – View of Repaired Upstand Wall at the Toe of the Slope
(Record Photograph Extracted from HyD Report on RMI of
17 April 1998)

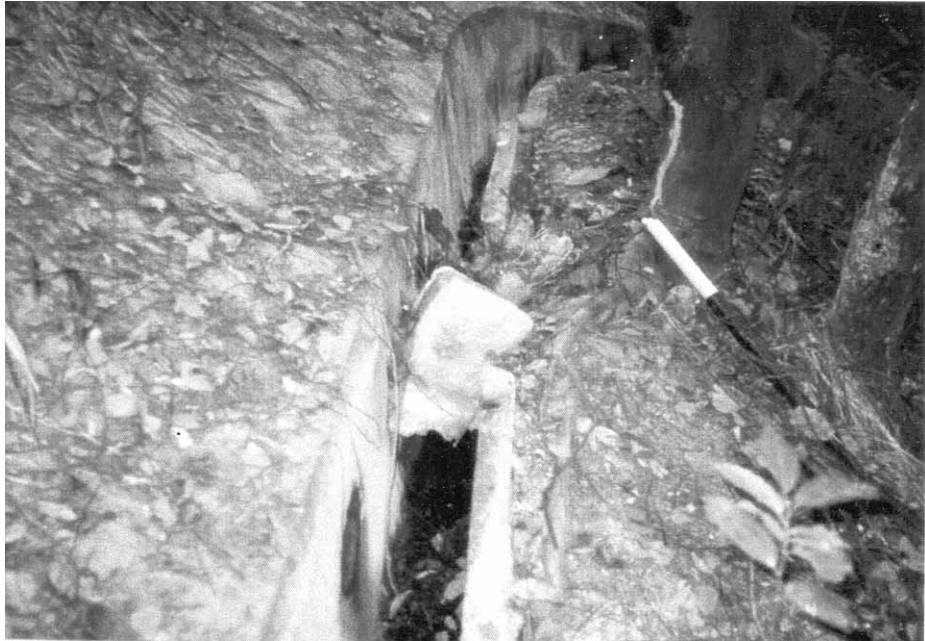
The RMI of 14 January 1999 noted that apart from some unplanned vegetation and debris blocking the drainage channels, there were no obvious signs of distress that could be identified. The corresponding RMW were noted as being complete by 19 March 1999. Record photographs attached to the inspection report indicated slight seepage from one of the overflow pipes and on the slope surfaces in the lower batter.

Plate M – View of Slight Seepage/Dampness at the Discharge Point of the Overflow Pipe (Record Photograph Extracted from HyD Report on RMI of 14 January 1999)

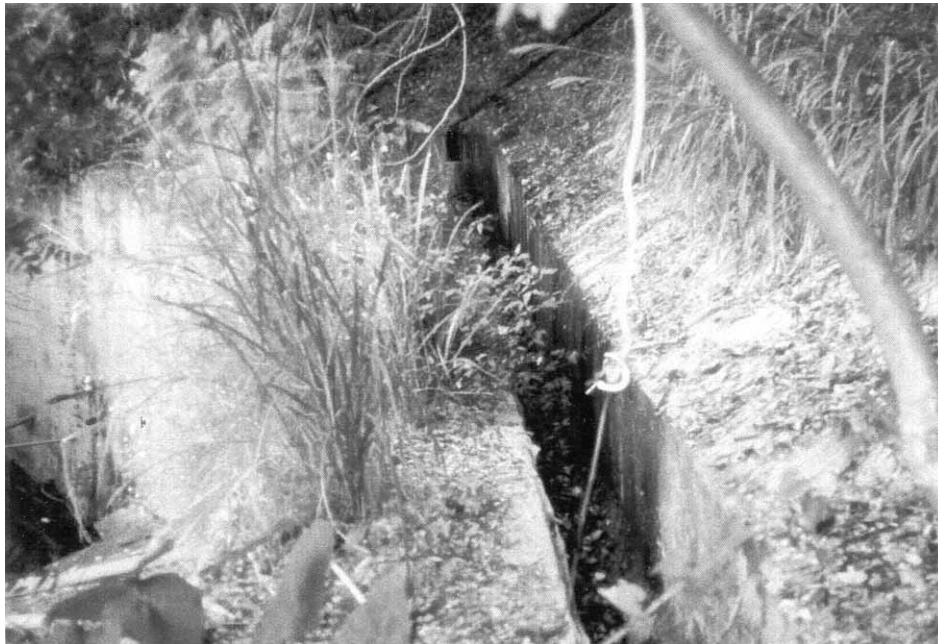
Plate N – View of Seepage at the Toe of the Slope (Record Photograph Extracted from HyD Report on RMI of 14 January 1999)

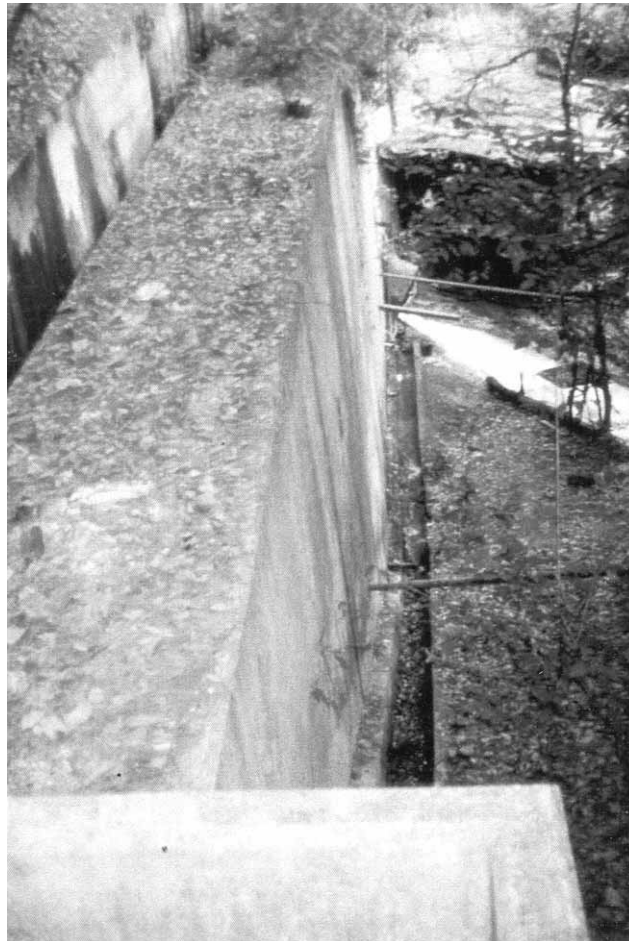
Plate O – View of Seepage/Dampness along Upstand Wall at the Toe of the Slope (Record Photograph Extracted from HyD Report on RMI of 14 January 1999)
