# **REVIEW OF 1999 LANDSLIDES**

**GEO REPORT No. 127**

**K.K.S. Ho, H.W. Chan & T.M. Lam**

This report presents the findings of a detailed review of landslides that occurred in 1999. It serves to review the performance of Government's slope safety system and identify improvement to current slope engineering practice in Hong Kong.

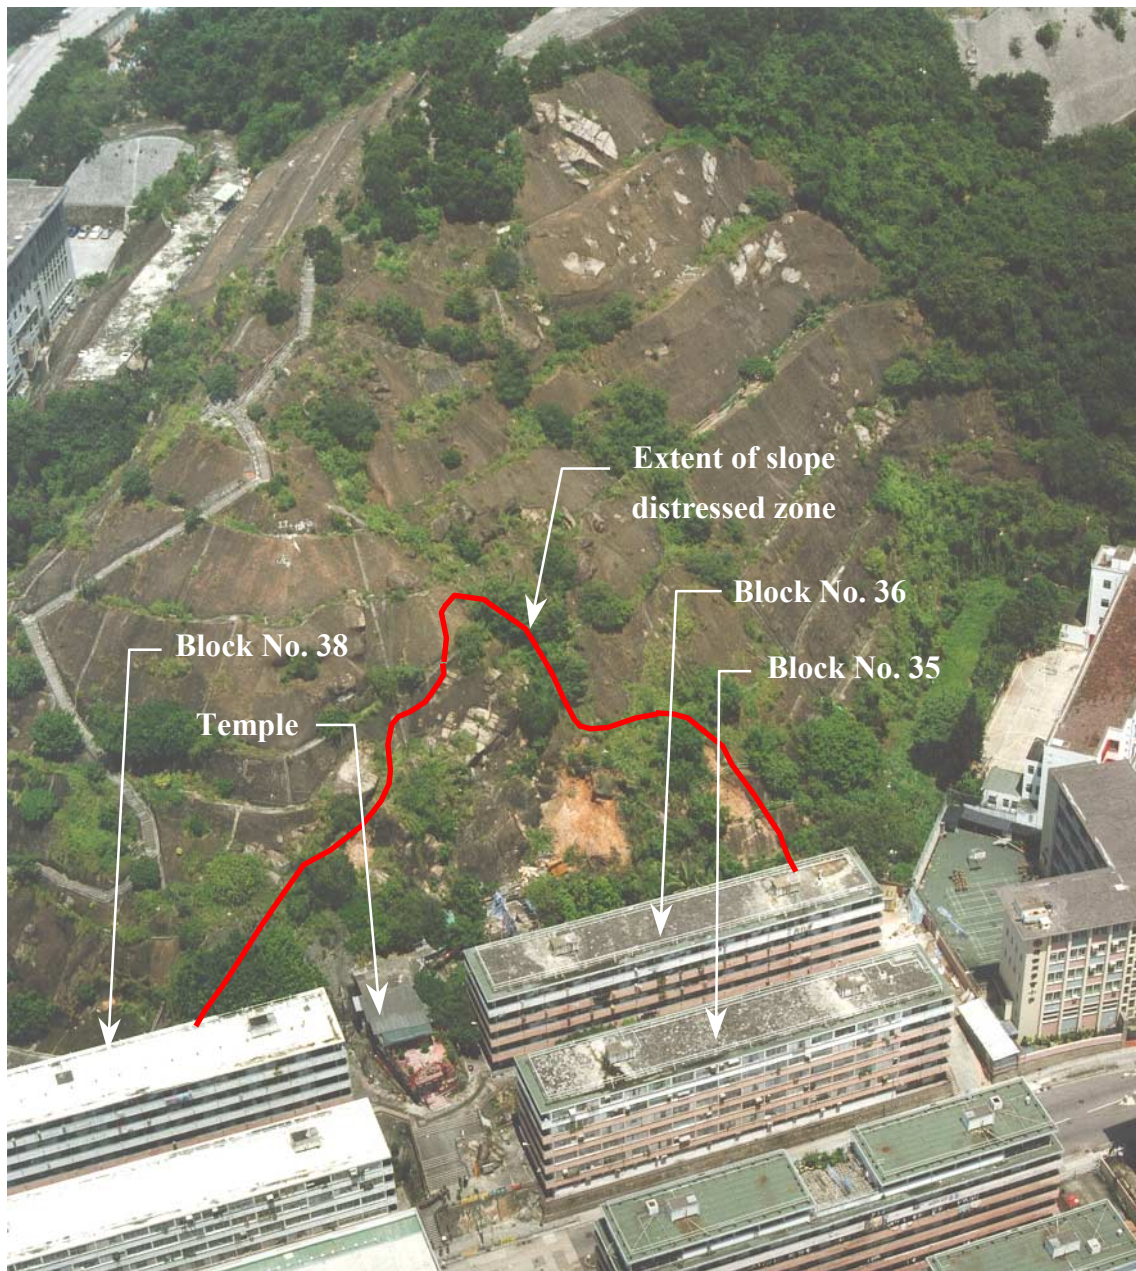
Plate 1 - Shek Kip Mei Landslide (FMSW, 2000a)

Of the two massive landslides on soil cut slopes previously processed as being up to the required geotechnical standards, one (i.e. Shek Kip Mei) had a relict massive failure. Of the five massive landslides at 'pre-GEO' catalogued soil cut slopes, at least two (i.e. Lai Chi Yuen and Shum Wat Road) had relict sizeable failures. Thus, there is a significant percentage of massive landslides on soil cut slopes with relict sizeable failures.

Description : A massive landslide occurred on a sizeable old cut slope. The incident resulted in the permanent evacuation of three public housing blocks.

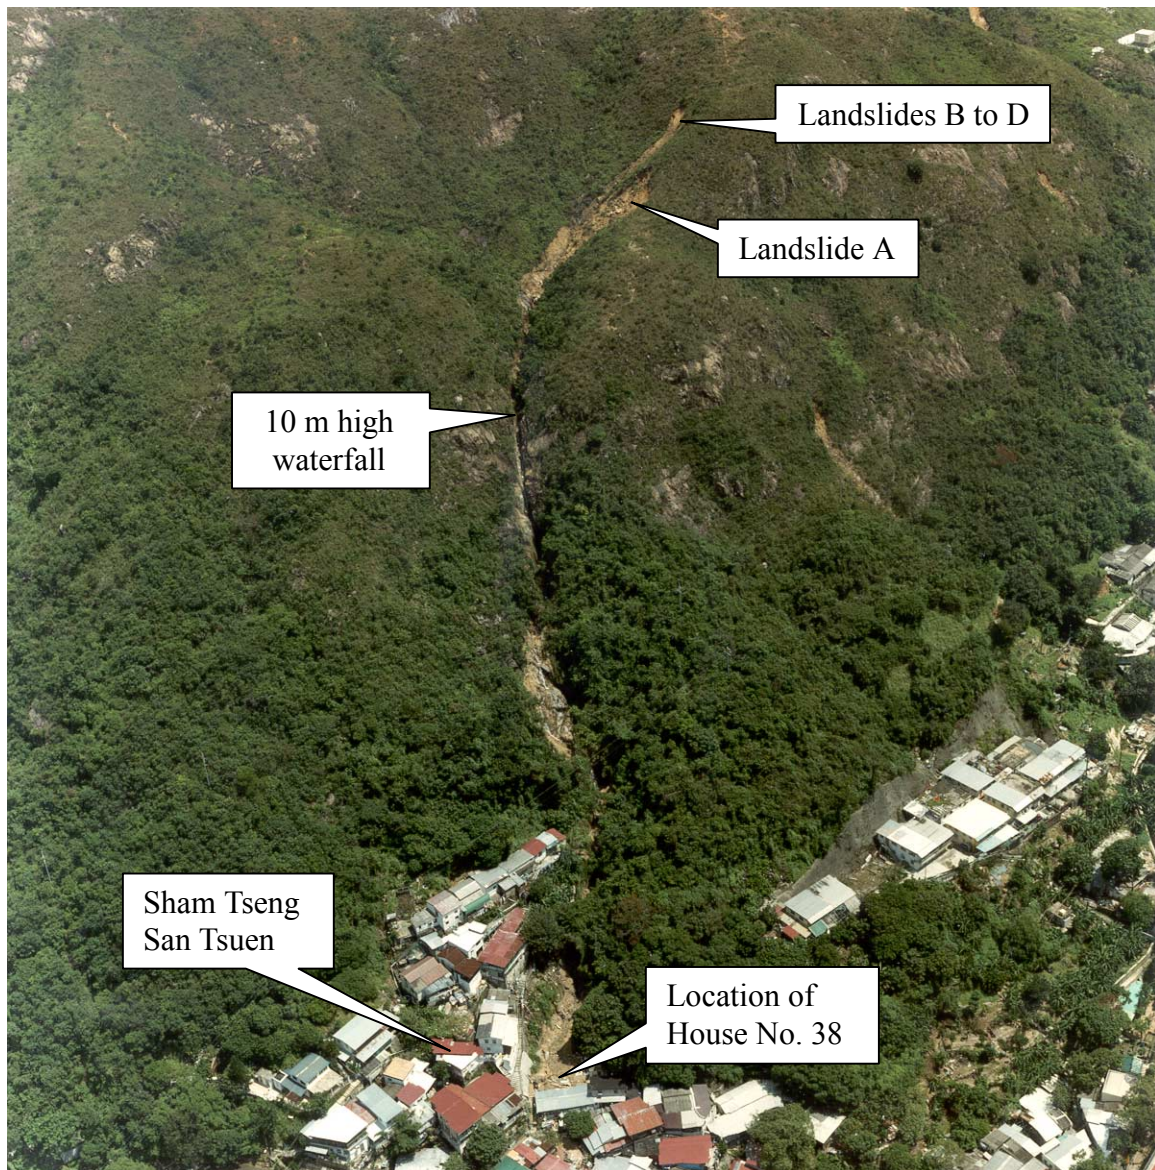
Plate 2 - Sham Tseng San Tsuen Debris Flow (FMSW, 2000b)

Description : Landslides occurred on natural hillside giving rise to a debris flow down a stream course. The debris flow demolished a number of squatter dwellings and resulted in one fatality and 13 injuries.

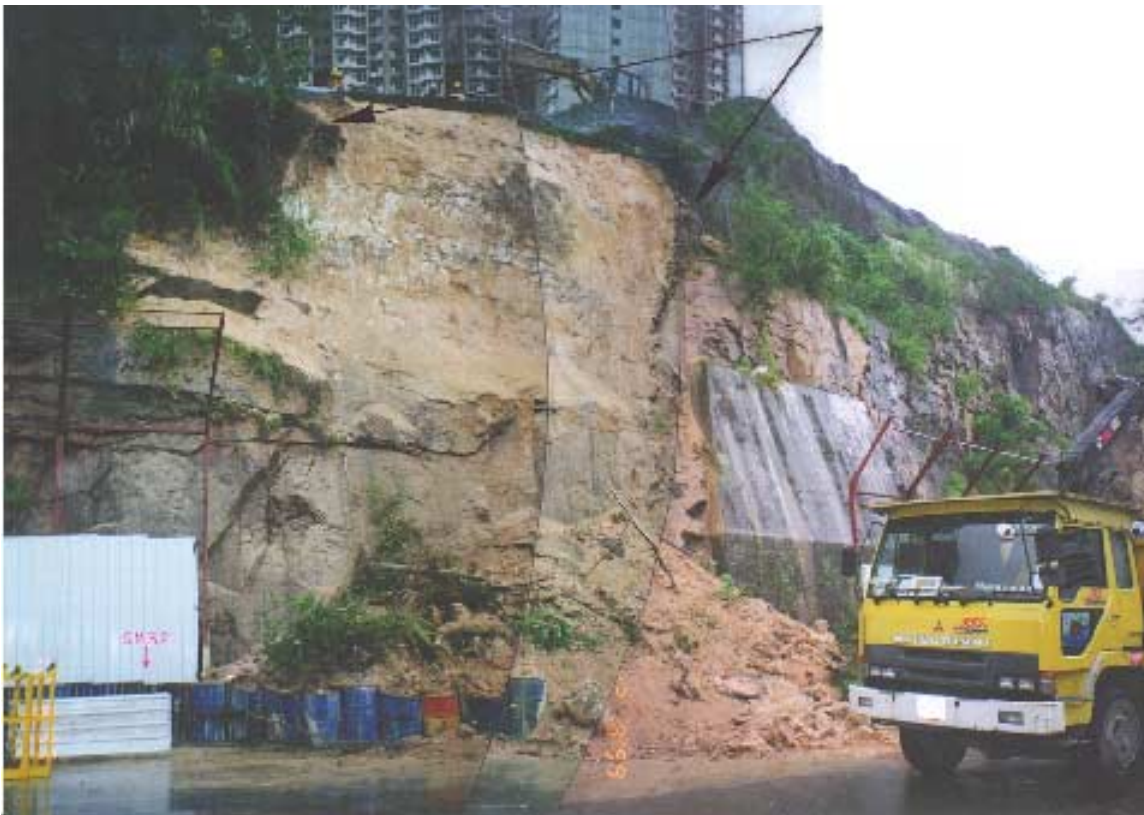
Plate 3 - Cha Kwo Ling Road, Yau Tong (FMSW, 2000c)

Description : The landslide involved a slope which was previously upgraded. At the time of failure, the slope was within an active construction site with excavation works in progress above the crest of the slope. The failure resulted in the temporary closure of Cha Kwo Ling Road.

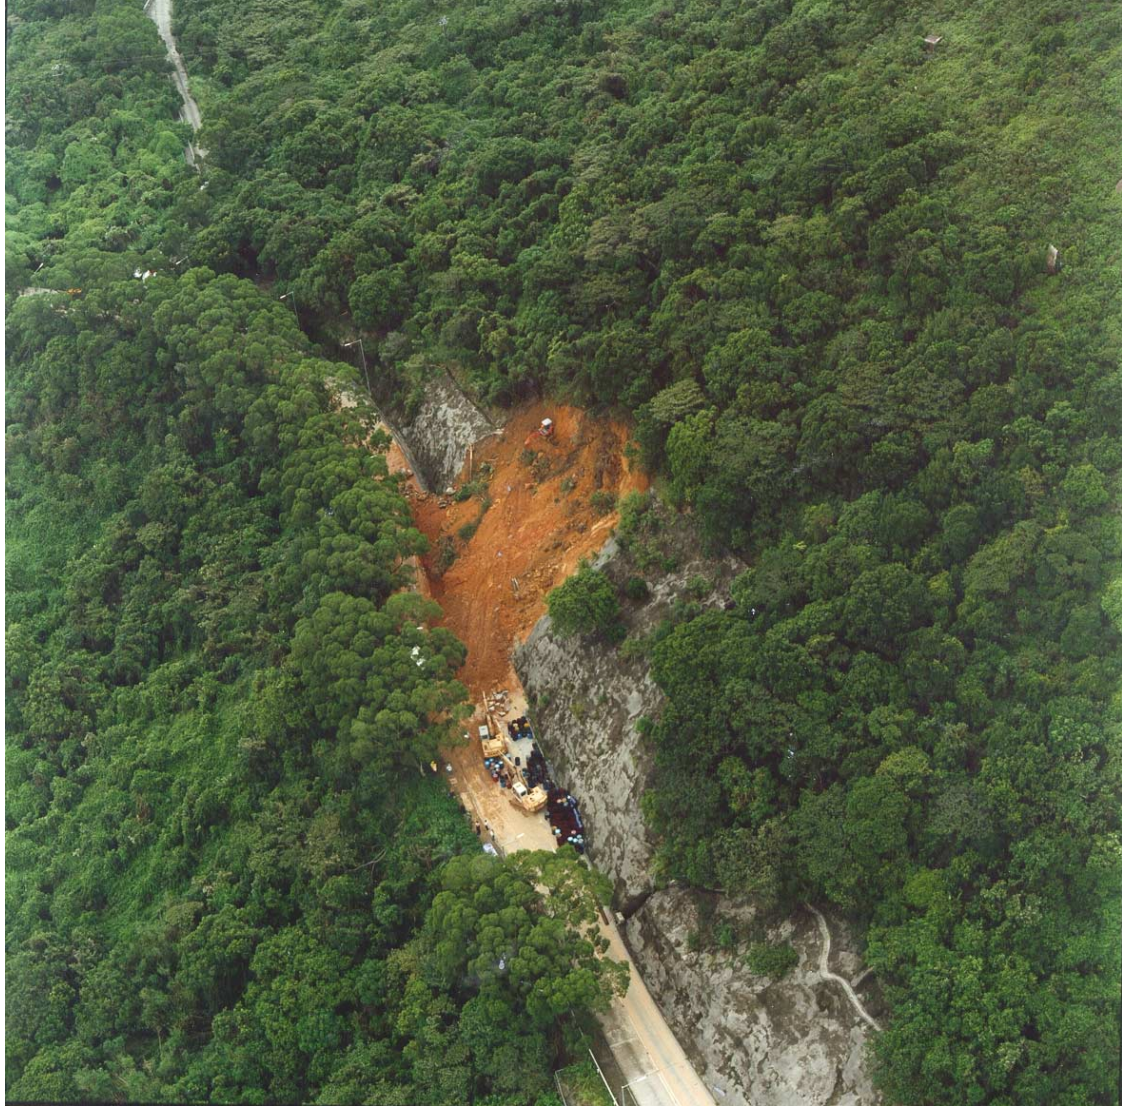
Plate 4 - South Lantau Road, near Lai Chi Yuen, Lantau Island (FMSW, 2001a)

Description : A massive landslide occurred on old cut slopes and the ground above which had a history of instability. A van was damaged by the landslide debris and the failure resulted in the complete closure of South Lantau Road for two weeks.

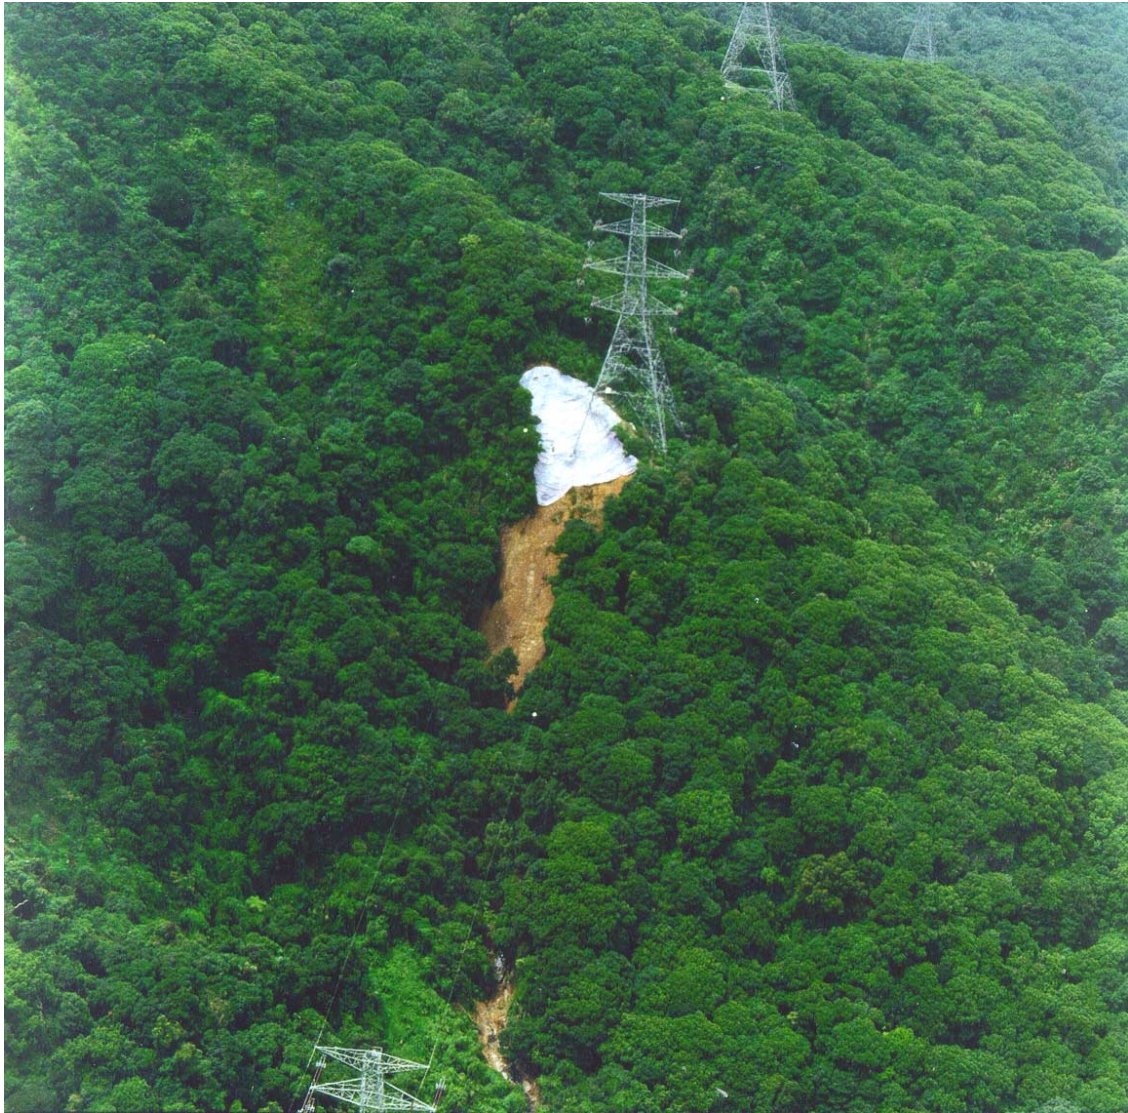
Plate 5 - Kap Lung, near Shek Kong (FMSW, 2001b)

Description : A massive landslide occurred on a hillside that was assessed as being up to the required geotechnical standards. The landslide debris became channelised and travelled for about 600 m.

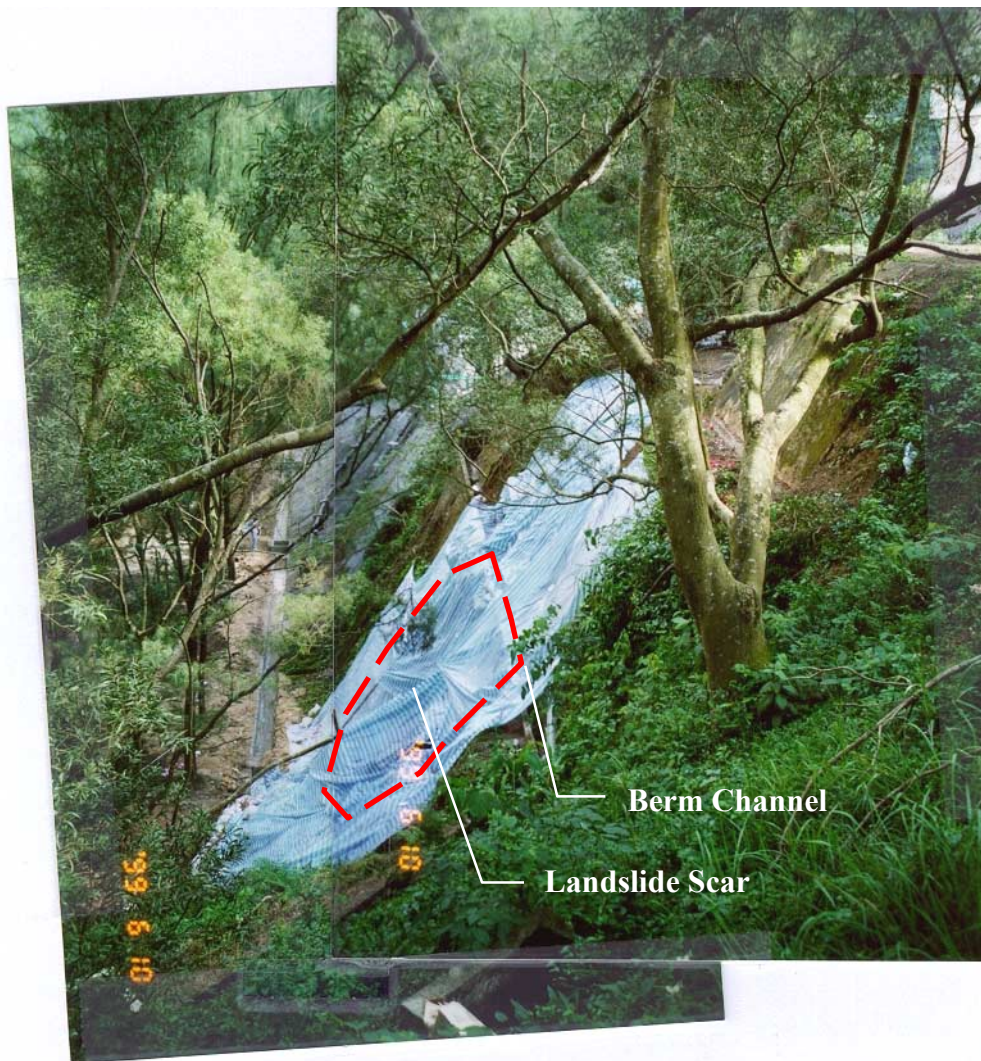
Plate 6 - Benjamin Franklin Centre, The Chinese University of Hong Kong  
(FMSW, 2001d)

Description : The landslide occurred on an old cut slope which was previously assessed as being up to the required geotechnical standards. Leakage of services was a major contributory factor in the failure.

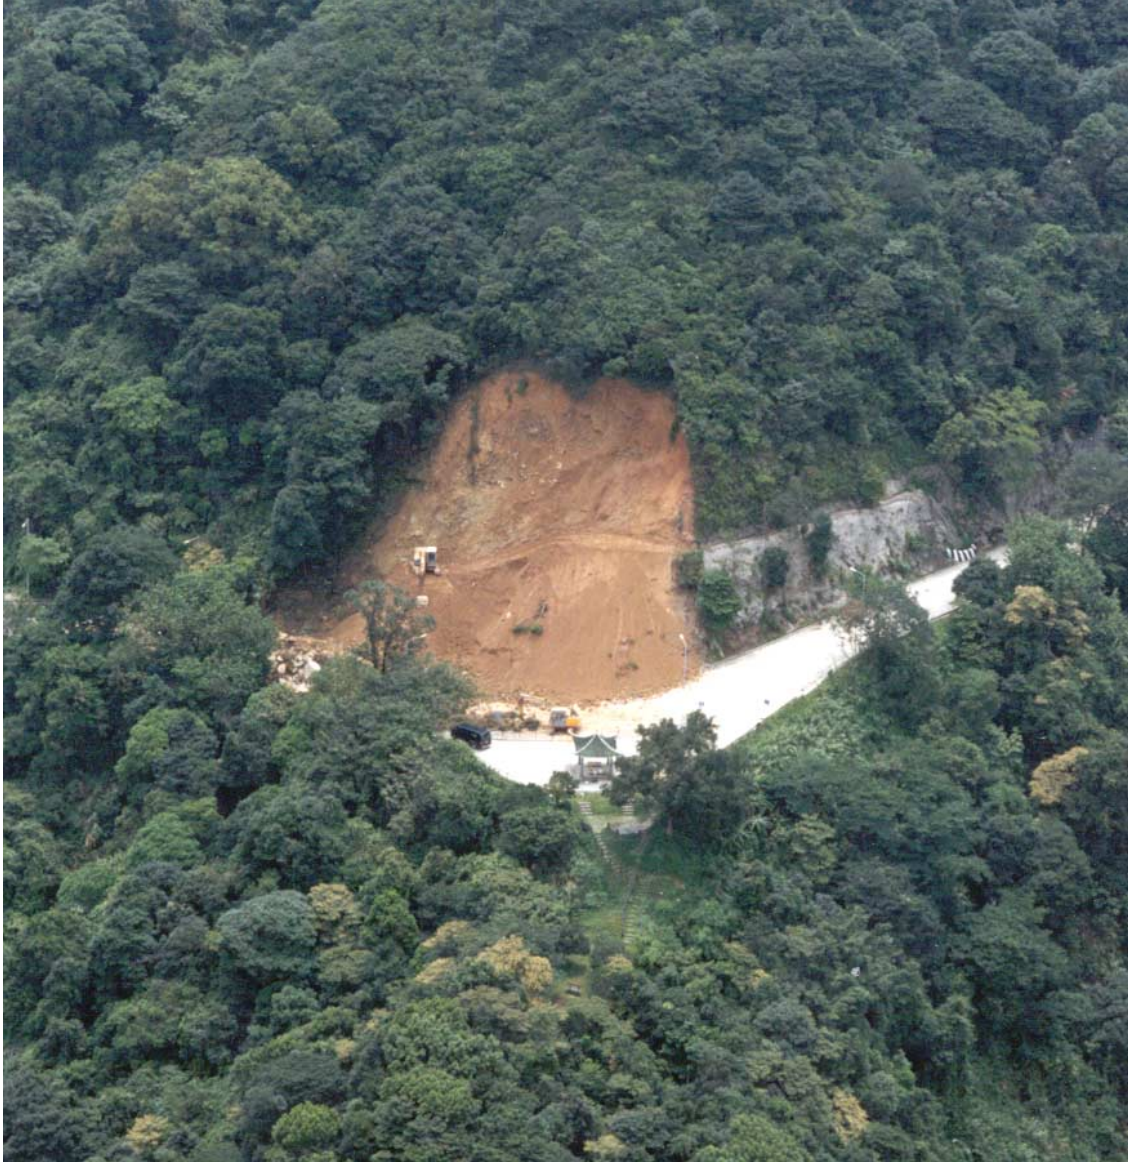
Plate 7 - Route Twisk Opposite the Lookout Point, near Shek Kong (FMSW, 2001a)

Description : A massive landslide occurred on an old cut slope which had a history of instability. The failure resulted in the complete closure of Route Twisk for several weeks.

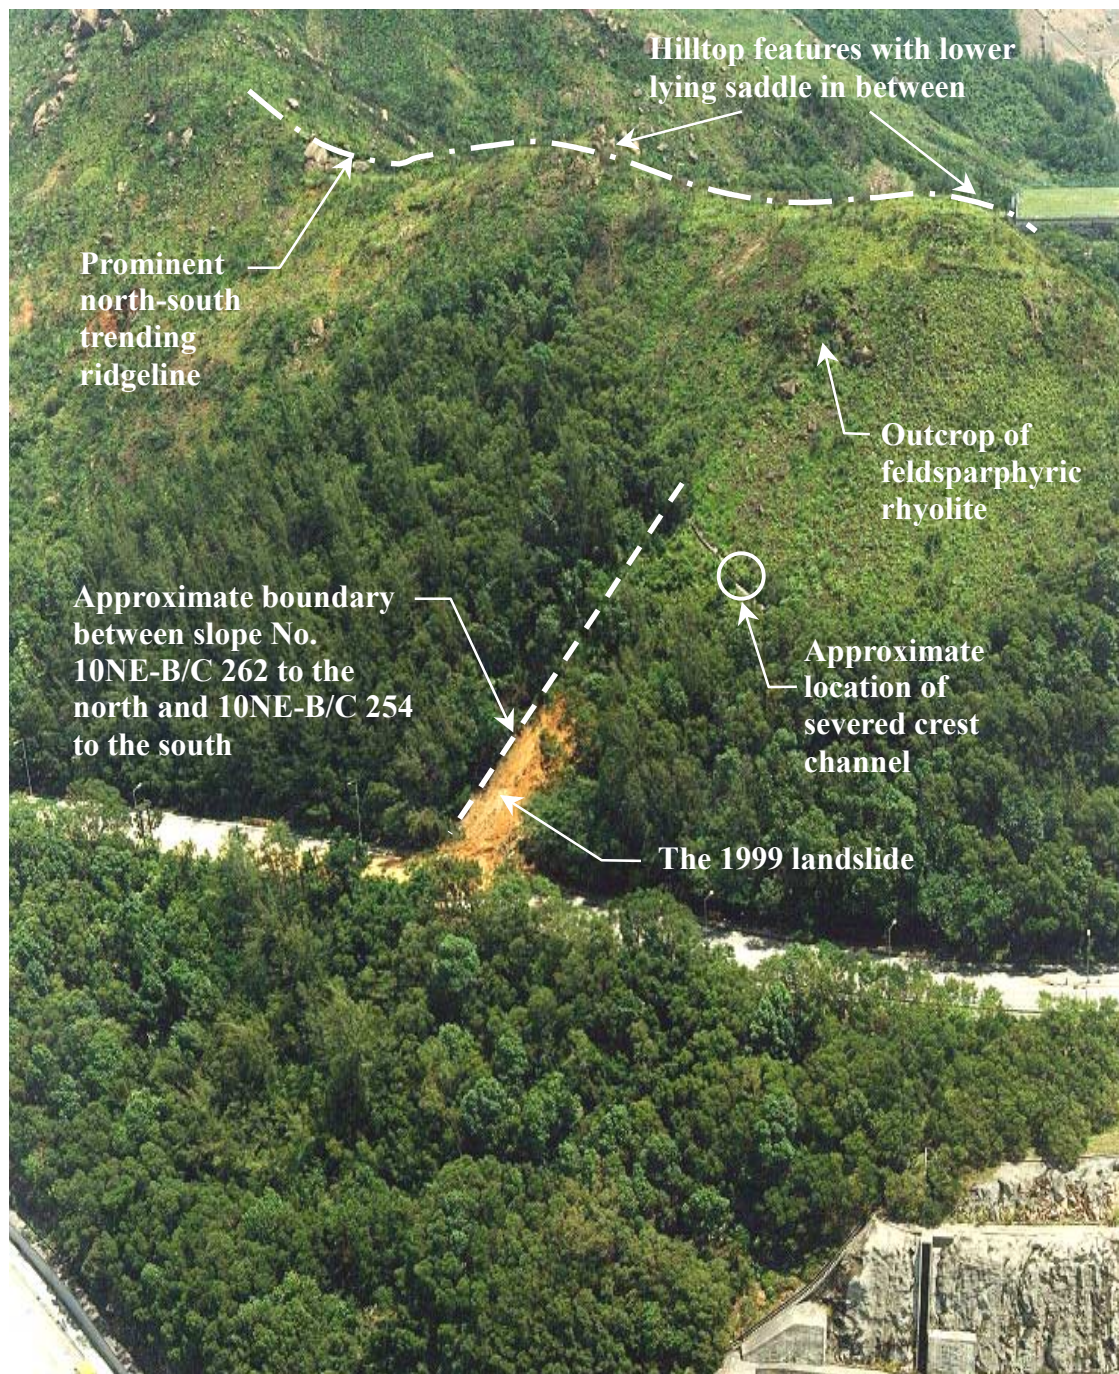
Plate 8 - Tsing Yi Road, Tsing Yi Island (FMSW, 2001c)

- (a) care must be taken in confirming the absence of signs of distress or slope deformation during maintenance and landslide inspections, and
- (b) slopes with past significant movements are liable to deteriorate as any unstable ground continues to open up without significant detachment (e.g. during a severe rainstorm) and could fail in subsequent less severe rainstorms, giving rise to landslides that are a 'surprise' in that the slopes apparently survived more severe rainstorms. Given continued deterioration, slope instability may change from a 'ductile' mode to a 'brittle' mode, particularly where there is water ingress into ground which has opened up significantly, e.g. the 24 August 1999 Tsing Yi Road landslide.

Description : A massive landslide occurred on a cut slope which was previously designed to the required geotechnical standards. Significant signs of distress and slope movement were observed several months prior to the landslide. The failure resulted in the complete closure of Tsing Yi Road for 6 weeks and the landslide debris affected a taxi and a lorry.

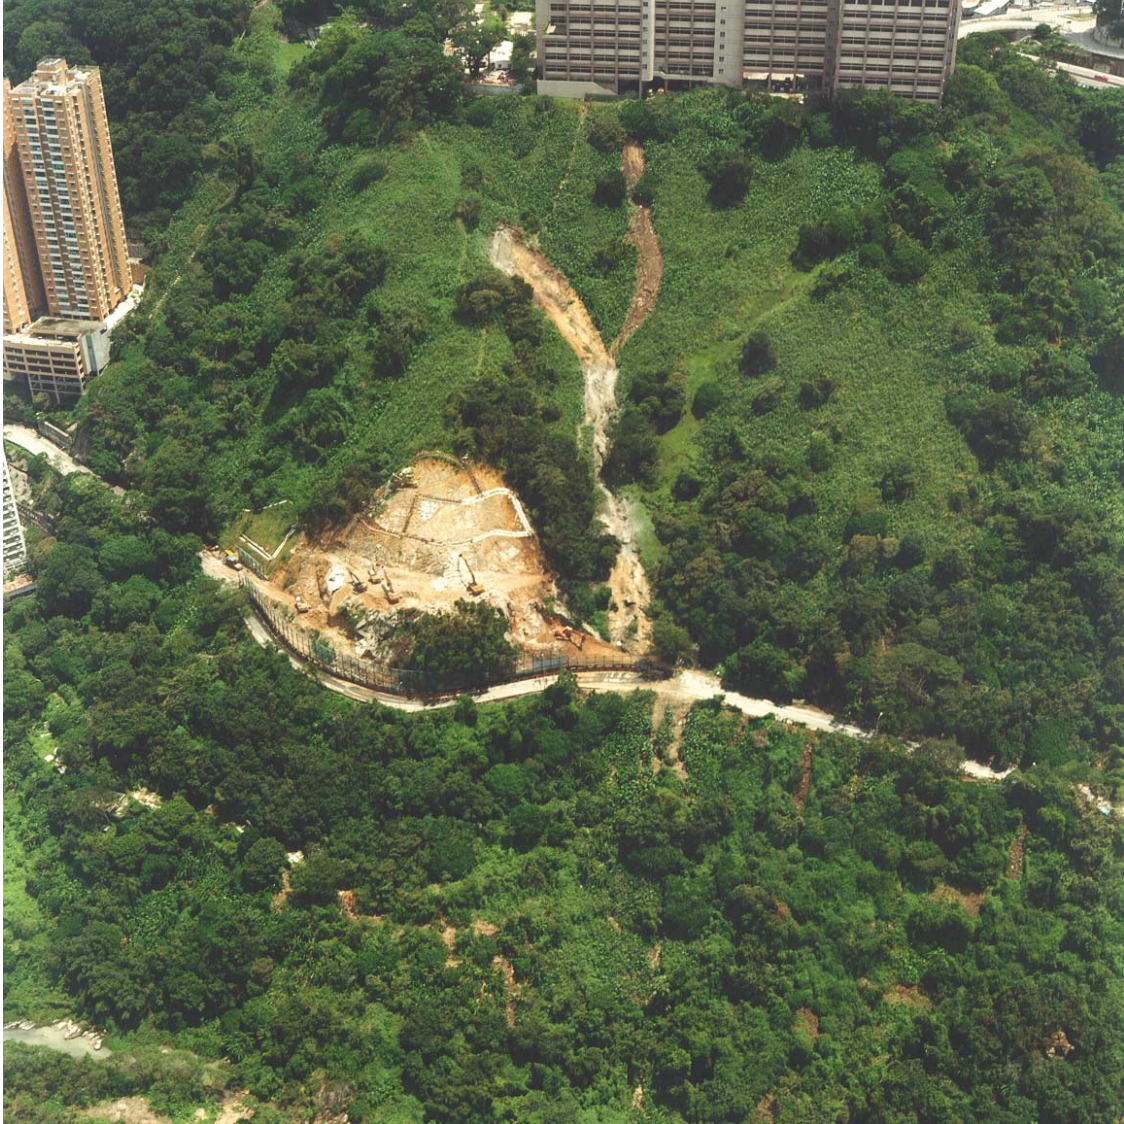
Plate 9 - Vocational Training Centre Pokfulam Skills Centre, Pokfulam Road (FMSW, 2001b)

Description : Two major landslides occurred within the same local catchment of the hillside. One of the failures involved unregistered end-tipped fill while the other involved natural terrain. Debris from both landslides became channelised in an ephemeral stream course and was transported to Victoria Road.
