APPENDIX A

AERIAL PHOTOGRAPH INTERPRETATION

APPENDIX B

ESTIMATES OF VOLUMES OF LANDSLIDES B AND C

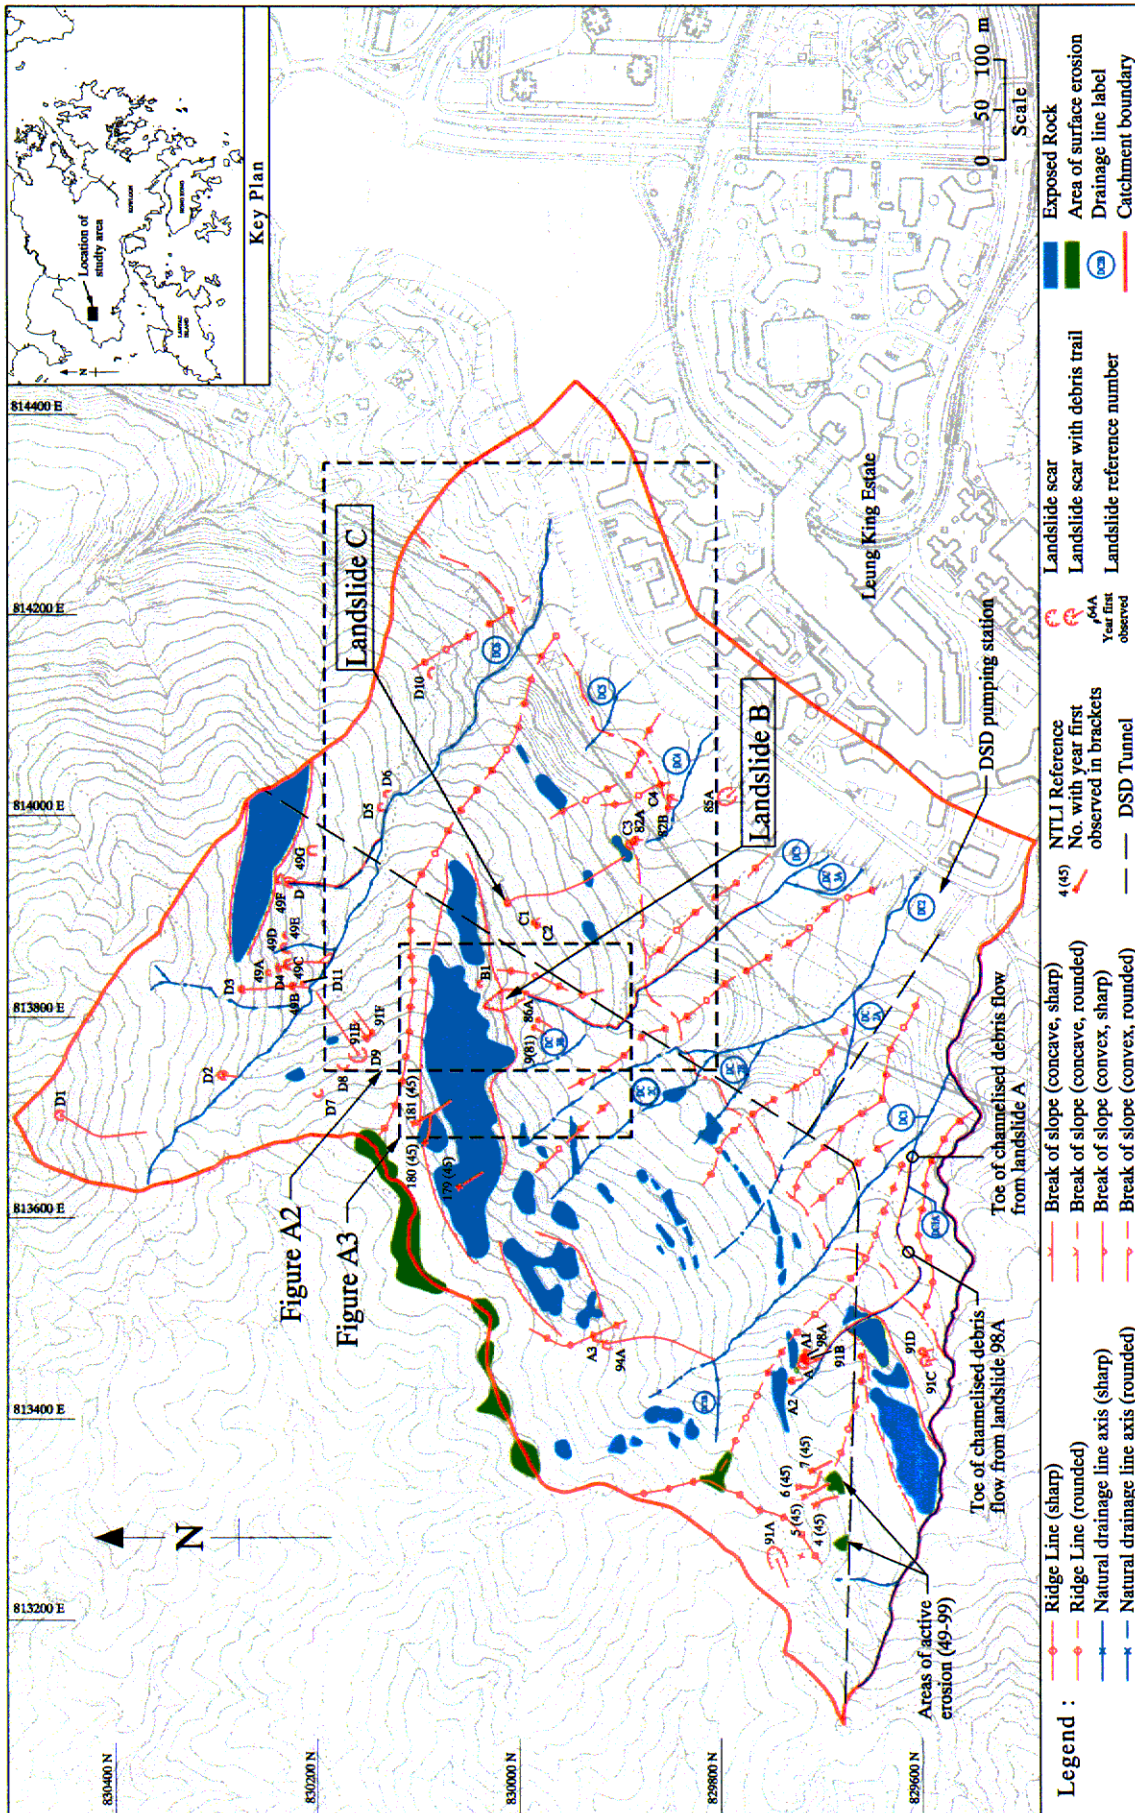
The geomorphological features within the site (defined as the catchment of Landslides A to D), interpreted from the 1949 and 1999 aerial photographs, are shown on Figure A1. All recorded landslides, both recent and relict, are also shown on this figure. Minor landslides are labelled A1, A2 etc. Figure A2 shows details of the mining activities in the vicinity of Landslide C (based on the 1949 aerial photographs), and Figure A3 shows the details of the geomorphology and interpretative observations in the vicinity of Landslide B (based on the low-level 1973 aerial photographs). Figure A4 shows the extent of hillfires identified from all available aerial photographs.

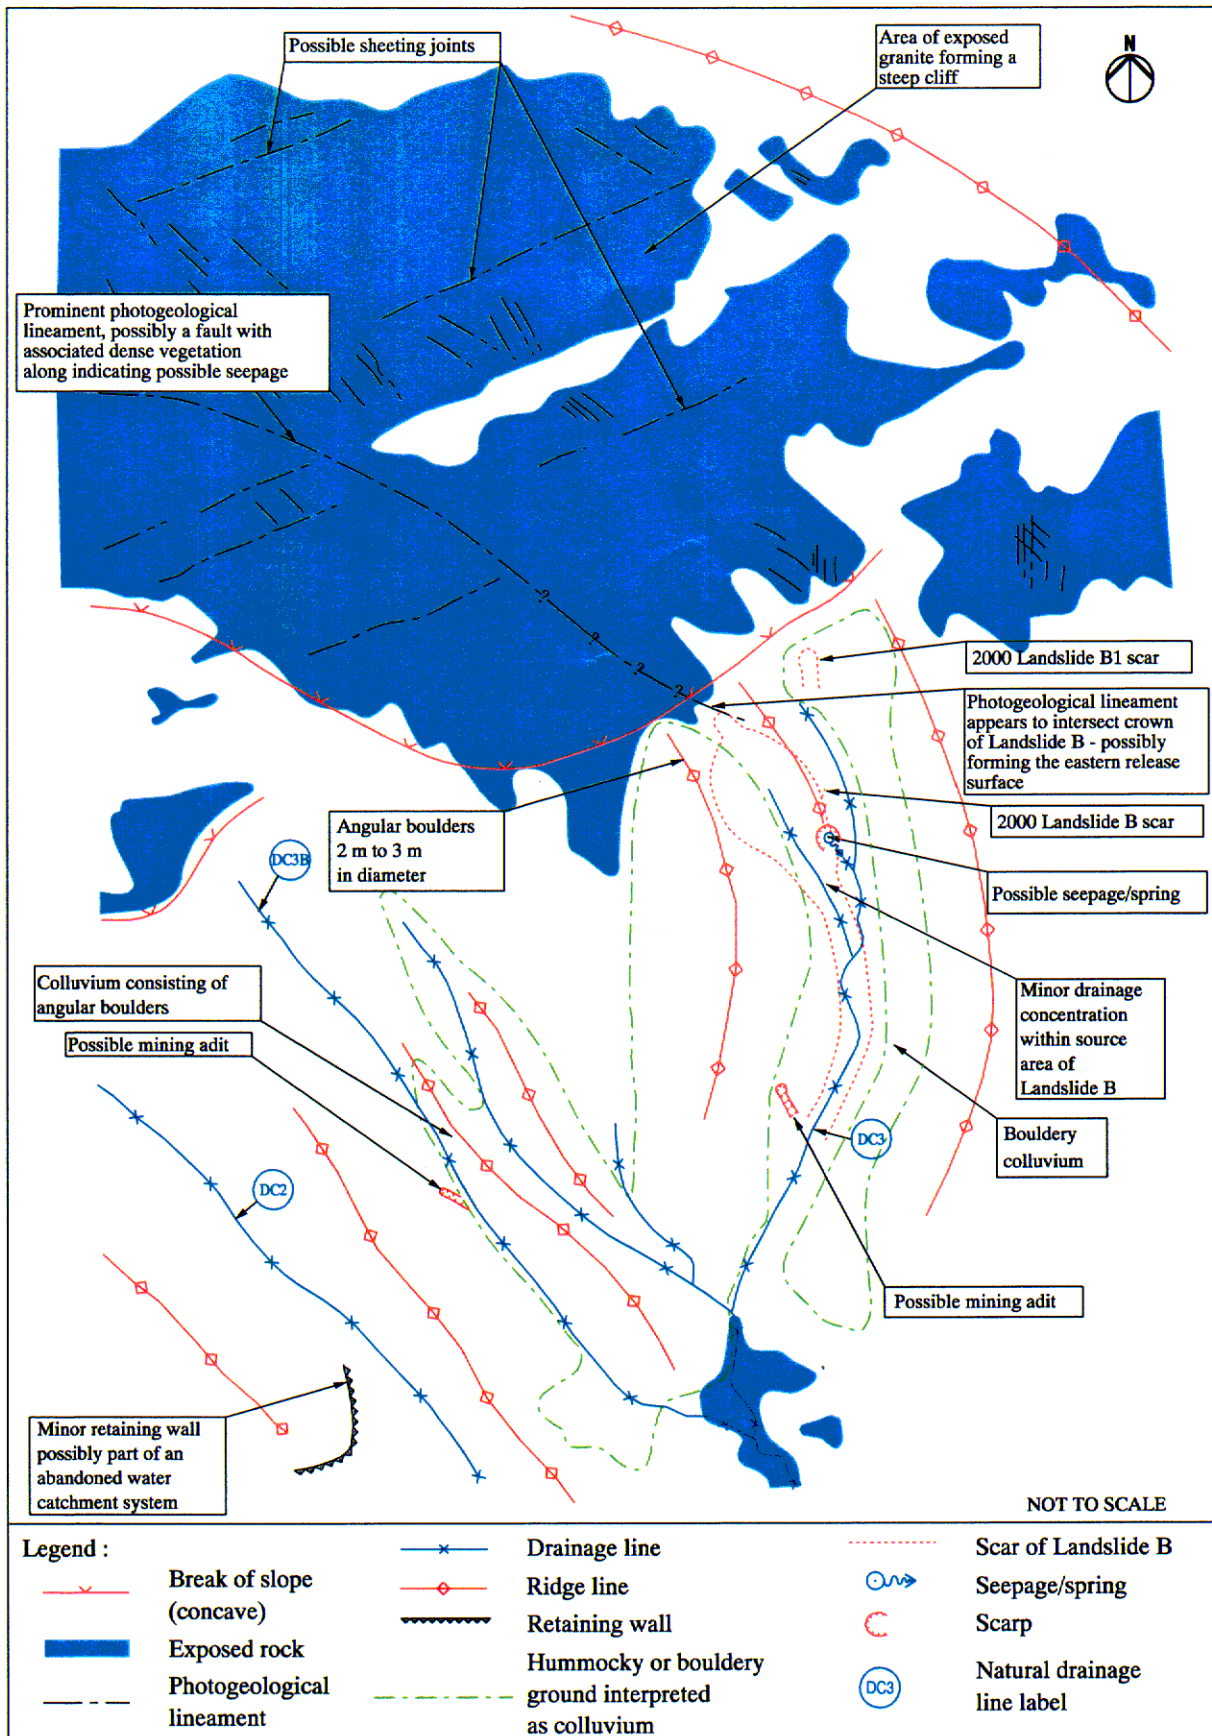
Figure A3 - Detailed Aerial Photograph Interpretation in the Vicinity of Landslide B
(Based on Photographs taken in December 1973)

YEAR	OBSERVATIONS
	<p>No recent failures are visible within the site. The fill shows signs of only minor recent surface erosion, though the previously eroded gullies are clearly visible.</p> <p>This low level photographs clearly shows the ground conditions at the locations of Landslides B and C.</p> <p>LANDSLIDE B (Figure A3) A lozenge shaped body of what appears to be colluvium (bouldery ground apparently overlying exposed rock) is visible below the exposed rock cliff to the west of natural drainage line DC3. A second accumulation of colluvium consisting of angular boulders is visible within the adjacent natural drainage line to the west (DC3B). Close to the head of the drainage line is what appears to be a minor recent failure, with a gully leading directly from this failure into the drainage line below. It is considered likely that this represents a natural seepage (spring). The possible spring is located within the source area of Landslide B. A minor natural drainage concentration is visible along the centre line of the source area of the landslide. A prominent steeply inclined cliff of exposed granite is visible directly above the source area. A series of parallel west to east trending persistent photogeological lineaments (probably sheeting joints) traverse the exposed rock cliff face. Sparse vegetation is visible along these lineaments. A single curved lineament (fault?), with a broadly northwest to southeast trend cuts (and appears to displace) these parallel features and appears to run towards the location of the source of Landslide B. Dense vegetation is visible along parts of this feature indicating possible seepage.</p> <p>LANDSLIDE C. The mining cut slope along which Landslide C occurred appears higher, possibly by 2 m to 3 m, than the adjacent mining cut slopes. The crest of the slope in plan forms a partly crenulated boundary, probably as a result of numerous juxtaposed minor failures and local areas of erosion on the slope. Irregular lobes of fill, marked by the absence of vegetation, and bouldery ground occur below the cut slopes. In places, the cut slopes have been exposed to past concentrated surface water flows resulting in the formation of erosion gullies both in the fill and natural ground. To the west of the source area is a rounded depression from which a poorly defined natural drainage line forms. An irregular area of exposed rock forming a minor cliff is located above the source area. Regular photogeological lineaments visible on the cliff are probably associated with jointing. A second exposure of rock is visible in the drainage line below the source area (a retaining wall located on this rock exposure, noted in the July 2000 site inspection, has yet to be constructed).</p>

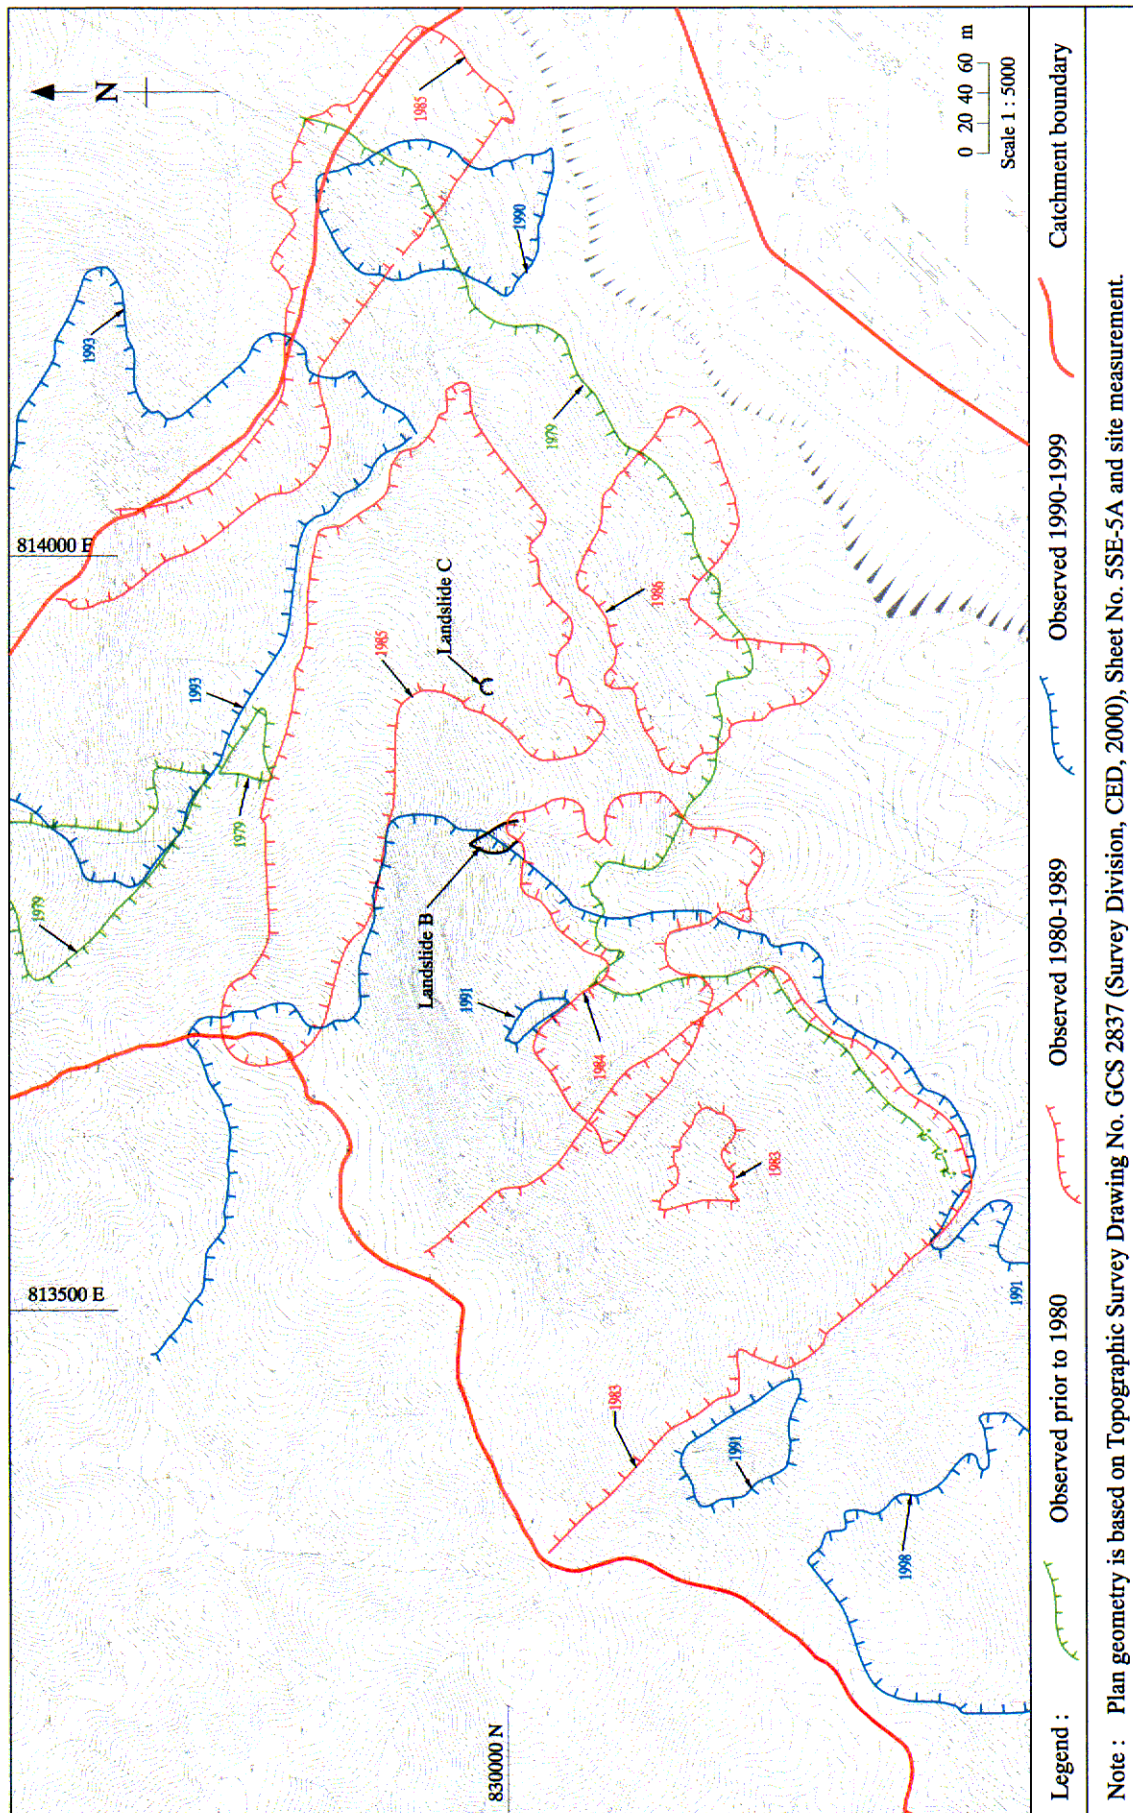
Figure A4 - Location of Hillfires within Study Area (Based on Aerial Photographs taken between 1949 and 1999)

YEAR	OBSERVATIONS
	<p>An area of pale coloured ground, due to a minor hillfire, is visible at the eastern end of the site (Figure A4). Where the vegetation has been burnt, the gullies within the fill are clearly visible.</p> <p>A single recent failure (85A) is visible above the recently excavated cut slope on the west flank of DC4.</p>
1985	<p>A pale disturbed area of vegetation indicating a recent hillfire is visible on the southwest flank of DC6</p>
1986	<p>A crib wall (Slope No. 5SE-B/R5) is under construction at the base of the cut slope (Slope No. 5SE-B/CR26) above Leung King Estate.</p> <p>Much of the hillside has been affected by a major hillfire. As a result of removal of the vegetation cover, linear zones of pale surface coloration leading from the areas of erosion along the ridgelines, down the natural drainage lines are clearly visible. These features on the NTLI are shown (incorrectly) as debris trails.</p> <p>A minor open hillside type failure (86A) is visible on the natural hillside between DC3 and DC3B</p>

YEAR	OBSERVATIONS
	road appears complete. Otherwise there is no visible change.
1993	Construction of the DSD pumping station is complete. A hillfire has affected the natural hillside to the northeast of DC6 (Figure A4). A landslide scar (93A) is visible at the same location as the 1991 failure (91B) at the head of DC1A.
1994	A recent partially channelised failure is visible on the northeast flank of DC1 (94A). Otherwise there is no visible change.
1996	An area of previously natural hillside adjacent to the southwest boundary of the site is under cultivation. Otherwise there is no visible change.
1996	Evidence of minor recent hillfires visible adjacent to DC1 and to the northwest of DC6 (Figure A4). Otherwise there is no visible change.
1998	A prominent channelised failure visible at the head of DC1A (98A). The debris has accumulated within a relatively level area below a rock exposure.
1998	High level poor quality photographs. Damage from a minor hillfire is visible at the southwest boundary of the site (Figure A4).
