**INVESTIGATION OF SOME
SELECTED LANDSLIDES
IN 2000
(VOLUME 2)**

GEO REPORT No. 130

**SECTION 1:
DETAILED STUDY OF
THE 24 AUGUST 2000
LANDSLIDE ON FILL
SLOPE NO. 15NE-B/FR123
BELOW SHEK O ROAD**

**This report was originally produced in July 2001
as GEO Landslide Study Report No. LSR 5/2001**

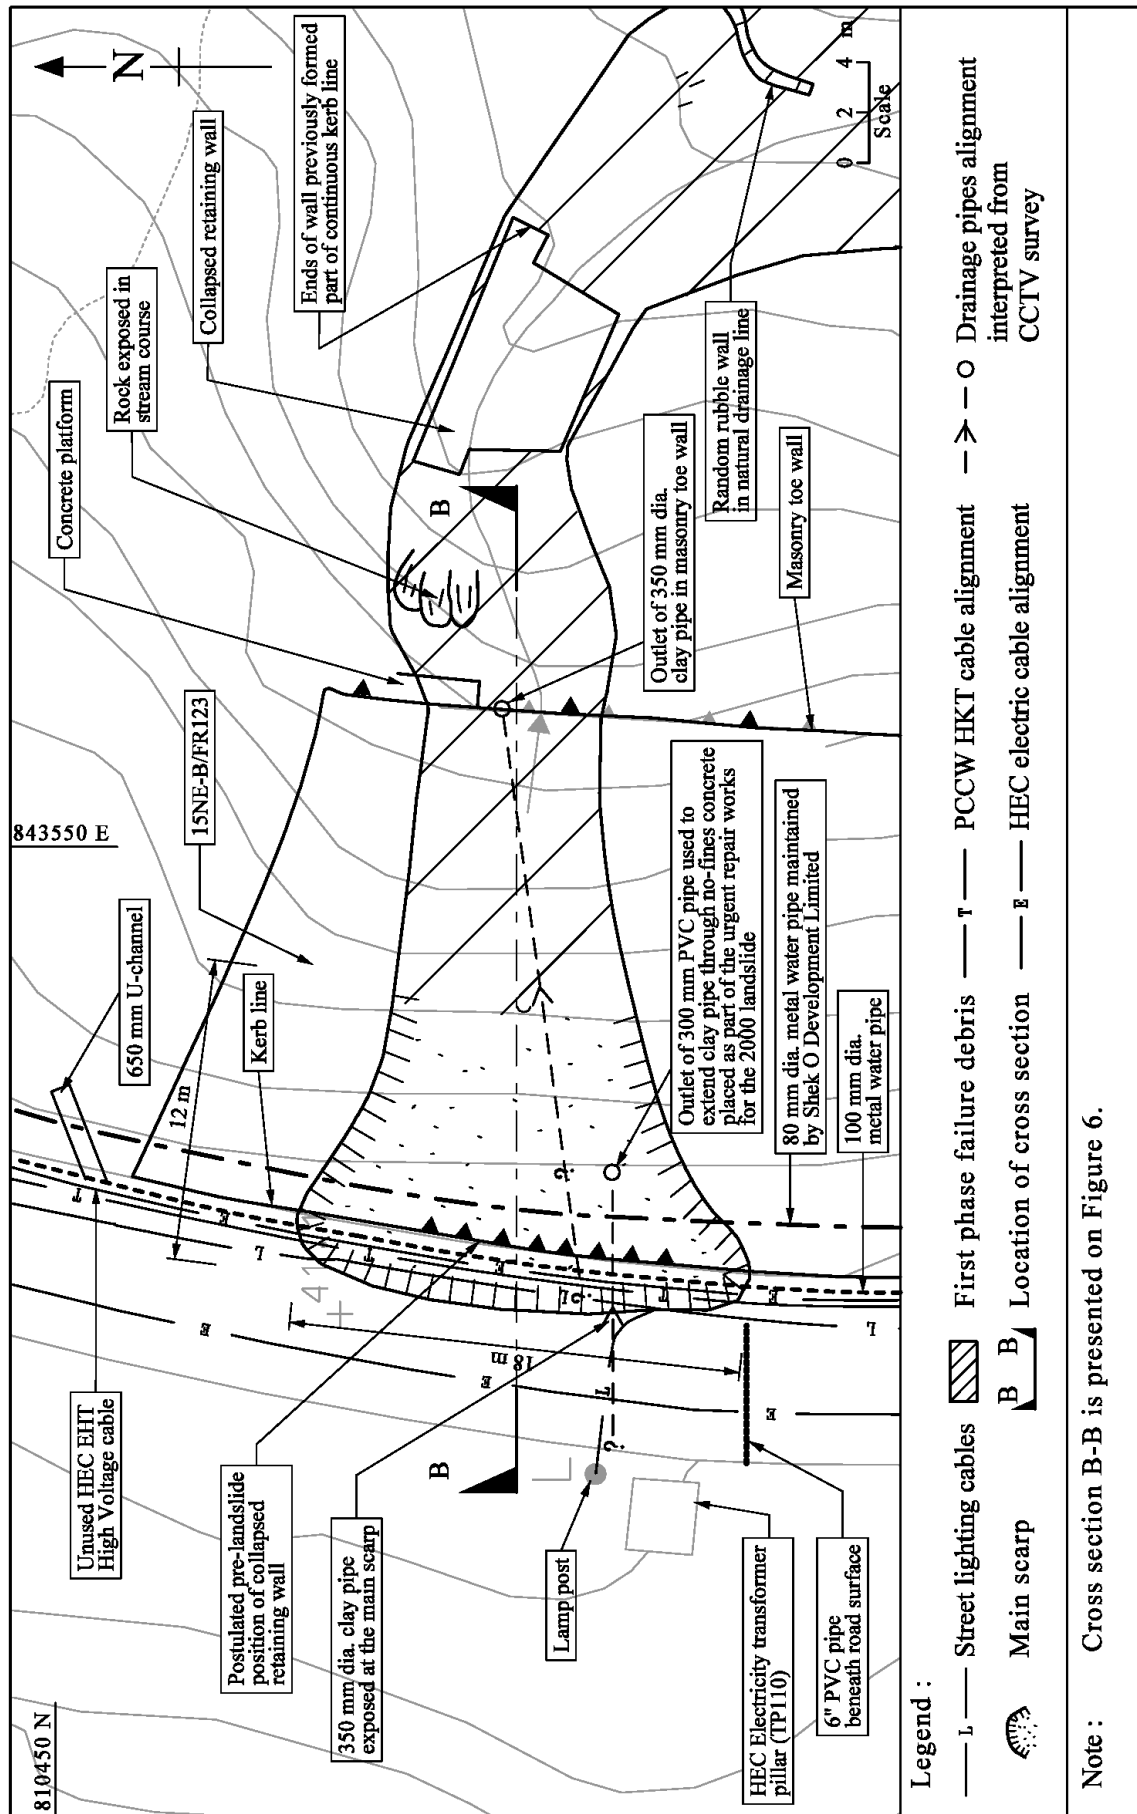
Figure 4 - Detailed Plan of the Landslide Scar

During the inspection by FMSW at 12:15 hours on 24 August 2000, the landslide scar was estimated to be about 18 m wide, 12 m long and 8 m deep (Figure 4). The inclination of the main scarp was near vertical at the crown and varied between 70° and 25° along the flanks of the landslide scar downslope. The majority of the landslide debris comprised very loose, very wet, silty sand with much gravel and occasional cobbles. Fragments of concrete and asphalt from the road surface were also found in the debris (Plate 3). Fragments of chunam cover and concrete blocks, probably from a platform at the base of the concrete retaining wall as identified by API (see Section 2.3), were also found within the landslide debris during subsequent site inspections by HCL (see Section 3.4).

A plot of the inferred alignment (Figure 4) of the two pipes indicates that the pipes might converge at a point on the western side of Shek O Road. These pipes could not be probed to a point further than underneath the Shek O Road surface. An inspection pit was excavated to a depth of 2.1 m, adjacent to the HEC transformer pillar, at the estimated position of the point of convergence for the pipes. No evidence of a catchpit or buried pipes was found.

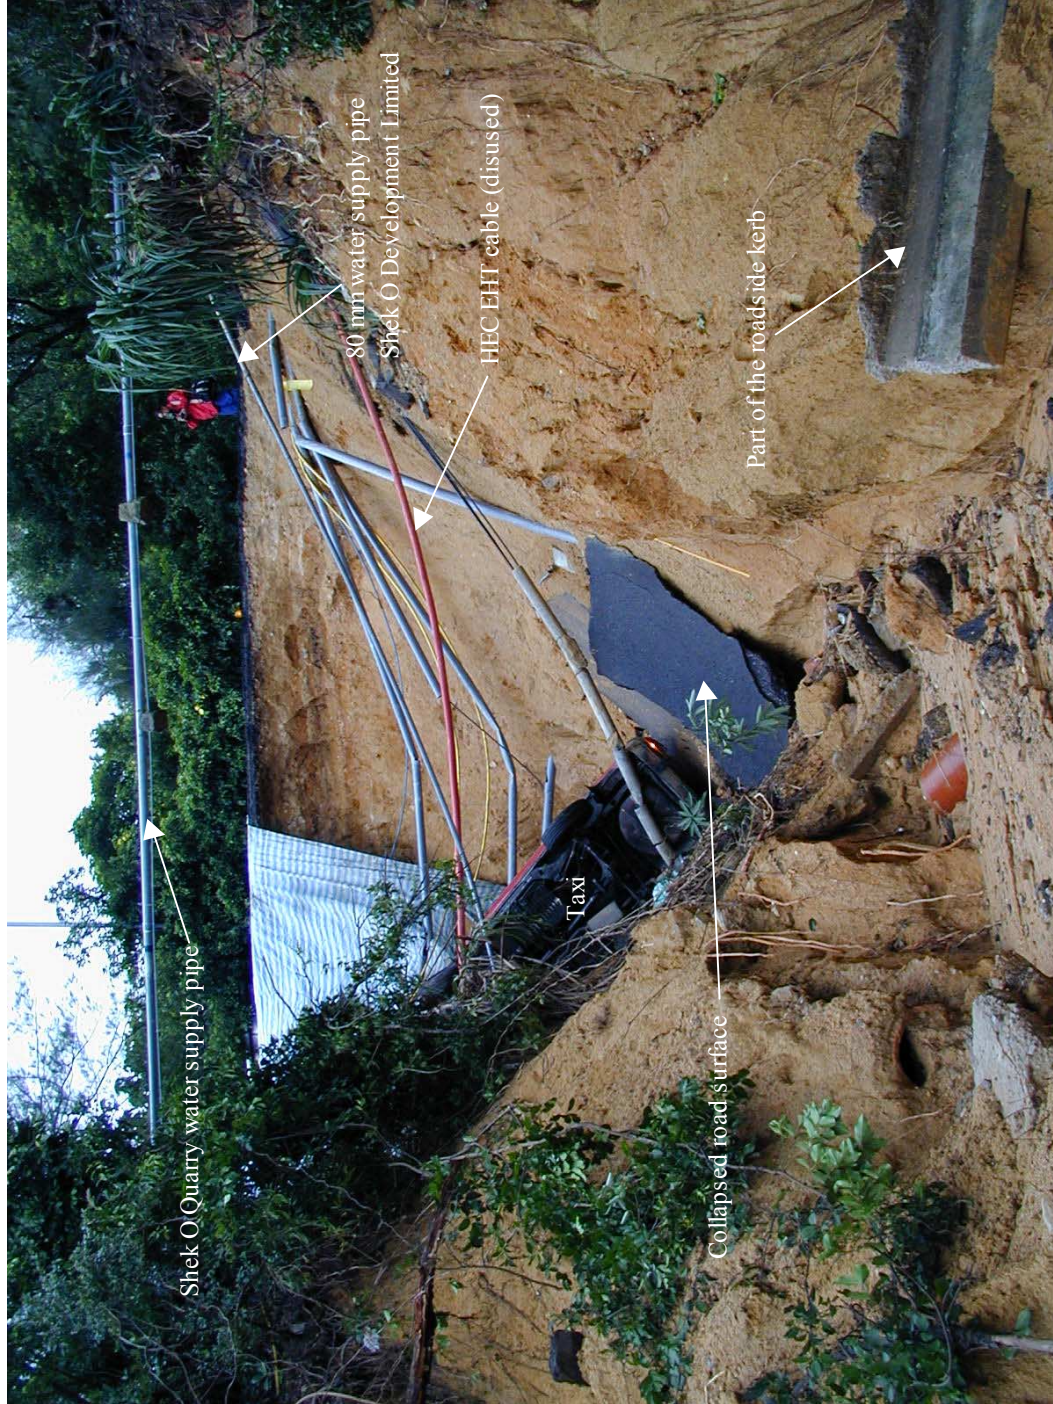
Shek O Quarry Limited maintained a 100 mm diameter metal water pipe (Figure 3 and Plates 3 and 4) that runs along the top of the kerb, supported on a series of concrete bosses, on the eastern side of Shek O Road at the crest of the fill slope. According to the Lands Department, this water pipe was installed in the early 1990’s to supply water to the casting basin at Shek O Quarry. The pipe was not damaged by the landslide. Pioneer Quarries Limited, who operate Shek O Quarry, confirmed in March 2001 that the water pipe was operational at the time of the landslide and remains in operation. Since the end of 2000,

Plate 3 - General View of the Landslide (Photograph Taken on 24 August 2000)

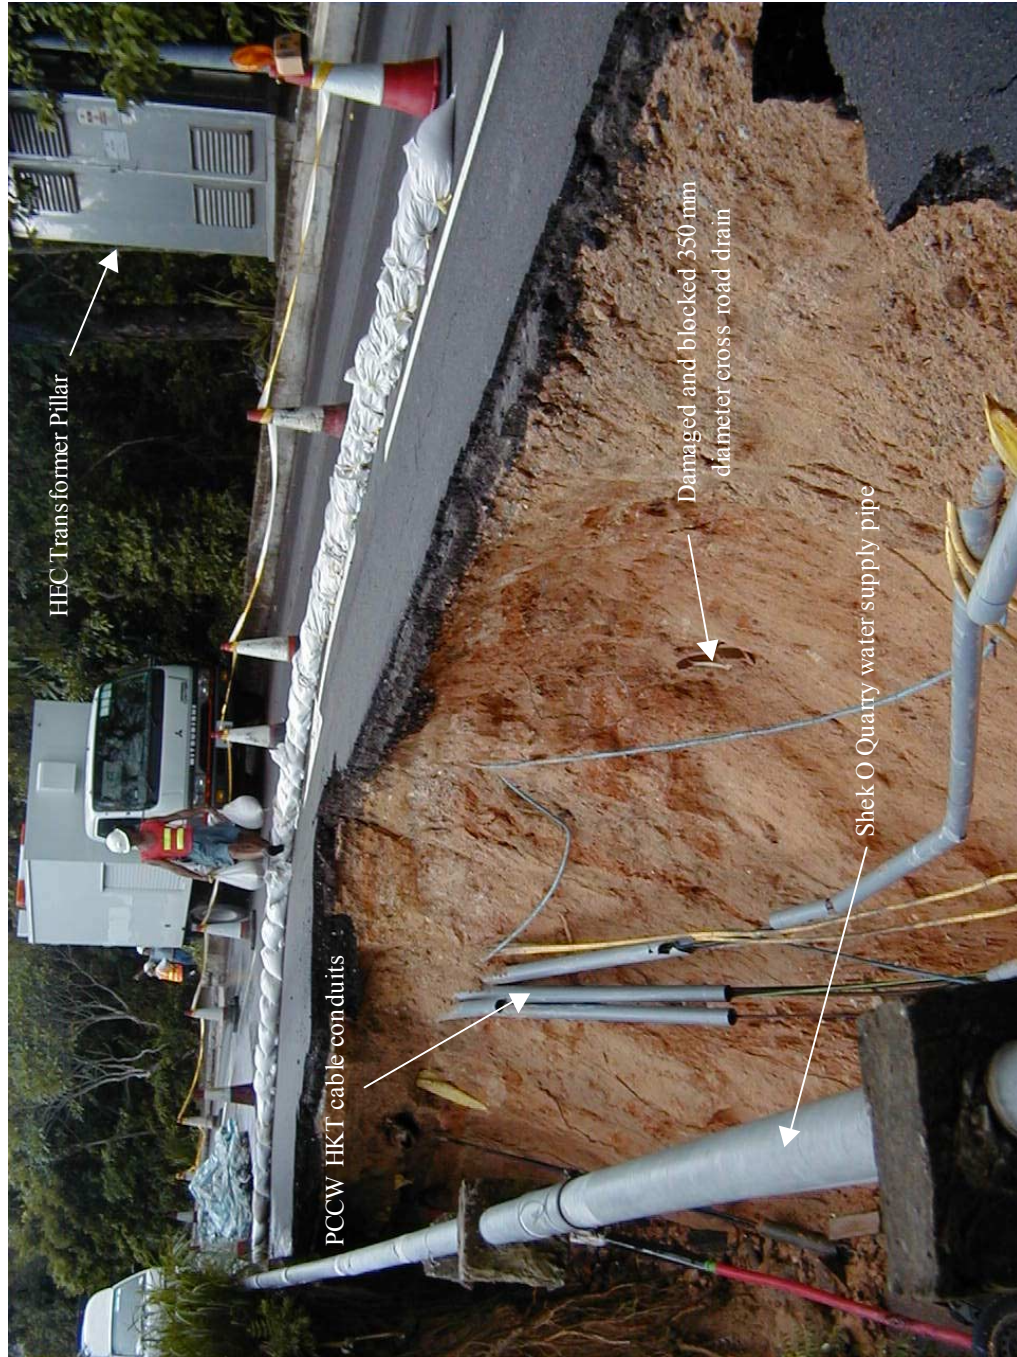
Pacific Century Cyberworks Hongkong Telecom Limited (PCCW HKT) maintained six 107 mm diameter PVC cable conduits beneath Shek O Road (Figure 3), two of which were installed in 1973 while the rest were installed in 1989. All six conduits, which were confirmed by PCCW HKT to have friction-fit joints, were exposed and broken by the 2000 landslide (Plate 4).

Plate 4 - General View of the Main Scarp of the Landslide (Photograph Taken on 24 August 2000)

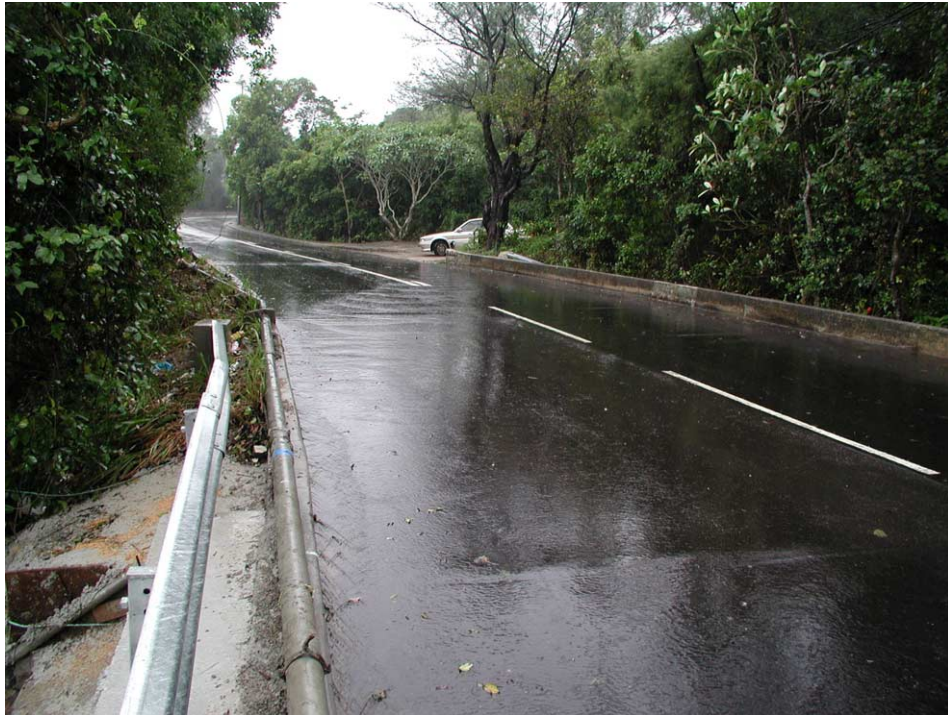
Plate 5 - Water Flowing from Access Road to No. 18 Shek O Road towards Slope No. 15NE-B/FR123 (Photograph Taken on 20 October 2000)

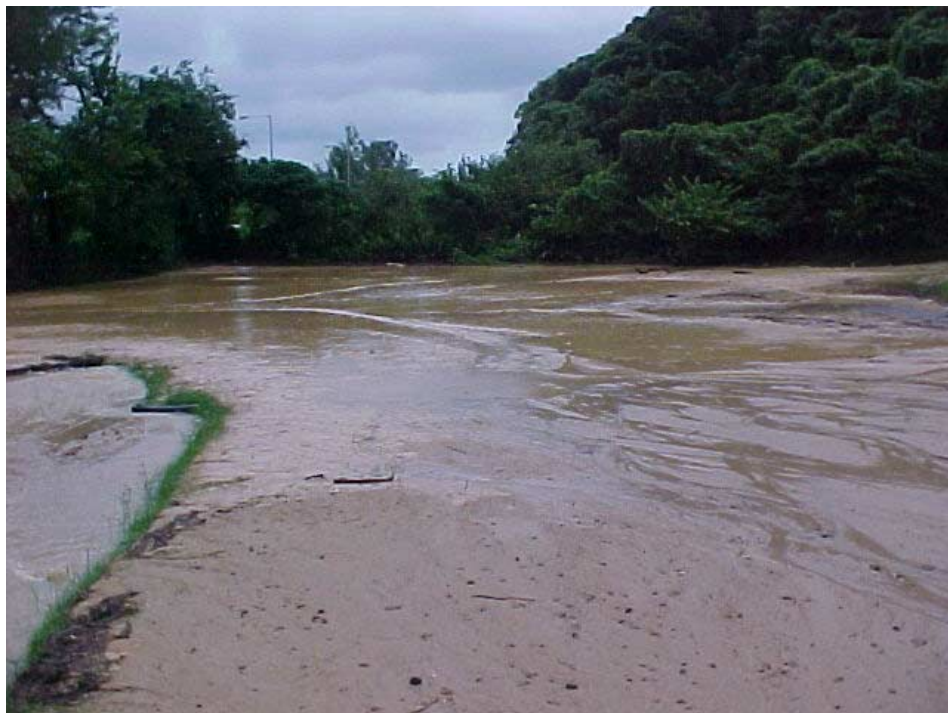
A detailed inspection of the debris trail and the collapsed retaining wall was not possible by FMSW, since at the time of their inspection “soil continued to spall intermittently off the nearly vertical main scarp”. During a later inspection by HCL on 29 August 2000, it was observed that much of the landslide debris had been washed away by intense rainfall. However, it could be observed that landslide debris had travelled along a natural drainage line below the masonry toe wall, and spread in two directions with the majority of the landslide debris deposited in the natural stream course (Figure 3). It is probable that a large volume of water was flowing down the natural stream course at the time of, and after, the landslide. This caused flooding of the area below and washed out fine-grained material, essentially sandy silt, from the landslide debris depositing it over a wide area of the golf course (Figure 2 and Plate 6).

Plate 6 - Debris Washout onto the Golf Course
(Photograph Taken on 24 August 2000)

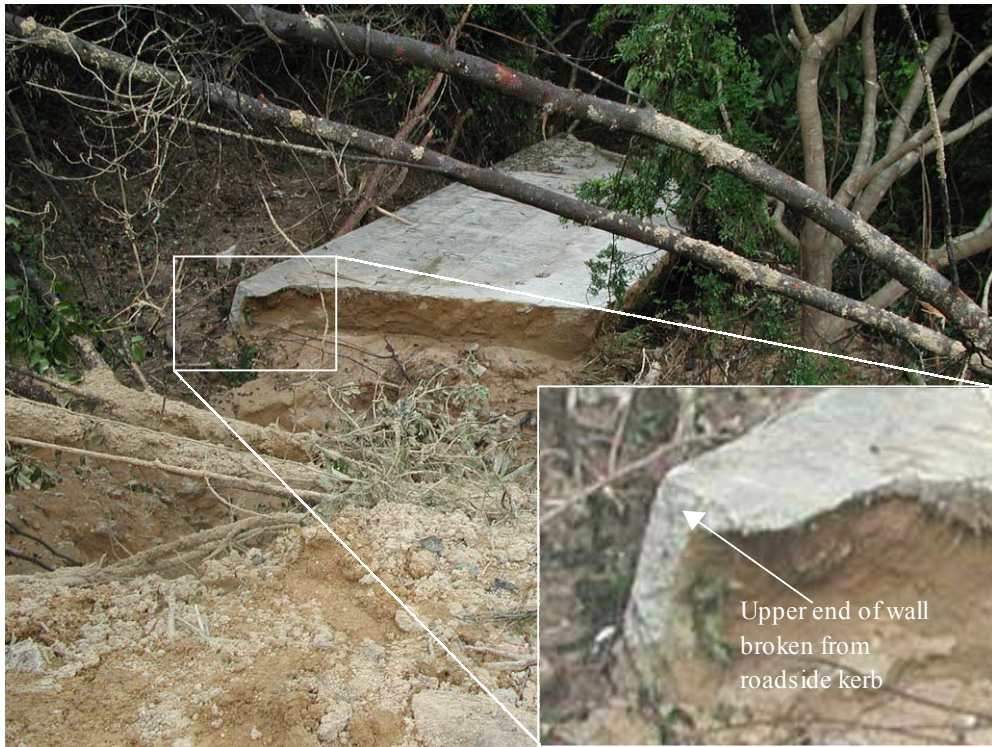
The concrete retaining wall at the slope crest, that had previously supported the eastern side of Shek O Road, was transported as an intact block about 40 m downslope within the natural drainage line (Plate 7). The wall was deposited on its rear face and had been rotated through about 90° with its northern side facing downslope (Figures 3 and 4). It was observed that some fill material remained attached to the collapsed wall and was partially embedded in the concrete. This suggests that the wall had probably been constructed as a mass concrete retaining wall directly onto the fill. It was observed that the upper 0.2 m of both ends of the concrete retaining wall were broken locally at the crest (Plate 7), which demonstrates that the roadside kerb was probably cast into the retaining wall forming a continuous upstand along the edge of the road. The concrete retaining wall was about 10 m long at the crest and 6.5 m long at the toe with a maximum height of 3.6 m. The wall was 0.5 m thick at the top and about 1.4 m at the base. The wall base was typically inclined at about 75° to 80° away from the front face (Figure 6). The front face of the wall, based on the right-angle between the top of the wall and the front face, was probably vertical prior to failure.

Plate 7 - General View of the Collapsed Retaining Wall
(Photograph Taken on 29 August 2000)

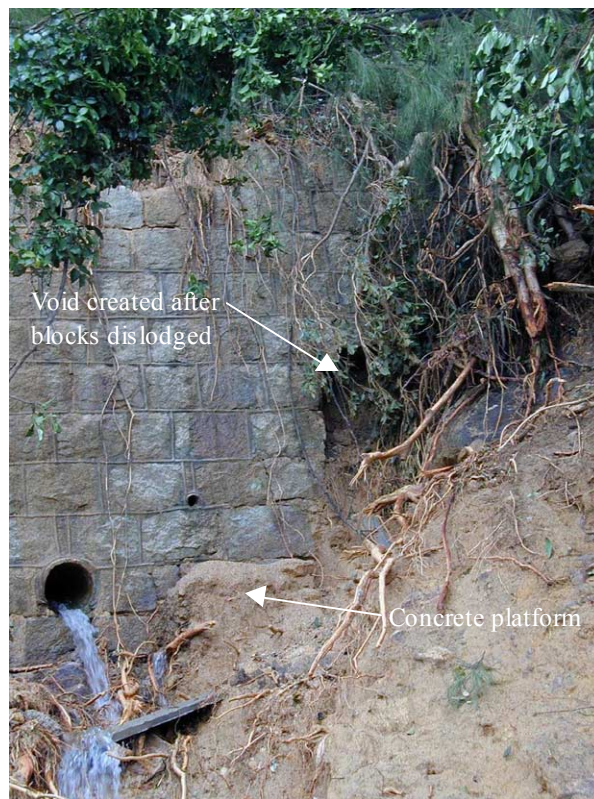
Minor signs of distress were observed in the masonry toe wall, including minor loss of pointing and minor displacement (< 3 mm) of blocks, although one or two blocks appeared to have been dislodged from the northern end of the wall (Plate 9).

Plate 9 - View Showing Northern End of the Masonry Toe Wall and Location from Where Masonry Blocks have been Dislodged (Photograph Taken on 24 August 2000)

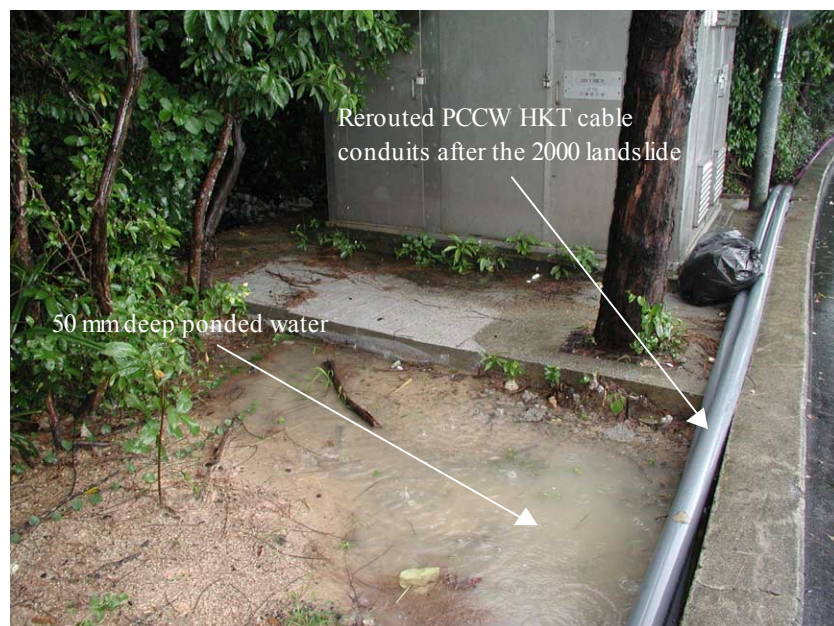
Adjacent to the electricity transformer pillar (see Section 2.6), on the western side of Shek O Road, is an almost flat area, approximately 3 m by 3 m in size, covered with recently deposited sand. The sand was angular and sharp and therefore probably construction debris. Pounded water, about 50 mm deep, was observed in this area on 24 August 2000 by FMSW and later by HCL on 20 October 2000 after a rainstorm (Plate 10).

Plate 10 - Ponding Water Adjacent to HEC Transformer Pillar (Photograph Taken on 20 October 2000)

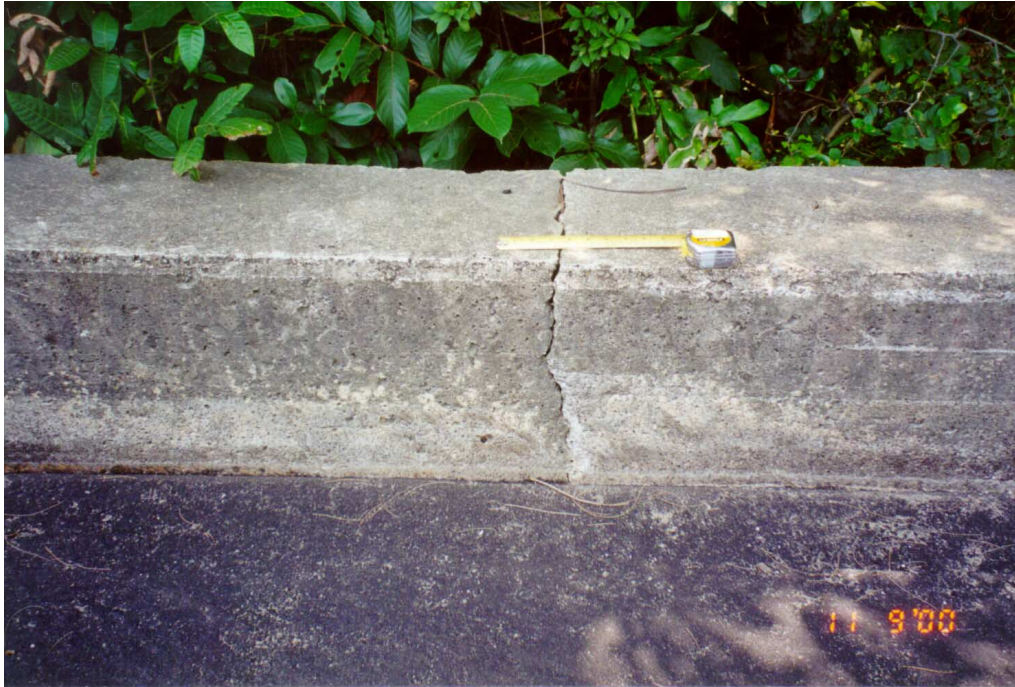
Cracks, up to 5 mm wide, were observed at intervals of between 6 m and 8 m in the concrete kerb on the western side of the road (Plate 11). Cracks up to 10 mm wide, with discoloured surfaces and recent concrete repairs to the transformer pillar foundation pad were also observed (Plate 12).

Plate 11 - View Showing the Crack on Kerb on the Northbound Lane of Shek O Road (Photograph Taken on 11 September 2000)

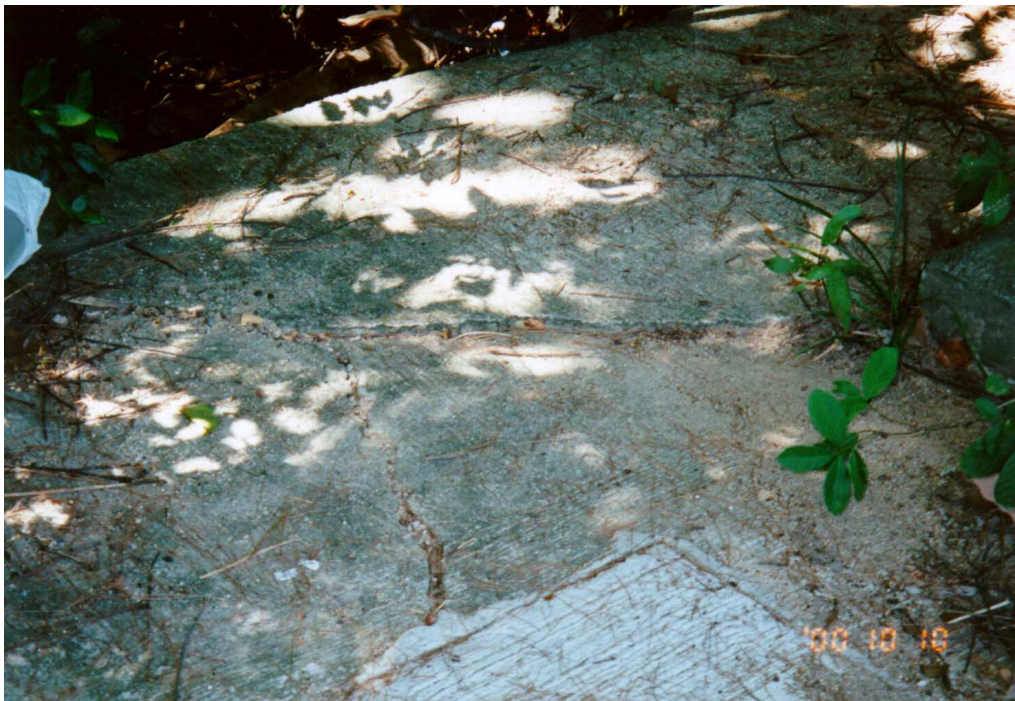
Plate 12 - The Cracks with Maximum Width of 10 mm on the Concrete Foundation Pad of HEC Transformer Pillar (Photograph Taken on 10 October 2000)

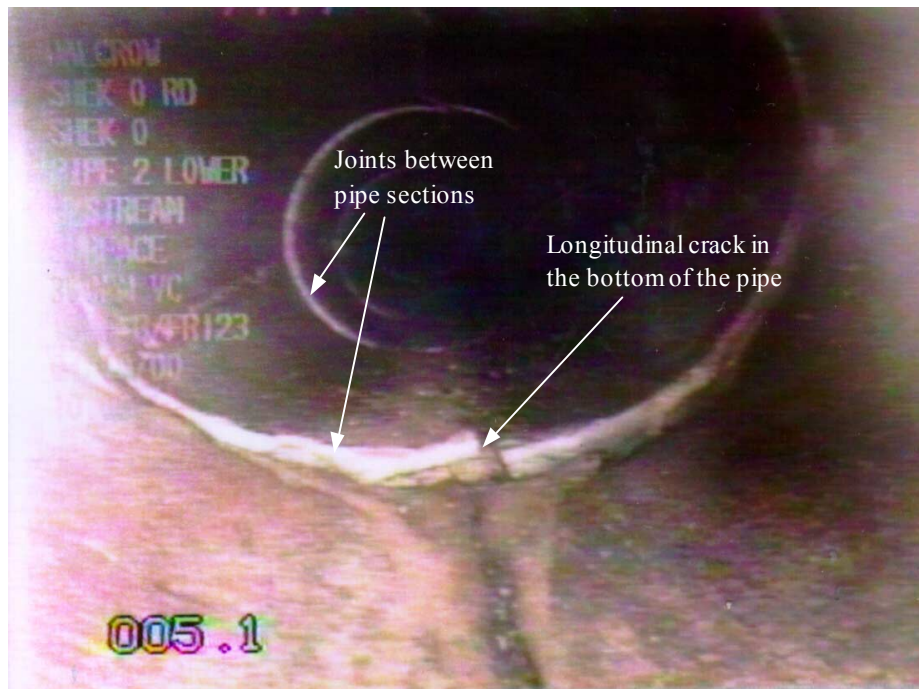
The survey revealed that the pipe was clear and comprised sections of approximately 0.7 m in length. Longitudinal cracks (Plate 13) of greater than 10 mm width were observed at the base of some pipe sections. Towards the end of the surveyed portion, the pipe was severely cracked and deformed (approximately ellipsoidal).

Plate 13 - Internal Condition of Lower 350 mm Diameter Vitrified Clay Drainage Pipe from CCTV Survey (Photograph Taken on 4 October 2000)

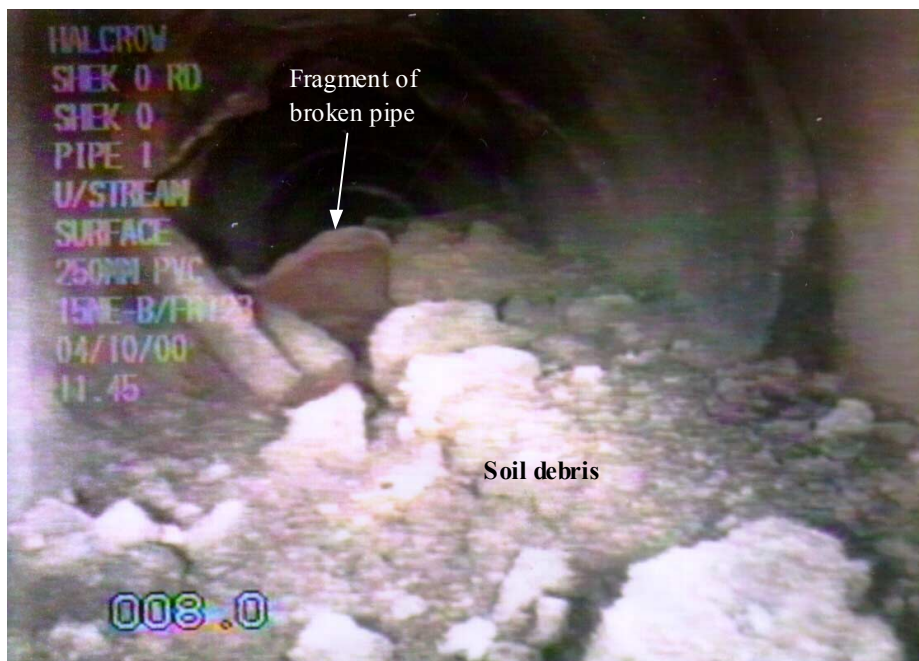
The upper pipe (approximately 2 m below Shek O Road, with an outlet level of 38.61 mPD) was surveyed to a total length of about 14 m. The first 6 m of the survey was within PVC pipe attached to the end of the old vitrified clay pipe as part of the urgent repair works for the 2000 landslide. The 300 mm internal diameter clay pipe section was severely cracked and much soil material was present in the pipe (Plate 14). The survey was terminated at about 14 m, at which point the pipe was blocked with soil and fragments of

broken clay pipe. The pipe appeared to have collapsed at that end, and it is unlikely to have been in working order prior to the August 2000 landslide.

Plate 14 - Internal Condition of Upper 350 mm Diameter Vitrified Clay Drainage Pipe Showing Soil Debris from CCTV Survey (Photograph Taken on 4 October 2000)
